# **Corrosion Behavior and Mechanical Properties of 30CrMnSiA High-Strength Steel under an Indoor Accelerated Harsh Marine Atmospheric Environment**

Abstract: In this work, the corrosion behavior and mechanical properties of 30CrMnSiA highstrength steel under a harsh marine atmosphere environment were systematically studied using accelerated test technology, along with corrosion kinetic analysis, microstructure and phase composition analysis, electrochemical measurements, and mechanical property tests. The influence of corrosion time on corrosion kinetics was characterized by the weight loss method. The corrosion layer and its product evolution were analyzed by SEM, EDS, XRD, and XPS. The corrosion behavior of steel was studied by a potentiodynamic polarization curve and EIS. Finally, the influence of corrosion on mechanical properties was studied by tensile and fatigue tests. The results show that 30CrMnSiA high strength steel has good corrosion resistance in a harsh marine atmosphere environment. Its corrosion behavior is cyclical: the outer rust layer exfoliated, the inner rust layer became the outer rust layer, and the matrix became inner rust due to the attack by the corrosiv

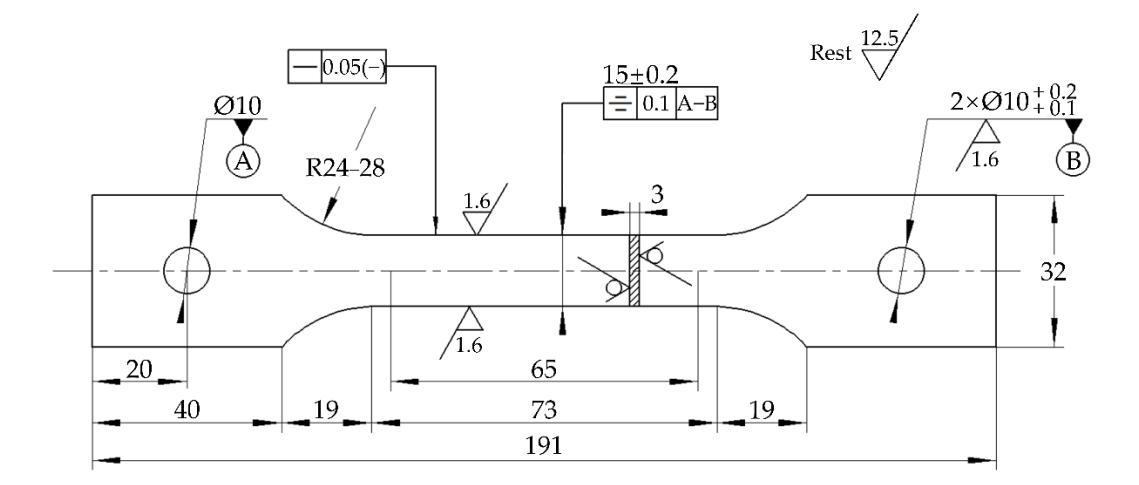
Figure 1. The dimensions of the tensile and fatigue specimens (unit: mm).

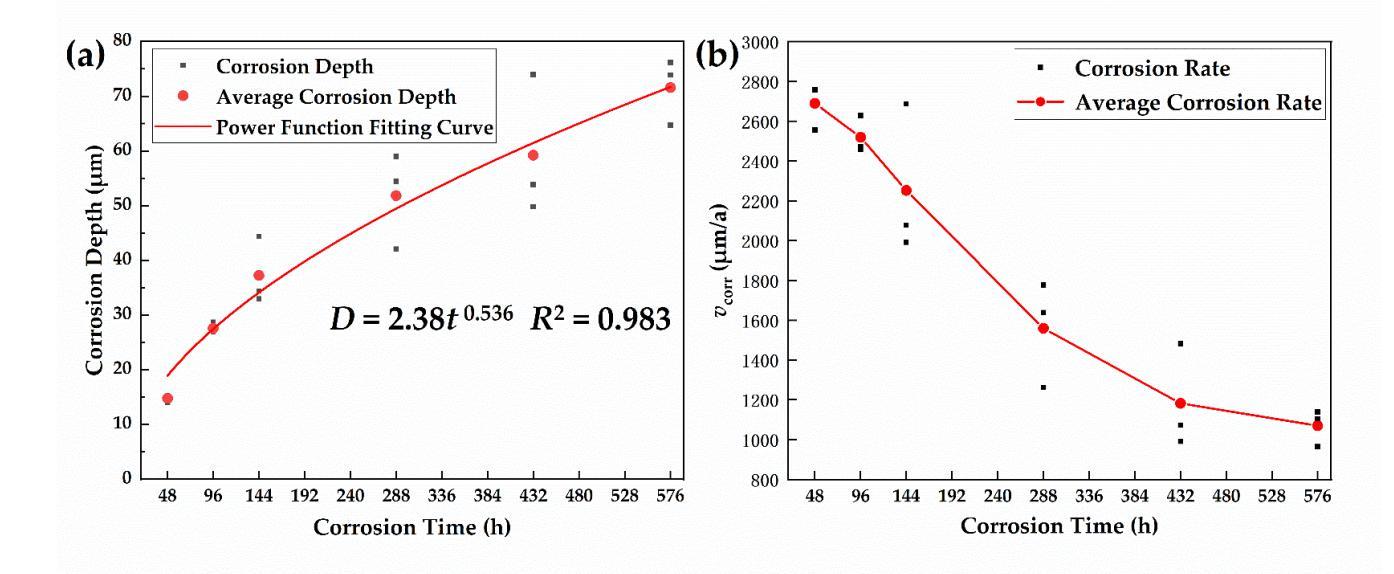
As shown in Figure 2a, the corrosion depth of the corrosion products was increased, whereas the increment was reduced with prolonged corrosion time. It is widely accepted that the atmospheric corrosion of steel conforms to the power function model of the following type:  $D = At^n$  [17]. The corrosion depth data in Figure 2a has been fitted with a power function model, and the fitting curve is shown as the red line. The regression model of the corrosion depth data of the 30CrMnSiA steel with corrosion time is as follows:

where D represents the corrosion depth of steel ( $\mu$ m), t is the corrosion time (h), and A and n are constants. The parameter A can be considered as a measure of the initial corrosion resistance of the steel, while *n* reflects the development trend of corrosion [28]. Generally, when n < 1, corrosion is decelerating, and the rust layer of the material is protective to the matrix [29]. In a previous study, the *n* values of the two steels (Q235 and Q450NQR1) exposed in a tropical marine zone of the Spratly Islands were both greater than 1, which means that both corrosion processes exhibit accelerated trends [30]. Meanwhile, the value of *n* is inversely proportional to corrosion resistance [8]. The corrosion resistance here can also be understood as the protective effect of the rust layer on the matrix. Wu et al. studied the synergy of Cu and Sb to enhance the resistance of 3%Ni weathering steel under a marine atmospheric environment. The results showed that the n value of the BM steel was close to 1 (0.964), suggesting an almost powerless resistance to corrosion, but after adding 0.5%Cu and 0.2%Sb in the steel, *n* changed to 0.687, which implies a significant improvement in the corrosion resistance after Cu and Sb addition [8]. In contrast, from the fitted data, n is 0.536, which means that the rust layer of 30CrMnSiA high-strength steel under a marine atmospheric environment has an obvious protective effect on the matrix.

The average corrosion rate decreased rapidly during the first 288 h and then gradually slowed down. From 2014 to 2018, our research group carried out 30CrMnSiA highstrength steel exposure tests at the Wanning Outdoor Exposure Test Station. Wanning is a typical marine atmospheric corrosive environment, and the environmental information is shown in Table 3. The results show that the average corrosion rates of steel in the natural marine atmosphere were 379.3548, 363.1173, and 314.809  $\mu$ m/a, respectively. The average corrosion rate was more than 1000  $\mu$ m/a during the whole process of the alternate immersion test, which proves that the test has a good acceleration effect and can simulate harsh marine atmosphere environments.

**Figure 2.** Corrosion Kinect analysis after a 576-h alternate immersion test: (**a**) calculated corrosion depth; (**b**) corrosion rate.

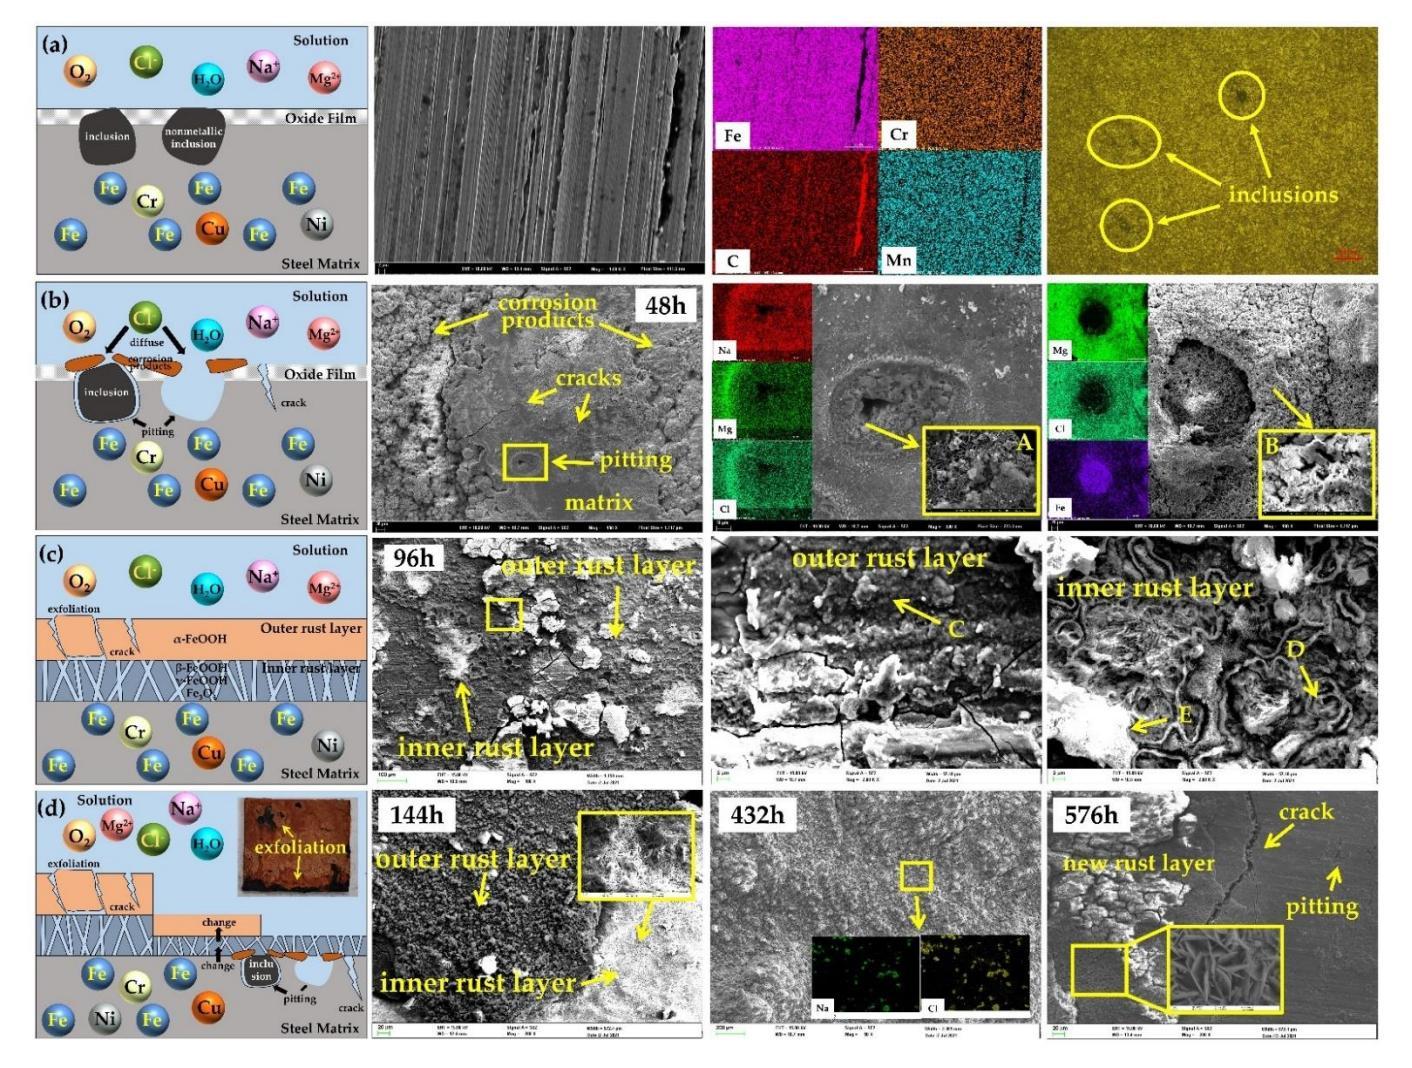
Combining the observation of surface microscopic morphology and EDS results, the corrosion behavior of the 30CrMnSiA high-strength steel under the indoor accelerated harsh marine atmosphere environment is shown in Figure 3.

Figure 3a shows that the surface of the uncorroded specimen was covered with parallel machining traces. It is easy to accumulate Cl- in the grooves of machining traces, which may lead to the occurrence of corrosion. The distribution of elements analysis on the surface by EDS revealed a large number of elongated and spot-like non-metallic inclusions. A metallographic examination of the blank specimen revealed substantial inclusions on the surface of the steel, where corrosion began [31]. It has been widely mentioned in previous studies that chloride ions can significantly affect the development of corrosion [32,33]. In marine atmospheric environments, thin liquid films rich in corrosive anions such as Cl<sup>-</sup> will form on the surface of steel, and Cl<sup>-</sup> will preferentially adsorb and accumulate at high energy positions such as inclusions. Cl- not only has electrical conductivity, but also can induce the pitting of passivated metals, promoting the development of pitting [34]. Generally, there are two kinds of inclusions in steel: anode inclusions and cathode inclusions. The corrosion mechanisms of steel that they cause are different [35,36]. The potential of anodic inclusions is more negative than the potential of the oxide film on the surface of steel. When a liquid film is produced on the surface, the inclusions will dissolve completely or partially, forming micro-cavities on the surface of steel. Therefore, cavitation can be seen in the pitting corrosion of the anode inclusion in SEM observation. Clwill then accumulate in the micro-cavity and form a closed acidified autocatalytic battery, which leads to the continuous growth of the micro-cavity and finally leads to pitting. Cathode inclusions are more stable in a corrosive environment due to their positive potential and appear as cathodes in the pitting process. At this time, pitting occurs between the inclusion and the steel matrix. In SEM observations, a gap can be seen in the steel matrix around the inclusion and gradually develops into pitting, accompanied by a large number of corrosion products attached to the pitting.

**Figure 3.** Corrosion behavior diagram with SEM and EDS analysis: (**a**) blank; (**b**) pitting; (**c**) exfoliation; (**d**) corrosion cycle.

As shown in Figure 3b, a large number of cracks appeared on the surface of the specimen after corrosion for 48 h, and corrosion products began to accumulate at the same time. The source of the cracks may be the stress caused by the corrosion products and the surface strength decline caused by the dissolution of grain boundaries on the steel surface. Two kinds of pitting can be observed on uncorroded metal matrices. Around the anodic pitting, there were some cigar-shaped crystals typical of akaganeite with fine plates of lepidocrocite ( $\gamma$ -FeOOH) with a "flowery" structure, marked as A [37]. EDS analysis shows that MgCl<sub>2</sub> and NaCl were enriched around the pitting. Liu et al. [38] studied the influence of different hard metals on the corrosion of carbon steel in a chloride ion atmospheric environment and found that Mg<sup>2+</sup> was greater than Na<sup>+</sup> and K<sup>+</sup> in terms of corrosion rate and corrosion current density, proving that Mg<sup>2+</sup> had a catalytic effect on the corrosion of steel. On the other hand, in an environment containing Mg<sup>2+</sup>, the relative content of akaganeite was higher, and the protection ability of the rust layer was inferior to an environment containing Na<sup>+</sup> and K<sup>+</sup>. Many corrosion products were found around the negative pitting, and a massive amount of chloride was deposited on the cotton ball akaganeite ( $\beta$ -FeOOH), marked as B [37], in the microscopic morphology. In marine atmospheres, due to the enrichment of Cl<sup>-</sup>, a special corrosion product, akaganeite, is produced on steel, which not only accelerates the corrosion rate but also reduces the protection ability of the rust layer [39–41]. EDS analysis showed that there are quantities of MgCl<sub>2</sub> deposited on the surface corrosion products, which is due to the low solubility and precipitation at the low critical relative humidity of MgCl<sub>2</sub>. A large number of pits and cracks on the surface of the specimen provided channels for corrosive media (H<sub>2</sub>O, O<sub>2</sub>, and Cl<sup>-</sup>) to pass through

from pitting to the uniform corrosion stage. After corrosion for 96 h, the rust layer on the specimen surface showed obvious stratification, as shown in Figure 3c. A large number of globular characteristics typical of goethite ( $\alpha$ -FeOOH), marked as C [37], existed in the outer rust layer. Plenty of cracks and even exfoliation occurred on the outer rust layer, where the exposed inner rust layer contained doughnut-shaped formations typical of magnetite (marked as D), spongy whitish formations typical of akaganeite (marked as E) [42], and fine plates of lepidocrocite. Goethite in the outer rust layer protected the steel matrix to some extent, and this protection disappears after exfoliation. Akaganeite in the inner rust layer has the strongest oxidation activity among these iron oxides, so it is easily reduced in the wetting stage to form amorphous intermediate products, thus accelerating the corrosion of steel [42]. The inner rust layer is exposed in the atmosphere due to the exfoliation of the outer rust layer, and its corrosion products provide a channel for the corrosive medium to pass through the rust layer and reach the steel matrix due to the characteristics of the structure.

Thus, the atmospheric corrosion of steel enters a cycle: Firstly, the surface of the matrix gradually becomes the inner rust layer due to the occurrence of corrosion. The inner rust layer then grows and becomes the outer rust layer. Finally, the outer rust layer falls off, exposing the inner rust layer to the corrosive environment and providing a channel for the corrosive medium to attack the matrix. As shown in Figure 3d, the macroscopic features of the surface of the specimens that corroded for 144, 288, 432, and 576 h were basically the same, and the outer rust layer showed exfoliation behavior. There were substantial chloride particles deposited on the surface of the rust layer, as shown by the microscopic morphology of the outer rust layer on the specimen that corroded for 432 h, which proves the protective effect of the outer rust layer on steel. At the same time, it can be seen that the outer rust layer of the specimen that corroded for 432 h is denser than that of the specimen that corroded for 96 h, but the area of exfoliation is also larger. In the microscopic morphology observation of the specimen after 144 h of corrosion, a large number of fine plates of lepidocrocite can be observed in the inner rust layer, indicating that the matrix in this region has been corroded for a period of time. With the continuous development of corrosion, this part of the inner rust layer will gradually become the outer rust layer. In addition, the inner rust layer with fine plates of lepidocrocite was observed in the microscopic morphology of the specimen that corroded 576 h after the exfoliation of the outer rust layer. After removing part of the inner rust layer, the matrix of the specimen could be observed, and there were some pits and cracks on the surface of the matrix. By studying the corrosion behavior of 30CrMnSiA high-strength steel under an indoor accelerated harsh marine atmospheric environment, it was demonstrated that, although the corrosion is uniform, corrosion occurs at different stages in the fine area of the exposed surface, which leads to specimen thinning due to the exfoliation of the outer rust layer. The surface of the matrix was also rugged due to pits and cracks. This had a fatal effect on the mechanical properties of the specimens, as will be explained in the following sections.

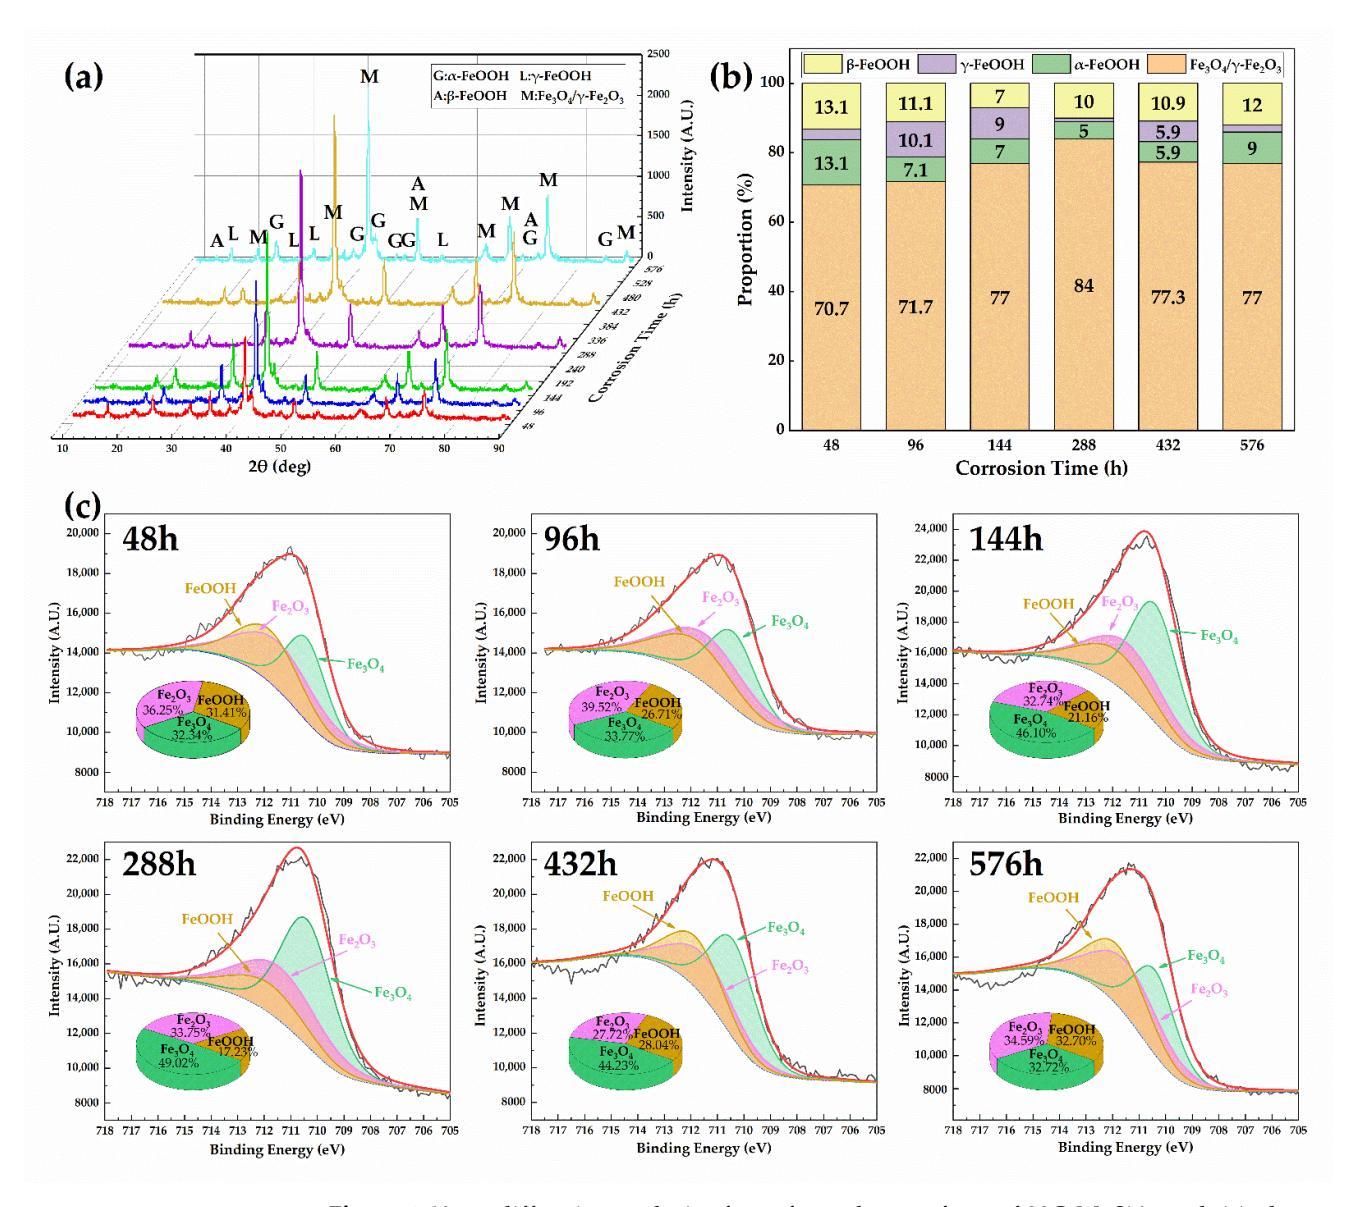
**Figure 4.** X-ray diffraction analysis of rust formed on surfaces of 30CrMnSiA steel: (**a**) phase compositions; (**b**) the relative proportion of each phase; (**c**) XPS spectra of Fe2p3/2 and the atomic percentage of each phase in the rust film for 48, 96, 144, 288, 432, and 576 h.

Figure 4a shows that the main composition of the rust layer of the 30CrMnSiA highstrength steel under an indoor accelerated harsh marine atmospheric environment is the same as that in an outdoor exposure test in a marine atmospheric environment, which is mainly Fe<sub>3</sub>O<sub>4</sub>/ $\gamma$ -Fe<sub>2</sub>O<sub>3</sub>,  $\alpha$ -FeOOH,  $\beta$ -FeOOH, and  $\gamma$ -FeOOH. Analyzing the strongest diffraction peak, the content of Fe<sub>3</sub>O<sub>4</sub>/ $\gamma$ -Fe<sub>2</sub>O<sub>3</sub> increased gradually with the occurrence of corrosion and stabilized after corrosion for 144 h.

Figure 4b shows the relative content of each phase in rust at different corrosion times. Since Fe<sub>3</sub>O<sub>4</sub> and  $\gamma$ -Fe<sub>2</sub>O<sub>3</sub> are difficult to distinguish by XRD, the total mass fraction of  $Fe_3O_4/\gamma$ -Fe\_2O\_3 is given [46]. The corrosion products contain more than 70% of relatively dense Fe<sub>3</sub>O<sub>4</sub> with a certain anionic selection ability and 5–13% of  $\alpha$ -FeOOH with a dense structure, which can slow down corrosion to a certain extent. This is the same as the result of microscopic morphology observation. Since the relative content of each product changes dynamically with the corrosion time, some scholars use the protective index PAI to evaluate the protective effect of the rust layer on the steel matrix [47]. The protective index *PAI* [48] is defined as the ratio of  $\alpha^*$  (the sum of the relative content of  $\alpha$ -FeOOH and Fe<sub>3</sub>O<sub>4</sub>/ $\gamma$ -Fe<sub>2</sub>O<sub>3</sub>) to  $\gamma^*$  (the sum of the relative content of  $\gamma$ -FeOOH and  $\beta$ -FeOOH), as shown in Equation 4. When this protective index of the rust layer is close to or over 2, the rust layer has good protective effects [30]. Figure 4b shows that the protective index PAI values of the 30CrMnSiA high-strength steel's rust layer were all above 4, indicating that the rust layer has a good protective effect on the steel matrix. Simultaneously, the  $\beta$ -FeOOH content was not low in the corrosion products at all stages of the test, which proves that Cl<sup>-</sup> in the marine atmosphere plays an important role in the corrosion of steel.

To further distinguish the content difference between Fe<sub>3</sub>O<sub>4</sub> and  $\gamma$ -Fe<sub>2</sub>O<sub>3</sub>, XPS technology was used to study the rust components. The XPS spectra of Fe<sub>2</sub>p<sub>3</sub>/2 in the rust layer are shown in Figure 4c. It can be seen that the spectrum of Fe<sub>2</sub>p<sub>3</sub>/2 contains three peaks at 710.4eV [49], 711.4eV [50], and 711.8eV [51], corresponding to Fe<sub>3</sub>O<sub>4</sub>,  $\gamma$ -Fe<sub>2</sub>O<sub>3</sub>, and FeOOH, respectively. The relative content of each phase was calculated by the area of the peak splitting curve, and the results are also shown in Figure 4c. With the increase in corrosion time, the content of Fe<sub>3</sub>O<sub>4</sub> gradually increased, the content of  $\gamma$ -Fe<sub>2</sub>O<sub>3</sub> basically remained unchanged, and the content of FeOOH gradually decreased. On one hand, the high content of Fe<sub>3</sub>O<sub>4</sub> made the corrosion products denser and prevented anions from attacking the steel matrix; on the other hand, the inhibition of the corrosion products on corrosion was gradually enhanced. This is all consistent with the previous results.

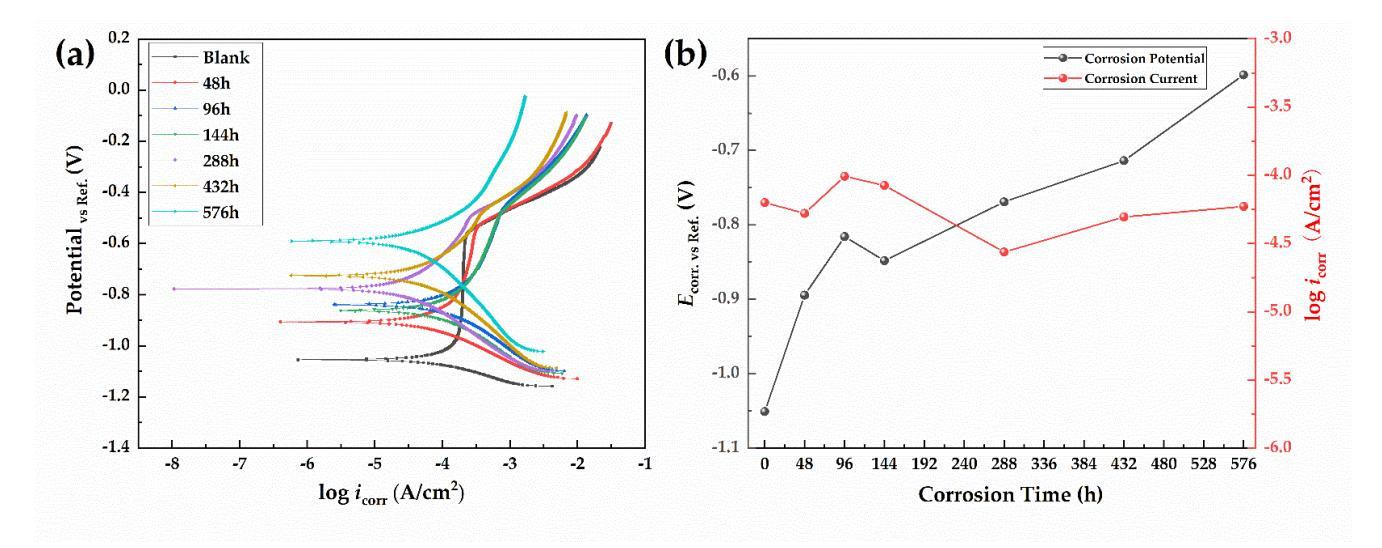
The potentiodynamic polarization curves of the 30CrMnSiA steel at different times are shown in Figure 5a. The corrosion potential ( $E_{corr}$ ) and the corrosion current density ( $i_{corr}$ ) was obtained from extrapolation of the Tafel curves, as shown in Figure 5b. Other parameters derived from Tafel curves are shown in Table 4.

With the increase in corrosion time, the corrosion potential gradually shifted to the positive direction, from -1.05 to -0.5983 V. This means that the corrosion products on the surface of the specimens inhibited the corrosion. In the early stage of the test, an obvious passivation zone and pitting potential were found in the anodic zone of the polarization curve. With the increase in corrosion time, the passivation area gradually disappeared. The corrosion changed from pitting to uniform corrosion. It is obvious that the corrosion current first rose and then declined. The corrosion current began to rise from 0 h and then reached the maximum value of 98.4011  $\mu$ A/cm<sup>2</sup> at 96 h. The corrosion current then began to decrease, reached a minimum value of 27.4536  $\mu$ A/cm<sup>2</sup> at 288 h, and then gradually

stabilized. The similar shapes of the polarization curves show that the corrosion mechanism of the steel did not change. The cathodic process was controlled by the charge transfer during the rust layer reduction reaction, and the anodic process was controlled by the iron dissolution reaction [40]. In the equipotential case, in the cathodic process, with the development of corrosion, its current presented an increasing trend, indicating that the rust layer involved in the reduction reaction was gradually increasing. In contrast, in the anodic process, its current showed a decreasing trend, indicating that the iron dissolution reaction was gradually reduced, which further explains the protection mechanism of the rust layer. A similar conclusion can be obtained from the gradually increasing  $\beta_a$ . Therefore, throughout the whole test process, the current in the cathode process gradually increased, while the current in the anode process gradually decreased, resulting in the fluctuation of the corrosion current of the corrosion system within 100  $\mu$ A. This indicates that the corrosion mechanism of the 30CrMnSiA high-strength steel did not change significantly in the test, and the positive shifting of the corrosion potential reflected the accumulation of the corrosion products and their influence on the whole corrosion system. The polarization curve analysis results also confirm the above results.

Figure 5. Potentiodynamic polarization curves (a) and corrosion potential (b) of 30CrMnSiA steel.

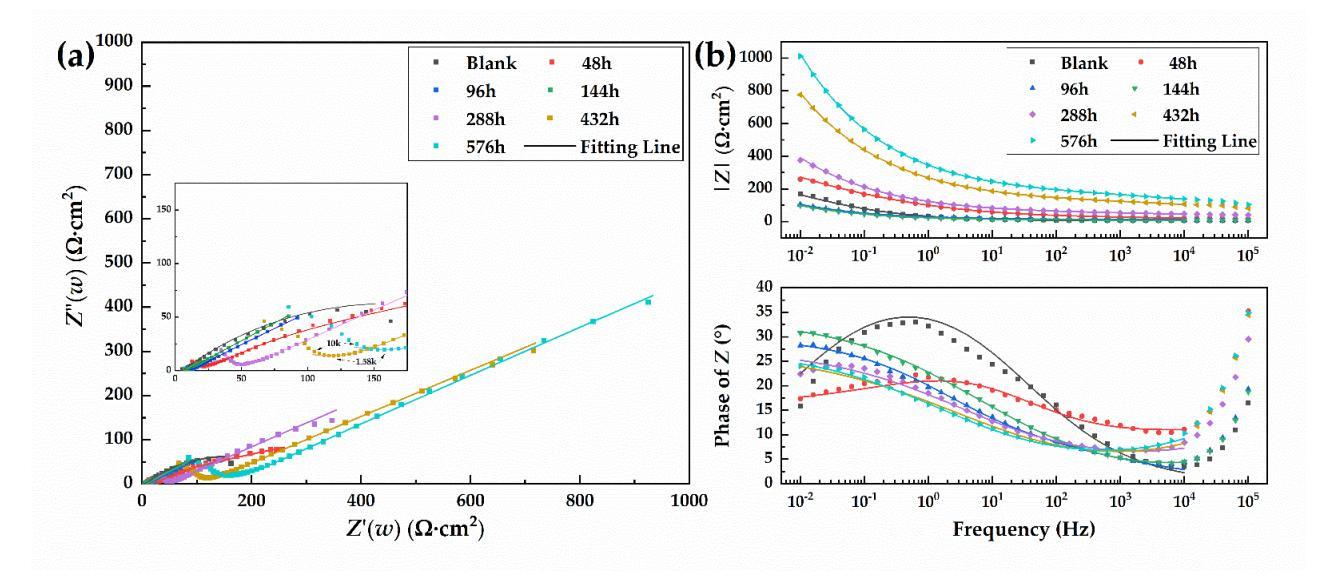
The EIS measurement results of the 30CrMnSiA steel under different corrosion times are shown in Figure 6. As the Nyquist plots show in Figure 6a, the electrochemical impedance curve of the blank specimen consists of a small capacitive loop at the intermediate frequency region, and a Warburg impedance at the low frequency region appeared on the electrochemical impedance curve at 48 h. Subsequently, as the corrosion products build up, the curve should contain two capacitance loops from the double capacitance layer and the rust layer at the intermediate frequency region, as well as a Warburg impedance in the low frequency region. The appearance of Warburg impedance indicates that the electrode process changes from the charge transfer process to the mass transfer process of corrosion products. In the Nyquist diagram, the high frequency region is related to the charge transfer process of the double electric layer, reflecting the inhibition effect of the rust layer on corrosion. The low frequency region is related to the diffusion process of electrolytes through the rust layer, reflecting the electrode process between the rust layer and the metal interface [53].

Figure 6. Nyquist plot (a) and Bode plot (b) of 30CrMnSiA steel for different corrosion periods.

The characteristic frequencies of capacitive loops and Warburg impedance are presented according to the Bode plots, as shown in Figure 6b. In the Bode diagram in Figure 6b, the |Z| of the low frequency region fluctuates around 200  $\Omega$ ·cm<sup>2</sup> in the first 144 h of corrosion, then increases with the increase in corrosion time and reaches a maximum value of 1000  $\Omega$ ·cm<sup>2</sup> after 576 h of corrosion. This phenomenon shows that, in the early stage of corrosion, the rust layer has little resistance to the penetration of the corrosive medium into the matrix. Simultaneously, the reduction in the value of |Z| could be ascribed to the formation of the rust layer, which may accelerate the electrochemical corrosion process on the matrix. However, with the development of corrosion, the rust layer becomes increasingly dense, and this resistance increases. In the Bode diagram, several peaks of the phase angle often represent several time constants caused by state variables in the impedance spectrum. The peak of the uncorroded specimen near 1 Hz gradually weakened and disappeared with the occurrence of corrosion, confirming the occurrence of pitting corrosion on the specimen surface and the disappearance of the passivation film. At the same time, a new peak was generated in the low frequency region, which represents the appearance of the rust layer protecting the matrix. This phenomenon illustrates the presence of the rust layer and the need to use different equivalent circuits to fit the EIS data.

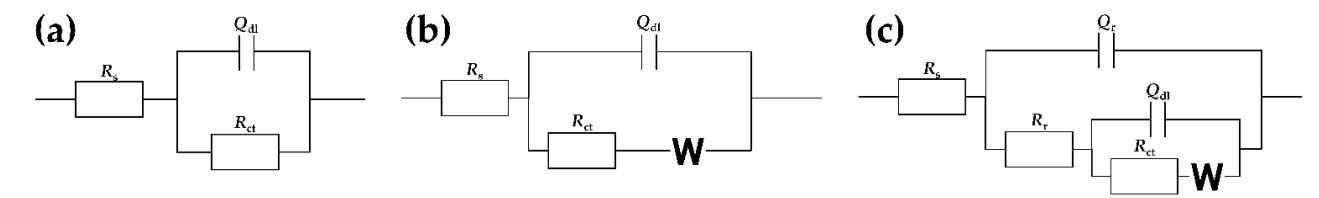
In order to determine the impedance parameters under different corrosion times, combined with the above analysis and relevant literature [34,38], the equivalent circuit as shown in Figure 7 was used to fit the data measured by EIS. The arc at very high frequency  $(10^4-10^5\text{Hz})$  is due to the reference electrode, so the data points in the  $10^4-10^5\text{Hz}$  range were deleted in the fitting process. The components are interpreted as follows:  $R_s$  is the solution resistance without compensation,  $R_r$  and  $Q_r$  are the pore solution resistance and capacitance of the rust film,  $Q_{dl}$  is the double-layer capacitance,  $R_{ct}$  is the charge transfer resistance, and W is the diffusion-induced Warburg element. Q is the constant phase element (CPE) used to represent the capacitance of the double-layer and rust layers. The diffusion-induced Warburg element is known as the finite-space diffusion Warburg impedance. It represents the transition from Warburg behavior ( $45^\circ$  line) to a capacitive behavior

in the low frequency range. All circuit parameters are used to describe the interface mechanism. The error ( $\chi^2$ ) of all the fitting results is between 10<sup>-3</sup> and 10<sup>-5</sup>, indicating that the equivalent circuit can fit the measurement data well. The results of the fitted data are shown in Table 5.

Figure 7. The equivalent electrical circuit for the EIS data: (a) blank; (b) 48 and 96 h; (c) 144, 288, 432, and 576 h.

Table 5 shows that the parameter  $R_{ct}$ , which is used to evaluate the difficulty of charge transfer, first decreased from 313.3 to 27.18  $\Omega \cdot cm^2$  and then increased to 427.7  $\Omega \cdot cm^2$  at 576 h. The value of  $R_{ct}$  on the blank specimen indicates that there is an oxide film on the surface of the uncorroded specimen. The phenomenon that  $R_{ct}$  decreases first indicates that the rupture of the oxide film and the protection of the rust layer on the matrix is weak in the early stage of corrosion development, which should be attributed to the promotion of the electrochemical corrosion process on the matrix by the corrosion products.  $R_{ct}$  then increases significantly with the increase in corrosion time, indicating that the charge transfer of the corrosion system becomes increasingly difficult with the development of corrosion, and corrosion was inhibited by the rust layer. At the same time, the  $R_r$  value also increased significantly from 4.754 to 153.5  $\Omega \cdot cm^2$ , indicating that it is more difficult for the corrosion medium to reach the metal matrix, and indicating the protection of the rust layer.

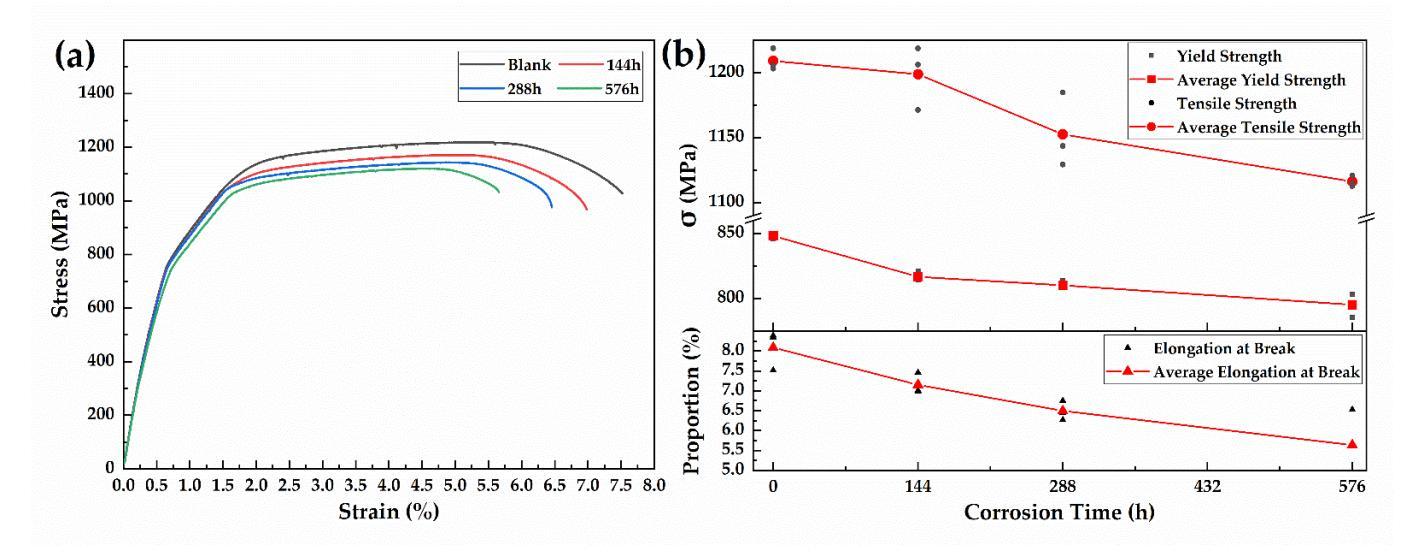
The tensile property degradation results of the 30CrMnSiA high-strength steel specimens after the 576 h alternate immersion test are shown in Figure 8. Figure 8a clearly shows that corrosion degrades the tensile properties of 30CrMnSiA high-strength steel. With the passage of corrosion, the tensile properties of the specimen deteriorated more seriously. Because 30CrMnSiA high-strength steel has no obvious yield plateau in the tensile test, the yield strength of the 30CrMnSiA high-strength steel is characterized by  $\sigma_{0.2}$ . The data in Figure 8b show that, under corrosion times of 144, 288, and 576 h, the yield strength of 30CrMnSiA high-strength steel decreased by 3.72%, 4.49%, and 6.25%, the tensile strength decreased by 0.86%, 4.68%, and 7.69%, and the elongation at break decreased by 11.57%, 19.68%, and 30.27%, respectively. Combined with the observations of the surface morphology analyses of the specimens, it can be seen that with the progress of the test, the rust layer on the surface accumulated and when it reached a certain thickness, exfoliation occurred. Exfoliation results in a significant decrease in the cross-section area of the working section of the specimens, and the original flat surface of the specimen becomes rugged, which results in a conspicuous decrease in the tensile properties of specimens after corrosion.

**Figure 8.** Stress–strain curve (**a**) and mechanical property parameters (**b**) of 30CrMnSiA steel after the 576-h alternate immersion test.

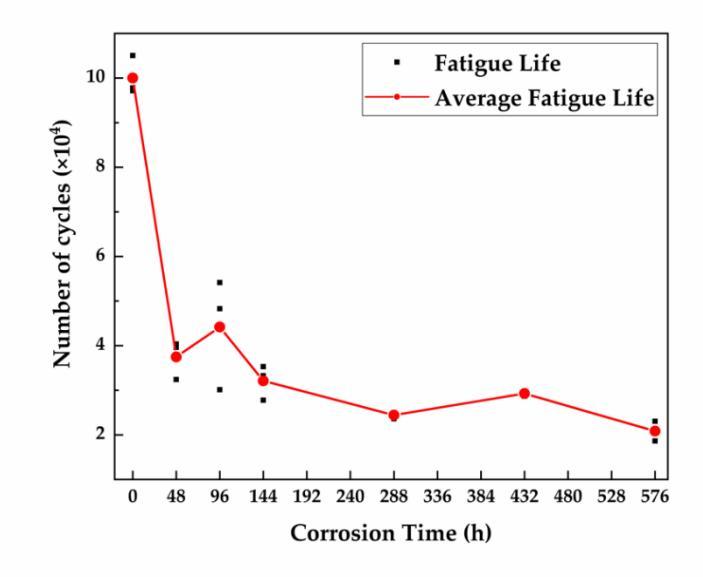
Figure 9 shows the fatigue life of specimens under different corrosion times. The results show that the fatigue life of specimens decreases rapidly after corrosion—by more than 50%. Studies show that corrosive environments will significantly reduce the fatigue resistance of steel and ultimately fail to reach the fatigue limit [54,55]. As is known, the process of fatigue fracture includes three stages, fatigue crack initiation, fatigue crack propagation, and final rupture, and the corrosion of steel has varying degrees of influence on these three stages.

Figure 9. Fatigue life of 30CrMnSiA steel after the 576-h alternate immersion test.

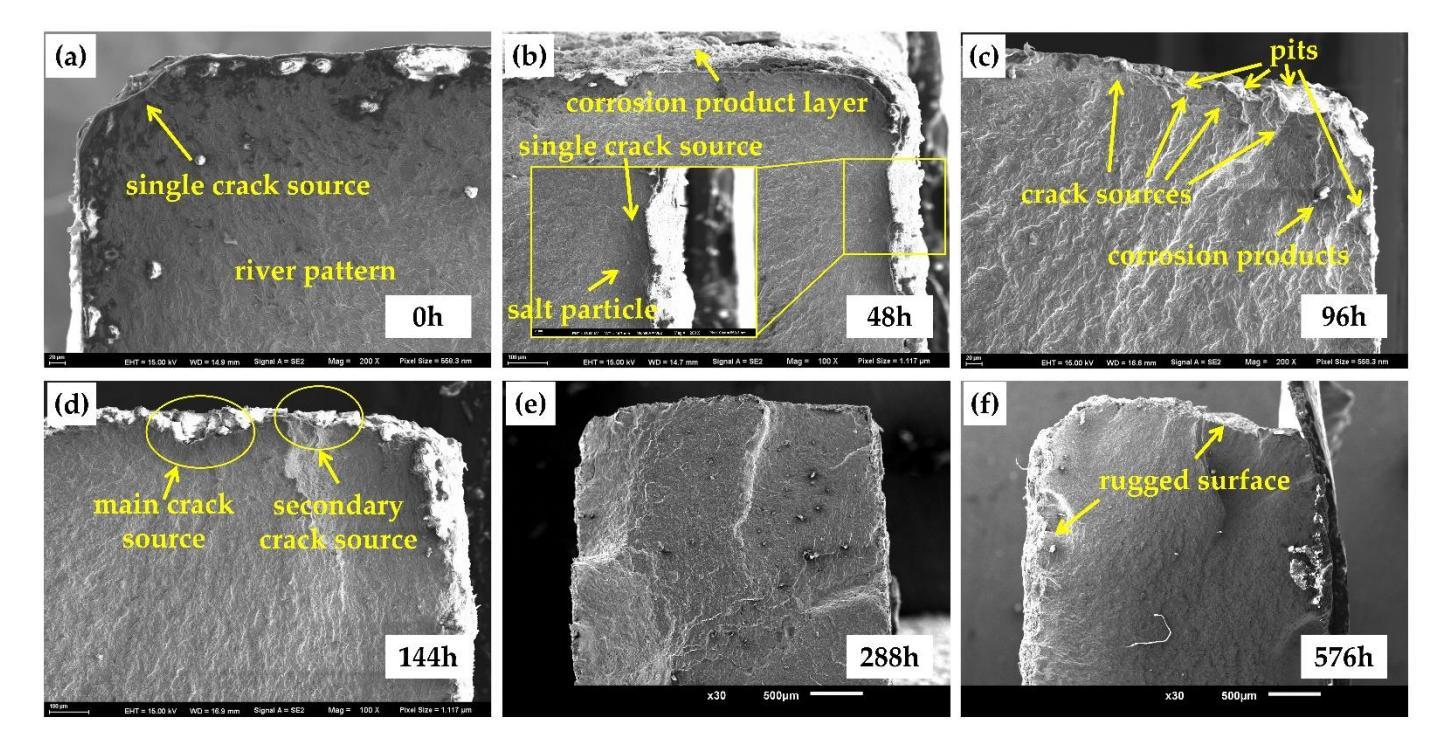
Figure 10 shows the microscopic morphology of the fatigue crack initiation region after different corrosion times. Figure 10a shows that the fatigue crack originated from the corner of the uncorroded specimen, and the crack source was single. Meanwhile, obvious river patterns were observed. After 48 h, a thin layer of corrosion products was observed on the surface of the specimen, and there were corrosion pits of different sizes and shapes. At this time, the fatigue cracks originated from a pit on the secondary surface of the specimen (the surface was the corroded product). The fatigue source area appeared semicircular, and some fine salt particles were observed. However, the fatigue crack source was still single at this time, which originated from the largest pit near the corner of the specimen, as shown in Figure 10b. After 96 h, this situation changed. Many corrosion pits helped crack initiation, and the single crack source became multiple crack sources. Converging diverging river patterns were observed, and corrosion products were also attached to the fatigue source region, as shown in Figure 10c. After 144 h, the specimen showed an exfoliation phenomenon, and the surface became rugged. In the fatigue source area, the intersection of a primary crack source from the deepest corrosion pit on the surface and a large number of secondary crack sources was observed, as shown in Figure 10d. With the further development of corrosion, because the specimen surface is more rugged, cracks no longer initiate from the corner of the specimen and may initiate from multiple corrosion points on the matrix surface, as shown in Figure 10e,f. This phenomenon makes it more difficult to judge the fatigue crack initiation region. As the initiation stage of fatigue cracks occupies the vast majority of the fatigue life of materials, and pitting has a substantial impact on the initiation of cracks [56,57], the occurrence of corrosion has a substantial impact on the fatigue life of materials, which is reflected in the test by the fact that the fatigue life of specimens was reduced by 50% as long as they were corroded.

**Figure 10.** The microscopic morphology of the fatigue crack initiation region: (**a**) blank; (**b**) 48 h; (**c**) 96 h; (**d**) 144 h; (**e**) 288 h; (**f**) 576 h.

To sum up, corrosion will act on the three stages of fatigue fracture and then lead to a serious decline in the fatigue life of steel. As shown in Figure 10f, Figure 11i, and Figure 12f, corrosion has a serious impact on all three stages of fatigue fracture. The results show that the fatigue life of specimens that has corroded for 576 h decreases by about 80%.

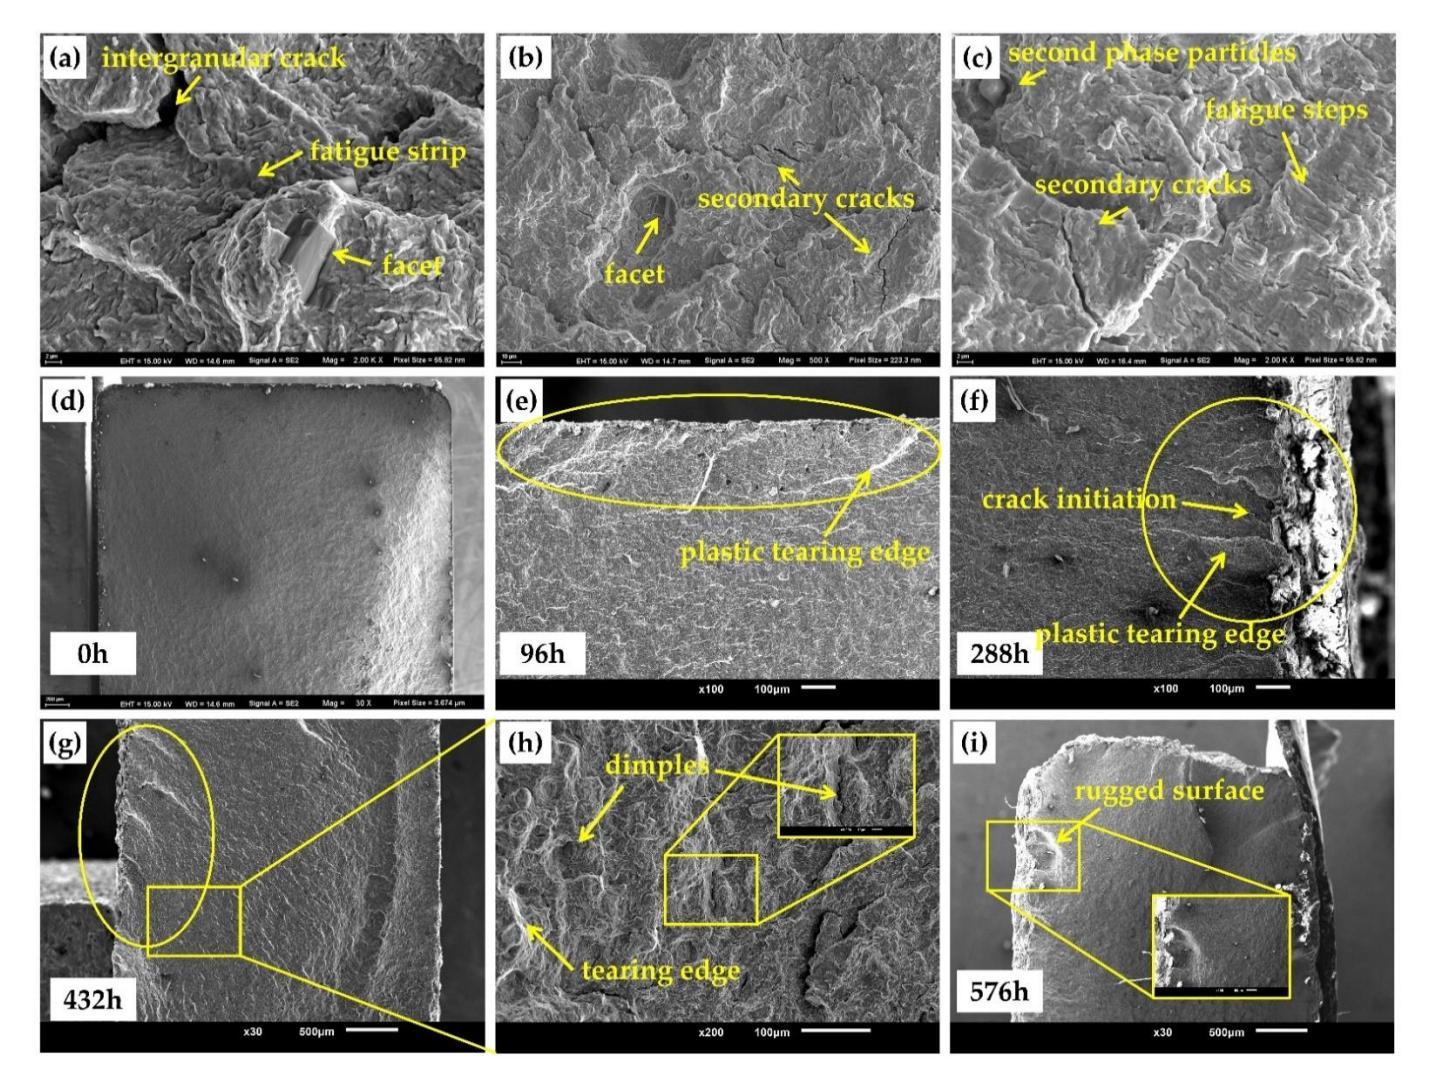
Figure 11 shows the microscopic morphology of the fatigue crack propagation region after different corrosion times. In the crack propagation region, the corrosion could not invade into the steel, so it had little influence on the micromorphological characteristics. As shown in Figure 11a,b,c, a large number of secondary cracks, intergranular cracks, fatigue steps, fatigue strips, and small facets can be observed in this area, which are the

common microscopic morphology characteristics of the crack propagation region of highstrength steel. However, corrosion still has a negative effect on the crack propagation stage, which comes from the interlace between the specimen surface and the crack growth region. Figure 11d shows that the surface of the uncorroded specimen was flat, and cracks started from the corner and gradually expanded. However, after corrosion, the surface of the specimen became rugged, and the corrosion pits were all over the crack propagation path. When the crack expanded to the vicinity of the corrosion pits, due to stress concentration or strength shortage, the direction of the crack growth shifted, which was shown by the characteristics of irregular steps and white plastic tearing edge in the SEM observations, as shown in Figure 11e. At the same time, under the action of fatigue load, some corrosion pits also generated small fatigue cracks, which coincided with the expansion path of the main crack, as shown in Figure 11f. As the corrosion deepened, the characteristics of the steps that can be observed become more obvious, and the height of the steps was also higher, as shown in Figure 11g. By further magnifying the step characteristics, it could be found that there were many dimples and tearing edge features in the vicinity, which can often be found in the instantaneous fracture regions of fatigue, as shown in Figure 11h. These phenomena indicated that corrosion can change the propagation speed and direction of fatigue cracks and then reduce the fatigue life of specimens.

**Figure 11.** The microscopic morphology of the fatigue crack propagation region: (**a**–**c**) micromorphological characteristics; (**d**) blank; (**e**) 96 h; (**f**) 288 h; (**g**) 432 h; (**h**) yellow box of (**g**); (**i**) 576 h.

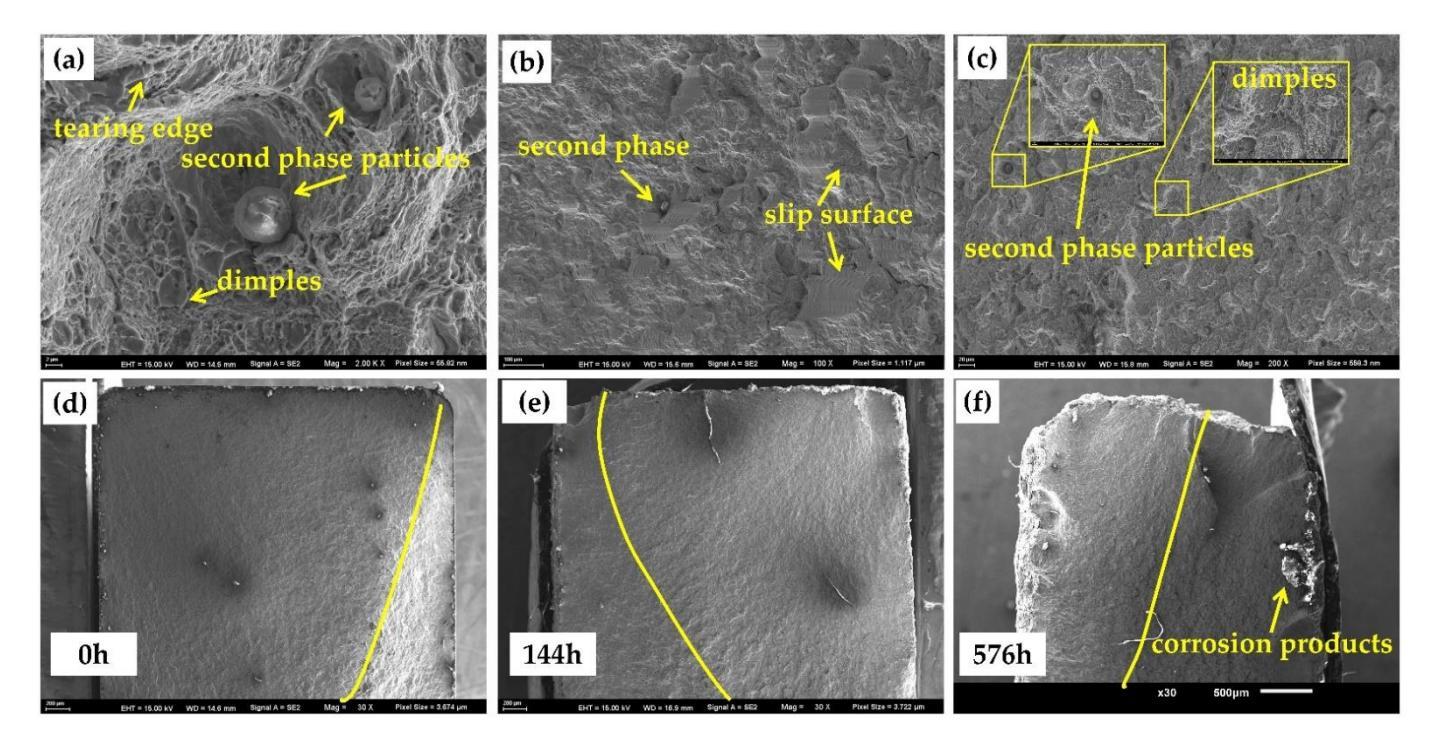
Figure 12 shows the microscopic morphology of the final rupture region after different corrosion times. For this region, a large number of tearing edges, dimples, slip surfaces, and second phase particles could be observed, as shown in Figure 12a–c. Because the corrosive medium cannot attack the internal structure of steel, the microscopic characteristics of the final rupture region were basically the same. However, due to the occurrence of corrosion, the surface of the specimen became rugged, and the cross-sectional area of the specimen decreased. Therefore, the contribution of corrosion to the final rupture region can be summed up in two aspects: On the one hand, due to the reduction in the specimen's sectional area, the ability to cope with the same load decreased, which manifested as the increase in the area of the final rupture region in the SEM observations, as shown in Figure 12d-f. The yellow line in the figure represents the boundary between the fatigue crack propagation region and the final rupture region by artificial observation. On the other hand, the rugged surface of the specimen led to stress concentration, which further reduced the static strength of the specimen. As shown in Figure 12f, serious corrosion was observed in the final rupture region, and a large number of corrosion products invaded the surface of the specimen. The results of this section are similar to the results of the stretch test.

**Figure 12.** The microscopic morphology of the final rupture region: (**a**–**c**) micromorphological characteristics; (**d**) blank; (**e**) 144 h; (**f**) 576 h.
