Article

Microstructural Features, Defects, and Corrosion Behaviour of 316L Stainless Steel Clads Deposited on Wrought Material by Powder- and Laser-Based Direct Energy Deposition with Relevance to Repair Applications

Reynier I. Revilla * D and Iris De Graeve

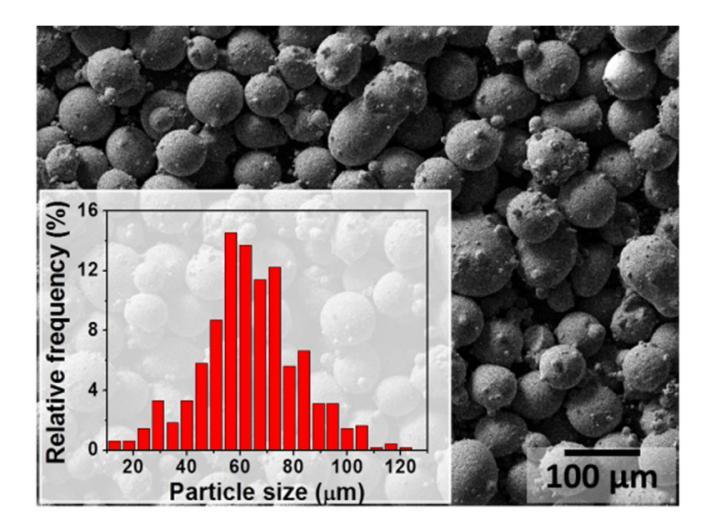
Figure 1. Secondary electron image of the 316L stainless steel powder used to print the samples together with the particle diameter distribution.

For this study, gas atomised 316L SS powder with an average particle diameter of $63 \,\mu\text{m}$ was utilised (see micrograph of the powder particles together with the particle size distribution in Figure 1). The nominal chemical composition of austenitic 316L SS is shown in Table 1. The samples were fabricated using an in-house hybrid laser metal deposition and high-speed milling machine (MiCLAD) of the Vrije Universiteit Brussel (VUB) [38]. During LMD, the laser beam melts the powder fed by a coaxial nozzle directly on the metallic substrate, forming a deposit that is fusion-bonded to the substrate. Several clads were printed on a 316L SS base plate by LMD using several sets of process parameters. The laser was focused on the surface of the wrought 316L SS substrate. The samples were fabricated using laser power ranging from 200 to 360 W, scanning speeds from 500 to 1200 mm/min, carrier gas flow rate of 2 to 5 NL/min, and argon as shielding gas with a flow rate of 1 to 2.5 NL/min. No post-heat treatment was applied on the samples. The workflow of the current study is schematically represented in Figure 2. Cross sections of the deposits were mechanically ground and polished, finishing with 0.04 µm standard colloidal silica suspension (OP–S). The microstructures of the samples were characterised by means of field-emission scanning electron microscopy (FE-SEM) combined with energy dispersive X-ray spectroscopy (EDX). A FE–SEM JEOL JSM–7100F was used, operating at 15 kV acceleration voltage, 5 pA probe current, and a working distance of 10 mm. To highlight the microstructural features, some samples were etched in Glyceregia reagent (15 mL glycerol, 15 mL HCl, and 5 mL HNO₃). Corrosion tests were carried out by immersing the samples for 1 week in 3.5 wt.% NaCl or in 3.5 wt.% NaCl with pH adjusted to 2. The corrosion morphology was then analysed by FE–SEM.

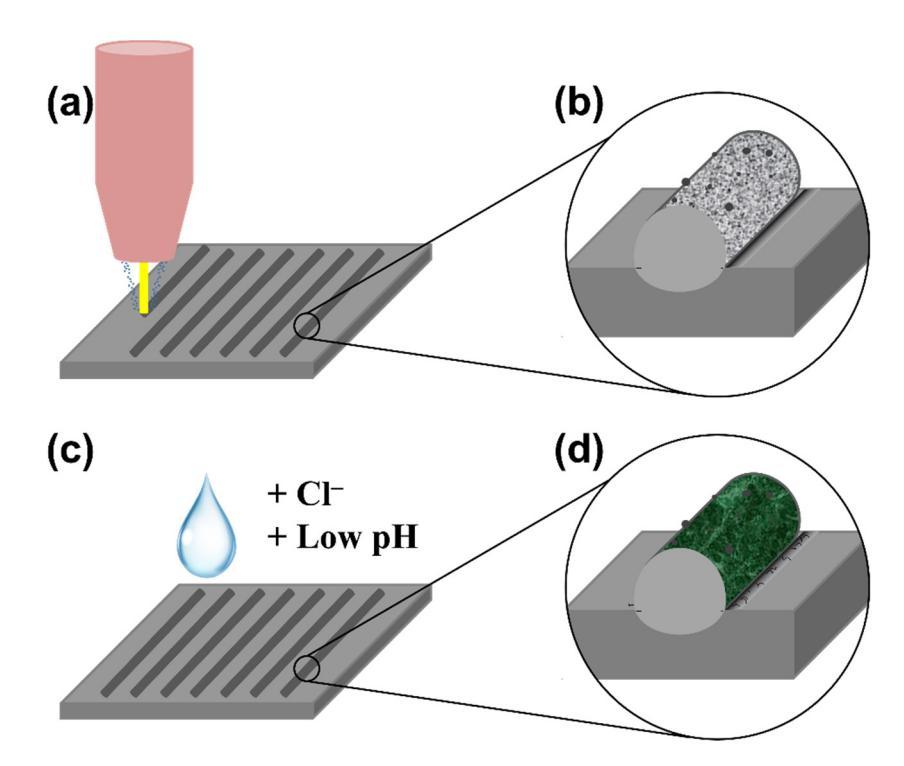
Figure 2. Schematic representing the workflow of the current study (from step a to d). (a) Printing of several 316L SS clads by LMD on wrought 316L base plate. (b) Analysis of microstructural features and defects. (c) Exposure of the samples to corrosive electrolyte (containing Cl⁻ and Cl⁻ + low pH). (d) Corrosion morphology analysis to determine the role of the different defects and microstructural features.

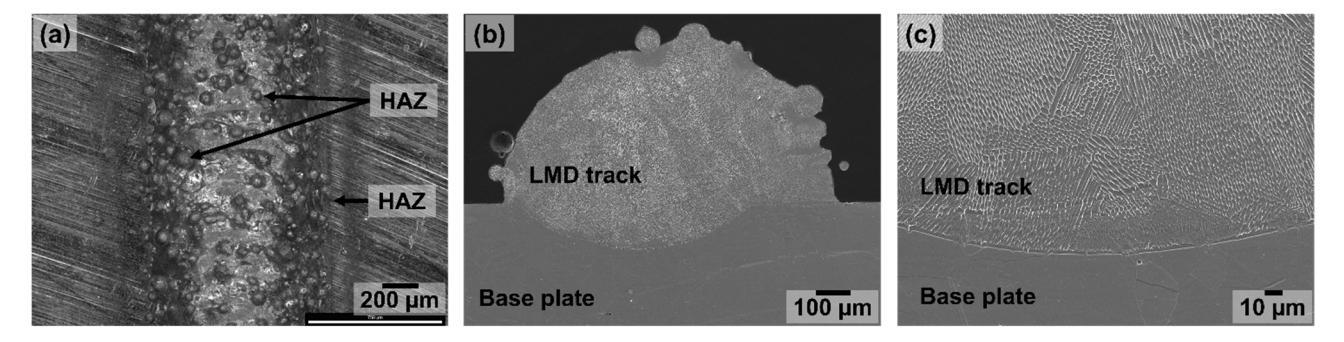
Figure 3. (a) Optical image of the top view of a typical printed clad in which partially un-melted powder particles and the heat-affected zone (HAZ) can be seen. Secondary electron images of (b) the cross section of a typical printed clad, and (c) high resolution image of a region around the interface between the printed clad and the base plate.

Figure 3a,b show representative images of the top view and the cross-section of a typical printed clad, respectively. Features such as partially un-melted metal powder particles on the surface of the clads and heat-affected zones parallel to the printed clads (on the base plate) could be easily identified on all the samples independently of the set of process parameters used. Even though the specific combination of process parameters influenced variables such as the density of partially un-melted powder particles per surface area, the same type of features and defects were present in all the printed clads. The specific relation between the manufacturing parameters and the microstructure and morphology of the clads will be discussed in a future work. The study presented in this work focused on identifying the different types of defects that can exist when depositing 316L SS on a wrought plate by LMD and their role in the corrosion of these systems (LMD-deposited clads on wrought 316L SS).

Figure 3b,c show the microstructure of the LMD-prepared clads. In these figures, the deposited clad and the base plate can be observed. A well-defined interface between the LMD-prepared clad and the conventional 316L SS base plate can be seen in Figure 3c. While the base plate presents polygonal-shaped austenitic grains (distinctive of wrought 316L SS), a sub-granular network of cells with etch-resistant borders can be seen in the LMD part. This special, sub-granular structure has already been described in several studies [2–10]. These cells, elongated in the direction of the thermal gradients, are characteristic of L-PBF-prepared 316L SS, as well as LMD-prepared specimens [10]. The borders of these cells were shown in earlier works to be enriched in alloying elements Cr, Ni, Mo, Mn, and Si [10]. Previous studies have shown that the formation of this sub-granular cellular network seems to play an important role in the increased pitting corrosion resistance of these additively manufactured materials compared to the conventional alloy [10,26–28]. The average cell diameter calculated for these printed clads ranged from 1.6 to 3.9 μm.

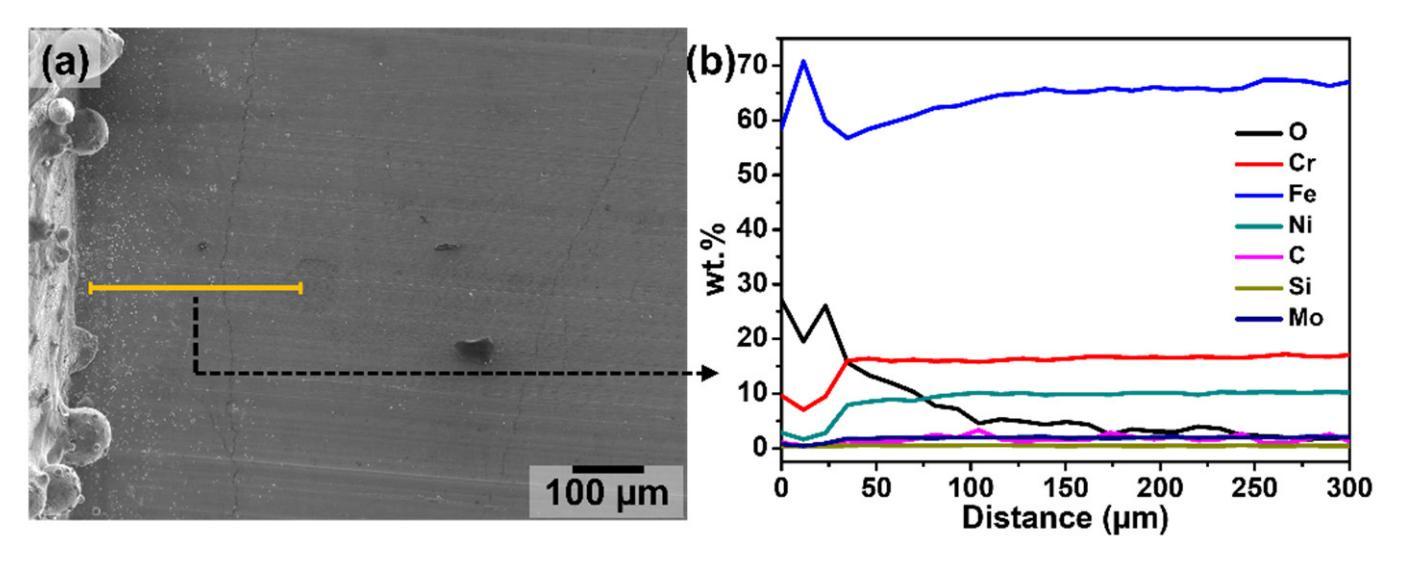
Figure 4. (a) Secondary electron image of a region around the HAZ, and (b) energy dispersive X-ray (EDX) composition analysis of a line scanned across the HAZ.

The heat-affected zones on the base plate in the vicinity of the printed clads were analysed by EDX. Figure 4 shows a representative example of an elemental analysis of a line scanned across the HAZ. These HAZ regions were characterised by a large depletion of Cr (7–13 wt.%), Ni (2–6 wt.%), and Mo (0.4–0.9 wt.%). The amount of Si was also slightly lower in these regions compared to the rest of the base plate. Cr and Mo are known to play a very important role in the corrosion resistance of stainless steels. A decrease in Cr and Mo denotes a decrease in the pitting resistance equivalent number (PREN = $1 \times %$ Cr + $3.3 \times %$ Mo + $16 \times %$ N [39]). The value of PREN calculated in the wrought base plate

decreased from approximately 22.8 to values around 8 to 12 in the region adjacent to the printed clads (within 30 to 40 μ m from the clads). The depletion of alloying elements in the HAZ is a known issue from welding applications and has been discussed in earlier studies [40,41].

The specific elemental composition within the HAZ varied along each deposited clad. However, in general, a depletion of Cr, Ni, Mo, and Si in these zones was always detected for all the printed clads. Since variations in the exact chemical composition of the HAZ were even seen along one single clad, no relationship could be established between the specific set of process parameters and the elemental composition of the HAZ. Nevertheless, the width of the HAZ was observed to depend on the specific set of process parameters, as also shown in previous works [32,42,43]. The greater the energy input into the material, the more extended the HAZ would be.

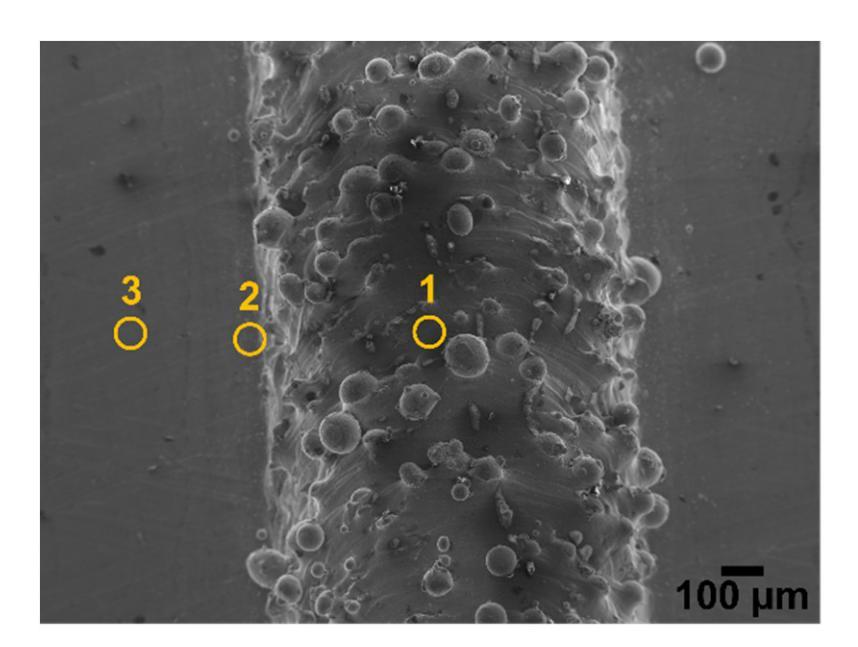
Figure 5. Secondary electron image of the top view of a printed clad in which three regions are marked from where EDX analysis was conducted: (region 1) on the top of the printed clad, (region 2) in the close vicinity of the printed clad at the HAZ, and (region 3) on the base plate relatively far from the printed clad.

Aside from the large depletion of alloying elements, these HAZ regions were characterised by an elevated content of oxygen (between 20 and 30 wt.%), marking a high level of oxidation in the areas next to the deposited clads. An EDX analysis on the top surface of the specimens also revealed a high level of oxidation on the surface of the LMD-deposited clads (from 10 to 25 wt.%). However, in general, in a single clad a higher content of oxygen was always measured on the HAZ compared to the surface of the clad. Figure 5 presents the top view of a printed clad, showing three representative zones where EDX spectra were acquired. The measured chemical composition of the zones highlighted in Figure 5 are shown in Table 2. As can be seen in these representative examples (Figure 5 and Table 2), the surface of the clads is highly oxidised, however, an even higher oxygen content was measured on the HAZ. On the other hand, a very low oxygen content was measured on the base plate relatively far from the printed clad, a content that is typical of surface native oxides. These high levels of oxygen on the clads and in their close vicinity are thermally driven oxides. Even though argon was used as shielding gas, this is only located around the stream of powder ejected from the nozzle, as seen in the schematic of Figure 6. The portions of the printed clads that are left behind by the moving nozzle during manufacturing and their surroundings are exposed to ambient air while still being at elevated temperatures, promoting thermal oxidation. The relatively higher content of oxygen in the HAZ compared to the surface of the clads can be due to the fact that the HAZ is not reached by the stream of shielding argon gas (Figure 6), being exposed to air at all times during the printing. On the other hand, the surface of the clads are temporarily protected by shielding Ar gas and left behind by the moving nozzle only after some cooling has already occurred, being exposed to air at relatively lower temperatures than the HAZ region.

Table 2. Elemental composition calculated from the EDX spectra acquired in the regions highlighted in Figure 5.

Fe	0	Cr	Ni	Мо	Si	Mn	S
Spectrum 1	53.9	15.6	16.3	10.2	2.5	0.5	1	_
Spectrum 2	57.1	21.2	13.6	5.3	0.9	0.3	1.4	0.1
Spectrum 3	68.2	1.3	16.6	10.0	2.0	0.5	1.5	-

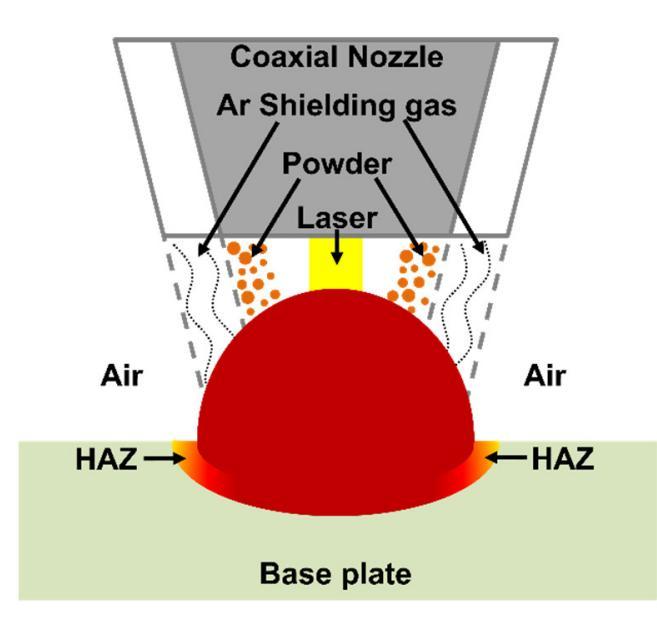
Figure 6. Schematic representation of the coaxial nozzle system with laser and powder flow being surrounded by Ar shielding gas. Portions of the printed clads that are left behind by the moving nozzle during manufacturing and the vicinity of the clads (for instance the HAZ region) are exposed to ambient air while still at elevated temperatures.

The high content of thermal oxides formed during the DED manufacturing process on the HAZ and on the surface of the printed clads can be the source of the high amount of oxide inclusions often found in multi-layered DED 316L SS [10,30,44,45]. While no inclusions could be found on the deposited single clads analysed, this was not the case when several layers of the material were deposited by DED. Figure 7 shows micrographs of regions in DED printed parts made up of several layers in which numerous manganese silicate inclusions can be observed (as measured with EDX analysis). The schematic of Figure 8 graphically represents the formation of oxide inclusions from the thermal oxides formed on the HAZ and on the surface of the printed clads when multiple overlapping clads are deposited by DED. These oxide inclusions can greatly affect the corrosion performance of the manufactured parts by negatively influencing the passivity of the native oxide layer. However, this is out of the scope of this work since the present study is dedicated to the characterisation and corrosion performance of single clads (the simplest system relevant for repair applications), in which these oxide inclusions could not be found. The investigation of the effect of inclusions on the corrosion behaviour of DED printed parts will be the topic of a future study.

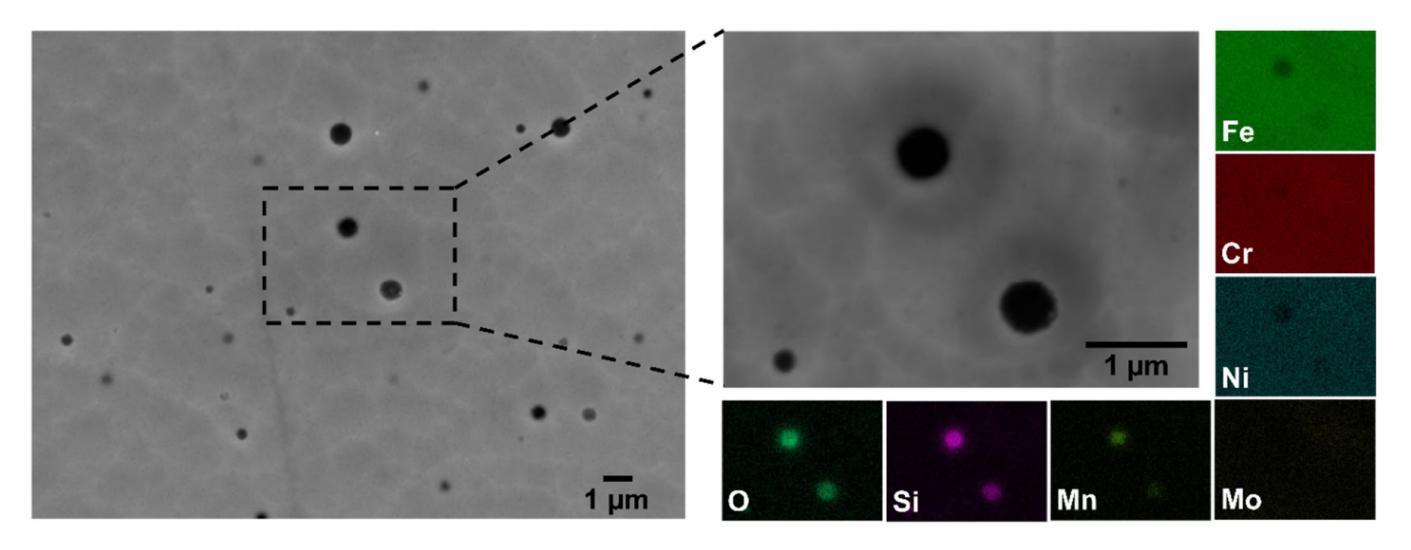
Figure 7. Secondary electron micrographs of regions in DED printed parts made up of several layers in which numerous manganese silicate inclusions can be observed (as measured with EDX analysis). The samples were fabricated with an overlapping of the clads of about 20%.

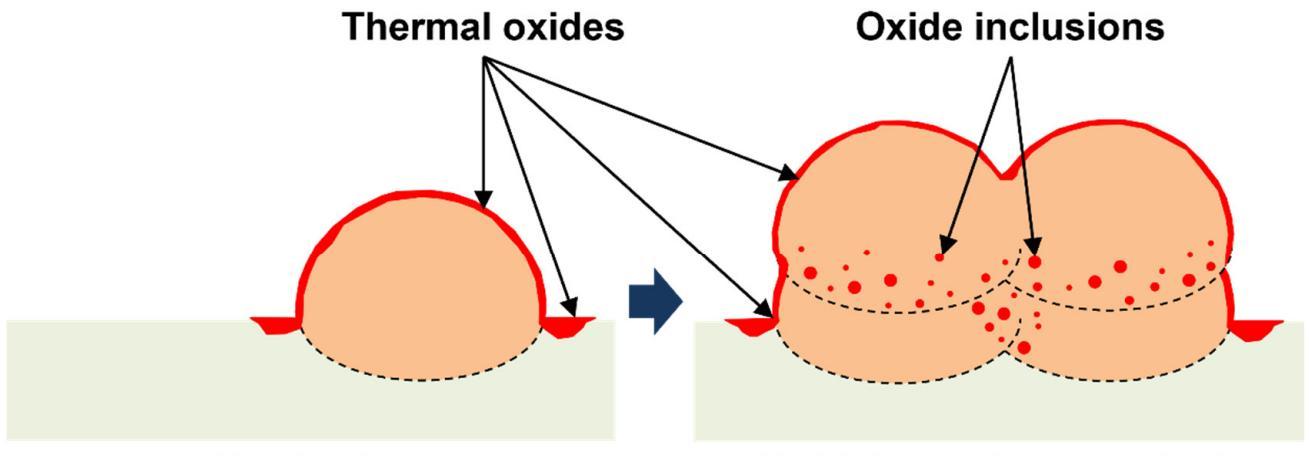
Single clad

Multiple overlapping clads

Figure 8. Schematic representing the formation of oxide inclusions from the thermal oxides formed on the HAZ and on the surface of the printed clads when multiple overlapping clads are deposited by DED.

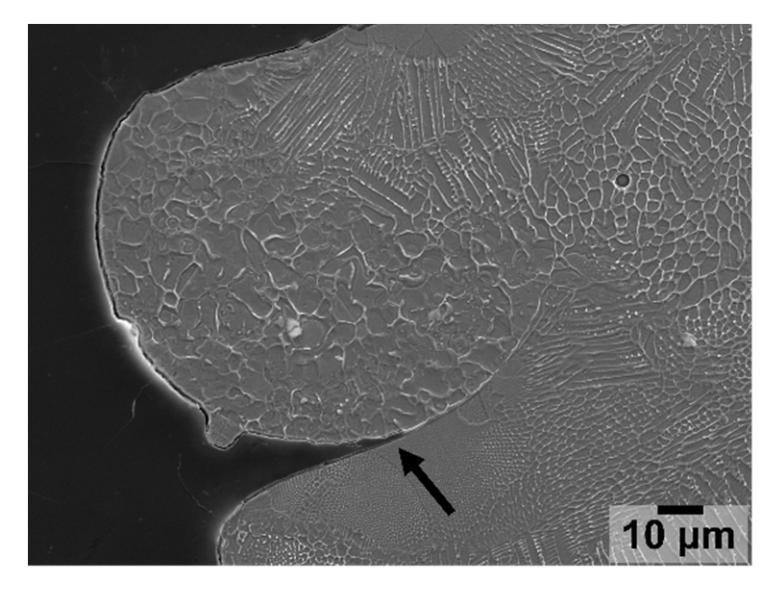
Figure 9. Secondary electron image of a partially un-melted powder particle at the top of the deposited clad.

Partially un-melted powder particles were observed randomly distributed across the surface of the printed clads. Different degrees of fusion between these particles and the deposited clads were observed. While some particles were almost fully fused on the printed clad, others were only fused in part, also presenting regions in which a gap could be identified between the particle and the surface of the clad (see Figure 9). Particles presenting a gap with the LMD-deposited material, such as that represented in Figure 9, were mainly observed on the lateral sides of the clads, and to a much lesser extent on the top surface of the clads. These gaps between the partially un-melted powder particles and the deposited material are of special interest during the analysis of the corrosion behaviour of these samples since these locations are potential hot spots for corrosion initiation in the form of crevice corrosion.

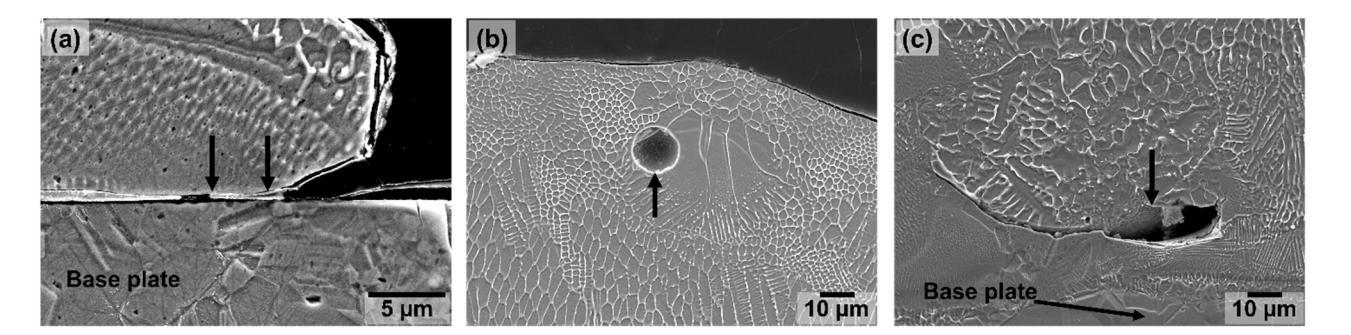
Figure 10. Secondary electron image of (**a**) a region at the border of a deposited clad showing a gap due to insufficient fusion between the deposited clad and the base plate, (**b**) a region in the cross section of the printed clad in which a gas pore is visible, and (**c**) a region around the interface between the printed clad and the base plate in which a lack-of-fusion pore can be seen.

Alongside some gaps between un-melted powder particles and the printed clads, other voids and pores could also be identified during the analysis of the cross sections of the samples (see Figure 10). These voids and pores were seen distributed in a seemingly random fashion on all the samples analysed, independently of the process parameters. One type of void observed was occasional gaps between some regions at the border of the clad and the base plate (see Figure 10a). These gaps are caused by insufficient fusion between the deposited clad and the base plate. They were seen in cross sections of clads prepared with a relatively low energy density, as well as in clads deposited with a relatively high energy density (laser energy input into the material). Therefore, no clear link could be established between the processing condition and the formation of these defects for the range of process parameters analysed. As discussed for the case of gaps between partially un-melted powder particles and the surface of the printed clads, these gaps are also regions of interest since corrosion could potentially initiate there in the form of crevice corrosion due to the direct access of the environment and corrosive media to these voids.

Pores within the deposited material were also observed during the analysis of the cross sections. These pores could be divided into two types as seen in Figure 10b,c. The first type is relatively small (typically bellow 10–20 μ m in diameter) with an approximately spherical shape (Figure 10b). These are trapped-gas pores resulting from gas trapped during the metal deposition or from gas previously trapped within the powder particles during gas atomisation. The second type of pores were found at the interface between the deposited clad and the base plate (Figure 10c). These pores were larger in size than the gas pores and had an irregular shape. These are lack-of-fusion pores, which are the result of insufficient fusion between the deposited metal powder and the base material. These types of defects, extensively described in the literature, will play no role in the corrosion performance of these samples during simple exposure of the system to a corrosive media since they are positioned in the interior of the material. Nevertheless, they might play a role in the susceptibility of the printed parts to corrosion fatigue and stress corrosion cracking. However, these issues are out of the scope of this study. In any case, it is important to highlight that the samples analysed presented almost no porosity, and the images portrayed in Figure 10b,c are some of the very few micrographs analysed in which porosity was observed.

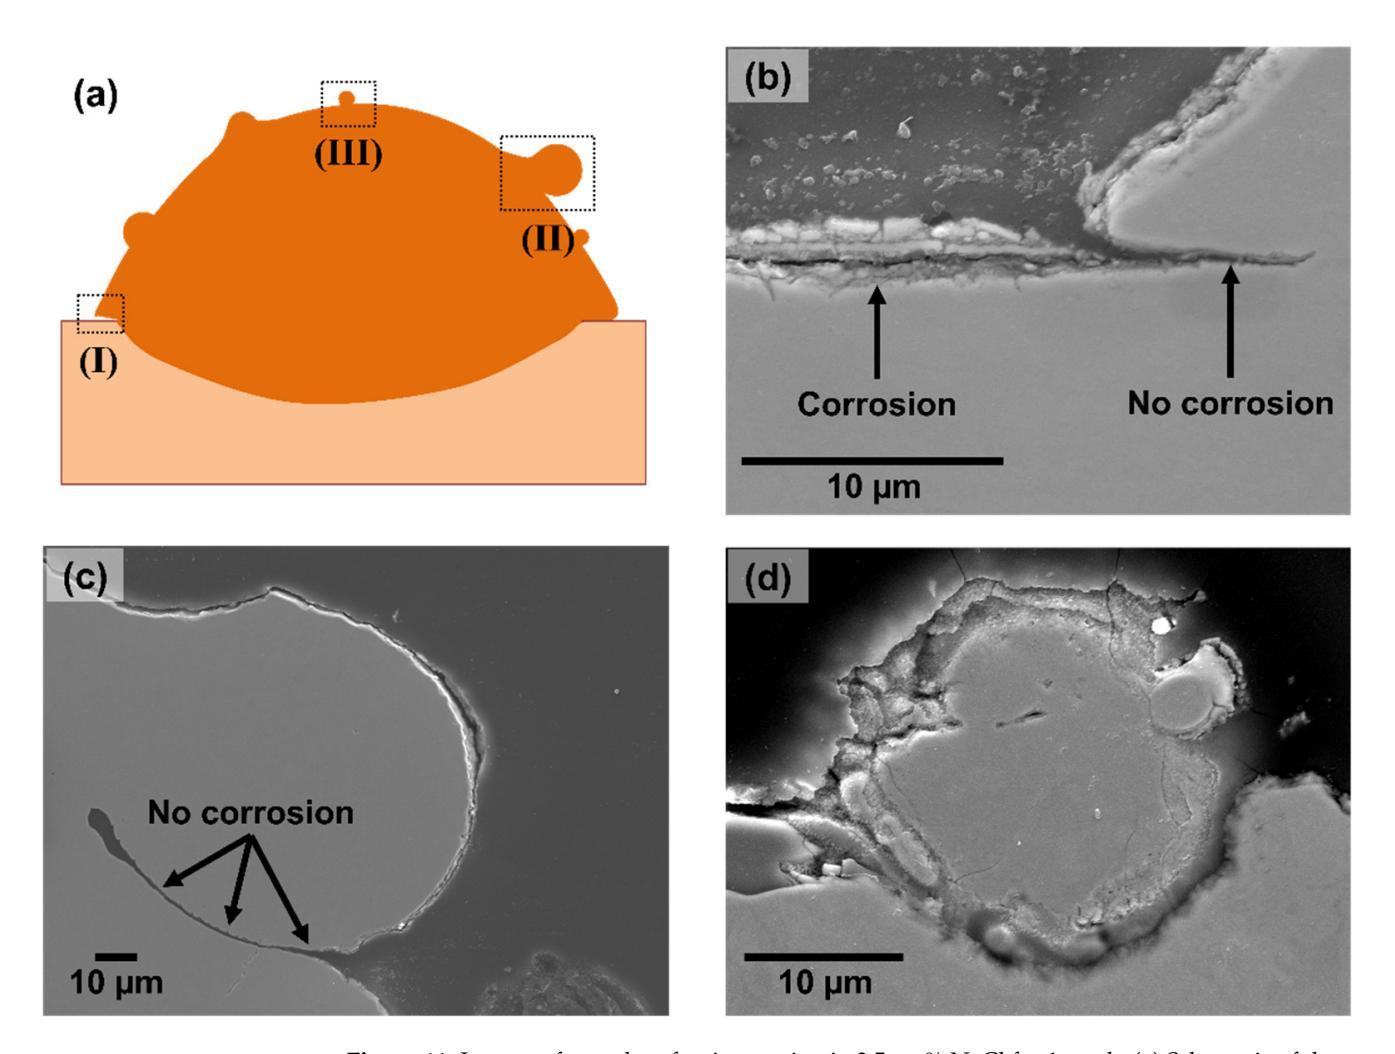
Figure 11. Images of samples after immersion in 3.5 wt.% NaCl for 1 week. (**a**) Schematic of the cross section of a typical printed clad in which specific features are highlighted: I—(**b**) region at the border of the deposited clad in which a gap exists due to insufficient fusion between the deposited clad and the base plate (corrosion is not seen at the gap but rather next to the clad, at the heat-affected zone), II—(**c**) region at the surface of the printed clad with a partially un-melted powder particle of average size or larger (no corrosion was observed around these relatively larger particles), and III—(**d**) region at the surface of the printed clad in which a small, partially un-melted powder particle is visible (corrosion around these small particles was systematically observed).

After immersing the samples in the corrosive media described in the experimental section, cross sections and top views of the deposited clads/base plate were analysed. General inspections of the samples as well as a dedicated examination of the regions of interest (as seen in the schematic in Figure 11a) were carried out. Overall, limited corrosion attack was seen on the samples after one week of immersion. However, this exposure time was enough to clearly identify the main features contributing to the corrosion initiation process.

Figure 11 presents results of corrosion after immersion in 3.5 wt.% NaCl. Most corrosion activity was noticed on the surface of the base plate in close vicinity of the deposited clad, exactly where the heat-affected zone is located. The analysis of regions at the border of the deposited clad, in which a gap exists due to insufficient fusion between the deposited clad and the base plate, showed that these gaps made almost no contribution to the corrosion process, but rather the HAZ was the main region affected (see Figure 11b). The high susceptibility of the HAZ to corrosion attack can be explained by the high depletion of alloying elements (especially Cr and Mo) in these regions, which greatly reduces the pitting resistance of this zone. Furthermore, the EDX analysis carried out on the surface of the HAZ (Figure 4b) showed that the HAZ is mainly composed of Fe oxides, which do not offer much protection against corrosion under the given exposure conditions. Furthermore, a detailed analysis of the corrosion morphology on the HAZ revealed a more severe corrosion attack for samples prepared using a relatively higher energy density. This can be seen in Figure 12, in which two clads deposited using different scanning speeds, and hence different energy densities, are shown. The energy density indicates the laser energy input into the material, and was calculated in this case as the laser power divided by the scanning

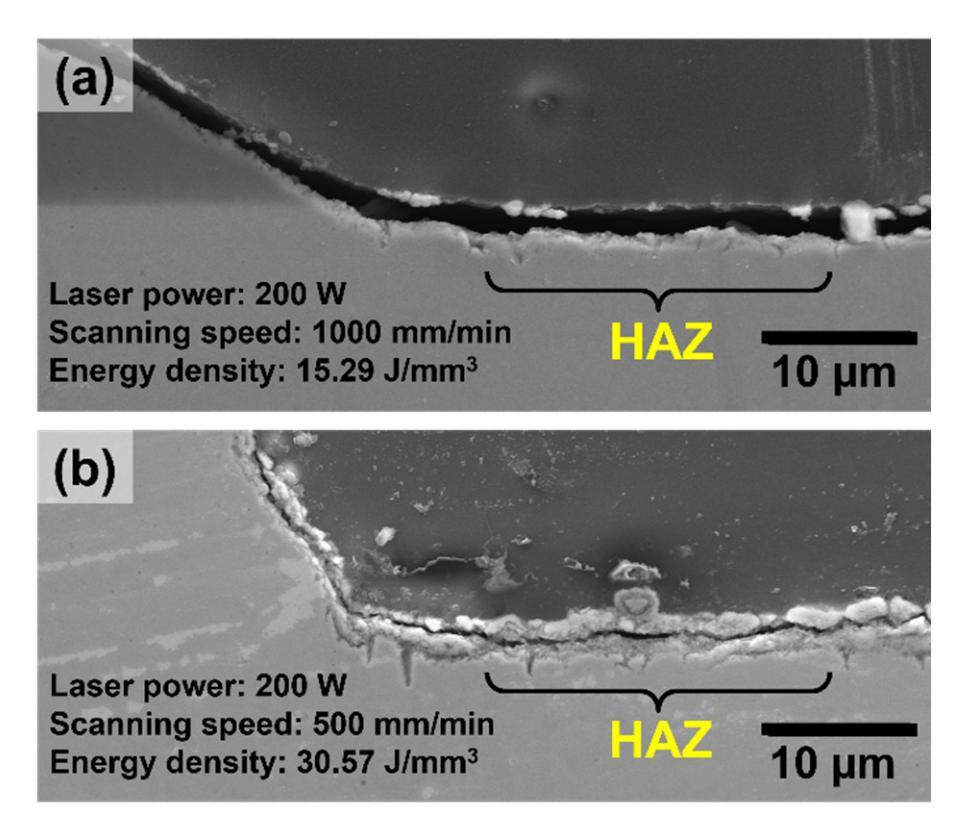
Figure 12. Cross-section secondary electron images of the corrosion morphology on the heat-affected zone of clads deposited using relatively low (**a**) and high (**b**) laser energy density. A much more severe corrosion attack can be seen for clad (**a**) than for clad (**b**).

speed and the area of the laser spot, which had a diameter of 1 mm. The clad presented in Figure 12a was manufactured with an energy input of 15.3 J/mm³, while the clad in Figure 12b was fabricated using 30.6 J/mm³. The use of a relatively higher energy density can lead to a greater diffusion/depletion of alloying elements in the HAZ and, therefore, to a larger decrease in the PREN of that region.

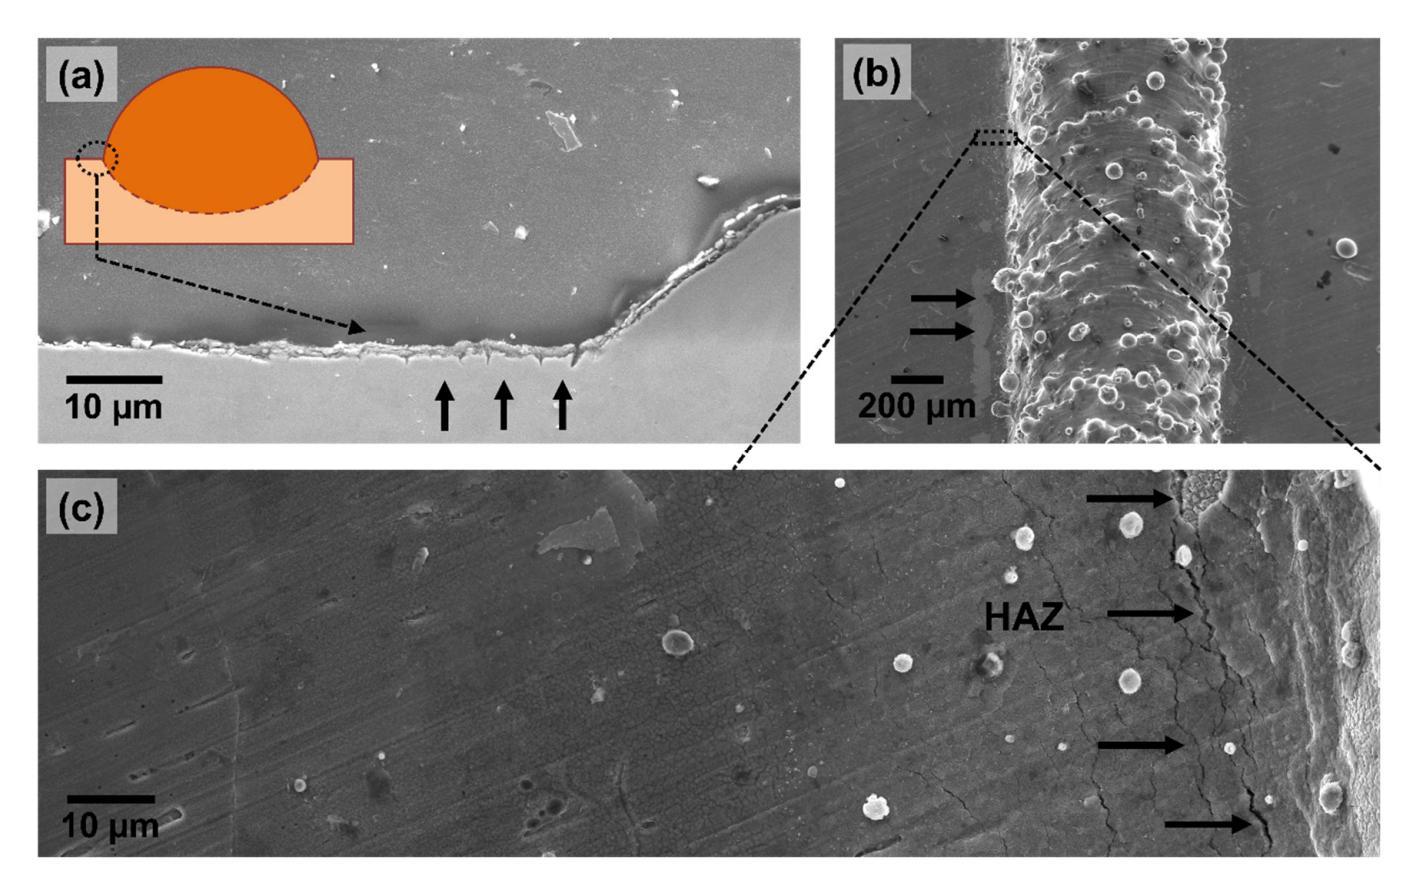
Figure 13. Images of samples after immersion in 3.5 wt.% NaCl at pH 2 for one week. Secondary electron images of (**a**) the cross section and (**b**) the top view of a printed clad. (**c**) High magnification of the region marked in (**b**) around the heat-affected zone.

The corrosion morphology of the samples immersed in acidified 3.5 wt.% NaCl also revealed particularly severe corrosion attacks along the HAZ and on relatively small or highly irregular powder particles partially melted on the surface of the clads. Nevertheless, in this case, some scattered areas on the surface of the clads were also noticed to be affected by slight general corrosion. Under these low-pH conditions, Fe oxides are known to be

unstable and easy to dissolve which initiates general corrosion. In any case, as with the samples immersed in the neutral NaCl solution, the heat-affected zones were the most severely affected areas of the samples by the corrosion attack. This is marked by arrows in the cross section and top view images shown in Figure 13. From Figure 13a,c it can be clearly seen that the corrosion on the base plate in the vicinity of the clad does not extend further than 30 to 40 μ m from the printed clad, exactly coinciding with the heat-affected zone described in the previous section.
