Keywords: ultra-high-performance concrete (UHPC); flexural behavior; fire condition

Citation: Zhou, T.; Sheng, X. Experimental Study of Flexural Performance of UHPC–NC Laminated Beams Exposed to Fire. *Materials* 2022, *15*, 2605. https:// doi.org/10.3390/ma15072605

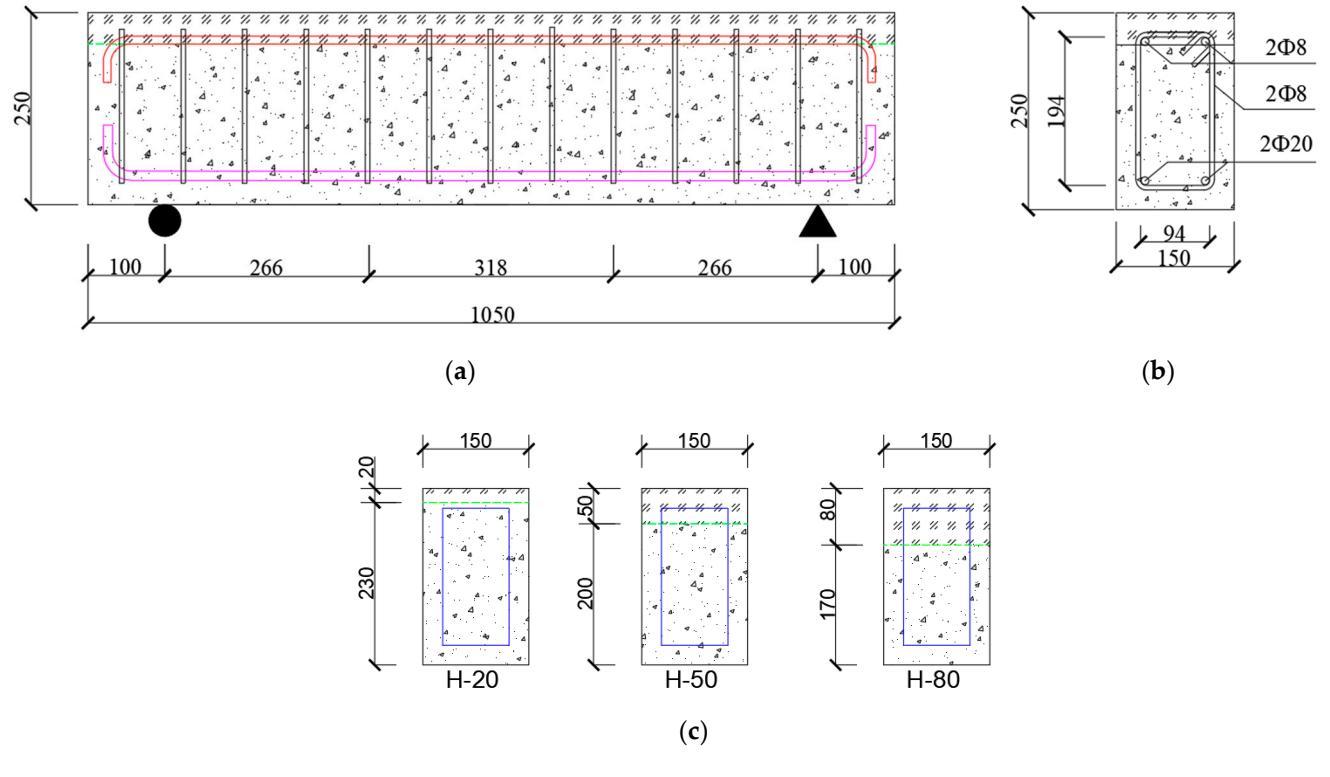
The specific construction of the specimens is shown in Figure 1a,b. The dimensions of all specimens were 150 mm  $\times$  250 mm  $\times$  1050 mm. the lower and upper parts of all specimens were constructed with NC and UHPC, respectively. During the specimen casting, NC was cast in the lower part of the specimen first, and then UHPC was cast in the upper part of the specimen. The thickness of the protective reinforcement layer was 20 mm, and the top and bottom of the beam were constructed with structural reinforcement of 8 mm diameter and tensile reinforcement of 20 mm diameter. In addition, 8 mm stirrups were arranged at a spacing of 80 mm. The side view of the specimens with different UHPC thicknesses is shown in Figure 1c. With the UHPC thicknesses (20 mm, 50 mm, 80 mm) and temperatures (ambient, 200 °C, 400 °C, 600 °C) as test variables, a total of 12 specimens were designed and the details of each specimen are shown in Table 4.

**Figure 1.** Specimen details: (a) front view; (b) side view; (c) specimens with different UHPC thicknesses (mm).

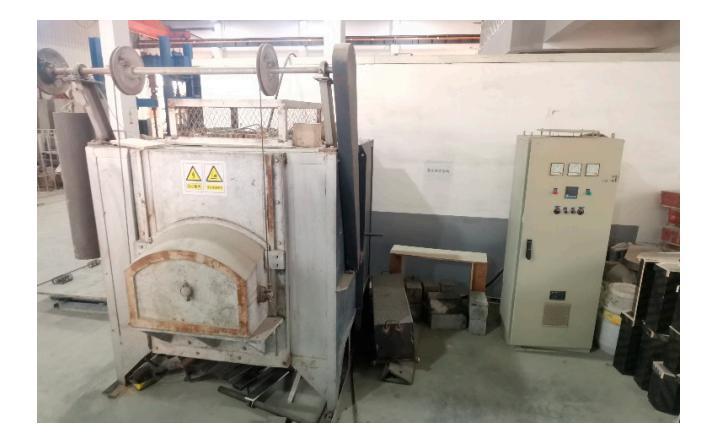
The heating test of the specimens was carried out in Jiangsu Province, China, and the equipment adopted was an RX3-45-9 resistance furnace as shown in Figure 2. Considering the possibility of the UHPC bursting during heating, the specimens were dried before heating and then put into the heating furnace. In this test, the temperature-time curves shown in Figure 3 were used for the heating and cooling treatment [26]. First, the specimens were heated from room temperature to 200 °C, 400 °C and 600 °C at a rate of 10 °C/min, taking care to monitor the temperature during the heating process. After completing the heating, the specimens were exposed to this temperature for 1 h to make the internal temperature of the specimens consistent with the surface temperature in order to ensure uniform heating, and then the heating was terminated. Finally, the specimens were moved to the ground and naturally cooled to room temperature. Note that during the specimen.

Figure 2. Heating equipment.

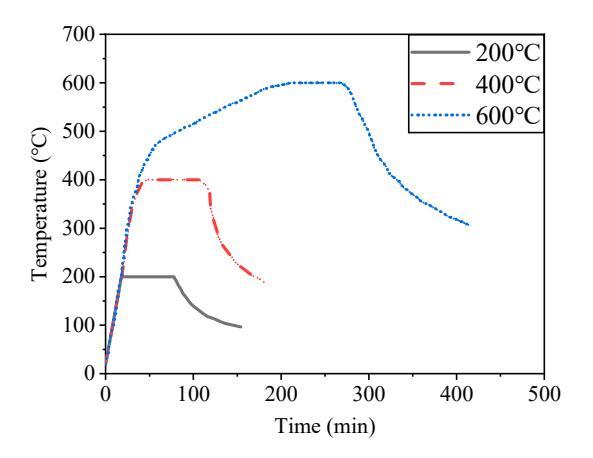
Figure 3. Temperature-time curves.

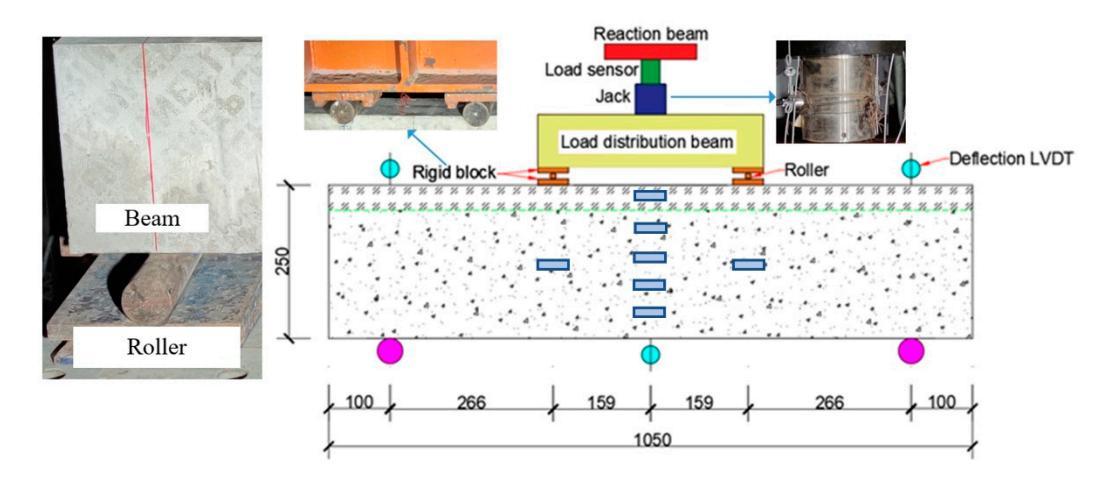
The four-point-bending-test device with the model of YES 500 used in this test is shown in Figure 4. The hydraulic jack is placed between the reaction beam and the distribution beam, and the load applied by the hydraulic jack is measured by a force transducer. The generated load is uniformly transferred to the specimen by means of the steel plates with rollers, and the steel plates serve to prevent stress concentrations from being locally generated in the beam during the loading process. The loading process consists of a preloading phase and a formal loading phase. In the preloading stage, the specimen was preloaded with 80 kN with reference to the calculated flexural load capacity of the specimen, in order to eliminate the gaps and the influence of various unstable factors in the various parts of the loading system. After 10 min of preloading, the readings of each

Figure 4. Test setup (mm).

During the test, concrete strain, reinforcement strain and deflection of the specimens were measured by strain gauges with the model of BF 350 and displacement gauges with the model of KTC 400, and the corresponding data were collected via the TZT3826E strain collector produced by Jiangsu Test Equipment Manufacturing Co., Ltd in Taizhou, China. A total of 7 strain gauges were arranged on the side of the specimen as shown in Figure 4. In the mid-span section, 4 strain gauges were placed at a spacing of 50 mm for the NC layer and 10 mm for the UHPC layer at the top of the specimen. In addition, 2 strain gauges were placed at half the height of the beam at the loading section. Moreover, 3 strain gauge at the bottom in the span of each specimen. In addition to the strains, the deflections at the span, loading point, and support of the specimen were also measured by displacement gauges.

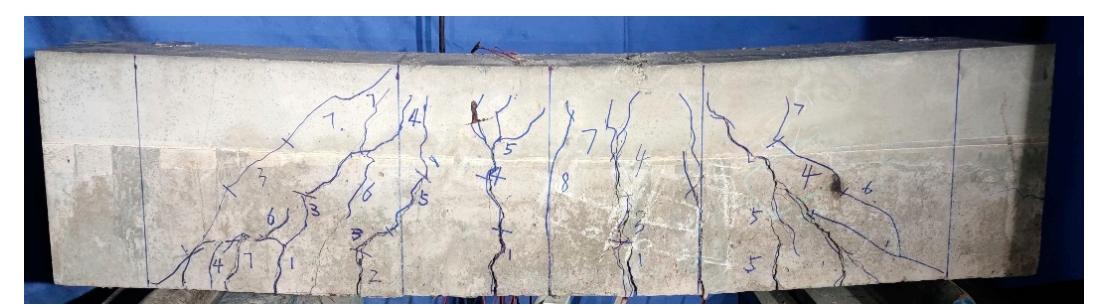
The failure mode and crack development of the test beam with mainly flexural failure are described by taking the T600-H80 test beam as an example (as shown in Figure 5a). The cracks first appeared as vertical cracks in the middle of the span of the laminated beam, when the load was about 60 kN, and as the load increased the number of cracks began to gradually increase and extend upward. However, when the load reached about 80% of the ultimate load-carrying capacity, the cracks extended to the pouring surface of UHPC and the concrete and began to slowly develop. Shortly afterwards, the first cracking sound occurred at the UHPC layer, and then the sound began to occur intensively. Eventually the UHPC in the compressed zone exceeded its ultimate compressive strain, and the UHPC on both sides of the top surface of the span was staggered and caused the beam to be unable to continue to carry the load in the compressed zone, and the beam was finally broken. From the test results, the increase in the height of the UHPC can delay the upward development of cracks. Since the reinforcement in the tensile zone is designed based on overstrength, the UHPC in the compressive zone can bear more pressure on the cross-section due to its good compressive properties, which responds to the material performance advantages of the laminated beam in terms of the tensile resistance of the steel bar and the compressive resistance of the UHPC.

(a) Flexural failure of T600-H80 test beam

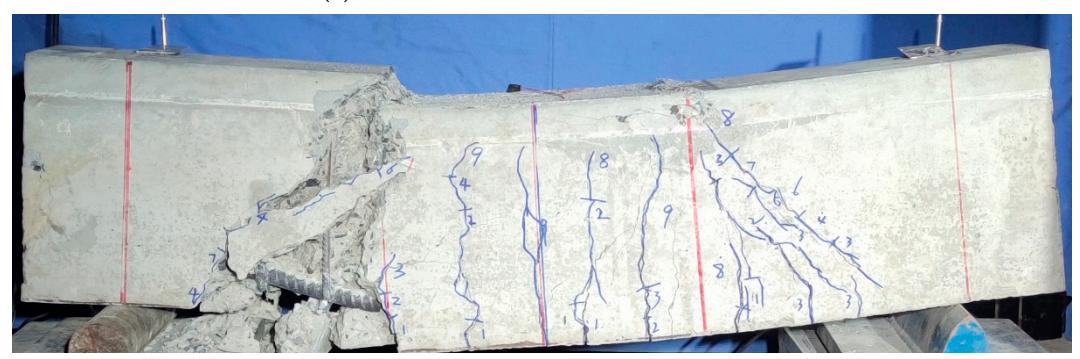
(b) Shear failure of T600-H80 test beam

Shear damage only occurred in the T600-H20 of all the test beams (as shown in Figure 5b), and the damage of the specimens was mainly caused by diagonal compression failure due to the development and expansion of the oblique cracks near the bearings. The final damage occurred with diagonal cracks of larger crack width, with an angle of

about  $45^{\circ}$  to the horizontal line. The cracking sequence was as follows: (i) the first vertical crack occurred near the middle of the span and expanded outward from the bottom of the beam; (ii) as the load increased, a set of vertical cracks was generated and expanded toward the shear span of the beam; (iii) when the load reached  $40 \sim 60\%$  of the peak load, a diagonal crack was formed on top of the vertical cracks in the shear span. Unlike the bending damage of the beam, the damage of the test beam to which shear damage occurred was brittle.

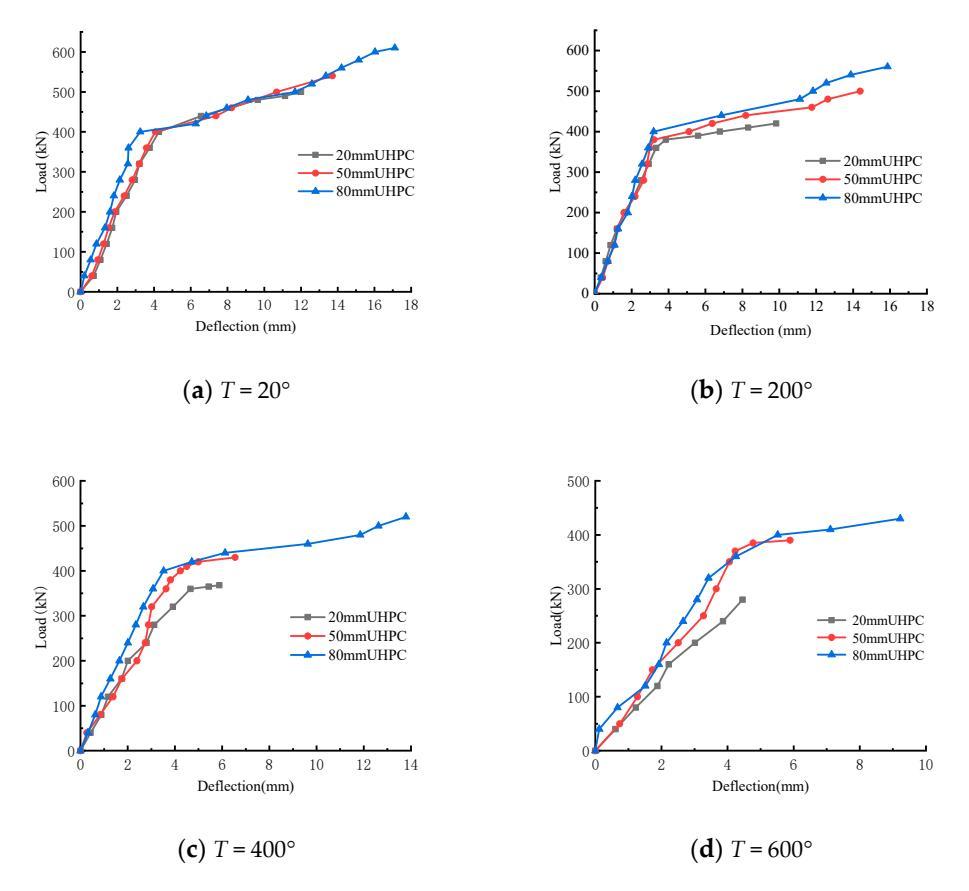
The load-displacement curves of laminated beams at different temperatures and different UHPC heights are respectively shown in Figures 6 and 7, where the displacement is measured in the span of the beam. The load–displacement-variation trend of composite beams under different UHPC thicknesses and temperatures is discussed. It can be seen from the figure that, in general, the load–displacement curve with lower temperature envelopes the load-displacement curve with higher temperature, and the load-displacement curve with larger thickness envelopes the load-displacement curve with smaller thickness of UHPC layer. Except for the shear failure of the T600-H20 test beam, the other eleven test beams were all subjected to bending failure. The load-displacement curve of the former has only one stage, namely the linear elastic stage, during which the load and displacement increase approximately uniformly. With the increase in cracks, before the UHPC concrete at the top of the beam was crushed, the concrete at the bottom of the beam reached the ultimate tensile strain, and the test beam rapidly failed and could not continue to bear the load. The load–displacement curve of the latter can be roughly divided into two stages. The first stage is also the linear elastic stage. In the second stage, with the increase in mid-span deflection, the speed of load growth slows down and gradually reaches the yield load. It can be seen that under the coupling effect of temperature and upper-UHPC-layer thickness, the influence on the failure mode of the test beam is not linear.

Figure 6. Load-displacement curves at different temperatures.

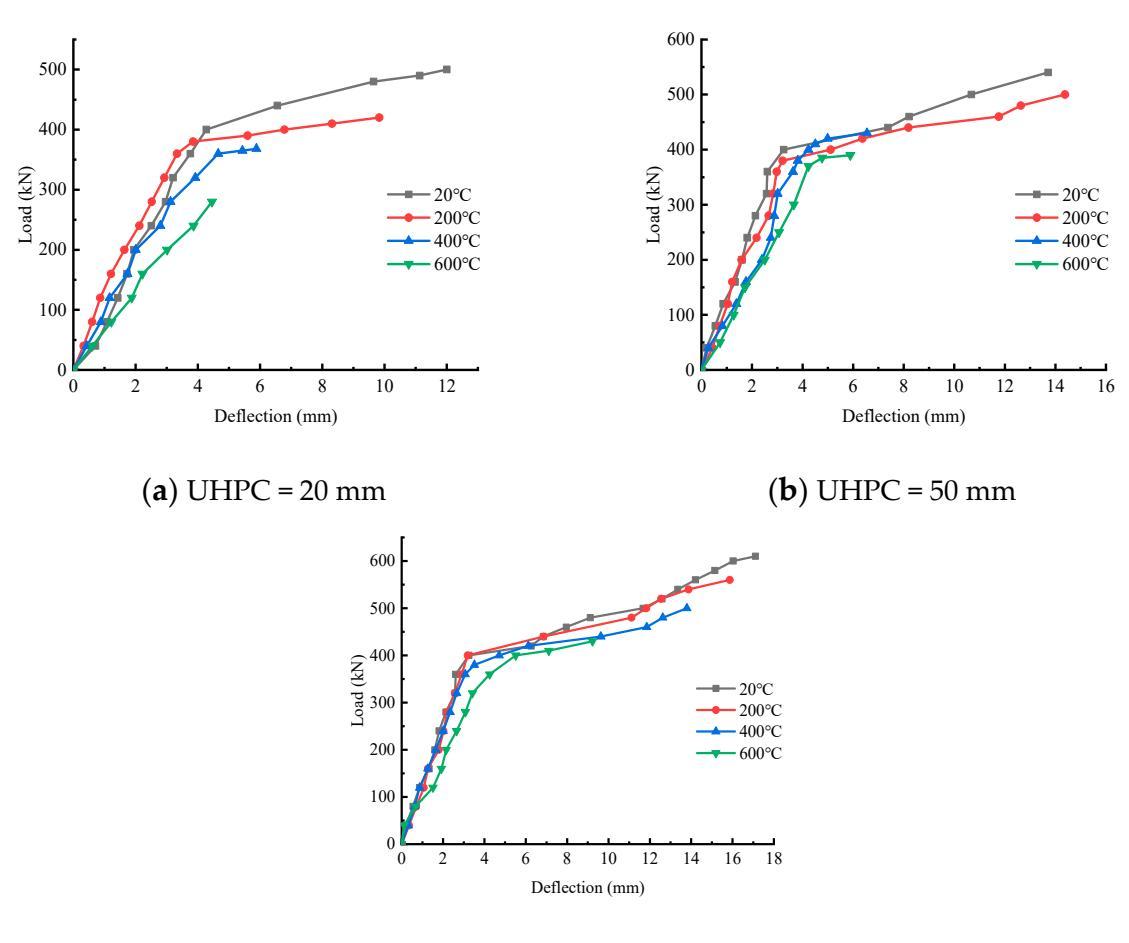
Figure 7. Load–displacement curves at different UHPC heights.

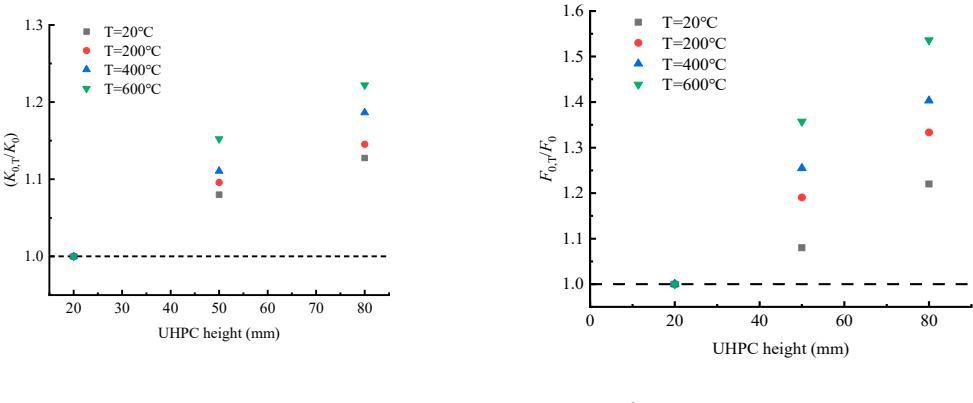
Under the action of high temperature, the ultimate load (Pu) and stiffness (K) of the test beam, which control the law of the load–displacement curve, weaken significantly. However, the height of UHPC layer can strengthen the beam, which significantly improves the bearing capacity of the test beam. Figure 8 shows the variation trend of the bearing capacity of the test beam under the action of temperature. Compared with room temperature, the ultimate load (Pu) of the test beam with the same thickness of the UHPC layer was reduced by 20%, 30% and 40% when heated to 200 °C, 400 °C and 600 °C, respectively. This is because the rise in temperature will lead to the loss of the bond and friction of the steelconcrete binder, deterioration of the concrete matrix, the loss of pore water, decomposition of CSH gel and incompatible strain in the steel bar and concrete, thus leading to the loss of the load-transfer mechanism of the test beam. Figure 8 shows the variation trend of bearing capacity of the test beams with different UHPC heights at the same temperature. The ultimate load (Pu) of composite beams at four temperatures increased by 40–60% as the height of the UHPC layer increased. Of all the temperature–UHPC-layer-height combinations considered in the study, it was observed that the combination with the lowest ultimate bearing capacity (T600-H20) had about 46% of the bearing capacity of the combination with the highest yield load (T20-H80).

Figure 8. Influence of temperature on load-bearing capacity and initial stiffness of test beams.

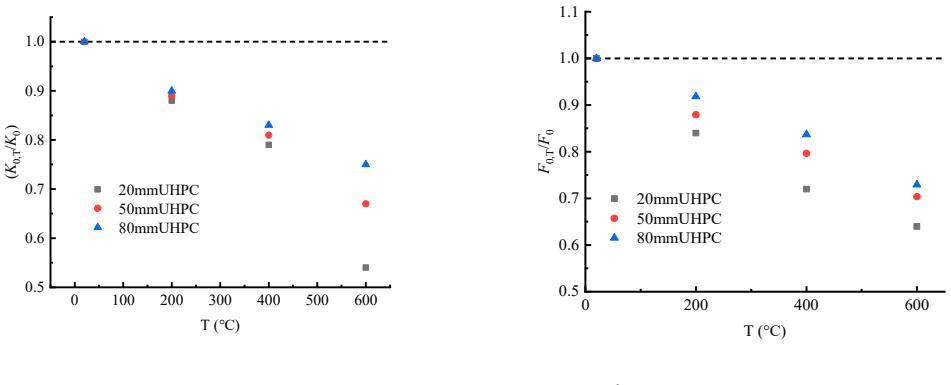
The secant stiffness corresponding to the yield load of 40% was taken as the initial stiffness of the test beam. Figure 9 shows the influence of the thickness of the UHPC layer on the initial stiffness of each component. At a certain temperature, although the thickness of the UHPC layer increased the stiffness of the beam, the effect was not obvious. Figure 9 shows the influence of temperature on the initial stiffness of the test beam. The initial

stiffness of the composite beams conspicuously decreased with the increase in temperature, indicating that the initial stiffness is more sensitive to temperature. The composite beam with the most significant stiffness reduction is T600-H20, which is only 54% of that of T20-H20. Compared with T20-H80, the stiffness of T600-H80 decreased by 25%, indicating that the sensitivity of the initial stiffness of the test beam decreases with the increase in the thickness of the UHPC layer.

Figure 9. Influence of UHPC height on load-bearing capacity and initial stiffness of test beams.

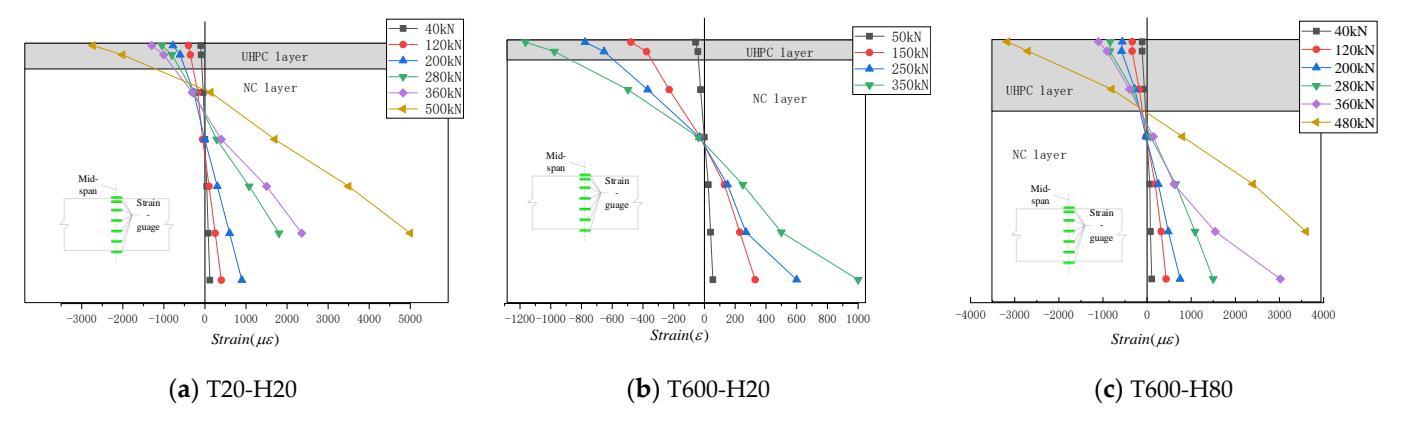
Figure 10 shows the strain distribution of the concrete surface along the section height in the mid-span of the three test beams (T20-H20, T600-H20, and T600-H80). From the figure, it can be seen that when the load is small at the initial stage of loading, the strain on the concrete surface conforms to a linear distribution along the height and satisfies the assumption of a flat section. From Figure 10a, it can be seen that when the tensile strain of concrete in the tensile zone exceeds the ultimate tensile strain, cracks appear and the tensile strain increases significantly. Near the peak load, the concrete in the tensile zone cracks, leading to the severe failure of the bottom strain gauges. However, due to the good compressive properties of UHPC, in the test beam damaged by bending (as shown in (a) for T20-H20), the top UHPC strain gauges in the span can reach 0.3% at the time of damage. In addition, the test beam underwent a significant upward shift in the neutral axis at the time of failure, reflecting the cracking of the concrete on the tensile side exiting the work. The tensile force of the cross-section was borne by the reinforcement, and the height of the compressive zone was greater than the thickness of the UHPC, which made full use of its excellent compressive properties before the damage. For the T600-H20 test beam where shear damage occurred, the compressive strain of UHPC in the compressive zone at the time of damage was far from the ultimate compressive strain of UHPC (as shown in (b) of

Figure 10), which indicates that the compressive zone of the UHPC in the laminated beam did not provide much shear-bearing capacity.

Figure 10. Strain distribution of mid-span.

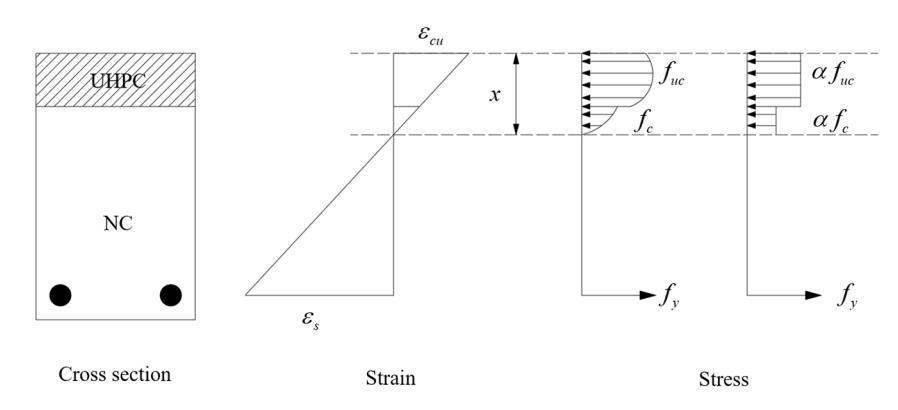
When a flexural failure occurs in the UHPC–NC beam, the strain distribution of the beam cross-section is shown in Figure 11. The stress distribution of the corresponding cross-section can be obtained based on the constitutive model of each material, where  $\varepsilon_s$  and  $\varepsilon_{cu}$  are the tensile strain of steel and compressive strain of UHPC, respectively; *x* is the height of the compressive zone of the cross-section;  $f_y$  is the stress of tensile steel;  $f_{uc}$  and  $f_c$  are the compressive stress of UHPC and concrete, respectively.

Based on the relationship between the height *x* of the compressed zone and the height  $h_u$  of the UHPC, the two cases can be classified as: (a) when  $x > h_u$ , the pressure in the compressed zone is shared by concrete and UHPC; (b) when  $x < h_u$ , the UHPC layer is only partially compressed. In fact, the stress distribution of UHPC and concrete is curvilinear. In order to simplify the calculation and to consider the effect of plastic development, the compressive stress of concrete and the compressive-stress distribution of UHPC are both simplified to a rectangular shape. The simplification principle is in accordance with the

equal joint forces and equal joint moments, and the simplified stress distribution is shown in Figure 11.

Figure 11. Strain and stress distributions of the beam in the mid-span during failure.

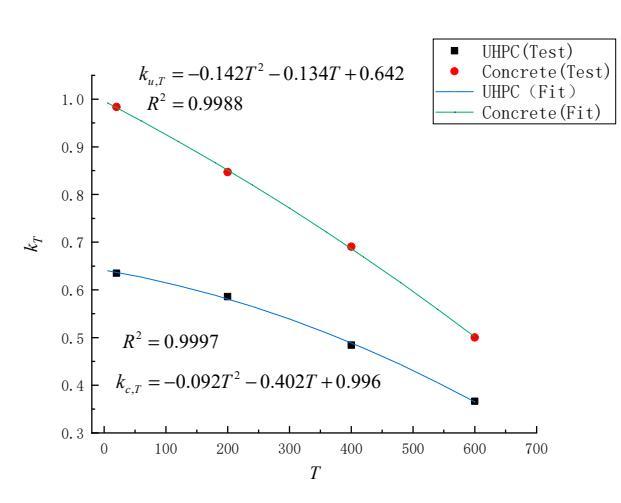
From the results in Table 6, it can be seen that the strength-degradation coefficients of UHPC and concrete obtained by back-propagation based on 20 mm and 50 mm thicknesses satisfy the error requirements, so the fitting of Equation (2) is performed based on the results in Figure 12. The three parameters to be fitted are *a*, *b* and *c*. The fitted values and standard errors of the parameters to be fitted can be obtained by fitting the strength-degradation coefficients  $k_{c,T}$  and  $k_{u,T}$  using four sets of data, and the overall effect of the fitting is given by  $\mathbb{R}^2$ , and the fitting results are listed in Figure 12.

Figure 12. Comparison of fitting results and experimental results.
