Article Effect of Thermal Aging on the Mechanical Properties of SAC305

Abstract: Many electronic products are subjected to heat for long periods, depending on their operations. Thus, it is expected that the physical and mechanical properties of electronic elements, including the soldering joints, will be affected. In this study, the impact of thermal aging time and temperature on the microstructure and mechanical properties of 96.5Sn-3.0Ag-0.5Cu (SAC305) was investigated. The samples used were SAC305 solder balls attached to copper pads. The research began by examining the microstructure of the aged samples at 150 °C for 100 and 1000 h. Then, this was compared to the microstructure of the same samples without thermal aging. Then, five groups of 10 samples were prepared from a shear stress-shear stain experiment. The first group was as produced, the second group was aged for 2 h, the third group was aged for 10 h, the fourth group was aged for 100 h, and the fifth group was aged for 1000 h. All groups were aged at a temperature of 150 °C. An Instron testing machine was used to plot a shear stress-shear stain curve until the ball was completely sheared off the pad. The mechanical pr

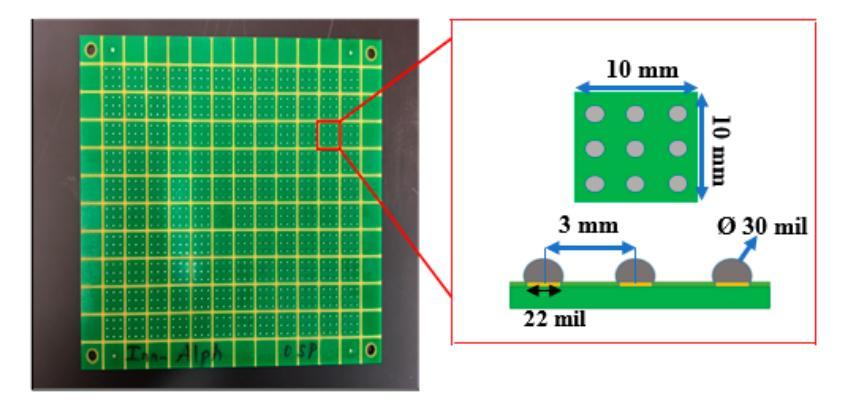
Figure 1. Test vehicle design.

In the present work, SAC305 solder alloys have been used as the test material. Solder balls 0.75 mm in diameter were placed directly onto 0.55 mm diameter copper pads on ideal printed circuit boards (PCB). Then, the boards were placed at a temperature of 245 °C for 45 s to remelt the balls, thus soldering the copper pads. Each test board contained 120 squares, each square was 10 mm \times 10 mm in dimension, and each square included nine solder joints (spheres). The test board and solder joints are shown in Figure 1. Moreover, the cross-section of a solder joint is shown in Figure 2.

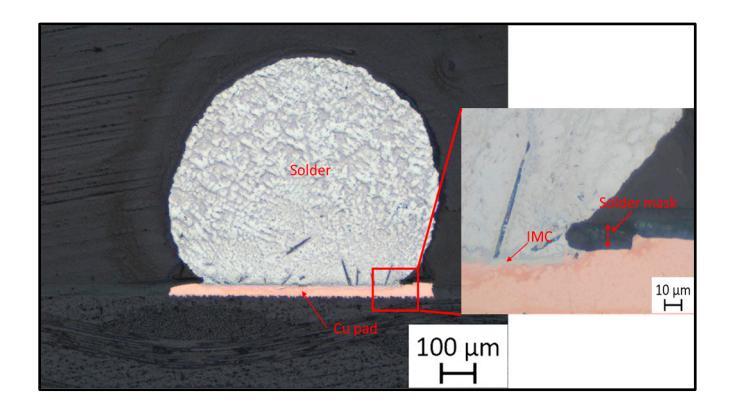
Figure 2. Cross-section of a solder joint after soldering to a copper plate.

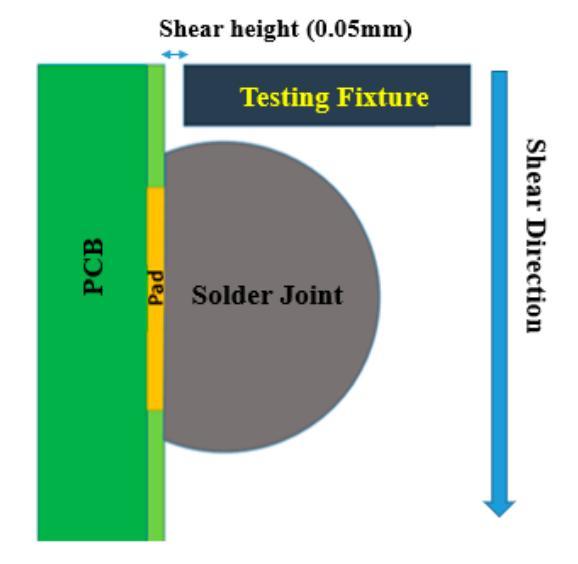
Figure 3. Shear testing schematic.

Ball shear testing was utilized to perform the shear strength test. Although high shear strength alone is not sufficient to ensure the reasonable reliability of solder joints, low shear strength indicates weak solder joints. In our work, an Instron 5948 Micro-Mechanical testing system was used to perform shear strength tests on the aforementioned solder joints. The testing system had a customized fixture. Using a preloaded ball screw drive system, the system achieved an axial displacement resolution of 20 nm. The shear force was measured with a universal 50 N load cell. The shear testing process followed the JESD22-B117 standard for shear testing. The test schematic in shown in Figure 3. On the back side of the PCB, strong glue was applied evenly, and the PCB was glued to a metal workpiece. The shear direction was constantly applied from top to bottom until the solder joint was completely sheared off the Cu pad. According to previous studies, shear strength is affected by two parameters: shear stain rate and shear height. As a result, the shear strain rate and height were chosen to be 0.05 mm and 0.01 s^{-1} , respectively. Furthermore, the test was applied to each solder joint at room temperature. The Instron system was used to draw the shear stress-shear strain curves for the specimens aged at 150 °C. The curves were analyzed to determine other mechanical properties. For specimens aged at 100 °C, the ultimate tensile strength was estimated. The peak value of the shear force divided by the cross-sectional area of the solder joint attachment to the pad was used to calculate the ultimate shear strength.

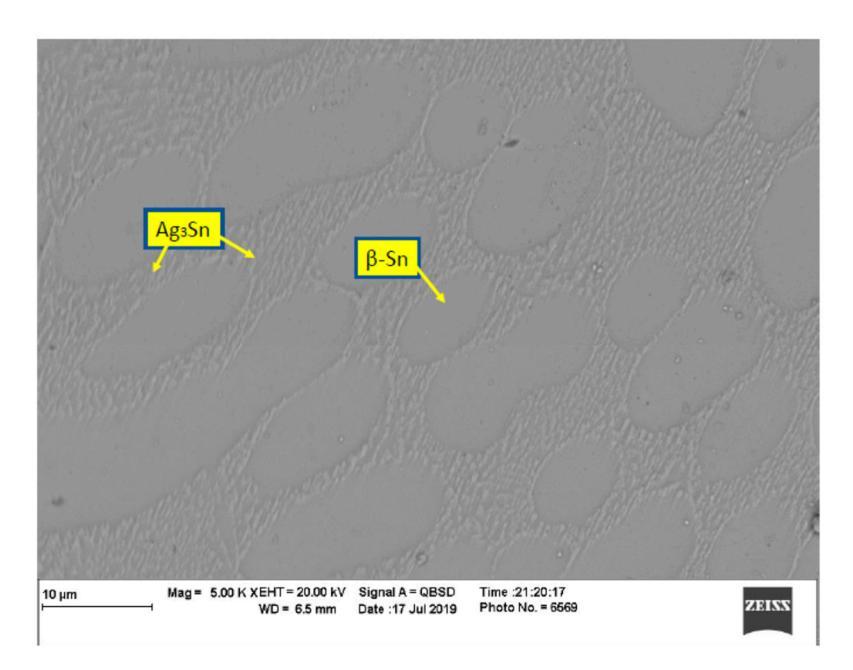
Figure 4. Microstructure of SAC305 as prepared (no aging).

In order to evaluate the thermal aging effects on microstructure, many scanning electronic microscope (SEM) images were taken. The images were organized, filtered, and analyzed. Figure 4 shows the microstructure of SAC305 as prepared, and it is clear that two phases existed, Ag3Sn and β -Sn. There were large spots of β -Sn phase that were completely free of the Ag3Sn. The approximate shape of each spot was oval, and their long diameters typically ranged from 10–20 μ m. Because the solder joint shearing experience depends on the diffusion strength between the solder joint and the copper pad, it is important to study the microstructure of this region. Figure 5 shows the area where the joint connected between the copper pad and SAC 305 solder. In this figure, two layers of Cu6Sn5 and Cu3Sn are shown formed over the copper pad. Cu6Sn5 and Cu3Sn are intermetallic compounds

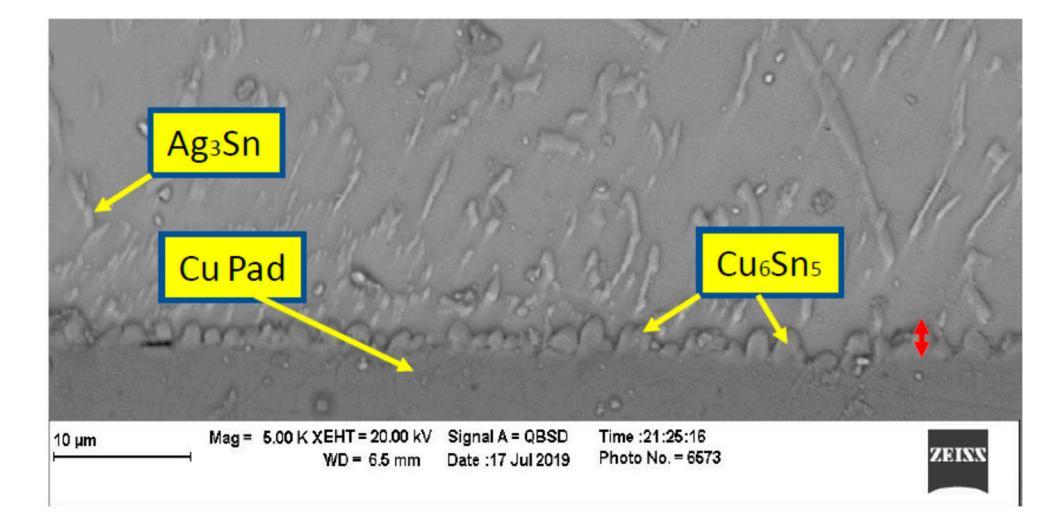
Figure 5. Microstructure of SAC305 fused to a copper pad as prepared (no aging).

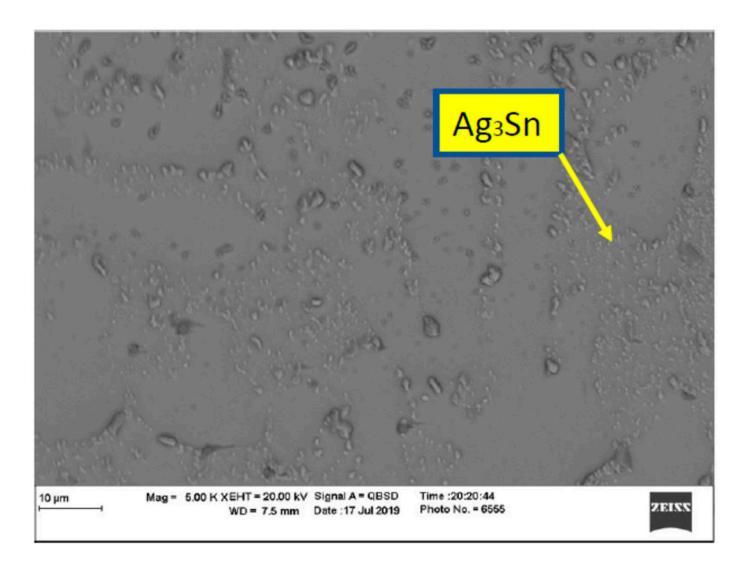
Figure 6. Microstructure of SAC305 thermally aged at 150 °C for 100 h.

(IMCs). After applying thermal aging at a temperature of 150 °C for a period of 100 h, many changes were observed. Figure 6 shows that Ag3Sn was more distributed, and the regular oval spots almost disappeared. However, small regions of β -Sn can still be observed. In Figure 7, more Cu6Sn5 developed and grew to form a large layer adjacent to the copper pad. As the thermal aging duration increased to 1000 h, the previous differences continued to expand. Ag3Sn was further distributed, as shown in Figure 8. Furthermore, the layer of Cu6Sn5 grew additionally, as shown in Figure 9. An interphase crack could form due to material shrinkage during solidification, as shown in Figure 7. Moreover, cracks could form on the phases formed on the surface for the same reason, as shown in Figure 9. Figure 10 shows the energy-dispersive X-ray spectroscopy analysis of the SAC305/copper interface

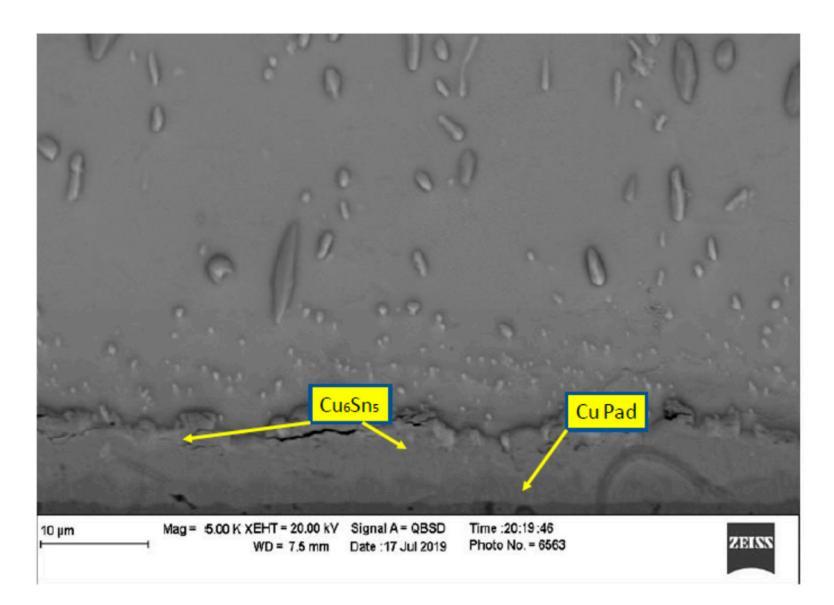
Figure 7. Microstructure of SAC305 fused to a copper pad then thermally aged at 150 °C for 100 h.

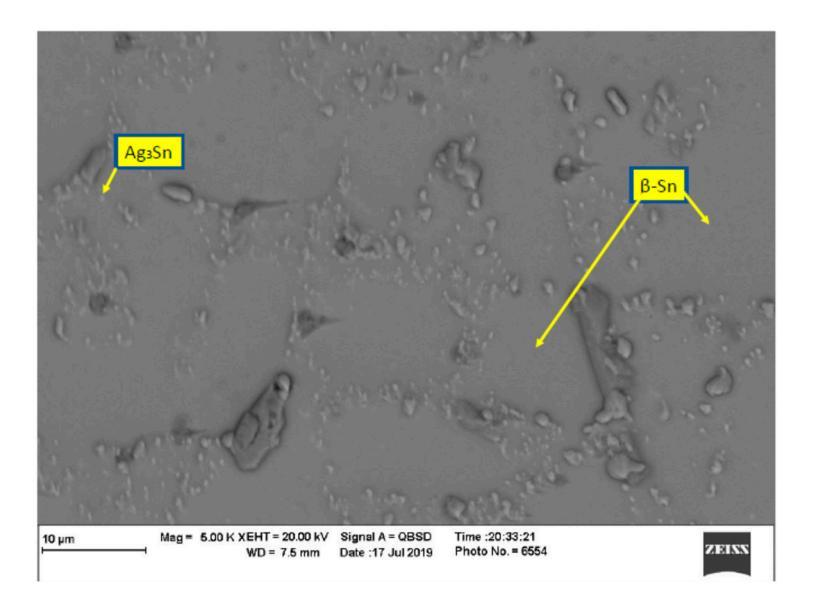
Figure 8. Microstructure of SAC305 thermally aged at 150 °C for 1000 h.

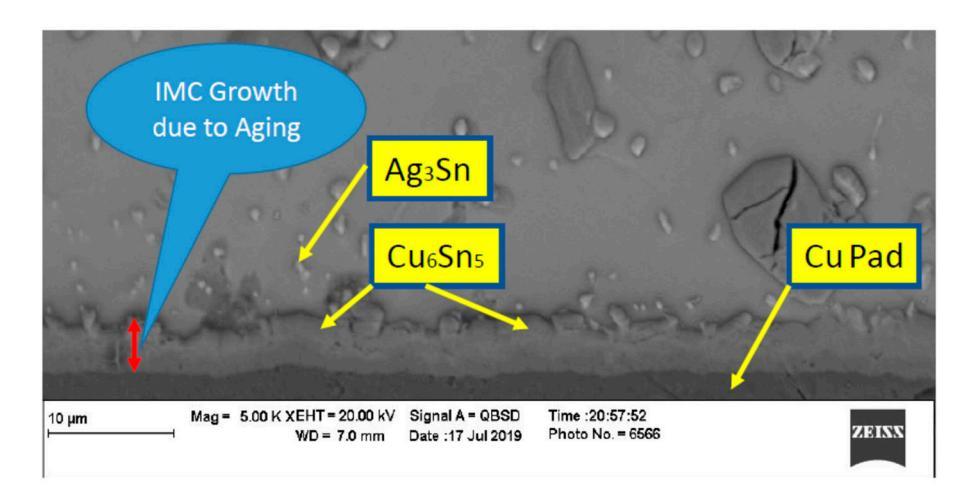
Figure 9. Microstructure of SAC305 fused to a copper pad and then thermally aged at 150 $^\circ C$ for 1000 h.

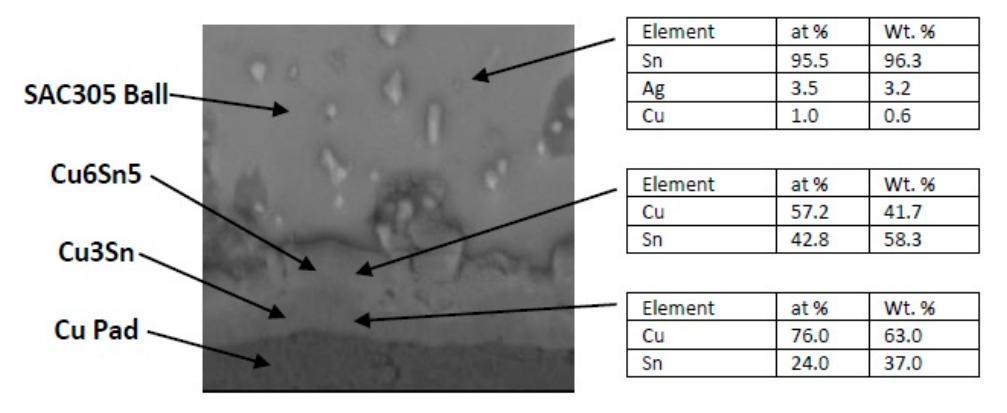
Figure 10. EDAX analysis at select locations on the SAC305/copper interface.

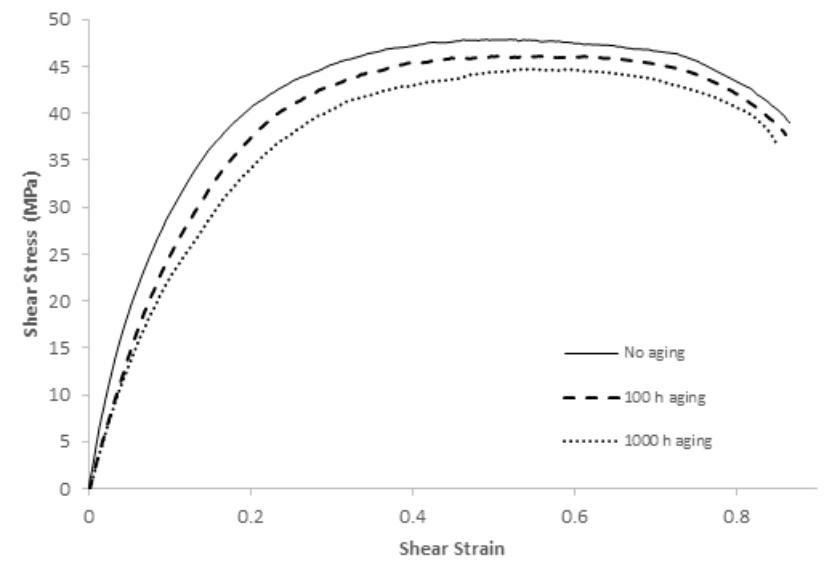
Figure 11. Shear stress-shear strain diagram for samples thermally aged at 150 °C.

As mentioned above, five out of 10 boards were subjected to thermal aging at 150 $^{\circ}$ C for 0, 2, 10, 100, and 1000 h to help evaluate the mechanical properties of SAC 305 after thermal aging. A shear stress–shear stain diagram was constructed, as shown in Figure 11.

In order to minimize error, 10 random solder joints from each board were tested, and the average curve was constructed. The first look at this figure provides a few observations: (1) ultimate shear strength declined with thermal aging, (2) the modulus of elasticity decreased with thermal aging, as shown in Table 3, and (3) toughness decreased with aging. After an analysis of this curve for different aging times, three mechanical properties were extracted, as shown in Table 4: the ultimate shear strength (USS), the total energy exerted to shear off the solder joint, and the ultimate energy to shear off the solder joint.

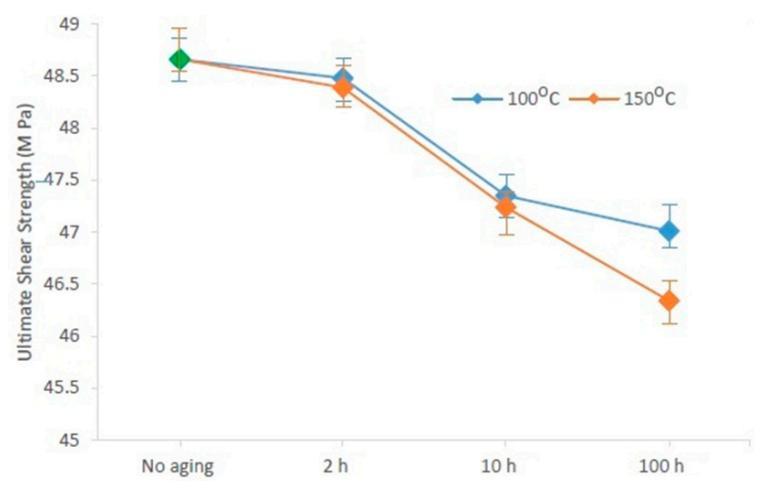
Figure 12. Comparison of USS thermally aged at 100 and 150 °C.

For the boards aged at 100 °C, USS was estimated for 10 solder joints, and the average was considered. Figure 12 shows the effect of aging temperature on USS. It is clear that the drop in USS was higher at higher temperatures.
