# Article High-Temperature Corrosion Behavior of Selected HVOF-Sprayed Super-Alloy Based Coatings in Aggressive Environment at 800 °C

**Abstract:** This study is focused on the high-temperature corrosion evaluation of selected thermally sprayed coatings. NiCoCrAlYHfSi, NiCoCrAlY, NiCoCrAlTaReY, and CoCrAlYTaCSi coatings were sprayed on the base material 1.4923. This material is used as a cost-efficient construction material for components of power equipment. All evaluated coatings were sprayed using HP/HVOF (High-Pressure/High-Velocity Oxygen Fuel) technology. High-temperature corrosion testing was performed in a molten salt environment typical for coal-fired boilers. All coatings were exposed to the environment of 75% Na<sub>2</sub>SO<sub>4</sub> and 25% NaCl at the temperature of 800 °C under cyclic conditions. Each cycle consisted of 1 h heating in a silicon carbide tube furnace followed by 20 min of cooling. The weight change measurement was performed after each cycle to establish the corrosion kinetics. Optical microscopy (OM), scanning electron microscopy (SEM), and elemental analysis (EDS) were used to analyze the corrosion mechanism. The CoCrAlYTaCSi coating showed the bes

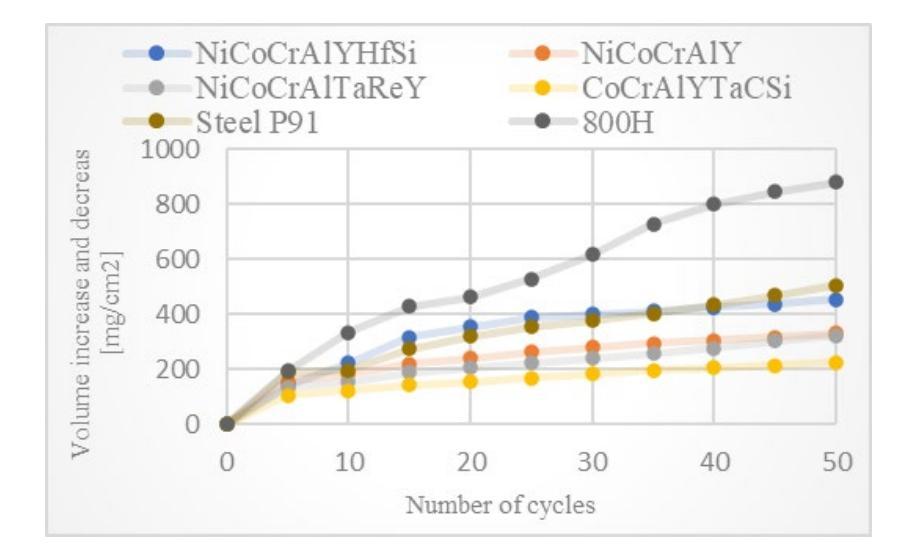
**Figure 1.** The graph of weight gains per area unit related to the number of cycles for all evaluated coatings subjected to 50 cycles of the high-temperature corrosion test in 75% Na<sub>2</sub>SO<sub>4</sub> and 25% NaCl at 800 °C. Reference to uncoated boiler firewall or heat exchange tube represents bulk steel P91 and alloy 800 H (brown and dark grey plots respectively).

The high-temperature corrosion tests were evaluated using the thermogravimetric method of corrosion products kinetics. The individual specimens were weighed together with a ceramic cup after each testing cycle and weight change was recorded. Figure 1 shows the graph of cumulative weight gains per specified area unit of exposed coating.

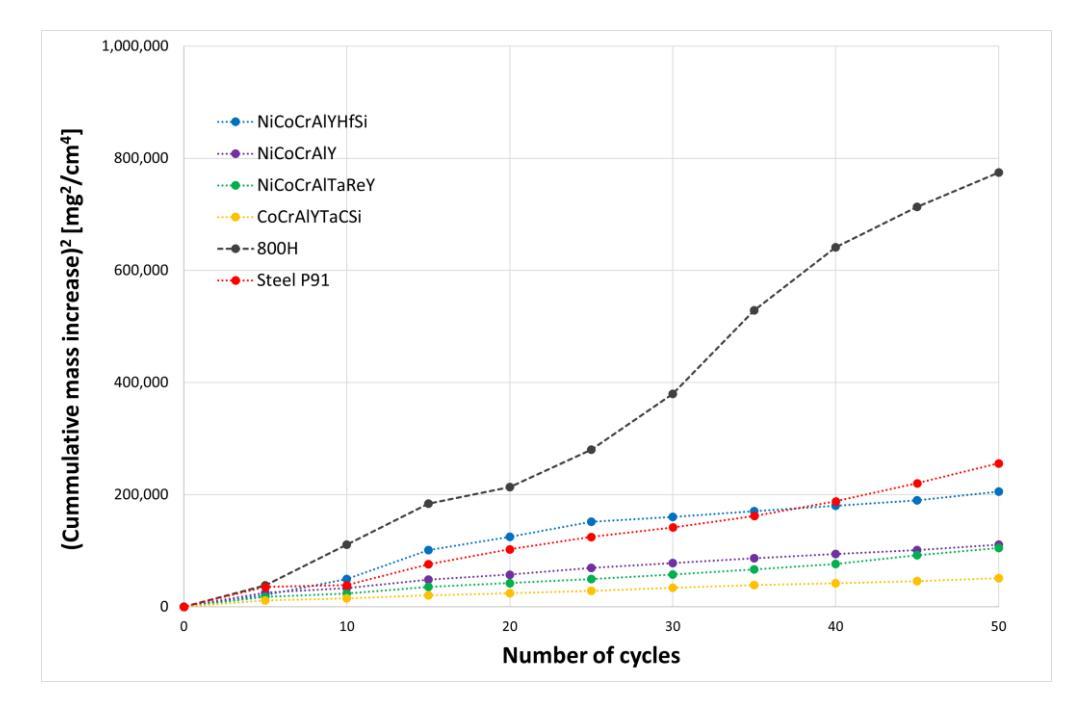
**Figure 2.** The parabolic graph of weight gains per area unit related to the number of cycles for all evaluated coatings exposed to 50 cycles of the high temperature corrosion test in 75%  $Na_2SO_4$  and 25% NaCl at 800 °C. References are uncoated boiler firewall or heat exchange tube representing bulk steel P91 and alloy 800 H (brown and dark grey plots, respectively).

Figure 2 shows a parabolic law of weight gains in dependence on the number of cycles. Rapid weight gains were observed for all evaluated specimens during the first five cycles. This weight change was caused by the formation of the oxide layer and by the stabilization of the entire process/test. Further weight gains observed during the high-temperature corrosion test were caused by the formation of corrosion products. It can be consequently assumed that a specimen with the lowest weight gain showed the best resistance to the high-temperature corrosion.

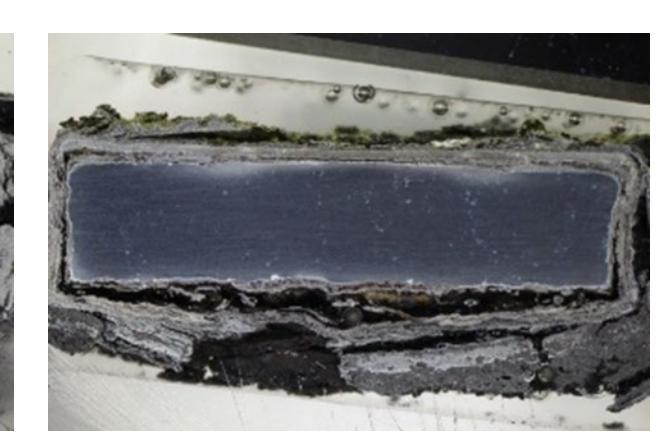
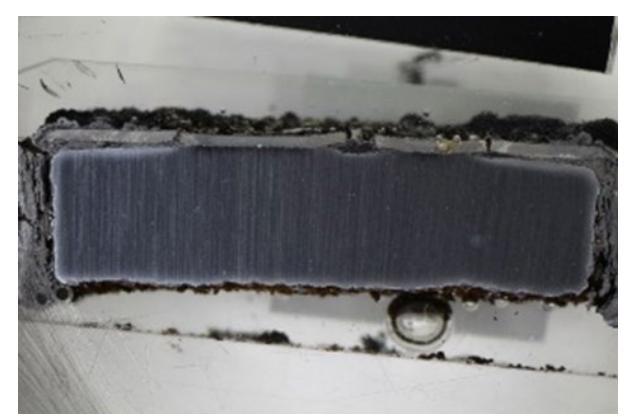
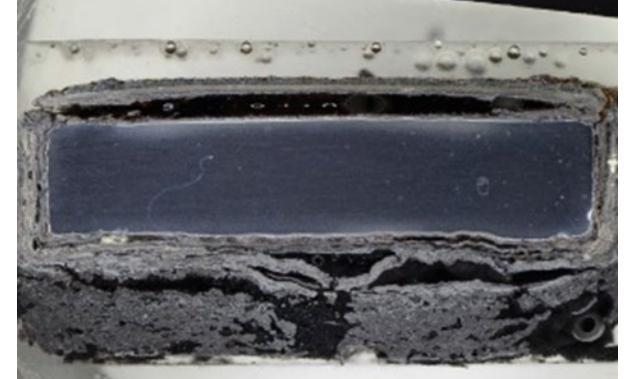
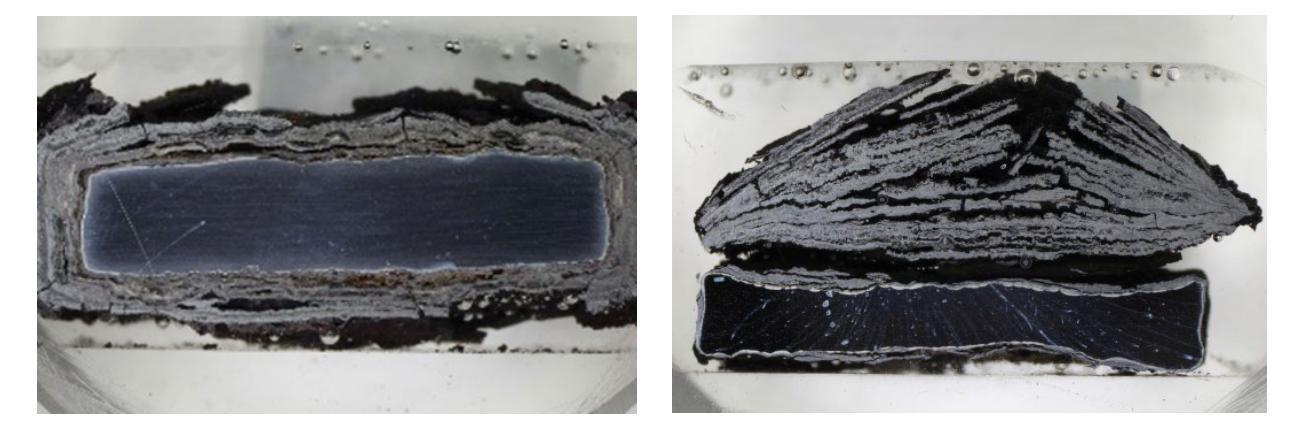
(a) NiCoCrAlYHfSi

(b) NiCoCrAlTaReY

(c) NiCoCrAlY

(d) CoCrAlYTaCSi

(e) Steel P91

(f) Alloy 800 H

**Figure 3.** The macroscopic images of the coatings (**a**) NiCoCrAlYHfSi, (**b**) NiCoCrAlTaReY, (**c**) NiCoCrAlY, (**d**) CoCrAlYTaCSi, (**e**) reference steel P91 and (**f**) alloy 800 H showing cross-sections after the high-temperature corrosion test.

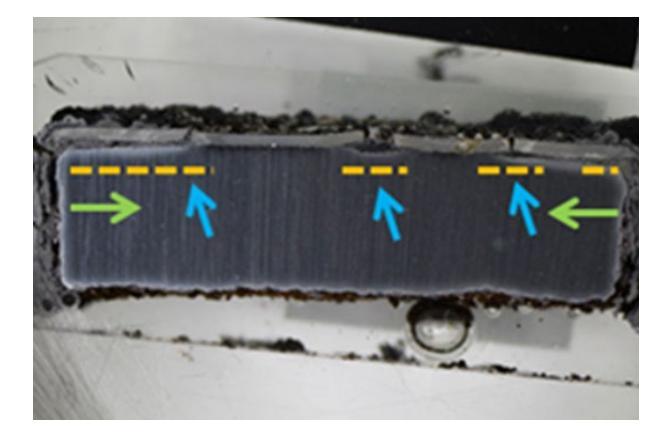
**Figure 4.** Macroscopic cross-section image of the NiCoCrAlYHfSi-coated specimen after exposure to the corrosive environment.

Figure 4 presents a macroscopic cross-section image of the NiCoCrAlYHfSi-coated specimen after exposure to the corrosive environment showing corrosion attack on all

uncoated surfaces. Coating delamination is indicated by yellow dashed lines and cracks are indicated by blue arrows. The corrosion attack of uncoated sides further expanded through the substrate below the coating (green arrows) causing a partial loss of adhesion between the coating and the base material (Figure 5a). The resulting cavity was filled with corrosion products; see SEM images in Figure 5a,b. The SEM images in Figure 5d–f show a visible corrosion attack on the interface between the splats and in the individual splats as well. The corrosive environment has penetrated through the coating due to the porosity and attacked the base material. The formation of the corrosion products resulted in the coating deformation and the development of vertical cracks caused by stresses in the material (Figure 5b).

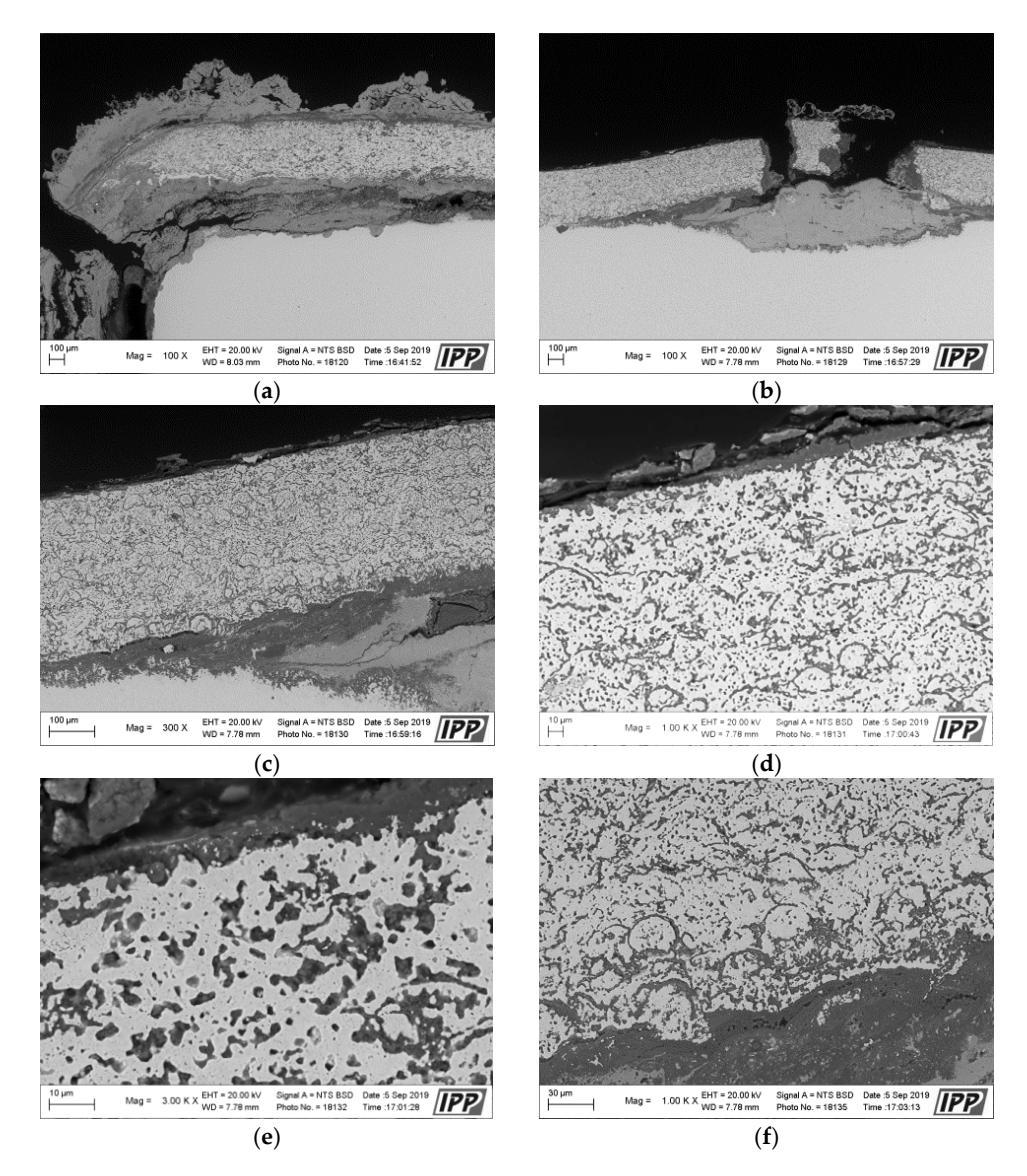
**Figure 5.** SEM analysis images in the cross-section of the NiCoCrAlYHfSi-coated specimen after the exposure to the corrosive environment: (**a**) left side area with  $100 \times$  magnification, (**b**) center area with  $100 \times$  magnification, (**c**) center area with  $300 \times$  magnification, (**d**) center area—coating surface with  $1000 \times$  magnification, (**e**) center area—coating surface with  $3000 \times$  magnification, (**f**) center area—coating underside with  $3000 \times$ .

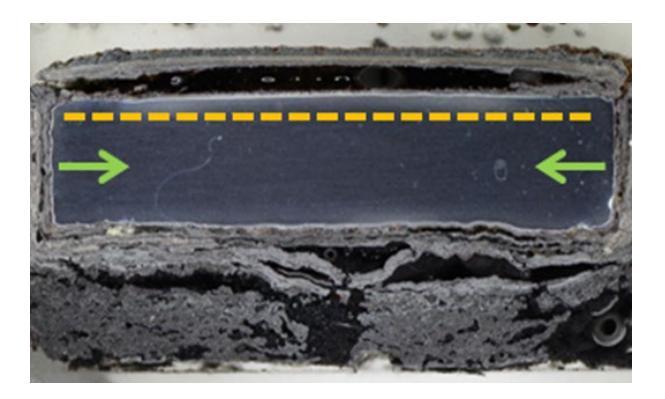
**Figure 6.** Macroscopic cross-section image of the NiCoCrAlTaReY-coated specimen after exposure to the corrosive environment.

The principle of corrosion attack on the NiCoCrAlTaReY-coated specimen was similar to that for the NiCoCrAlYHfSi coating. The corrosion attack spread from the uncoated specimen sides under the entire coating and caused the coating delamination. The macroscopic cross-section image of the coating after the exposure to the corrosive environment in Figure 6 shows the corrosion attack on all uncoated specimen sides. The corrosion products on the specimen underside indicate that the base material was significantly attacked by corrosion in this area. The upper third of the coating shows initial corrosion attack of individual splats and their interfaces, as in Figure 7.

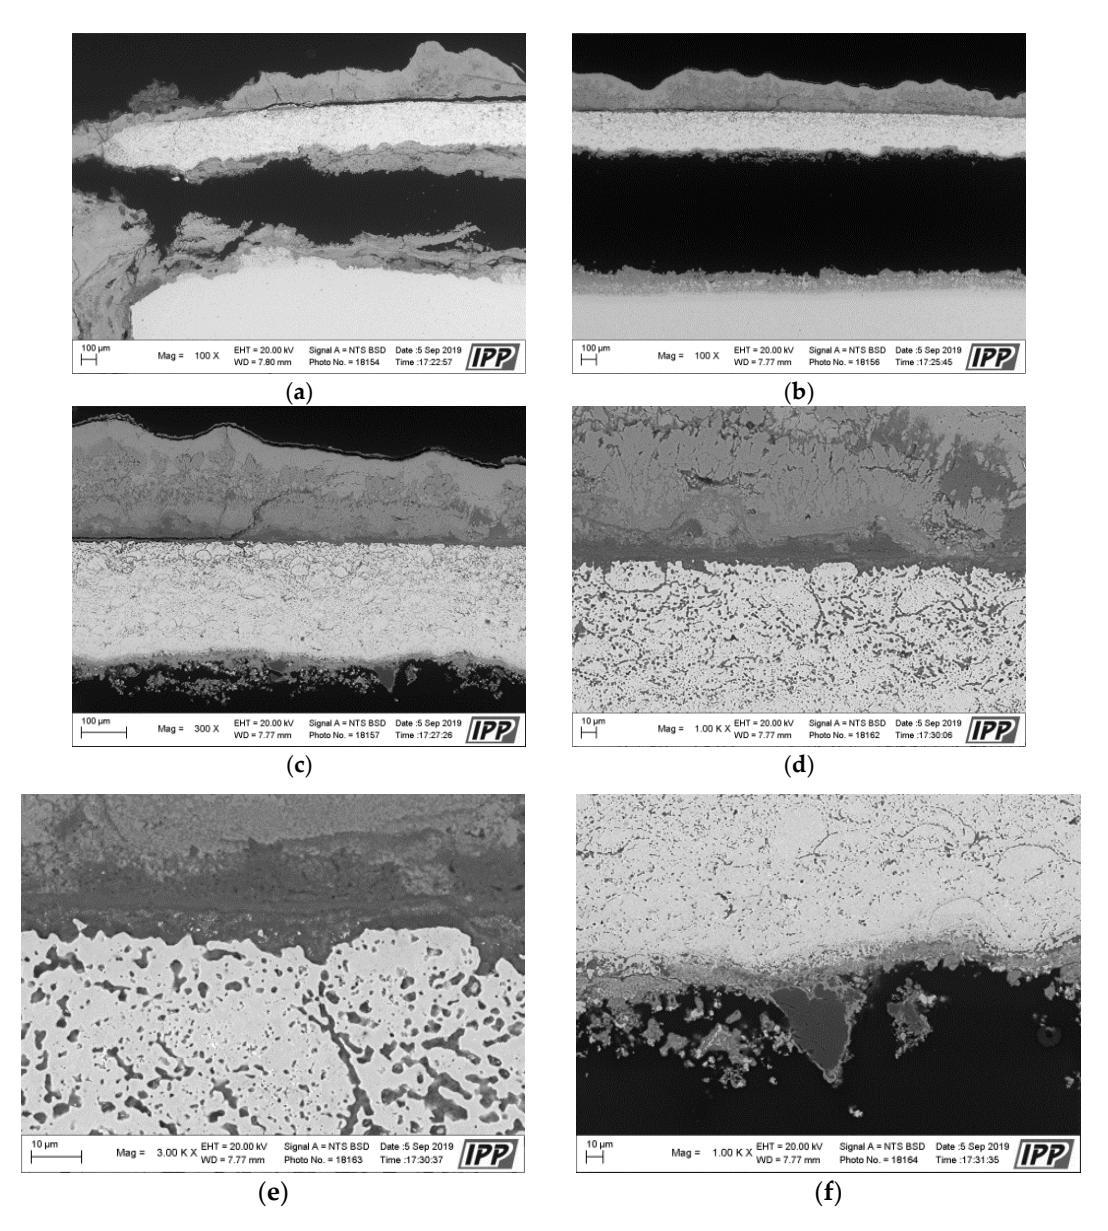
**Figure 7.** SEM analysis images in the cross-section of the NiCoCrAlTaReY-coated specimen after the exposure to the corrosive environment: (**a**) left side area with  $100 \times$ , (**b**) center area with  $100 \times$ , (**c**) center area with  $300 \times$ , (**d**) center area—coating surface with  $1000 \times$ , (**e**) center area—coating surface with  $3000 \times$ , (**f**) center area—coating underside with  $3000 \times$ .

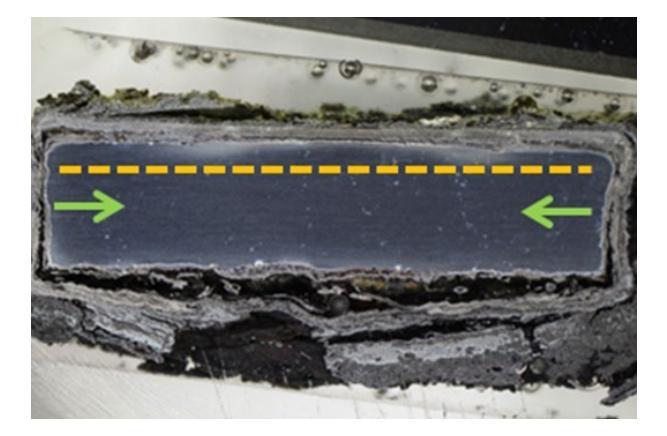
**Figure 8.** Macroscopic cross-section image of the NiCoCrAlY-coated specimen after the exposure to the corrosive environment.

The loss of flatness and layering of the corrosion products along the specimen perimeter show that all uncoated surfaces of the NiCoCrAlY-coated specimen were corroded during exposure to the corrosive environment of chloride salts. The macroscopic image in Figure 8 shows a severe corrosion attack on the uncoated underside of the base material.

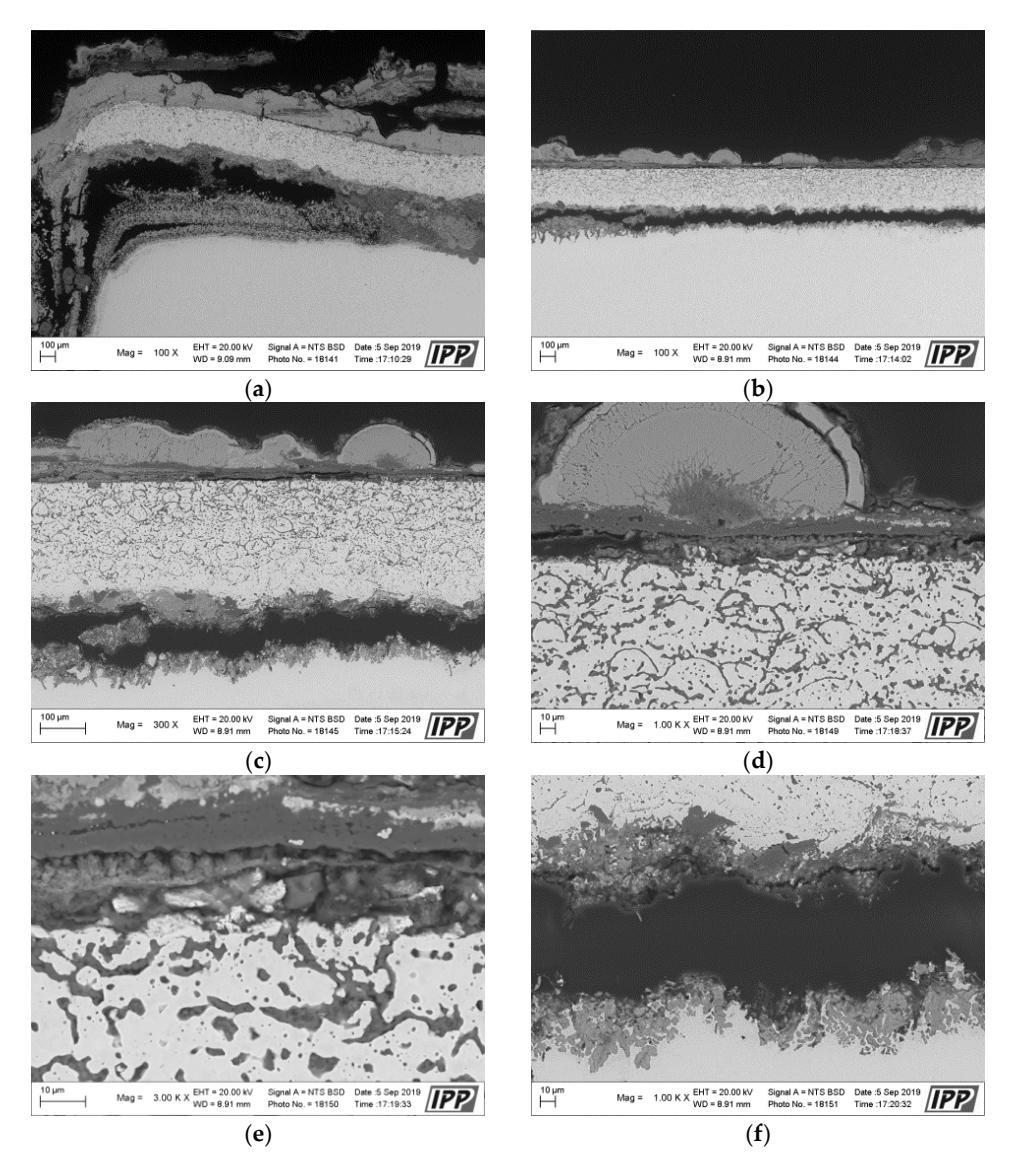
**Figure 9.** SEM analysis images in the cross-section of the NiCoCrAlY-coated specimen after exposure to the corrosive environment: (**a**) left side area with  $100 \times$ , (**b**) center area with  $100 \times$ , (**c**) center area with  $300 \times$ , (**d**) center area—coating surface with  $1000 \times$ , (**e**) center area—coating surface with  $3000 \times$ , (**f**) center area—coating underside with  $3000 \times$ .

As with the NiCoCrAlYHfSi coating, this specimen also shows the corrosion attack on the uncoated side edges, which further spread through the base material under the coating. The corrosion attack caused the loss of adhesion between the coating and the base material and subsequent coating delamination, see the SEM images in Figure 9. The corrosion of the NiCoCrAlY coating attacked the splat interfaces and the splats themselves. The corrosion attack on the coating is shown in the SEM images in Figure 9d,e.

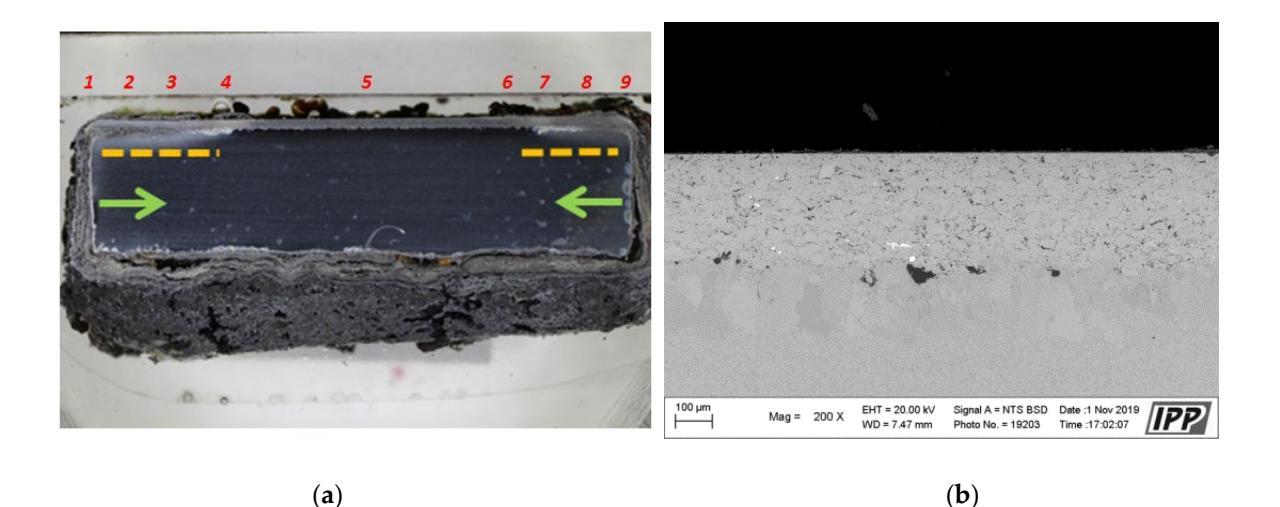
Figure 10. (a) Macroscopic cross-section image of the CoCrAlYTaCSi-coated specimen after the exposure to the corrosive environment, area 5—(b) SEM analysis image with  $200 \times$ —the coating center taken from an area 5 (red number 5 on the image (a)).

Since the CoCrAlYTaCSi coating showed the best resistance to the high-temperature corrosion within the evaluation by the thermogravimetric method, a more detailed analysis was performed. The macroscopic image of the CoCrAlYTaCSi coating in Figure 10a clearly shows the lowest corrosion attack in comparison with three others evaluated MCrAlY coatings. As previously described for the other coatings, the lateral corrosion attack of the base material spread under the coating.

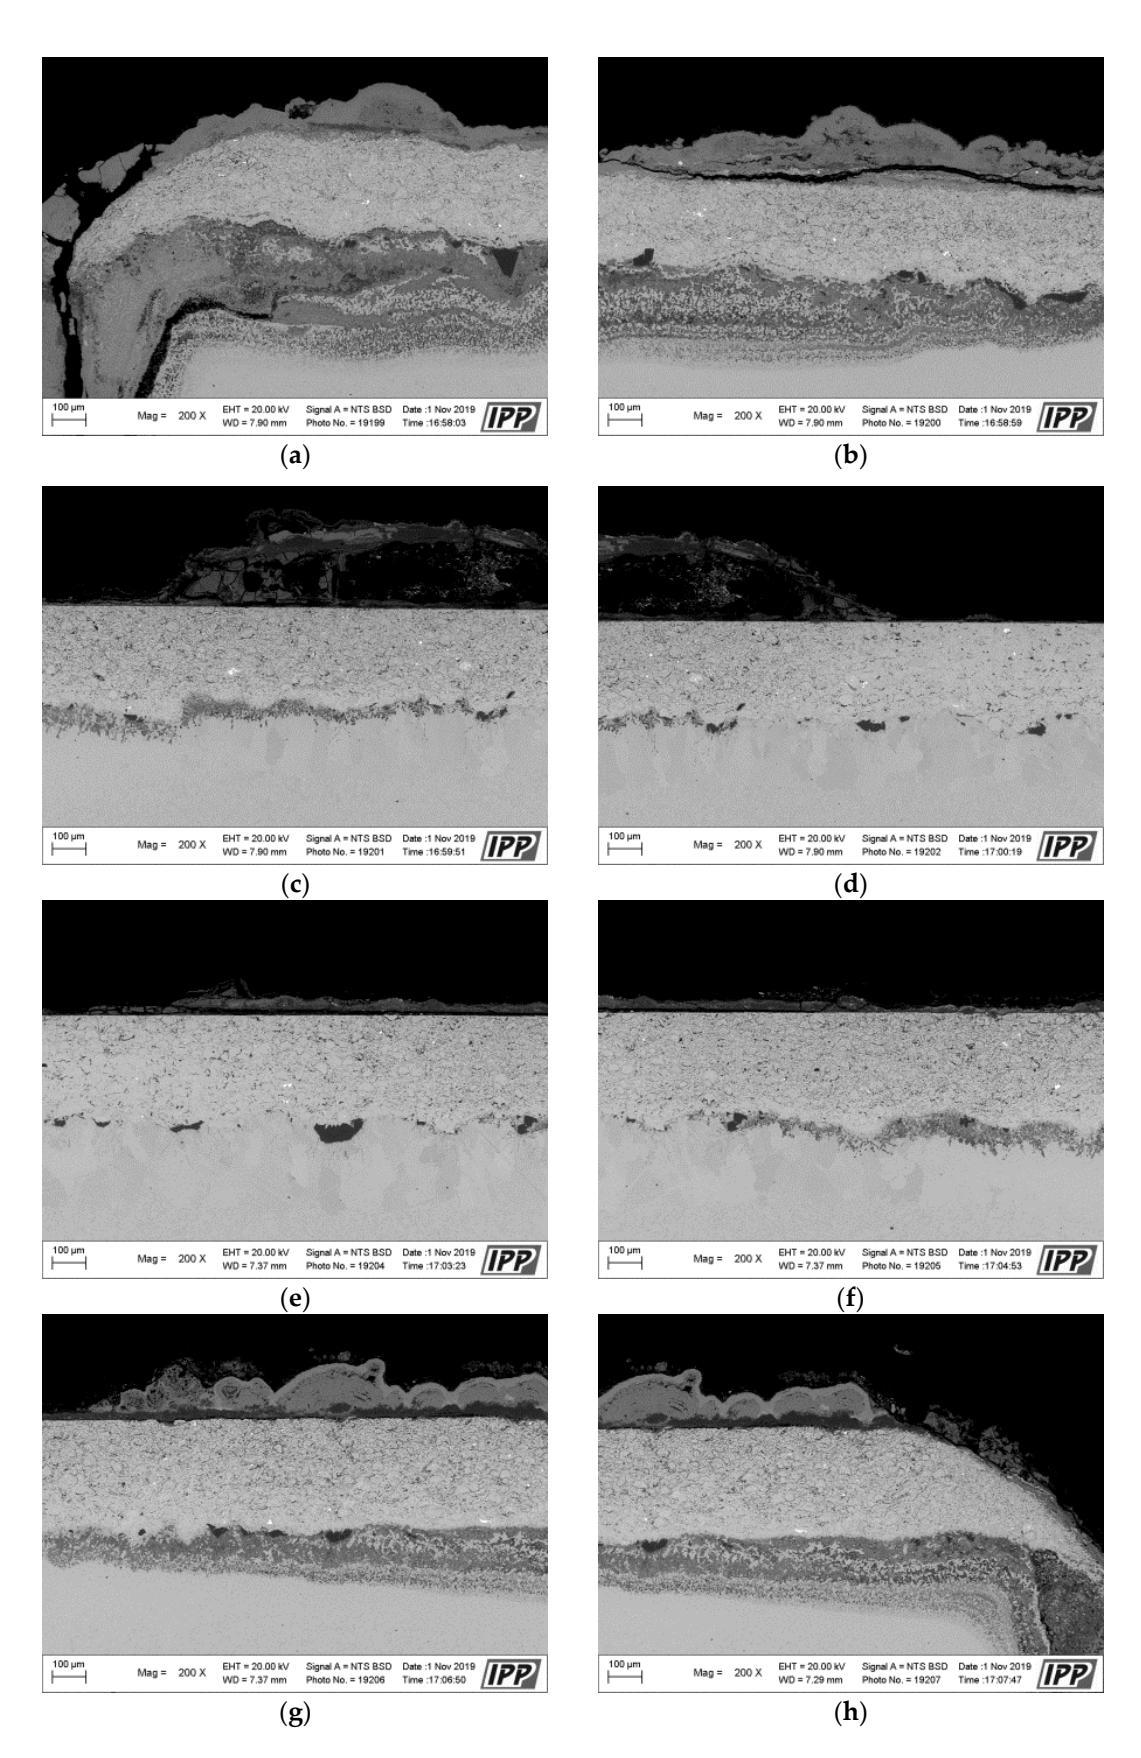
**Figure 11.** (**a**–**h**) SEM analysis images of the cross-section of the CoCrAlYTaCSi-coated specimen (coating with best results in the test), after the exposure to the corrosive environment, from left to right.

The corrosion attack in the coating cross-section is shown in detail in the SEM analysis images in Figure 11. The metallographic cut of the coating cross-section after the exposure to the corrosive environment was divided into nine parts (see the macroscopic image in Figure 10a), and the entire coating cross-section was analyzed in detail. Figure 11 shows the SEM analysis images of the specimen left side (positions 1-4) and the specimen right side (positions 6–9). The specimen shows a strong corrosion attack spreading below the coating from both sides up to a distance of several millimeters, see Figure 11a–d,f–h. The peripheral coating areas show a chromium-depleted region across the entire coating width. Chromium has accumulated at a high density in corrosion products (the EDS image in Figure 12). Figure 12 presents a thin alumina layer visible in the corrosion products. The oxides of chromium and aluminum were detected by the EDS analysis of oxygen. In addition, iron originating from the base material was detected on the coating surface in the corrosion products. A strong presence of chlorine, sodium, and sulfur was reported at the coating-substrate interface in the delaminated areas (see the EDS image in Figure 12). These elements confirm the presence of the corrosive medium at the coating-substrate interface. The coating shows almost no attack in the central part, see Figure 10e. A thin corrosion layer was formed on the coating surface and occasionally attacked the coating leading to a small thickness.

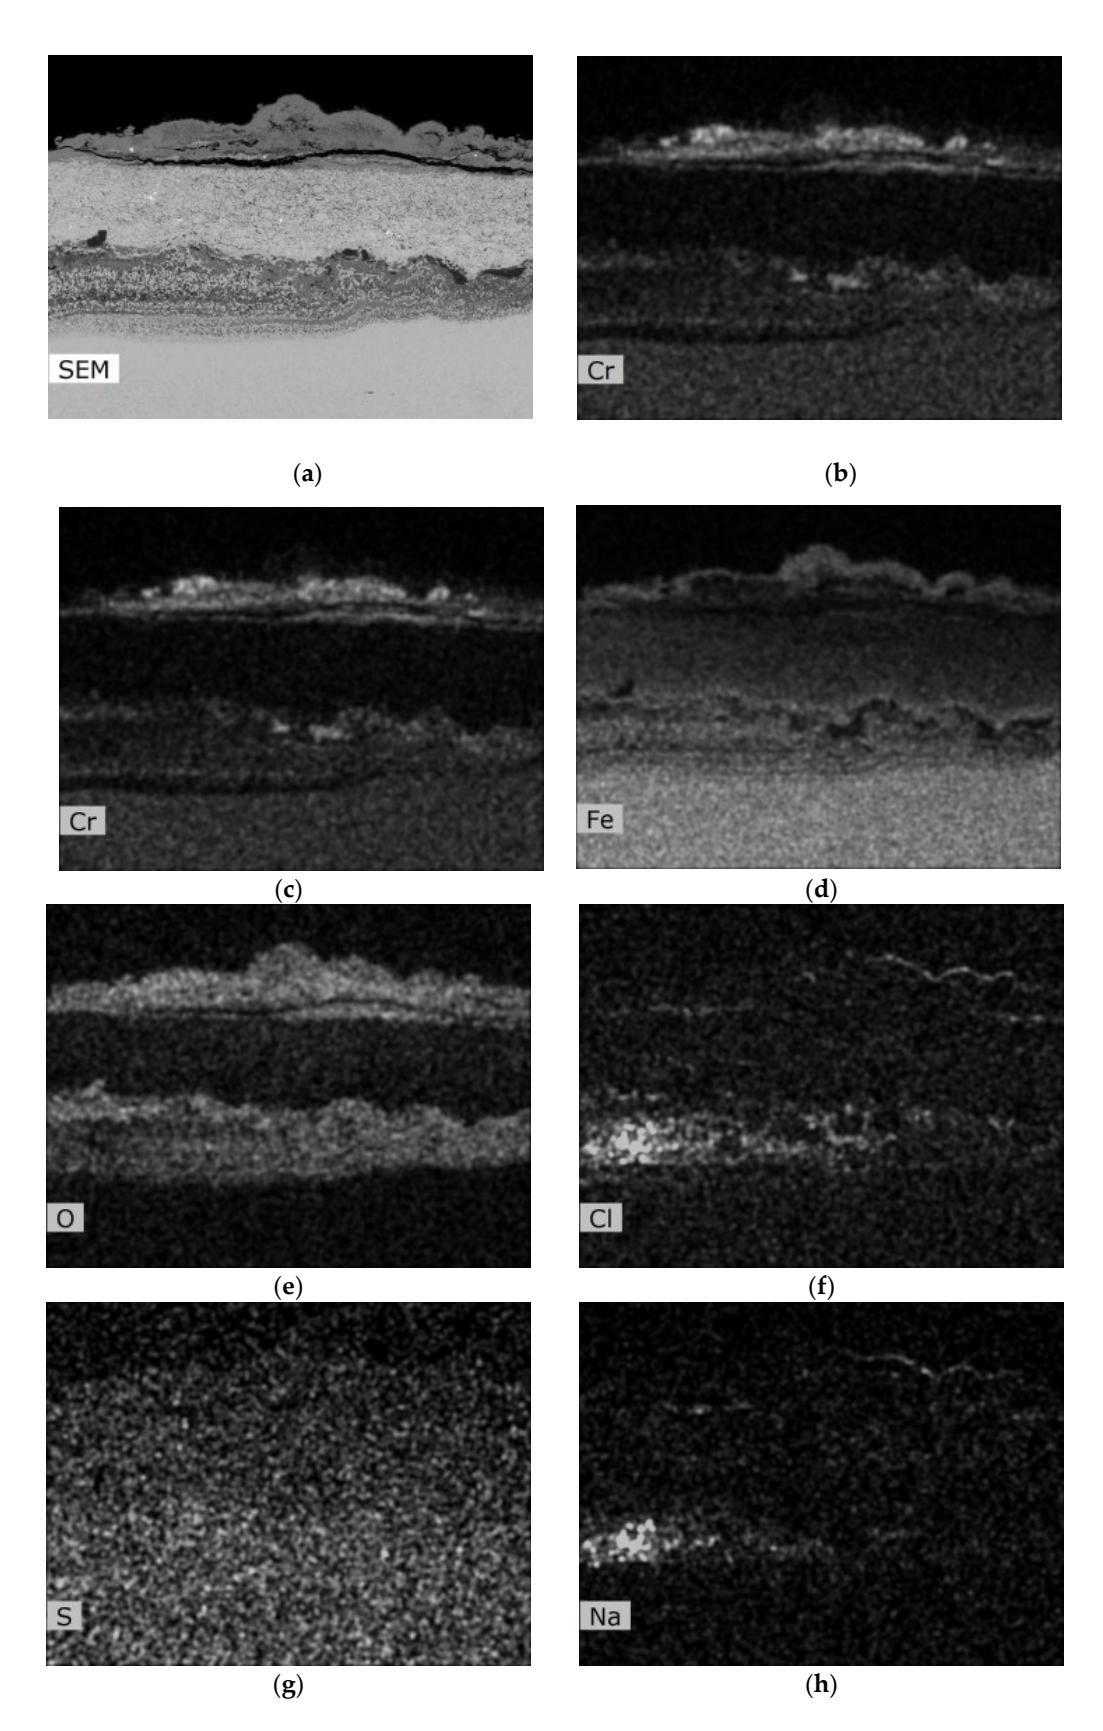
**Figure 12.** EDS analysis images of the CoCrAlYTaCSi-coated specimen (coating with best results in the test); (a) SEM image of the area of EDS analyzes, (b) EDS map of Cr content, (c) EDS map of Al content, (d) EDS map of Fe content, (e) EDS map of O content, (f) EDS map of Cl content, (g) EDS map of S content, (h) EDS map of Na content.

According to EDS analysis of the central coating part, a thin oxide layer based on aluminum was formed on the surface and prevented from or slowed further corrosion attack, see Figure 13; according to the aluminum and oxygen maps shown in Figure 13, the oxide layer consists of alumina, which is to be expected for corrosion-resistant material in an oxidizing environment. It is the formation of a compact alumina layer that is desirable for the successful retardation of corrosion processes [7,24–26]. A structural change (particularly in splats interface) was observed only by a few splats below the coating surface. A deposit containing iron oxides (iron is not a part of the coating composition) was observed on the coating surface. It probably originates from the deposit of corrosion products from the base material.

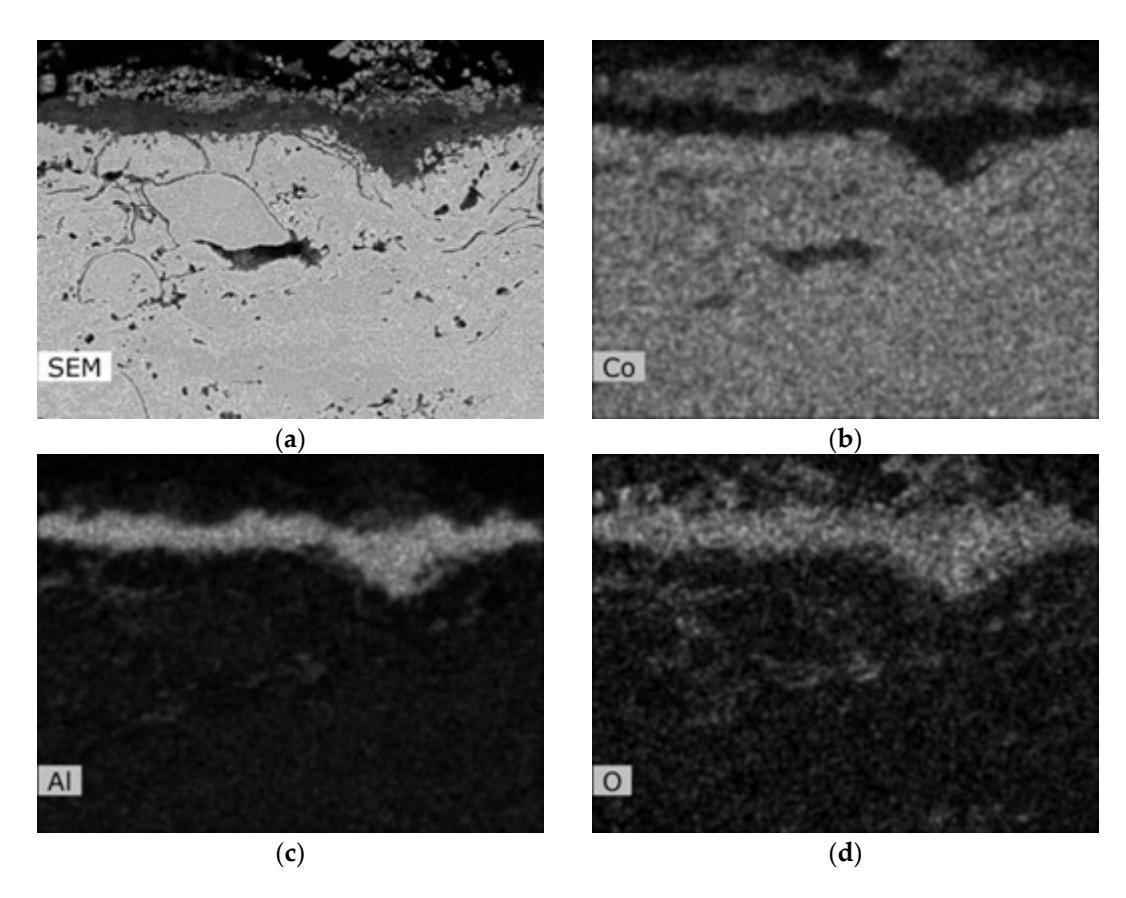
**Figure 13.** EDS analysis images of the CoCrAlYTaCSi-coated specimen (coating with best results in the test)—central part; (**a**) SEM image of the area of EDS analyzes, (**b**) EDS map of Co content, (**c**) EDS map of Al content and (**d**) of O content show presence of continuous protective aluminum-rich oxide layer on the surface.

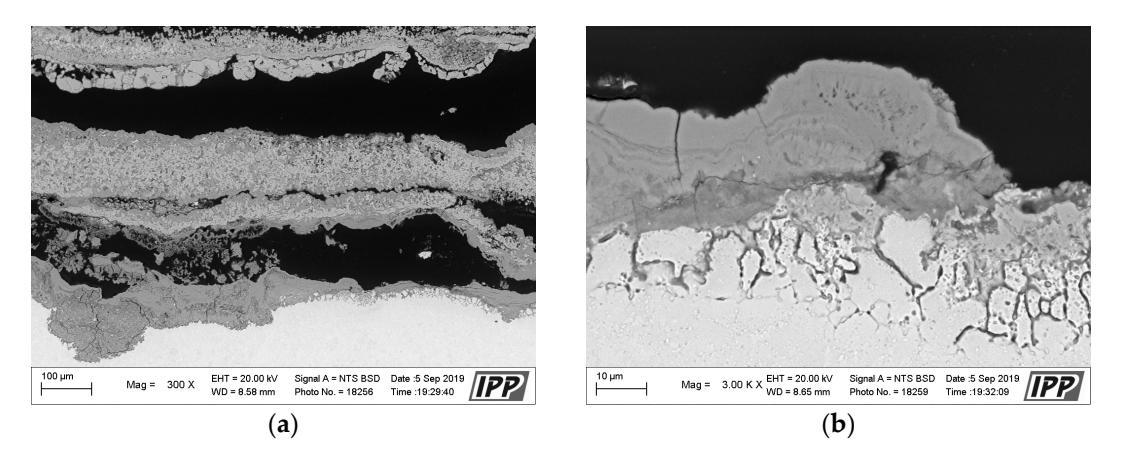
**Figure 14.** EDS analysis images of the P91 steel specimen after exposure to the corrosive environment at (a)  $300 \times$ , (b)  $3000 \times$ .

The corrosion attack on the specimen from all sides can be derived from the layering of corrosion products around the whole specimen. Detailed images of the corrosion attack from the SEM analysis are shown in Figure 14. The uncoated P91 chromium-molybdenum steel specimen showed very low corrosion resistance during the high-temperature corrosion test; see the macroscopic image of the coating cross-section in Figure 15.

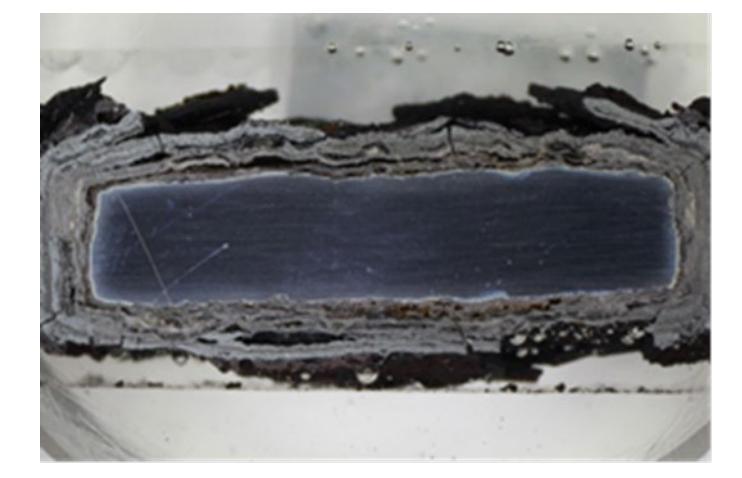
**Figure 15.** Macroscopic image of the cross-section of the P91 steel specimen after exposure to the corrosive environment.

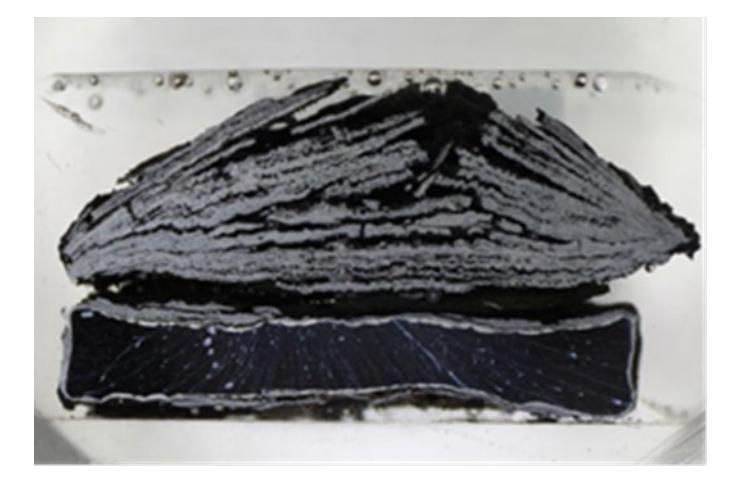
**Figure 16.** Macroscopic cross-section image of the 800 H alloy specimen after exposure to the corrosive environment.

The 800 H alloy specimen showed a very low corrosion resistance in the high-temperature corrosion test in the selected environment. Figure 16 shows the macroscopic cross-section image of the specimen after exposure to the corrosive environment. The specimen lost its original rectangular shape due to the severe corrosion attack. The corrosion products were layered mainly on the coating upper part. Loose deposits of the corrosion products from the other sides of the specimen fell off during handling. Figure 17 shows SEM analysis of the cross-section images of corrosion attack on 800 H alloy.

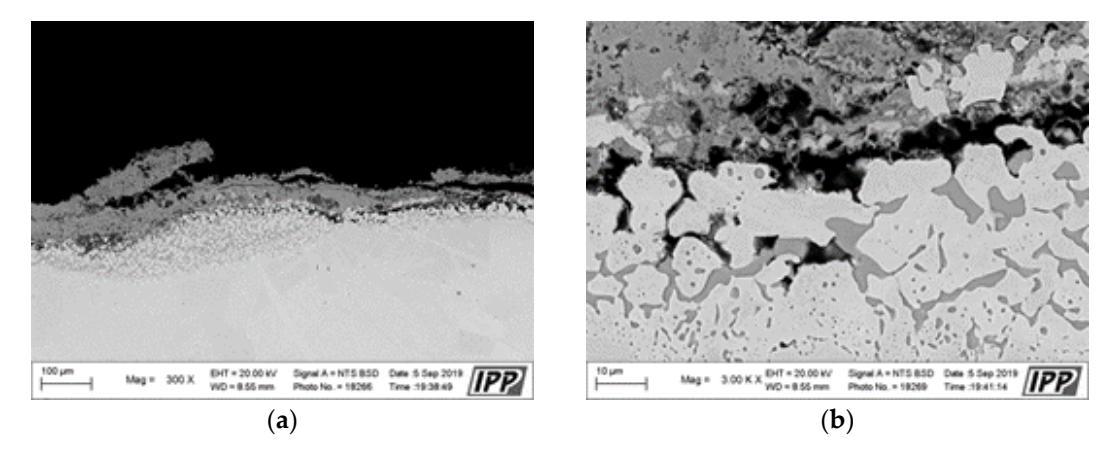
**Figure 17.** SEM analysis images of the cross-section of the 800 H alloy specimen after exposure to the corrosive environment with magnification of (a)  $300 \times$ , (b)  $3000 \times$ .

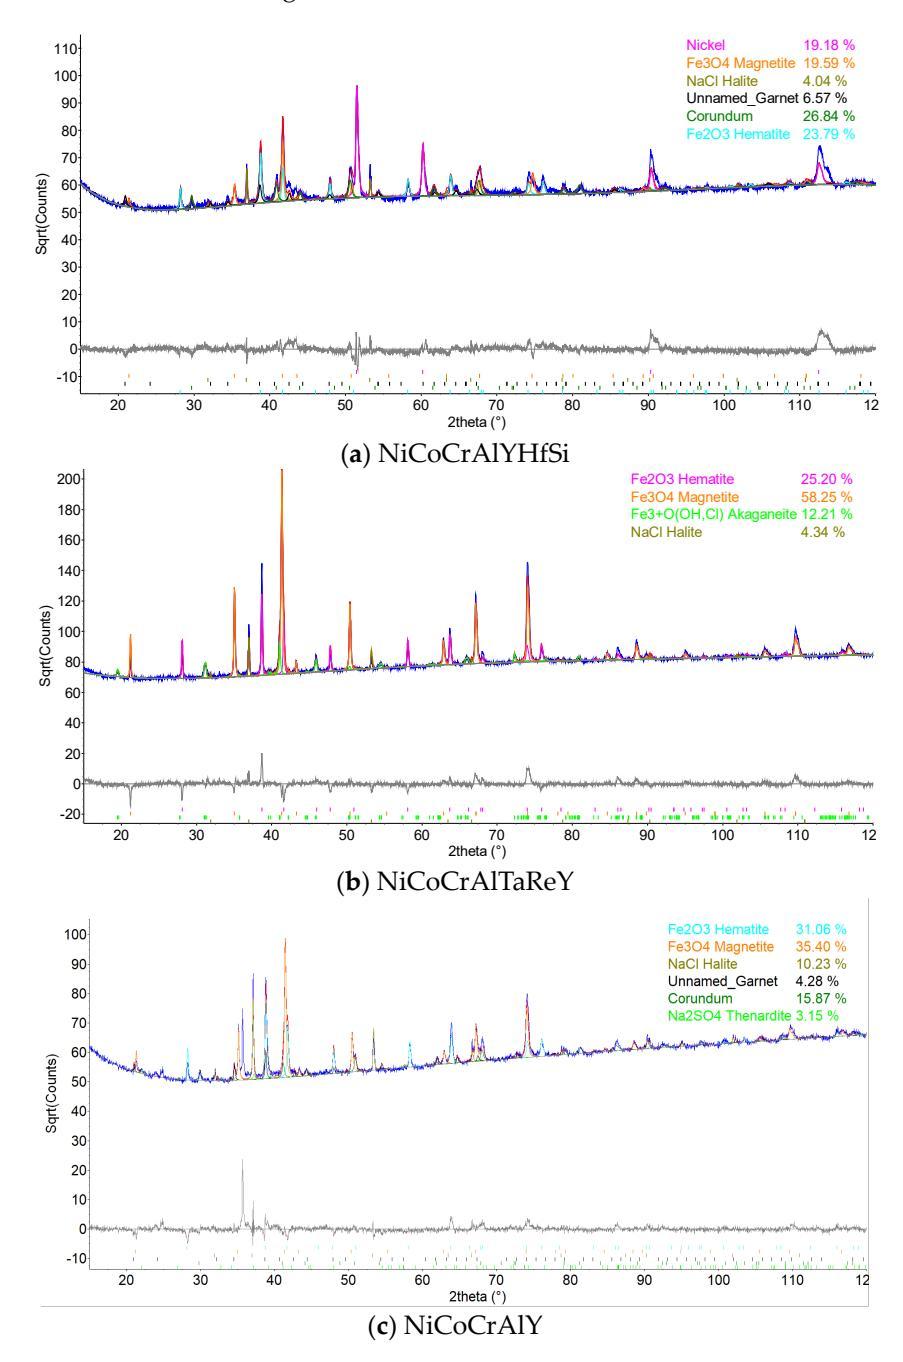
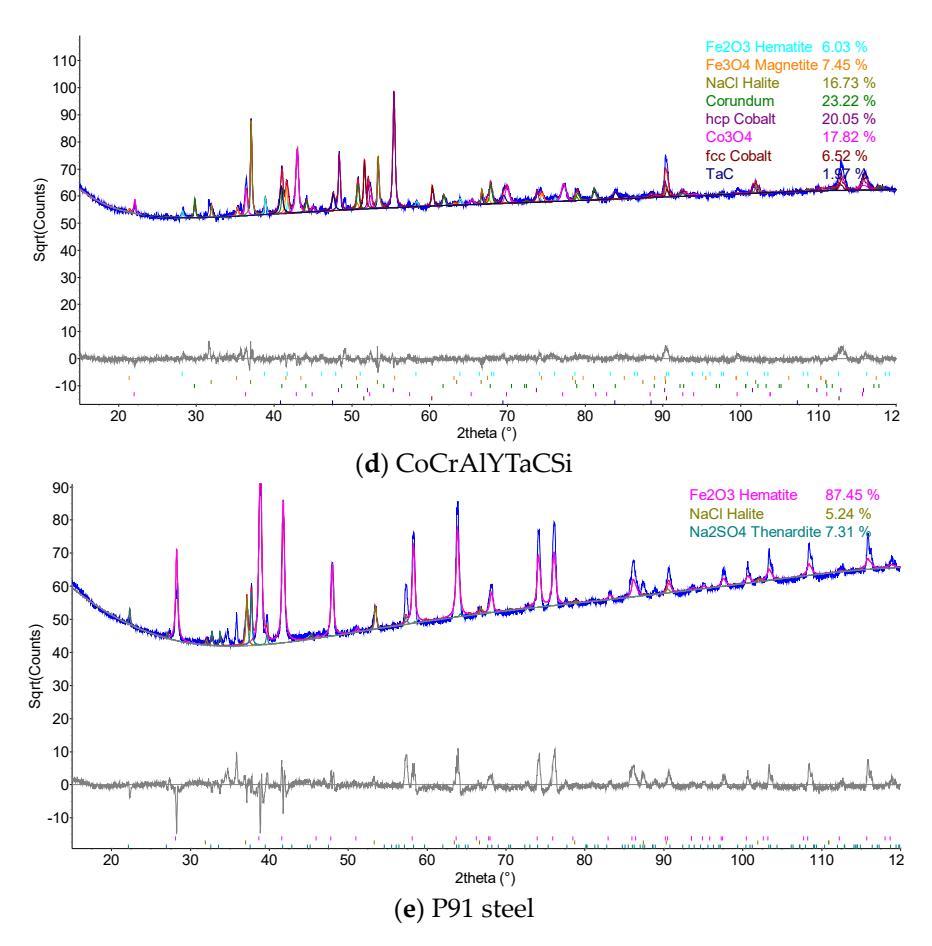
Figure 18. Cont.

**Figure 18.** Phase composition analysis by XRD: (a) NiCoCrAlYHfSi, (b) NiCoCrAlTaReY, (c) NiCoCrAlY, (d) CoCrAlYTaCSi, (e) P91 steel.

A phase composition evaluation by XRD analysis of selected coatings after the corrosion test and steel P91 for reference is depicted in the Figure 18. The detected phases for each specimen are summarized in the Table 1. The analysis was carried out on the surface of the specimen and the penetration depth of the radiation used was approximately

10–30  $\mu$ m. All the samples analyzed contained iron oxide phases in the form of Fe<sub>2</sub>O<sub>3</sub> and/or Fe<sub>3</sub>O<sub>4</sub>, which originated from the P91 steel substrate material. In most cases, sodium sulphate Na<sub>2</sub>SO<sub>4</sub> and sodium chloride NaCl, as remnants of the corrosive environment, were present in minority in all samples. Aluminum oxide Al<sub>2</sub>O<sub>3</sub> was detected in the NiCoCrAlYHfSi, NiCoCrAlY, and CoCrAlYTaCSi coatings, which probably formed an oxide protective barrier. In addition, cobalt oxide in the form of Co<sub>3</sub>O<sub>4</sub> was present in the CoCrAlYTaCSi coating.
