Article Comparison of Wear Resistance of Overlay Welded Layers and Thermal Sprayed Coatings in Real Conditions

Michał Szymura¹, Grzegorz Gąsiorek¹, Artur Czupryński^{2,*}, Waldemar Kwaśny², and Viktor Kvasnytskyi³

Abstract: Tribological tests in real conditions enable obtaining full data on the life of interacting machine parts. This article presents the results of operational tests on the elements of the support ring guidance system in a vertical ball-race mill. The guide and active armour operate under abrasive wear conditions with moderate-impact loads. The wear resistance of elements with overlay welding layers deposited with flux cored wire with a structure of high-alloy chrome cast iron and with a coating flame-sprayed with nickel-based powder was compared. The wear intensity of the overlay weld deposits was much lower than that of the sprayed coatings. The scope of this study also included the analysis of the chemical and phase composition, macro- and microscopic metallographic examinations, and the measurement of the hardness of the deposited layers and coatings.

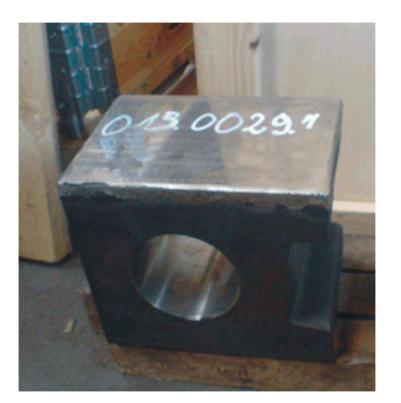
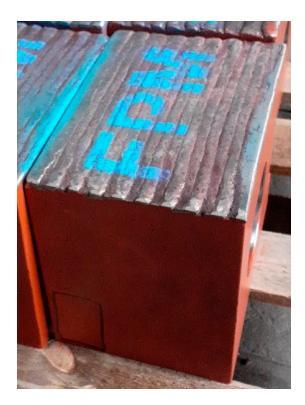
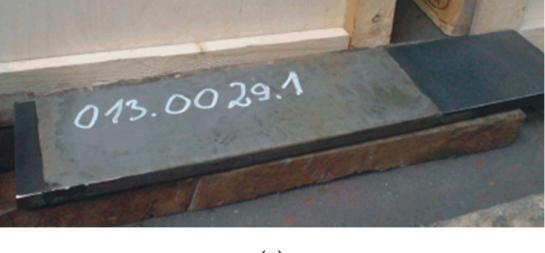
Figure 1. Images of (**a**) guide with a thermal sprayed coating; (**b**) guide with a flux cored arc surfaced layer; and (**c**) active armour with a thermal sprayed coating.

For operational tests, two sets (guide and active armour) of the EM-70 mill thrust ring guidance system manufactured by FPM were made. The guides are made of cast steel for general engineering uses, GS240 according to EN 10293 [25], and the active armour is made of non-alloy structural steel, S235JR according to EN 10025-2 [26]. The chemical composition and mechanical properties of these material are provided in Tables 1 and 2. The working surfaces of the elements of the first set were surfaced with self-shielded flux cored wire SK A43-O produced by voestalpine Böhler Welding (Voestalpine AG, Linz, Austria), ensuring an overlay weld deposit of high-alloy chrome cast iron, Fe15 according to EN 14700 [27]. This wire is recommended for protecting surfaces exposed to intense abrasive wear with moderate- and high-impact load. The chemical composition and hardness of the weld deposit of the filler material are provided in Table 3. Metco 15E powder from Oerlikon Metco (OC Oerlikon Corporation AG, Pfäffikon, Schwyz, Switzerland) was used to flame spray the surface of the guide and the active armour of the second set. According to the manufacturer, coatings that are thermally sprayed with Metco 15E powder are resistant to

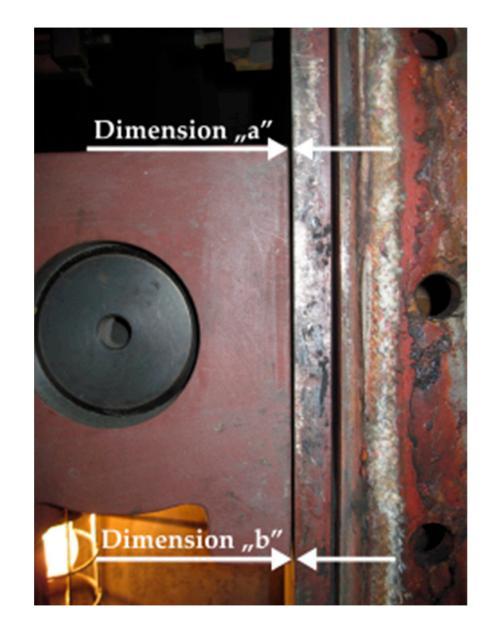
Figure 2. Location of a pair of measurements of the size of the gap between the guide and the passive armour.

Operational tests of two sets of support ring guidance systems were carried out in the EM-70 ball-race mill located in a combined heat and power plant powered by hard coal. The tests were performed in real conditions during the standard operation of the heat and power plant. The wear resistance of the made layers and coatings was defined as the operating time (in hours) per unit of wear (corresponding to the size of the structural gap between the guide and the passive armour). The larger value of the pair of gap width measurements in the upper and lower areas was considered as the gap size (Figure 2).

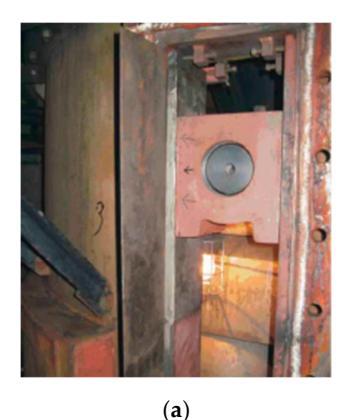
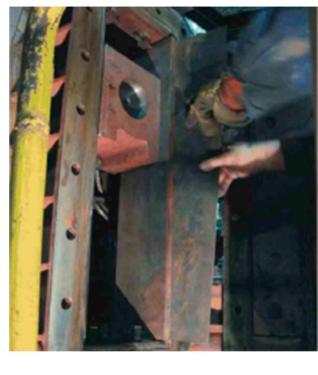
Figure 3. Installation of the guide and active armour with a sprayed coating in the guide chamber: (a) view of the installed elements and (b) adjustment of the gap between the guide and the passive armour.

The correct installation of the guidance system and its appropriate adjustment during the mill's operation period requires maintaining the mentioned construction gap in the range of 2 ± 1 mm. The gap width measurements were performed during scheduled mill inspections, i.e., approximately every 700–800 h of operation. In accordance with the technical and operational documentation, in order to assemble the guide set, the guidance chamber was opened, and the previous guide and active armour were demounted. Then, the guiding set with the sprayed coating was installed, Figure 3a, and the construction gap was established, Figure 3b. Before closing, the conduction chamber was sealed. The same procedure was followed for the set with the overlay welded layer.

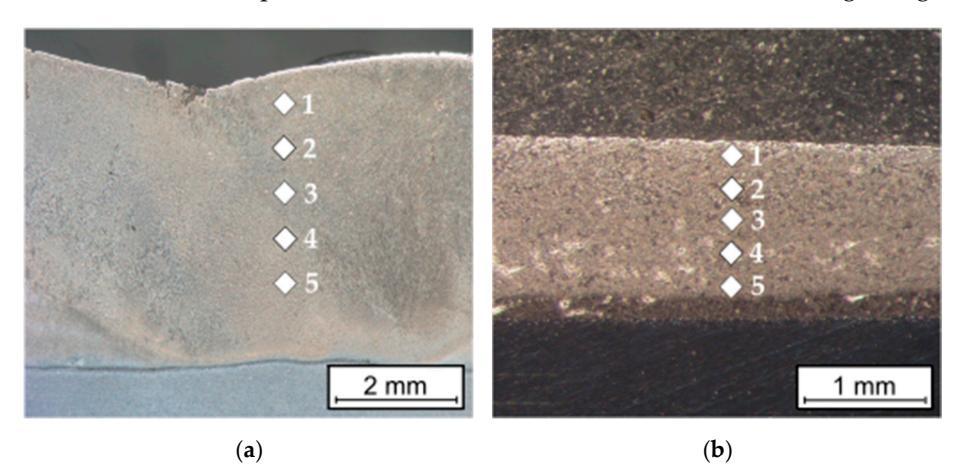
Figure 4. Pictorial diagram of the location of hardness measurement points on the cross-sectional surface of (**a**) the overlay welded layer and (**b**) sprayed coating.

The hardness measurements of the overlay welded layer and the sprayed coating were carried out using the Vickers method at a load of 2.942 N, in accordance with the ISO 6507-1 [28] standard using the Future-Tech FM-ARS 9000 hardness tester with an automatic measurement line and an image analysis system (Future-Tech Corp., Kawasaki, Japan). Measurements were performed on the cross-sectional surface according to Figure 4.

M - (1 - 1	T'11	Hardness Measurement Point HV0.3 According to Figure 4						
Method	Filler Metal	1	2	3	4	5		
Self-shielded flux cored arc surfacing Flame spraying	SK A43-O Metco 15E	928 634	965 616	1067 579	864 640	837 714

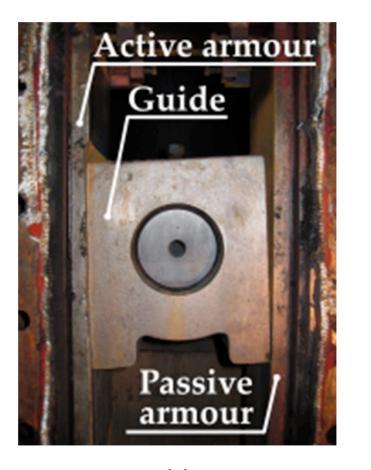
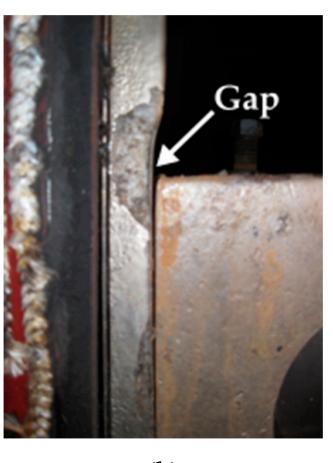
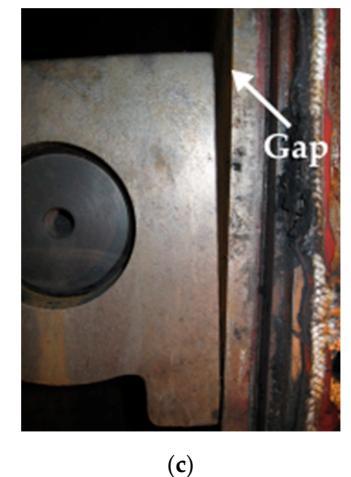
Figure 5. Guidance system with thermal sprayed coatings after 1578 h of operation: (**a**) view of the entire system, (**b**) view of the gap between the guide and the active armour, and (**c**) view of the gap between the guide and the passive armour.

The set with thermal sprayed coatings was used for 1578 h and was dismantled because after that period the gap between the guide and the passive armour was 11.0 mm, and this could result in an improper operation of the mill. At 748 h after installation, the gap was adjusted, which was 6.7 mm in the upper area and 2.8 mm in the lower area. In both periods of operation (after 748 h and after 1578 h), the sprayed coating wore out unevenly. The sprayed coating was abraded on the analysed elements (Figure 6), which resulted in a significant increase in the intensity of wear. After the overwearing of local coating (holes formed in the base material), the guide was further localized into the active armour, and as a result, the construction gap reached a value of 11.0 mm. Small areas of adhering

ground carbon were visible on the surface of the sprayed coatings. The determined wear resistance of the set with sprayed coatings was 159 h/mm for the first period (748 h into the operation from installation) and 92 h/mm for the second period (another 830 h after installation). In both analogous periods, the wear resistance of the sprayed guidance system was much lower than that of the overlay welded system. In the study [7], thermal sprayed coatings with the composition of a nickel alloy with fine borides and carbides also showed a lower abrasion resistance than the hardfacing layer with the structure of high-alloy chrome cast iron.

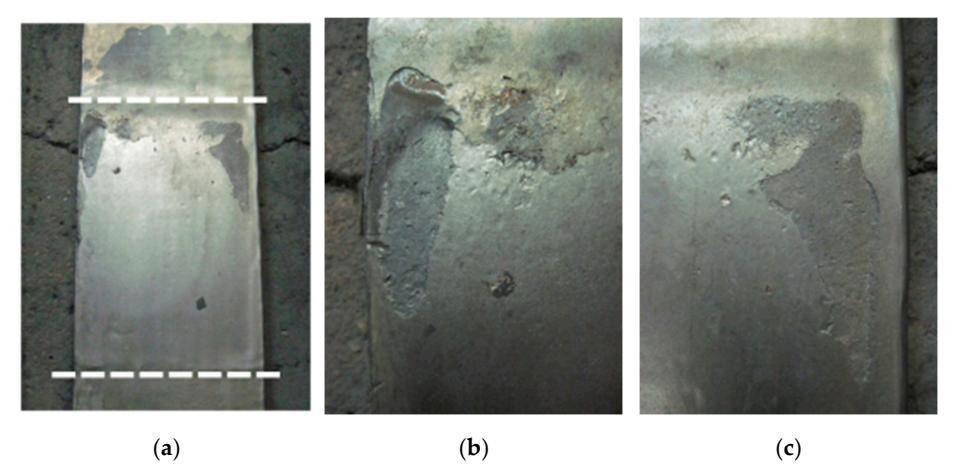
Figure 6. Active armour with a flame-sprayed coating after 1578 h of operation: (**a**) view of the coating with the working area of the friction pair marked (white-dashed lines) and (**b**,**c**) view of the coating in the areas with the greatest wear.

The aim of the study was to compare the wear resistance of layers and coatings applied to guides and active armour in real conditions. The results of measurements of the gap width in relation to the operating time of the analysed guide sets and the determined wear resistance are presented in Table 7. A view of the guidance system with sprayed coatings after 1578 h of operation is shown in Figure 5, and the view of the sprayed active armour after disassembly (after 1578 h of operation) is shown in Figure 6.

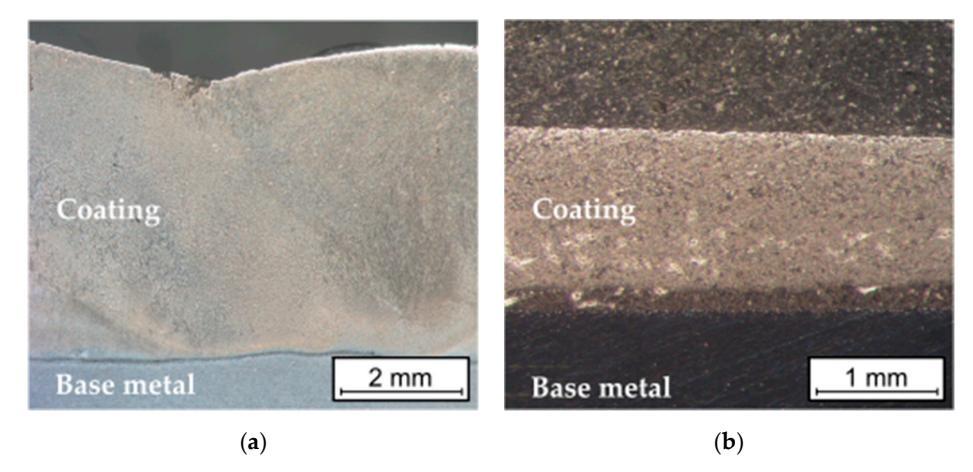
Figure 7. Macrostructure of (a) self-shielded flux cored arc surfacing layer and (b) flame-sprayed coating.

The metallographic tests carried out did not reveal any defects in the applied layers and coatings, Figure 7.

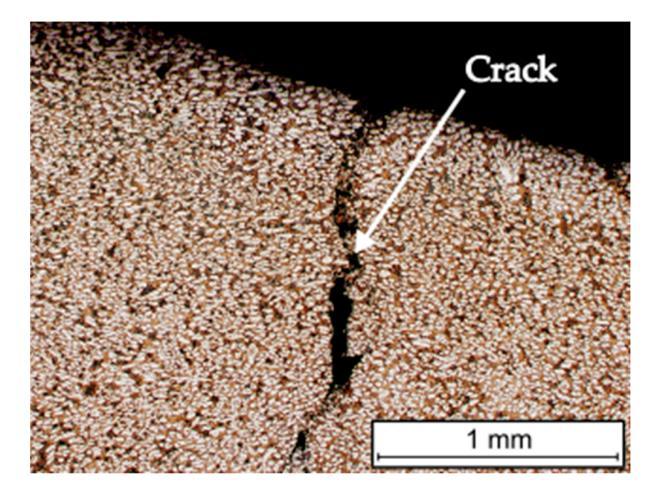
Figure 8. View of a crack in a layer produced by self-shielded flux cored arc surfacing.

The cracks were found in the overlay welded layer (Figure 8), which ran perpendicular to the direction of deposited beads and did not penetrate the base material. These types of cracks (relief-check cracks) enable the relaxation of stresses arising from the solidification and cooling of the layer during the overlay welding process. In surfaced layers with chromium cast iron alloys intended for operation in abrasive wear conditions with low-impact loads, cracks are permissible if they do not penetrate the base material, are not oriented parallel to the fusion surface, and do not lead to the detachment of fragments of the welded layer [30–32]. In tribological tests, where abrasion occurs under high pressures or significant impact loads, the uneven wear of the weld deposits could occur as a result of fragments being chipped off [9,30]. No cracks were observed in the sprayed coatings. Both

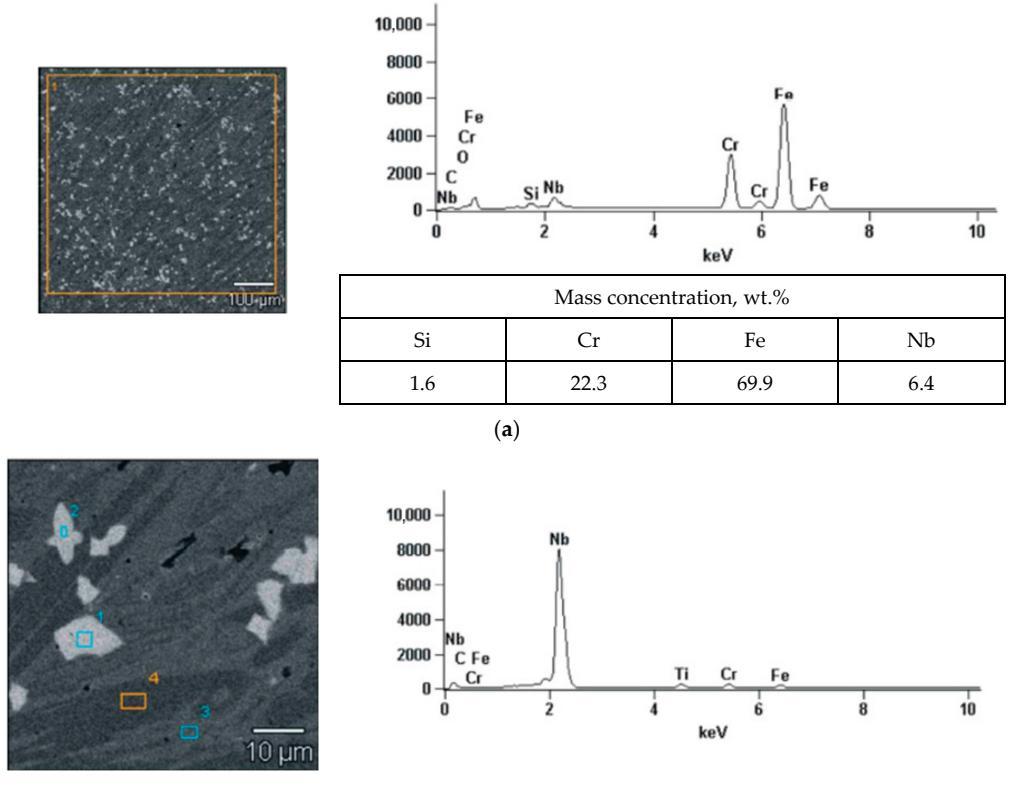
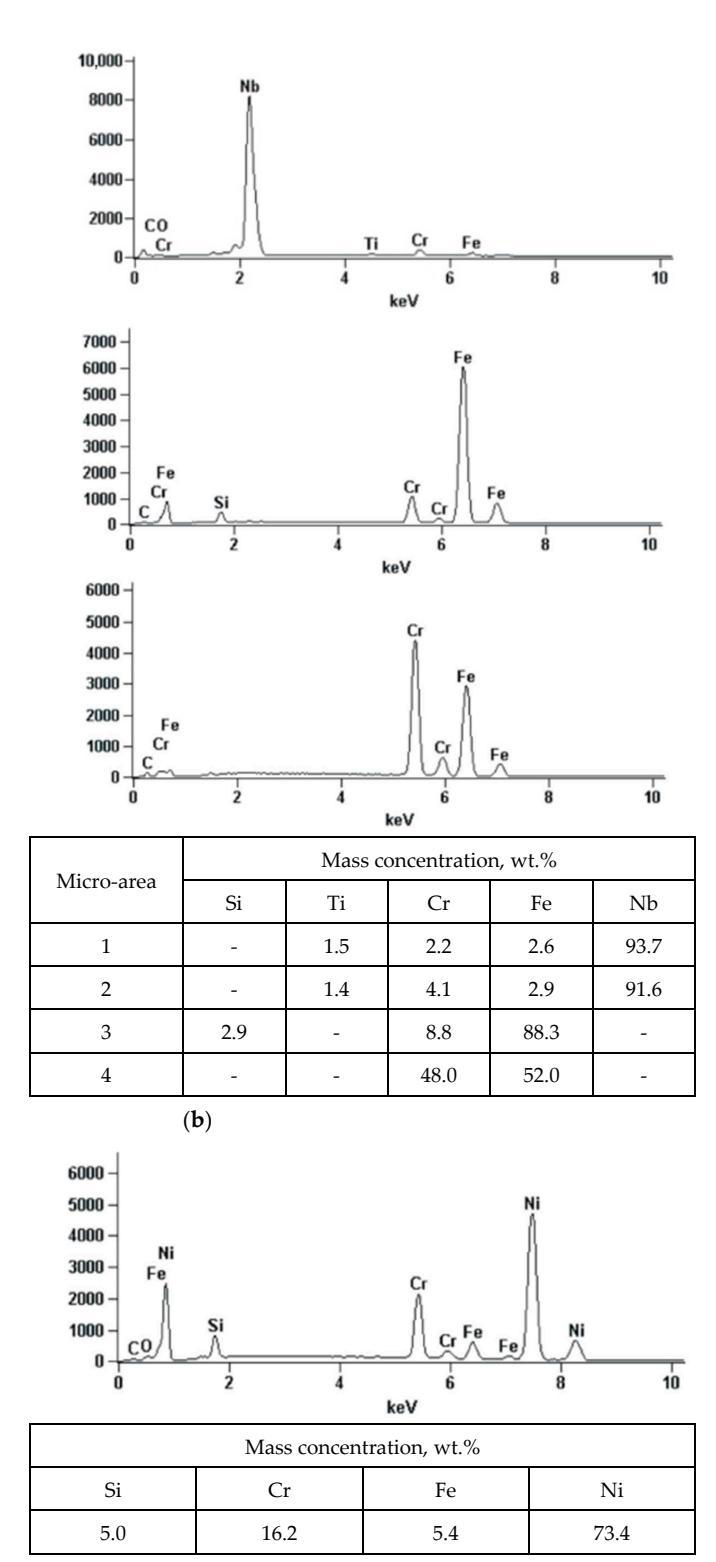
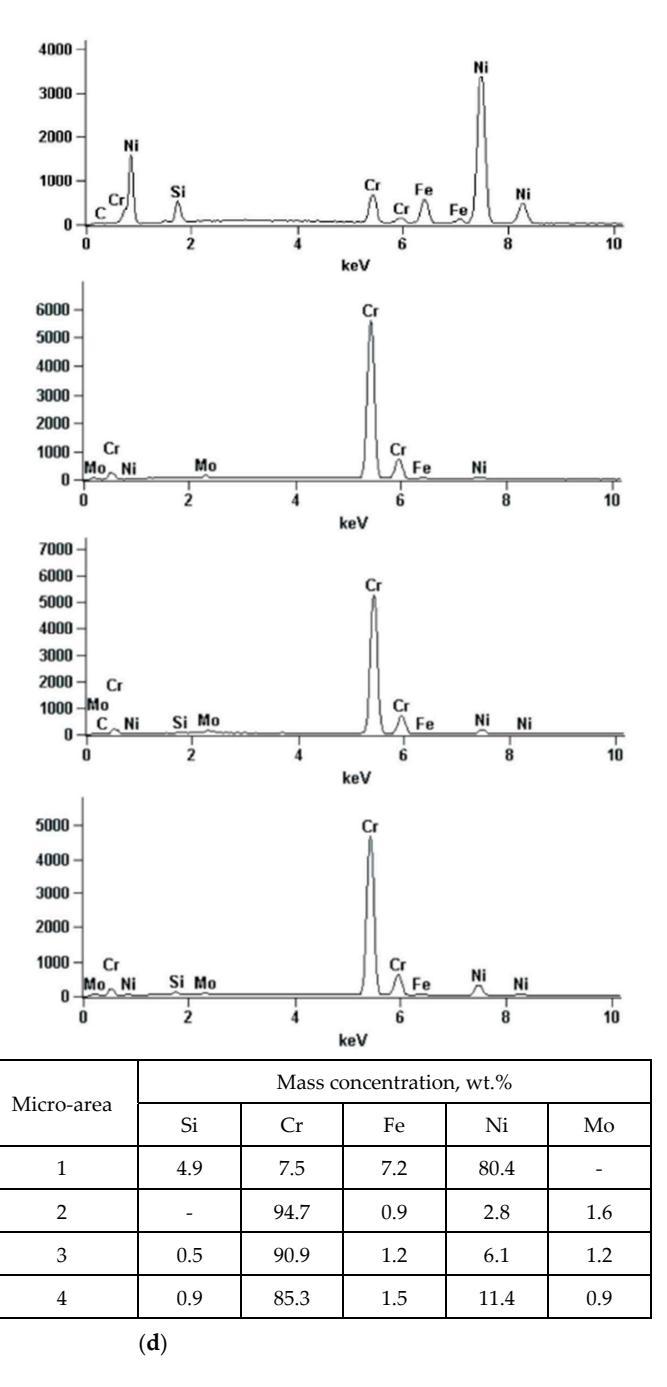
Figure 9. The examined micro-area along with the results of the analysis of the chemical composition of EDS: (**a**,**b**) self-shielded flux cored arc surfacing layer and (**c**,**d**) flame-sprayed coating.

Based on the analysis of the chemical composition (Figure 9) and the identification of the phase composition (Figure 10), as well as microscopic metallographic examinations (Figure 11), it was possible to conclude that the overlay weld had a structure composed of larger Cr_7C_3 carbides and smaller NbC carbides in an austenite matrix. The sprayed coating consisted of CrB borides and Cr_7C_3 carbides in a matrix of γ -Ni solid solution and Ni₃B. According to Kim et al. [35], melting the sprayed Ni-Cr-B-Si-C coating results in obtaining CrB and Cr_7C_3 . The analysis of the chemical composition in micro-areas (Figure 9) indicated the occurrence of Si mainly in the matrix of the γ -Ni solid solution.

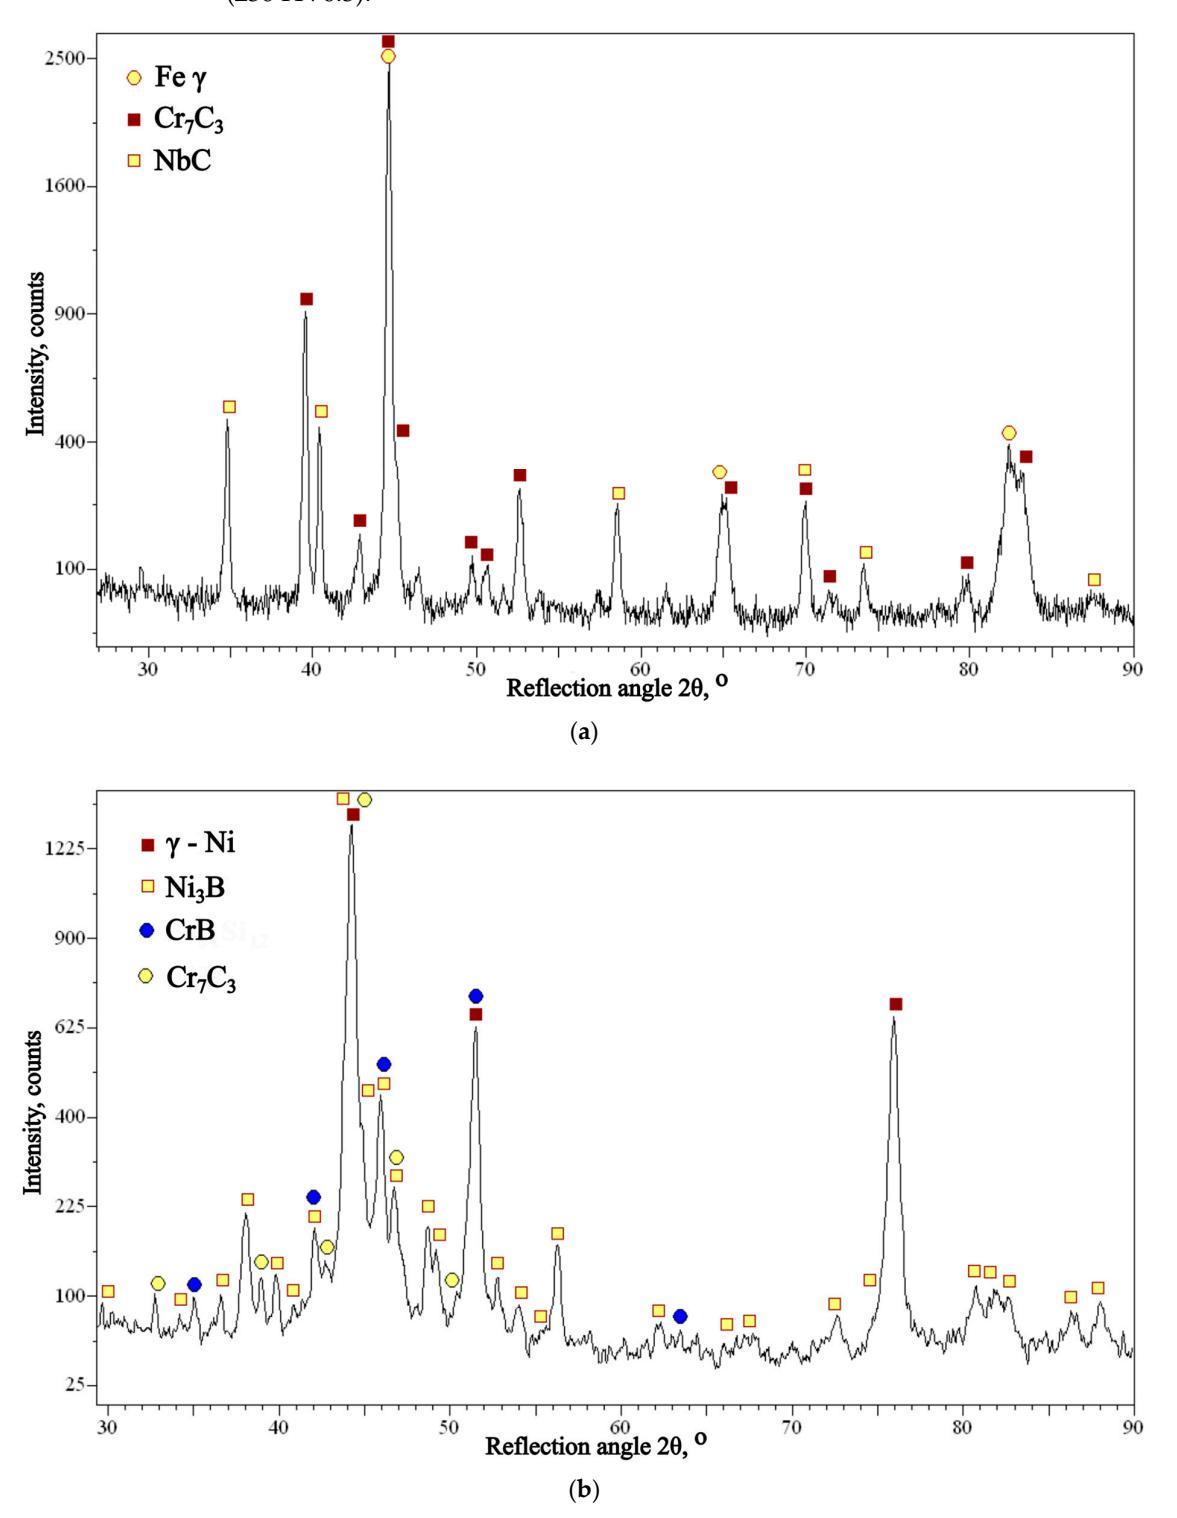
Figure 10. X-ray diffractogram of (a) self-shielded flux cored arc surfacing layer and (b) flame-sprayed coating.

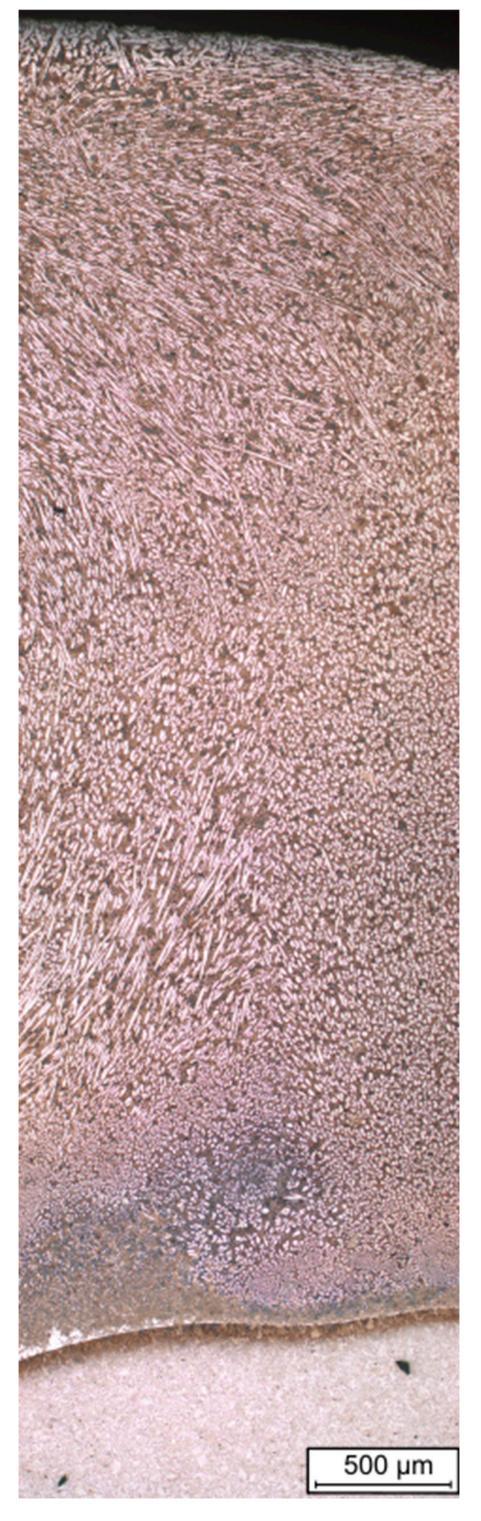
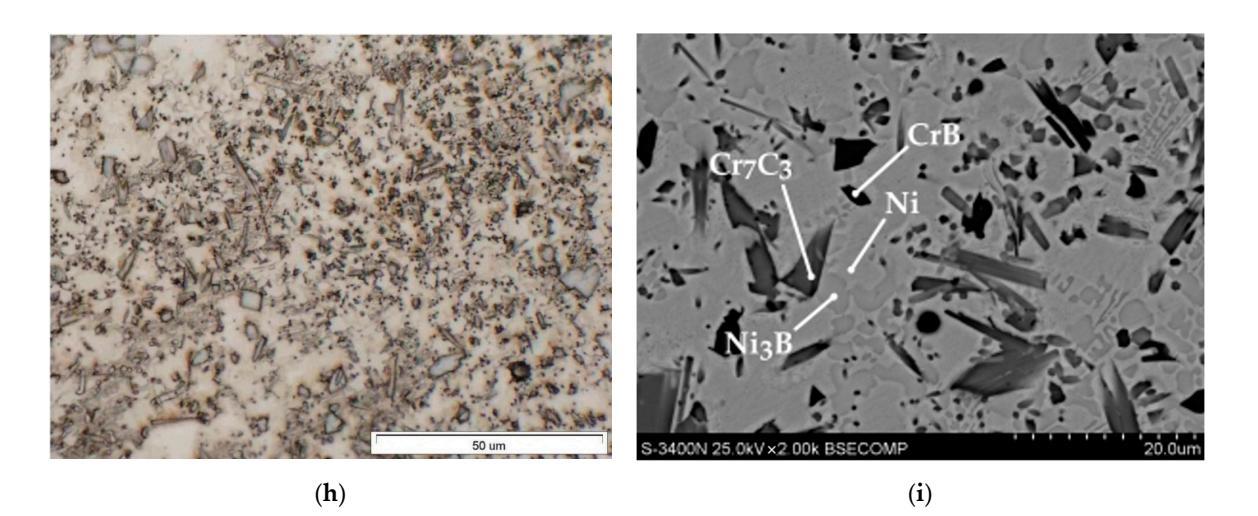
Figure 11. Microstructure of (**a**–**e**) self-shielded flux cored arc surfacing layer and (**f**–**i**) flame-sprayed coating.

overlay welded layers and thermal sprayed coatings are properly bonded to the substrate material. The sprayed coating was completely melted, which proves that the melting process was carried out correctly [22,33]. There was no melting of the surface of the base material of samples flame-sprayed with the powder. The coating had a homogenous and non-lamellar structure, which is characteristic of sprayed coatings [34].
