# Article Condition Monitoring of Horizontal Sieving Screens—A Case Study of Inertial Vibrator Bearing Failure in Calcium Carbonate Production Plant

Jacek Wodecki 💿, Pavlo Krot \*🗅, Adam Wróblewski 🗅, Krzysztof Chudy 🗅 and Radosław Zimroz 🕩

Faculty of Geoengineering, Mining and Geology, Wroclaw University of Science and Technology, Na Grobli 15, 50-421 Wroclaw, Poland

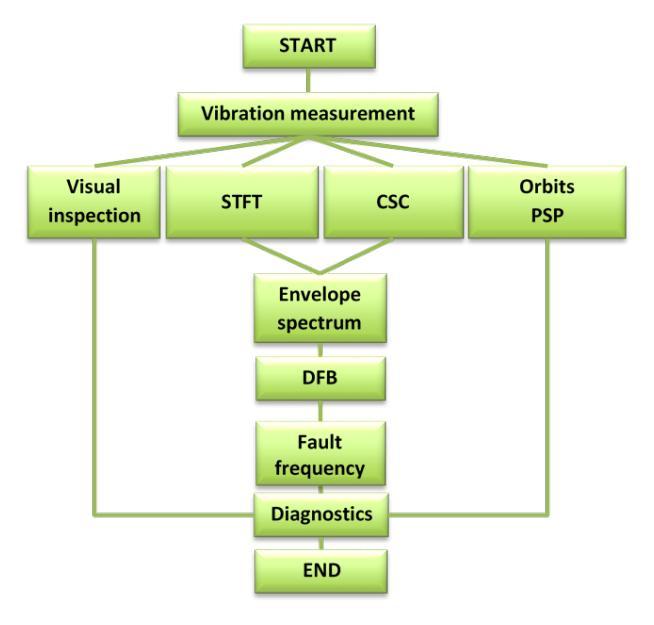
**Figure 1.** The scheme of diagnostics methodology: STFT—short FFT; CSC—cyclic spectral coherence; PSP—phase space plot; DFB—diagnostic frequency band.

The scheme of the research methodology is depicted in Figure 1. It includes vibration measurement, with accelerometers on the bearings of the vibrating screen taking signals in two orthogonal directions. Then, several methods are applied to the raw data, namely visual analysis of time series, short FFT, cyclo-maps, and orbits with phase space plots building. The envelope function is also appropriate for data analysis. Based on the results

obtained in the frequency domain, the diagnostics frequency band is determined to contain different ranges, including the characteristic frequencies of bearings defects. After that, the conclusion about the sources of high-amplitude components is derived and the final diagnosis is formulated. Until the dismounting and inspection of machine units, the diagnosis remains to be a hypothesis.

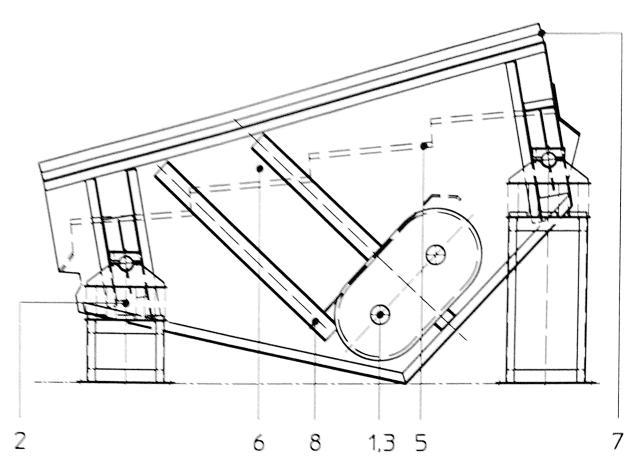
Figure 2. The overall side view of the vibrating sieving screen.

The whole view of the investigated vibrating sieving screen is shown in Figure 2. It consists of shafts with bearings (1, 3); Cardan couplings (4); spring supports (2); grizzly deck (5); side walls with protection (6); and reinforced bars (7). Electric motors of 30 kW power and 1470 RPM rotation speed (situated on the opposite side) are connected with two unbalanced vibrators by the Cardan shafts, providing technological excitation of the screen. The vibrators are dynamically synchronized without kinematic links between them. This is the most typical design of vibrating screens used in the calcium carbonate plant of Omya Group and other enterprises of the mineral processing industry. The only difference there can be is belt drives instead of Cardan shafts. The overall top view of the screen with sensors placement is shown in Figure 3.

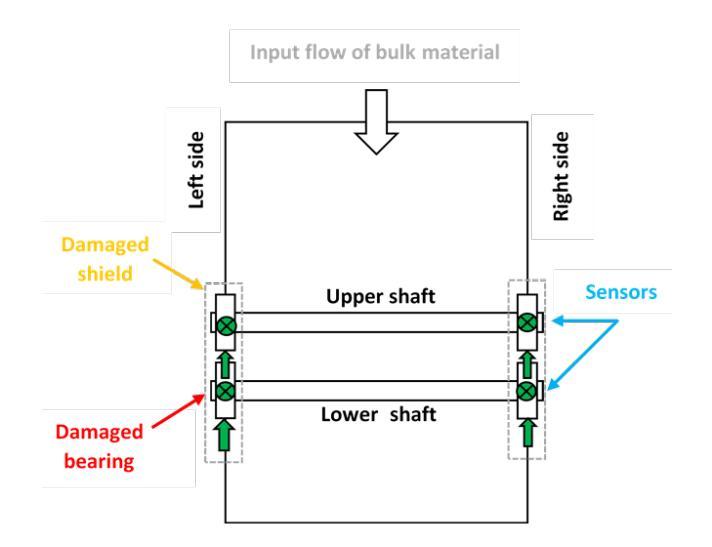
**Figure 3.** The overall top view with sensors placement and position of damaged bearing and vibrator shield.

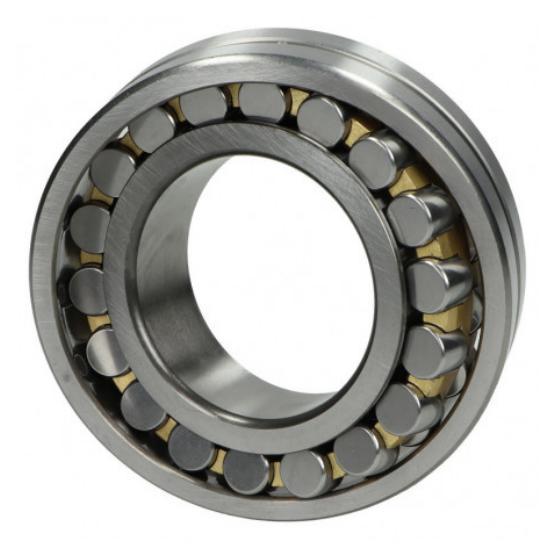
**Figure 4.** The special series spherical roller bearings (SKF22324VAJ): basic static load—1120 kN; dynamic load—850 kN; and limiting speed—2000 RPM.

The special series SKF 22234 VAJ spherical roller bearings (see Figure 4) installed on the vibrators' shafts can accommodate heavy loads in both directions. They are self-aligning and compensate shaft misalignment and deflections, with virtually no increase in friction or temperature. Nevertheless, these elements of vibrators are subjected to high loads and cyclic fatigue. By the specification of the producer (SKF), bearings for the vibrating sieving screen have greater than normal clearances, which play the most important role in their durability [73,74].

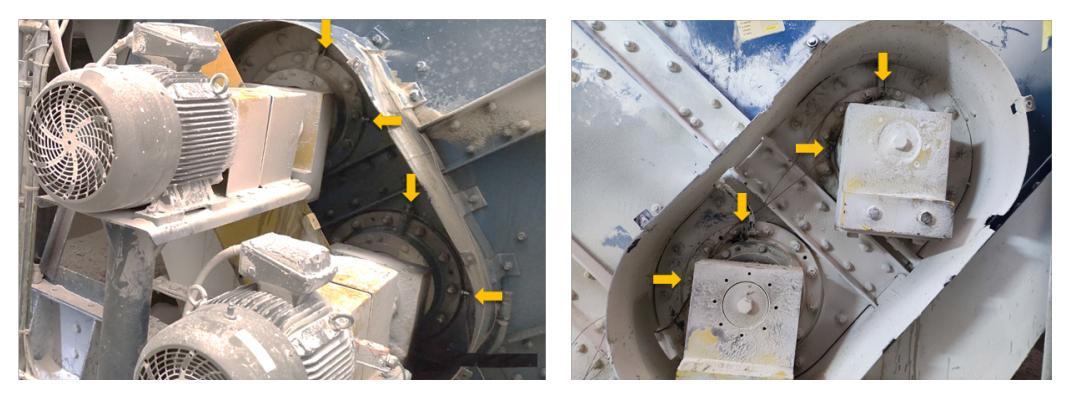
Figure 5. Vibration sensors' (accelerometers) placement on the upper and lower shafts of the vibrating screen.

Measurements were made using the Kistler LabAmp 5165A data acquisition system, Kistler 8702B500 accelerometers, and Bruel & Kjaer 4189 microphone. The places and directions of the accelerometers' installation on both sides of the screen are shown in Figure 5. The sampling frequency of both vibration and sound signals was 50 kHz. The acoustic signal contains all effects from the loudest environmental sources. For this reason, the audio record is only used to validate the main machine operation cycles of shaft rotation observed in the vibration data, since the rotation sensors were not used in these experiments. The raw signals collected on the machine (before bearings replacement—with expected bearings problems—and after bearings replacement with new bearings installed) are presented in Figures 6 and 7. The measurements were taken on the left and right sides of the screen, in two directions.

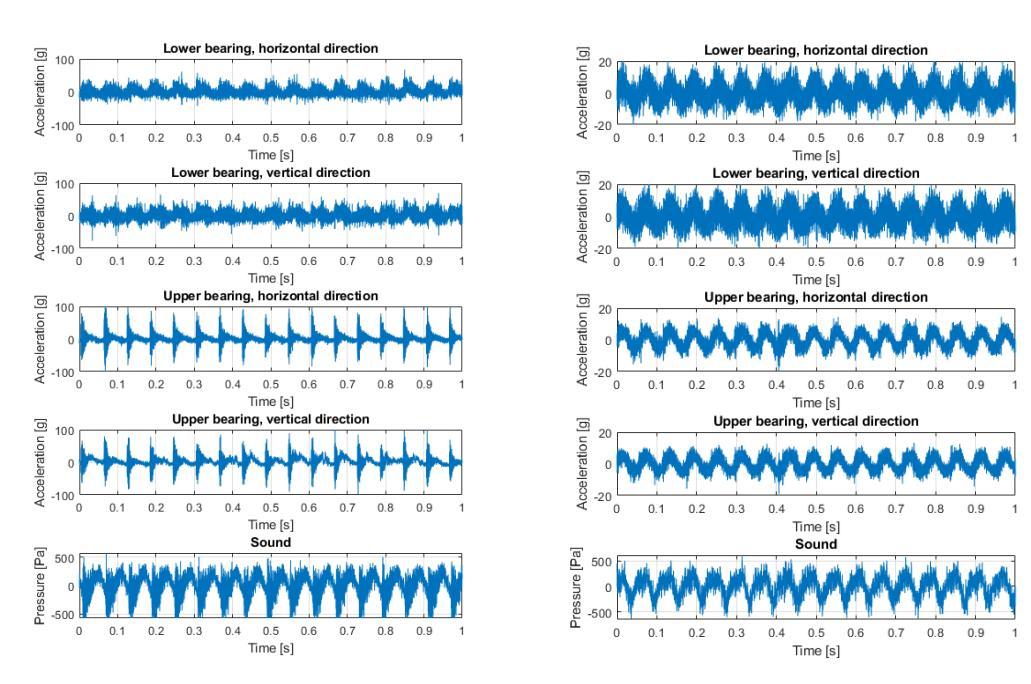
(a) Raw signals, left side before repair.(b) Raw signals, right side before repair.Figure 6. Raw signals : left and right side before repair.

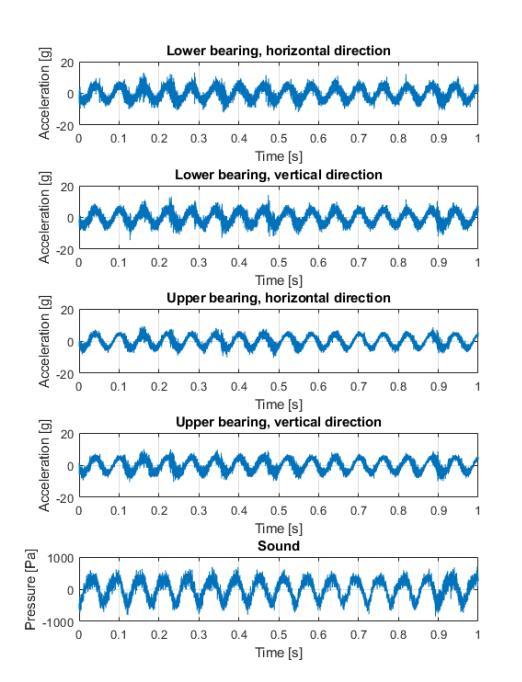
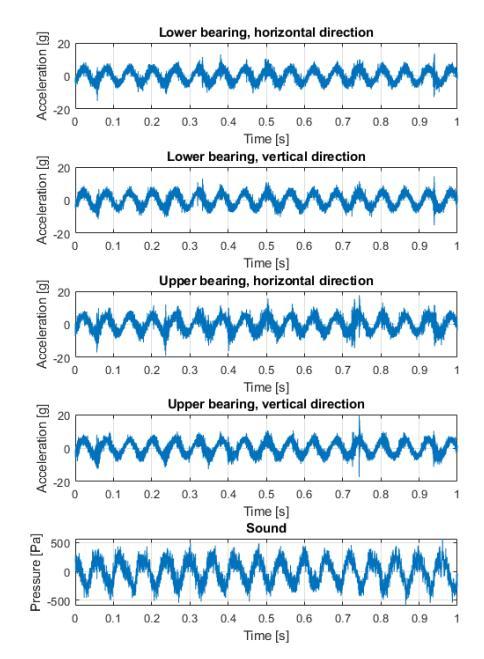
(a) Raw signals: left side after repair.

(b) Raw signals: right side after repair.

Figure 7. Raw signals: left and right side after repair.

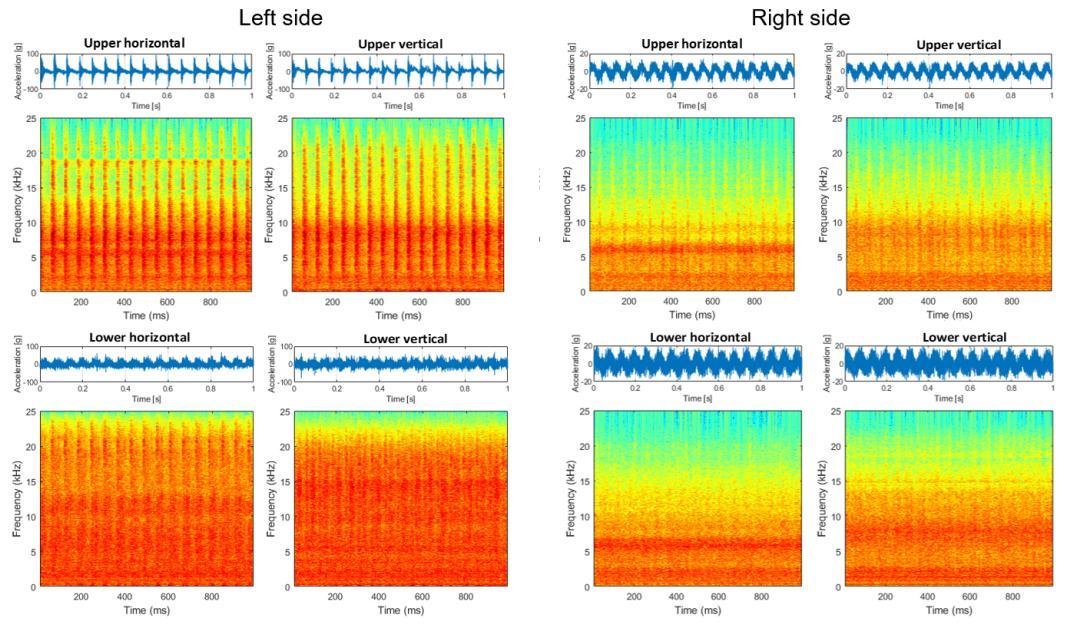
Signals from the screen are highly nonstationary, thus time–frequency analysis is a reasonable approach to understanding the properties of the signal. In Figure 8, signals and the corresponding spectrograms of these signals are presented. It is seen that signals from the left side (both horizontal and vertical directions of the upper left bearing) are highly dominated by cyclic impulses. The period of these impulses is related to rotational frequency, and the reasons for these impulses are mechanical shocks. It is also seen on the upper bearing on the right side (vibration transmission effect), as well as on the lower left bearing. This phenomenon is barely observed on the lower right bearing, as the distance between excitation and the sensor is the biggest in all cases. It is worth noticing that the

lower left bearing generates a lot of noise (in the sense of amplitude as well as spectral content—it is more wide-band than other signals).

Figure 8. Signals and spectrograms before repair.

To compare signals before (Figure 8) and after repair with damaged bearing replacement (Figure 9), in the latter case, all time series are similar; there are some minor differences in time–frequency maps, but one may approximately conclude they are almost the same (level and spectral structure).

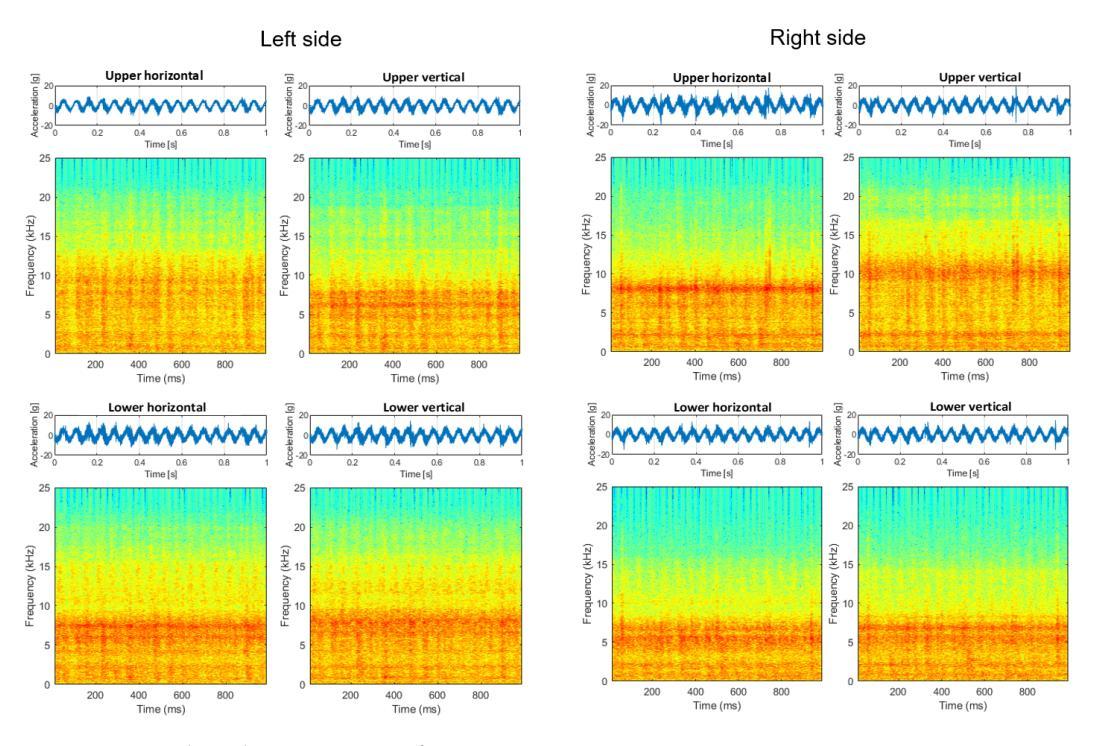
Figure 9. Signals and spectrograms after repair.

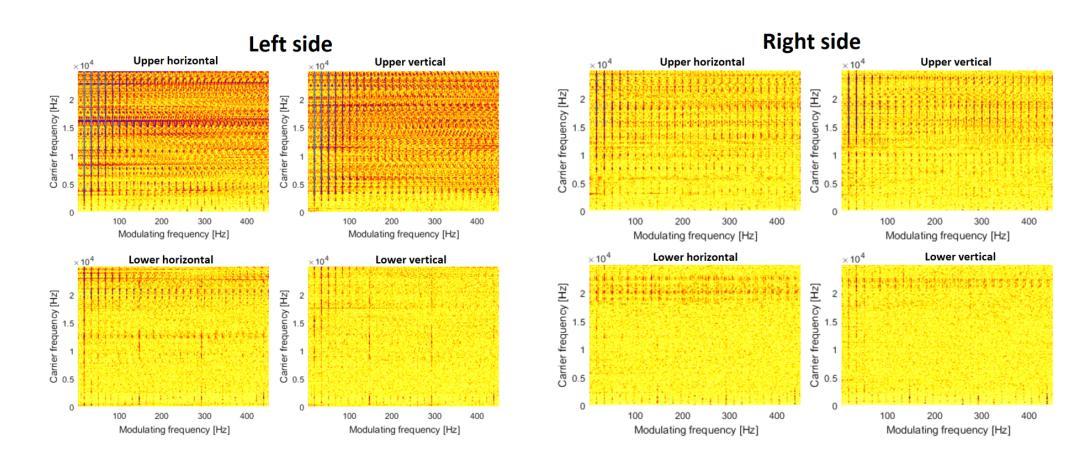
The time–frequency map allows us to understand spectral content and its variation over time, but to identify nonlinear modulation between components, it is better to use the CSC map presented in Figures 10 and 11. In Figure 10, by analogy to spectrograms, one

may see a family of modulating harmonics, however, there are two sources of modulation. First, it is seen that cyclic impulses in the time domain cause amplitude modulation. The carrier band is really wide, and modulating frequency is related to shaft rotation. This signature is present in each CSC map, the most significant modulation is visible in pictures related to the left upper bearing. The second source of modulation is related to the faulty bearing. The fault frequency is equal to 141 Hz. The clearest picture is related to the lower bearing in the vertical direction. The fundamental frequency and two harmonics are seen. As the fault signature is rather weak, it is not visible on other maps (from other sensors).

Figure 10. Cyclic spectral coherence (CSC) before repair.

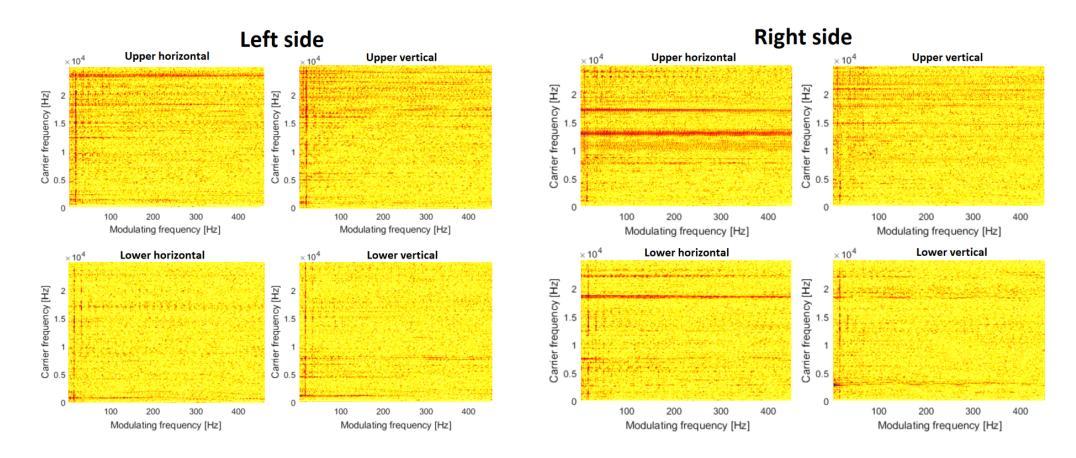
Figure 11. Cyclic spectral coherence (CSC) after repair.

The situation completely changes after the replacement of the bearings. Additionally, the problem of cyclic shocks was also solved. So, in Figure 11, there are almost empty maps and no modulation (just fundamental rotating frequency). This is evidence for the no-damage case.

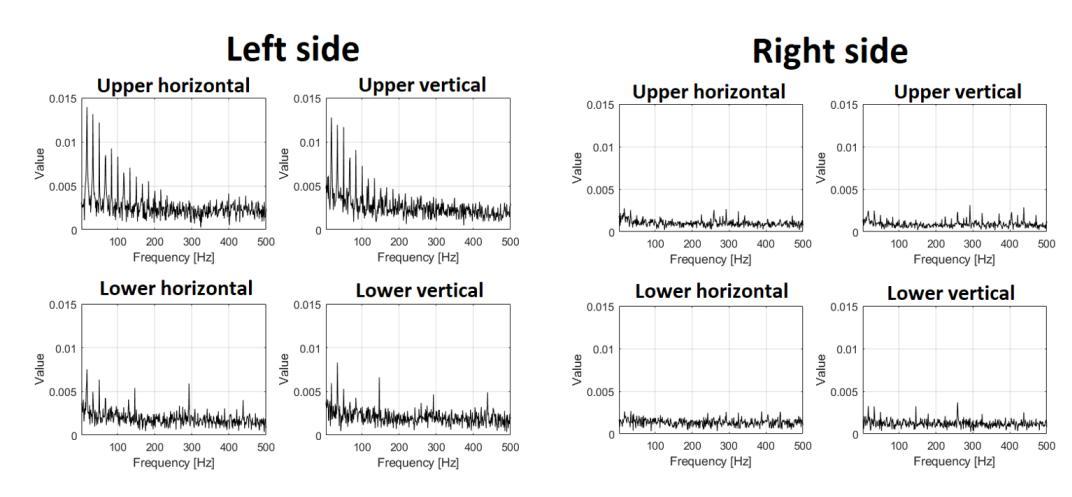
In Figures 12 and 13, envelope spectra for each sensor (the same layout) are presented. Envelope spectra for the upper left bearing contain a family of harmonics corresponding to rotating frequency. As we present all spectra in the same scale (Y axis), the right side of the screen has almost nothing in the envelope spectrum (shocks are transmitted but with much lower amplitudes). The spectrum for an envelope from the lower left bearing contains some components, so detection of the damage is possible, but they are not so clear for the CSC map.

Figure 12. Envelope spectrum before repair.

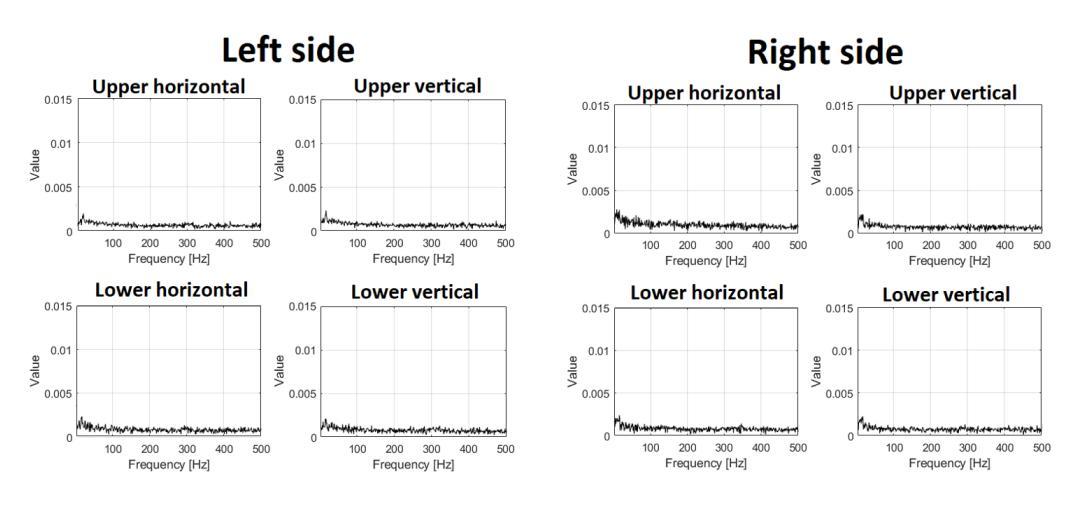
Figure 13. Envelope spectrum after repair.

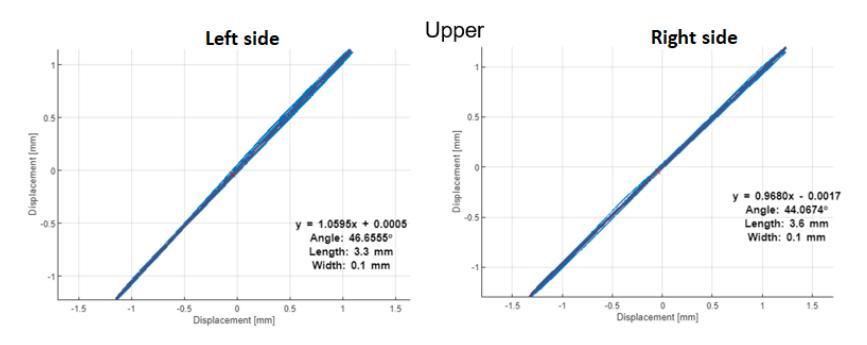
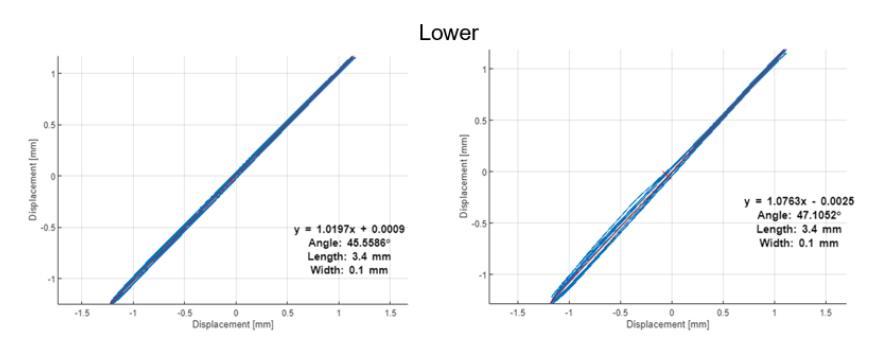
The orbits in Figures 14 and 15 with PSP in Figures 16 and 17 are built by the vibration signals recorded before bearing replacement and right after repair, respectively. The difference is visible between the trajectories of shaft motion affected by the damaged shield on the upper left support and the bearing damage on the lower left bearing. Since all corresponding graphs have the same scales on both axes, we can conclude that external excitation from the vibrator's impacts on the shield affects both the orbit and PSP of the upper shaft, while the bearing defect has less effect in the orbit but significantly changes the PSP. The numerical values of orbits and PSP geometry parameters are summarized in Table 2 for the damaged bearing (left side of the lower shaft). The form factor of PSP and angle of orbit inclination are both less sensitive to either the external excitation or the internal bearing defect, because these parameters of dynamics are mainly determined by the

Figure 15. Orbits after repair.

After shaft repair and damaged bearing replacement, the orbits and PSP graphs on both sides and both shafts of the screen have no differences in forms and amplitudes of trajectories. Hence, such methods as orbits and PSP can be assumed and easily realized as reliable health indicators in the condition monitoring systems of vibrating machines (not only in sieving screens). It is worth noting that the orbits method needs two orthogonal signals, but PSP needs only one sensor on each bearing.

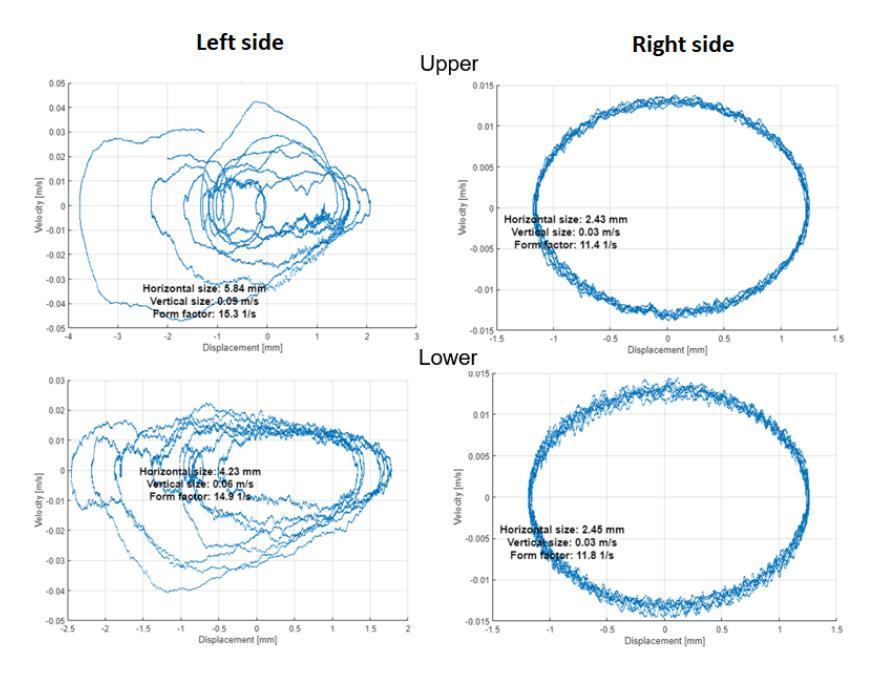
Figure 16. Phase space plots (PSP) before repair.

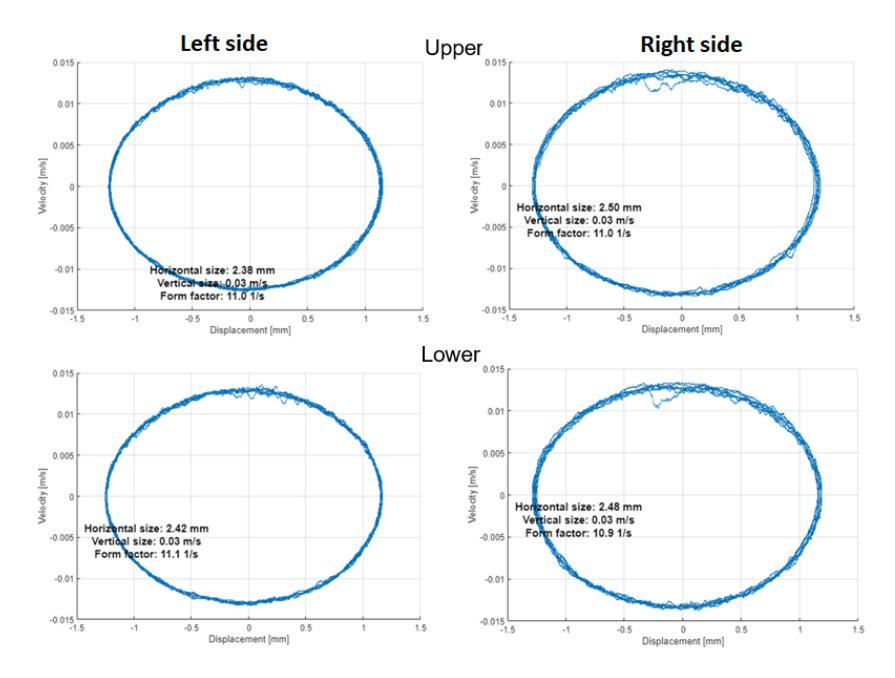
Figure 17. Phase space plots (PSP) after repair.

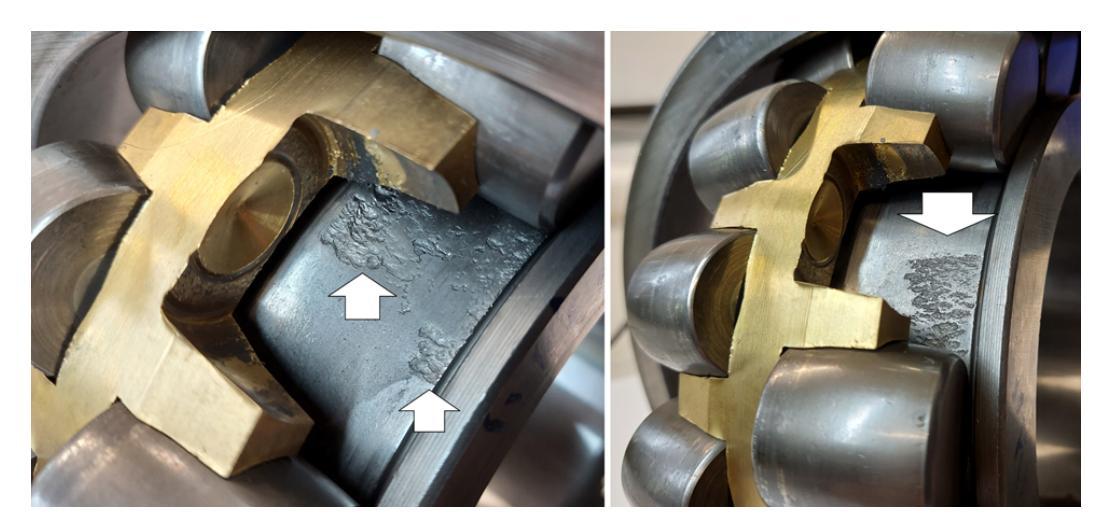
After bearing replacement, we were able to visually investigate the real condition of the bearing elements. According to our findings, the problem is related to the inner race. In Figure 18, pictures of the inner race surface are shown. It is clearly seen that a lot of pits are preset. Definitely, the surface of the inner race is worn. This picture confirms our findings.

Figure 18. Picture of damaged inner race.

The condition of the raceway is also confirmed by the effect observed in the signals: if the damage was of a more local nature (e.g., a transverse fracture), the rolling elements would interact with the failure ones at a time, and we would see distinct short spikes in the time domain in the signals. However, in the case of distributed damage to the surface, several rolling elements are in contact with the damaged surface at any moment in time, so the effect is much more "smoothed" in time than we observed in the signals. Despite this, it did not prevent the identification of the cycle of interaction, and thus the indication of the damaged element.

The online calculator available on the SKF website confirms the values of the observed frequencies (see Table 3). The detected defect frequency of about 141 Hz is related to the rolling of the barrels on the inner race, which indicates local damage to the inner race. The replaced (lower) bearing on the day of the second measurement showed noise with energy 39% higher than the upper shaft bearing, which confirms the presence of the temperature difference. Visual inspection confirmed the presence of significant damage to the inner race of the bearing. The damage is in the form of degeneration of the raceway surface (so-called pitting) in the angular range of approximately 1/3 of the entire circumference (almost exactly 120°).

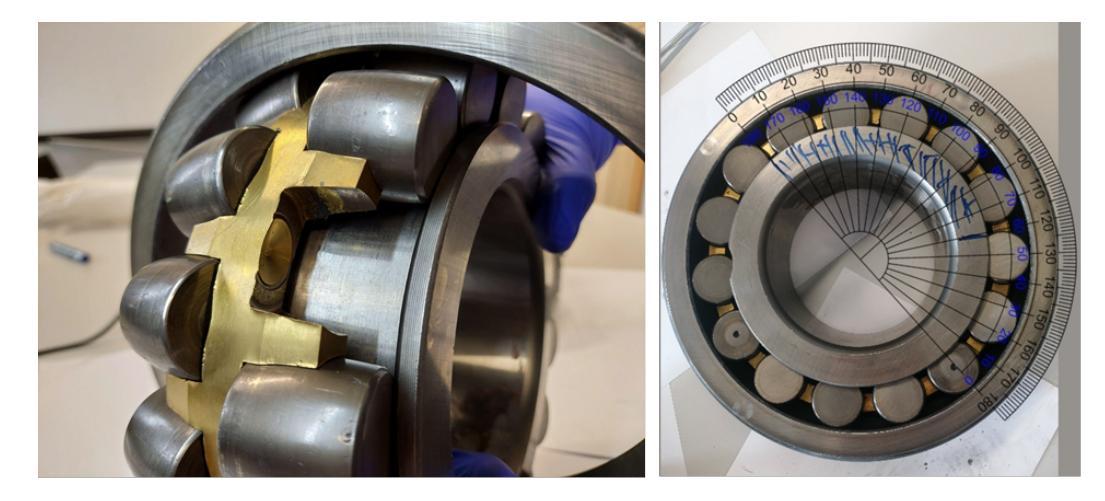
Figure 19 (left) shows the part of the ring in the healthy condition, which allows comparing its condition with the previous photos (see Figure 18) where pitting occurred over the entire width of the raceway (under both rows of rolling elements). The angular size of pitting is approximately 120°.

**Figure 19.** Picture of the not-damaged surface of the inner race and pitting angular size over the ring perimeter.
