Article Cavitation Erosion Characteristics of the EN AW-6082 Aluminum Alloy by TIG Surface Remelting

Keywords: TIG remelting; aluminum alloy; cavitation erosion

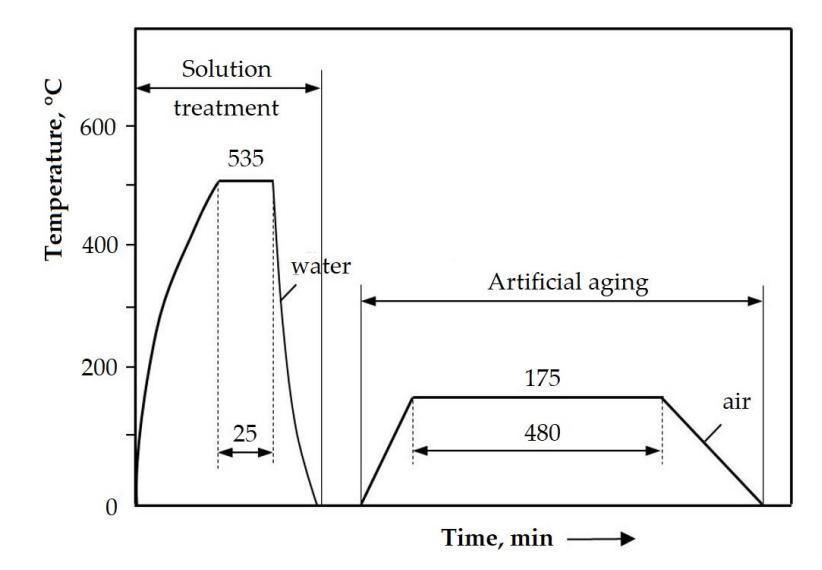
Figure 1. Heat treatment cycle.

The heat treatment was carried out by applying a solution at 535 ± 5 °C/25 min/water, followed by artificial aging at 175 ± 10 °C/8 h/air (Figure 1).

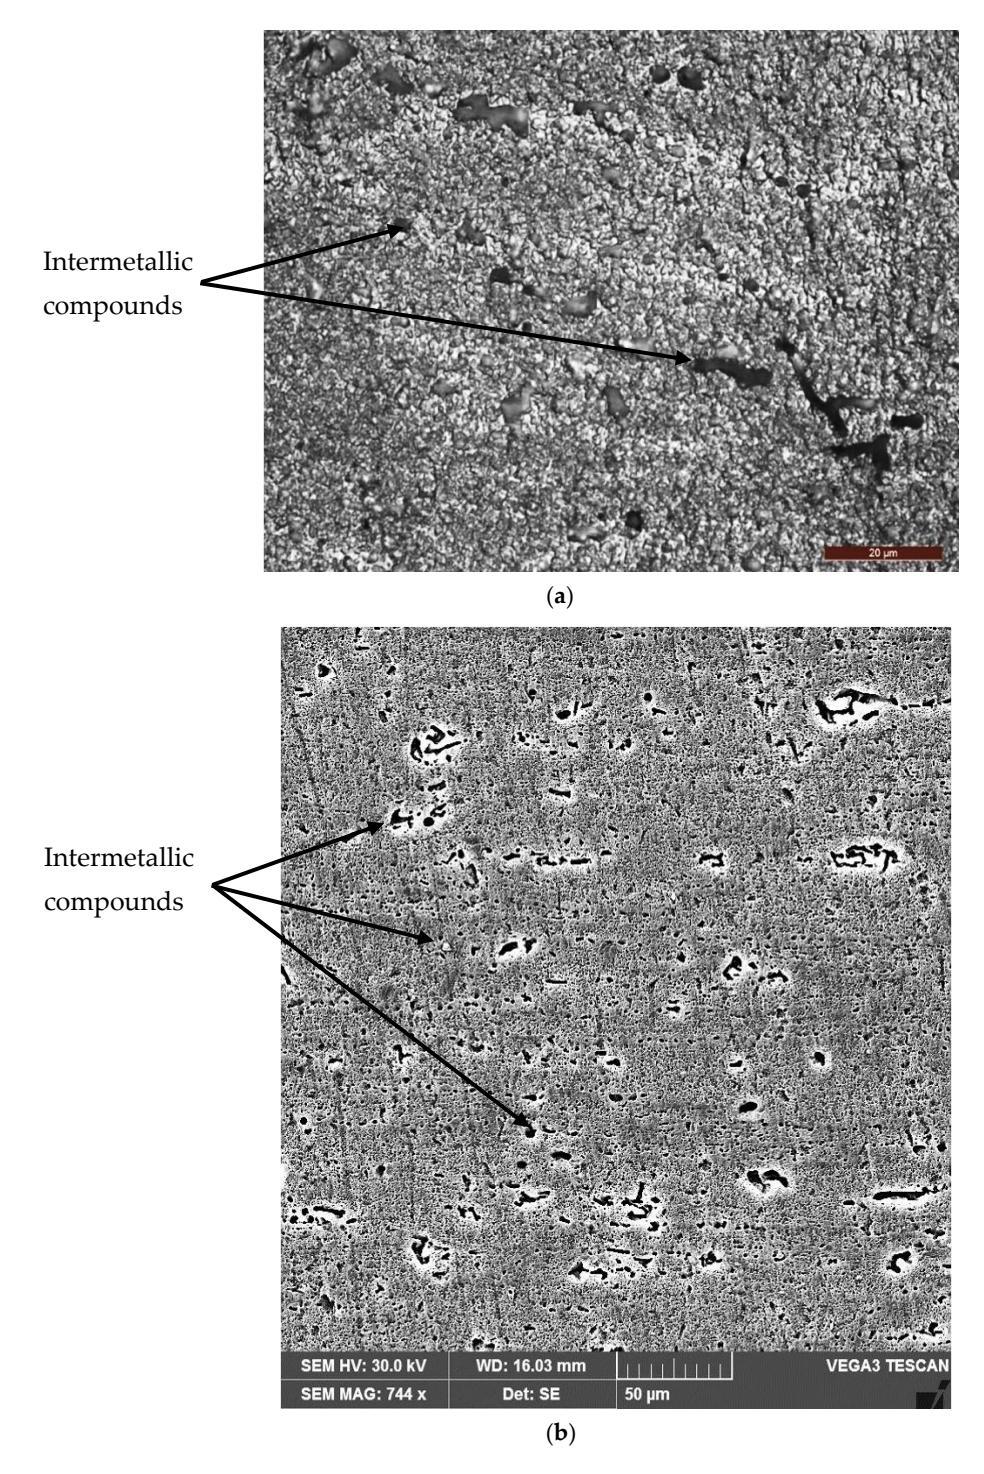
Figure 2. Microstructure of the alloy after solution heat treatment followed by artificial aging: (a) MO \times 500; (b) SEM \times 744.

Figure 2, the microstructure obtained after this heat treatment was composed of γ solid solution grains with an aluminum base having a polyhedral shape, and inside and on the separation boundaries between them, there were particles of intermetallic phases, consisting of Mg₂Si for the large ones, Al₅FeSi for those in the form of a plate, and Al₁₂(Fe, Mn)₃Si for the spherical ones [18]. This alloy shows the highest values for the mechanical resistance characteristics among all the 6xxx series alloys and is used in the aeronautical, marine, automotive and food industries [7,18].

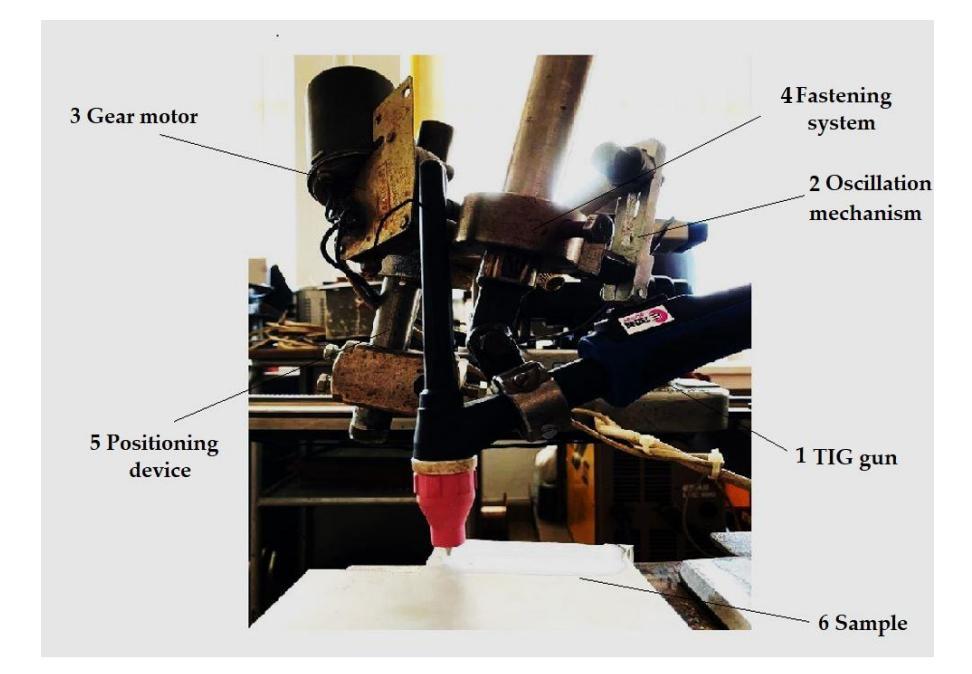
Figure 3. The welding experimental stand.

The surface was remelted using a TIG welding equipment (Weld Guru, Buda, TX, USA, Figure 3) in the following working conditions:

- base metal: Al-6082 alloy;
- welding equipment: MAGIC WAVE 300 (Fronius);
- alternating current frequency: 70 Hz;
- nature of current: alternating current;
- balance: 60/40;
- shielding gas: Ar 100%;
- electrode type: EWLa 15;
- electrode diameter: 3.2 mm;
- gas flow: 10 L/min;
- tilt of the gun: 90 degrees.

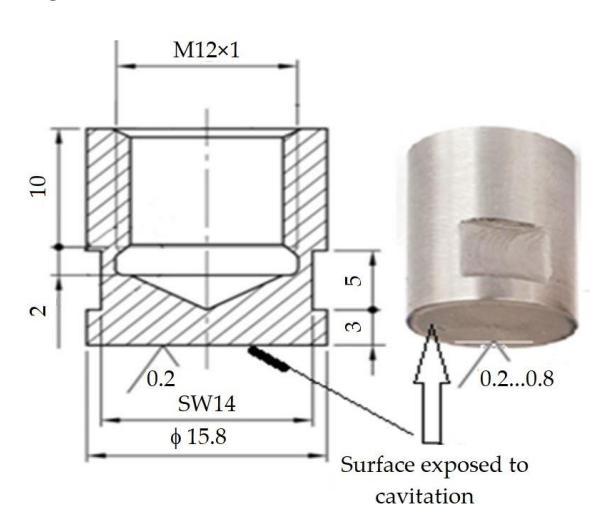
Figure 4. Geometry of the cavitation samples (mm).

Further, both from the locally surface remelted plates and from the reference ones, cavitation samples were processed by chipping; their shape and dimensions are shown in Figure 4.

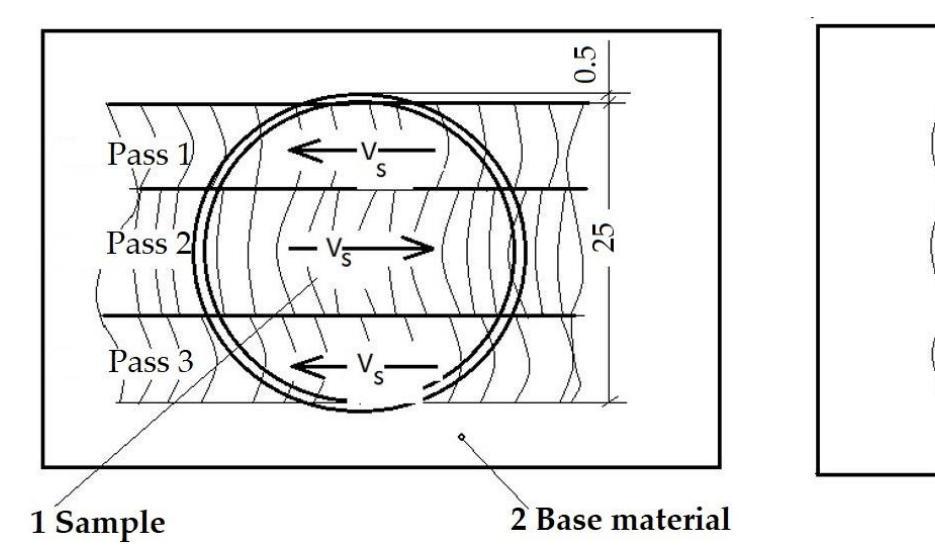
Figure 5. Details of the surface TIG remelting process.

According to the technological recommendations, the base material was preheated to a temperature of 100 °C, and the temperature between passes was maintained at values of 120–150 °C. In order to maintain a constant welding speed, the TIG welding head was mounted on a welding installation, the process being mechanized. For the surface remelting of the samples, parallel passages were made, with a step between passages equal to 2/3 of the width of a passage so as to achieve an overlap of the passages of approx. 1/3 of the width of a passage. The remelting details are shown in Figure 5. This made it possible to obtain a smooth molten surface without welding defects (lack of melting or marginal notches). The passages performed aimed at obtaining a width of the remelted area of at least 25 mm to provide cavitation samples with well-specified dimensions, shown in Figure 3.

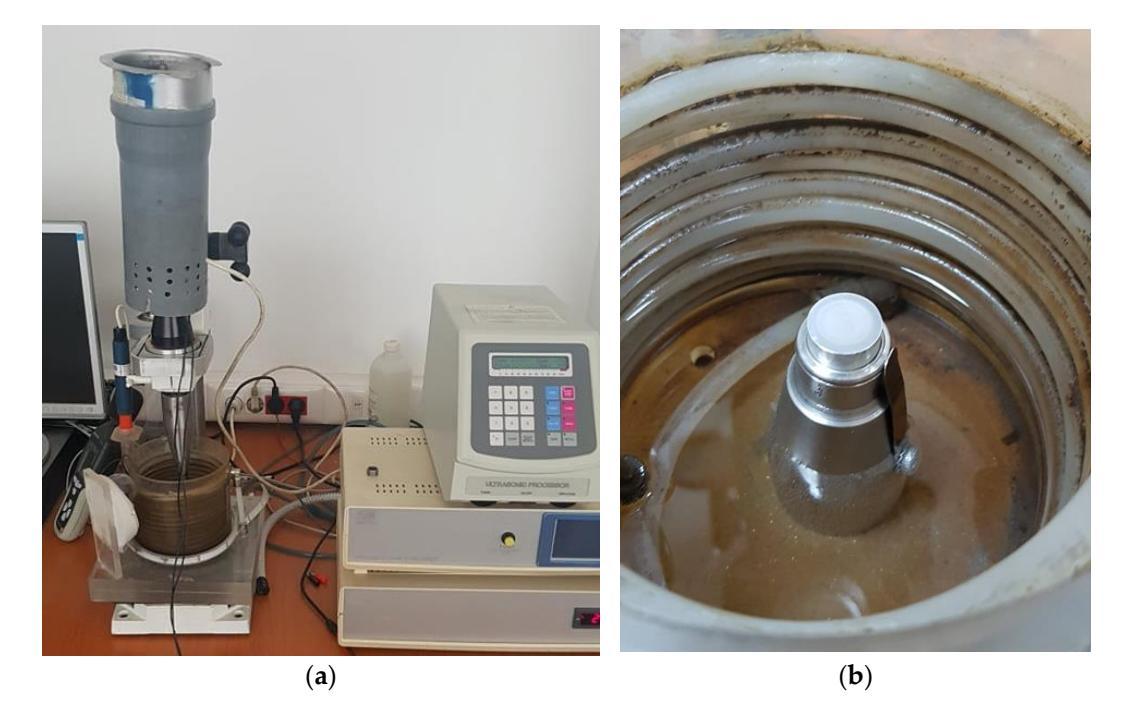
Figure 6. Experimental stand: (a) overview; (b) detail of the sample-fixing system.

The cavitation tests were conducted on sets of three samples for each remelting regime, using a vibrating device with piezoceramic crystals (Figure 6) [7,8] made in accordance with the requirements of Standard ASTM G32-2016 regarding the indirect testing method [19].

- vibration amplitude, $20,000 \pm 1\%$ Hz;
- vibration amplitude, 50 μm;
- power of the electronic ultrasound generator, 500 W;
- working environment, potable water having a temperature of 22 ± 1 °C.

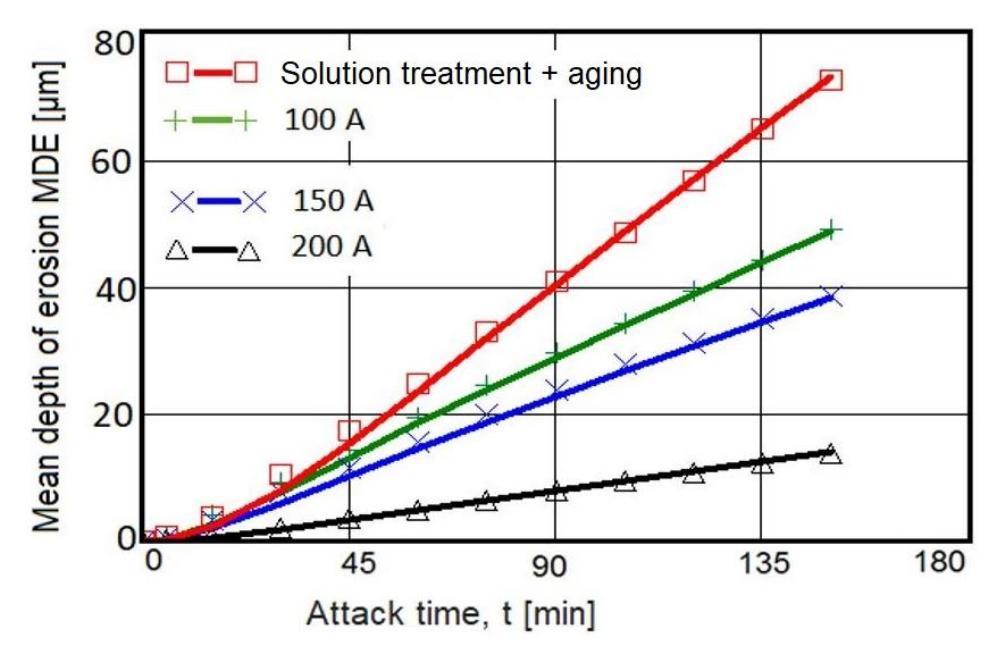
Figure 7. Evolution of the mean penetration depth of erosion with the cavitation attack time.

In Figures 7 and 8, the characteristics of the cavitation erosion curves are shown comparatively and indicate the variation of the parameters MDE (mean penetration depth of erosion) and MDER (mean penetration rate of erosion) with the duration of the vibrating cavitation attack, for the three structural states obtained after local surface remelting as well as for the reference material subjected to the solution-based heat treatment followed by artificial aging. It is specified that the experimental values in these diagrams represent the mean values of the three tested sets of samples, for each type of material processing.

- TIG remelting of the considered alloy surface at the currents Is = 100 A, 150 A, and 200 A caused an increase in the cavitation erosion resistance, Rcav, from 1.5 times to 5 times (where Rcav. = 1/MDER, t = 165), compared to the conventional heat treatment specific for this material;
- the use of welding currents of 200 A provided the lowest values of the MDE and MDER;
- during the stabilization period, until the end of the test duration (165 min), the erosion rates of the remelted TIG surfaces acquired values of approx. 0.10–0.32 μm/min, and those specific to the age hardening heat treatment were approx. 0.50 μm/min.

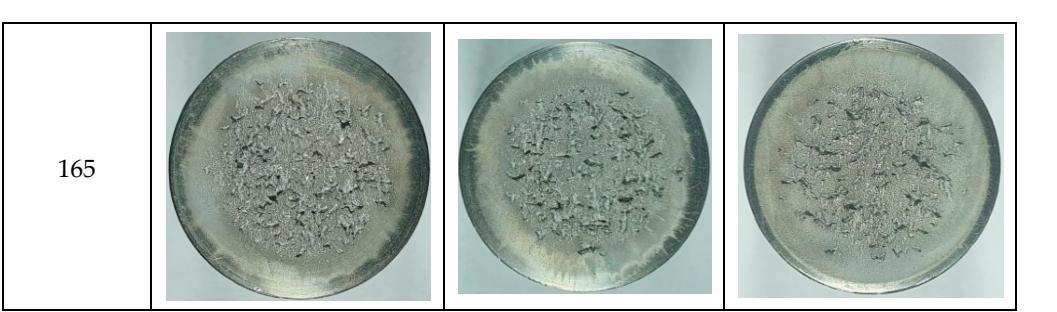
Figure 9. Macrographic images of the surface in cavitation tests of variable durations.

With the help of a Canon Power Shot A480 camera, images of the cavitation exposed surfaces were obtained at each test time. Figure 9 shows these characteristic images for each value of melting current with respect to the linear energy. The energetic impact generated by the collapse of the cavitation bubbles made the samples surface uneven. Up to 30 min of attack, no surface degradation was observed. At longer times, the formation of a ring from the surface periphery together with more and more microcraters (pinches) with variable sizes and uneven distribution was revealed. Thus, for cavitation attack times greater than 90 min, the remelted samples surfaces, especially with Is = 100 A and Is = 150 A, became very rough, which implies a strong damage to them. On the contrary, the degree of surface damage of samples remelted with Is = 200 A was lower, which proved that their cavitation erosion resistance was significantly improved. The main reason for this phenomenon can be the existence of fine grains and a microstructure with a uniform distribution of the constituent phases. After cavitation erosion for 165 min, the pinches on the material surface developed into an irregular group of cavitation craters.

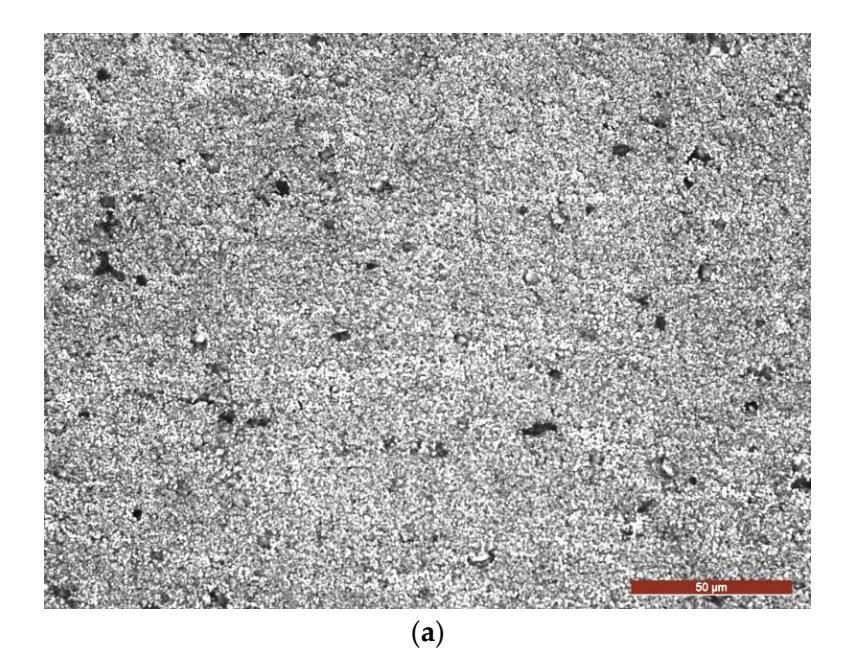
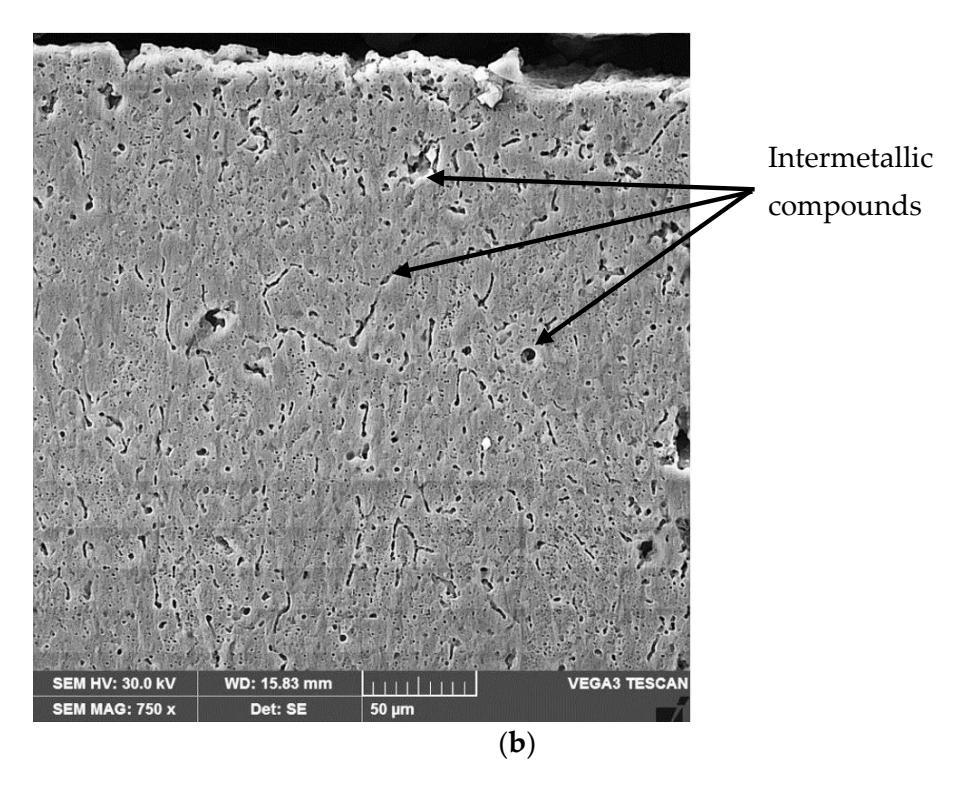
Figure 10. Cont.

After the TIG remelting process, the surface of the material solidified at a higher degree of subcooling, with respect to that at a lower real temperature than the equilibrium temperature, so that the dimensions of the germs were smaller, their number was larger, and the microstructure obtained was finer. In Figure 10a,b the microstructure of the layer obtained at a current I = 200 A and a linear energy $E_1 = 15,840$ J/cm is shown. It was observed that it contained small, equiaxial, unoriented crystals of α solid solution with an aluminum base and fine particles of intermetallic compounds [18], a microstructure that provides isotropic mechanical properties and an improvement of the use characteristics due to the strengthening mechanism resulting from the refinement of the granulation. The initiation and subsequent propagation of microcracks in the surface layer occurred at the interface between the particles derived from chemical combinations and the aluminumbased solid solution matrix (Figure 10b). Exposure of the material surface to repeated shock waves and/or repeated microjets led to an accumulation of plastic deformations until microdamages occurred that caused material loss. With the increase of the cavitation attack time, there was a fragile removal of the phases of the chemical combinations, after which a uniform degradation of the solid solution grains took place, the breaking phenomenon having a ductile character.

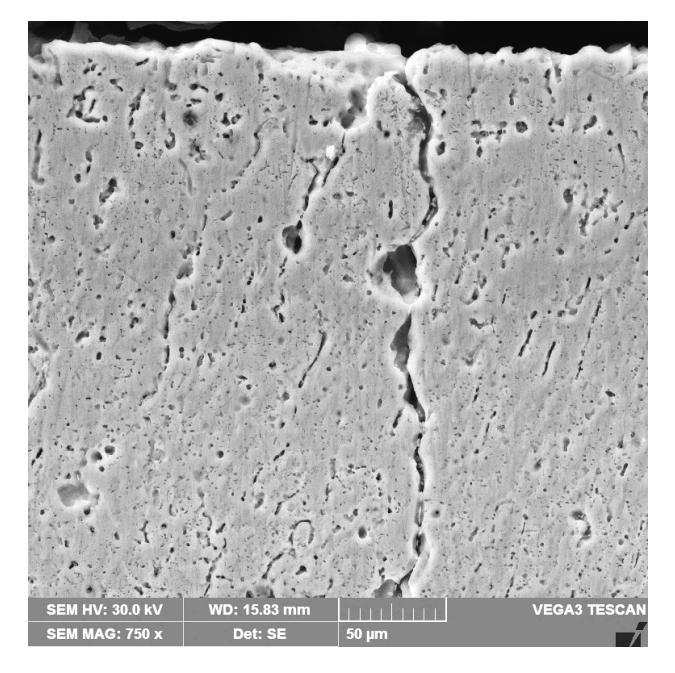
Figure 11. SEM image of a cross section with microcracks through the remelted layer, with Is = 250 A.

At melting current values over 200 A and linear energies higher than 15,840 J/cm, the very high thermal shock action induced by the surface melting process caused the appearance of microcracks in the edge layer (Figure 11).

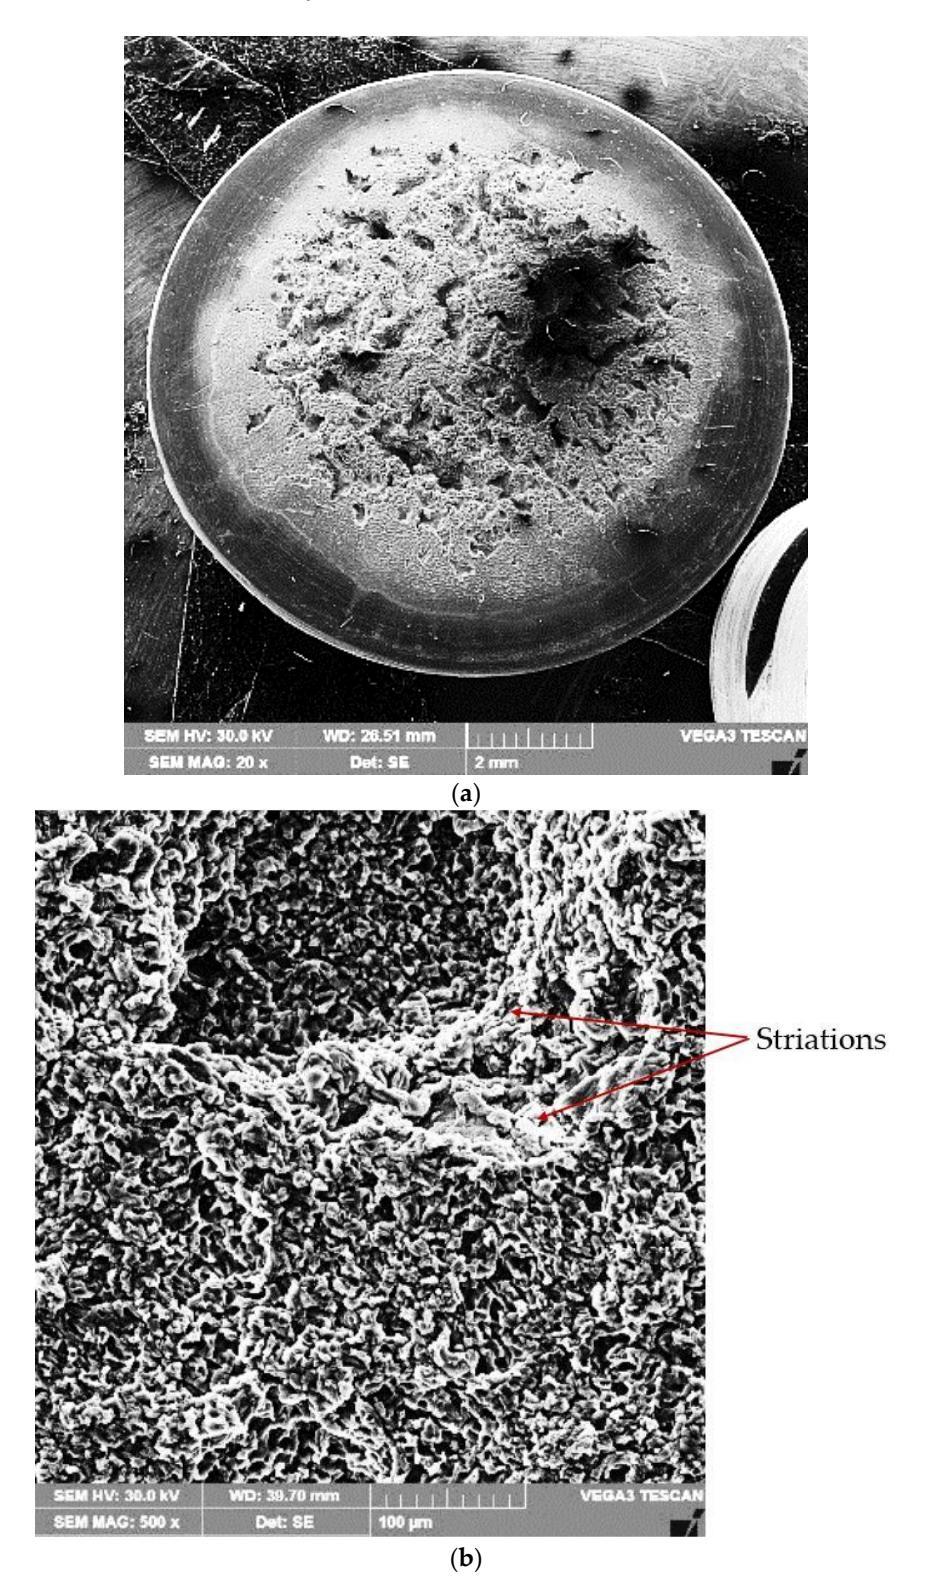
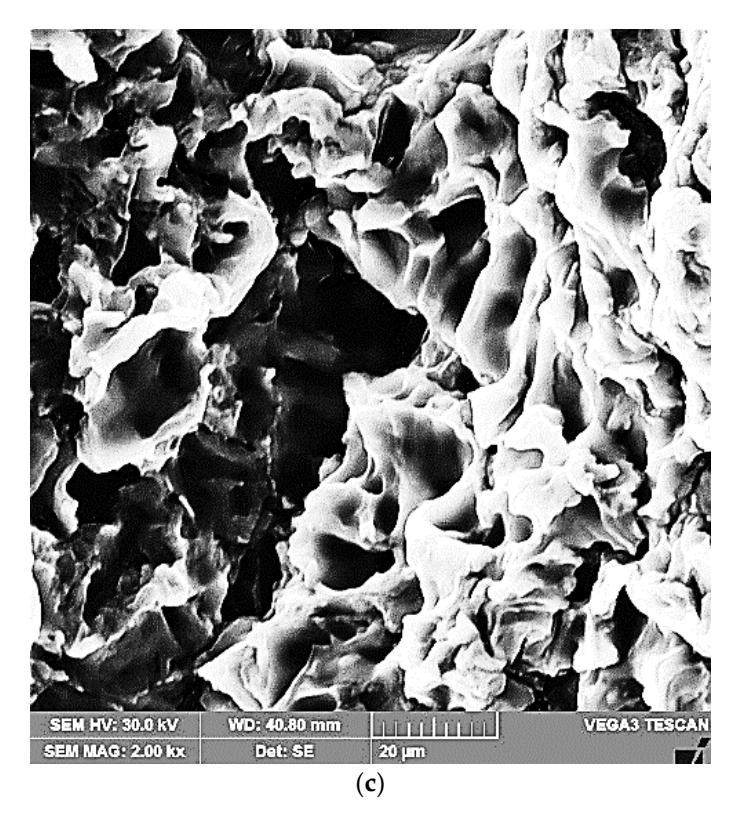
Figure 12. SEM image of the remelted surface, with Is = 100 A, and tested after 165 min for cavitation: (a) \times 20; (b) \times 500; (c) \times 2000.

A scanning electron microscope examination of the surfaces tested for cavitation (Figures 12 and 13) demonstrated that the erosion phenomenon occurred in a similar way to that of pure metals with a face-centered cubic lattice, fcc, namely, through plastic deformation followed by a ductile fracture over the entire surface.

The results of the metallographic investigations carried out with the optical microscope and the scanning electron microscope, in correlation with the hardness measurements, allowed explaining the mechanism of the cavitation erosion phenomenon. The finishing of granulation and microstructure after the local surface remelting process, beside the hardness increase, were responsible for the cavitation erosion improvement, along with the material removal. The high capacity of mechanical embrittlement (low stacking fault energy) of the solid solution matrix with the fcc crystalline network led to erosion by ductile fracture on the entire surface. The loss of material occurred preferentially in isolated regions, apparently with a random distribution, the formed microcraters showing typical striations similar to the fatigue fractures of aluminum alloys [4,6,9,13].

However, with this alloy containing up to 3% of alloying elements, the material was preferentially lost in isolated regions, apparently randomly, leaving behind striated, flatbottomed microcraters [1,2,4,7]. The fracture surface of these microcraters was similar to that of fatigue fractures in aluminum alloys. The microcraters expanded laterally to macroscopic sizes without undergoing changes in their topographical characteristics. The diameter of the cavitation microcraters was approximately 20 μ m, and some of them reached 50 μ m and even 80–90 μ m.
