Wear Rate, Tribo-Corrosion, and Plastic Deformation Values of Co-Cr-Mo Alloy in Ringer Lactate Solution

Abstract: This study investigates the tribocorrosion performance of a cast Co-Cr-Mo alloy prepared using casting and electromagnetic stirring (EMS) at specific frequencies. The tribocorrosion behaviour of the alloy was evaluated when exposed to Ringer's lactate solution to optimize the EMS parameters and improve its properties. The research focuses on biomedical implant applications and explores how EMS affects alloy wear and corrosion resistance. As did the friction coefficient and wear volume, the wear rate of samples produced with EMS frequencies of 75 Hz and 150 Hz decreased. These improvements are attributed to the ability of EMS to refine grain size and homogenize the microstructure, thereby increasing the resistance to tribocorrosion. Techniques such as scanning electron microscopy (SEM) and profilometry were used for surface and wear analysis, while mechanical properties were evaluated through instrumented indentation tests. The findings confirm that EMS improves the alloy's durability and tribocorrosion resistance, making it highly suitable for demanding biomedical appl

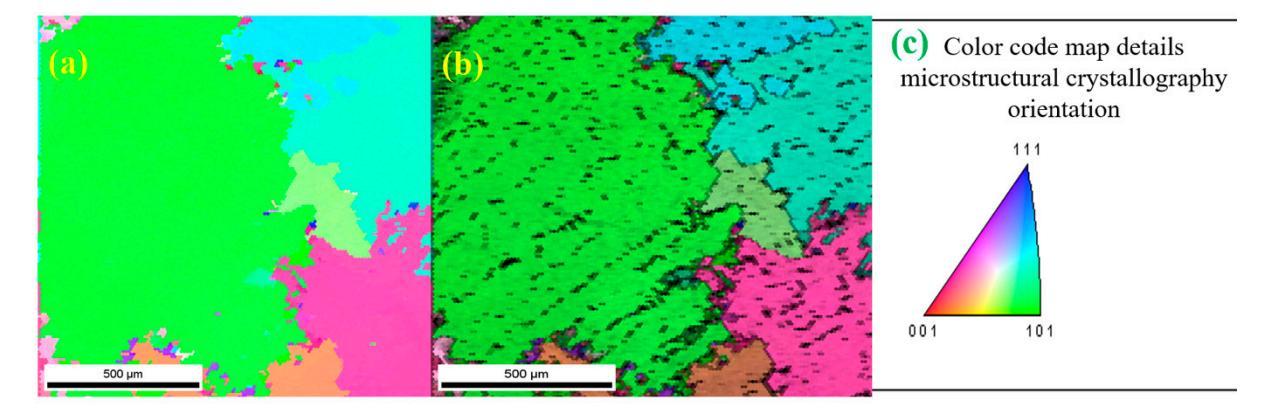
Figure 1. (**a**) Inverse pole figure (IPF) map shows alpha-Co; (**b**) inverse pole figure (IPF) + image quality (IQ); and (**c**) colour code map with microstructural crystallography.

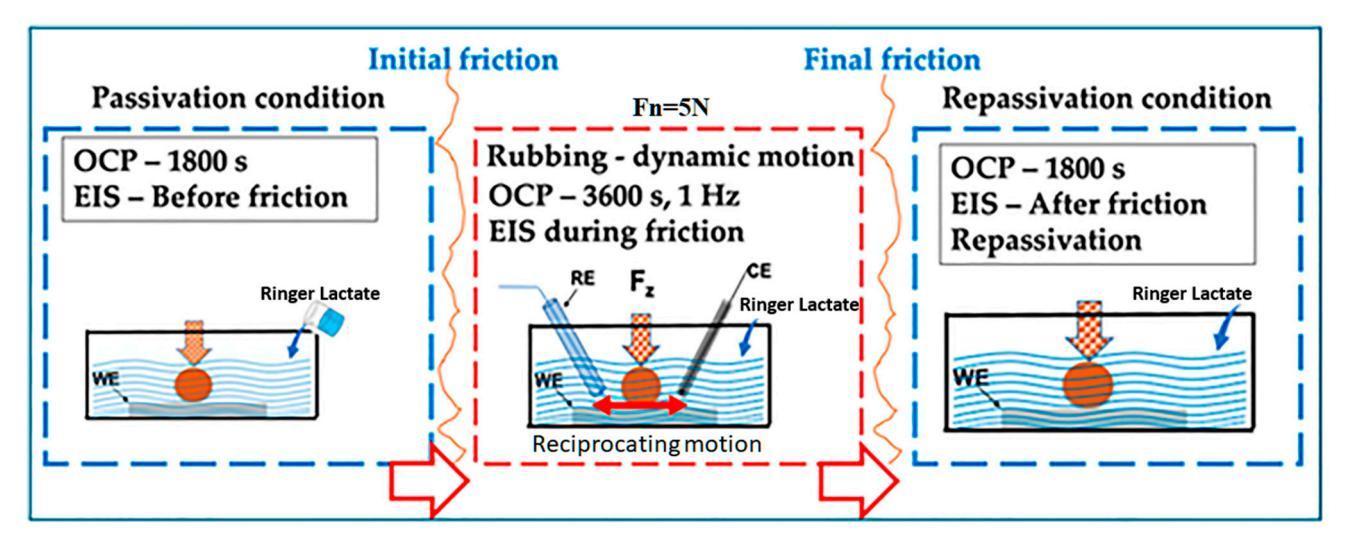
Figure 2. Schematic drawing of tribocorrosion cell showing the reference electrode (RE) Ag/AgCl, the platinum counter electrode (CE) and the working electrode (WE).

The OCPs test was run out for 1800 s before the friction test to allow for stabilization, during the friction test for 3600 s, and an additional 1800 s after the friction test to observe their stabilization behavior. The frictional force was measured using a load transducer. Qualitative and quantitative studies focusing on the interaction of the two processes, mechanical tribology, and electrochemical oxidation, have shown that the material degradation rate can be significantly or not-so-much affected. Figure 2 demonstrates the schematic drawing from the tribocorrosion cell, showing the three-step conditions: passivation, dynamic motion in a reciprocating way with OCP, and final passivation. During dynamic motion, a three-electrode electrochemical cell was used with the wear tester, the Ag/AgCl reference electrode (RE), a platinum counter electrode (CE), and the working electrode (WE). The results were analysed according to ASTM G3-14 [49].

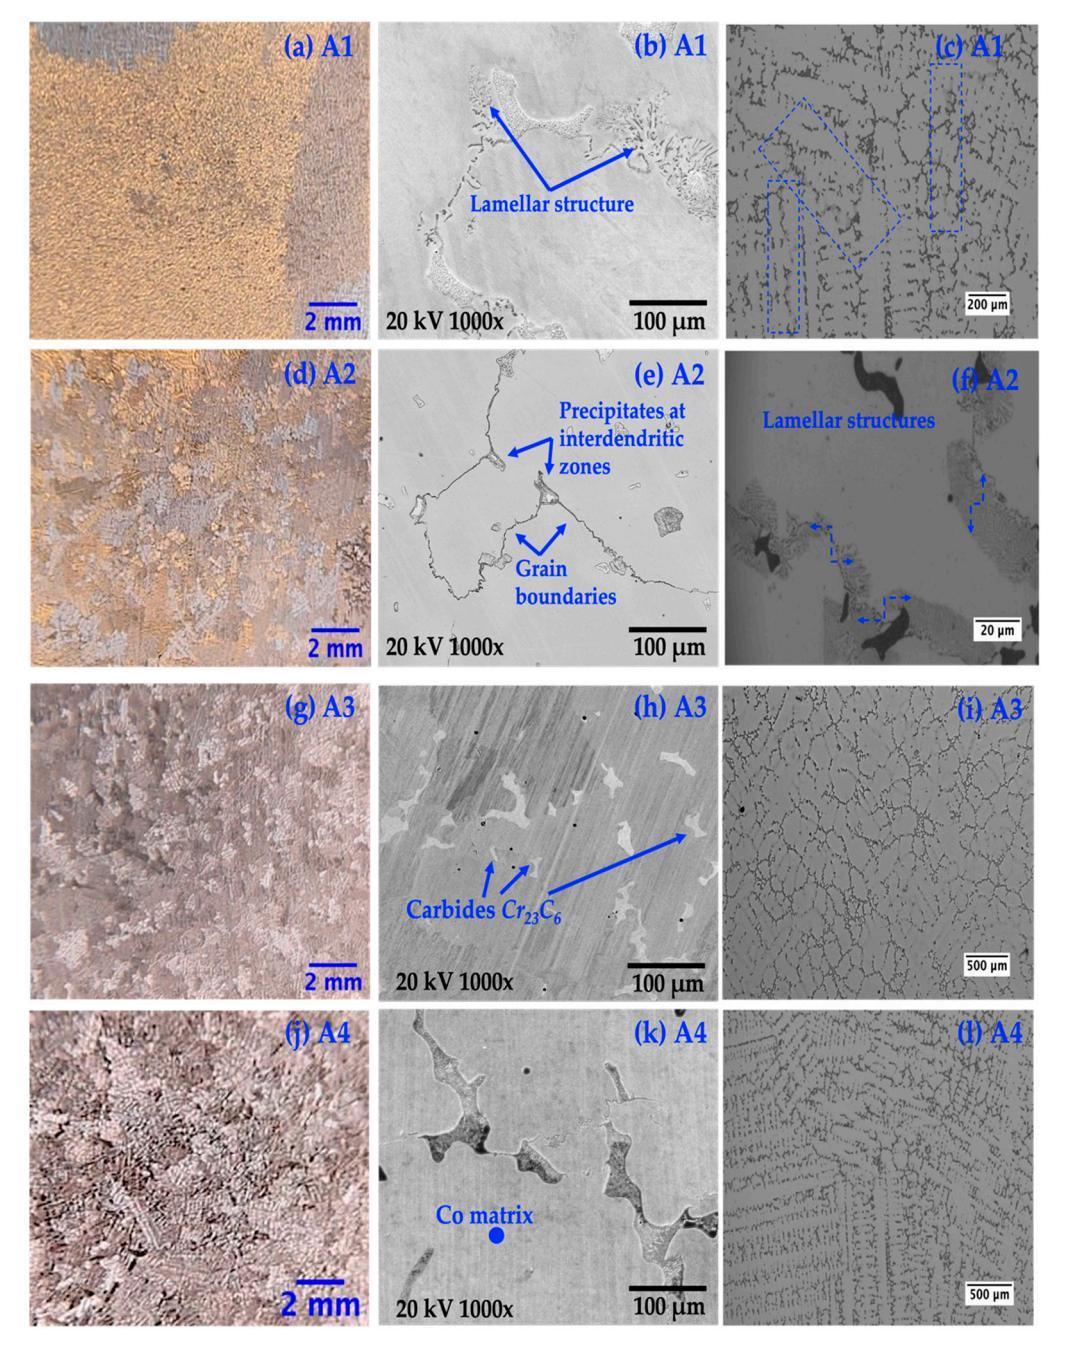
Figure 3. O.M images of Co-C-Mo alloy samples after foundry and SEM images. (**a**–**c**) A1 No EMS, (**d**–**f**) A2-15 Hz sample, (**g**–**i**) A3-75 Hz sample and (**j**–**l**) A4-150 Hz sample.

In the untreated sample A1 (Figure 3a, grain size was measured at 5.51 \pm 1.91 mm. Following electromagnetic stirring (EMS) treatment at different frequencies, samples A2, A3, and A4 exhibited significantly reduced grain sizes of 0.93 \pm 0.67 mm, 0.79 \pm 0.54 mm, and 0.84 ± 0.57 mm, respectively, as shown in Figure 3d,g,j. This EMS treatment led to notable changes in the microstructure, with dendritic structures and a high volume of second-phase particles within interdendritic zones observed in EMS-treated samples (Figure 3c,f,i,l)). Figure 3 shows the macrostructure of samples after the casting process, solidified without and with electromagnetic stirring (EMS). The samples were chemically etched to reveal the grain. In the case of solidification without an electromagnetic field, the grains start to grow from the side walls towards the central region of the mould. The effect of electromagnetically driven melt convection on the solidified structures is shown in Figure $3d_{g_i}$. As can be seen by comparing with Figure $3a_i$, the growth of the grains was significantly disturbed, possibly as consequence of the redistribution of the solute concentration and dendrite fragmentation due to fluid motion. On average, the grain of the electromagnetically stirred samples is smaller than that obtained during normal solidification. Electromagnetic agitation promotes the significant refinement of Co-Cr-Mo alloy grains, casted by investment casting. In the previous work [3], it was proved that the modification of the investigation process by investing in casting, through electromagnetic stirring (EMS), during solidification allowed the decrease in the size of the Co-Cr-Mo alloy grains (innovation in the manufacture of these alloys).

The lamellar structure visible in the untreated sample A1 (Figure 3c) contrasts sharply with the refined microstructures of the EMS-treated samples. Figure 3f illustrates the lamellar and alpha phases in sample A2 treated at 15 Hz. Sample A3, treated at 75 Hz, shows dendritic microstructures with carbides highlighted against a cobalt-rich matrix in Figure 3i. Sample A4, receive the highest frequency of 150 Hz, displayed the most significant carbide volume fraction at 8.38%, depicted in Figure 31. SEM images provided further insight into the alloy's structural elements. Lamellar structures were observed in Figure 3b, while Figure 3e revealed areas with interdendritic precipitates at the grain boundaries. Figure $3h_k$ showcased chromium-rich carbides ($Cr_{23}C_6$) and cobalt-rich zones, respectively, marking differences in microstructural details across the samples. A shift in carbide prevalence from M_7C_3 to predominantly $M_{23}C_6$ -type carbides was noted with a reduction in carbon content to approximately 0.2%, corroborated by findings from Davis [50], Patel [11], and Zhang [51]. This transition, favouring $Cr_{23}C_6$ carbides due to chromium's significant presence and affinity for carbon in the alloy, emphasizes the critical role of EMS in sculpting the microstructure through the solidification and cooling phases, offering a nuanced view of the alloy's development.

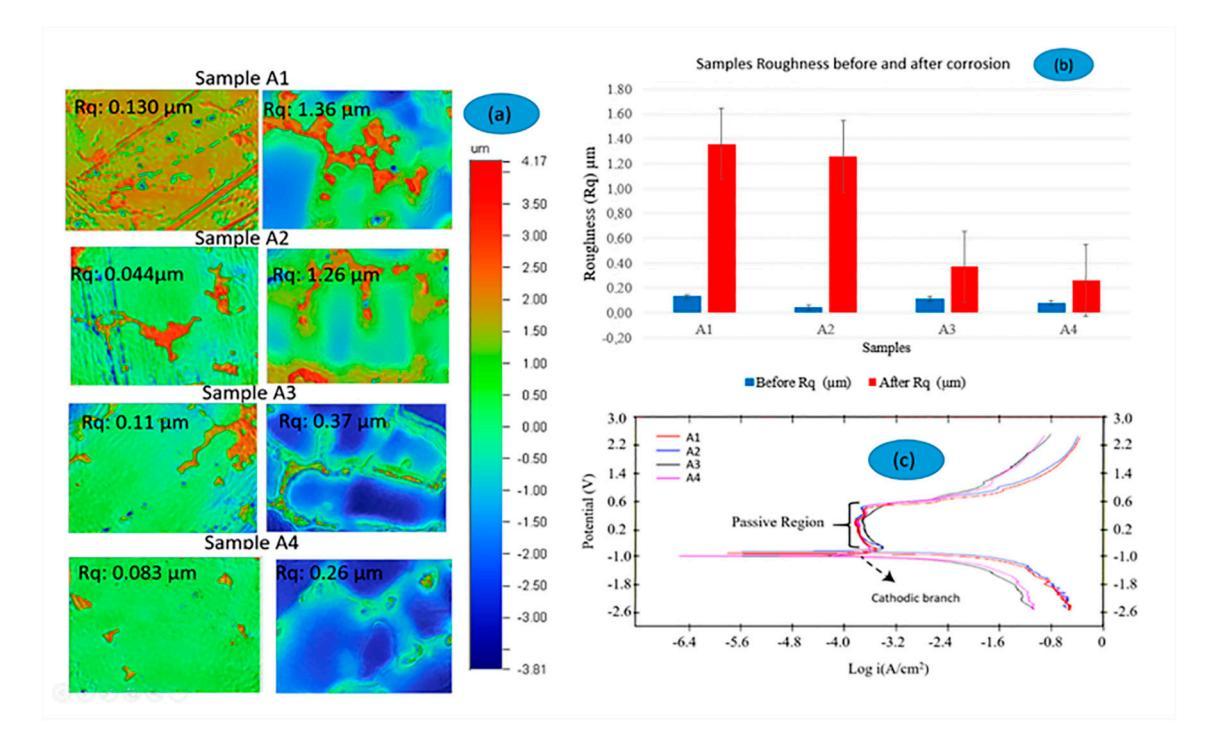
Figure 4. (a) Surface roughness morphology. (b) roughness comparison. (c) polarization curves of the Co-Cr-Mo alloy samples (A1-no EMS, A2-15 Hz, A3-75 Hz and A4-150 Hz). All samples were analysed in the Ringer lactate solution.

Figure 4 showcases three images that elucidate the tribocorrosion processes in the Co-Cr-Mo alloy samples (A1–A4). Figure 4a displays the surface roughness morphology of these samples before and after exposure to tribocorrosion in Ringer lactate solution, as captured by an optical profilometer. The images are color-coded: red represents the surface peaks, and blue signifies the valleys. Figure 4b illustrates the roughness before and after tribocorrosion tests.

Figure 4b focuses on the roughness values (Rq) of the samples before and after tribocorrosion. Here, it is notable that sample A1, which did not undergo Electro Magnetic Stimulation (EMS) treatment, exhibited the highest level of corrosion, with a roughness value of 1.36 μ m. Conversely, samples A2 to A4, which benefited from EMS treatment, displayed significantly lower corrosion, underscoring the effectiveness of EMS in enhancing grain refinement and, consequently, corrosion resistance. The section also introduced the concept of passivation, which occurs either when the solubility product of the passive film is reached or due to a structural change in the film to a non-porous form. This passive behaviour is crucial for the material's resistance, but beyond a certain point, known as the transpassive region, the protective film deteriorates.

Figure 4c, along with Table 6, compares the EMS frequency's impact on various parameters such as corrosion current density, corrosion potential, open circuit potential (OCP), and roughness for each sample (A1-no EMS, A2-15 Hz, A3-75 Hz, and A4-150 Hz). Potentiostatic measurements depicted in this figure were performed to assess the potential's effect on corrosion kinetics and metal ion release. Despite the differences among samples, all curves shared a similar morphology, highlighting the Co-Cr-Mo alloy's intrinsic passive nature that favours the spontaneous formation of a protective oxide layer vital for tribocorrosion resistance.

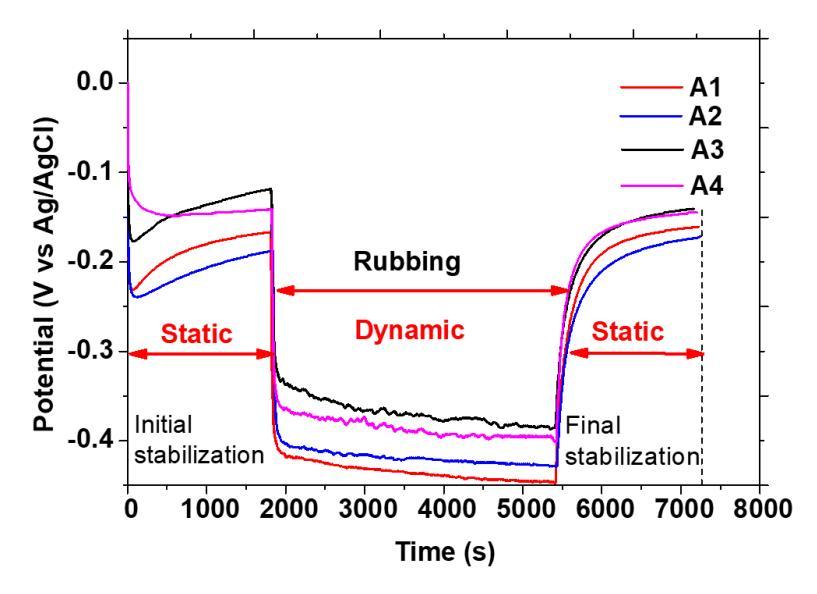
Figure 5. Evolution of open circuit potential (OCP vs. Ag/AgCl) values before, during, and after tribocorrosion tests, using an alumina sphere against the following samples A1, A2, A3 and A4.

Figure 5 shows the open circuit potential at air environment. Remarkably, sample A1 displayed significantly lower static OCP values compared to others (-0.16 mV), suggesting more pronounced passive layer degradation. The sharp OCP decline, especially evident in sample A1, indicates potential disruption of the oxide film, a phenomenon also seen when dynamic motion (rubbing) initiates.

The A2 sample (-0.19 to -0.42 V) exhibited an intermediate behaviour between A1 and A4, with its OCP partially recovering to -0.14 V, suggesting some resilience in passive layer regeneration. Sample A3 demonstrated the most robust corrosion resistance; despite an initial drop to -0.36 V during rubbing, its OCP gradually returned to -0.14 V, evidencing superior surface protection against corrosion.

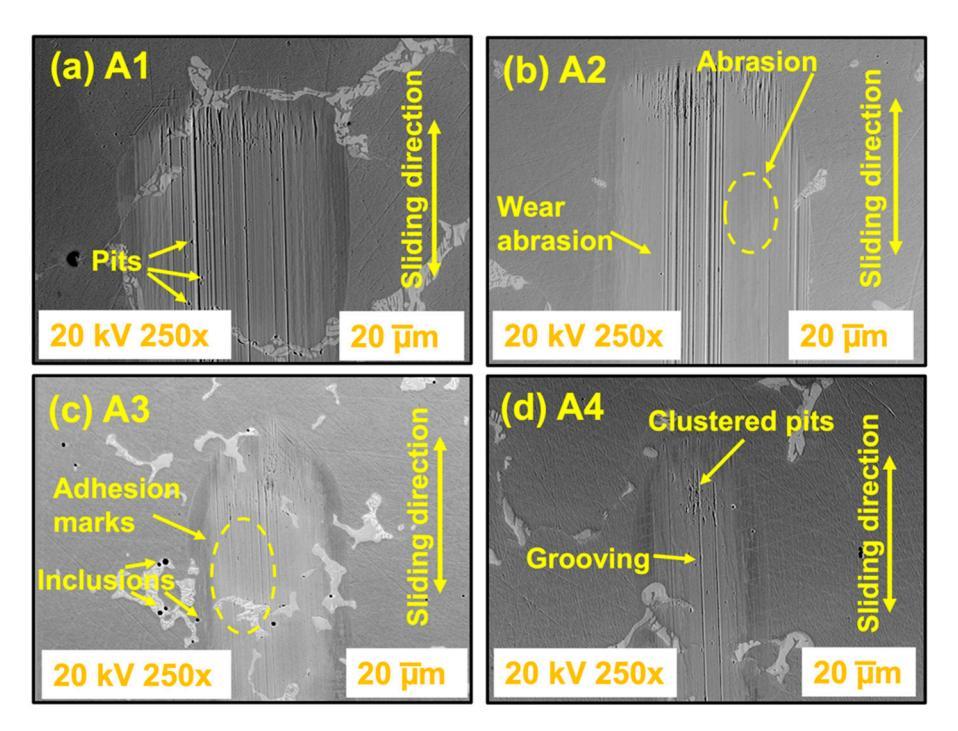
Figure 6. SEM images (**a**–**d**) from wear tracks. Scanning electron microscopy (SEM) images of corroded and worn surfaces in the presence of Ringer lactate solution from the samples: (**a**) A1; (**b**) A2; (**c**) A3, and (**d**) A4.

After the tribocorrosion test under the conditions of abrasive (mechanical) wear and corrosion (electrochemical), it is possible to verify the wear tracks in the samples, as shown in Figure 6. It helps us to understand the physical constitution of sample/electrolyte/sphere interactions in the wear process/corrosion. Figure 6 shows the morphology of the wear track of all samples. This alloy presented a microstructure of primary carbides dispersed in a eutectic interdendritic matrix of solid cobalt solution and many carbides and lamellar structures [58]. Figure 6 shows the wear track covered by a compacted film of oxide debris after a corrosion–wear test. Figure 6a shows the wear marks, plus many pits, and the width of the larger wear track compared to samples A3 and A4. Figure 6b exhibits increased extruded deformation lines on the wear track. Figure 6c shows the sample with clustered pits and several grooves aligned along its length. All worn tracks show sliding grooves that can be attributed to abrasive wear. Arrows indicate the direction of sliding.

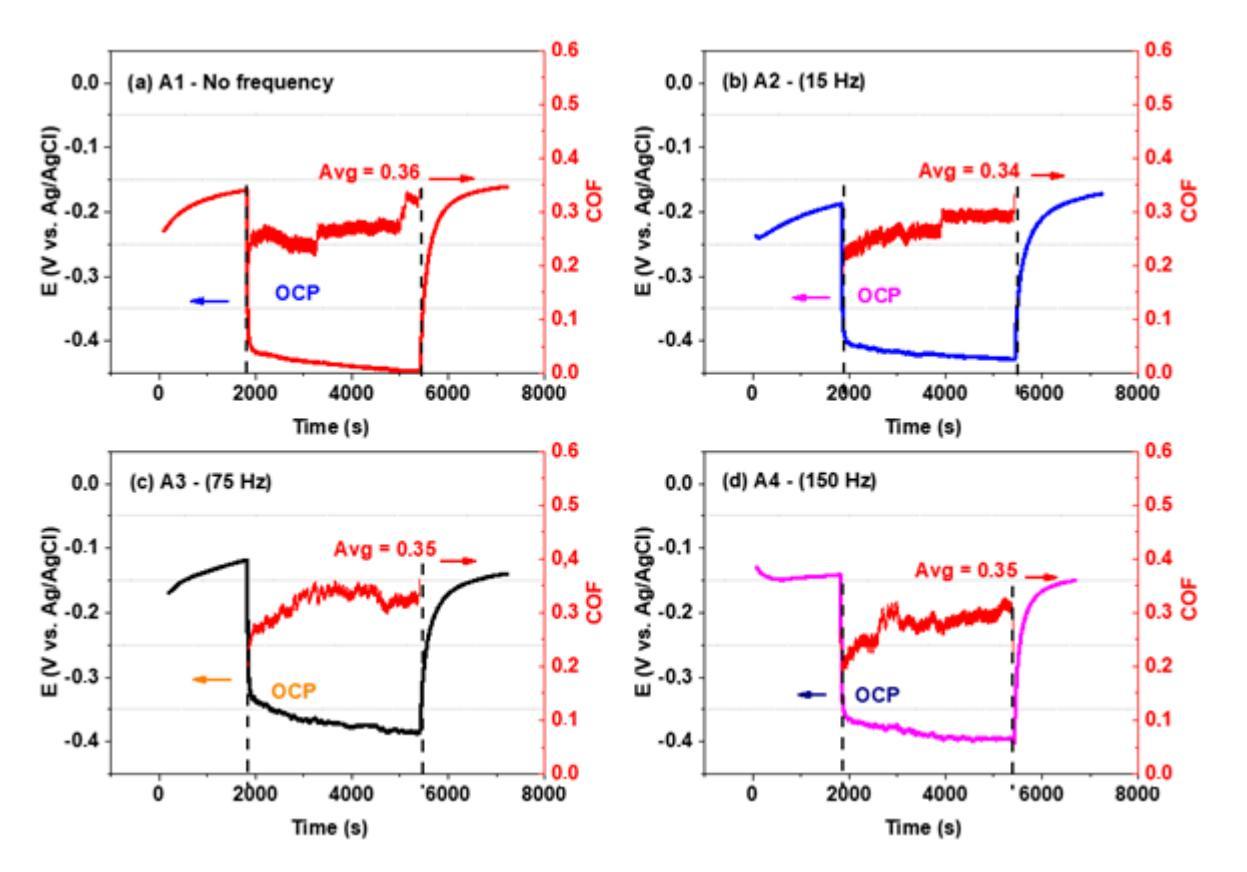
Figure 7. Dynamic coefficient of friction and OCP in Ringer's lactate solution. Samples (**a**) A1 (no EMS), (**b**) A2 (15 Hz), (**c**) A3 (75 Hz) and (**d**) A4 (150 Hz).

Figure 7 illustrates the variation in the friction coefficient throughout the tribocorrosion tests (from 2700 s to 5400 s), including the OCP stabilization periods before and after the wear test. An initial sharp increase in friction coefficient was observed, attributed to the surfaces' need to adapt to each other. Notably, fluctuations in the friction coefficient were linked to debris (termed the third body) trapped between the sliding surfaces, as indicated by references [25,64]. These oscillations suggest that applying an external anodic potential may accelerate metallic surface dissolution and induce additional corrosion due to friction, a phenomenon detailed by Mischler et al. in reference [31]. This interaction also highlights the removal of a thin passive film on the surface due to mechanical wear from tribological contact.

A comparison of sample results reveals varied behaviours in the friction coefficient over time, with Figure 7a showcasing a sample without EMS, which displayed a larger grain size and a relatively high coefficient of friction (0.36 ± 0.09), indicating a significant presence of wear-induced particles. A sharp increase in the friction coefficient after 3500 s was noted, reaching an average of 0.36 ± 0.08 . In contrast, Figure 7b demonstrates that the 15 Hz sample (A2) experienced a gradual increase in the friction coefficient, eventually stabilizing at 0.34 ± 0.15 , despite a decrease in OCP. Similarly, the 75 Hz (A3) and 150 Hz (A4) samples, shown in Figure 7c,d, respectively, displayed a pattern of increasing friction coefficient until a certain point, after which it stabilized at 0.35 ± 0.06 and 0.35 ± 0.08 , respectively. These observations are consolidated in Table 6. The OCP fluctuations noted during sliding

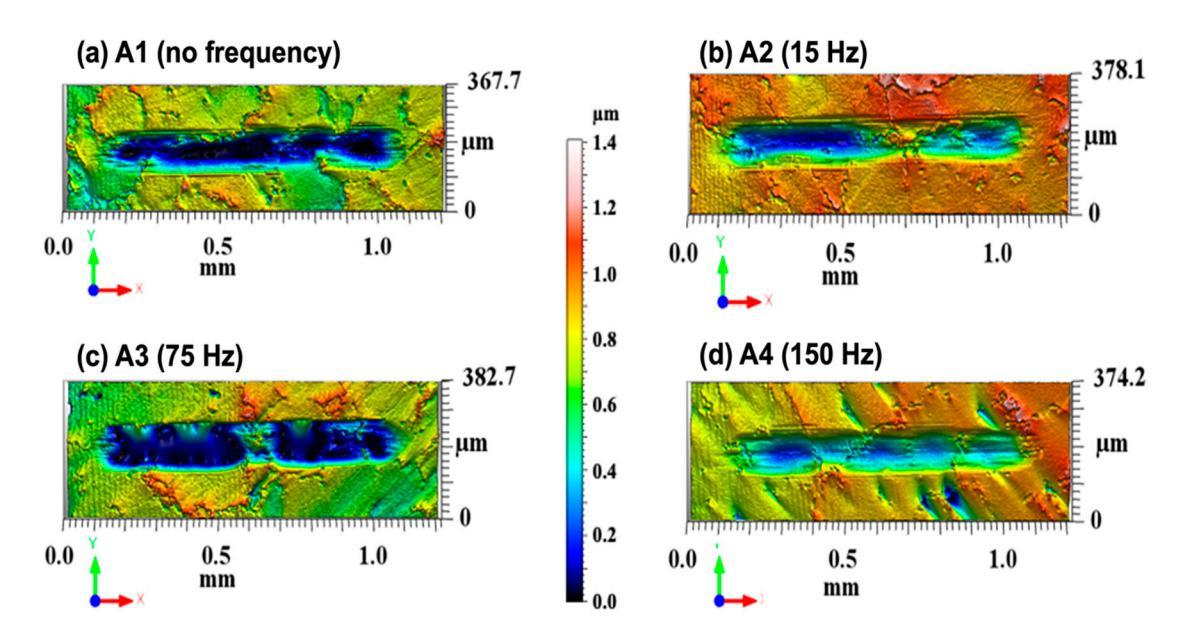
Figure 8. Profilometric analysis of tracks worn by tribocorrosion in Co-Cr-Mo (A1–A4) alloy samples. Wear marks were measured halfway through the track test. (**a**) is related to Sample A1; (**b**) relates to Sample A2, (**c**) relates to Sample A3, and (**d**) relates to (A4).

The applicability of the methods used to reduce materials' degradation (wear or corrosion) could be measured by material loss. The wear profile can indicate the amount of material loss due to the area under the surface and the profile of the wear erosion [11]. The cross-sectional view can be used to determine how the wear has occurred. The alloy wear track profiles measured by the bi-dimensional profilometry of the worn samples and the corresponding wear track volume are shown in Figure 8-transversal wear profiles of the cross sections from profilometry. The track profiles presented in Figure 8 show that the tracks were A1 (~0.33 µm), A2 (~0.41 µm), A3 (~0.29 µm) and A4 (~0.44 µm) deep. It is possible to correlate the profiles of samples A1–A4 (depth \times width) shown in Figure 8 with 2D interferometer images of tracks worn by tribocorrosion in samples of the Co-Cr-Mo alloy (A1–A4). Figure 8a shows that the wear tracks contain the largest wear area in the peak region, which the colour scale can identify. Figure 8b shows a different behaviour with a sharper peak. Figure 8c shows the most prominent peak with the smallest width. Figure 8d shows a shallower depth among all samples, showing a more prominent peak. A comparison of these results indicates that the 150 Hz sample presented better results in track area and worn volume than the remaining samples.

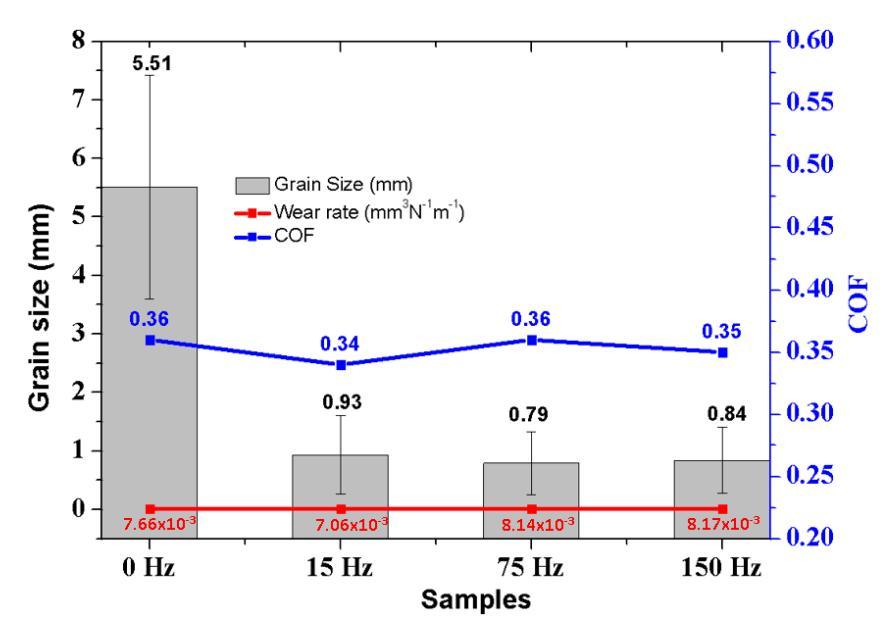
Figure 9. Comparative between medium grain size, wear rate and COF.
