# Article The Corrosive Effects of Aftermarket Oil Additives on High-Leaded Tin Bronze Alloy

**Abstract:** Aftermarket additives are used to enhance the performance of internal combustion engines in specific aspects such as reducing wear, increasing power, and improving fuel economy. Despite their advantages, they can sometimes cause corrosion-related problems. This research evaluated the corrosiveness of four aftermarket additives on the corrosion of a high-leaded tin bronze alloy over 28 days at 80 °C in immersion tests. Among the evaluated products, three showed corrosive effects ranging from intermediate to severe. Notably, the visual appearance of the surfaces often did not indicate the underlying corrosive damage. Therefore, the assessment of corrosiveness was based on chemical characterizations conducted on both the drained oils and the bronze surfaces. The study found minimal oil degradation under the testing conditions, indicating that the primary cause of corrosion was the interaction between the specific additives and the metal elements of the alloy, rather than oil degradation itself. A direct correlation was observed between the dissolution of lead and copper and the

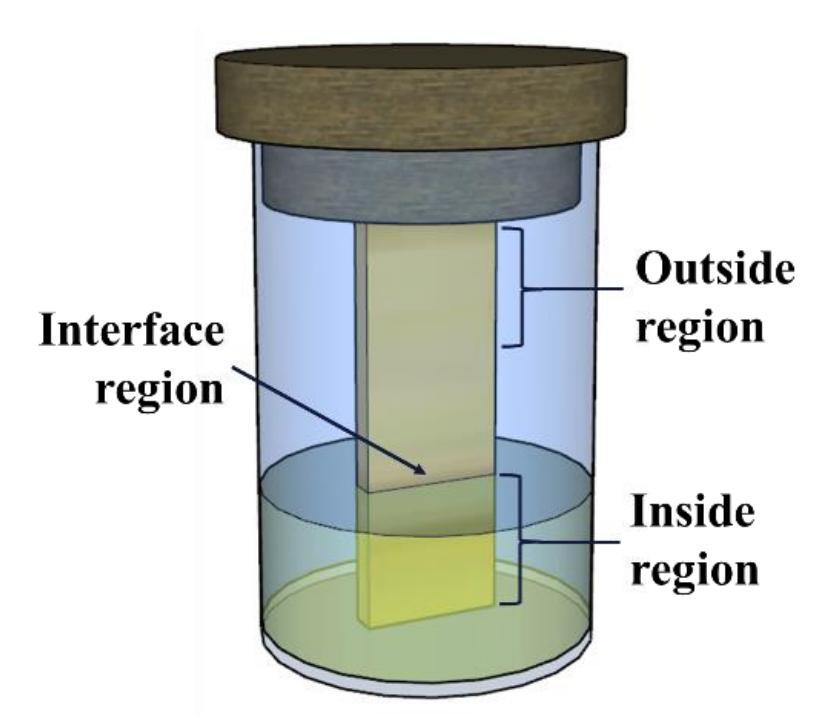
Figure 1. Schematic design of the immersion test.

The glass containers containing the samples (both bronze and lubricant) were hermetically sealed and placed in a heating oven, maintained at a controlled temperature of  $80 \pm 1$  °C. Control samples consisting solely of the lubricants (without any immersed parts) were also prepared. The bronze parts were positioned vertically, immersed up to about a third of their height (~10 mm), as depicted in Figure 1. Containers with each type of tested lubricant were removed at intervals of 14, 21, and 28 days. Subsequently, the bronze pieces were extracted, cleaned in an ultrasonic bath using pure acetone, dried with warm air, and stored in a vacuum to prevent oxidation prior to the surface characterization.

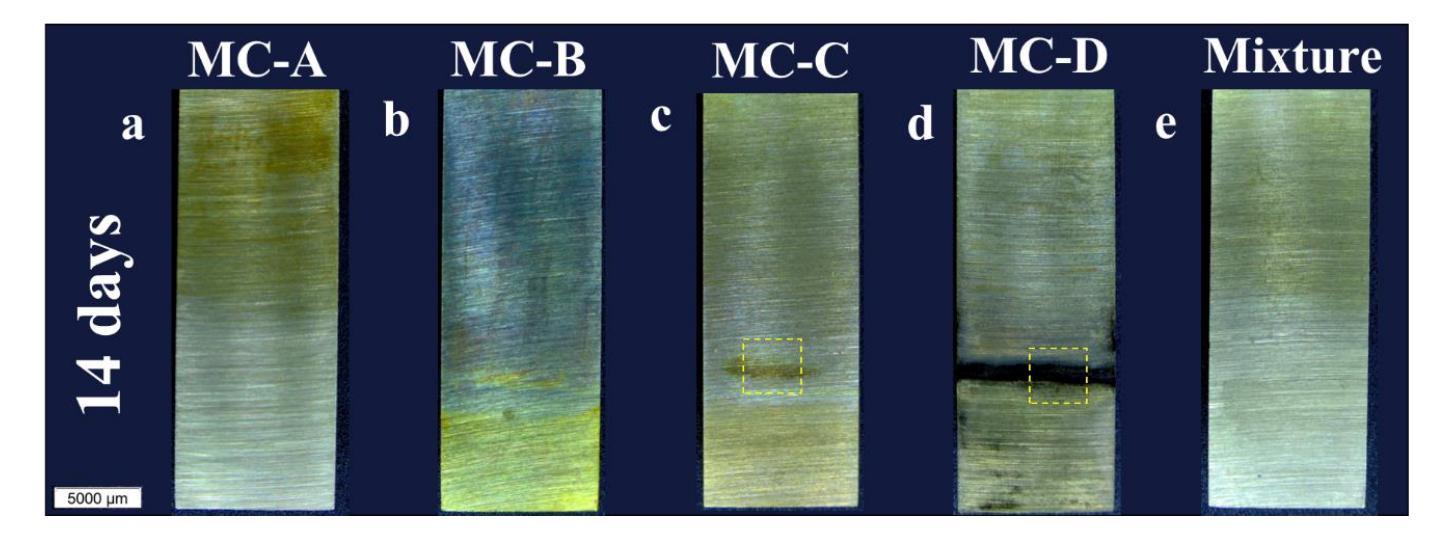
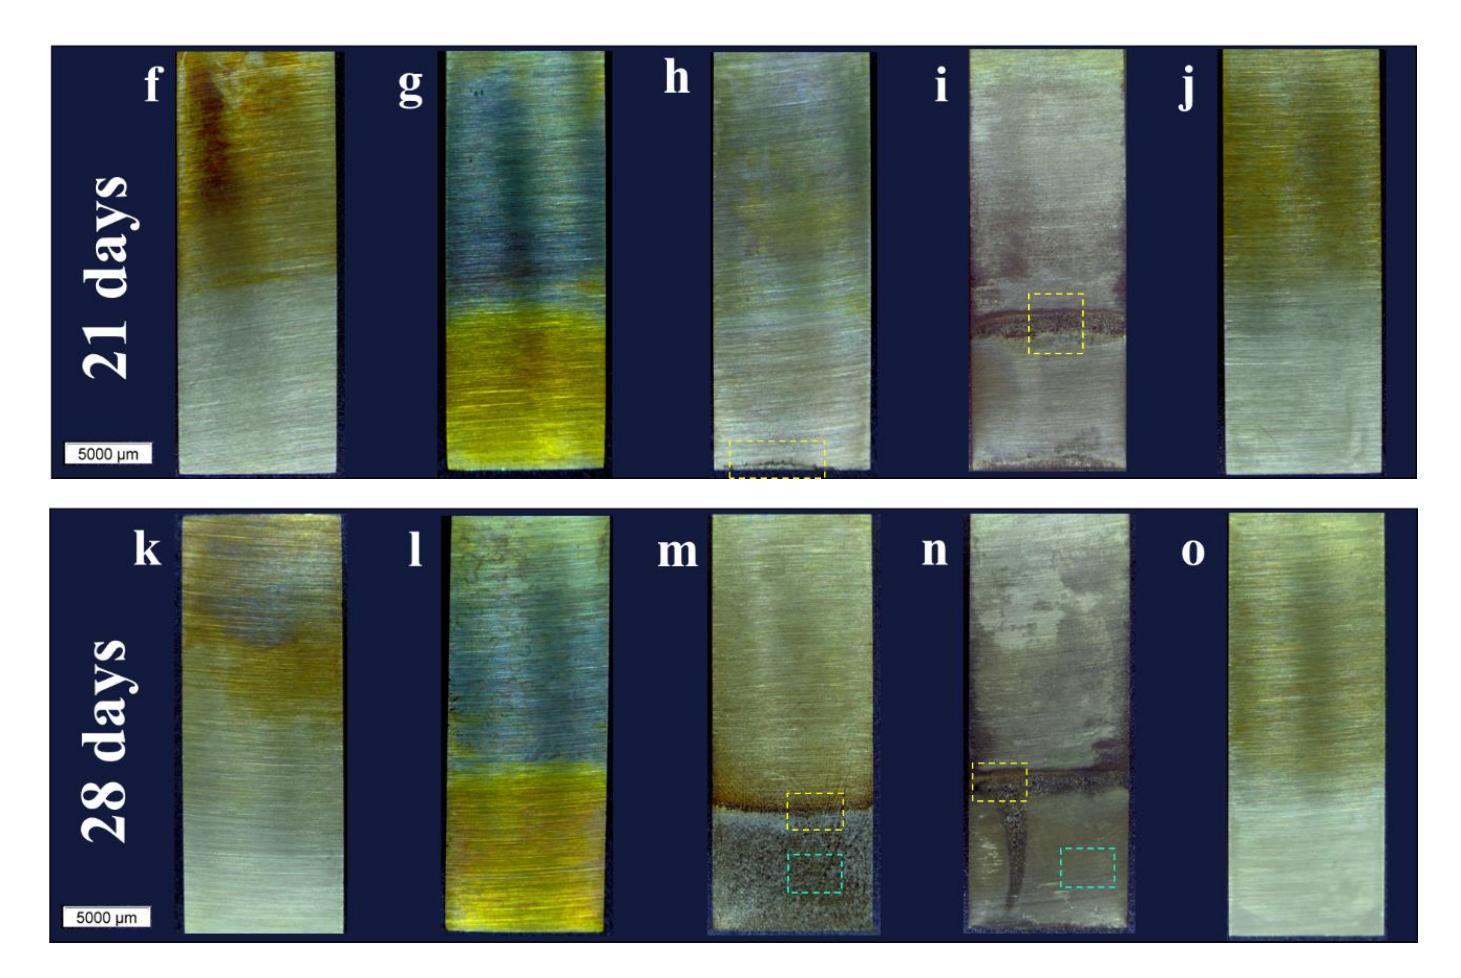
**Figure 2.** Stereoscopic macrograph of the end-of-test condition for 14, 21 and 28 days. Oil bath at 80 °C in MC-A (**a**,**f**,**k**), MC-B (**b**,**g**,**l**), MC-C (**c**,**h**,**m**), MC-D (**d**,**i**,**n**) and mixture (25:1) of SAE 10W-30 and MC-D (**e**,**j**,**o**). The colored rectangles represent the enlarged areas shown in Figure 3.

Figure 2 displays images of the pieces in their end-of-test condition at 14, 21, and 28 days. Approximately one-third of each piece's surface, specifically the lower region shown in Figure 2, was submerged (called inside region in Figure 1). All samples exhibited color changes during the test, varying in intensity and location. The color change was particularly noticeable in the MC-A samples (Figure 2a,f,k) and the mixture (Figure 2e,j,o) in the non-submerged areas, whereas the MC-B sample (Figure 2b,g,l) showed color changes throughout the entire piece. Microscopic observations do not conclusively determine whether there was corrosion in the MC-A, MC-B, and mixture samples throughout the duration of the test.

On the other hand, the samples tested in MC-D showed corrosion at the interface between the lubricant and the air from 14 days (Figure 2d), which then propagated until the end of the test from the interface (Figure 2n). Regarding the MC-C samples, corrosion

In MC-D, the evolution of corrosion followed a different mechanism, beginning and spreading from the interface between the lubricant and air (Figure 2d). In the magnified view of this interface in Figure 3e (14 days), regions of the sanded surface that remained unattacked are observable, while the extensive matrix underwent corrosion (dark areas). At 21 days, at the interface (Figure 3f), regions of the sanded surface are still visible along with the growth of a layer of corrosion products projecting from the surface. By the end of the test, the corrosion morphology differed between the interface (Yellow square in Figure 2n) and the immersed region (blue square in Figure 2n). At the interface (Figure 3g), the surface texture results from corrosion products with varying shades. In the immersed region (Figure 3h), the original sanded surface marks are still visible alongside areas of localized attack as well as widespread surface corrosion.

An unexpected result was the Pb content in the drained MC-A and the mixture (Table 4). This reveals that they caused selective corrosion of lead in the high-leaded tin bronze parts during all evaluation periods. In these lubricants, the Pb content increased over the duration of the test. These results are surprising since neither the macrographs in Figure 2 nor the micrographs exhibit evident signs of corrosion. The only notable change was the loss of color and brightness in the immersed region of the pieces tested with MC-A (Figure 2a,f,k) and the mixture(Figure 2e,j,o).

The bronze pieces immersed in MC-B only showed coloration changes (as shown in Figure 2b,g,l) and no alloy metals were detected in the drained oil (Table 4). Also, the low levels of oxygen on the surfaces, indicates a limited formation of oxides. One potential explanation is that the drained oils indeed contained alloy elements, yet their concentrations fell below the detection limit of the ICP-OES technique, suggesting a very slight degree of corrosion. On the other hand, it is also possible that its additives (detergent, antioxidants, or corrosion inhibitors, associated with the contents of Zn, P, Ca, Mg, and Na in the new MC-B, as per Table 4) played a key role in surface protection.

The test results with MC-A and the mixture can be categorized as a mild corrosive attack: the bronze surfaces only exhibited loss of coloration (as seen in Figure 2) and the ICP-OES analyses (Table 4) suggest a selective corrosive attack on lead, whose content progressively increased over time in the drained oils. In comparison to the tests with MC-A, the mixture led to the formation of a layer of surface oxides, as confirmed by the higher oxygen content (up to 16.43 wt.%, Table 5). Additionally, the presence of sulfur on the surfaces (Table 5) and in the oil formulations, can be linked to this localized attack, as seen in Figure 7a. Consequently, in both cases the whitening of the surface in the immersed region and the interface is related to the depletion of lead from the surfaces.

Finally, the MC-C and MC-D additives demonstrated a severe corrosive effect on the bronze alloy under evaluation. Both exhibited signs of obvious macroscopic corrosion (as shown in Figure 2), along with the presence of copper and zinc contents (Table 4) and millimetric particles of corrosive wear in the drained oils. Additionally, throughout the test, a layer of corrosion products projecting from the surface was observed to grow (as seen in Figure 3) in the regions most affected by each lubricant. The SEM-EDS analyses (Table 5) suggest that the area with the highest concentration of chlorine coincides with the incidence of corrosion: greater attack was observed with MC-C in the immersed region (Figures 2m and 3d) and with MC-D at the interface (Figures 2n and 3g).

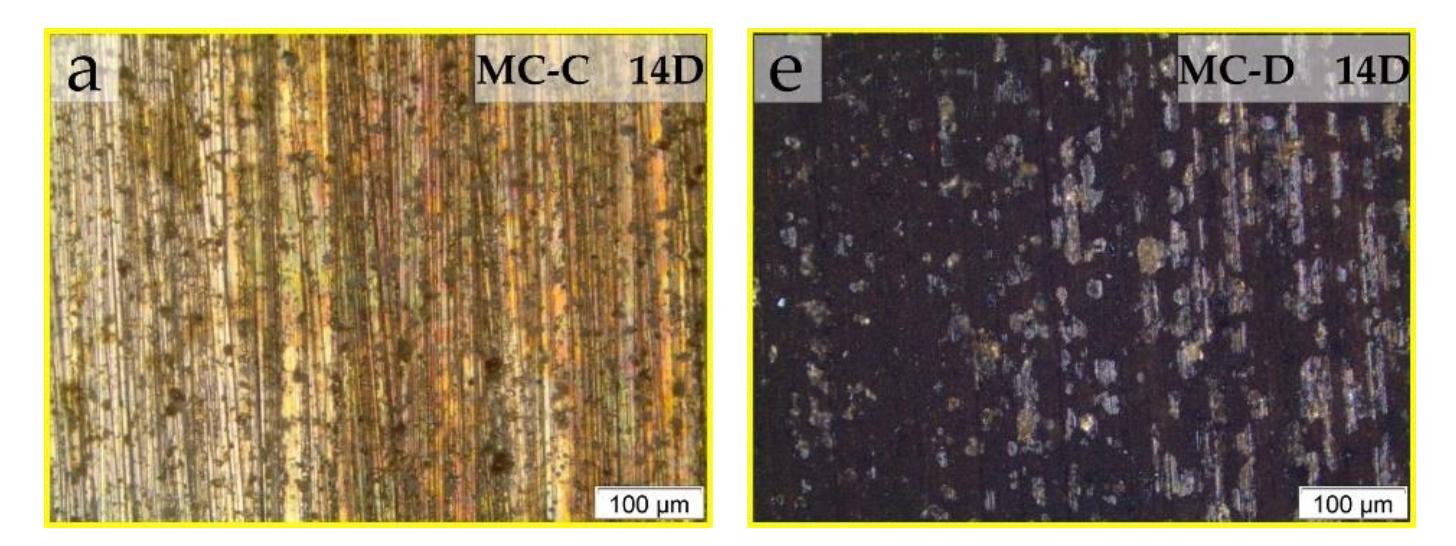
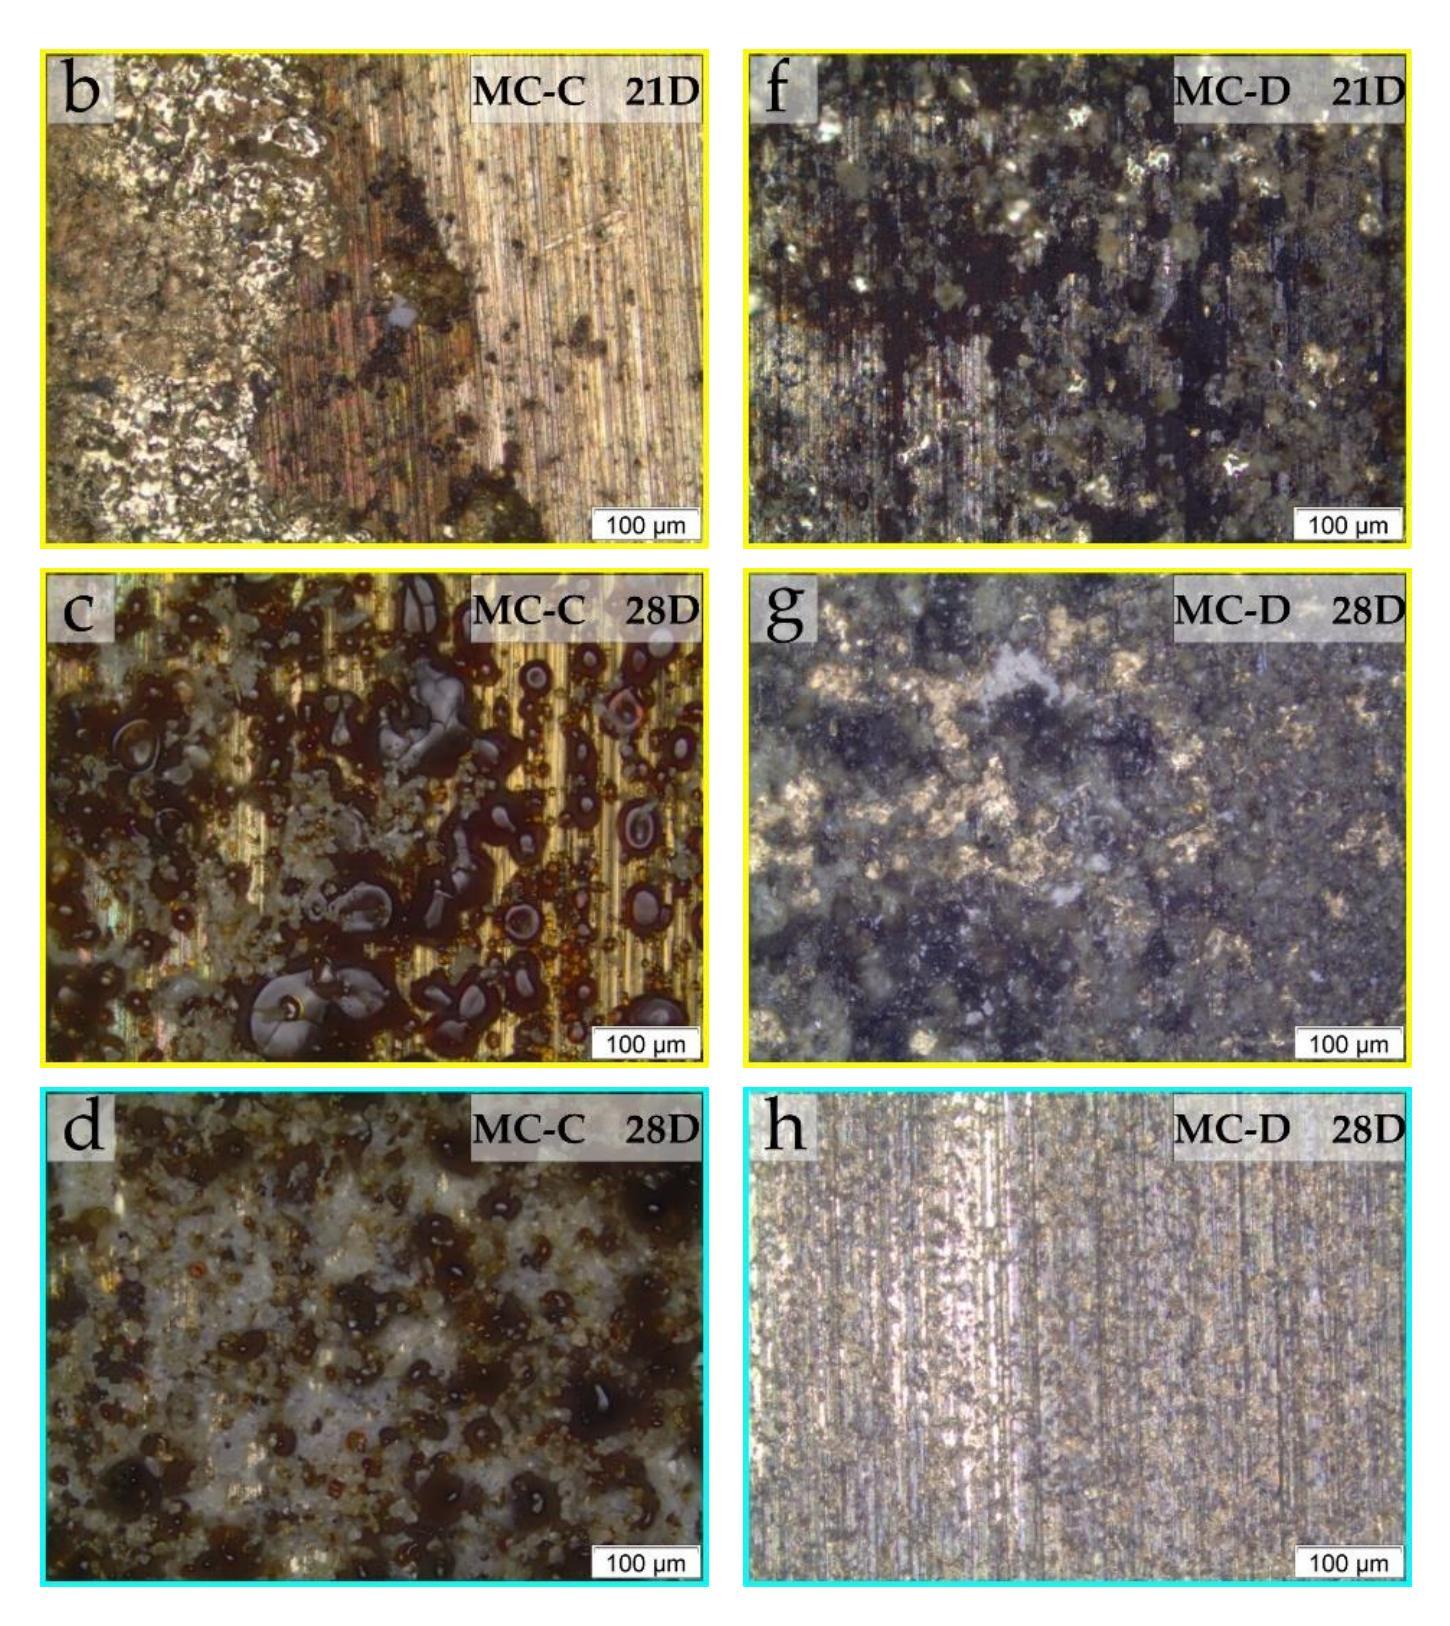
**Figure 3.** Optical micrographs enlargements of the end-of-test condition for 14, 21 and 28 days. Oil bath at 80 °C in MC-C (**a**–**d**) and MC-D (**e**–**h**). The magnification regions are identified in Figure 2.

Higher magnification optical micrographs within the dashed squares of Figure 2 were taken to detail the corrosion of the samples tested in MC-C and MC-D. Figure 3 shows the magnified views of these dashed regions for all evaluation periods. On the surfaces in contact with MC-C (Figure 3a–d), an evolution of corrosion products was observed throughout the testing period. This progression appears to have begun at 21 days at the lower end (Figures 2h and 3b) and subsequently spread uniformly across the immersed region (Figures 2m and 3c,d). The surface texture of the piece tested in MC-C (Figure 3b–d) seems to be the result of the growth of a layer of corrosive deposits emerging from the surface.

The surface region with the highest chlorine content appears to coincide with the incidence of corrosion: a more significant attack was observed with MC-C in the immersed region (Figures 2m and 3d) and with MC-D at the interface (Figures 2n and 3g). The parts tested in the mixture showed the greatest diversity of additive elements (Ca, Na, Cl). This outcome is a result of the lubricant used, SAE 10W-30, being a fully formulated oil.

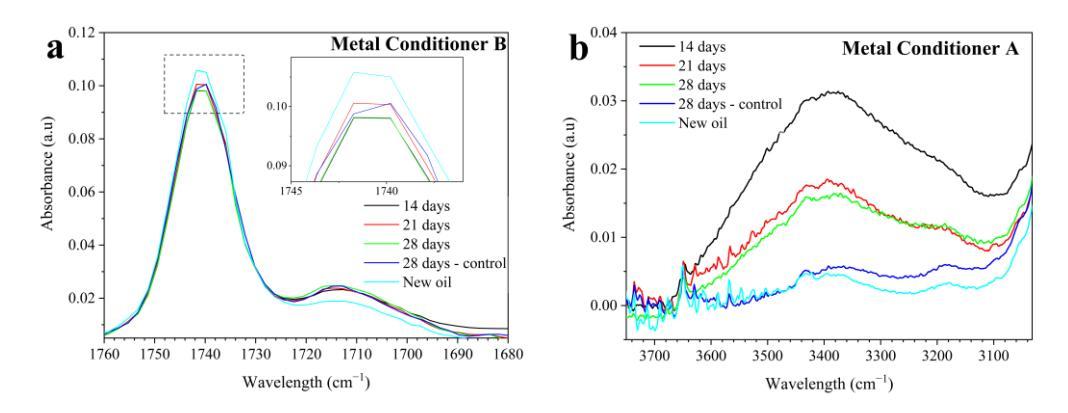
Figure 4. Representative infrared spectrum of (a) the oxidation region; (b) the OH absorption region.

Additionally, for all lubricants, an increase in absorbance was observed in the region between 3600 and 3150 cm<sup>-1</sup> (Figure 4b, Table 3), compared to the condition of new (fresh) oil. Figure 4b representatively shows the results for one of the conditioners, as similar trends were observed in the others. The 3600–3150 cm<sup>-1</sup> region corresponds to the intermolecular O-H bond [17]. Therefore, an increase in this region is commonly observed due to water contamination [17] or the formation of degradation products in the oil, such as alcohols, carboxylic acids, and OH- radicals [9]. Considering that the tests were conducted under 'closed-cap' conditions (Figure 1) with limited air exposure, and that the spectra of lubricants in contact with the parts (over all time periods) showed higher absorbances than the 28-day control oil in the 3600–3150 cm<sup>-1</sup> region (Table 3), it is likely that the observed increase predominantly relates to the formation of oil degradation products. Some of these products may have originated from the decomposition of ester-type additives, as indicated by the decreased absorbance at the ~1740 cm<sup>-1</sup> peak observed in Figure 4a, a trend observed across all lubricants.

All lubricants exhibited minor changes in the infrared spectrum, such as the reduction in the intensity of the ester peak (Figure 4a) and the increase in absorption of the intermolecular O-H bond (Figure 4b). FTIR analyses of the metal surfaces revealed the adsorption of the O-H bond on parts immersed in MC-A, MC-C, MC-D, and the mixture (Figure 6). Both results indicate that the products of partial oil degradation were reactive with the bronze alloy and, consequently, became adsorbed.

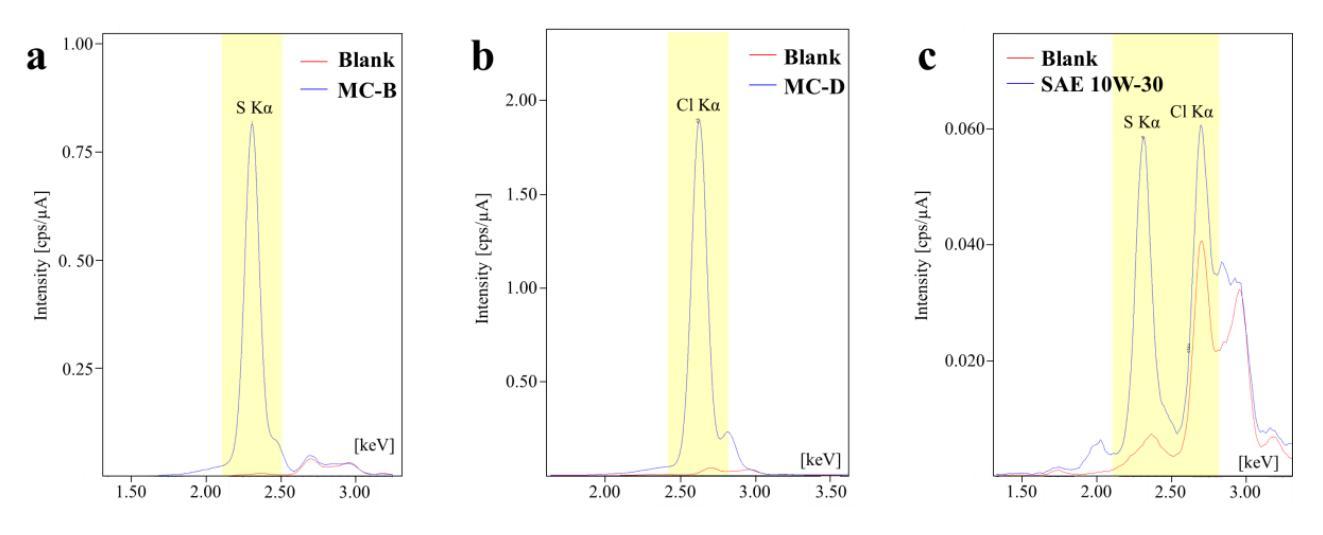
**Figure 5.** Energy Dispersive X-ray Fluorescence (EDXRF) spectra of (**a**) MC-B, (**b**) MC-D, and (**c**) SAE 10W-30 API SL JASO MA.

Notably, the spectra of MC-B (Figure 5a), MC-A (not included in the figure), and SAE 10W-30 (Figure 5c) revealed a distinct peak in the S-K $\alpha$  region. Whereas for MC-C and MC-D (Figure 5b), no prominent signal appeared in the S-K $\alpha$  region but rather in the Cl-K $\alpha$  region. Additionally, the SAE 10W-30 sample (Figure 5c) also exhibited a peak for Cl-K $\alpha$ . However, the analysis of chlorine posed a challenge due to background interference. The characteristic X-rays from the X-ray tube overlapped with the target peak in the spectra of MC-A and MC-B (Figure 5a), particularly in the range of 2.5–3.0 keV. This overlap complicates the confirmation of chlorine compounds in these samples.

The similar results between the tests conducted on MC-A and the mixture suggest that S-containing additives or sulfur compounds (identified by EDXRF, Figure 5a,c) cause a selective attack on the lead islands in the microstructure (as seen in Figure 7, Pb content in Table 4). In the case of MC-B, which also contains sulfur (confirmed by EDXRF, Figure 5), it is possible that the antioxidant additives or corrosion inhibitors were effective in protecting the surfaces. Another possibility is the effect of sulfur speciation in its corrosivity, as observed by [10,12,14] in copper corrosion tests. Indeed, Jayne, Shanklin, and Stachew (2002) [12] demonstrated that the presence of secondary ZDP produces severe corrosion of pure lead and negligible corrosion of pure copper, while primary and aromatic ZDP have the opposite effect.

On the other hand, the corrosive effect of Cl-containing additives (content verified by EDXRF in MC-C and MC-D, Figure 5b) on the bronze alloy under study was observed. These additives showed selective corrosion of the matrix (mainly Cu, the major element), resulting in corrosive wear with the detachment of copper (MC-C) and copper + zinc (MC-D) from the surfaces. The corrosive process in both lubricants produced a layer of oxides and corrosion products that protruded from the surface, where chlorine was the sole additive element detected by SEM-EDS (Table 5). The non-detection of tin (in ppm, Table 4) by ICP-OES is likely attributable to its concentration being below the equipment's lower detection limit [18]. Cl-containing additives have a greater affinity (and higher chemical reactivity) with metallic surfaces, hence their consideration as being more effective in forming a sacrificial layer compared to S-containing additives [16,22]. Despite the galvanic differences of the high-leaded tin bronze alloy, which theoretically favor the corrosion of other elements before copper (order of nobility or resistance to corrosion Cu > Sn > Pb > Zn), the chlorinated compounds showed a marked affinity with the matrix, as seen in the SEM-EDS maps of Figure 7b.

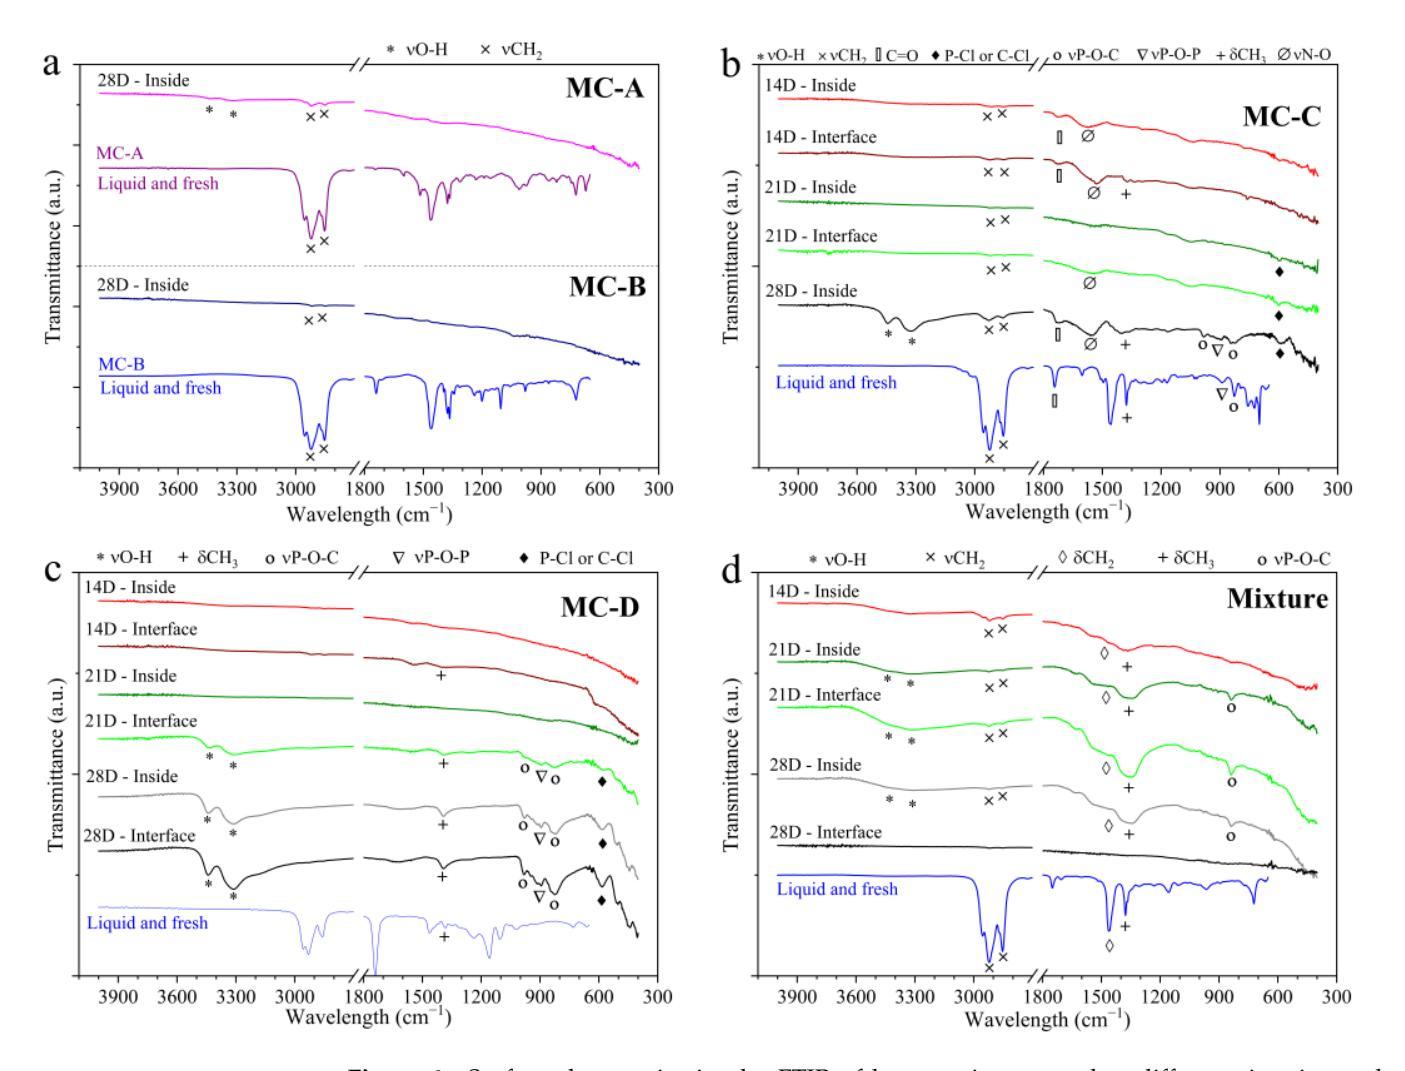
**Figure 6.** Surface characterization by FTIR of bronze pieces tested at different time intervals: (a) MC-A and MC-B; (b) MC-C; (c) MC-D; (d) the mixture. Band assignment based on [13,17].

Figure 6 presents the FTIR spectra of the surfaces. For comparative purposes, the spectrum of each oil in its new condition is also presented, with the analysis conducted in the liquid state. Overall, Figure 6 demonstrates that a limited number of organic groups remained adsorbed on the metal surfaces after the cleaning procedure. The characteristic peaks of the surface spectra are broader and less intense compared to the spectrum of the new oils, this observation aligns with the findings of Piras, Rossi, and Spencer (2003) [13].

In the spectra of the parts tested in MC-C (Figure 6b), MC-D (Figure 6c) and in the mixture (Figure 6d), peaks identified in the region between 1000 and 775 cm<sup>-1</sup> were associated with stretching vibrations of P-O-P and P-O-C (vP-O-P, vP-O-C). According to [13], these bonds originate from the degradation of antiwear additives such as Zinc dialkyldithiophosphates (ZDTPs). Furthermore, it is noteworthy that from 21 days onwards in MC-C and MC-D, the peak located at 585 cm<sup>-1</sup> could possibly be associated with the stretching of halo compounds such as P-Cl or C-Cl. This is supported by the detection of chlorine by EDXRF and in the surface analyses performed by SEM-EDS, as will be presented subsequently.

Finally, one or two broad bands in the 3500–3250 cm<sup>-1</sup> region associated with the O-H stretching vibration (vO-H) are identified in the spectra of the surfaces in MC-A, MC-C, MC-D, and the mixture (Figure 6). The presence of the O-H group on the surfaces confirms

Despite FTIR determinations that organic groups such as P-O-P, P-O-C, P-Cl, or C-Cl were adsorbed on the surfaces immersed in MC-C and MC-D (Figure 6b,c), only those containing chlorine were detected by SEM-EDS (Table 5, Figure 7b). Two hypotheses can be considered: (i) Due to the test conditions (80 °C, no tribological contact), only chlorinated compounds remained adsorbed on the surfaces after the cleaning procedure (before SEM-EDS analysis); (ii) the P-containing compounds were not present in sufficient quantities to be detected by SEM-EDS. The greater corrosive power is attributed to MC-D, which initiated corrosion in a shorter time (14 days, as seen in Figure 2d) compared to MC-C (21 days, as shown in Figure 2h). This analysis underscores the complex interactions between lubricant additives and metal surfaces, highlighting the importance of considering the specific chemical nature of additives and their potential for causing corrosion, which will be discussed in the subsequent section.

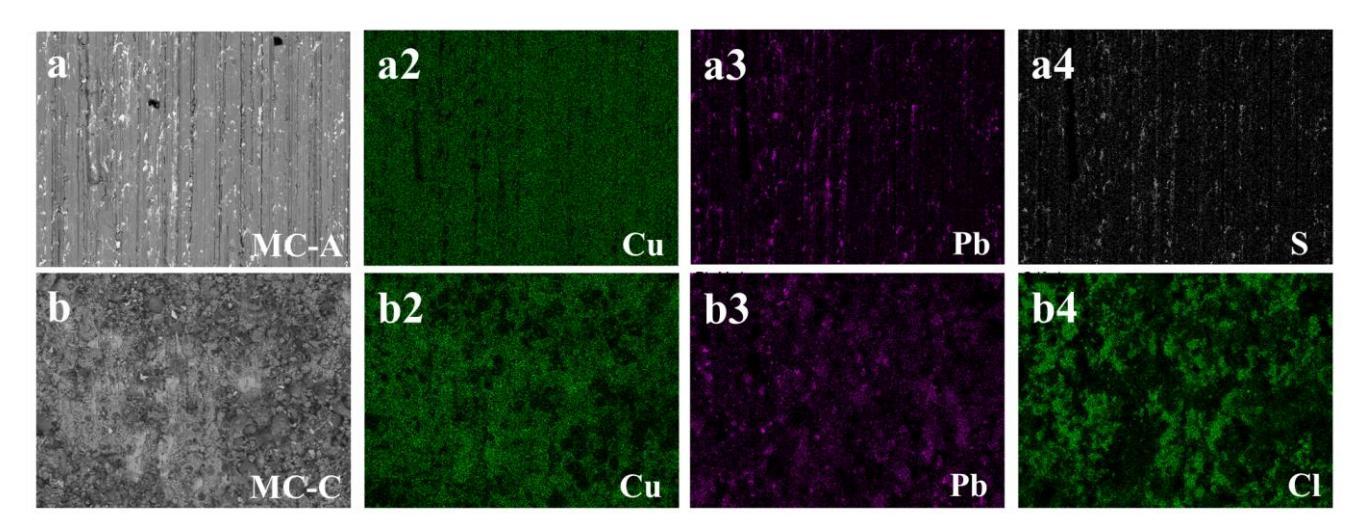
**Figure 7.** Elemental mapping images using SEM/EDS analysis of the end-of-test (28 days) surfaces immersed in (**a**–**a**4) MC-A and (**b**–**b**4) MC-C. The maps for copper (**a**2,**b**2), lead (**a**3,**b**3), sulfur (**a**4), and chlorine (**b**4) are respectively organized.

The analyses conducted using SEM-EDS enabled the identification of a preferential distribution of the additive elements sulfur (S) and chlorine (Cl) in the microstructure of the bronze, as demonstrated in Figure 7. Under the conditions in which sulfur or chlorine are adsorbed onto immersed surfaces (Table 5), a representative case for each of these elements was selected for presentation in Figure 7a4,b4, respectively.

In Figure 7a, a significant correlation emerges between the intensity of the sulfur element (Figure 7a4) and the presence of lead islands (Figure 7a3) within the microstructure. Conversely, the analysis presents a different scenario for chlorine, as depicted in Figure 7b. The map for chlorine (Figure 7b4) displays extensive coverage across the matrix of the microstructure, predominantly composed of copper. These findings indicate a selective affinity: sulfur for regions rich in lead, and chlorine for the copper matrix. This pattern
