# Communication Observation of External Wounding on Green Ash (Fraxinus pennsylvanica Marshall) Trees Associated with Tree Injection Systems

**Abstract:** Field observations of external wounds associated with two common tree injection methods compared open (plug-less) and sealed (plug) systems in green ash (*Fraxinus pennsylvanica* Marshall) trees. A wound from any cause within 1.37 m above the ground was common with 28.8% of all trees. The open system had statistically fewer (p < 0.001) trees with at least one wound (11.6% of trees) than the sealed system (47.4% of trees). The open system had fewer (p < 0.001) wounds (0.17, 0.04 SE) per tree and a smaller (p < 0.001) total wound area (25.5 cm<sup>2</sup>, 8.7 SE) per tree, compared to the sealed system wounds (1.14, 0.13 SE) per tree and the total wound area (99.7 cm<sup>2</sup>, 16.2 SE) per tree. The incidence of a tree with a wound(s) within 1.37 m above the ground was 7.2 times more likely with trees treated though the sealed system. Wounds in the sealed system were observed to appear to have a high rate of improper application of plugs, which was associated in 77% of the cases to explain the wounds. Implications of study res

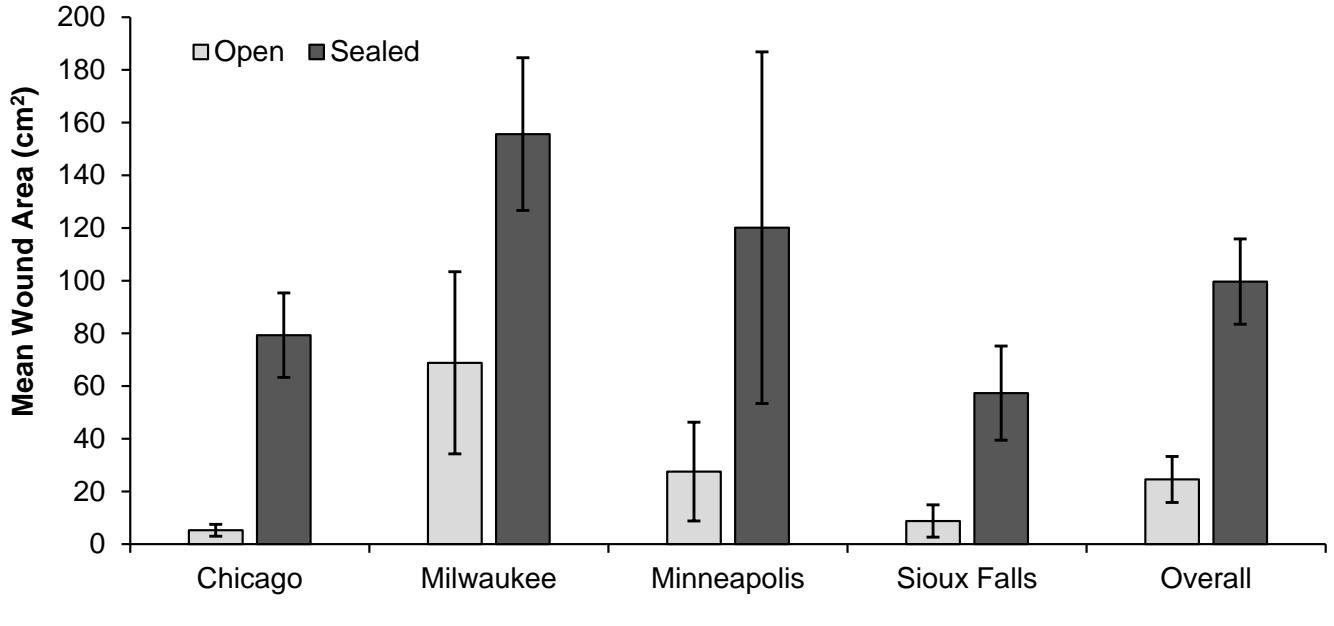
**Figure 1.** Mean total wound area by treatment and metropolitan region for open (plug-less) and sealed (plug) systems for emerald ash borer (*Agrilus planipennis* Fairmaire) treatment in green ash (*Fraxinus pennsylvanica* Marshall) trees. (Bars are SE, F(1, 363) = 17.406, p < 0.001).

A significant (p < 0.001) difference between treatment systems occurred with wound number (Table 2, Figure 1). Trees injected with the open system had a mean of 0.17 (0.04 SE) wounds per tree compared with the sealed system of 1.14 (0.13 SE) wounds per tree. Similarly, mean total wound area for open treated trees was significantly (p < 0.001) less (24.5 cm<sup>2</sup>, 8.7 SE) compared with the sealed (99.7 cm<sup>2</sup>, 16.2 SE) system (Figure 1). No difference (p < 0.249) in tree condition was found in the open (90.1%) compared with the sealed (80.2%) system. There was no significant difference between injection systems for canopy thinning (p = 0.583) or distance from the ground to the base of a wound (p = 0.884). Trunk diameter in the open system trees was significantly less (p = 0.012) by 5 cm (2 in) compared with the sealed system trees.

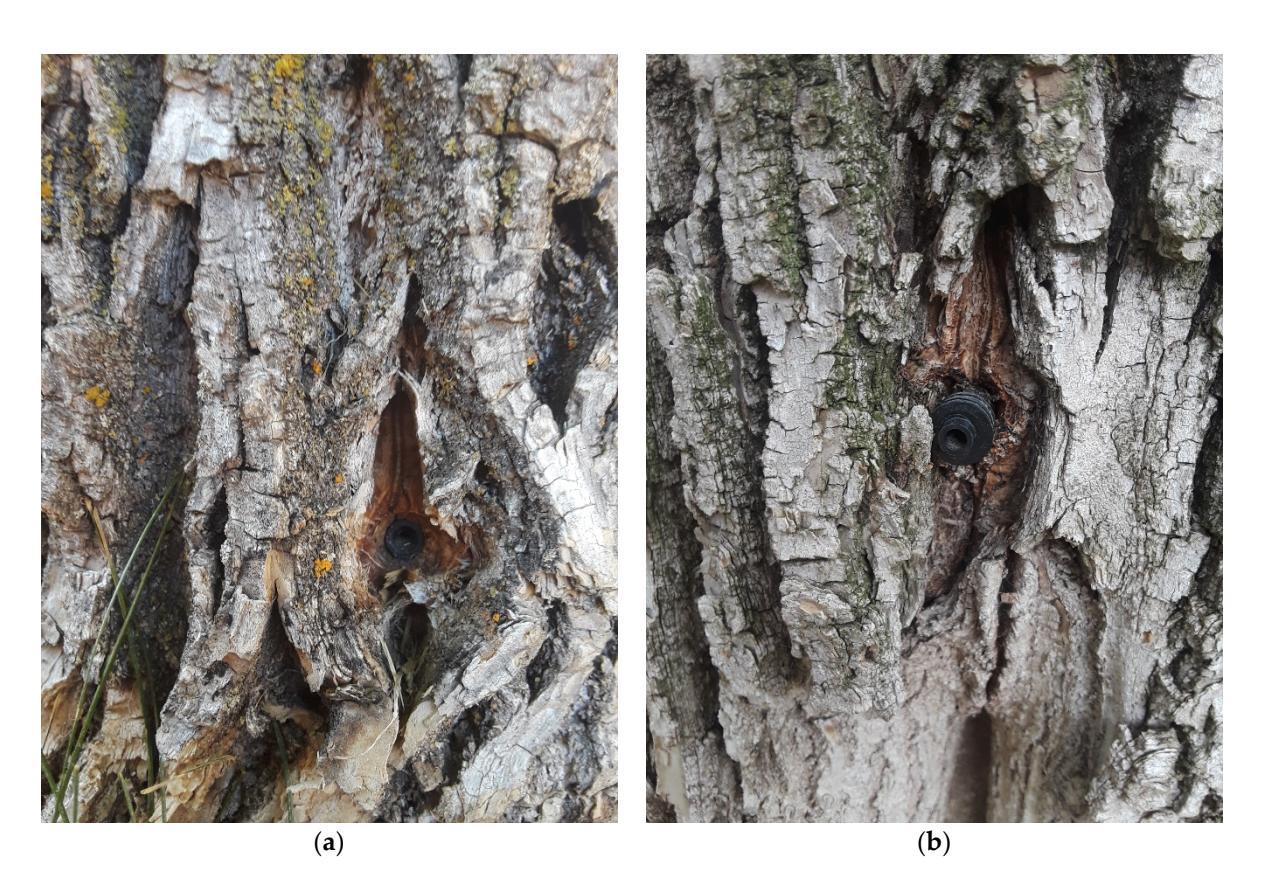
Figure A2. Plug appearance of improper application (a) set shallow and associated (b) bark cracking.

Treatment method appears to be one factor explaining differences in wounding. In this study the open system had fewer wounds and wound area than the sealed system. Drilling through bark and into wood damages vascular tissue and factors such as the drill bit angle, sharpness, diameter, and drilling speed are all potential factors that if done incorrectly could lead to tissue necrosis [10,14,34]. These factors were not possible to assess in this field study, but a future study could test the effects of drilling. However, we observed that correct application is important, and as such the improper inserting of plugs in the sealed system largely explained higher wounding in this study. We observed plugs were often set too shallow, sometimes even falling out, and not set in the sapwood as the manufactures installation instructions clearly require [10]. Following manufacture recommendations is advised as a best practice for tree injection, and proper plug placement depth is part of this [10].

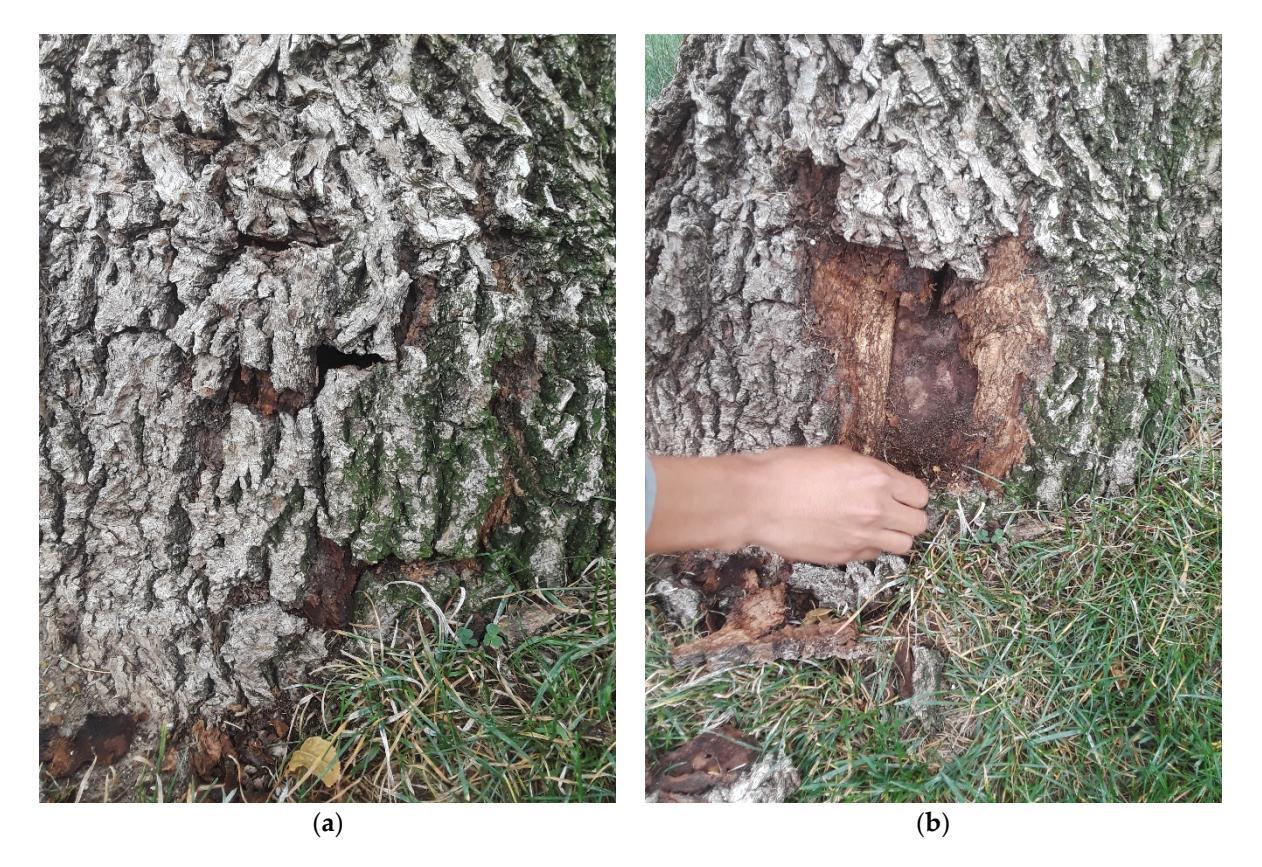
**Figure A3.** (a) Appearance of dead bark covering a wound; (b) Appearance of wound after bark was removed.

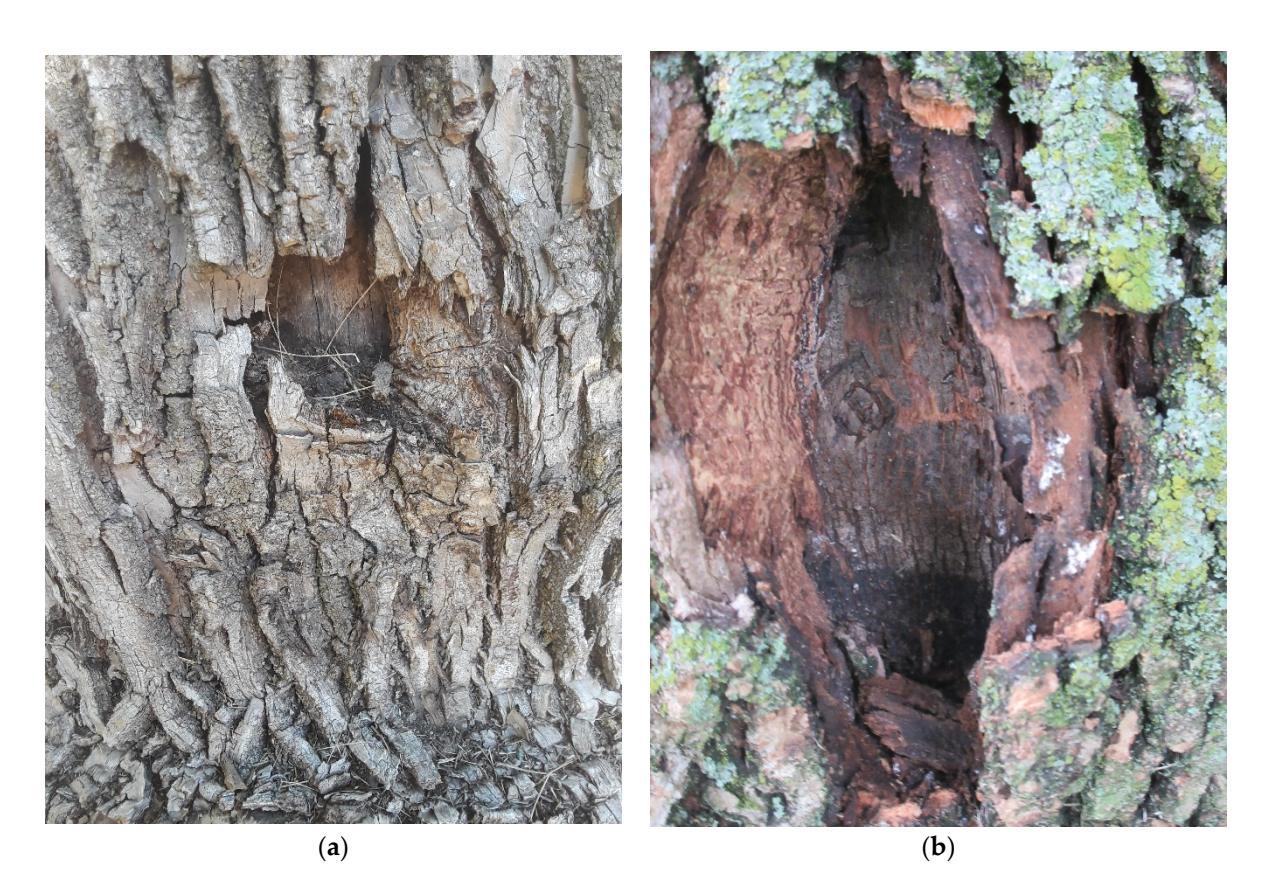
**Figure A4.** (**a**) Example appearance of wound with wound wood development; (**b**) Example wound with sunken appearance and wound wood development.

with a plastic-silicone plug. In this study tissue necrosis of bark, cambium, and wood was observed. Exposed wood tissue was observed in half of the wounds and was similar for both systems. Initial bark cracking appears to become closed with callus and later wound wood formation [24].

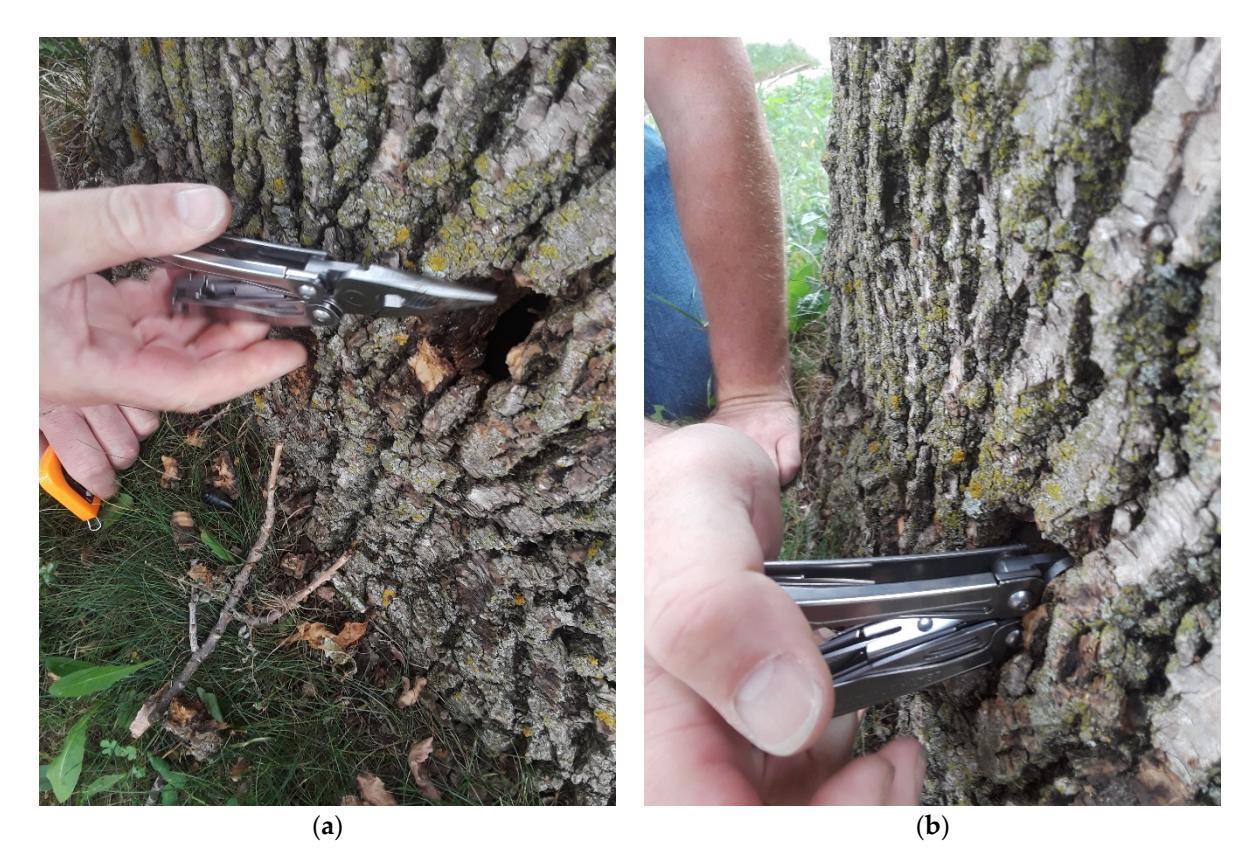
**Figure A5.** (a) Example wound partially obscured by bark; (b) Example wound partially obscured by bark with tool inserted.
