# Article The Use of Multilayer Perceptron (MLP) to Reduce Delamination during Drilling into Melamine Faced Chipboard

Keywords: MLP classifier; tool condition monitoring; drilling; laminated chipboard

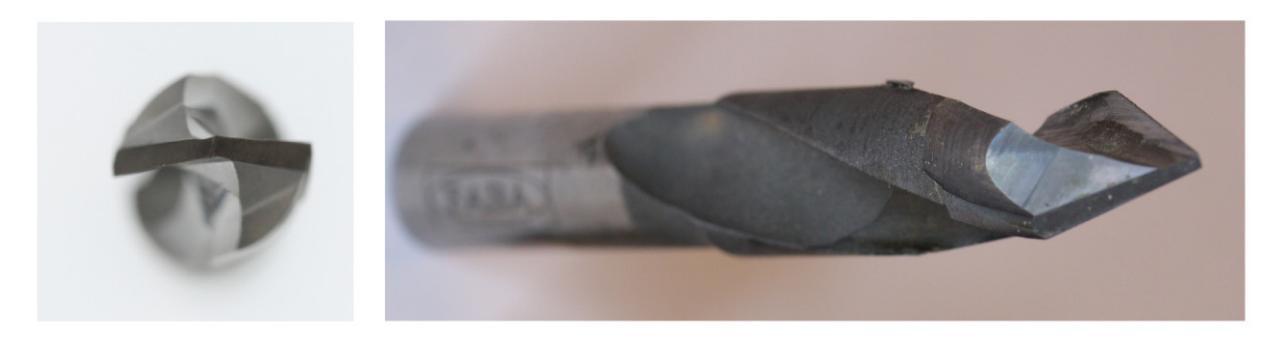
Figure 1. General view of the drill used in the experiments (FABA WP-01).

During experimental research, the Computerized Numerical Control (CNC) machining center (Jet 100; Busellato, Thiene, Italy) was used. For the tools, six two-blade drills with diameters of 12 mm were used, with sintered carbide blades (FABA WP–01; Faba SA, Baboszewo, Poland—Figure 1) that are normally used for through-boring in wood-based panels. The holes were made in a three-layer laminated (melamine faced) chipboard (Kronopol U 511 SM; Swiss Krono Ltd., Żary, Poland) at a spindle speed of 4500 rpm and a feed speed of 1.35 m/min (in accordance with the drill bit manufacturer's recommendations).

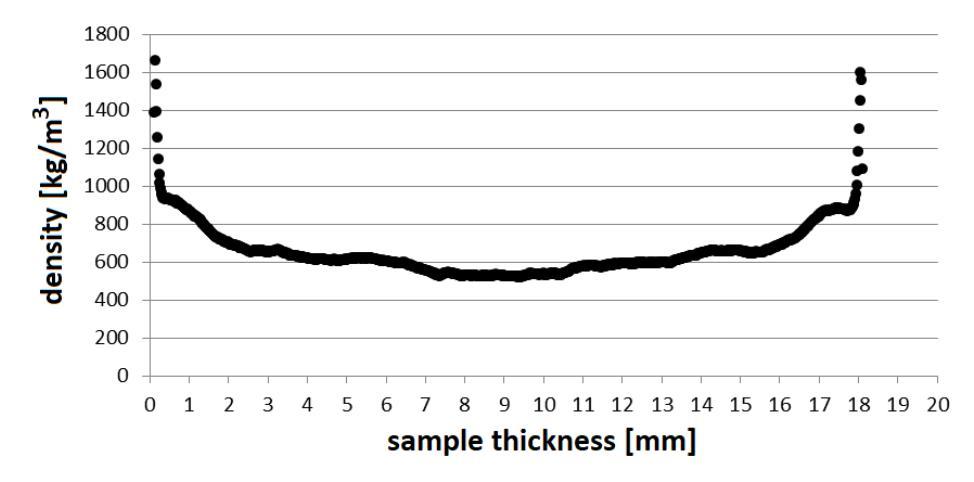
Figure 2. Density profile of the chipboard used in experiments.

A density profile of the chipboard was determined using a GreCon DAX device (Fagus-GreCon Greten Gmbh & Co. KG, Alfeld, Germany) and is shown in Figure 2. Other material parameters were as follows: the bending modulus of rupture was 15.4 MPa; the bending modulus of elasticity was 2950 MPa; and the surface Brinell hardness (HB) was 2.1. The material tests were performed according to [23,24] using an Instron 3382 (Instron, Norwood, MA, USA) testing machine and a Brinell CV 3000LDB tester (Bowers Group – UK, Camberley, UK), respectively.

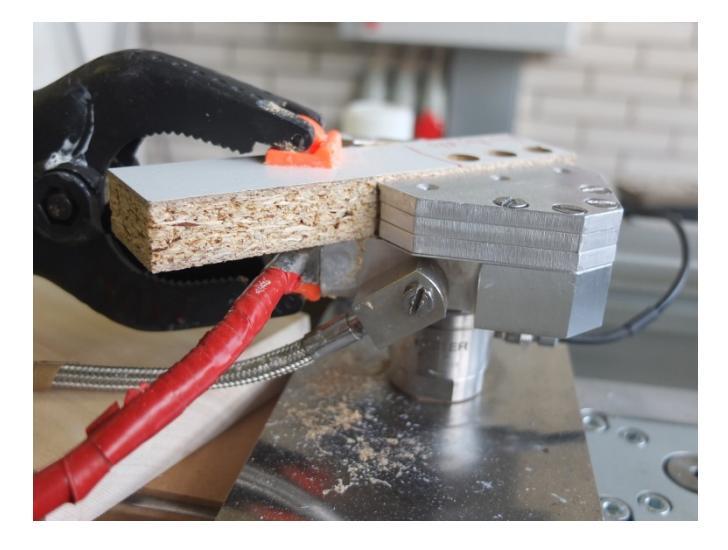
**Figure 3.** A detailed view of the workpiece (clamping on a piezoelectric dynamometer), acoustic emission sensor (fixed with a flexible carpentry clamp) and the accelerometer (fixed with a screw).

The workpiece clamping and sensor installation are shown in Figures 3 and 4.

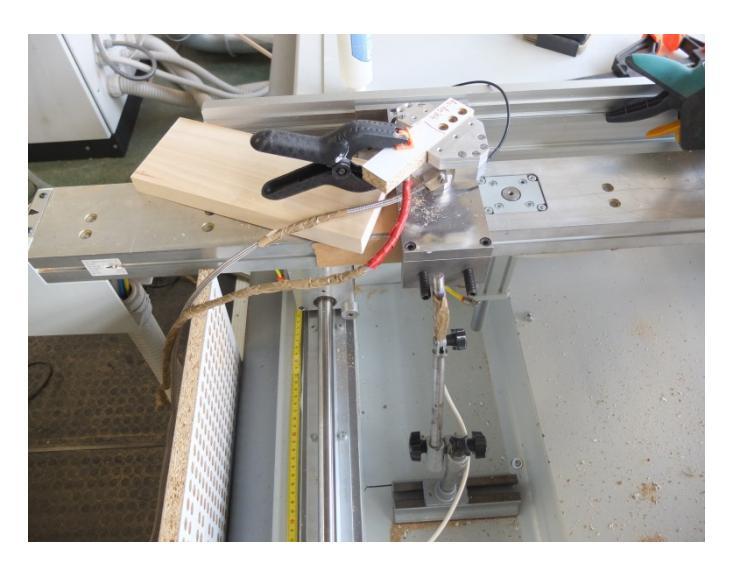
**Figure 4.** A general view of the workpiece (clamping on a piezoelectric dynamometer) and the microphone (mounted on the stand near the machining zone).

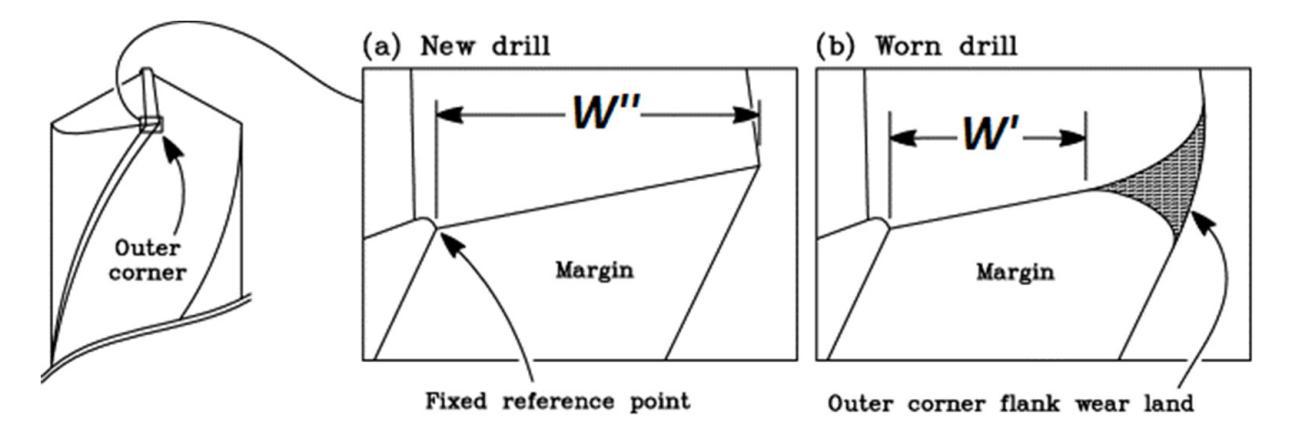
Figure 5. The method for tool wear measurement: (a) view of a brand new tool, (b) view of worn tool [25].

The real condition of drill bits was (for the purpose of further learning and testing, the MLP network effectiveness) directly monitored and assessed using a standard workshop microscope (TM—505; Mitutoyo, Kawasaki, Japan) with a digital camera. As a direct indicator of the condition of the drill bits, the amount of wear (abrasion) of the outer (periphery) corner was assumed. The amount of wear (*W*) was separately determined for each of the two drill cutting edges, according to the following equation:

where W'' is the initial width of a brand-new cutting edge near the outer corner (mm) (Figure 5), and W' is the current width of a brand-new cutting edge near the outer corner (mm) (Figure 5).

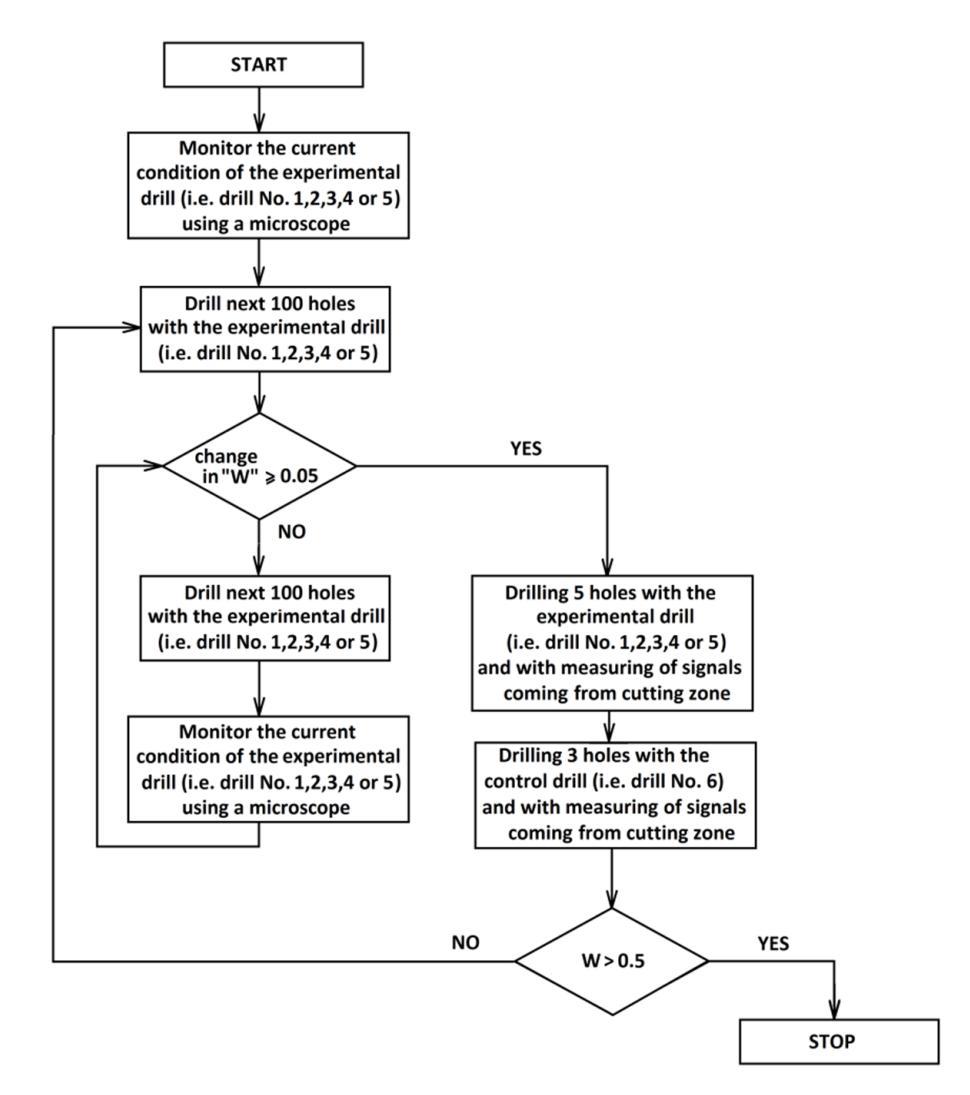
**Figure 6.** The experimental schedule as a standard flowchart in a metaphorical form (as if it was an algorithm of a computer program and not a procedure performed by a human being).

The detailed experimental schedule is presented in a standard flowchart (algorithm diagram) and is shown in Figure 6. The experimental procedure is presented in this figure in a metaphorical form (as if it was an algorithm of a computer program and not a procedure performed by a human being).

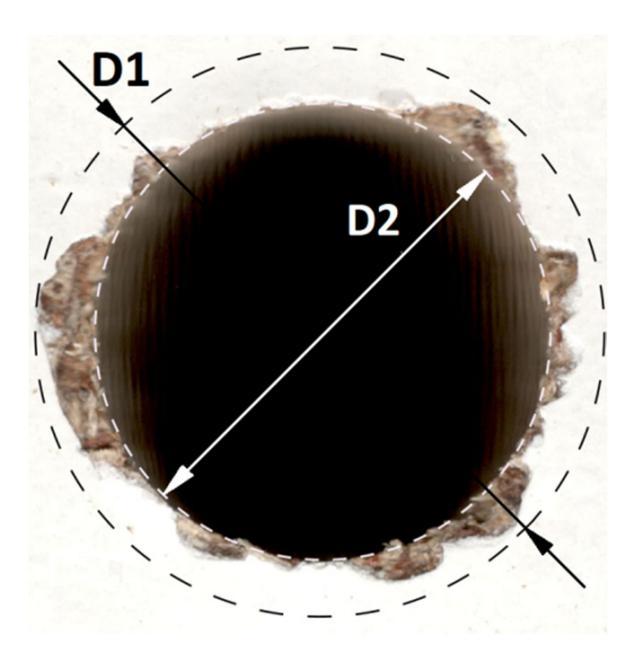
**Figure 7.** Delamination factor (Fd) calculation method. The circles with a diameter of D1 and D2 are drawn with a black and white dotted line, respectively.

where D1 stands for the diameter of the smallest circle containing the delamination zone (mm) (Figure 7), and D2 stands for the diameter of the largest circle inscribed in the outline of the hole (mm) (Figure 7).

Both of these diameters (D1 and D2) were determined automatically using computer image analysis based off of scans (1200 dpi) of all experimental workpieces taken with a standard office scanner.

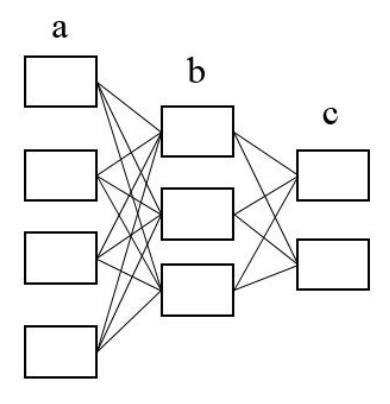
**Figure 8.** The general structure of the two-layer MLP neural network: a, input layer; b, hidden layer; c, output layer.

As part of the research task, a standard MLP algorithm was adopted. The MLP network is one of the best-known neural networks [26]. It consists of several neuron layers, and the transmission of the signal between neurons takes place in one direction, starting from the input layer and going through hidden layers to the output layer, where the signal is interpreted. The general structure of two-layer MLP neural network is shown in Figure 8. There can be any number of hidden layers. Neurons connect with each other by means of synapses. Weights—numerical values—are associated with synapses. The weights influence the modification of the values of signals transmitted by neurons in individual layers during network learning. The purpose of the modification of the weights is to obtain the best possible discrimination of samples that reach the input field, i.e., the entry. The weights are an important element of the network because they are responsible for the knowledge it collects. As a result of the weights of synapses, the input information is developed and leads to the classification result. The neuron with a greater weight, when transmitting the signal to the next layer, causes the signal to have an advantage over others. Therefore, as the weight value increases, the variable becomes more important.

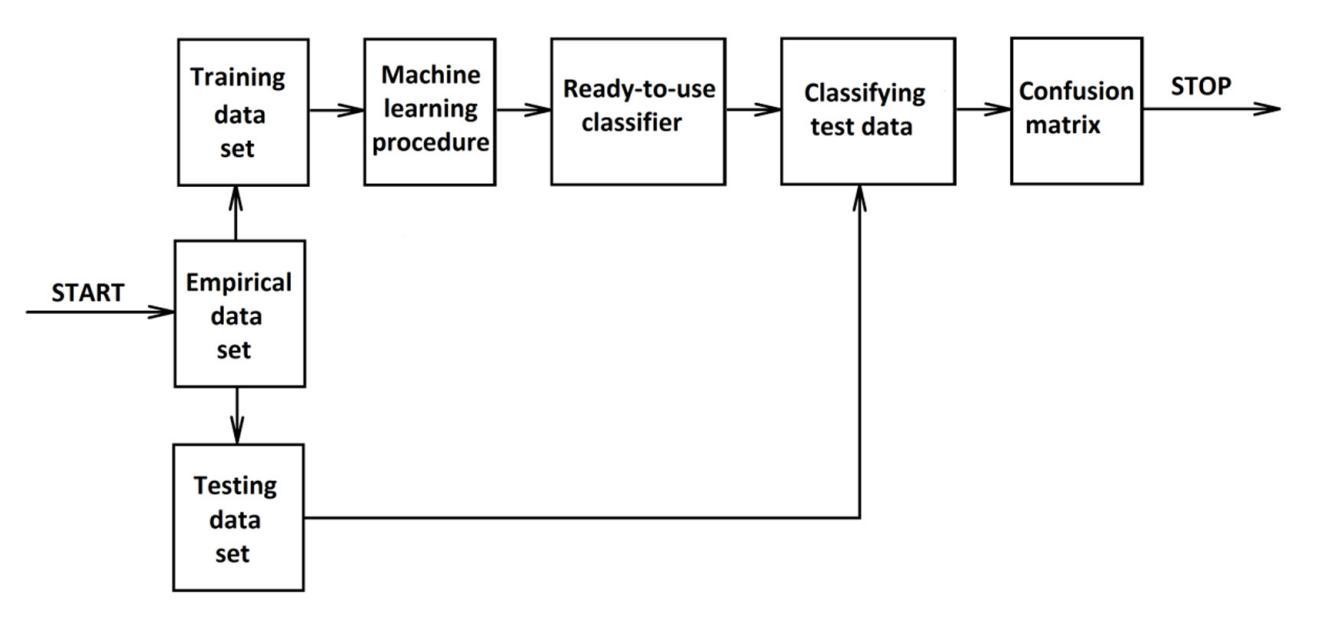
Figure 9. The standard procedure of learning and testing the identification system.

The basic factor determining the operation of the MLP network is learning, and not the structure itself. Therefore, the standard procedure of learning and testing the identification system was adopted (Figure 9).

First, the "test data" and "training data" sets were created. The "test data" set only included the features of signals registered on the measuring stand with the participation of one drill bit specified as a "test drill" (it was one of the five experimental drills, which had not been used to create the "training data" set). All features used in the study (455 features in total) were extracted using standard functions available in the MATLAB Signal Process-ing Toolbox and Wavelet Toolbox (MathWorks, Natick, MA, USA). They were standard statistical parameters (such as arithmetic mean, root mean square, variance, skewness, kurtosis, frequencies on histograms etc.) and parameters calculated using wavelet packet transform. The "training data" included the database of five other drill bits (i.e., four other experimental drills and the control drill), which covered both their real, actual classes of tool conditions ("Green," "Yellow" or "Red") and features of all signals registered with their participation on the measuring stand. Then, the MLP algorithm was activated in order

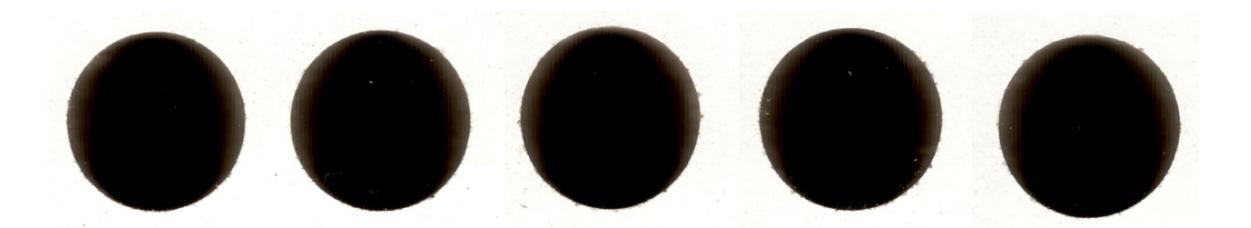
Figure 10. The sample holes made with relatively sharp drills. ("Green" tool wear class—*W* < 0.2 mm).

Firstly, the machining quality (hence the delamination problem) was analyzed. The sample holes made with drills representing three different tool wear classes are shown in Figures 10–12.

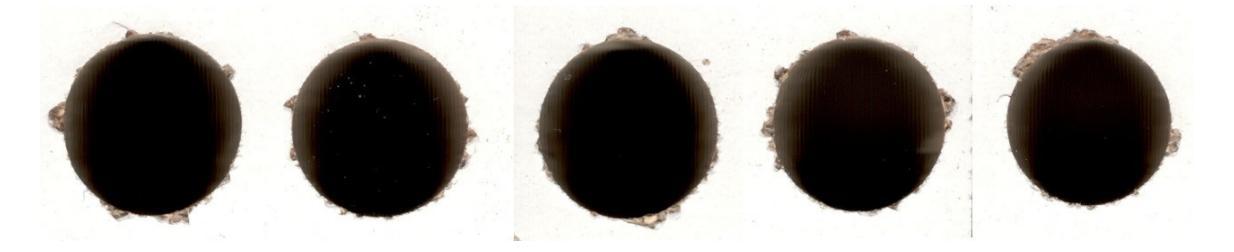
**Figure 11.** The sample holes made with drills representing excessive (but not extreme) tool wear ("Yellow" tool wear class— $0.2 \le W < 0.35$  mm).

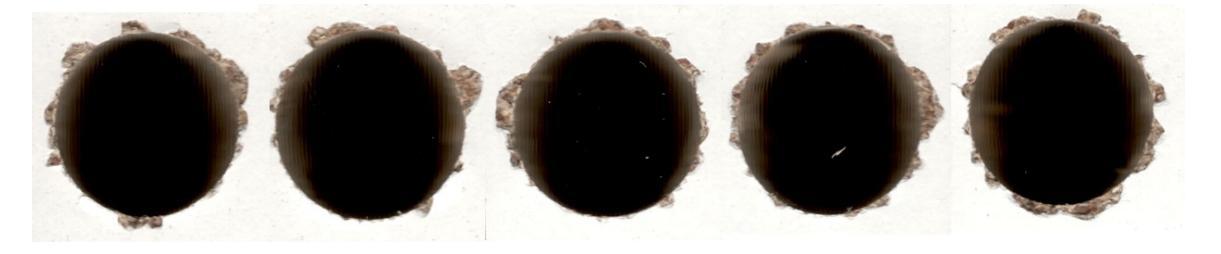
**Figure 12.** The sample holes made with completely worn-out drills ("Red" tool wear class— $0.35 \le W$ ).

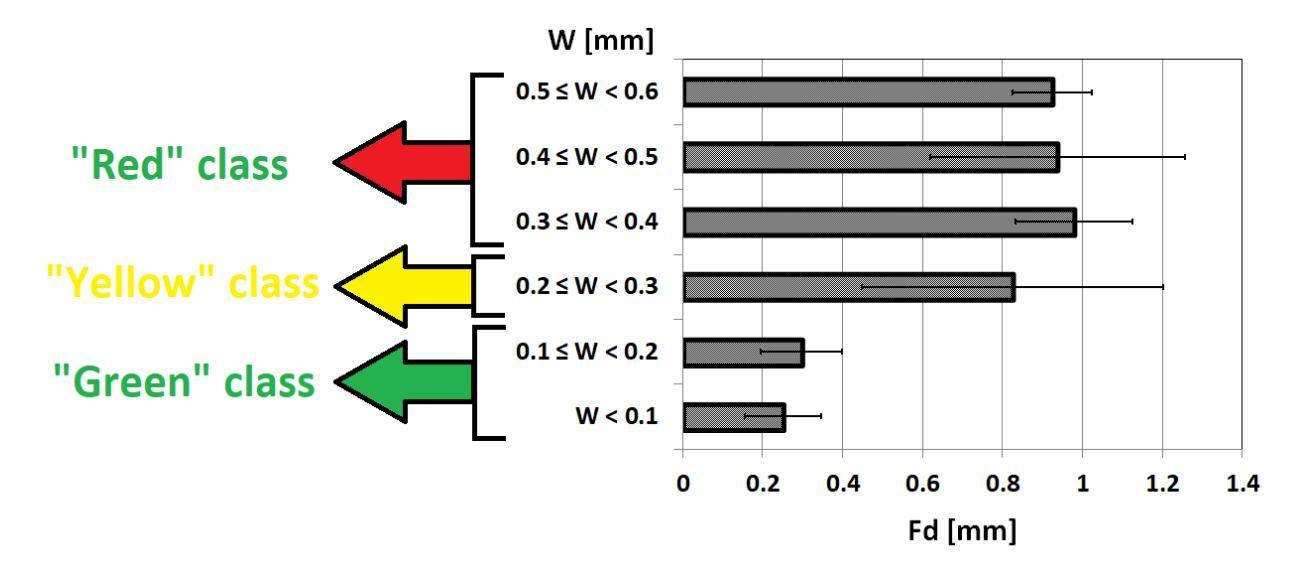
Figure 13. The values of delamination factor (Fd) in different classes of tool wear.

Figure 13 shows the statistical relationship between the degree of tool wear (*W* index) and the delamination factor (Fd). Ultimately, the drilling quality in the "Green" class (W < 0.2 mm) was clearly better and more stable than in the other two classes ( $W \ge 0.2$ ). This confirmed the legitimacy (practical utility) of the tool wear limit suggested by the drill production company.
