Article Stiffness and Cavity Test of Concrete Face Based on Non-Destructive Elastic Investigation

Abstract: A non-destructive testing (NDT) method was used in a concrete face rockfill dam (CFRD) to identify the condition of the concrete face slab and detect any existing cavities between the concrete face slab and the underlying support layer. The NDT for the concrete face slab was conducted using the impulse response (IR) method and the electrical resistivity tomography (ERT) method with the application of non-destructive electrodes. Information regarding the dynamic stiffness and average mobility of the concrete was obtained based on the mobility-frequency of the IR method, and cavity detection under the plate structures was analyzed using the two-dimensional (2D) electrical resistivity section of the ERT method. The results of the IR method showed that zones with low dynamic stiffness and high average mobility were expected to be found in concrete of poor quality and in cavities beneath the concrete face slab. The results of the ERT method showed that zones with high resistivity were expected to be cavities between the concrete face slab and the underlying support layer. As a re

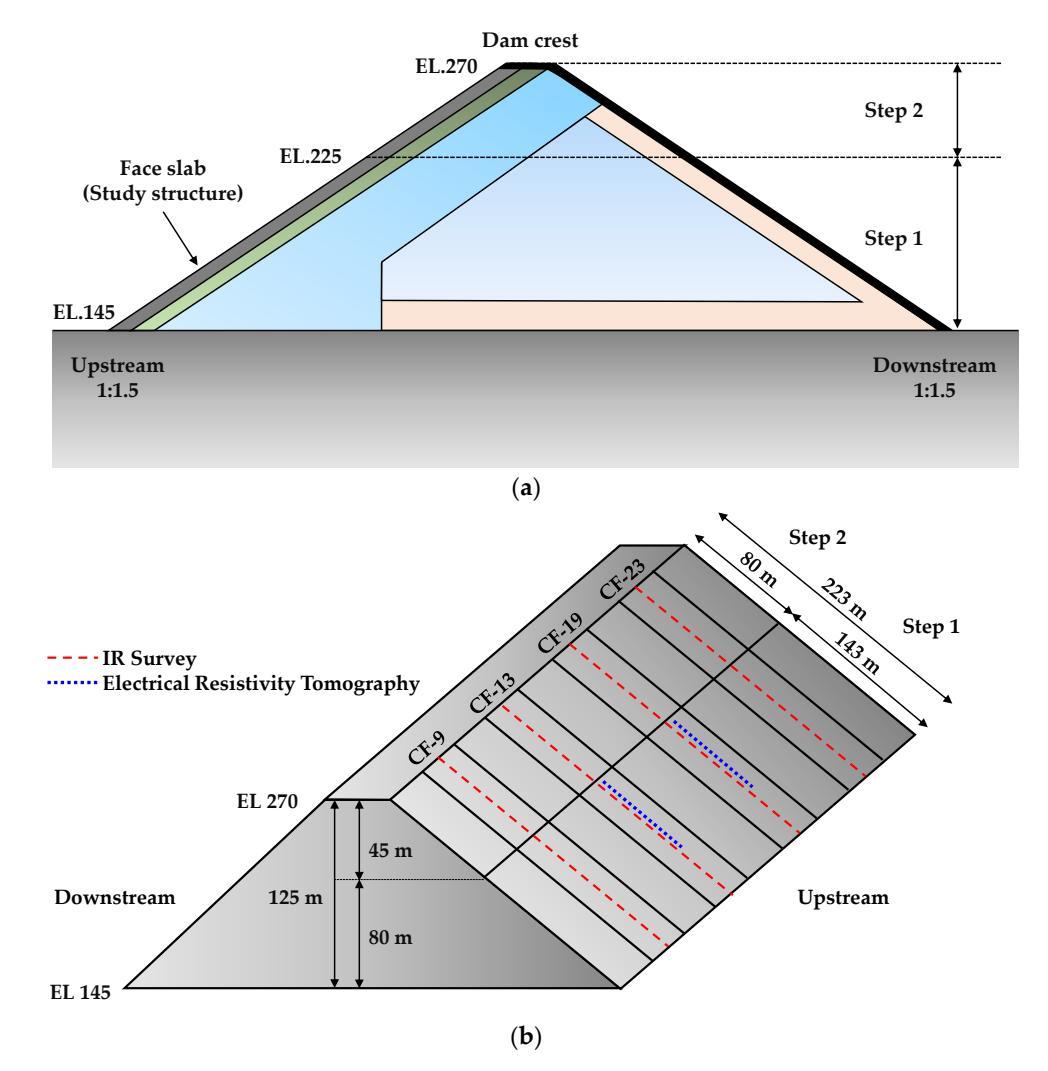
Figure 1. (a) Schematic of the concrete face rockfill dam (CFRD) that was used as the study object. The concrete face slab was located on the upstream slope and was divided into steps 1 and 2. The concrete construction time and concrete thickness of each step were different. (b) Schematic of impulse response (IR) and electrical resistivity tomography (ERT) survey lines. Each line was centrally located at CF-9, -13, -19, and -23 on the concrete face slab with a width of 15 m. The IR survey was carried out on steps 1 and 2, and the ERT survey was carried out on CF-13 and -19 of step 2.

The target object was a CFRD located in the northern district of the Republic of Korea, with a dam height of 125 m, a crest length of 601 m, a maximum reservoir capacity of 2.63 billion m³, and a ratio of upstream slope to downstream slope of 1:1.5 (Figure 1a). Step 1 of the dam was completed in 1989, and step 2 in 2006.

Figure 1b shows a schematic of the IR and ERT survey lines of the study object, namely, CF-9, -13, -19, and -23 of a concrete face slab, with a width of 15 m upstream, all of which are located at the center. The IR survey was carried out in steps 1 and 2, and the ERT survey was carried out at CF-13 and -19 in step 2. Both surveys were conducted from top to bottom. Through the IR survey, 21 stations were acquired for a length of 79 m in step 2, and 23 stations were acquired for a length of 80 m in step 1. The spacing of the stations was set to 2.5 m for the cavity estimation examined through a GPR survey [15], and 5 m for the other section. Through the ERT survey, 32 channel cables were used, and the electrode spacing and line length were set to 1 and 31 m, respectively, when taking into account the thickness of the concrete face slab and the steel reinforcement.

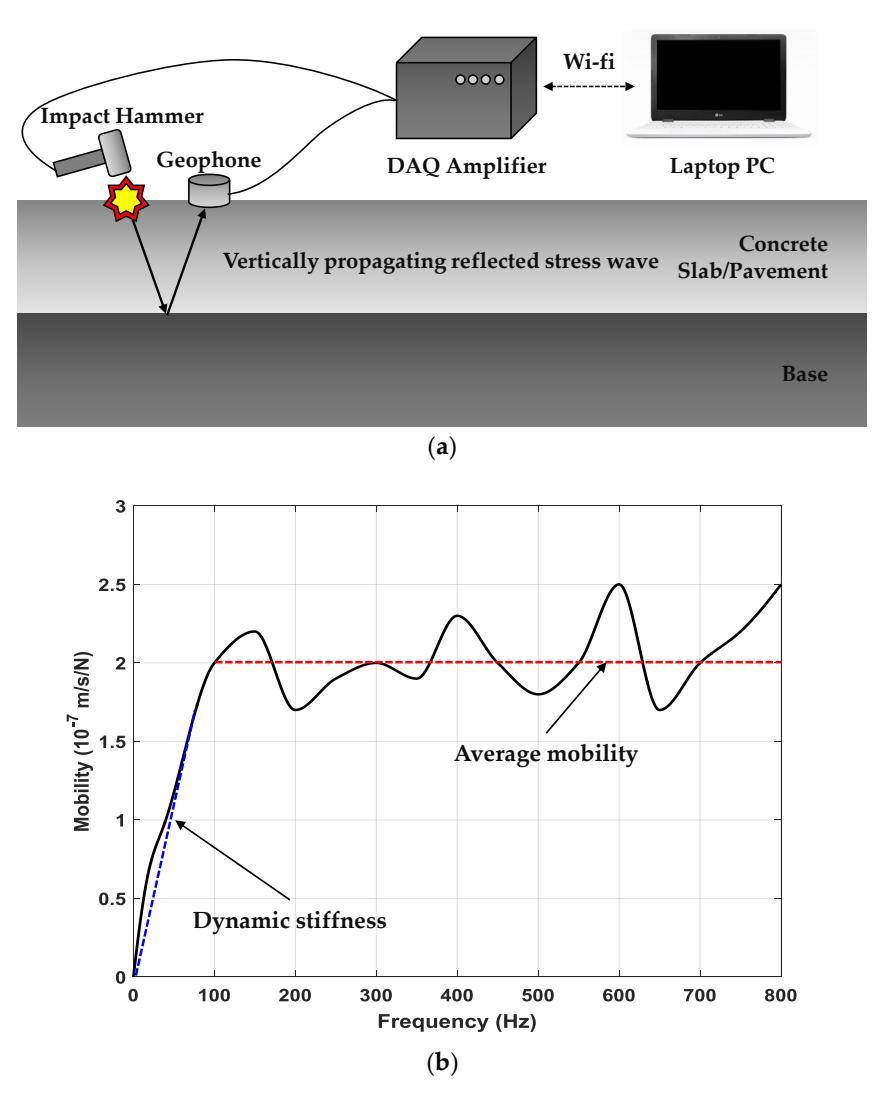
Figure 2. (a) Schematic of the impulse response tester. This equipment consisted of an impact hammer, a data acquisition device (DAQ) amplifier, a geophone, and a laptop PC. (b) The mobility plot of a typical concrete face slab. The dynamic stiffness was defined as the reciprocal of the slope at a frequency of less than 80 Hz. The average mobility was defined as the arithmetic mean of the mobility within the 100–800 Hz frequency range.

Figure 2 shows a schematic of the impact response tester developed by Chung et al. [17] and a graph of the mobility-frequency of a plate-like object such as a typical concrete face slab. Figure 2a shows the data acquisition device (DAQ), impact hammer with a load cell, and geophone applied. During an IR measurement, communication between the DAQ and a laptop PC is achieved through the wireless fidelity (Wi-Fi) ad hoc mode, and data are saved wirelessly. The stored data is transformed into the frequency-domain using a fast Fourier transform algorithm after applying bandpass filtering to the spectrum of the time-domain generated by the impact source and geophone velocity transducer. When an impact is applied to the study object using an impact hammer, the object on the plate reacts in bending mode within a frequency range of 0 to 800 Hz, and the geophone measures the velocity of the

bending motion [18]. The IR method obtains the transfer function from the impact force measured in the load cell attached to the impact hammer and the velocity of the bending motion measured using the geophone. The transfer function is defined as the ratio of the velocity spectrum to the force spectrum, which is called mobility. The mobility at a frequency range of 0–800 Hz also includes the parameter information based on the conditions and integrity of the concrete study object. Figure 2b shows an example graph of the dynamic stiffness and average mobility in a plate-like object such as a concrete face slab. The dynamic stiffness is defined as the reciprocal of the slope at a frequency of less than 80 Hz where the mobility increases linearly in the mobility-frequency graph. The dynamic stiffness indicates the flexibility around the measurement point and depends on the quality of the study object, the thickness of the plate, and the supporting state of the plate. The average mobility is defined as the arithmetic mean of the mobility within the 100–800 Hz frequency range. The elastic wave caused by the applied impact source is attenuated by the intrinsic rigidity of the plate. The average mobility within the 100–800 Hz range is directly related to the plate density and thickness. The average mobility increases when the thickness of the plate becomes thinner or the distance between two layers of the specimen decreases.

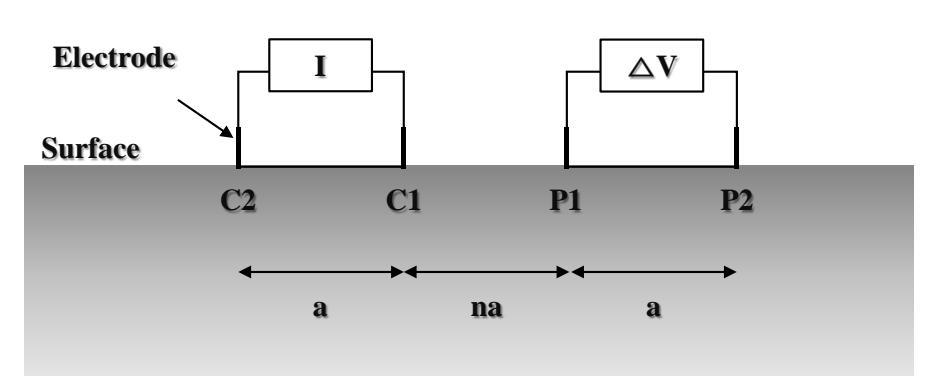
Figure 3. A dipole-dipole array of a typical electrical resistivity tomography (ERT) survey. The resistivity of the study object was calculated by measuring the potential difference between two current and two potential electrodes.

Figure 3 shows a schematic diagram of an ERT survey using a dipole-dipole array. The potential difference (ΔV) was measured by flowing a current (*I*) during the ERT survey, as characterized through Equations (1) and (2) below:

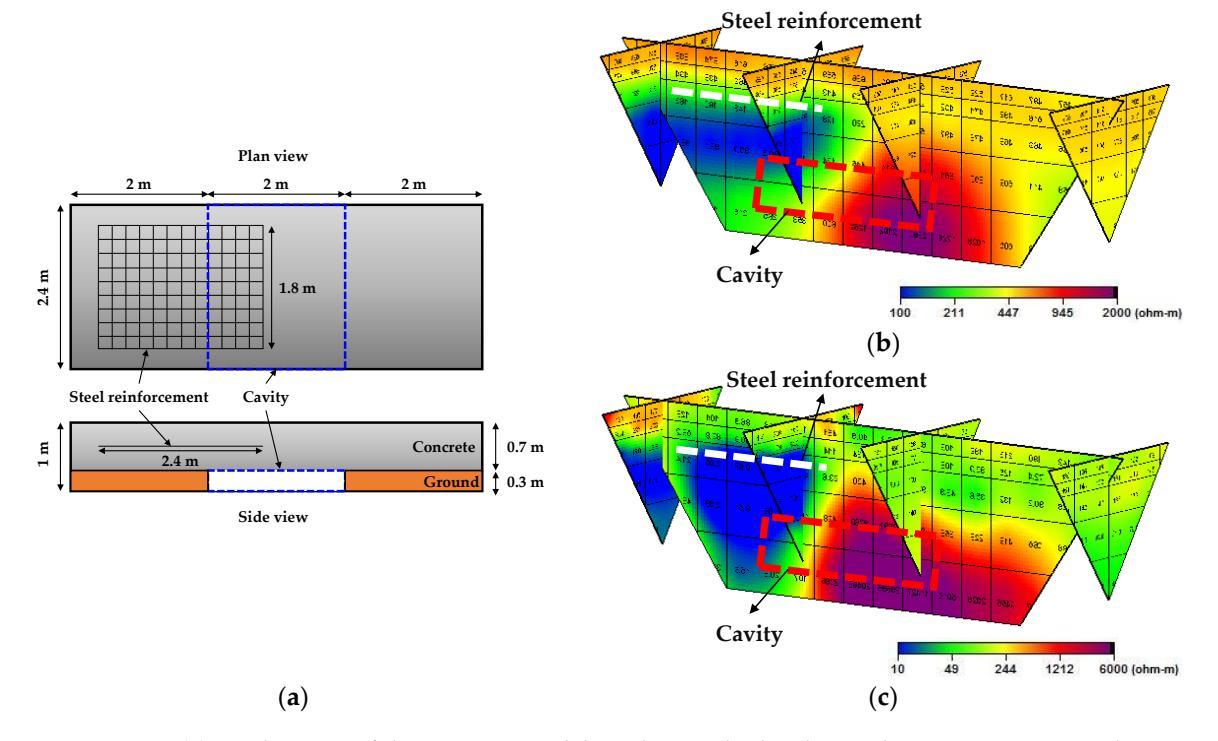
Figure 4. (a) A schematic of the concrete model used to apply the electrical resistivity tomography (ERT) survey using non-destructive electrodes. This model was designed to investigate the effects of the steel reinforcements and cavities in the interior and bottom of the concrete. (b) ERT survey results using non-destructive electrodes, and (c) ERT results using forward modeling. In both models, the steel reinforcements showed low resistivity effects, and the cavities showed high resistivity effects.

Figure 4 shows the concrete model manufactured for reviewing the applicability of an ERT survey of concrete, as well as the results of inverse and forward modeling. The concrete model was made to confirm the effects of the steel reinforcement and cavities, and was $2.4 \times 6.0 \times 1.0$ m³ in size (Figure 4a). Steel reinforcements were arranged at the center of the left side of the concrete at 0.2 m intervals with a 25 mm diameter mesh. The cavity was located at the center of the bottom of the concrete and was $2.4 \times 2.0 \times 0.3$ m³ in size. Sand, gravel, and clay were used to support the concrete on the left and right sides of the cavity, and at the same time, to reduce the change in the height of the cavity owing to a consolidation of the ground.

Figure 4b,c show the inversion using non-destructive electrodes, and the forward modeling results, respectively. In both results, the effect of the electrical resistivity was shown through the low resistivity effect at the location of the steel reinforcement and the high resistivity effect at the location of the cavity. Both effects also fitted well with the actual location. As a result of both models, an absolute difference in the resistivity value existed, although this occurred because the resistivity value of the actual concrete was different from the resistivity value used for the forward modeling. However,

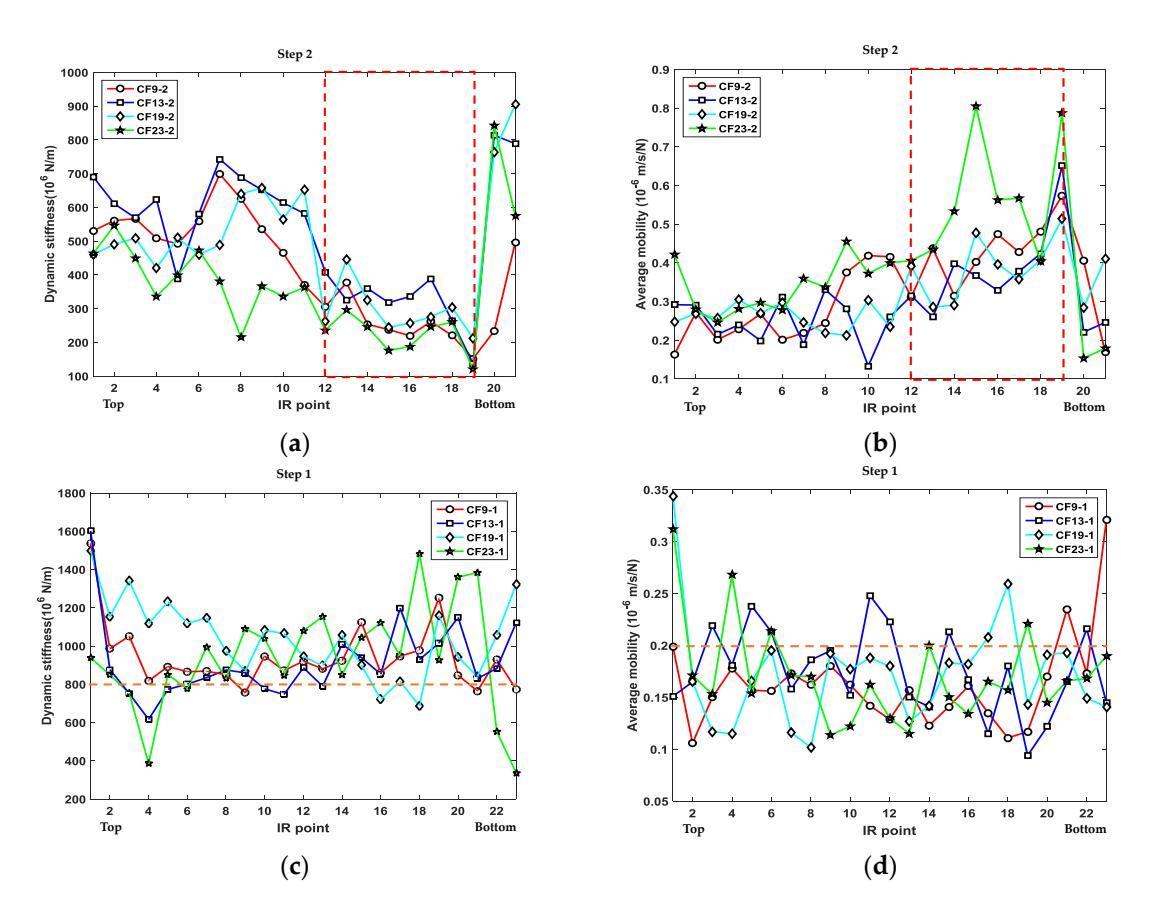
Figure 5. Dynamic stiffness and average mobility of the concrete face slab at CF-9, -13, -19, and -23 in steps 1 and 2. (a) The dynamic stiffness and (b) average mobility in step 2 showed a poor concrete quality owing to a low dynamic stiffness and high average mobility at the bottom (red dotted box). In step 1, (c) the dynamic stiffness was more than 800×10^6 N/m and (d) the average mobility was less than 0.2×10^{-6} m/s/N, demonstrating a constant trend but representing an unstable concrete condition at certain points.

Figure 5 shows dynamic stiffness and average mobility graphs for each step. Figure 5a,b show the dynamic stiffness and average mobility at CF-9, -13, -19, and -23 of the concrete face slab. This plot shows an inverse relationship between the general dynamic stiffness and average mobility. The overall dynamic stiffness decreased from top to bottom (IR points 1–19), and then tended to increase sharply at the bottom (IR points 20 and 21). In particular, at IR points 12–19, the entire concrete face slab showed a relatively low dynamic stiffness and high average mobility (red dotted box). In addition, throughout the concrete face slab shown in this box, CF-23 was expected to be the most vulnerable. The overall upstream slope of step 2 indicated that the state between the concrete face slab and the underlying support layer was more unstable at the bottom than at the top, and that a cavity was likely to exist at the bottom. IR points 20 and 21 exhibited a sharp high dynamic stiffness and low average mobility, which was presumed to maintain the high quality of the concrete because the supporting soil in the red dotted box was lost, accumulated at the bottom, or no space existed where the supporting soil would be lost near the bottom.

Figure 5c,d showed the dynamic stiffness and average mobility at CF-9, -13, -19, and 23 of the concrete face slab. In steps 1 and 2, the concrete face slab showed a tendency to remain relatively constant in terms of the dynamic stiffness and average mobility, the former of which tended to remain at above 800×10^6 N/m. The average mobility tended to remain constant, usually at below 0.2×10^{-6} m/s/N, however, the average mobility of some of the IR points was relatively large. IR points 4, 22, and 23 showed a low dynamic stiffness and a poor concrete quality compared to the other points on the concrete face slab. In particular, IR point 4 of CF-23 tended to have a low dynamic stiffness and high average mobility. These points were relatively weak at supporting the concrete face slab and predicting potential cavities.

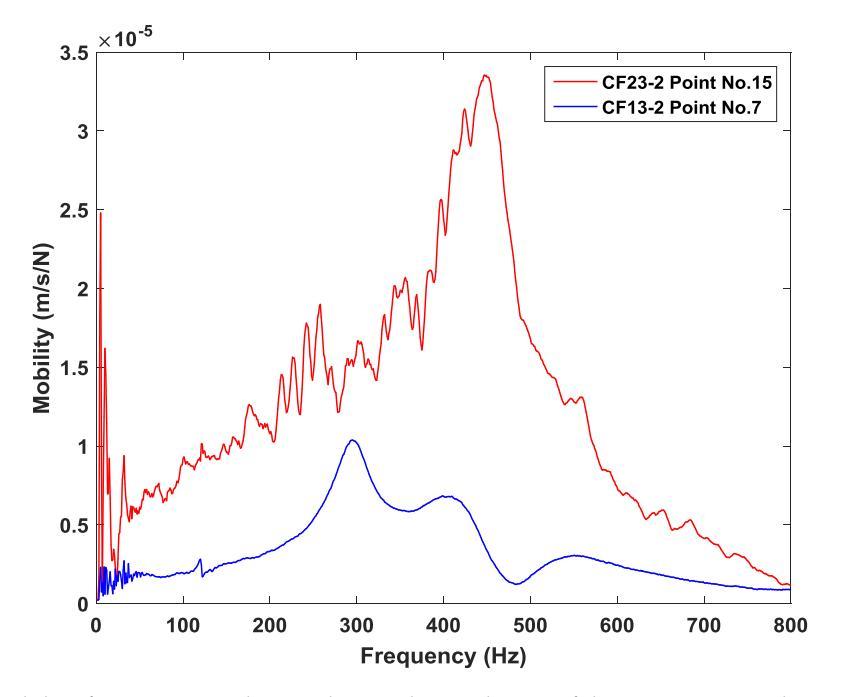
Figure 6. Mobility-frequency graph according to the conditions of the concrete. Impulse response (IR) point 15 of CF-23 had the highest average mobility and a low dynamic stiffness. IR point 7 of CF-13 was relatively high in dynamic stiffness and low in average mobility.

Figure 6 shows a mobility-frequency graph for the concrete face slab in step 2 according to the concrete conditions. IR point 15 of CF-23 was very low in dynamic stiffness and the highest in mobility. In contrast, IR point 7 of CF-13 was very low in average mobility and very high in dynamic stiffness. In general, the increase in mobility at below 80 Hz indicated that a cavity was likely to exist below the concrete face slab, and if a crack was present in the concrete, the mobility slope tended to increase [21]. IR point 15 of CF-23, which showed this tendency, demonstrated a relatively poor concrete quality, whereas IR point 7 of CF-13 was relatively stable before and after 80 Hz, indicating a high concrete quality. Therefore, the concrete condition can be distinguished according to the mobility-frequency characteristics of the raw data, and an IR survey is considered to be suitable for evaluating the condition of a concrete face slab.

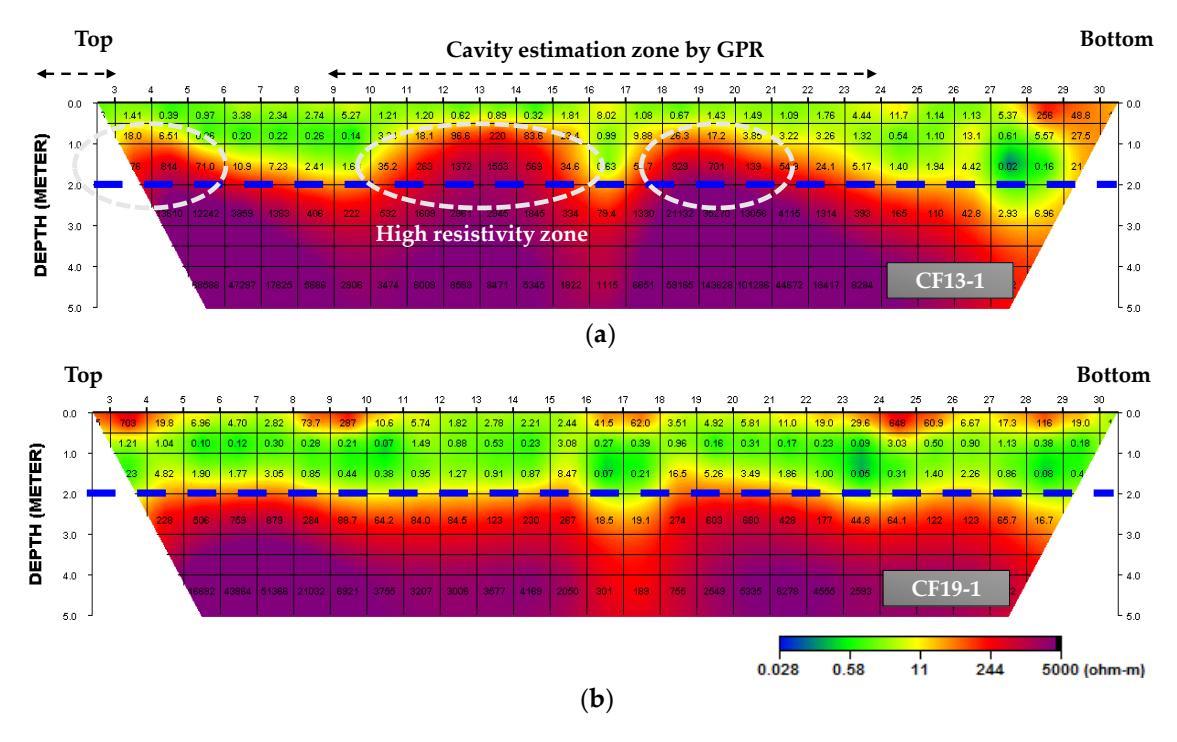
Figure 7. Results of the electrical resistivity tomography (ERT) survey of CF-13 and -19 in step 1. (a) CF-13 showed a heterogeneous high-resistivity effect in the cavity estimation zone based on ground penetrating radar (GPR). (b) CF-19 showed homogeneously low resistivity effects. Therefore, the high resistivity was expected to be due to the presence of a cavity.

Figure 7 shows the ERT survey results of CF-13 and -19 and the cavity estimation zone using GPR. In Step 1, the thickness of the concrete face slab was 0.7–1 m, and the steel reinforcements were located at a depth 0.2–0.35 m. However, overall ERT results showed a lower resistivity range of up to 2 m in depth, the reason for which is that steel reinforcements have a greater impact. Therefore, the ERT results should be interpreted with caution in terms of depth of investigation when considering the steel reinforcements.

Considering the effects of the steel reinforcements, CF-13, which was in a cavity estimation zone, had a non-homogeneous high resistance effect within a depth of 2 m (Figure 7a). In addition, it was confirmed through GPR that the high resistivity zone coincided with the cavity estimation zone. However, CF-19 without a cavity estimation zone exhibited a homogeneously low resistivity effect horizontally up to about a 2 m depth (Figure 7b). Therefore, the effect of high resistivity within a 2 m depth can be interpreted as the possible existence of a cavity based on the ERT survey.

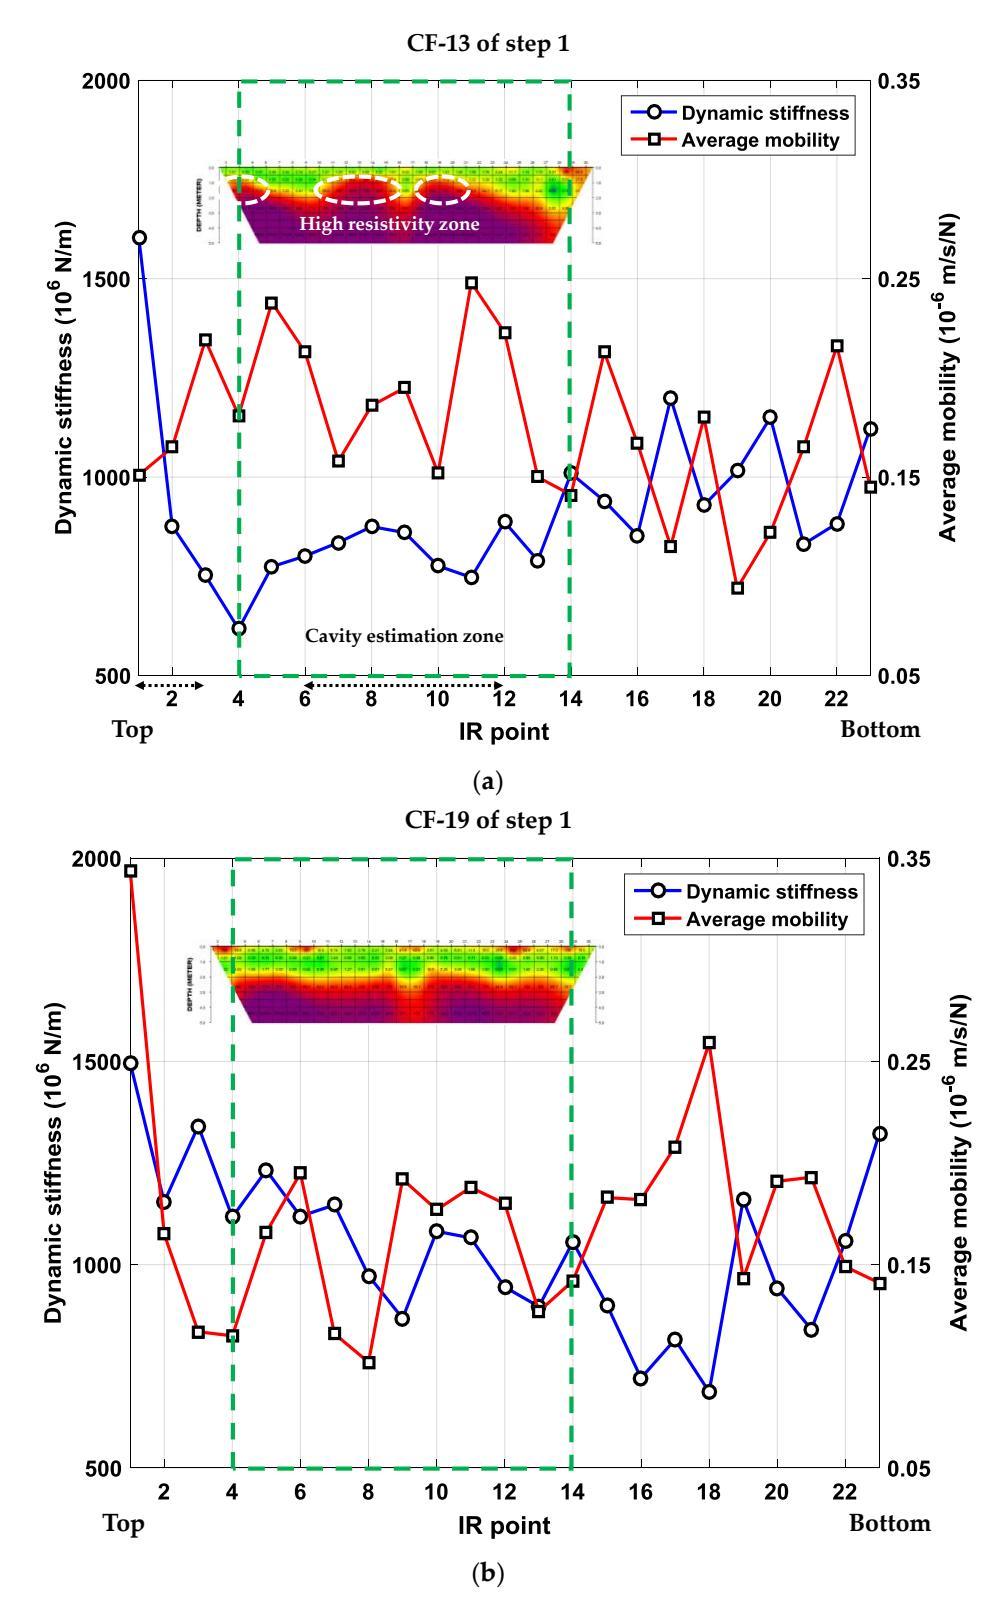
Figure 8. Impusle response (IR) and electrical resistivity tomography (ERT) survey results of CF-13 and -19 in step 1: (a) High resistivity appeared in the cavity estimation zone based on ground penetrating radar (GPR). The dynamic stiffness was relatively low, and the average mobility was high at certain points. (b) There was no cavity estimation zone and the low resistivity effect appeared to be homogeneous. In addition, the dynamic stiffness and average mobility tended to be stable.

Figure 8 shows the IR and ERT survey results for CF-13 and -19. In Figure 8a, the cavity estimation zone based on GPR was located at IR points 1–3 and 6–12. However, the IR points when including the IR and ERT results of the cavity estimation zone were 6–12. As a result of the ERT survey of IR points 6–12, it was possible to identify an anomaly zone with a high resistivity effect within a depth of 2 m. As a result of the IR survey in this section, it could be confirmed that the dynamic stiffness was low and the average mobility was higher than at the other points. Therefore, this section could predict the presence of cavities between the support layers and concrete with poor quality. In Figure 8b, no cavity estimation zones appeared, and relatively stable parameters were shown. To compare the IR and ERT results, IR points 4–14 were analyzed. As the results of the ERT survey, this section did not represent the anomaly zone shown in Figure 5. At certain points, the dynamic stiffness was low (IR point 9) and the average mobility was high (IR point 6), but the concrete was not of poor quality. Therefore, compared to CF-13, CF-19 could be confirmed from the results of the IR and ERT surveys to be a location of high-quality concrete.

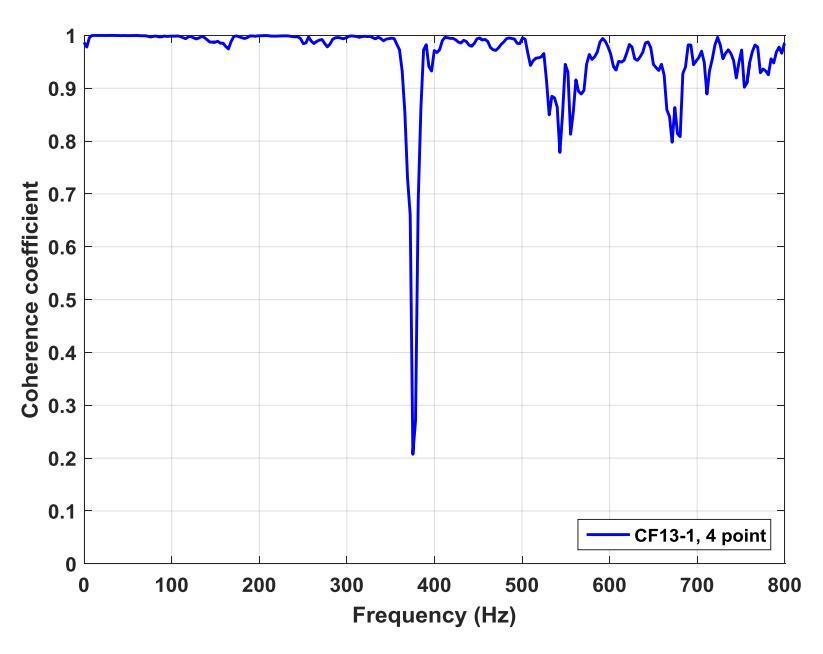
Figure 9. Consistency analysis results for impulse response (IR) point 4 of CF-13 in step 1.

Figure 9 shows a consistency analysis of IR point 4 with the lowest dynamic stiffness at CF-13 in step 1. A consistency analysis was conducted using two measurements at the same point for statistical consistency of the frequency sounding measurement. As a result of the analysis, the coherence factor showed a high reliability with a maximum value of 0.99 and an average value of 0.96 or more. However, when the frequency was higher than 300 Hz, the coherence factor was reduced to about 0.2, and a factor of between 0.8 and 1 indicated that the reliability of the average mobility was slightly lowered. As shown in Figure 9, the dynamic stiffness was very low, but the average mobility did not show such an anomaly. Therefore, it is expected that the average mobility will actually be higher, and poor concrete quality is expected.
