# Mechanism for Controlling Floor Heave of Mining Roadways Using Reinforcing Roof and Sidewalls in Underground Coal Mine

Abstract: Controlling floor heave plays an important role in the stability of mining roadways that is pivotal to the sustainable, safe, and efficient development of coal resources in underground coal mines. In order to propose highly efficient and economical methods of controlling floor heave, numerical simulation, laboratory physical simulation, and engineering practice were carried out to reveal the mechanism of reinforcing roof and sidewalls to control the floor heave of the mining roadway, return airway 15208, in the Xinjing Coal Mine in the Yanquan mining area of China. The numerical simulation demonstrated that the surrounding rock of the roadway underwent expansion and deformation, accompanied by redistribution of the surrounding rock stress due to the reinforcement of the roof and two sidewalls. The laboratory physical simulation revealed that the reinforcing roof and sidewalls decreased the bed separation of the floor and reduced the quantity of the displacement of the floor in Coal Seam 15. Engineering practice showed that the floor heave in the roadwa

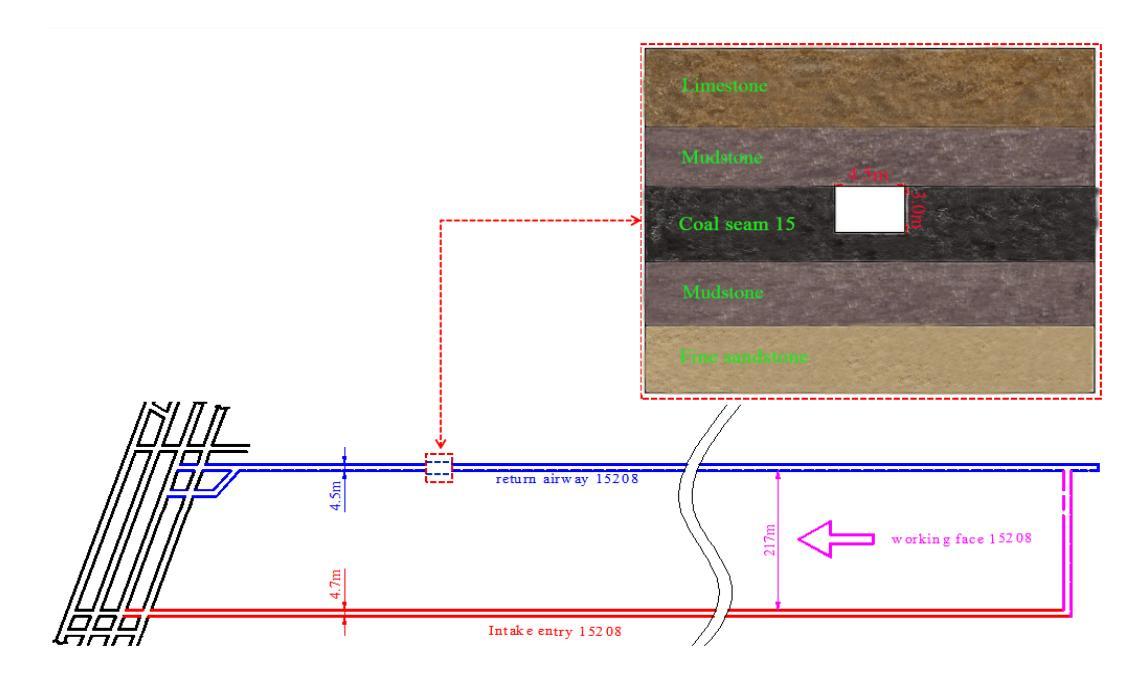
Figure 1. Location and cross-section of return airway 15208.

Coal Seam 15 was extracted using the long-wall mining, which was one of main workable coal seams in the Yangquan mining area. The strike length and the dip width of working face 15208 in Coal Seam 15 in the Xinjing Coal Mine were 1458 m and 217 m, respectively, as shown in Figure 1. The buried depth of the return airway in working face 15208 was 490 m. The cross-section of the roadway was 4.5 m wide and 3.0 m high. The roof strata of Coal Seam 15 were mainly composed mudstone and limestone, whilst the floor lithology mainly consisted of mudstone and fine sandstone as shown in Table 1.

The support scheme used bolting with wire mesh in return airway 15208. Five cables per row in the roof, of which diameter, length, and inter-row spacing were 21.6 mm, 8300 mm, and 1025 mm  $\times$  800 mm, respectively. In the roof, pre-tightening force of each cable was not lower than 250 kN, and each row of cables cooperated with a corrugated steel strip (Length  $\times$  Width  $\times$  Thickness: 4400 mm  $\times$  280 mm  $\times$  4 mm). There were three cables per line in each sidewall. Additionally, the diameter, length, and inter-row spacing of cables were 21.6 mm, 4500 mm, and 1025 mm  $\times$  800 mm, respectively. In both sidewalls, pre-tightening force of each cable was not lower than 120 kN.

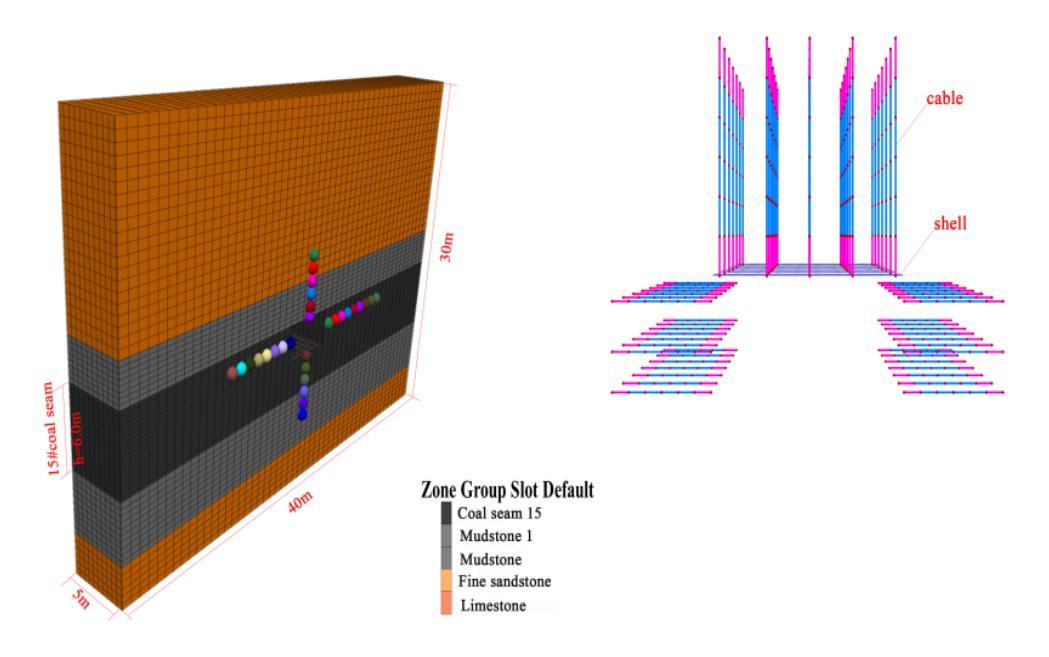
Figure 2. Numerical simulation models and supporting units.

The numerical simulation by means of FLAC3D from Itasca of USA [26] was performed to analyze the characteristics of the stress distribution of surrounding rock before and after reinforcing the roof and sidewalls, which set a foundation for the mechanism. Two models were designed and established on the geological conditions of the return airway in working face 15208 (the length, width, and height were 40 m, 5 m, and 30 m, respectively). The whole model was divided into 48,000 units. A standard hexahedral format was used with free boundaries for the upper part or upper side [27], as shown in Figure 2.

The units of cable and shell were adopted for simulating bolts and steel belts, respectively. The equilibration of each step was evaluated using the maximal unbalanced force. To analyze the effect of controlling floor heave through reinforcing roof and sidewalls, both stress and plastic zones were extracted in the calculation process [28].

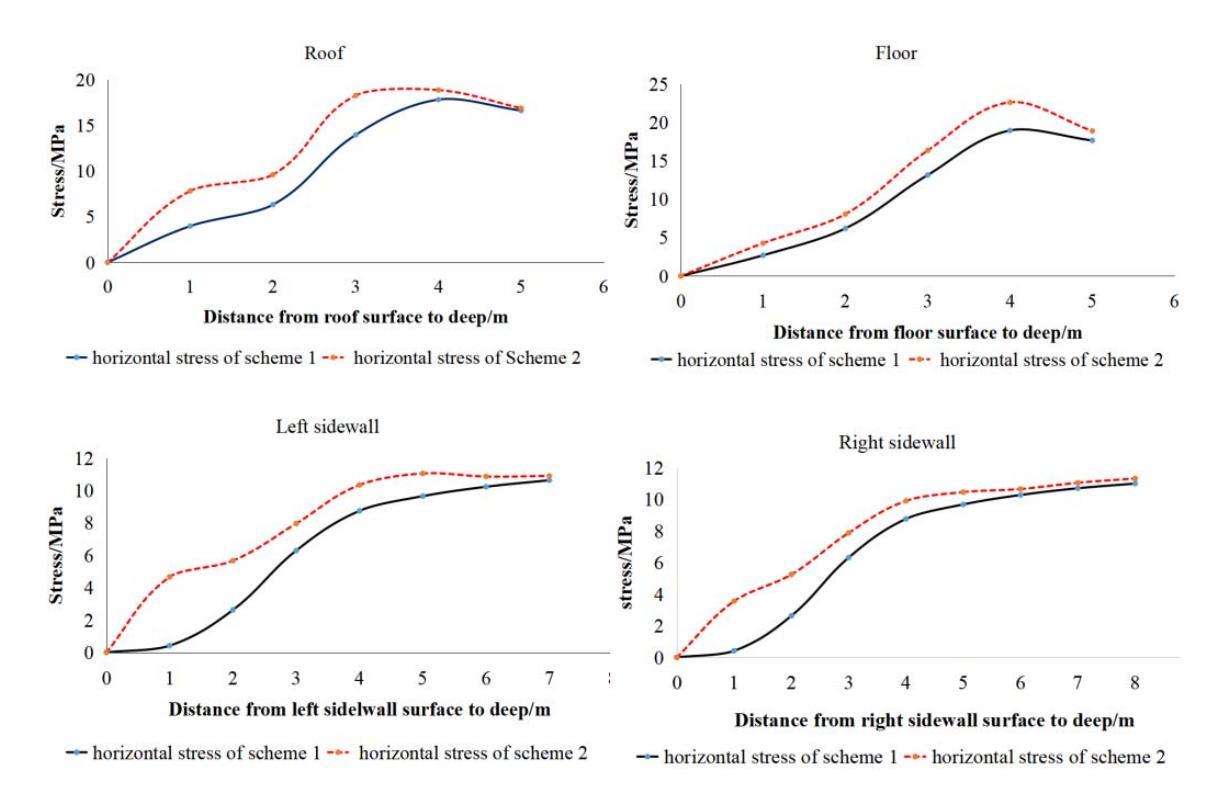
Figure 3. Horizontal stress of surrounding rock in two schemes.

According to above calculation, the stress distribution of the surrounding rock was obtained before and after reinforcing the roof and sidewalls, distance from surface to the depth of roadway surrounding rock as shown in Figure 3.

According to Figure 3, the increasing of stresses in the shallow reinforced surrounding rock indicated that the residual strength of reinforced area was obviously improved. The horizontal stress in the reinforced area quickly increased from the roadway surface to 1-m-deep surrounding rock, whereas the horizontal stress of reinforced area in 1–2-m-deep surrounding rock gradually increased. The horizontal stress in the roof, left sidewall, and right sidewall were found to be approximately 8 MPa, 5 MPa, and 5 MPa, respectively. The stress increased gradually to a new peak with further calculating. The high stress was transferred to far field areas from the surface of surrounding rock, because the roof and two sidewalls were reinforced.

The stress in the shallow region in the floor in Scheme 2 gradually increased but remained higher than the stress of Scheme 1, which could demonstrate that the residual strength of floor was improved simultaneously.

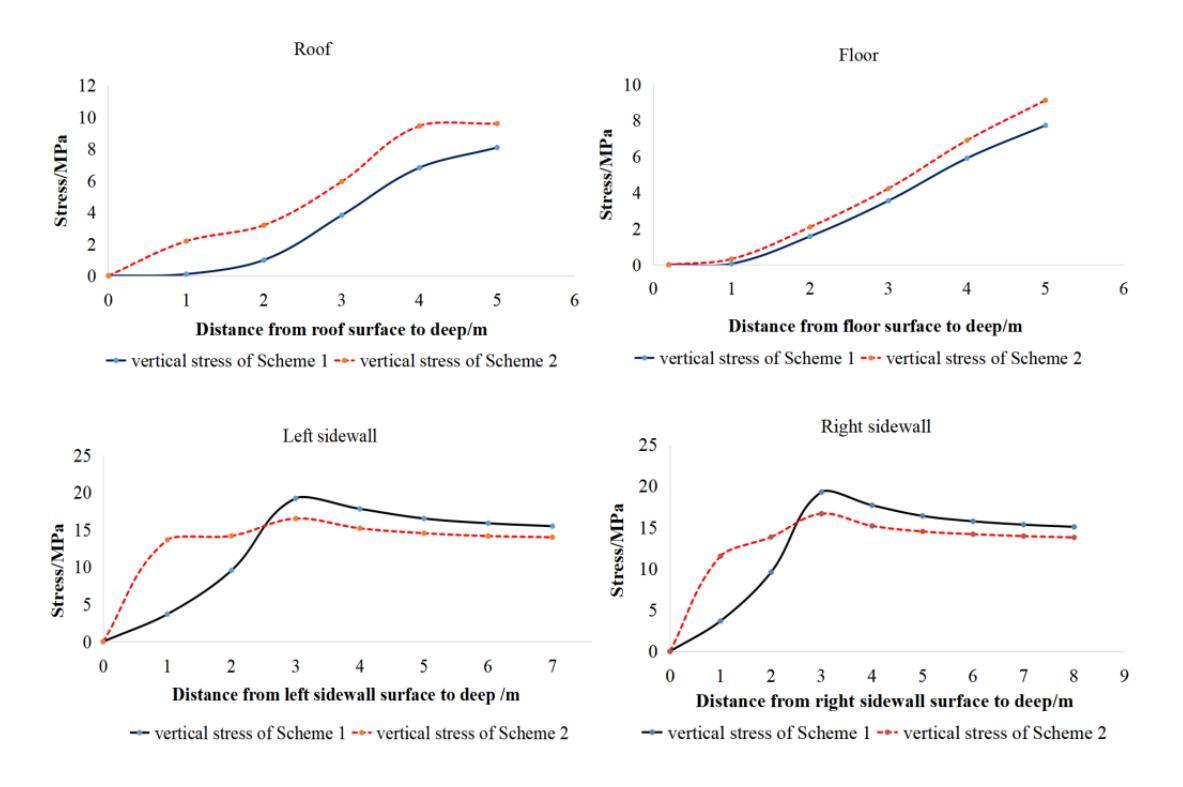
Figure 4. Vertical stress of surrounding rock in two schemes.

The vertical stress distribution of the surrounding rock was obtained from simulation calculation results, as shown in Figure 4.

Figure 4 shows that the vertical stress of roof and floor is in agreement with the horizontal-stress. However, the figure also showed that there was obvious otherness in stress distribution characteristics of vertical and horizontal stresses of two sidewalls.

With the reinforcement of two sidewalls, its carrying capacity was improved, and the deformations of surrounding rock were reduced. Therefore, the vertical stress of Scheme 2 was apparently higher than Scheme 1 within 2.5 m of two sidewalls.

However, the vertical stress between 0-m-deep and 2.5-m-deep surrounding rock of sidewalls in Scheme 2 was reduced compared with Scheme 1. There were two reasons to illustrate the situation. Firstly, high vertical stress decreased due to deformation of surrounding rock. Secondly, high vertical stress main concentrated within 2.5 m-deep anchorage rock mass. The decrease of vertical stress in two sidewalls contributed to the floor protection.

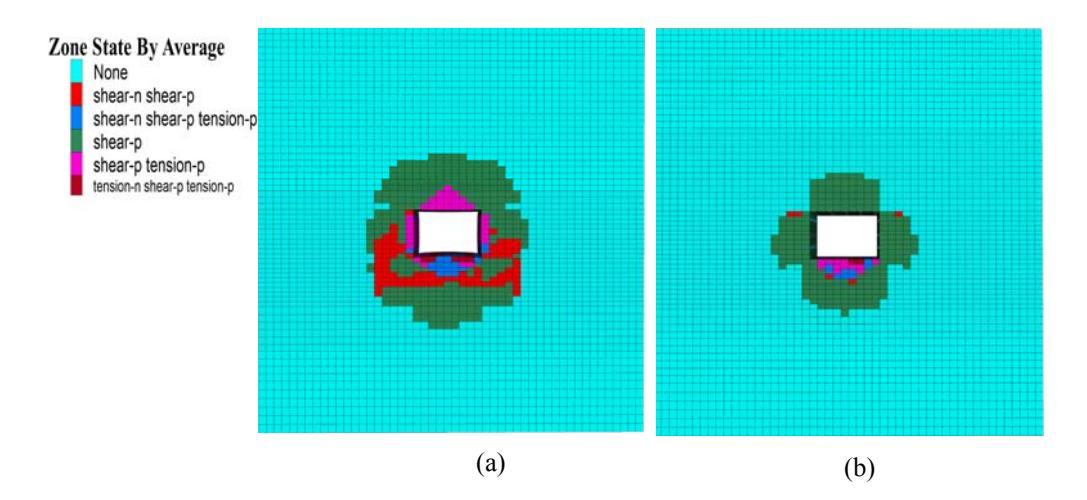
Figure 5. Plastic zone of two schemes: (a) Scheme 1; and (b) Scheme 2.

As shown in Figure 5, the form and scope of the plastic zone distribution of Scheme 1 was significantly different from Scheme 2. Plastic zone form of the former was approximate to oval, whilst the latter was a cross. The boundary maximum value of Scheme 1 was 2.5 m bigger than Scheme 1. The most obvious effect of reinforcing roof and sidewalls was that plastic zone was eliminated in all four corners of the roadway.

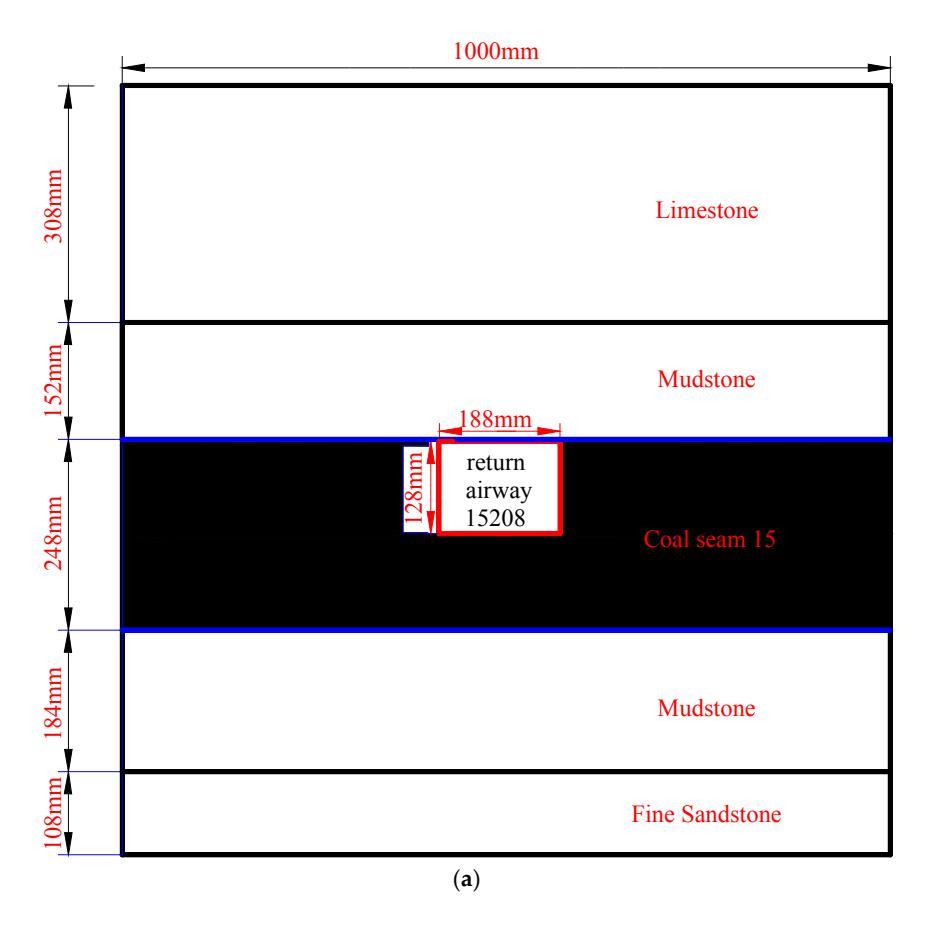
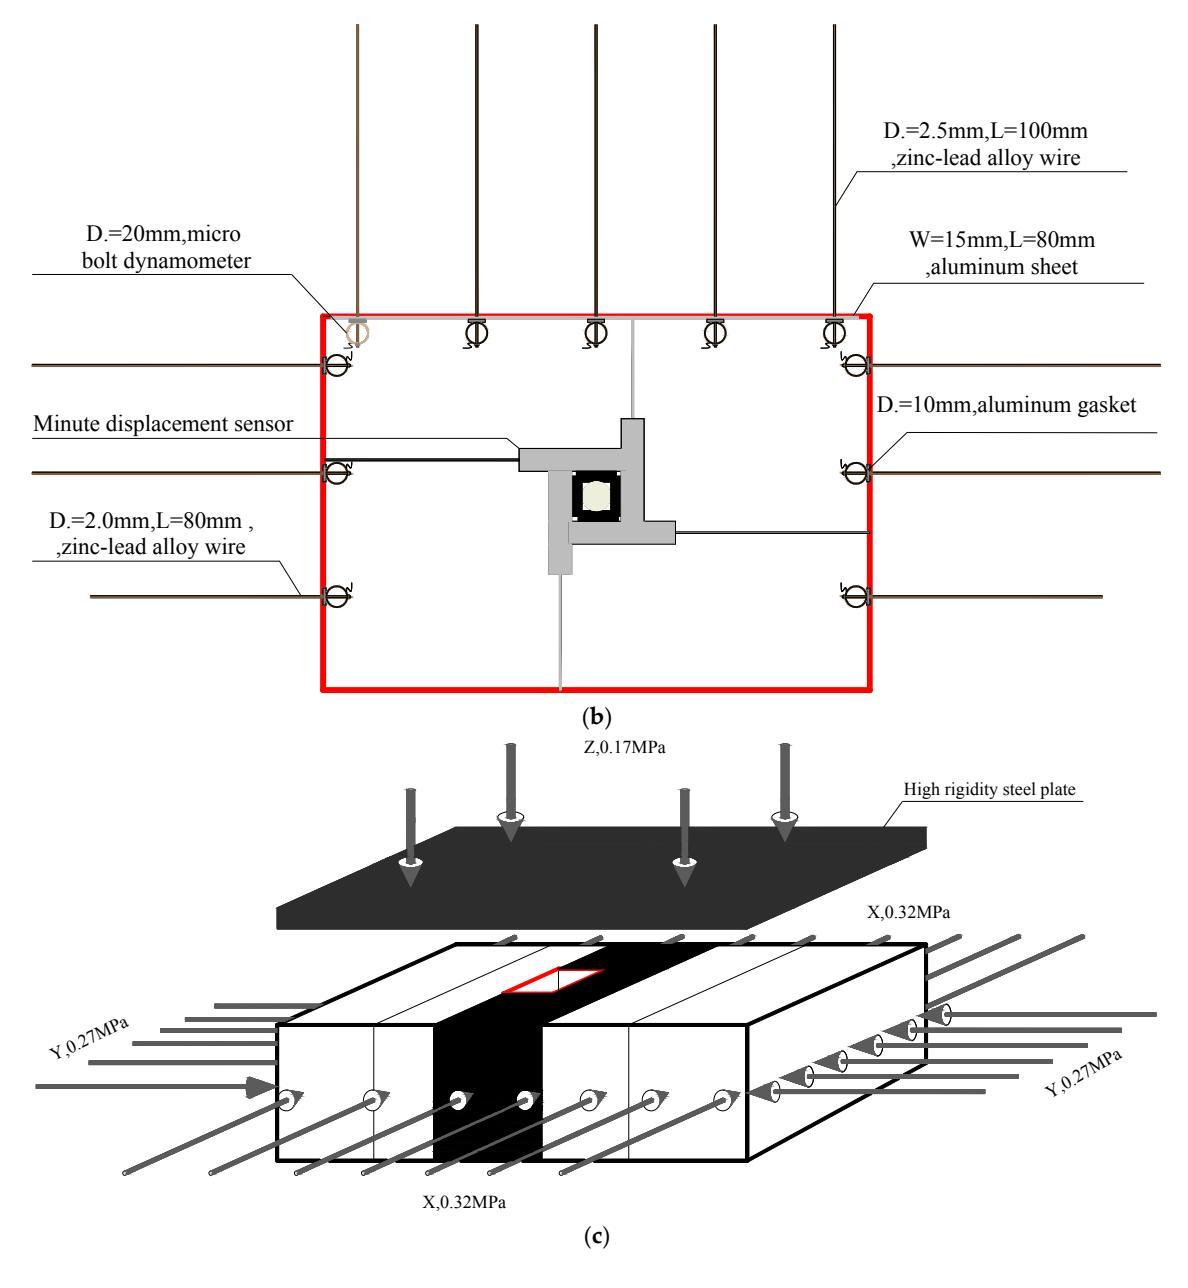
Figure 6. Experiment model scheme; (a) physical size; (b) supporting units and equipment; and (c) loading regime.

Regarding whether to reinforce the roof and sidewalls, the experiment was divided into two schemes. The roof and sidewalls were not reinforced in Scheme 1, and the contrary was the case in Scheme 2. In Scheme 2, the roof and sidewalls were reinforced by 75 sets of bolting models, which included the component and five steel belts. Ten micro bolt dynamometers were employed to record stress variation of bolting models. A camera system was used to collect information of alteration of surrounding rocks surface. Figure 6 shows Scheme 2.

In the mining process of working face 15208, the abutment pressure had increased gradually with coal working face advancing. To simulate the field site, the boundaries stress model was applied using multi-stage loading. There were 8 h of non-working time in each 24-h period, and the distance of mining was about 5 m each day; the distance of 12 m required 2.4 days of mining. According to the similarity ratio, the boundary stresses were loaded in three sessions (12 m/5 m = 2.4) over 9.3 h (2.4 days × 16 h/5); the time interval was 1.6 min (8 h/5).

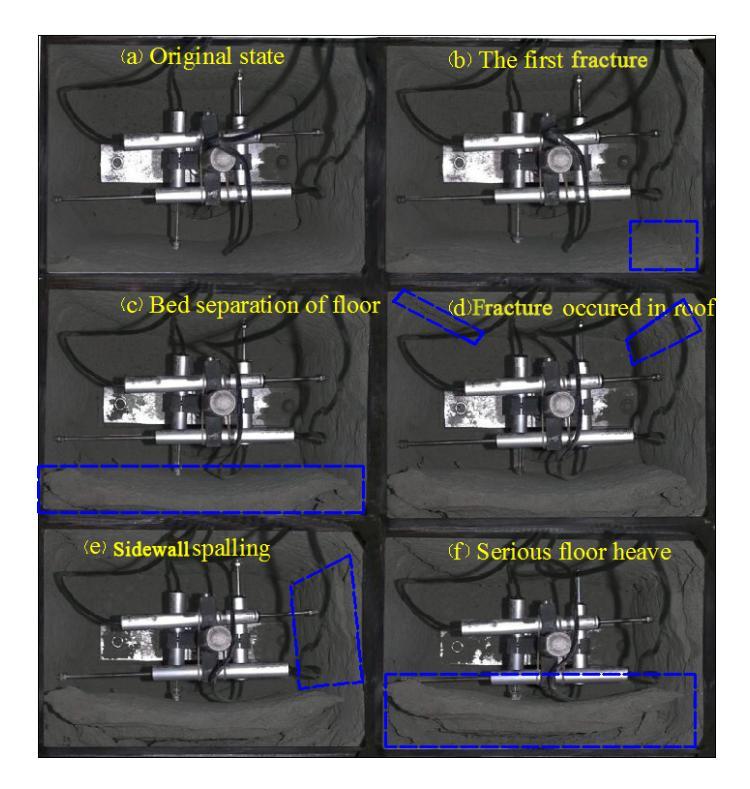
Figure 7. Failure process of surrounding rock in Scheme 1.

When the stress reached about one third of the design load value, fractures first appeared in the corner of floor and right sidewall. Fractures continued extending and passed through the floor along left-right direction, which is thin layer, resulting from the increase of stress in surrounding rock,

as illustrated in Figure 7a–c. The loading value reached two thirds of design load value, fractures developed in both the corners of roof and two sidewalls, and the value of floor heave was about 300 mm; Figure 7d shows the position of fractures and floor heaves. Note that these fractures developed in roof, floor, and related sites only, meaning that high horizontal stress can affect the stability of roof and floor severely. A 1.7-m-long fracture was formed in the right sidewall (Figure 7e). It was quite clear that the stress progress in surrounding rock had the destructive effect of breaking the stability of surrounding rock.

An increasing number of fractures formed in surrounding rock as the stress developed. Overall, there was a very serious deformation and damages in surrounding rock; the maximum heave floor, reduction of cross section, and the roof convergence were about 1700 mm, 45%, and 400 mm, respectively. Figures 7f and 8 shows the fractures characteristics of the surrounding rock.

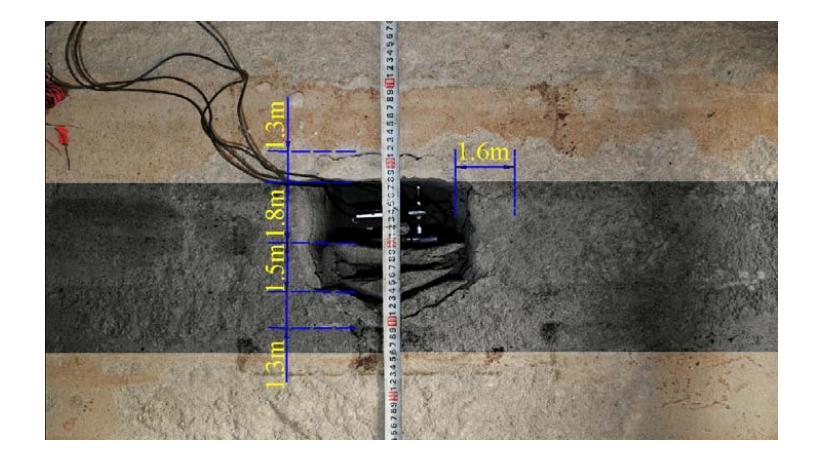
Figure 8. Fractures in surrounding rock in Scheme 1.

When the stress reached about one third of design load value, the first fracture appeared in the corner of floor and right sidewall. Fractures continued extending and passed through the floor along left-right direction, which is thin layer, resulting from the increase of stresses in surrounding rock, as illustrated in Figure 7a–c. The loading value reached two thirds of design value of load, and the fractures were developed in both the corners of roof and two sidewalls; the value of floor heave was about 0.3 m; Figure 7c shows the position of fractures and floor heaves. Note that these fractures were developed in roof, floor, and related sites only, meaning that high horizontal stress can severely affect the stability of roof and floor. A 1.7 m long fracture was formed in the right sidewall in Figure 7e. It was quite clear that the stress progress in surrounding rock has the destructive effect of breaking the stability of surrounding rock.

By contrasting Figures 8 and 10, it is clear that the displacement and bed separation of floor was significantly reduced. Bedding separation of roof was not observed at that same time. Two distinct outlines of fracture occurred in two sidewalls. The maximum floor heave, reduction of cross section, and the roof convergence was about 0.45 m, 25%, and 0.4 cm, respectively.

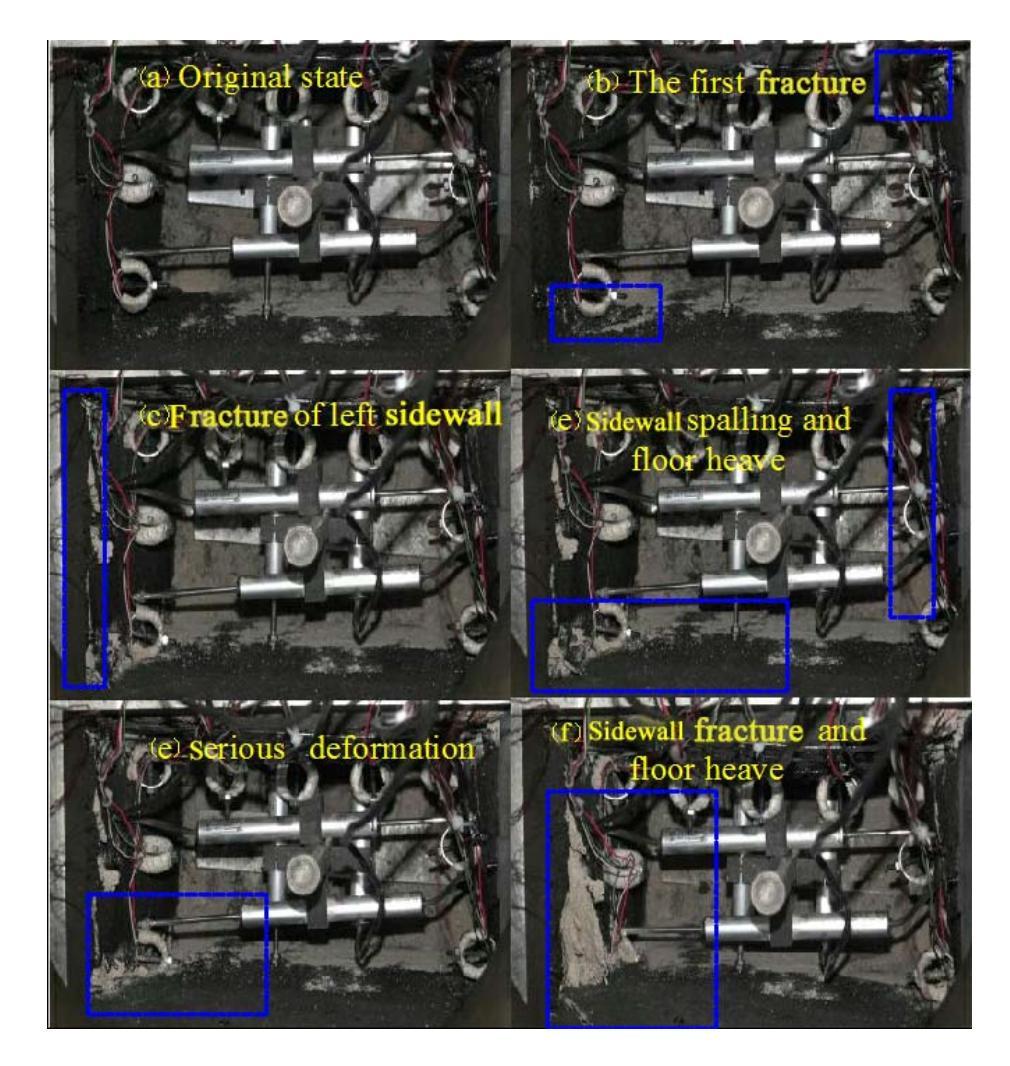
Figure 9. Failure process of surrounding rock in Scheme 2.

According to the design of the Scheme 2, the roof and sidewalls of the surrounding rock were reinforced. Figure 9 shows the deformation and fractures evolution of surrounding rock during loading procedure.

When the stress reached about one third of designed load value, the fracture occurred in the corner of lower left and upper right, as shown in Figure 9b. The fracture increased further as the loading progressed. When the loading reached one second of designed load value, the fracture (3 m'long)

crossed the left sidewall along up-down direction first. This was far different from Scheme 1, in which the fracture developed in floor first. The Figure 9c shows the fracture state at that moment.

The fracture developed at the corner of lower left and upper right during the stress reached by two thirds of the designed value. It is obvious that floor deformation of lower left and upper right increased much both, but nonetheless, the quantity of floor heave was much smaller than Scheme 1 on an equal footing, as shown in Figure 9d.

With the stress in its final stage, minute displacement sensor of lower left was buried by deformation of surrounding rock. The phenomenon of bed separation of floor was not observed in the visual field at that same time. Figure 9e shows the final status of roadway section. Figure 10 shows the fracture final status of surrounding rock.

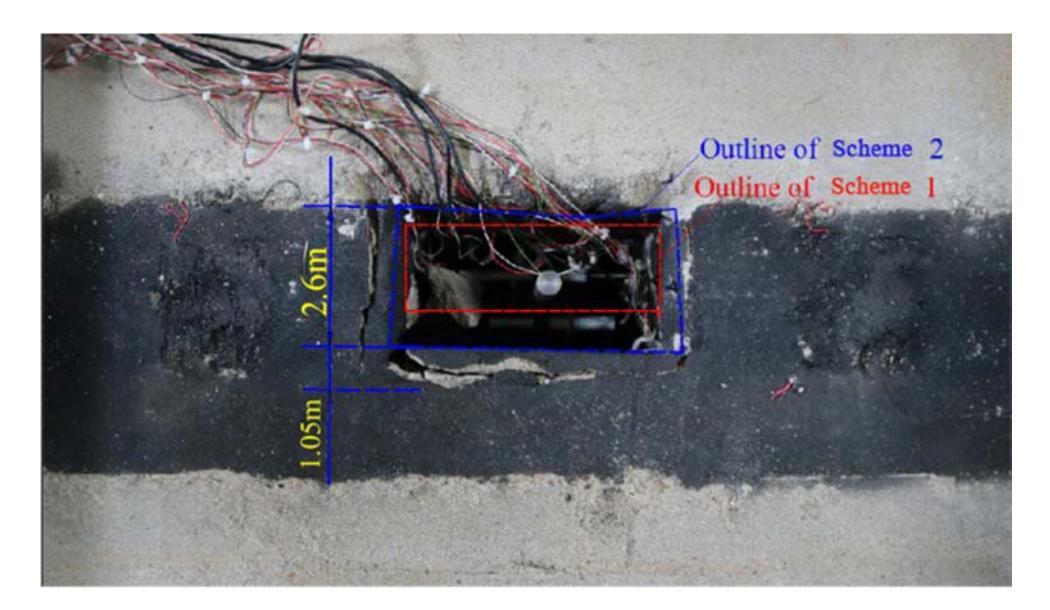
Figure 10. Fractures in surrounding rock in Scheme 2.

In the same way, with the help of analyzing the video data, the process of surrounding rock failure of Scheme 2 in following steps: lower left corner  $\rightarrow$  upper right corner  $\rightarrow$  roof  $\rightarrow$  upper right corner  $\rightarrow$  lower left corner  $\rightarrow$  upper right corner  $\rightarrow$  upper left corner  $\rightarrow$  two sidewalls  $\rightarrow$  floor  $\rightarrow$  roof  $\rightarrow$  two sidewalls  $\rightarrow$  floor.

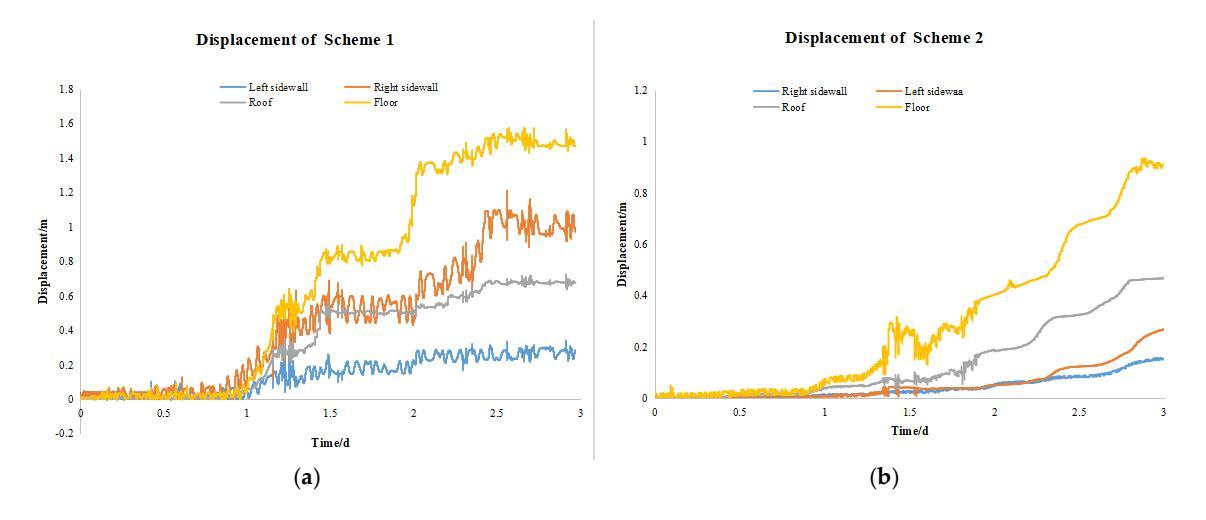
Figure 11. Displacements of two schemes: (a) Scheme 1; and (b) Scheme 2.

As shown in Figure 11a, the displacement of surrounding rock began to increase on the first day. There was a stage of increasing rapidly 1–1.5 days after first day. Moreover, the displacement velocities in the right sidewall and floor were significantly faster than the left sidewall and roof. The curve of displacement appeared in state of fluctuation in the period of stopping loading (1.6–2.0 day). A new

increase in right sidewall and floor occurred on the second day while the loading continued working, with unmarked, corresponding increases in the roof and left sidewall. The displacement of floor, right sidewall, roof, and left sidewall were maintained at the approximate value of 1.6 m, 1.0 m, 0.6 m, and 0.3 m in the end, respectively.

Through displacement curve comparison in Figure 11, there was a remarkable change of curve shape before and after the reinforced of roof and two sidewalls; the displacement curve of Scheme 2 became relatively flatter, and with the increasing displacement, the fluctuation of curve became smaller after 1.8 day. The maximum displacement of floor was about 1.0 m, which decreased displacement by 38% compared to the Scheme 1. The displacement of right sidewall, roof, and left sidewall were maintained at the approximate values of 0.2 m, 0.4 m, and 0.3 m in the end, respectively.

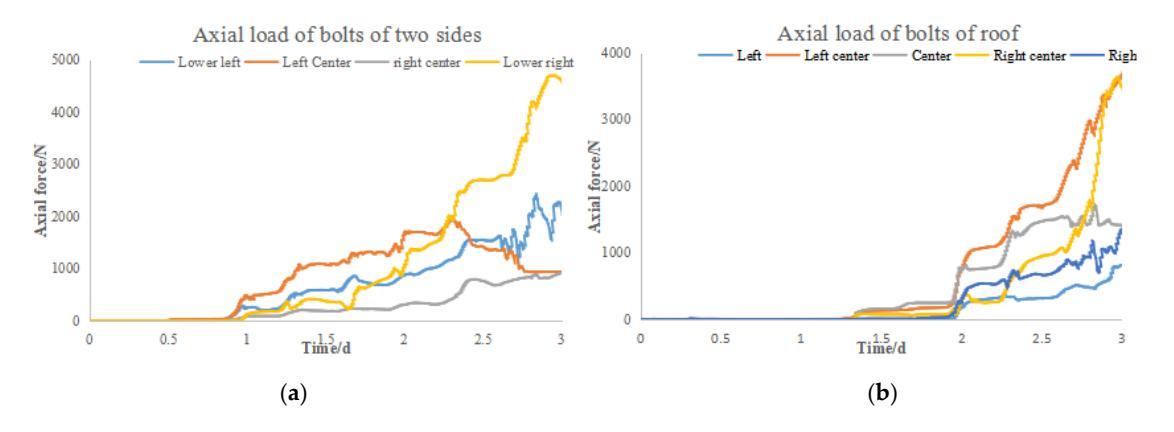
Figure 12. Axial loads of bolts: (a) two sidewalls; and (b) roof.

Figure 12a showed that the change of bolt axial force of two sidewalls in the process of experiment. Firstly, the axial force increased at about 0.9 day, and subsequently, it decreased. At last, the axial force tended to stabilize. The figure also shows that the force value of lower left and lower right sidewalls was bigger than that of the center, which illustrates that the lower parts of two sidewalls were high stress concentration districts. The obvious fluctuation of axial loads indicates that the failure occurred in surrounding rock of two sidewalls, for example, the curve of left center had a fluctuation on the second day; this illustrates the force could not pass it to the sensor immediately, and the surrounding rock appeared loose or broken along bolt axis.

As shown in Figure 12b, the curve slope was obviously higher than Figure 12a, and the majority of displacements mainly focused on third day. The increasing point of the roof was prolonged 0.4 days than two sidewalls, which verified the two sidewalls were firstly in failure state. The figure also showed that the axial loads of bolts in the right and left center in the roof were greater than those of the central, left, and right parts in the roof, indicating that the force condition of roof is approximate symmetric.

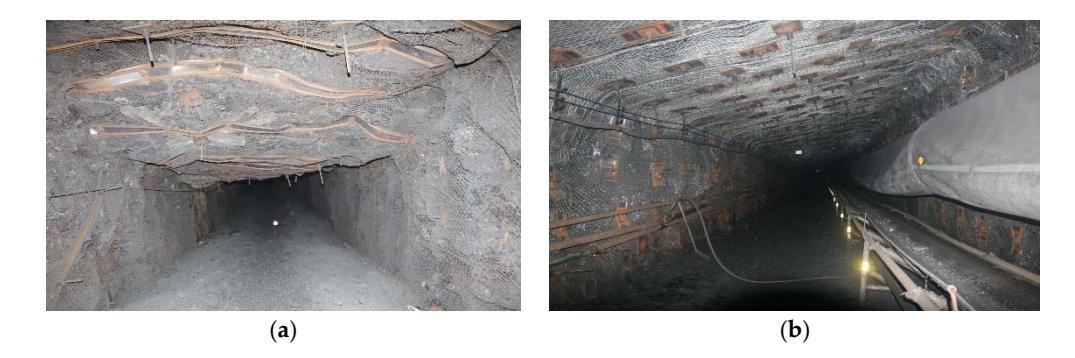
**Figure 13.** Rock deformation: (**a**) low support strength for return airway 15208; and (**b**) high support strength for return airway 12580.

The deformations of surrounding rocks of the roadway were monitored using explosion-proof camera. Figure 13 shows the situations in the field sites.

According to the pictures, when the roof and sidewalls were reinforced by low support strength, the deformation of surrounding rock was serious, especially floor heave, and seriously threatened the safety in production. On the contrary, the strength of roof and sidewalls were improved by high strength structure. The rocks surrounding return airway 12580 was relatively stable; thus, both safety and high-efficiency during mining were ensured.
