Article Analysis of Production Safety in the Construction Industry of China in 2018

Xin-Hui Zhou¹, Shui-Long Shen^{2,*}, Ye-Shuang Xu¹, and An-Nan Zhou³

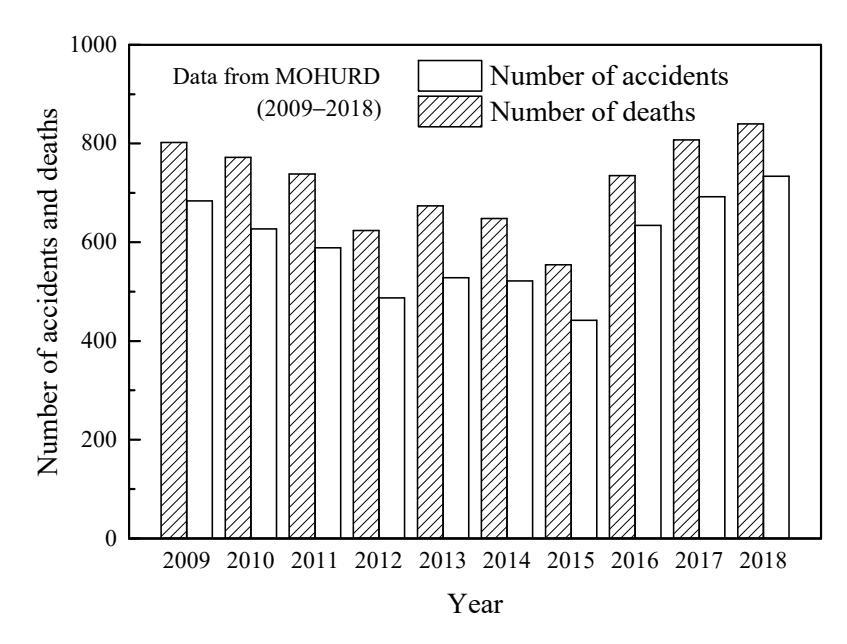
Figure 1 summarizes the fatal accidents related to production safety in the construction industry in the past ten years in China. As shown in Figure 1, from 2009 to 2015, the numbers of accidents and fatalities showed a clear decreasing trend annually, which indicates that production safety gradually improved in general. However, the number of accidents per annum from 2016 to 2018 increased significantly. A reason for the sudden increase in accidents in 2016 is that the way accident data is reported was adjusted [36]. The validation date of the former reporting regulations for production safety accidents, established in 2014, became invalid in 2016. A more comprehensive statistical report regulation on production safety accidents was issued and implemented in 2016 [37]. The number of non-fatal, small accidents and number of deaths after an accident should be included in the report data under the new reporting regulations, which led to a significant increase in the number of reported accidents and deaths. However, the main reason for the annual increase in the numbers of accidents and fatalities since 2016 is the ineffective governance in the safety management. It is worth noting that the data in Figure 1 is from MOHURD [36], which does not fully cover all accidents for the problems in the accident reporting system and its implementation in China. Although some less serious accidents may not be reported, the data is still important for research on the overall trends.

Figure 1. Fatal accidents related to production safety from 2009 to 2018 in China.

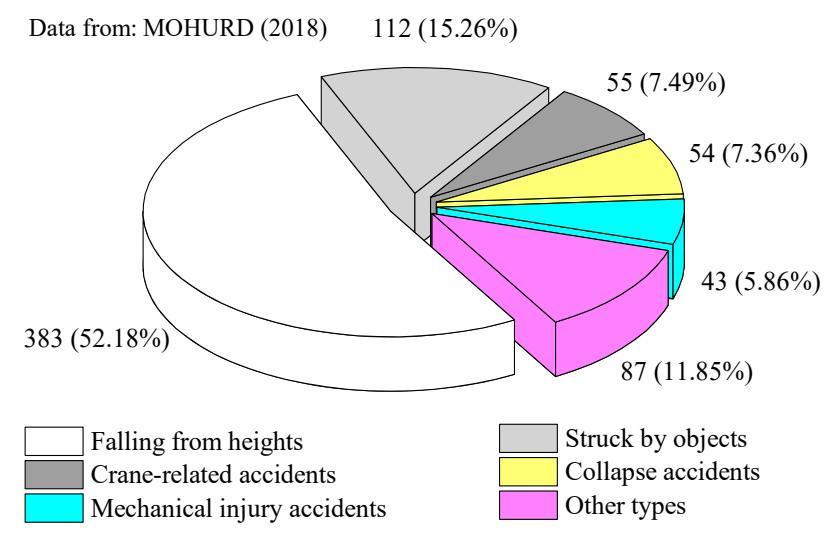
According to MOHURD (2018), the production safety accidents related to construction engineering can be divided into the following six types: collapse accidents, falling from heights, struck by objects, mechanical injury accidents, crane-related accidents, and other types of accidents [39]. The "other" types include vehicle injuries, electric shocks, poisoning, fires, and explosions. Figure 2 shows the number and proportion of various types of accidents in China in 2018, including the four levels of accidents. As shown in Figure 2, the percentage of falling accidents is the largest, accounting for 52.18%, while being struck by objects and mechanical injury accidents reached 15.2% and 5.86%, respectively. The percentages of crane-related accidents and collapse accidents were similar (both around 7.4%), whereas the percentage of other types of accidents was 11.85%. Falling from heights was the most

Figure 2. Accident types in 2018.

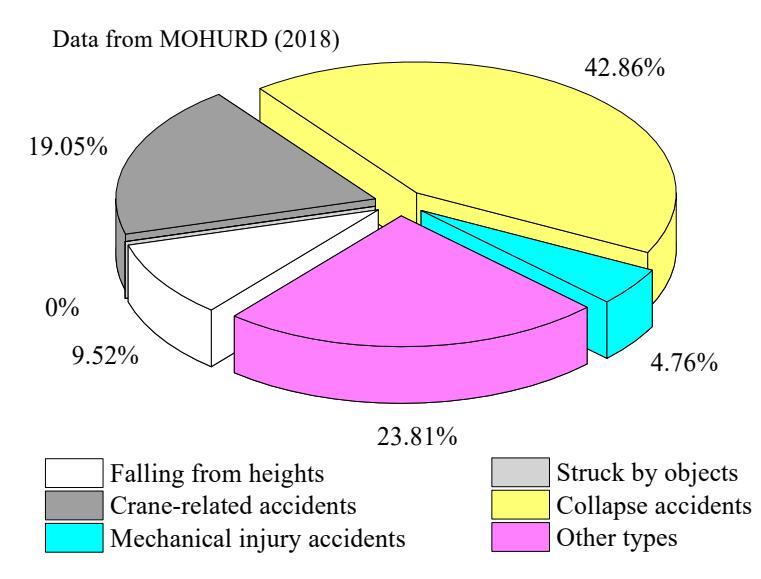
Figure 3 illustrates the number and proportion of large accidents in 2018. As shown in Figure 3, 21 large accidents in 2018 included 9 collapse accidents, 4 crane-related accidents, 2 falling from heights accidents, 1 case of mechanical injury accident, 5 cases of other types of accident, including 1 case of electric shock, 1 case of landslide, and 3 cases of poisoning and asphyxiation. Although there were 112 cases of people being struck by objects, no large accidents of this type occurred in 2018. The number of collapse accidents was ranked fourth among the total accidents, however, first in the category of large accidents, which implies that the consequences of collapse accidents are often more serious.

Figure 3. Proportion of large accidents in 2018.

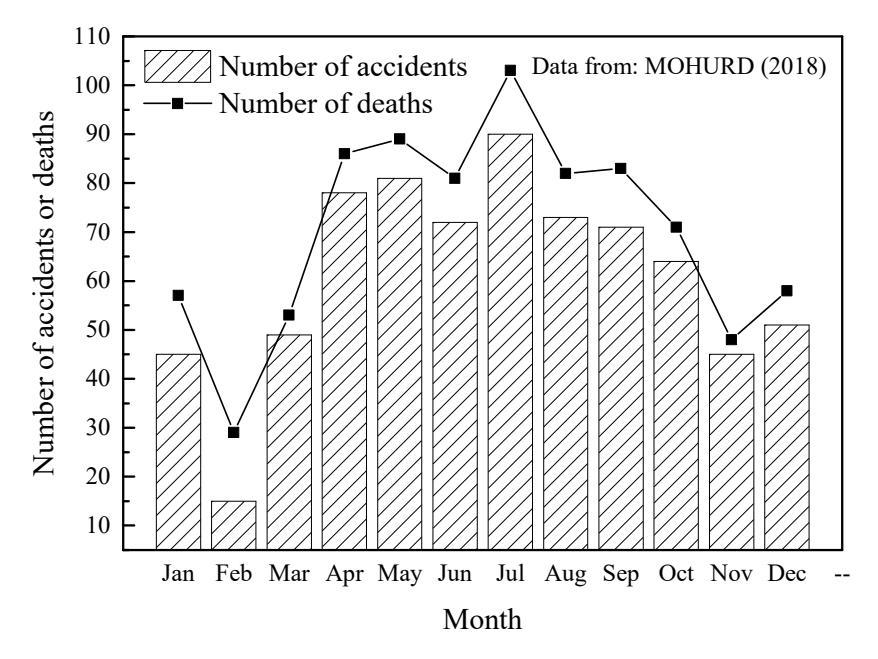
Figure 4 demonstrates the monthly distribution of four levels of accidents with death numbers in 2018. As shown in Figure 4, the accidents in 2018 mainly occurred in April to September, whereas the number of accidents was lower after October and before March. The month with the lowest number of accidents was February. This can likely be attributed to the traditional Chinese Spring Festival in February, during which most construction projects were suspended.

Figure 4. Monthly distribution of accidents with death number in 2018.

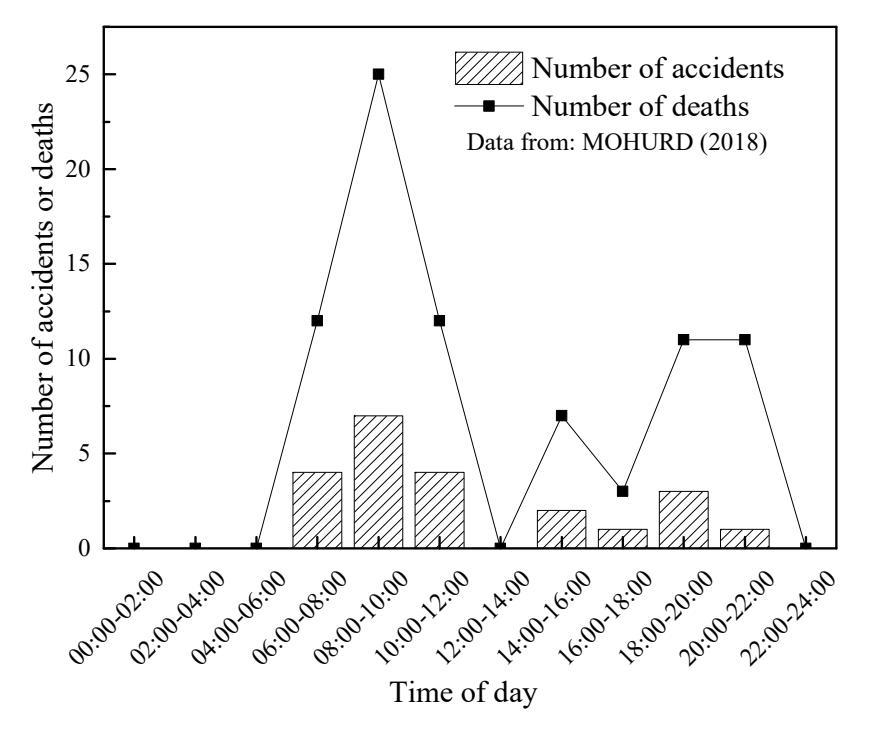
The time distribution for large accidents with deaths in 2018 is presented in Figure 5. As shown in Figure 5, the large accidents in 2018 mainly occurred in the morning. No accidents were reported around noon, because in China, midday is generally a rest time. There were still some accidents reported after 18:00, which may be due to overtime work during tight construction periods.

Figure 5. Daily distribution of large accidents in 2018.

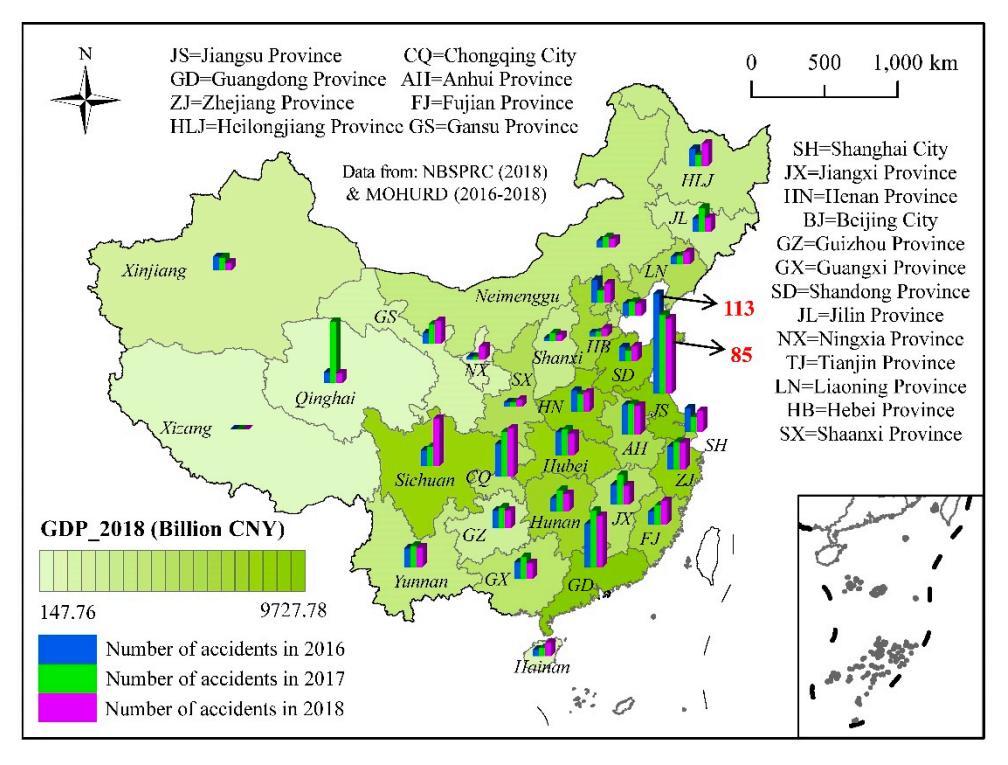
provinces of mainland China from 2016 to 2018. The top ten provinces in terms of number of accidents were Jiangsu, Guangdong, Chongqing, Sichuan, Anhui, Zhejiang, Fujian, Heilongjiang, Gansu, and Hubei, according to the accident statistics in 2018. It is noted that four provinces (Sichuan, Heilongjiang, Fujian, and Gansu) were newly ranked in the top ten in 2018. Furthermore, the number of accidents in these four provinces increased annually from 2016 to 2018. This statistical result can be attributed to the fast-booming economy and inadequate security awareness in these provinces from 2016 to 2018.

Figure 6. Number of accidents in 31 regions of China from 2016 to 2018.

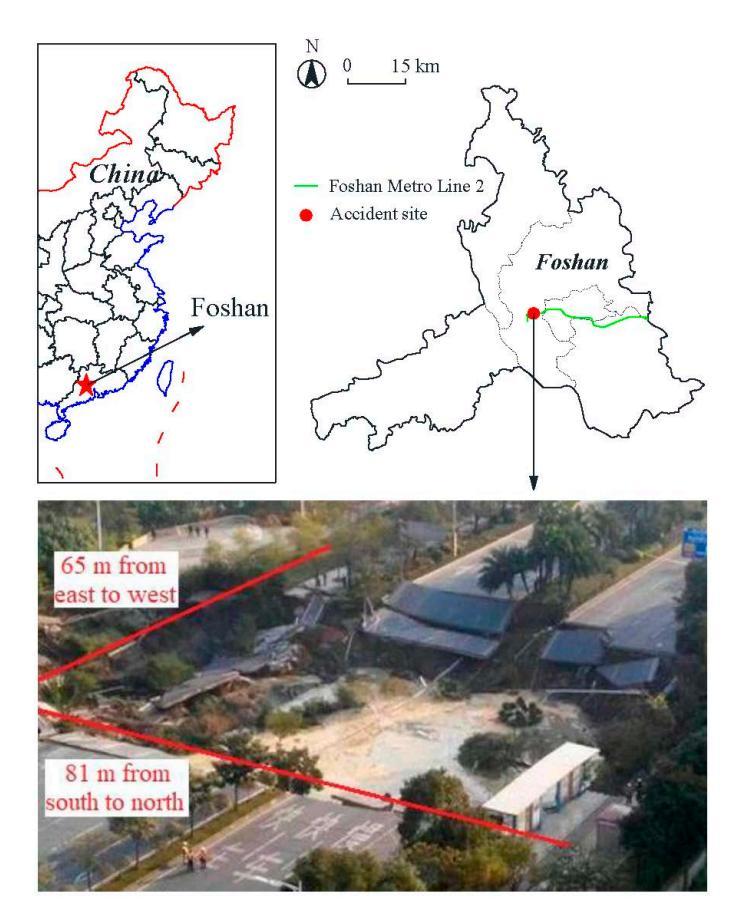
On February 7, 2018, a collapse accident occurred (8:40 p.m.) during the shield tunnel construction of Huyong Station to Ludaohu Station in the first phase of rail transit line 2 in Foshan City, Guangdong Province. Figure 7 illustrates the geographical location of this safety accident, showing the ground collapse. The ground collapse was approximately 6 m to 8 m in depth. The area of the ground collapse was about 4192 m² and the volume of the collapse was close to 25,000 m³ [40]. Based on the standards shown in Table 1, this accident was classified as a major accident, which resulted in 11 deaths, 1 missing person, 8 injuries, and about 53.238 million RMB¥ (\$USD7.724 million) direct economic loss. Yu et al. [41] investigated the technical issues related to the accident. The results showed that this accident was the only major accident in the construction industry in 2018. The post-accident report showed that there were many management problems in this project [40].

Figure 7. The collapse during tunnelling in Foshan metro line 2 in 2018, induced by groundwater leakage.

According to the investigation from the Guangdong Provincial Government [40], there are three direct technical causes of the accident [41]: (i) the geological and hydrological conditions at the site were very challenging, and therefore the risk of groundwater leakage was high when the shield machine passed through this section; (ii) the sealing device at the tail of the shield machine did not work well during the construction process. Some seepage channels were generated under high external water and earth pressures; and (iii) after the tunnel structure failed, a large amount of muddy sand swiftly entered the tunnel, forming strong mud-sand flows and air waves along the longitudinal direction of the tunnel.

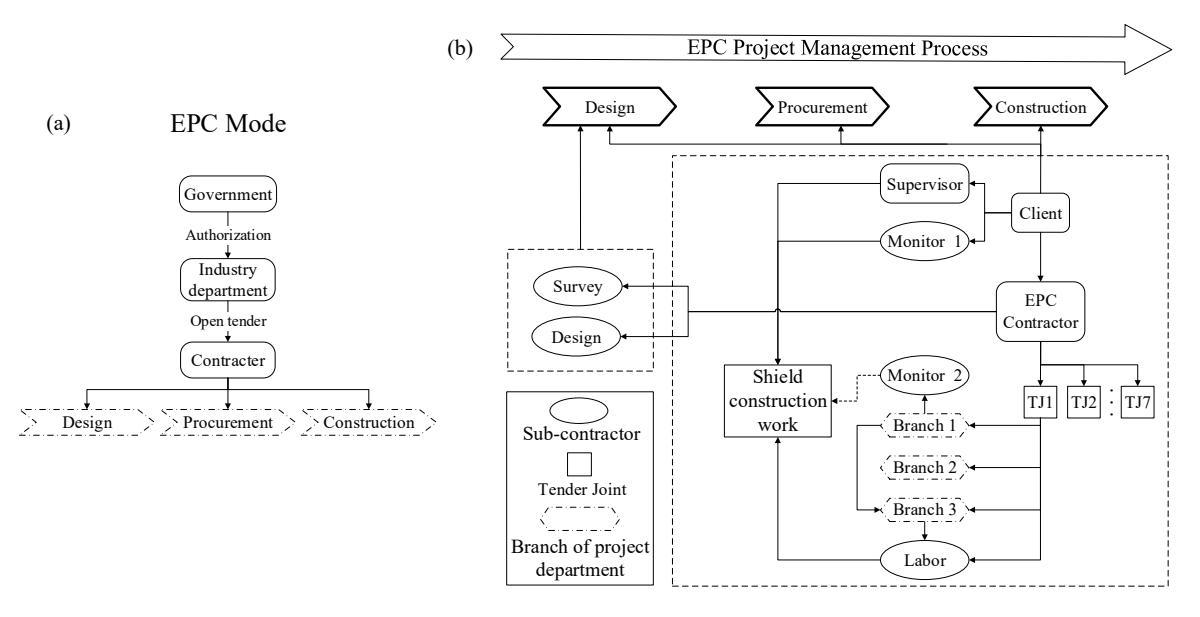
In addition, the government investigation showed the management causes of the accident [40]. This was an engineering procurement construction (EPC) project. Figure 8 shows the EPC management relationship chart. For comparison, the original mode of EPC project management is also presented in Figure 8a. As shown in Figure 8b, there were 12 parties involved in the construction management of this project, involving investment, construction, supervision, operation, exploration, design, and labor dispatch. As shown in Figure 8, compared to the original EPC mode, there are many management levels, resulting in increasing safety and environmental risks. For example, the right-line shield machine experienced several instances of shield tail leakage before the accident, which presented great risk to the shield tunneling. The construction party did not eliminate this safety hazard. As a violation of the Labor Law [42], the working hours of construction site staff were extended in this project. Moreover, safety production inspections were not carried out regularly. There was inadequate supervision of some government departments, such as the transportation bureau, fire station, and production safety supervision bureau. The project was a safety production risk point in Foshan city, nevertheless it was constructed without the relevant formalities, such as construction project planning permit, and fire design plan reviews. Even worse, some construction workers continued to carry out rescue work in the tunnel in this dangerous situation, which led to serious casualties. Technical problems were the direct cause of this collapse accident, whereas adequate safety management could have avoided the accident.

Figure 8. The EPC project management relationship chart (data from EMBF, 2018 [40]). (**a**) the original mode of EPC project management, (**b**) the EPC management situation of Foshan Metro Line 2.

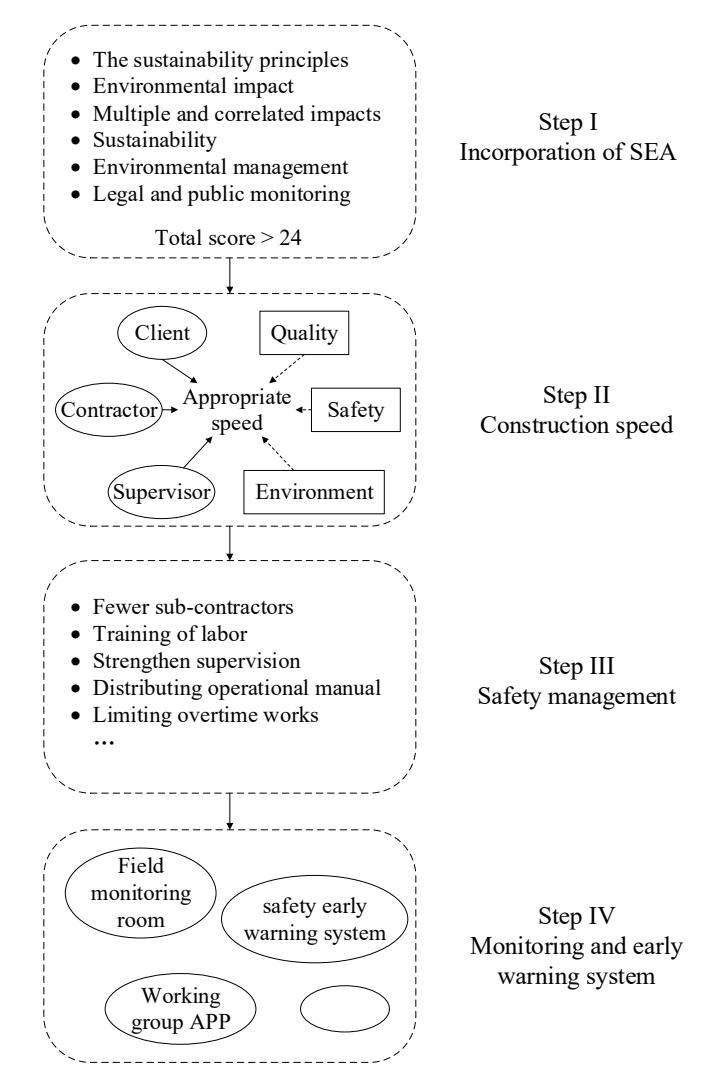
Figure 9. The guidelines for risk management.

- (i) Step I: Incorporation of SEA. We propose the SEA concept be incorporated into project management. Strategic risk assessment should be conducted at the project level. The total score of the SEA should be higher than 24. He et al. [14] verified that when an SEA score increased from 16 to 24, the environmental risk (land subsidence) was reduced greatly.

- (ii) Step II: Limitation of Construction Speed. Based on SEA results, the appropriate construction speed of the project should be discussed and determined by the supervising government body, the client, and the contractor.

- (iii) Step III: Strengthen Safety Management. There are many subcontractors with loose connections, and it is crucial to reduce the numbers of subcontractors. The training of the laborers should be improved. However, when the number of subcontractors cannot be reduced, supervision and monitoring should be improved during implementation. An operational manual should be distributed to all engineers and workers in the field. Moreover, overtime work in the field should be limited.

- (iv) Step IV: Establishment of Monitoring and Early Warning System. The full monitoring system should include not only field monitoring but should also establish a working group application for cell phones. An overview of the field situation should be uploaded each day, and when a risk warning is received, this information should be uploaded every minute. A comprehensive safety early warning system should be established to replace the passive after-the-fact safety management model with active advanced warning.
