Environmentally Degraded Mining Areas of Eastern Slovakia As a Potential Object of Geotourism

Abstract: The paper deals with the possibilities of further use of environmentally degraded and polluted areas on the example of (mining and industrial) activities residues in the Central Spiš region in eastern Slovakia. On the example of the Slovinky mining tailing pond, the Markušovce mining tailing pond, and two mining dumps in Rudňany, we deal with the analysis of their condition in terms of heavy metal content, as well as the real and potential alternative use of these sites. Data were collected using field trips and field research in sediment sampling in all localities and by preparing a questionnaire for opinion polls. The content of heavy metals from all four places, the results of field trips, and the questionnaire were analyzed. The article points out the current state of these objects in terms of their load with heavy metals and considers their possible alternative uses, especially in terms of geotourism or education. The implementation of geotourism in the studied sites brings along benefits, not only for visitors and students, but also has a positive impact on sites themselve

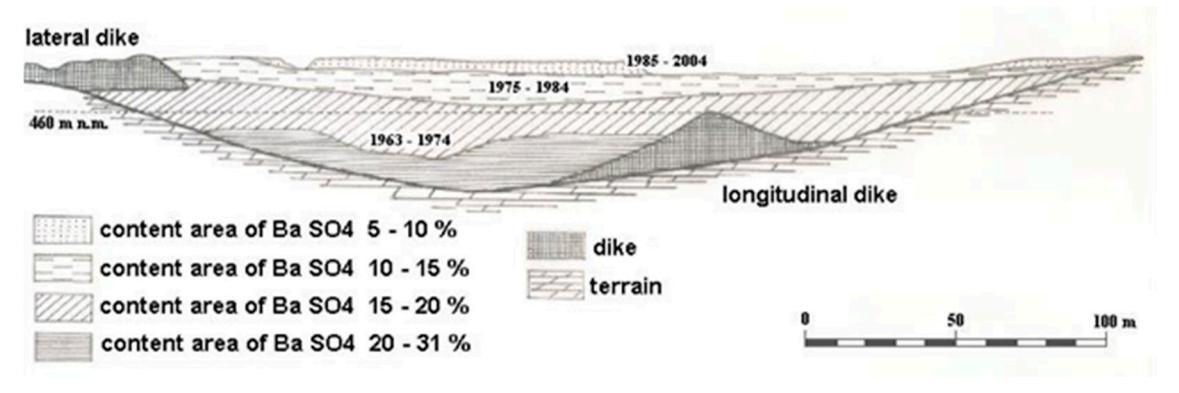
The evolution of the tailing pond composition can be described in a simplified way by three stages with different influences on the internal characteristics of the bed, as shown in Figure 3.

Figure 3. Stages of Markušovce tailing pond [28].

1. Stage of the "old tailing pond"

It was created in the early stages of building the treatment complex in 1963–1974, while in addition to the front and side dams there was also a longitudinal southern dam separating the deposited part of the valley (to the level of approximately 460 m above sea level) from the non-deposited part with the brook and the original road at the bottom of the valley.

2. "Middle section" stage

The original tailing pond was flooded (including the southern dam) after the upper and lower dams were raised and completed, the tunnel for draining Markušovský brook was excavated, and the lateral northern dam was built (development in 1975–1984, reached approximately 470 m above sea level).

3. The "poor packaging" stage

Originating in the years 1985–2004, it is characterized by reduction in the content of useful ingredients in the by-products of the treatment due to radically improved ore flotation parameters. In recent years, the surface morphology of the tailing pond has been changed by flotation sludge mining. Extraction of upper layers had some influence on industrial exploitable sands (on the filling of gas pipelines).

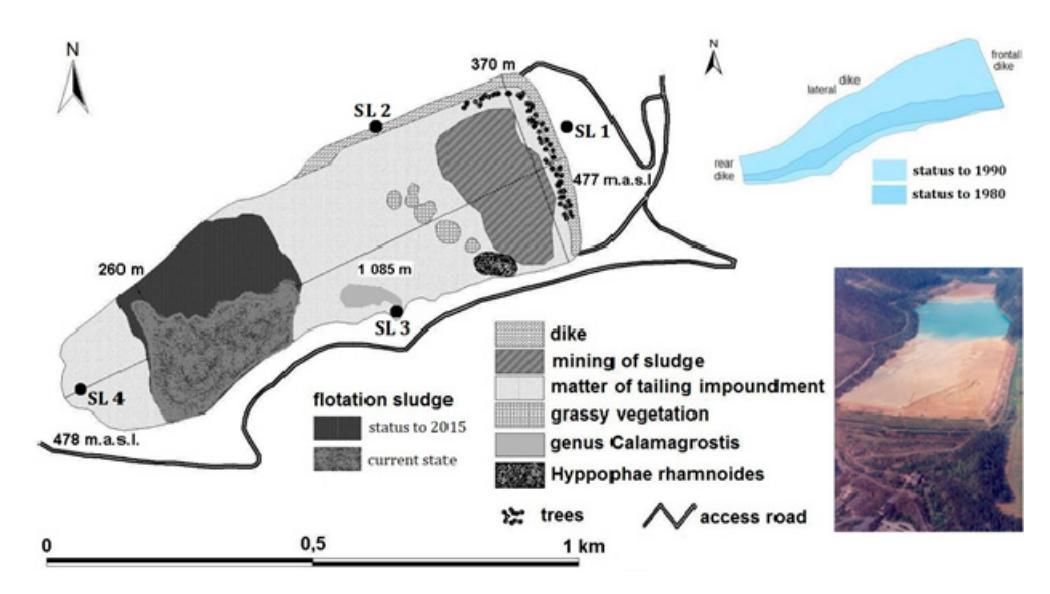
The tailing pond has a complicated internal structure, as shown in Figure 4, due to the different distribution of components and size fractions represented. When sludge is deposited in the tailing pond, substances of different granulometrics and different specific weights are separated. This is influenced by the development of treatment technologies and their efficiency and by the composition of the ores extracted. The internal construction reflects the development of treatment of mined ores from the construction of the so-called new industrial plant in 1963 to the present. In the initial phase in 1963–1970, the treatment technology was not sufficiently mastered. Since 1984, the flotation process has improved and the treatment parameters of the BaSO4 component have substantially improved. The internal structure is also influenced by the natural gravitation classification of substances during its deposition when the grains of different sizes and specific gravity behave differently. Larger and heavier grains settle at the beginning of depositing, while finer and easier grains travel from the outlet to the center of the pool. In general, the central part of the tailing pond is represented by a rather finer material and a lower proportion of barite, and the edges of the tailing pond by rougher proportions and a relatively higher proportion of barite [59].

Figure 4. Structure of Markušovce tailing pond.

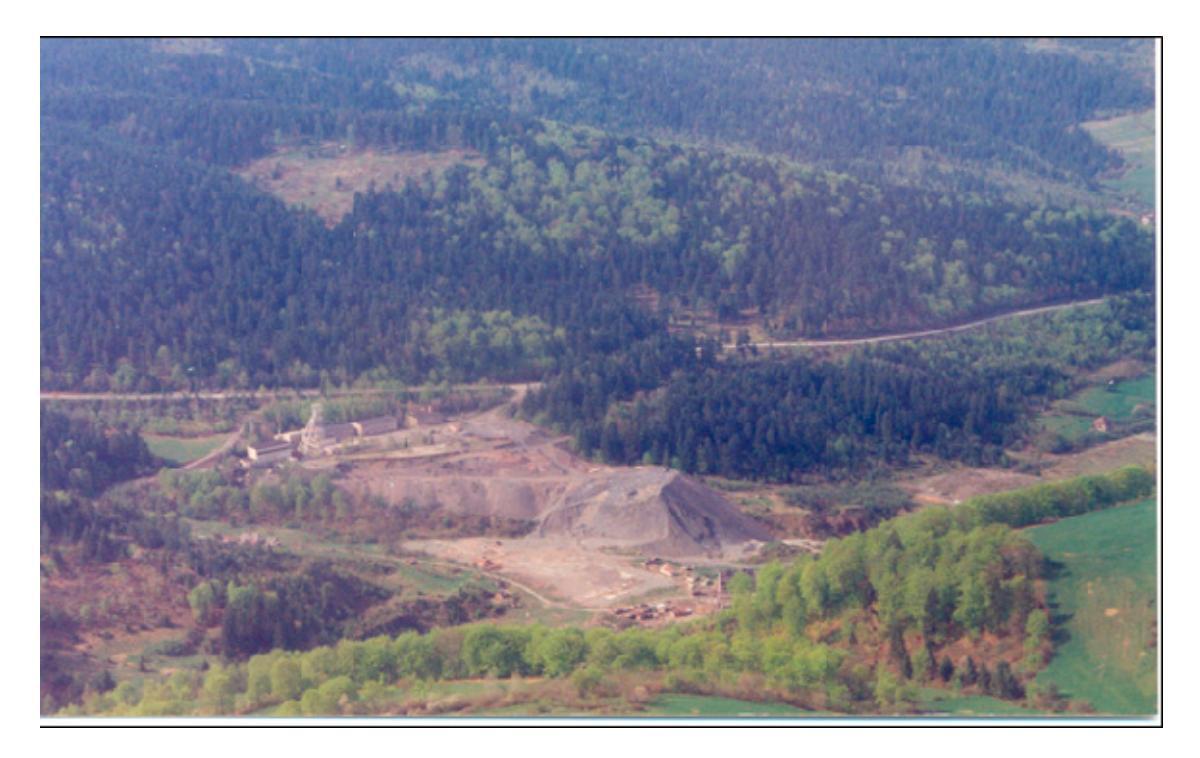
The Pätoracké Roma settlement, as shown in Figure 6, is one of the most endangered Roma settlements in the entire region of Central and Eastern Europe [63]. As a result of the former mining activity and industry, the entire settlement area is contaminated by toxic emissions, dumps, and left-over tailings. The settlement itself is located in the cave zone of former mines in the dump of mining waste, which is highly contaminated with heavy metals and where secondary mineralization and emissions to the surrounding environment (air in the form of dust and water in the form of leaches) take place. The majority of the population was once evacuated from this place because of terrain movements and

Figure 6. Aerial view of Pätoracké heap from 1993.

slides that threatened local houses [61,64]. Sporadically, there occur slides, and larger caving occurred in 2001, 2009 (when a crater with a diameter of 10 m developed), and 2011.

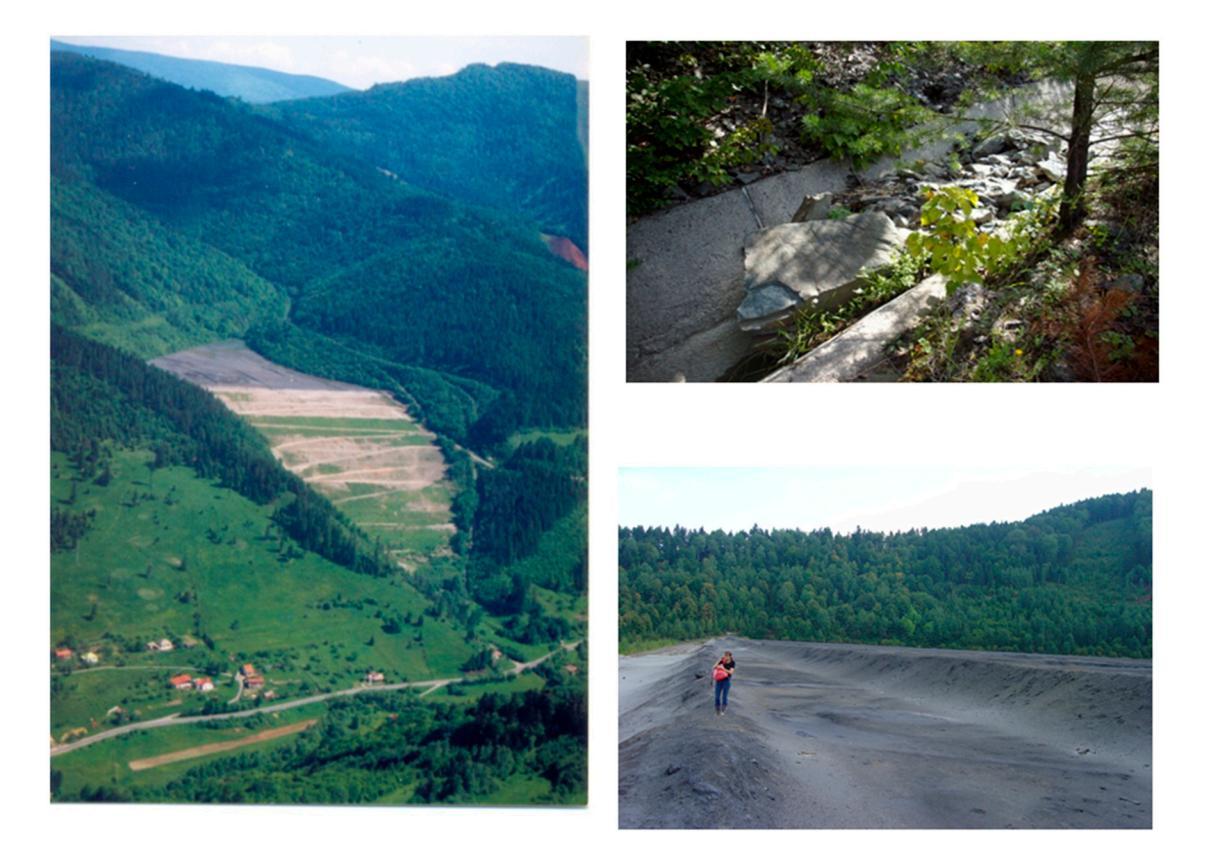
The tailing pond, as shown in Figure 7, is located in the cadastral area of Krompachy. Although it is located on the territory of the town of Krompachy, it belonged to the mine of Slovinky. The construction of a new tailing pond started after an accident and the shutting down of the old one. It was in operation between 1968 and 1993 when the deposit was closed. The transport of sludge in the form of a hydro-mix

Figure 7. Aerial viewpoint of Slovinky tailing pond (on the left), bad condition of concrete drainage troughs (up on the right), and the tailing pond body surface (down on the right).

There are two layers in the vertical section of the tailing pond. The upper part of Slovinky tailing pond consists of dark slag from the Kovohuty Krompachy plant, thickness 5–6 m, under which flotation sludge originating from the processing of siderite-sulfide ores is placed. The pond is dry, and the surface layer is not reclaimed. The mineral material of the pond consists mainly of quartz, siderite, chalcopyrite, tetrahedrite, arsenopyrite, and pyrite. Analyses of the overall composition of the tailing pond material revealed a significant difference in the composition of the top slag layer and the deeper deposited flotation sludge. Of the potentially toxic elements that may be a potential environmental risk, increased concentrations were found in the upper layer of the tailing pond (slag) and at the bottom of the tailing pond, especially the values of Cu, Zn, Cr, Pb, Ba, Sn, As, and Sb.

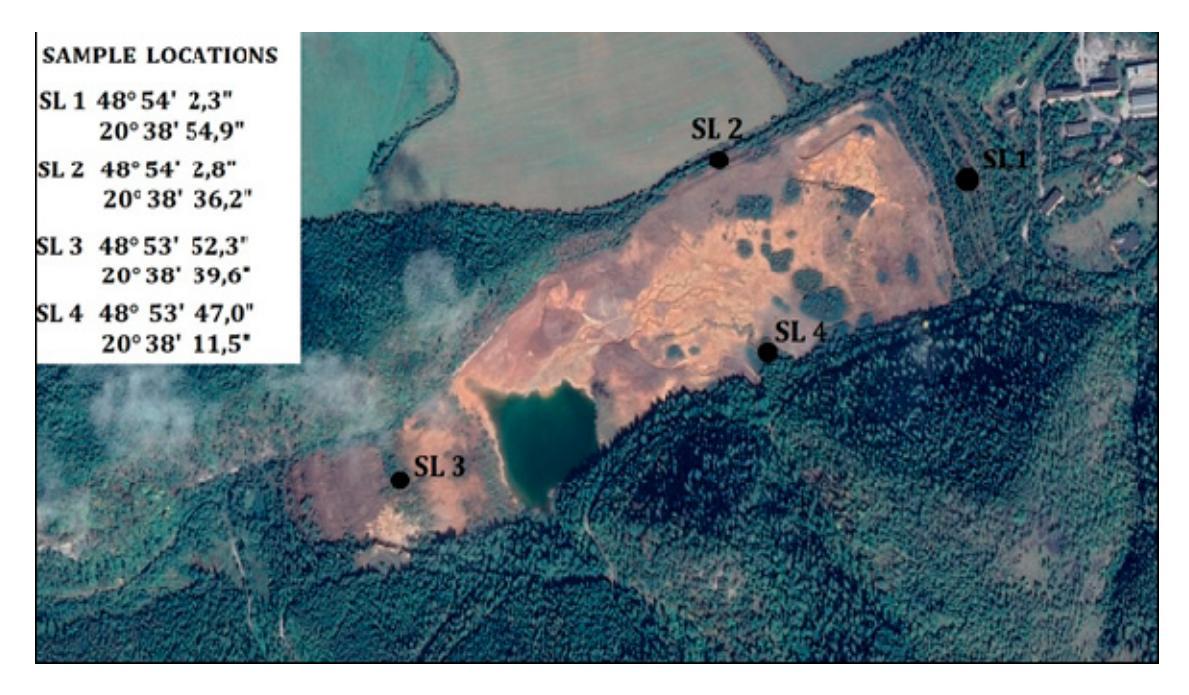
Sediment sampling was performed in all four sites in the studied area, as shown in Figures 8–11. Samples were sent to the laboratory for heavy metal content. The samples were analyzed in the accredited testing laboratory of the Ministry of the Environment of the Slovak Republic for Geology and the Environment according to STN EN ISO/IEC 17025: 2005. The content of Cu, As, Pb, Ni, and Cr was determined by RFS—X-ray fluorescence spectrometry, and the content of Cd and Co was determined by AAS—atomic absorption spectrometry. In addition to internal controls, checking the correctness of laboratory techniques in the laboratory is regularly ensured by an external control system in the form of inter-laboratory comparative tests with a success rate of more than 90% of all extents for all soil and water types. The measured values of heavy metals were compared with the limit values of hazardous substances stipulated by Act No. 220/2004 on the Protection and Use of Agricultural Land and on the Amendment of Act No. 245/2003 Coll. on Integrated Prevention and Control of Environmental Pollution. Values exceeding the limits of individual heavy metals were graphically described by using the so-called traffic lights method [44]. Values that meet the legal standard are green. For over-limit values, we have calculated how many times the limit value has been exceeded. Subsequently, we determined the intervals for exceeding the limit values, which correspond to the shades of orange to red.

Figure 8. Sediment sampling places in the Markušovce tailing pond.

SL1—tailing pond dam, SL2—bushes close to the body (mirror) of the tailing pond (north), SL3—body (mirror) of the tailing pond (south), SL4—body (mirror) of the tailing pond (south-west).

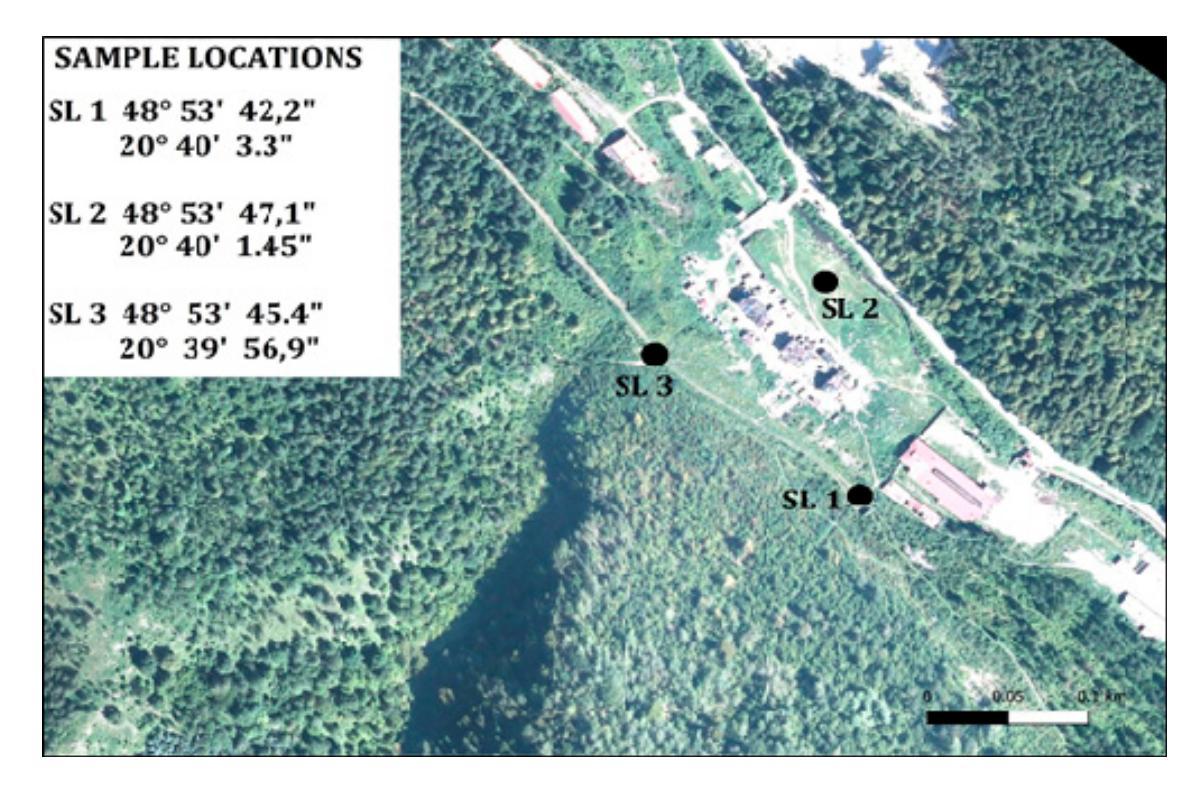
Figure 9. Sediment sampling places on the Zabíjanec heap.

In case of Zabíjanec mining heap, as shown in Table 2, Figure 13, samples were taken at three locations, as shown in Figure 9—one directly from the surface of the heap (SL2) and two more in close proximity, all near the Roma settlement. Content of As reaches the highest value in all three locations,

SL1-behind the heap, SL2-directly on the heap, SL3-behind the heap in the forest.

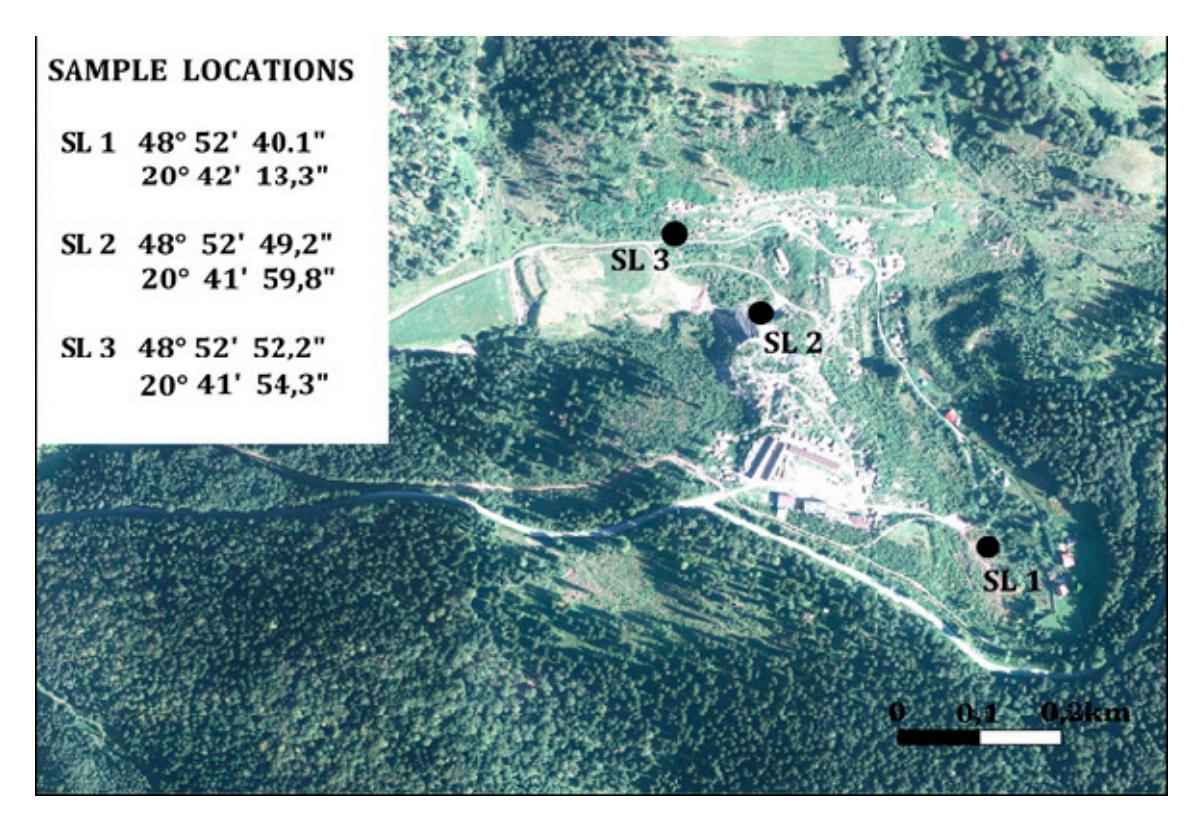
Figure 10. Sediment sampling places on the Pätoracké heap.

In case of the Pätoracké mining heap, as shown in Table 3, Figure 14, samples were taken at three locations, as shown in Figure 10—south-east of the heap edge in the forest (SL1), directly on the surface of the heap body (SL2), and north-west in close proximity to the Roma settlement (SL3). Here the content of Cu (SL2) and As (SL3) was exceeded in the interval 5.1–10 times. Most other elements exceed limit values in the range of 0–5 times. For Cd at all three locations and Ni (SL2), the limit values were not exceeded.

SL1—behind the heap, east part near the forest, SL2—directly on the heap, SL3—behind the heap close to the Roma settlement.

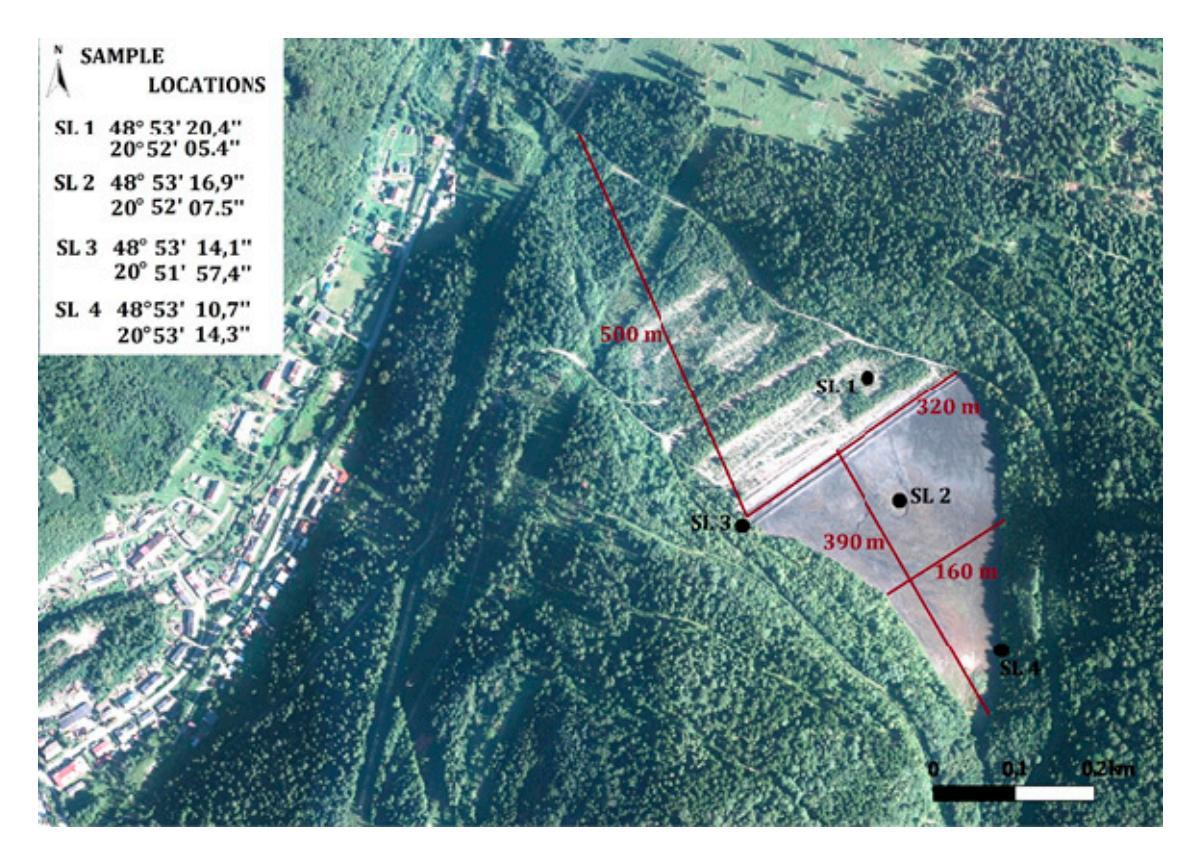
Figure 11. Sediment sampling places in the Slovinky tailing pond.

In case of Slovinky tailing pond, as shown in Table 4, Figure 15, four samples were taken, as shown in Figure 11—directly from the tailing pond "mirror" (SL2, SL4), the dam (SL1), and 70 m south-west of the tailing pond mirror (SL3). The analysis clearly shows that in the tailing pond the limit values are exceeded to the greatest extent out of all four monitored tailing and heap sites. The worst results are related to Cu, where the limit values at the sampling location SL2 are exceeded 165 times and at the

SL1—tailing pond body, SL2—body (mirror) of the tailing pond (north), SL3—forest 70 m south-west of the body (mirror) of the tailing pond, SL4—body (mirror) of the tailing pond (east).

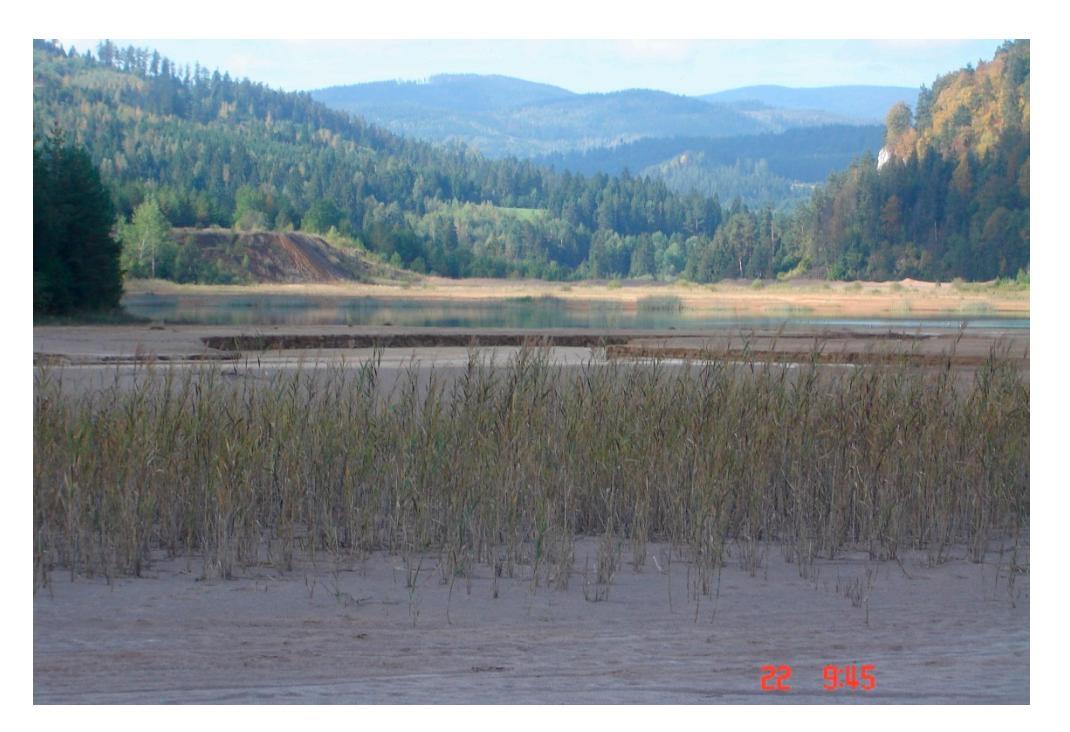
Figure 16. Vegetation on the mirror of Markušovce, deposits in the background.

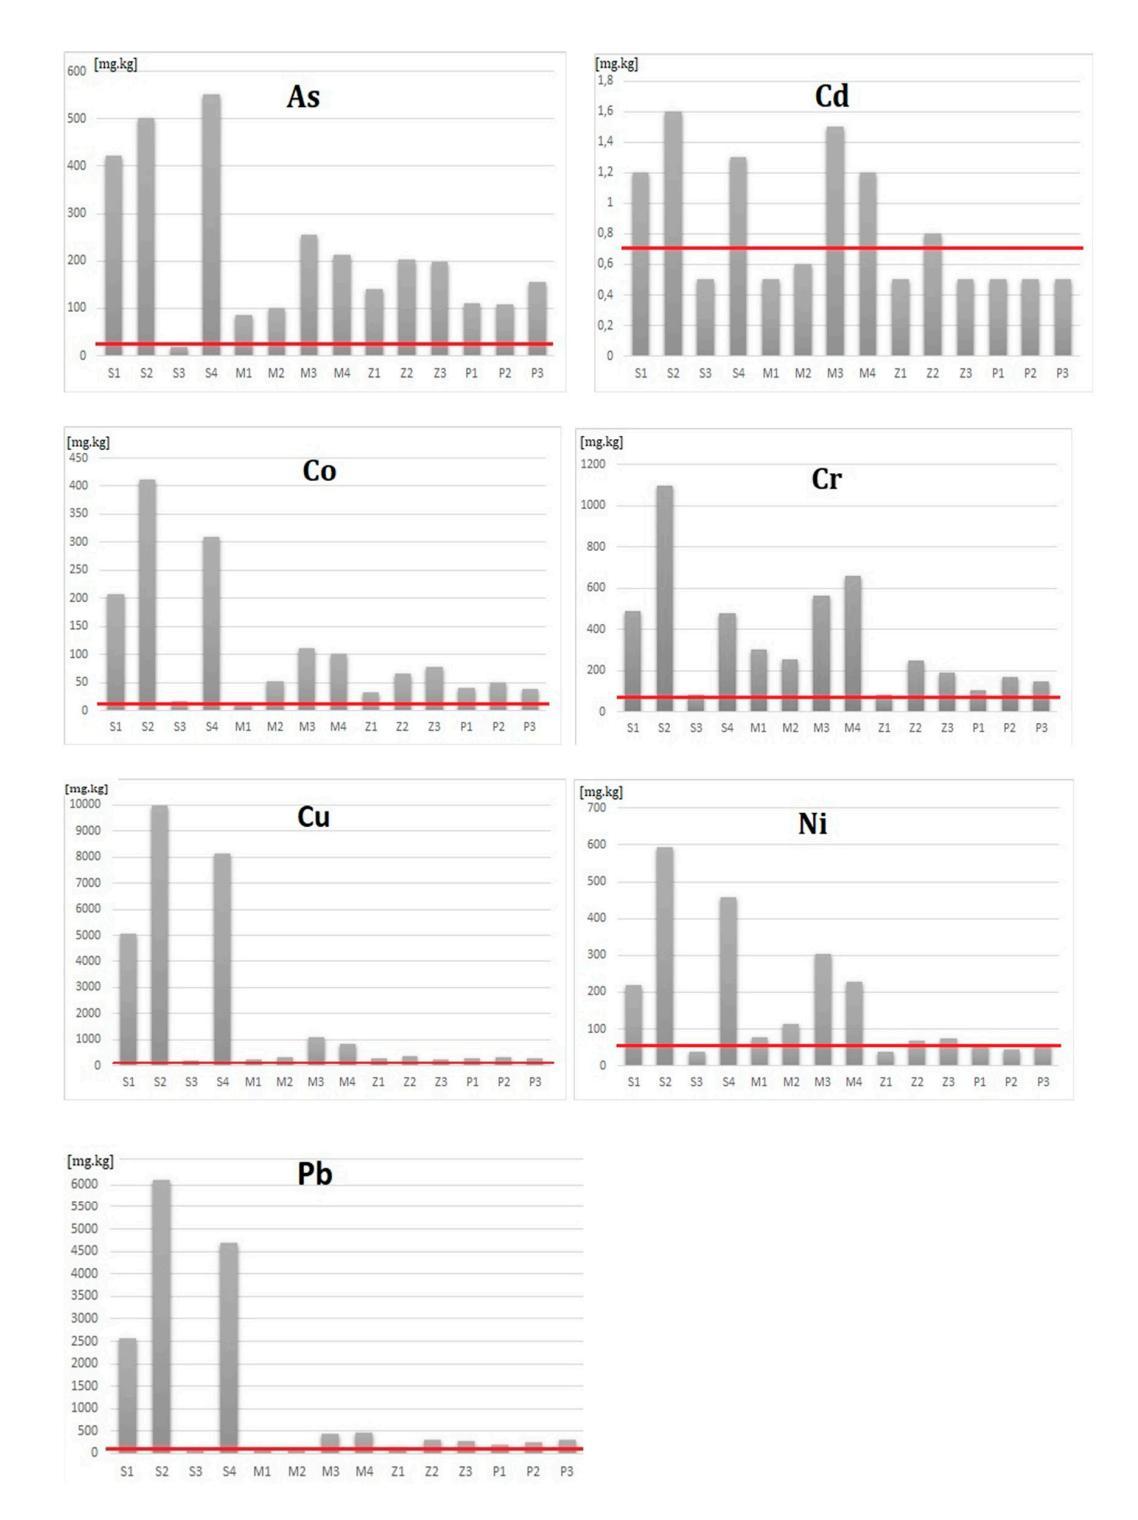
The heavy metal content in the researched sites, as shown in Figure 18, is very high, and in some cases extreme, in accordance with the data for tailing ponds in the works of other authors [56,57]. It often exceeds the limit values several times. This burden is enormous for all monitored elements, especially in the case of the Slovinky tailing pond. Occurrence of these elements in the tailing ponds and heap bodies, as well as their possible penetration into the environment through, e.g., leaks, represents

Figure 18. Comparison of heavy metal content from all the sites with the limit value (red line). (S1–S4: Slovinky tailing pond, M1–M4: Markušovce tailing pond; Z1–Z3: Zabíjanec mining heap; P1–P3: Pätoracké mining heap).

great danger for the landscape. This results in possible contamination of surface and ground water, and in windy weather it is difficult to breathe in the surroundings of these sites. An alarming fact is the existing settlement directly on the body of both heaps, namely the settlement of the Roma ethnic group, as well as the proximity of human settlement in the case of both tailing ponds.
