Article Centrifuge Modeling and the Analysis of Ancient Landslides Subjected to Reservoir Water Level Fluctuation

Songlin Li, Qiang Xu *, Minggao Tang, Huajin Li, He Yang and Yong Wei

State Key Laboratory of Geohazard Prevention and Geoenvironment Protection, Chengdu University of Technology, No. 1 East Third Road, Erxianqiao, Chengdu, Sichuan 610059, China; lsl68@foxmail.com (S.L.); tomyr2008@163.com (M.T.); Huajinlee@yahoo.com (H.L.); yanghexq@163.com (H.Y.); ceweiyong@hotmail.com (Y.W.)

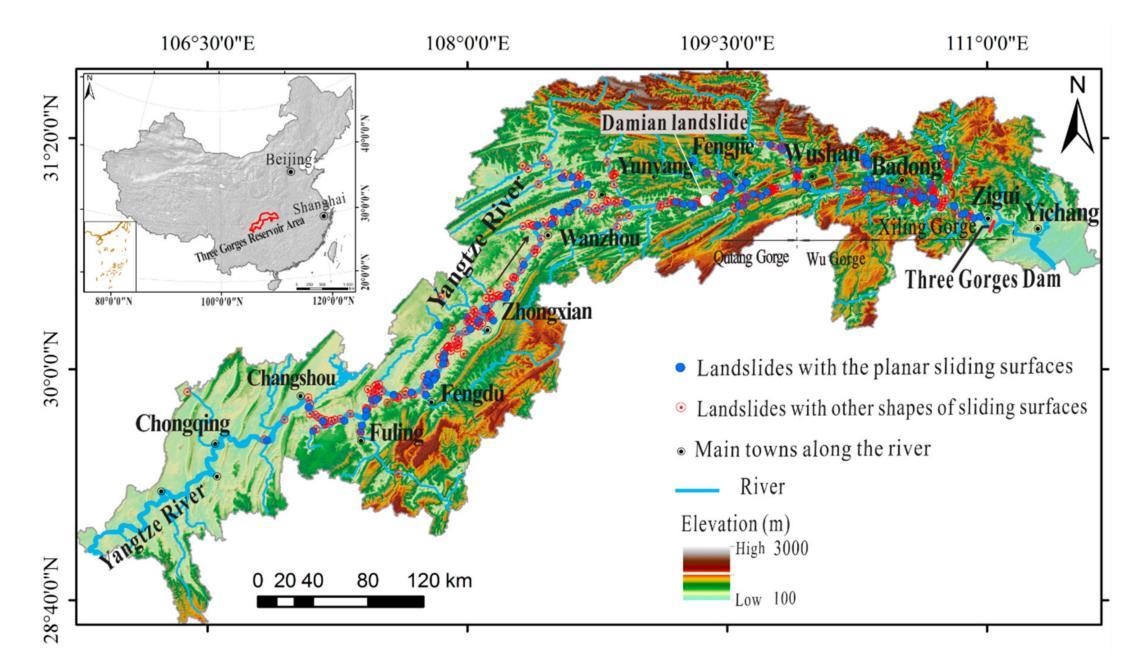
Figure 1. The distribution of landslides with planar sliding surfaces in the Three Gorges Reservoir Area.

The Three Gorges Reservoir Area is situated at the junction of the Sichuan Basin and the Middle-Lower Yangtze plains (Figure 1), and a series of arc fold structural assemblages are generally present in regional geological structures. As a consequence, the TGRA includes complex geological settings [38,39]. The total lengths of the riversides of the reservoir are approximately 600 km. It has commonly been assumed that the fluctuation in the reservoir level and precipitation are the dominant factors causing the reactivation of landslides. Moreover, landslides are typically susceptible to the presence of slope structures that dip toward the slope free face (i.e., consequent slope), whereas, a few failures tend to occur where structures dip into the slope (i.e., reverse slope) [40–43].

In this paper, landslides with planar sliding surfaces are selected as the reference prototype (Figure 2), which accounts for 30% of all landslides in the TGRA. The landslides mainly occurred in the consequent slope of monoclinal stratified rocks with low and moderate dip angles, such as from Fengjie to Yunyang and Fengdu to Fuling (Figure 1). The Damian landslide is typical of this

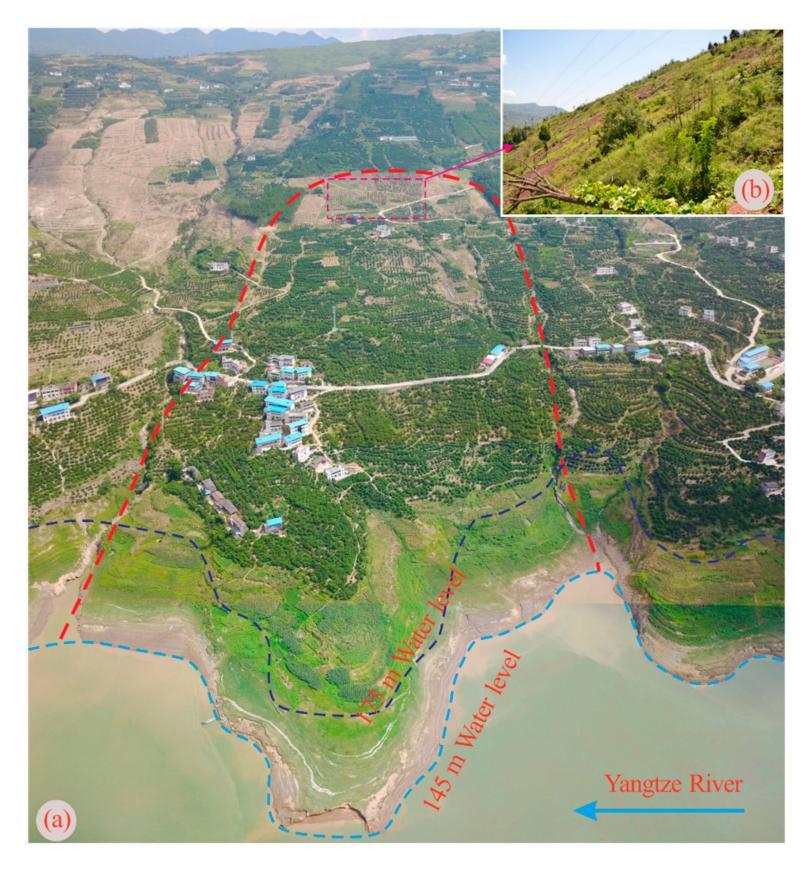
Figure 2. (a) The panoramic photograph of the Damian Landslide (the landslide boundary is depicted with the dashed red line) and (b) the exposed planar sliding surface at the rear edge.

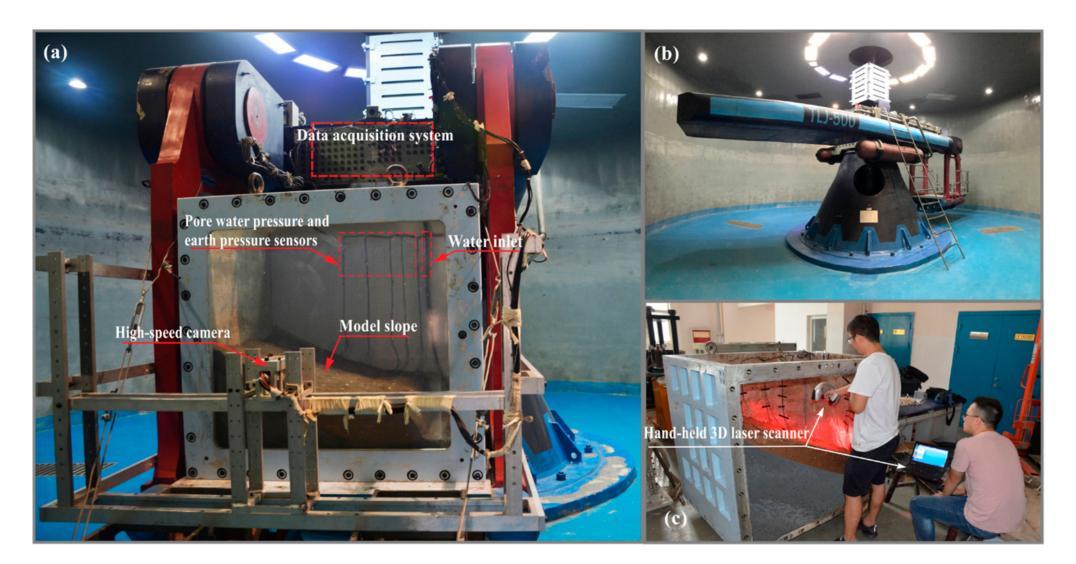
Figure 3. (a) Overview of the centrifuge model, (b) the appearance of the TLJ-500 geotechnical centrifuge and (c) application of the hand-held 3D laser scanner after the experiment.

The TLJ-500 geotechnical centrifuge facility, which was jointly manufactured by Chengdu University of Technology and China Academy of Engineering Physics, and established at 2013 in Chengdu University of Technology, as shown in Figure 3b, was utilized in this study. The centrifuge has an effective rotation radius of 4.5 m and a maximum capacity of 500 g tons, and the other specifications of the apparatus are shown in Table 2. In addition, the model slope topography was scanned by 3D laser scanning before and after the test (Figure 3c).

In addition, the model was scanned by a hand-held 3D laser scanner with high accuracy and resolution before and after the test (Figure 3c), and the vertical displacement of the model surface could be obtained. Thumbtacks with a diameter of 10 mm that can be identified as calibration points by applying Polyworks 10.0 software were arranged on the model slope surface.

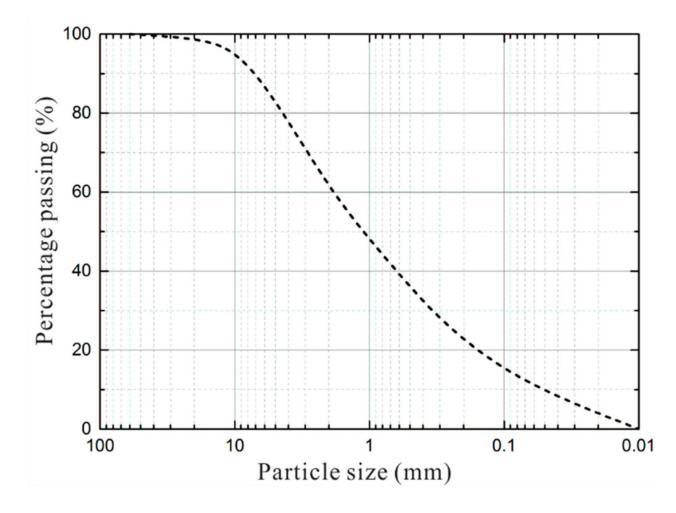
Figure 4. Particle size distributions of soil materials in this dissertation.

The soil materials used to create the slope model were taken from the field of the Damian landslide, which occurred in Jurassic red strata along the An'ping bank slope in the TGRA (Figure 1). The scaling relations of centrifuge modeling have been strictly established. The air-dried soil sample was pulverized, and gravel particles beyond the size of 2 cm were removed. Figure 4 shows the particle size distributions of soil materials in this dissertation.

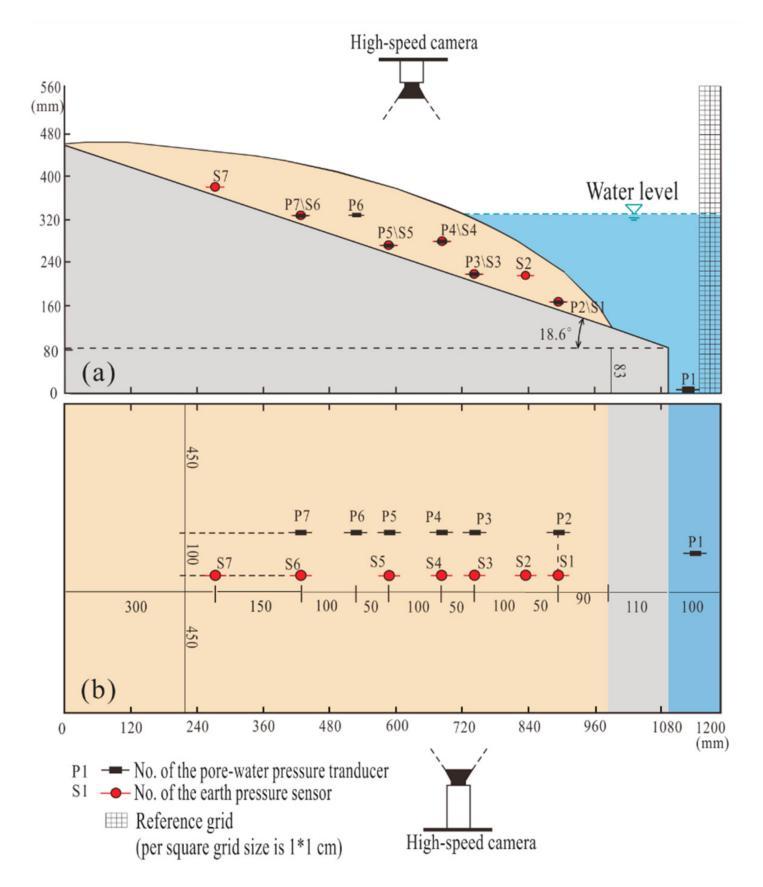
Figure 5. Schematic view of the model setup and location of the instrumentation: (**a**) front view and (**b**) top view.

The multiple monitoring systems composed of seven pore water pressure transducers (P), two high-speed digital cameras and seven earth pressure sensors (E) in this test. Ps and Es were embedded along two longitudinal sections, as shown in Figure 5. The Ps measure pore pressure up to 1 MPa with a resolution of 0.2 kPa. One of them was fixed at the bottom of the river to monitor the reservoir water level. The Es, with a measurement range of 0-1 MPa, were arranged to measure the earth pressure.

The Ps and Es all recorded data in real-time two times per second. A 5-megapixel camera was mounted on top of the model box to record videos; the other camera was installed on the side of transparent glass used to photograph the slope section during the test, and several marking points were placed in the slope section. The PIV technique, which has been commonly applied to compute the displacement or velocity in geotechnical engineering, was implemented to determine the displacement of the model through the free PIV software PIVlab [46].

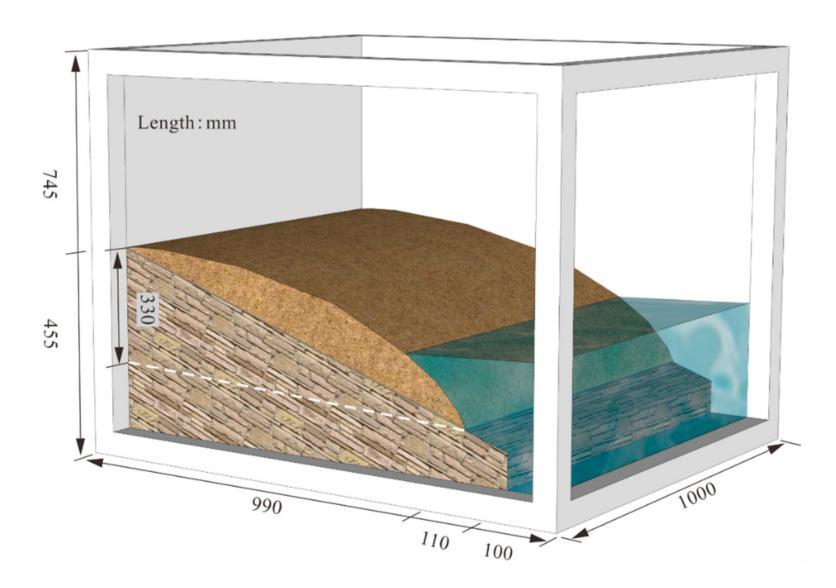
Figure 6. 3D illustration and the size of the centrifuge test model.

The large-scale centrifugal model was carried out on the largest model box in this laboratory. The size of the box is $1.2 \text{ m} \times 1.0 \text{ m} \times 1.2 \text{ m}$, the size of the landslide model is 99 cm (long) $\times 1 \text{ m}$ (wide) $\times 33$ cm (high), and the conceptualized model is shown in Figure 6. Because the sliding zone was too thin to conform to the similarity criteria to affect the deformation process, the sliding zones were not simulated.

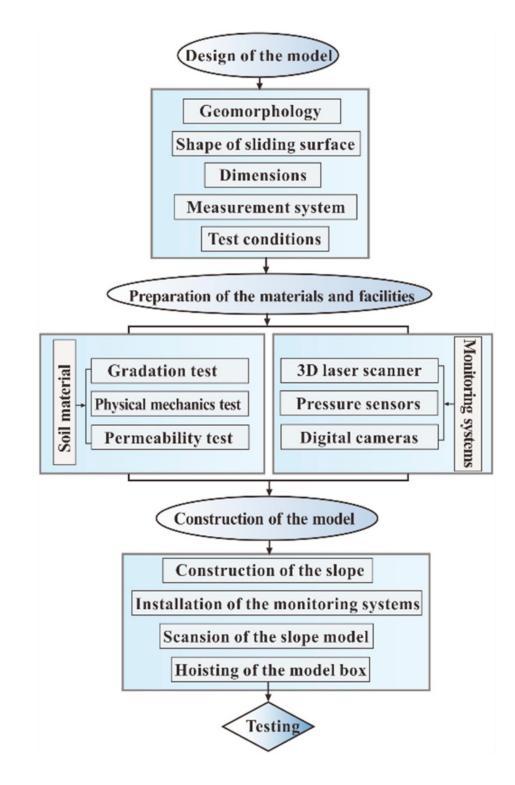
Figure 7. The schematic workflow diagram of the conducted experiments.

First, the quality of soil and water needed was calculated, and the soil sample and water were evenly mixed in agreement with the proportion to achieve the designed water content. Next, the model was constructed layer by layer according to the contours of the soil layers, which were drawn on the lateral walls of the model box. In addition, the lubricant oil was brushed on the lateral walls of the model box to reduce the frictional force at the boundary. Additionally, the marking points and transducers were placed at the designed positions when the soil layers reached the corresponding heights. Ultimately, the model was covered with a thin film and cured for 24 h. In summary, the schematic workflow of the conducted experiments is shown in Figure 7.

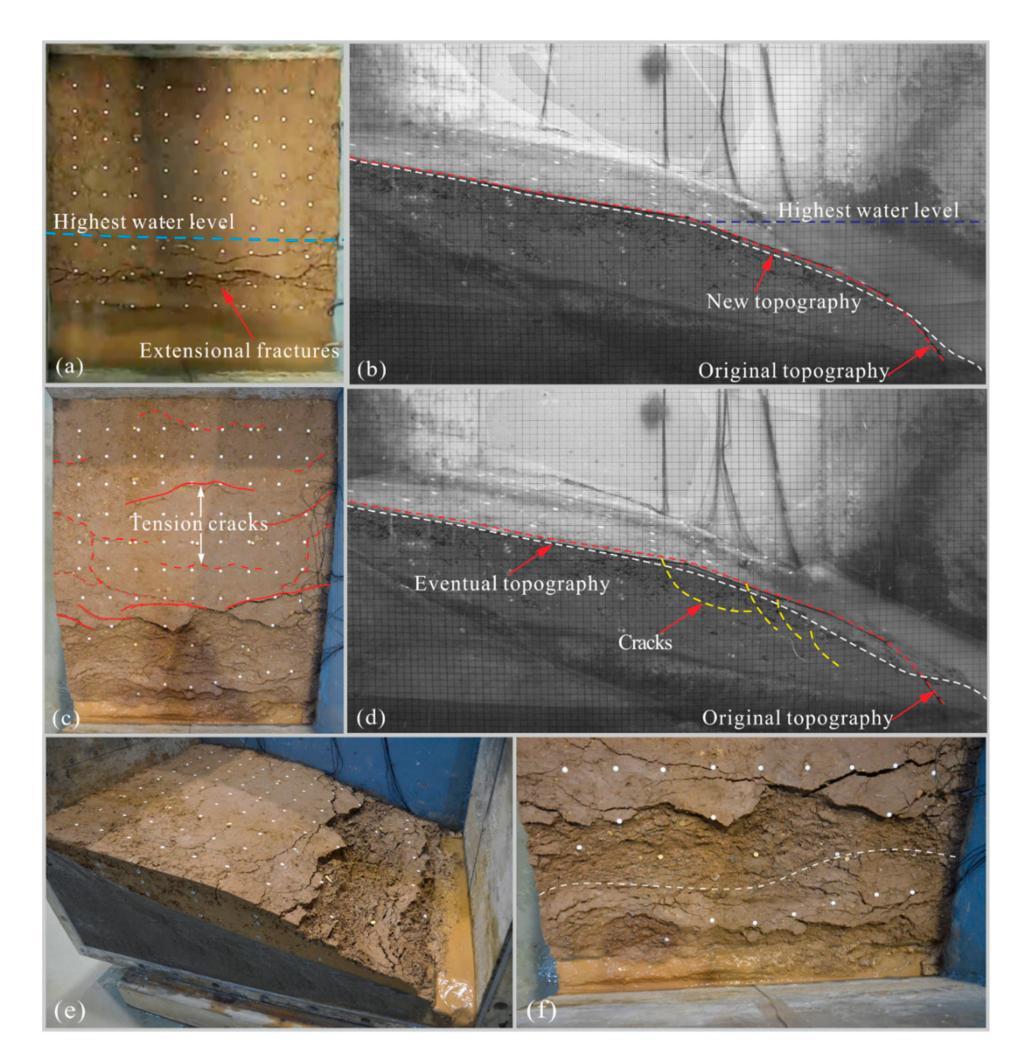
Figure 8. Deformation characteristics of landslides in different periods: (**a**) deformation characteristics of the slope surface after the first drawdown, (**b**) real-time image of the slope profile after the first drawdown, (**c**) deformation characteristics of the slope surface after the second drawdown, (**d**) real-time image of the slope profile after the second drawdown, (**e**) overall view of the slope eventually and (**f**) deformation characteristics of the slope toe.

Then, the water level began to fall for the first time. At 5250 secs, transverse tensile cracks (Figure 8a) occurred at the front of the model. With constant drawdown, the cracks expanded and penetrated rapidly, which led to the formation of a fracture zone with a width of approximately 20–30 mm (Figure 8c). At 5340 secs, the water level dropped to a low level with an elevation of 20 cm. In the meantime, the vertical deformation of consolidation and compaction were dominant at the middle and rear parts.

During the second impoundment process, there was no obvious deformation. The water level began to fall for the second time at 7200 secs after the water level had risen again to its highest level. As the drawdown continued, the frontal sliding body in the wading area continued to slide along the original fracture zone, showing partial collapse and sliding with a sliding depth of approximately 20–50 mm that was shallow on both sides, with a depth ranging from approximately 10–30 mm (Figure 8f). And, only the front submerged part of the landslide collapsed and fell into the river at the end of the test (Figure 8e). The whole sliding process lasted for approximately 13 minutes, while no obvious deformation behavior occurred at the middle-rear part of the slope. According to the deformation evolution characteristics of the landslide, the landslide type is a typical hydrodynamic pressure landslide. It presents obvious self-adjusting and self-stabilizing phenomena for the mid-rear parts of the landslide, and this phenomenon is very common in the actual bank slope.

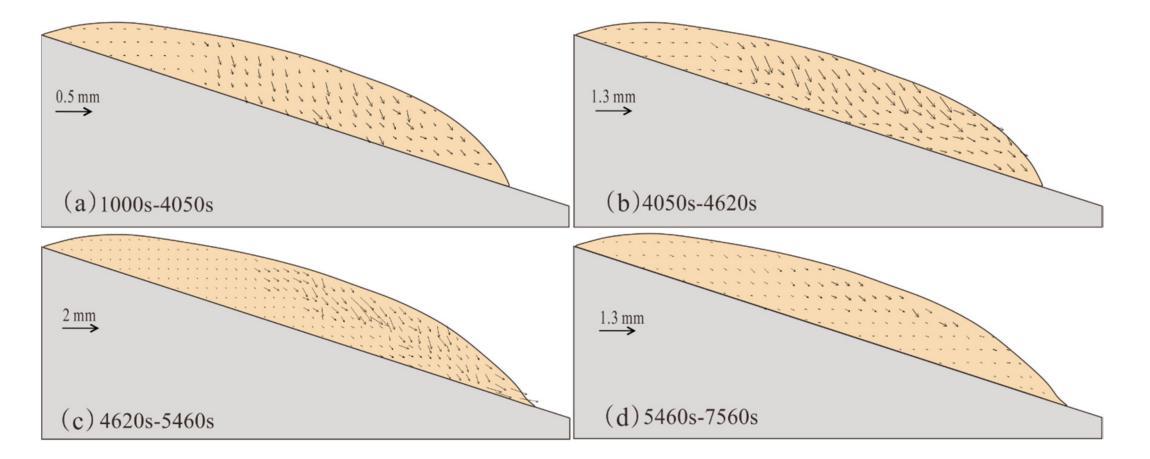
Figure 9. Landslide displacement vectors varying with time. (a) during the period of the first impoundment, (b) during the early period of the first drawdown, (c) during the later period of the first drawdown, (d) during the early period of the second impoundment.

The PIV technique based on image processing was utilized to acquire the displacement vector fields. The images of the slope section were obtained twice per second by the high-speed camera. The displacement vector fields of the slope section during different periods are shown in Figure 9. In the initial period of the experiment, a small vertical displacement in the middle part increased gradually with increasing centrifugal acceleration, which was the normal consolidation behavior of soil, and small horizontal displacement appeared.

The displacement vector field of the landslide in the early period of the first drawdown are shown in Figure 9b. It can be seen that the displacements of the mid-rear part included both vertical subsidence and horizontal deformation, and the vertical displacement predominates and is not caused by centrifugal acceleration compared to that of the first reservoir filling. The deformation of the frontal part was dominated by horizontal displacement. In the later period of the first drawdown, the deformation of the mid-rear part decreased gradually (Figure 9c). Consequently, the deformation process made the soil in the mid-rear slope more compact, which may lead to the self-stabilizing phenomena of these parts.

Small deformation of approximately 0.2-0.4 mm occurred in the middle of the landslide during the second reservoir filling (Figure 9d). During the second drawdown, the displacement rate in the frontal slope became faster, and failure eventually occurred along the original fracture surface. However, due to the consolidation and compaction of the mid-rear and the deep part of the slope, global failures could not occur.

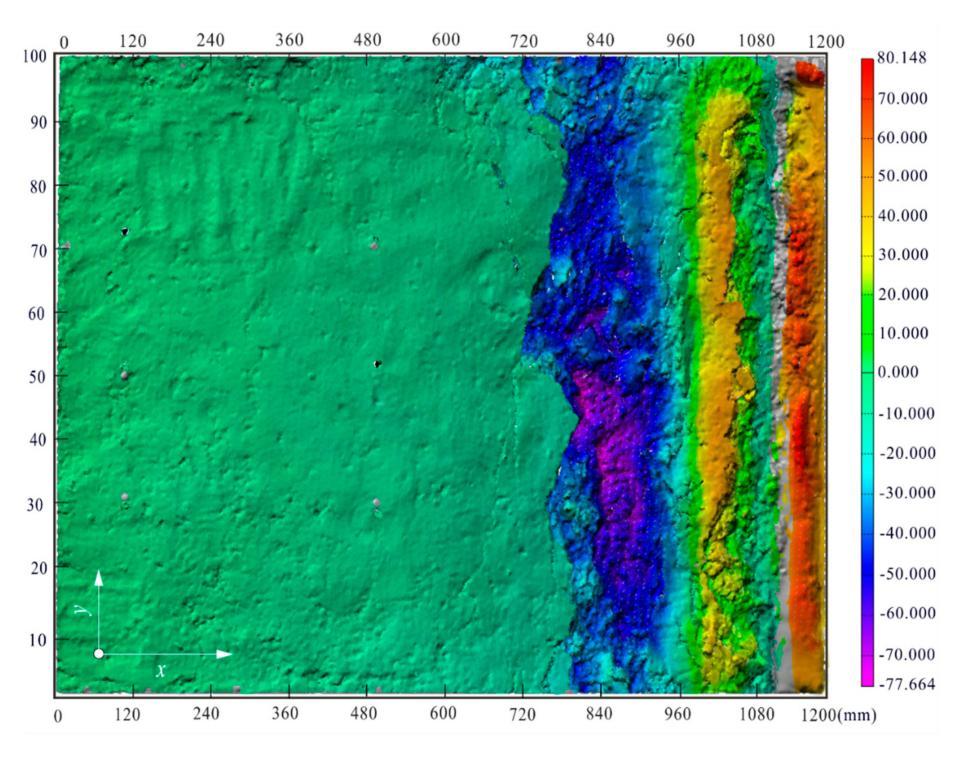
Figure 10. The variation in slope surface elevation is shown with color gradients.

To understand the vertical displacement of the whole slope surface, the geomorphological data of the slope between the ultimate failure and initial state before the test are processed and analyzed based on Polyworks 10.0 software. As shown in Figure 10, the vertical displacement of the middle part is approximately 8-12 mm and gradually decreases to the rear part. The displacement of the rear edge is the smallest, which is approximately 1-2 mm. The maximum sliding depth of the sliding zone in front of the landslide is approximately eight cm. It could be concluded that the middle part is the area with the largest vertical displacement.

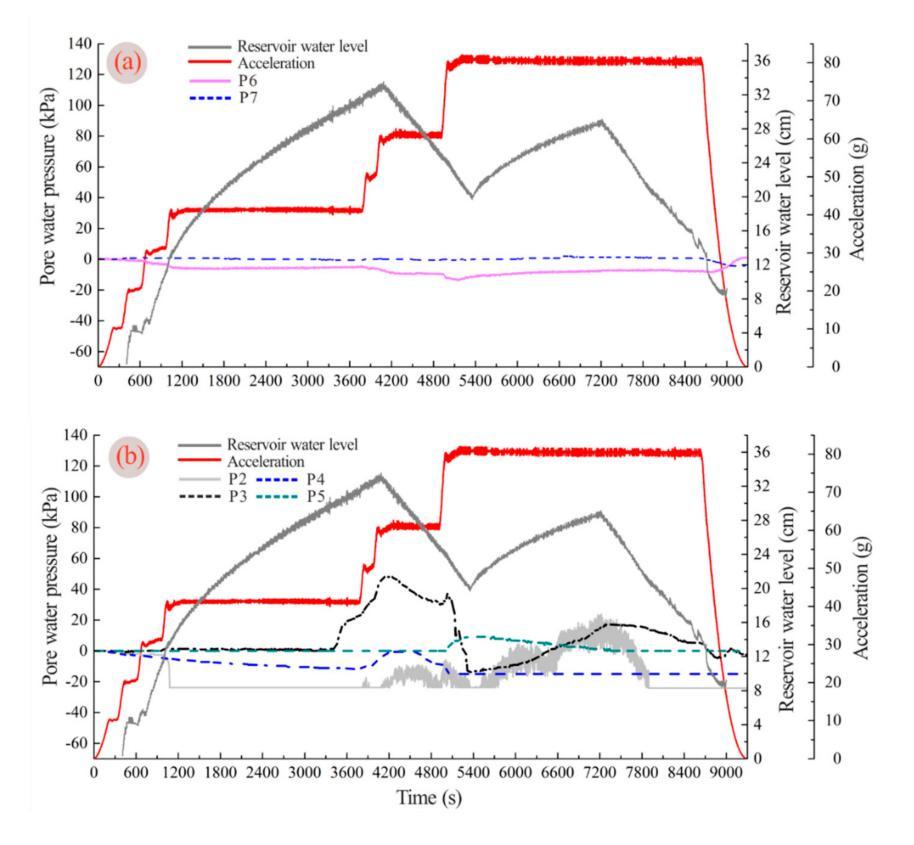
Figure 11. The time histories of the pore water pressure at each monitoring point. (**a**), the pore water pressure at P6 and P7 in the non-submerging area (**b**) and at P2-P5 in the submerged zone.

Because P6 and P7 were not submerged and were placed at the mid-rear part of the landslide, their values were stable, as shown in Figure 11a. The pressure of P6 slightly decreased to a negative value in the shallow layer of the sliding body. The pore water pressures at P3 and P4, which were located at the middle part, increased rapidly after approximately 3500 secs and 3800 secs, respectively, reflecting the consecutive arrival of the reservoir water at the middle part. The maximum water level is only 1 cm higher than the position of P4. Therefore, the pore pressure had no obvious change during the second fluctuation of the water level. However, the pore pressure at P5 increased gradually at approximately 5020 secs when the water level was 27 cm lower than its position and lagged behind P4 for approximately 20 minutes. Continuing infiltration of the water should occur as the water level increased; hence, the increment was also small.

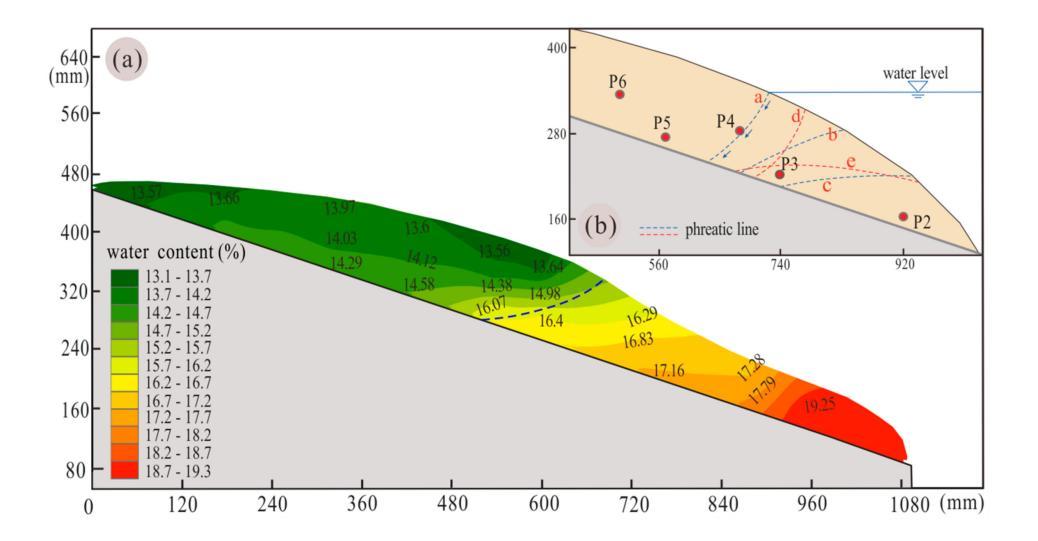
Figure 12. (a) Distribution of the water contents of the landslide and (b) the phreatic line of the model slope at different times; dashed line a denotes the first impoundment period, lines b and c indicate the first drawdown period, and dashed lines d and e denote the second period of impoundment and drawdown, respectively.

To further interpret the infiltration characteristics and phreatic line, the water pressure values and corresponding water head of each transducer at the same time were extracted [37], as shown in Table 4. After that, the phreatic line could be drawn as shown in Figure 12b at different periods during the test. The water contents of 24 soil samples, which were acquired from a longitudinal section of the landslide within half an hour after the experiment, were measured, and the water content of the whole section was obtained through interpolation of the data. As a consequence, the water content distribution of the landslide after the test is shown in Figure 12a.

Dashed lines *a* and *d* are the phreatic lines for the first and second water impoundments, respectively. The phreatic line has a concave shape directed toward the interior of the slope. Simultaneously, the phreatic line indicated that the reservoir water infiltration included vertical and horizontal directions, and the vertical direction was the main direction. Dashed lines *b*, *c*, and *e* are the phreatic lines during water level drawdown, and they are all convex shapes pointing out of the slope. As the water level decreased, the angle between the phreatic line and the horizontal line gradually decreased and rotated to below horizontal, i.e., below horizontal, from concave to convex. The phreatic lines at the drainage stage are similar to the contour of water content measured after the test; thus, the results could be verified by each other.

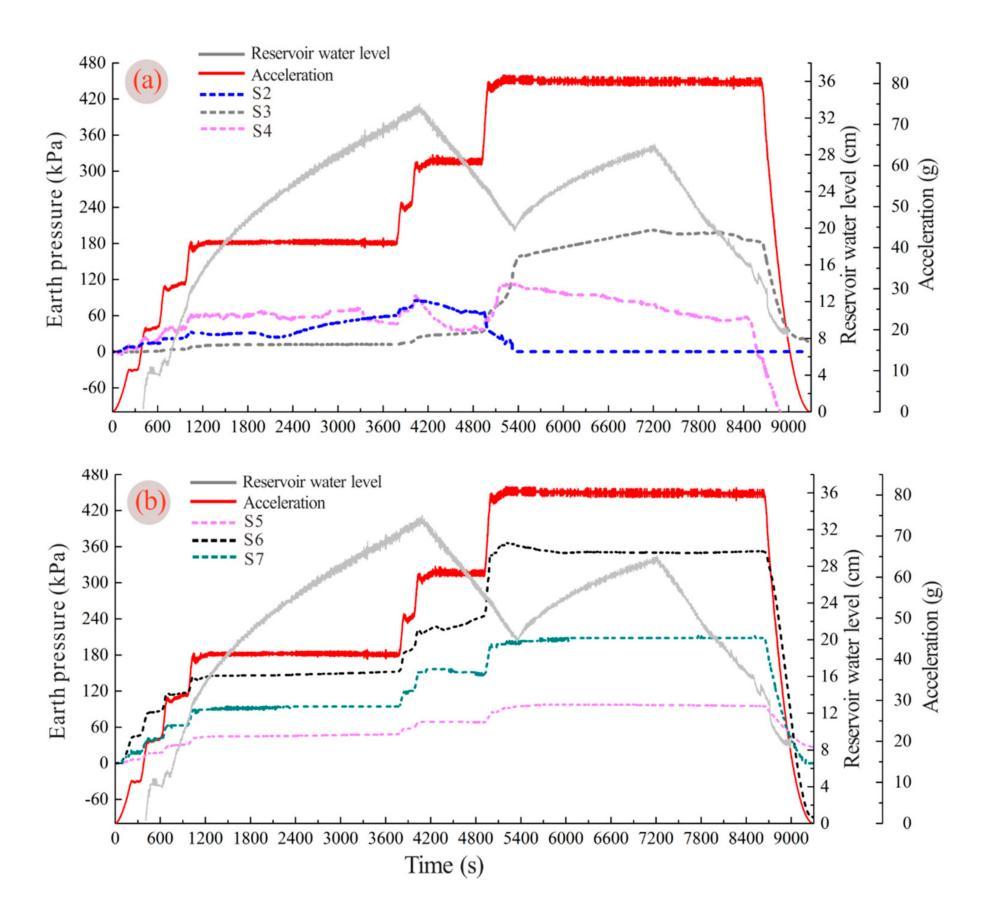
Figure 13. Measured earth pressure varying with time. (**a**) the earth pressure at S2-S4 in the submerged zone (**b**) and at S5-S7 in the non-submerging area.

The variations in earth pressure at S5, S6, and S7 in the non-submerging area during the test are shown in Figure 13a. Their variation trends are roughly the same, and the measured values are affected by the acceleration. This result is mainly observed because the three sensors are buried in the deep areas of the mid-rear part, where the deformation was slight and had little impact on earth pressure. Only S6 had a slow increase of approximately 50 kPa, while S7 gradually decreased by 25 kPa during the period from 4400 secs to 4900 secs. This is due to the creep deformation that occurred in this area, and the stress gradually released downward.

The earth pressure in the front part of the slope was obviously affected by the hydrostatic pressure inclined intra-slope at the beginning of the test. For example, the earth pressure at S2 gradually increased to approximately 80 kPa from 2000 secs to 4000 secs, following the water level increase from 22 cm to 28 cm (Figure 13b). As the water level began to drop at 4050 secs, the earth pressures at S2 and S3 decreased gradually. At 5000 secs, the earth pressure at S2 rapidly decreased by approximately 40 kPa in one minute; subsequently, tensile cracks appeared at the slope surface above the S2 sensors at 5250 secs. With the slope deformed continuously, the earth pressure at S2 rapidly decreased to zero, and its transmission line was pulled off and no longer worked. However, the earth pressures at S3 and S4 increased gradually, which indicated that the slope had the deformation characteristics of downward creep.

During the second water level rise, the earth pressure at S3 increased slowly, while that at S4 decreased continuously, which indicated that there was a process of tiny creep deformation and stress migration. When the water level dropped again, the earth pressures at S3 and S4 both began to decrease, which led to the continuous expansion and deepening of the cracks on the slope surface above S4 and local instability of the soil above S3.

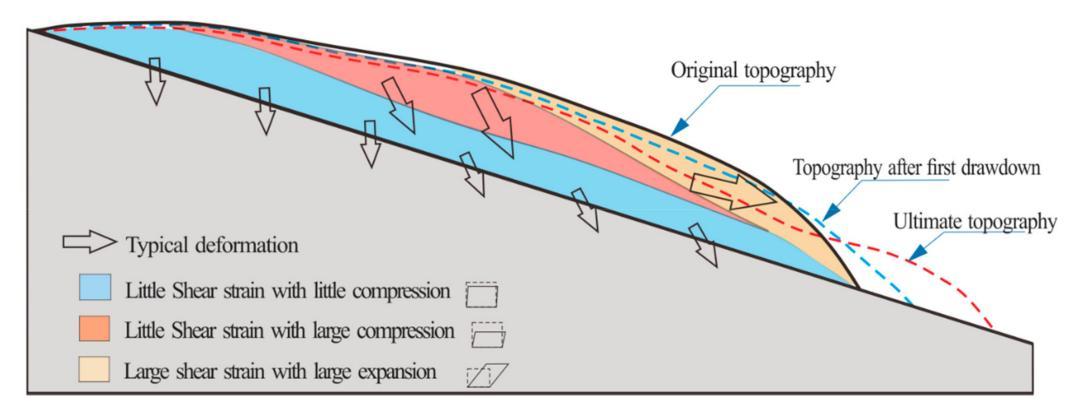
Figure 14. Deformation mode of the landslide subjected to reservoir water level drawdown.

The compression deformation dominates in the middle part of the slope, which is the strong compaction area. While the deformation in the rear is small, the weak compaction zone is predominant. Furthermore, the compaction deformation decreases with increasing depth. The deformation mode and zones of the deformation characteristic are shown in Figure 14.

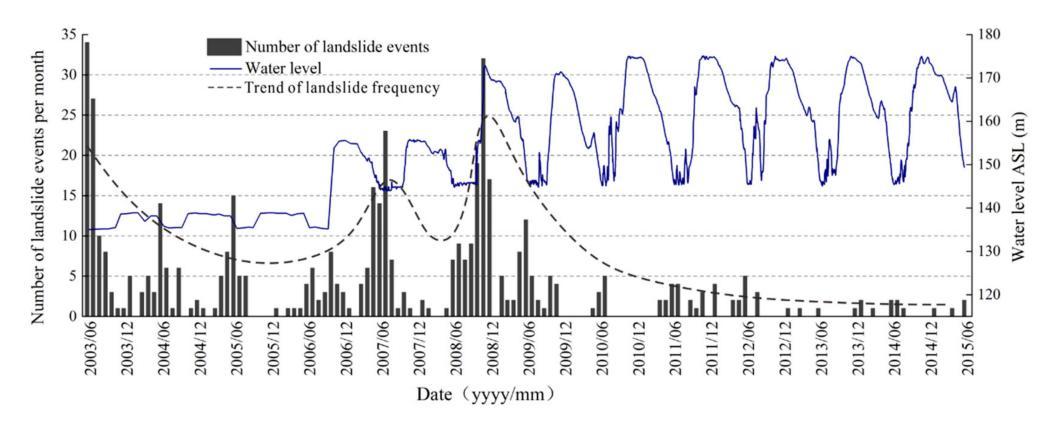
Figure 15. The correlation between the fluctuation in water level and the frequency of reactivated landslides.

From a worldwide perspective, most reservoir-induced landslides show an evolutionary characteristic of severe deformation at initialization and later stability [47–50]. The correlation between the fluctuation of the water level and the frequency of reactivated landslides is shown in Figure 15.

This result indicated that abundant landslides reactivated during the period of initial impoundment. For instance, in the first three years of the trial impoundment phase, the frequency of landslides reached its peak. However, as the landslides periodically underwent the disturbances of water level fluctuations, the frequency of reactivated landslides exhibited a decreasing trend, and it decreased dramatically after 2009, i.e., one year after experiencing the highest water level. Many scholars also believed that the reactive landslides are concentrated in the initial stage of water storage, and the frequency of activation as well as the degree of deformation decrease gradually after the last phase of water storage [51,52]. The experimental results in this study also show that the front of the slope slid along the original rupture zone during the second drawdown, but the mid-rear parts had no obvious deformation, which is different from the creep deformation induced by the traction of the front part during the first drawdown; further, its stability was improved after the first deformation.

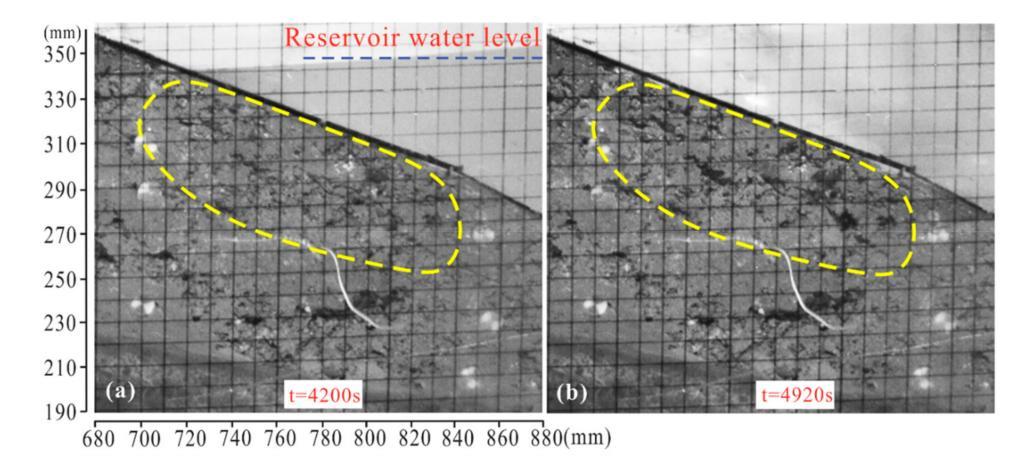
Figure 16. Erosion effect through seepage caused by the reservoir water level drawdown. (**a**), the primary structure of soil in the slope. (**b**), some micro holes are formed after the first drawdown.

The process of seepage erosion and the destruction of the structure of the soil skeleton can be seen from the high-definition images (Figure 16). The soil of the slope was softened and collapsed after being saturated, forming some micro holes. In addition, the soil around the primary pore continuously collapsed, and the pore gradually enlarged and underwent the action of water erosion. Moreover, the fine particles or collapsed materials were carried away by groundwater seepage. The series of processes leads to the continuous development and expansion of holes in some areas of the slope and ultimately leads to damage to the internal structure of the slope. This phenomenon can also be found in the prototypes according to previous studies [19,53]. Some researchers have proved that most fine particles in the pore structure are rushed out under the seepage force action and the seepage channels gradually develop and become interconnected in the seepage process by permeability test [54,55].

It can be seen that the landslide moves or slides along these holes or fissures, which were developed or produced by seepage erosion. The fissures and holes gradually disappeared again after the sliding process, resulting in soil compaction and consolidation again. Therefore, the damaging effect of the seepage erosion of groundwater on the slope structure is also an important factor causing landslide deformation. However, the effect is significantly weakened in the later period.

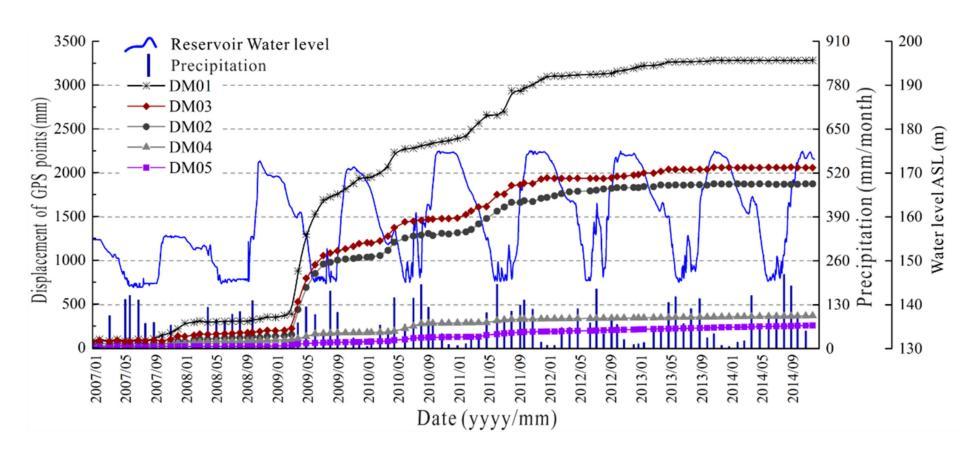
Figure 17. Monitoring curves of accumulative displacement of the Damian landslide.

For instance, the displacement of the Damian landslide decreases gradually from the front (DM01) to the middle (DM03, DM02), while the rear (DM04, DM05) has the smallest deformation, as shown in Figure 17. The overall deformation is characterized by progressive retrogression. After the first 175 m impoundment, the landslide deformed severely from April to July in 2009, and thereafter, the displacement decreased gradually in the same period of 2010 and 2011 and reached basic stability with rare deformation eventually after 2012. The deformation and failure mode similar to this kind of landslide has also been studied by many researchers in the TGRA [56,57].
