Article **Experimental Study on Damage Evolution Characteristics of** Concrete under Impact Load Based on EMI Method

Abstract: In this paper, the damage evolution characteristics of C50 concrete under impact load were studied, based on the electro-mechanical impedance (EMI) technique. A parallel test was conducted based on the internal relationship between EMI technology and a resonant frequency test to verify the sensitivity and accuracy of EMI technology. In addition, another mechanical test was conducted on specimens with different levels of damage to establish the empirical relationship between the degree of damage and the mechanical properties of concrete. The degrees of damage were discussed by calculating the root mean square deviation (RMSD) index. Results illustrated that the damage changes of concrete can be well monitored by PZT patches. Based on the evolutionary characteristic of the RMSD index, worrying information can be obtained before the destruction of the concrete. On the other hand, mechanical test results indicated that the value of the RMSD was correlated with the splitting tensile strength of the concrete specimens; therefore, it can be used as a reference to

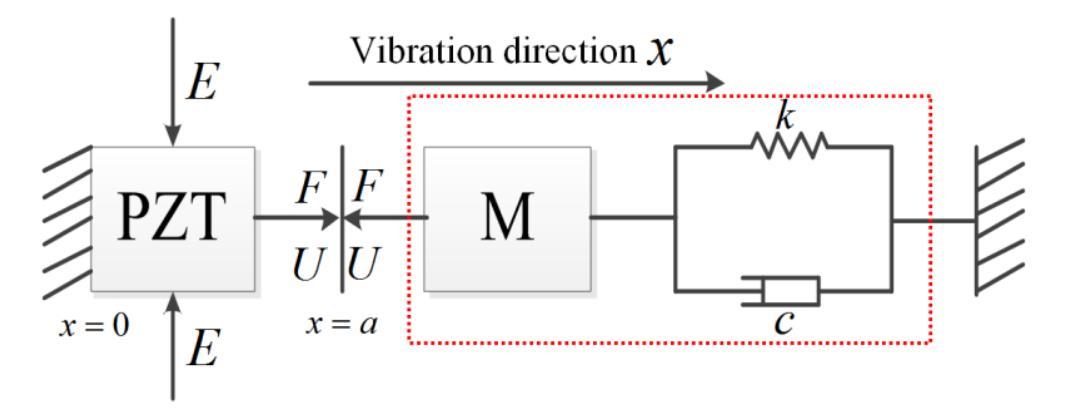
Figure 1. One-dimensional vibration theory model for PZT.

According to the classical electromechanical one-dimensional coupling model (Figure 1) introduced by Liang et al. and Su et al. [24,25], a spring-mass-damping system (which considers one degree of freedom) was used to describe the dynamic response of PZT sheets attached to the surface of the structure in an electronic field.

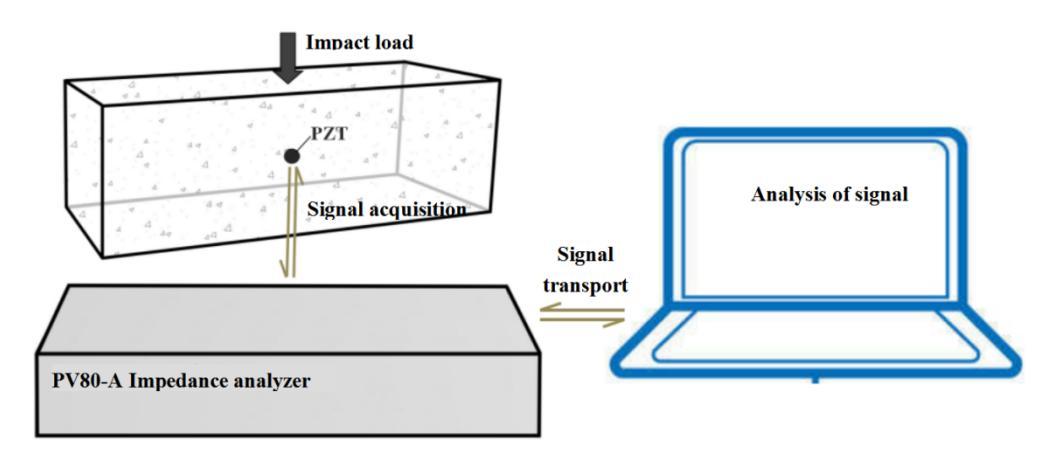
Figure 2. Flow chart of the EMI test.

Figure 2 shows the test procedure of the EMI method. In the test, shown in Table 4, impact loads with different energies were obtained by changing the drop height. During the tests, the specimens are placed horizontally and freely on a rubber plate with a thickness of 10 mm.

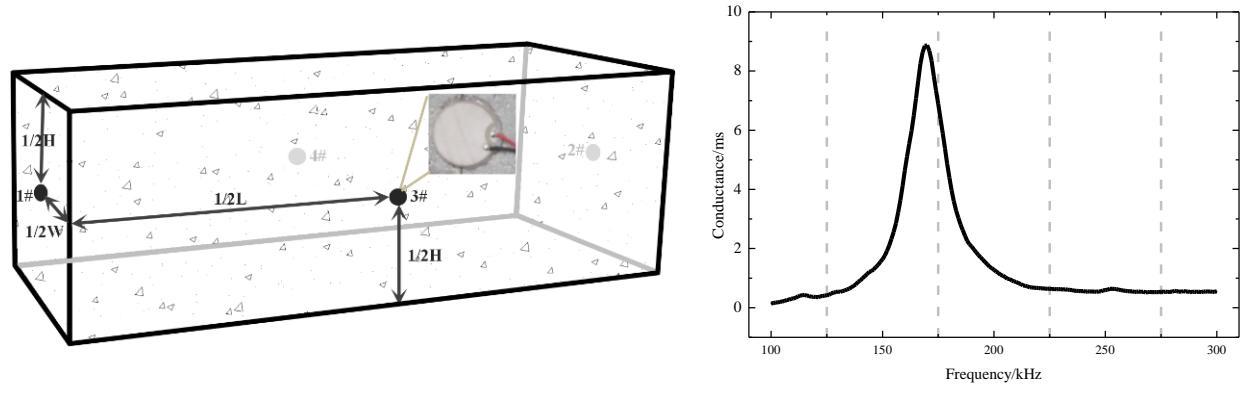
Figure 3. Basic information about the PZT patches.

ameter of 15 mm and a thickness of 0.5 mm. Through additional work by the manufacturer, the two electrodes of the PZT-5 patches were on the same side, so that it could be pasted closely to the concrete surface, as shown in Figure 3.

The patches of the PZT-5 were attached symmetrically, on both ends (Patches 1# and 2# are shown in Figure 3a) and in the middle of the specimen (Patches 3# and 4# are shown in Figure 3a), as shown in Figure 3. Therefore, four sets of test data could be obtained from the two prepared specimens for each experimental condition. Thus, information about the damage state of the concrete specimens could be perceived comprehensively through the electrical admittance signal from different locations. This provides basic data for further analysis. The adhesive between the PZT patches and the specimens was AB glue.

A PV80-A impedance analyzer, with sweep frequency ranging from 1 kHZ to 1 MHZ, was used to collect the piezoelectric signal. It was validated that the PZT patches become sensitive to their own conditions, rather than the conditions of the structure they are bonded to, when excitation frequency is higher than 500 kHz, which is much higher than the first resonant frequency [26–28]. Also, frequencies 100 kHz and 300 kHz were proven to be reasonable ranges to study the damage state of the concrete, according to research work conducted by Liu and Prteek Negi [11,18]. Thus, the excitation frequency during the experiment ranged from 100 kHz to 300 kHz, and the number of sampling points was 200. The conductance curve for the free PZTs is shown in Figure 3b.

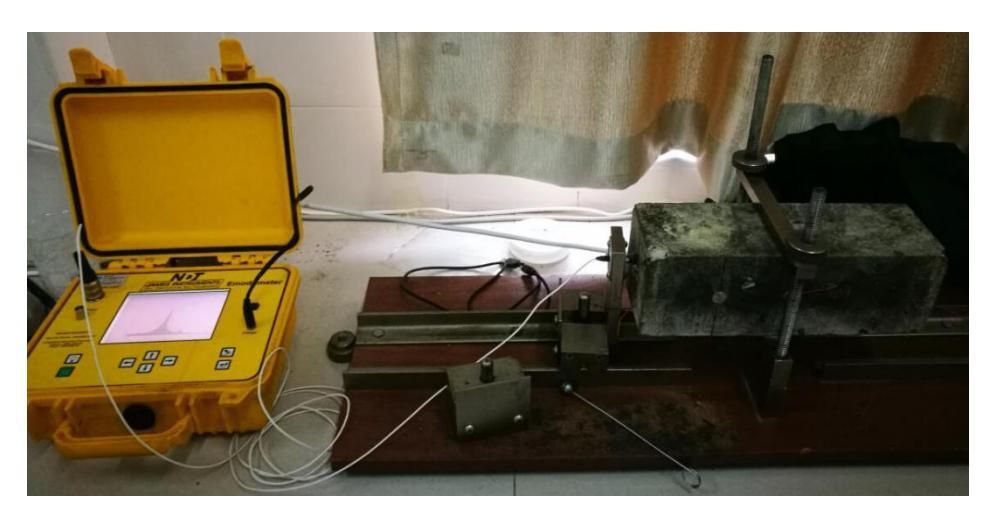
Figure 4. E-Meter MK II resonance frequency tester.

An E-Meter MK II resonance frequency tester, with an accelerometer sensitivity of 9.60 mV/g, was adopted to capture the vibration response characteristics of the concrete specimen (Figure 4). The vibrating accelerations in the time domain can be recorded directly using the E-Meter MK II resonance frequency tester. Then, the vibration accelerations in the time domain can be transformed into the frequency domain by Fourier analysis. Therefore, acceleration resonance frequency can be easily obtained, which is the frequency with maximum amplitude. On the basis of the operator's manual [24], the acceleration resonance frequency was automatically converted into dynamic elastic modulus by:

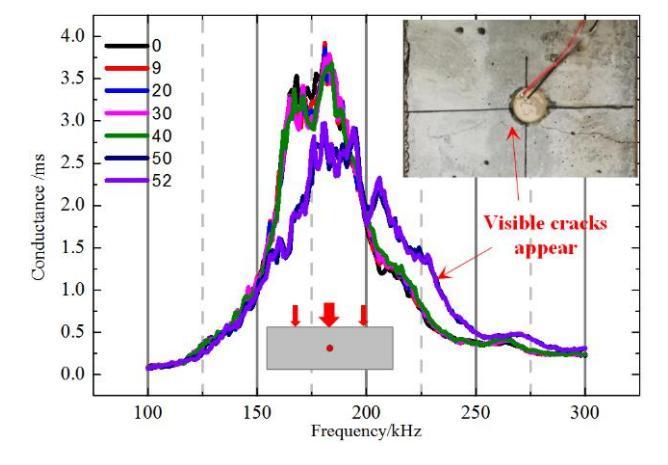
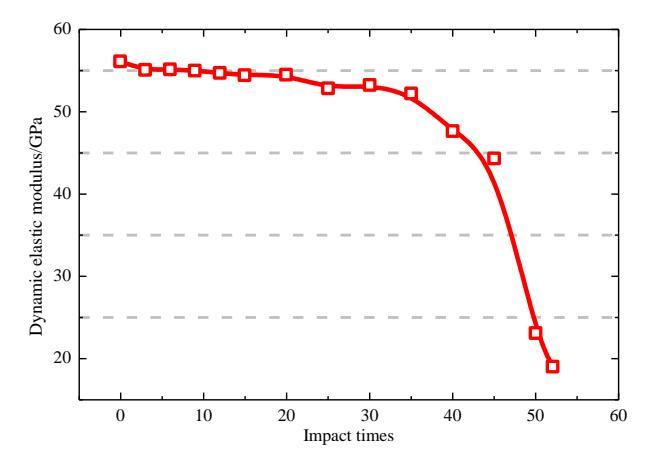
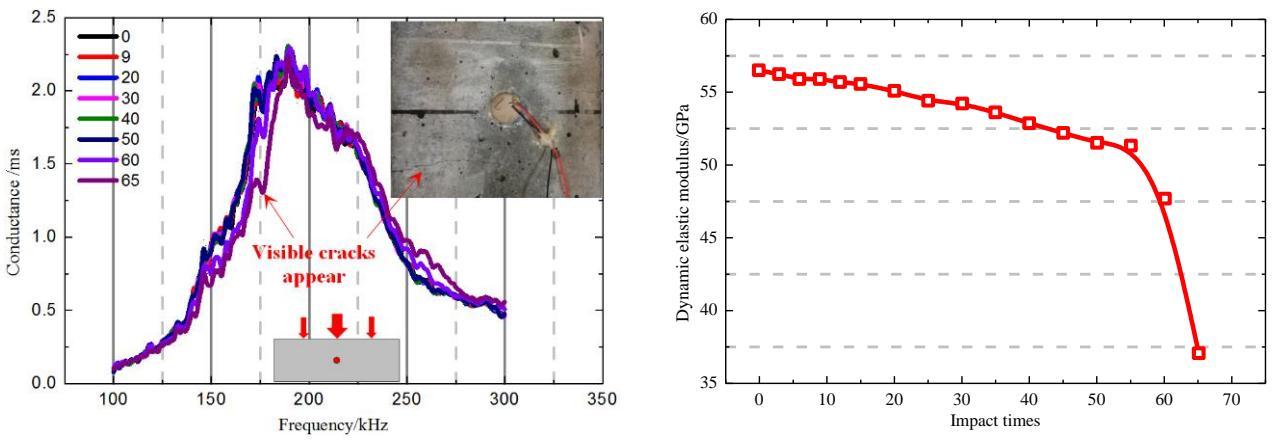
(b) Changes in dynamic elastic modulus of specimen I

(c) Changes in conductance signal of specimen II

(d) Changes in dynamic elastic modulus of specimen II

Figure 5 shows experimental results of the EMI method and the resonant frequency test of group-A. On the basis of the evolution characteristics of the piezoelectric signal and dynamic elastic modulus, it shows that the damage caused by the impact on the concrete specimens increased gradually during the early stage of the impact experiment. It is inferred that the inner micro-cracks accumulated and developed in this period. In the end, visible cracks suddenly appeared when the damage accumulated to a certain degree. Simultaneously, the piezoelectric signal changed abruptly, along with a sharp deduction of the peak values of signal, as shown in Figure 5a. In addition, the mechanical properties of the specimens decayed dramatically in this period, which is consistent to the conclusion of the previous study [11].

As shown in Figure 5, the attenuation law of the dynamic elasticity modulus was highly consistent with the change in piezoelectric signals, which confirmed that the EMI method was effective in capturing the development process of the specimen's damage.

However, it was noticed that the peak values of the conductance signal did not drop sharply, as shown in Figure 5c. Comparing the crack positions of specimens I and II, there was a relatively long distance between them and the PZT-5 patches, as shown in Figure 5c. In addition, the cracks of specimen II did not penetrate through the specimen, as they did in specimen I. These are the main reasons for the limited changes in conductance signal of specimen II. In addition, the anisotropy and heterogeneity of the concrete contributed to the diversities of the conductance test results, to some extent.

According to the experimental results of Group A (Figure 5), the development process of damage caused by impact can be generally divided into three stages. In the early stage of damage evolution, internal micro-cracks emerge rapidly as the impact load continues. The internal structure of the specimens, such as porosity, was reconstructed in this period, which lead to the obvious change in piezoelectric signals. With the development of internal cracks, flexibility of the specimen gradually increased, as did buffering capacity. Thus, damage of the specimen grew slowly and stably. However, the damage still accumulated gradually, and micro-cracks continued to develop and connect to each other. Finally, visible cracks appeared suddenly, and the value of the piezoelectric signals dropped sharply; therefore, it can be stated that the evolution of the damage caused by impact showed significant nonlinearity.

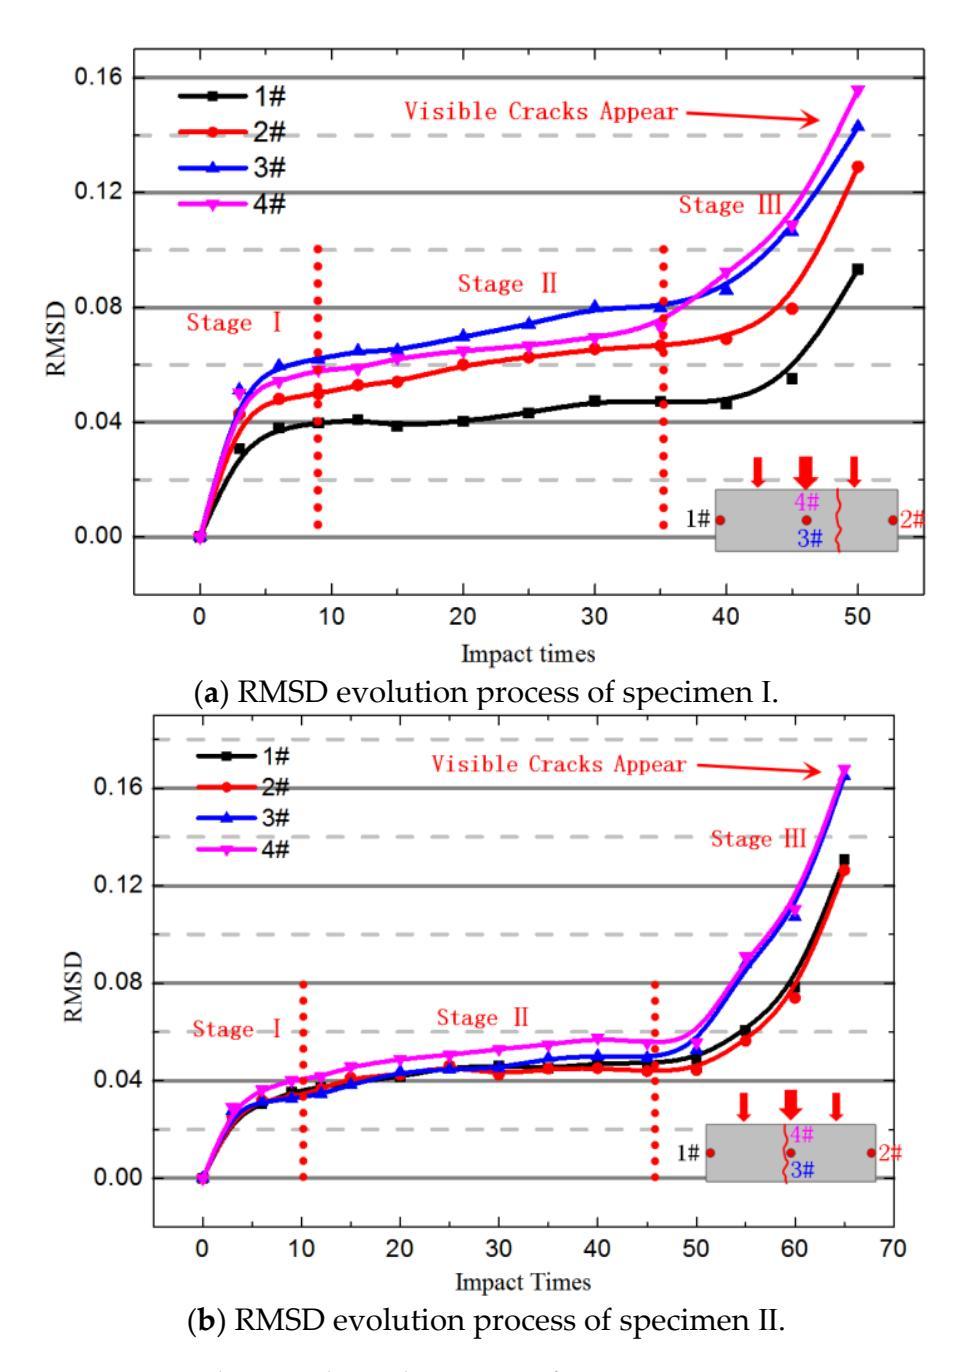
Figure 6. RMSD damage value evolution curve of Group A.

Figure 6 illustrates that the amplitude of the 3# and 4# piezoelectric signals were obviously higher than those of the 1# and 2# piezoelectric signals. The degree of damage in the middle of the specimen was higher than that at the end of specimen because of the way the damage had been fabricated. Results verified that the change in piezoelectric signals were not only related to the degree of damage, but also to the distance between the pasting position and the damaged area; the shorter the distance, the more sensitive the signal was, which indicated the validity of the experimental results.

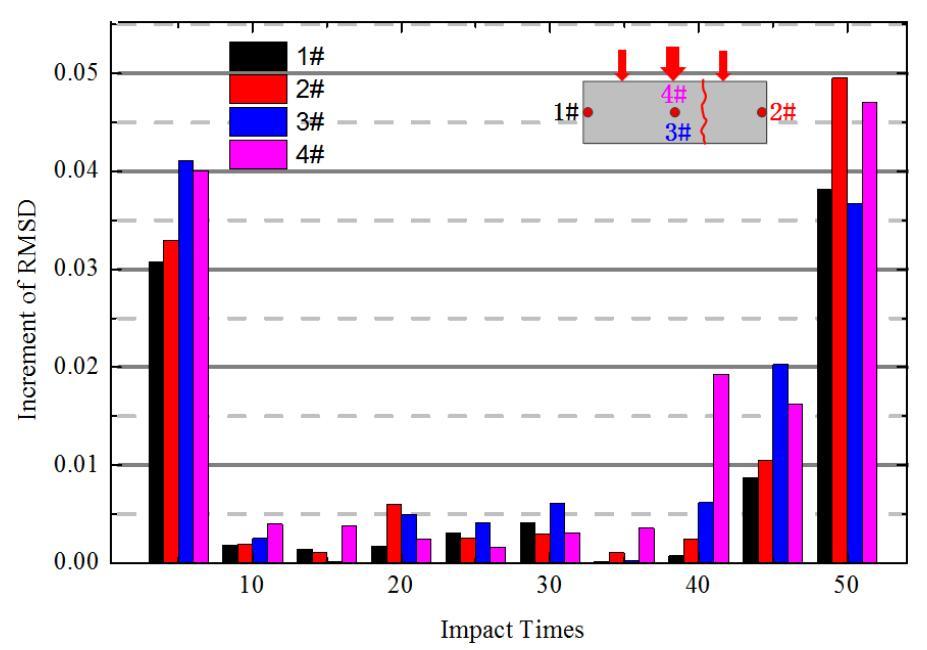
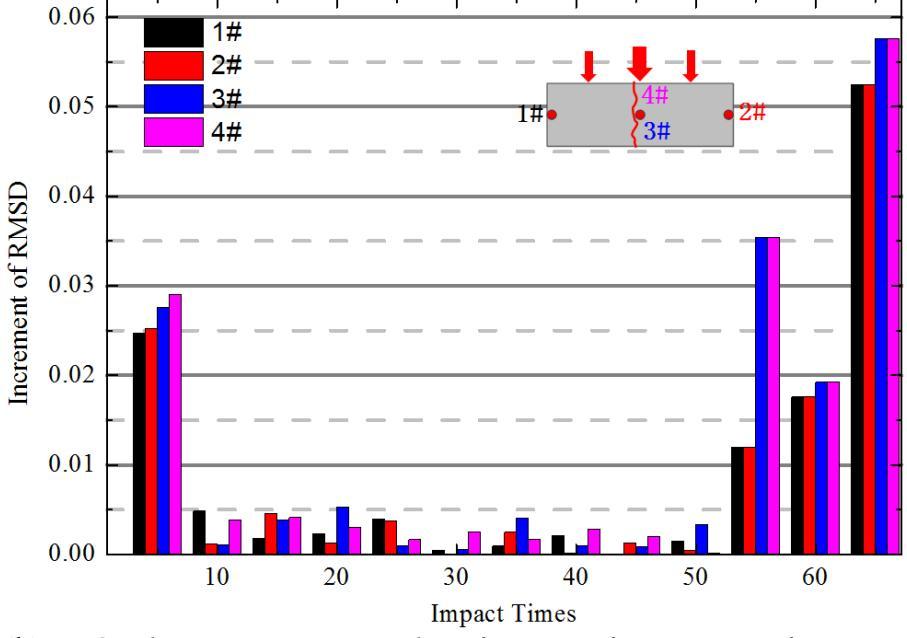
(a) RMSD damage increment value after every five impacts of specimen I.

(b) RMSD damage increment value after every five impacts of specimen II.

Figure 7. RMSD damage increment value distribution of Group A.

Figure 7 shows the increment values of the RMSD after every five impacts on specimens in group A.

In the early stage of damage emergence, damage of the specimens increased greatly due to the transition from non-damaged state to damaged state. In the middle of the damage accumulation stage, the RMSD increment of the specimens were relatively small. In the final stage of failure, visible cracks were about to appear and the increment of the piezoelectric signals significantly improved, compared with the second stage, which can be used as an alarm signal before specimen failure. When visible cracks appeared, the increment value of the damage reached its maximum value. The concrete specimen had basically lost its function, and it was on the verge of brittle fracture. Thus, this can be used as a sign of failure.

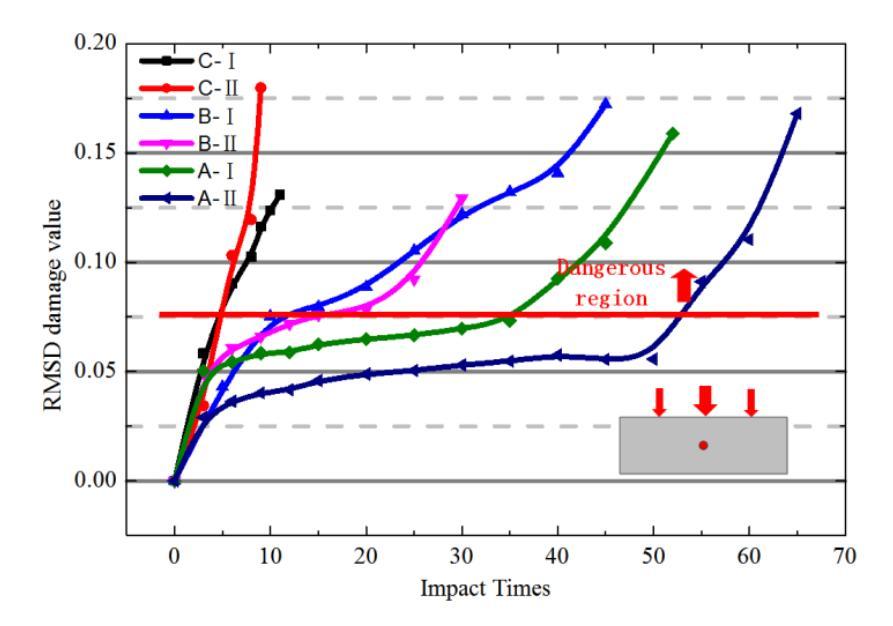
Figure 8. Development trend of concrete RMSD damage values, under different impact loads.

Figure 8 shows the evolution process of the damage value of the RMSD for different impact energies, against impact times. As can be seen in Figure 8, damage increment at the early stage increased with the rise of impact energy. The second stage of damage accumulation was observably shortened.

In particular, as shown by Group C in Figure 8, the damage value of the RMSD increased rapidly, until the concrete specimen broke. The stage of damage accumulation barely existed during the condition of high impact energy, and the number of impact times that specimens could bear dropped dramatically, as impact energy increased (Figure 9). In conclusion, as a quasi-brittle material, concrete is extremely sensitive to impact energy, and its structure may be vulnerable when the impact load exceeds a critical threshold.

Comparing the data in Figures 8 and 10, the evolution characteristics and the turning point of the damage value defined by the RMSD value were consistent with that defined by the dynamic modulus. Hence, it can be stated that the EMI test results, and the dynamic elasticity modulus test results, were different expressions of the same damage state of the concrete specimens. It also proved that the change in piezoelectric signals derive from the change of structural resonant frequency, which can be accurately reflected in the damage state of concrete material. Although noting that there is a thin layer between the patches and concrete formed by the binder, previous researchers have validated that the influence of this small layer is negligible.

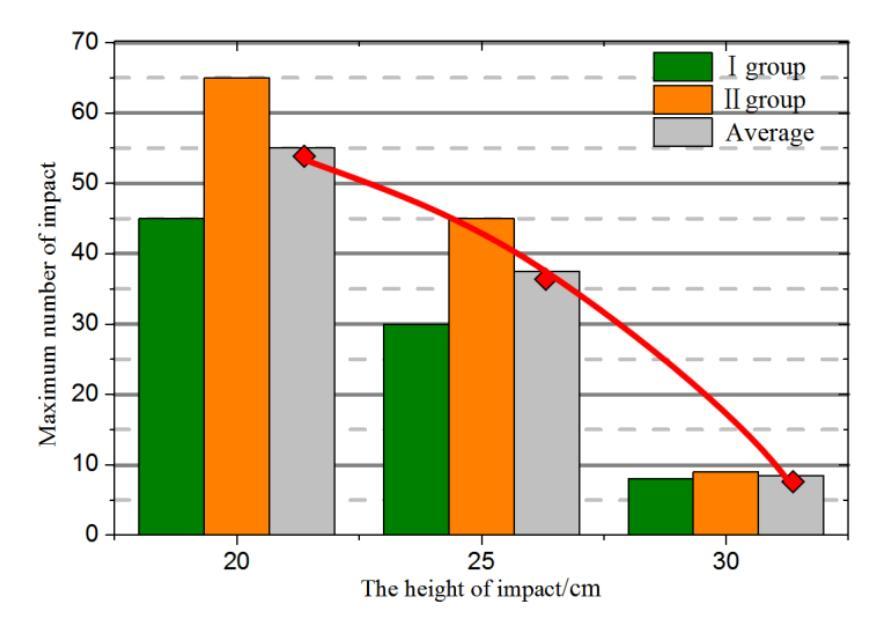
Figure 9. Schematic diagram of ultimate impact times of concrete, under different impact heights.

On the basis of the damage evolution characteristics of group A, B, and C, the degree of damage of the concrete specimens developed rapidly when the RMSD value of the specimen exceeded 0.075. The mechanical performance of the concrete specimens was highly likely to deteriorate in the interim. Hence, the RMSD index can be used to define the range of danger in the concrete structure. Experimental results indicate that the RMSD index can be used to effectively define the damage status of plane concrete.

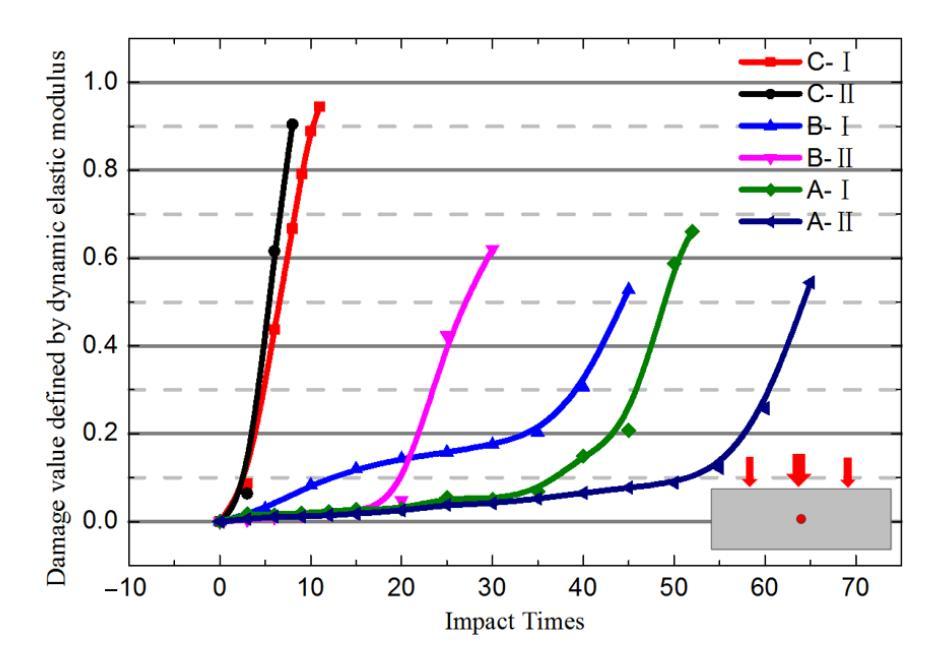
Figure 10. Development trend of damage value under different impact loads.

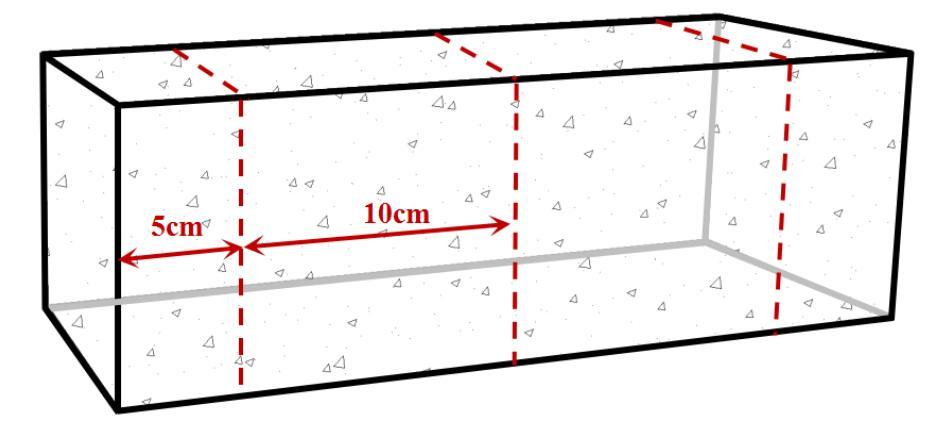
Figure 11. Schematic diagram of typical section location.

According to test results, affected by the degree of damage fabrication, the split tensile strength of one certain section of almost all the specimens was close to that of the concrete specimen with no damage. Because of the inability to show the difference in damage, these data were eliminated from this paper. Two relatively smaller values, of split tensile strength and their mean value, were chosen as the characterization of the tensile strength. The experimental data is shown in Figure 12.

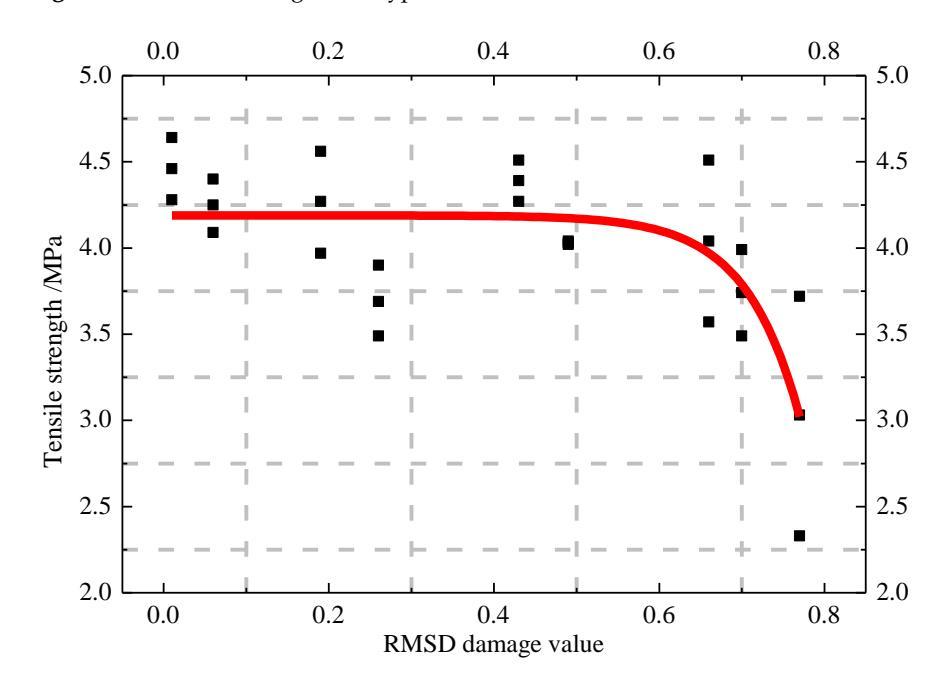
Figure 12. Correlation between split tensile strength and the RMSD damage value.

The fitting function in Figure 12 is:

$$f = -2.924E^{-5} \times \exp(-\frac{\text{RMSD}}{0.00688}) + 4.237$$
(11)

The fitting curve is marked red in Figure 12. It is indicated that the split tensile strength of the concrete specimen exponentially attenuated as the RMSD value increased. Similar to the damage evolution characteristics observed in previous research, the split tensile strength of concrete reduced slowly in the stage of damage initiation and accumulation. In the interim, there was no significant change in mechanical properties of the concrete specimen. When the damage gradually accumulated and exceeded a certain threshold (RMSD \geq 0.075), the concrete split tensile strength may enter the rapid decay stage. At this stage, even slight development of the RMSD damage value may also cause the concrete split tensile strength to reduce significantly, triggering brittle fracture of the specimens. The RMSD damage value has a certain correlation with the split tensile strength of the concrete specimen. Once quantitative relations between the damage state and mechanical strength are established, the proposed procedure be used to predict the mechanical properties of the concrete specimen, without disturbance and destruction.
