# Implementing the Technologies of Additional Impermeable Layers in a Building of the Monuments Office (Káčerov Majer) from a Sustainability Point of View

Abstract: This article presents the results of an experiment that involved applying additional impermeable layers on an historical building in the area of Káčerov Majer. The building showed a high level of waterlogging, which was detected by an initial inspection and subsequent moisture measurements that involved taking a set of measurements and recording the data in a spreadsheet linked to the plan view of the building. Then, a suitable method was devised to prevent rising damp and to assist in drying out the building. Several measurements after the application of remediation interventions were used for this purpose. The interventions, together with a comprehensive restoration, were intended to contribute to the reuse of the building, and thus its sustainability from technical, environmental, functional, and economic points of view. The aim of this research was to demonstrate the degree of effectiveness of undercutting technology in combination with local application of stainless-steel sheet piling and grouting technology, as o

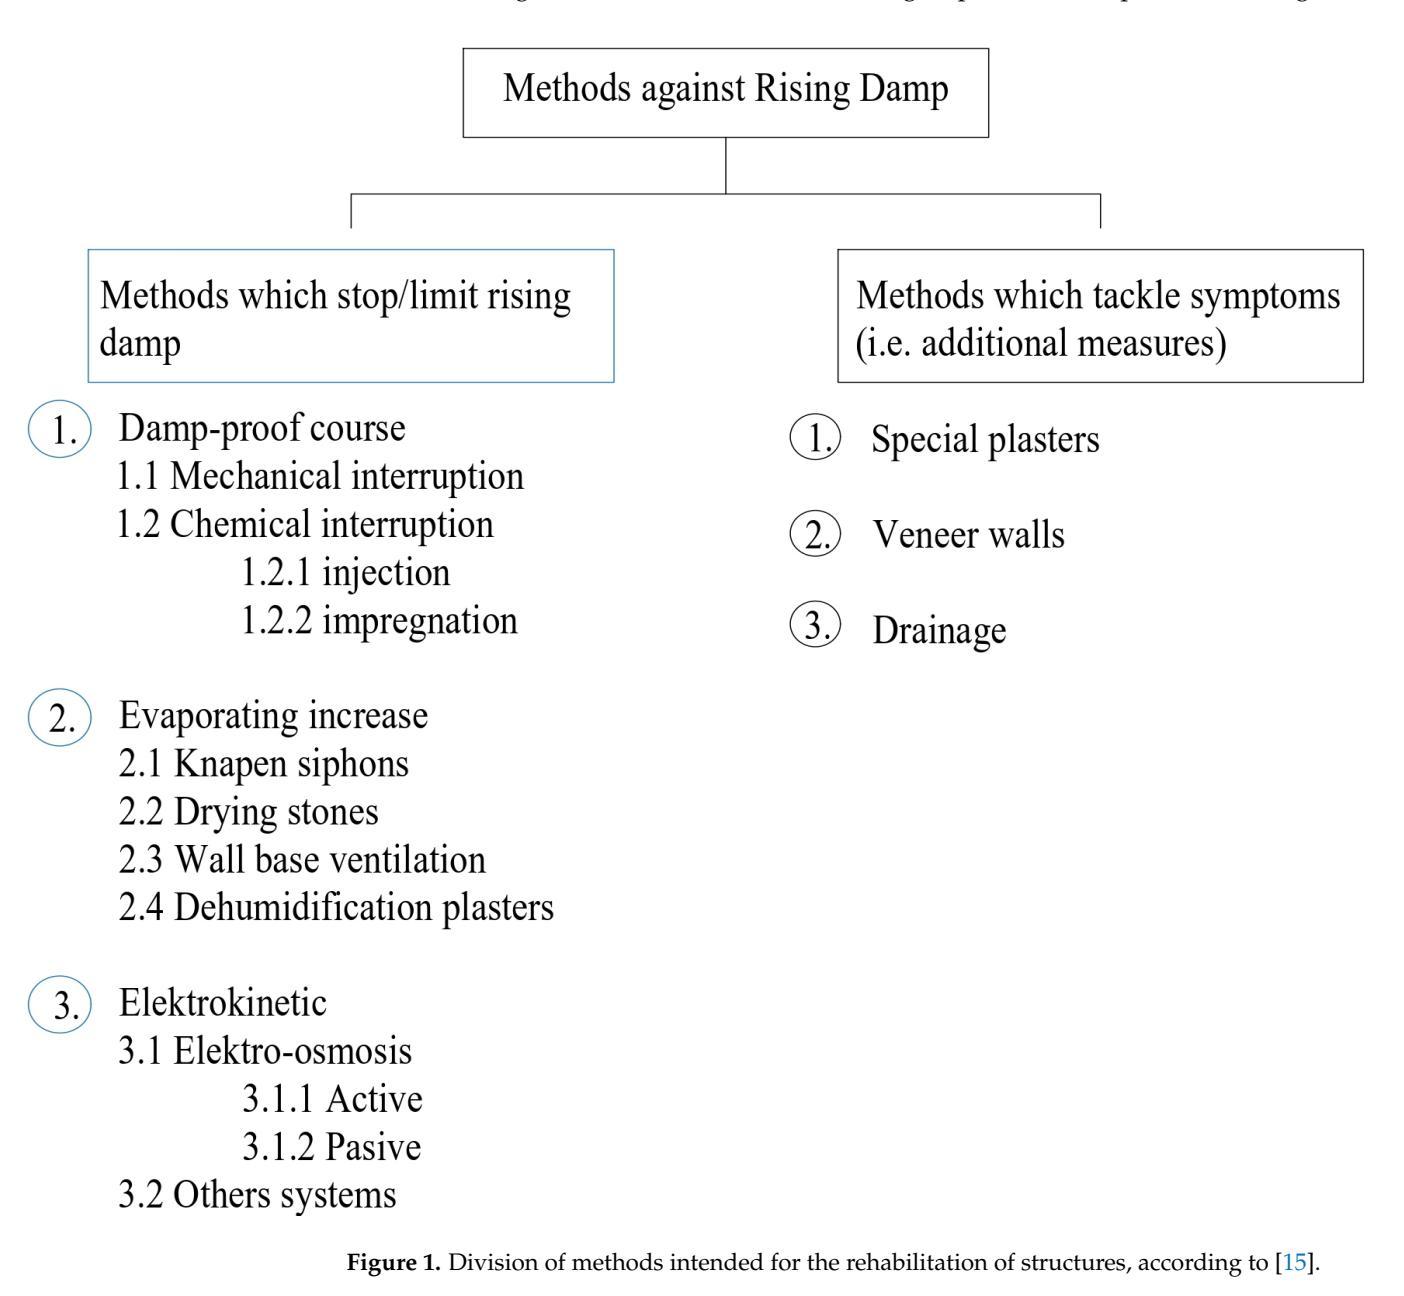
There are many methods of remediation described in various publications [12,13] that may not cope adequately with high levels of dampness and in some cases are not effective at all. These technologies have long been variously divided from a global point of view. R. W. Sharpe [14] divided these methods into traditional and non-traditional methods. Among the traditional methods he included technologies providing the insertion of an impermeable layer. The second group, i.e., non-traditional methods, included grouting and electroosmotic systems. A similar classification has been described in other publications. An interesting and more specific division was given in the EMERISDA project [15], where these technologies were divided into two main groups, which are presented in Figure 1.

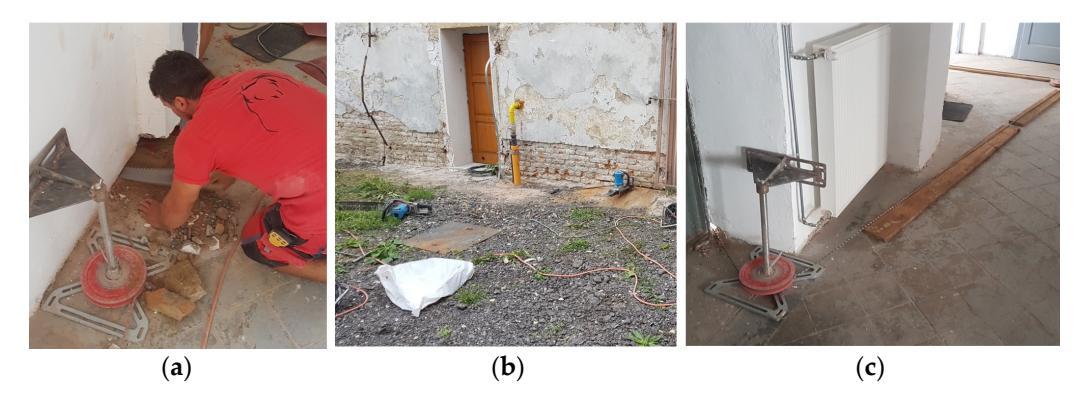
Figure 3. Undercutting technology: (a) By hand saw; (b) by chainsaw; (c) by diamond rope.

Several remediation technologies were investigated by applying them, to some extent, to the building under study. The primary technology was masonry undercutting. Due to the difficulty and complexity of the building, almost all undercutting methods were used. Handsaw cutting (Figure 3a) and chainsaw cutting (Figure 3b) were used in some areas of the building, but diamond rope cutting (Figure 3c) was used in the majority of the building. Undercutting technology was implemented on approximately 95% of the building.

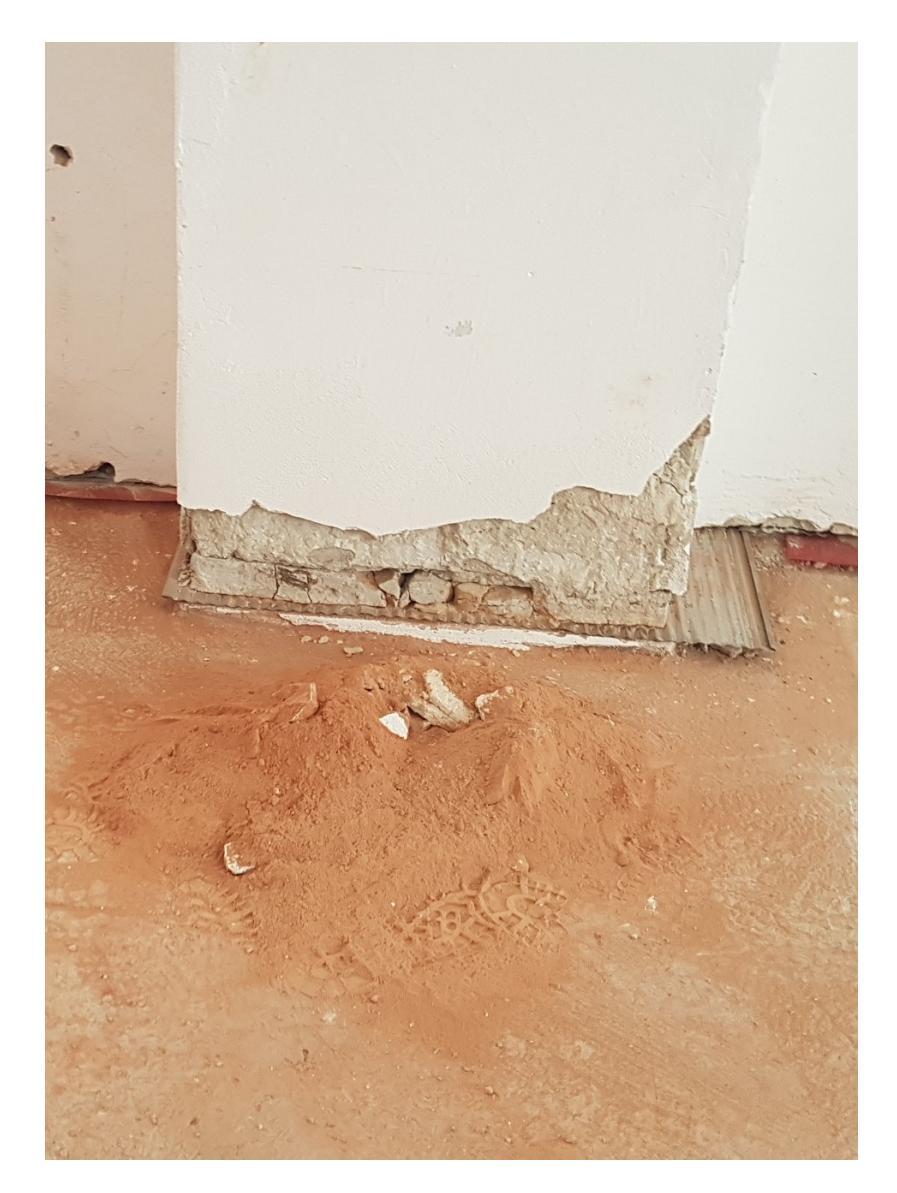
Figure 4. Application of corrugated stainless-steel plate stamping.

In areas where it was not possible to undercut the masonry, stainless-steel sheet piling technology was applied (Figure 4). This was implemented in minimal quantities in areas where the masonry was crumbling or where plastic elements could not be used due to the thickness of the masonry. Stainless-steel corrugated sheets with side locks were used as insulation against rising damp.

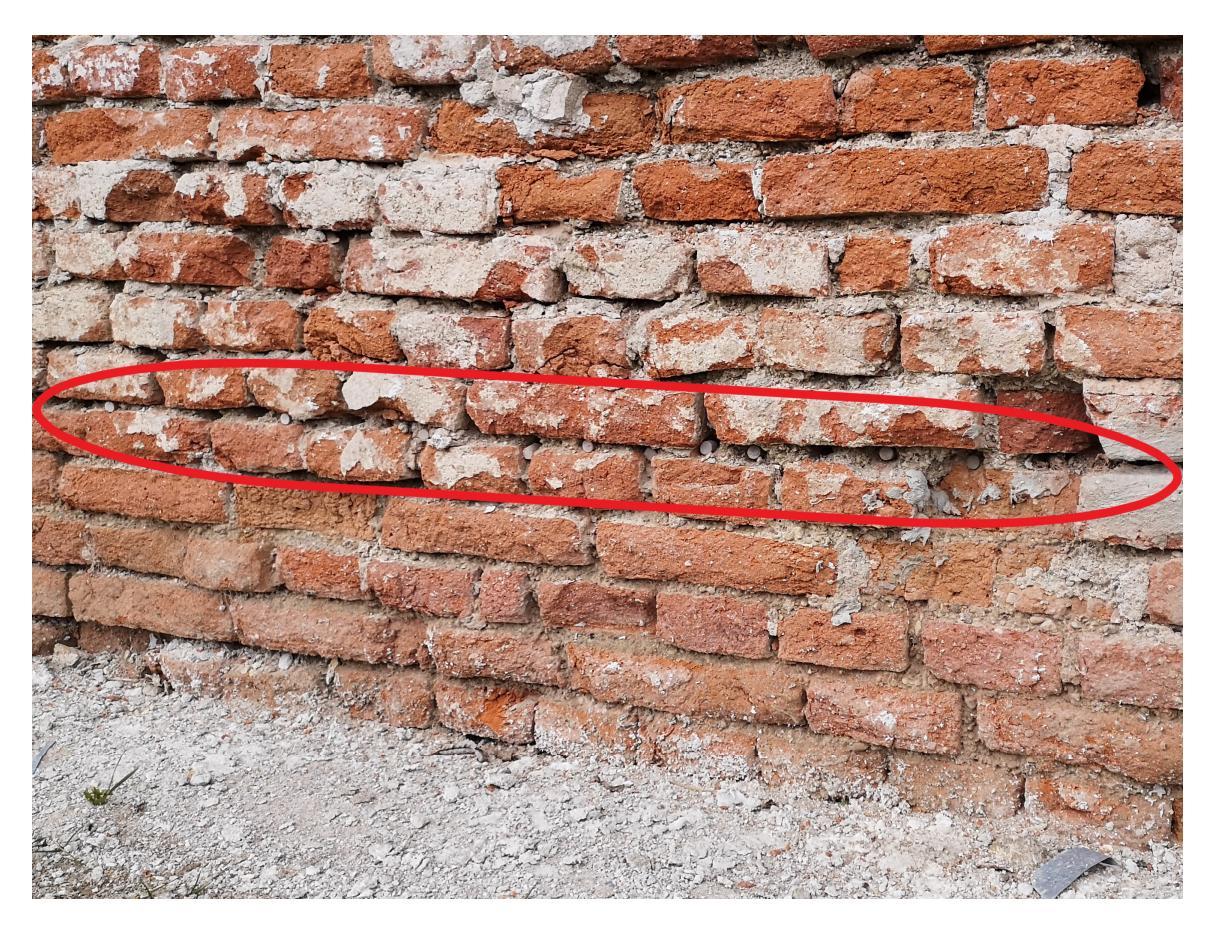
Figure 5. A grouting application line within the investigated building.

The third technology used was grouting (Figure 5). This was used in areas where access was not possible with the previous technologies. The other technologies could not be implemented due to the fact that it was not possible to undercut across the masonry at these locations, because the owner of the property renovating the indoor sanitary facilities in these locations. There were new tiles in these areas, as well as fittings, and in order to preserve them and to keep them intact, grouting was proposed. The individual implementation procedures are described in the following sections.

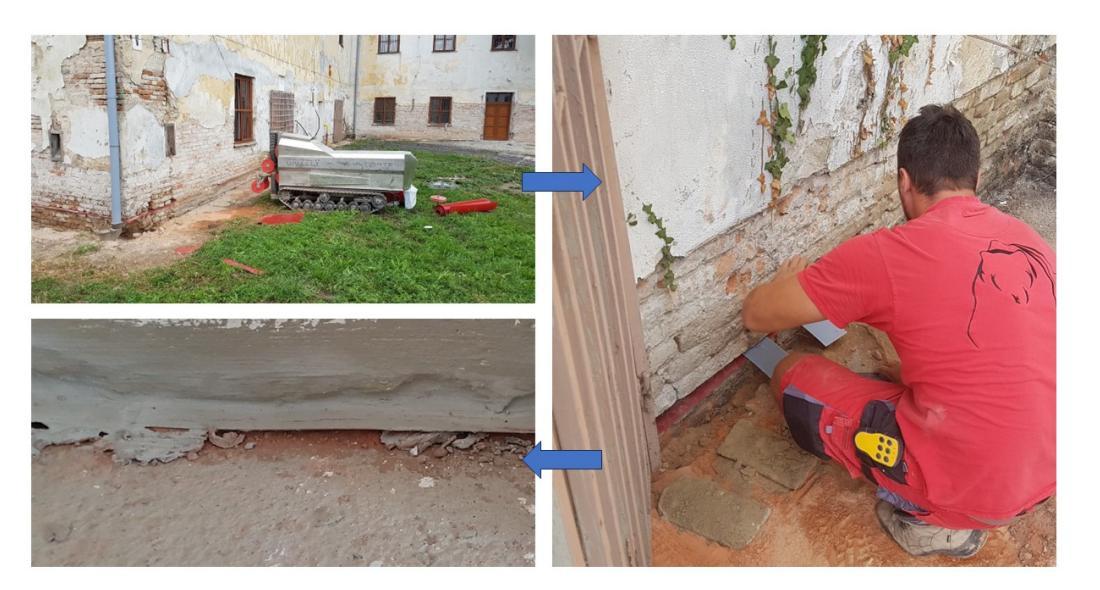
Figure 6. Sequential steps (abbreviated) of the implementation of the undercutting technology.

The primary technology deployed on the study site was undercutting technology. This was implemented in sequential steps using a diamond wire rope or, in exceptional cases, using a hand saw or chainsaw. The working span for the formation of the bedding joint was approximately 0.4 m long to ensure stability and safety. Subsequently, after undercutting (within the working width), the storage joint was cleaned. This procedure is important for the removal of mortar fragments and original masonry. If the joint had not been cleaned, it would not have been possible to ensure smooth insertion of the waterproofing strips into the joints. Cleaning was followed by the insertion of the waterproofing, and then the joints were lined with plastic anti-setting wedges. During implementation, attention was also given to the overlap of the individual waterproofing strips, which, in this case, was between 5 and 10 cm. In this procedure, the entire section of the building was undercut (except where another method was applied). Then, PVC pipes were fitted into the structure, and the structure was sealed at the surface with mortar. Once the mortar had hardened, the joint through the pipes was filled with expansion mortar. The individual sequential steps are presented in Figure 6.

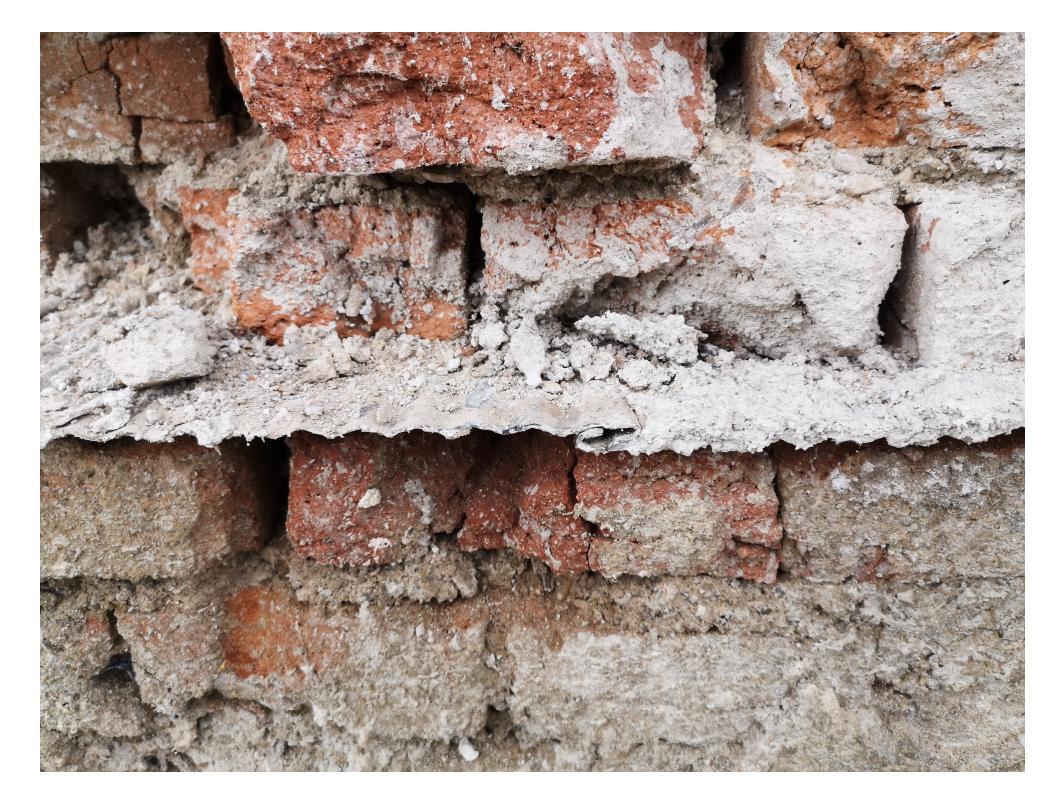
In the area of the building where the masonry was crumbling, stamping technology was deployed in order to maintain the stability of the structure. This technology was used on a small scale, but for the purpose of completeness it is appropriate to describe its implementation. Additional insulation was implemented by embedding corrugated stainless-steel sheets into the masonry joints (Figure 7). These sheets were driven into the masonry by using a machine with compressed air. The insulation was grouted with a weaker displacement, but with a high frequency, i.e., rapid pressure vibration of the sheet at a frequency of 1200 beats/min.

**Figure 7.** Slotted sheets applied to the building under observation. Detail of the lock, which ensures the waterproofness of the joints.

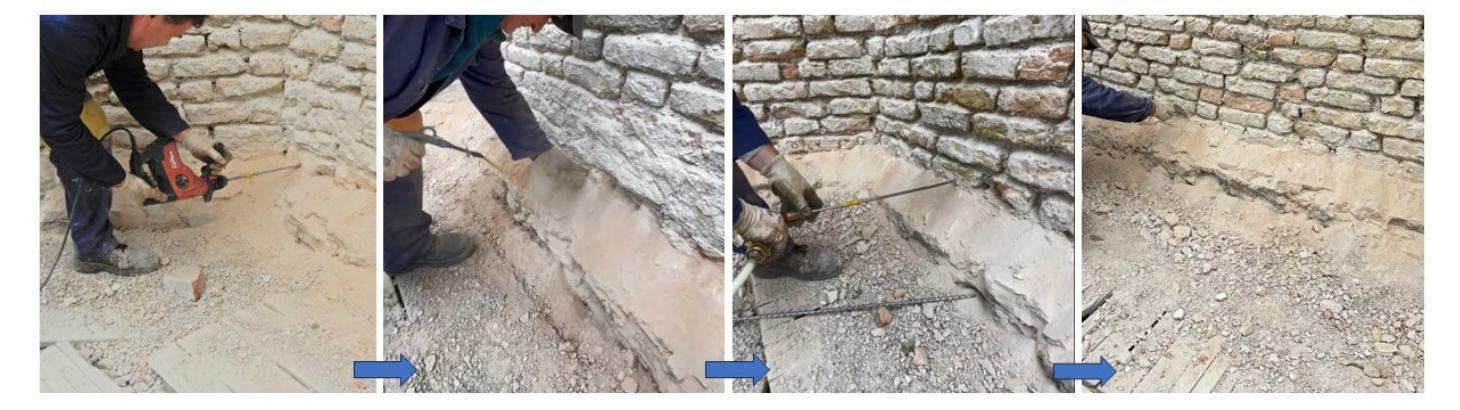
Figure 8. Grouting application procedure.

In the case of the building, grouting was carried out using a hydrophobic agent for remediation of wet masonry against capillary rising moisture using a system of drilled holes of the Remmers Kiesol C infusion screen (Figure 8). This substance can be characterized as solvent-free silane cream, and it is suitable for brick masonry forming a remediated structure.

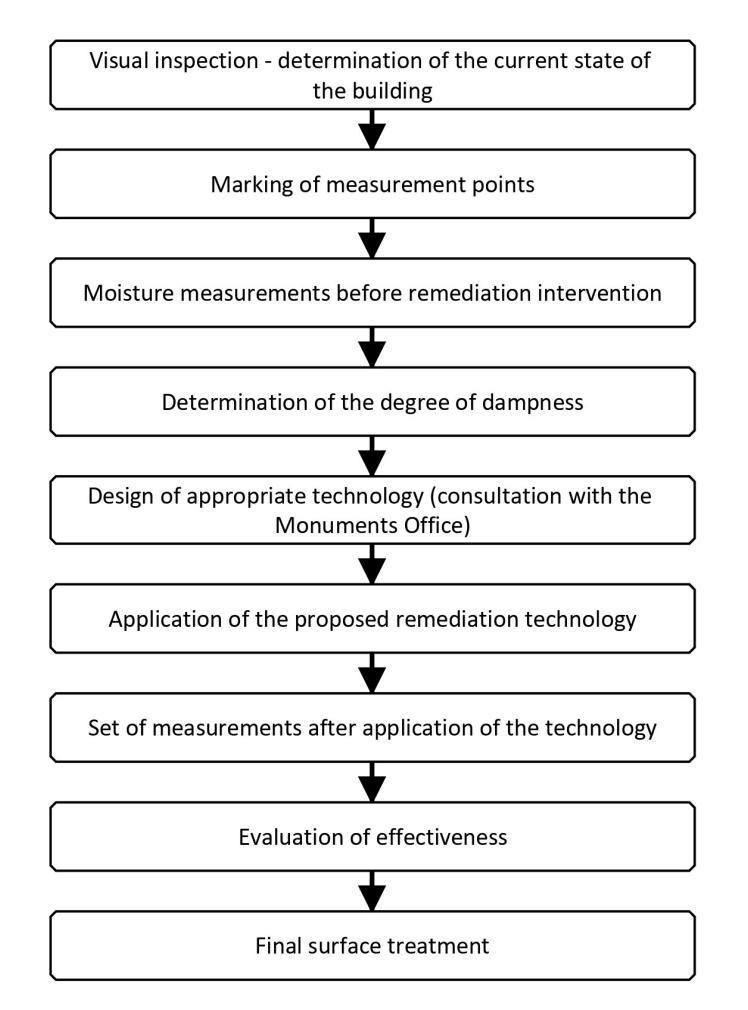
Figure 9. Flow chart describing the research methodology.

For better visualization and clarification, in Figure 9, the research methodology is elaborated as a flow chart, which simplifies the sequence of steps.

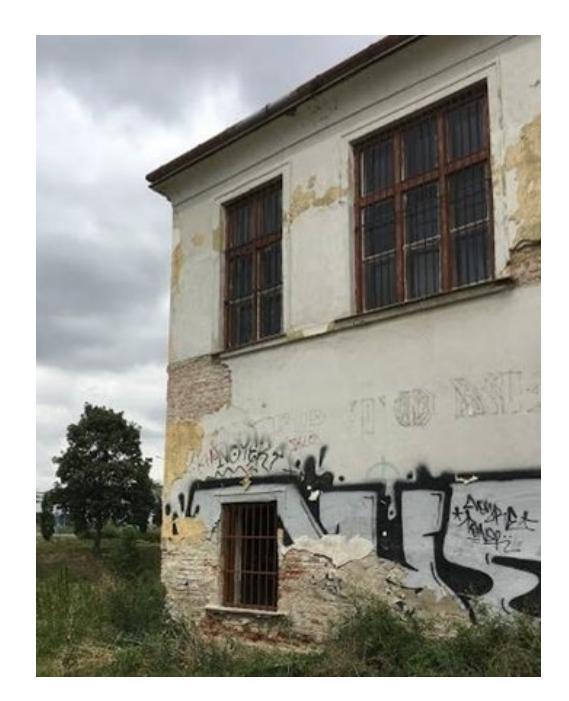
The entire history of the building, especially its use for military purposes, has had a negative impact on the condition of the building. The building has been neglected, as can be seen in Figure 10.

**Figure 10.** Detailed photograph of the degree of damage to the building caused by both dampness and salinity.

As can be observed from Figure 7, the building does not have a positive visual impact on the surrounding area. The dilapidated condition is also visible. During the initial inspection, several deficiencies of the building were found, such as a high level of dampness caused by rising damp. This had gradually attacked the various layers of the structure and, together with the water-soluble salts which had crystallized on the surface and formed efflorescence, was having a destructive effect on the plaster. The salinity levels were determined in aqueous leachate and were analyzed in the laboratory; however, the salinity level is not the subject of this study. From the results of the initial inspection and measurements, there was a need for a quick and radical solution to prevent the rising damp from having a destructive effect on the structure.

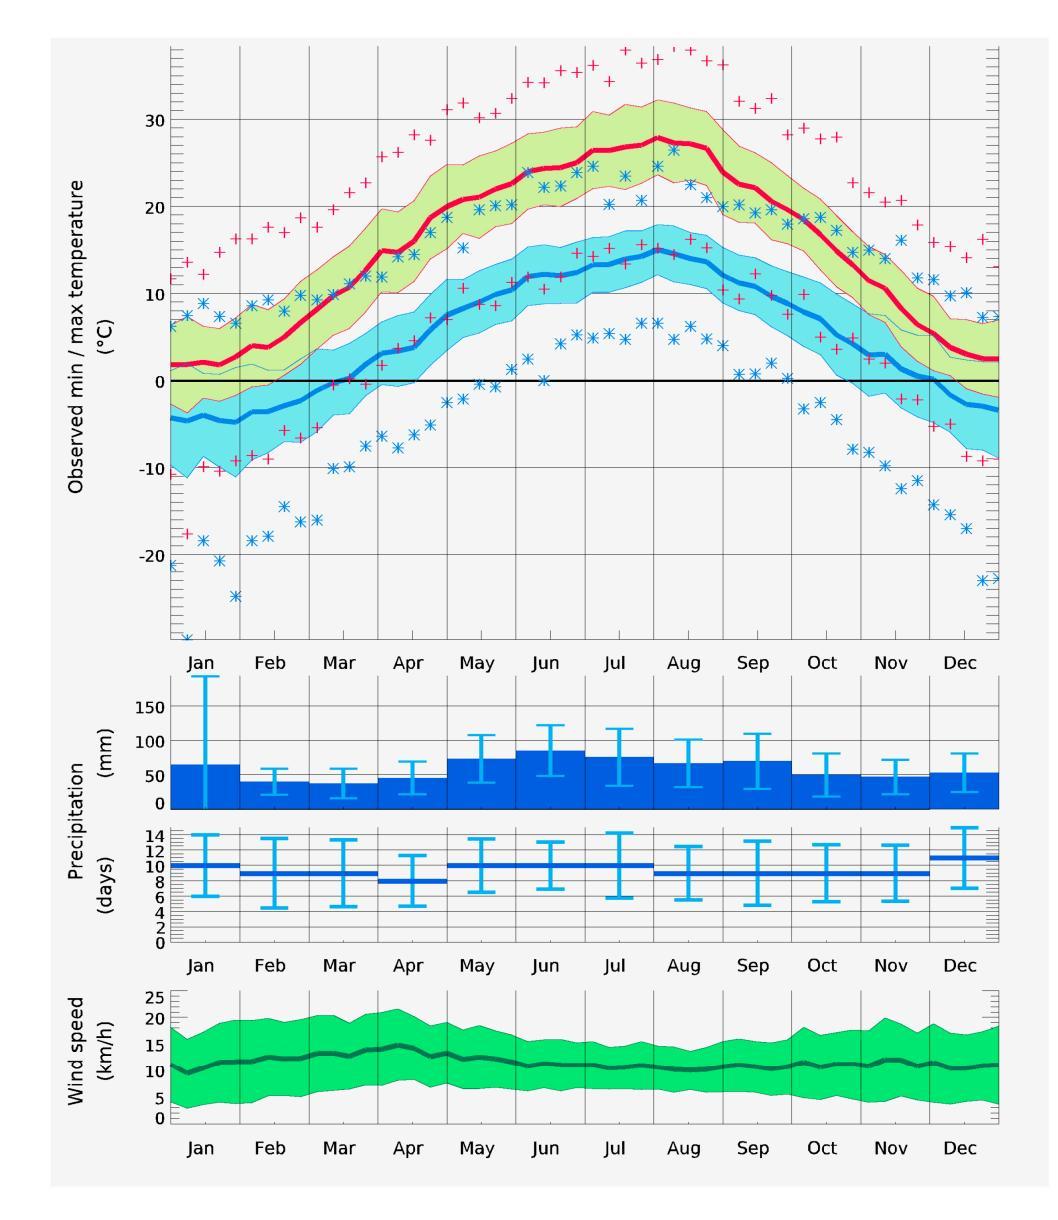
Figure 11. History of weather conditions in the vicinity of the building under study [32].

As part of the research, we used a meteogram which provided the necessary data to create an overview of the weather conditions of the area. A meteogram shows the annual course of temperature, precipitation amount and days, as well as wind measurements from the closest weather station. The weather variables shown depended on the availability of complete and consistent measurements from the measurement station and were aggregated on a weekly or monthly basis [32]. The above described is shown in Figure 11.

The first diagram shows the average, the maximum (red), and the minimum (blue) temperatures. Extreme values are represented by + and \* characters. Two-thirds of the observed temperatures lie within the colored temperature range. The second diagram shows the precipitation amount (in mm) and the range of monthly means in two-thirds of the years. The third diagram shows the number of days per month with precipitation and the two-thirds variation within the bars. The last diagram (No. 4) shows the observed daily mean wind speed and the two-thirds range of weekly means [32].

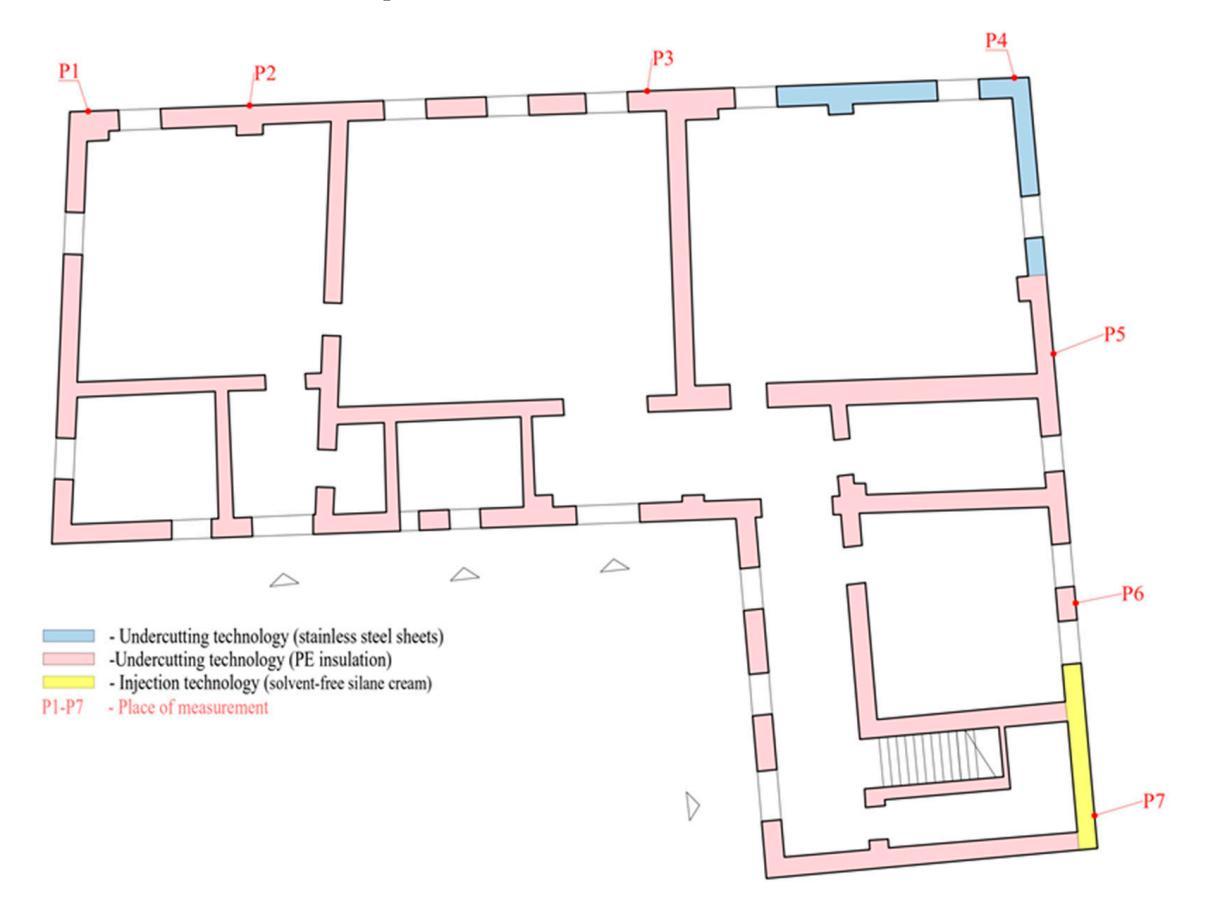
visually, the building did not look satisfactory. The condition was mainly due to the high dampness caused by rising damp. A request was made to restore this building for new use as a depository. For this reason, research was carried out to measure the dampness, and then to design a suitable technology to remove it. The different measurement locations and technologies used within the building under investigation are represented in Figure 12. The rate of dampness is shown in Table 3. The research was carried out between 2017 and 2020.

Figure 12. Moisture measurement points and indication of the range of applied technologies.

The different techniques of remediation interventions in this research were chosen mainly because of the complexity of the structure and the surrounding conditions. Grouting was applied in areas where it was not possible to apply stainless-steel plate stamping and undercutting technology. Stamping technology was chosen in areas where the original masonry was crumbling and undercutting could lead to its complete destruction. In these areas, sheet metal also performed a reinforcing function and the crumbled part above the level of the insulation was replaced. However, the disadvantage of this technology is the possible problematic contact between the sheets, through which dampness can continue to rise if executed improperly. In other areas, undercutting technology was used and applied to the largest part of the building. The advantage of applying one technology to the largest possible extent is uniformity of execution, which subsequently affects price and quality. The disadvantage is the large working space required for the execution. The scale and scope of technology deployment is represented in Figure 9.

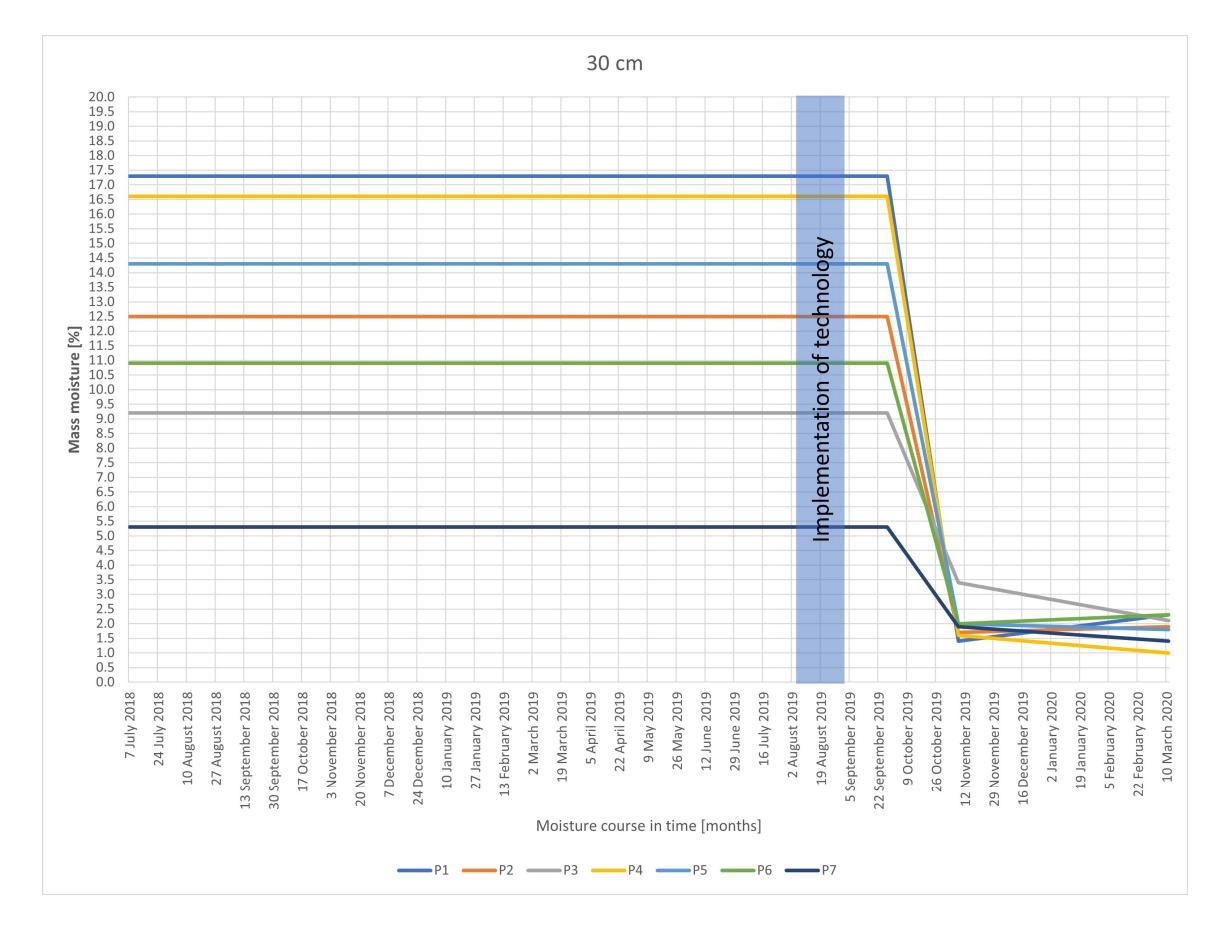
We recorded the individual values, and then listed the resulting values in a table that is included in this paper and shown above. The results were also depicted in graphs (see Schemes 1 and 2) that represent the dampness trends over time before and after the implementation of the damp-proofing interventions. There are two graphs, one graph shows the dampness content measured at 30 cm above ground level and the second graph represents the dampness and its progression at 150 cm above ground level.

**Scheme 1.** Graph showing the dampness progression of the structure before, during, and after implementation of the damp-proofing technologies measured at a height of 30 cm.

Based on the measurements, it is certain that, in the areas just above the ground where the highest humidity was concentrated according to the first measurements, it had receded considerably. When assessed according to the technical standards [13], it can be concluded that the structure had dried out, as demonstrated by the results in Table 4, which describe the individual dampness structure before and after remediation, dividing the results according to the technology and the measurement height. The table also includes a percentage assessment of the dampness loss.

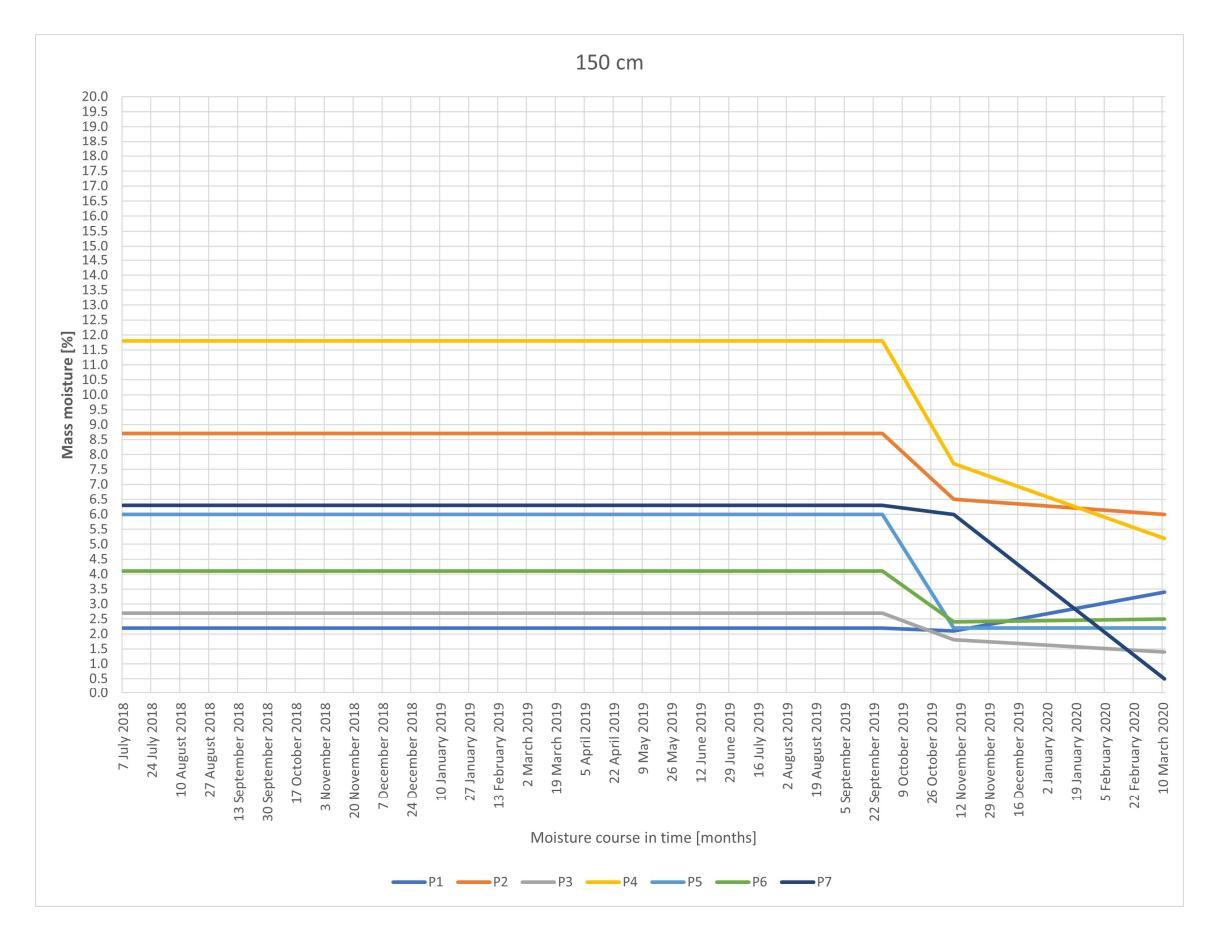
**Scheme 2.** Graph showing the dampness progression of the structure before, during, and after implementation of the damp-proofing technologies measured at a height of 150 cm.

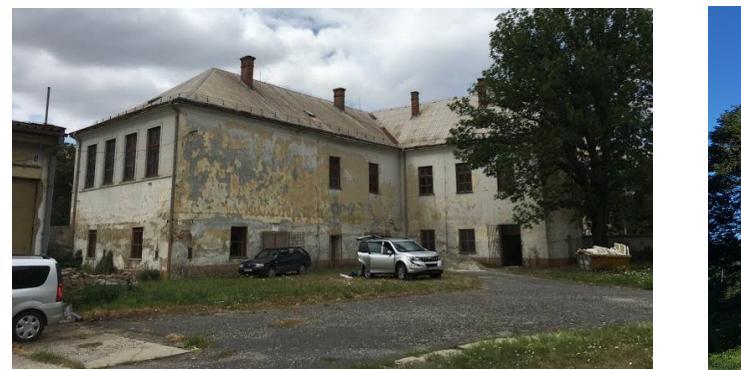
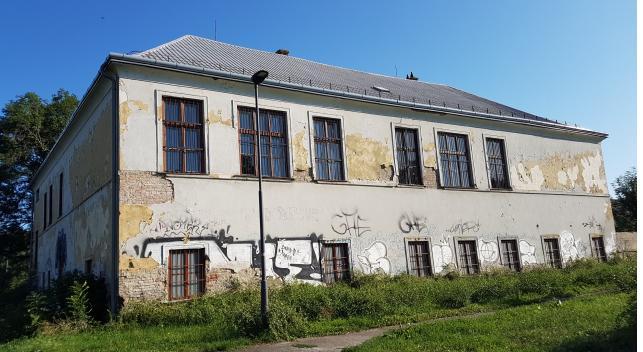
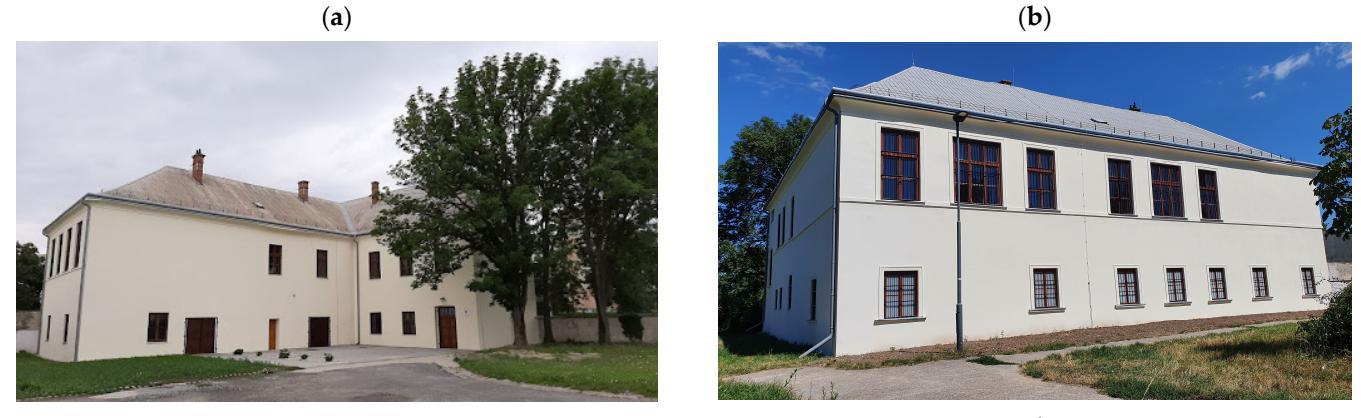
The positive effects of the interventions can also be seen in Figure 13, which shows before and after photographs of the building under study. It is also worth noting that the building has found a new use and serves as a depository for the Regional Monuments Office in Trnava.

Figure 13. View of the state of building: (a,b) Before; (c,d) after recovery.
