Article Robot-Assisted Floor Surface Profiling Using Low-Cost Sensors

Abstract: Low cost and accurate 3D surface profiling can help in numerous industry applications including inspection tasks, cleaning, minimizing bumps in navigation of non-uniform terrain, aid navigation, and road/pavement condition analysis. However, most of the available systems are costly or inaccessible for widespread use. This research presents investigation into the capability of cheap and accessible sensors to capture the floor surface profile information. A differential drive robotic platform has been developed to perform testing and conduct the research. 2D localization methods are extrapolated into 3D for the floor capturing process. Two different types of sensors, a 2D laser scanner and an RGB-D camera, are used for comparison of the floor profile capture ability. The robotic system is able to successfully capture the floor surface profile of a number of different type floors such as carpet, asphalt, and a coated floor. A key finding is that the surface itself is a significant factor on the measured profile, i.e., dirt or other materials can cause false height measurements. Overall, the methodology ha

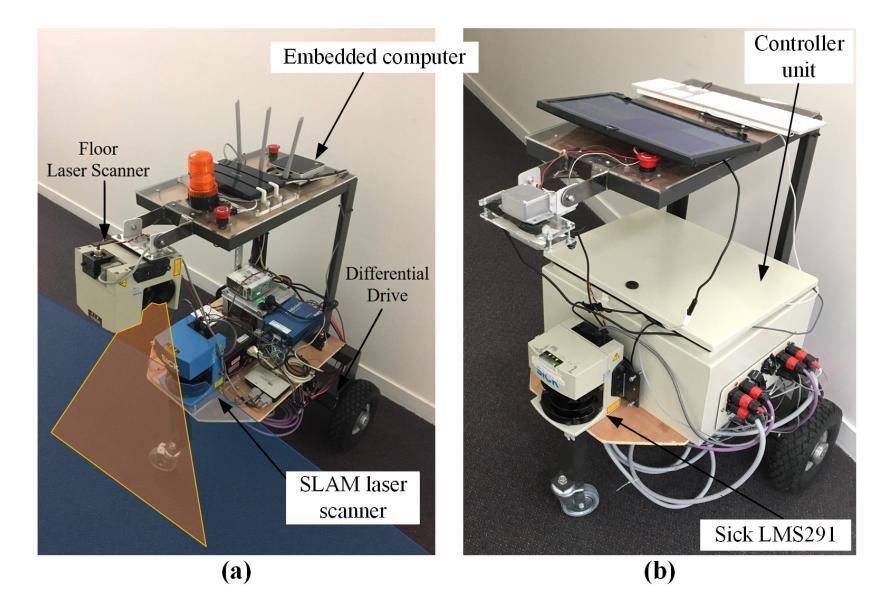
Figure 1. Mobile robotic platform. (**a**) Platform with two laser scanners for SLAM and floor scanning. (**b**) Platform with a SLAM laser scanner and a floor scanning RGB-D camera.

The robotic platform (Figure 1) is a differential drive robot with two drive motors at the rear. The front of the platform is supported by a castor wheel. The robot has two levels: one providing a base for a horizontal laser scanner for SLAM, and the other holding components for control and communication and providing a mount for a second sensor to scan the floor. An adjustable sensor mount was developed to provide the means for measuring a floor profile at various angles and with different sensors. The mount was designed to be relatively universal and sufficiently strong to hold a variety of floor scanners in position as the robot moves around the room. The mount was designed to hold components weighing at least 6 kg and could easily be adjusted 180-degrees in pitch and then locked in place. It was made out of 3 mm steel bent into shape. Figure 1 inset shows the adjustable mount with an Intel RealSense RGB-D camera on the underside and an IMU on the top. The camera is mounted on a second adjustable frame that can be manually tuned to ensure that the camera is level. The motors are mounted directly into the supports of the frame using 4x M5 bolts. This mounting is sufficient for the test platform, but it may need to be strengthened for the final robot due to additional loading from the weight of the extra components.

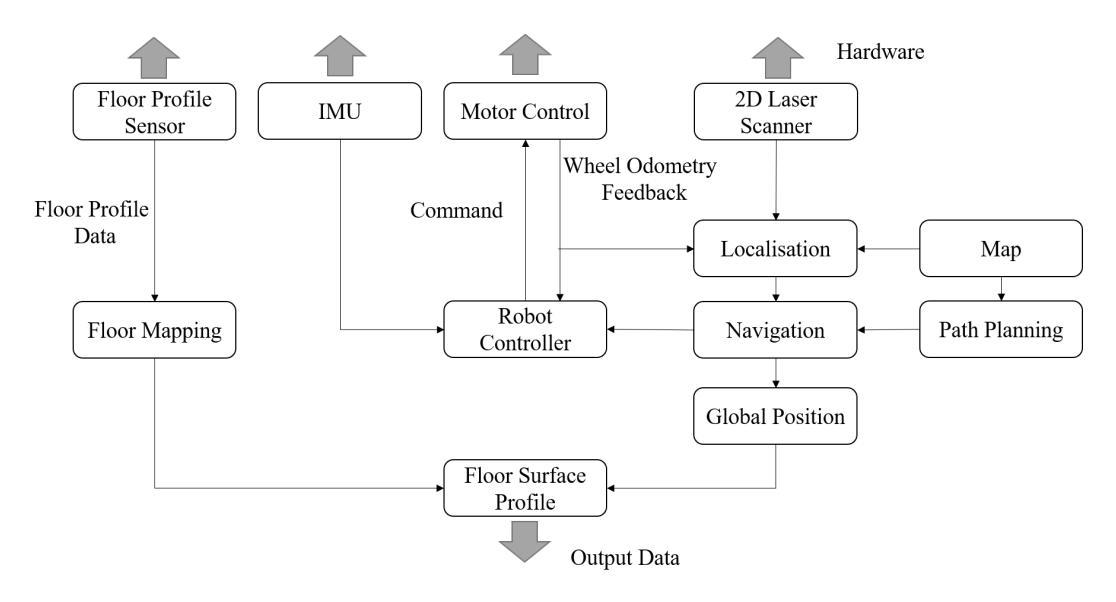
Figure 2. ROS system architecture.

The robot uses the Robotic Operating System (ROS) framework for internal communication and control [13]. ROS is an open-source system that allows for the creation of many nodes that can communicate efficiently through the use of topics and services. The ROS system begins with a core, which provides the base communication framework. Nodes can be added to the system, which can communicate through the roscore using topics and services. Any node can publish or subscribe to any topic or service, providing a highly modular system. Due to the open-source nature of ROS, a community has provided a number of existing solutions to common problems, such as Adaptive Monte Carlo Localization (AMCL), Gmapping, and SLAM. This results in an efficient and proven framework. ROS was selected as the software framework because of its open-source nature, the modularity provided by nodes, and the ability to accelerate development using existing solutions. The ROS system for the research platform requires a number of components; the general architecture is shown in Figure 2.

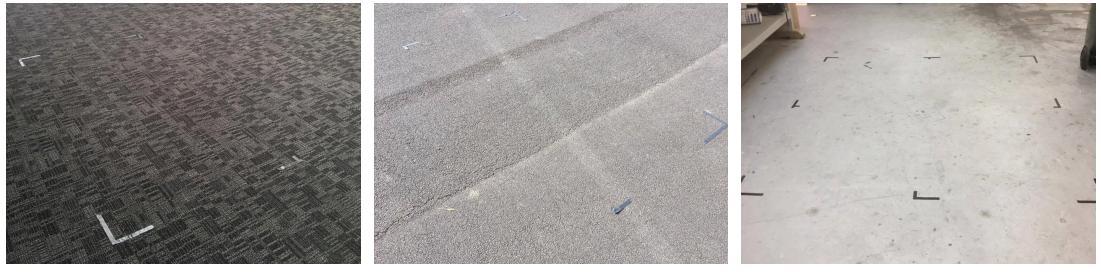
(a) Carpeted floor

(b) Asphalt floor

(c) Coated asphalt floor

Figure 3. Test surfaces used for mapping.

The scanning experiments were set in an area of $2 \times 2 \text{ m}^2$ marked out with black electrical tape (Figure 3a–c). This tape has low reflectivity and high absorbency, resulting in a poor laser scan measurement that helps to identify the boundaries of the scanned area in the final assembled point cloud. The robot was positioned outside the lower left-hand corner of the square and then followed a coverage path (Figure 4). This path provided sufficient space for the robot to perform a turn and record scans of the surface. The robot moved at a relatively slow velocity of 0.1 ms^{-1} . At the beginning of each test, all laser scans were recorded in a ROS bag file for later analysis if required, and the real-time laser scan to point cloud conversion begun. This point cloud creation process involved capturing every laser scan and associated transform and placing them in a 3D coordinate system. The assembly of laser scans was then converted to a single point cloud of the floor, which was then saved as a .pcd file for analysis. In each test it took around six minutes to complete the coverage path. The robotic platform was used to map three different surfaces: carpet flooring (Figure 3a), outdoor asphalt pavement (Figure 3b), and a coated asphalt floor (workshop floor) (Figure 3c). These surfaces were chosen to provide a representative sample of various types of indoor flooring. The test surfaces were expected to give insight into how well the laser scanning could identify areas of interest for the different surfaces. Each surface was mapped three times and cross-analyzed to determine accuracy. A contour plot from the resulting point cloud was created and used to identify high and low areas of the floor.

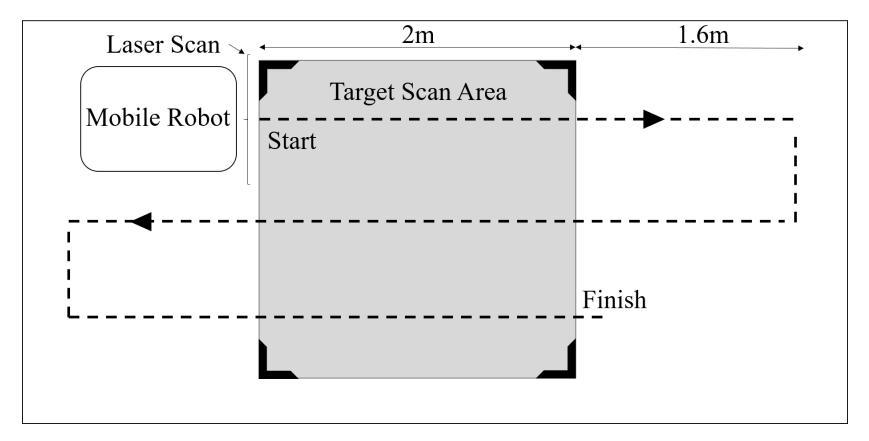
Figure 4. Coverage path for scan area.

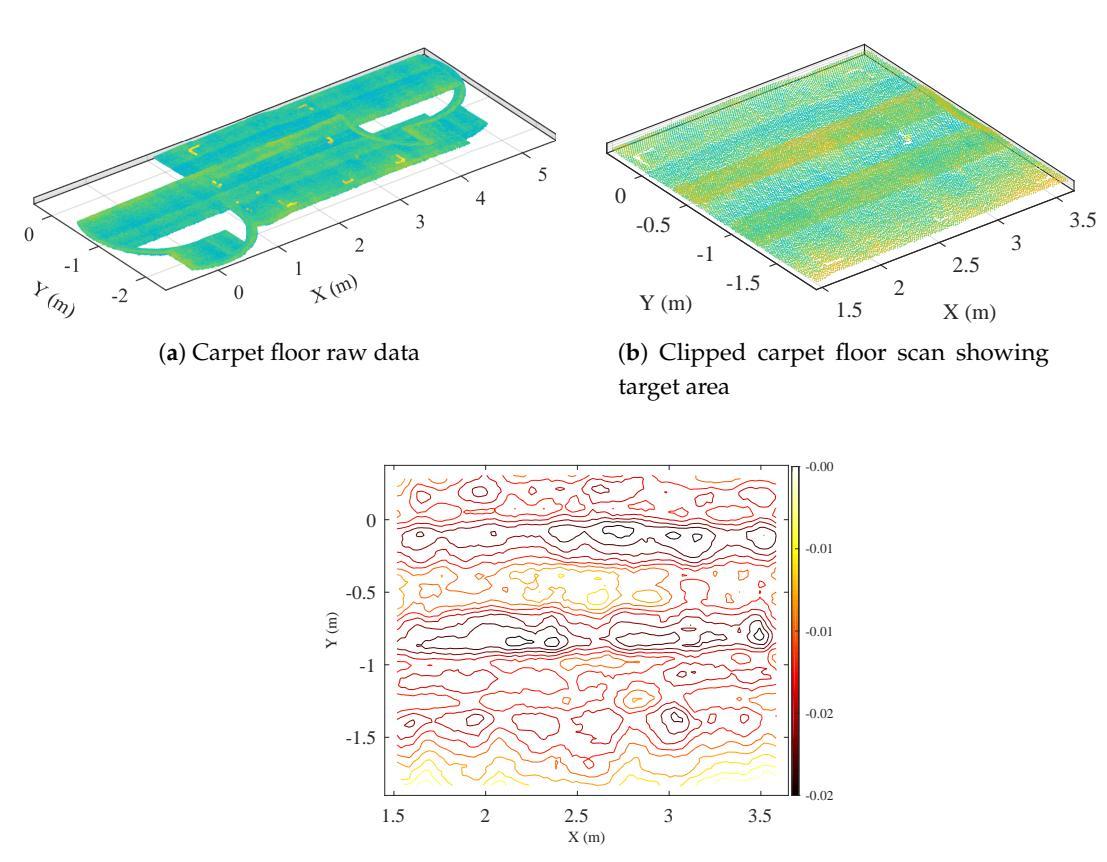
(c) Contour plot of carpet floor

Figure 5. Results for carpeted surface.

The carpeted floor was successfully mapped (Figure 5) despite being anticipated to be a difficult surface for consistent performance due to the fiber orientations of the carpet. The laser scan provided a reasonably thick surface measurement of 0.1 m. The carpet was difficult to inspect visually and appeared to be relatively flat. The contour plot (Figure 5c) shows a relatively flat area (with the systematic center scan error) and a slight high area towards the bottom of the target area.

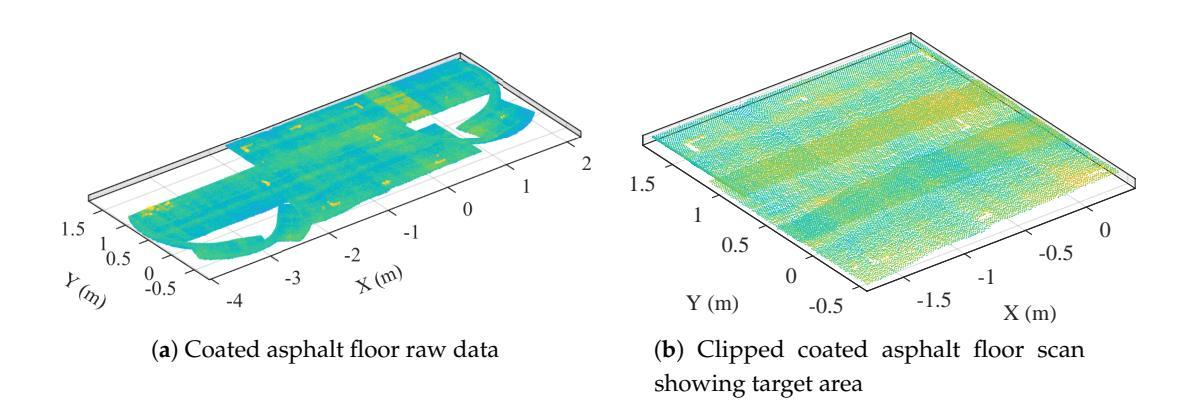
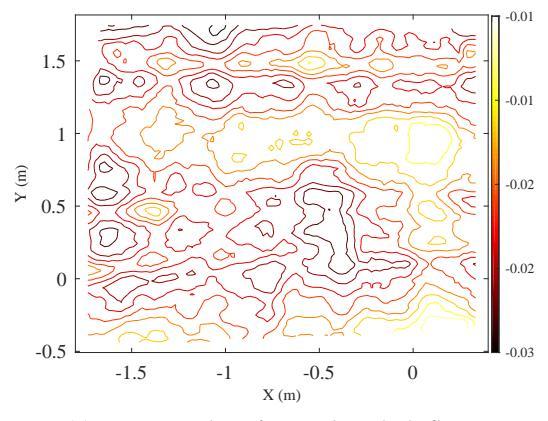
(c) Contour plot of coated asphalt floor

Figure 6. Results for coated asphalt surface.

The workshop floor is an example of an indoor surface covered with dust, cracks and pits. This type of surface could be hard to map; however, from the results (Figure 6) it is clear that the scanning system could successfully create a consistent point cloud of the coated asphalt (workshop) floor. Despite the consistent low center measurement due to a systematic error, a high area was

identified by the surface scanning system at the middle right of the target area (Figure 6c). This area was confirmed by visual inspection as a large step change in the floor. There are two-coin sized dents (30 mm diameter) in the floor of the workshop that the mapping system was unable to detect. However, the system did detect a general slope along the y axis.

clean, however, outside of this it has some areas of dirt. As observed in Figure 6a, these dirty areas are detected by the mapping system as being higher than the rest of the floor, by 0.01 m. This suggests that the different reflectivity of the dirt area results in the inaccurate measurement of the profile. This would have to be accounted for in application, as it could lead towards false high or low areas.

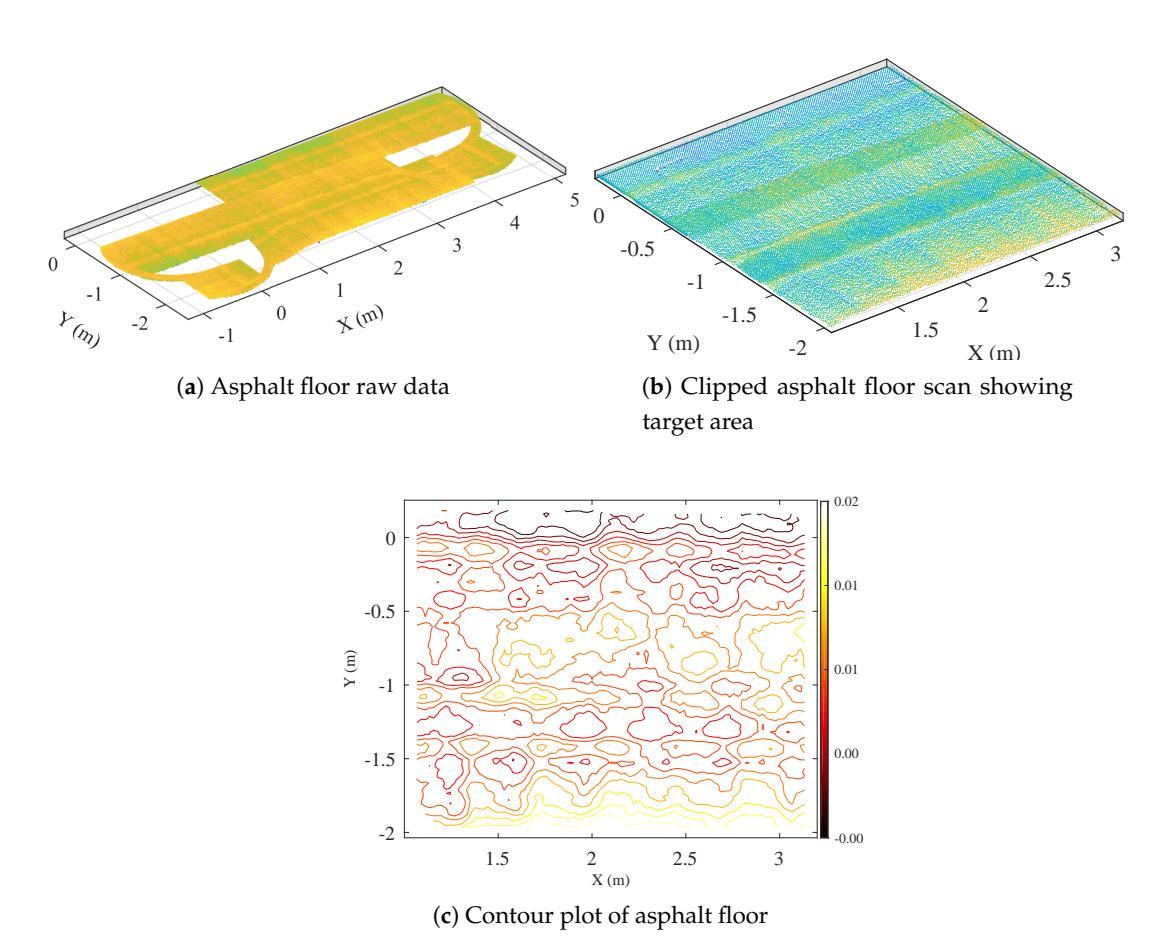
Figure 7. Results for asphalt surface.

Asphalt is another example of a difficult surface to map, as the colour and texture may vary due to weathering and wear and tear. This surface was also successfully mapped (Figure 7), demonstrating the strength of the developed system. Even though the entire surface was on a gradual slope, and no IMU data was available, the surface profile suggested a high point to the right and a low point to the left of the start position. A ridge in the surface was detected similarly to the coated asphalt floor, but upon inspection this high region was due to a rougher area of asphalt. The contour plot (Figure 7c) illustrates the general slope of the surface, with some deviations of the slope due to surface roughness and the systematic errors.

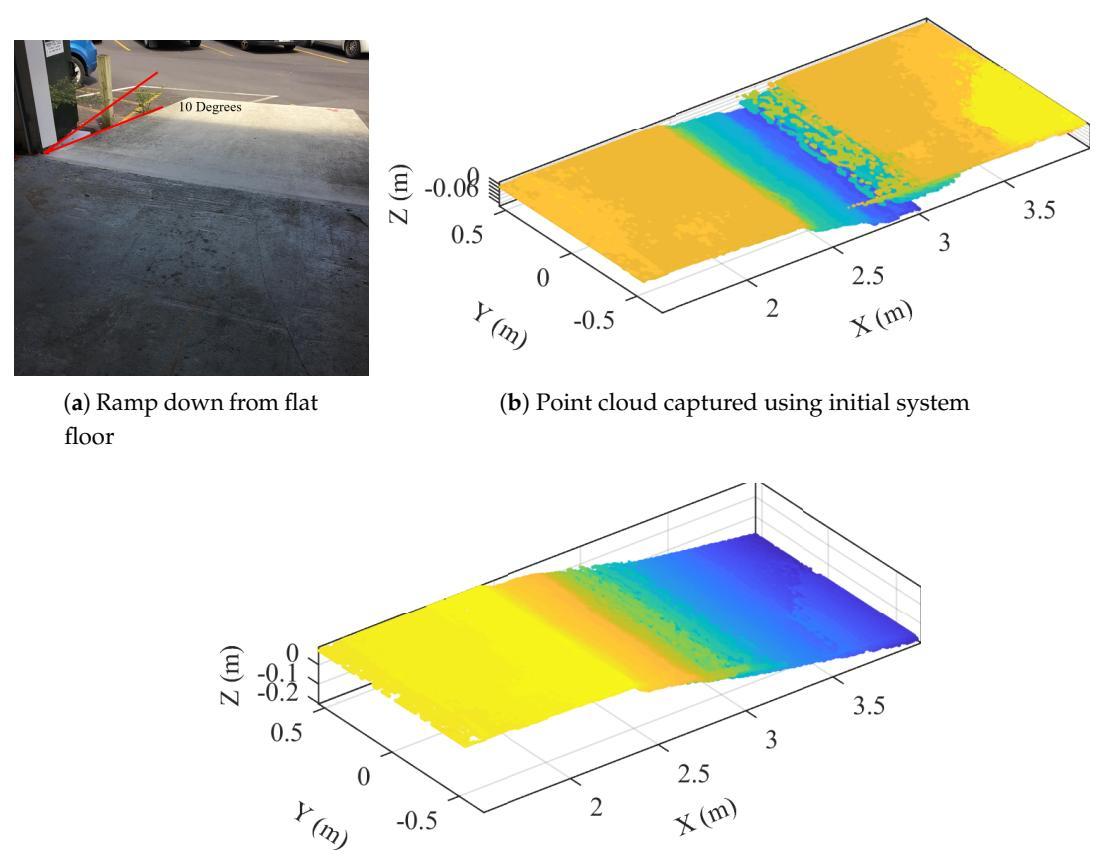
$({\bf c})$ Point cloud captured using improved system

Figure 8. 3D extrapolation verification test.

An extreme situation was tested to verify this approach, involving capture of the floor profile of a slope in the form of a 10-degree ramp down from a relatively flat floor (Figure 8a). Limitations of the previous system resulted in the floor profile being incorrectly captured, particularly due to the measurement performed being the distance from the sensor to the floor. As seen in Figure 9, when the robot is on a constant slope the measured distance to the ground is the same as when measuring on a flat floor. This, combined with 2D localization assumptions and no consideration of changes in global z height, results in the system incorrectly capturing a flat floor. To overcome this, the pitch of the robot and the global z height must be considered. To capture the floor, the robot drove forwards at a speed of 0.1 ms^{-1} and recorded the resulting point cloud information. The captured point cloud using the improved capture system is shown in Figure 8c; for comparison, Figure 8b shows the point cloud captured with no z compensation or consideration of slope. There is significant improvement in the floor capture capability, with the slope of the ramp continuing to be captured even when the robot is fully on the ramp. This suggests that the z height compensation helps to extrapolate the 2D system into a full 3D capture.

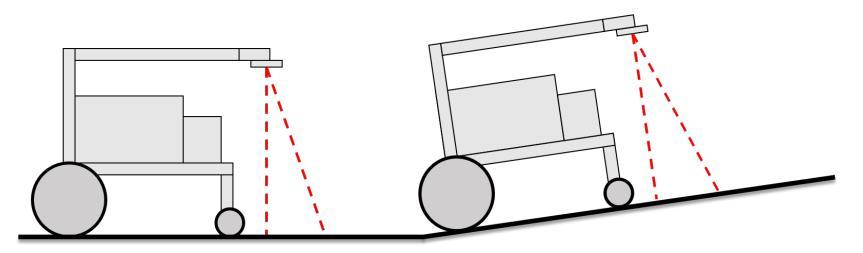
Figure 9. Diagram of robot floor measurement on a slope.

$$\delta_{pos} = \sqrt{(x_i - x_{i-1})^2 + (y_i - y_{i-1})^2} r = \sqrt{(x_0)^2 + (z_0)^2} \Delta z = \tan{(pitch)} * \delta_{pos} z = r * \cos{(pitch + \pi/2 + \theta_0)} + \Delta z x = r * \sin{(pitch + \pi/2 + \theta_0)}$$
(1)

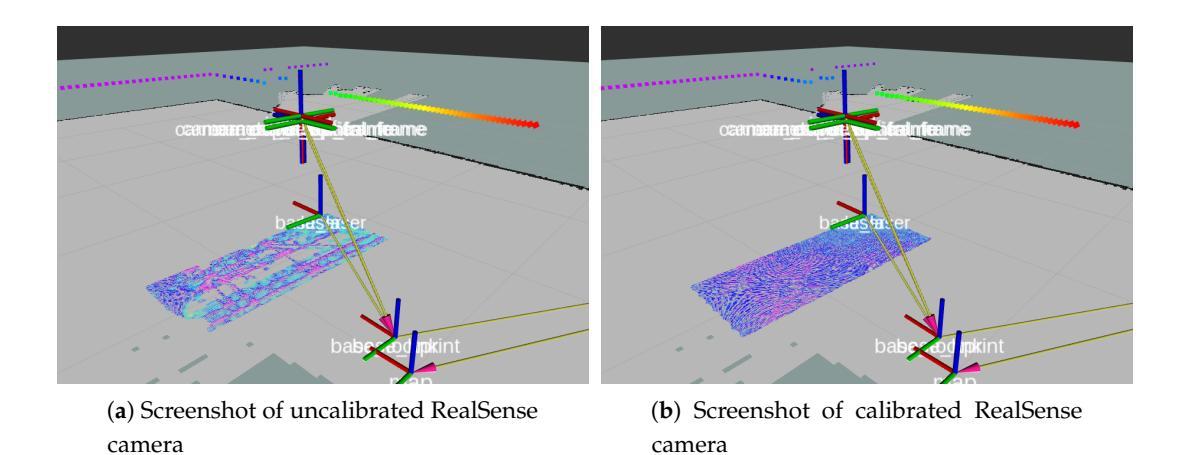
Figure 10. RealSense lighting calibration.

In addition to calibration of the odometry and AMCL, the floor sensor itself must be calibrated prior to testing. The RealSense camera is highly susceptible to infrared light, particularly differences in lighting conditions. This can introduce errors or even result in no measurement. Figure 10a,b highlight the difference between no auto-exposure and an auto-exposed (calibrated) depth cloud. The performance of the RGB-D camera is greatly improved with auto-exposure, capturing a greater region of the view and containing fewer artefacts (missed measurement areas). Errors due to changes in lighting conditions can result in a patterned floor result or even parts of the floor unmeasured (Figure 10a). These errors are overcome through calibrating the RealSense camera (Figure 10b) using the auto-exposure function for 2–5 s.

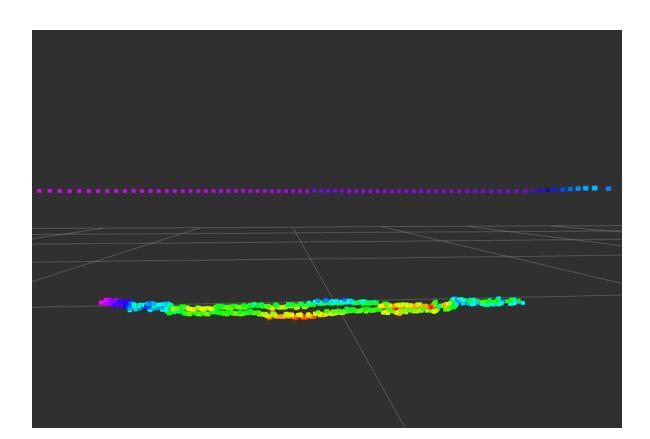
Figure 11. Corrected laser scan (above) shown with raw laser scan (below).

The Hokuyo short range laser scanner produces a laser scan result at angles spanning 270-degrees. The raw laser scan data must be converted from polar coordinates to Cartesian coordinates to accurately capture the floor profile. If this conversion is not performed, the laser scan has an obvious skew, which can be visualized when looking at a flat floor (Figure 11). The uncorrected laser scan of the flat floor has a bent shape (bottom curve of Figure 11), due in particular to the mapping of coordinates and changes in angle of incidence. This can be corrected through remapping the laser scan data points to the correct position relative to the angle of the scan (Equation (2)). In Figure 11, the z height is indicated by colour, with purple corresponding to the highest z value and red to the lowest. This results in a significantly improved measurement of the floor, although the scan still contains noise and measurement errors.

$$scan_{filtered}.ranges[i] = scan_{filtered}.ranges[i] \pm 0.03 * exp(-fabs(sin(angle)))$$
(2)

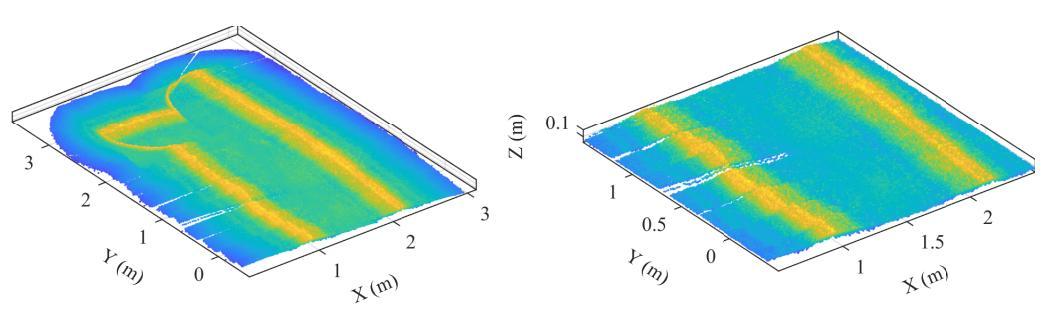
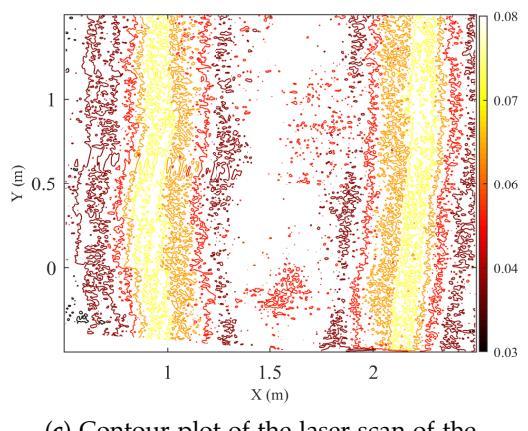
(a) Laser scan of carpet floor raw output

(**b**) Cropped surface of the laser scan of the carpet floor

(c) Contour plot of the laser scan of the carpet floor

Figure 12. Laser scan results for carpet floor.

The carpeted floor was successfully mapped by both the laser scanner (Figure 12) and the RGB-D camera (Figure 13); however, the laser scanner appears to not have captured some features of the floor as well as introduced systematic errors. The laser scan of this floor (Figure 12b) shows a relatively flat floor with high areas down the middle of each pass. These high areas are consistent with robot position, suggesting systematic error rather than measured deviations. In contrast, the floor captured by the RGB-D camera system (Figure 13b) shows again a relatively flat floor, but with small deviations in certain areas. Visually, the floor looks flat with no obvious deviations in flatness across the measured floor area. Upon closer inspection of the floor using a straight edge, the high areas captured by the RGB-D camera were confirmed.

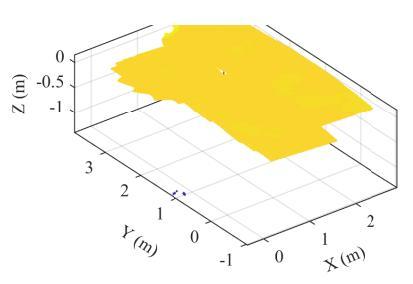
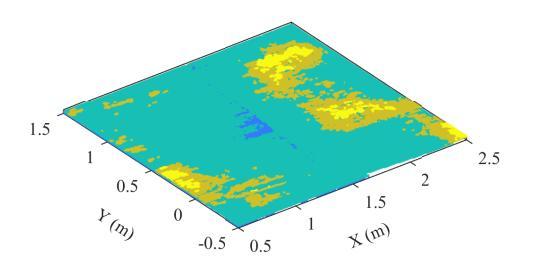
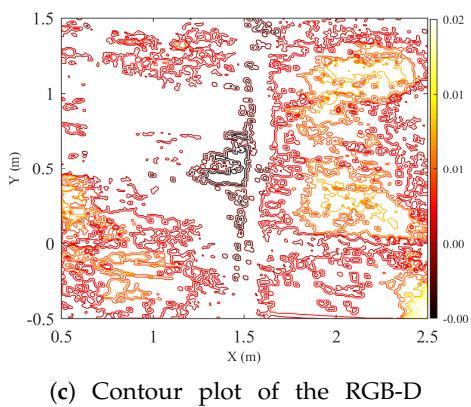
(**a**) RGB-D capture of carpet floor raw output

(**b**) Cropped surface of the RGB-D capture of the carpet floor

Figure 13. RGB-D capture results for carpet floor.

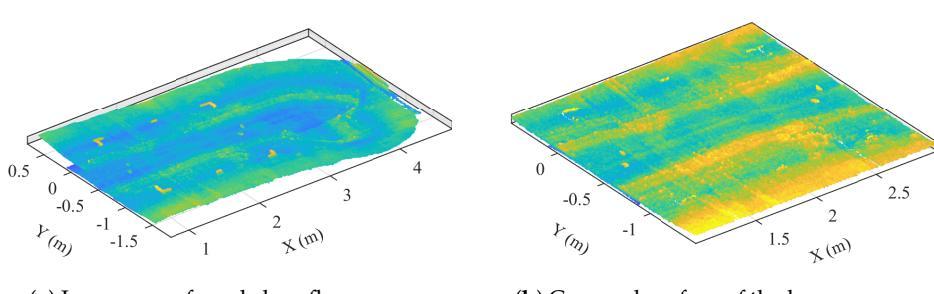
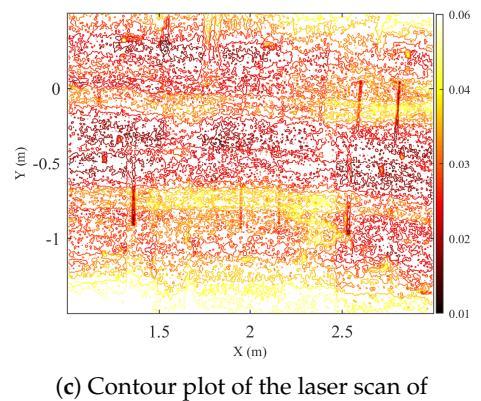
$({\bf a}) \ Laser \ scan \ of \ workshop \ floor \ raw \ output$

(**b**) Cropped surface of the laser scan of the workshop floor

Figure 14. Laser scan results for workshop floor.

The workshop floor was captured more successfully by both systems (Figures 14 and 15). The laser scan continued to show the systematic high area in the middle of the scan (Figure 14b) that was observed in the carpet tests. Some deviations from flatness were detected, in particular at the sides of the target area. The RGB-D camera successfully captured (Figure 15b) a number of high areas that were confirmed both visually and with a straight edge. The accuracy of the size of the high areas is not known.

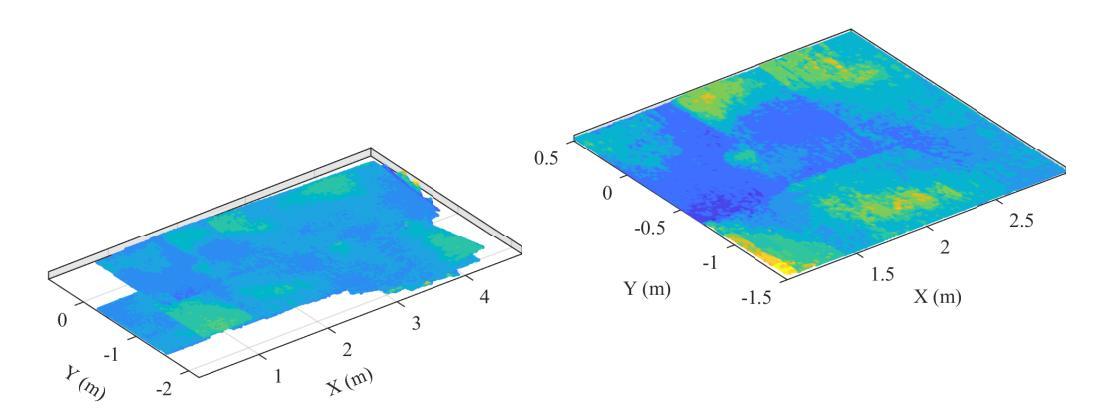
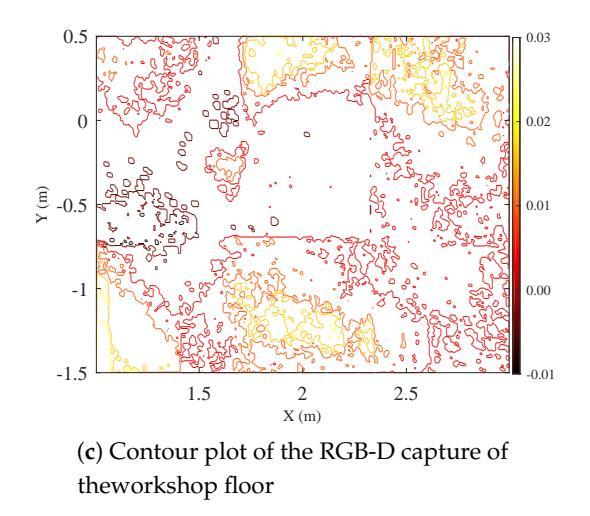
(**a**) RGB-D capture of workshop floor raw output

(**b**) Cropped surface of the RGB-D capture of the workshop floor

Figure 15. RGB-D capture results for workshop floor.

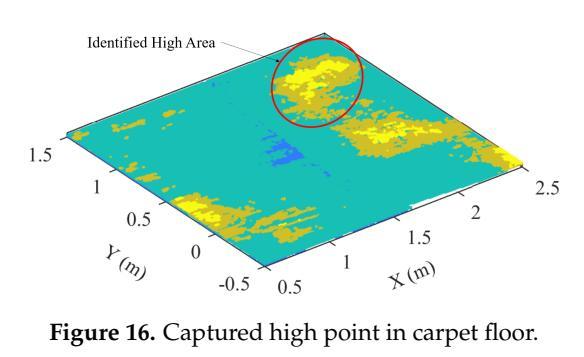
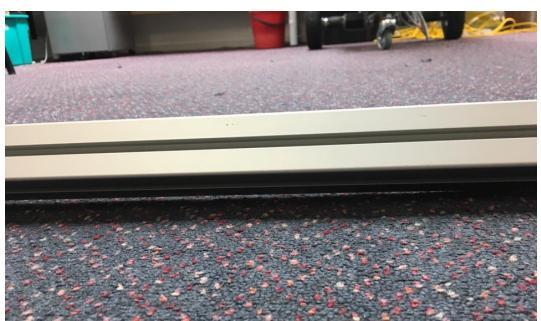
Figure 17. Investigation of corresponding high point in carpet floor using straight edge.

The RGB-D camera was able to highlight areas of interest, particularly high and low areas of the floor. While some errors were observed, the overall floor deviations appear to have been estimated. In the carpet 2 m \times 2 m test, the sensor detected a high area in the middle of the first pass (Figure 16). This area was analysed after the test using a straight edge and was confirmed to have a deviation from flatness of around 2 mm over 200 mm of floor (Figure 17).

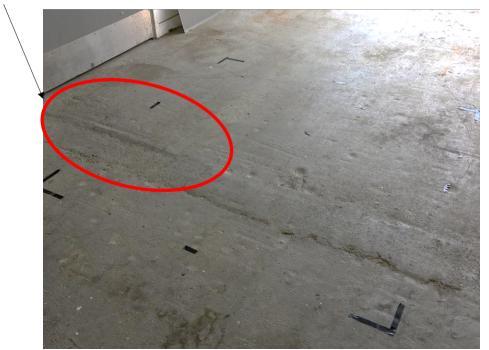
Identified High Area

Figure 18. Workshop floor with significant bump highlighted.

Similar performance was observed in the workshop floor experiments. Areas in the floor that had visually detectable deviations were successfully detected by the RGB-D sensor capture process. There was a significant bump in the workshop floor marked in Figure 18 that was also successfully detected during the floor capture process (Figure 19). A second area of interest was investigated using a straight edge and was also confirmed to be a deviation from flatness (Figure 20). The accuracy of these detected high areas is yet to be validated.

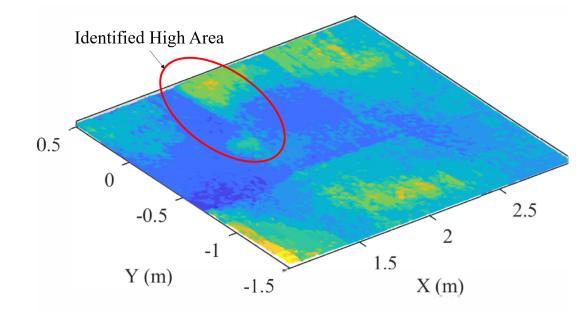
Figure 19. Capture of workshop floor high point.

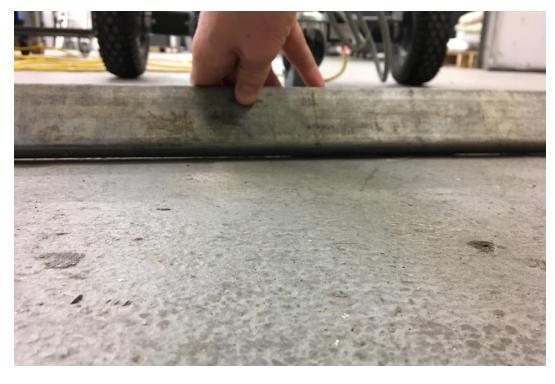
Figure 20. Investigation of high point in workshop floor using straight edge.
