Article Detection of Terrain Deformations Using InSAR Techniques in Relation to Results on Terrain Subsidence (Ciudad de Zaruma, Ecuador)

Marcelo Cando Jácome, A. M. Martinez-Graña¹ and V. Valdés *

Keywords: terrain deformation; mining galleries; subsidence; InSAR

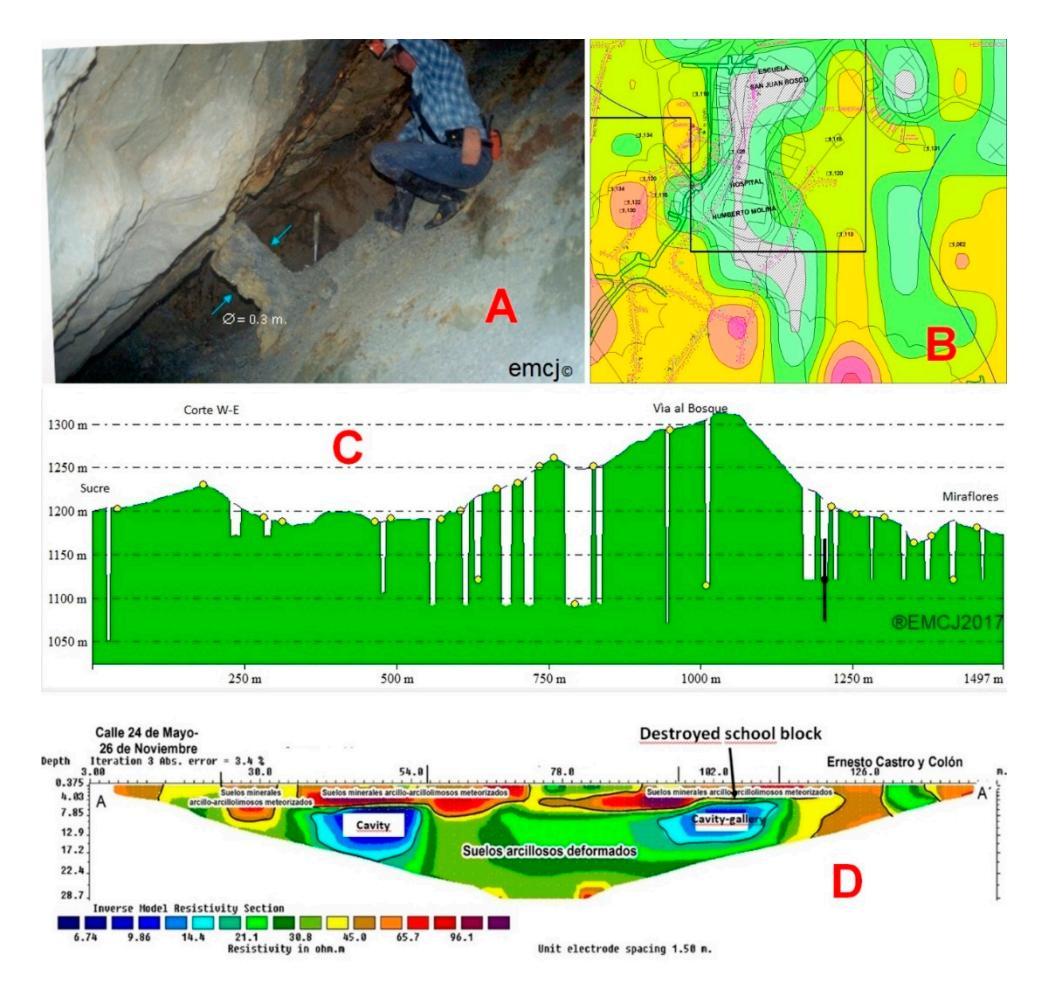
Figure 2. (**A**) Pillars exploited and destroyed, without resistance to the load of the upper rock and soil that in the sector reaches more than 50 meters thick. (**B**) Sinking dating back to 2001 using the flow pattern technique and morphological rupture lines. (**C**) W–E Topographic profile and subsidence caused by mining galleries in underground projection to the top of the galleries. (**D**) Electrical tomography of the subsoil in the streets May 24, November 26, Ernesto Castro, Colon and Gonzalo Pizarro. The collapse of the La Immaculada-Fé y Alegría school block was possibly due to the instability caused by the underground gallery that exists below (blue spot). This sinking was reactivated in 2019.

In particular, the stress efforts caused by the bending and cutting component of these deformations have damaged the building materials making them almost fragile. These ground deformations and subsidence were verified in 2001 by inspecting the underground mining galleries, in addition to the geological characterization, without using the DInSAR technique, which did not exist at that time. The technique used and developed was the analysis of flow patterns and morphological rupture lines, developed by the authors of this article, and topographic–geological information of each gallery investigated by ex-National Directorate of Geology, National Directorate of Geology [2–4], among researchers. An example of the state of deformation in 2001 can be seen in Figure 2B in the hospital sector of the city Humberto Molina and the San Juan Bosco school, where there is a anthropogenic subsidence zone (area with black slanted lines), caused by the mining galleries represented by green and cyan lines.

A topographic profile W–E from Sucre Street to Miraflores Street, is presented, Figure 2C, from the surface to the top of the inventoried mining galleries at that time. This topographic profile shows the intensity of subsidence caused by the underground galleries. The last study carried out by the Secretariat of Risk Management by means of electrical tomography of the subsoil in 2016, verified that the areas susceptible to subsidence detected in the previous decade were activated and caused the collapse of the La Inmaculada-Fé y Alegría School. Subsequently in 2019, subsidence occurred on

24 May and 26 November on Ernesto Castro, Colon and Gonzalo Pizarro Streets. Subsidence that were previously detected, Figure 2D.

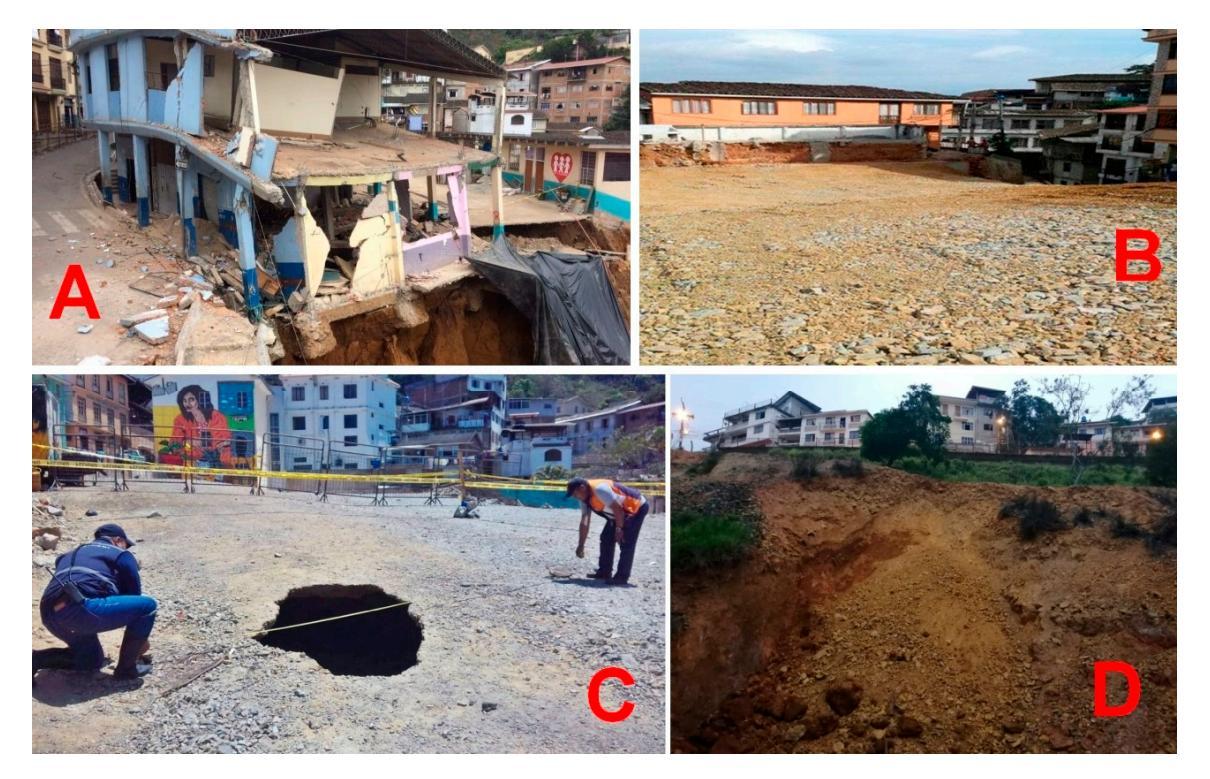
Figure 3. (**A**) Collapse of the Fe y Alegría School, in October 2916. (**B**) Technical filling done at the site in 2017. (**C**) Reactivation of the collapse in the place where the school was in 2017. (**D**) New collapse near Gonzalo Pizarro Street in 2019. Images taken from El Expreso Newspaper, Ecuador en vivo, Pichincha Universal and Arden los Socavones Facebook page.

In December 2016, the Immaculate School-Fe y Alegría, completely collapsed possibly due to being in an old gallery and in illegal exploitation, which sank the ground, as determined by several recent technical reports [3]. The classroom block collapsed as its foundations sank, and consequently the structures fractured and collapsed.

Figure 3 shows the collapse of the school in October 2016 (A), the technical filling done in 2017 (B), the new collapse in the same place (C) and the new collapse in the Gonzalo Pizarro Street sector (D), which occurred in 2019.

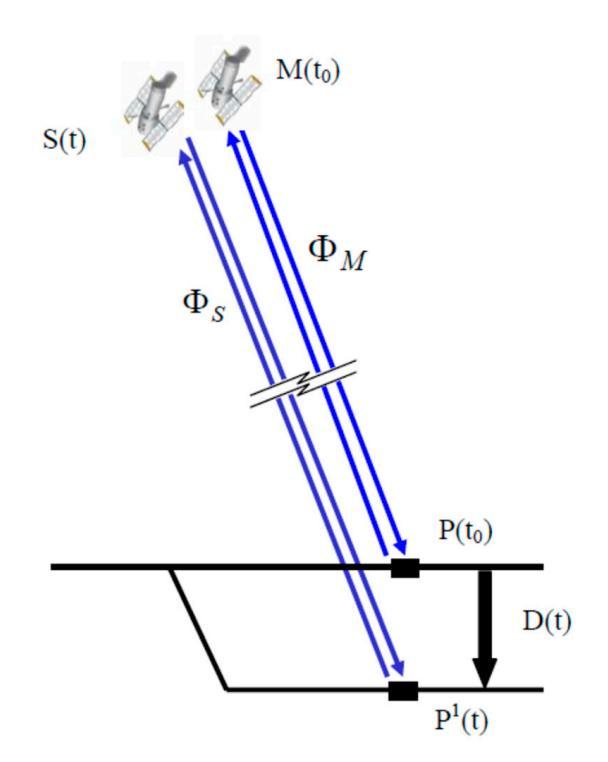
Figure 4. Displacement diagram of topographic relief and phase change of the signal [11].

In reference to Figure 4 for the acquisition of an interferogram, have followed what M. Crosetto et al., describes about the basic principles of Interferometry from the Synthetic Aperture Radar (SAR) [30].

At time $t_{0,}$ the sensor obtains a first SAR image, measuring the phase Φ_M (Equation (1)), an image called master, M. If a deformation of the ground D occurs, over a time, point P moves to P¹. Subsequently, the satellite obtains a second image at time t, and measures the phase Φ_S . This image is called slave, S. The InSAR technique calculates the phase difference between Φ_S and Φ_M , a difference called interferometric phase $\Delta \Phi_{Int}$.

$$\Delta \Phi_{Int} = \Phi_S - \Phi_M \text{ (eq. 1)} \tag{1}$$

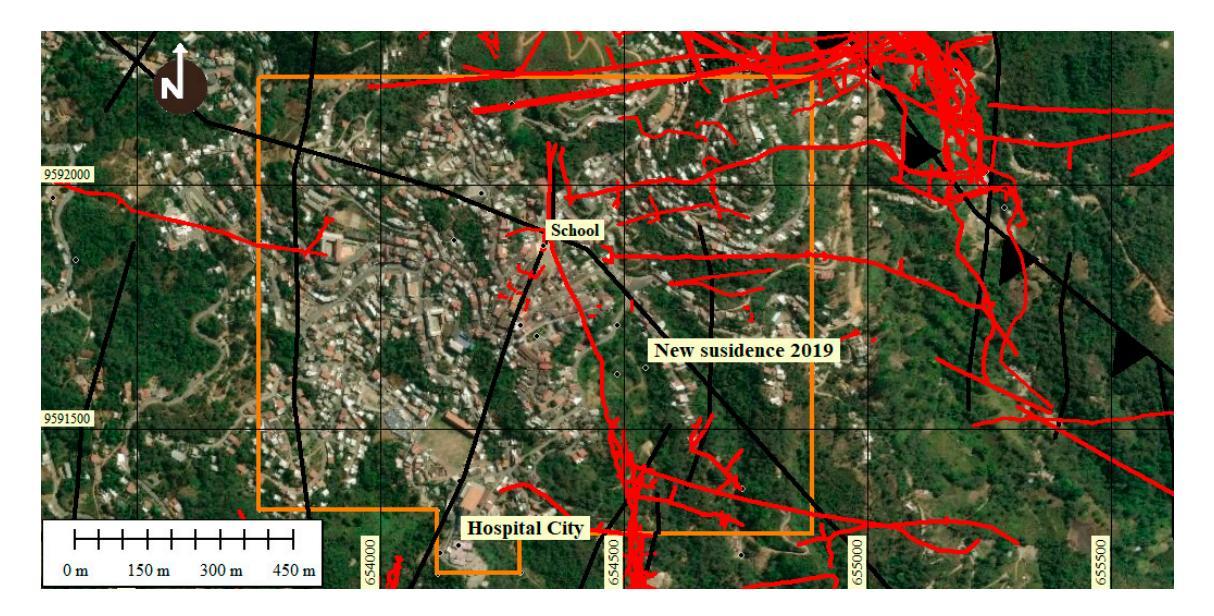
Figure 5. Underground locations of mining galleries outside and within the exclusion area of the Zaruma city. In ocher color, the Exclusion Zone polygon, the mining galleries from the center to the east in red lines, the mineralized structures and geological faults in black color lines. Dots black color are bocamines. Data source: Risk Management Secretariat.

There are historical studies that report severely damaged buildings, possibly due to being in subsidence areas in the Colonial Center of the Zaruma city. Figure 5 shows the location of the city, the mining exclusion area (ocher color), the underground mining galleries (red lines) in the central part and to the east, the veins and mineralized structures a geological faults (black color lines). In the western part, there are no surveys of mining galleries except for one represented with a red color line (possibly, there is no survey of the mining cadaster in this area).

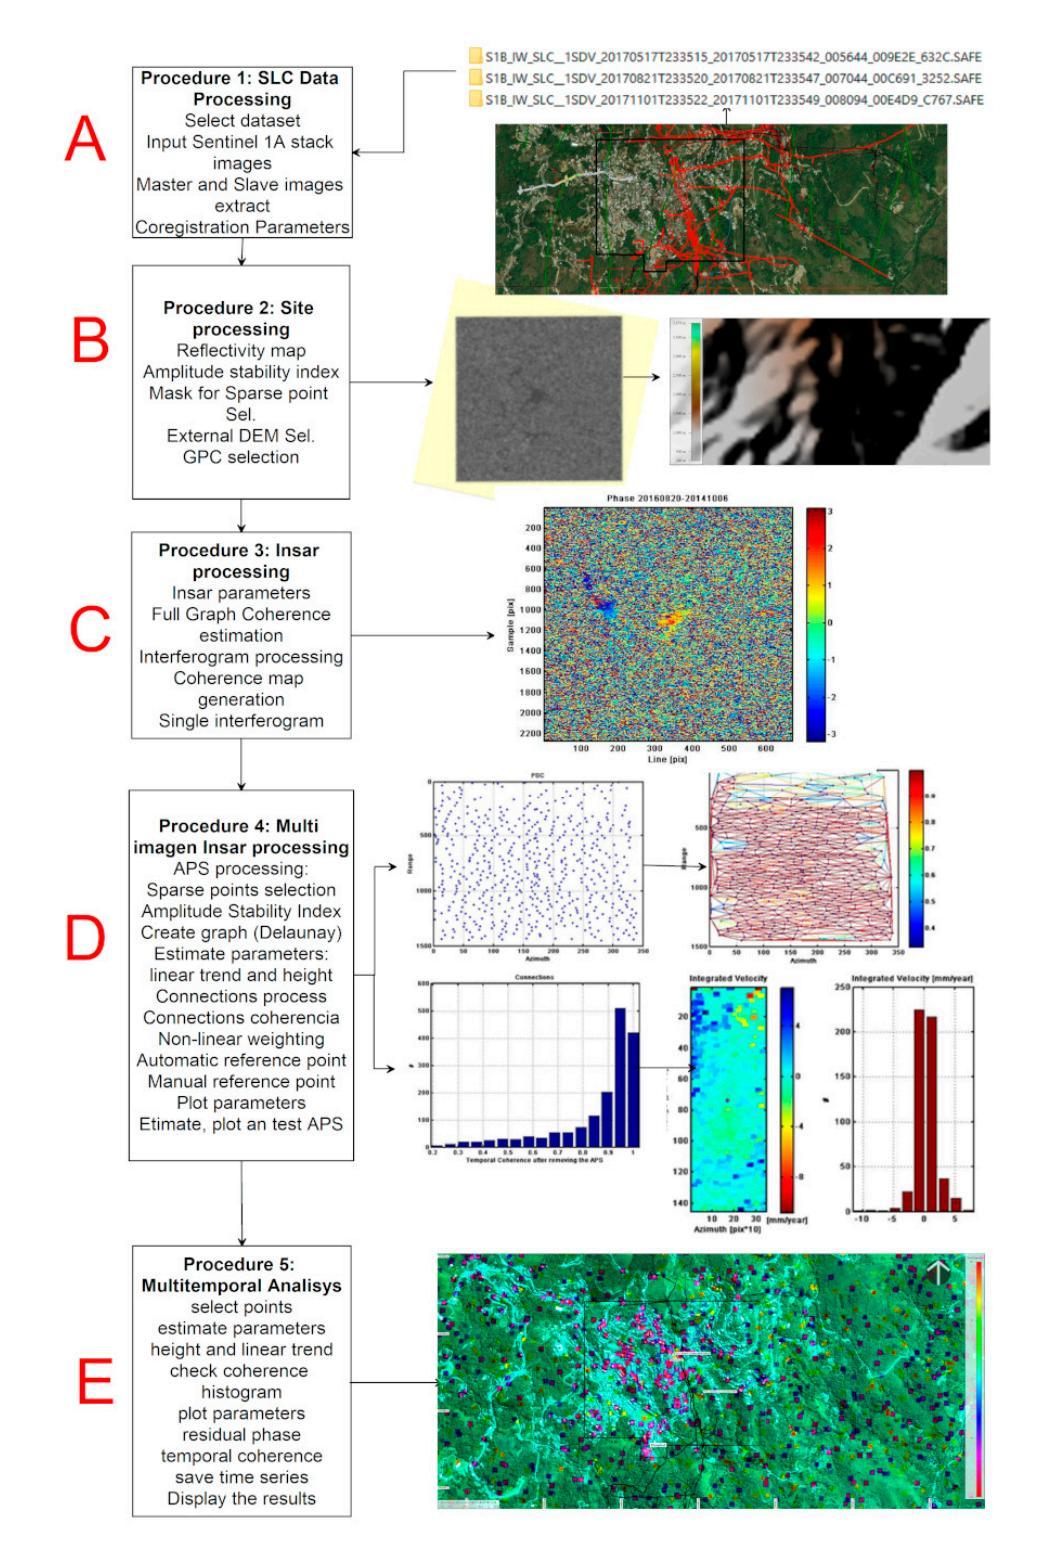
Figure 6. The SARPROZ software process used to obtain the relief deformations by DInSAR analysis. Steps (**A**–**E**) of each portion of the routine. See text for further explanation.

To analyze the multitemporal displacement of the Fe y Alegría-La Inmaculada School, the available images of Sentinel 1 B, on the stack [30] were used to obtain results before the beginning of the collapse in the school (26 October 2016), and during the evolution of the deformation of the land, until the reactivation of the sinking in the site and the new sinking in Gonzalo Pizarro Street. The project followed standard interferometric process in the SARPROZ software, according to the flow chart of Figure 6 [32–34].

Procedure 1: SLC (A) data processing to import or update extracted data from Sentinel 1 images. Master and slave images are extracted and defined by selecting them manually or automatically. In the star chart in Figure 7A, the master image is close to half the perpendicular and temporal baseline domain between 1B and right, to try to minimize the effects of normal and temporal baselines. Finally, the Co-registration Parameters of the pixels of the corresponding master and slave images are defined for the elaboration of interferograms correctly.

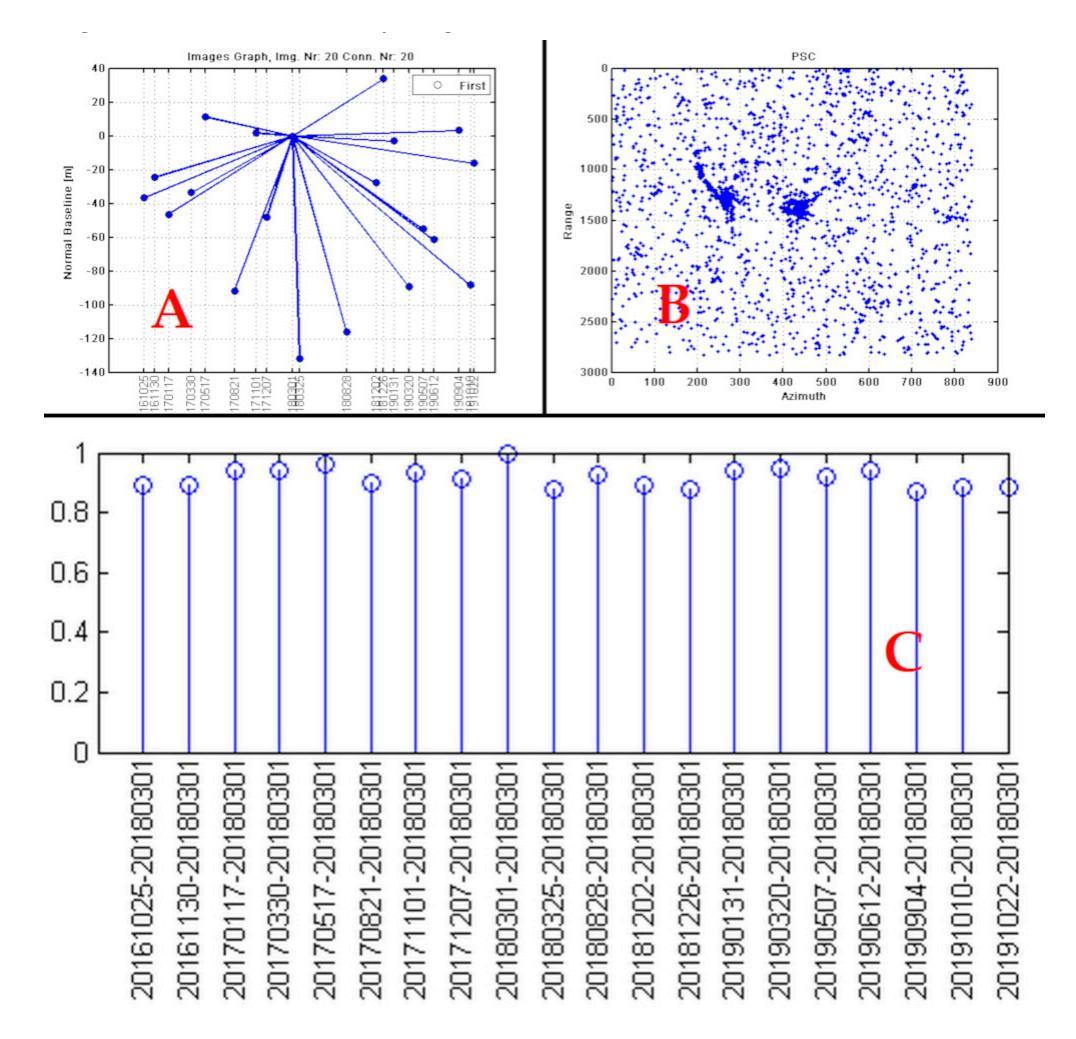
Procedure 2: is called Site Processing (B), in which preliminary parameters of the images such as the reflectivity map are extracted, from the average time reflectivity of all the images in the stack. The amplitude stability index is calculated which is a unique number that provides a statistical property of the amplitude series with ranges between 0 and 1. A mask is generated for the selection of the scattered points based on a threshold value of the index of amplitude stability, whereby values above the threshold enter the interferometric process and values below this threshold will be masked and will not enter the process, Figure 7B. Select an external Digital Elevation Model (DEM), to eliminate the topographic phase and geocode the images with the option Ground Control Point Selection-GPC, for orbital correction, flattening of interferograms and definition of persistent dispersers. The basic characteristic of a DEM is that it has positioned reference points; in this case, it is in relation to the Shuttle Radar Topography Mission -SRTM- that has a high degree of confidence in its position. Other external DEMs of various spatial resolutions can be used, provided they have stable static reference points (stable reflectors) that have not changed over time. Finally, the complete graphic coherence is calculated, to estimate the coherence of all the possible connections (interferograms) in the image scene.

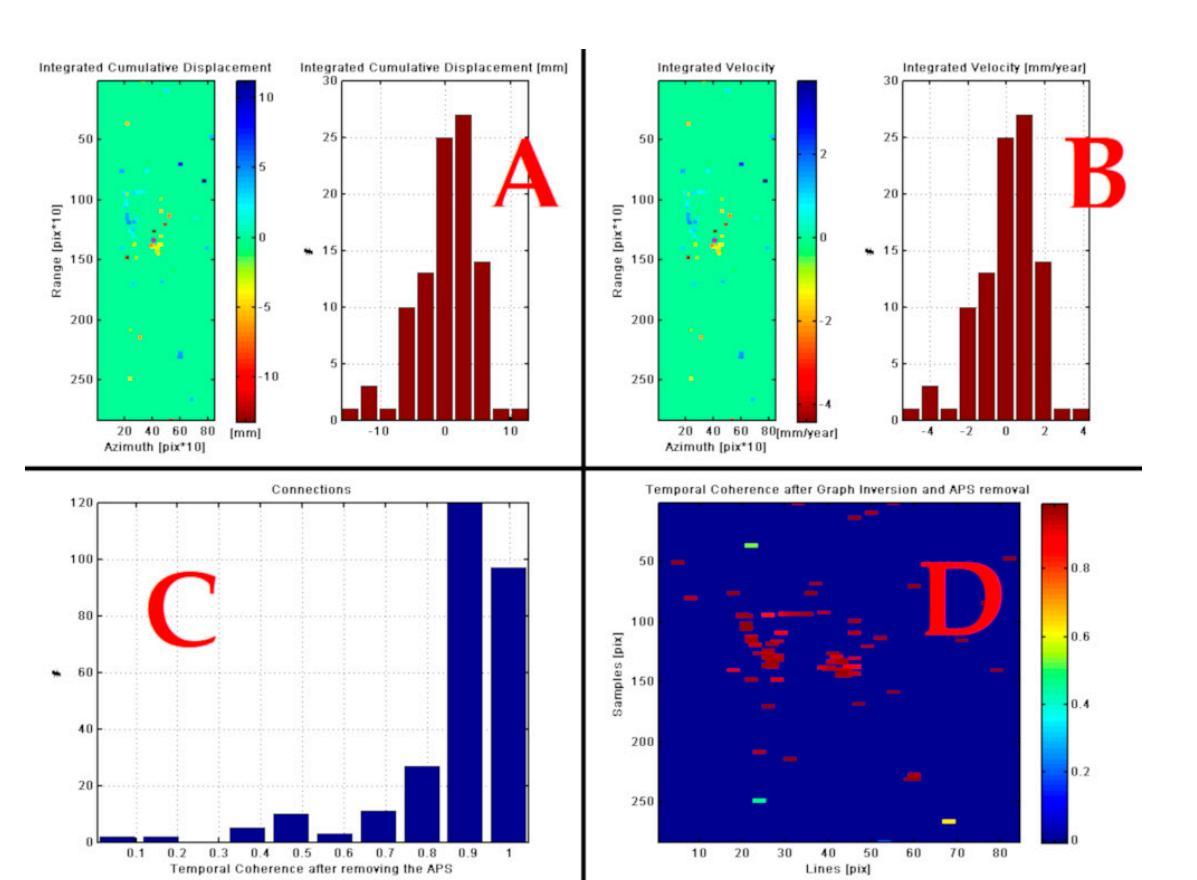
Figure 8. (**A**) Histogram of integrated cumulative displacement connections, (**B**) Integrated velocity, (**C**) Histogram and Temporal Coherence after removal of APS noise (**D**).

The histograms verified that the connection speed and the connection residual height are consistent in the distribution of the residual value of travel velocity (mm/year) / height (m), as presented in Figure 8A–C, where a histogram is seen, without jumps and high coherence (connecting lines with a red tendency), Figure 8D.

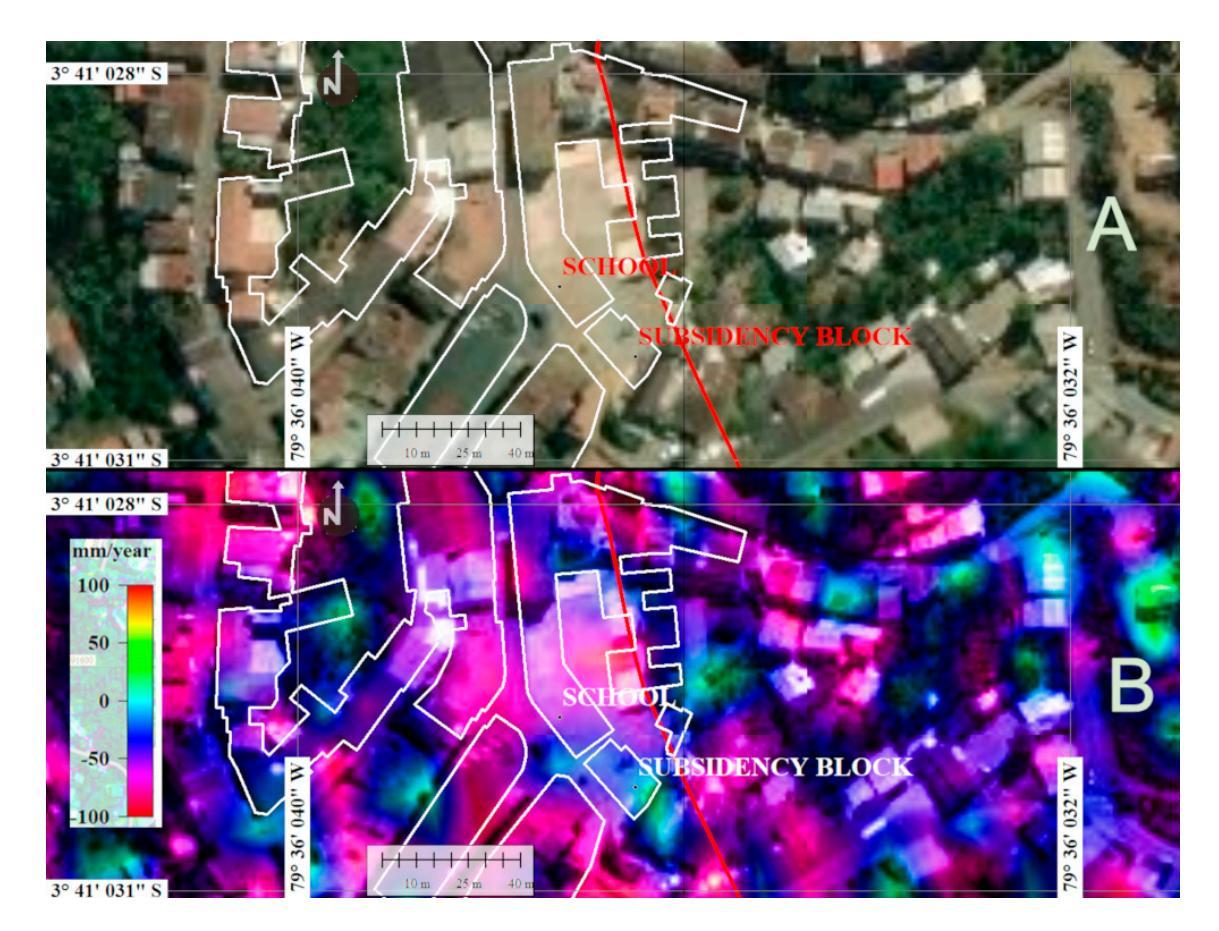
Figure 9. (**A**) Location of Fe y Alegría-La Immaculada School in the study area before the collapse of the block of school classrooms. (**B**) Block collapse of school classrooms on October 25 of a day before the collapse that began on October 16, 2016, and completely collapsed in December 2016. The faint blue color indicates that before October 25, 2016 the sinking of the area was in process. Gallery is in red color and blocks houses are in white color.

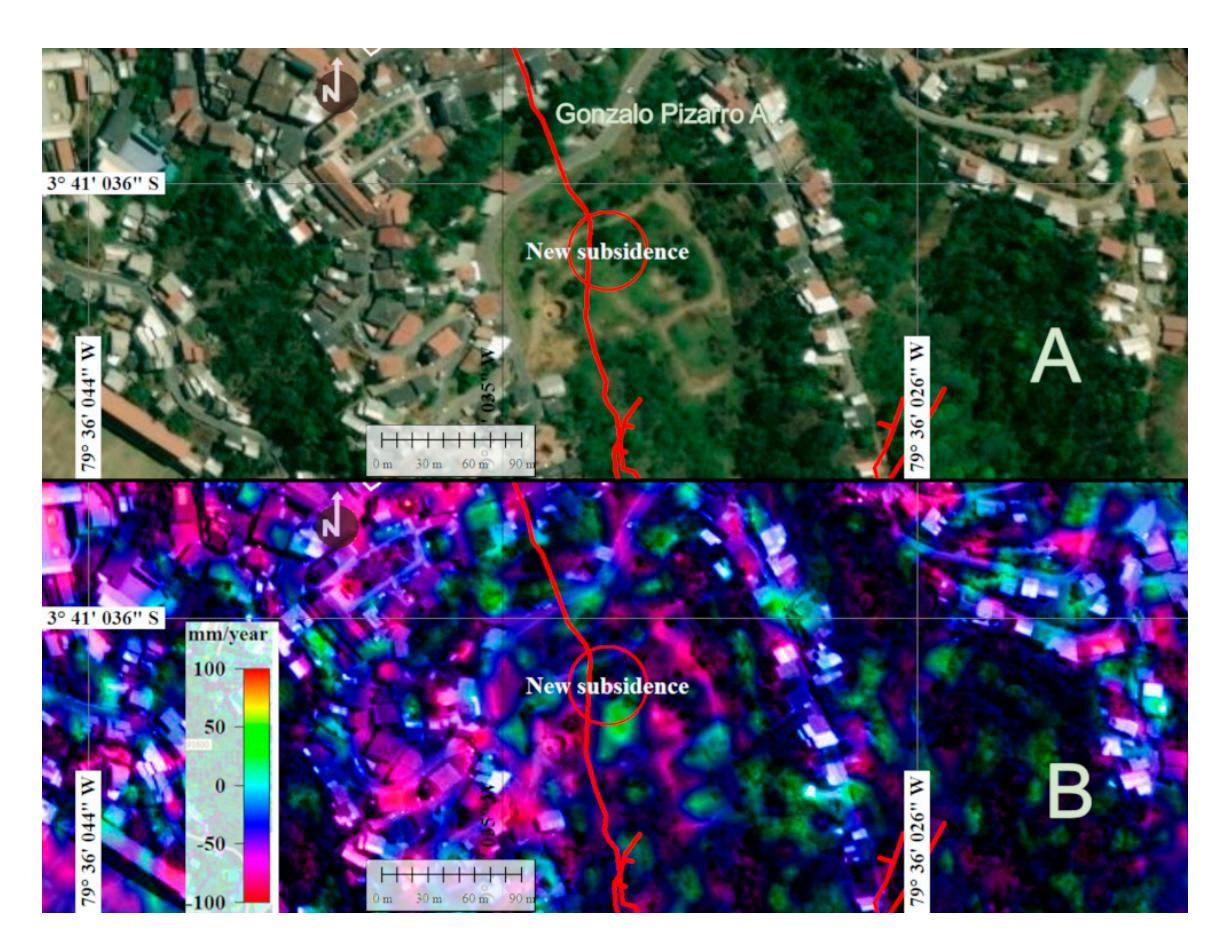
Figure 10. (**A**) Sites of new subsidence in Gonzalo Pizarro Street in August–September 2019. (**B**) The intense blue represents a range of high subsidence.

The results of the interferograms obtained from the stack between 25 October 2016 to 22 October 2019, show that the subsidence processes were in progress producing a new subsidence on Gonzalo Pizarro Street (Figure 10).

The reclassified images of subsidences currently occurring in the city obtained by the InSAR method have a more detailed value than those presented in images 9 to 13 in a range of 20 mm/year (lifting relief) to -30 mm/year (subsidence relief) with an error of +/-5 mm, therefore InSAR performs a quantitative analysis since it starts from points that it identifies on the ground as stable and are geo-referenced in a coordinate system (in this case UTM; WGS84; 17 Sur Zone), to determine the elevation difference of the same point taken in two different periods of time and prepare the interferogram. This is presented in the following image. The images obtained demonstrate the ranges of subsidence that currently occur in the sector in a period of time 2016 to 2019, which is in values similar to the ranges of displacement obtained by the INIGEMM that are 15 mm in two months (very short time to have more real data) (Figure 10).

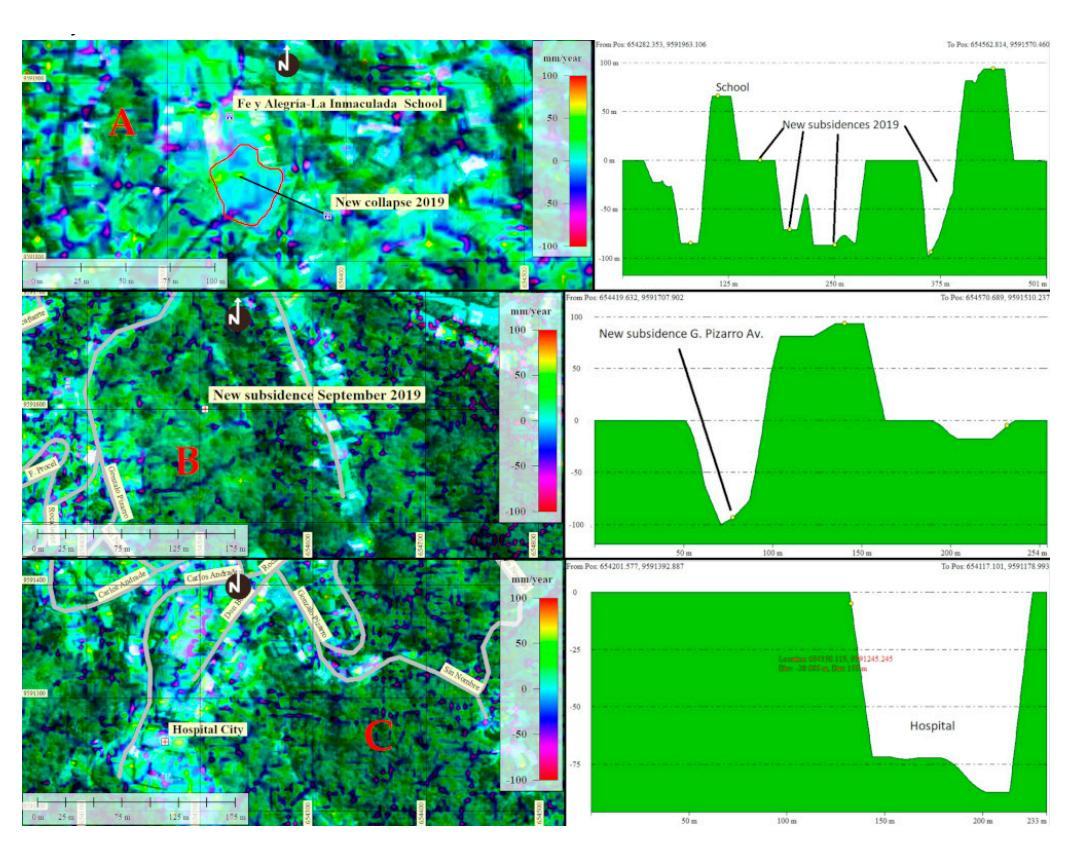
Figure 11. (A) Lifting velocity and subsidence of the ground at Fe y Alegría School (**A**), Gonzalo Pizarro Street (**B**), the city hospital(**C**), obtained from the interferometric analysis. These results corroborated previous studies and verified the analysis performed in this article.

Figure 11 shows the velocity of elevation and subsidence of the terrain within a range of -20 to 50 mm, to classify the most accurate rank levels at the site. (A) The new collapse in the Fe y Alegría school, (B) the new subsidence in Gonzalo Pizarro Street and in (C) the subsidence that are occurring in the city hospital, among other places that were analyzed by the authors in 2001 [2] and served to verify the results of this article.

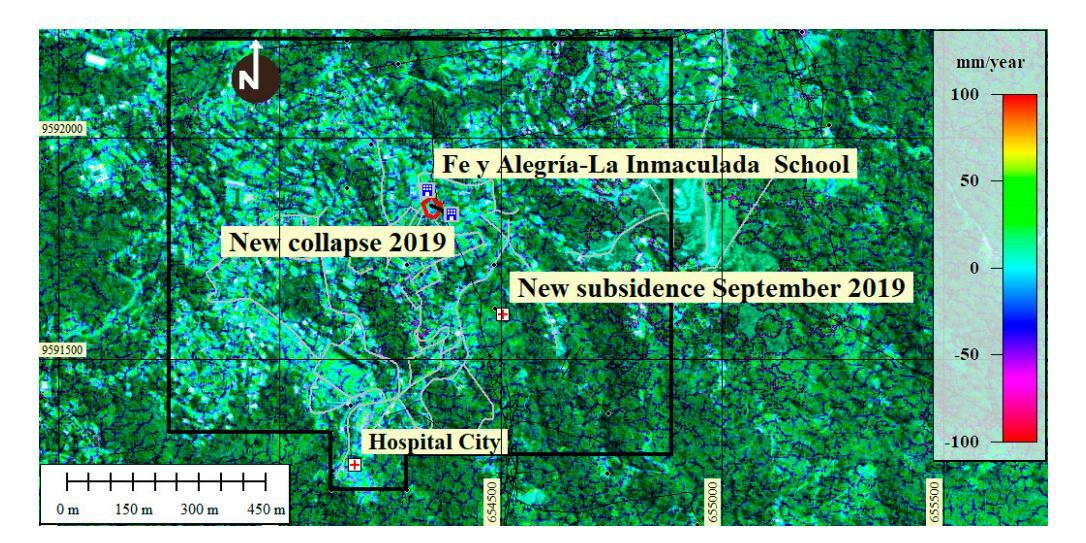
Figure 12. Determination of the "traces" (blue stripes) of connections of unmapped mining galleries. These galleries, generally illegal and abandoned, are connected to mineralized veins and legal mapped galleries, breaking the balance of the rock mass, intensifying the subsidence of the topographic surface of the sector.

The correlation of the subsidence areas that occurred in 2001, 2016 and 2019 through the interferometric analysis performed with the DInSAR methodology and correlated with the geotechnical and subsidence investigations carried out by INIGEMM and the thesis author [36] (Figure 12), allowed the determination of progressive surface deformations that can cause current subsidence mainly in several sectors and its neighborhood.

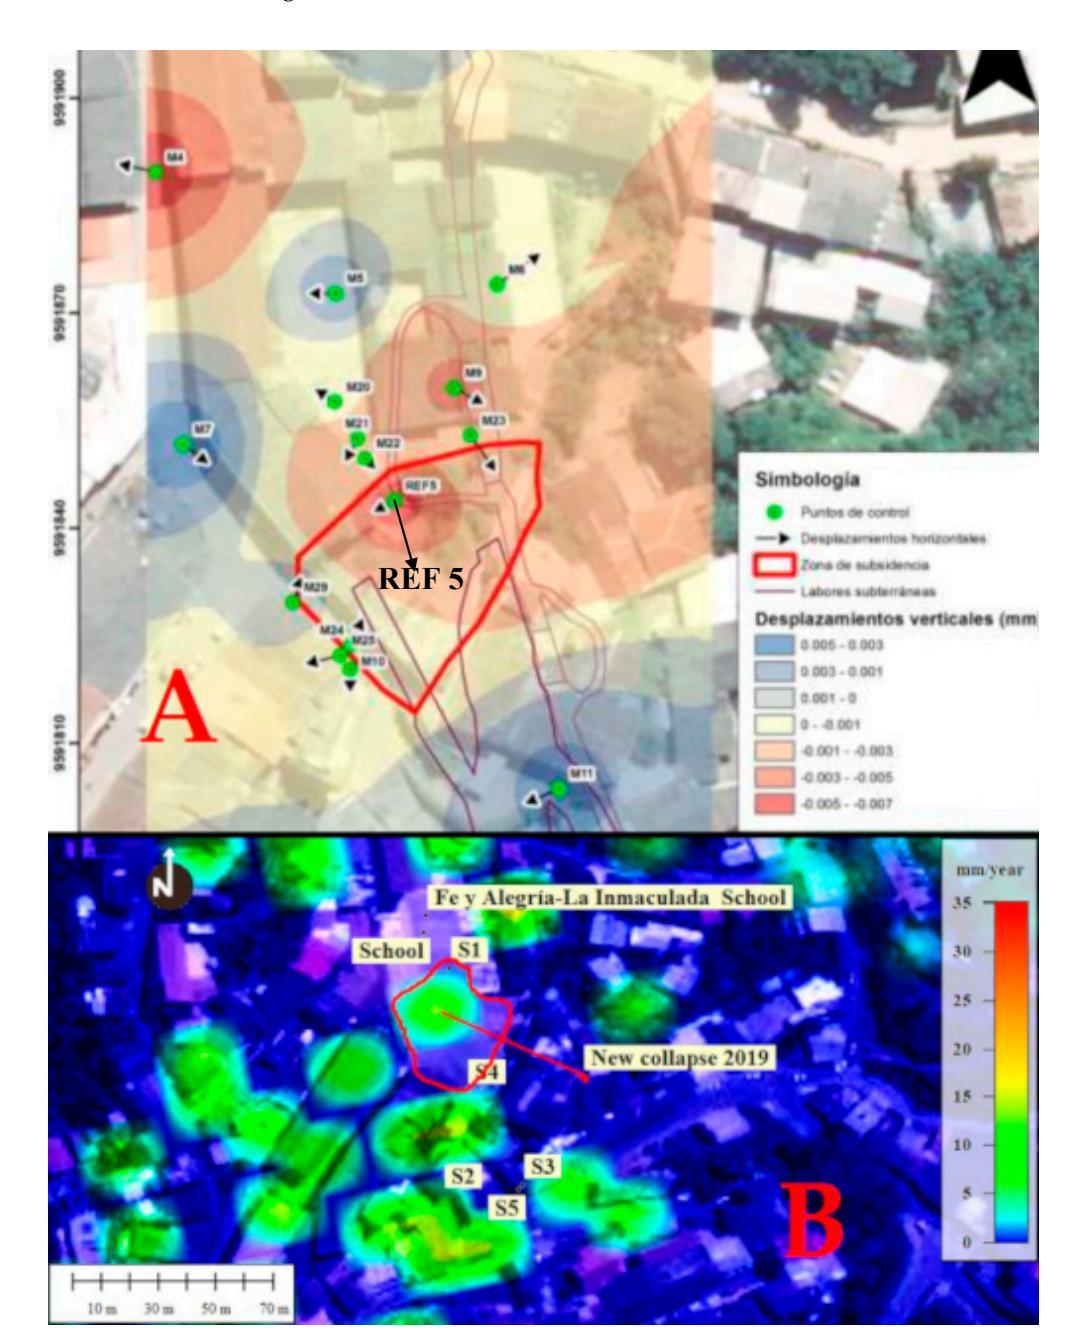
Note the correlation between the sinking areas CF5 of Figure 13A and the new collapse occurred at the same site in 2019 of Figure 13B.

Figure 13. Correlation between the results obtained from areas of subsidence by InSAR Interferometry with the geotechnical investigations of subsidence carried out by INIGEMM and the author of the thesis [37]. Image 13A has low resolution since its origin. Note the correlation between the sinking areas CF5 of (**A**) and the new collapse occurred at the same site in 2019 of (**B**). S1 to S2 surveys conducted by INIGEMM.

Most interferograms reveal continuous surface movements in the central part of the exclusion zone of the city of Zaruma, at sites where several underground mining galleries were located (Figure 13).

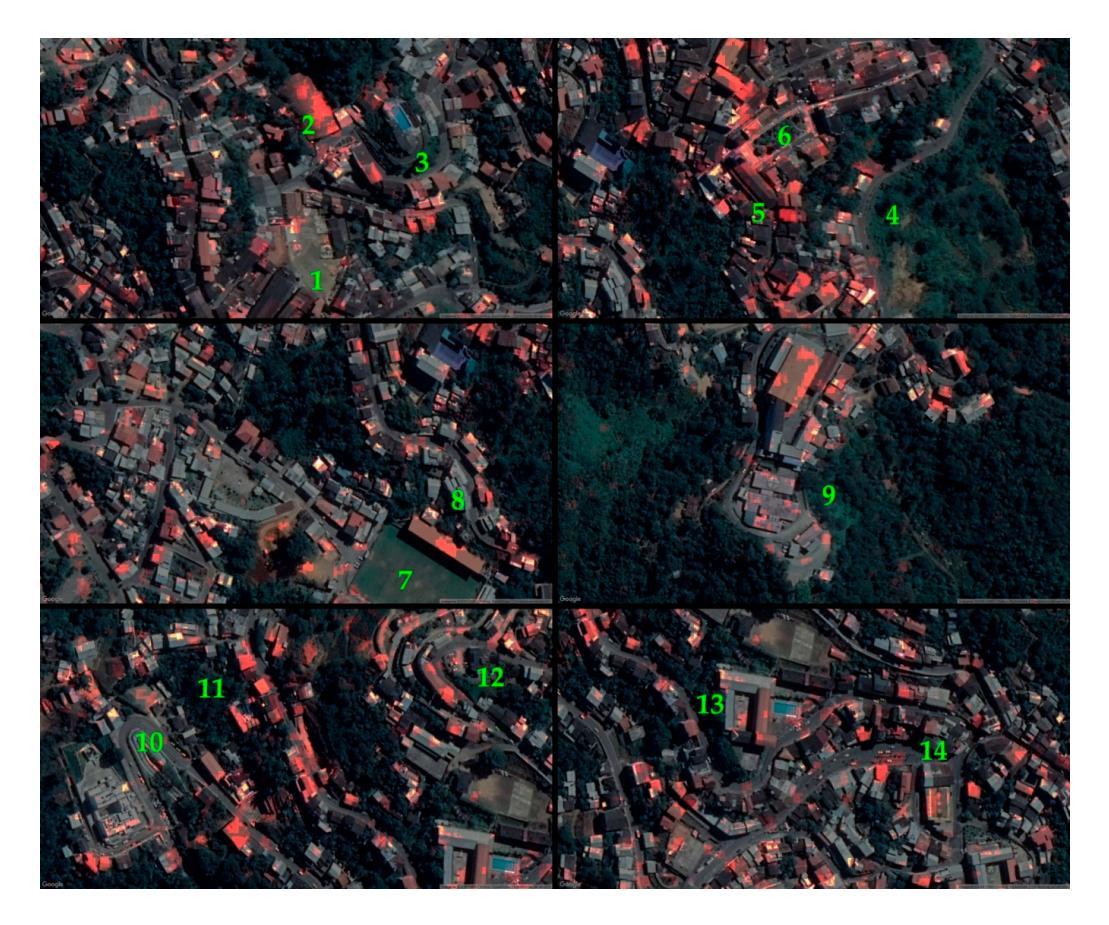
Figure 14. DInSAR analysis, determined that there are many constructions with potential sinkholes in some sectors of the city (red spots on the roofs).

The sectors that presently present subsidence according to the SAR interferometry study, can be seen in Figure 14 and are the following: the municipal market, the Fe y Alegría-La Inmaculada School (1), sports coliseum (2), municipal pool and jail (3), Gonzalo Pizarro Street (4), Church (5), Central Park and Municipality (6), City Stadium (7), El Oro Avenue, (8), City Hospital, San Juan Bosco School (9), Gil Gilbert Street (10), Roground Hotel (11), El Sexmo (12), November 26 School(13), Reinaldo Espinosa Street (14), among other sectors.
