Article Deformation Monitoring and Analysis of Reservoir Dams Based on SBAS-InSAR Technology—Banqiao Reservoir

Abstract: Most dams in China have been operating for a long time and are products of the economic and technical limitations at the time of construction. Due to decades of aging engineering and ancillary problems, these reservoirs pose great threats to the safety of local people and the development of the surrounding economy. In this study, the surface deformation information for the Banqiao Reservoir is monitored with the small baseline subset–synthetic aperture radar interferometry (SBAS-InSAR) method using 80 Sentinel-1A images acquired from 3 January 2020 to 20 August 2022. Additionally, ground measurements from the BeiDou ground-based deformation monitoring stations were collected to validate the InSAR results. Based on the InSAR results, the spatiotemporal deformation features of the dam were analyzed in detail. The results show that the deformation uncertain velocity of the Banqiao Reservoir dam and other hydraulic engineering facilities varies between -1 mm/y and -4 mm/y. The Ru River area has a relatively obvious subsidence trend, and the maximum subsidence veloci

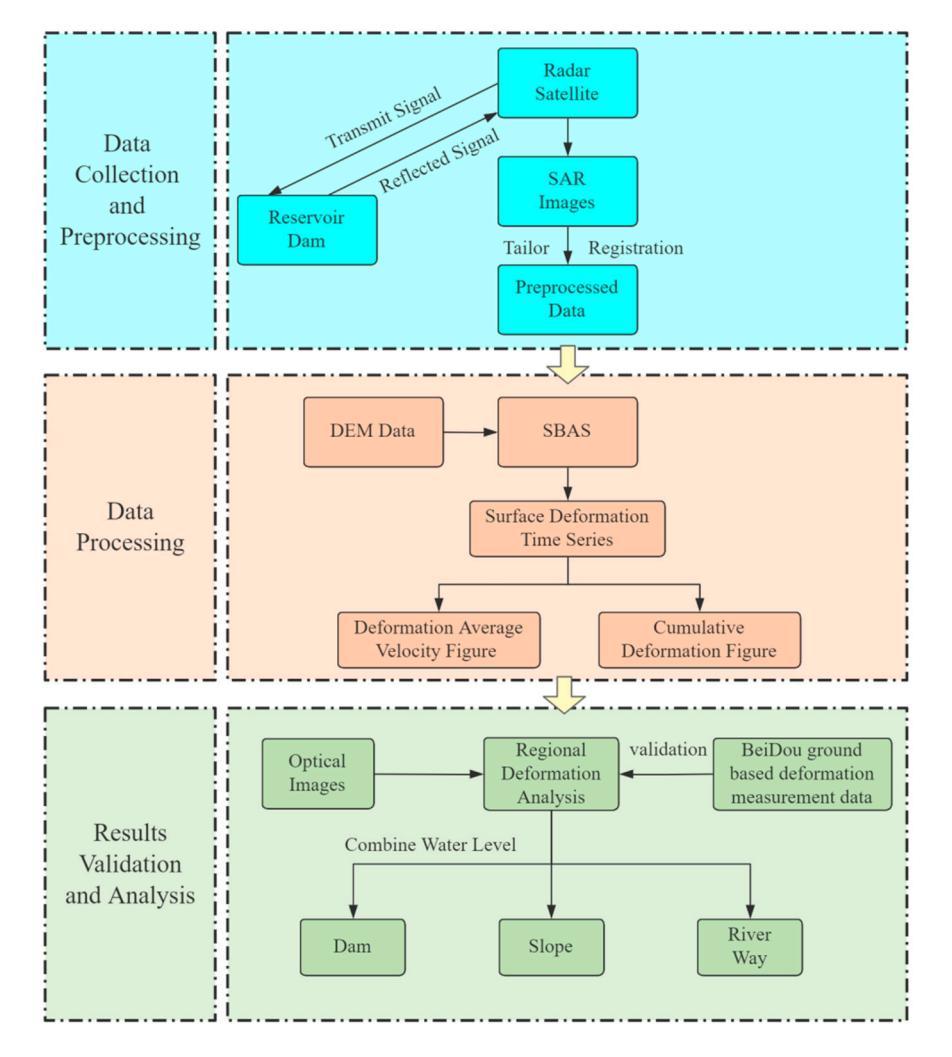
Figure 1. Flowchart showing SBAS-InSAR for reservoir dam monitoring.

The work processing flow presented in this paper is shown in Figure 1, which is divided into three main steps. First, this study obtained time-series SAR data for the study area and completed image tailoring and registration, as well as other preprocessing. Second, SBAS technology was used to invert the surface deformation time series. The basic steps included (a) setting the spatiotemporal baseline threshold to generate interferometric pairs; (b) applying interferometric processing to generate interferogram and unwrapping results; (c) screening the interferometric results; (d) refining and flattening the orbit; (e) estimating the deformation velocity and residual topography; (f) calculating the displacement within the time series and estimating and eliminating the atmospheric phase; and (g) geocoding. After processing, the average deformation velocity results and cumulative deformation results were obtained. Finally, this work studied the temporal deformation characteristics of different areas in the dam and analyzed the factors affecting the deformation combined with optical images and water level information.

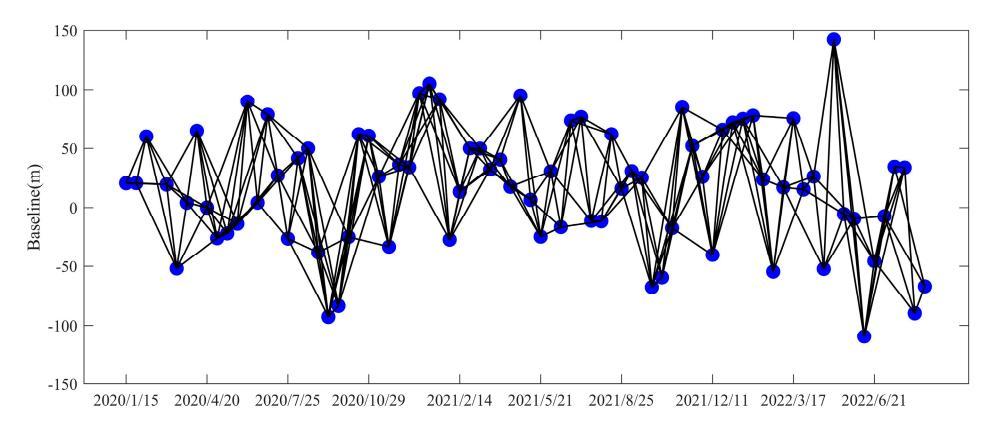
Figure 3. Spatiotemporal baseline for the SBAS-InSAR inversion.

The time baseline and spatial baseline thresholds were set to control the number of generated interferometric pairs, and after adjustment, a time baseline of 50 days was ultimately selected. The spatial baseline was set to 50% of the maximum baseline distance, which generated a total of 272 interferometric pairs for surface deformation parameter estimation. The time distribution of the data and the connection of the interferogram are shown in Figure 3. The data acquisition dates are shown in Table A1 in the Appendix A.

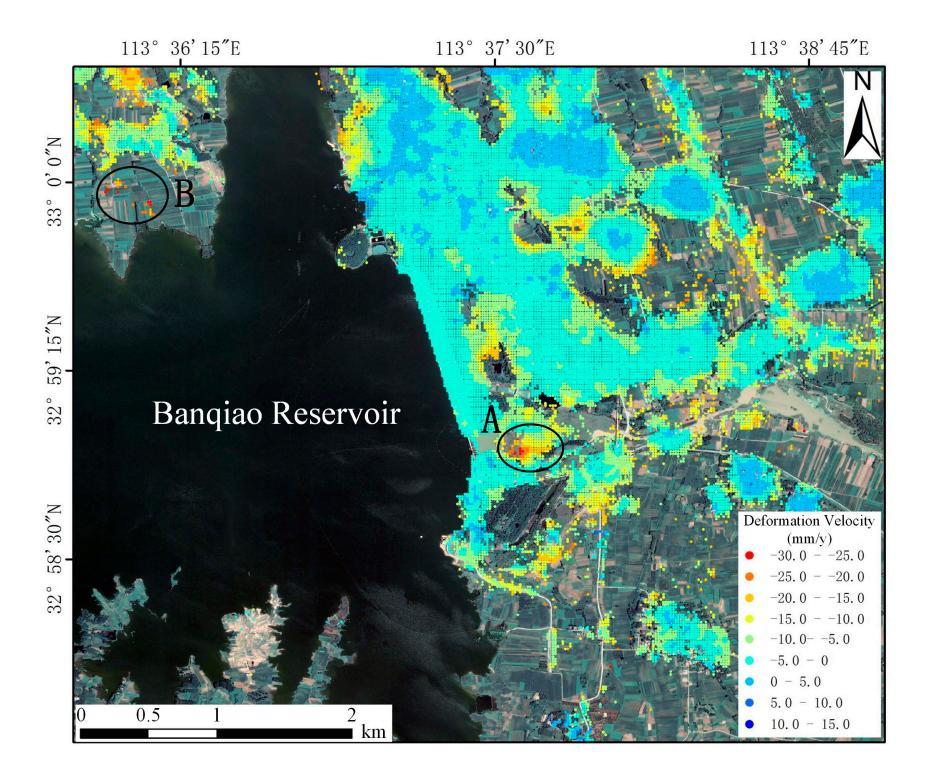
Figure 4. The average deformation velocity of the Banqiao Reservoir and surrounding areas. Area A is the Ru River area, and area B is cultivated land.

Figure 4 shows the overall deformation monitoring results for the Banqiao Reservoir obtained in this study. For better visualization, the corresponding optical image was set as the base image. The study period from 2020 to 2022 showed an overall stabilized state. The majority of the area was monitored for only slight deformation, with deformation velocities varying from -5 to 5 mm/y. However, for some areas, there was also a comparatively rapid velocity of deformation, and there was a certain degree of deformation. The areas with high deformation velocity were mainly concentrated in the Ru River area (Area A) and some cultivated land around the village (Area B), with a maximum deformation velocity of -30 mm/y.

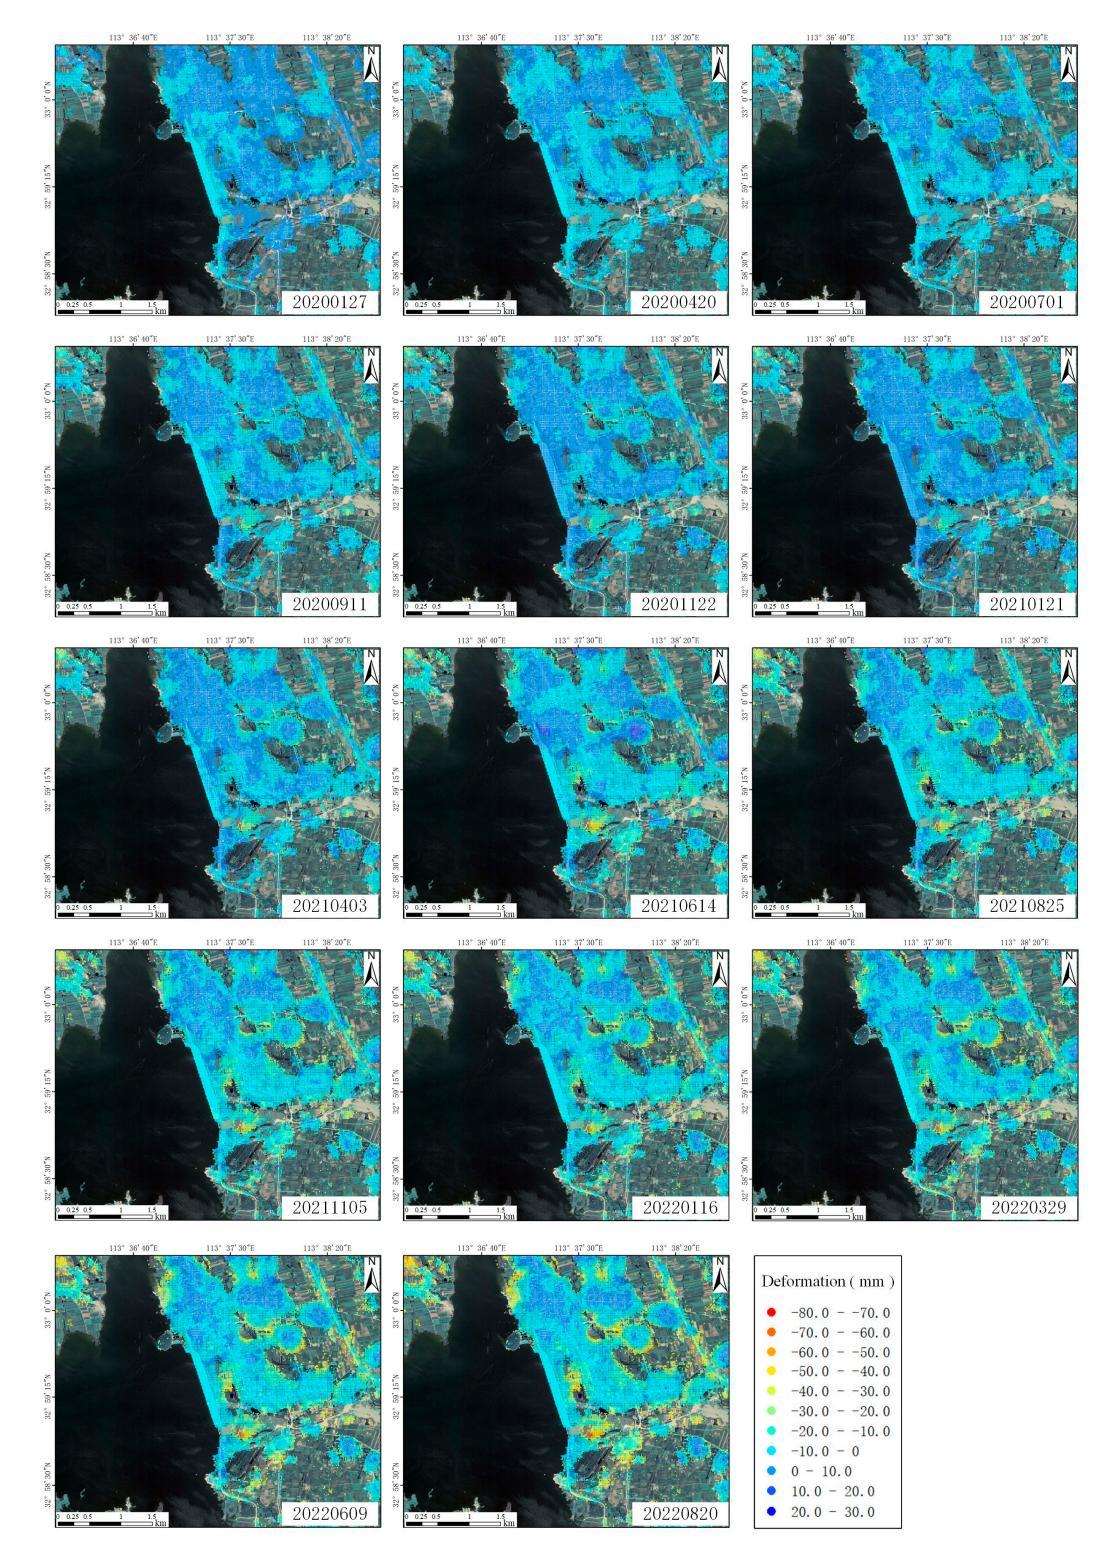
Figure 5. Cumulative deformation of the Banqiao Reservoir area from 2020 to 2022.

over 3 years in the study area, as shown in Figure 5. Throughout the observation period, the surface deformation of the hydraulic facilities and the surrounding area of the Banqiao Reservoir were generally stable, with a small range of fluctuations in time-series deformation variables. However, there was significant localized subsidence in the study area, mainly on the southern banks of the Ru River and on the cultivated or bare ground around residential areas in Banqiao town, with a maximum of 8 cm. In addition, the deformation of artificially constructed areas, such as houses and roads, was small and relatively stable.

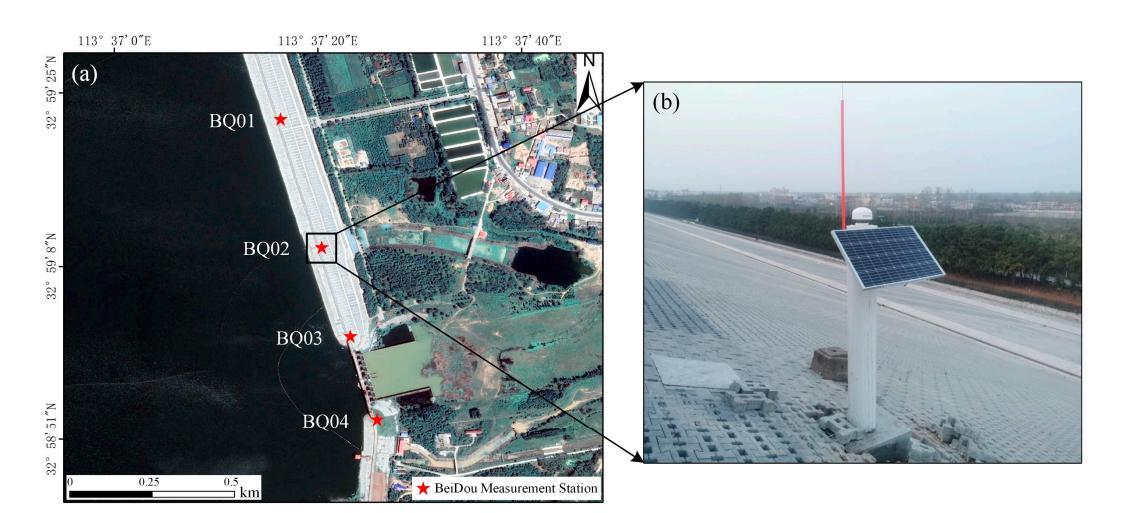
Figure 6. Distribution locations and the real scene at the BeiDou ground-based deformation measurement stations. (**a**) Location of the BeiDou measurement stations. (**b**) Image showing the BeiDou measurement station equipment.

To verify the accuracy of the InSAR monitoring results, the data from four BeiDou ground-based deformation measurement stations (BQ) at different positions in the Banqiao Dam were obtained to monitor the dam deformation. The distribution of the BeiDou ground-based deformation measurement stations is shown in Figure 6a. The deformation measurement data that overlapped with the Sentinel-1 data acquisition dates from July to August 2022 were selected for verification. The first phase was on 3 July 2022, recording the cumulative surface deformation at the monitoring points over a total of five phases. The data are shown in Table 1. Among them, the BQ02 monitoring point data were missing for 3 July 2022; thus, the data from 15 July 2022 were used to indicate the first phase.

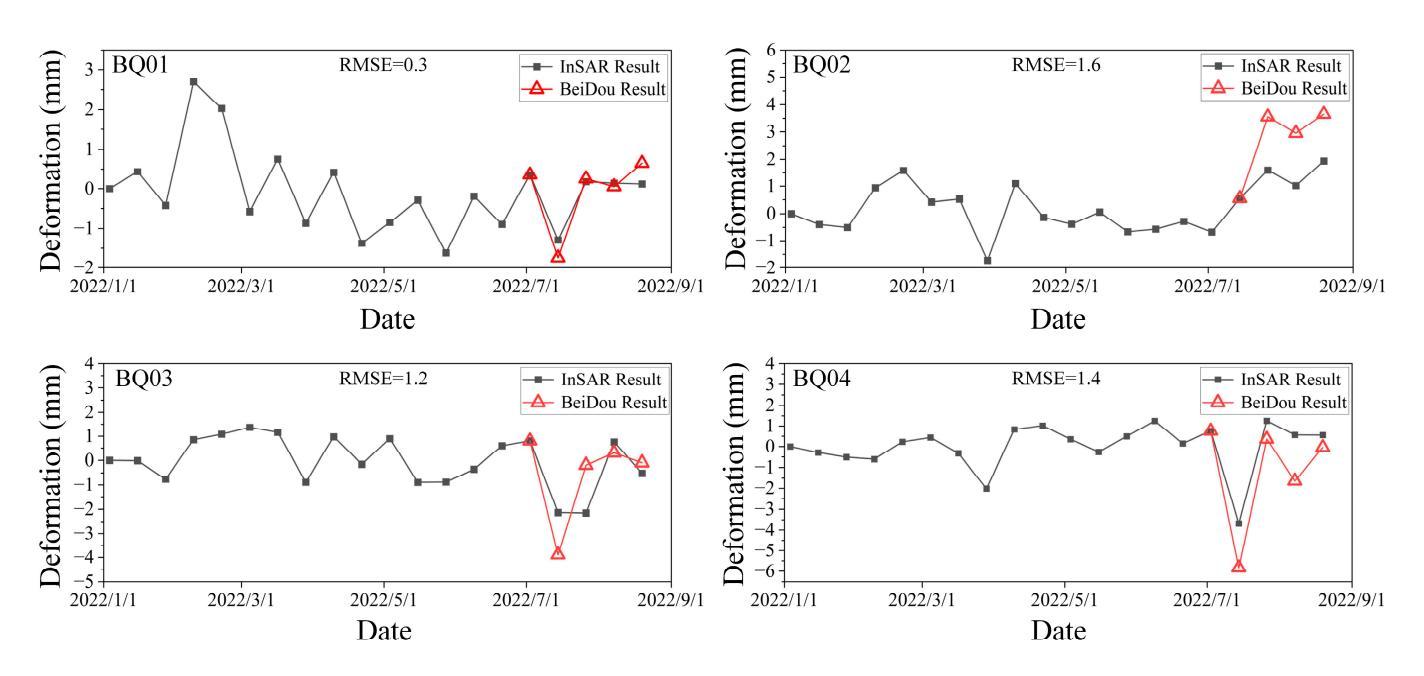
Figure 7. Comparison of BeiDou ground-based deformation measurements and InSAR monitoring results.

The InSAR monitoring points were selected and compared with the BeiDou groundbased deformation measurement data by applying the nearest-neighbor method. A comparison between the InSAR monitoring results and the ground deformation measurement data (Figure 7) showed that in the overlapping time range, there was good consistency between the trends and totals observed using both InSAR and the BeiDou ground-based monitoring stations. The root mean square error (RMSE) was used to measure the deviation between the InSAR monitoring values and the BeiDou ground-based deformation measurement values. The average RMSE of the four points BQ01, BQ02, BQ03, and BQ04 was 1.1 mm, which demonstrated that the InSAR monitoring results were reliable and useful for monitoring dam deformation.

The InSAR monitoring results were consistent with the change trend in the BeiDou groundbased deformation measurement data, but there was still a certain discrepancy between the two. This deviation may be caused by two aspects: (1). The latitude and longitude positions of the selected InSAR monitoring points and the BeiDou ground-based deformation measurement points do not completely align, and the different spatial positions lead to different deformation amounts and trends. (2). SBAS processing contains errors, such as atmospheric delay and phase noise, which cause deviations between the results and the true value.

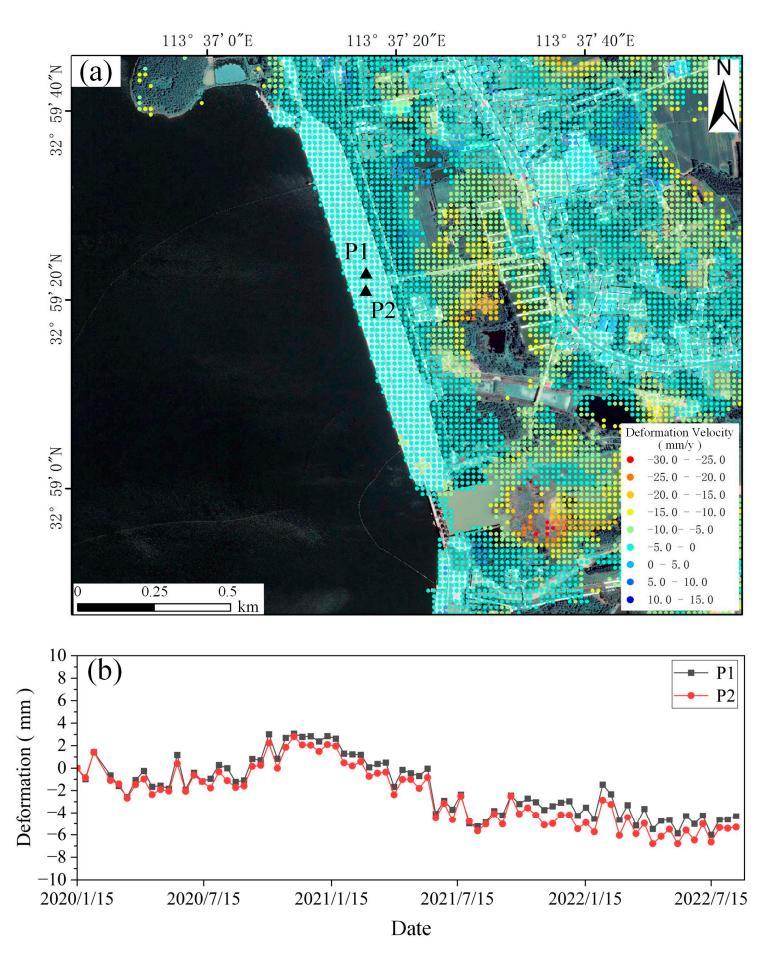
Figure 8. Dam body monitoring results. (**a**) The deformation velocity of the dam body. (**b**) The time-series deformation of the dam body.

Figure 8a shows the results for the subsidence velocity of the dam. In this study, two subsidence characteristic points, P1 and P2, were selected on the north bank of the dam area to study the subsidence in this area. The time series cumulative deformation fluctuation figure for both points (Figure 8b) shows that the deformation fluctuation in the dam is quite slight, the cumulative deformation is in the range of 4 to -8 mm, and the dam is comparatively stable. A short period of slow subsidence was produced in both August 2020 and August 2021. Beyond this period, slow uplift occurred, fluctuating within a certain range and showing cyclical variations. The reasons for the fluctuations were analyzed because of the high summer precipitation in the study area, resulting in a consequent increase in the amount of water stored in the reservoir, and the deformation may have some association with factors, such as changes in the amount of water in the reservoir. The rising water level in the reservoir increases the water pressure in the water table below the dam, causing the water table to rise. The rock and soil beneath a dam are subject to pressure from the water table, known as pore water pressure. As the water level rises, it changes the water pressure in the rock and soil underneath, causing the surface to lift slightly [24]. Therefore, this work considered the total water level data from this reservoir for further analysis.

The dam subsidence characteristic points were combined with the Banqiao Reservoir water level information from January 2020 to December 2021 to obtain the time-series deformation figure shown in Figure 9. The figure shows that between January 2020 and July 2020, there was a slight linear decrease in the reservoir level, during which time the dam deformation was comparatively stable with no significant fluctuations. In July 2020, a significant increase in the reservoir level occurred, followed by a surface rise at the dam, with a deformation variation of approximately 8 mm. Between October 2020 and March 2021, the water level in the reservoir remained nearly unchanged, while at the same time,

the deformation of the dam also stayed quite stable with almost no fluctuations. In April 2021, a short, slow increase in the reservoir level occurred; from May 2021 onward, the level started to decrease until it dropped to the bottom of the same year in July 2021. Over the same period, a slight uplift in the ground surface at the dam occurred, followed by a decline, producing a change of approximately 6 mm. Between July and September 2021, the reservoir level began to increase. An uplift in the surface of the dam occurred during the same period. Since October 2021, the water level has remained more or less constant, and the surface deformation of the dam has fluctuated slightly.

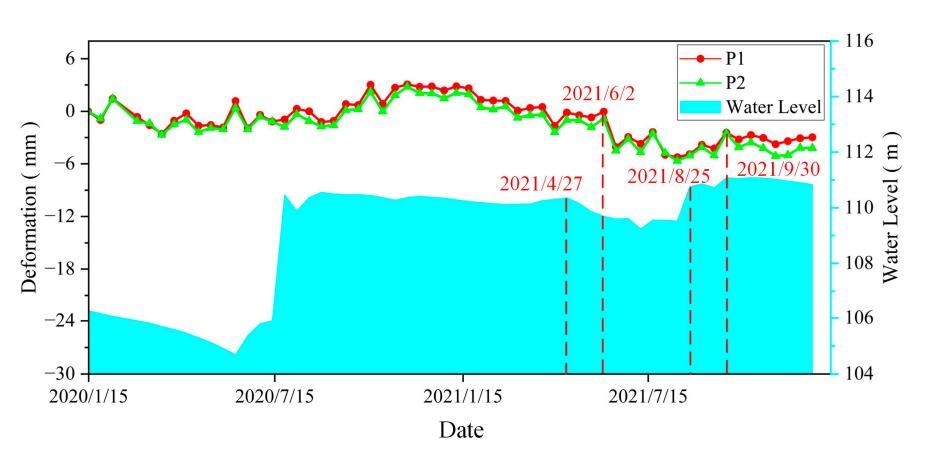
Figure 9. Time series showing the deformation in the dam study points combined with water level information.

Based on Figure 9 and the previous description, it is possible to conclude that the deformation tendency at the study point on the dam body shows a clear correlation with the water level variation in the reservoir. When the reservoir level decreases, the surface of the dam declines; when the reservoir level increases, the surface of the dam rises. From a temporal point of view, the deformation reaction in the dam is slightly later than the variation in the reservoir level. The variation in dam deformation occurs approximately 35 days after the variation in water level. The reason for the time delay between the water level changes in the reservoir changes, it affects the groundwater level at the dam site, which in turn affects the saturation in the rock and soil layers. However, the saturation process in the rock and soil layers takes time because it is influenced by the soil permeability and drainage path. This time delay can lead to a lag in the surface deformation response. Therefore, when the water level in the reservoir rises, the rock and soil layers gradually become saturated over time, and the associated surface deformation signal usually exhibits a certain lag effect. The same lag effect also exists when the water level drops.

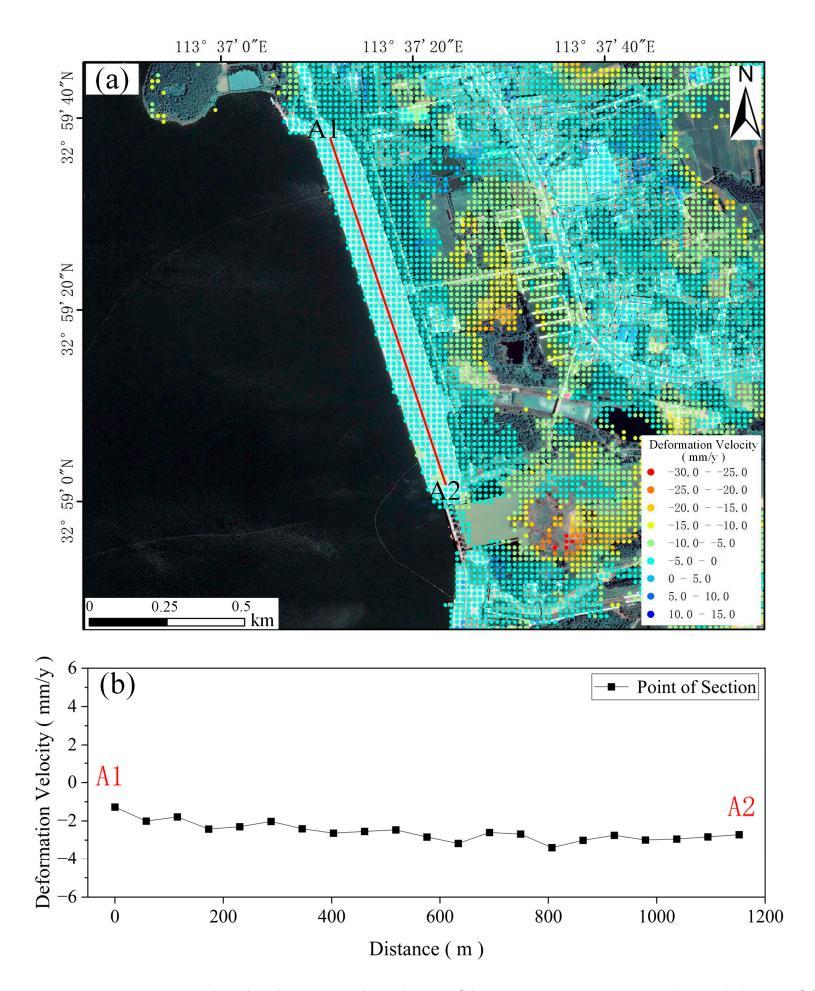
Figure 10. Dam body longitudinal profile monitoring results. (**a**) Profile line of the dam body. (**b**) Deformation profile.

To analyze the deformation of the dam, a longitudinal profile was taken of the dam region, labeled in Figure 10a using a single red line, and the two ends of the line were labeled A1 and A2. Information on the deformation data for the dam on this profile line was collected, and the deformation velocity law at the surface was analyzed. Figure 10b shows the deformation velocities covering this line, from which it is observed that the deformation velocities at the surface of the dam body were minor, with the data points all having deformation velocities in the range of -1 mm/y to -4 mm/y.

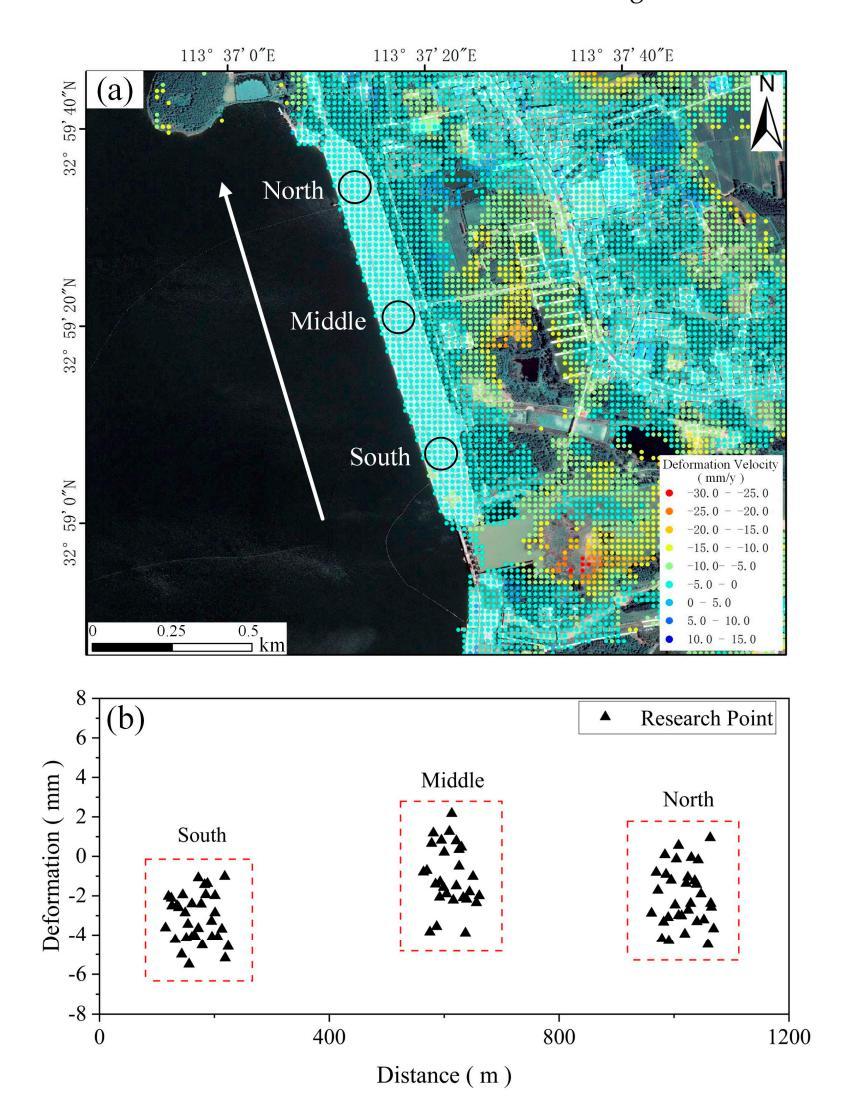
Figure 11. Dam deformation distribution monitoring results. (**a**) Selection of the dam deformation characteristic area. (**b**) Dam deformation distribution (from January 2020 to August 2022).

To explore the deformation characteristics of the dam in depth, as shown in Figure 11a, three regions in the southern, middle, and northern areas of the dam were selected from the dam body coherence points, and the cumulative deformation at each point was extracted for analysis. Figure 11b shows that slight subsidence occurred in the area south of the dam body. Some points in the middle and northern areas of the dam body subsided, and some points were uplifted. In addition, the number of subsidence and uplift points in the middle and northern areas were slightly different. Among them, the number of subsidence points in the number of subsidence points in the north was greater than the number of uplift points, but the overall deformation was minor. The cumulative deformation of the dam ranged from -6 mm to 3 mm.

The deformation velocity analysis of the dam body section and the deformation distribution in different regions of the dam body shows that there are certain differences in the deformation velocity and amount of deformation in various dam areas, although the overall variation is small, which indicates that the dam body deformation has good consistency.

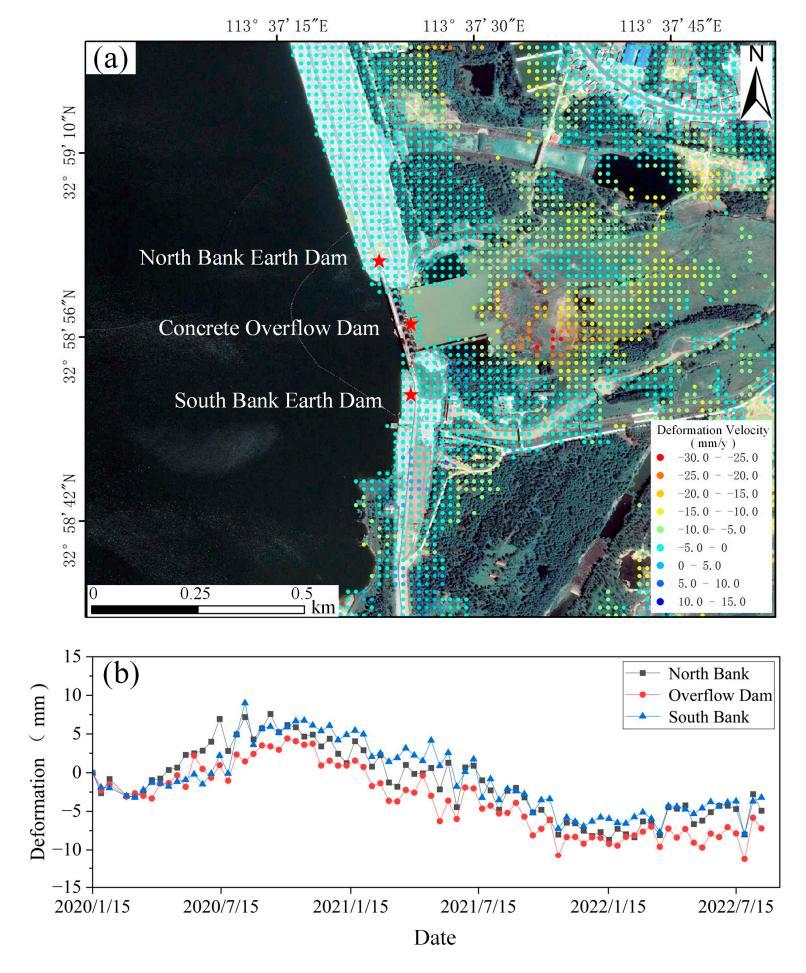
Figure 12. Monitoring results in different areas of the dam body. (a) Selection of points in different areas of the dam body. (b) Selection of points in different areas of the dam body.

The slope of the Banqiao Reservoir collapsed due to torrential rain in 1975. During the redevelopment process, the dam bodies on the north and south banks were earth dams, while the overflow dam was concrete. To explore whether the different structural materials at different positions of the dam body caused discrepancies in the degree of deformation in various dam areas, this study selected survey points at the earth dam on the south bank,

the concrete overflow dam, and the earth dam on the north bank and marked them with five-point red stars (Figure 12a). The deformation time series for each area was extracted for analysis.

Two study points were chosen in each region, and the mean value of their deformation time series was calculated to represent the temporal variability in the area, as shown in Figure 12b. The figure shows that the deformation trends in different locations were roughly the same, but the deformation amount in the spill dam area was slightly smaller than that in the dam on the north and south banks within the study time range. The possible causes of this slight difference are associated with the varied materials comprising the dam.

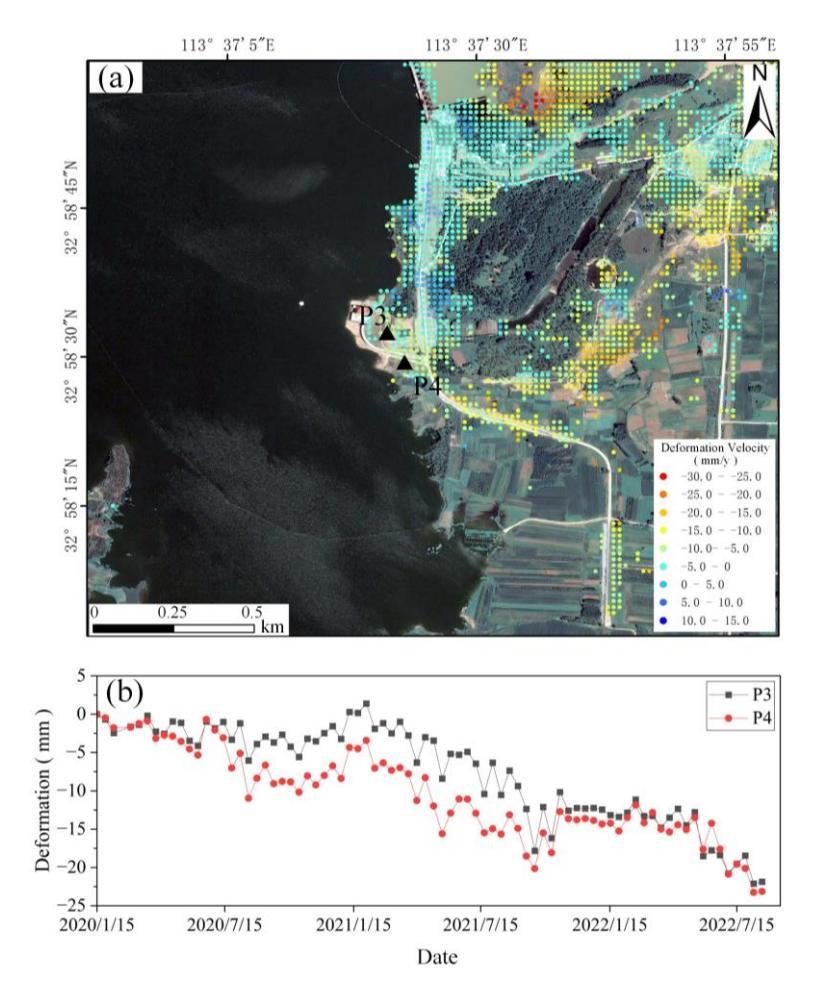
Figure 13. South bank slope monitoring results. (a) Slope deformation velocity. (b) Time series of slope deformation.

As illustrated in Figure 13a, to reflect the surface deformation law at the south bank slope area of the dam, two deformation feature points, P3 and P4, were chosen in the region for this study. From the cumulative deformation results for the time series of subsidence feature points in Figure 13b, it is evident that from January 2020 to January 2021, subsidence and uplift occurred successively in this area, and the amount of deformation was nearly the same. From February 2021 to September 2021, linear subsidence occurred in this area, and the subsidence amount was approximately 20 mm. After a brief uplift in October 2021, the deformation of this area stabilized. After May 2022, the area showed a subsidence trend of approximately 10 mm. On the basis of the available local information, the region was constructed as a fill, and the soil beneath the slopes of the reservoir was comparatively moist and loose. The cause of the greater surface deformation of this area is probably associated

with outside influences, such as rainwater scouring in precipitation and hydraulic erosion caused by the reservoir.

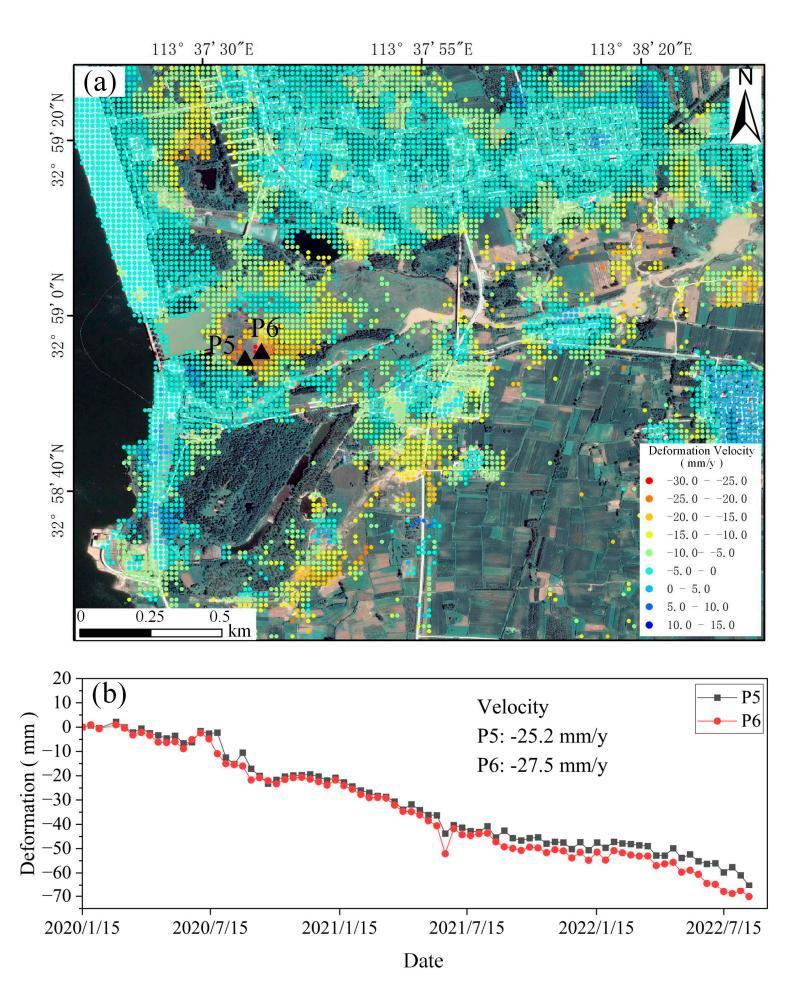
Figure 14. Ru River monitoring results. (a) Ru River deformation velocity. (b) Deformation time series of the Ru River.

Figure 14a shows the subsidence velocity, where the deformation velocity of the Ru River channel area was relatively large within the whole Banqiao Reservoir region. In this study, two subsidence characteristic points, P5 and P6, were selected in the region with greater deformation velocity on both sides of the Ru River, indicating the deformation of the region. The time-series deformation (Figure 14b) shows that from January 2020 to August 2022, the area had an average subsidence velocity and a deformation of approximately 70 mm over two years.

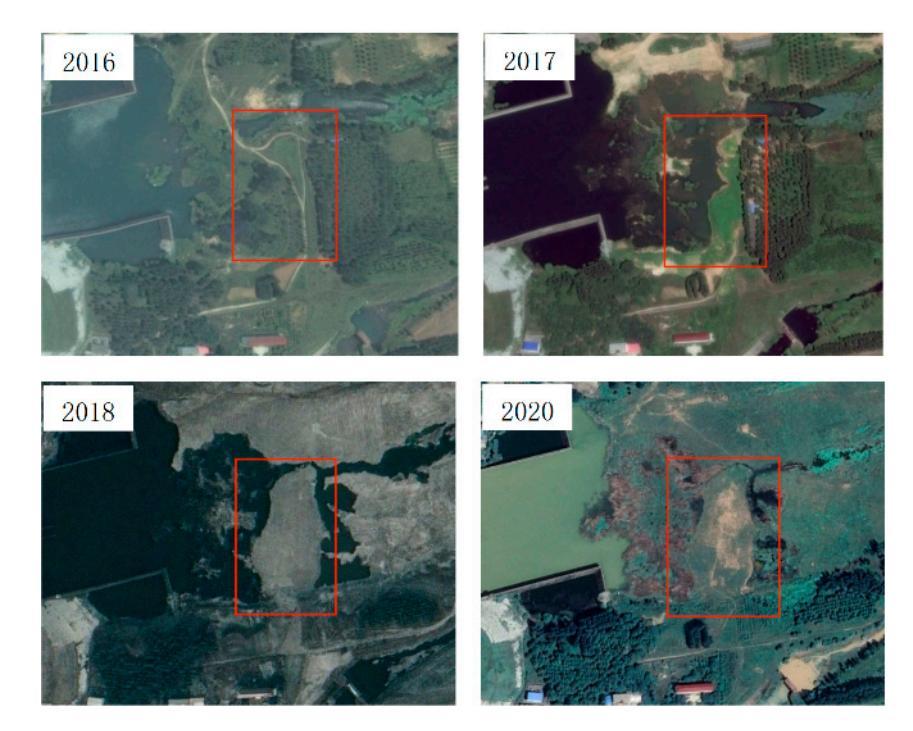
Figure 15. Optical image map showing the Ru River deformation feature points at different times.

To analyze the reasons for the subsidence in this area, optical images at different time points were selected, as shown in Figure 15. The figure shows that the subsidence area was located within a piece of land in the river near the overflow dam, which was covered with vegetation in 2016. Between 2017 and 2018, part of the surface was flooded with river water, and the area evolved from grassland to bare land. In 2020, the submerged area reappeared and was still bare. The reappearance of the submerged portions indicates that the river level fell, and the cause of the subsidence in this area may be related to the river level, the water level falling, and the surface subsidence. In addition, due to the high soil moisture in this area, it is relatively soft and vulnerable to scour by river water, which may also lead to ground surface subsidence.
