Article Characterizing Pavement Surface Distress Conditions with Hyper-Spatial Resolution Natural Color Aerial Photography

Su Zhang ^{1,*}, Christopher D. Lippitt ², Susan M. Bogus ¹ and Paul R. H. Neville ³

- ¹ Department of Civil Engineering, University of New Mexico, Albuquerque, NM 87131, USA; sbogus@unm.edu
- ² Department of Geography and Environmental Studies, University of New Mexico, Albuquerque, NM 87131, USA; clippitt@unm.edu
- ³ Earth Data Analysis Center, University of New Mexico, Albuquerque, NM 87131, USA; pneville@edac.unm.edu
- * Correspondence: suzhang@unm.edu; Tel.: +1-505-615-9896

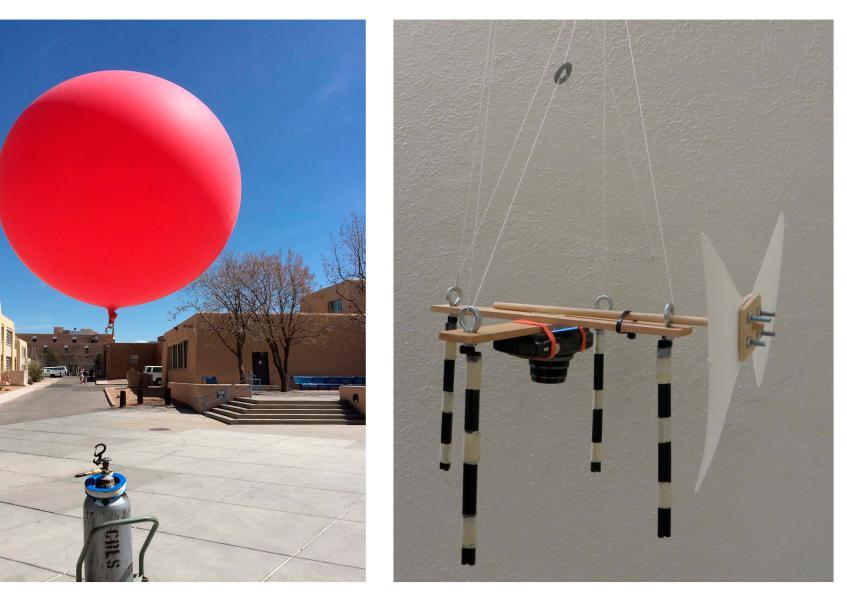
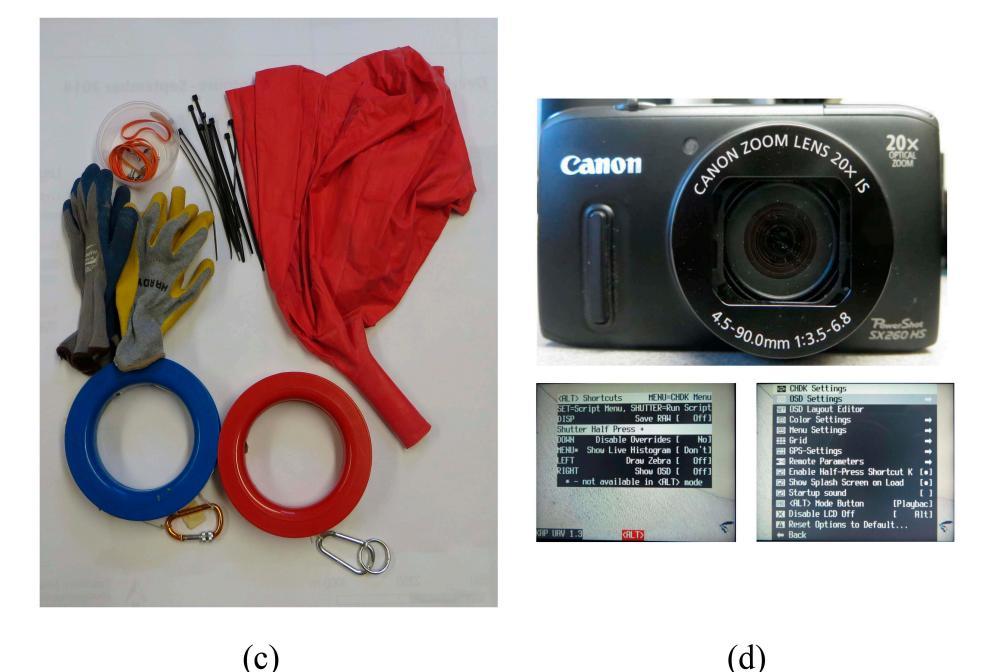
Figure 1. The helium weather balloon small-unmanned aircraft system (S-UAS); (**a**) a filled helium weather balloon and a helium tank; (**b**) customized rigging and mounted Canon SX260 HS digital camera; the characteristics of the rigging are lightweight, durable, resilient, capable of protecting the sensor, capable of removing the string in the aerial images and capable of dynamically adjusting the sensor position (*i.e.*, the lens always facing down the nadir or principal point); (**c**) balloon mapping kit, including a balloon, reels, gloves, rubber bands, and zip ties; (**d**) front facet of Canon SX 260 HS digital camera and Canon Hack Development Kit (CHDK) graphical user interface (GUI).

A low-altitude AGL and low-cost S-UAS was constructed to simulate the collection of HSR-AP from other untethered low altitude AGL S-UAS that are now common in the marketplace. This system includes a tethered helium weather balloon with custom-designed rigging based on the Picavet suspension system, as suggested by the Public Lab [43]. As mentioned in the previous section, a tethered helium weather balloon is permitted to fly in the United States of America as long as the flight meets the rules about location and altitude. The sensor affixed to the platform was an off-the-shelf small-format Canon SX260 HS digital camera. This camera has a 12-megapixel Complimentary Metal-Oxide Semiconductor (CMOS) detector array collecting in the visible blue, green, and red wavelength bands through Bayer array sampling and a built-in GPS unit. A firmware enhancement application known as the Canon Hack Development Kit (CHDK), was used to permit more control over the operation of the Canon SX260 HS camera, including shutter speed, shutter lag, aperture size, and intervalometer (Figure 1).

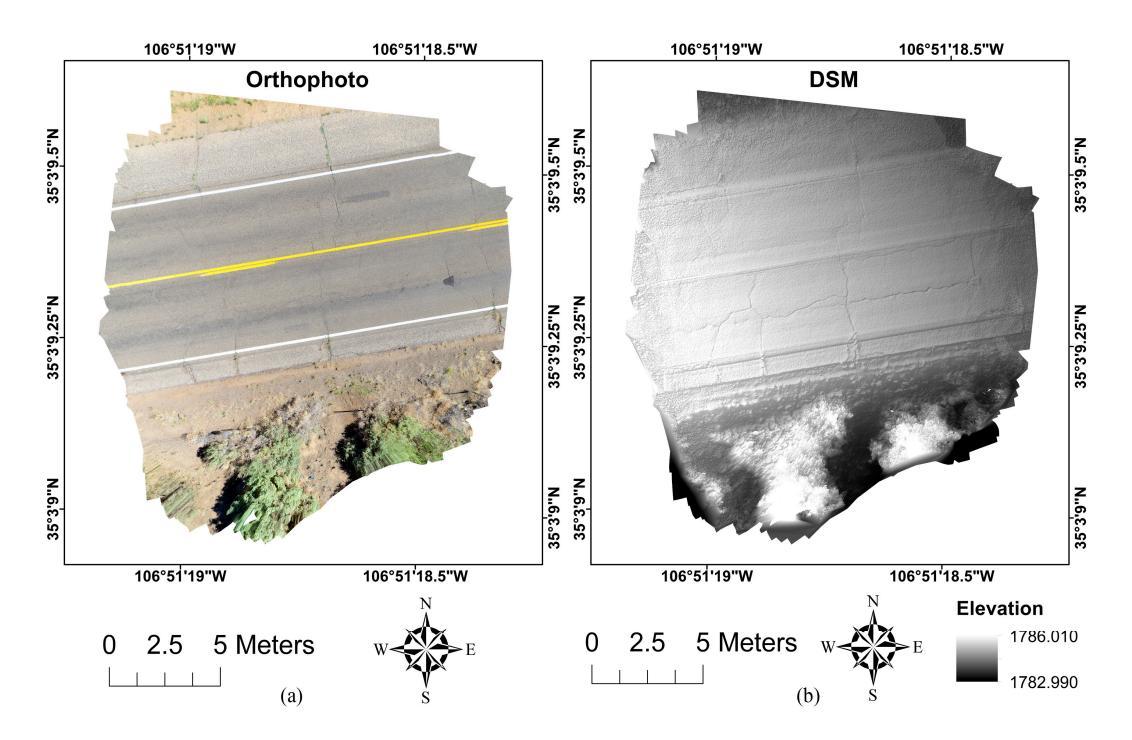
Figure 2. (a) An example of hyper-spatial resolution orthophotos with 0.003 m resolution and (b) an example of hyper-spatial resolution digital surface model (DSM) with 0.003 m resolution. The black to white color scale in (b) indicates elevations.

Once these processes were completed, orthophotos and the DSMs were exported as rasters in TIFF format at a spatial resolution of 0.003 m. Orthophotos and DSMs are generated in a single processing routine and are therefore tightly co-registered. An example of the orthophotos and DSM are showed in Figure 2. Orthophotos were used to assess the horizontal accuracy while DSMs were used to assess the vertical accuracy. Root-mean-squared-error (RMSE) was used to assess the accuracy [54], and the results show that the overall horizontal accuracy is 0.004 m while the overall vertical accuracy is 0.007 m. The number of overlapping images used and accuracy for each study site is reported in Table 1. More details regarding the accuracy assessment can be found in the study performed by Zhang *et al.* [51].

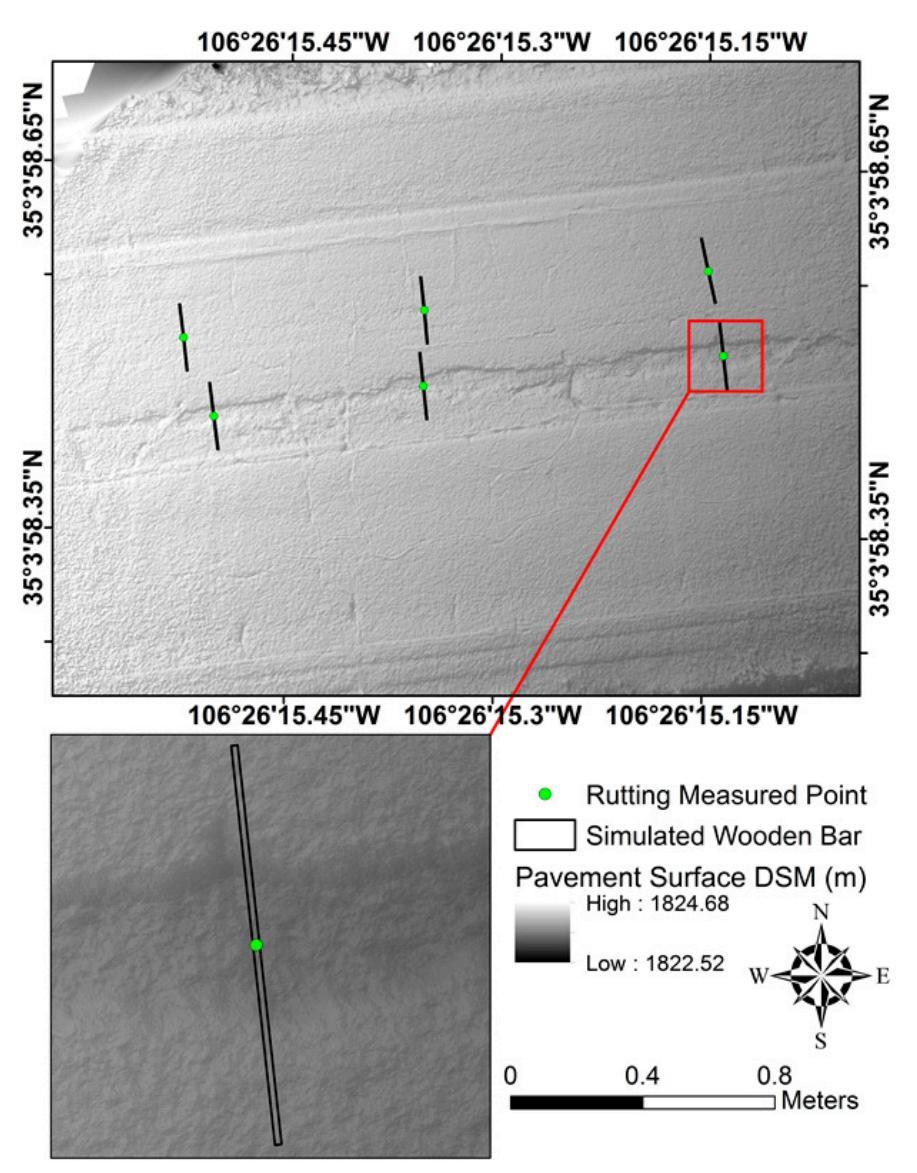
Figure 3. An illustration of the locations of rutting depth actual measured points and wooden bars.

DSMs (reconstructed 3D pavement surface) were used to measure rutting depths using a digital process designed to simulate the ground-based manual measurement. Points and polygons were created on DSMs to simulate the locations of the actual measured points and wooden bars. The actual measured points in the field and the locations of the wooden bars are shown in Figure 3. With the actual measured point (as photographed in the field) as the center, two polygons (one on either side of the filed measured point) with a size of 0.61 m by 0.02 m were created to simulate the location of the wooden bar.

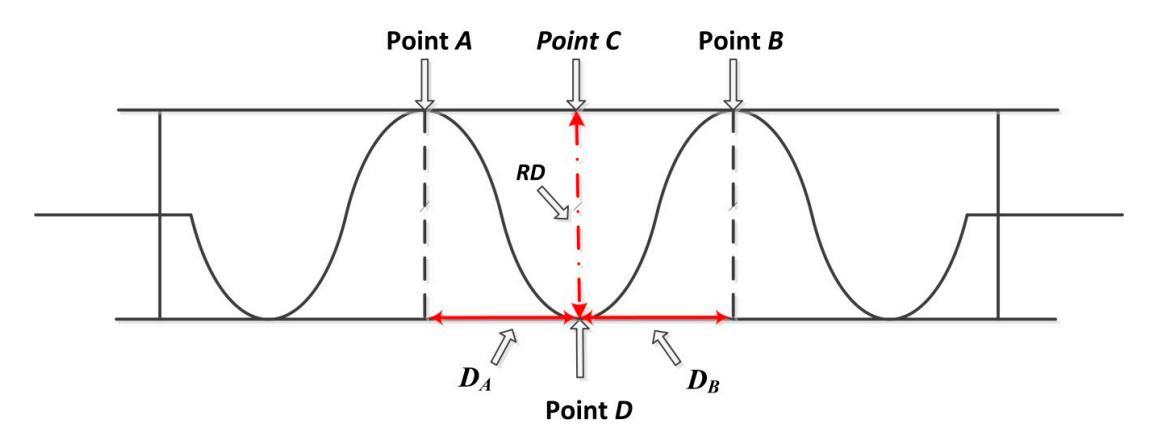
Figure 4. Rutting depth calculation process. D_A indicates the horizontal distance from Point *A* to Point *D*, while D_B is the horizontal distance from Point *B* to Point *D*. *RD* indicates the calculated rutting depth.

Unlike ground-based manual measurement, it is not possible to directly identify the highest point at the bottom of the wooden bar. Therefore, the following method was used to identify the highest and lowest points of rutting. Using the polygon as the boundary, the DSM pixels within the boundary were extracted and reclassified to find the highest point on both sides of the actual field measured points. If there were multiple pixels having the same highest value, the one closer to the actual measured point in the field was used. Then, as shown in Figure 4, we considered the two highest points within the two polygons as Point *A* and Point *B*, while the two measured points as Point *C* and Point *D*. The distance from Point *C* to Point *D* is the rutting depth. Points *A*, *B*, and *C* will have the same height if the heights of Points *A* and *B* are equal. However, under most circumstances the heights of Point *C*:

where *H* represents the height of a given point, and therefore H_A represents the height of Point *A*, and H_B represents the height of Point *B*. D_A represents the horizontal distance from Point *A* to Point *D*, while D_B represents the horizontal distance from Point *B* to Point *D*. *RD* represents the rutting depth. H_A and H_B were determined from the DSMs, while D_A and D_B were determined from the orthophotos.

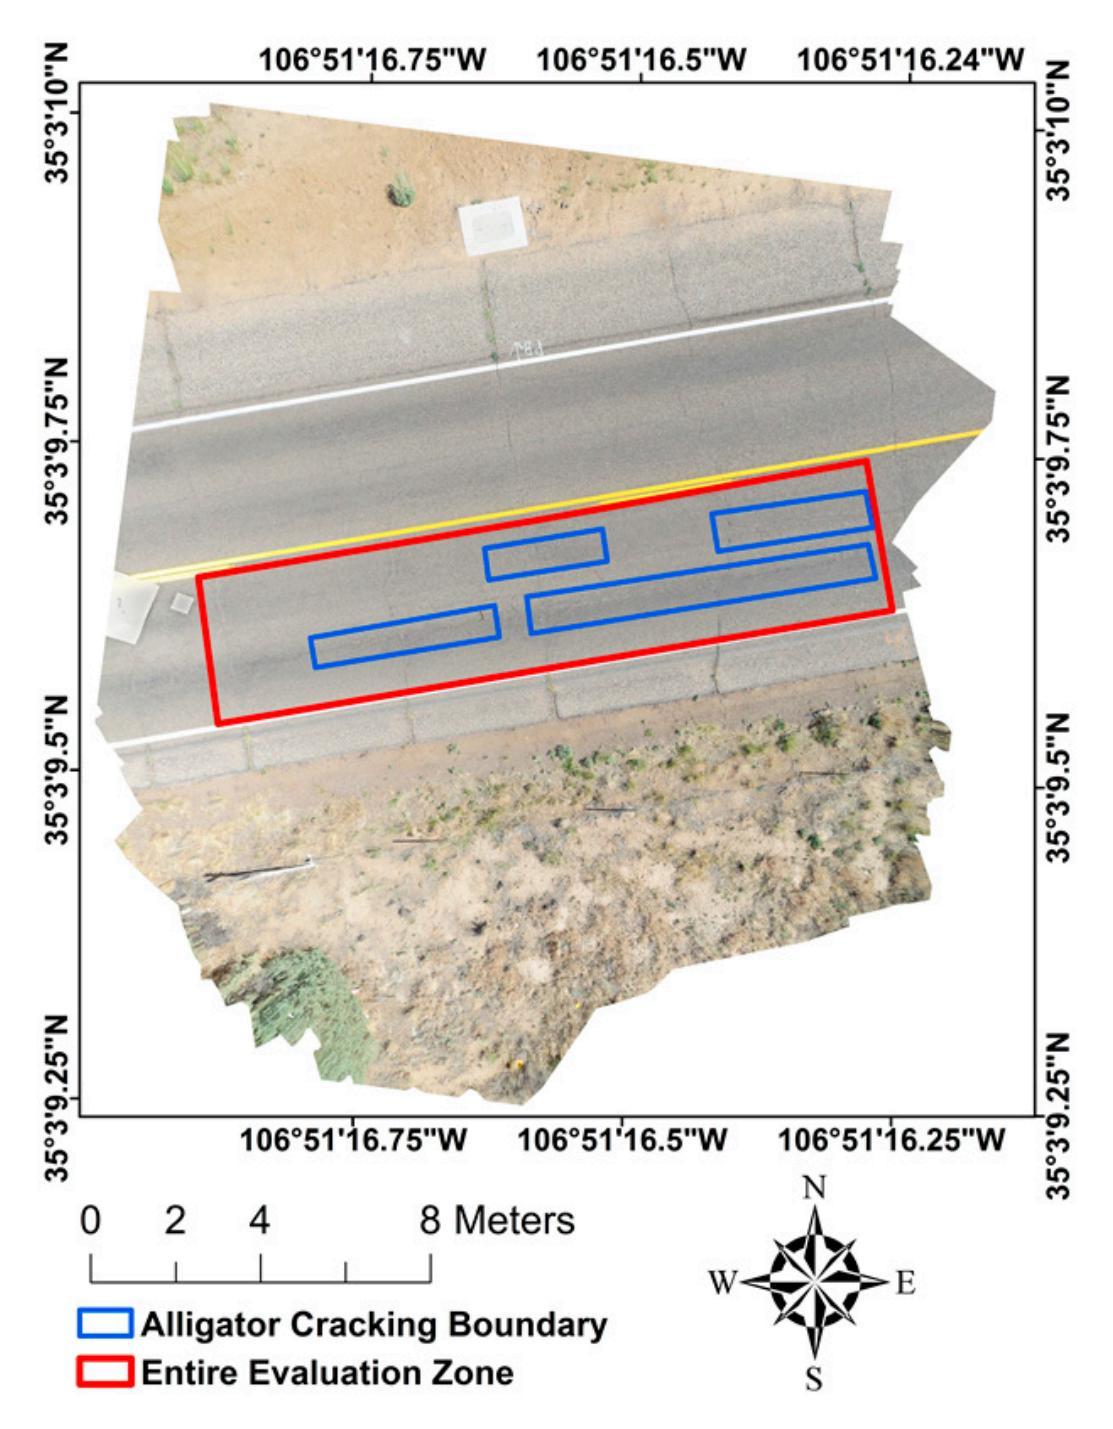
Figure 5. An illustration of orthophoto-based alligator cracking measurement. The blue polygons are the digitized alligator cracking area while the red polygon is the entire manual evaluation zone. Areas for these polygons can be calculated with GIS software and therefore, alligator cracking area percentage can be determined by dividing alligator cracking area by the entire evaluation zone area.

In order to simulate the alligator cracking measurement prescribed by the HPMS Field Manual, orthophotos were visually analyzed to locate alligator cracks and then mark them with on-screen digitization in GIS software. Polygons were digitized to represent both the entire evaluated pavement

section and the sections that alligator cracking occurred. The polygon defining the entire evaluated pavement section was used to calculate the total evaluated area, while the polygons defining alligator cracking were used to calculate the total area of alligator cracking. The area percentage of alligator cracking was then calculated by comparing the areas of the two sets of polygons. The use of polygons to determine area percentage of alligator cracking is shown in Figure 5. It should be noted that both actual area percentage and rounded area percentage were calculated for each site, but only rounded area percentage was used for comparison to ground-based manual measurements.

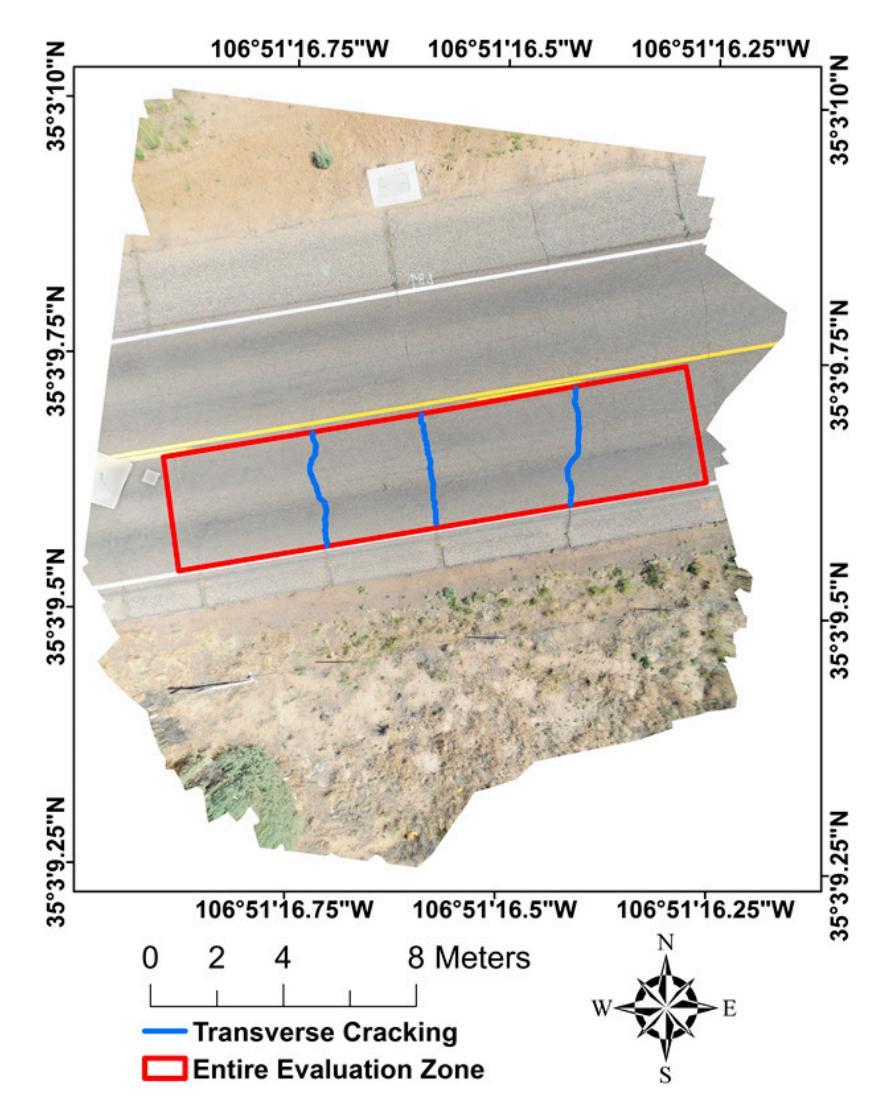
Figure 6. An illustration of orthophoto-based transverse cracking measurement. The blue polylines are the digitized transverse cracking while the red polygon is the entire evaluation zone. The lengths of these transverse cracks and the length of the entire evaluation zone can be calculated with GIS software and, therefore, transverse cracking length can be determined by dividing total transverse cracking length by the entire evaluation zone length.

In order to simulate the transverse cracking measurement prescribed by the HPMS Field Manual, orthophotos were visually analyzed and any transverse cracks longer than 1.83 m (6 feet) were identified and digitized in GIS software as polylines to facilitate the calculation of total length of transverse cracking (Figure 6). The same polygon created for the alligator cracking measurement representing the entire evaluated pavement section was used to measure the total length of the evaluated pavement section.

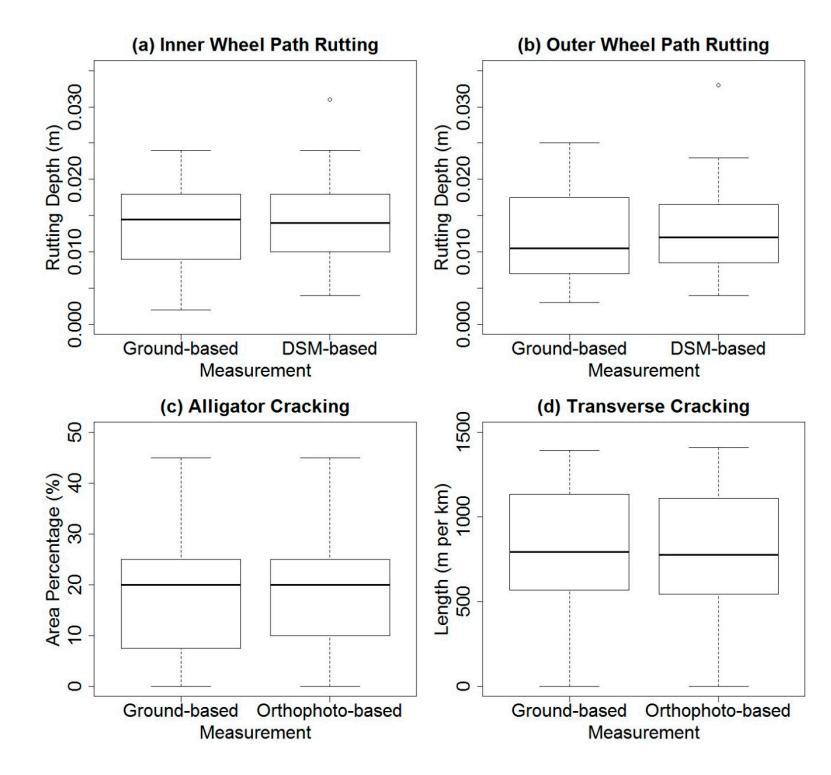
Figure 7. Box plot for each set of measurement. In each quadrant, the two boxes are ground-based measurement and HSR-AP derived products based measurement, respectively. (**a**) Inner wheel path rutting depth measurement; (**b**) outer wheel path rutting depth measurement; (**c**) alligator cracking area percentage measurement; (**d**) transverse cracking length measurement. The uppermost bar is the maxium measurement value, while the lowermost bar is the nimimum measurement value. The bar inside of the box indiciates the median. The dots in (**a**) and (**b**) indicate measurement outerliers.

The box plots, histogram plots, and radar plots displaying each set of measurements were visually examined and are shown in Figures 7–9. Box plots revealed that only DSM-based rutting measurement showed evidence of outliers (dots found above the whiskers). However, box plots did not show a substantial difference in the medians between ground-based measurements and HSR-AP derived products based measurements. There also did not appear to be a substantial difference in the box sizes. Histogram plots provide a visual presentation of the frequency distribution of each distress' measurement differences (residuals). Measurement difference was defined as the difference between ground-based measurement and HSR-AP derived products based measurement. The plots did not show a substantial difference in the two sets of measurements for each distress. Most of the residuals were distributed around the value of zero. Radar plots provide another visual presentation of the measured distress rates for each study site. The plots did not reveal a substantial difference in the shape and spread of distribution between the two sets of measurements for each distress.

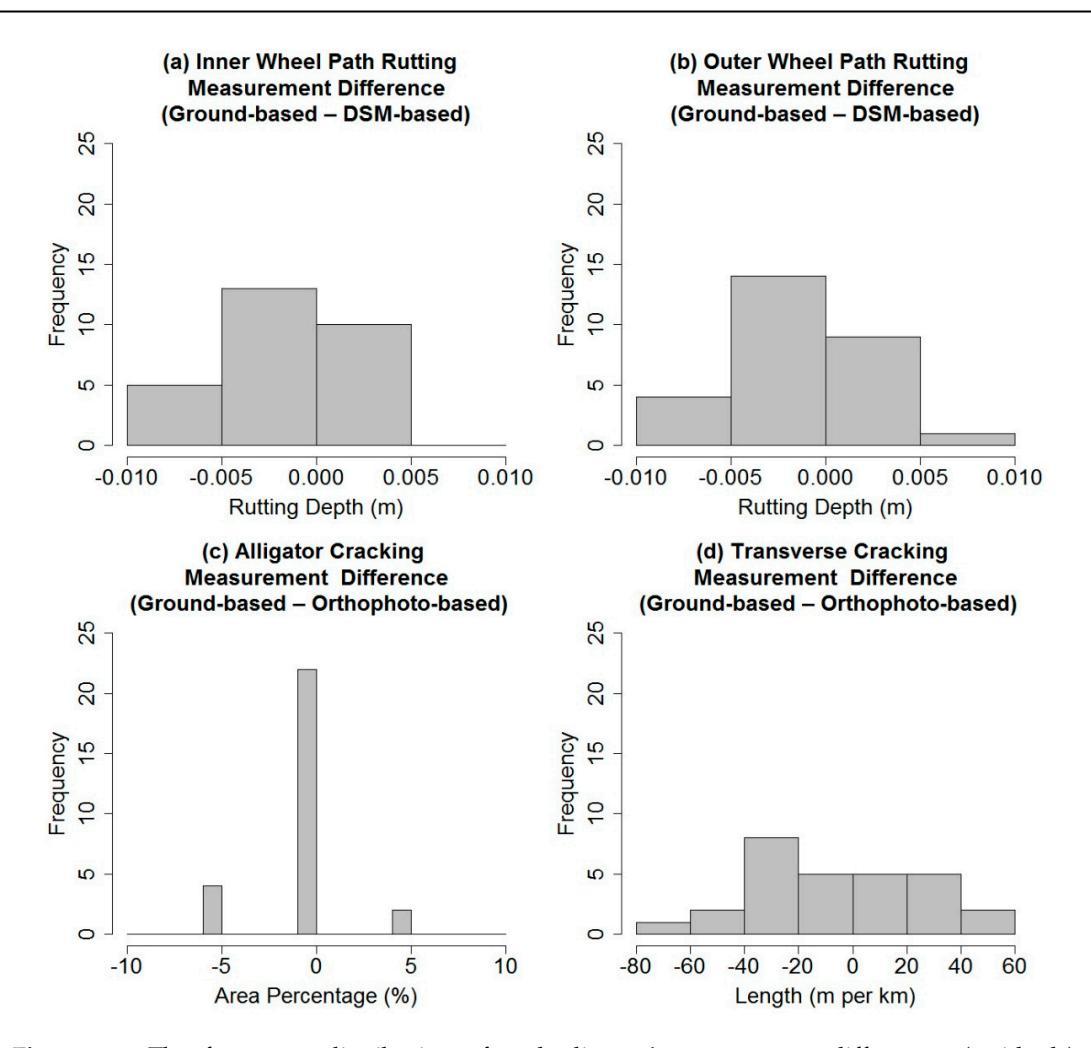
Figure 8. The frequency distribution of each distress' measurement differences (residuals); measurement difference is defined as the difference between ground-based measurement and HSR-AP derived products based measurement. (a) Inner wheel path rutting depth measurement difference; (b) outer wheel path rutting depth measurement difference; (c) alligator cracking area percentage measurement difference; (d) transverse cracking length measurement difference.

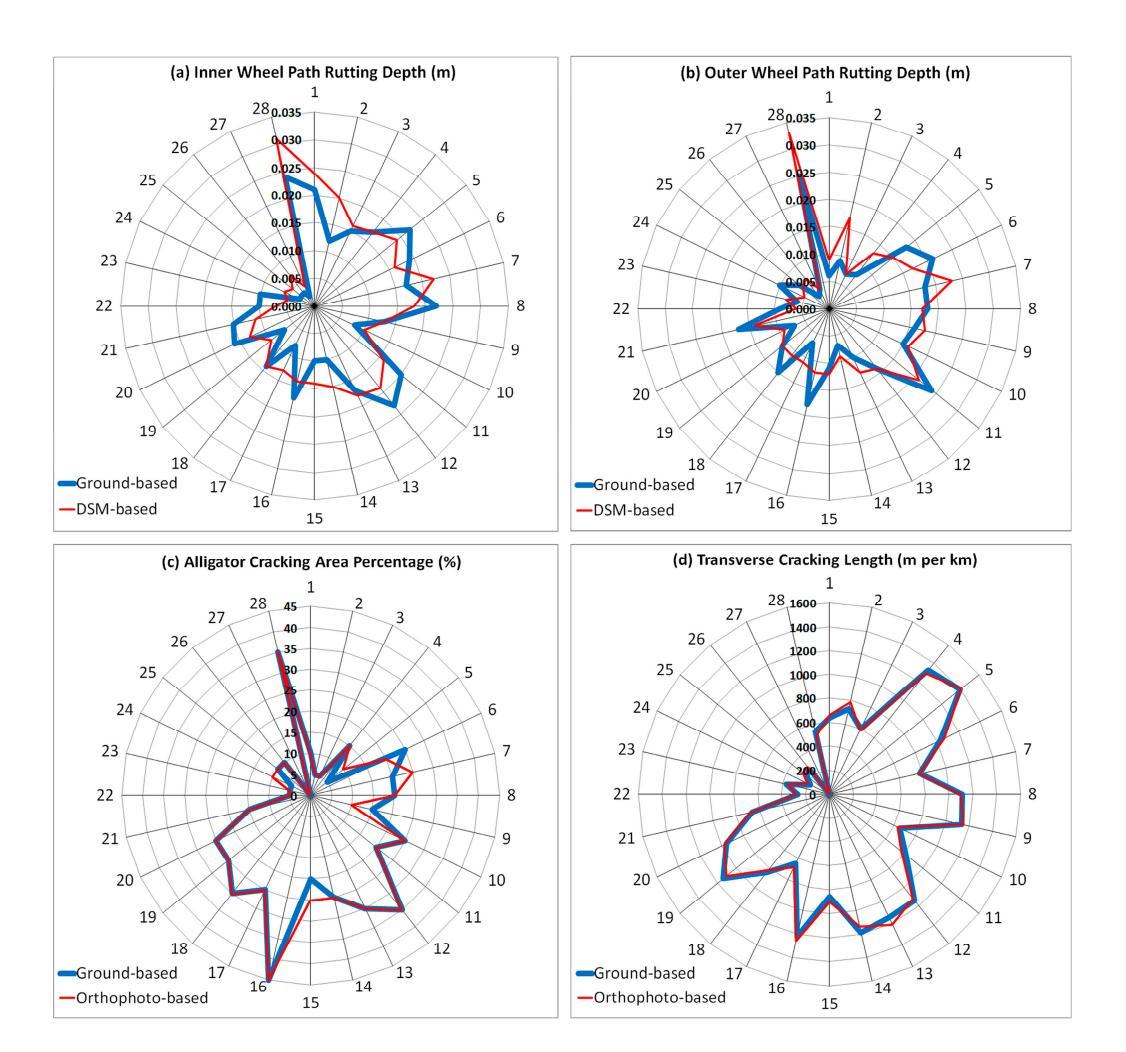
Figure 9. Radar plot for each set of measurement. In each quadrant, the whole numbers (*i.e.*, 1 to 28) adjacent to the outmost ring indicate each of the twenty-eight study sites. (**a**) Inner wheel path rutting depth measurement, and the decimal numbers adjacent to the multiple-rings indicate rutting depths in m; (**b**) outer wheel path rutting depth measurement, and the decimal numbers adjacent to the multiple-rings indicate rutting depths in m; (**c**) alligator cracking area percentage measurement, and the whole numbers adjacent to the multiple-rings indicate rutting length measurement, and the whole numbers adjacent to the multiple-rings indicate rutting indicate ruttiple-rings indicate alligator cracking area percentages; (**d**) transverse cracking length measurement, and the whole numbers adjacent to the multiple-rings indicate transverse cracking length in m per km.
