# Defect Detection Method for CFRP Based on Line Laser Thermography

**Abstract:** A continuous line laser scanning inspection technique for tracing load-bearing structures was developed and applied to defect detection of unidirectional carbon-fiber-reinforced polymers for aero engines. The heat transfer model of the material was analyzed using the finite element software COMSOL. Meanwhile, a laser platform was built and an image algorithm was used to verify the feasibility of the method. The potential of this technique for detecting defects and providing information on the location of defects in carbon fiber composites was analyzed. Results indicate line laser thermal imaging can successfully determine the size, location, and crack angle of surface damage with extremely high accuracy. The positioning accuracy error for impact and fracture defects is less than 20%, and the detection rate can reach 100% if the defect is in the special position of just leaving the heating area. The angle detection of fracture cracks can be accurate within 10°.

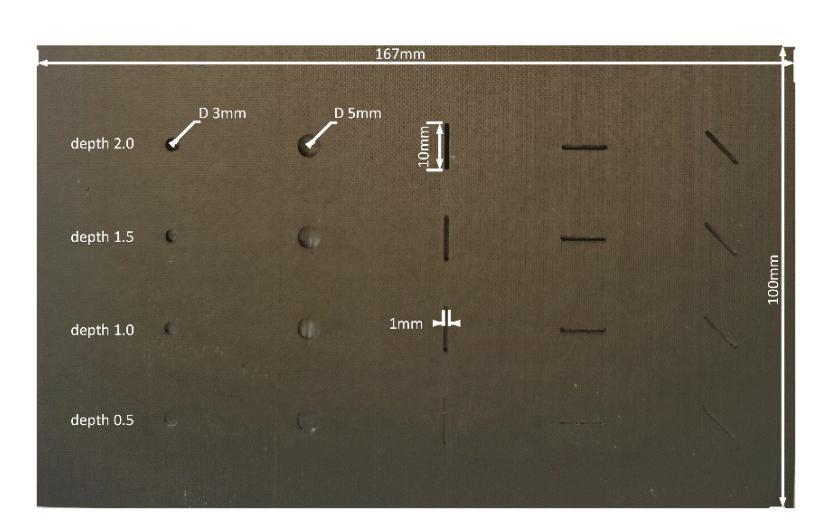
The geometric parameters of the carbon fiber used in the paper are shown in Figure 1. This composite type is T800H, and its properties were similar to those produced by TORAY. Its laying direction was  $0^{\circ}$ , it had a total of 14 layers, and the overall size was  $100 \text{ mm} \times 167 \text{ mm} \times 2.4 \text{ mm}$ . It consisted of defects of different sizes. It is mainly used to replace metal load-bearing parts in aero engines to reduce weight. Defects were manually cut to simulate various conventional damages that may occur in an actual production process. For example, impact damage was simulated with discs of different sizes and depths ( $\Phi$ 3 and  $\Phi$ 5 mm), and tensile fractures (1 mm  $\times$  10 mm) were simulated with different open cracks. The simulated damage thickness gradually increased from 0.5 to 2 mm at equal intervals of 0.5 mm. According to the microstructural characteristics of the carbon fiber sample, it is known that the diameter of each single fiber is very small (5  $\mu$ m), so the fiber sample can be equivalent to a cuboid with the same properties. We know that the thermal anisotropy of a fiber is determined by the thermal conductivity of the material along the axis. We checked the literature and material property table, and selected the thermophysical parameters shown in Table 1 for finite element simulation analysis [25]. In terms of heat conduction, the thermal conductivity in the axial direction is much higher than the thermal conductivity in the other directions. Each defect was filled with air, and

it is not described in this paper. Defect types are specified with numbers 1–5, which are 3 mm, 5 mm,  $0^{\circ}$ ,  $90^{\circ}$ , and  $45^{\circ}$ , respectively.

Figure 1. Geometric structure of carbon fiber composite material.

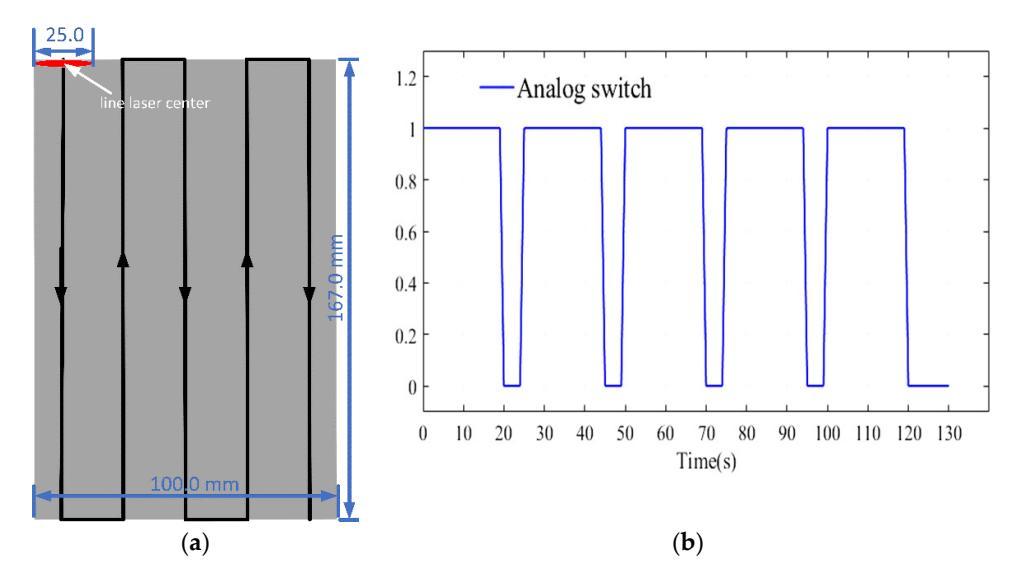
In this work, the simulated line laser length was 25 mm. Figure 2 shows the laser moving mode, i.e., vertical movement. It is easy to understand that the motion is related to the position change in 2D space. Figure 2a shows the coordinate change of the laser center. Figure 2b shows the numerical values 0 and 1 to simulate the switching state of the laser. The heating time used in the experiment was 0–20 ms, and cooling was 20–25 ms. These states are exploited to accurately control the operation of the simulated laser, and the temperature distribution on the surface of the material is observed and recorded. The incident heat flux function describes the frontal (heat source boundary) input of the carbon fiber composite sample, as shown below.

**Figure 2.** The laser focus moves in a specified way: (**a**) *x*-axis moving mode of laser and (**b**) focus changes along the *z*-axis.

where  $q^{in}(x, 0, z, \tau)$  is the heat flux function of the surface heat source, *p* is the laser modulated power (14 W), *R* is the diameter of the laser spot (4 mm), and *em* is the surface emissivity of the material. pw(t) is the laser running time, which indicates its status. The coordinate  $(x_0, z_0)$  is the start point when the laser focus moves in a specified way (as seen in Figure 2). We measured the appearance of the sample and then designed the laser shape to ensure the integrity and accuracy of the sample scan. Therefore, the purpose of Equation (2) is to convert a spot distributed over a concentric circle into an elliptical laser beam that approximates a line segment.

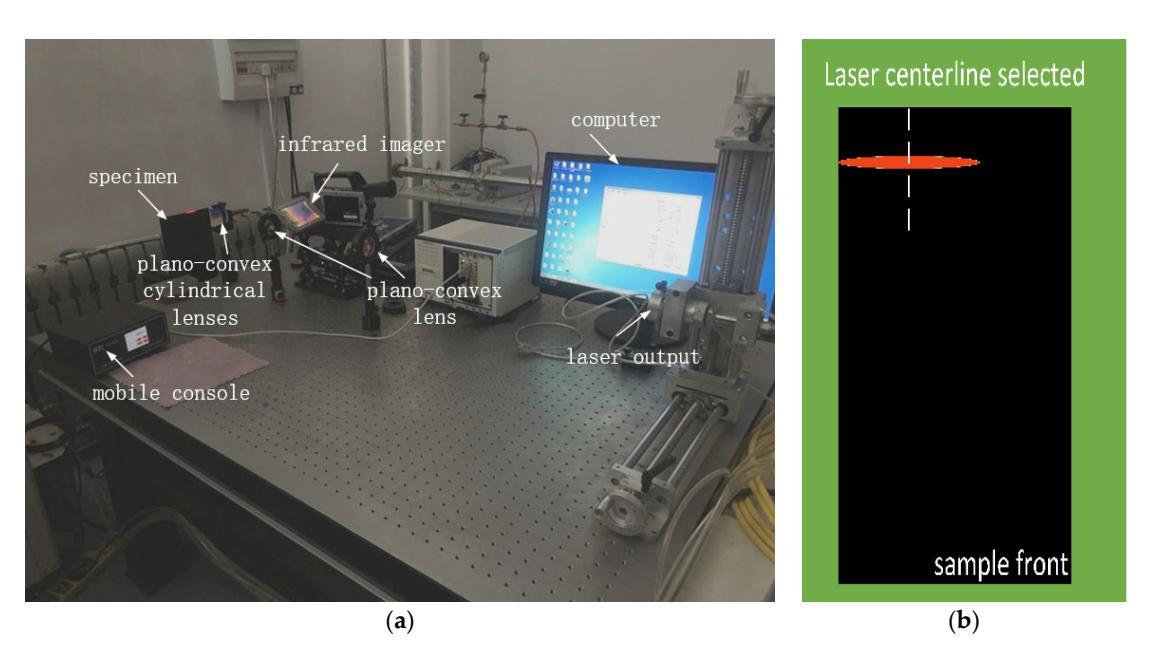
In this part, the principle of line laser scanning experiment will be introduced in detail. The laser pulse heat wave experiment is shown in Figure 3.

It is obvious that the entire experimental system consists of an external excitation source, optical system, sample, and signal receiver. The optical system consists of two lenses, namely, plano-convex lens and plano-convex cylindrical lens, which mainly change the laser shape. Figure 3b shows the geometry of the line laser in the experiment. A high intensity, high energy concentration continuous heat source acts on the composite material. The synchronized control platform changes the position of the sample in space according to a defined speed or course. The temperature changes of the material are recorded with a thermal imager. We believe that differences in physical properties (e.g., thermal conductivity) between damaged and healthy regions cause anomalous distribution of the surface temperature field [12,27,28]. The corresponding infrared radiation intensity will also be different.

**Figure 3.** Schematic diagram of the carbon-fiber, pulsed-laser, infrared thermal wave experimental device: (a) experimental device diagram; (b) the geometry of line-laser.

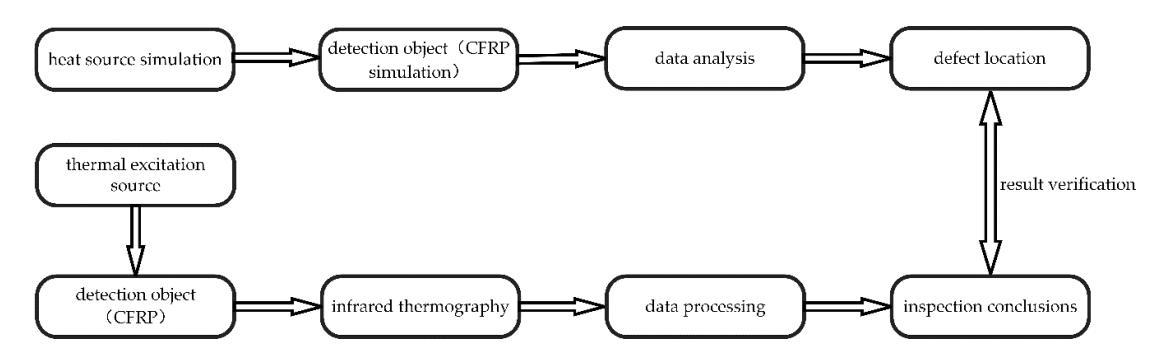
To explore the results of using continuous line laser to scan unidirectional carbon fiber damage, the entire experimental analysis process was designed according to Figure 4. In other words, the experiments combined theory and practice to investigate unidirectional carbon fiber damage.

Figure 4. Block diagram of experimental steps.

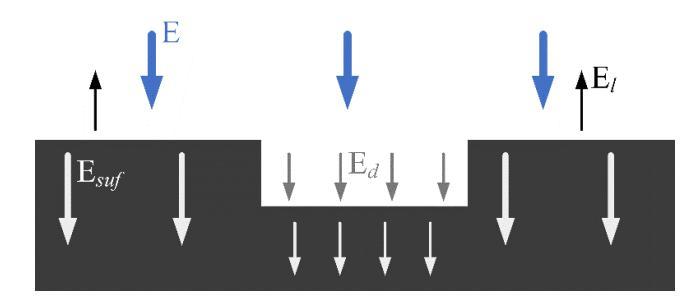
Due to the integrity of the material and the high thermal conductivity along the carbon fiber extension, the surface temperature of the material during scanning will characterize its structure. The temperature field of the material is uniformly distributed as the laser scans the healthy area. Typically, the defect is filled with a small amount of gas, which is thermally different from the material itself. When a laser scan encounters such an area, it detects weak thermal conductivity and strong thermal insulation. This will lead to huge abnormal fluctuations in the temperature curve of the damage, showing local "dark spots" on the material's surface. We mainly studied the temperature change of the material. We know that the defect temperature is approximately equal to the difference between the temperature of the surface and the temperature rise in the damaged area (as shown in Figure 5). As the presence of defects changes the heat transfer properties of the material, some values on the temperature curve will show a sharp rise. Increases or decreases in the parameters in Equation (7) can well explain a temperature change trend.

Figure 5. Heat conduction model of carbon-fiber-reinforced composite surface.

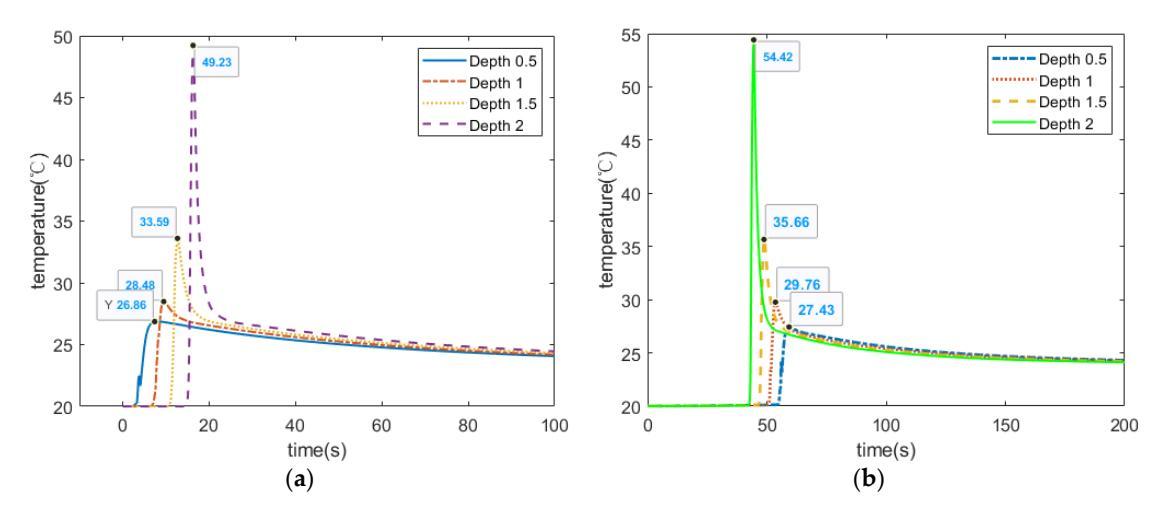
and the fracture crack at a certain angle was also explored. The temperature of the damage center was regarded as the actual temperature value. Figure 6a,b shows the temperature response curves of the impact damages of different sizes. It can be clearly seen that the temperature for the same diameter of defect increases exponentially with increasing depth. This temperature buildup will enhance the visual appearance of images in laser scanning thermal imaging. In addition, when the depth is certain, the temperature tends to rise as the defect diameter increases. Figure 7 reveals the temperature response curves of

**Figure 6.** Temperature simulation of impact damage. (a) Temperature simulation of 3 mm diameter defects. (b) Temperature simulation of 5 mm diameter defects.

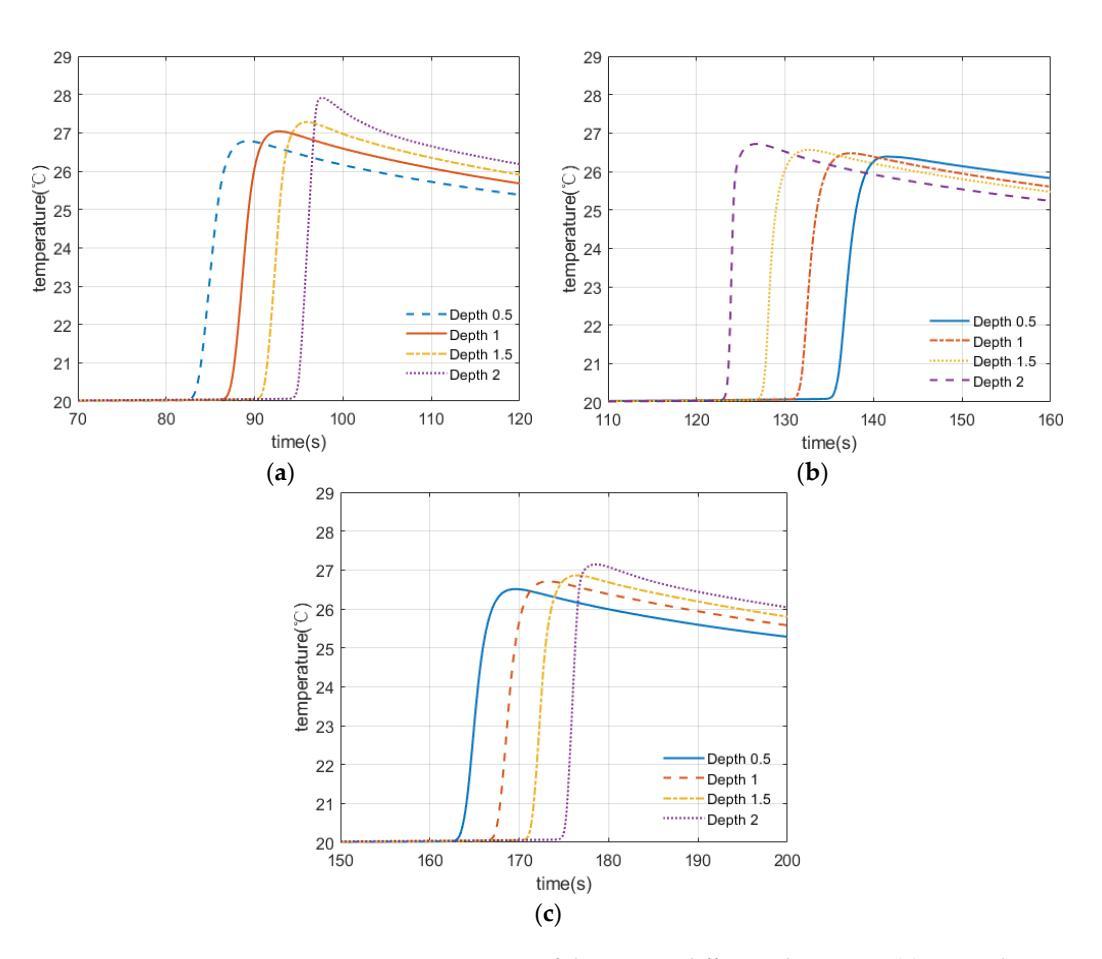
temperature for the same diameter of defect increases exponentially with increasing depth. This temperature buildup will enhance the visual appearance of images in laser scanning thermal imaging. In addition, when the depth is certain, the temperature tends to rise as the defect diameter increases. Figure 7 reveals the temperature response curves of damage in different directions caused by strain. The line laser in operation and these surface damages were at a certain angle in space. It is not difficult to find through the data comparison that the center temperature of the 0° crack was the highest, and its numerical growth trend is also sharper than those of other cracks. By observing the temperature changes of different defects, it can be concluded that the type, size, and depth of damage all affect the temperature change. We can observe from this that impact damage had a relatively high detection rate, because it had the most drastic temperature change, resulting in the best visualization of the image. For cracks, the larger the angle, the smaller the temperature rise around the damage during laser scanning. The scanning direction also has a significant effect on the detection of tensile fractures, so multiple scanning directions should be considered.

**Figure 7.** Temperature response of damage in different directions. (**a**)  $0^{\circ}$  crack temperature response curve, (**b**)  $90^{\circ}$  crack temperature response curve and (**c**)  $45^{\circ}$  crack temperature response curve.

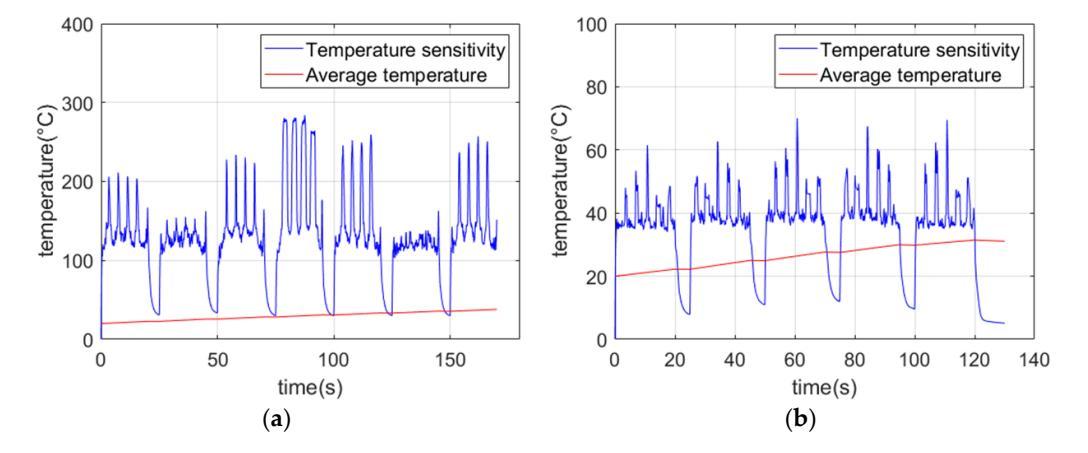
Figure 8 plots two different curves for the average temperature and temperature sensitivity of the material. Temperature sensitivity refers to the difference between the highest temperature and the lowest temperature of the material domain. Equation (7) explains in detail the reason for the sharp fluctuations of the curve. It is obvious that the damage has a specific physical size, so the temperature change at the damage point should last for a period of time. According to the formula mentioned, it is known that the energy absorbed by the damage in a short time will be very small. Then the natural phenomenon that comes to mind is that there must be an abnormal temperature peak here, and this value is much larger than the temperature fluctuation value of the healthy area (as shown in Figure 8, from 30 to 40 s). In other words, if it is a narrow mutation point or spike, it can be considered to be caused by the simulated boundary effect and temperature fluctuations in the healthy area, which is an abnormal change that can be ignored. This phenomenon is not considered as an abnormal fluctuation caused by damage interference, but can be considered as a suspicious point. For verification, a line laser or spot laser can be used for fixed-point heating to observe whether the surrounding temperature changes. As the laser continues to scan, the sample will gradually absorb heat, causing the average temperature to gradually increase.

**Figure 8.** Temperature field versus time curve of carbon fiber surface: (**a**) temperature field changes along the *z*-axis; (**b**) variation in temperature along the *x*-axis.

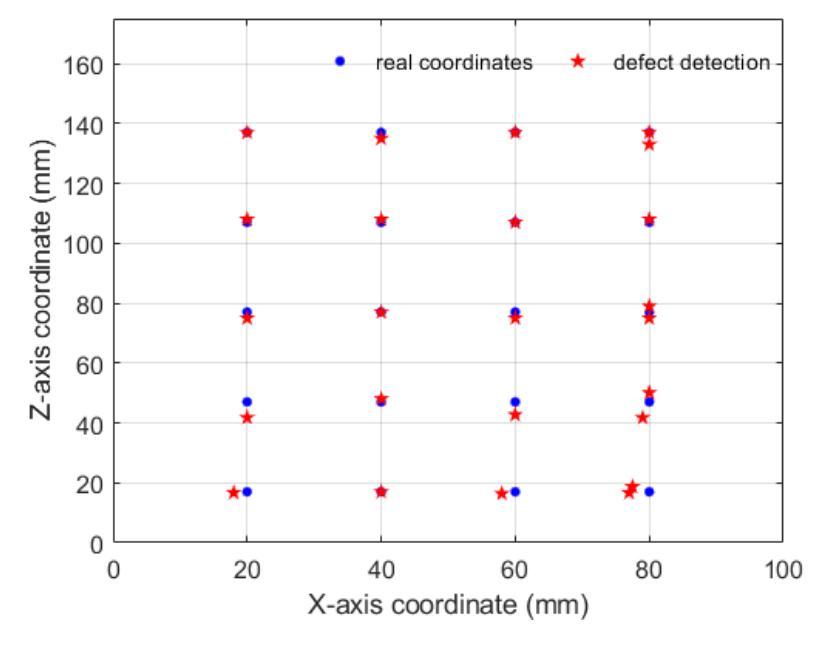
As we can see in Figure 9, the blue circles represent damage centers with certain physical dimensions, and the red asterisks are the coordinate values automatically detected by the algorithm. Using the laser trajectory map and temperature change, the location of the defect was calculated and visualized. Table 2 shows the damage detection results of unidirectional-carbon-fiber-based online laser scanning infrared thermal imaging. They

are based on the ratio of the Euclidean distance of the coordinates to the size of the object (referring to half the radius or length). Numbers 1–5 represent different types of defects. In the results in the figure, there is a point that was detected twice; there may have been repeated heating when the line laser scans back and forth. This is also the reason for inaccurate detection. By analyzing the results of the graphs and tables, it can be known that the detection accuracy for simulated delamination disc-shaped defects is higher than the detection accuracy for different tensile fracture damage. It can be seen that the direction and type of the damage impact thermal detection, and the detection error for defects perpendicular to the scanning direction was the largest (number #4). Therefore, it is necessary to perform a complete scan along the horizontal axis and the vertical axis to find cracks in different opening directions. It can be concluded from the coordinate detection results that this method has a certain accuracy for damage location and meets the basic requirements of detection. The laser or sample is made to move at a certain speed, and then the temperature parameter changes on the surface of the material are monitored in real time, and the size and location of the damage are obtained by analysis. This method is completely feasible and can also reflect the characteristics of damage.

Figure 9. Damage detection results for composite materials via laser scanning.

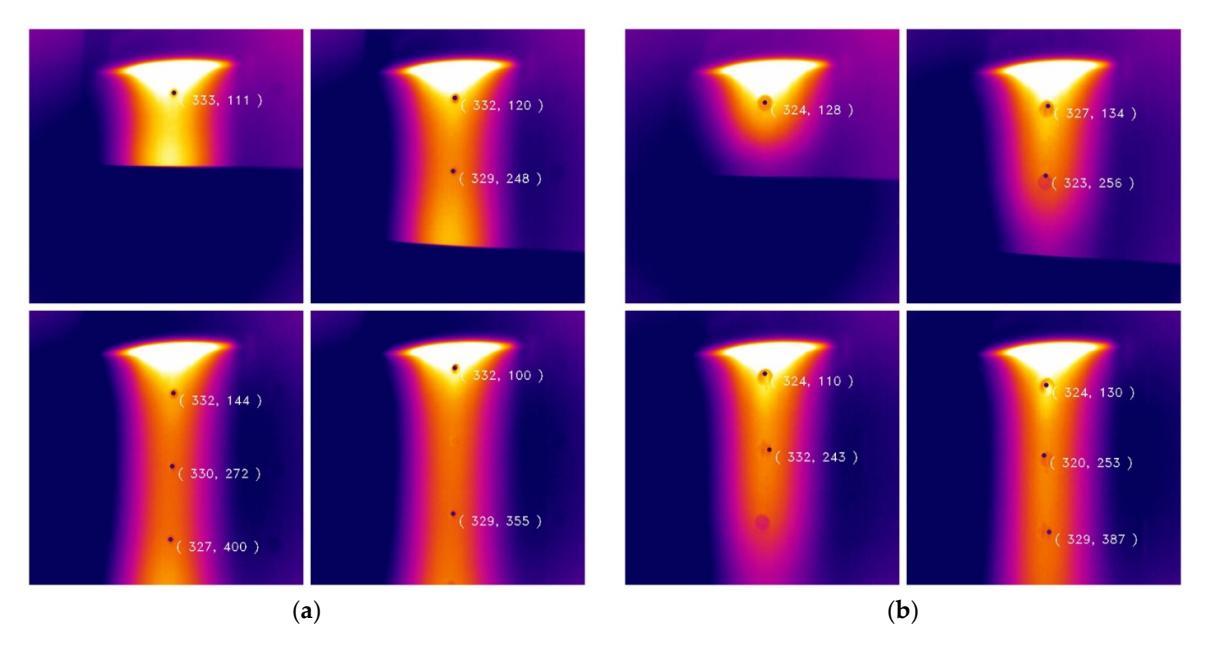
Figure 10 shows the inspection results for impact damage. We have visualized the coordinates of the defect centroids. It can be seen in Figure 10a that every 3 mm defect could be detected with extremely high accuracy. There is a defect in the last image that was not detected because the defect feature was submerged as it left the heated area and could not be detected properly. Figure 10b shows the detection results of 5 mm impact damage. Due to the relatively large size, it could be directly detected by the visual method. In the laser heating experiment, due to its size, the energy loss was relatively fast, resulting in different temperature values in the same target, and the defect features had different properties. Various reasons cannot be taken into account during image processing, resulting in inaccurate center detection. For detection of defects of the same type at different depths, it was found that the detection efficiency was relatively accurate when the defect slightly left or was about to leave the laser heating source, because the energy of the defect was the largest at this time. There was a sufficient temperature difference to appear in the image, and the numerical difference in the pixels was also adequate.

**Figure 10.** Impact defect detection results for defects of different diameters. (**a**) D3 mm defect detection and (**b**) D5 mm defect detection.

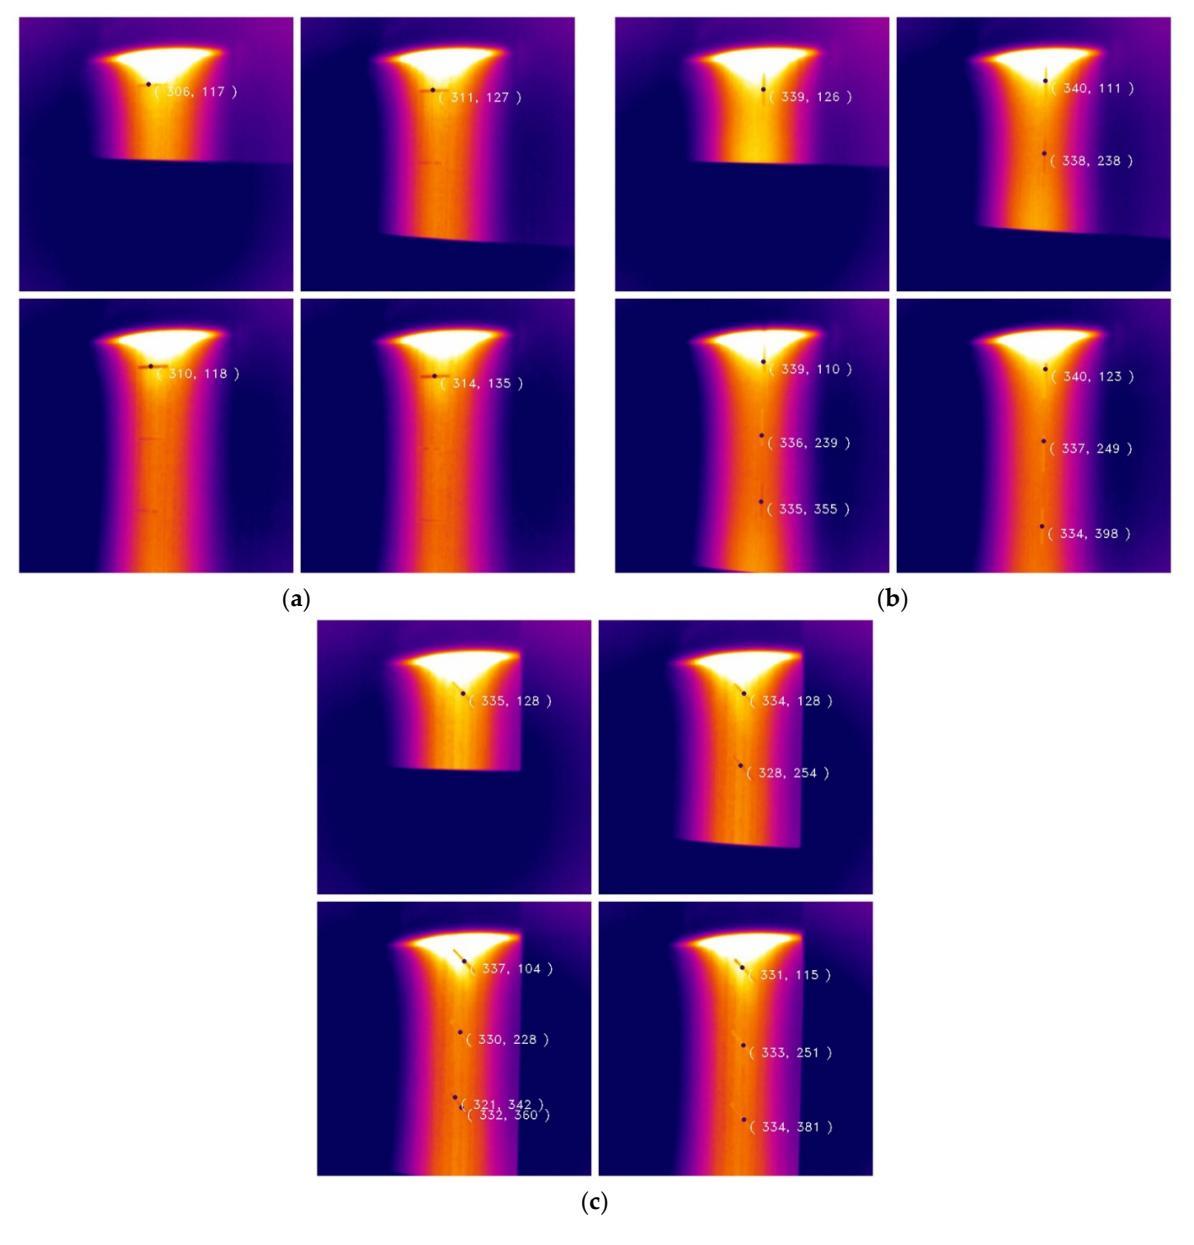
Figure 11 shows tensile fracture defect detection. It can be seen that defects with different fracture angles caused by external forces were detected well. Due to the particularities of such defects, the damage area must be determined to be large or small. For

larger defects, it can be easily detected by human eyes or machine recognition. Another situation is that the damage area is very small (fracture type) and the temperature changes too fast, which makes the characteristic signal too weak and difficult to detect. It is also for the reason mentioned that small fracture defects do not have different thermal properties in the composite, which also becomes an advantage. Result founds that the edge features were already submerged at a certain distance from the heat source. Therefore, the closer the defect is to the heat source, the more likely it is to be detected. The visualized results in figure also confirm the statement that the defect angle also affects the detection. Figure 11c shows the case where the third defect has 2 centroids, which is because the defect features are not obvious and are separated during the inspection process.

**Figure 11.** Detection results of cracks in different directions: (a)  $0^{\circ}$  fracture crack detection; (b)  $90^{\circ}$  fracture crack detection; (c)  $45^{\circ}$  fracture crack detection.
