Article Reliability of SnPbSb/Cu Solder Joint in the High-Temperature Application

Abstract: With the continuous miniaturization and increase in functionality of the electronic devices used in the aerospace and national defense industries, the requirements for reliability of the solder joints in these devices keep increasing. In this study, a SnPbSb solder with excellent wettability was used as the research object, and the effects of high-temperature aging at 150 °C on the microstructure and mechanical properties of SnPbSb/Cu solder joints were investigated according to the relevant industry standards. It was found that high-temperature aging does not change the eutectic structure of the SnPbSb solder, but it does significantly coarsen the Sn-rich phase and the Pb-rich phase in the solder. In addition, the interfacial intermetallic compound (IMC) layer in the SnPbSb/Cu solder joint changes from a Cu₆Sn₅ single layer to a Cu₆Sn₅/Cu₃Sn double layer after the aging, and the thickness of the IMC layer increases greatly. High-temperature aging significantly deteriorates the mechanical properties of the solder joints. After aging at 150 °C for 1000 h, the shear strength of the SnPbSb/Cu

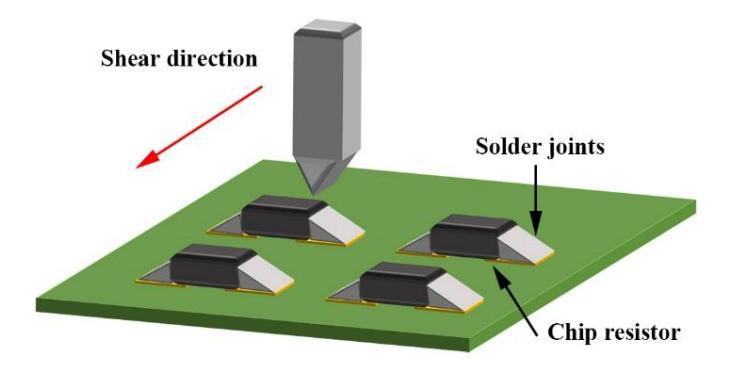
The mechanical properties of the solder joints were tested by an STR-1000 micro-solder joint tester. As shown in Figure 1, the 0805 chip resistors were soldered onto the printed circuit board with the prepared solder. Before the test, the shear instrument of the tester was placed at a location 2 mm in front of the center of the chip resistor, and then the shear pusher was pushed at a constant speed of 1 mm/min along the set shear direction until the solder joint was broken. The maximum force during the test process is recorded as the shear force of the solder joint, which is converted into the shear strength by dividing by the joint area. Five samples were tested under the same parameters, and the average value was calculated.

Figure 1. Schematic diagram of the shear test of the solder joint.

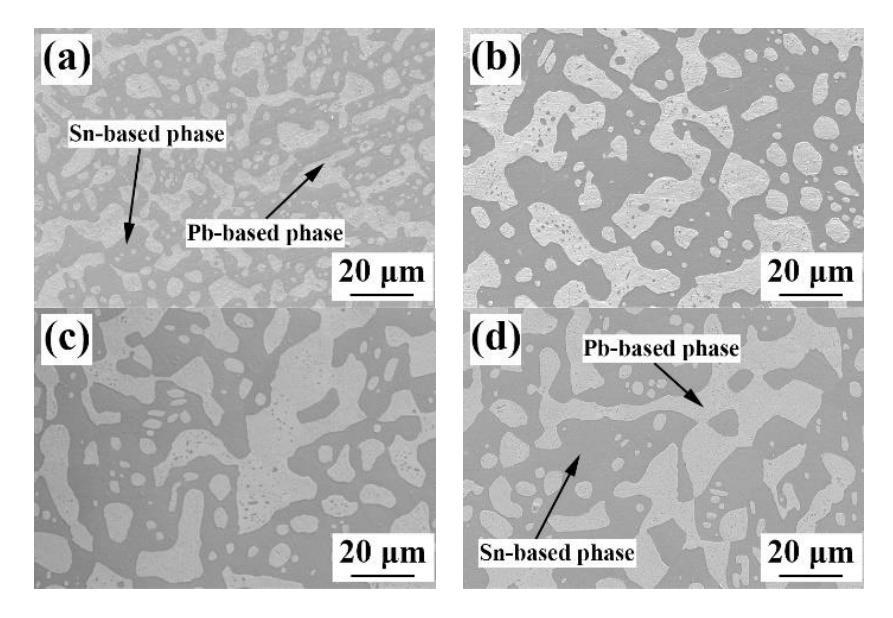
The microstructures of the SnPbSb solder in the solder joint aged at 150 °C for different times are shown in Figure 2. It can be seen from Figure 2a that there are two phases in the as-soldered SnPbSb matrix of the joint, i.e., the light-colored Pb-rich phase and the dark colored Sn-rich phase. The two phases were alternately distributed, showing the characteristics of a eutectic structure. As the Sb element was solid-soluble in the Sn-rich phase, no Sb-rich phase was detected. In addition, it could be found that the Pb-rich phase was finer and quite uniform in the as-soldered SnPbSb/Cu solder joint. After aging for 400 h, the eutectic structure hardly changed, while the Pb-rich phase coarsened obviously, as shown in Figure 2b. With a further increase in the aging time, the SnPbSb solder became coarser, while the size of the Pb-rich phase particles became very non-uniform after aging for 1000 h (see Figure 2c,d).

Figure 2. Microstructures of the SnPbSb solder aged at 150 °C for (**a**) 0 h, (**b**) 400 h, (**c**) 800 h and (**d**) 1000 h.

- Long-time high-temperature aging promoted the diffusion and migration of atoms, resulting in the continuous coarsening of the SnPbSb solder and the significant increase in size of the Pb-rich phase, while the eutectic structure characteristics were hardly changed.

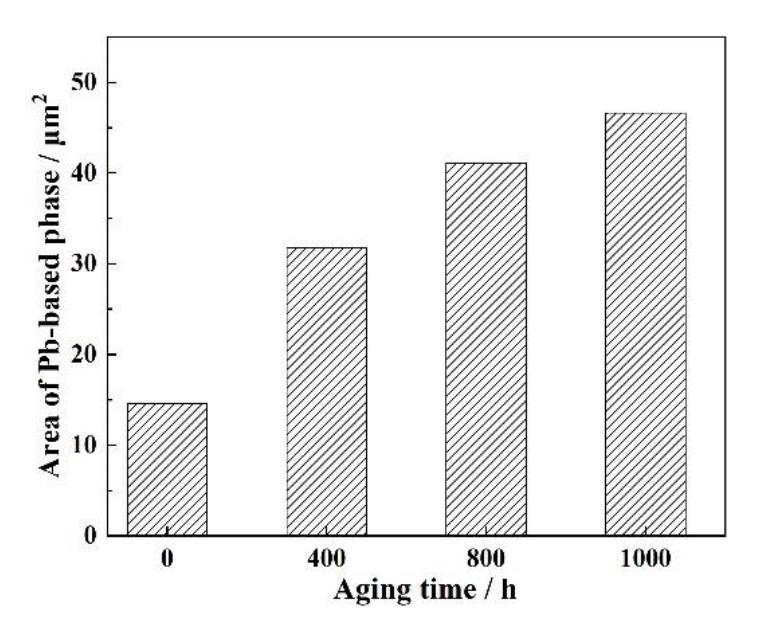
The average areas of the Pb-rich phase in the SnPbSb solders aged for different times are presented in Figure 3. For the solder in the solder joint without aging, it could be found from the image that the area of the Pb-rich phase was only 14.62 μ m². With increasing aging time, the size of the Pb-rich phase increased gradually. After aging for 1000 h, the area of the Pb-rich phase increased to 46.61 μ m², which was 218.81% higher than that before the aging, demonstrating that the coarsening trend of the solder was very significant.

Figure 3. Average areas of the Pb-rich phase in the SnPbSb solder aged for different times.

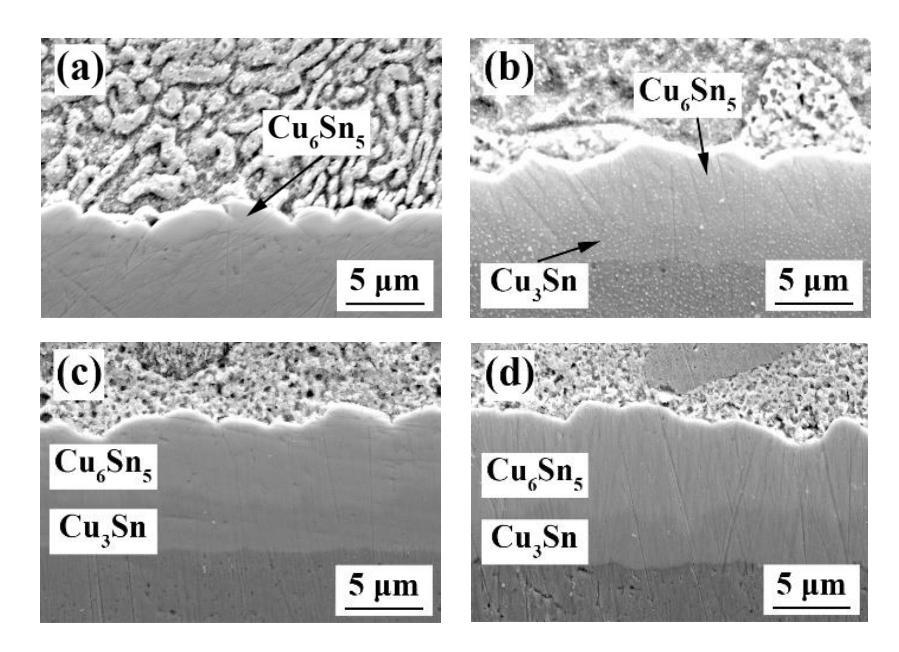
The formation of a continuous IMC layer between the Cu substrate and the SnPbSb solder indicates that a metallurgical bond is formed between the solder and the substrate. The microstructure and thickness of the interfacial IMC layer can significantly affect the mechanical properties and reliability of the solder joint. Figure 4 shows the morphologies of the IMC layers at the SnPbSb/Cu interfaces aged at 150 °C for different times. For the as-soldered SnPbSb/Cu interface, a thin Cu₆Sn₅ layer with a scallop-like morphology was obtained, as shown in Figure 4a. After aging for 400 h, the thickness of the Cu₆Sn₅ layer increased obviously, showing a flat interface, and a Cu₃Sn layer appeared between the Cu₆Sn₅ and the Cu substrate (see Figure 4b). With the thermal aging's progress, the Cu₆Sn₅ and Cu₃Sn layers both grew, which resulted in a significant thickness increment of the IMC layers compared to the as-soldered joint, as shown in Figure 4c,d.

Figure 4. Morphologies of the IMC layers in the SnPbSb/Cu interfaces aged at 150 °C for (**a**) 0 h, (**b**) 400 h, (**c**) 800 h and (**d**) 1000 h.

Figure 6 shows the top-view morphology evolution of the Cu_6Sn_5 grains during the aging process. As presented in Figure 6a, the Cu_6Sn_5 particles of the as-soldered joint were fine, hill-like grains, between which there are obvious gaps. This top-view morphology fit with the scallop-like morphology in Figure 4a. During the aging process, the size of the Cu_6Sn_5 grains increased, and hence the gaps were filled, making the top-view surface of the IMC layer flatter, which also fit with the cross-section morphology [13]. As the Cu_3Sn is located between the Cu_6Sn_5 and the Cu substrate, it cannot be observed from the top view.

The growth of the IMC layers at the Sn-based solder/Cu interfaces has been proven to be attributable to the thermal diffusion of the Cu atoms from the Cu substrate to the joint interface [12]. It can be found from Figure 6a that there were relatively wide gaps between the Cu_6Sn_5 grains, and thus there were two paths for migration of the Cu atoms towards the IMC/solder interface, as exhibited in Figure 7. The atoms diffused through path A would make the grains grow vertically to the interface by passing through the entire Cu_6Sn_5 grain, which was relatively difficult. In contrast, diffusion path B through the grain boundary was shorter and quicker, and thus path B was much easier for the migration of the Cu atoms, making the growth of the Cu_6Sn_5 induced by diffusion through path B more significant. As a result, the gaps between the Cu_6Sn_5 grains were filled during the aging process, resulting in the morphology changes shown in Figures 4 and 6.

- (2) The Cu₆Sn₅ layer grew gradually during the thermal aging process, and the Cu₆Sn₅/ solder interface transformed from a scallop-like morphology into a flat morphology; a Cu₃Sn layer appeared between the Cu₆Sn₅ and the Cu substrate. The thickness of the interfacial IMC layer increased significantly after long-time aging.

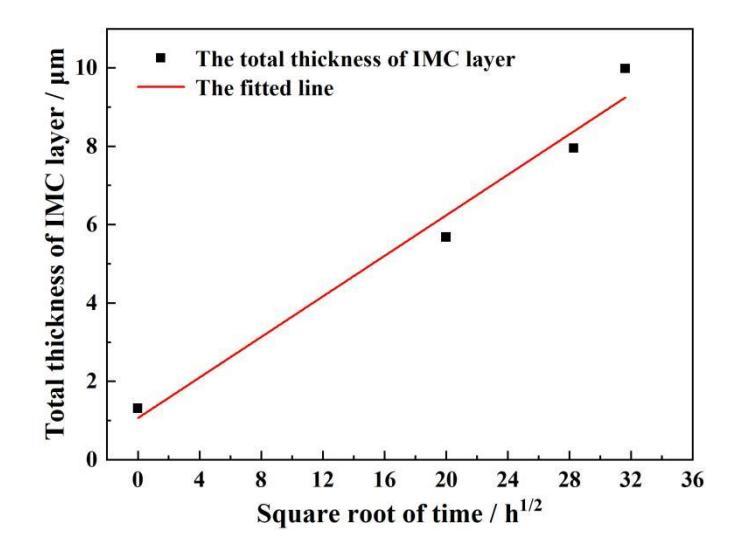
where X_0 is the thickness of the IMC layer in the as-soldered joint, and D is the growth coefficient of the interfacial IMC layer in the service environment, which is used to quantitatively characterize the interfacial reaction behavior of the solder joint. Using Equation (4) to fit the thicknesses of the IMC layers presented in Table 2, the growth curve shown in Figure 5 was obtained. Therefore, the growth equation of the IMC layer in the SnPbSb/Cu joint during thermal aging can be expressed as:

$$Xt = 1.06 + 0.259t^{1/2}$$
(5)

Based on Equation (5), the growth coefficient of the IMC layer of the SnPbSb/Cu joint was calculated to be 1.86×10^{-17} m²/s at 150 °C.

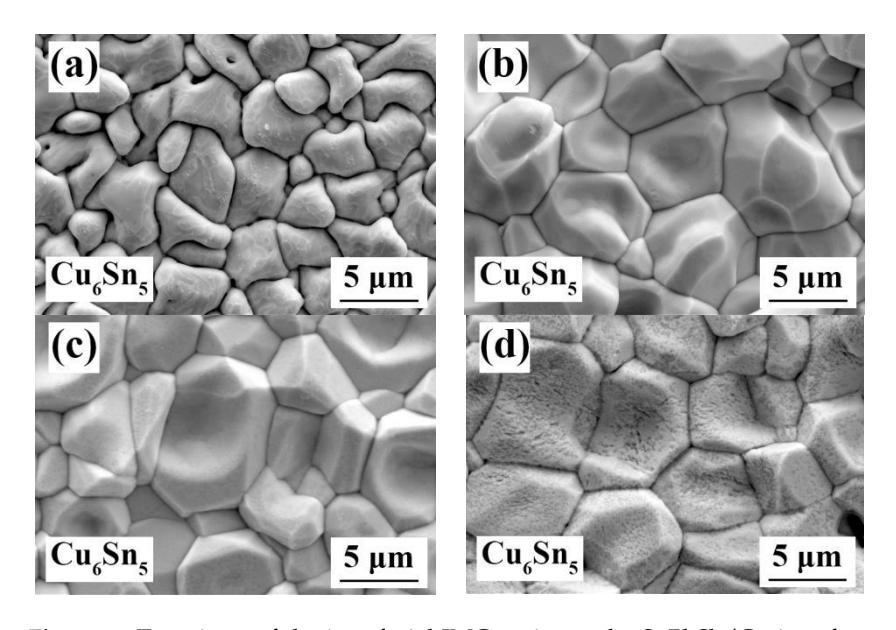
Figure 6. Top views of the interfacial IMC grains at the SnPbSb/Cu interface aged at 150 $^{\circ}$ C for (**a**) 0 h, (**b**) 400 h, (**c**) 800 h and (**d**) 1000 h.

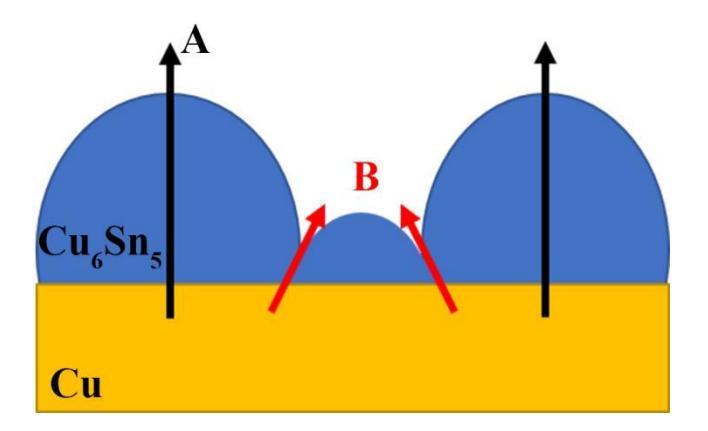
Figure 7. Schematic diagram on diffusion of the Cu atoms at the joint interface.

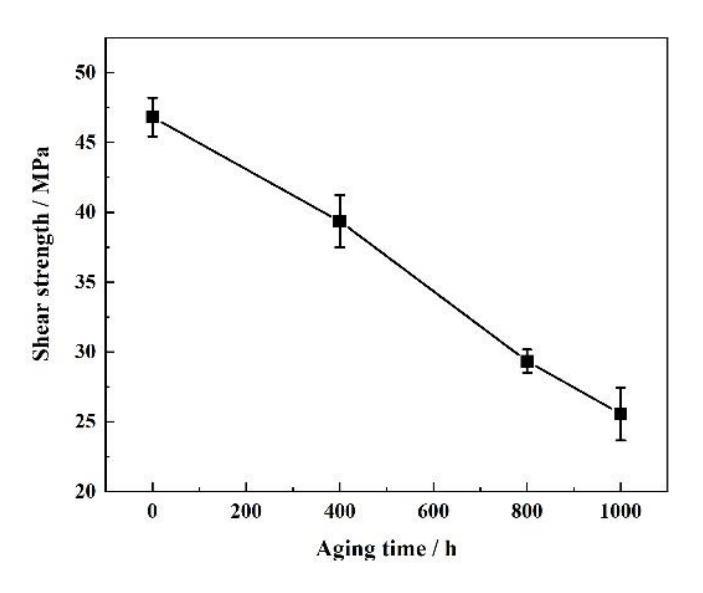
The shear strength of the SnPbSb/Cu solder joint during the thermal aging process is shown in Figure 8. It can be seen from the figure that the shear strength of the as-soldered SnPbSb/Cu joint reached 46.83 MPa, which indicated that a firm bonding had formed between the SnPbSb solder and the Cu substrate. However, after the thermal aging, the shear strength decreased continuously. After 1000 h of aging, the shear strength of the SnPbSb/Cu solder joint became 25.57 MPa, which was 45.39% lower than that before the aging.

Figure 8. Evolution in shear strength of the SnPbSb/Cu solder joint during the high-temperature aging process.

It has been revealed that coarsening the IMC layer significantly worsens the mechanical properties of the solder joint [14,15]. As the intermetallic compounds, the growth of the Cu_6Sn_5 and Cu_3Sn layers increased the brittleness of the solder joint interface, resulting in a higher fracture risk. In addition, the grain boundary can act as an obstacle to crack propagation. The alloy with a finer grain has a higher density of grain boundaries, and

thus the obstacle of grain boundaries to fracturing is more obvious, and the mechanical properties of the alloy will be better [16]. During the high-temperature aging process, the thickness of the IMC layer of the SnPbSb/Cu joint increased obviously; meanwhile, the solder matrix coarsened significantly. Due to the combined effect of these two factors, the shear strength of the SnPbSb/Cu solder joint decreased continuously.

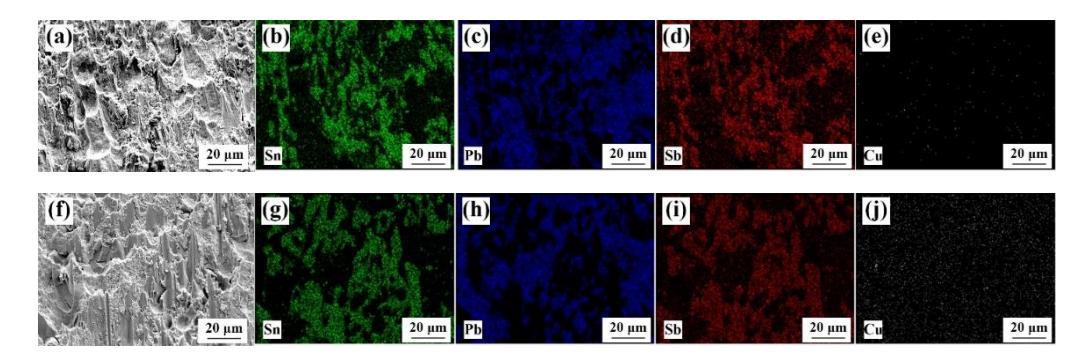
To further reveal the fracture mechanisms of the SnPbSb/Cu solder joint, the fracture morphologies of the as-soldered and aged solder joints were observed. As shown in Figure 9a, there were a large number of shear dimples on the fracture surface of the as-soldered joint, showing a very obvious ductile fracture characteristic. In addition, the elemental distribution shown in Figure 9b–e demonstrated that almost all the elements on the surface were Sn, Pb and Sb, while Cu was negligible. Hence, it could be predicated that the fracture of the as-soldered SnPbSb/Cu joint is a ductile fracture occurring inside the solder. After aging for 1000 h, shear dimples could still be observed on the fracture surface, whose depth had decreased, but still no brittle fracture feature was observed. The EDS results (see Figure 9g–j) also showed that after aging for 1000 h, the fracture of the solder joint was still a ductile fracture occurring in the solder, but the characteristics of the ductile fracture were not as obvious as in the as-soldered joint, which indicated that the toughness of the solder joint had decreased.

Figure 9. (a) Fracture surface morphologies and distributions of the (b) Sn, (c) Pb, (d) Sb and (e) Cu elements on the fracture surface of the as-soldered SnPbSb/Cu solder joint, (f) fracture surface morphologies and distributions of the (g) Sn, (h) Pb, (i) Sb and (j) Cu elements on the fracture surface of the SnPbSb/Cu solder joint aged at 150 °C for 1000 h.

Based on Figure 9, it can be predicated that although the increasing thickness of the interfacial IMC layer during the aging process made the joint interface more brittle, it was not the main reason for the decline in the mechanical properties of the solder joint. Fractures of both the as-soldered and the aged solder joints occurred inside the solder matrix, demonstrating that the worsening of the mechanical properties of the solder joints was closely related to the coarsening of the solder, and its effect was more significant than the coarsening of the interfacial IMC layer. The microstructure of the SnPbSb solder in the solder joint before aging was fine, and the average area of the Pb-rich phase was only 14.62 μ m². After aging for 1000 h, the solder matrix coarsened obviously, and the average area of the Pb-rich phase increased by 218.81%. As illustrated in Figure 10, due to the finer microstructure of the solder matrix, the density of grains before aging was higher, which can not only make plastic deformation occur uniformly in more grains and delay the generation of cracks, but also hinder crack propagation, giving the solder joints a higher strength. After the aging, the grains in the solder matrix coarsened obviously. As a result, the retarding effect of the grain boundary on crack initiation and propagation decreased; meanwhile, the interfacial IMC layer grew significantly, leading to the continuous worsening of the mechanical properties of the solder joints.

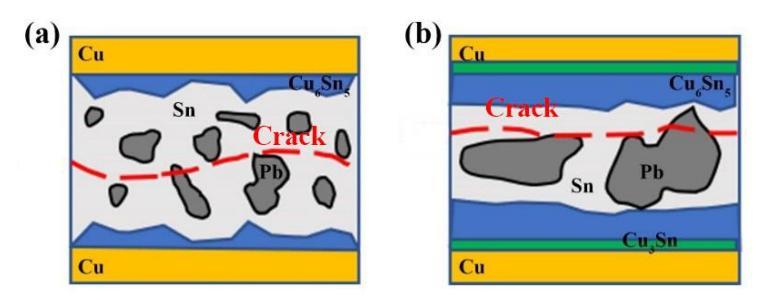
Figure 10. Schematic diagrams on shear behavior of the solder joints (**a**) before and (**b**) after thermal aging.
