Article

# Laser Damage Performance Study of Fundamental Frequency Dielectric Film Optical Elements

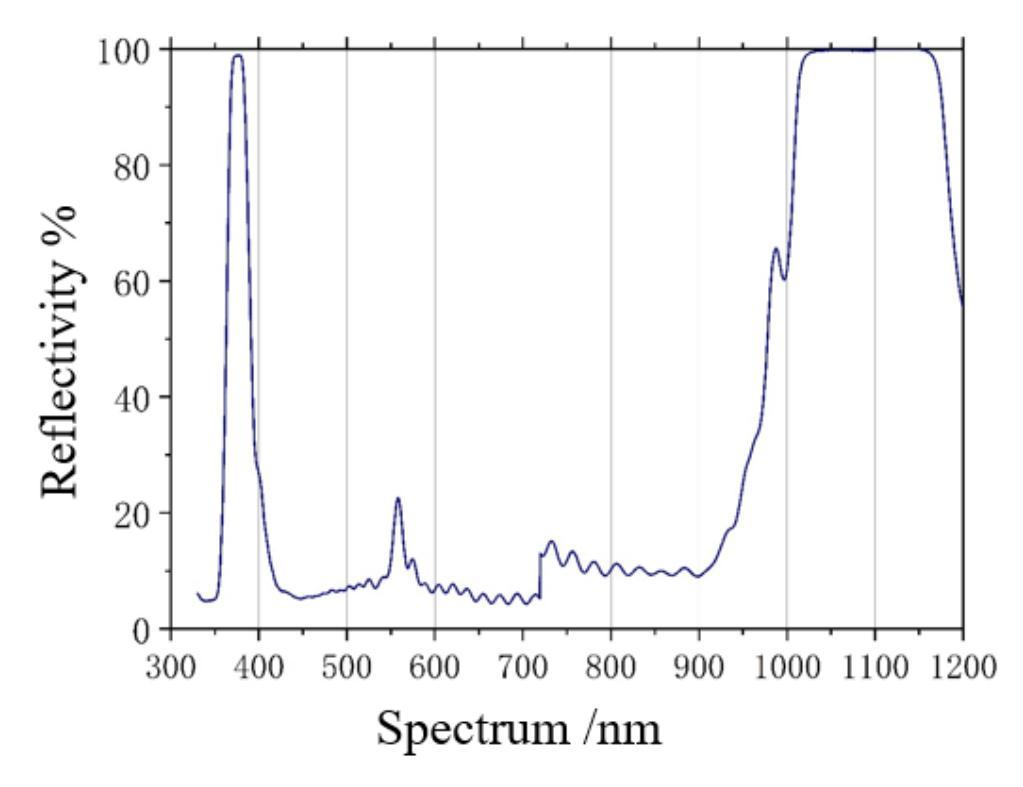
Figure 1. Sample surface testing chart.

Reflectance testing of the samples was carried out on a UV7600 double-beam UV– visible spectrophotometer from Lengguang technology, and the reflection spectrum of the sample was obtained, as shown in Figure 1. The reflectance of the sample can reach nearly 100% at the wavelength of 375 nm and 1064 nm. The reflectivity is 98.5% at 375 nm and 99.6% at 1064 nm. In the wavelength range from 400 nm to 900 nm, the reflectance is significantly reduced to less than 30%, which meets the requirements for engineering use. Using a DEXUN SPMI-600D Profiler, the test obtained a film roughness of 2.1 nm.

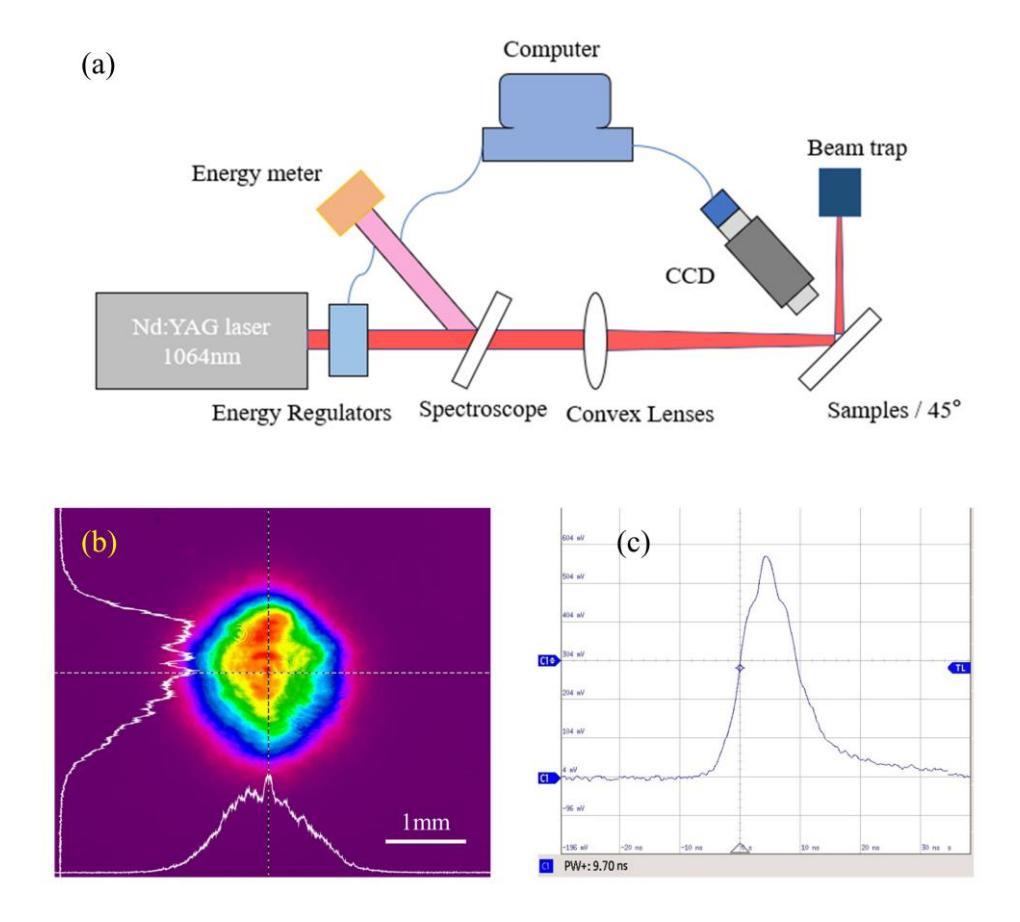
The multi-longitudinal mode Nd: YAG laser was used for the experiments. The schematic diagram of the laser damage testing device is shown in Figure 2a, with an output wavelength of 1064 nm and a pulse width of 9 ns (Figure 2c). The area of the light spot is 3.6 mm<sup>2</sup>, the quality of light is favorable, both transverse and longitudinal light intensities are relatively uniform, and the maximum energy output accuracy of the laser is 100 mJ. The microscopic imaging system was used to perform the online monitoring of the damage and consisted of a microscope and CCD for the online observation by computer with a resolution of ~6 µm. The dielectric film sample was placed at an angle of 45° to the optical path. The role of the beam splitter is to perform the fixed beam splitting of the main laser beam, and after beam splitting, the low-energy beam enters the beam diagnostic device, which gives the beam information, such as spatial distribution of the laser pulses, time distribution, and beam splitting energy. The outgoing laser is focused on the sample optical surface by the optical path, the sample position spot area is  $1.07 \text{ mm}^2$ , as in Figure 2b, and the spot tuning system is 1.8. The 1-on-1, R-on-1, and damage area growth experiments are performed on the sample using this device, and the damage of the sample is recorded by the microscopic imaging system during the experiments.

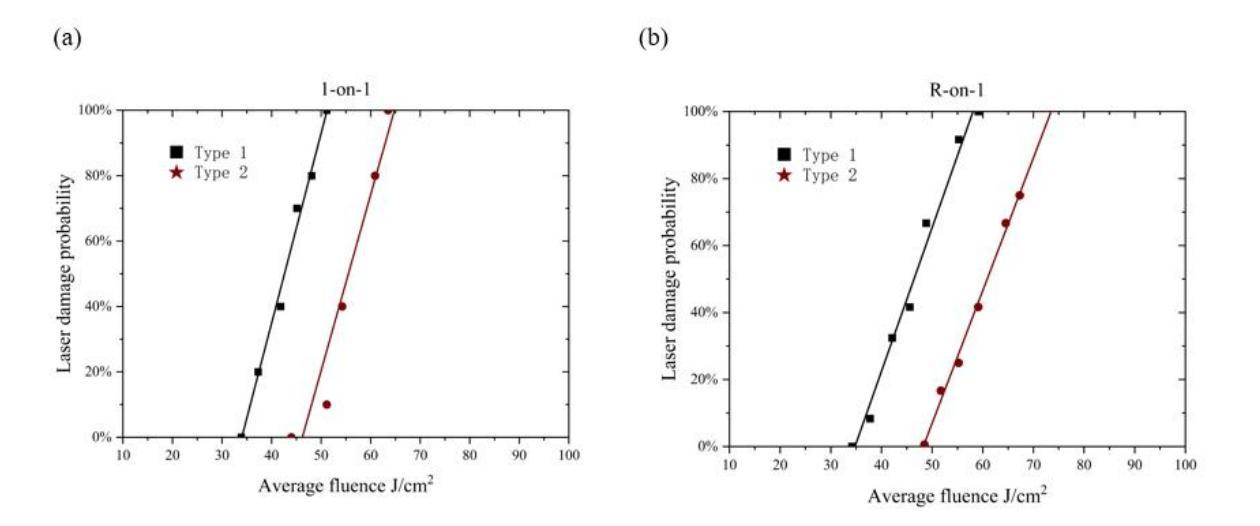
Figure 3. (a) The 1-on-1 experimental damage threshold curve and (b) R-on-1 experimental damage threshold curve.

The damage threshold test results for the samples are shown in Figure 3 and Table 3. In both test experiments, the type 1 damage threshold was lower than the type 2 damage threshold; in the 1-on-1 test, the type 1 damage threshold was 34.41 J/cm<sup>2</sup> and the type 2

damage threshold was 45.76 J/cm<sup>2</sup>; in the R-on-1 test, the type 1 damage threshold was 34.94 J/cm<sup>2</sup> and the type 2 damage threshold was 48.05 J/cm<sup>2</sup>. The R-on-1 test is slightly higher than the 1-on-1 test in both types of damage thresholds. The damage thresholds of the samples were more stable and the samples were of good quality. The laser irradiation produced different damage patterns for the two types of damage, and the subsequent experimental changes were also different.

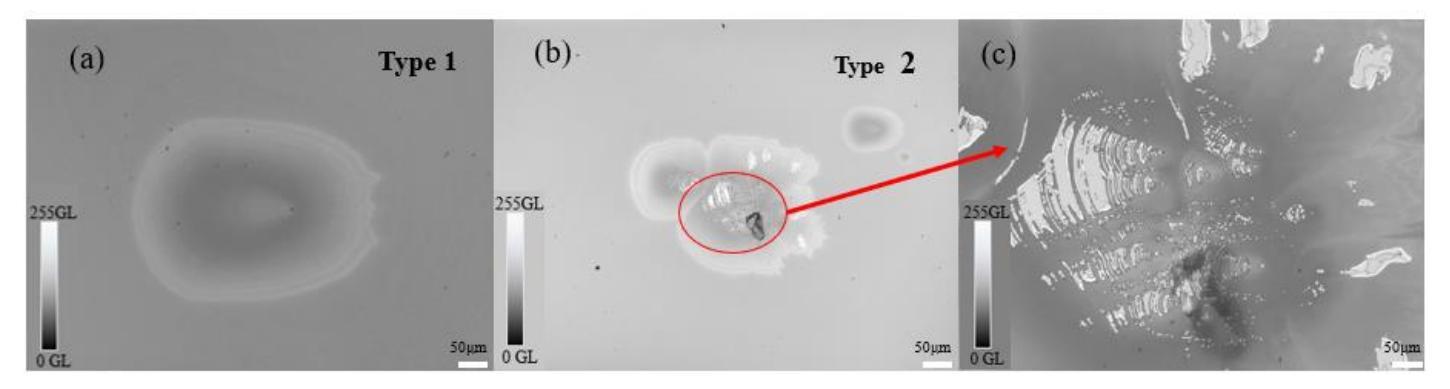
Figure 4. Microtopography of the sample damage. (a) Type 1; (b) type 2; and (c) local magnification of type 2 damage.

Type 1 damage is usually smaller in size and more dispersed. The main manifestation is the discoloration of the film layer, which becomes white or gray, and the color difference of the damaged area of the film layer can be observed under a high magnification microscope. In the experiments, the laser was incident at 45° to the sample surface, and the damage tended to be oval in shape. In Figure 4a, the edges of the damaged film surface are higher than the unirradiated film surface, and the area near the center is concave.

accompanied by ablation marks at the edge of the damage. In Figure 4b,c, the film layer fracture edge is clear, representing stress damage, and the height of the damage site is lower than that of the undamaged film layer. Melt-like damage appears in Figure 4c.

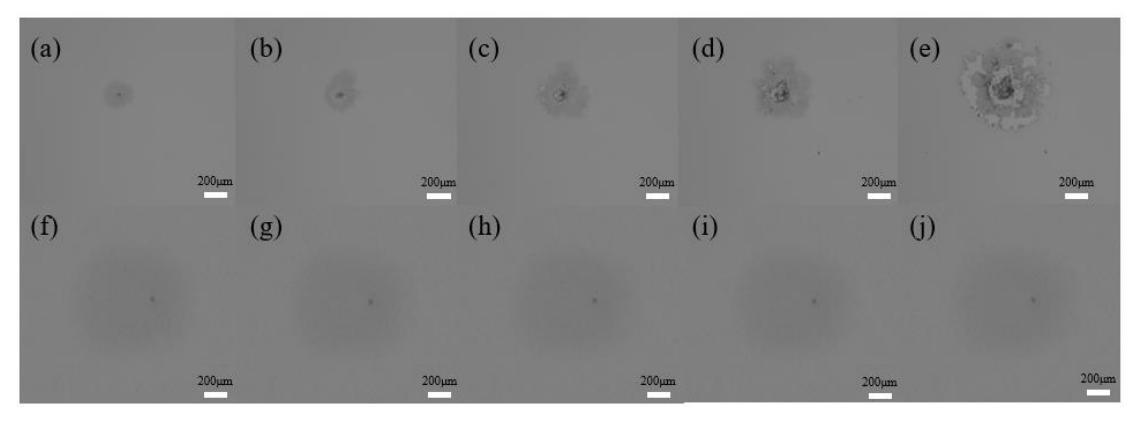
**Figure 5.** Damage growth morphology of 46.4 J/cm<sup>2</sup> experiment. (**a**) Initial damage morphology of type 2; (**b**–**e**) damage growth morphology of type 2; (**f**) initial damage morphology of type 1; and (**g**–**j**) damage growth morphology of type 1.

As shown in Figure 5a, the initial damage was caused by a fluence of 46.4 J/cm<sup>2</sup> and the damage is of type 2. In Figure 5b–e, the shape of the damage growth is at 43.7 J/cm<sup>2</sup> fluence for 1–4 hits, which is below the threshold fluence of type 2 damage. The damage grows and expands rapidly, forming a more serious shape of type 2 damage.

Figure 5f shows the initial type 1 damage caused by 46.4 J/cm<sup>2</sup> fluence, and Figure 5g–j shows the damage growth morphology at 43.6 J/cm<sup>2</sup> fluence for 5, 10, 15, and 20 hits, and it can be observed that the shape of the damage has not changed.

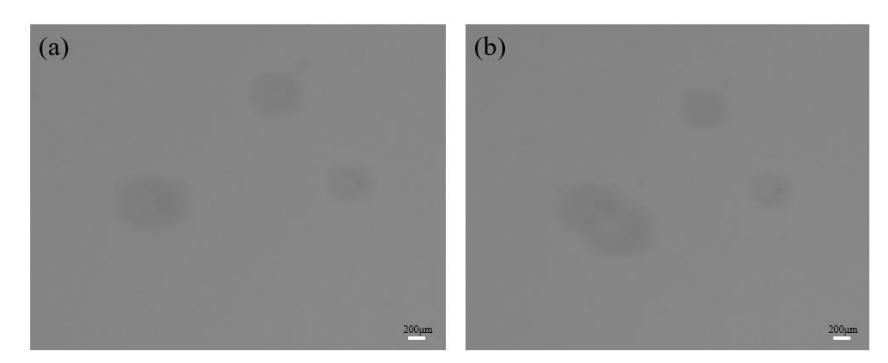
**Figure 7.** Damage profile of the high flux multiple irradiations. (**a**) Initial damage morphology and (**b**) damage profile of multiple irradiations.

As shown in Figures 6–8, Type 1 damage subsequently uses 46.4 J/cm<sup>2</sup> fluence (initial damage formation flux) or less than this flux, but when there is laser irradiation or there are multiple irradiation cases, there is no change in the damage.

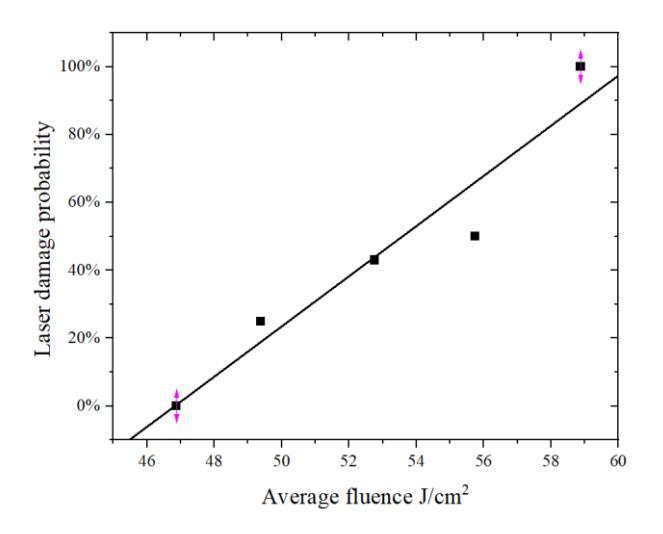
Figure 8. The threshold of type 1 damage transforming into type 2 damage.

In the subsequent striking process that uses a fluence greater than 46.4 J/cm<sup>2</sup> but less than 46.8 J/cm<sup>2</sup>, the area change is small. Either the area does not increase in the process of multiple strikes or any increase is not significant, and the growth of damage morphology is of type 1.

If the irradiation fluence is greater than 46.8 J/cm<sup>2</sup> (damage transformation threshold), part of type 1 damage will grow into type 2 damage, and the probability of growth increases as the laser fluence increases.

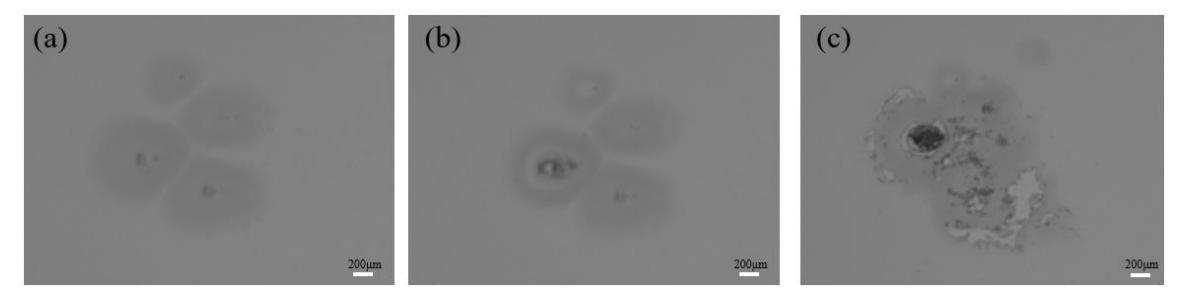
**Figure 9.** Damage profile of low flux multiple irradiations. (**a**) Initial damage morphology; (**b**) 5 irradiations; and (**c**) 10 irradiations.

From Figures 9–11, type 2 damage causes damage growth at fluxes above 26.3 J/cm<sup>2</sup>, which is much less than the type 2 damage threshold (and also less than the type 1 damage threshold). As the fluence increases, a small number of shots can cause a rapid increase in damage. This suggests that type 2 damage is often the result of thermal effects and thermal stress from laser irradiation.

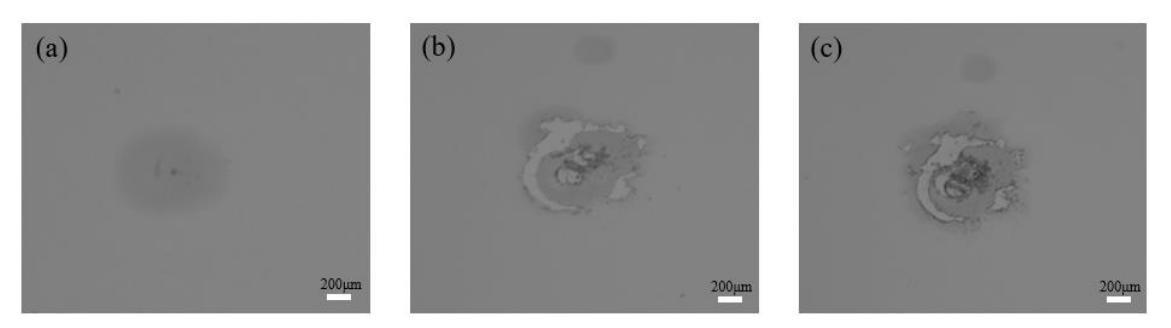
**Figure 10.** Damage profile of high flux multiple irradiations. (**a**) Initial damage morphology; (**b**) 2 irradiations; and (**c**) 3 irradiations.

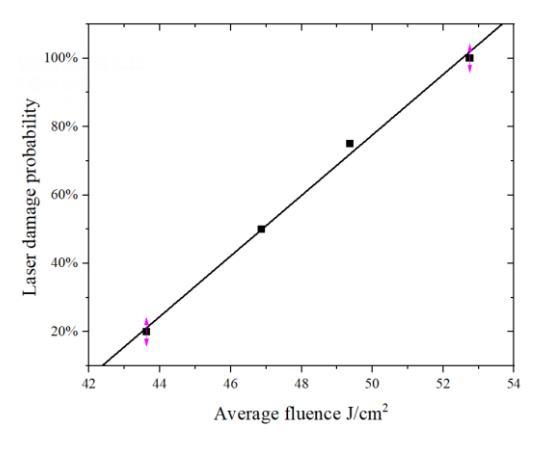
Figure 11. Growth threshold of type 2 damage.

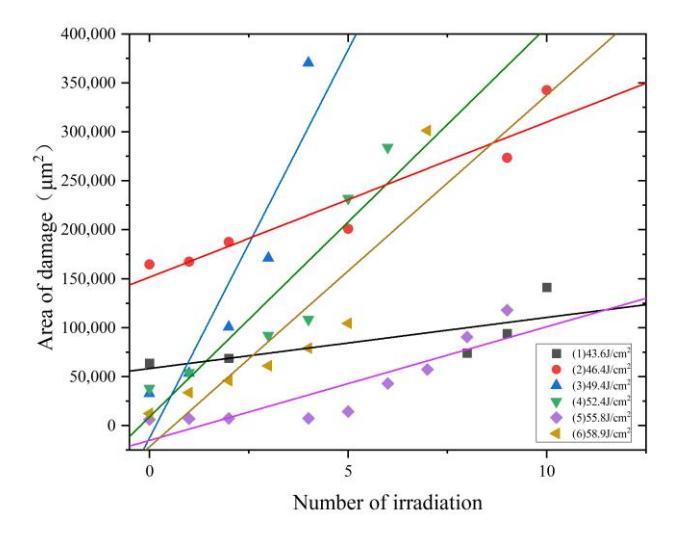
Figure 12. Fitting curve of the damaged area.

As shown in Figure 12, with the increase in the number of laser irradiations, the damaged area increases, and eventually, there is an upper limit to the damaged area, after which the damaged area remains unchanged and does not continue to grow, a phenomenon that may be related to the effective area of the laser spot size.

The slope of the fitting curve under different fluxes in Figure 12 can be observed, with the increase of laser irradiation flux, the damage area increases first and then decreases. The maximum growth rate of the damaged area was observed near the fluence of damage formation. The growth rate of the damaged area under the fluence of 58.9 J/cm<sup>2</sup> was greater than 55.8 J/cm<sup>2</sup>, which was considered to be too large a fluence, resulting in new damage to the sample. Regardless of the size of the initial damage area, whenever type 2 damage is produced, the damaged area grows rapidly under shorter hit times.

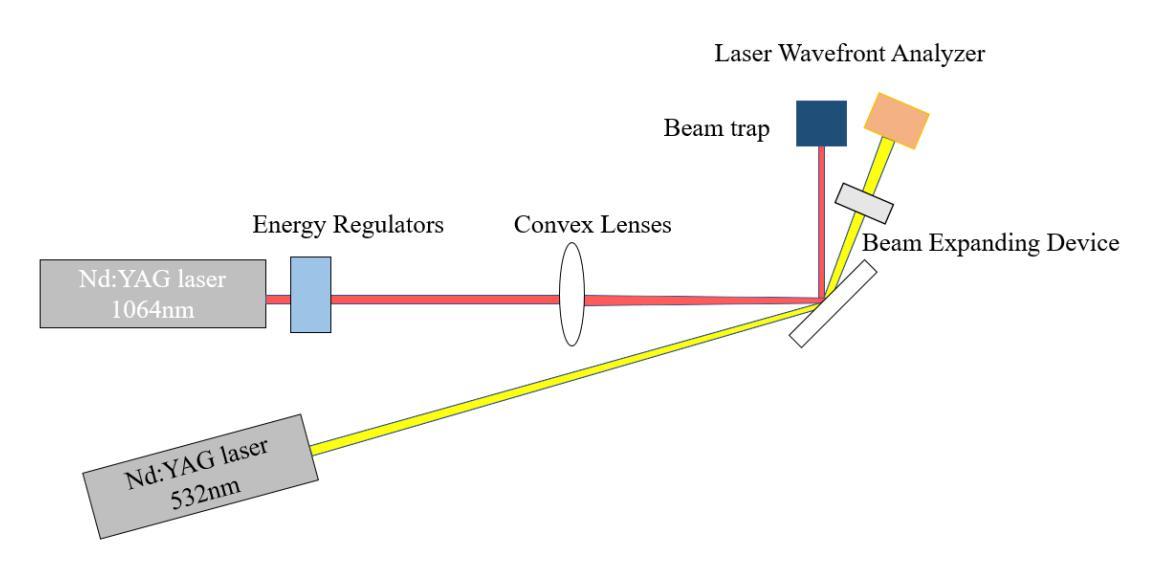
Figure 13. Sample surface shape test device.

In the experiments, it was observed that the two types of damage had different growth characteristics under subsequent irradiation: type 1 damage is more stable; the second type of damage grows when irradiated by laser light well below the damage threshold. The difference between the two types of damage may be due to the corresponding changes in the sample before and after laser irradiation. In order to analyze the reasons for the variability of the two types of damage, we tested the change in the reflective surface shape of the sample using an online experiment, and the experimental setup is shown in Figure 13.

A Nd:YAG laser with an output wavelength of 532 nm was used, the wavefront data test beam was output at the damage point and passed through the beam expander into the laser wavefront analysis device, which gave the wavefront data for the sample. The damage samples, type I damage samples, and type II damage samples were tested by this device, and the experimental results are shown in Figures 14 and 15.

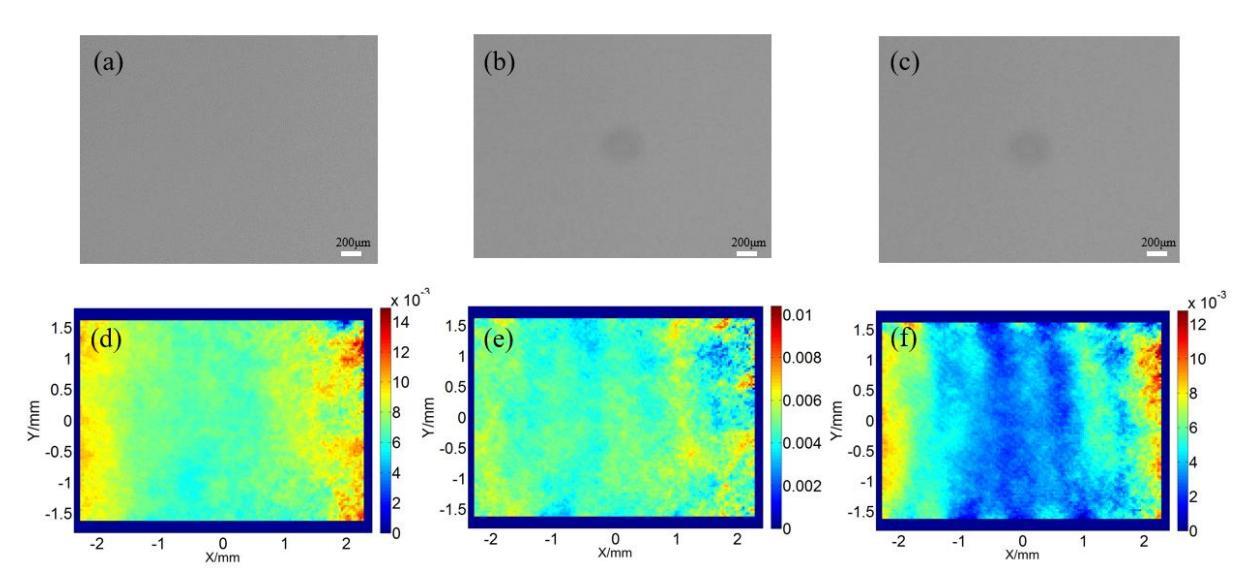
**Figure 14.** The experimental results of type 1 damage microscopic morphology and micro-surface shape test. (**a**) Pre-irradiation; (**b**) damage; (**c**) after 1 irradiation at the same flux; (**d**) pre-irradiation; (**e**) damage; and (**f**) after 1 irradiation at the same flux.

Figure 14 shows the microstructure of type 1 damage and the results of micro-zone wavefront tests, where (a) shows the microstructure of the sample before laser irradiation,

(b) shows the shape of type 1 damage produced after laser irradiation, and (c) shows the shape of damage produced after re-irradiation at the same fluence. Figure 14d–f shows the results of wavefront tests in the microregion corresponding to Figure 14a–c. Comparing Figure 14b,c, the damage did not grow after re-irradiation after the laser produced type 1 damage. Corresponding to Figure 14e,f, the wavefront of the sample changed before and after the damage was produced, and the re-irradiation after the damage caused further changes in the sample, but the actual maximum change was only  $0.006\lambda$ .

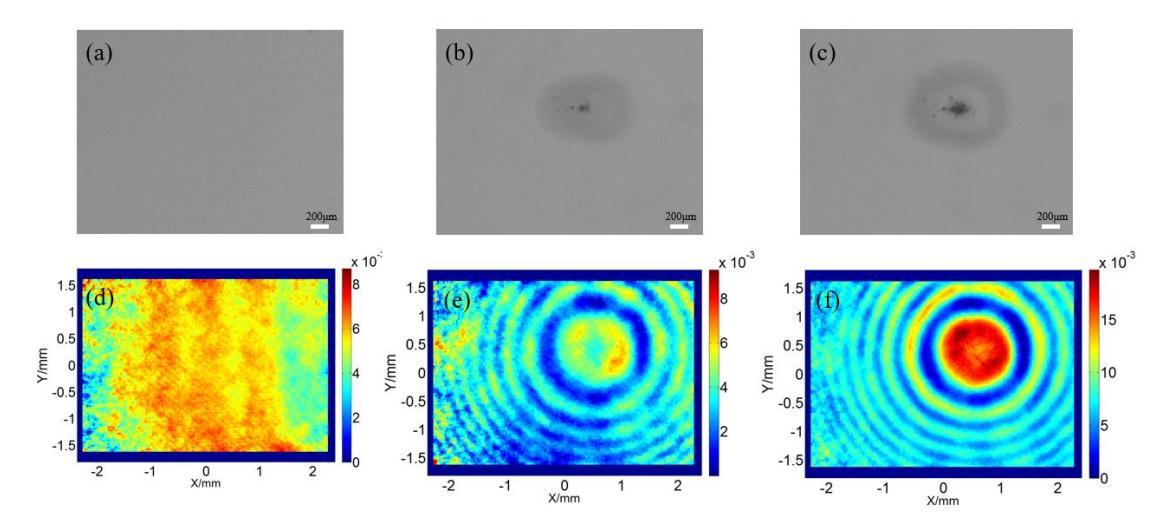
**Figure 15.** The experimental results of type 2 damage microscopic morphology and micro-surface shape test. (**a**) Pre-irradiation; (**b**) damage; (**c**) after 1 irradiation at the same flux; (**d**) pre-irradiation; (**e**) damage; and (**f**) after 1 irradiation at the same flux.

Figure 15 shows the microscopic morphology of the type 2 damage and the microzone wavefront test results, where (a) shows the microscopic morphology of the sample before laser irradiation, (b) shows the morphology of the type 2 damage after laser irradiation, and (c) shows the morphology of the damage after re-irradiation at the same fluence after damage generation. Figure 15d–f shows the results of wavefront tests in the microregion corresponding to Figure 15a–c. The wavefront distribution of the sample before and after the damage was produced, significantly changed the center of the damage point, and after the damage was irradiated again, the wavefront data around the damage point increased significantly, which corresponds to the growth of the damage point in Figure 15c compared with that in Figure 15b for the second type of damage.
