# Simulation and Experimental Investigation on Carbonized Tracking Failure of EPDM/BN-Based Electrical Insulation

Abstract: Ethylene propylene diene monomer (EPDM) is broadly employed as an insulating material for high voltage applications. Surface discharge-induced thermal depolymerization and carbon tracking adversely affect its performance. This work reports the electrical field modeling, carbon tracking lifetime, infrared thermal distribution, and leakage current development on EPDM-based insulation with the addition of nano-BN (boron nitride) contents. Melt mixing and compression molding techniques were used for the fabrication of nanocomposites. An electrical tracking resistance test was carried out as per IEC-60587. Simulation results show that contamination significantly distorted the electrical field distribution and induced dry band arcing. Experimental results indicate that electric field stress was noticed significantly higher at the intersection of insulation and edges of the area of contamination. Moreover, the field substantially intensified with the increasing voltage levels. Experimental results show improved carbonized tracking lifetime with the addition of nano-

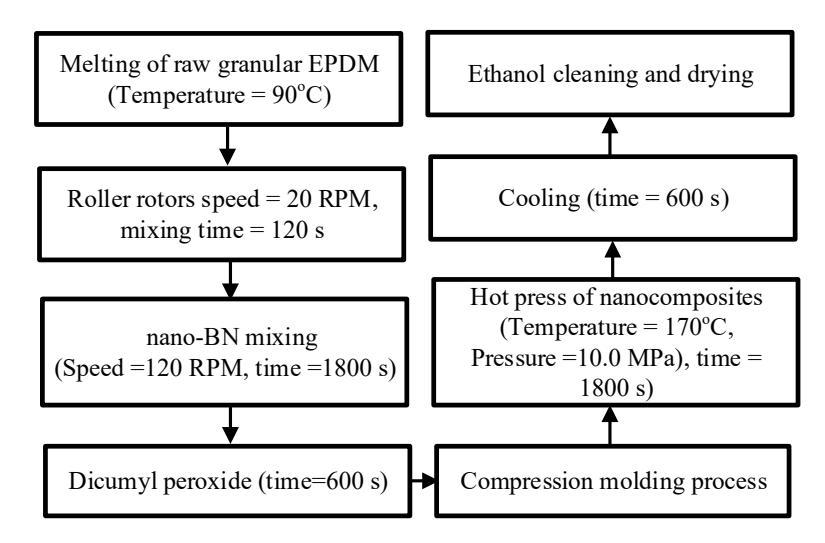
**Figure 1.** Step involved for the fabrication of the ethylene propylene diene monomer (EPDM) nanocomposite.

For nanocomposite synthesis, a pristine EPDM batch (Keltan<sup>®</sup>2470) with a density of 860 kg/m<sup>3</sup> was used in this study. This pristine pellet form of EPDM was composed of ethylene (69%) and a bicyclic monomer ethylidene norbornene (4.2%). Boron nitride (BN) thermally-conductive nanoparticles [25] with a size of 50 nm and a density of 2250 kg/m<sup>3</sup> were supplied by Beijing DK Nano Technology, Beijing, China. The surface of the nanoparticle was functionalized by KH570 silane coupling to reduce the degree of agglomeration in the composites. EPDM was crosslinked by adding dicumyl peroxide (DCP). The complete methodology of nanocomposites' preparation is described in Figure 1. In order to determine the nano-BN dispersion in the composites, SEM micrographs of selected samples are shown in Figure 2. Nano-BN particles were seen to be homogeneously distributed in the samples, while some degree of agglomeration was observed in the nanocomposites with loadings of 5 and 7 wt % due to the attraction effect of adjacent nanoparticles under high contents. Finally, all the samples were cleaned with ethanol and rested overnight in an oven before the experiments.

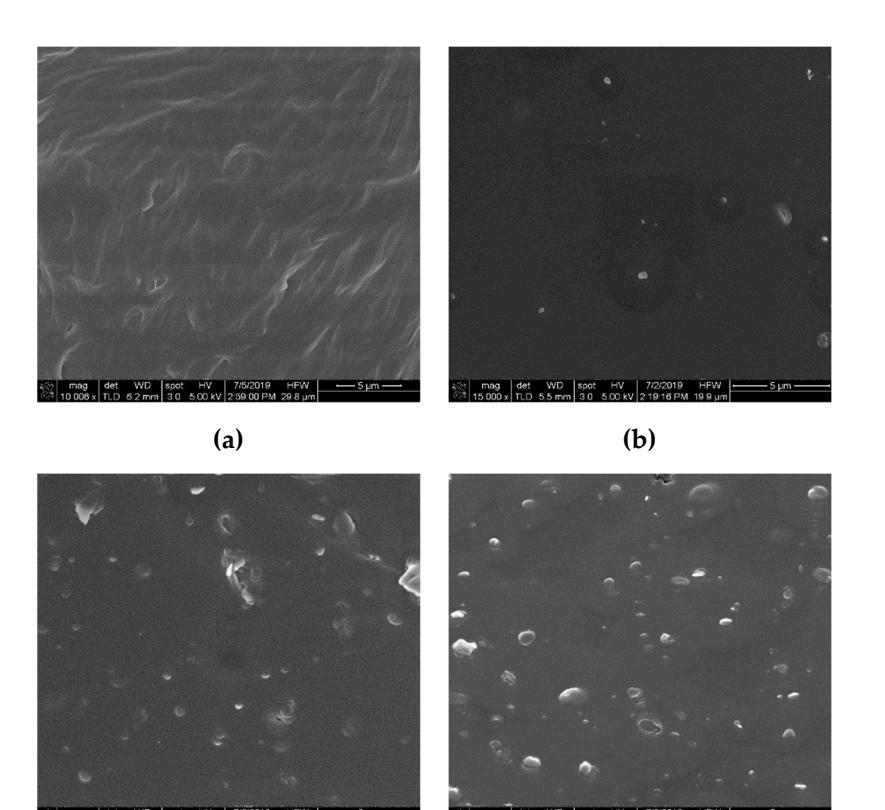
**Figure 2.** Nano-BN (boron nitride) distribution in (**a**) 0 wt %, (**b**) 1 wt %, (**c**) 5 wt % and (**d**) 7 wt % nanocomposites.

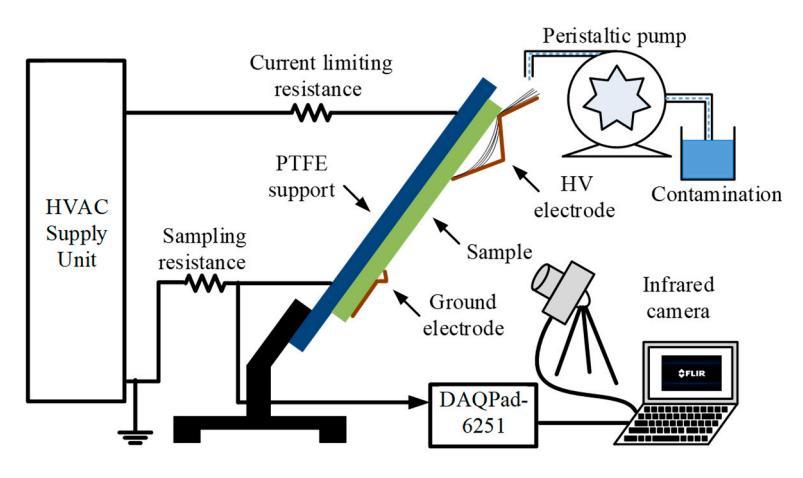
Figure 3. Inclined plane tracking test setup.

A protocol defined in IEC-60587 was used for the IPT [26], and a schematic diagram of the experimental arrangement is shown in Figure 3. The samples for the IPT were cast according to the standard with a size of  $5 \times 12 \times 0.6$  cm<sup>3</sup>, and five samples of each category were tested in order to estimate the failure criterion. The EPDM nanocomposites were mounted on an electrically-insulated polytetrafluoroethylene (PTFE) support. The top high voltage and bottom ground electrodes were mounted, and eight layers of filter papers were also inserted in the top high voltage electrodes to get a smooth contamination liquid path on the sample. The contamination liquid was prepared by mixing NH<sub>4</sub>Cl salt and Triton X-100 (Sigma-Aldrich, St. Louis, MO, USA) into deionized water. The electrical conductivity of the contaminant solution was adjusted at 2.50 mS/cm as per the standard. Protocol 2 of IEC-60587 was used with a starting applied voltage of 3000 V, and this was increased by 250 V per hour until the carbonized tracking failure criterion was achieved. The flow of contamination on the peristaltic pump was controlled at 0.30 mL per minute.

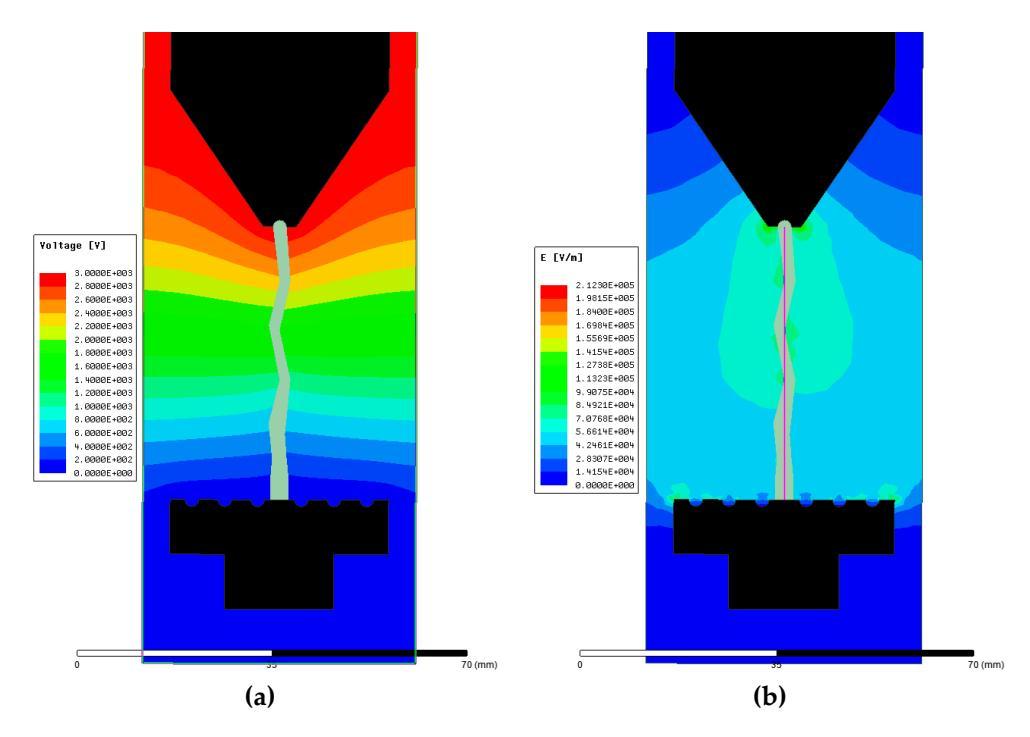
Figure 4. Voltage (a) and electric field distribution (b) in the inclined place test (IPT).

The ANSYS Maxwell® finite element analysis (FEA) software (2017.1, ANSYS, Inc., Pittsburgh, PA, USA) was used for the electric field and voltage distribution modeling of the EPDM insulation. IEC 60587 was used as a reference for the modeling of the parameters in the simulation (Table 1). A 2D EPDM insulation model with the size of  $5 \times 12$  cm<sup>2</sup> was designed along with steel high voltage and ground electrodes as per the standard, as shown in Figure 4. Field modeling was performed and validated at the complete formation of the contamination path according to IEC Standard 60587. The electrical conductivity and relative permittivity of the modelled items were required in the simulation. The relative permittivity of EPDM was measured through a dielectric spectroscopy experiment. The electrostatic solution type was validated in the 2D analysis. Figure 4a shows the voltage distribution at the complete development of the contaminated path. The applied voltage gradually reduced from the top to the bottom electrode. The electric field distribution on the surface of the sample is shown in Figure 4b. It can be noticed that electric field stress was elevated at the edges of the contamination. Figure 5 shows the profiles of the electric field distribution on a vertical line bisecting the sample (shown in Figure 4b) from the top to the bottom electrode. The results show that electric field strength was substantially higher at the intersection of the sample surface and the tapered section of the contamination.

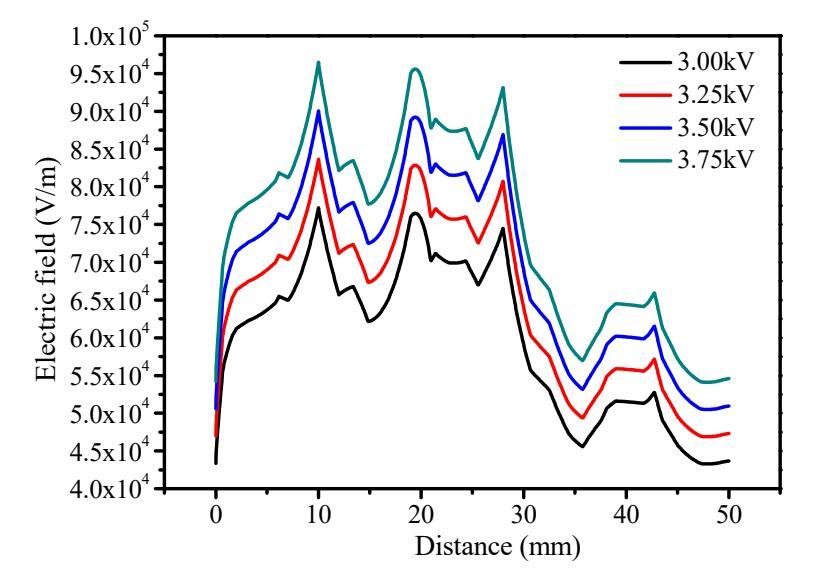
Figure 5. Electric field profiles at different voltage levels.

1. The electric field strength was substantially higher at the intersection of the sample surface and the edges of the area of contamination. An increasing field with increasing voltage intensified the dry band arcing activity, which initiated the ohmic heating-induced thermal depolymerization of EPDM and electrically conductive carbonized tracking.

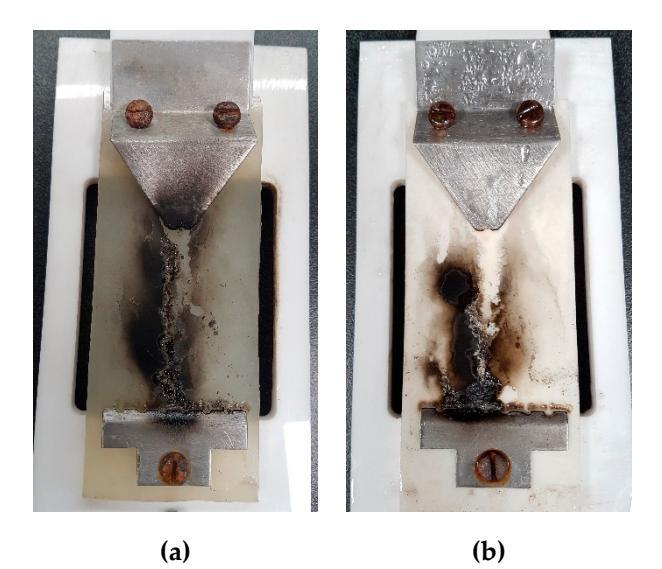
**Figure 6.** Carbonized tracking failure of the (**a**) 0 wt % and (**b**) 5 wt % samples.

Carbon tracking arises from a thermally decomposed carbon contents due to the high amount of heat that is generated by electrical discharges. The release of high energy during the IPT process initiates the thermal depolymerization of EPDM, and carbon tracking tends to start from the bottom electrode and grow towards the high voltage upper electrode. Figure 6 shows the formation of the carbon track and the failure pattern on the surface of selected samples. It is clearly seen that a carbon path, which was electrically conductive, was formed on the surface between the electrodes. The heat accumulation in the discharge area broke the C–H chemical bond in the EPDM, and it resulted in conductive carbon product on the surface of the EPDM. For comparison, the carbon tracking failure times of all the samples are shown in Figure 7.

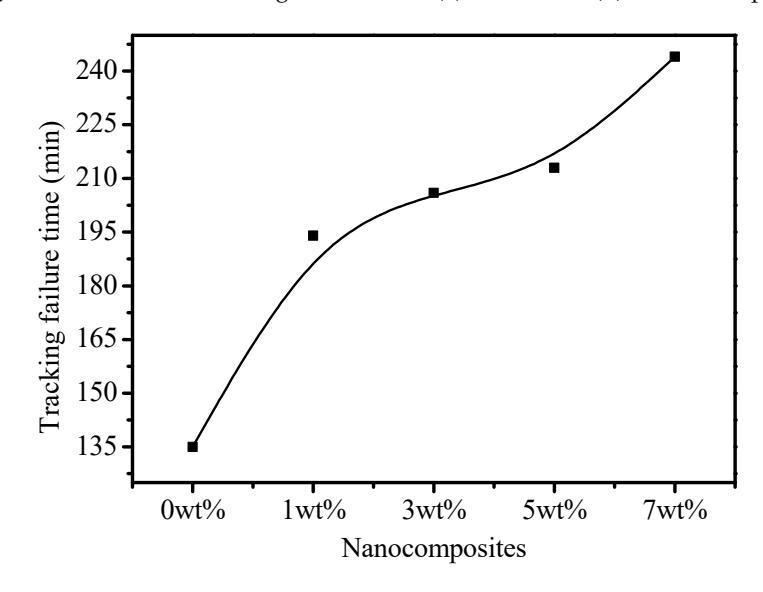
Figure 7. Carbonized tracking lifetime of the EPDM samples.

The tracking lifetime of the EPDM samples was measured at 135.0, 194.0, 206.0, 213.0 and 244.0 min for 0, 1, 3, 5 and 7 wt % loadings, respectively, as seen in Figure 7. Interestingly, the tracking life increased with BN loading in the EPDM. The results indicate that carbon tracking failure was substantially halted by the BN nanoparticles in the composites. The tracking lifetime was significantly higher in the nanocomposites with a higher contents of BN. Surprisingly, a small addition of nano-BN in the 1 wt % sample imparted significant resistance to the track formation and enhanced the failure time. The reason for the excellent tracking lifetime of the EPDM/BN could have been due to better heat distribution in the nanocomposites.

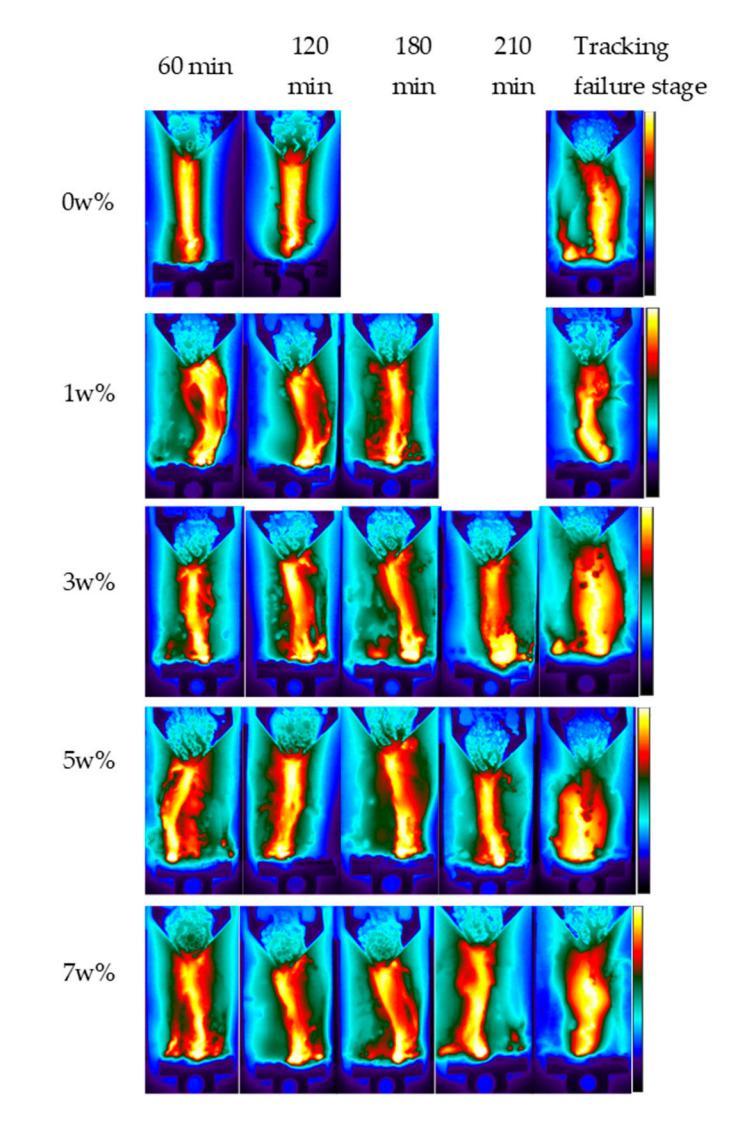
Figure 8. Infrared thermographs of the EPDM samples.

Carbon tracking failure occurs due to the thermal depolymerization of the insulating material due to excessive heat in the arcing area along the contamination path. Due to enhanced DBA activity with increasing voltage, the temperature on the surface of the sample varies on the journey of the tracking process. Here, infrared thermal micrographs were recorded over extended periods until the failure of each sample, as shown in Figure 8. Thermal accumulation activity mostly occurred in the central discharge area. Thermal accumulation was significantly enhanced with the IPT time lapse. The most severe DBA and thermal accumulation was exhibited at the failure stage of the samples.

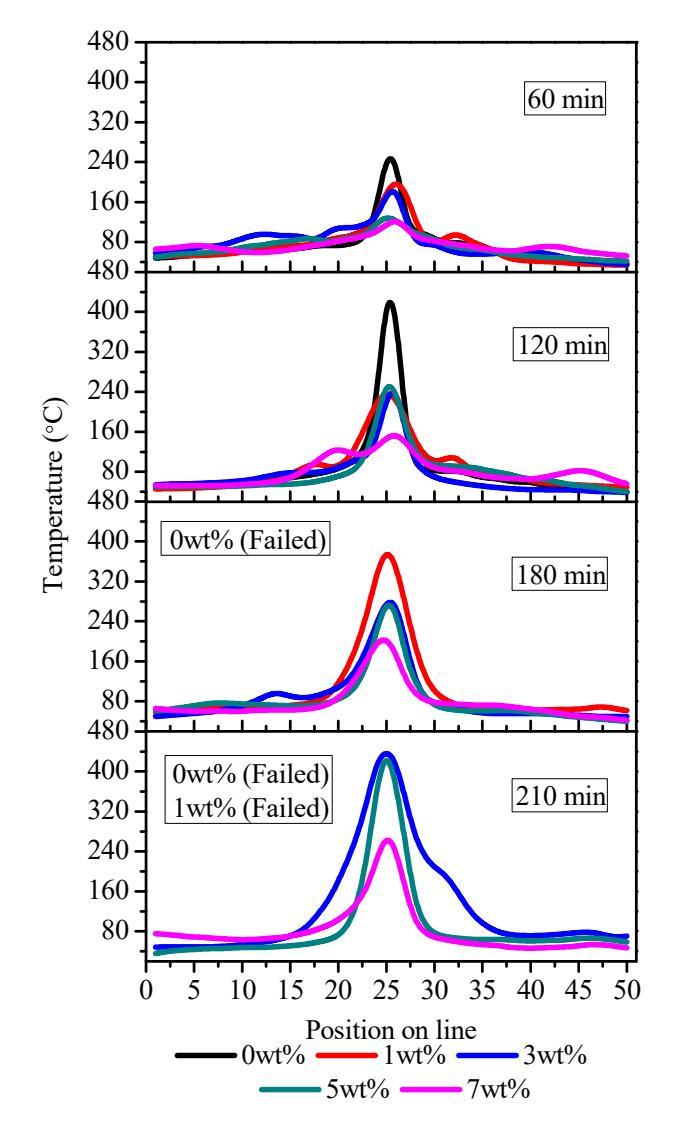
Figure 9. Thermal distribution profiles of the EPDM samples.

Figure 9 illustrates the thermal distribution of each sample according to the criteria described in Section 2.4. A higher thermal accumulation and a higher heat build-up in the central region are clearly witnessed in the infrared images. At the 60 min of the IPT, the recorded maximum temperatures for the nanocomposites were 256, 203, 190, 132, and 124 °C for the 0, 1, 3, 5 and 7 wt % samples, respectively. A significant increase on the surface temperature was seen at the end of 120 min of the tests for all samples except for that of 7 wt %. There was no failure seen in any sample at this point of the IPT.

A substantial thermal accumulation and a substantial temperature rise were seen in the third hour of the experiments. At 180 min, the temperatures were outstandingly increased to 386, 82, 283, 208 °C for the respective samples, as shown in Figure 9. The most interesting aspect of the results at this stage of the IPT was seen in a 0 wt %-unfilled sample, and it failed due to extreme DBA and thermal accumulation. At 210 min, the most severe DBA arcing and thermal accumulation activity was seen in the tests, and the temperatures were measured at 444, 446 and 275 °C for the 3, 5 and 7 wt % samples, respectively. Moreover, the 1 wt % sample also suffered carbonized tracking failure at this stage.

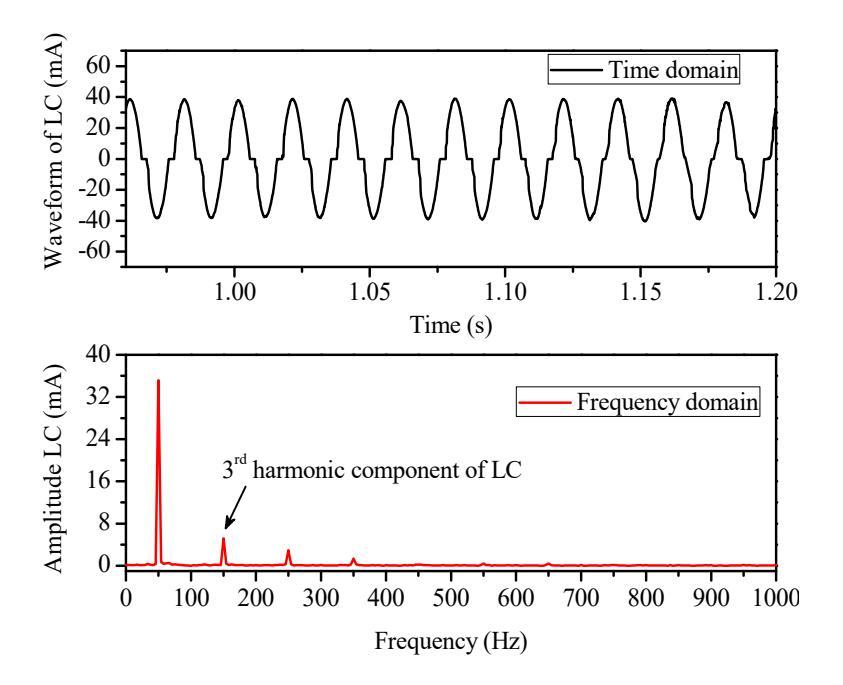
Figure 10. Time domain and frequency domain spectrum of leakage current.

The carbonized tracking failure and thermal accumulation in the IPT were correlated with the third harmonic component of the leakage current during DBA activity. Figure 10 shows the time

domain and frequency domain amplitude of the leakage current during DBA. With the enhanced DBA activity, the third harmonic amplitude was increased significantly and caused major damage. Therefore, the third harmonic component of the leakage current was analyzed by using a fast Fourier transform in this study.

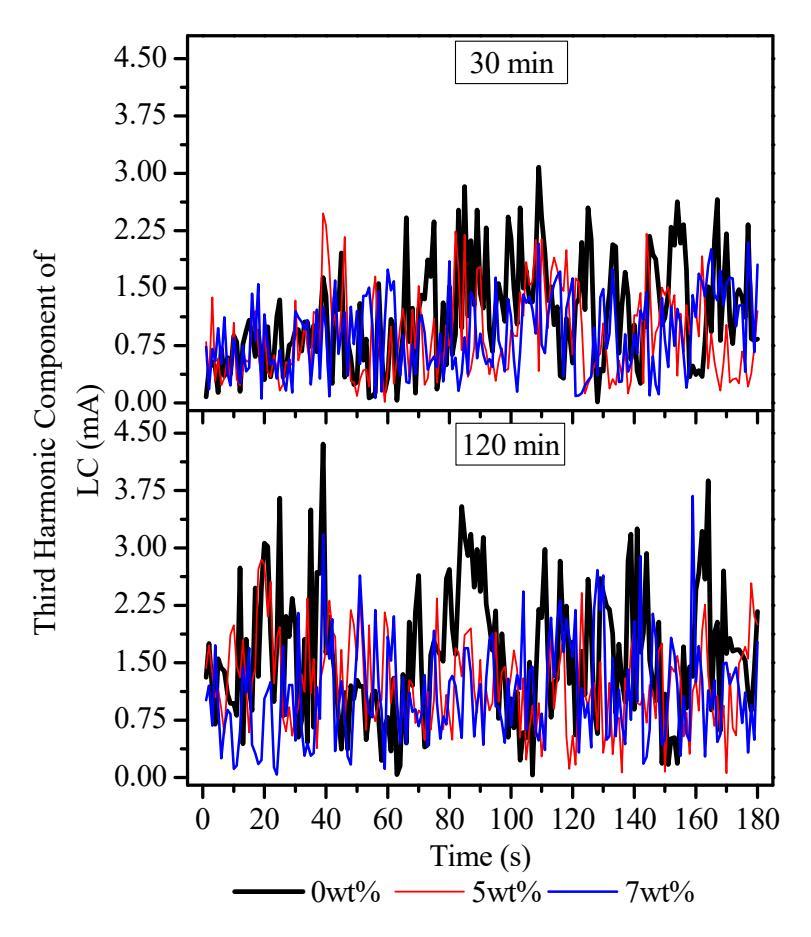
Figure 11. Third harmonic component of leakage current of the EPDM nanocomposites.

Figure 11 shows the third harmonic component of the leakage current of the samples. The result shows that the leakage current gained amplitude during the course of the IPT regardless of the nanoparticle loading. At 30 min of the IPT, the amplitudes were noticeably higher in the 0 wt % sample relative to its counterparts. Moreover, an increment in the peaks of leakage current were seen at 120 min of the IPT. As far as the particle loading is concerned, the amplitude of the third harmonic component in leakage current was seen to be consistent with leakage current results that were recorded at 30 min. Nonetheless, the 0 wt % sample attained a relative enhancement in the amplitudes of leakage current at 120 min, as it showed an increment in the DBA activity. This could have been due to the fast evaporation of the liquid contamination, which is a fundamental cause for this physical phenomenon. The results indicate that the EPDM filled with nano-BN could have restricted the third harmonic component in the leakage current, as compared to the unfilled 0 wt % EPDM. It is believed that nano-BN could have suppressed the third harmonic component in the leakage current on the surface of the nanocomposites and could have restricted the release of high energy. Hence, it impeded thermal depolymerization of the EPDM by suppressing the ohmic heating of the EPDM surface and prolonging the carbon track failure time.

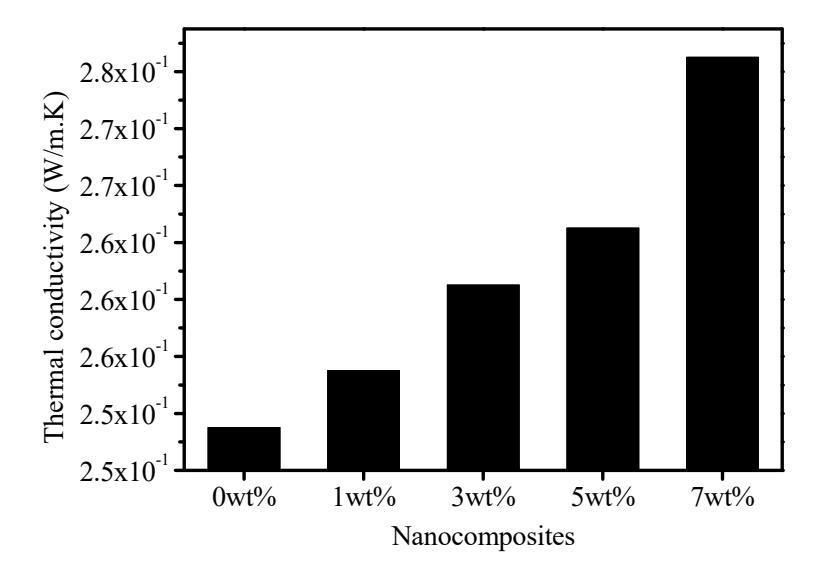
Figure 12. Experimental measured thermal conductivity of the EPDM nanocomposites.

A carbon track initiates due to a substantial amount of heat that is generated in discharge area, especially close to the bottom ground electrode, and it depolymerizes the chemical structure of EPDM. It is believed that long and severe DBA activity decomposes C–H bonds in EPDM, and this decomposition appears in the form of carbon, which produces an electrically conductive failure path on the surface [29]. A better thermal conduction in the discharge region could be a key player to suppress the thermal stress gradient in the discharge area [30]. Figure 12 shows the thermal conductivity of EPDM as a function of its nano-BN-filled counterparts. The results clearly suggest that the thermal conductivity of the filled counterparts was higher than that of the unfilled 0 wt % sample of EPDM. The thermal conductivity of the EPDM/BN nanocomposites increased with the addition of BN contents. The leakage current started to flow from the top to the bottom electrode, and, therefore, it was involved in the conduction, DBA, and heating of the surface. It is well known that a substantial degree of liquid evaporation occurs at the bottom electrode in an IPT, and it tends to enhance the dry band arcing in the region that initiates the carbonization. The EPDM/BN nanocomposites with higher thermal conductivity could conduct the heat out to the ambient from the discharge region and could suppress the temperature build-up. This process may have reduced the evaporation of liquid contamination on the surface of the nanocomposites. Therefore, it is highly likely that less evaporation on the surface of nanocomposites would reduce DBA activity and suppress discharge quantity [20]. On the other hand, less thermal conduction may enhance evaporation and increase DBA activity. Therefore, it is believed that nano-BN will assist in better heat conduction, less evaporation, reduced DBA, and better tracking lifetime of EPDM.

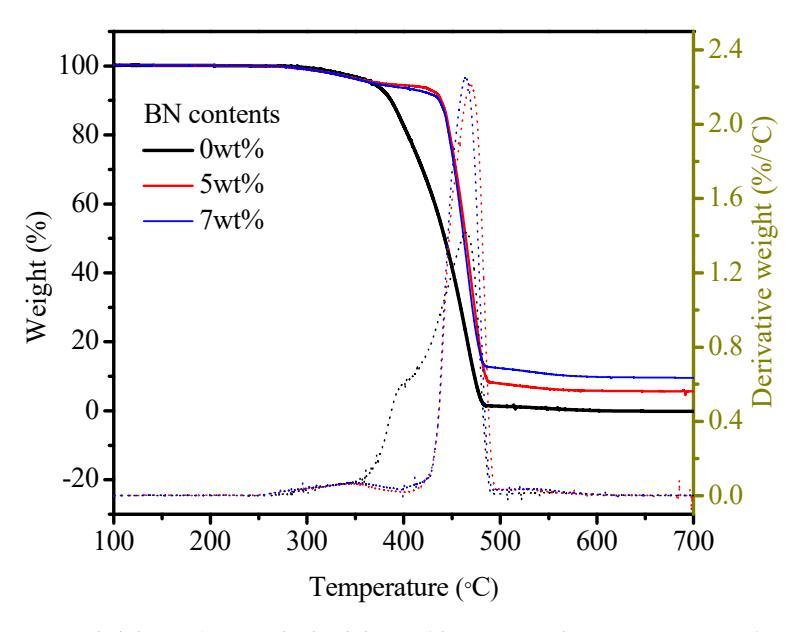
**Figure 13.** TGA; solid lines /DTG; dashed lines (derivative thermogravimetric) profiles of the EPDM nanocomposites.

The repetitive DBA process thermally depolymerizes EPDM; hence, the thermal stability of nanocomposites can play an important role in tracking performance [31]. Figure 13 shows the TGA/DTG profiles of the selected EPDM nanocomposites. The nanocomposites were found stable until 300 °C, and major degradation was observed beyond this temperature. The peak degradation was observed as the surface temperature exceeded 400 °C, which was consistent with infrared thermal analysis results. The initial degradation temperature (IDT) was measured as significantly higher in the filled nanocomposites relative to the 0 wt % sample, as shown from the DTG curves. Moreover, the primary thermal degradation temperatures of various weight losses of the nanocomposites are presented in Table 2.

It is noted that the  $T_{10\%}$ ,  $T_{25\%}$  and  $T_{50\%}$  weight losses of the filled nanocomposites were significantly higher than the unfilled 0 wt %. In addition, the percentage residual weight of the 0 wt % sample was almost zero at 700 °C, but it was significantly higher in the filled nanocomposites. From TGA/DTG results, it can be said that the carbonized tracking performance of the samples was directly correlated with the thermal stability performance of the nanocomposites. The nano-BN interaction with the EPDM matrix was the major factor that enhanced the thermal stability performance of the matrix. It is highly likely that a strong interaction between the EPDM matrix and nano-BN will enhance the chemical cross-linking and physical points, which will restrict segmental movement and improve thermal stability [24,32].

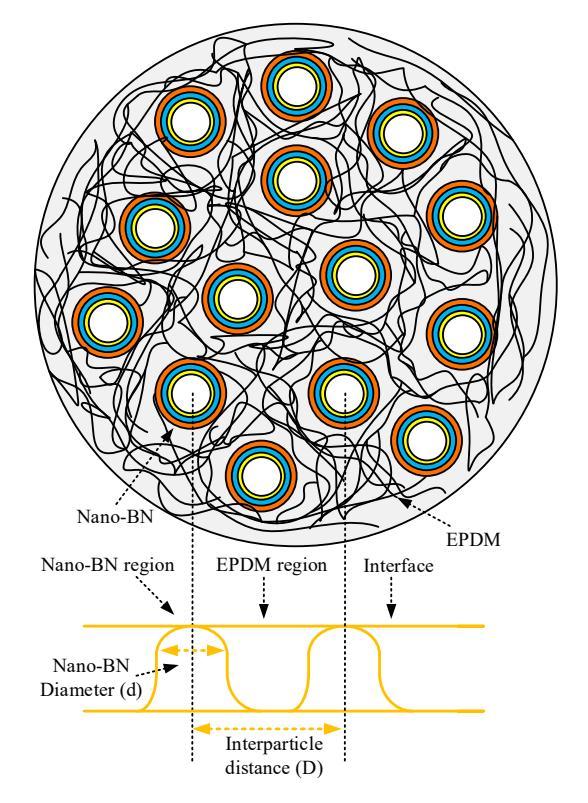
Figure 14. A model of nano-BN-filled EPDM.

Interparticle distances, the surface area of particles, and EPDM chain dynamics are key factors that play important roles in the tracking performance of EPDM. It is a common belief that interparticle distances sharply decline and the surface area of particles is drastically enhanced with increasing nanoparticle contents in composites. A proposed model of EPDM filled with spherical shape nano-BN is shown in Figure 14, and this illustrates the nano-BN region, the EPDM region, the interface, the particle size, and the interparticle distance.

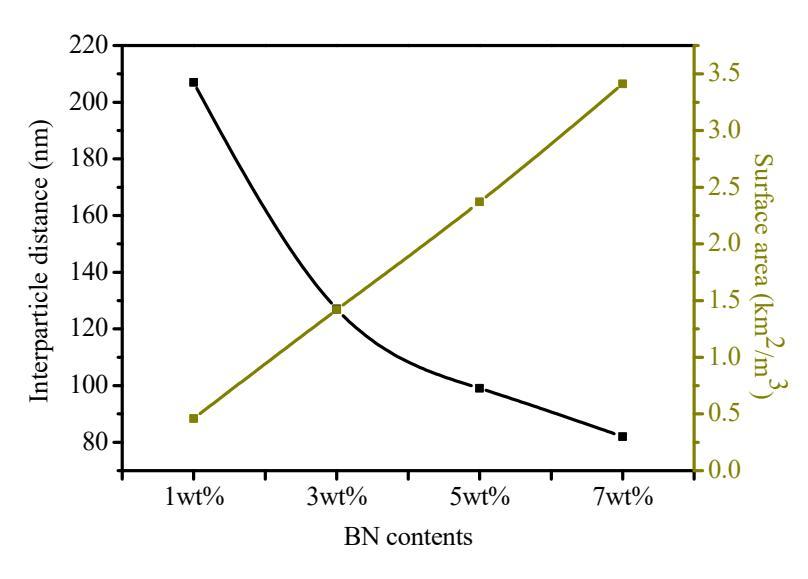
Figure 15. Results on mathematical calculation of interparticle distances and surface area of nano-BN.

Interparticle distances and the total surface area of the nano-BN particles in the nanocomposites were calculated according to the method provided in references [33,34] by assuming the ideal distribution, as shown in Figure 15. The interparticle distance between nano-BN declined whilst the total surface of nano-BN increased with the addition of BN contents. Realistically, there was a possibility of agglomeration in the nanocomposites, and interparticle distances can vary in the nanoscale range [8,35]. Moreover, it is expected that with increasing BN contents in nanocomposites, packing structure should be much better. Additionally, shorter interparticle distances will impart better shielding by reducing the chances of an EPDM matrix being exposed to dry band arcing.
