Article The Role of Orientation and Temperature on the Mechanical Properties of a 20 Years Old Wind Turbine Blade GFR Composite

Mohamed M. Z. Ahmed ^{1,2,*}, Bandar Alzahrani ¹, Nabil Jouini ^{1,3}, Mahmoud M. Hessien ⁴ and Sabbah Ataya ^{2,5}

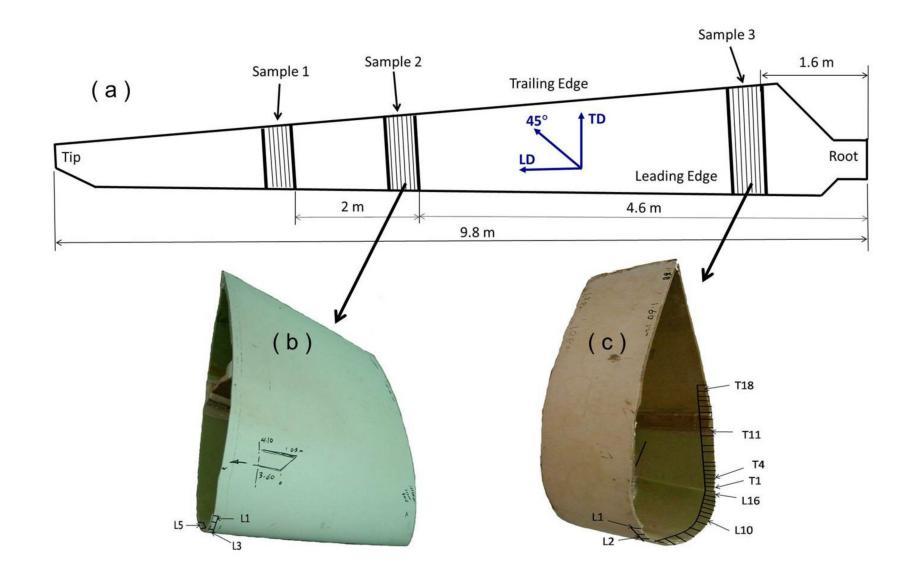
Figure 1. (a) Samples location and orientation with respect to the blade length. (b) Middle section (Sample 2) of the blade (c) Section near to the root (Sample 3).

GFRP samples were cut from a failed blade of a 100 KW wind turbine. The blade is 9.8 m in length and operated for 14 years in the wind turbines site in Hurghada, Egypt, and left out of service for 6 years in the atmospheric conditions. Such working life is nominally equivalent to a number of 6.8×10^7 cycles. In the mentioned site, the average measured wind speed over the year is 6.5 m/s at a height of 24 m. The blade under investigation has an internal longitudinal reinforcing foam web instead of GFRP carrying main spar or webs which are used in most construction of the currently designed blades [24–26]. The studied materials were taken from non-broken areas of the blade. Three sample positions were defined (as shown in Figure 1): sample (1) is the thinner test section which is near to the blade tip and at 6.6 m from the root (\approx 4.8 mm thick), sample (2) is at 4.6 m from the root (\approx 5.6 mm thick), and sample (3) is taken at 1.6 m from the hub (8–9.2 mm thick).

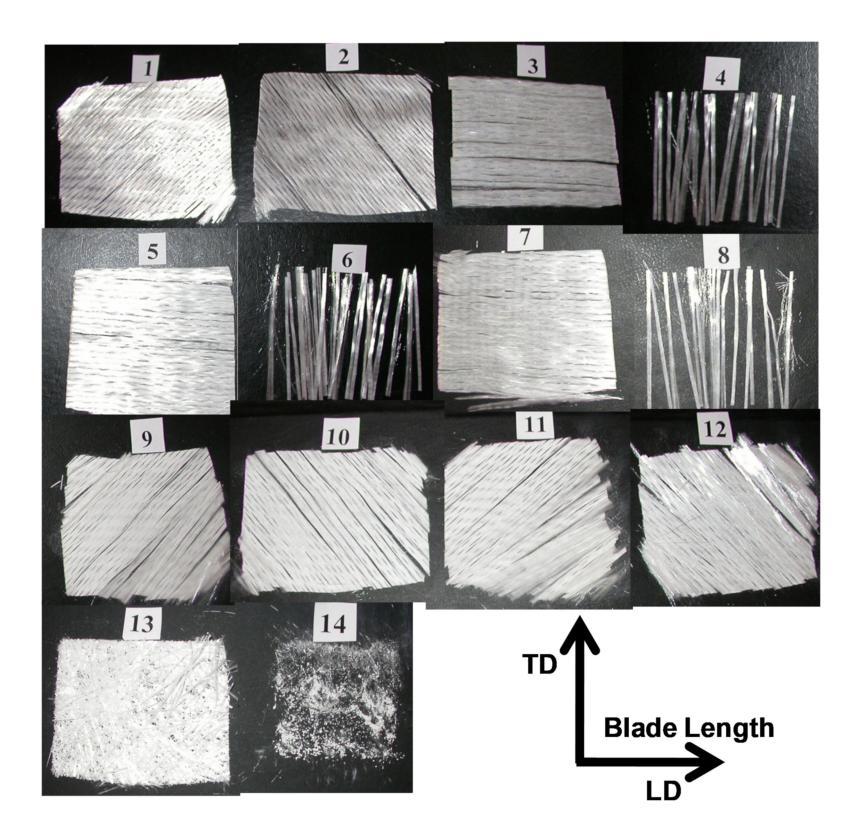
Figure 2. Lay-up sequence of fiberglass fabric layers sequence of S2 (sample 2) (5.6 mm thick) taken at 4.6 m from the root and obtained after sample calcination at 600 °C for 90 min. The numbering from 1 to 13 represent the numbers of glass fiber fabrics layers in the GFRP sample from the internal surface to the outer surface of the blade and 14 is the gelcoat layer.

that the number of fiber fabric layers are varied based on the distance from the blade rotor and it is decreasing as the distance increases. So that the number of the fiber fabric layers found to be 11, 13, and 19 for samples 1, 2 and 3, respectively, which correspond to sample thicknesses of 4.8 mm, 5.6 mm, and ~8.6 mm, respectively. Moreover, the fiber weight percent for the different samples is ranging between 55% and 60%. The GFRP structure from outside surface starts with a gelcoating layer (G) followed by a chopped strand mat of randomly (R) oriented fibers and then the different fiber layer fabrics. The Gelcoat thickness found to be around 0.4 mm. Usually the gelcoat thickness is ranging between 0.25 and 1 mm and in most cases it has a thickness of 0.6 mm [27]. The main functions of the Gelcoat are to protect the blade from ultraviolet degradation, water penetration and to increase the erosion resistance in the sand stormy environments. Filaments of the fiber fabric layer are held together using stitching yarn to keep each filament bundle in its position during the process of manufacturing. Figure 3 shows SEM image for the whole sample cross section starting from the gelcoating layer at the top and the different fiber fabric layers towards the bottom of the image. The dark background represents the polymer matrix, and the features of the different fiber fabric layers are in gray can be observed, as well as the pores, lack of penetration and the stitching yarn. The presence of the stitching yarns in the arrangement shown in Figure 3 indicates that the lay-ups are bidirectional stitched fiber layers. The stitching yarn is burned out during calcination process. The lay-up next to the chopped strand mat is one or more layers of bidirectional $\pm 45^{\circ}$ fibers, depending on the GFRP section thickness and location. Then it is followed by a number of bidirectional $0^{\circ}/90^{\circ}$ fibers and ended by one bidirectional $\pm 45^{\circ}$ fiber layer. The graded tapering, both in external shape and in thickness of the shells/beams/webs, is usually designed to ensure the same materials loadings, e.g., a maximum strain as design allowable [1]. The change in the density of the various layers can be observed in Figure 2 and from the fibers bundle size shown in Figure 3 which indicates that the fiber density in the blade length LD (0°) is much higher than the density of fiber in the transverse direction TD (90°). The densities of the fibers in the diagonal directions $+45^{\circ}$ and -45° are equal. A quantitative measurement of the density of the different layers (in gm/m^2) is presented in Table 2. To increase the rigidity and the load carrying capacity of the blade; which has no carrying spar; the manufacturer tends to increase the number of the $0^{\circ}/90^{\circ}$ which have higher fiber density in the blade length direction LD.

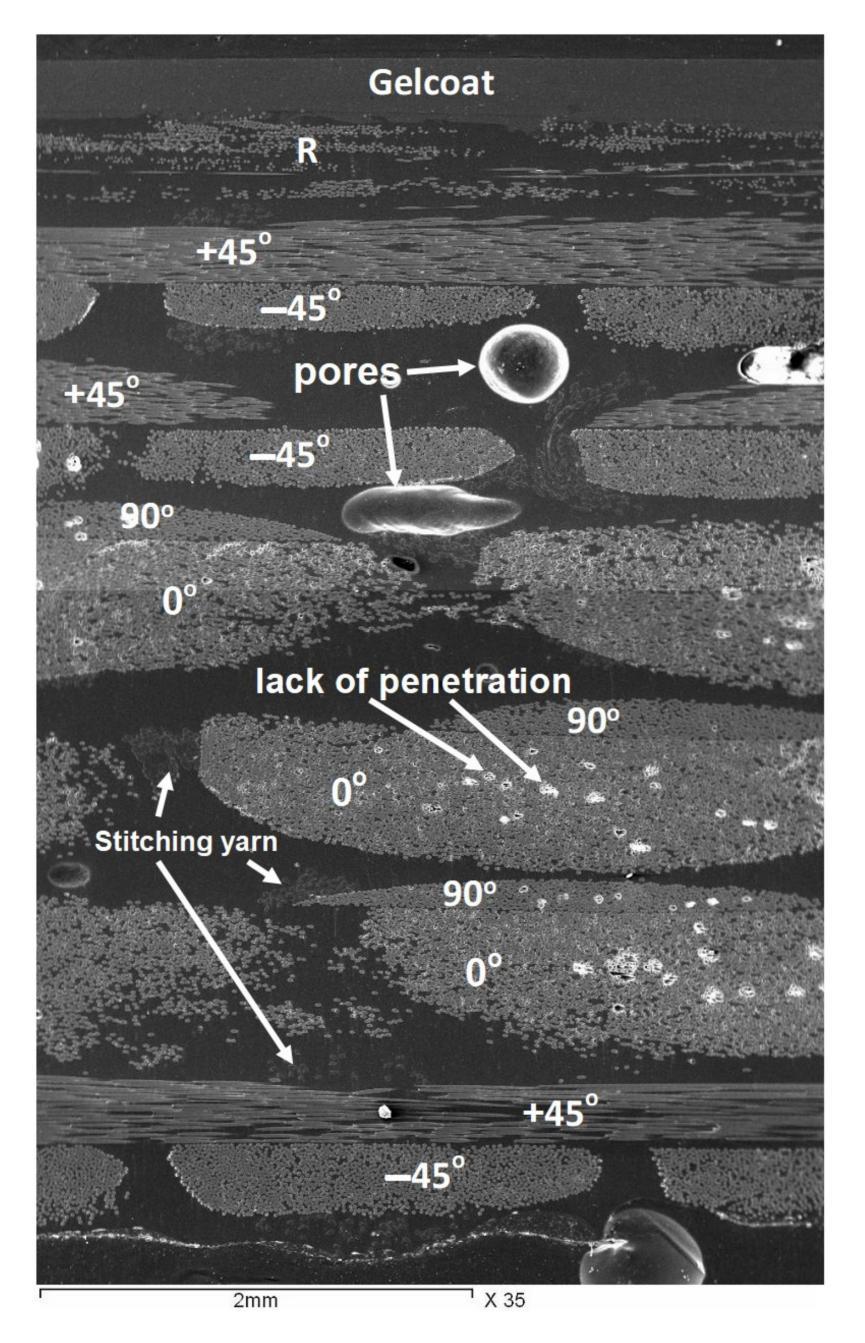
Figure 3. Scanning Electron Microscope (SEM) micrograph for the whole glass fiber reinforced polymer (GFRP) cross section for sample 1.

Figure 4a-c illustrates higher magnification SEM micrographs with more detailed features for the whole cross section SEM micrograph shown in Figure 3. Figure 4a shows two different orientations of the fiber glass fabric 0° (aligned with the LD of the blade) and 90° (Aligned perpendicular to the LD). It can be observed that the fiber fabric of the 0° orientation has the fiber highest density (858 gm/m² Table 2) to give the blade the required properties (load carrying ability, stiffness, and fatigue resistance), while the 90° orientation has the lowest fiber density (83 gm/m² Table 2) as there are no loads affecting in this direction. One of the whiter features in Figure 4a, observed in the 0° orientation fiber bundle is magnified and presented in Figure 4b. Generally, there is a good wettability for the fibers by the resin, except some little areas inside this high density bundle indicating lack of penetration which appearing as a whiter region. In addition, some larger pores were observed in the matrix regions, Figure 3. Figure 4c shows the circular cross section of the fiber while the stitching yarn which holds the different bundle orientations of the bidirectional oriented fiber bundles ($\pm 45^{\circ}$ and $0^{\circ}/90^{\circ}$) have a polygonal shape. Figure 4c includes micro-pores (marked by a circle) around some glass fibers and the stitching yarns too. It is difficult to decide if they lack penetration during production or fibers decohesion due to service fatigue loading of the investigated blade which operated for 14 years (6.8 \times 10⁷ cycles). This number of cycles is much higher than the usual fatigue test life of the full blade which assigned to be in the range 2×10^{6} – 2×10^{6} cycles according to the guidelines for design of wind turbine [28]. It will be discussed in the next sections if the larger pores and the lack of penetration contribute to the initiation of cracks and failure under tensile loading.

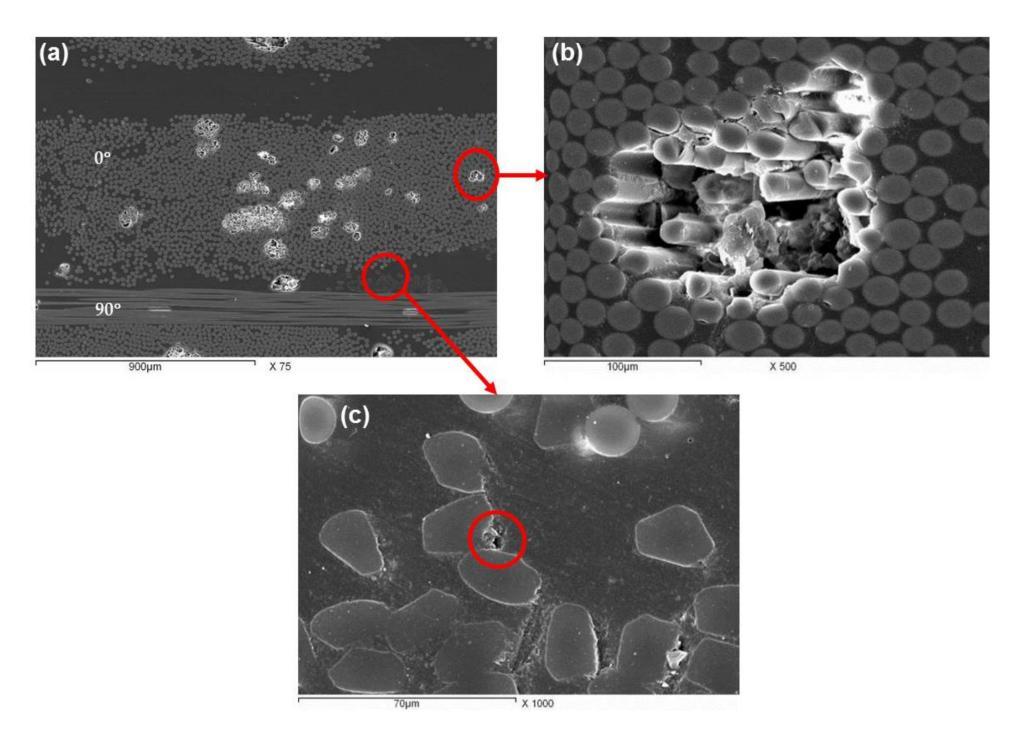
Figure 4. SEM micrographs of as-received wind turbine blade material sample taken in the LD direction. (a) Overview (b) and (c) different magnifications of the glass fibers and stitching yarn, respectively.

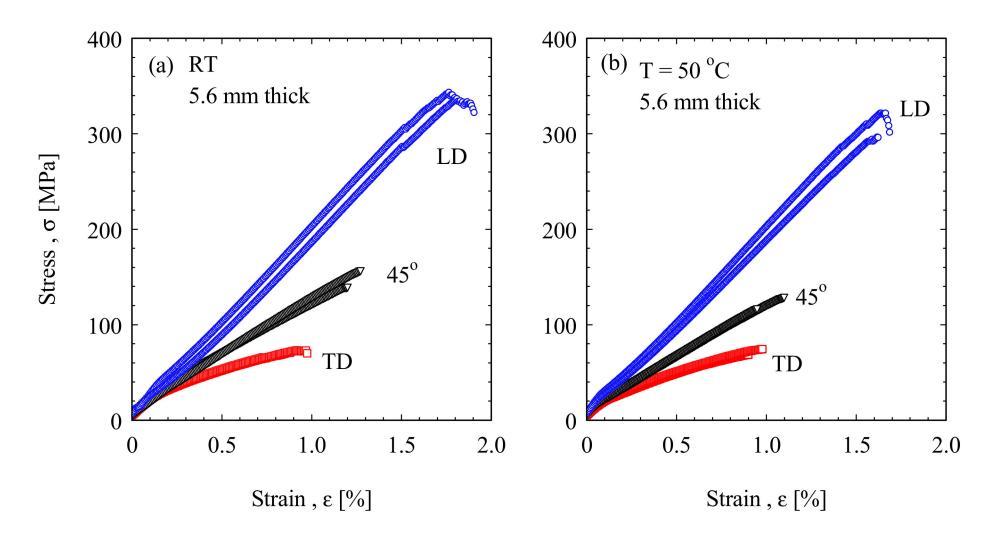
Figure 5. Tensile stress-strain curves of the old wind turbine blade GFRP tested at (**a**) RT and (**b**) 50 $^{\circ}$ C.

Figure 5 shows the stress-strain curves for the blade material loaded at the three different directions LD, TD, and 45° at room temperature and 50° C. A clear anisotropic property behavior of this material is shown from the different stress levels. It can be observed that the samples taken parallel to the blade length LD (0°) have the highest tensile strength at both temperatures. This is mainly due to the alignment of the reinforcing fiber with the tensile force axis. However, the samples taken perpendicular to the LD have the lowest tensile strength. This is mainly due to the alignment of the reinforcing fiber perpendicular to the tensile force axis. As it was expected, the results of the samples taken at 45° have tensile strength at intermediate values relative to the other two directions (LD and TD). This anisotropic behavior of fiber reinforced plastics is consistent with the density and direction of fiber within the blade materials. The ultimate tensile strength and tensile

strain at fracture for the curves in Figure 5 for the different sample orientations at RT and at 50 $^{\circ}$ C are plotted in Figure 6.

The elastic modulus was calculated and found to be about 15.6 GP for the specimens loaded in the longitudinal direction. Whereas the elastic modulus for the specimens loaded in TD and 45° is found to be 7.4 and 10.9 GPa, respectively. These values are much lower than the reported values of the new GFRP (26.7 GPa in LD and 9.2 GPa in the TD) [29]. However the long working life of the investigated materials (14 years, 6.8×10^7 cycles) can result in stiffness degradation and reduction of the elastic modulus [5,30]. In testing of GFRP containing 36 wt% fibers the elastic modulus was decreased from 24.6 GPa to ~19 GPa after fatigue loading life of 4×10^5 at R = 0.1 [29,30]. The attained tensile strength in this study at room temperature was around 350 MPa in the longitudinal direction is

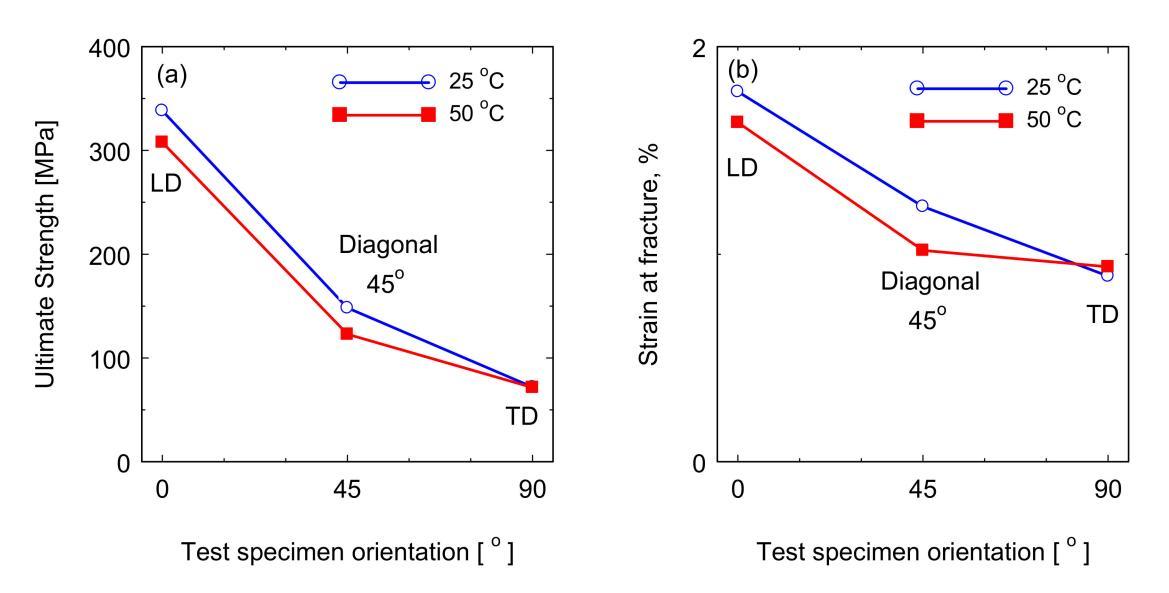
Figure 6. The relation between the tensile properties of the wind turbine blade composite materials tested at room temperature (RT) and 50 °C and the sample orientation relative to the blade length (**a**) ultimate tensile strength (**b**) strain at fracture.

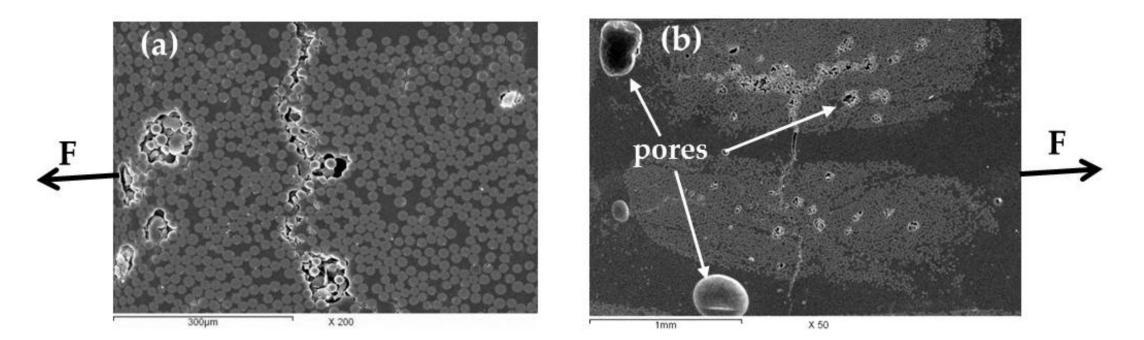
Figure 7. SEM micrograph for some fracture features observed in the fractured tension test sample of wind turbine blade material showing: (a) crack through fibers' bundle and (b) manufacturing pores are not the origin of the cracks.

The damage features of the tensile samples after testing is shown in the SEM micrographs in Figure 7. Under tensile load, the cracks were started from the lack of penetration areas and grown perpendicular to the tensile loading direction (F). A coalescence of initiated cracks was taken place in the fiber bundles and passed through the matrix to other fiber bundles (Figure 7b). Although the large matrix pores (which can be seen as a production defect) are located near to the crack pass or the highly loaded area, no cracks were observed to originate from these pores. It means that the pores cannot be described as a primary cause for the failure. In addition, fracture of the glass fibers aligned with the loading direction was also frequently observed.

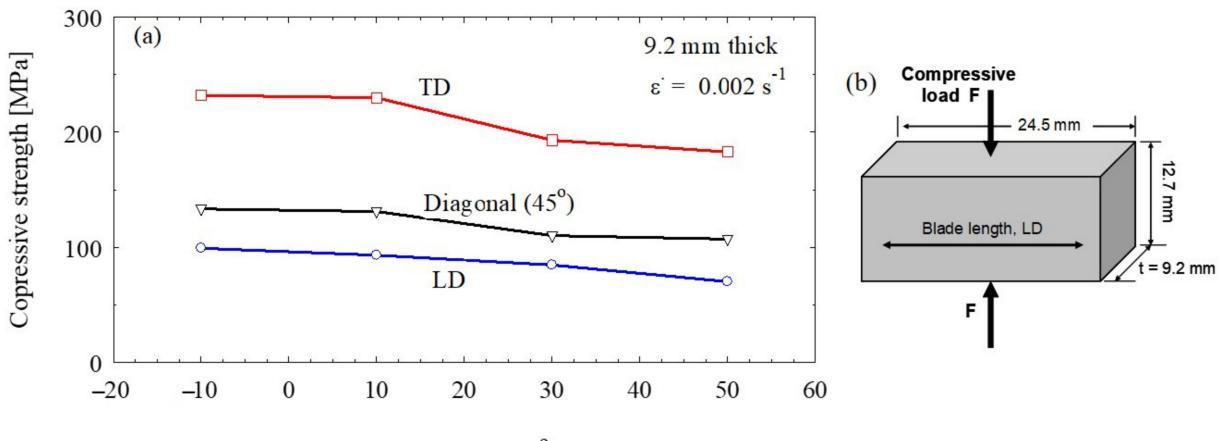
Figure 8. (a) Compressive stress–strain flow curves of wind turbine blade materials tested at various temperatures. (b) Schematic drawing for the compressive load position relative to the blade length upon testing.

Polymers are usually sensitive to temperature [32,33], so that is important to explore the temperature effect on the mechanical properties. Compression loading of GFRP at various temperatures (-10-50 °C) showed that the samples taken in the TD direction (90°)

have the highest compressive strength at all temperature (Figure 8). This is because most reinforcing fibers are aligned parallel to the applied force. However, the samples taken with the blade length (LD or 0°) has the lowest compressive strength at all temperatures, where most fibers are extending perpendicular to the applied force. At the tested temperature range, slight temperature effect was observed in LD and 45° samples. Generally, the compressive strength of the GFRP is higher than that of other competitive reinforcing materials such as natural or carbon fibers [31].

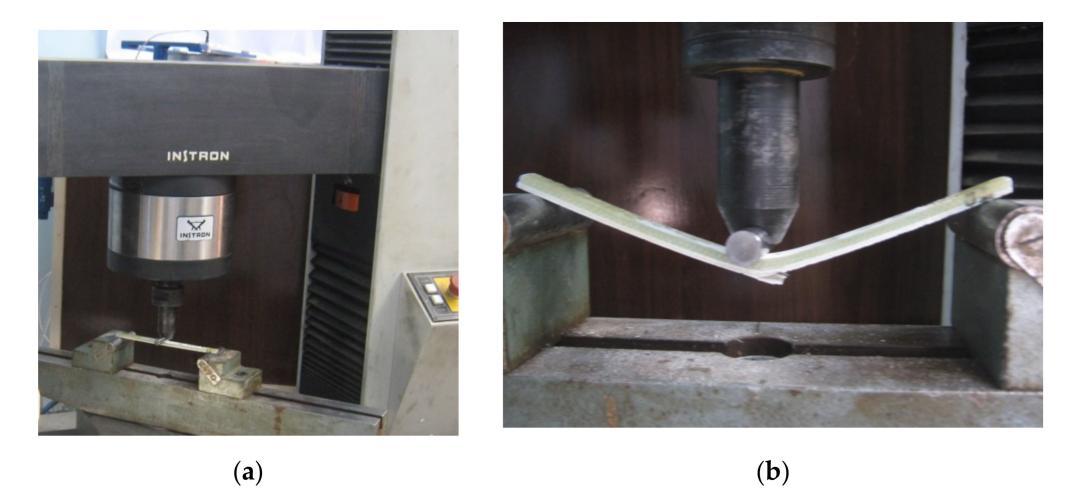
Figure 9. Three-point bending test of glass fiber reinforced polymer (GFRP) sample (S2) 5.6 mm (**a**) at the test start, and (**b**) at fracture.

Three-Point bending test assembly of the GFRP at the start of the test and after the sample loaded till fracture is shown in Figure 9a,b respectively. The test has been conducted for GFRP material from sample 2 and 3. Figure 10 shows the flexural bending load represented against the deflection of the GFRP tested samples. It can be noticed that, for the same sample, higher bending load was reached when the gelcoat was towards the top. Although the span distance *L* was changed in relation to the specimen thickness (*L* = 32 t mm) it has shown that higher deflection was achieved in the thick sections. The maximum flexural stress σ_f and flexural strain ε_f are calculated according to the formula indicated in ASTM D790 and ISO 178 for rectangular section:

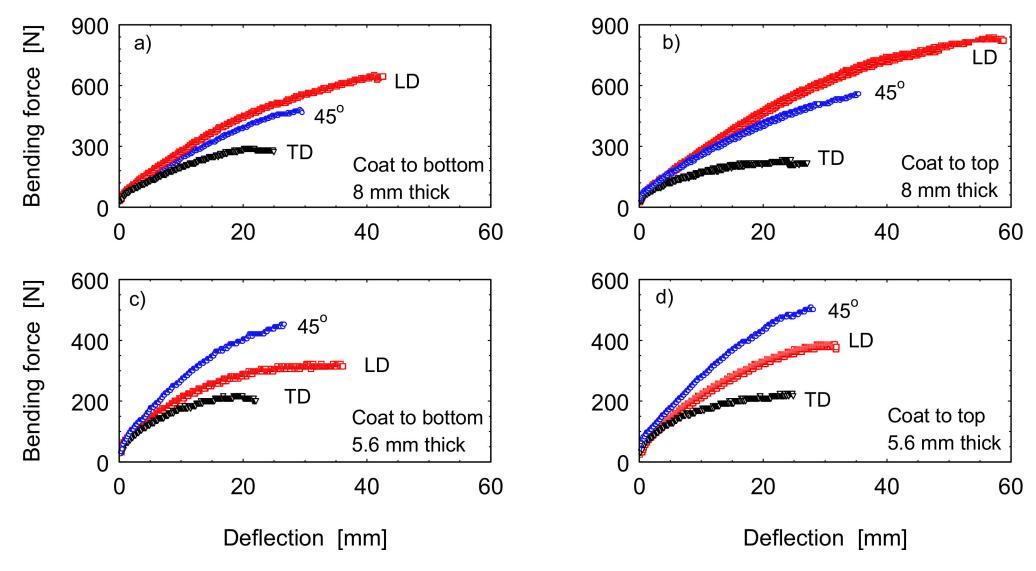
Figure 10. Effect of sample orientation and the gelcoating on bending load—deflection curves of the blade materials (**a**,**b**) samples S3 (8 mm thick) and (**c**,**d**) S2 (5.6 mm thick).

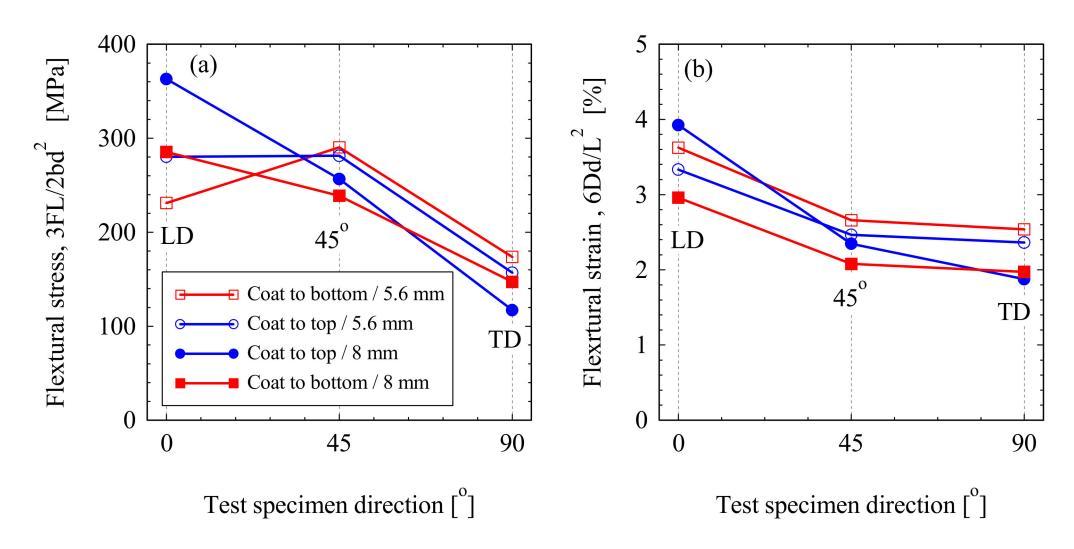
Figure 11. Effect of sample orientation and gelcoating of the blade materials on (**a**) bending maximum stress and (**b**) bending strain at maximum deflection. Note: Legend is the same for (**a**) and (**b**).

where *P* is the load, *L* is the support span, *b* is the width of test section, *d* is the height of test section, and *D* is the maximum deflection at the beam center. The maximum flexural bending stress and strain are presented in Figure 11. Logical arrangement of the bending load with the sample orientation can be shown in the thick section, Figure 10. Where higher load carrying capacity was observed in specimen taken from the thicker sample, which located near to the blade root. Six layers of the bidirectional stitched fabric $0^{\circ}/90^{\circ}$ of the highest density fibers in the LD (0°) direction and only two layers from the bidirectional stitched fabric $\pm 45^{\circ}$ of the equal density in both directions leads to increased load carrying capacity of the composites in the blade length. Whereas, away from the blade root, the number of the thinner reinforcing layer ($0^{\circ}/90^{\circ}$) in the blade length LD decreases to reach only three layers against three layers of 5.6 mm. The flexural strain in percent for the samples tested in the different orientations is presented in Figure 11b. specimens oriented in the blade length (LD) have shown the highest strain in the different samples, while the TD

specimens have indicated the lowest strain. Higher strain was attained on loading thinner specimens (S2) than on loading the specimens (S3) which taken at 1.6 m from to the root.

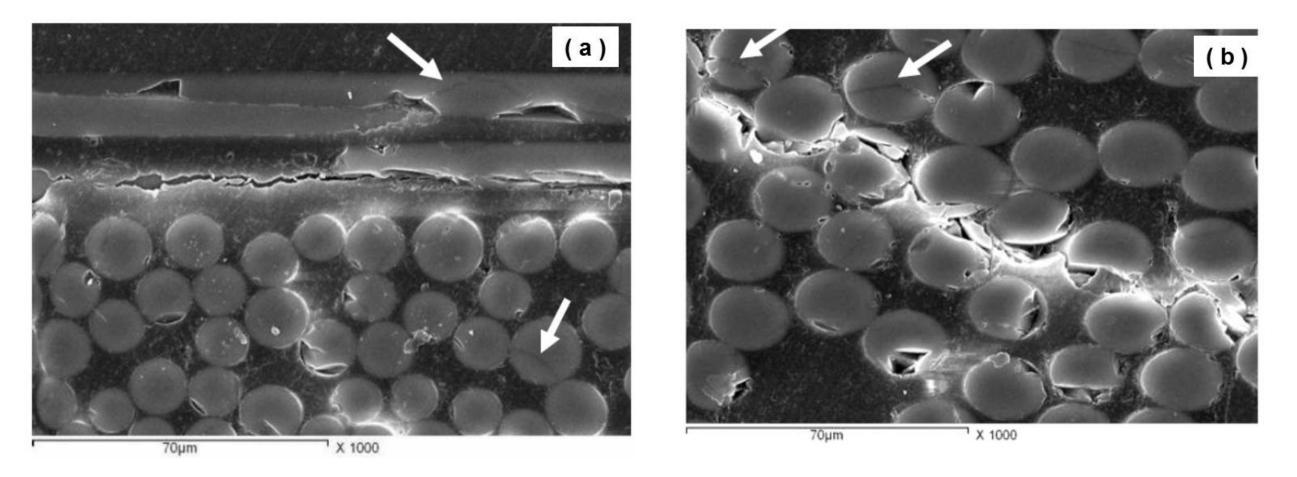
Figure 12. SEM micrograph of fractured bending test sample (S3, 8 mm thick) of wind turbine blade material showing fibers fracture; (a) through matrix cracking, and (b) through fibers bundle cracking.

Figure 12 shows the SEM micrograph of the bending test sample (S3, 8 mm thick), it shows cracking through the matrix area between the fiber layers (Figure 12a). Moreover, the fibers extending parallel to the specimens length showed partial fiber fracture (as indicated by the arrows), these lead finally to delamination of the GFRP section. Shear at 45° to the loading direction through the glass fiber bundles extending transverse to the specimen length with cracking at around 45° to the loading direction (Figure 12b). In addition, fiber fracture and fibers cracking (indicated by the arrows) were observed around the path of the main crack.
