# Experimental and Numerical Investigation of Joints for a Pultruded Fiber-Reinforced Polymer Truss

Abstract: Bolted connections usually govern the structural rigidity and load-carrying capacity of pultruded glass fiber-reinforced polymer (GFRP) truss structures. In this study, a novel bolted integrated gusset plate (IGP) connection is proposed to enhance the stiffness and capacity of GFRP truss structures. Nine double-lap shear tests of GFRP joints and numerical simulation were conducted to investigate the influence of variable design parameters of the bolted GFRP joints (number of bolts, width and thickness of GFRP, edge distance of bolts, and the employment of adhesive). Three fullscale GFRP truss joints were tested under static loading to study the response of a typical bolted connection, a bolted gusset plate connection, and the proposed IGP connection. The nine double-lap shear tests showed that the bolted-bonded mixed connection has 50% higher shear stiffness and 27% higher ductility compared with bolted joints, and bearing failure dominated the capacity of most specimens, which agreed well with numerical simulation results. Tests on the three full-scale GFRP truss joints s

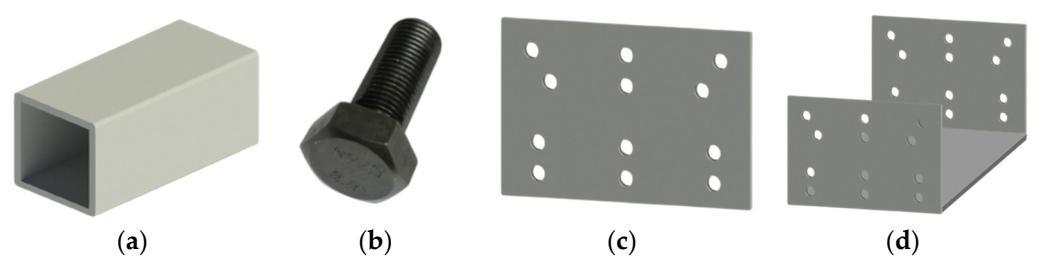
**Figure 1.** Materials used in tests of this study: (**a**) pultruded GFRP profiles, (**b**) steel bolt, (**c**) gusset plate, and (**d**) proposed integrated gusset plate.

The materials of the GFRP pultrusion profiles used in the tests (Figure 1a) are commercially available products from Nanjing Kangte composite materials company in Nanjing China. The resin used is unsaturated resin and the fiber is glass fiber. The material properties of the specimens were obtained directly from the walls of the pultruded profiles by an automatic CNC engraving machine (Tianxiang Inc., Tengzhou, China). Five tensile tests along and perpendicular to the fiber direction (Figure 2a), five compression tests (Figure 2b) and five longitudinal interlaminar shear tests (Figure 2c) were completed, and the results used were the average of the tests. The tensile strength of the GFRP profile was 308 MPa, the compressive strength was 210 MPa and the interlayer shear strength was 18.2 MPa, which were experimentally obtained according to Chinese code [47]. The modulus of elasticity of GFRP was 46 GPa according to the manufacturer. The bolts (see Figure 1b) used in the test were external hexagonal grade 8.8 high-strength M12 bolts, with a tensile strength of 800 MPa and yield strength of 640 MPa [12]. The modulus of elasticity of steel bolts was 210 GPa according to the manufacturer. The structural adhesive was an epoxy resin adhesive with shear strength  $\geq$  12 MPa and temperature resistance of -60 °C to 120 °C according to the manufacturer.

The GFRP and high-strength bolts used in the three GFRP truss tests were the same as in the double-lap direct shear tests. The Q235 steel gusset plate (see Figure 1c,d) was used to combine different members in the truss series, with a density of 7850 kg/m<sup>3</sup> and a modulus of elasticity of 200 GPa.

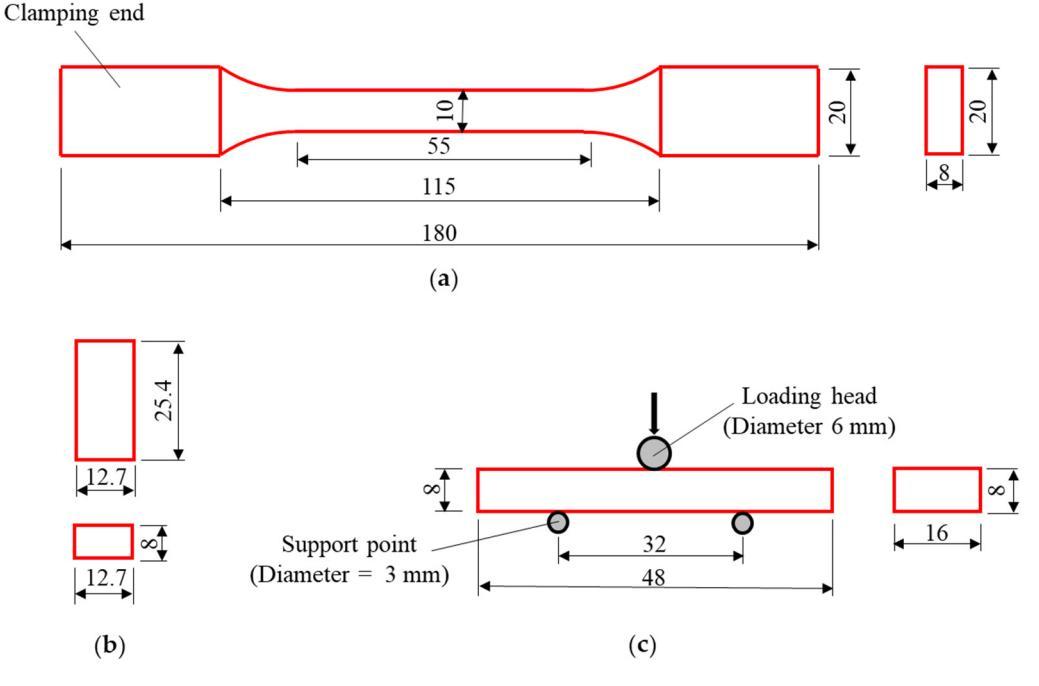
**Figure 2.** Geometric sizes of material test coupons: (a) tensile test, (b) compression test, and (c) shear test (units in mm).

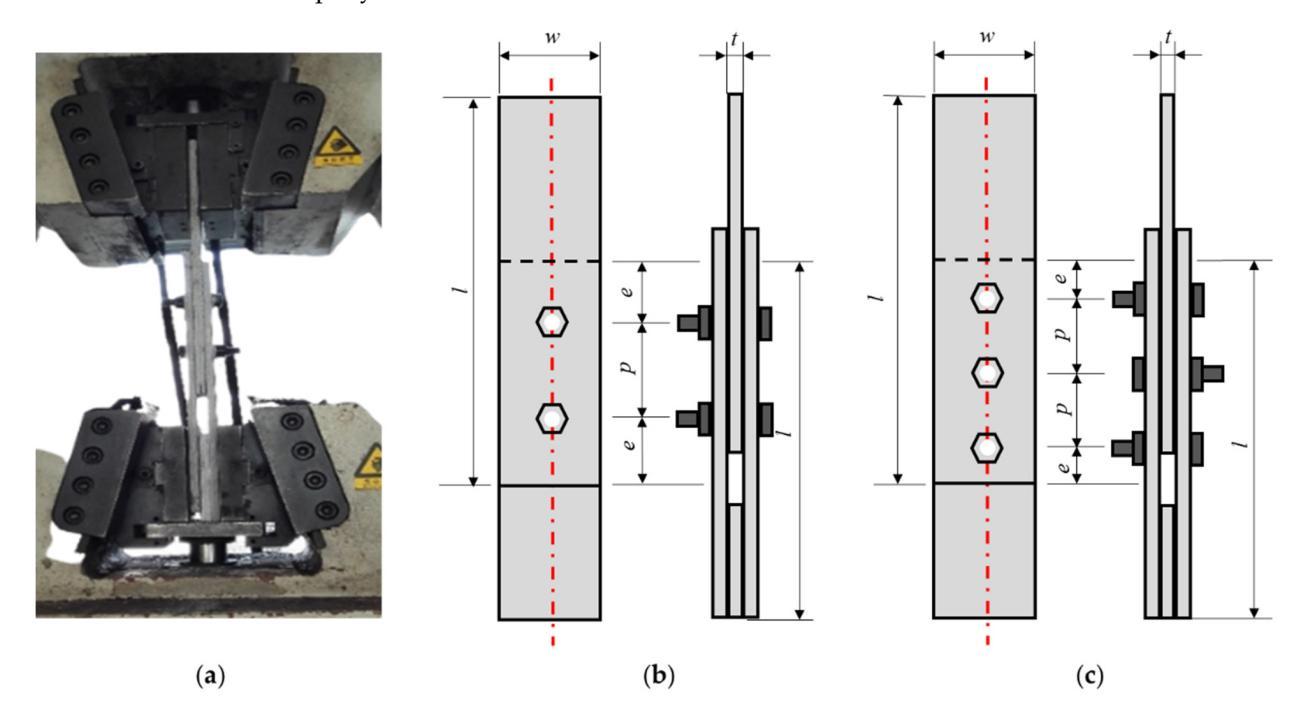
**Figure 3.** Double-lap shear test setup and geometric configuration of specimens: (**a**) actual photo, (**b**) specimen with two bolts, and (**c**) specimen with three bolts.

The GFRP double-lap direct shear connector test (Figure 3) used the SANS-SHT4106 universal testing machine (Sansi Eternal Technology Co., Ningbo, China). In order to eliminate the possible gap between the bolt and the plate, it was first loaded at a speed of 2 mm/min to reach 20 kN and then unloaded, and finally the main loading started at a loading speed of 2 mm/min. The test was terminated once the part was damaged or the specimen experienced a large displacement.

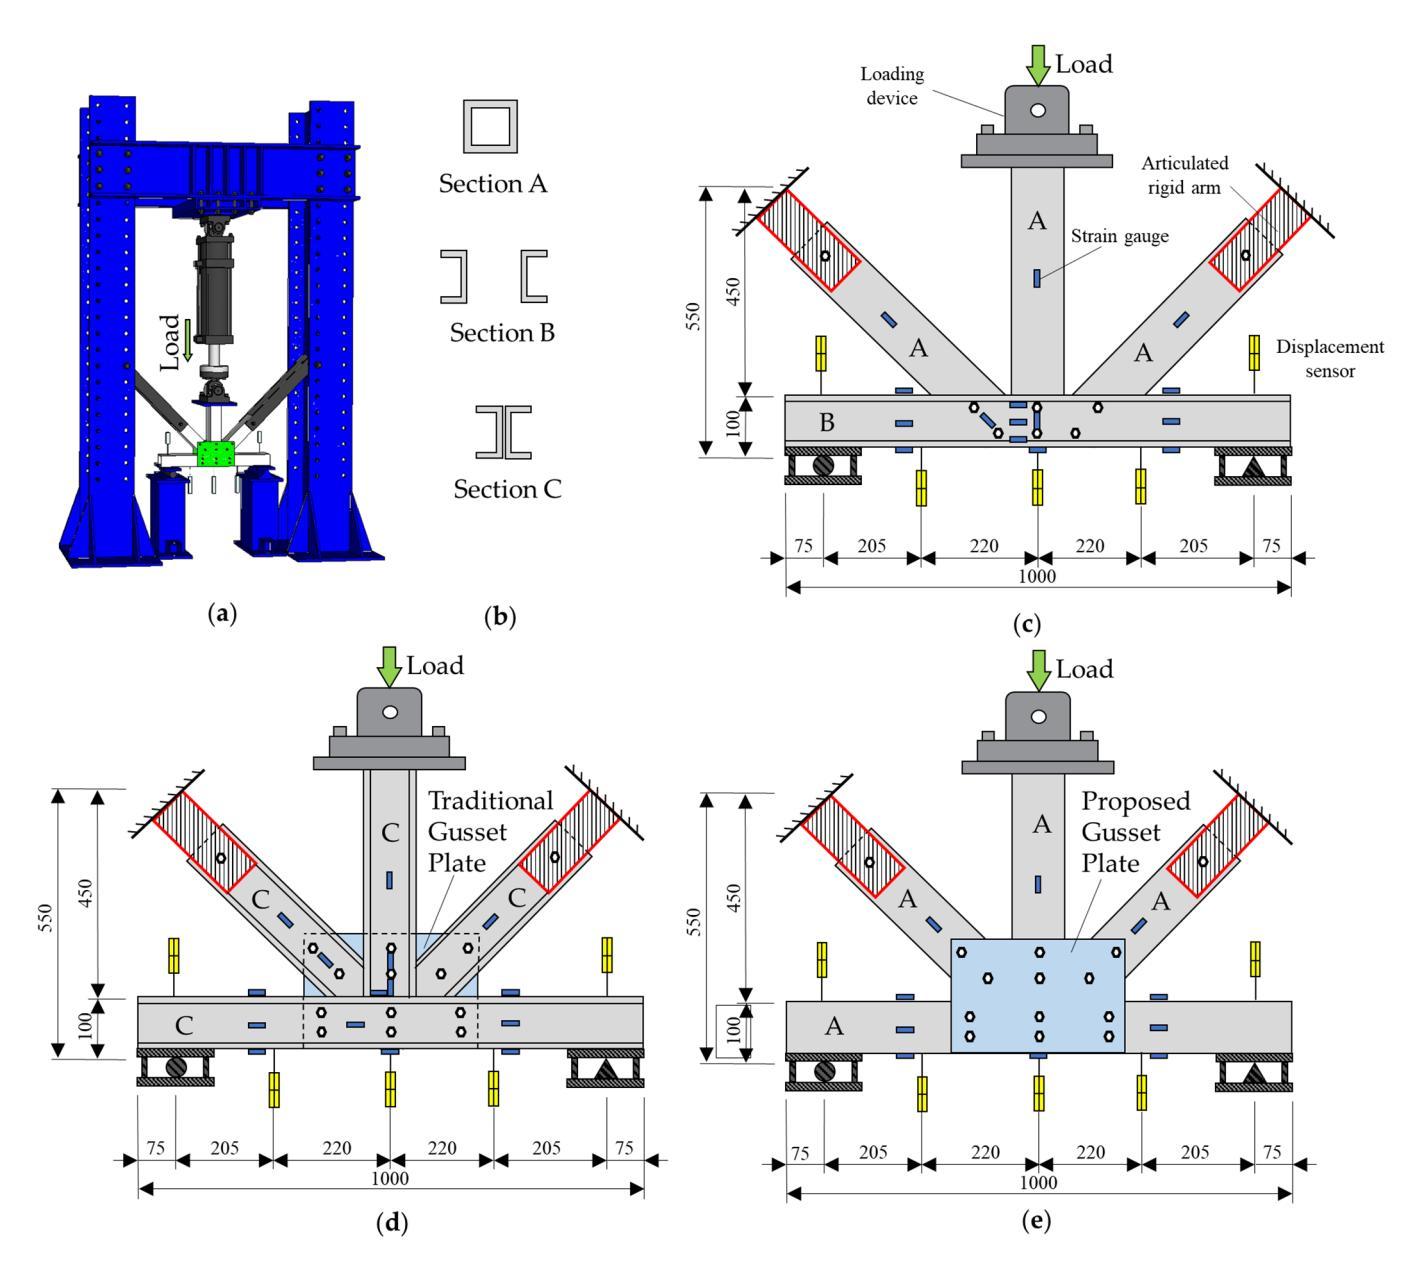
**Figure 4.** Full-scale test of GFRP truss joint: (**a**) test setup, (**b**) cross sections of members, (**c**) specimen BJ, (**d**) specimen GP, and (**e**) specimen IGP.

One full-scale typical clamping truss joint (specimen BJ, which stands for bolted joints), one typical gusset plate connection joint (specimen GP, which stands for bolted gusset plate joint), and one proposed integrated gusset plate connection joint (specimen IGP, which stands for integrated gusset plate joint) were designed. Each specimen was composed of a single 1000 mm lower chord web chord, two 450 mm  $45^{\circ}$  diagonal chords, a single 450 mm vertical chord, and a steel gusset plate connection. The cross-sectional dimensions of the pultruded section bars used for the joint specimens were the same, all of which were 100 mm  $\times$  100 mm closed rectangular sections. In order to maintain the consistency in the number of pultruded profiles, the required groove chords were cut by a CNC machine along the axis of rectangular section square tubes. Among them, the web of bottom chords of the typical clamping truss joint consisted of two 1000 mm web chords with a sectional size of 50 mm  $\times$  100 mm. The steel gusset plate connection-type truss joint was composed of two 1000 mm profile channel profiles, the lower chord web chord, and four 450 mm profile channel profiles to form a 45° diagonal chord, and two 450 mm profile channel profiles to form a vertical web member. The sectional size of all profile channel profiles was 50 mm  $\times$  100 mm. The test setup can be seen in Figure 4a. The three GFRP pultruded profile truss joints are shown in Figure 4c–e.

A hydraulic servo actuator with a maximum range of 300 kN acted directly on the top of the vertical bar for loading. The displacement and strain data of the joint static performance test were recorded by a TDS-7130 high-speed static strain data acquisition system produced by Tokyo Institute of Instrumentation, Japan. Due to the rotation of the spherical joint at the loading end of the hydraulic servo actuator, the load eccentricity occurred in the test process. Before loading, the sub-solid high-precision horizontal laser instrument (accuracy error 1 mm within 5 m) was used to accurately locate the vertical axis of the actuator and the vertical chord of the specimen to ensure that the actuator was consistent with the vertical axis of the vertical chord. YHD-50 displacement measurement range is 50 mm, and the accuracy error is controlled within 0.05%.

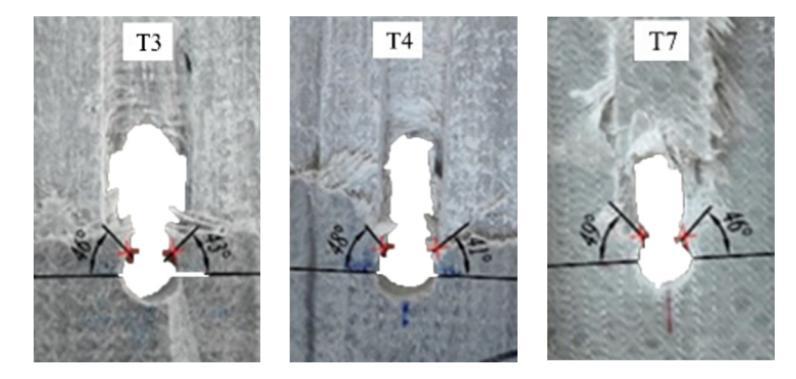
**Figure 5.** Shear failure at 45° of the bolt hole.

Three failure modes formed in the double-lap shear test, as shown in Table 2. It can be found that when the  $w/\varphi$  is small, the GFRP tensile specimen is prone to tensile failure. When the  $w/\varphi$  is large, the GFRP plate is prone to bearing failure along the adjacent region of bolt holes. Between the above two cases, shear failure occurred along the pultrusion direction. The observed results, without considering  $e/\varphi$ , are consistent with the situation of the test results of Okutan [33] and also prove the reliability of the test results and showed that most double-lap shear tests failed in bearing failure. The development direction of cracks grew about 45° along the bolt hole perimeter, as shown in Figure 5.

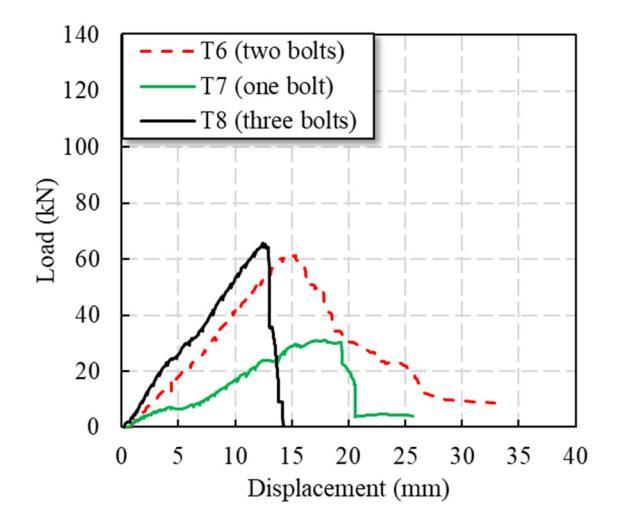
Figure 6. Load-displacement curves of specimens with different numbers of bolts.

It can be seen in Figure 6 that when the number of bolts increased from 1 to 2, the bearing capacity of a single bolt ( $P_u$ ) increased significantly, and the double-lap direct shear thin plate connector increased by nearly 76.3%. At the same time, as shown in Table 2, T6 experiences tensile failure, while T7 experiences shear-out failure, indicating that shear-out failure can achieve a higher bearing capacity, which is the failure mode we prefer to obtain. When raising from a double bolt to three bolts, the double-lap direct shear bolted gusset plate connection  $P_u$  only increased by 5.6%. It can be found from Figure 6 that the stiffness of the specimen was also increased with the increase in the number of bolts. Similarly, when the specimen was increased from a single bolt to a double bolt, the increase in the moving stiffness of the specimen was more obvious. The greater the number of bolts, the smaller the corresponding displacement when the specimen reached the ultimate load.

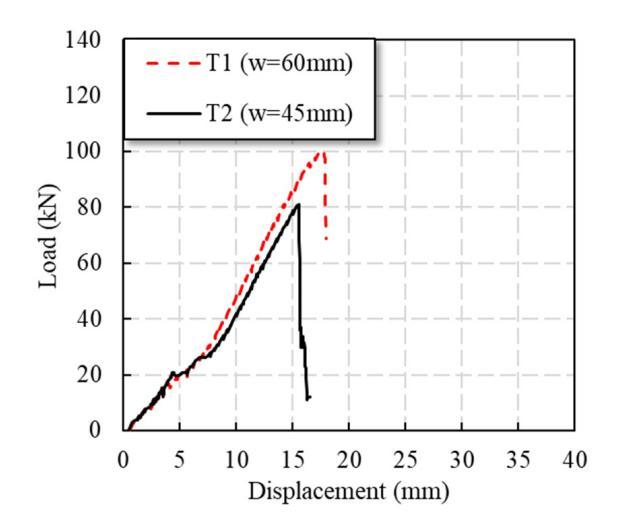
Figure 7. Load-displacement curves of specimens with different plate widths.

As Figure 7 shows, the T1 specimen basically maintained linear loading during the whole loading process. At 16 kN (0.16  $P_u$ ), there was a small sudden drop in load due to the existence of bolt holes. During the loading process after this, the specimen continuously emitted the sound of fibers tearing, which increased sharply in the later stage of loading. When the load reached the peak load of 100.7 kN ( $P_u$ ), the specimen suddenly failed.

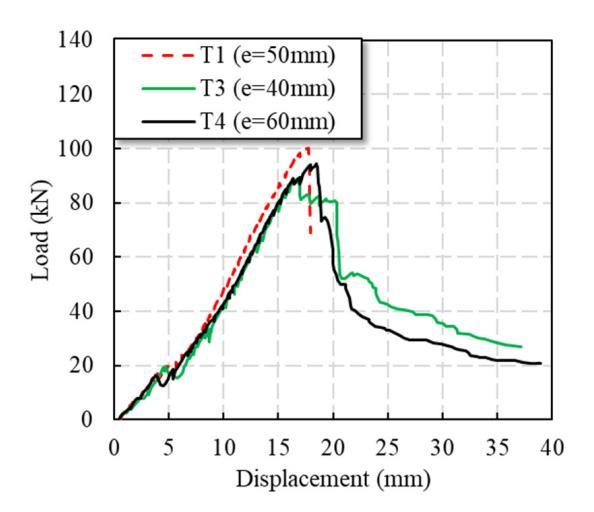
Figure 8. Load-displacement curves of specimens with different end distances.

The end distance is determined according to the size of the hole diameter. The control end distance/hole diameter ( $e/\varphi$ ) ratio is 3.3 at minimum. The test phenomenon of the T3 and T4 specimens was similar to that of T1, but the T3 and T4 specimens had post-peak load responses until gradual failure, which was caused by the automatic stop of laboratory instruments in the T1 specimens. It can be seen from Table 1 and Figure 8 that the change in GFRP plate end distance between approximately 40 and 60 mm had little effect on load response, meaning that it can almost be ignored.

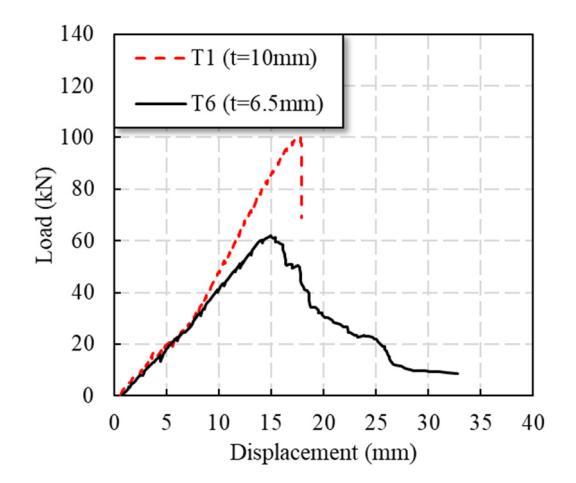
Figure 9. Load-displacement curves of specimens with different plate thicknesses.

It can be seen from Table 1 that the thickness of the GFRP plate can improve the  $P_u$  of specimens, which can also be found in Figure 9. The failure mode of T6 is tensile failure. The peak load of specimen T1 was 62.3% higher than that of T6. Figure 9 shows that the stiffness of the T1 specimen was significantly increased compared with the T6 specimen after 40 kN. However, the T1 specimen did not show post-peak response, whereas the load of specimen T6 gradually decreased after the peak load.

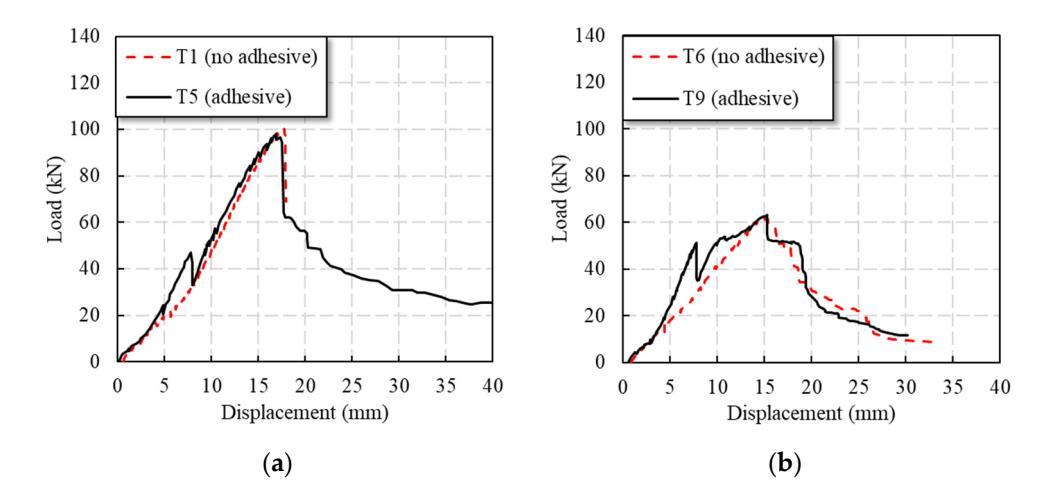
**Figure 10.** Load–displacement curves for comparison of the bolted and bolted–bonded hybrid connection: (**a**) thick plate, and (**b**) thin plate.

As Figure 10a shows, during the loading process of the T5 specimen, before 10 kN (0.10  $P_u$ ), the load basically continued to rise linearly, and the initial tensile stiffness of the specimen was small; after 10 kN, the stiffness of the specimen increased slightly. When the load reached 49 kN (0.50  $P_u$ ), the adhesive layer was shear damaged, and the specimen made a loud cracking sound. At the same time, the load suddenly dropped to 33 kN (0.34  $P_u$ ), and then the stiffness of the specimen made a crisp sound of fiber tearing; when approaching the peak load of the specimen, the fiber emitted a continuous fiber tearing sound; after the peak load of 97.9 kN ( $P_u$ ), the load suddenly dropped to 64 kN, and then the load decreased in a curve. In the later stage of load reduction, the specimen showed good ductility.

As Figure 10a shows, the stiffness of the T9 specimen was relatively small before 10 kN (0.16  $P_u$ ). After 10 kN, the stiffness of the specimen increased significantly and the load increased linearly. When the load was 50 kN (0.79  $P_u$ ), due to the shear failure of the adhesive layer, there was a loud cracking sound, and the load suddenly dropped to 35 kN. Then, the load continued to rise, but the stiffness of the specimen decreased. When the load was 54 kN (0.85  $P_u$ ), the specimen slipped, and the tensile stiffness of the specimen was further reduced. When the load was continued, the specimen emitted a continuous fiber tearing sound. After reaching the peak load of 63.2 kN ( $P_u$ ), the load decreased, where two descending plateaus were observed.

It can be seen from Table 1 and Figure 10 that the interface adhesive did not increase the specimen's  $P_u$ . The initial stiffness of the specimen was significantly increased. When the load reached the shear strength of the adhesive layer, the load of the specimen decreased obviously. In the later stage of loading, the specimen mainly depended on the bolt to bear the load, so the  $P_u$  of the specimen was basically the same as the pure bolted connection. The specimens T6 and T9 have similar shear strength, but it can be clearly observed that the adhesive layer failure occurred when T9 was about 50 kN. At the same time, comparing the glued specimens in the two groups of thick and thin plates (the same plate width and the same adhesive layer area), it can be found that the adhesive layer shear failure occurred in the specimens at about 50 kN, indicating that the shear bearing capacity of the adhesive layer in the same area was the same.

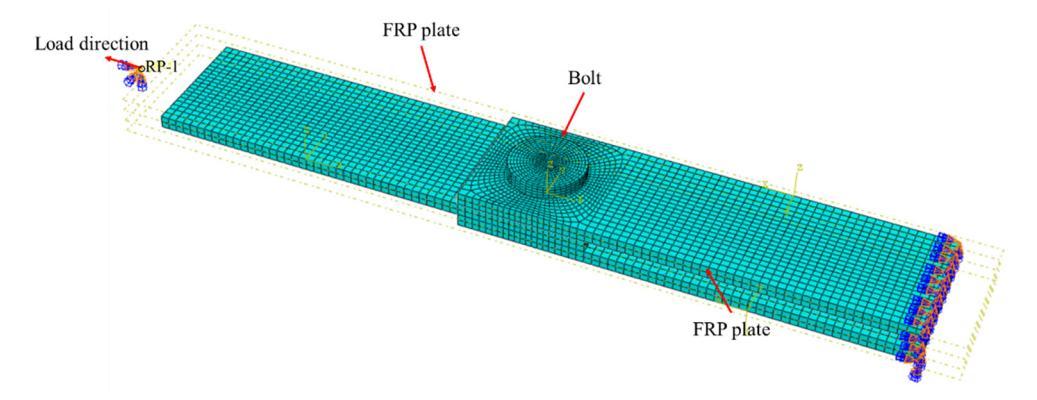
Figure 11. FE model of double-lap shear test of GFRP bolted joints.

A finite element (FE) model of the GFRP bolted joint was established in this study by using Abaqus, as shown in Figure 11. The bolt shank, nut, washer and GFRP plates were modeled according to the dimensions in Table 1 in the FE model, where a similar method has been shown in [48]. A reference point RP-1 was set on one end of the FE model of the GFRP bolted joint, and the reference point was coupled with the end surface, and the other end was constrained by consolidation.

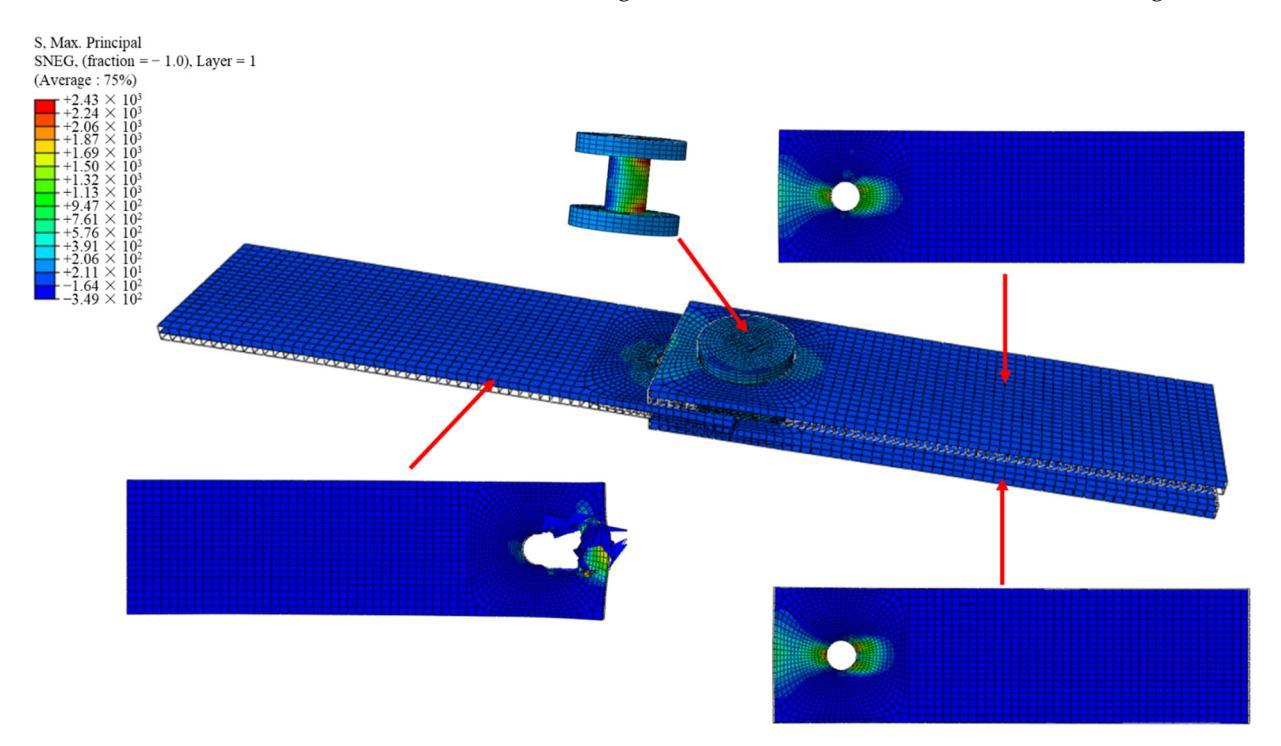
Figure 12. Maximum principal stress cloud of double-lap shear test of GFRP bolted joints.

The FE simulation results (Figure 12) show that the stress concentration phenomenon occurred in the 45° direction of the hole in the GFRP bolt connection. The failure mode matched well with the experimental results, as shown in Figure 13. In the experimental observations, the failure modes of T7 are both bearing failure and shear-out failure, which was also found in the results of numerical simulations, as shown in Figures 12 and 13. The simulated failure process can be extracted frame by frame, providing a more complete picture of the damage process of the specimen than can be achieved in a test. It should be noted that a deformation magnification factor of 8.5 times was selected in Figures 12 and 13.

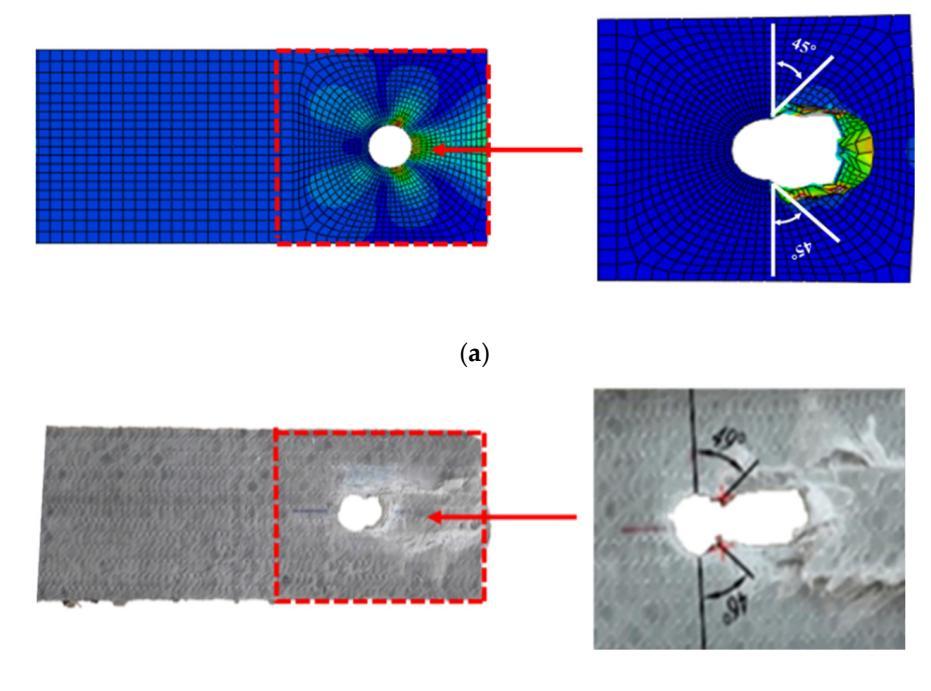
**Figure 13.** Comparison of (**a**) shear stress predicted by FE model, and (**b**) shear out failure mode of specimen T7.

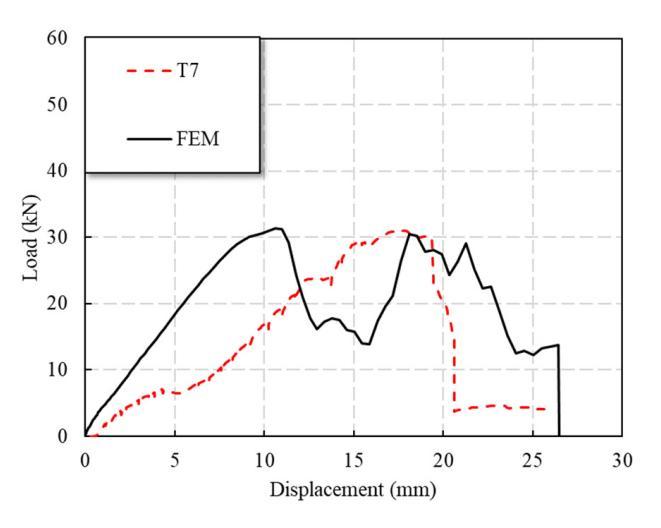
Figure 14. Comparison of FEM and test results of load response of specimen T7.

Figure 14 shows that the results of the numerical simulation were close to the results of the experimental test in terms of the maximum load. However, the displacement corresponding to the maximum test load was about 5 mm larger than the simulation results, which might be due to the initial gap between the loading head and the GFRP plate specimen.

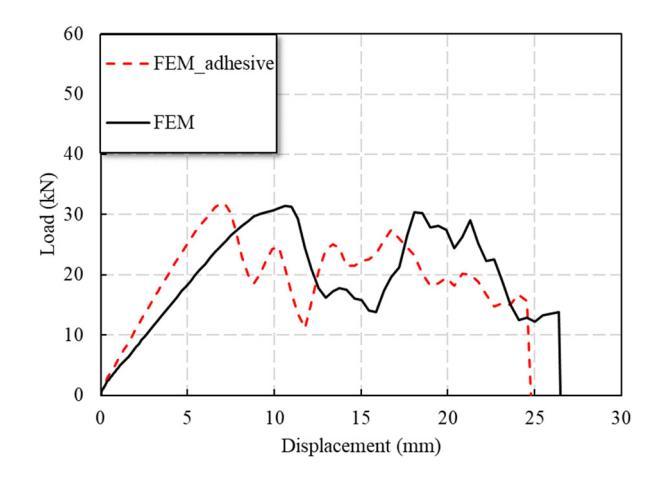
Figure 15. Comparison of FE model results: bolted and bolted-bonded hybrid connection.

Referring to the numerical model of the T7 specimen, the numerical model of the double shear single bolt with adhesives was established. As can be seen from Figure 15, the FE model of specimens with adhesives showed a higher initial stiffness of the specimen, and the load was significantly reduced after the failure of the adhesive layer. The load response predicted by the FE model was in good agreement with the experimental observations of the double-shear connection specimens T5 and T9.

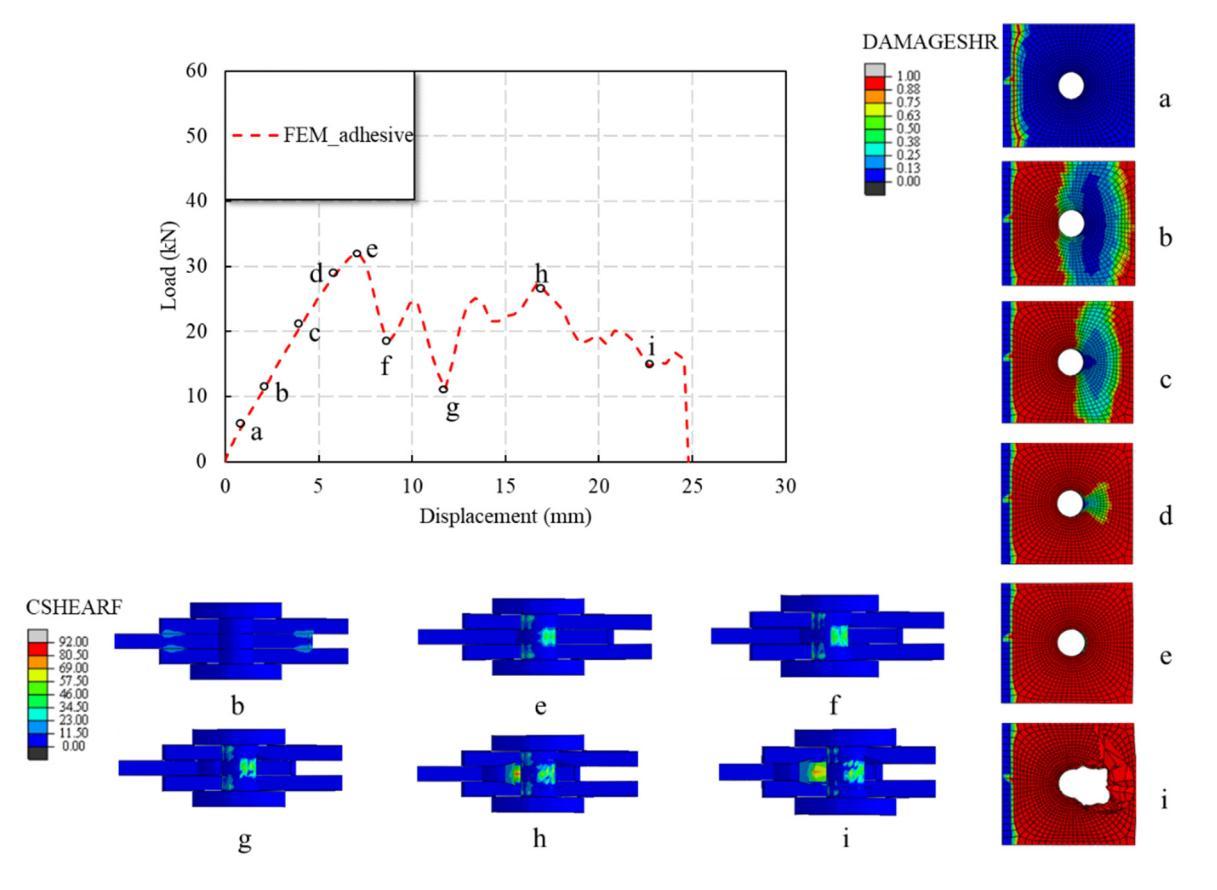
Figure 16. Progressive failure of the bolted-bonded hybrid connection specimen.

Figure 16 demonstrates that the adhesive on the loading end side first failed (see Point A in the load–displacement curve in Figure 16), and then the failure of adhesive near the fixed end was observed. As the displacement increased, the interfacial damage on one side of the fixed end extended to both sides and the middle. With the increase in displacement, the load reached a plateau after the peak of the load. This plateau, according to the authors' analysis, is due to the progressive failure of the interfacial adhesive, as can be shown by Points F, G, and H in the load–displacement curve in Figure 16. This process was not apparent during the experiments, but some acoustic activities were heard during the test. Finally, the adhesive layer failed completely at the end of the post-peak plateau of the load (see Point I in the load–displacement curve in Figure 16).

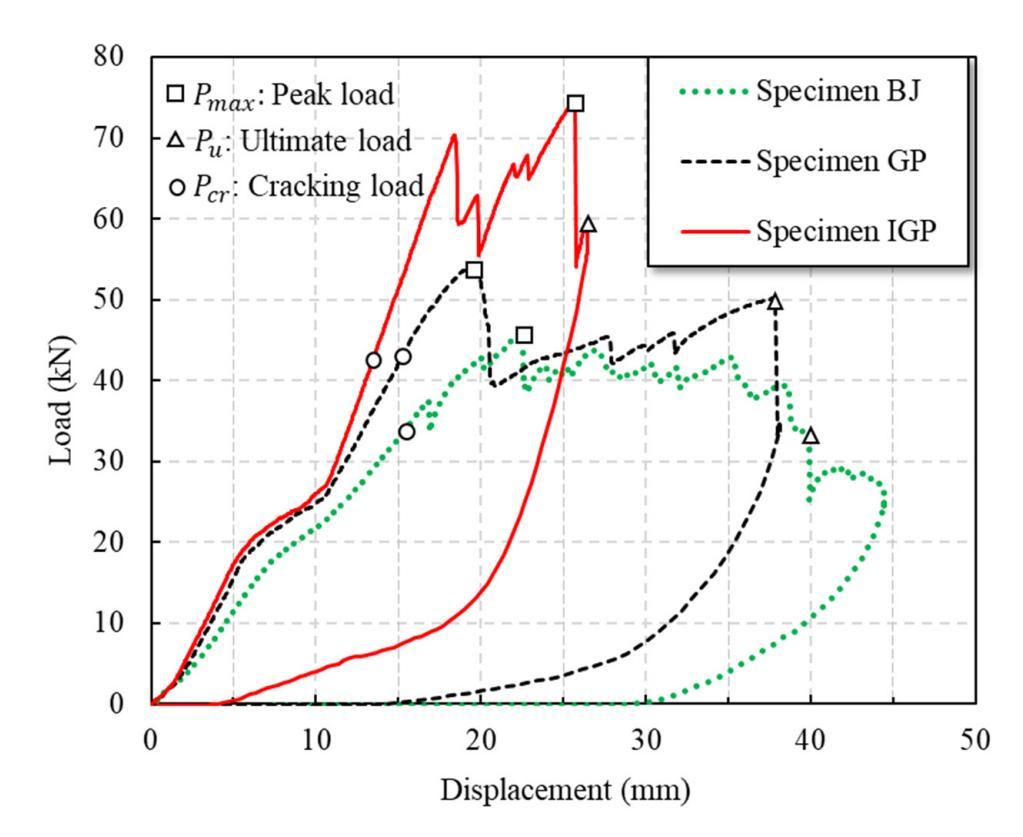
Figure 17. Load-displacement curve of GFRP truss joints.

The load–midspan displacement curves of specimen BJ, GP and IGP are shown in Figure 17. For specimen BJ, the first crack formed at the web–flange junction of the horizontal chord when the load reached 33.8 kN. At 37.4 kN, longitudinal shear cracks appeared between the upper row of bolts in the rear grooved web chord joint, while shear cracks formed at the hinge of the left diagonal chord. At 41.8 kN, multiple parallel longitudinal web shear cracks formed between the bolts of the front grooved web chord. When the bottom chord web chord reached the ultimate bearing capacity, the load dropped suddenly, and the end of the vertical chord extended out of the core area.

Comparing the load–displacement curves of specimen BJ, GP and IGP (Figure 17), it can be seen that the typical bolted gusset plate (specimen GP) did not significantly increase the maximum load carrying capacity of the members. This might be caused by the fact that the lower chord pultruded profile was divided into two halves along the middle of the specimen in which the novel bolted gusset plate was incorporated. However, the inclusion of the novel bolted gusset plate significantly reduced the cracking and increased the ductility characteristics of the specimens by 21.62%. The employment of the proposed gusset plate substantially improved the peak load but reduced the ductility when compared with the rest two specimens. The reason for this improvement, according to the authors' analysis, is that the proposed IGP works as a strengthening component of the joint and allows the bolts to work together to withstand the load. It is noted that ductility was estimated from the displacement to the point where the load dropped sharply after reaching the peak load.

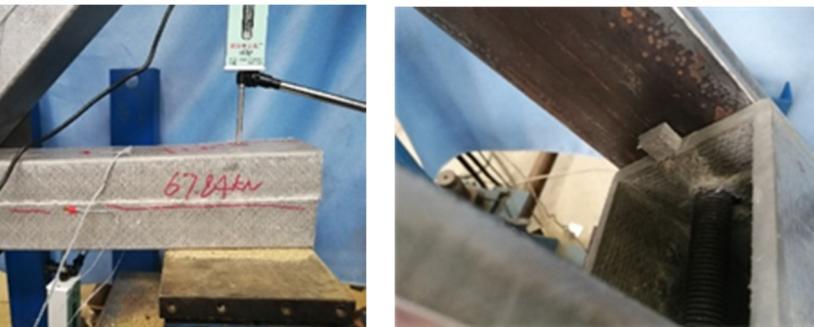
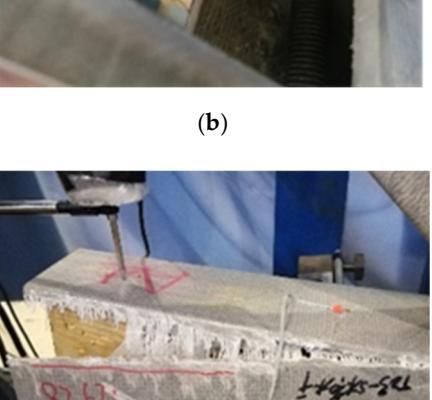
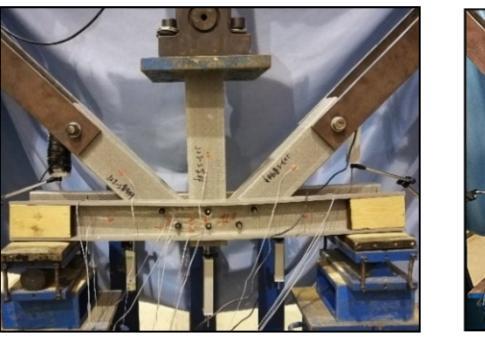
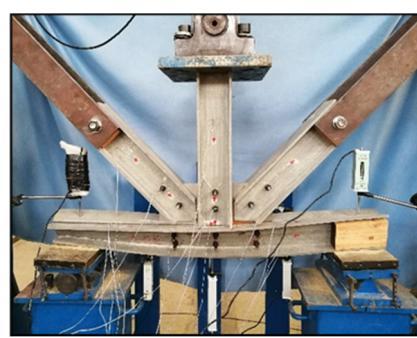
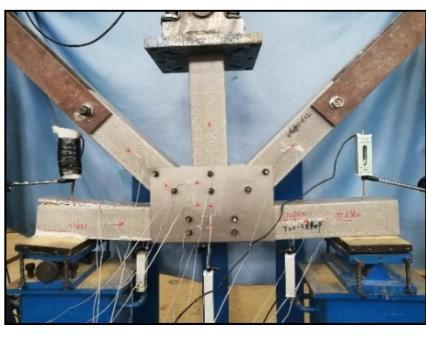
**Figure 18.** Failure modes of GFRP truss joints: (**a**) shear-out of webs, (**b**) shear-out of diagonal chords, (**c**) crush of top flanges, (**d**) separation of top flange and webs, (**e**) failed specimen BJ, (**f**) failed specimen GP, and (**g**) failed specimen IGP.

There were four typical failure modes in the static performance test of GFRP pultruded truss joints, as shown in Figure 18. Among them, specimen BJ showed shear out at the end of the diagonal chord, collapse of the top plate of the lower chord and buckling of the lower chord (see Figure 18e). Specimen GP was characterized by longitudinal shear of web, shear out of diagonal chord end and bottom chord buckling (see Figure 18f). Specimen IGP had a failure mode of shear failure at the web–flange junction (see Figure 18g).

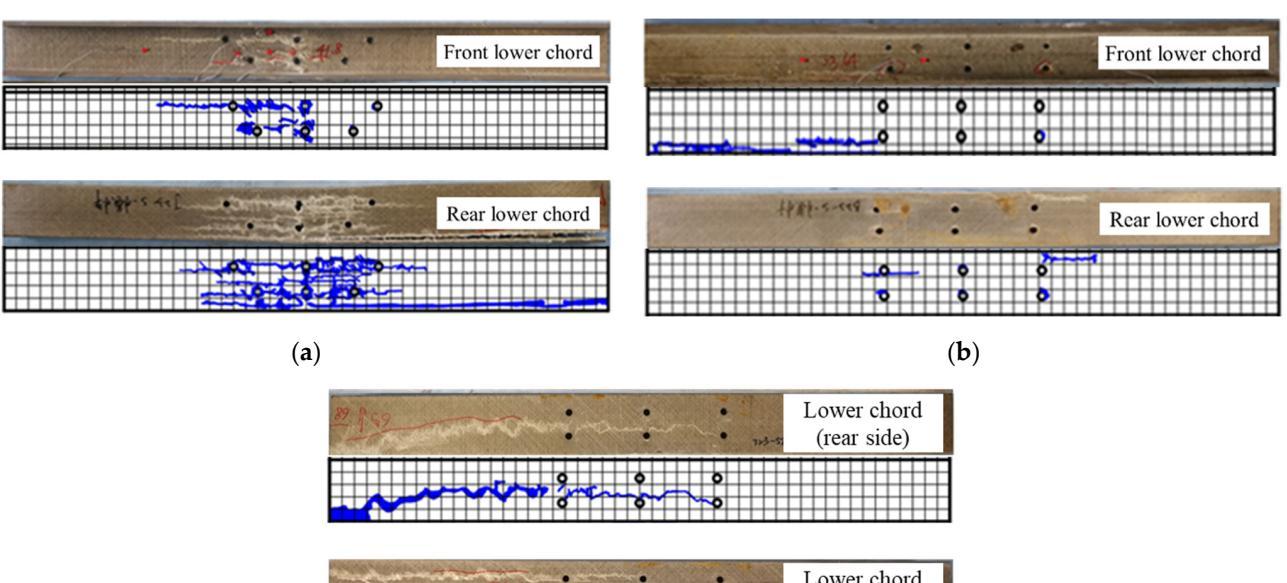
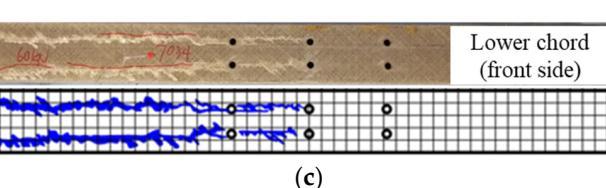
**Figure 19.** Distribution diagram of cracks in the lower chord: (**a**) specimen BJ, and (**b**) specimen GP, and (**c**) specimen IGP.

After disassembling the failure joints, the distribution of the static failure cracks of the bottom chord web is shown in Figure 19. A large number of longitudinal shear cracks appeared in the bottom web chord under the action of vertical load, and some large cracks extending into the core area of the joint directly led to the failure of the web chord. There was no full-length crack through the bottom chord. It should be noted that the distribution of all shear cracks was biased towards one side of the member. This was because the occurrence of shear cracks significantly reduced the stiffness of one side of the member, resulting in a small rotation of the joint around the core area, resulting in asymmetric failure on both sides of the lower chord web chord. The load orthogonal to the pultrusion direction of GFRP controls the mechanical resistance of the bolted connection, so it is recommended to add an adhesive between gusset plates and GFRP truss members to improve the capacity.

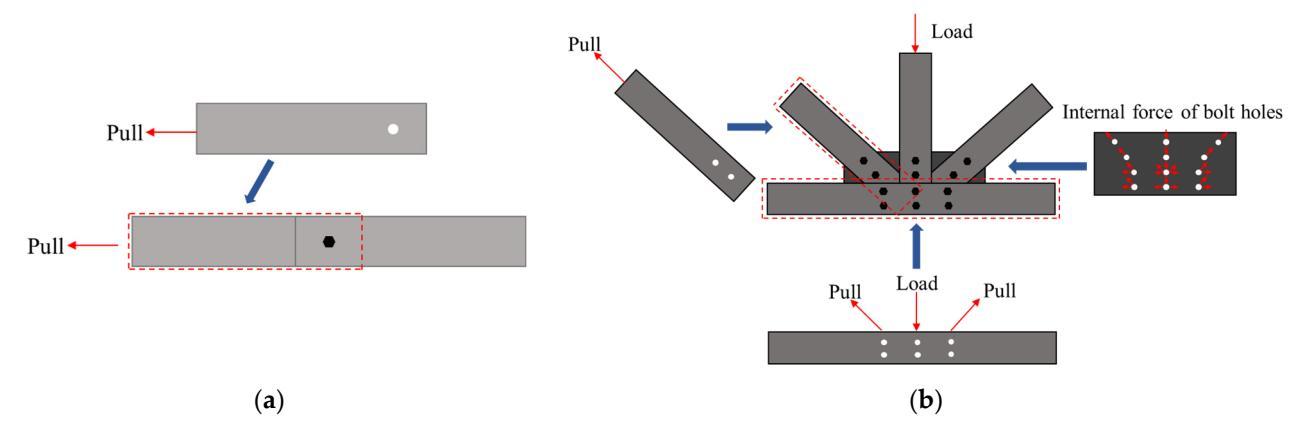
Figure 20. Failure modes of GFRP truss joints: (a) double-lap shear test, and (b) full-scale GFRP joint test.

In terms of the load transferring mechanism (Figure 20), the double-lap direct shear test specimen can represent the loading transferring from vertical and diagonal chords to the gusset plates and horizontal truss members. However, most failure modes occurred at the webs of the horizontal GFRP member, which was not well represented by the direct shear test. So, it can be concluded that the direct shear test can better replace the connecting capacity of vertical and diagonal chords.
