Article

# **Experimental Investigation on Post-Fire Mechanical Properties of Glass Fiber-Reinforced Polymer Rebars**

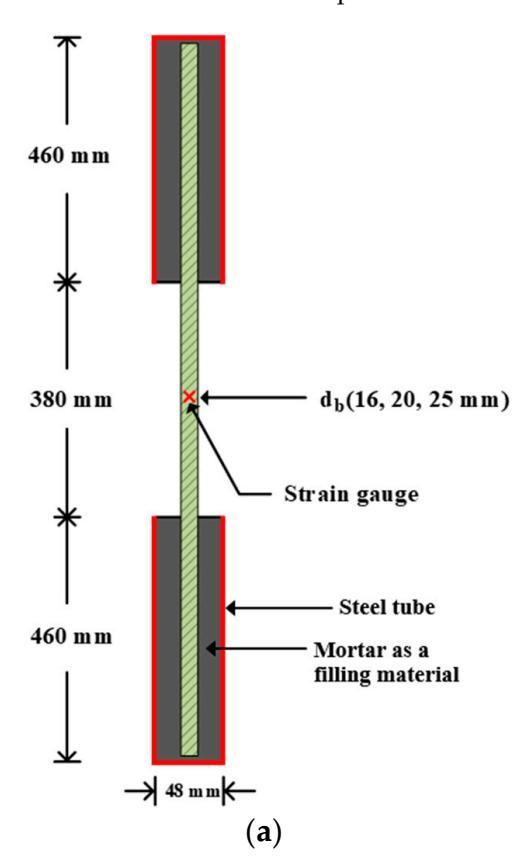
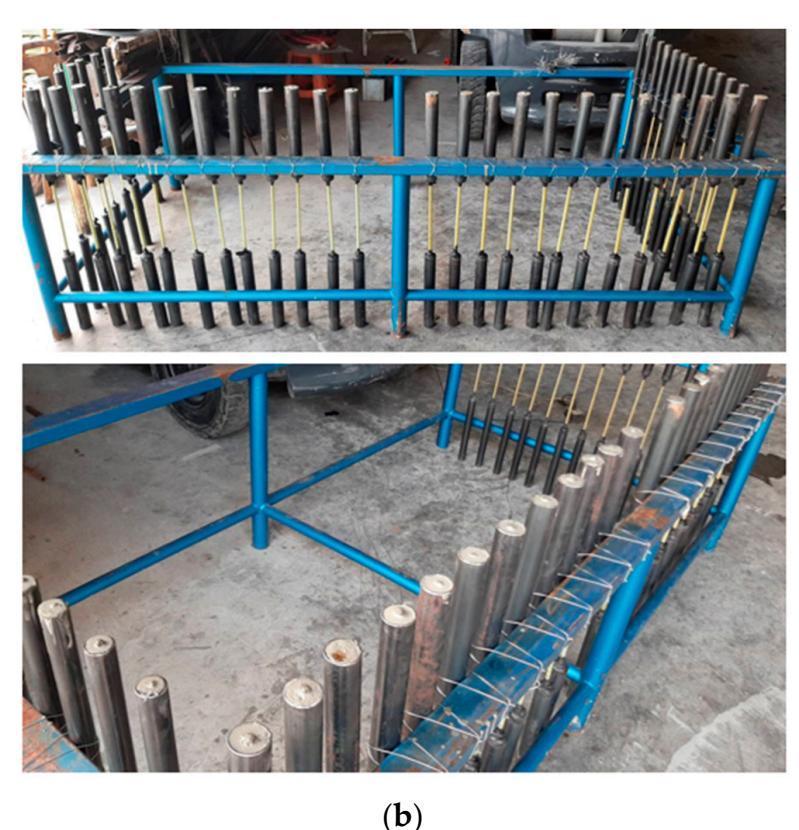
**Figure 1.** Test specimens: (**a**) details of a specimen (ASTM D7205/D7205M-06 [27]); (**b**) illustration of specimens and anchorages.

Figure 1a indicates details of a specimen that was set according to ASTM D7205/D7205M-06 [27]. All the rebars in this research were firmly covered by a steel pipe that was 460 mm long and had a diameter of 48 mm that was filled with mortar at both ends to act as interfaces between rebars and the loading head of the loading machine during the tensile tests. Installing the anchors reduced the stress concentration at the interfaces, which is observed frequently in tensile testing of GFRP rebars; hence, premature tensile failures in the GFRP rebars could be prevented to obtain the full tensile capacity of the specimens. In addition, there was a clear length of rebars between anchors of 380 mm that was heated and attached to a strain gauge to investigate the mechanical properties. The illustration of specimens and anchorages are shown in Figure 1b.

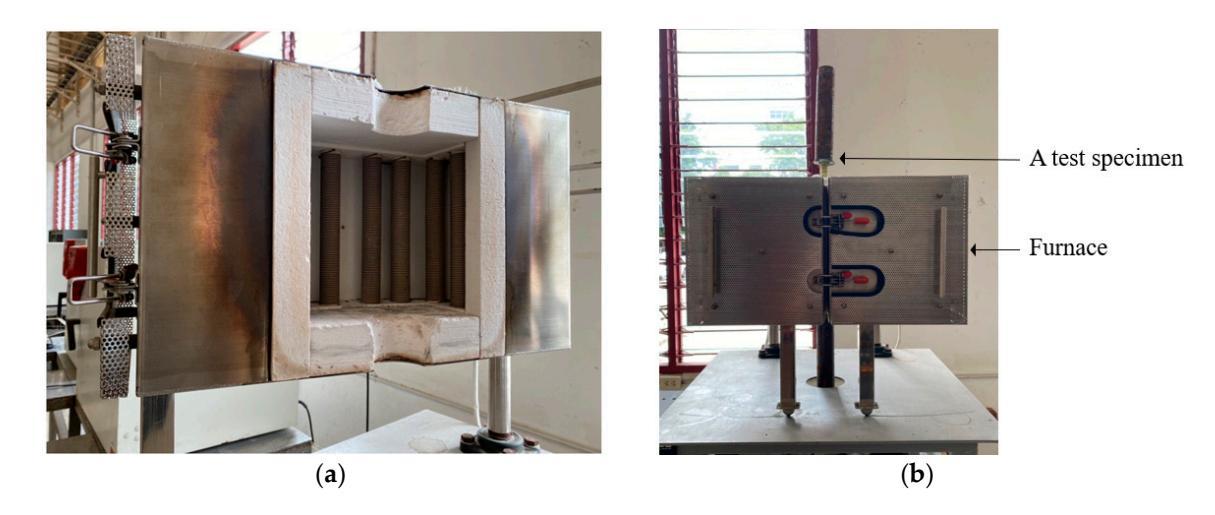
Figure 2. Fire testing: (a) internal furnace for heating test; (b) fire-testing setup.

Prior to the experiment, a furnace, capable of heating to 1200 °C, was modified to dimensions of 200 mm, 200 mm, and 200 mm in width, depth, and height, respectively, as shown in Figure 2a to ensure heating occurred only in the desired area. By doing so, the high temperatures were unable to influence and harm the anchors, which played a crucial role during the tensile test as interfaces between the rebars and the loading head of the loading machine.

During the heating process, a GFRP rebar was installed in the modified furnace, as shown in Figure 2b. Then, the specimen was heated to reach the targeted temperature using a heating rate of 20 °C/min [30], as illustrated in Figure 3. After reaching the targeted temperature, the specimen was left for 1 h to simulate a fire at the constant targeted temperature. Then, the designated cooling process was performed on the specimen.

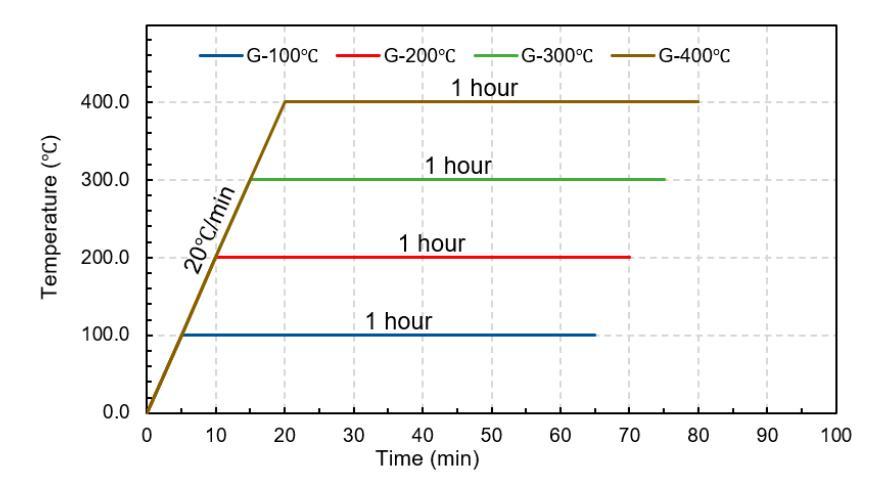
Two techniques of cooling were investigated. The first was air cooling, with each specimen left at room temperature of about 25 °C for 24 h after the heating process. The second method used water cooling, where the burnt part of the rebar was submerged in room temperature water immediately after the heating process, and left submerged for 24 h to emulate the influences of cooling on the post-fire mechanical properties of the specimen.

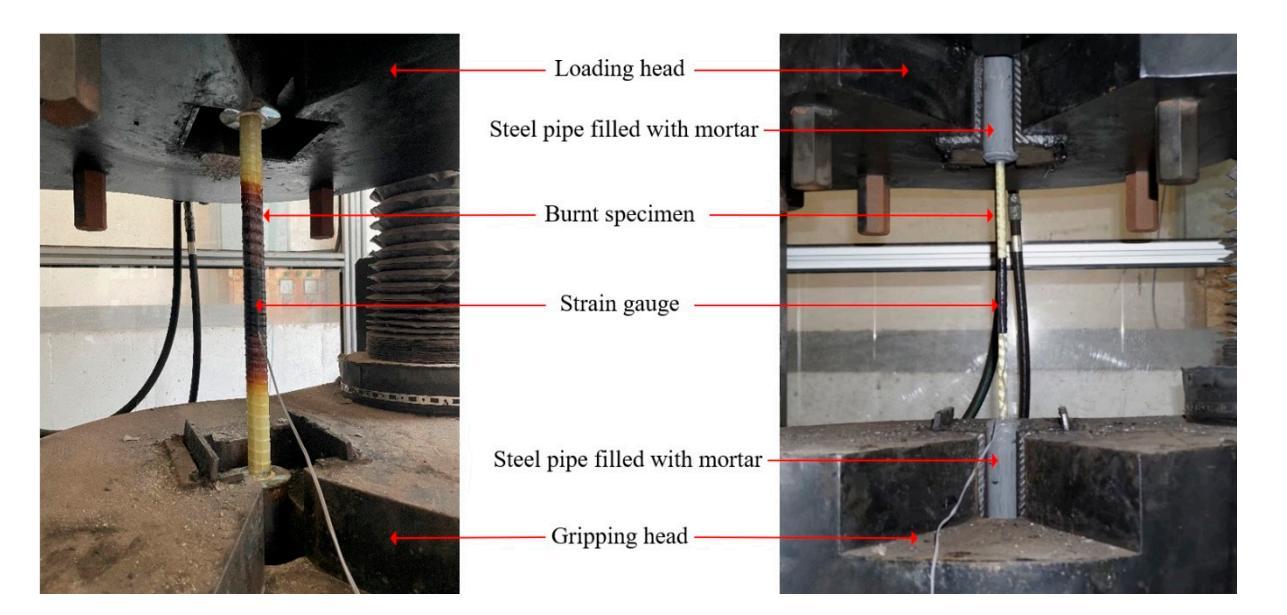
Figure 4. Tensile testing setup.

After allowing the specimen to cool for 24 h, the standard tensile test according to ASTM D7205/D7205M-06 [27] was conducted, as shown in Figure 4.

First, the anchorage zones of the specimen were firmly attached to the loading head of the loading machine in such a way that slipping during applying the tension force would not occur and the loading direction corresponding to the longitudinal axis of the rebar could be ensured. Next, the burnt rebar surface was polished until a satisfactory level of smoothness was achieved for strain gauge attachment. Finally, before applying the tensile load on the specimen, a strain gauge was attached at the mid-length of the clear range of the rebars for measuring the mechanical properties of the specimen after the fire.

The tensile test was performed by applying tension force to the specimen through the loading head, which was subsequently increased continuously at a loading rate of 2 mm/min [25] until failure was observed. During the loading process, the tensile stress and tensile strain were recorded to obtain a stress–strain relationship.

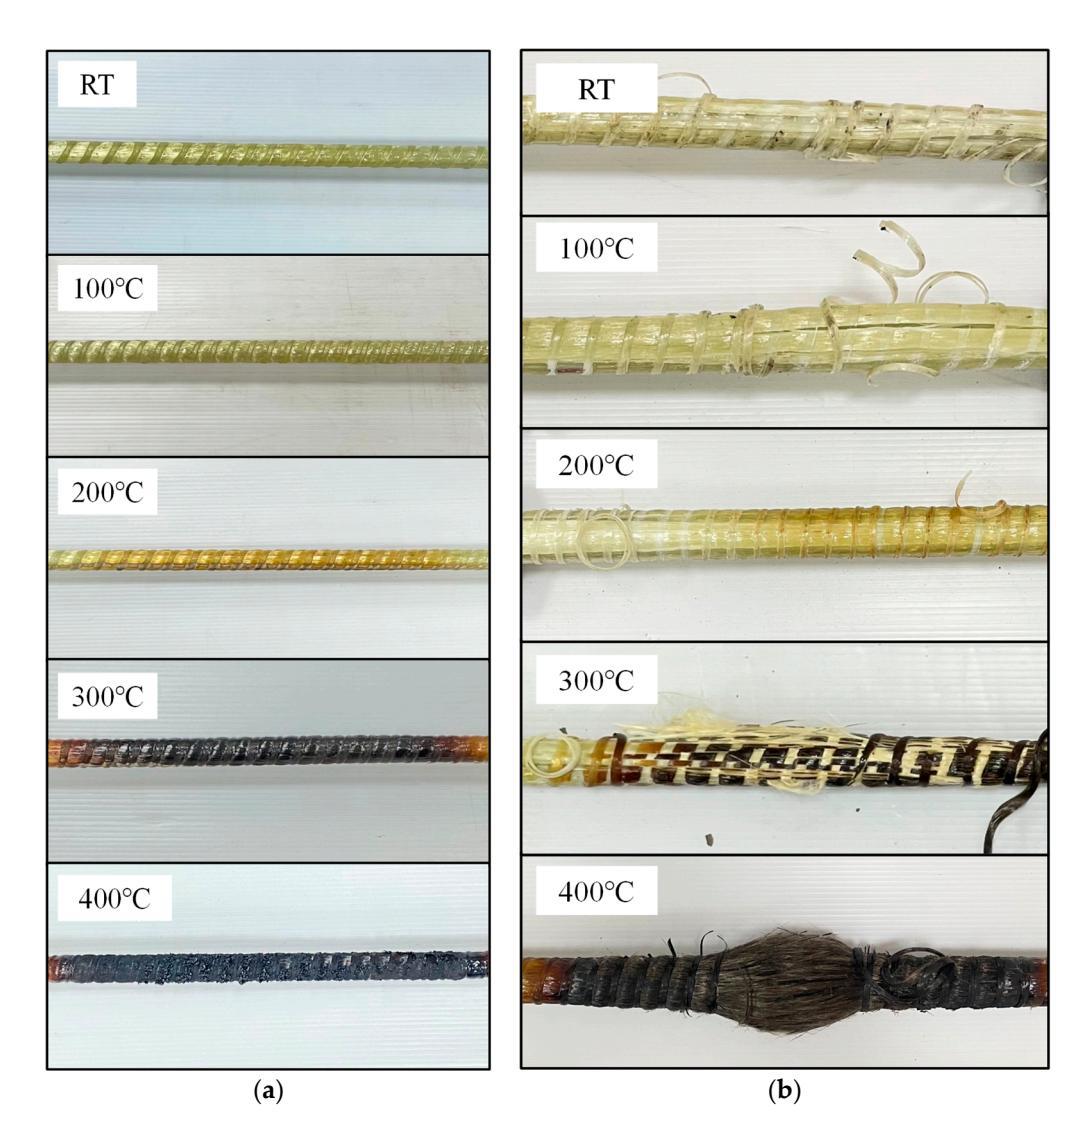
Figure 5. GFRP after fire exposure: (a) before tensile test; (b) failure mode after tensile test.

After removing the GFRP rebar samples from the heat treatments, samples were observed to have expanded (Figure 5a). This phenomenon may have been attributable to the high values of the resin's coefficient of thermal expansion; this should be noted as the important point since it may contribute to the spalling of concrete under fire conditions. In addition, Figure 5a depicts the GFRP rebars exposed to varying temperatures for the same duration. The rebars exhibited almost no external color change at 100 °C. The surface yellowed when the GFRP rebars were heated to 200 °C and darkened when heated to 300 °C. By the end of their time in the oven at 400 °C, the GFRP rebars had turned an extremely dark color and the surface had turned to ashes in some parts. The hue change was attributable to the decomposition of the polymer matrix during heating. The observed hue shift was clearly correlated with the exposure temperature.

In the tensile test, regardless of the elevated temperature or cooling method, all GFRP rebars failed in a similar manner, with fiber rupture at ultimate loads. Due to surface debonding between the fibers and matrix, the failure manifested as a sudden longitudinal central fiber delamination; however, when the GFRP rebars were heated to 300 °C, a similar but more dramatic failure mode was observed, with more fibers collapsing and debonding. At 400 °C, severe delamination was replaced by fiberization. The divergent fibers of each rebar that resulted from the failure are depicted in Figure 5b. Brittle fracture was identified as the predominant mode of failure observed in all the investigated GFRP rebars in this study. This outcome is in accordance with previous studies [31], which have consistently reported the brittle fracture as the common failure mode in GFRP rebars.

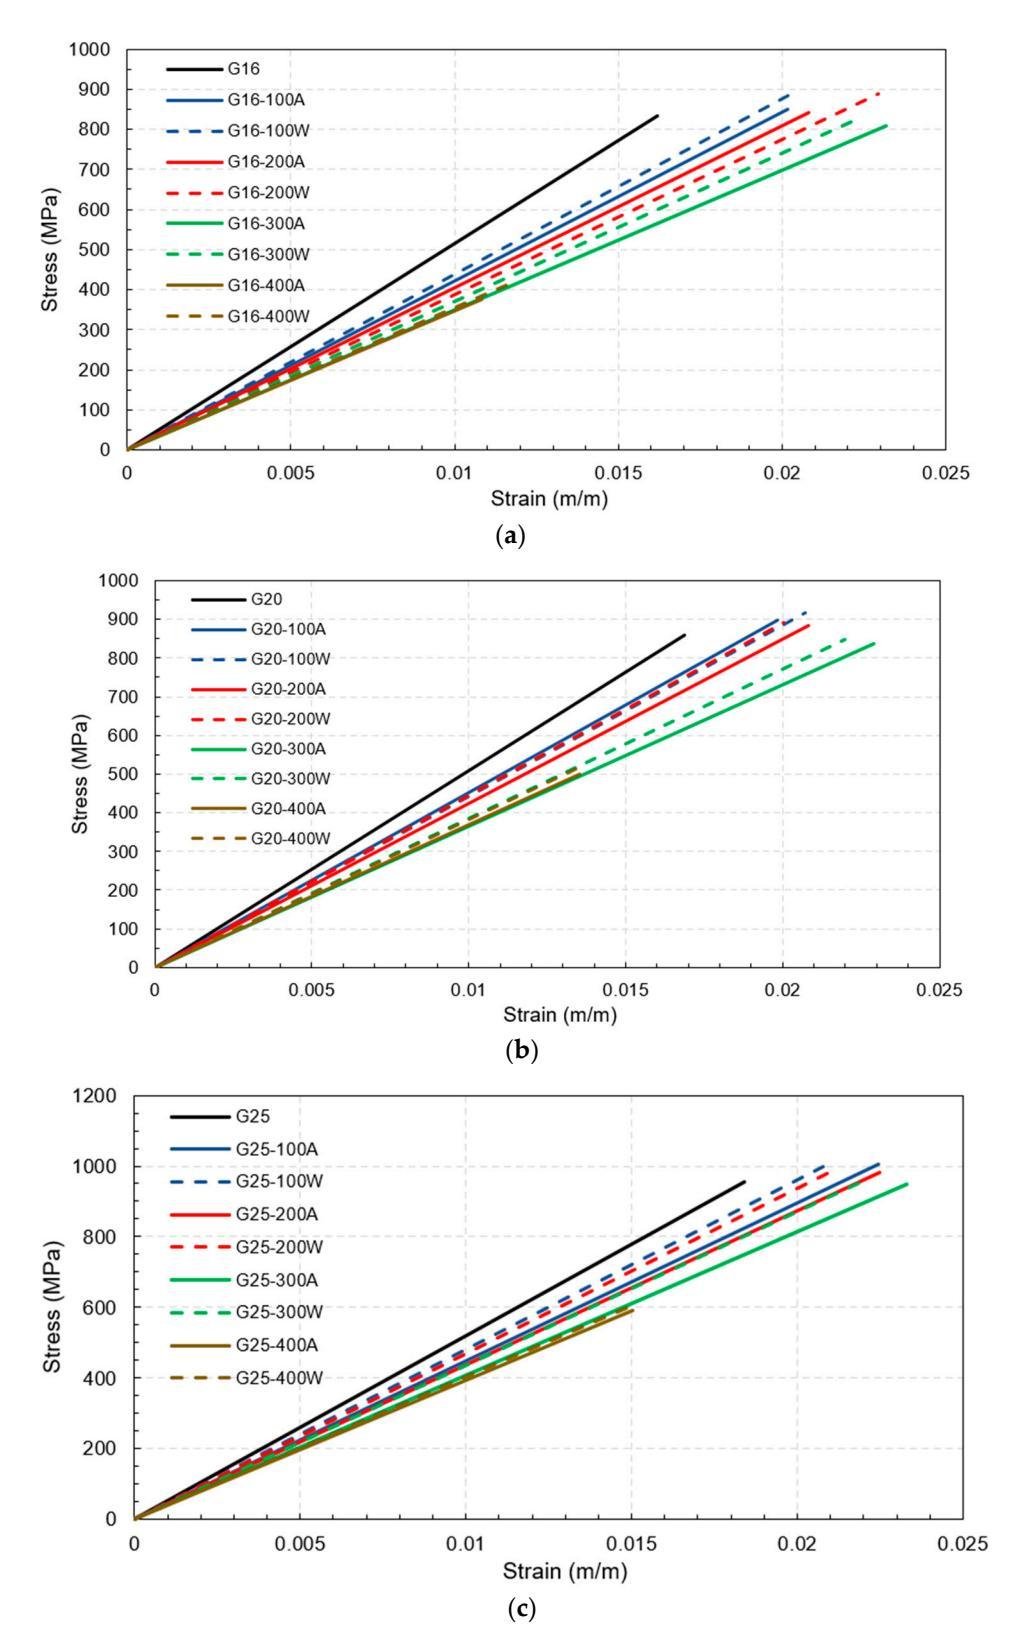
Figure 6. Stress-strain curves for all tested combinations: (a) 16 mm (b) 20 mm (c) 25 mm.

Figure 6a–c illustrate the stress–strain curves for G16, G20, and G25, respectively. Based on the test results, the stress–strain relationship of post-fire GFRP bars increased linearly from the beginning until failure. These results agreed well with Spagnuolo et al. [28], who conducted experiments to investigate the residual mechanical behavior of GFRP bars following exposure to temperature treatments ranging from 100 °C to 700 °C. Notably, their study did not specifically explore the effect of the water-cooling technique.

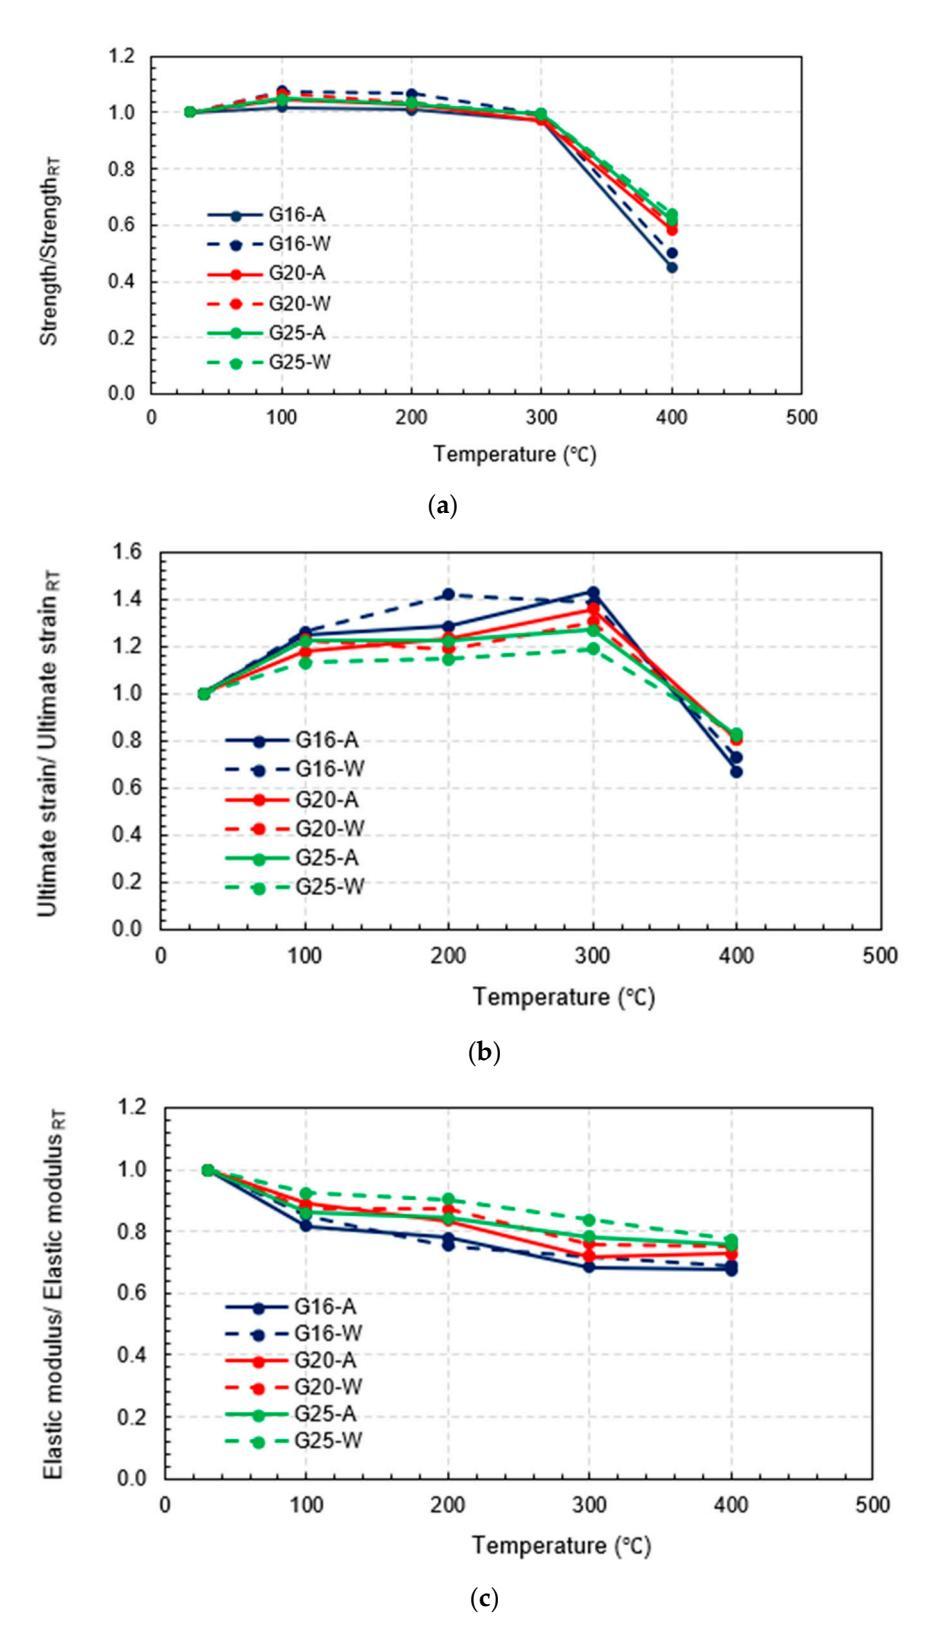
**Figure 7.** Results of all testing combinations normalized by results at room temperature: (**a**) normalized tensile strength, (**b**) normalized ultimate strain, and (**c**) normalized elastic modulus.

The normalized elastic modulus in Figure 7c demonstrated a clear pattern that as maximum temperature increased, the modulus of elasticity decreased. In addition, some specimens (16 mm and 20 mm rebars heated to 300 °C and 400 °C before being cooled by water as well as all 25 mm water-cooled rebars) had a greater modulus of elasticity compared to those that were air cooled. However, Figure 10 shows that these relationships did not hold true for the 16 mm and 20 mm rebars heated to maximum temperatures of 200 °C and 100 °C, respectively.

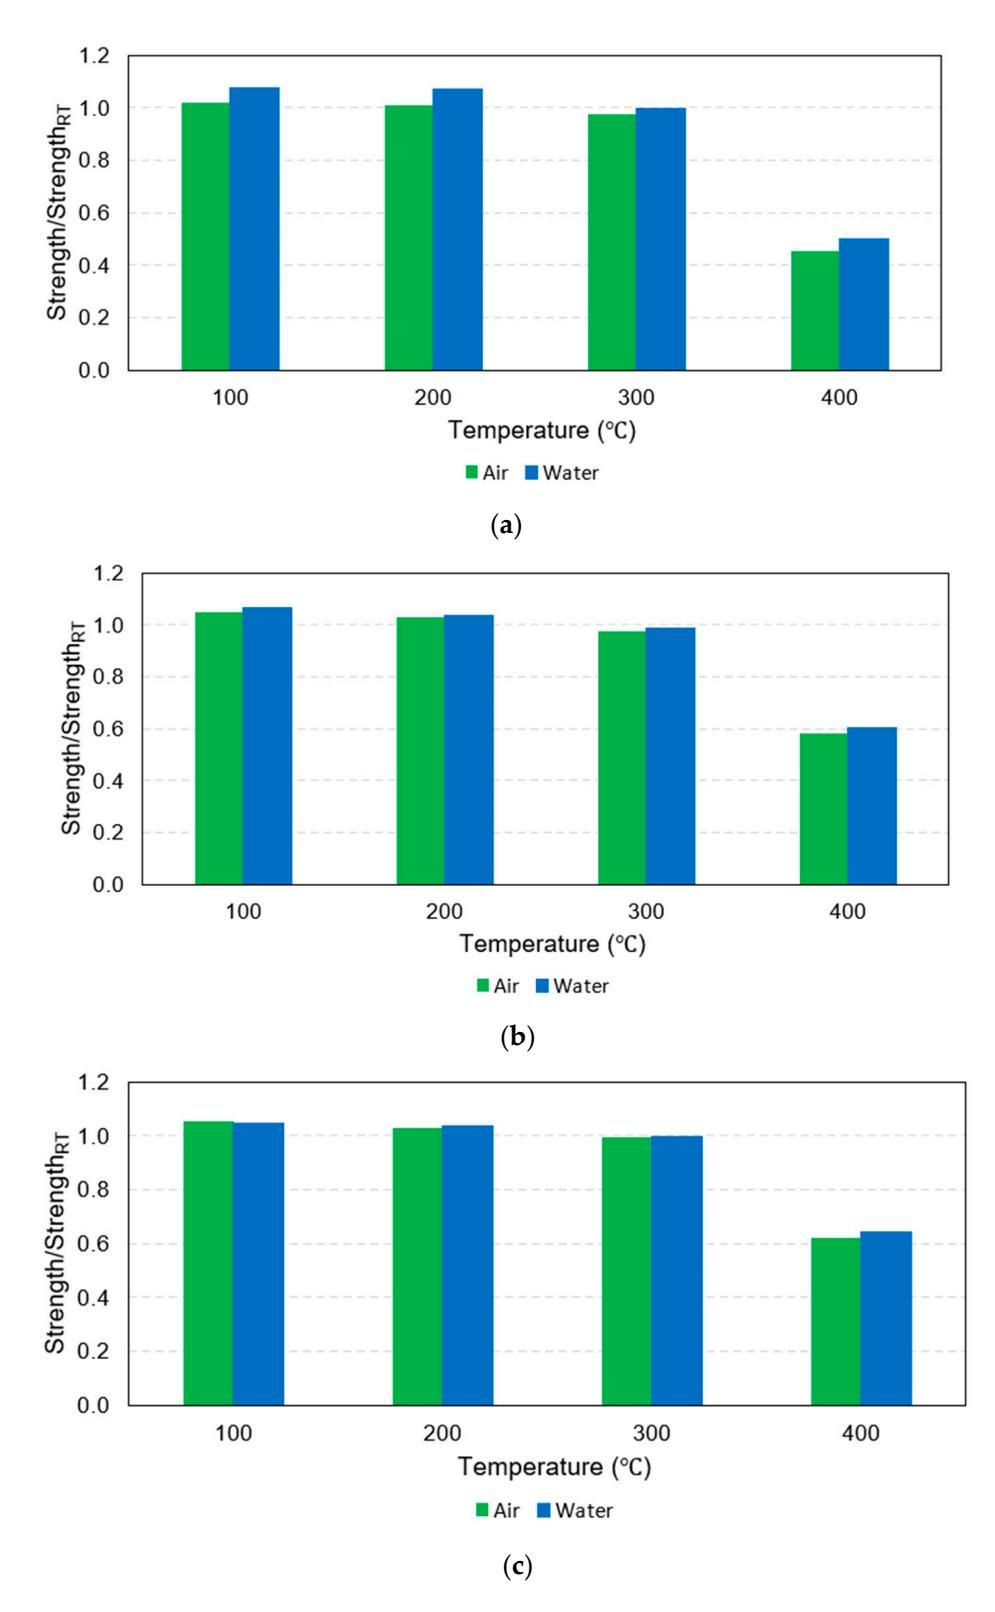
Figure 8. Bar charts of normalized tensile strength: (a) 16 mm, (b) 20 mm, and (c) 25 mm.

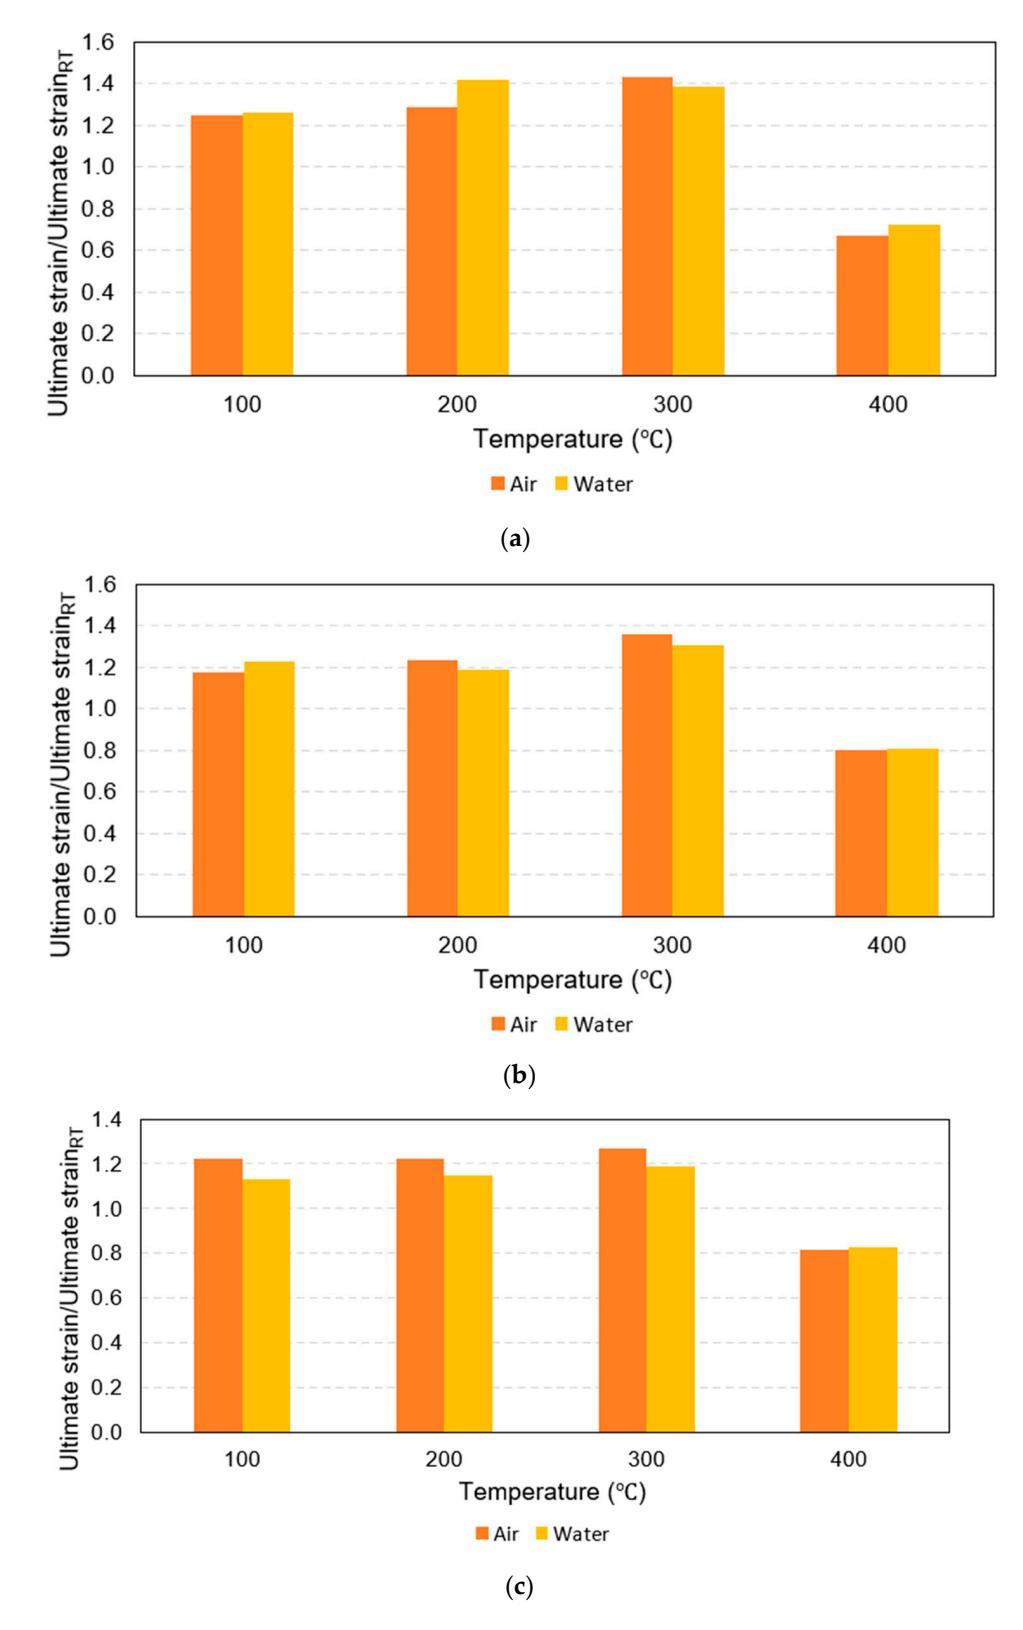
Figure 9. Bar charts of normalized ultimate strain: (a) 16 mm, (b) 20 mm, and (c) 25 mm.

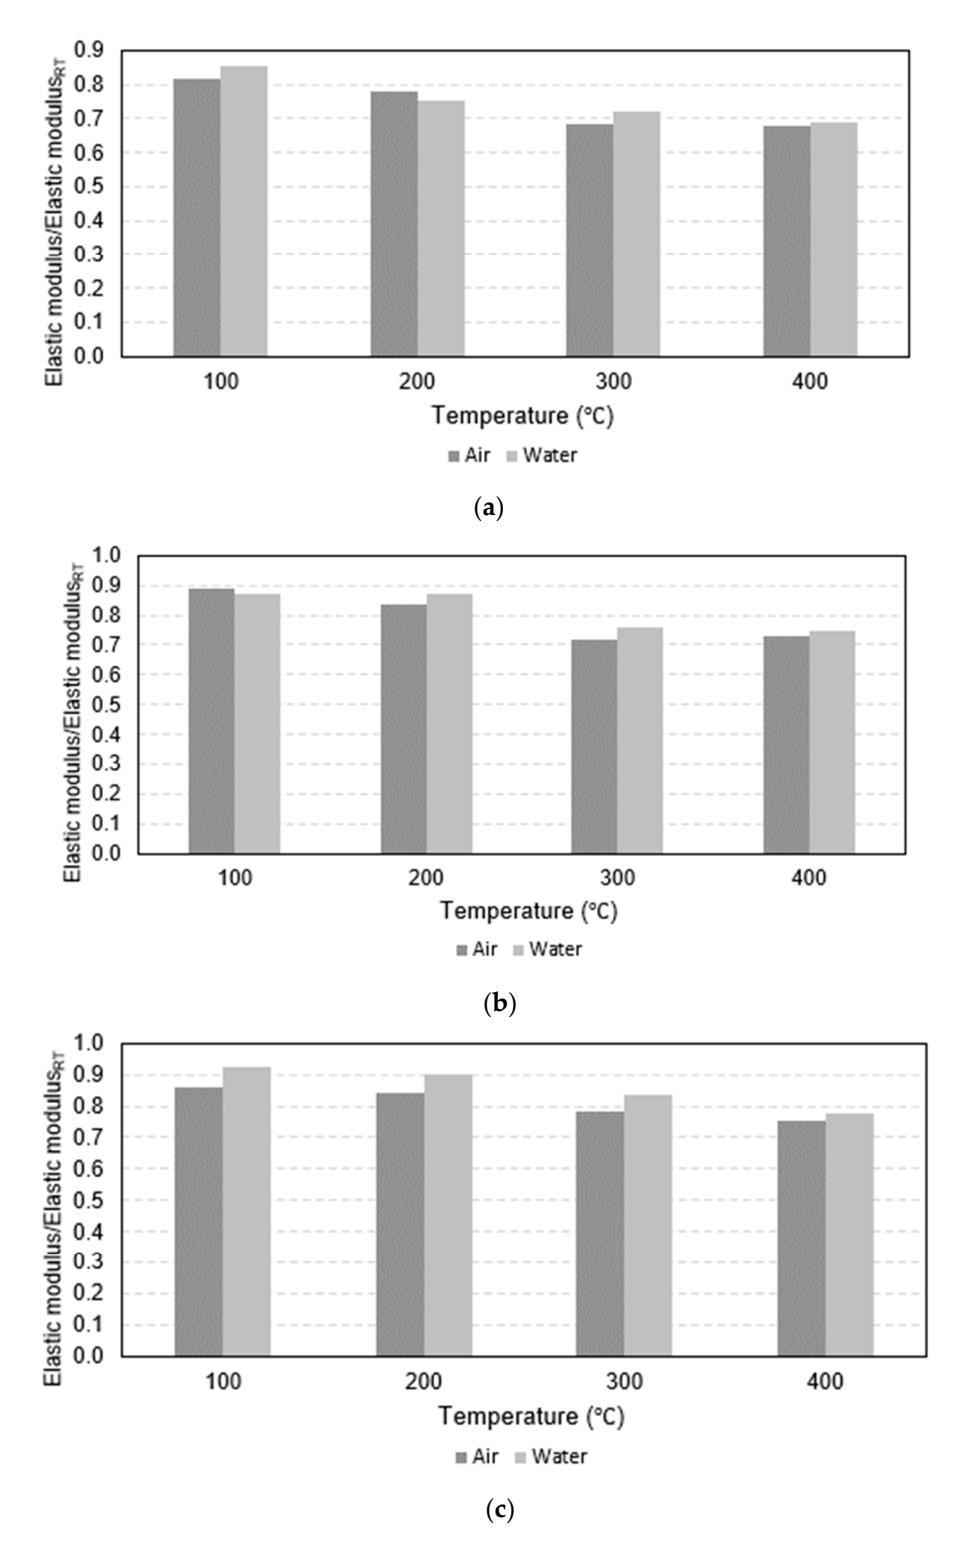
Figure 10. Bar charts of normalized elastic modulus: (a) 16 mm, (b) 20 mm, and (c) 25 mm.

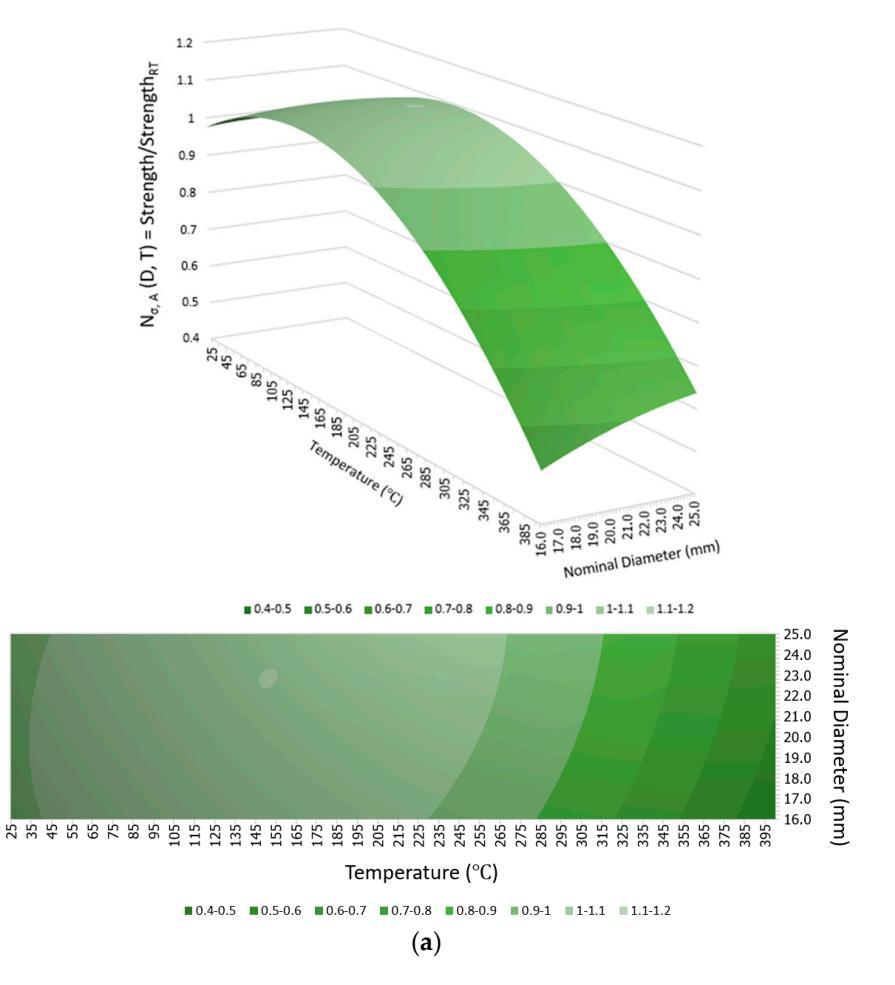
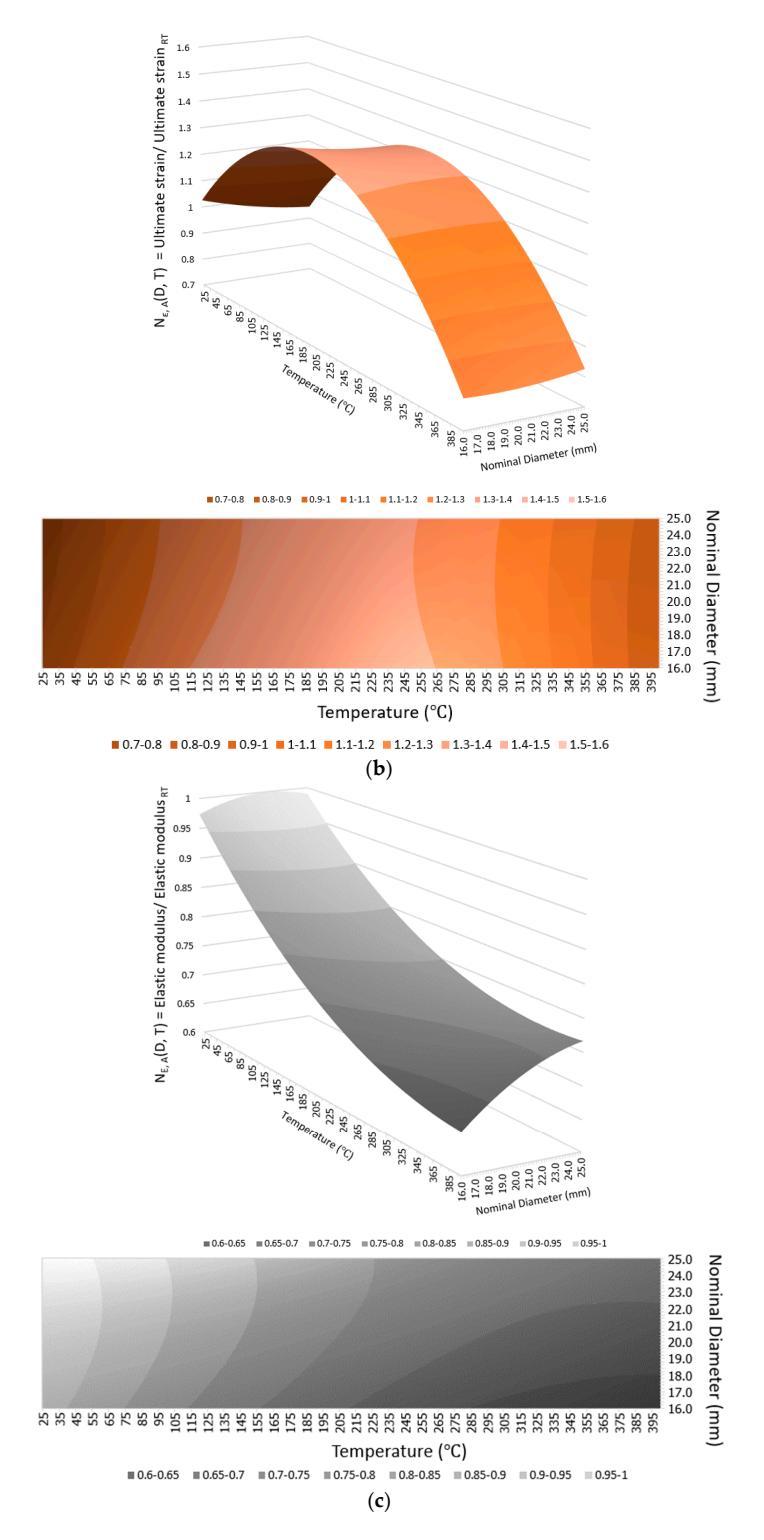
**Figure 11.** Models of mechanical properties of various nominal diameter GFRP bars after exposure to different maximum fire temperatures followed by air cooling: (**a**) strength variation, (**b**) ultimate strain variation, and (**c**) elastic modulus variation.

The mechanical properties of the GFRP rebars were normalized using the pre-fire properties to provide an indication of post-fire mechanical properties variation. These normalized properties, namely  $N_{i,j}$  where i denotes strength ( $\sigma$ ), ultimate strain ( $\epsilon$ ), and elastic modulus (E) while j denotes the implemented cooling method (A and W for the air and water cooling method, respectively), were plotted against the maximum fire temperature exposures as well as the nominal diameters in Figures 11 and 12, respectively, for air and water cooling, respectively, to show the more apparent course of the correlation between these two parameters and the dependent variables when implementing different cooling methods. After that, the variation trend was fitted with a quadratic response surface model, as shown in Equation (1):

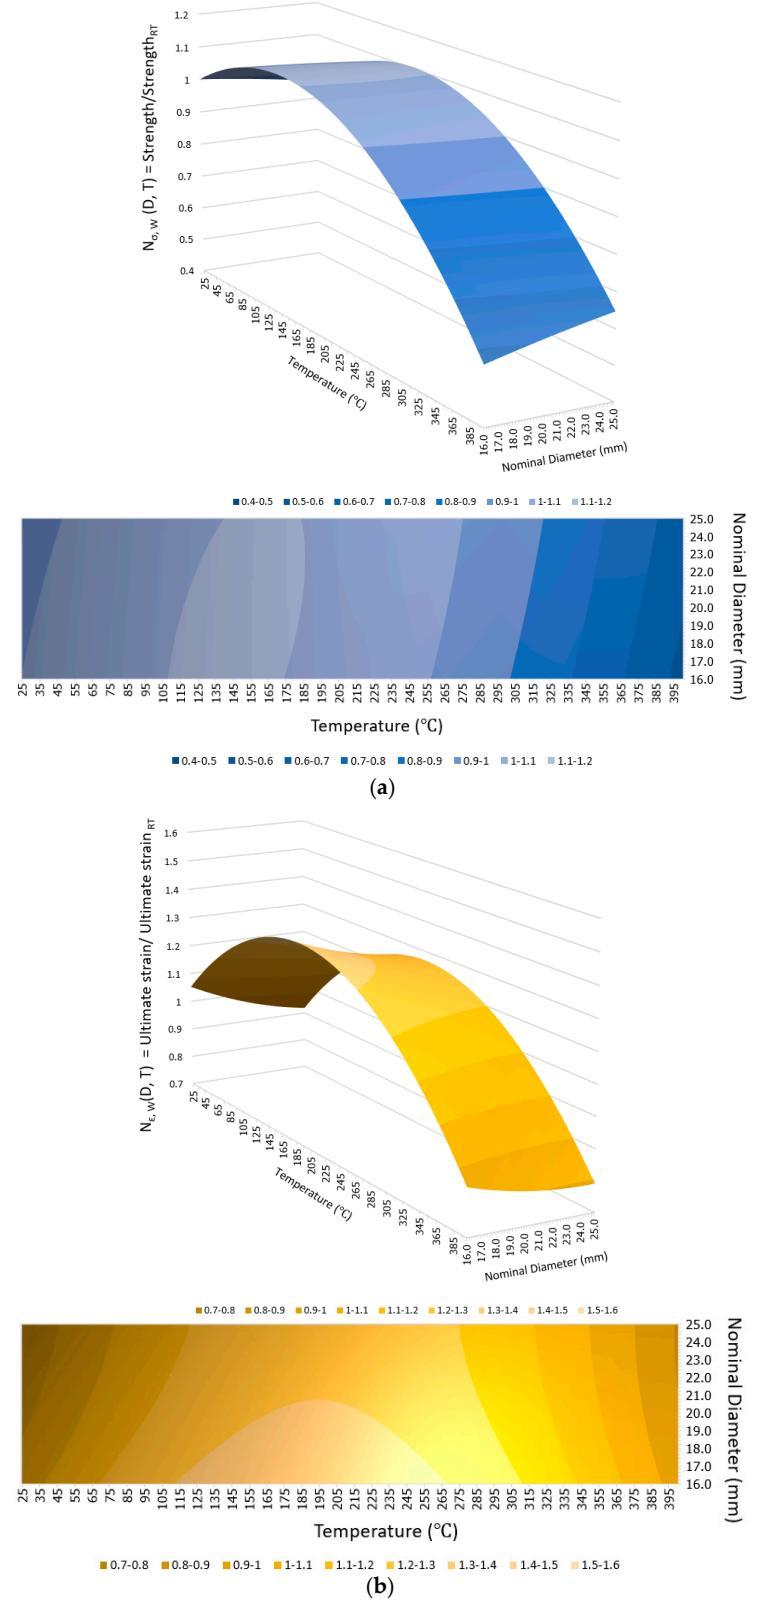
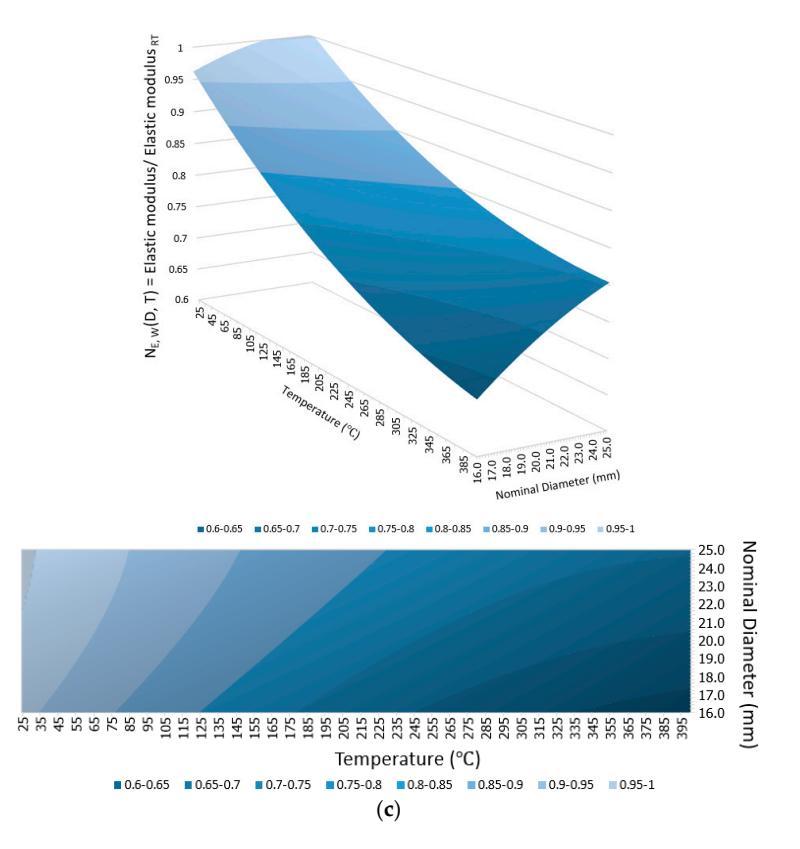
**Figure 12.** Models of mechanical properties of various nominal diameters of GFRP bars after exposure to different maximum fire temperatures followed by water cooling: (**a**) strength variation, (**b**) ultimate strain variation, and (**c**) elastic modulus variation.
