A Preliminary Study of the Failure Modes and Process of Landslide Dams Due to Upstream Flow

Abstract: In the process of mineral development, large-scale flash floods (or debris flows) can be induced by the failure of landslide dams formed by the disorganized stacking of mine waste. In this study, the modes and processes of mine waste dam failures were explored using 13 experimental tests based on the field investigation of landslide dams in the Xiaoqinling gold mining area in China. Our 13 mine waste dam experiments exhibited three failure modes: (i) Piping, overtopping, and erosion; (ii) overtopping and soil collapse; and (iii) overtopping and erosion. In addition, the failure processes of the landslide dams included impoundment, seepage, overtopping, and soil erosion. Different experimental conditions would inevitably lead to different failure processes and modes, with the failure modes being primarily determined by the seepage characteristics. Overtopping was the triggering condition for dam failure. The landslide dam failure process was determined based on the particle size of the mine waste and the shape of the dam. These findings will provide a scientific reference for the p

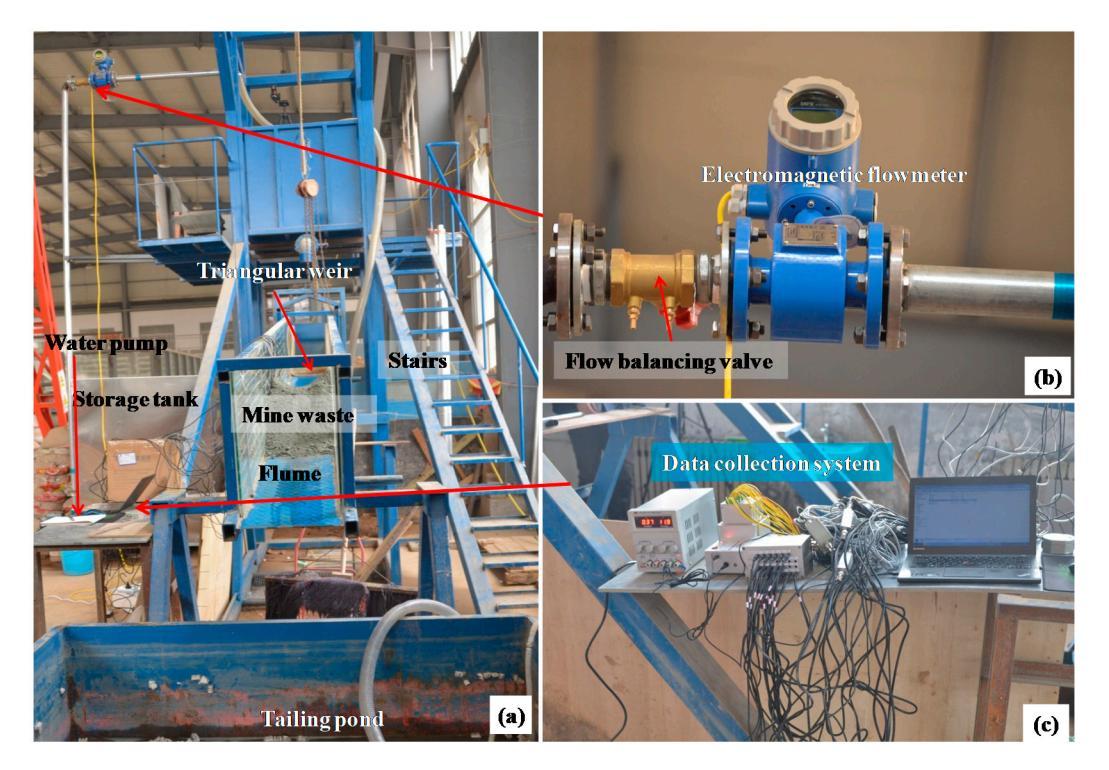
Figure 2. The experimental setup. (**a**) An overview of the experimental setup; (**b**) The electromagnetic flowmeter and flow balancing valve; (**c**) The data collection system of the experimental setup.

Based on the data obtained from the field investigations, an experimental flume was developed to explore the failure modes and process of the mine waste landslide dams in gullies in the Geological Hazard Simulation Laboratory at Chang'an University [11,24]. Figure 2a presents an overview of

the experimental setup. The experimental flume was composed of three sections: A storage tank, a flume, and a tailings pond. The storage tank was 1.3 m in length, 1.3 m in width, and 1.8 m in height. Water was pumped directly into the upper part of the flume using a water pump installed on the left side of the tank. An electromagnetic flowmeter and a flow balancing valve were installed in the middle of the pipeline to control the flow rate of the water with an error rate of less than 5% (Figure 2b). A triangular weir was also installed in the upper part of the flume and was used to adjust flow stability. The flume was 4 m in length, 0.3 m in width, and 0.5 m in height. The bottom of the flume consisted of a rough steel plate with two tempered glass sides, which made it possible to observe the failure process of the dams. The slope of the flume could be adjusted between 6° and 35°.

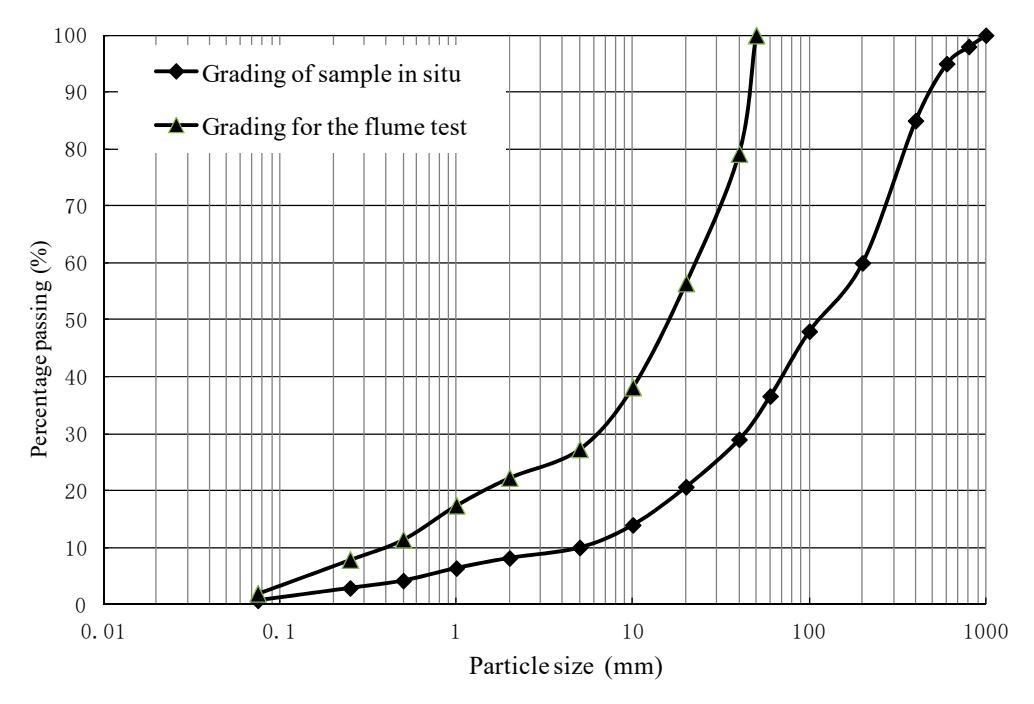
Figure 3. Particle size distribution of the modeled mine waste and the in-situ particle size.

The mine waste material used for our experiments was collected from mine waste dumps in the Daxicha Gully. The grain composition of the in-situ sample is shown in Figure 3. According to the field specific particle size distribution in Figure 3, the maximum particle size was up to 1 m. Obviously, due to the limitations in the hydrodynamic conditions of the experimental setup in our flume tests, larger particles should be excluded. The critical starting velocity for cohesionless sediment is determined by Zhang et al. [25].

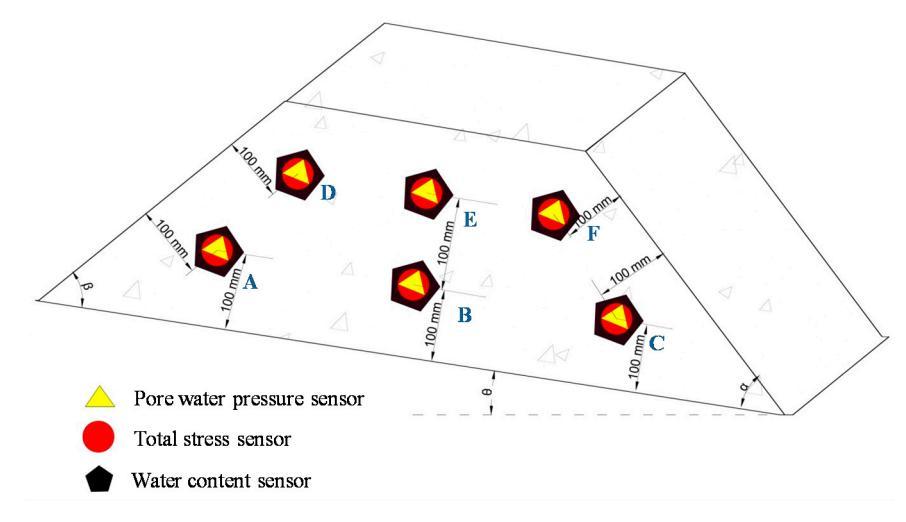
Figure 4. Distribution and serial number of the monitoring points in the landslide dam.

Six monitoring points were arranged inside the landslide dam of each test. Each monitoring point contained one pore water pressure sensor, one total stress sensor, and one water content sensor. The positions and serial numbers of the monitoring points are shown in Figure 4. All sensors have their instructions of factory calibrations, which give us the conversion formula correspondingly. However, the general calibration may not be applicable for our experiments, and we performed laboratory calibration before using them. The soil samples were prepared with soil volumetric moisture contents of 5%, 7%, 10%, 15%, 17%, 27%, and 36%, and then the water content sensor was placed in these samples to calibrate. The pore water pressure sensors were calibrated in a water column, which was 1.5 m in height and marked with graduations. The total stress sensor was loaded and unloaded cyclically on a set of calibration devices to obtain the relationship between the output electrical signal (V) and the surface vertical stress (kPa). Table 1 shows the technical specifications of sensors. Three cameras were used to record the erosion and transport processes of the mine waste from the front side, the right sides, and the top of the setup. The flume gradient and inflow rates were adjusted before each model test according to Table 2. During each test, cameras were used to record the experimental process, and the data acquisition instrumentation was turned on to record the time-varying values from the sensors. In addition, the depth of the outburst flow was recorded by a metric ruler placed downstream from the landslide dam, and the flow velocities were determined using the float method.

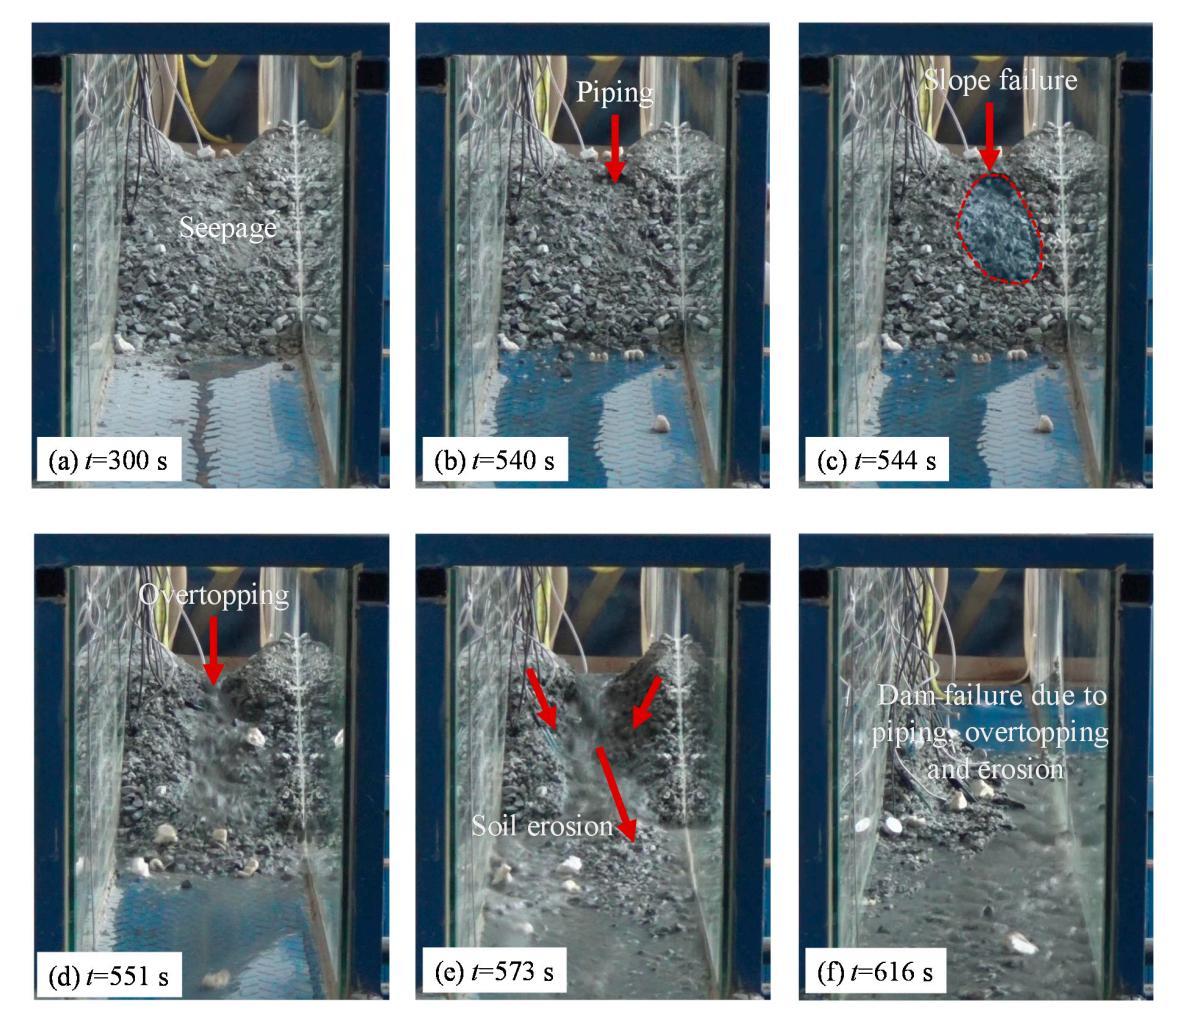
Figure 5. Failure process of a landslide dam ($Q_0 = 0.3 \text{ L/s}$, $\theta = 7^\circ$). (**a**) t = 300 s; (**b**) t = 540 s; (**c**) t = 544 s; (**d**) t = 551 s; (**e**) t = 573 s; (**f**) t = 616 s.

The failures in tests 2, 3, and 4 were the result of piping, overtopping, and erosion. An analysis of test Number 3 indicates that landslide dam failure processes occurred with continuous inflow from upstream, and the water level gradually increased, resulting in high pore water pressure and seepage (Figure 5a). The continuous seepage through the landslide dam formed a complete seepage path, causing the piping effect (Figure 5b). Subsequently, a small landslide occurred on the downstream

surface of the dam, reducing the overall height of the dam (Figure 5c), which was followed by dam overtopping (Figure 5d). Then, lateral and headward erosion began to occur throughout the dam (Figure 5e). Finally, the dam material was quickly eroded and transported by an outburst flood (or debris flow) (Figure 5f).

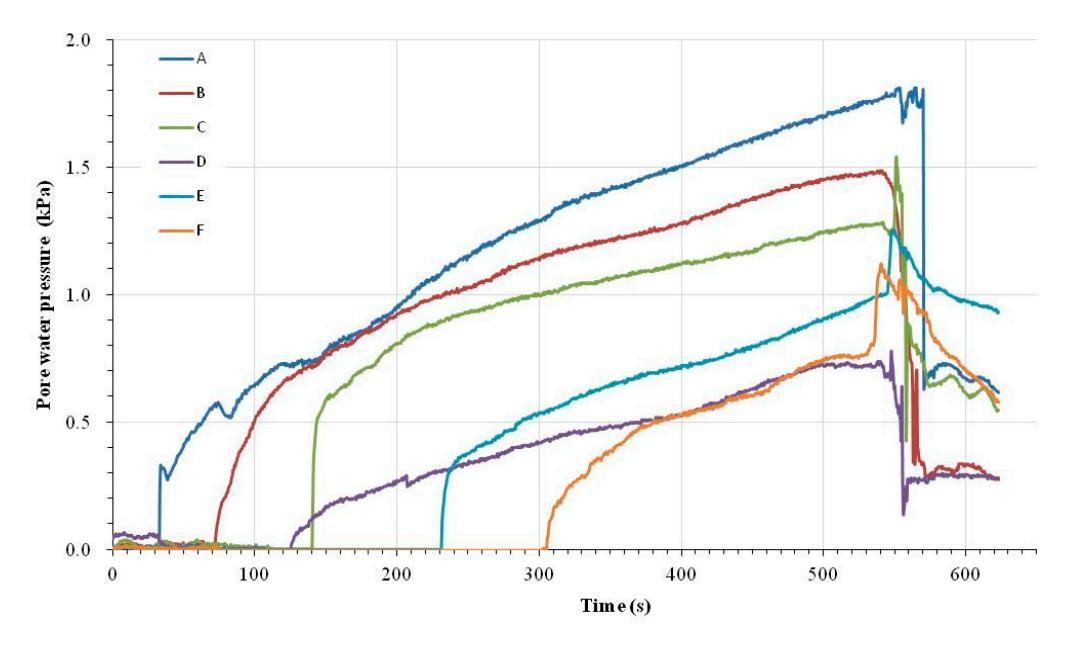
Figure 6. Variation in pore water pressure with time for observation points (i.e., sensor locations) in the landslide dam ($Q_0 = 0.3 \text{ L/s}, \theta = 7^\circ$).

During the experiment, the total stress, pore water pressure, and water content inside the dam were recorded by the sensors. Figure 6 displays the variation in the pore water pressure at the six sensor locations (i.e., observation points). In Figure 6, the pore water pressure at sensors increases in the sequence A-B-D-C-E-F, which indicates that the water level in the dam slowly increased, and the initial water flow and infiltration were mainly horizontal (the pressure increased at sensors A and B first). As the water level gradually increased, the pore water pressure in the upper part of the dam began to increase (the pressure at sensor D increased). Then, the pore water pressure at sensor C began to increase, which indicates that a complete seepage path in the lower layer had formed. Finally, the pore water pressure increased at sensors E and F. In addition, the pore water pressure dramatically changed at about t = 540 s at each of the six sensor locations shown in Figure 6, following a pressure change sequence of F-E-D-C-B-A. The variation in the pore water pressure during the experiment indicates that local failure occurred at t = 540 s, which is consistent with the failure process shown in Figure 5.

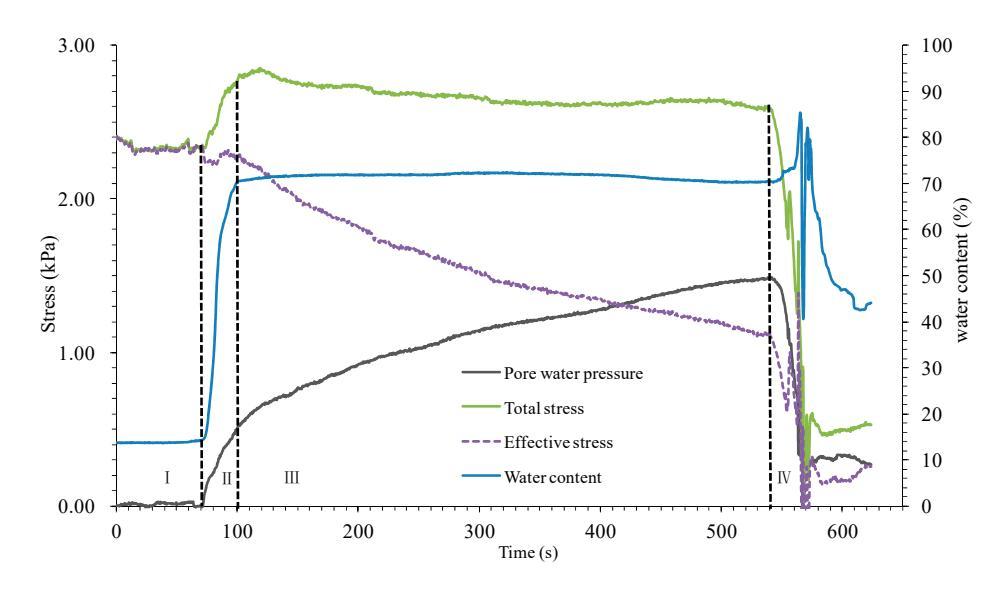
Figure 7. Transient variations in the pore water pressure, water content, and total stress at point B in the experiments ($Q_0 = 0.3 \text{ L/s}, \theta = 7^\circ$).

The transient variations in the water content, pore water pressure, and total stress at point B when Q_0 was 0.3 L/s and θ was 7° are shown in Figure 7. The failure process of the landslide dam can be divided into four stages: In stage I, the water level gradually increased as the inflow discharge filled the dam reservoir. However, the water content and pore water pressure were unchanged because the water did not penetrate to observation point B in this stage. The total stress changed slightly due to the slow deformation of the landslide dam. In stage II, water penetrated observation point B, which indicates that the water content rapidly increased until the pore space of the landslide dam was saturated. The pore water pressure and total stress also increased significantly. In stage III, as the water level in the reservoir gradually increased, a complete seepage path formed, and the pore water pressure continually increased, resulting in a decrease in the total stress. In stage IV, a small landslide occurred on the downstream surface of the dam, and the overall height of the dam was reduced, which was followed by dam overtopping. Finally, when the dam rapidly failed, several sensors were exposed to the upstream flow, and the acquired data had no reference value.

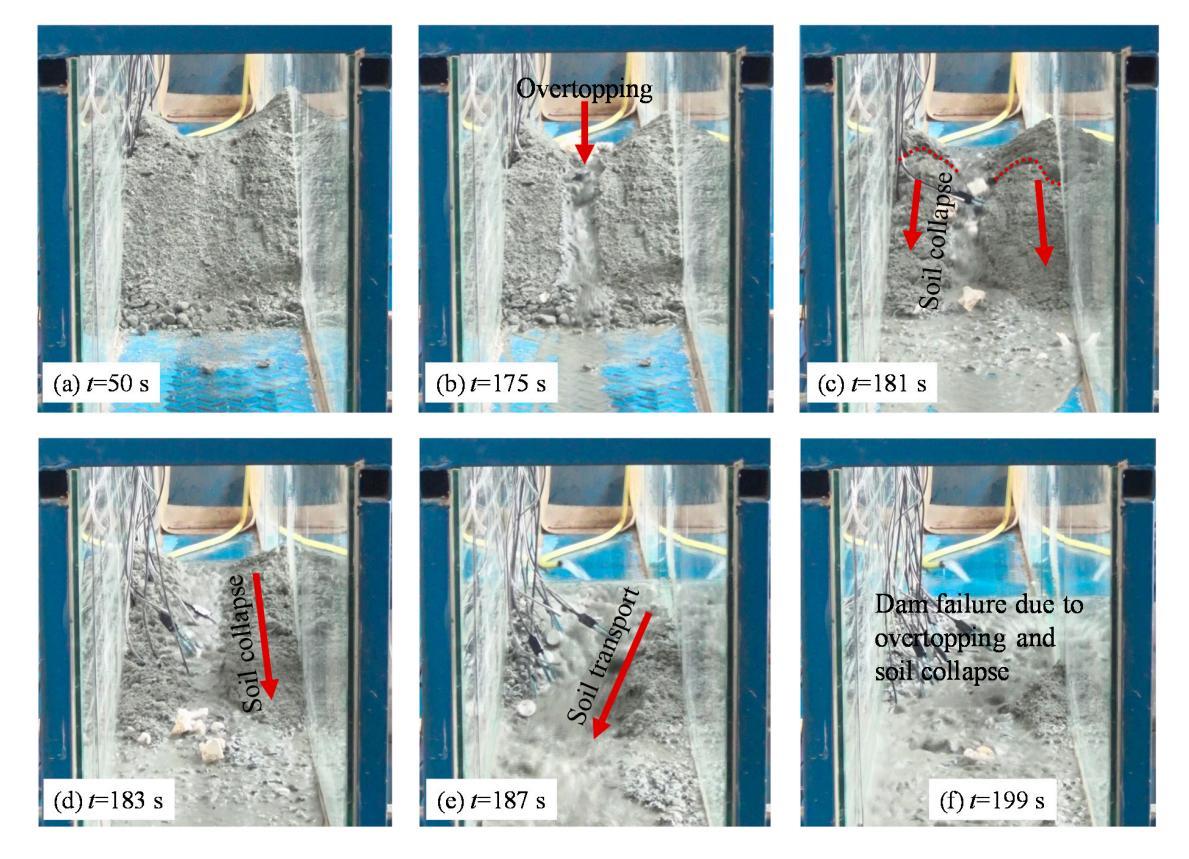
Figure 8. Failure process of a landslide dam ($Q_0 = 0.3 \text{ L/s}$, $\theta = 9^\circ$). (**a**) t = 50 s; (**b**) t = 175 s; (**c**) t = 181 s; (**d**) t = 183 s; (**e**) t = 187 s; (**f**) t = 199 s.

Dam failure due to overtopping and soil collapse occurred in experiment Number 5, and the failure processes involved the following. The water level upstream of the dam gradually increased, and a high water head initially formed, which led to seepage through the landslide dam (Figure 8a). However, a complete seepage channel had not formed due to the impediment caused by the fine particles. The complete seepage channel had still not formed by the time the dam reservoir was filled and began to overtop (Figure 8b). The dam became unstable, resulting in sudden soil collapse (Figure 8c). While the entire dam slid downstream (Figure 8d), the mine waste was eroded and rapidly transported by an outburst flood (or debris flow) (Figure 8e) until the end of the test (Figure 8f).

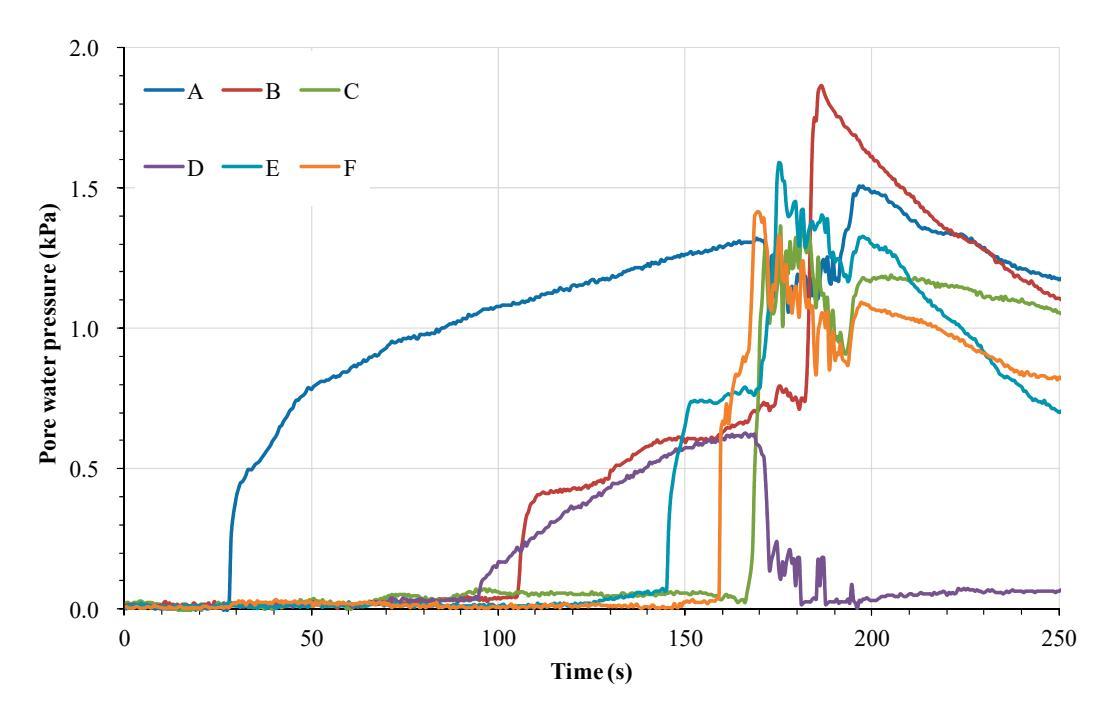
Figure 9. Variation in water pressure with time at different points in the landslide dam ($Q_0 = 0.3$ L/s, $\theta = 9^\circ$).

Based on our analysis of the variation in pore water pressure with time during the experiment, the order of the pore water pressure variation was A-D-B-E-F-C. Based on the experimental process shown in Figure 9, we conclude that the pore water pressure at observation point D increased before that at point B because the fine particles blocked the seepage path. Then, the pore water pressure at observation point E substantially increased. The pore water pressure at observation point F increased before the pressure at observation point C, which indicates that a complete seepage channel had not formed when the dam failed.

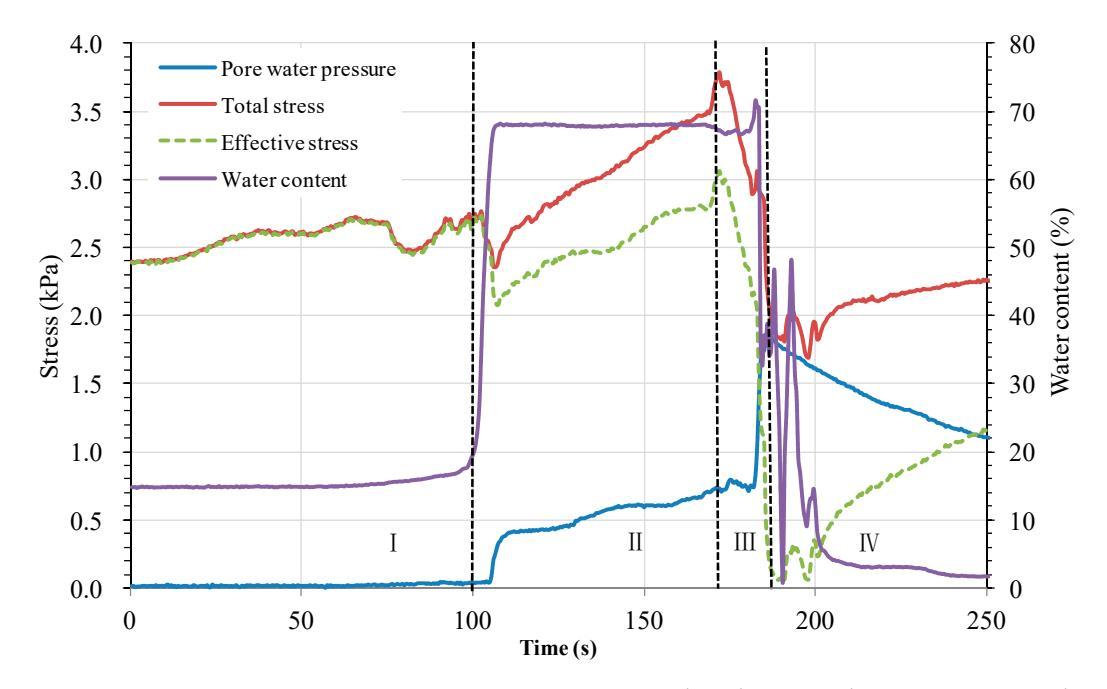
Figure 10. Variations in pore-water pressure, water content, and total stress with time at point B in the experiment ($Q_0 = 0.3 \text{ L/S}$, $\theta = 9^\circ$).

The transient variations in water content, pore water pressure, and total pressure at point B when Q_0 was 0.3 L/s and θ was 9° are shown in Figure 10. The failure process of the landslide dam can be divided into four stages. In stage I, the water level gradually increased as the inflow discharge began to fill the dam reservoir. However, the water content and pore water pressure remained unchanged

because the water did not penetrate to observation point B in this stage. At the same time, the total stress changed slightly due to the slow deformation of the landslide dam. In stage II, the water penetrated to observation point B, and the pore water pressure and total stress increased. The water content rapidly increased until it was saturated. In stage III, the landslide dam deformed due to overtopping, causing an instantaneous increase in pore water pressure. As the effective stress decreased, the soil collapsed, and the entire dam slid downstream (Figure 8c). In stage IV, the data acquired from the sensors had no reference value because the dam had failed and several of the sensors were exposed to the upstream flow.

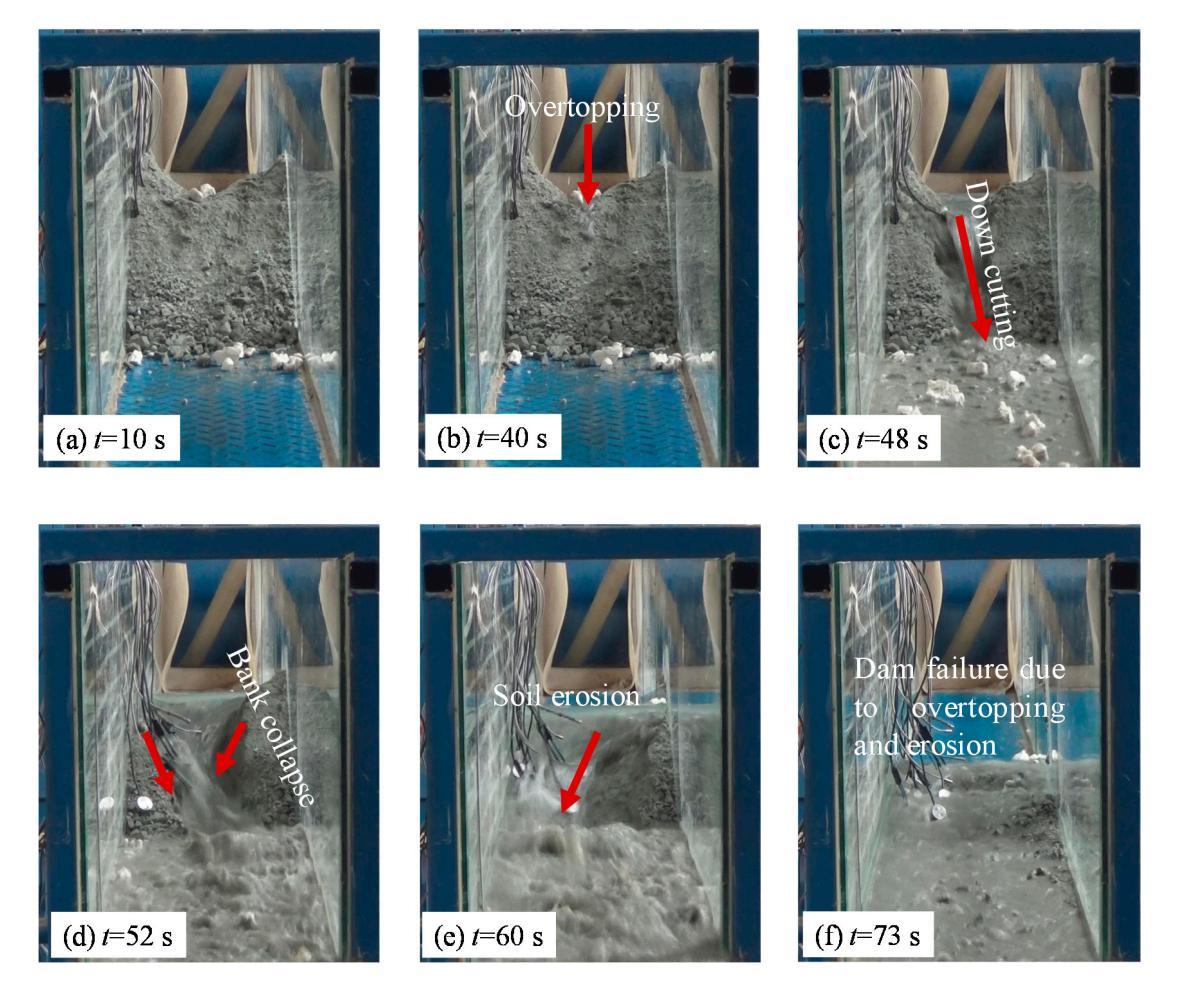
Figure 11. Failure process of a landslide dam ($Q_0 = 1.5 \text{ L/S}$, $\theta = 6^\circ$). (**a**) t = 10 s; (**b**) t = 40 s; (**c**) t = 48 s; (**d**) t = 52 s; (**e**) t = 60 s; (**f**) t = 73 s.

In these experiments, eight tests were conducted (Numbers 6–13 in Table 1), and dam failure was caused by overtopping and erosion. Taking test Number 9 as an example, the reservoir filled up in a short time due to a greater amount of inflow from upstream. Then, the dam was overtopped (Figure 11b). A channel formed and quickly cut down into the dam materials as the overflow continuously eroded the back surface of the dam (Figure 11c). Afterwards, the dam material on both sides of the spillway was unstable and experienced continuous failure (Figure 11d). The spillway rapidly widened, and the mine wastes was rapidly transported (Figure 11e). Finally, the dam material was completely eroded away (Figure 11f).

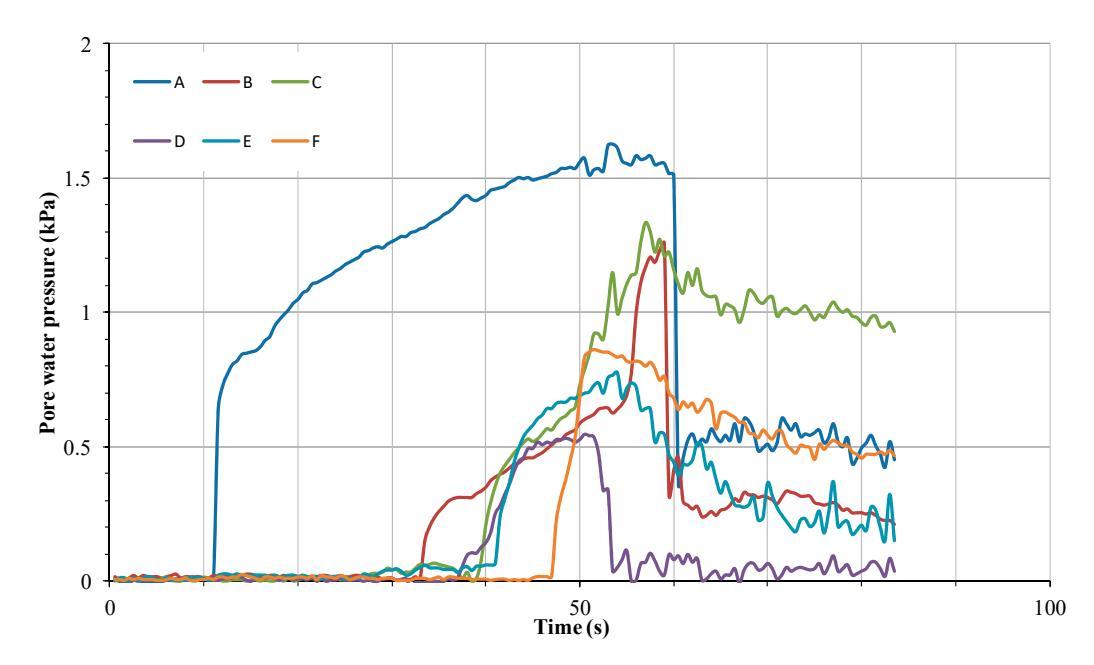
Figure 12. Variation in pore water pressure with time at different points in a landslide dam ($Q_0 = 1.5$ L/S, $\theta = 6^{\circ}$).

Based on our analysis of the variation in pore water pressure with time during the experiment (Figure 12), the pore water pressure increased in the sequence of A-B-D-C-E-F. Combined with the failure process illustrated in Figure 11, the pore water pressure of the lower layer (A and B) initially increased due to seepage during reservoir filling. However, when there was a greater inflow discharge, the water level in the reservoir and the pore water pressure at observation point D increased rapidly. With continuous seepage, the pore water pressure increased at observation point C, and then a complete seepage path formed. Finally, the pore water pressures of the upper layer (E and F) gradually increased due to overtopping.

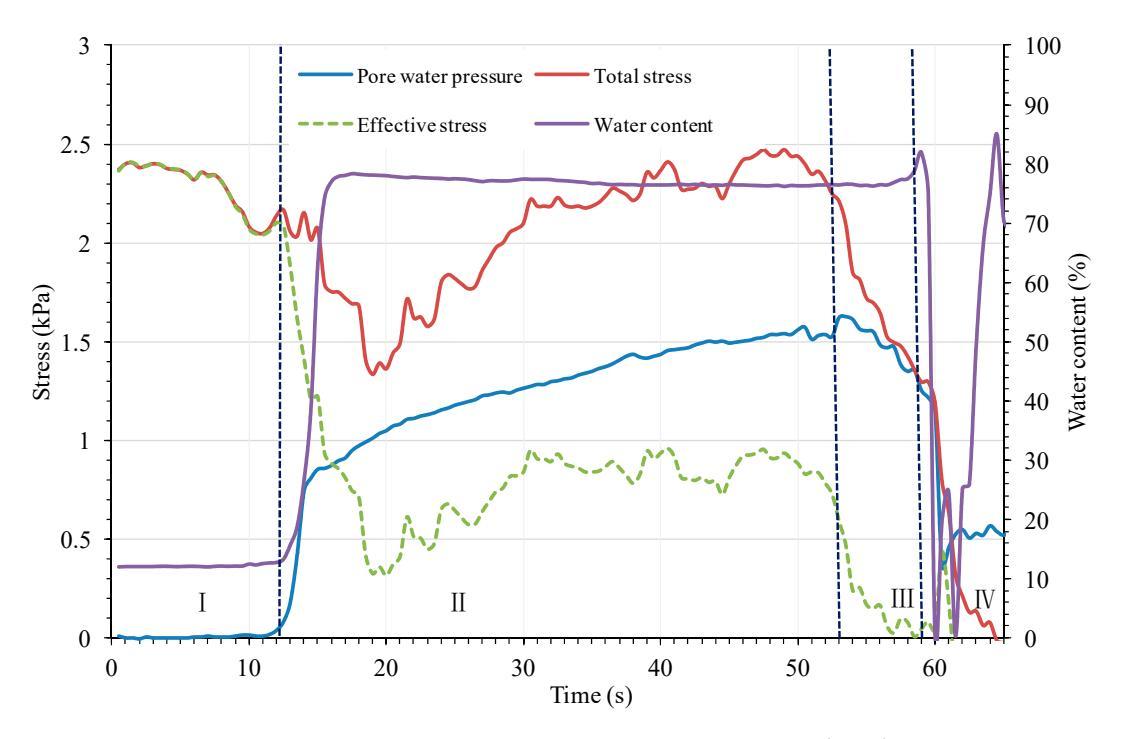
Figure 13. Transient variations in pore-water pressures, water content, and total stress at point A in experiments ($Q_0 = 1.5 \text{ L/s}, \theta = 6^\circ$).

In this failure mode, since the failure process of the landslide dam was extremely short, the data acquired at observation point A constituted the longest portion of the test. Therefore, the sensor data from observation point A were chosen to analyze variations in the parameters with time. The variations in water content, pore water pressure, and total stress with time at point A are shown in Figure 13. The failure process of the dam can be divided into four stages. In stage I, the water level rapidly increased as the inflow filled the dam reservoir. However, the water content and pore water pressure remained unchanged because the water did not penetrate to observation point A in this stage. In stage II, the water penetrated to observation point A, and the water content increased rapidly until the pore space was saturated. At the same time, the pore water pressure and total stress increased significantly. In stage III, as the upper layer of the mine waste dam was rapidly eroded, the total stress decreased rapidly. However, the pore water pressure slowly decreased due to the high rate of outflow over the spillway and the relatively high water level. In stage IV, as the dam failed, several sensors were exposed to the upstream flow, so the acquired data had no reference value.

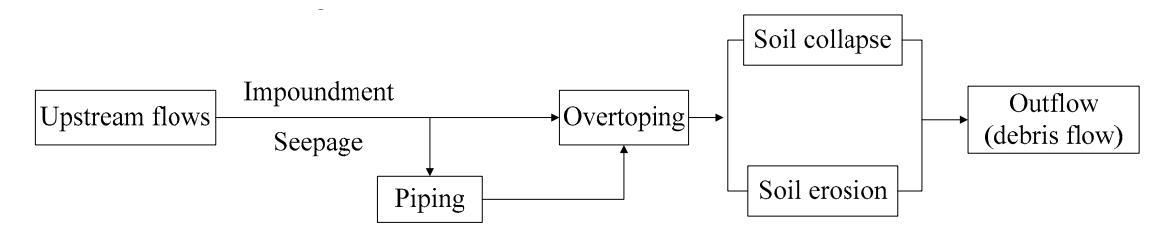
Figure 14. Failure process and the relationship between the failure modes.

By analyzing the failure modes and processes of the 13 experimental tests under different working conditions, we concluded that the seepage that occurs before overtopping is extremely important. As the inflow discharge continued to fill the reservoir, the water level gradually increased. If the grain composition of the dam was conducive for seepage, piping might be formed. However, Costa et al. [13] reported that there were very few cases of dam failure caused by piping. In our tests, we did not observe dam failure due solely to piping. In test Number 1, the inflow discharge from upstream was equal to the seepage discharge, so the dam remained stable. If the dam remained stable, it would experience overflowing, which was a key factor and triggering dam failure. In this stage, the dam would fail due to soil collapse (as shown in test Number 3) or soil erosion (as shown in tests Number 6–13). As the dam materials were eroded by the outflow, an outburst flood (or debris flow) occurred. The failure process and the relationship between the failure modes is summarized in Figure 14.

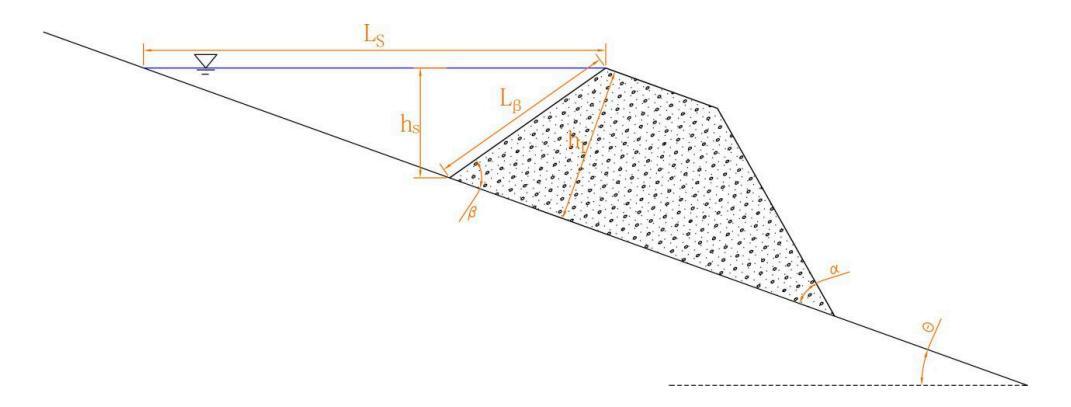
Figure 15. Physical dimensions of the landslide dam.

In this stage, the water level rapidly increased as the inflow discharge began to fill the dam's reservoir. At the same time, the dam was infiltrated and deformed (e.g., piping). Figure 15 shows the physical dimensions of the landslide dam, where V_k is the reservoir storage capacity, h_l is the dam's height, θ is the flume gradient, β is the slope angle of the upstream face of the dam, and *B* is the dam's width.

$$V_{\rm k} = \frac{1}{2} \times h_1^2 (\cot \theta - \cot \beta) \times B$$
⁽²⁾

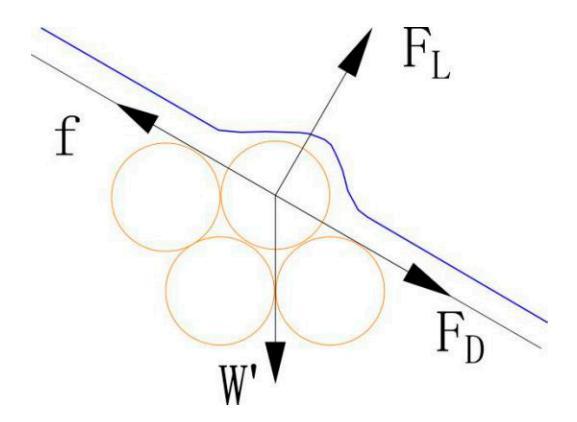
Figure 16. Force analysis of the mine waste particles in the downstream face.

When the dam suffered overtopping, a channel was formed and quickly cut down into the dam material as the overflow continuously eroded the back surface of the dam. Afterwards, the material of the dam on both sides of the spillway was unstable and continuously failed. The spillway was rapidly widened by strong headward erosion. Finally, the entire dam failed and eroded. Quantitative analysis of this stage indicates that overland flow occurred on downstream face when the water overflowed and some of the mine waste started to move (Figure 15). The force analysis of mine waste particles on the downstream face is shown in Figure 16, in which F_D is drag force, F_L is the uplift force, W' is gravity, and f is frictional resistance. Because the mine waste was loose and accumulated naturally, the cohesive force was ignored in this analysis.

where *D* is the particle size, γ_s is the unit weight of particles, γ is the unit weight of water, α is the slope angle of the downstream face of the dam, θ is the flume gradient, φ is the internal friction angle, C_D is the drag force coefficient, C_L is the uplift force coefficient, v is the flow velocity, A is the maximum cross-sectional area of the particles, and ρ is the water density. In the overtopping stage, the limit of the equilibrium equation for the particles in the downstream face of the dam can be expressed as follows:

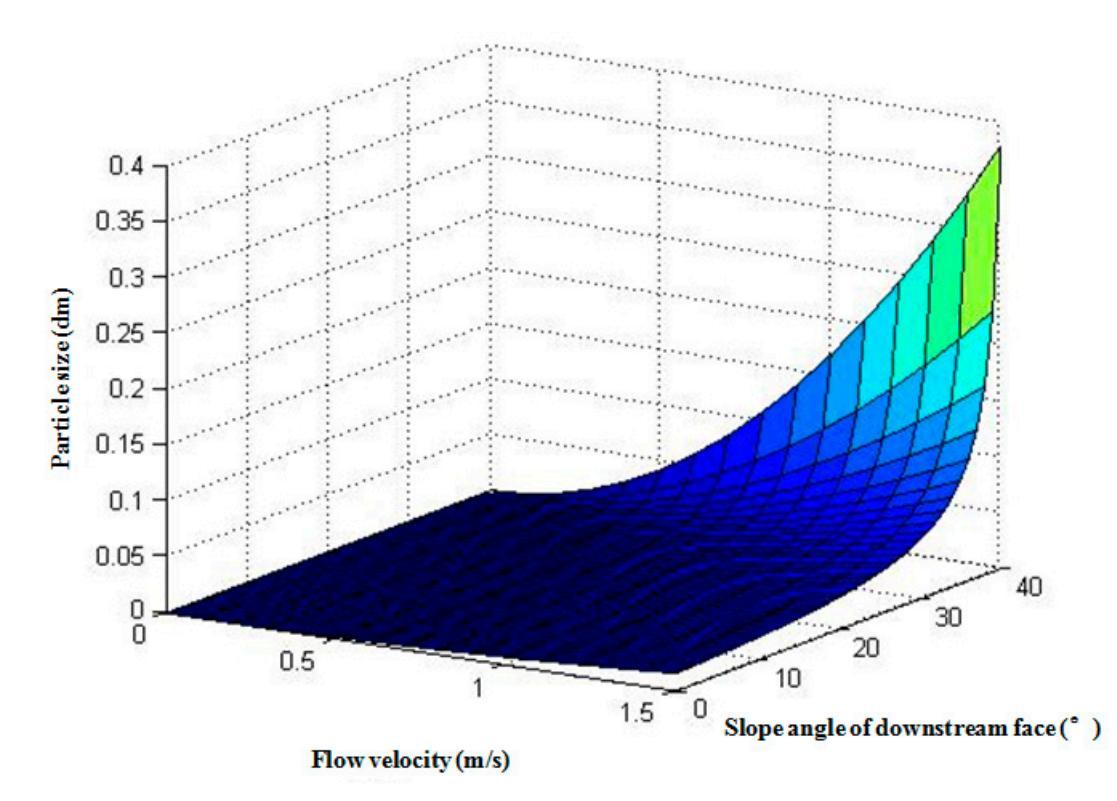
Figure 17. Relationship between the maximum particle size that can be moved (*D*), the flow velocity (*v*), and the total slope angle of the downstream face ($\alpha + \theta$).

Based on our field investigations, the internal friction (φ) of the mine wastes used in our experiments was 41.6°. The maximum particle size was 5 cm, and the water density was 1 g/cm³. As in the model test conducted by Chepil [29], the value of C_L was set as 0.068, and C_L/C_D was set as 0.53. The outflow velocity measured using the float method was from 0.16 m/s to 1.50 m/s in the experimental tests. The initial 40° slope of the downstream face gradually decreased during the experiments due to the headward erosion. Equation (8) can be solved using Matlab. Figure 17 shows the relationship between the maximum particle size that can be moved (D), the flow velocity (v), and the total slope angle of the downstream face ($\alpha + \theta$). The failure process of the landslide dam was determined based on the particle size of the mine waste and the shape of the dam (dam height, slope angle of the downstream face, outflow velocity, and discharge).
