# The Evolution of Gravel-Bed Rivers during the Post-Regulation Period in the Polish Carpathians

**Abstract:** This study provides a conceptual model of the functioning of gravel-bed rivers during the post-regulation period in Poland and forecasts their subsequent evolution. The main difference between fluvial processes during the pre-regulation and post-regulation period is that they are limited to a zone that is currently several times narrower and trapped in a deep-cut channel. During the river post-regulation period, the construction of additional river training works was significantly limited in river channels. Moreover, all forms of economic activity were significantly reduced in the channel free migration zone, particularly bed gravel extraction operations. As a result of these changes, a limited recovery of the functioning and hydromorphology of the river channel occurred via a return to conditions in effect prior to river regulation. In recovering sections of river, the channel gradually broadens, and its sinuosity and number of threads increase. The overall process can be called spontaneous renaturalization, which yields a characteristic post-regulation river channel. Th

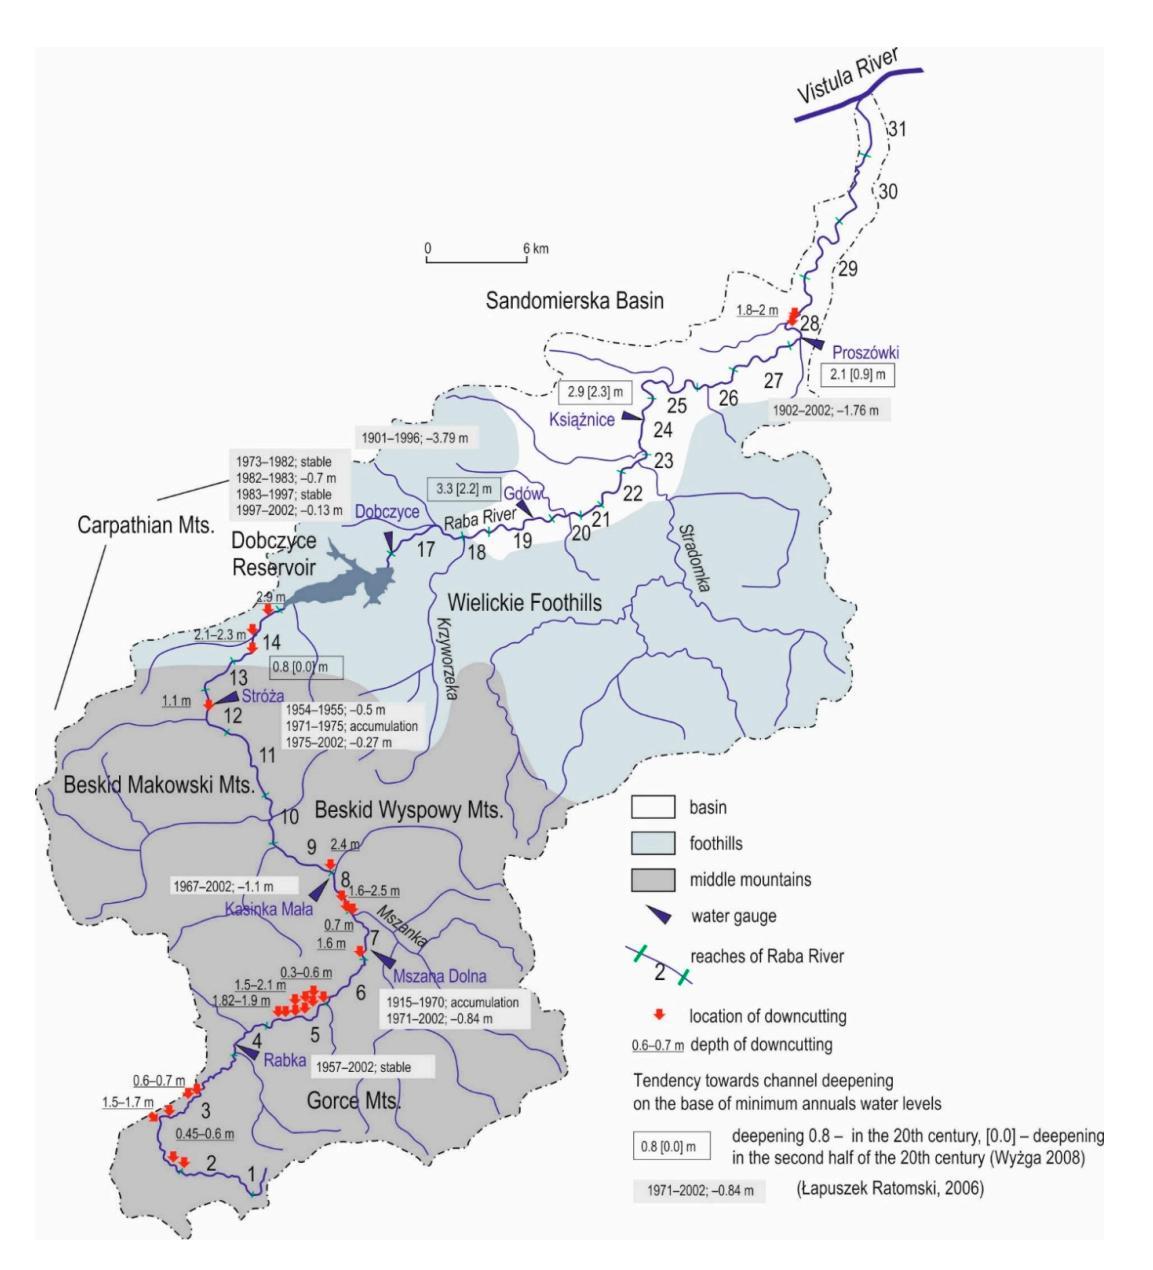
Figure 2. Location and intensities of downcutting in the Raba river channel.

Increases in channel depth were noted in all the examined reaches of the Raba River. Average increases equaled 1.8 m, with a maximum increase of 3.8 m in a downstream reach of the Raba river channel surrounded by levees (Figure 2). It is important to remember though that an increase in river

Minimum annual water levels measured at gauging sites in the middle and lower course of the Raba River were used to assess the tendency towards channel deepening in the 20th century [10,52,53]. According to Wyżga [10,53] the Raba river channel became deeper by 2 or 3 m in its downstream section in the 20th century. Nonetheless, both periods of increased erosion and gradual debris accumulation occurred throughout the 20th century in the Raba river channel (Figure 2). Łapuszek and Ratomski [52] provide similar results. In the years from 1901 to 1996 the downstream reach of the river became deeper by 3.79 m in Gdów and 1.76 m in Proszówka. In the upstream reach of the river, the onset of erosion dates to 1971, and by 2002 the river channeled had become, on average, about 1.4 m deeper (Figure 2).

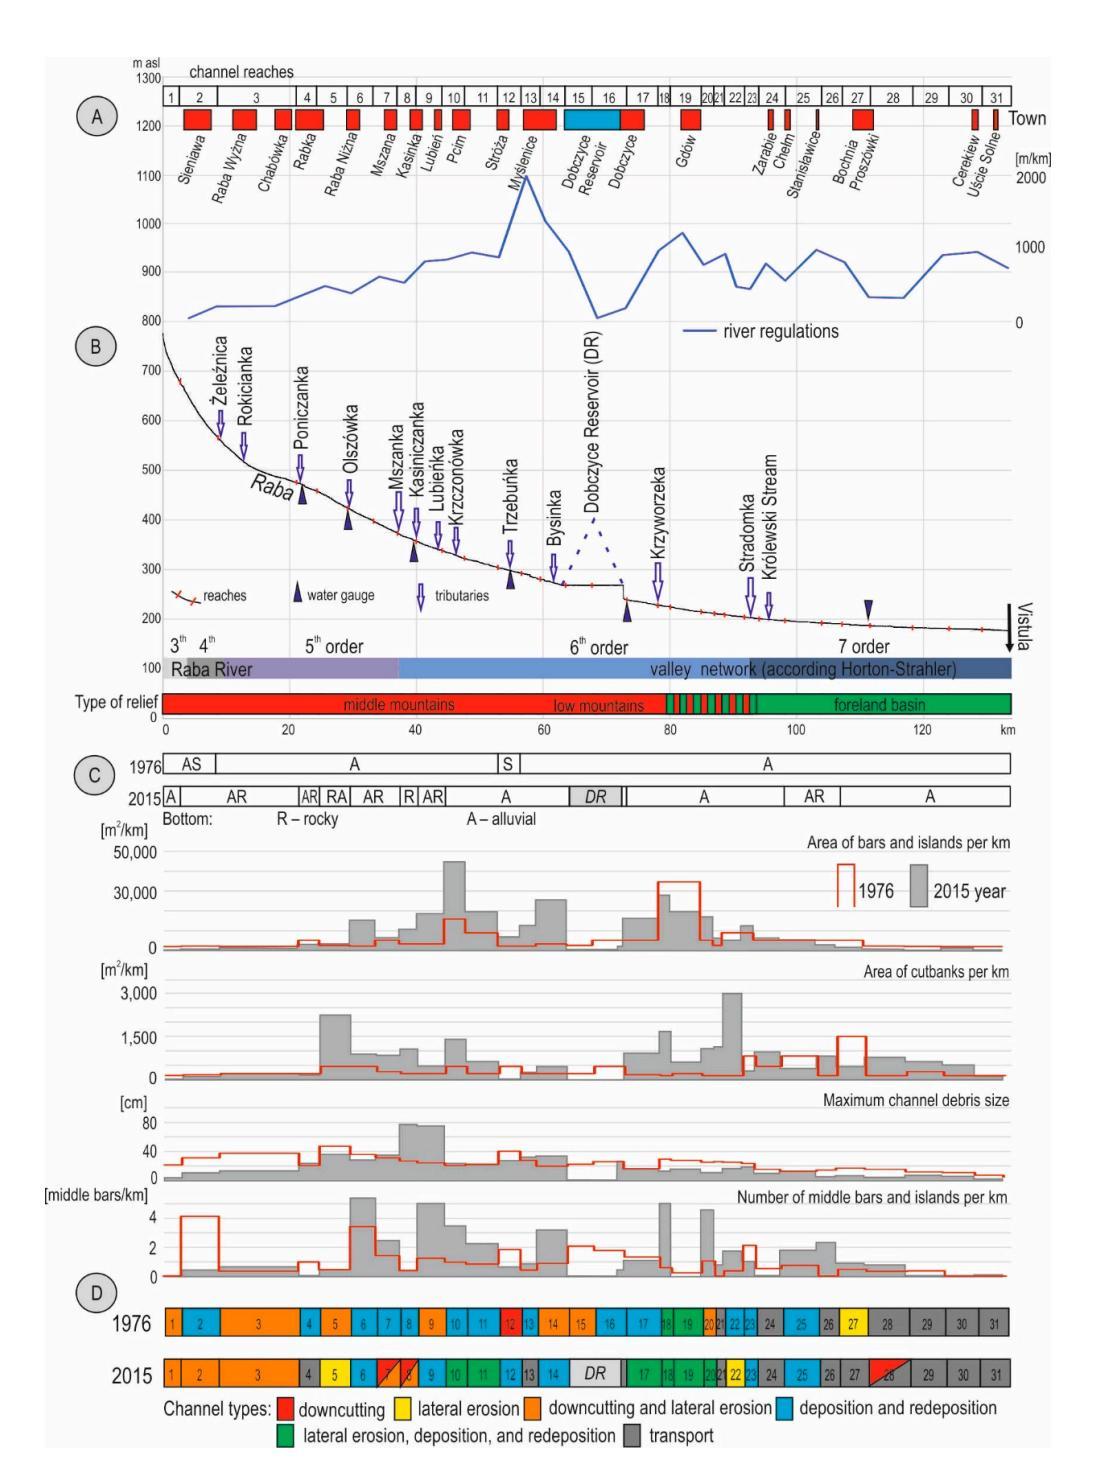
**Figure 3.** Raba river channel in 1976 and 2015: (**A**) Human impact in the Raba River valley, (**B**) longitudinal profile of the Raba River, (**C**) morphology of the Raba channel in 1976 and 2015, and (**D**) channel types of the Raba River in 1976 and 2015.

In 1976, more than 90% of the length of the Raba river channel was alluvial type. The largest number of river reaches were shaped by deposition and redeposition processes as well as lateral erosion in some cases. These reaches occupied 49% of the total length of the Raba River and were characterized by the largest area of bars and large area of undercuts in relation to other reaches of the same river. Downcutting and lateral erosion were detected along 28% of the length of the Raba river channel. In the 1970s, as much as 23% of the river channel consisted of sections with transport function and with levees reinforcing banks (Figure 3).

The river's braiding ratio [33] also increased to some degree, by an average of 0.43 middle landforms per kilometer of river, over the 40 year period between the first and second survey. An increase in the braiding ratio was noted in more than 50% of the reaches in the study. The largest increase in the braiding ratio (4.4 middle landforms per kilometer) was noted in a reach of the Raba River found downstream of the Dobczyce Reservoir where a tributary flowed into the Raba River (Figure 3).

The largest changes in the river channel were noted upstream of the Dobczyce Reservoir at sites where tributaries would supply large amounts of debris to the Raba River in the course of floods (Figure 4). Lateral erosion and deposition processes are very active at these sites, which has led to a rise in the Raba's riverbed due to the deposition of a portion of the material transported downstream of each point of confluence, as well as upstream of each point of confluence, due to limited discharge driven by abrupt increases in stream load in the confluence zone of the Raba and its tributaries. This evolution scenario for the Raba River was determined for reaches found downstream of the points of confluence of the following rivers: Olszówka, Kasiniczanka, Krzczonówka, and Bysinka (Figure 3).

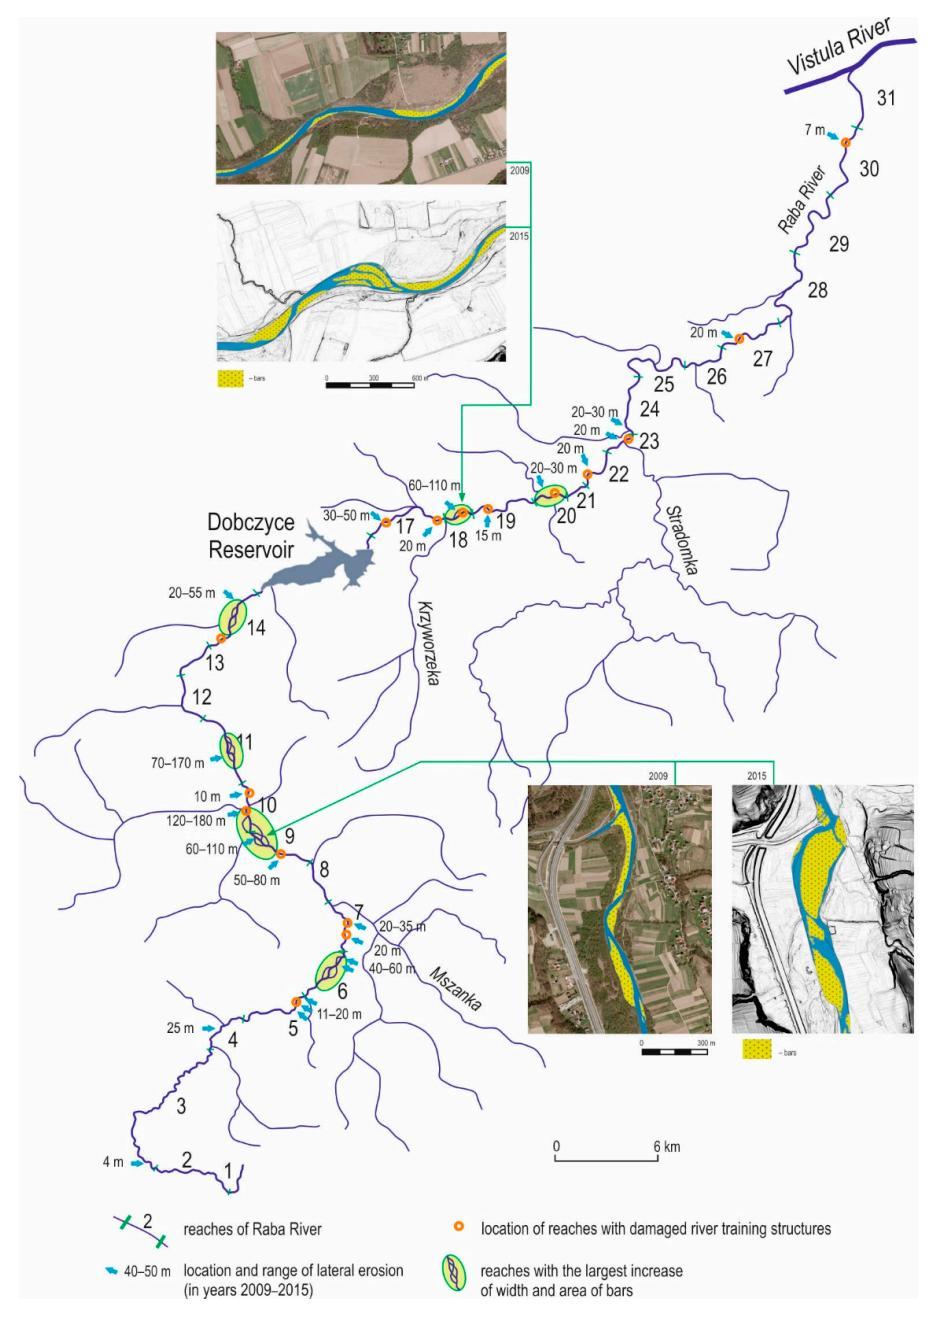
**Figure 4.** Location of sections undergoing a spontaneous renaturalization in the Raba river channel from 2009 to 2015.

There are some reaches where the channel is narrower than in 1976. In one case, it is narrower by 18 m (Figure 4).

The most readily observable present-day change in the Raba river channel in comparison with 1976 is the increase in the area of bars (Table 1). Today the area of Raba bars is twice as large as that in the 1970s. Increases in bar and island areas, in 2015, relative to 1976 were noted in almost 75% of Raba River reaches and equal an average of 2190 m<sup>2</sup>·km<sup>-1</sup>. The largest increase in the area of accumulation landforms found in the Raba river channel reached almost 30,000 m<sup>2</sup>·km<sup>-1</sup>. It occurred at the point of confluence between the Raba River and one of its major tributaries, the Krzczonówka River (Figures 3 and 4). This reach was also characterized by the largest increase in river channel width. This reach has been viewed as a classic example of a bead of morphologic diversity strung on the string of the studied river channel [27]. Similar accumulation zones occur in most reaches of the mountain section of the Raba river channel. A total of six large accumulation zones and more than 25 rather small channel broadening zones with lateral bars were observed in the present study (Figure 4).

All the floods discussed above accelerated erosion and accumulation in the Raba river channel. The increase in the intensity of lateral erosion led to a widening of the river channel at about 50% of the studied reaches, although it did not affect the entire length of each reach. In areas where channel widening did occur, its width, in 2015, increased in most cases by several meters or several tens of meters relative to the year 2009. The river channel widened by more than 100 m relative to the year 2009 in several reaches, i.e., in the middle section of the river in the area where the Mszanka and Krzczonówka join the Raba River as well as in the section just below the Dobczyce Reservoir (Figure 4).

In addition, increased channel sinuosity and the formation of multiple threads were observed in some reaches (Figure 4). The effects of the 2010 and 2014 flood events discussed herein are representative of the evolution of a river channel after a series of large floods, as described by the flood pulse model [21]. The widening of the channel and formation of a multithreaded river also suggest that connectivity between the river channel and floodplain has been regained for a period of time and the floodplain has reformed.

Significant, although much smaller, changes in the morphology of the Raba river channel after foods were observed in the foothill section of the Raba channel downstream of the Dobczyce Reservoir. The retention of floodwaters and their sediment load by the Raba River inside the Dobczyce Reservoir limits the morphogenetic potential of flood events below the Dobczyce Dam. However, the floods of 2010 and 2014 have changed the morphodynamic function of these reaches from transport-dominated reaches to reaches with deposition with lateral erosion. A particularly large change in the morphology of the Raba river channel occurred downstream of the point of confluence of the Krzyworzeka River, which is also downstream of the Dobczyce Reservoir. In the flood period from 2010 to 2014 the channel of the Raba River made the transition from single-threaded to multi-threaded along this particular stretch of the river (Figure 4).

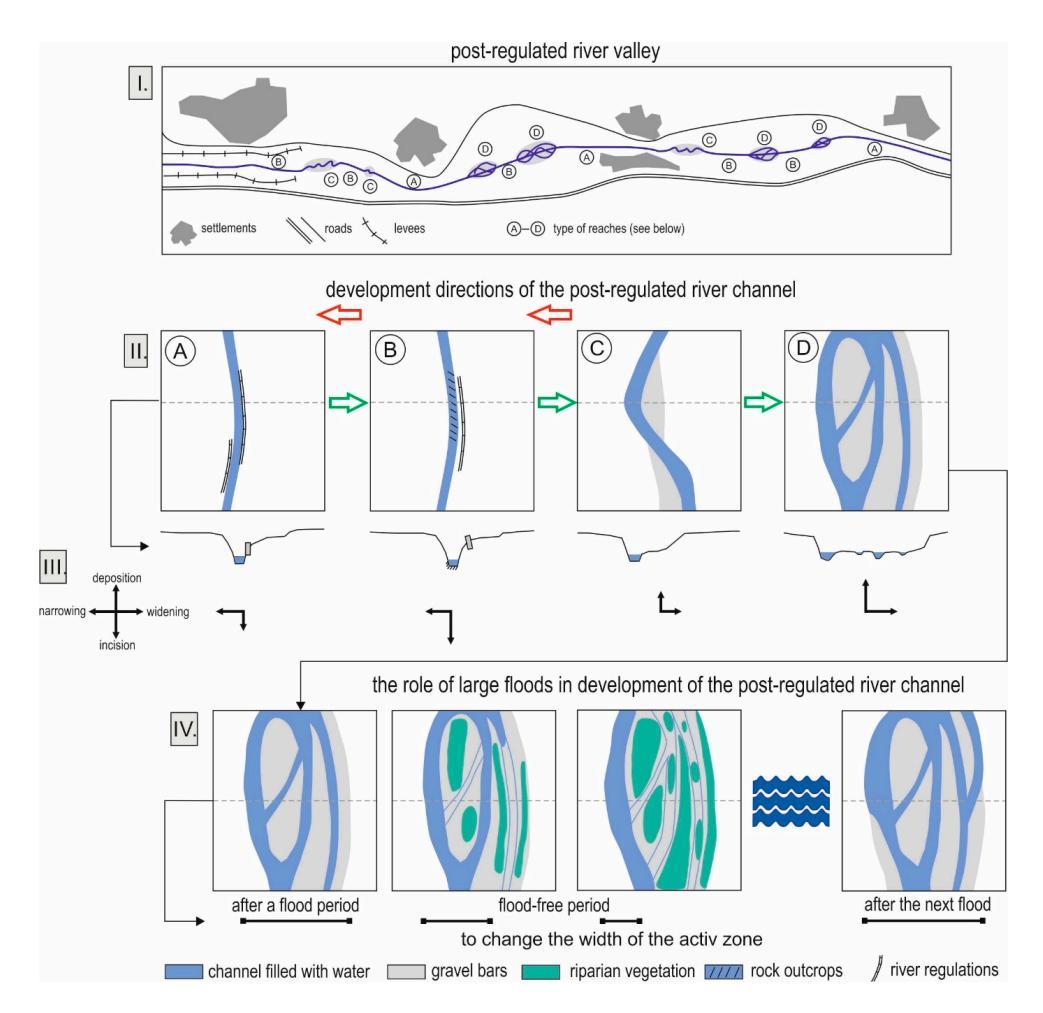
**Figure 5.** Conceptual model of the evolution of a gravel-bed river in a mountain area during a post-regulation period.

The location of the above-mentioned reaches, types A through D, in the river system is due to both natural determinants such as geologic structure, relief, and climate, as well as due to human impact associated with river channel regulation, road infrastructure, land use, and human settlement. This is why it is difficult to unequivocally determine the reasons for the occurrence of reaches of type C and D where the pattern of occurrence is the result of a combination of fluvial processes present in a post-regulation river (Figure 5I,II).

type A and B reaches can suffer further decline as a result of increased downcutting, which makes it impossible for them to transition into type C. In the event of repeated river regulation, type B, C, and D reaches can transition back to type A (Figure 5II).
