# The Process of Microbiological Remediation of the Polluted Słoneczko Reservoir in Poland: For Reduction of Water Pollution and Nutrients Management

Abstract: The article discusses the impact of nutrients from sewage on the state of the sewage receiver. Bioremediation was carried out through the use of effective microorganisms. The potential recovery of valuable mineral and organic substances in the form of fertilizers was also examined. The Słoneczko Reservoir is a bathing area and serves many people in the summertime as a place of water recreation. Water quality deteriorated intensively from 2006 as a result of illegal wastewater discharge and the impact of fecal pollution from bathers. The high concentration of nutrients in the water was the cause of the eutrophication process and blooms of cyanobacteria, which pose a threat to human health in the bathing area. The bathing area was also closed many times by sanitary services as a result of exceeding the number of *Escherichia coli* and *Enterococcus faecalis* in the water. At the bottom of the reservoir, there was a layer of sediments with a thickness of 30–70 cm. Thus, the processes of anaerobic decomposition generated odor,

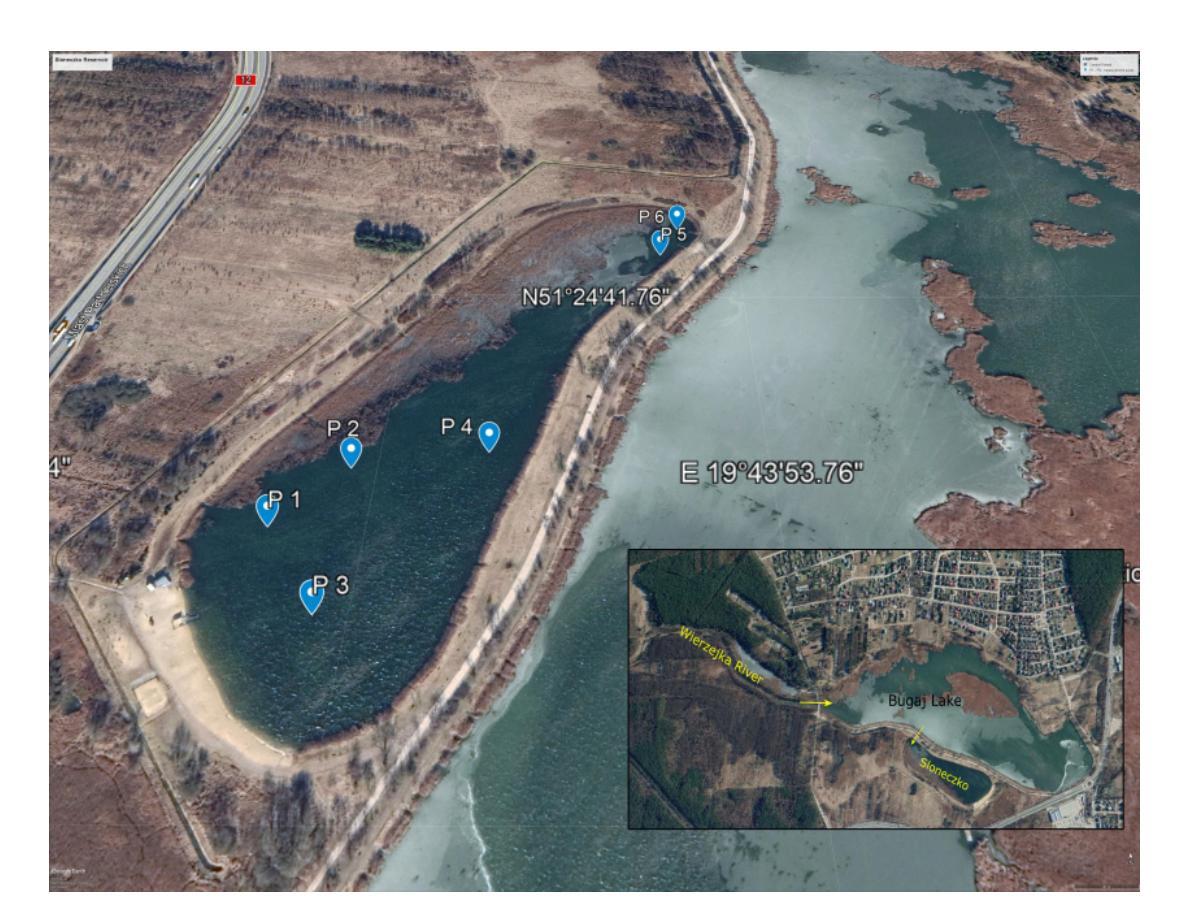
Figure 1. Map of the measurements points at Słoneczko Reservoir.

Outside the bathing area, the reservoir is covered with rush vegetation in the coastal and littoral zones. Słoneczko belongs to small and shallow water reservoirs with full water mixing in all periods of the year. The water supply to the Słoneczko bathing water is directly from the Bugaj dam reservoir located on the Wierzejka river (Figure 1).

The measurements were carried out at selected measuring points P1–P6 (Figure 3) in 2016–2018. The samples were taken five times during May, July, October, and November. Six samples (V = 1 dm<sup>3</sup> each) were taken at each point. Laboratory analyses were done from each sample for the selected physicochemical parameters, i.e., COD, BOD<sub>5</sub>, P<sub>tot</sub>. (total phosphorus), N<sub>tot</sub>. (total nitrogen), TSS (total suspended solids), in six or four repetitions (Table 2). The in situ measurements, i.e., pH, O<sub>2</sub> concentration, sediment depth, and water transparency were carried out during the same research campaign in the number of 2–4 times (Table 2).

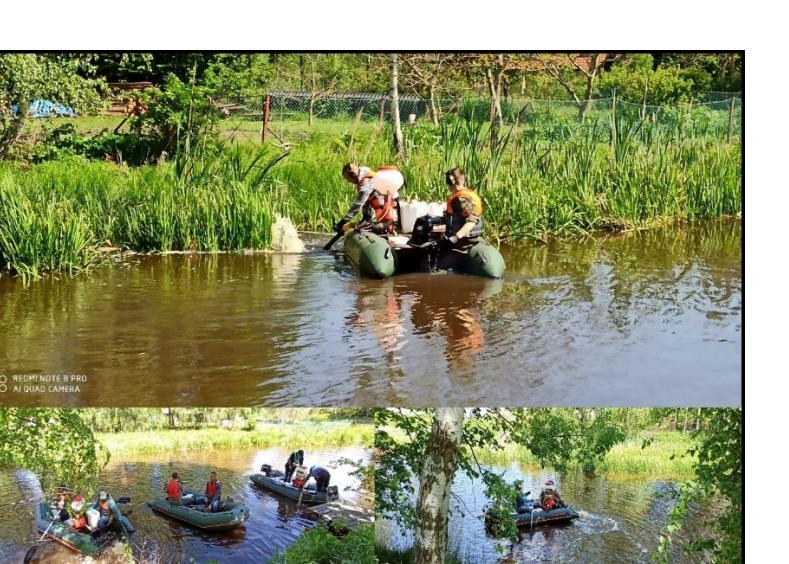
**Figure 2.** Biopreparation application into the water and bottom sediments by liquid injectors (tailored for these purposes).

These biopreparations were introduced to the water and sediments of the Słoneczko reservoir at the beginning of May 2016, and then in 2017 and 2018. The application of the bio-mixture was carried out with the use of specialized equipment with liquid injectors (Figure 2).

The application of biopreparations was carried out in a zone about 0.5 m from the water surface and the bottom surface in order to effectively colonize both components of the reservoir (water and bottom sediments). Additionally, periodic macrophyte removal was performed, but only from a narrow coastal and littoral zone, which had a positive effect on the improvement of water quality, but these were small-scale treatments.

The mixture was evenly dispersed under the water surface, which ensured the efficient mixing of the biopreparations with water. The ACS ODO—1 biopreparation was introduced at a depth of approx. 0.5-0.8 m (V = 3 m<sup>3</sup>) under the water surface. The ACS aqua mixture 2 (V = 1 m<sup>3</sup>) was dosed with a gentle dispersed stream to the sludge layer to minimize the agitation of the sediments. The application process was carried out more evenly over the entire surface area of the Słoneczko reservoir.

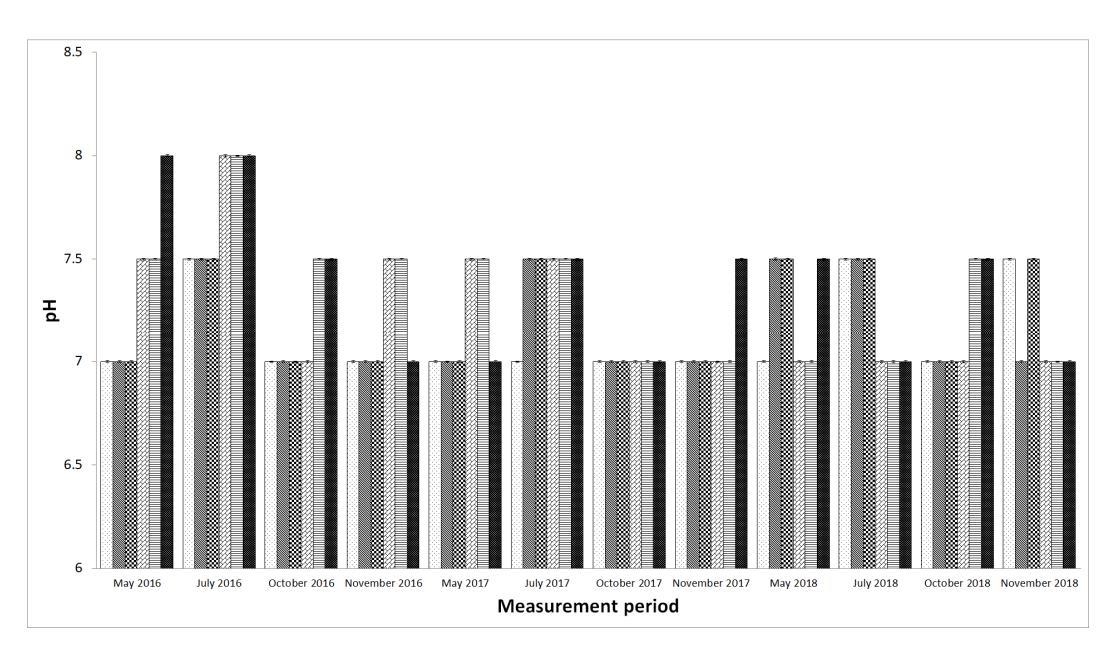
Figure 3. In the pH value at points P1–P6 in the reservoir. Measurement campaigns 2016–2018.

Measurements of the pH value did not show significant changes during the treatment process, slight fluctuations in the range of 7–7.5 (Figure 3) are completely normal in the water environment. Stable pH values positively influenced the adaptation and development of microorganisms introduced from biopreparations. Only in the initial period, local increases in pH to the value of 8 in the period May and July 2016 were observed. However, they are still within the local variability range in the aquatic environment and may result from the increased local algae bloom in the water.

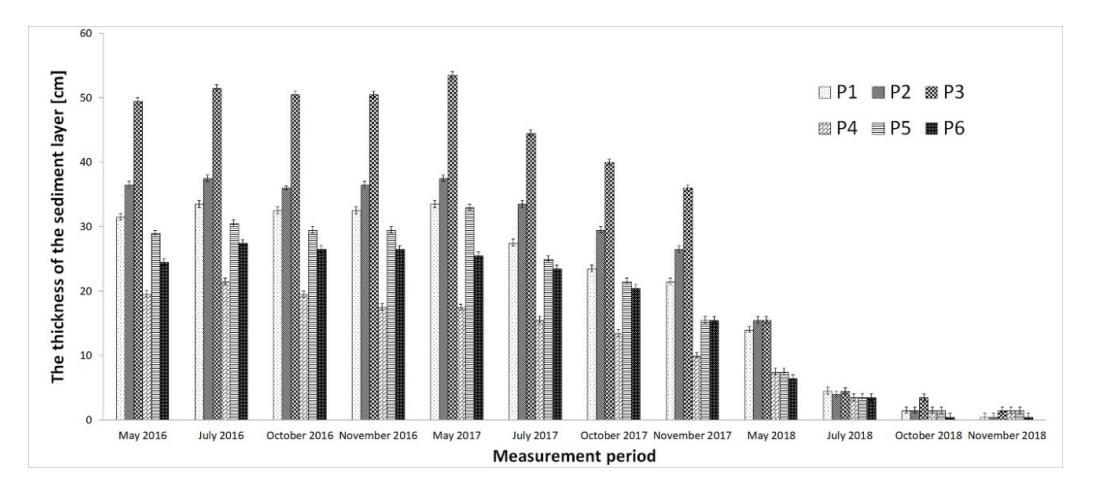
**Figure 4.** Changes in the thickness of bottom sediments in 2016–2018 at points P1–P6. Measurement campaigns 2016–2018.

The thickness of the sediments (soft fractions) before the application process in 2016 varied in the range of 20–50 cm at measuring points P1–P6 (Figure 4). Research results indicate that during the two seasons of biopreparations application, an intensive reduction of organic fractions was observed. In the area since 2018, the bottom of the reservoir was sandy with almost complete descent at sedimentation points (Figure 4).

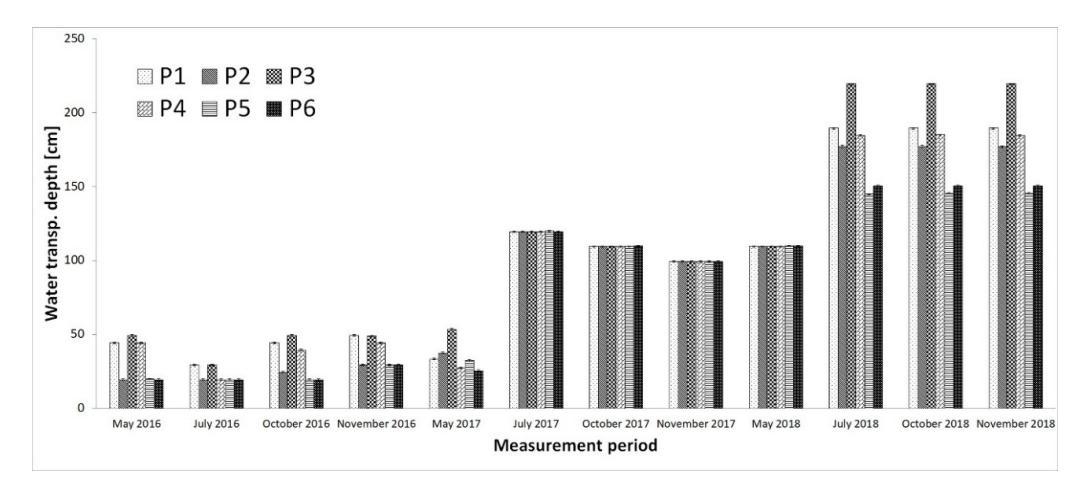
Figure 5. Changes in water transparency in the years 2016–2018, measured with a Secchi disk.

Intensive eutrophication processes took place in the Słoneczko reservoir until 2017, and the suspended solids associated with algal bloom and the presence of additional suspended fractions (mineral and organic) significantly reduced light transmission in the water. In early spring and late autumn, the water transparency naturally improved (Figure 5), while in the late spring and summer months it dropped to 20 cm (Figure 5). After the application of biopreparations, the transparency was maintained even up to 120 cm even in the summer, and in the following season the bottom was visible in virtually all measuring points (Figure 5).

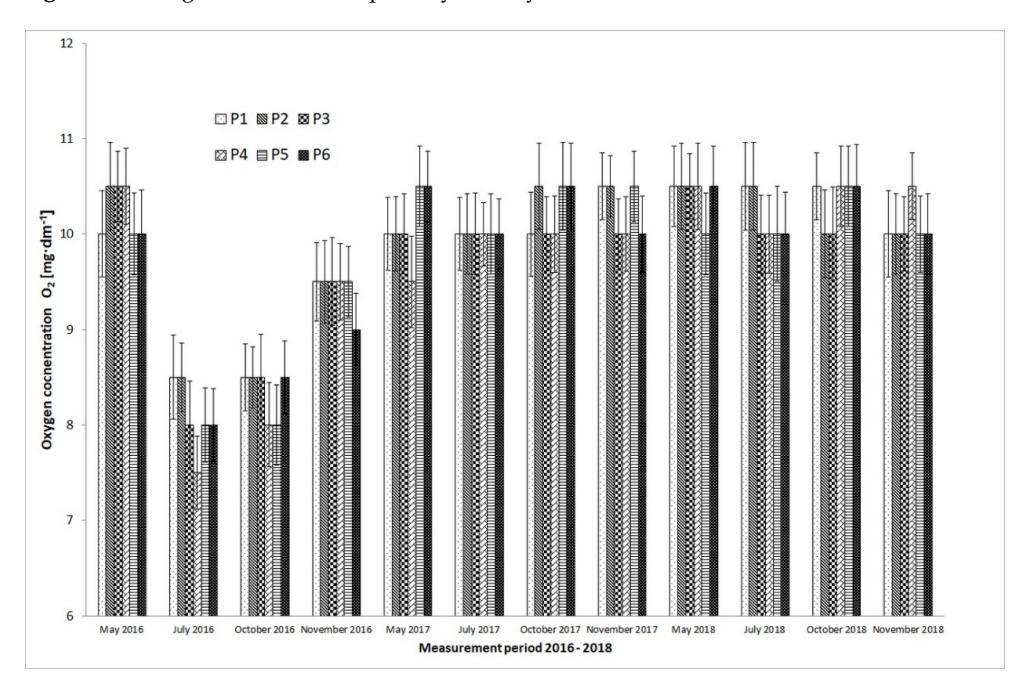
Figure 6. Changes in oxygen concentration in reservoir water in the years 2016–2018.

Oxygen concentration at measuring points before the application of biopreparations was variable at different times of the year. The summer months due to the intensive eutrophication process was characterized by a decrease in oxygen concentration to the level of about 8 mg·dm<sup>-3</sup> (Figure 6), which for ecosystems of stagnant water in the lake may be a problem for sensitive organisms.

After the application of biopreparations and the cessation of intense algae blooms, no significant decreases in dissolved oxygen concentration were observed in 2017 and 2018 either. Statistical analyses confirmed the differences between the test periods for the average of all points (Table 4), while post-hoc tests showed differences before the application of biopreparations and in relation to subsequent research periods (Table S1). The differences in the subsequent months after application are no longer statistically significant, which indicates that the level of oxygen concentration in the lake's waters has normalized (Figure 7).

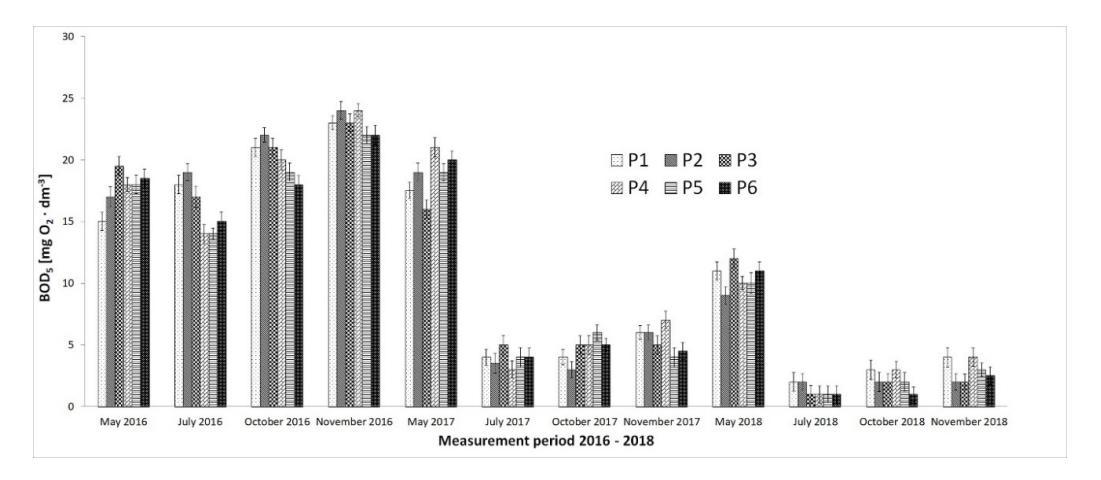
**Figure 7.** Changes in the BOD<sub>5</sub> (Biochemical Oxygen Demand) value at points P1–P6 in the reservoir. Measurement campaigns 2016–2018.

Organic pollutants expressed in BOD<sub>5</sub> and COD concentration are a mixture of organic fractions derived from the eutrophication process and pollutants from mixed points and surface sources. Concentrations for the BOD<sub>5</sub> reservoir water in the range 15–25 mg  $O_2 \cdot dm^{-3}$ , and COD 32–42 mg  $O_2 \cdot dm^{-3}$  indicate an exceeding value [50]. These values were maintained in the year preceding the application process and until May 2017. After the application of biopreparations, significantly lower BOD<sub>5</sub> concentrations below 5 mg  $O_2 \cdot dm^{-3}$  (for summer and autumn periods) in 2017 were recorded, and up to about 2–3 mg  $O_2 \cdot dm^{-3}$  in the summer of 2018 and up to 5 mg  $O_2 \cdot dm^{-3}$  in the autumn of 2018. A similar trend was observed for the concentration of COD values, whose level dropped to the range of 20–25 mg  $O_2 \cdot dm^{-3}$ , in the summer and autumn of 2017, and 16–25 for 2018 (Figures 7 and 8).

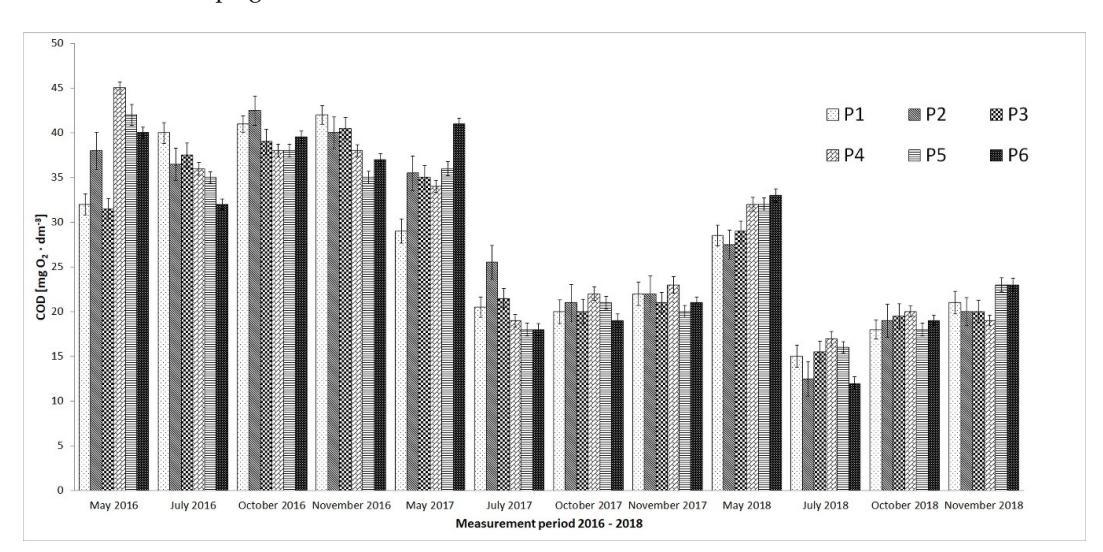
**Figure 8.** Changes in COD (Chemical Oxygen Demand) value at points P1–P6 in the reservoir. Measurement campaigns 2016–2018.

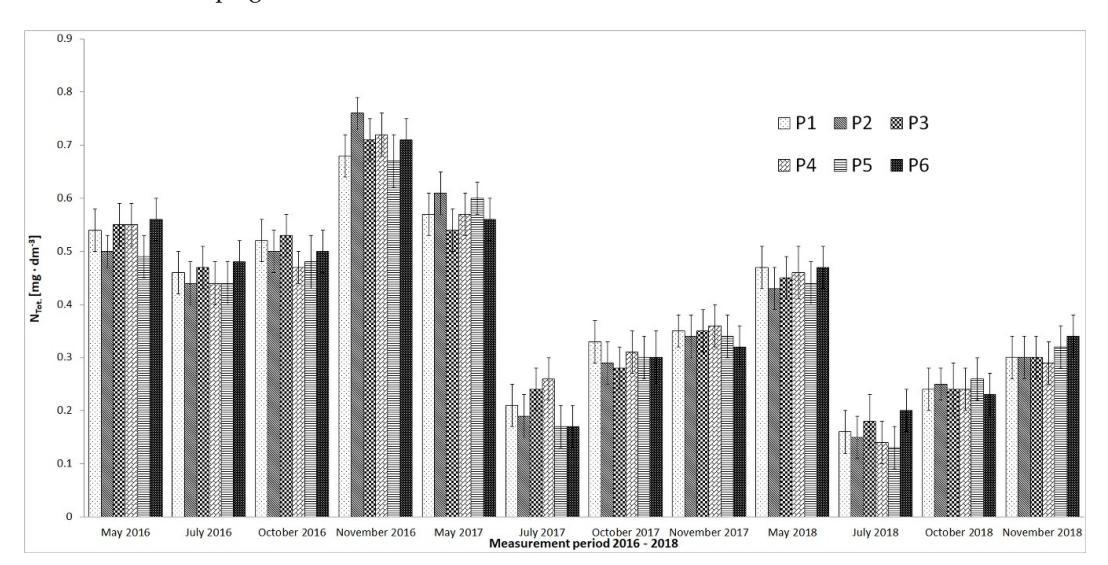
Figure 9. Changes in  $N_{tot}$  value at points P1–P6 in the reservoir. Measurement campaigns 2016–2018.

The laboratory analysis of nutrients showed that in the period before the application of biomixtures,  $N_{tot}$  concentrations ranged from 0.45–0.75 and  $P_{tot}$  0.062–0.095 mg·dm<sup>-3</sup> (Figures 9 and 10). They reached the highest values in the autumn 2016 and early spring 2017 (Figures 9 and 10). However, after application, the levels of both nutrients began to drop significantly, which is quite a surprising trend, given the intensive process of bottom sediment mineralization and the distribution of organic pollutants. These compounds may have been bioaccumulated by the significant macrophyte growth.

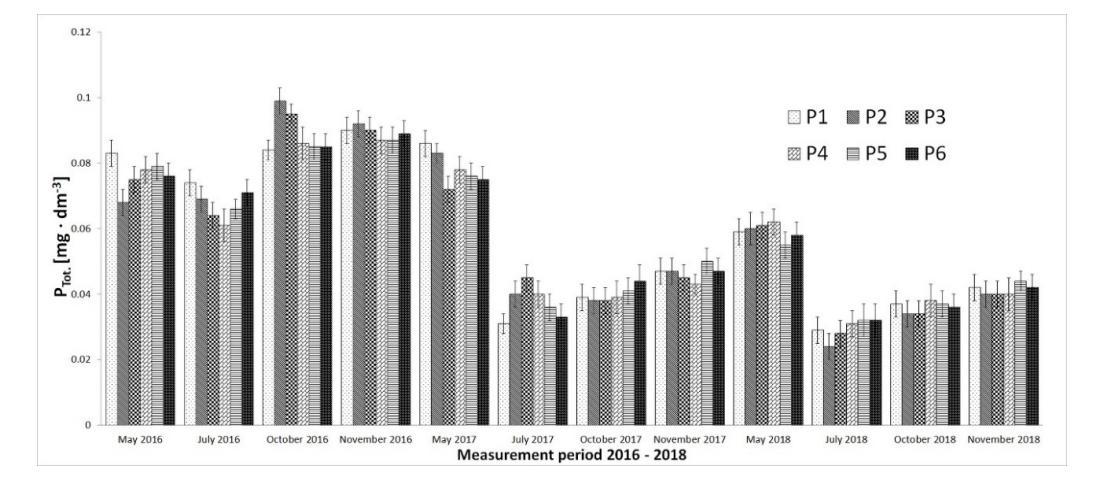
Figure 10. Changes in Ptot value at points P1–P6 in the reservoir. Measurement campaigns 2016–2018.

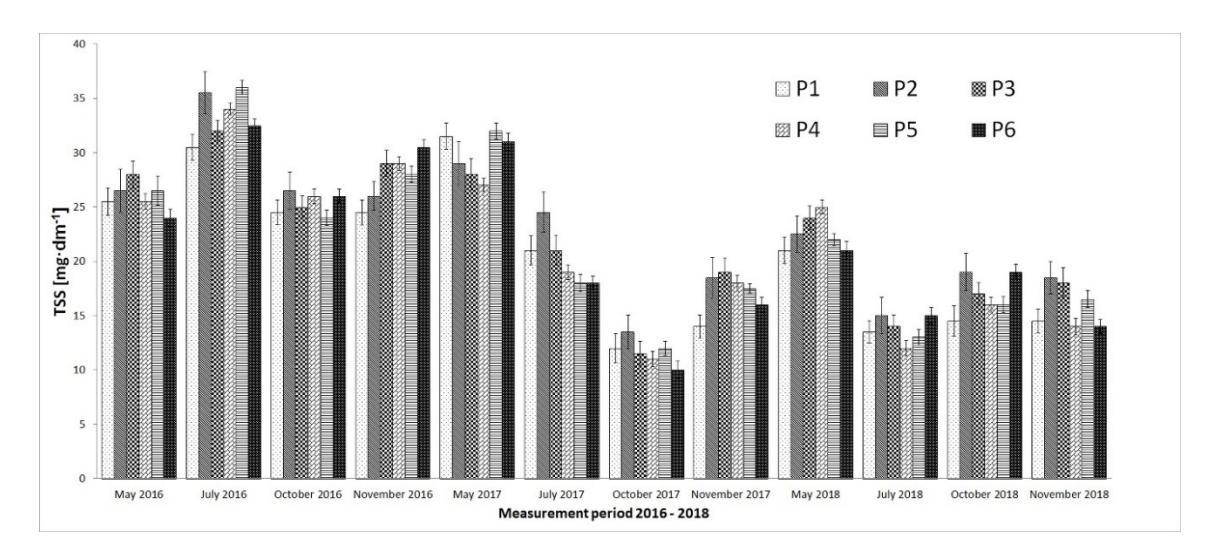
**Figure 11.** Changes in TSS (Total Suspended Solids) value at points P1–P6 in the reservoir. Measurement campaigns 2016–2018.

TSS in the case of surface waters depends on many parameters, which is why its interpretation requires expert knowledge of the examined site. The Słoneczko reservoir belongs to transitional, river waters due to its origin. In 2016, TSS values ranged from 24–37 mg·dm<sup>-3</sup> (Figure 11) for this water class without additional geological conditions, this level is significantly exceeded [50]. The highest values were observed in July 2016, due to the peak of the eutrophication process and a slight decrease in the remaining months of the year. After the application of biopreparations, a significant reduction of TSS was noted in July 25—19 mg·dm<sup>-3</sup>, which is a significant difference compared to the current year (Table 4). In the next season of 2018, TSS values remained at a low level of approx. 15 mg·dm<sup>-3</sup>, with slight fluctuations (Figure 11).

Statistical tests of Pearson's correlation showed a strong inversely proportional correlation of TSS changes in the examined months with changes in water transparency in the corresponding periods in 2016–2018. Pearson's correlation coefficient was—0.766 with a *p*-value =  $3.874 \times 10^{-140}$  (for the condition *p* < 0.05, the assumption was met). The interpretation of this result is intuitive, because suspended solids are a key factor affecting the transparency of water, so reducing the content of suspended solids has a positive effect on increasing the transparency of water and light transmission in the water column.
