Cohesive Channel Response to Watershed Urbanization: Insights from the Sand River, Aiken SC

Abstract: Stream channel degradation is among the most widely documented symptoms of urban stream syndrome arising from watershed urbanization. Nevertheless, our present understanding of space and time scales associated with channel response to urbanization is poorly constrained and largely limited to assessments of non-cohesive systems. The purpose of this study is to assess the evolution of a cohesive, ephemeral river channel in response to watershed urbanization. The assessment of historical images document the stable, pre-urbanized channel conditions from 1870 to 1930. Historical assessments revealed a 131% increase in urbanized watershed area from 1930 to 1992, and a minimal increase in urbanized extent from 1992 to 2012. A 2012 lidar dataset was used to generate the modern long-channel profile, to reconstruct cross-channel profiles observed in 2002, and to estimate the volume flux of sediment removed from the channel from 1930 to 1992, and from 1992 to 2012. The long-channel profile reveals incision of up to 35 m in response to urbanization from 1930 to 1992. Cross-channel profiles re

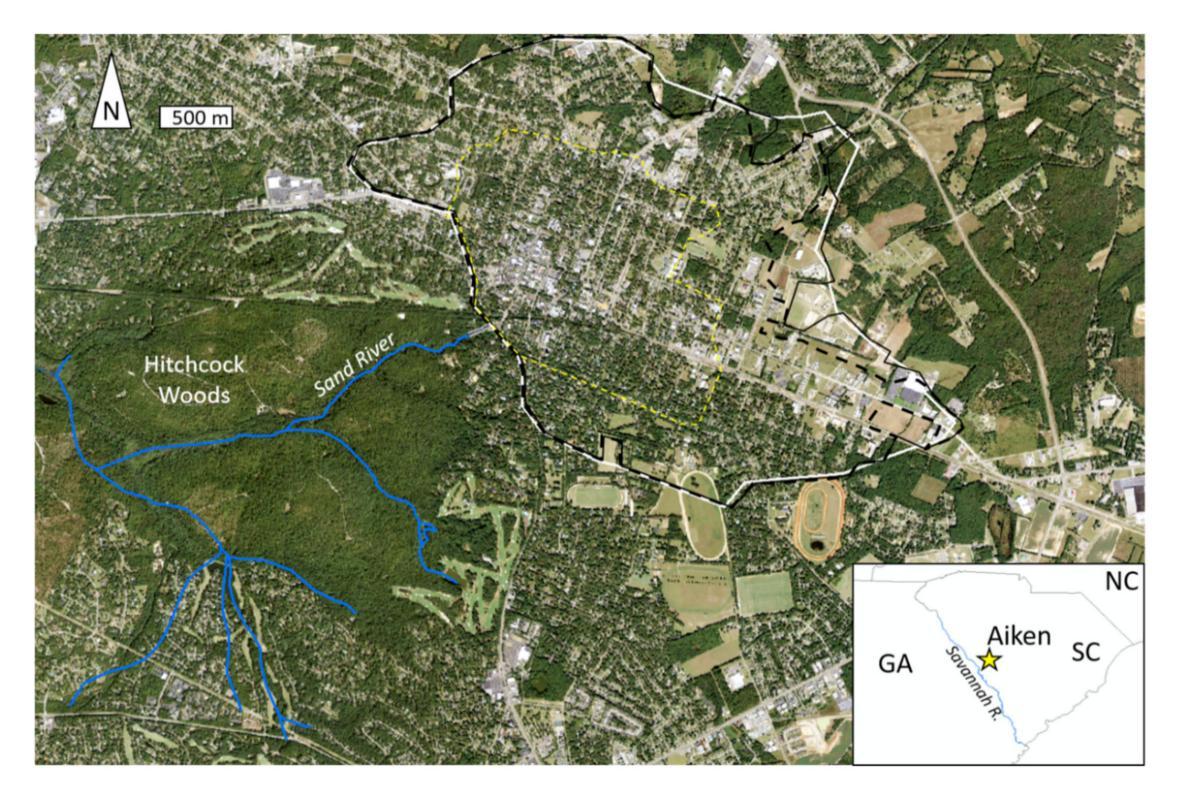
Figure 1. The Sand River is a first-order tributary of the Savannah River. The Sand River drains a 9.0 km² area including the downtown business district and neighboring suburbs. The river runs through the Hitchcock Woods, a 2000 acre forest preserve. The dashed yellow and black lines mark the increased extent of urbanized watershed area in 1930 and 1960, respectively. Similarly, the solid black and white lines show the extent of the watershed in 2002 and 2012.

The Sand River is a natural, first-order tributary in the Savannah River drainage basin, with headwaters located in Aiken, SC, USA (Figure 1).

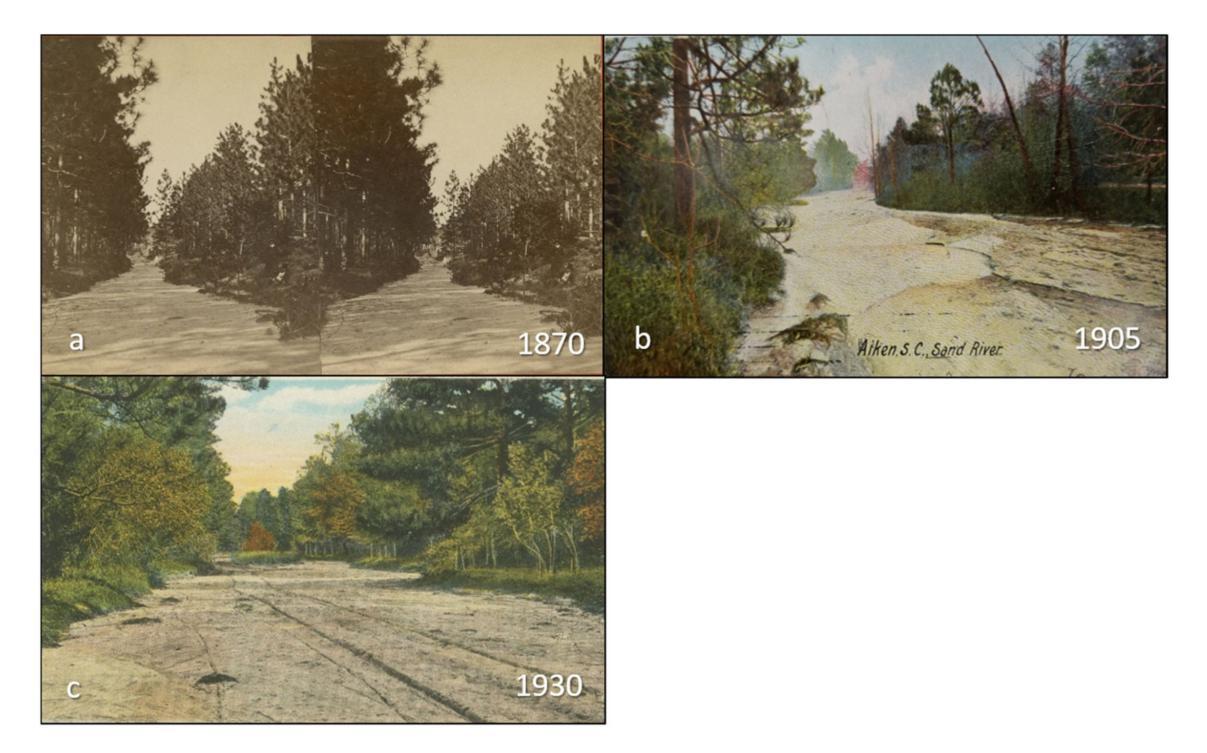
Figure 2. (a) A stereo pair image from 1870, and postcard images from (b) and (c) 1930 reveal the shallow nature of the pre-urbanized Sand River channel. The images reveal no apparent change in the channel morphology over the 60-year period.

From 1870 to 1930, the Sand River was characteristic of a shallow stream with a width and depth of ~6 and 1 m, respectively (Figure 2a–c). The images do not reveal any obvious change in the overall channel morphology over the 60-year period, and this suggests that there was no major disturbance to the system up until 1930. This period of stability was interrupted, however, by rapid urban development arising from a boom in economic growth associated with establishment of the Savannah River Nuclear power plant in the late 1940s. By the early 1950s, roughly two thirds of the natural watershed had been sold for timber and real estate development [68]. The epicenter of this urban growth was Aiken's downtown business district, situated within the Sand River's natural drainage area.

Century-scale changes in urbanized watershed area were assessed with a series of historical maps, aerial photographs, and images. First, a stereopair image from 1870 (Figure 2a), and postcard images from 1905 (Figure 2b) and 1930 (Figure 2c) provided an assessment of the pre-urbanized channel. This set of historical images showed no apparent change in the overall channel morphology from 1870 to 1930, indicating that the Sand River was not undergoing major alteration in response to natural or human activity, up until 1930. Therefore, 1930 was set as the pre-disturbed reference condition [73] of the channel. From there, a series of georeferenced topographic maps and aerial photos were obtained from the Nationwide Environmental Title Research website (https://netronline.com) for years 1930, 1992, 2002, and 2012. Then, the georeferenced images were brought into ArcGIS to estimate changes in the extent of urbanized lands within the watershed for each year. The percent change in urbanized area for the periods 1930–1992, 1992–2002, and 2002–2012 was calculated. These time intervals were selected because they corresponded to (1) the time interval following pre-disturbed channel conditions; (2) post-outfall pipe conditions; and (3) active, decadal-scale channel adjustment. Hence, this approach provides a holistic assessment of cohesive channel response to human impacts in that it captures the channel morphology before and after watershed urbanization.

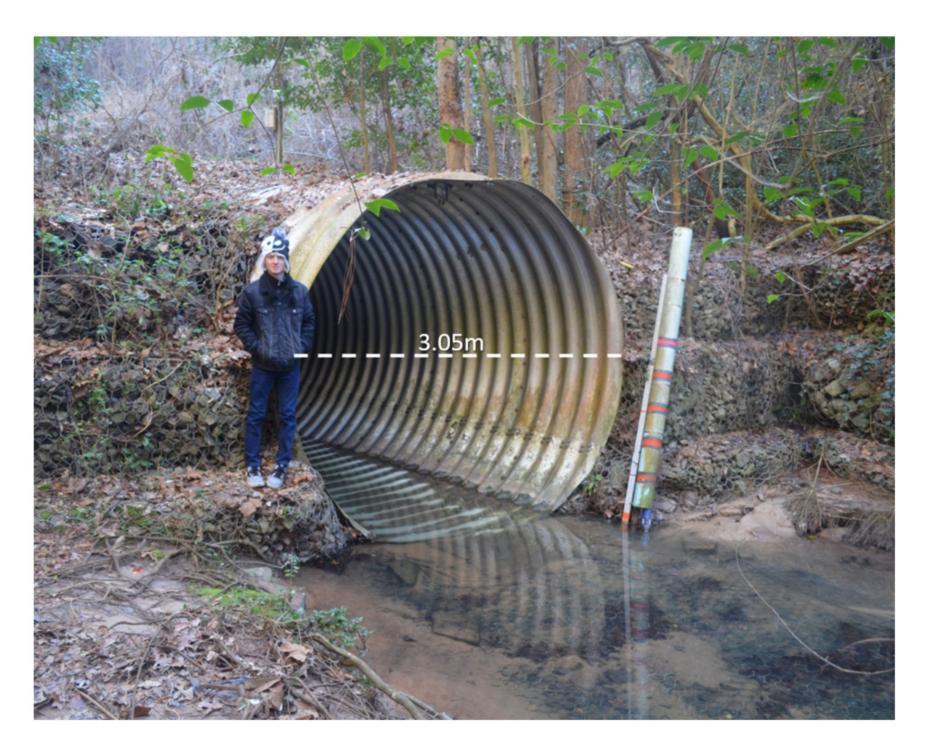
Figure 3. Photograph of the 3.05 m outfall pipe and gabion lined canal installed in 1992.

Over the next few decades, erosion of the channel resulted in a deeply incised canyon that threatened the primary road used to access the Hitchcock Woods, a 2000-acre urban forest preserve (Figure 1). In 1992, the network of stormwater drainages distributed throughout the city limits were connected to a 3.05 m diameter outfall pipe, which was laid onto the channel bed and extended 100 m downstream of the Hitchcock woods access way. The outfall pipe was laid onto the canyon bed and the 100 m reach of channel between the access way and the pipe mouth was filled and covered with a vegetative layer (Figure 3). At the same time, the channel bed and walls, along the first 100 m downstream of the pipe mouth, were lined with gabion (erosion-resistant rock lining held by wire mesh) to help dissipate the energy of flows entering the natural channel bed. Essentially, in 1992 the natural headwaters of the Sand River were replaced with a major stormwater outfall pipe (Figure 3).

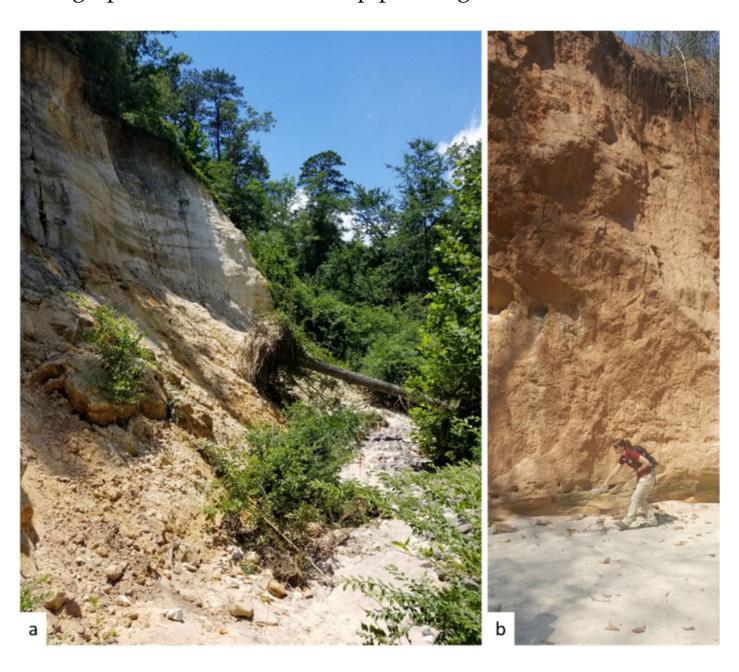
Figure 4. (a) 2017 Photograph of the modern Sand River canyon; (b) 2017 Photograph showing undercutting of the banks due to active channel flows increases instability of the channel banks, leading to frequent bank failures.

through a deeply incised canyon with widths and depths of up to 35 m along upstream reaches (Figure 4a) near its headwaters, narrowing and shallowing to ~10 m in the downstream direction. The canyon is composed of unconsolidated Late Cretaceous Eocene fluvial and deltaic sediments [51,72]. Beyond the gabion canal, the natural channel banks consist of mostly quartz sand with interstitial silt and clay throughout [51] which cause the banks to be cohesive [5,72]. Recurring bank failures primarily due to undercutting of the channel (Figure 4b) and disconnection to the floodplain suggest that the ephemeral study reach is in its active widening state of channel evolution [30,51].

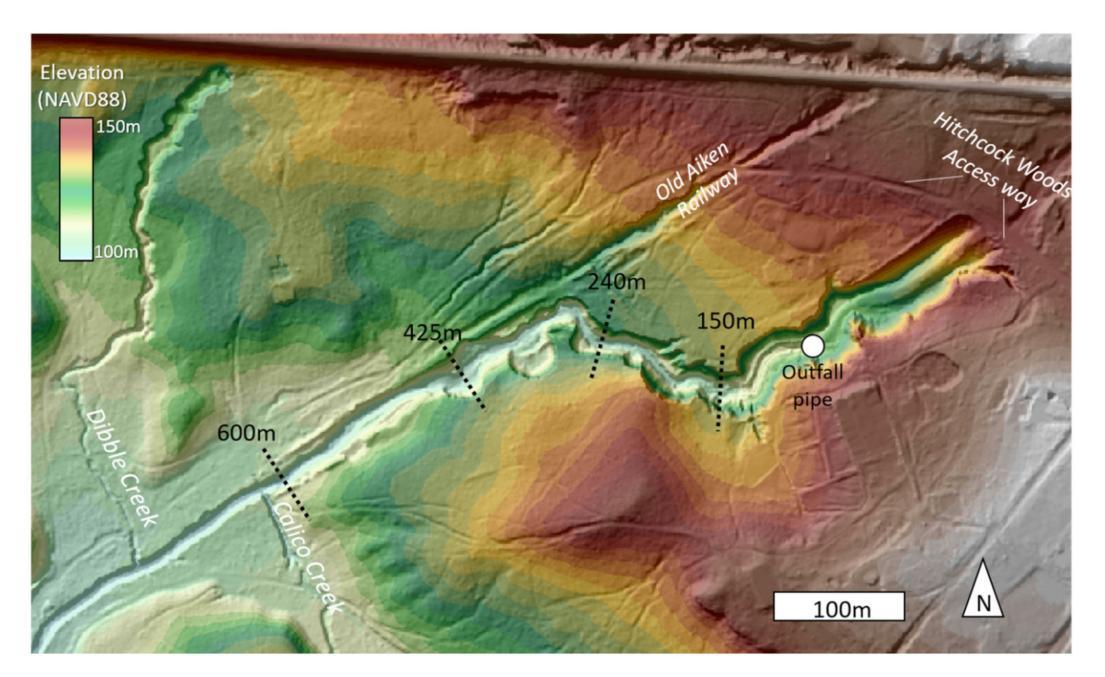
Figure 5. 2012 lidar DEM of the Sand River study reach. Warm to cool colors represent high to low elevations, respectively. The black dashed line marks the transect locations used to generate cross section channel profiles.

The 2012 lidar DEM highlights the 600 m ephemeral reach of the Sand River, and other less obvious surface features. For instance, the DEM reveals a linear embankment running roughly parallel to, and converging with, the northern bank of the Sand River ~300 m downstream (Figure 5). This feature is associated with the Aiken Inclined Plane [74], as evident by field observations of railroad tracks belonging to the South Carolina Canal and Railroad Company, c. 1839–1852 [74], which have been excavated by channel erosion. The DEM also highlights two tributaries of the Sand River, i.e., Dibble Creek and Calico Creek (Figure 5), which are also experiencing incision and widening in response to recent land use change.

The DEM reveals that the 600 m ephemeral canyon has a maximum valley elevation of 126 m (all elevations referenced to NAVD88), decreasing to 105 m at 600 m downstream (Figure 5). The valley width is greatest near the upstream outfall pipe where the distance between north and south valley banks is 35 m. Valley width decreases in the downstream direction, reaching 5 m at the confluence of Calico Creek (Figure 5). The first 100 m of the channel corresponds to the infilled reach of the pre-outfall pipe canyon. The atypical shape of this channel reach is attributed to the infilling of the canyon when the outfall pipe was installed in 1992. Downstream of the outfall pipe, the modern canyon tends to meander along the first 300 m, becoming straighter in the downstream direction (Figure 5).

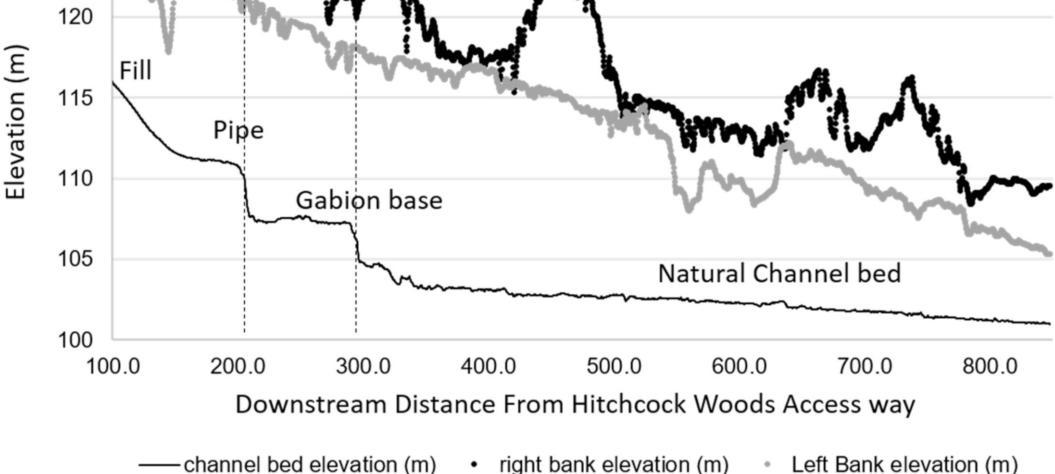
Figure 6. Long-channel profile of the Sand River study reach as a function of downstream distance from the Hitchcock Woods access way. The solid black line marks the location of the channel bed, while the black and gray dots mark the valley banks. A break in the channel bed slope occurs at 200 m downstream and is associated with opening of the outfall pipe. Another slope break occurs at 300 m downstream where the gabion canal transitions to natural channel bed.

Figure 6 shows the long-channel profiles of the north and south valley banks, and channel bed for the 600 m ephemeral reach. The south valley bank elevations range from 122 m to 109 m over the 600 m study reach, yielding a slope of 0.021. The north valley bank is relatively lower than the south, with a maximum and minimum elevation of 123 and 105 m, respectively, yielding a slope of 0.03. Channel bed elevations range from 116 m at the upstream limit of the infilled channel to 101 m downstream, where the valley bank elevation eventually converge with the channel bed (Figure 6).

This general view of the long-channel profile is interrupted by two abrupt breaks in channel bed elevation. The first occurs at 200 m downstream and is associated with the transition between the filled channel reach and the opening of the outfall pipe at the start of the gabion lined canal (Figure 6). The second occurs at 300 m downstream and marks the transition between the gabion canal and the natural channel bed (Figure 6). These two breaks in channel bed elevation highlight channel incision that occurred from 1930 to 1992, and from 1992 to 2012, or pre- and post-outfall pipe installation, respectively. The bed elevations along the natural channel reach between 300 and 600 m downstream range from 105 to 100 m, yielding a slope of 0.008.

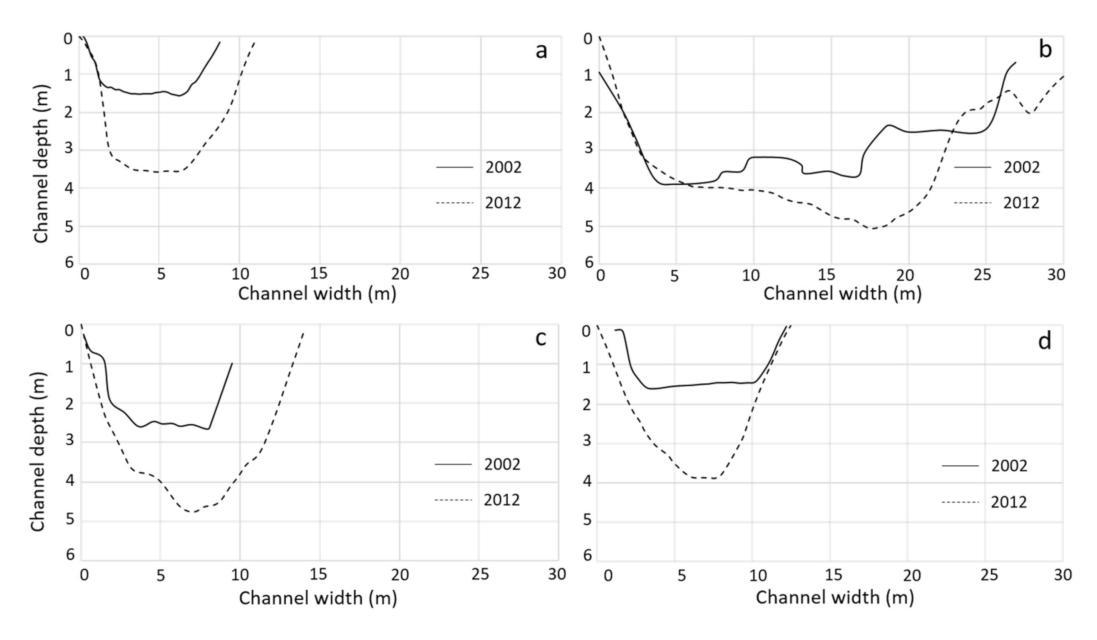
Figure 7. Cross-section profiles at (**a**) 150 m; (**b**) 240 m; (**c**) 425 m; and (**d**) 600 m downstream of the stormwater outfall pipe. The solid line represents the 2002 transects of Julian and Torres (2006). The dashed line shows the cross-section profiles extracted from the 2012 lidar DEM. The comparison of the 2002 and 2012 profiles reveals deepening and widening of the channel over the 10-year interval.

The 2002 and 2012 cross-section profiles are shown in Figure 7. At 150 m downstream of the outfall pipe, the channel width is 11 m, and the average depth is 2.42 ± 1.23 m. At 240 m downstream, channel width is 14 m and is associated with an active cut-bank (Figure 7). The mean depth along the 240 m cross-section profile is 3.17 ± 1.35 m. The channel is widest at 425 m, where the bank-to-bank distance is 30 m due to the presence of an active cut-bank. The average depth along the 425 m profile is 3.16 ± 1.47 m. At 600 m downstream, the channel width is 12.4 m, with an average depth of 2.38 ± 1.28 m.

Comparing the 2002 and 2012 cross-section profiles reveals channel widening and deepening at all transect locations (Figure 7). Specifically, the channel width increased by 2, 4, 3, and 1 m at 150, 240, 425, and 600 m, respectively. More often than not, the channel widening was associated with erosion of the right (southern) bank (Figure 7). The comparison also reveals incision, or deepening, of the channel over the 10-year period. For instance, the average depth at 150 m increased from 1.14 to 2.43 m. Likewise, average depths increased from 1.94 to 3.17 m at 240 m downstream (Figure 7). At 425 m, the average depth increased from 2.85 to 3.16 m. At the 600 m site, the average channel depth increased from 1.21 to 2.38 m. This 2D assessment reveals that, on average, the active channel of the Sand River canyon widened by 2.5 m from 2002 to 2012. At the same time, channel incision occurred at all transect sites over the 10-year period, albeit at a lesser extent than changes in channel width.
