Article

Performance of Field-Scale Phosphorus Removal Structures Utilizing Steel Slag for Treatment of Subsurface Drainage

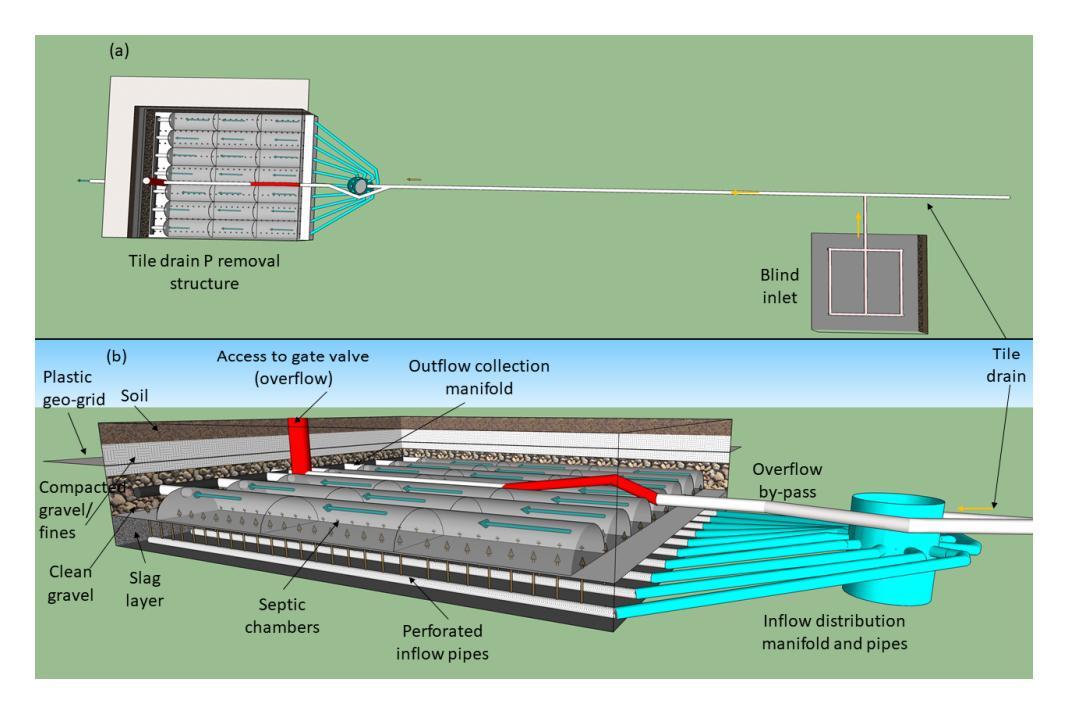
Figure 1. (a) Overhead view of the blind inlet/subsurface tile drain P removal structure, and (b) side view and details of the tile drain P removal structure. The blind inlet collects surface water at the site and is plumbed into the field tile drainage system, which is all treated by the subsurface P removal structure. The yellow and blue arrows indicate the flow path of the untreated and treated water, respectively. Water flows from the bottom-up and discharges at the same elevation as the inlet.

The subsurface P removal structure was designed to treat the tile drainage water from the field, plus surface runoff that flowed into a blind inlet via plumbing into the 15 cm diameter tile drain main (Figure 1). The blind inlet was located up-pipe of the P removal structure and constructed in a depression according to conservation practice Standard 620 of the Natural Resource Conservation Service. A back-flow preventer (Rectorseal, Houston, TX, USA) was installed where the blind inlet joined the tile drain main in order to prevent field tile drain water from back-flowing into the blind inlet. Because of a lack of hydraulic head via slope at the site, the structure was designed to flow from the bottom-upward, where the elevation of the inlet is equal to the outlet.

In order to allow an open head space between the top of the slag bed and the drainage outlet, 21 Infiltrator H-20 septic chambers (Infiltrator Water Technologies, Old Saybrook, CT, USA) were placed on top of the slag bed. This permitted approximately 40 cm of head space to permit for settling of and prevent loss of precipitant/floc that would develop in the treated water. Preliminary pilot-scale experiments showed that using a traditional corrugated tile drainpipe near the top of the slag bed was not sufficient as an alternative to an open "dead space" for settling, as the corrugated pipe quickly clogged with the precipitant/floc. The Infiltrator H-20 septic chamber is specially designed to handle traffic, which was necessary in this case because the landowner would need to drive over the buried P removal structure without crushing the chambers. Three chambers were connected for seven rows, with a 10 cm diameter pipe plumbed to the chamber at the end of each row, which were then connected to a single 15 cm diameter manifold pipe that served to drain the entire slag bed (Figure 1).

For the subsurface P removal structure, the inlet was monitored at the distribution manifold (i.e., 0.76 m diameter × 1.3 m unit shown in Figure 1) with an ISCO Signature 330 bubbler (Teledyne-ISCO, Lincoln, NE, USA) for pressure head and an ISCO 6712 autosampler for taking water samples before flowing into the slag bed. A composite vault (described in detail by Smith and Livingston; [50]) was buried near the outlet, with the 15 cm outlet pipe plumbed into it and connected to a 15 cm

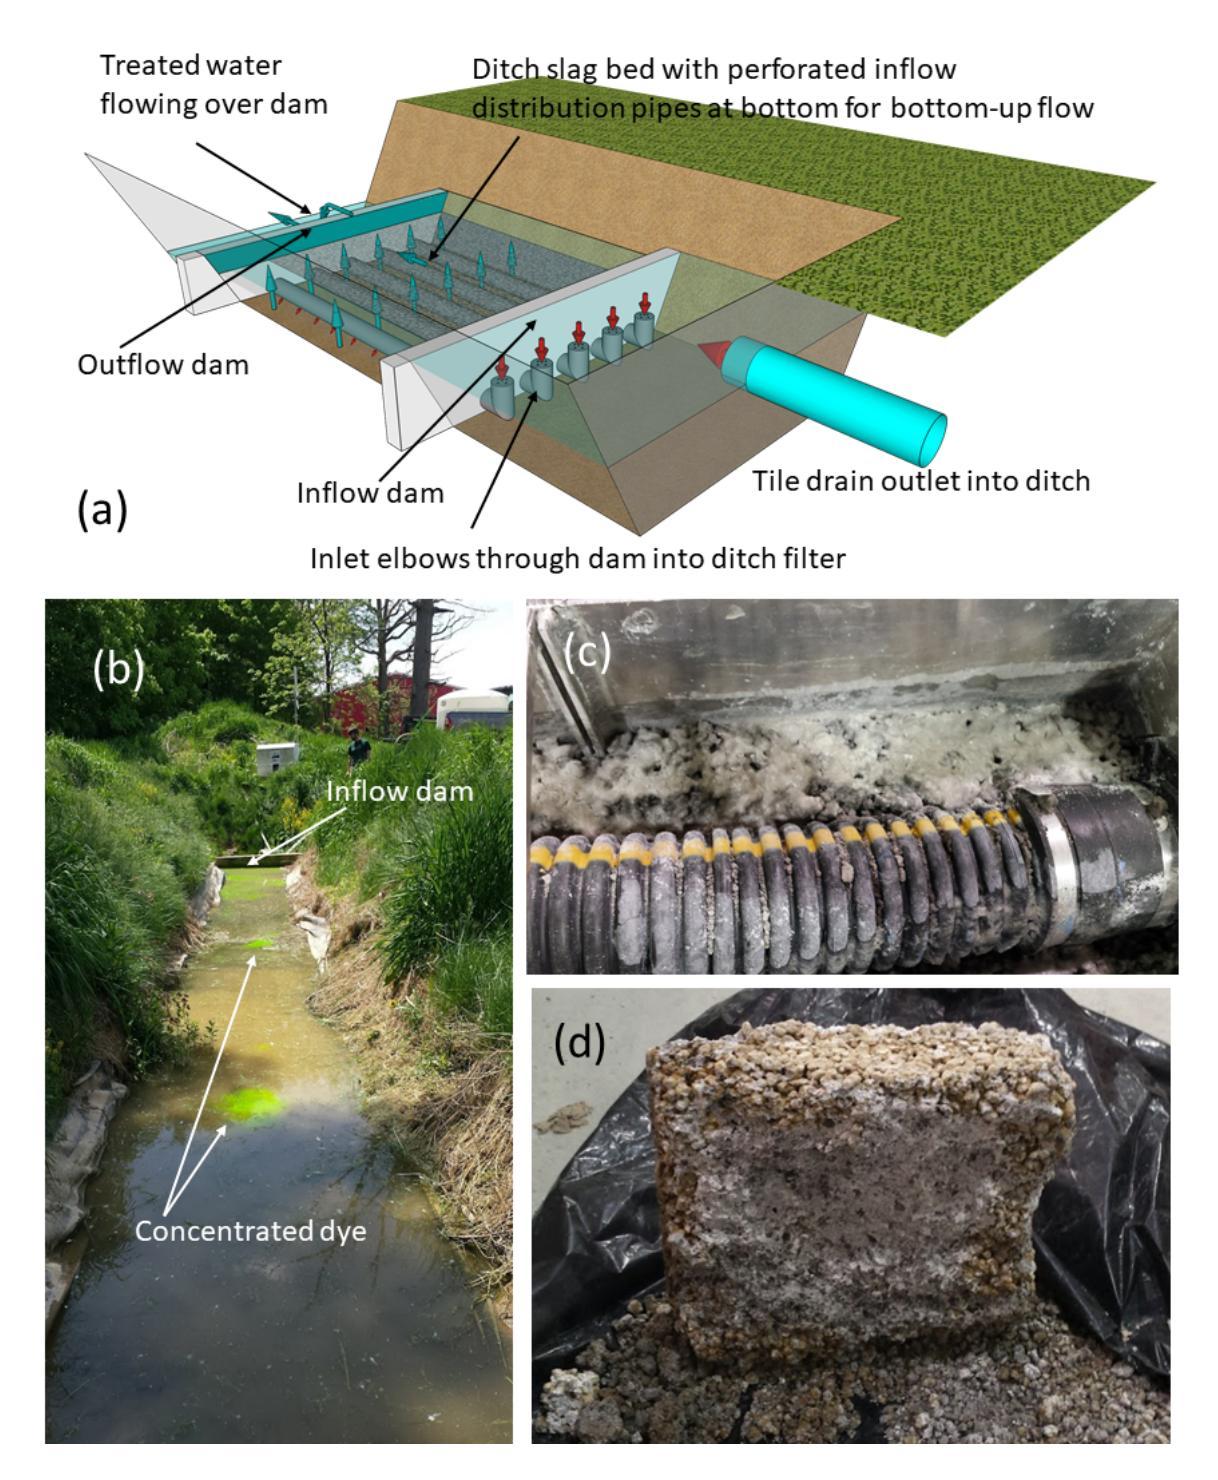
Figure 2. Schematic of the ditch phosphorus removal structure (**a**) and photograph taken during a dye test (**b**) illustrating the lack of uniform flow through the slag media and clogging of the ditch structure. Photograph (**c**) shows the flocculant/precipitant that forms through the dissolution and reprecipitation of calcium minerals that can fill the slag matrix and reduce pore connectivity (**d**).

In July 2018, a ditch-style P removal structure was constructed in which the inlet water was treated from the bottom-up. Tile drainage water from a 10 mm diameter tile drain outlet flowed into a 72 m long ditch before entering into a wetland. The ditch bottom width was 2 m, while the top width and depth varied. Based on slag characterization and flow characteristics obtained from previous monitoring (annual flow volume of 5 million L y⁻¹, dissolved P concentration of 1 mg L⁻¹) and a P removal goal of 40% cumulative dissolved P removal over 15 y, the structure was constructed using 45 Mg slag. In order to meet the peak flow rate of 32 L s⁻¹ while attaining a retention time of at least 10 min, the slag was oriented approximately $72 \times 2 \times 0.33$ m deep within the ditch. A pond liner (2.3 mm thickness) was placed under the slag bed in order to prevent seepage loss between inlet and outlet flow monitoring/sampling equipment. At the upstream side of the ditch slag bed, a 76 cm tall dam was built with concrete and five 10-cm diameter elbows were set near the bottom, serving as the inlet into the slag bed (Figure 2). Five corrugated perforated drainpipes (10 cm diameter) were attached to each elbow on the downstream side of the dam and extended nearly 72 m where the ends were capped off.

On the downstream side of the ditch, a 50 cm tall concrete dam was constructed, serving as the outlet for treated water. In cases where flow rate exceeded the slag flow capacity, the inflow water could simply over-top the inflow dam and flow to the outlet without being treated (Figure 2). In May of 2019, a dye test was conducted by slowly releasing water with added dye (fluorescent yellow/green; Kingscote chemicals, Piqua, OH, USA) from a 2000 L tank at the upstream side of the inflow dam. The structure was then visually monitored for 90 min in order to assess preferential flow paths or potential clogging.

After approximately 11 months following installation, a dye test was conducted on the ditch structure as a qualitative assessment for clogging of the slag bed. After adding dye and water to the upstream side of the inflow dam (Figure 2a), it was observed that dye only appeared in several small areas, indicating that water flow through the slag bed was significantly limited due to clogging (Figure 2b). This indicated that during flow events, very little water would be able to flow through the slag bed and instead would over-top the inflow dam and flow directly on top of the slag bed to the outlet dam with little to no slag contact, therefore escaping treatment.

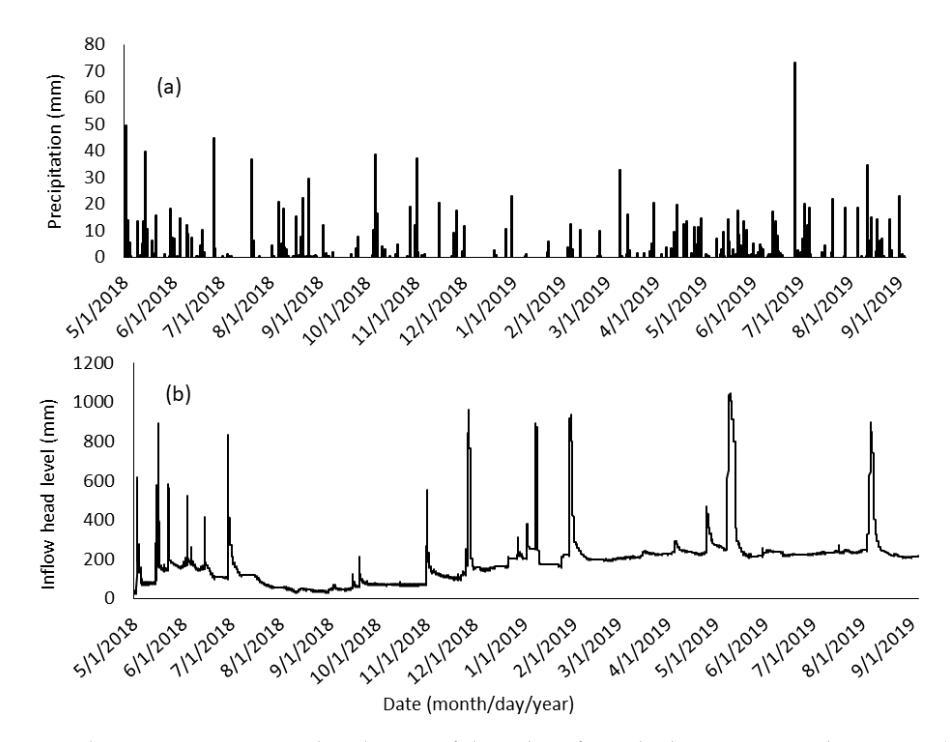
Figure 3. Daily precipitation record at the site of the subsurface tile drain P removal structure (**a**) and inflow pressure head level (**b**) measured at the inflow distribution manifold, illustrated in Figure 1.

Figure 3 shows both the precipitation and the degree of pressure head at the inflow of the subsurface P removal structure, illustrated in Figure 1. An increase in pressure head indicates that water was "backed-up" above the P removal structure to some degree. Clearly, this is expected to occur during high flow events, but notice that not all instances of increases in pressure head were concomitant with large precipitation events, indicative of the importance of antecedent soil moisture conditions in influencing flow events. For example, the P removal structure nearly ceased flowing from July 2018 to September 2018 (Figure 4), even though appreciable rainfall events occurred during that time period. Williams et al. [42] showed that both rainfall amount and antecedent moisture controlled flow generation for these tile drainage systems. Next, notice that the baseline pressure head level slowly increased starting in November 2018 (Figure 3). This suggests that the slag contained in the P removal structure may have been slowly clogging, decreasing the ability of water to flow through it and therefore requiring a greater hydraulic head.

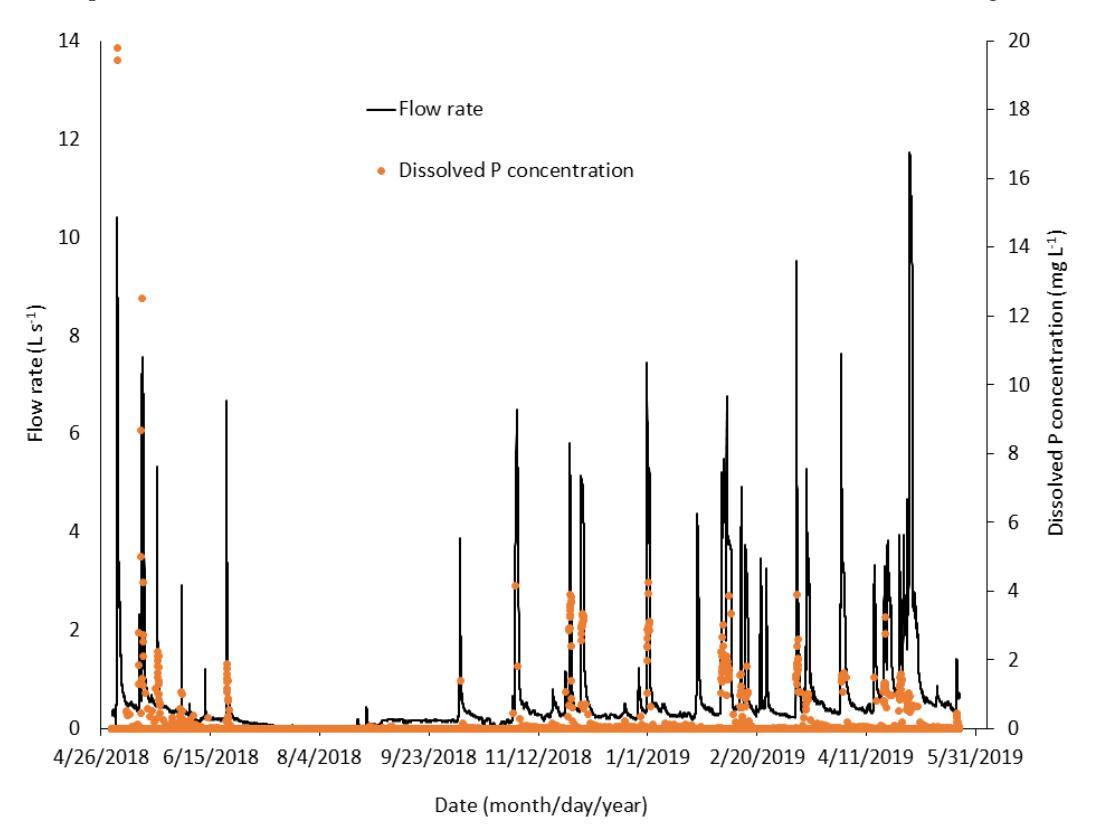
Figure 4. Hydrograph and associated inflow dissolved phosphorus (P) concentrations measured at the inlet of the subsurface tile drain P removal structure shown in Figure 1.

Flow rates through the P removal structure ranged from nearly zero to about 12 L s⁻¹. Inflow dissolved P concentrations generally followed the same pattern as flow rate, with low concentrations observed during baseflow conditions and spikes occurring at event peak flow rates (Figure 4). In fact, there was a significant (p < 0.05) and positive relationship between flow rate and inflow dissolved P concentration: inflow P concentration = 0.52 * flow rate – 0.056, where P concentration and flow rate are in units of mg L⁻¹ and L s⁻¹, respectively. A similar trend was also evident in non-point drainage monitoring in several other studies [36,66,67]. Similarly, mean flow-weighted concentrations for precipitation-induced flow events were much greater than baseflow concentrations, which was only 0.17 mg L⁻¹ (Table 2).

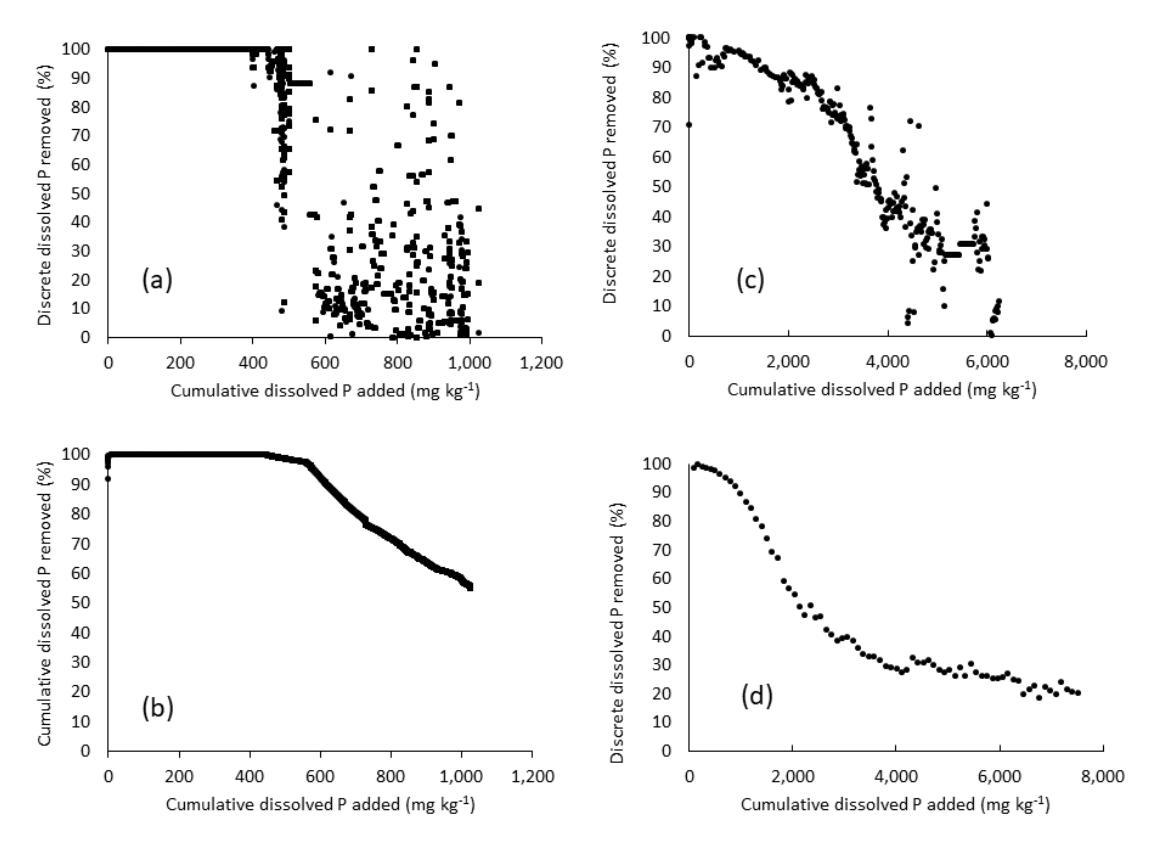
Figure 5. Discrete (**a**) and cumulative (**b**) dissolved phosphorus (P) removal by the subsurface tile drain P removal structure as a function of cumulative dissolved P loading to the slag media. Laboratory flow-through discrete P removal curves for the same slag sample are shown in (**c**) and (**d**) for comparisons to field performance under the conditions of a ten-minute retention time and inflow dissolved P concentrations of 0.5 and 2 mg L⁻¹ (**c** and **d**, respectively). Discrete dissolved P removal for the structure (**a**) is shown excluding negative values in order to improve clarity, but cumulative dissolved and total P removal (**b**) is calculated with inclusion of those negative values. Note that the horizontal axes scales for (**a**) and (**b**) are different from (**c**) and (**d**).

Overall dissolved P removal was 19.2 kg or about 55% of the total input to the structure (Table 2 and Figure 5). The structure removed 58% of the P that entered during precipitation-induced events, compared with -31% removal for baseflow. Poor baseflow P removal was likely due to the fact that baseflow provided relatively low concentrations of dissolved P compared with storm flow (Table 2); consider that P concentration partly dictates the chemical potential for calcium phosphate precipitation, which is the dominant P removal mechanism for EAF slag. Even though baseflow caused slag to behave as a net P source, recall that only a small amount of P was delivered during baseflow, so this only resulted in the loss of about 0.4 kg of P. The majority of the trapped P was removed during event 1 (Table 2).

Figure 5a illustrates that the structure removed 100% of all P input until the cumulative loading reached about 500 mg P kg⁻¹ slag; after that point, the P removal became quite variable. Table 2 also shows that discrete P removal by event, was nearly 90% or greater until event 8, and after event 10, the discrete event P removal drastically decreased, with some events resulting in net P release. The lowest retention time (total pore volume divided by flow rate) observed for the structure was 12 min (Table 2), occurring during the greatest measured flow rate. Note that the structure was designed to achieve a minimum retention time of 10 min during peak flow.

Figure 5c,d shows the discrete P removal flow-through curve determined in the laboratory for the same slag sample used in both P removal structures described in this study. Comparison of Figure 5a–d clearly indicate that the P removal structure greatly under-performed compared to

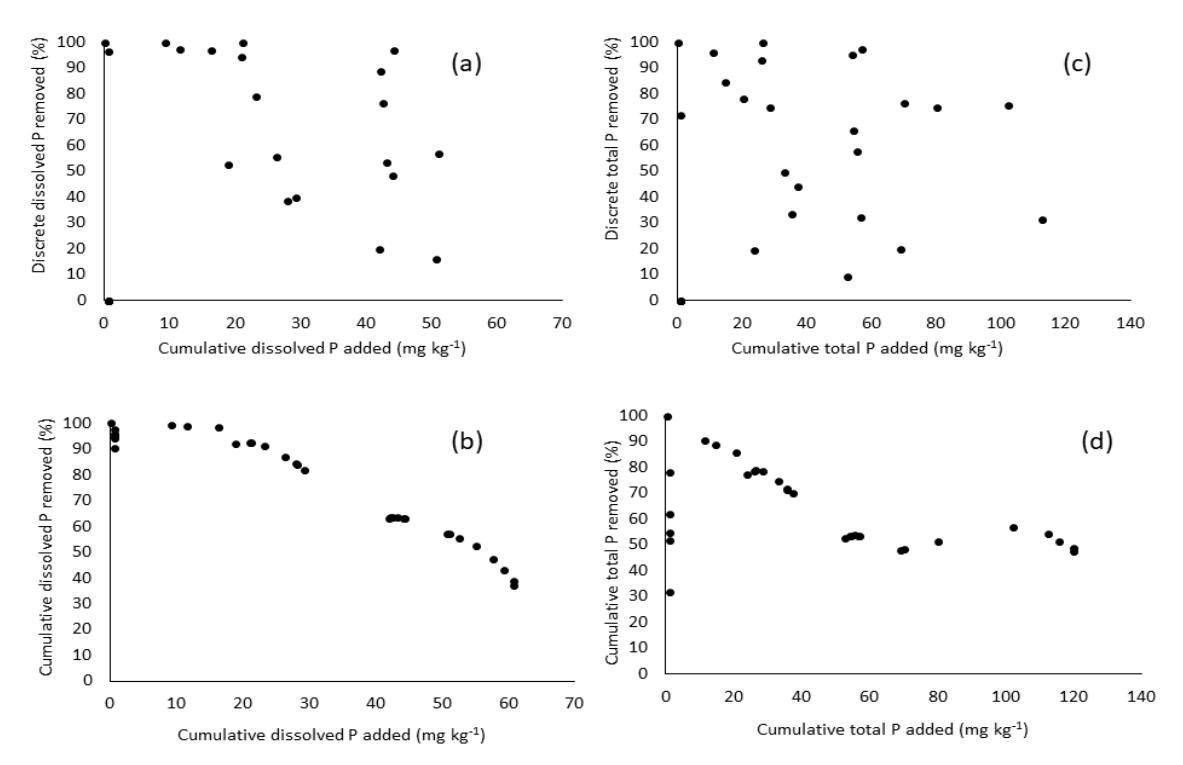
Figure 6. Discrete and cumulative dissolved and total phosphorus (P) removal for the ditch P removal structure, shown as a function of cumulative P loading to the structure. Discrete dissolved and total P removal (**a** and **c**) are shown excluding negative values in order to improve clarity, but cumulative dissolved and total P removal (**b** and **d**) are calculated with inclusion of those negative values. Note that the horizontal axes scales for (**a**) and (**b**) are different from (**c**) and (**d**).

The ditch-style P removal structure removed 37% of the cumulative dissolved P inflow load for a total of 0.9 kg removed (Figure 6). Similar to the subsurface tile drain P removal structure, dissolved P removal was near 100% for the first few events before drastically decreasing (Figure 6a). A comparison of Figure 6a to Figure 5c,d illustrate how the slag in the ditch P removal structure underperformed compared to testing the same slag under laboratory flow-through conditions. Discrete total P removal was highly variable (Figure 6c), but cumulative total P removal was 2.3 kg, equivalent to nearly 48% of the total P that flowed into the structure (Figure 6d).

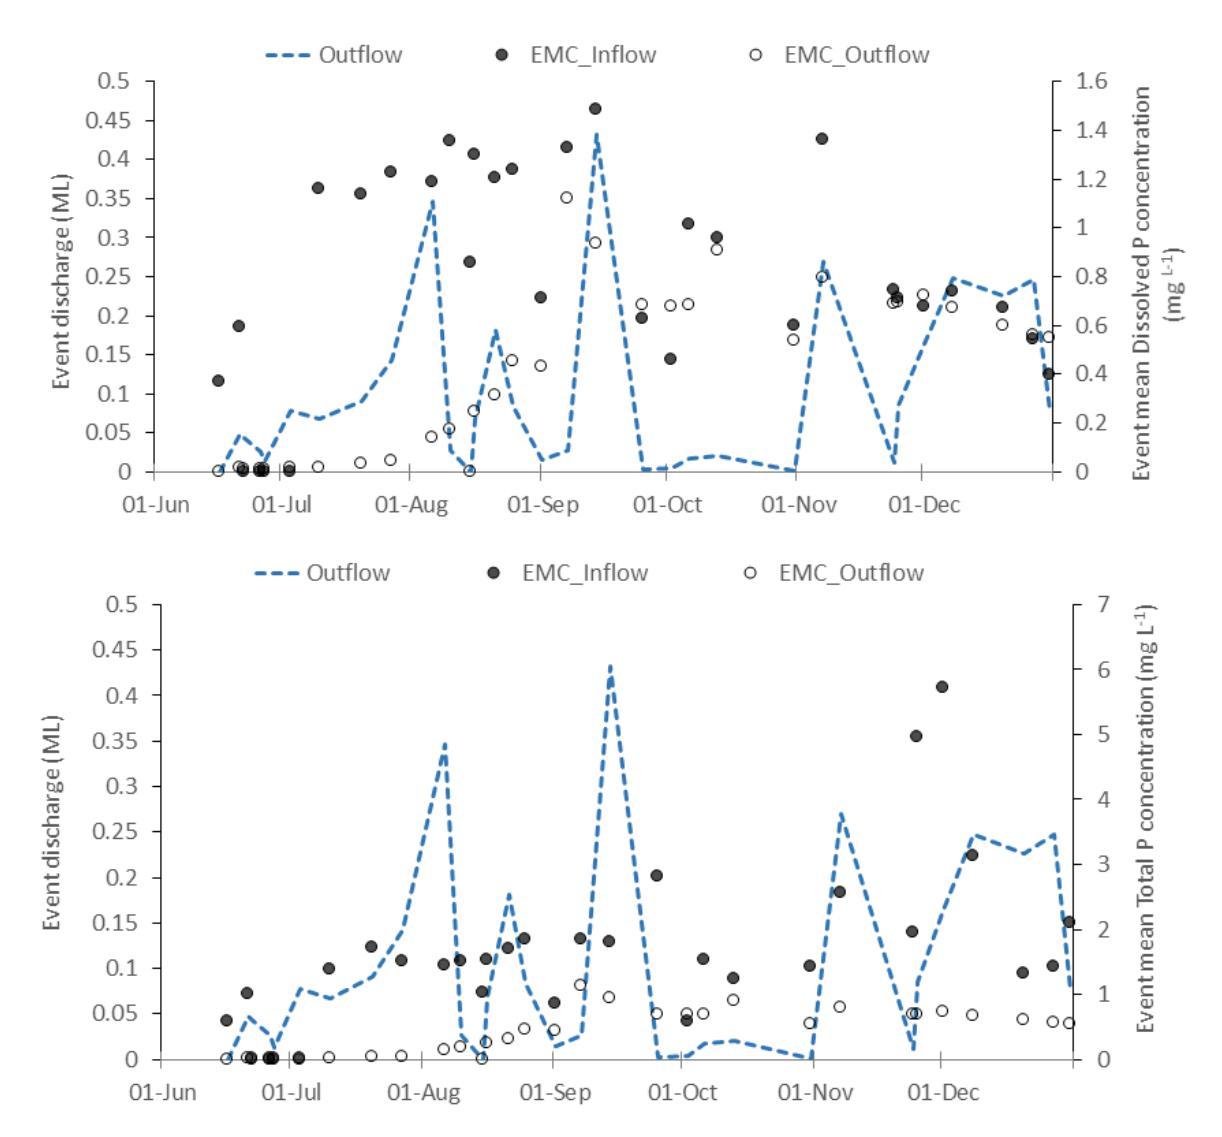
Figure 7. Discharge and event mean concentrations (EMC) of dissolved phosphorus (P) (upper figure) and total P (lower figure) for both inflow and treated outflow water from the ditch P removal structure shown in Figure 2.

Inflow dissolved P concentrations varied from about 0.4 to 1.4 mg L⁻¹, with the highest concentrations delivered between July and October. About 21% of the cumulative dissolved P load was delivered during a single event that took place on September 7th, in which the structure removed 20%. Figure 7 clearly illustrates how the ditch structure was initially operating at a high P removal efficiency and then decreased with further loading. Total P concentrations entering the structure were fairly steady at around 2 mg L⁻¹, indicating that about 50% of the total P was in the dissolved form. Total P removal was also steady throughout the monitoring period, unlike dissolved P removal. This indicates that the structure was additionally removing particulate P through physical

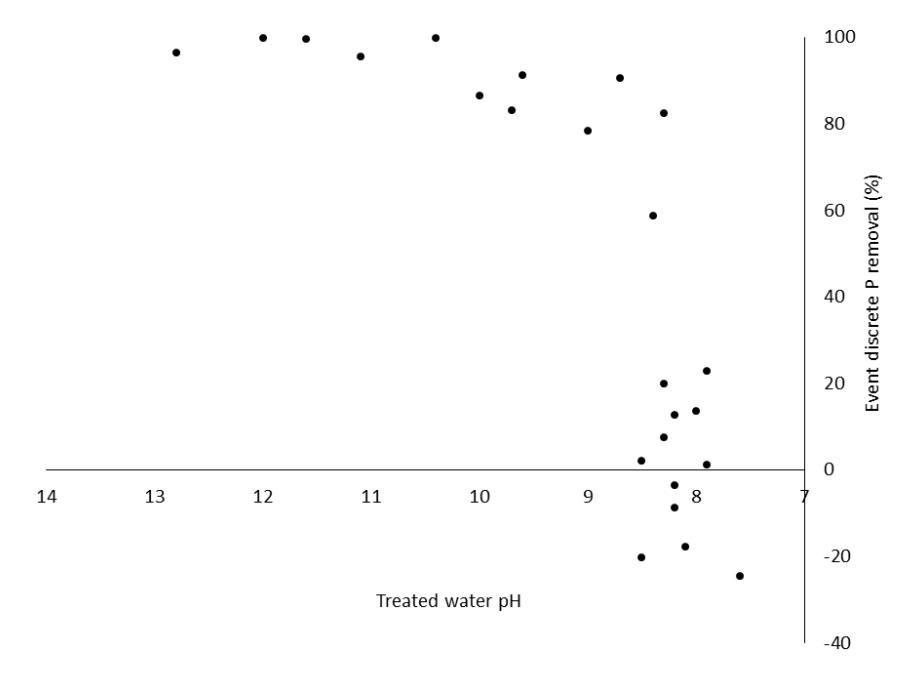
Figure 8. Impact of treated water pH on discrete dissolved phosphorus (P) removal for the subsurface tile drain P removal structure shown in Figure 1.

Consider that the laboratory flow-through experiments conducted on the slag used in this study (Figure 5c,d) were executed using a P solution made from pure de-ionized water, which therefore contained little dissolved CO₂, bicarbonate, or carbonate. However, in field application, this slag was used to treat tile drainage water, which will contain appreciable amounts of various forms of carbonate. This difference in water chemistry may be partly responsible for the underperformance of the slag contained in both P removal structures, evident when comparing Figures 5a and 6a (field-measured P removal) to Figure 5c,d (laboratory flow-through P removal). Further evidence for the hypothesis of calcite formation reducing calcium phosphate precipitation in the slag beds is found in the observation of changes in treated water pH with time. Initially, when the highly soluble and alkaline slag minerals were dominant, the treated water pH was >9. Indeed, Figure 8 indicates that event P removal was around 80% or greater and then drastically decreased when pH dropped to less than 9, which occurred during event 11 in the subsurface P structure, resulting in P removal of 13%. Notice that the pH of the treated water appeared to stabilize at around 8.2 (Figure 8), which is the equilibrium pH for calcite. Similarly, Dunets et al. [80] showed that P removal of greenhouse wastewater with slag decreased dramatically at a pH of around 8.5.
