Article Submerged Vane Technology in Colombia: Five Representative Projects

Carlos Rodríguez-Amaya *, Argelino Durán-Ariza * and Santiago Duarte-Méndez *

Hidroconsulta SAS, Colombian Society of Engineers, SCI, Bogotá 48 #9175, Colombia

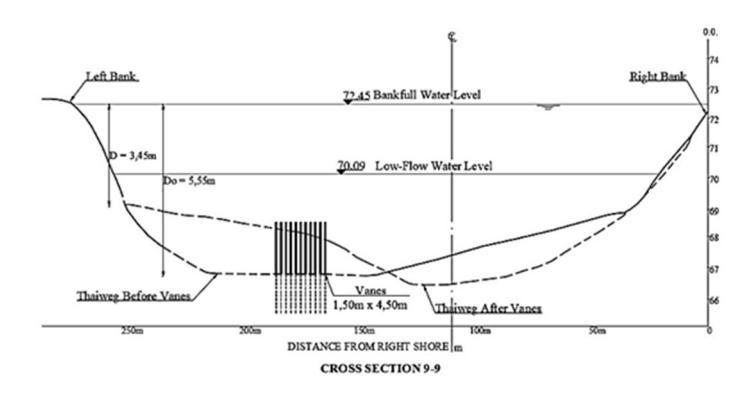
Figure 2. Cross section 9-9 used in the design of the vane field in front of the Aromatics dock.

The conditions for the design in cross section 9-9 (Figure 2) were as follows: flow, $Q = 3.850 \text{ m}^3/\text{s}$; average slope, S = 0.00029 m/m; mean sediment diameter, $D_{50} = 4.69 \text{ mm}$; width of the full section, B = 219.77 m; speed range, $V_{\text{max}} = 2.29 \text{ m/s}$ and $V_{\text{min}} = 1.69 \text{ m}$; radius of curvature, $R_c = 770 \text{ m}'$ approximately. For the design, vanes of $1.50 \times 4.50 \text{ m}$ were adopted, with a separation of 4.0 m between panels and 40 m between arrays (Odgaard and Wang, 1991a [3]; Hidroconsulta, 1991 [8]). According to Odgaard and Mosconi (1987) [4], the resistance parameter of the channel (m) was 7.29 m, corresponding to a Darcy-Weisbach friction coefficient of 0.025. It was concluded that there was a need for at least 58 vanes to be distributed in nine sets of seven units each. However, due to the lack of a clear definition of the edge for section 7-7 (Figure 3), it was decided that the first array would comprise 15 vanes, while the other eight would consist of seven units each, for a final design with a total of 71 vanes (Figure 3).

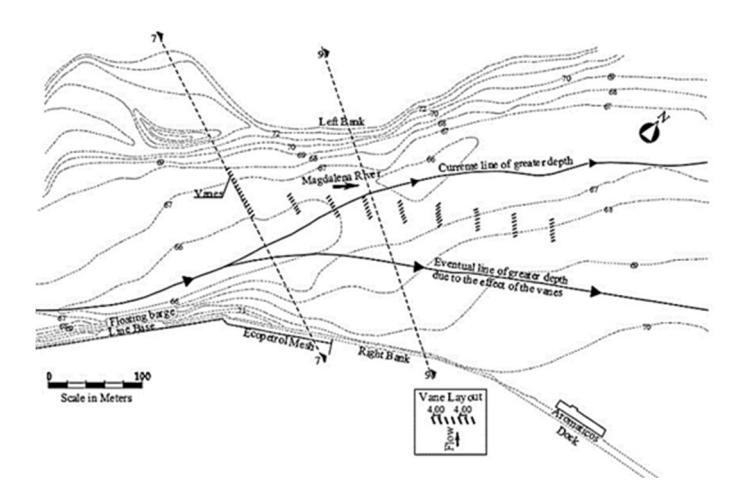
Figure 3. Location of the submerged vane field in front of ECOPETROL's Aromatics pier (Hidroconsulta, 1991).

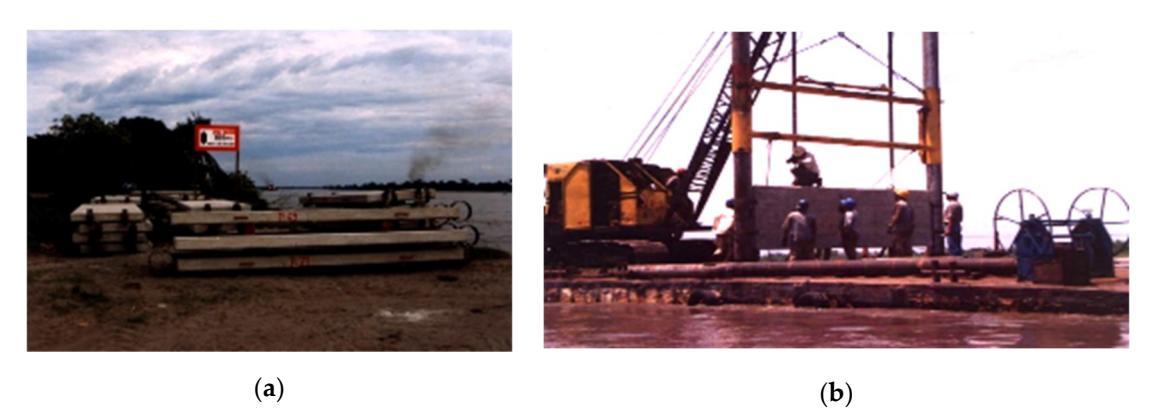
Figure 4. Magdalena River, ECOPETROL Aromatics pier: (**a**) storage of vanes in the riverfront before installation; (**b**) vane installation process (Hidroconsulta, 1993).

The panels were made of reinforced concrete of $f'c' = 4000 \text{ psi} (280 \text{ Kg/cm}^2)$, 0.20 m thick, with four rings in a plate of $1/4'' \times 0.10$ m as a guide for the metal piles for which steel pipes $14'' \times 7$ m in length were used fixing them in the bed. The initial design envisioned a 10'' pipeline, but the use of a 14'' oil pipeline, supplied directly by ECOPETROL, was chosen. Figure 4 shows the storage of vanes at the riverfront and the installation process.

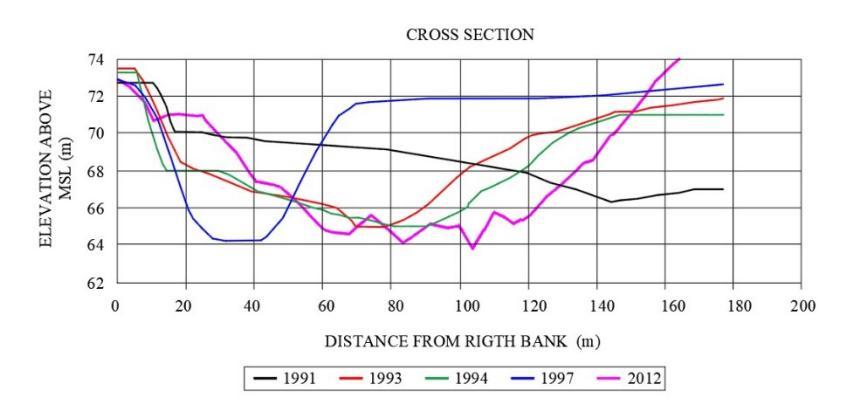
Figure 5. Effect of the submerged vane field installed in front of ECOPETROL's Aromatics pier in 1993 over time.

By facilitating the access of ships to the dock 45 days after it was installed, the scouring generated by the vane system near the pier was, in practice, immediate. The modification of the cross-section through sedimentation around the vanes and the deepening of the canal in front of the pier are shown in Figure 5 for the years 1991–1997, a period during which the system was followed. The figure also includes the results of a bathymetry performed 20 years later in 2012, which highlights a new sedimentation progression near the pier, the causes of which have not been investigated but suggest that the design and construction of a second stage of vanes should be considered.

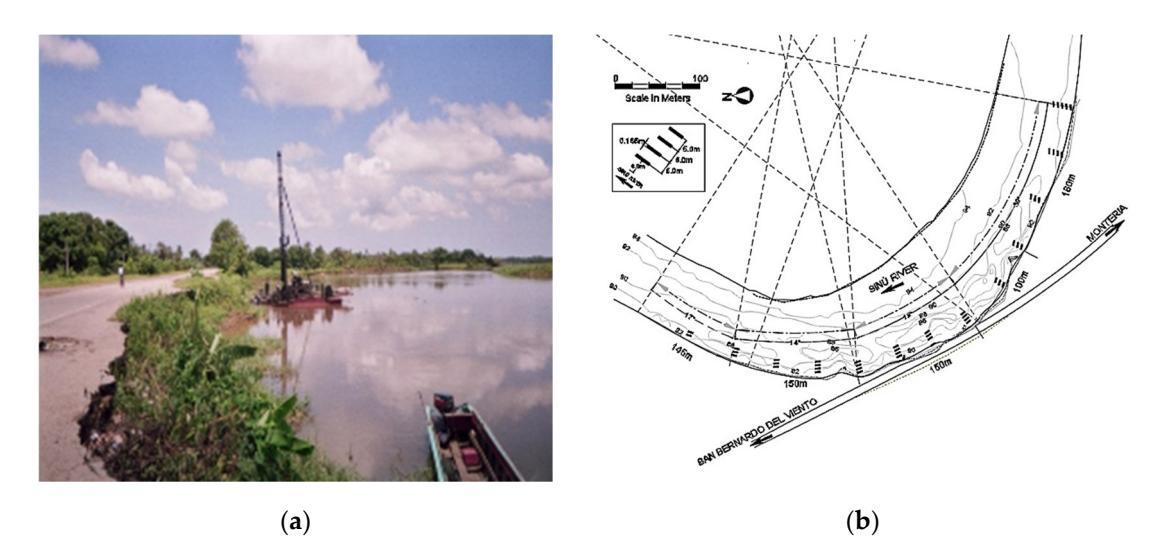
Figure 6. Sinú River, Trementino: (**a**) condition at the start of the project; (**b**) representative geometry used in the design (Hidroconsulta, 2004).

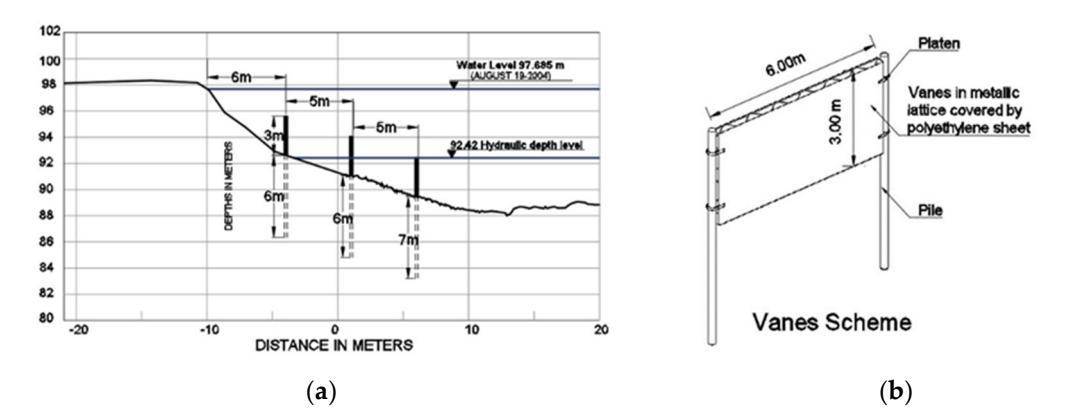
Figure 7. Sinú River, Trementino: (**a**) installation scheme; (**b**) characteristics of the panels (Hidroconsulta, 2004 [9]).

The vanes were initially designed using reinforced concrete, and were $6.0 \times 3.0 \times 0.165$ m, weighing 7.13 tons each; however, they were later redesigned to facilitate handling and installation operations. As a result, metal lattices coated with sheets of high-density polyethylene were made reducing the individual weights to only 780 Kg. The installation scheme and dimensions of the vanes that were ultimately adopted are presented in Figure 7.

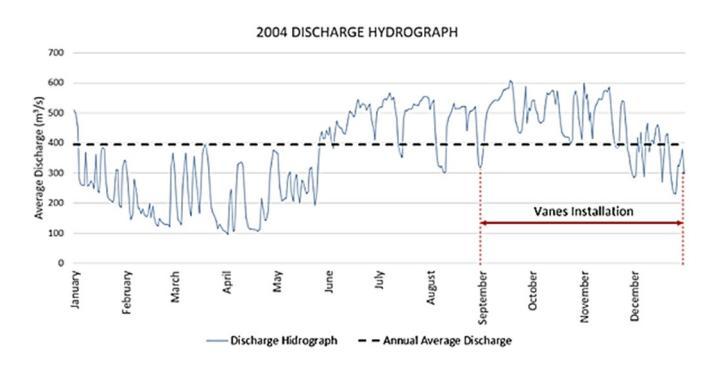
Figure 8. Sinú River, Trementino: daily flow series in 2004 (Source: Limnimetric Station The Doctrine, IDEAM).

The installation was carried out over 85 effective days between mid-September and December 2004 under extreme flow and water level conditions (Figure 8), as the flow rates during the construction

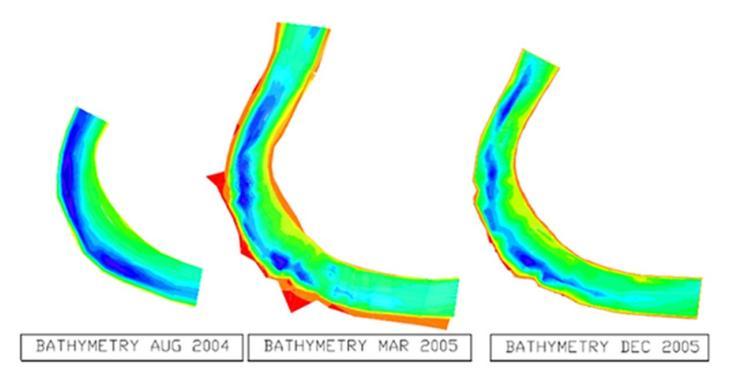
Figure 9. Sinú River, Trementino: evidence of the almost immediate effect of the displacement of the thalweg through the submerged panel field installed.

The effectiveness of the vane field installed in Trementino was determined by observing the changes in sedimentation and the transfer of the thalweg to the center of the channel over the course of a few months (Figure 9). These changes facilitated the rehabilitation and resurfacing of the affected section of the road. No maintenance has been required to date (2019).

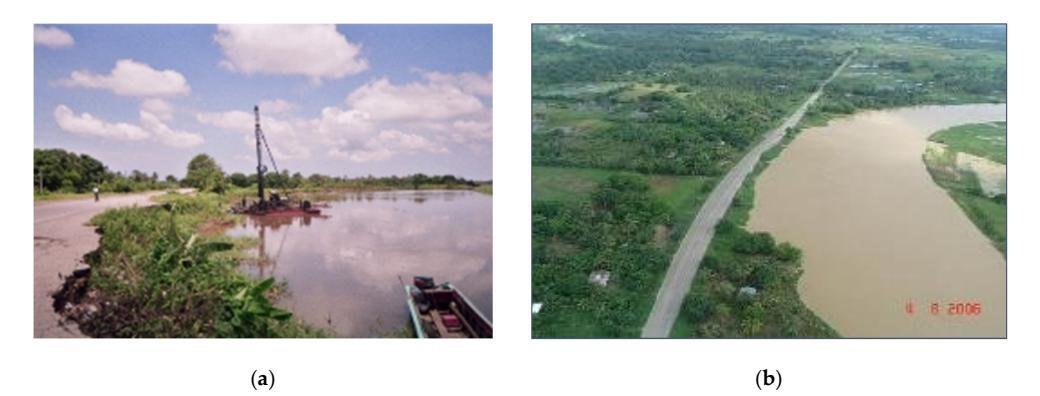
Figure 10. Sinú River, Trementino: (**a**) at the beginning of the panel installation in September 2003; (**b**) condition in August 2006, three years later (Hidroconsulta, 2003; 2006).

Figures 10 and 11 show the long-term effects (in the years 2006, 2011, and 2018) of the vane field installed in 2003. To date (2019), the site is stable, and no maintenance has been required since its construction.

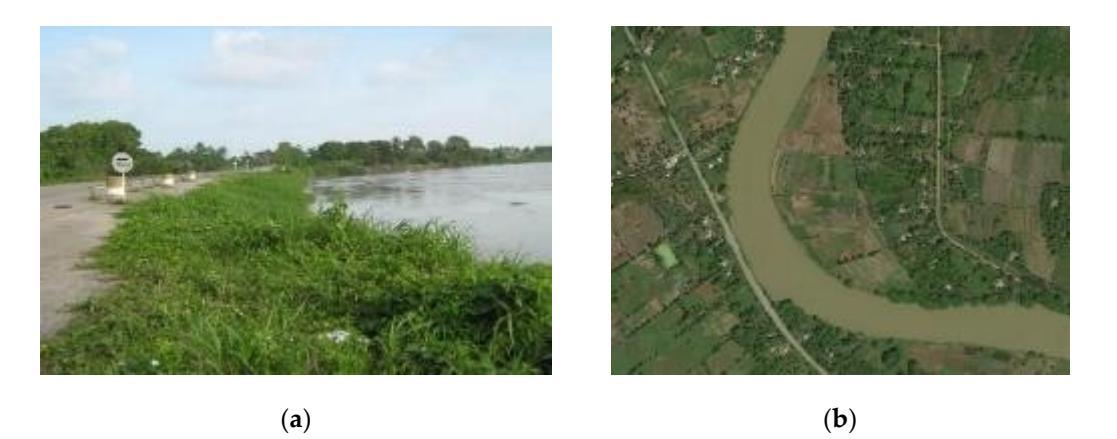
Figure 11. Sinú River, Trementino: (**a**) condition in March 2011, seven and a half years after installation; (**b**) condition in 2018, 13 years after installation (Hidroconsulta, 2011; ESRI, 2018 [11]).

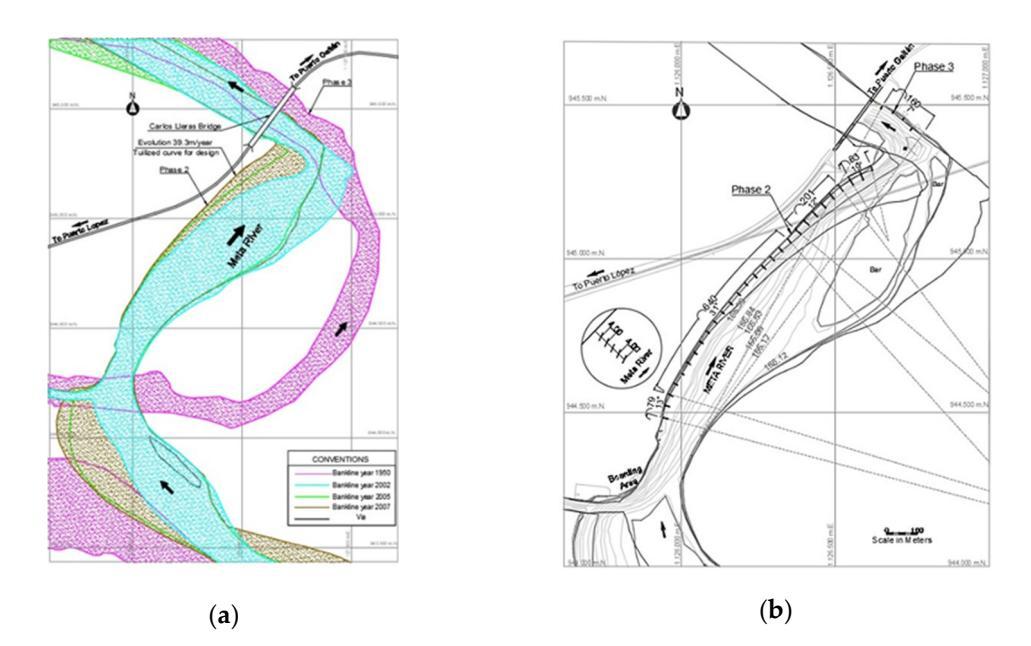
Figure 12. Rio Metica, Puerto López: (**a**) summary of the analysis of the evolution of the river among 1950, 2002, 2005, and 2007; (**b**) sector geometry and panel field design. Note the proximity of the river to the road in 2005 (Hidroconsulta, 2005 [13]; 2007 [12]).

The objective of the project was to control the evolution of a huge meander on the left bank of the Metica River in Puerto López through the so-called Phase 2 (Figure 12), which has approached the Puerto López–Puerto Gaitán highway at a rate of 39 m/year between 1939 and 2007 [12]. The road was less than 50 m from the river in 2005 (Figure 12a).

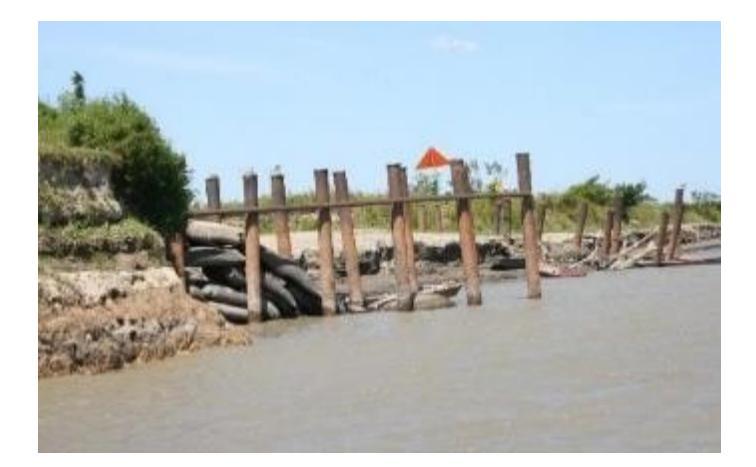
Figure 13. Rio Metica, Puerto López: the two spurs that remain, although highly deteriorated, of the six previously built.

A previous intervention consisted of six spurs built with two lines of metal pipe with the space between them filled with bags of concrete. Except for two of them (Figure 13), the spurs were soon destroyed by the river. Thus, it was decided to apply the submerged vane tecnology based on the geometry shown in Figure 12b (Hidroconsulta, 2005 [13]), which was adjusted two years later (Hidroconsulta, 2007 [12]) when its construction was initiated.

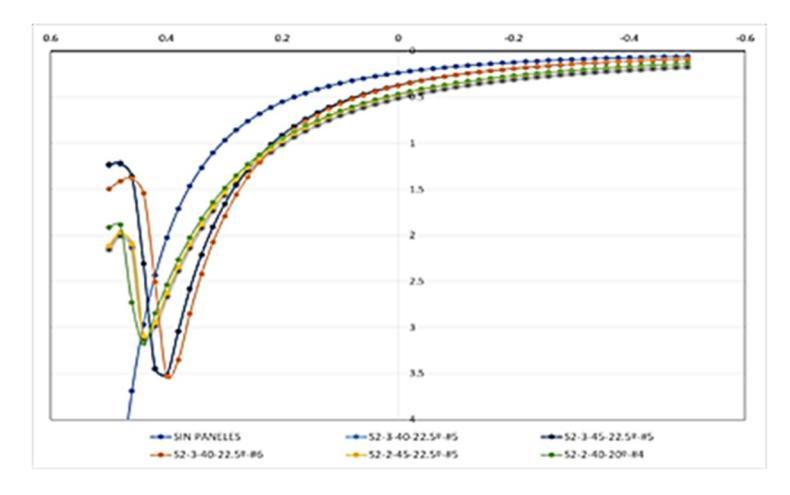
Figure 14. Rio Metica, Puerto López: optimal selection for the vane system.

For the estimated discharge of 1132 m³/s that fills the section, the results of the HEC-RAS model (USACE, 2001 [14]) were used in model BVANE (Odgaard [10]) (Figure 14) to design the vane field for units of 1.50×4.50 m. The general parameters used were as follows:

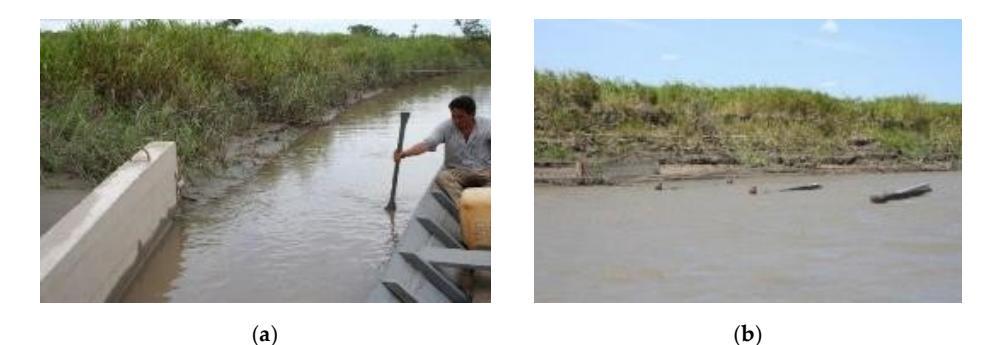
Figure 15. Metica River, Puerto López. (**a**) The sedimentation around the first panels of one of the sets generated bed depths of approximately 0.50 m, 15 days after installation. (**b**) Sedimentation progression as a result of submerged panels in January 2008 (Source: Hidroconsulta, 2007).

The system response in terms of the sedimentation produced was obtained in a very short time, as can be seen in Figure 15a,b.

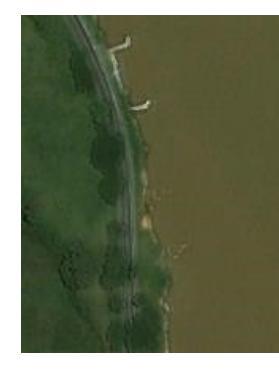
Figure 16. Cauca River, Guarumo: directional spurs around the 40 m long defense as a left bank protection (Source: BING Maps Aerial).

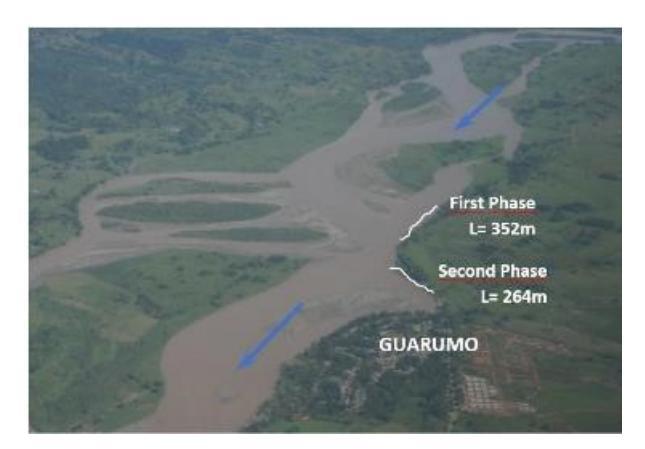
Figure 17. Cauca River, Guarumo: location of the two vane fields (Hidroconsulta, 2008).

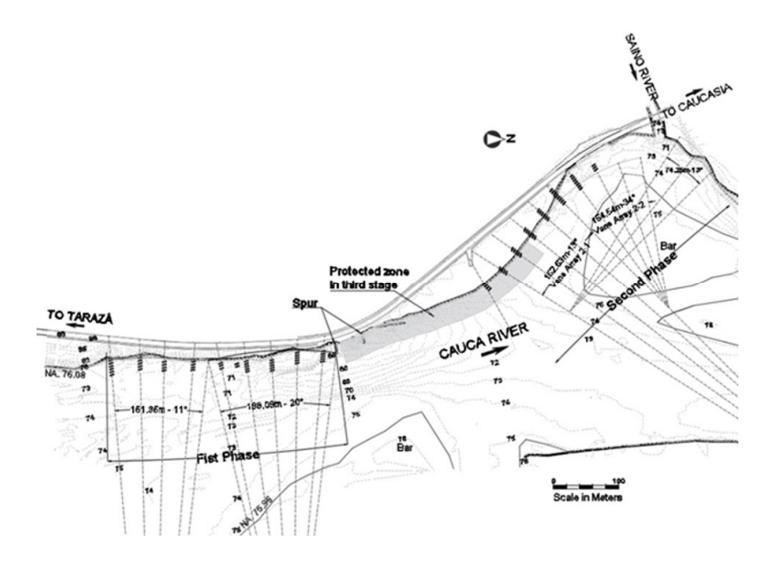
Figure 18. Cauca River, Guarumo: topo-batimetry and sector geometry for the design of the submerged vane fields (Hidroconsulta [11]).

Figure 18 shows the topography of the Cauca River in Guarumo and the geometry adopted for the design of the vane fields. Initially, the basic hydraulic parameters were determined for a full section flow of 1945 m³/s using the HEC-RAS model (USACE [14]), while the design was made with the BVANE program (Odgaard [10]) for vanes of 2.2×6.2 m and 1.2×6.2 m, which were used either independently or combined to achieve heights of up to 3.4 m. Thus, the optimal solution was determined for each sector. Figure 19 uses a depiction of subsector 1 as an example of the first stage.

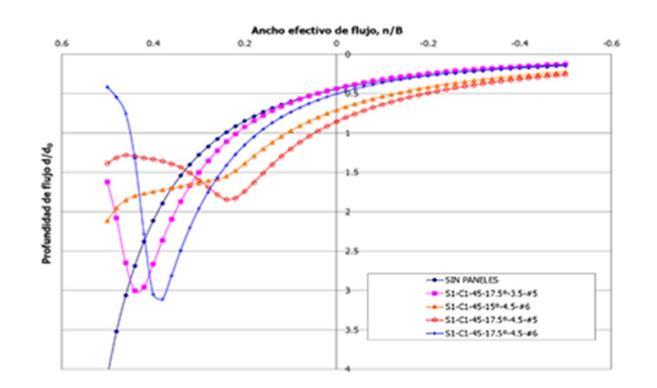
Figure 19. Cauca River, Guarumo: results of the BVANE program (Odgaard [10]) for the selection of the optimal solution with vanes using subsector 1, Stage I, as an example.

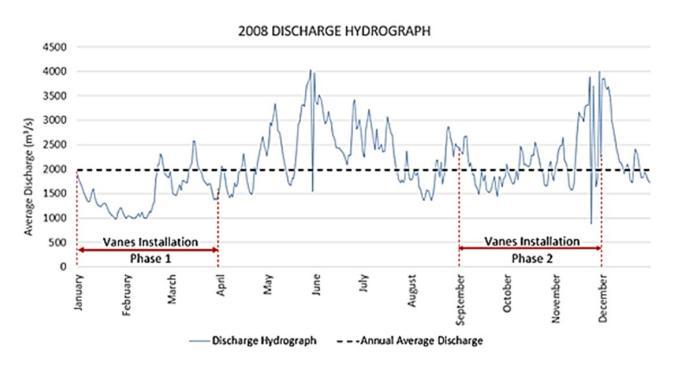
Figure 20. Cauca River, Guarumo: series of daily flows in 2008 (Source: La Coquera Station, IDEAM).

The first stage was completed in 95 days, from 26 December 26 2007 to 31 March 31 2008, while the second stage took 50 days, from 8 September to 25 November 2008 (Figure 20). During the development of the works, there were high flow discharges with velocities of approximately 4.0 m/s as well as changes in the direction of the current that were not present during the initial design of the panels. This presented a frontal attack on the slope between arrays 5 and 6 of the first stage, so the installation of the additional array 5A (consisting of two panels) was required.

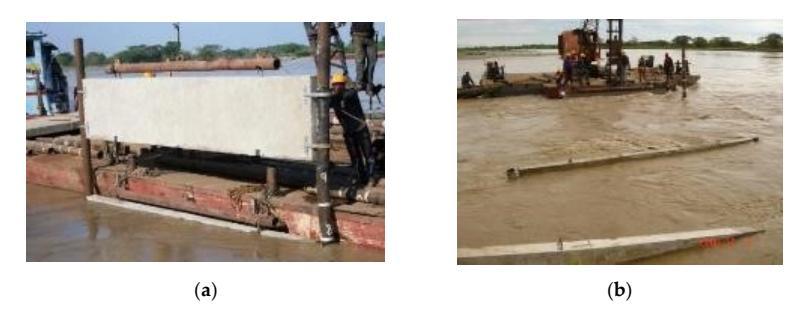
Figure 21. Cauca River, Guarumo: (**a**) positioning and installation of a double unit; (**b**) a set of vanes in the process of installation (Hidroconsulta, 2008).

The effect of the panel fields installed in Guarumo (Figure 21) became apparent from the very moment of installation, as shown in Figure 22a. Ten years later, in 2019, the protected sector is stable, as shown in Figure 22b.

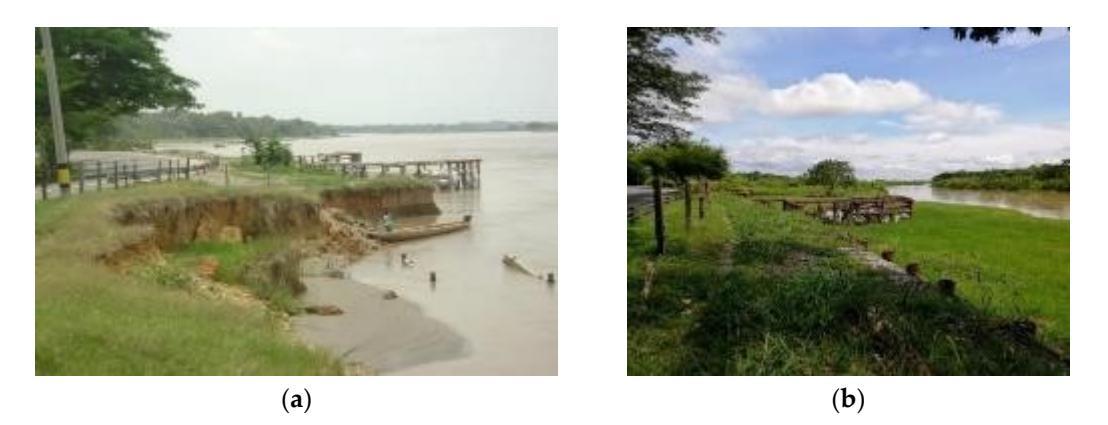
Figure 22. Cauca River, Guarumo site: (**a**) sedimentation generated shortly after the installation of the assemblies in front of the sector where the channel was initially less than 2 m from the road; (**b**) overview, in 2019, of the effect of vanes around the spurs shown in Figure 15 (Hidroconsulta, 2009; 2019).

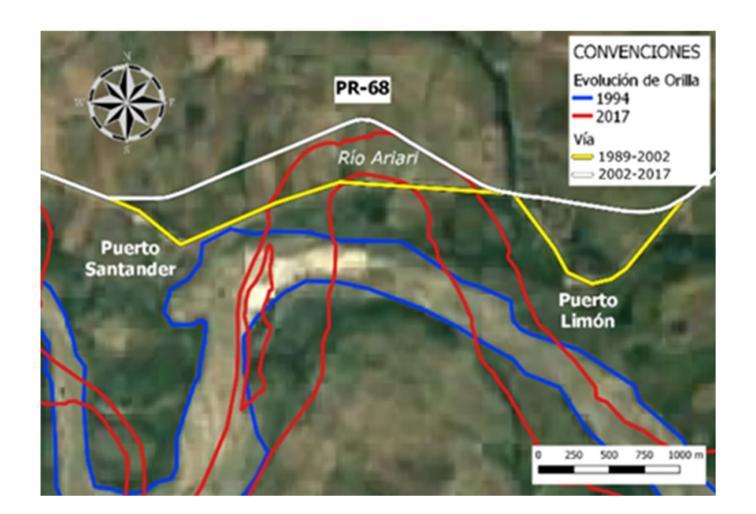
Figure 23. Ariari River, PR68: Position of the riverbed in 1994 and 2017, with respect to the original road and northern variant, near the municipality of Fuente de Oro. Note the direct threat along the river over the road (Source: Landsat, 1994 [17] – 2001 [18] – 2002 [19]).

Figure 23 shows the condition of the Granada-San José del Guaviare highway in 1994, in the vicinity of the PR68, where the road was slightly moved away from the left bank, to avoid the problem.

The river continued its process of evolution, with total damage to the road forcing the construction of the northern variant approximately 3 km from the river (Figure 23). However, as a result of the dynamics of the river in the area, this new variant was totally destroyed (Figure 24), revealing an evident need to prioritize control of the evolution of the river around the PR68 over the construction of new variants. Thus, to solve this recurring problem, the use of submerged vane technology was adopted.

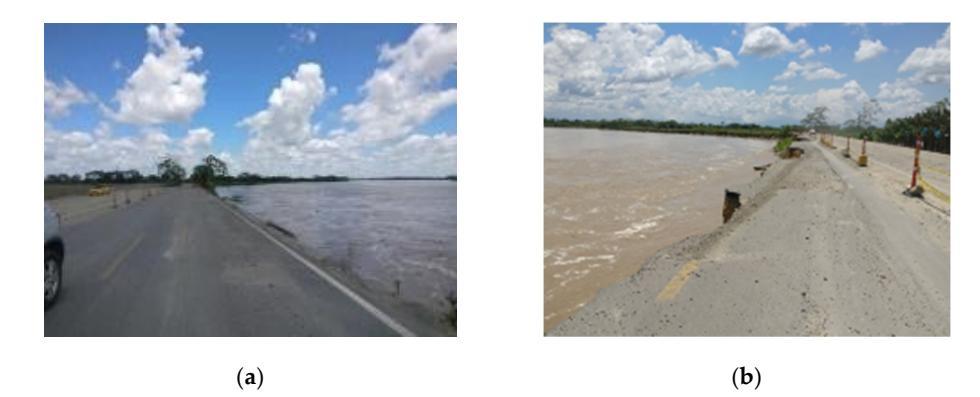
Figure 24. Ariari River, PR68: (**a**) road sector threatened by the river, without damage (before 2016); (**b**) halftrack bank was destroyed in 2017 (Hidroconsulta, 2017 [16]; 2018 [20]).

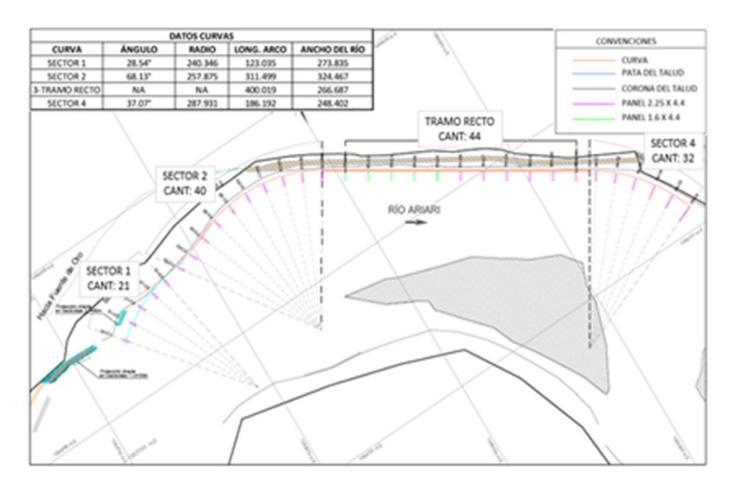
Figure 25. Ariari River, PR68: sectors defined for the design and layout of the vane system (Hidroconsulta [16]).

The design of the vane system (Hidroconsulta, 2017; 2018) was carried out considering a water discharge of 467 m³/s, with the hydraulic parameters obtained from the HEC-RAS (USACE, 2015 v5.0.1 [21]) and the BVANE model (Odgaard [10]) for panels of 4.4 m in length and 1.6 and 2.2 m in height. The four sectors are shown in Figure 25: one straight that was 420 m long, and three curved sectors of variable lengths and radii, all of which combined to determine a total length of 1110 m along the riverbank. As a result, the vane field was composed of 137 units distributed in 31 arrays, as shown in Table 3. Figure 26 shows the results of the VBANE model.

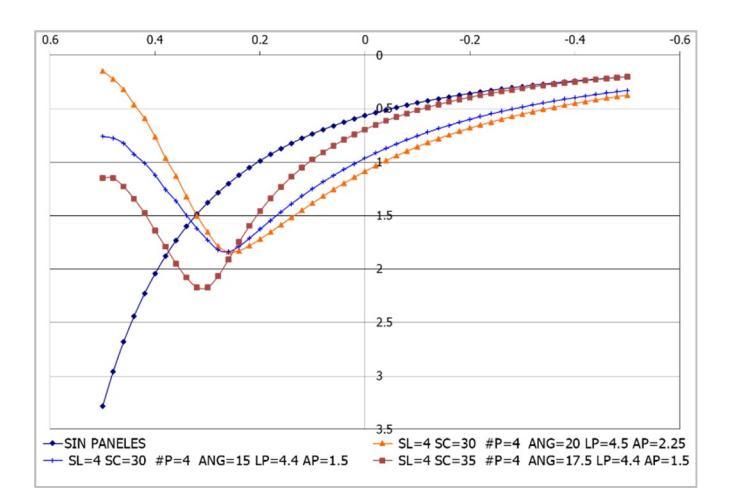
Figure 26. Ariari River, PR68: hydraulic modeling results with BVANE for different combinations of elements for the protective design, in a representative section.

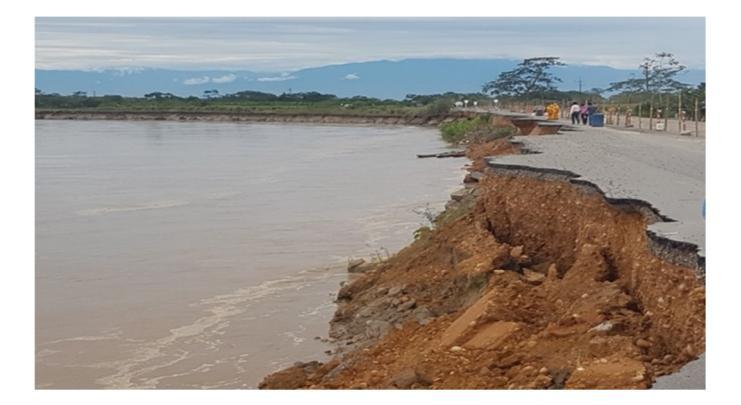
Figure 27. Ariari River, PR68: increased damage to the road embankment from intensive rains during May and June 2018 (Source: Hidroconsulta).

Seven months after the design was completed, beginning 4 May 2018, the C3 to C8 arrays were installed, in order, followed by the C1 to C3 assemblies. At this point, unfortunately, the rainy period intensified in the region, the intensities and durations of which generated increasingly frequent, large water flows and high transports of solids and vegetal materials. Thus, a wide isle of sediment was developed in the center of the channel, upstream of the arrays already installed. Fractionation of flows in the sector directed them from the right arm to the left bank, thus exacerbating the erosion of this bank. In addition, an effect of this significant new evolution was the even greater deterioration of the remaining embankment of the road, which in practice was completely razed (Figure 27).

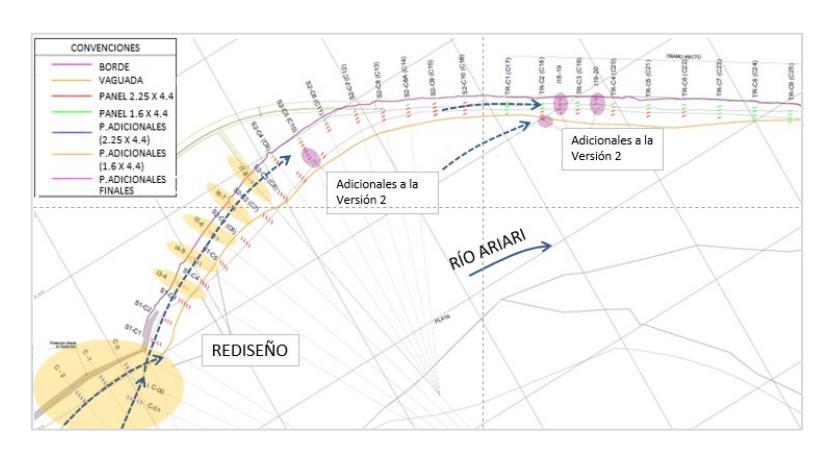
Figure 28. Ariari River, PR68: vane field installed according to version 2 of the redesign and additional vanes.

As a result, it became inevitable to redesign the vane system and radically counteract the frontal attack of flows on the bank. Thus, version 2 of the system was developed (Figure 28), with the addition of 34 units. Arrays C-00 and C-01 were placed on the major thalweg, and arrays C-0, C-1, and C-2 were placed in front of the upstream end of the system; all were installed between 9 and 20 June 2018. However, two sites were identified during the installation that showed a potential risk of erosive attacks by flows, so, to prevent possible future problems, version 2 of the redesign was complemented with 15 vanes that distributed in three new intermediate arrays: C18, C19, and C20. Thus, the vane field was eventually made up of a total of 186 units (Figure 28) that were distributed in 39 arrays.

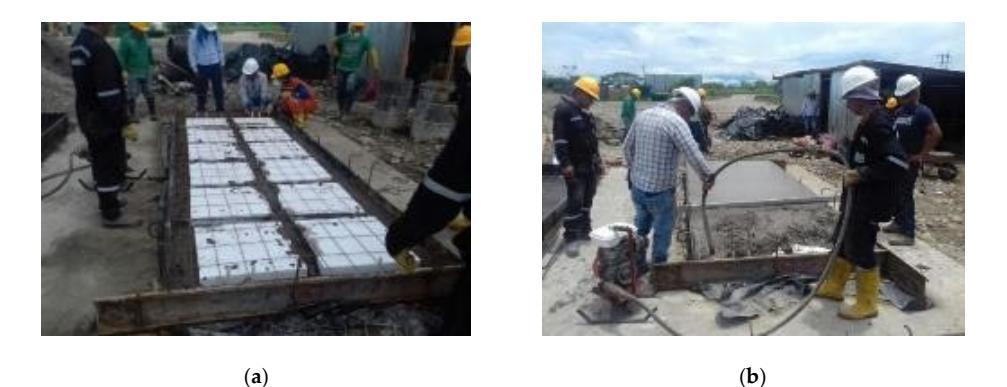
Figure 29. Ariari River, PR68: on-site manufacturing of reinforced concrete vanes, lightened. (a) Provision of the lightening material; (b) placement of concrete.

For the system, flat plates in reinforced concrete class C (280 kg/cm²), which were prefabricated in situ and lightened with 0.22 m thick polystyrene sheets, were used (Figure 29). To fix the vanes, steel pipe piles with 7" inner diameters and minimum wall thicknesses of 6 mm (0.24") were installed. The installation process is shown in Figure 30.

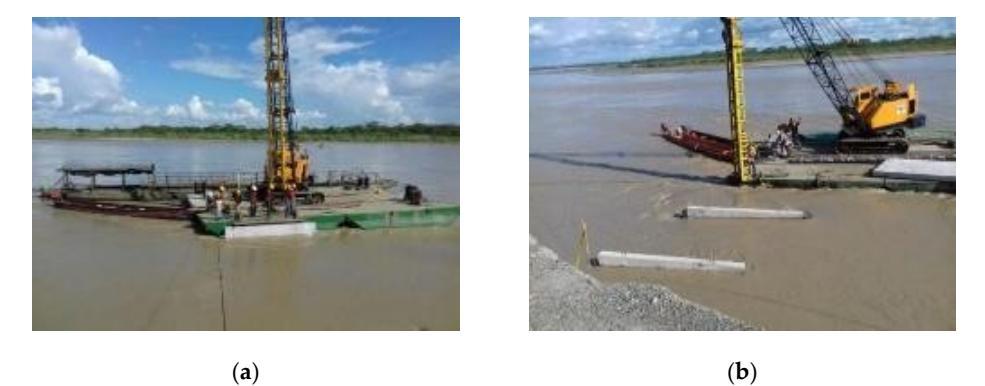
Figure 30. Ariari River, PR68: installation of vanes. (**a**) Positioning according to the design; (**b**) array in the process of installation.

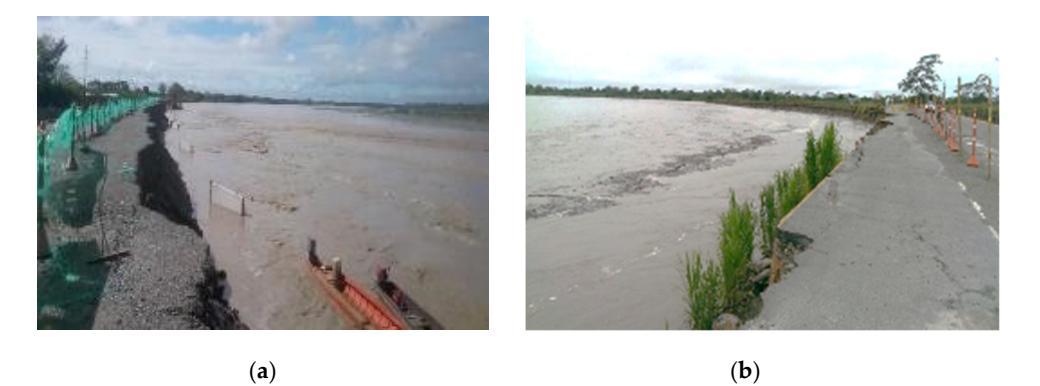
Figure 31. Ariari River, PR68: surface condition of the flows shows the transfer of the thalweg to the center of the riverbed by the panels. (**a**) Downstream view; (**b**) upstream, facing the semi-destroyed road. Compare with Figure 24 (Source: Hidroconsulta).

In the short period since construction between May and September 2018, the beginning of the sedimentation process envisaged in the designs was evident (Figures 31 and 32), and continued over time. The cost of the project amounted to only USD 1 million, which is very favorable compared to the construction of variants that have an average value from USD 1.5 million to USD 3.0 million per

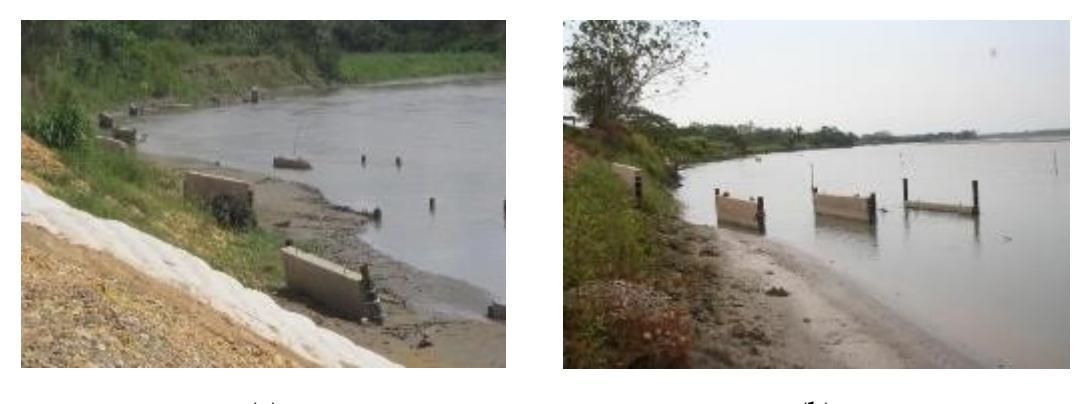
Figure 32. Ariari River, PR68: sedimentation in process around the vanes. (**a**) In the upstream sector; (**b**) before the straight section (Source: Hidroconsulta).
