Article

# Possibility of Capsizing of a Dredger during Towing

Jarosław Soliwoda, Adam Kaizer and Tomasz Neumann \*

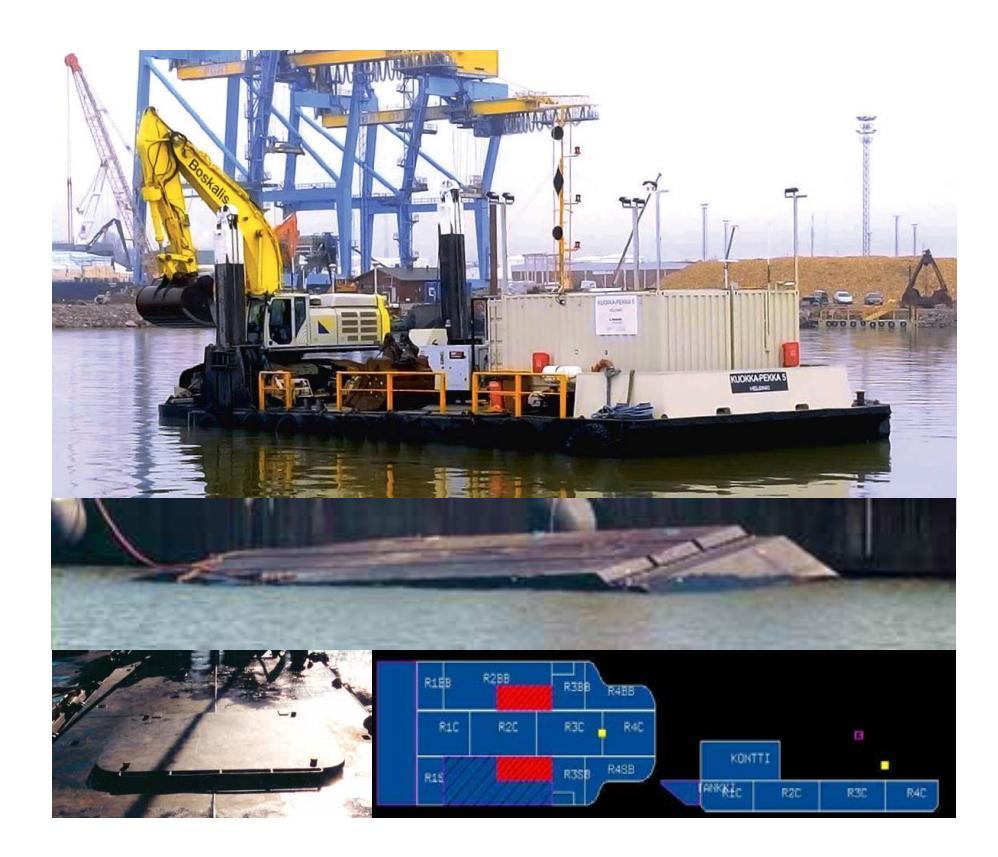
**Figure 1.** Dredger "Kuokka Pekka 5" capsized. GRT 104, Length 21.0 m, Breadth 9.4 m, Draught 1.7 m.

The accident took place on 19 April 1997, when this dredger was being towed from the Kotka port to Mäntyluoto by the tugboat "Nico". While towing in the open sea, sea water from the waves drained down into the left compartment of the winch through the hatch. As a result, this led to the dredger capsizing, which however remained buoyant (Figure 1).

The post-accident analyses indicate that the left winch compartment was being flooded for about 4.5 h. Finally, about 35 tons of water got into it. This caused the tilt and, together with the weather conditions, resulted in the dredger capsizing. Before the cruise, no stability analysis had been performed and the vessel's tightness had not been verified.

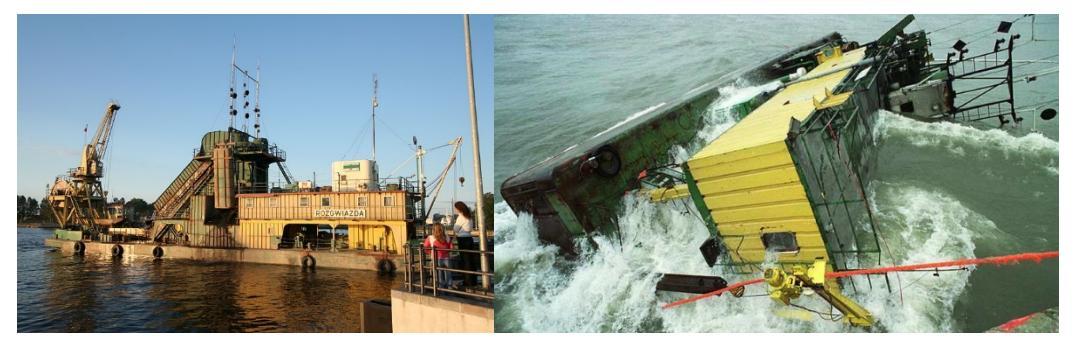
Figure 2. Dredger "Rozgwiazda" capsized. BRT 749, Length 51.4 m, Breadth 12.0 m, Draft 2.45 m.

The incident took place on 17 October 2008, about eight miles from the coast, between Kołobrzeg and Darłowo. The dredger "Rozgwiazda" was towed by the tugboat "Stefan" belonging to the corporation from Gdańsk, Poland (Dredging and Underwater Works Company Ltd.). Due to the increasing wind force and the sea state, the tugboat "Goliat" joined the towing; it was towing the tugboat "Stefan". During towing, the towing rope connecting "Rozgwiazda" with the tugboat "Stefan" broke. Twenty minutes later, the detached dredger, with no propulsion, capsized and began to sink. There were five crew members on board, who died as a result of capsizing of the dredger. The direct cause of the disaster, that the vessel sank, was the damage of the dredger's stability. Most probably it was due to the partial flooding of the boatswain's store room and the holds located on its starboard side near the bow with outboard water. The leakage was caused by the fact that during the journey the openings through which the line of the working anchor passed remained unsealed. This resulted in the dredger overturning with the keel up and the loss of buoyancy after the interior was flooded with sea water, which also entered through the open skylight to the engine room (Figure 2).

The dredger was not properly prepared for sea towing, which requires ensuring that the hull does not leak.

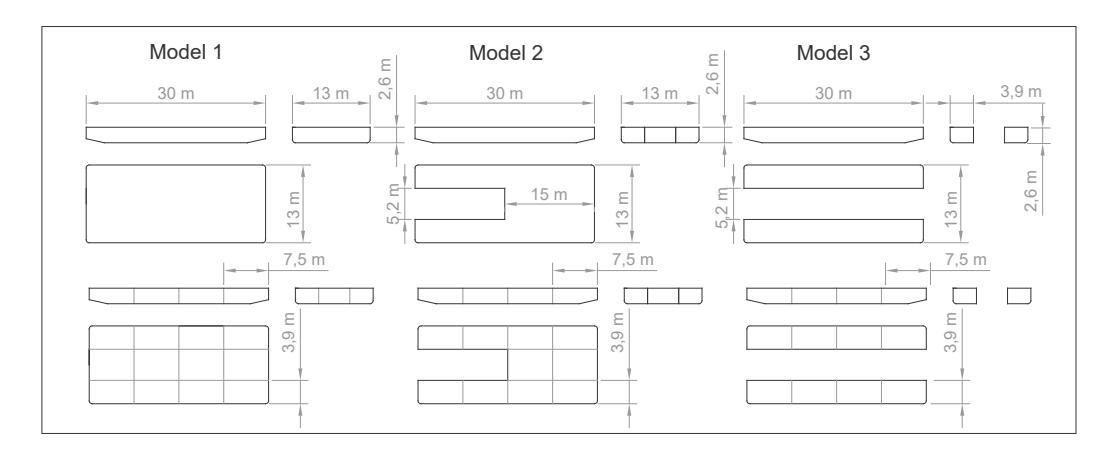
Figure 3. Models of dredgers.

The analysis of the risk of capsizing concerns three characteristic hulls of dredgers with equal primary dimensions, differing in the hull structure (Figure 3). Dredgers were divided into watertight compartments with identical dimensions for each model [18]. The hull shape of dredgers is similar to the capsized dredgers "Kuokka Pekka 5" — model 1 (Figure 4) — and Rozgwiazda" — model 2 (Figure 5). Model 3 (Figure 6) is based on existing harbor dredgers. The simulation analysis was carried out for a model similar to the dredgers actually used by PRCIP company in Polish harbors. The shapes and dimensions of the models have been simplified in order to compare the obtained results (Tables 2 and 3).

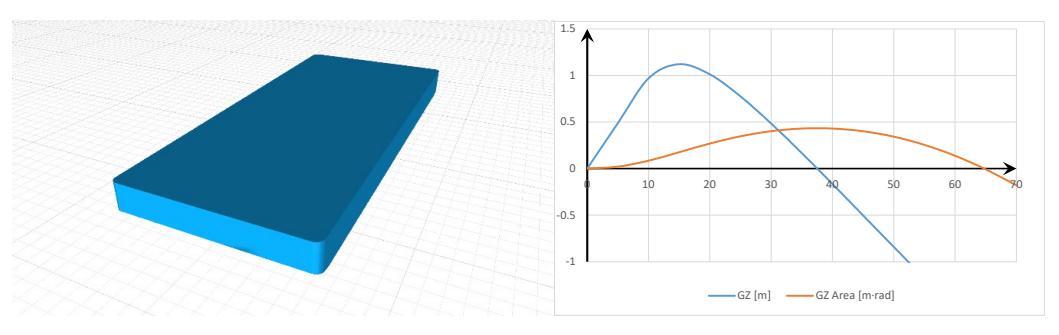
Figure 4. Model 1. GZ and Work (GZ Area) curve for initial condition.

All dredgers' models adopted for the analysis fulfill the stability requirements ISC'2008.

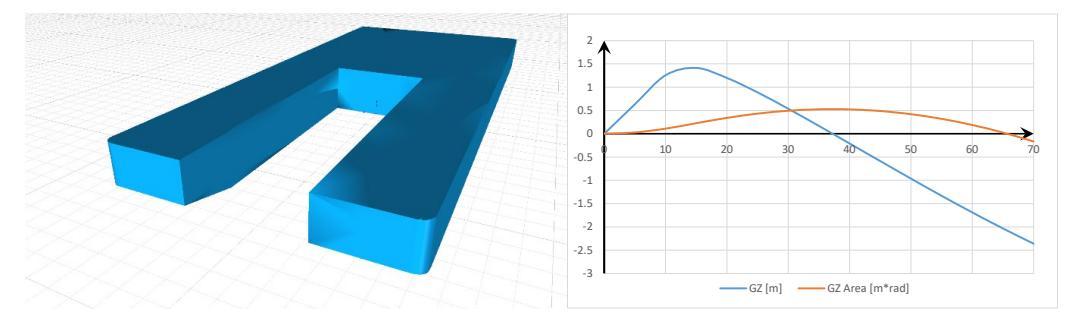
Figure 5. Model 2. GZ and Work (GZ Area) curve for initial condition.

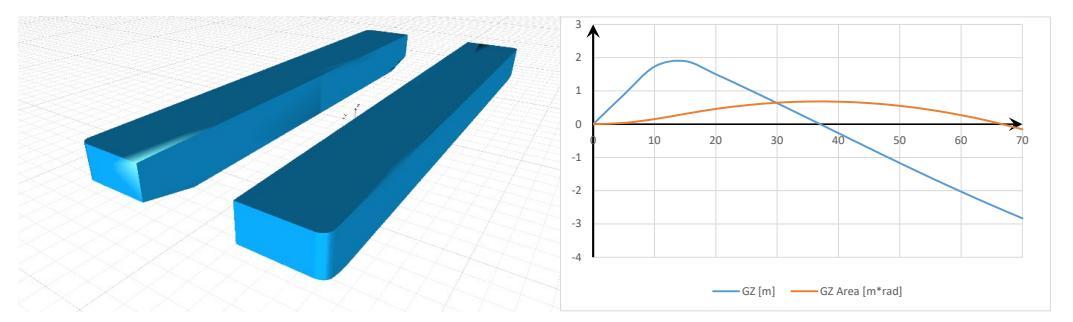
Figure 6. Model 3. GZ and Work (GZ Area) curve for initial condition.

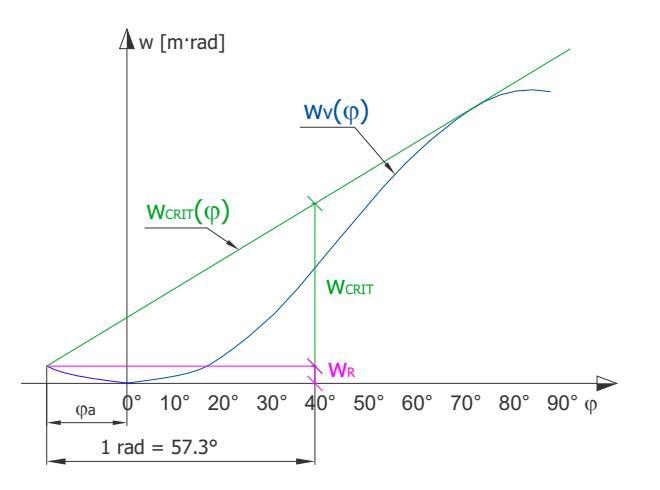
Figure 7. Critical work—*W*CRIT.

Dynamic overturning arms have been defined as the work required to overturn a craft per one ton of its mass (Figure 7).

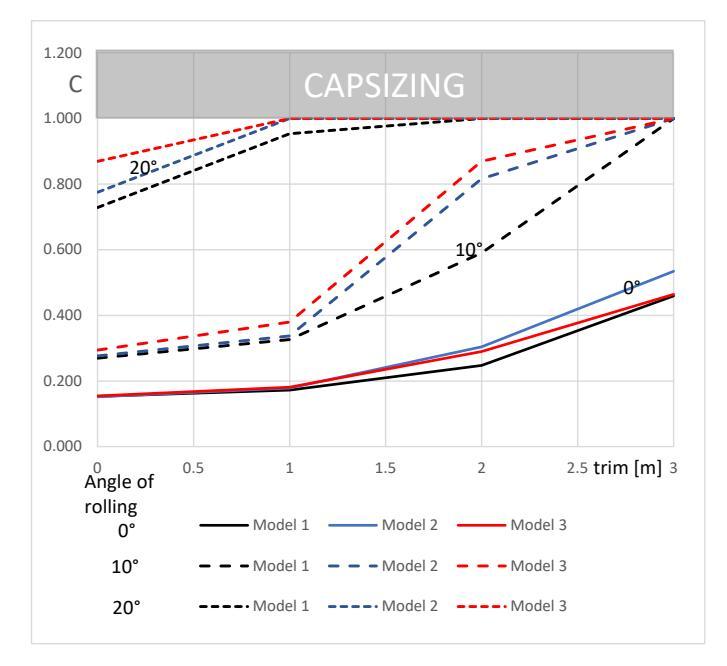
Figure 8. Values of the vessel's capsizing coefficient (C) depending on the trim and its rolling.

If the *C* coefficient is lower than 1.00, it means that the ship will survive the simultaneous phenomena of rolling, tow jerking and squall. However, reaching a value above one, indicates the capsizing of the ship (Figure 8).

For all models, capsizing is possible only when rolling exceeds 10° and a trim is up to 3.00 m for bow, and when the rolling is of 20° and the trim is more than 1 m. This means that significant longitudinal pitching, which increases the momentary trim of the vessel (diving), with simultaneous jerk of the tow and gust of the wind, may be a direct cause of vessel capsizing.

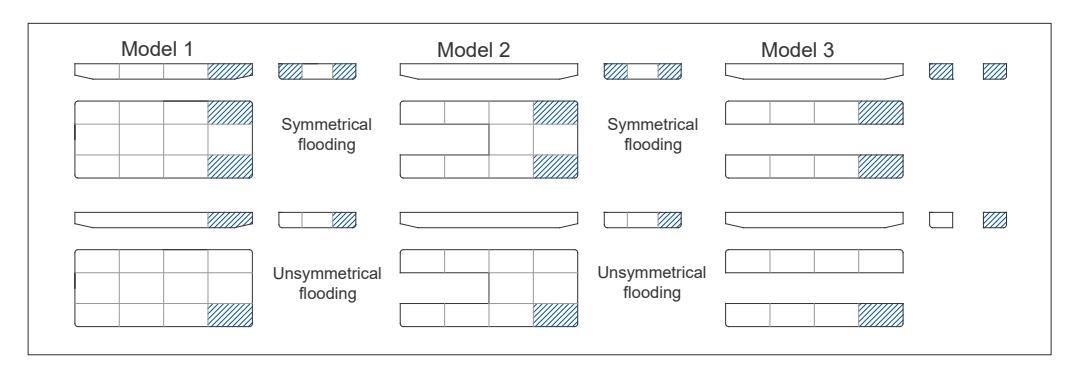
Figure 9. Flooding of watertight compartments.

In the dredger capsizing simulation, the phenomenon of unsealing of bow compartments, and their slow flooding, was analyzed (Figure 9). Two variants of flooding of watertight compartments were analyzed (Table 4):

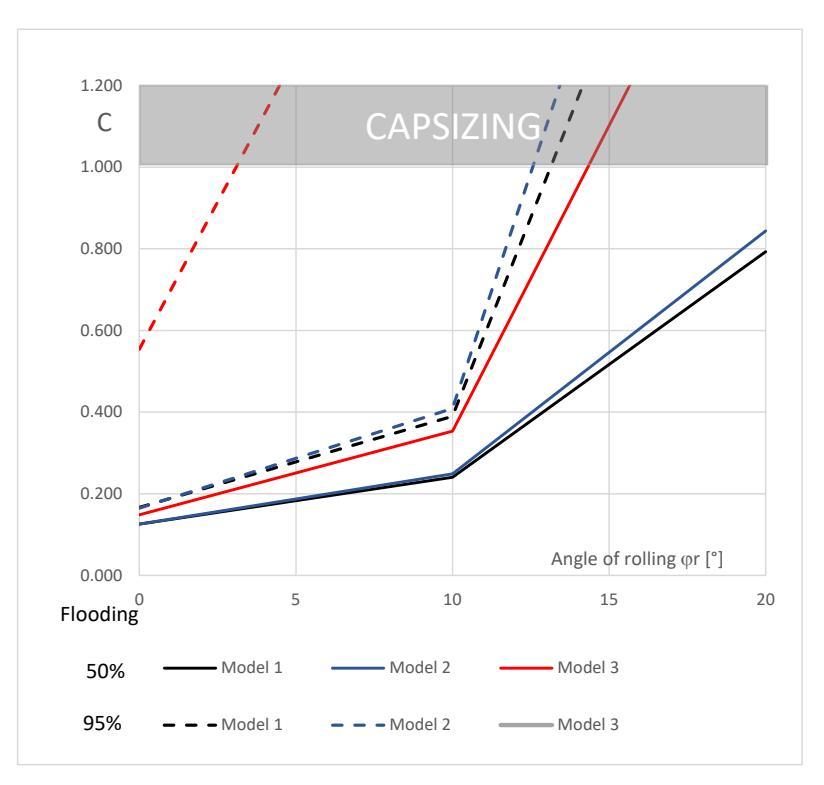
Figure 10. Values of the vessel's capsizing coefficient (C) depending on the trim and its rolling.

In the case of symmetrical flooding (Table 5), flooding of watertight compartments up to 95% of their capacity causes a trim of about 1.00 m for bow in models 1 and 2. On the other hand, in the case of model 3 it is 1.60 m. With increasing trim, the stability parameters of vessels decrease (Figure 10). What is more, when the rolling is greater than 13°, in the case of models 1 and 2, the impact of wind and the jerk of the tow may cause the watercraft to capsize. On the other hand, in the case of model 3 this may occur with the rolling of approx. 3°.

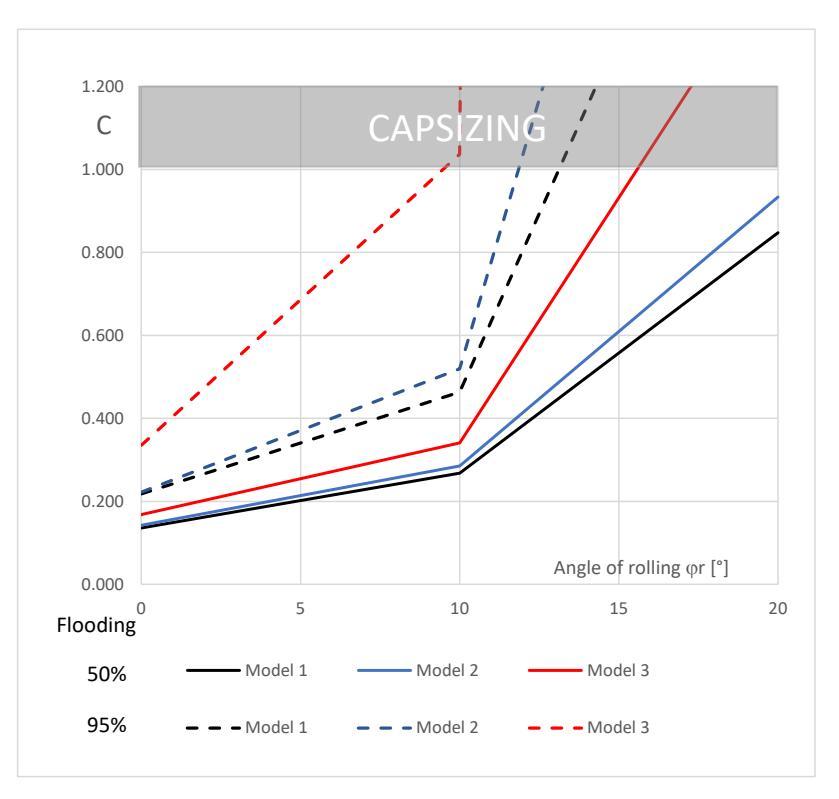
Figure 11. Values of the vessel's capsizing coefficient (C) depending on its rolling.

In the case of unsymmetrical flooding (Table 6), the flooding of a watertight compartment up to 95% of its capacity, causes heels of about 4° (Figure 11). The capsizing of the vessel 1 and 2 occurs at a rolling of  $12^{\circ}-13^{\circ}$ . On the other hand, the capsizing of the vessel 3 is possible at  $10^{\circ}$ .
