Campus Study of the Impact of Ultra-Low Flush Toilets on Sewerage Networks and Water Usage

Peter Melville-Shreeve ^{1,*}, Sarah Cotterill ², Alex Newman ³ and David Butler ¹

Keywords: sewer network; ultra-low flush toilets; water demand management

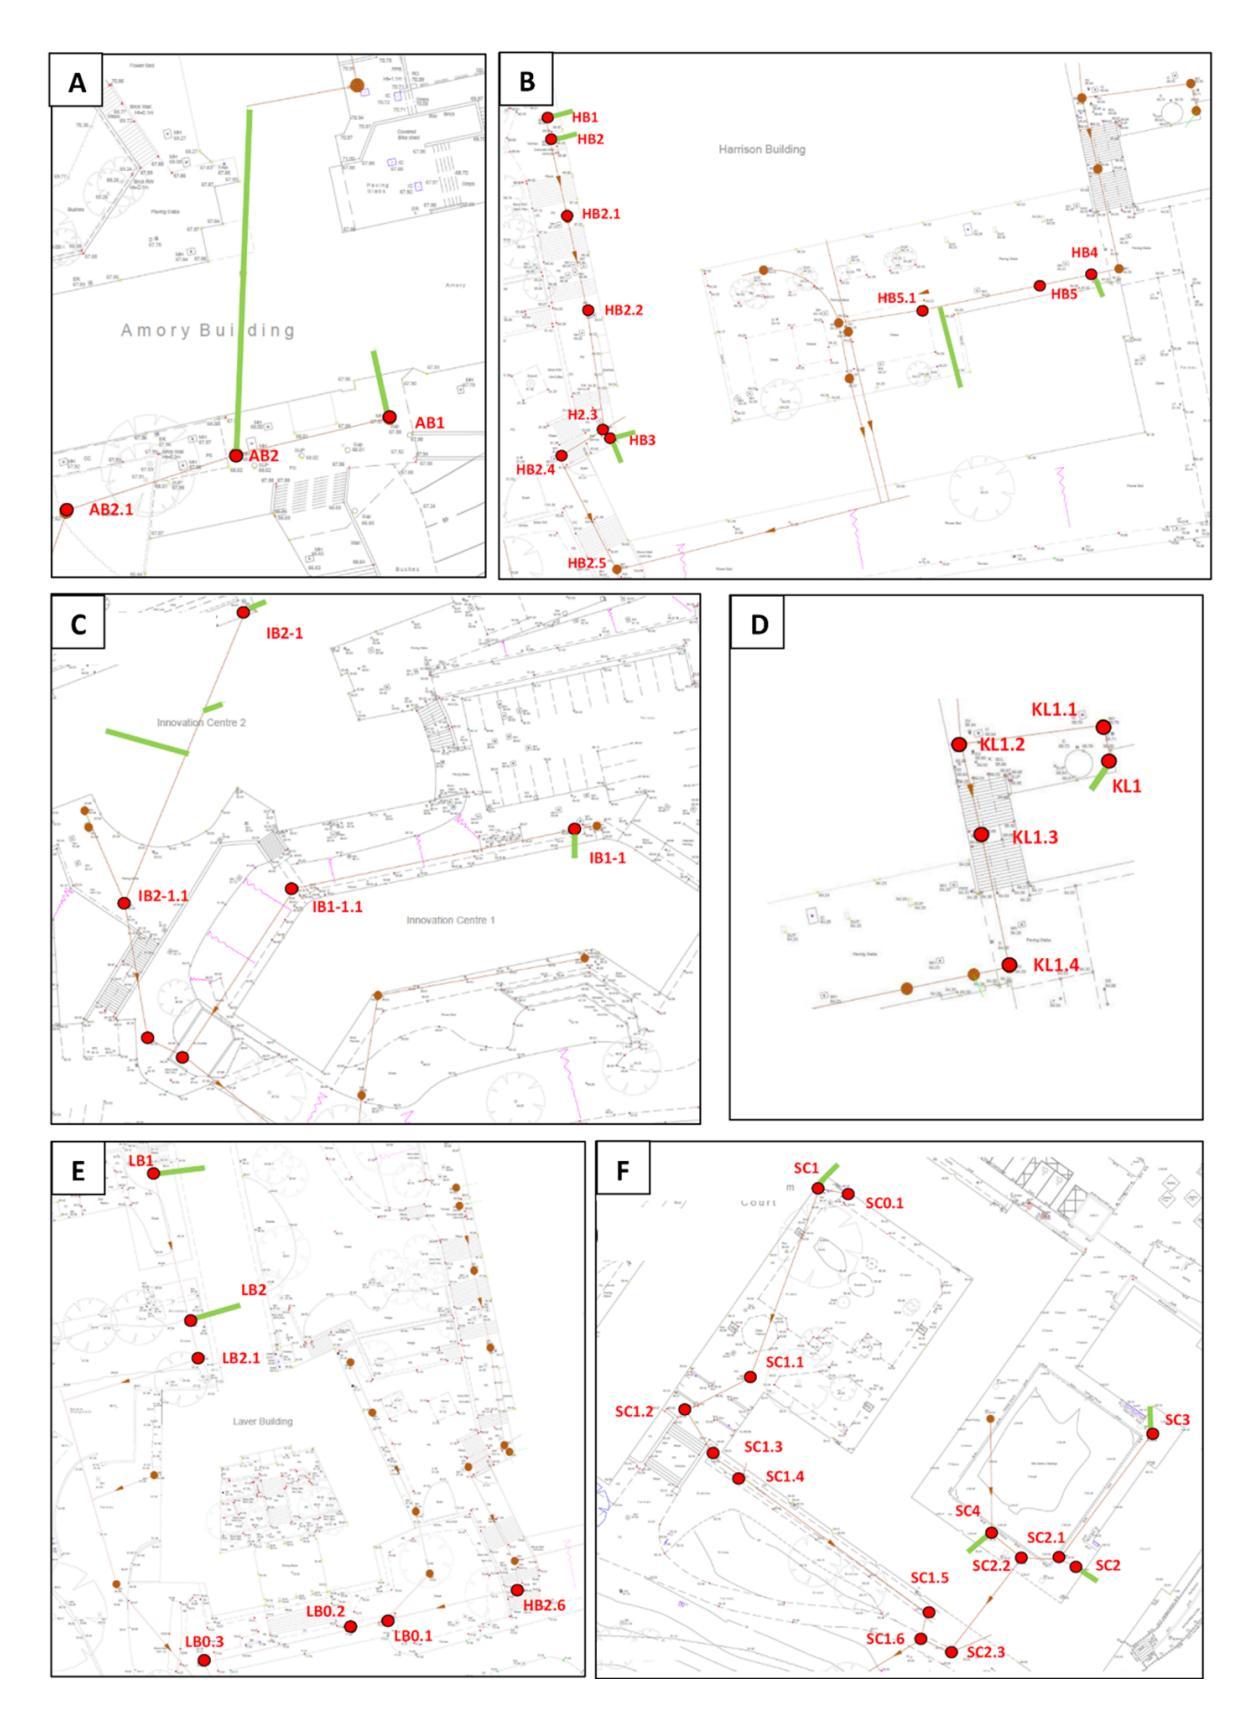
Figure 1. Survey locations for sub sections of the Drainage Survey where: (**A**) Amory Building, (**B**) Harrison Building, (**C**) Innovation 1 and 2, (**D**) Kay Building, (**E**) Laver Building and (**F**) Streatham Court. Red dots indicate manholes surveyed (with associated manhole ID), green lines indicate where a washroom with ULFTs enter a manhole chamber.

The spatial resolution of the survey was dictated by the physical arrangements of the drainage system. Initially, it was proposed that CCTV data would be obtained up and downstream of each foul manhole. However, this scope was expanded during the study period to assess for potential issues in chambers further downstream of each building. The survey locations for each building—identifying the manhole ID of each inspected manhole—is provided in Figure 1.

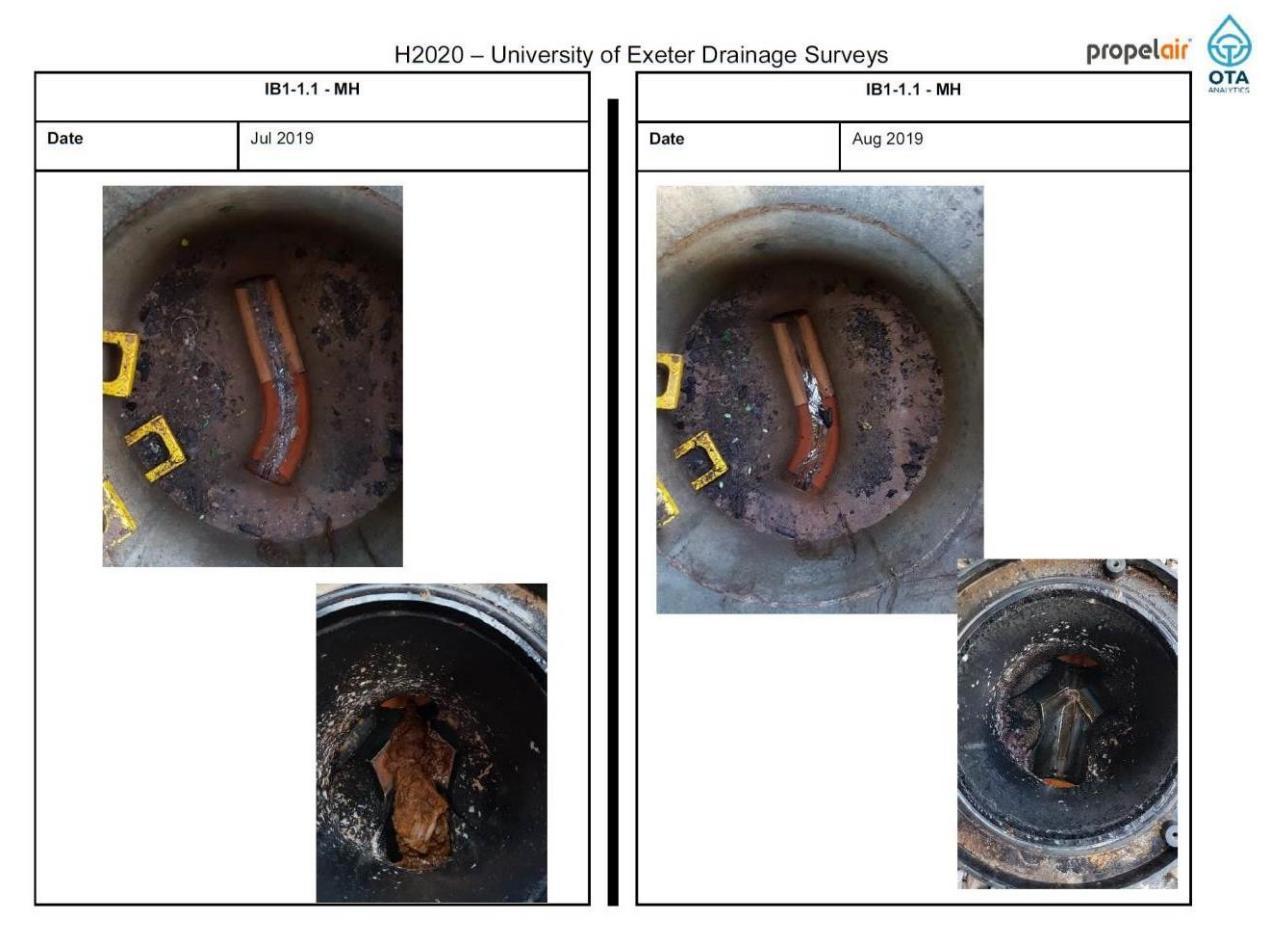
Figure 2. Example page from the Drainage Survey Summary Report illustrating changes to flow conditions on two separate survey dates (July–August 2019). (The drainage engineer observed that the upstream chamber (RHS) shows some waste build up in July 2019, which was no longer present in August 2019).

The surveys had a dual role. Firstly they provided monthly reports for the UoE estates team to identify any issues (e.g., root ingress/paper-towel blockages) which may warrant immediate attention. Secondly, they provided an evidence base which can be used to reflect on the flow conditions over a 12-month period downstream from the new WCs. An example of the survey sheets is illustrated in Figure 2.

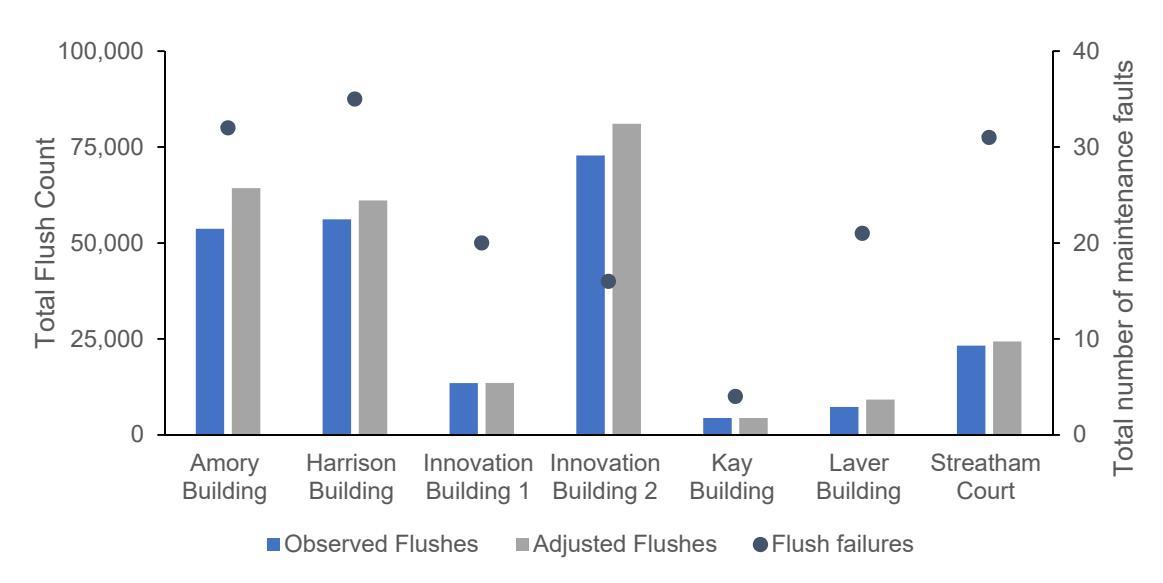
Figure 3. Total observed and adjusted flushes per building during the six-month study. Total number of maintenance issues resulting in a failure to flush shown on the secondary axis.

In the 6-month study period 231,114 flushes were recorded. This equates to approximately 6082 flushes per washroom. However, when adjusted to account for missing data (as described in 2.5) the total number of flushes was estimated as 257,925. The average adjusted flush count per washroom was therefore 6788 flushes. However, some larger buildings were used considerably more than others, with some experiencing nearly 25 times greater usage than others (Figure 3).

During the six-month study, 159 maintenance faults were recorded (Figure 3) of which, 95 were associated with the ULFTs (59.7%). This included 41 blockages, 33 instances where a ULFT did not flush, 8 broken components, 4 instances where the ULFTs were flushing constantly, 2 odour issues and 7 other complaints. Blockages occurred in five out of the seven buildings observed, with no blockages in Innovation Building 1 and Kay Building. The average number of flush failures per toilet across the six-month study at seven buildings was 0.55 ± 0.66 , which suggests an average toilet may fail to flush approximately once per year. There was a high variability between building, where the number of flush failures ranged from 0.1 flush failures per toilet in Streatham Court to 2 flush failures per toilet in Kay Building. It could be argued the data from the Kay Building is an outlier, potentially with a single toilet that needed frequent adjustment. If the Kay Building is removed, the average number of flush failures per toilet across the remaining

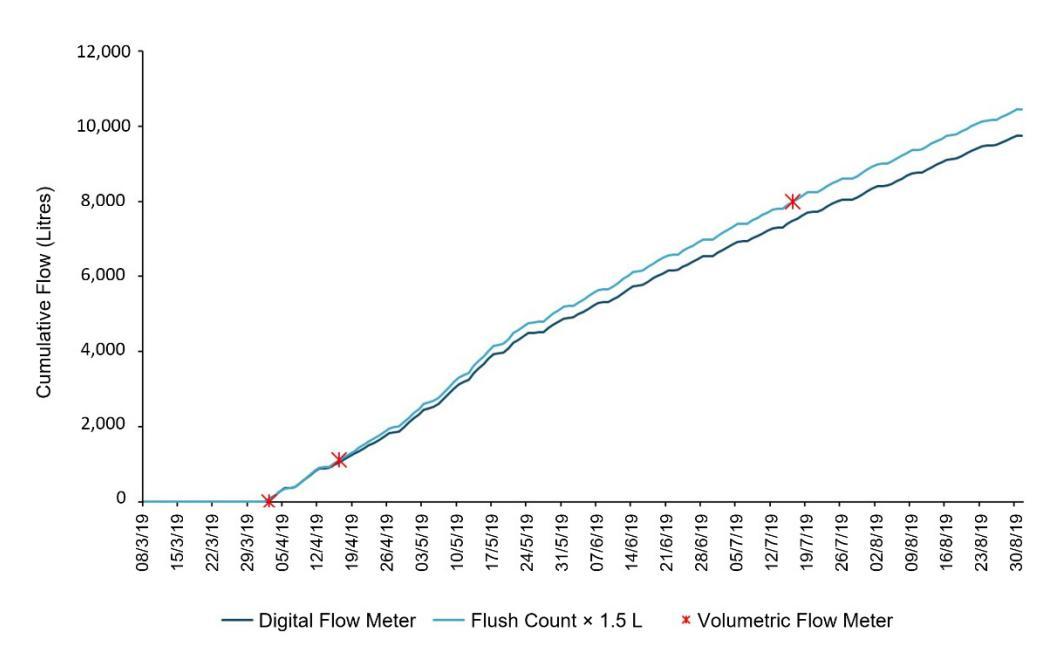
Figure 4. Comparison of flush counts, flow meters and water meter at HB-02-289-M-2.

Data from the Harrison Building's flow meters is presented alongside the flush count data and manual water meter readings for a single washroom in Harrison Building (Figure 4). Although an imperfect fit is observed, this offers validation that the flushcount method is robust in capturing water demand and reinforces its usage as a water demand monitoring method in the remaining buildings. It is observed that the volumetric water meter reading (as illustrated by the red asterisk on Figure 4) shows a discrepancy against the flush counts. Notwithstanding the fact that some volumetric meters could not be fitted with idealized straight-pipe runs entering/leaving them, this meter data is considered a reliable benchmark and confirms the flow meter to be performing accurately. However, the flow meter appears to over report the water demand by 0.2 L/flush (i.e., indicates a mean flush volume of 1.7 L, not 1.5 L) within the Harrison building. Several potential causes of this are considered. These are set out in order of likelihood based on the authors' observations. Firstly, a discrete event (i.e., a leaky toilet running for a long period of time) could draw flow through the flow meter without being recorded by the flush counter. Secondly, this might occur as a continuous fault, with a given toilet entering this failure mode on more than one occasion (perhaps for a short period of time after each flush). It is also plausible that the flush counting mechanism can miss double-flushes. In certain instances it is also plausible that an unknown appliance is connected downstream of the flow meter installation (that was not identified when the plumber surveyed and installed the systems). Further case by case analysis is necessary to explore such discrepancies; however, for the purpose of establishing the accuracy of the monitoring equipment deployed in the study, it is conservatively estimated that each WC flush is, on average, associated with 1.7 L of water demand (despite the 1.5 L cistern volume of the deployed ULFTs). It is noted that such a phenomenon is described within the leaky loo studies which indicate that standard WCs also exhibit water demand characteristics in excess of their design flush volumes [22].

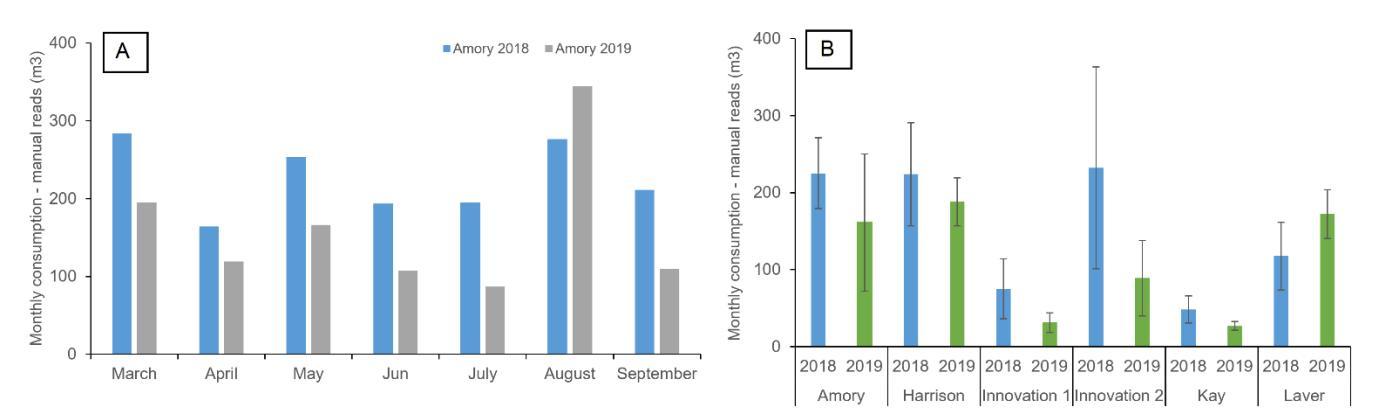
Figure 5. Comparison of estimated monthly consumption based on (**A**) manual monthly readings the Amory building between March–September 2018 (prior to ULFT installation; blue) and March–September 2019 (during this study; grey); and (**B**) mean meter readings for the aforementioned periods in 2018 (blue), 2019 (green) for each building.

Actual meter readings (used for billing purposes) were obtained at the building level from UoE estates team (A Mitchell, personal communication, 7 Jan 2020). These readings are obtained manually approximately monthly, but there is some variation in the time interval between readings. Therefore, a monthly consumption estimate (in m³) was calculated by subtracting the previous monthly meter reading from the current one, dividing by the time interval between readings, and multiplying by the number of days in that month. Monthly consumption was compared for two comparable time periods; one of which covered the duration of the study described in this paper, and one which covered the same number of months one year prior to the study. This enabled a comparison of the monthly meter readings at the building level, prior to and after ULFT installation (Figure 5A). Monthly consumption was lower in 2019 (after ULFT installation) than 2018 (before ULFT installation) in all buildings except for Laver (Figure 5B).

Estimates of building-level monthly potable water consumption were compared for two comparable seven-month periods in 2018 (prior to ULFT installation) and 2019 (after ULFT installation). The assumption of normality of data was violated, as assessed by Shapiro–Wilk's test (p = 0.005). The distribution of differences was not symmetrical for any of the buildings and therefore the related-samples sign test was selected as an appropriate non-parametric statistical test. The sign test was used to compare the differences in monthly consumption estimates in each building across the two years. There was a slight decrease in median monthly water consumption, which was not statistically significant in three buildings: Amory, where monthly consumption averaged 119 m^3 in 2019 and 211.0 m^3 in 2018, z = -1.512, p = 0.125 (Figure 5A); Innovation 1, where median monthly consumption was 24.6 m³ in 2019 and 71.1 m³ in 2018, z = -1.512, p = 0.125; and Harrison, where monthly water use averaged 184 m³ in 2019 and 210.0 m³ in 2018, z = -1.225, p = 0.219. Two buildings saw a statistically significant reduction in mean monthly metered consumption across these time periods. This included Innovation 2, where monthly consumption averaged 184.9 m³ before ULFT installation and 81.2 m³ after ULFT installation, z = -2.268, p = 0.016; and Kay where monthly water use averaged 48.1 m³ in 2018 and 25.9 m³ in 2018, z = -2.268, p = 0.016 (Figure 5B). Finally, there was a slight increase in median monthly water consumption in Laver (2018 = 108.9 m³; 2019 = 182.8 m³), but this was not statistically significant, z = 0.756, p = 0.453.

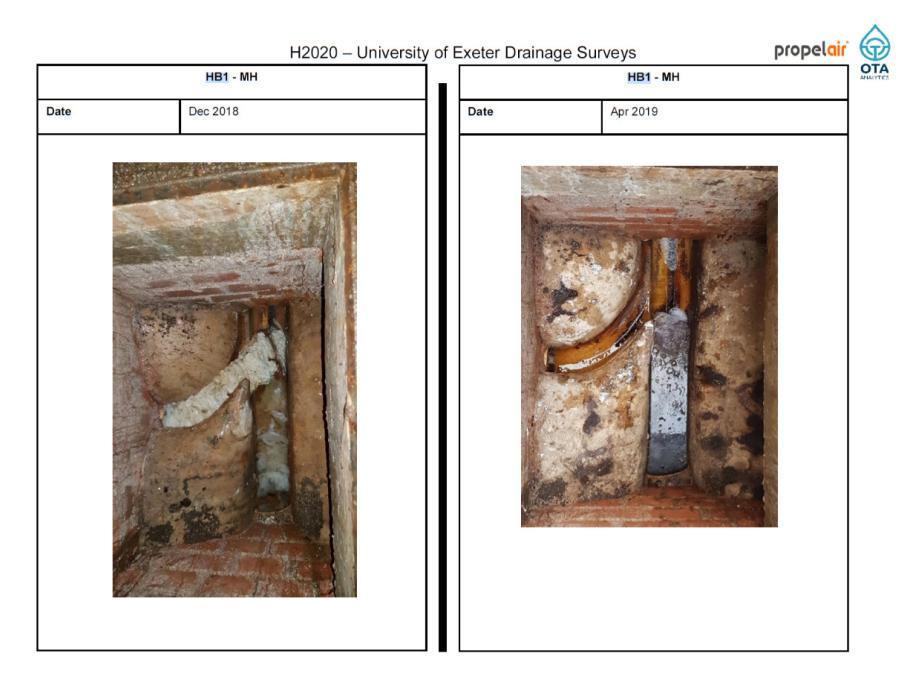
Figure 6. Photograph of Manhole HB 1 from lift and look surveys in December 2018 and April 2019. The image on the left-hand side shows a blockage in the chamber caused by a build-up of rag.

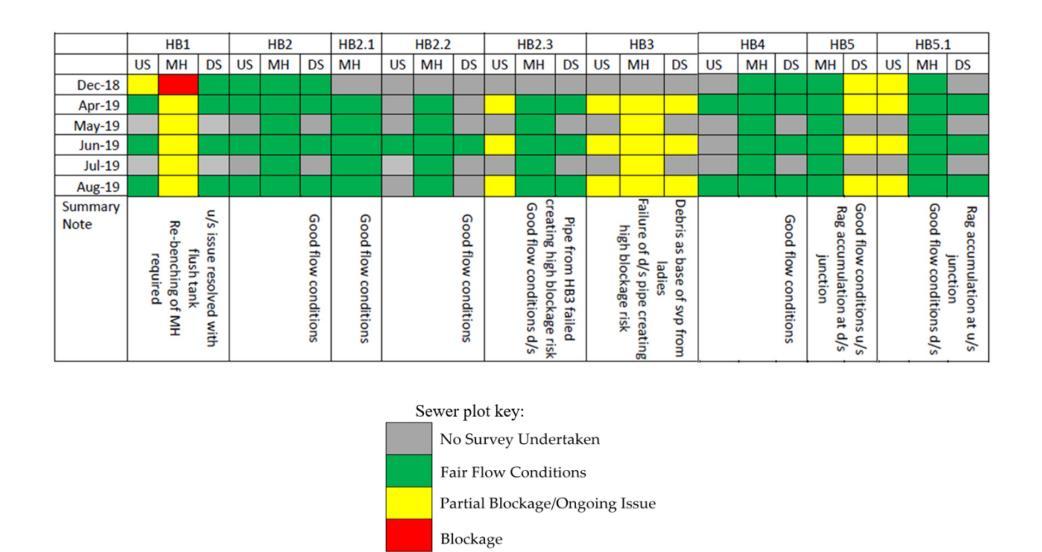
Figure 7. Example traffic light plot illustrating changes in sewer conditions at a series of nine manhole chambers outside the Harrison Building.

The drainage engineer's reports were compiled to provide qualitative observations linked to each manhole chamber evaluated in the project. To support consistent observations, every survey was conducted by the same engineering staff and the academic team and Propelair[®] technicians were able to attend these surveys in an oversight role. In order to visualise the data, a traffic light plot was developed for each chamber (Figure 7).
