Article Channel Deformations and Hazardous Processes of the Left-Bank Tributaries of The Angara River (Eastern Siberia)

Marina Y. Opekunova^{1,*}, Natalia V. Kichigina¹, Artem A. Rybchenko² and Anton V. Silaev¹

Citation: Opekunova, M.Y.; Kichigina, N.V.; Rybchenko, A.A.; Silaev, A.V. Channel Deformations and Hazardous Processes of the Left-Bank Tributaries of The Angara River (Eastern Siberia). *Water* **2023**, *15*, 291. https://doi.org/ 10.3390/w15020291

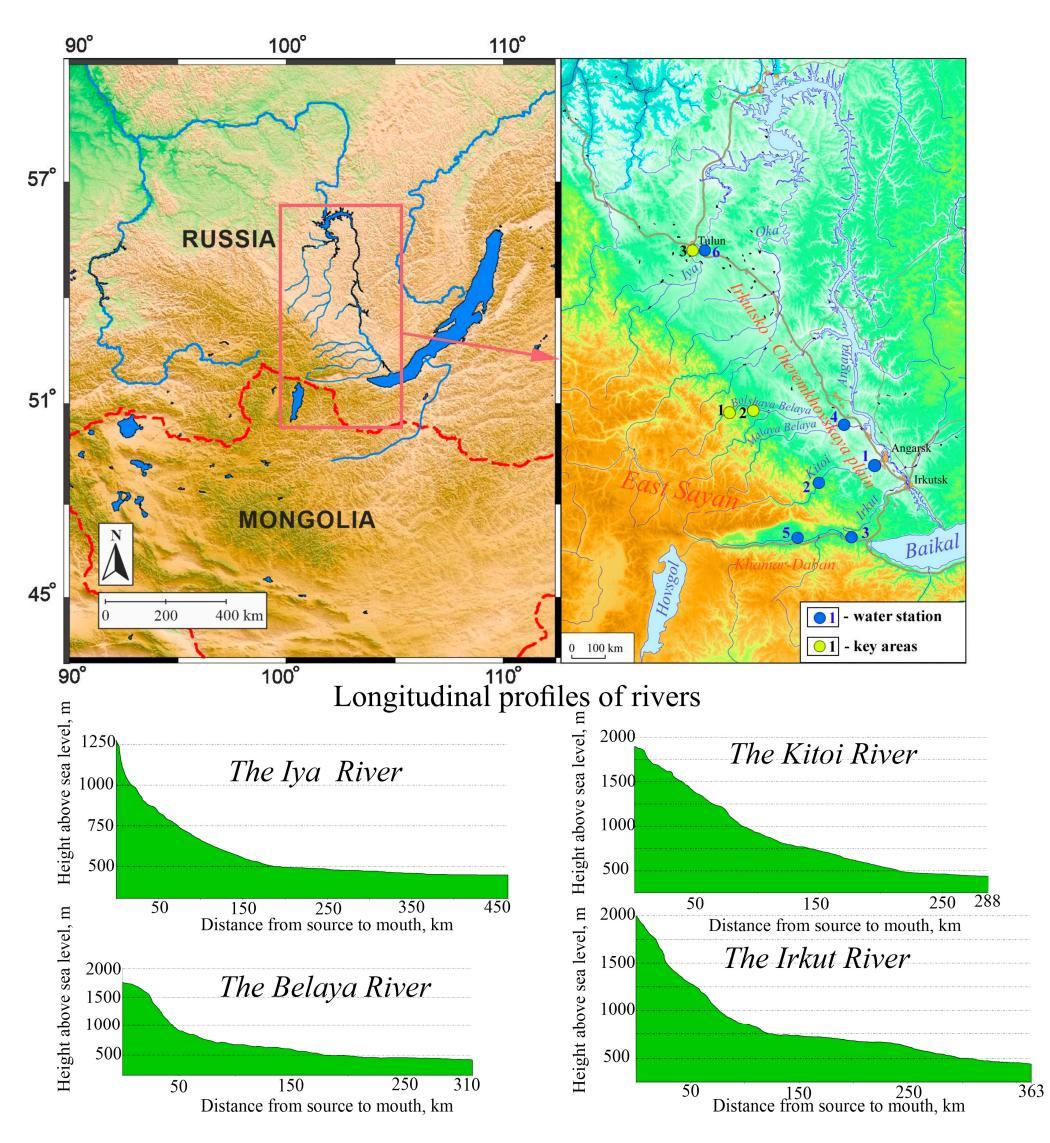
Figure 1. Location of studied rivers and water stations: 1—Kitoi–Kitoi; 2—Kitoi–Dabady; 3—Irkut–Tibel'ti; 4—Belaya–Mishelevka; 5—Irkut–Tunka; 6—Iya–Tulun. Key areas: 1—Novostroika, 2—Bolshebel'sk, 3—Tulun.

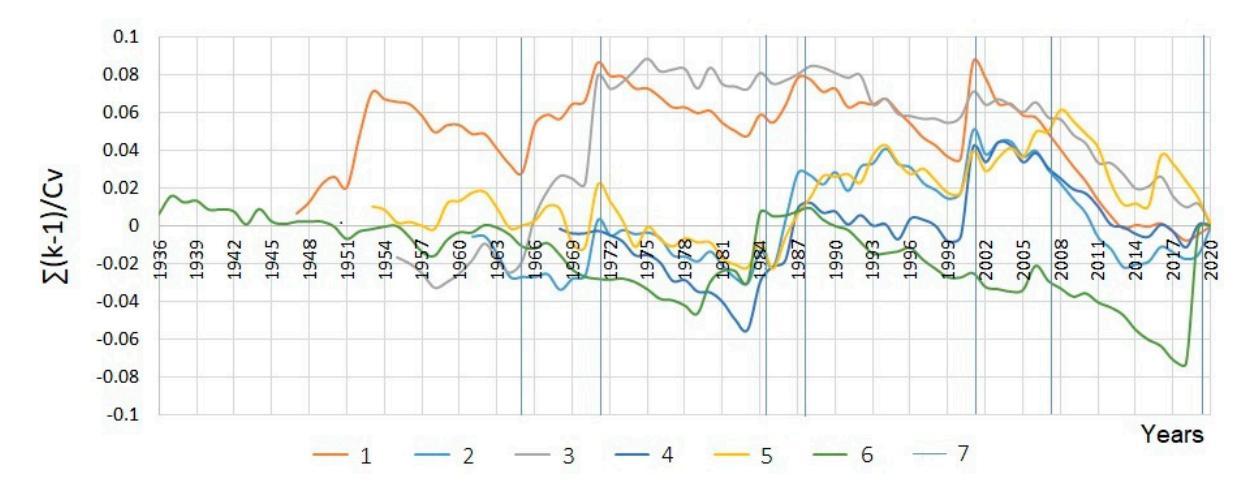
Figure 2. Long-term changes in the maximum annual discharges in the Angara River basin in the form of differential integral curves; k—modulus code, Cv is variation coefficient. 1—Kitoi–Kitoi, 2—Kitoi–Dabady, 3—Irkut–Tibelti, 4—Belaya–Mishelevka, 5—Irkut–Tunka, 6—Iya–Tulun, 7—periods of water content.

Long-term fluctuations of the maximum annual runoff were assessed using differential integral curves that reflect long-term periods of increased and decreased water content (Figure 2).

The analysis showed that, despite the existing differences in long-term runoff fluctuations of the rivers of the Angara basin, there is some synchronism in their fluctuations. As a result, there was a high-water flow phase in the rivers from the early to mid-1960s until 1971.The most abundant year was 1971, when floods occurred in several rivers (most notably the IrkutRiver), and then a gradual decrease in maximum annual discharges was observed in the rivers until 1983. Between 1983 and 1988, there was an increase in water content, except for the IrkutRiver, where the average water content was maintained from 1971 to 1992. The period between 1989 and 2001 wascharacterized by relatively high maximum discharge values ofall rivers, with a slight decrease after 1994. In 2001, a catastrophic flood occurred in the left tributaries of the Angara, after which the period between 2001 and 2006 was characterized by increased water content. After 2007, a low-water period began, and the maximum annual discharges decreased until the high-water year 2019, when an extreme flood occurred in the Irkut, Kitoi, Belaya, and IyaRivers. As a result, six periods of water content change were identified according to the maximum annual discharges for the period spanning from the start of observations until 2019 forthe rivers under consideration.

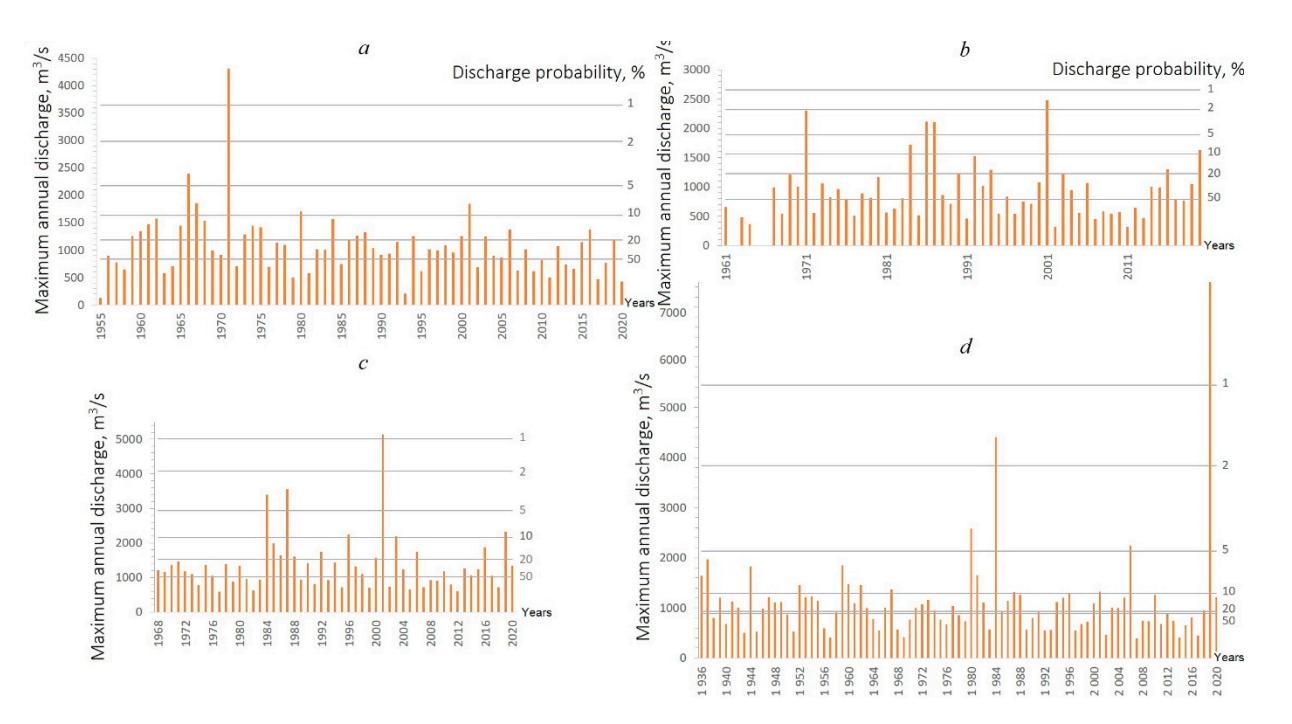
Figure 3. The observed maximum annual water discharges and the values of their standard probabilities calculated according to thePearson curve (type III) with parameter assessment using the method of moments: (**a**)—Irkut–Tibelti, (**b**)—Kitoi–Dabady, (**c**)—Belaya–Mishelevka, (**d**)—Iya–Tulun.

according to the Pearson curve (type III), with the estimation of parameters using the method of moments (Figure 3).

Floods of these rivers were caused by heavy rains in 1971, 2001, and 2019. Thus, the probability of floods in 1971 was about 0.5% at the IrkutRiver gauging station (the village of Tibelti) and about 2% at the KitoiRiver gauging station (the village of Dabady). The probability of floods in 2001 was about 1% for the Belaya River (the village of Mishelevka) and about 1.5% for the KitoiRiver (the village of Dabady). During reconstructions, using different methods, of the catastrophic flood of 2019, the value of the maximum discharge at the gauging station of the IyaRiver (the town of Tulun) was estimated by various experts to be in the range of 5640–6100 m³/s. [37–39]. At the same time, Roshydromet set the value of the maximum flow rate much higher, 500 m³/s, and we have to operate with it. [28]. The reliability of this flow rate, depending on the approximation method, varies from 0.1, according to the Kritsky and Menkel distribution with the assessment of parameters according to the maximum likelihood estimation, to 0.8, according to the Vinogradov C-3 curve in terms of accuracy. The reliability of this flow rate is about 0.5% according to the Pearson type III distribution with the estimation of parameters using the method of moments.

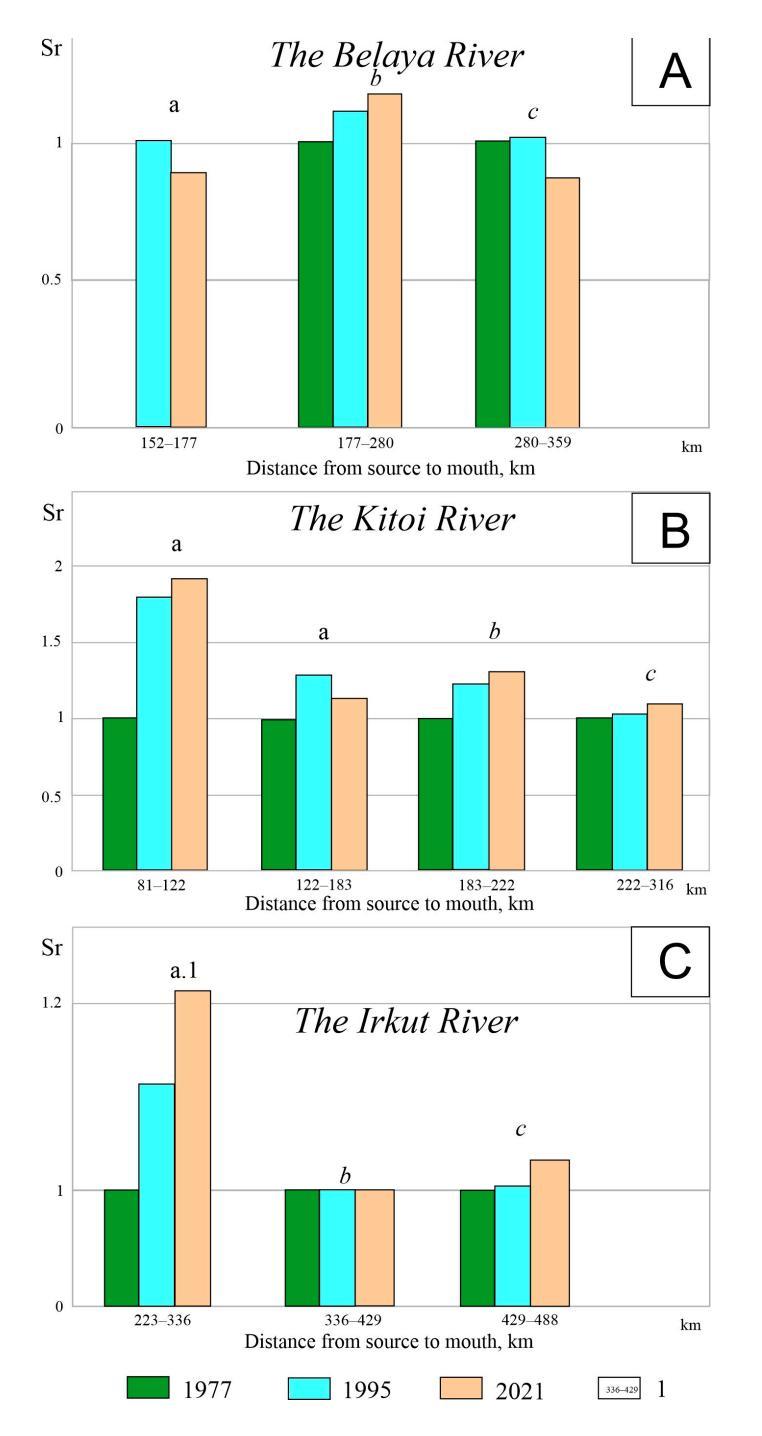
Figure 4. Diagram of changes in the area of the floodplain islands between 1977 and 2021. Dynamics of the area of the floodplain islands of the left-bank tributaries of the Angara River between 1977 and 2021 in various geodynamic areas (periods: 1977—medium water; 1995—relatively high water and 2021—high water (**A**)—The Belaya river; (**B**)—The Kitoy river; (**C**)—The Irkut river). Areas (Sr) are given in relative units (the floodplain area in 1977 is taken as 1); 1–distance from the riverhead.

To identify the dynamics of planned channel deformations within the identified geomorphological regions, we calculated the areas of the floodplain islands for different periods of observation (Figure 4).

The Belaya River best illustrated the dynamics of the channel–floodplain system (Figure 4A). For the Belaya River, the minimum values of the long-term variability of the floodplain area were revealed. For the mountainous part, where incised and adapted branched channel types were predominantly developed, a decrease in the floodplain area was observed due to the flooding of the islands from 1995 (the low-water period) to 2021 (the high-water period).

A significant increase (almost twice as large) in the floodplain area occurred in the mountainous part of the KitoiRiver (Figure 4C) within the channel sections with significant slopes of 5–12‰. Downstream, in the braided reach, the area changes wereinsignificant, increasing with the growth of islands in a relatively dry period and decreasing due to the reduction in the area of islands during flooding in a high-water period. The semi-mountains and floodplains with anabranching channels werecharacterized by the increasing area of the floodplain islands.

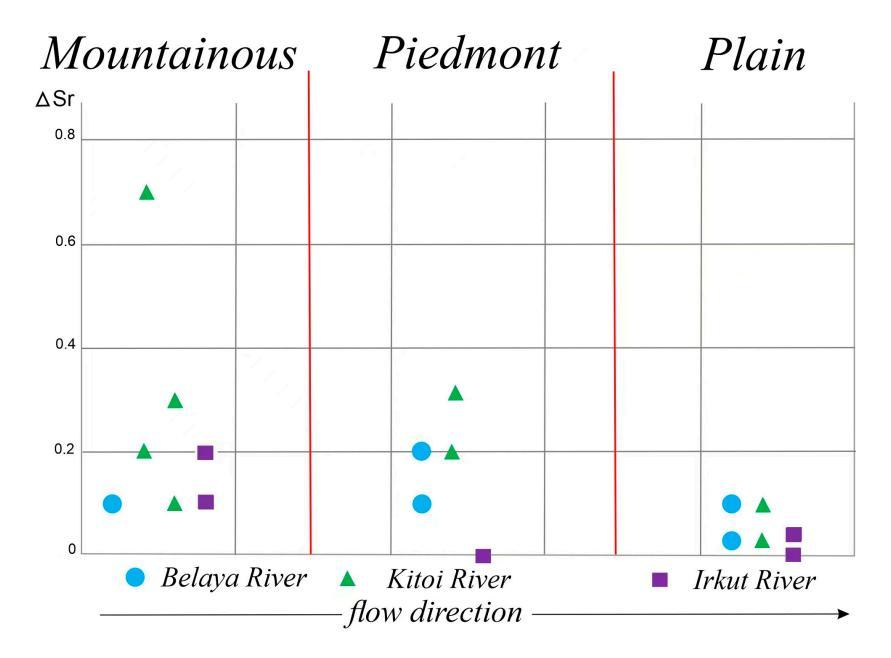
Figure 5. Distribution of indicators of relative variability of floodplain islands of the left-bank tributaries of the Angara River from 1977 to 2021 in various geodynamic areas.

The values of the relative variability (Δ Sr) of the floodplain islands within different geodynamic areas for 1977–1995 and 1995–2021 (Figure 5) showed that the mountains and piedmonts werewithin the same interval of0.1–0.4. The exceptions were the minimum and maximum values of0 and 0.7, respectively, near the IrkutRiver in the piedmonts and the KitoiRiver in the mountains.

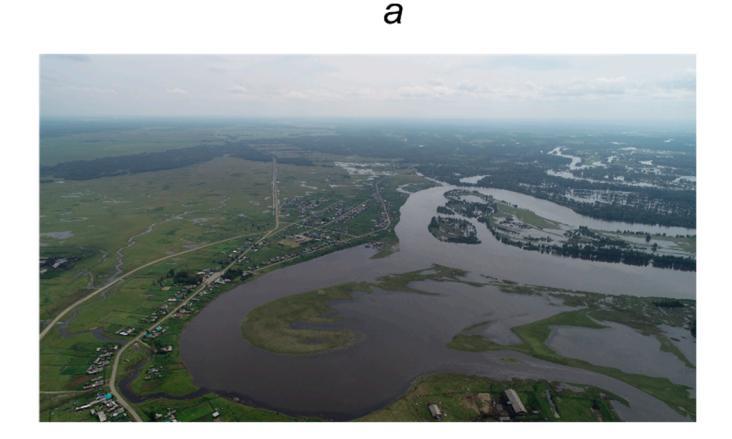
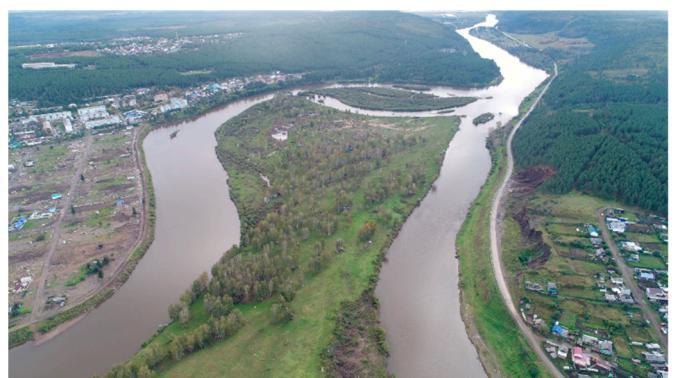
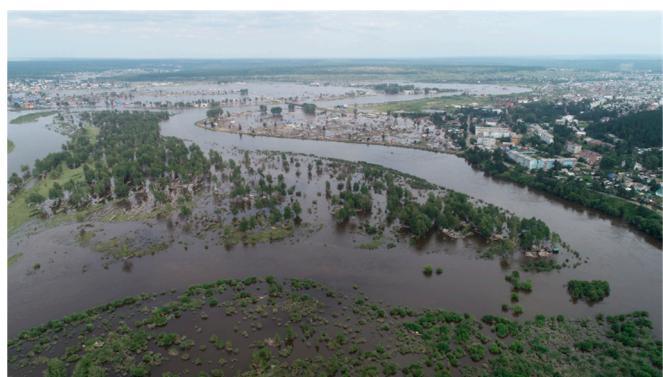
Figure 6. Impacts of floods on the IyaRiver: (a)—flooding of the wide floodplain section of the valley in the vicinity of Tulun; (b)—consequences of bank erosion; (c)—processes of bank destruction and landslides (area of the gauging station in Tulun). Survey coordinates: 54°24′27.4218″ N, 100°43′23.1820″ E. Shooting: 2 August 2019.

The nature of freshets and inundations resulted from the development of the morphodynamic type of the channel and floodplain, as well as their combination in different sections of the flow, is illustrated by the examples below. The IyaRiverwas characterized by such an alternation: a wide floodplain channel when crossing sandstone fields and an incised or adapted type when the river crossed Triassic traps. During the second stage of the summer flood of 2019, three sites in the IyaRiver valley were studied. The first site was located near the village of Gadalei. A wide floodplain-type channel with free meandering has developed here. During the second flood stage, the negative forms of the floodplain microrelief were flooded (Figure 6a).

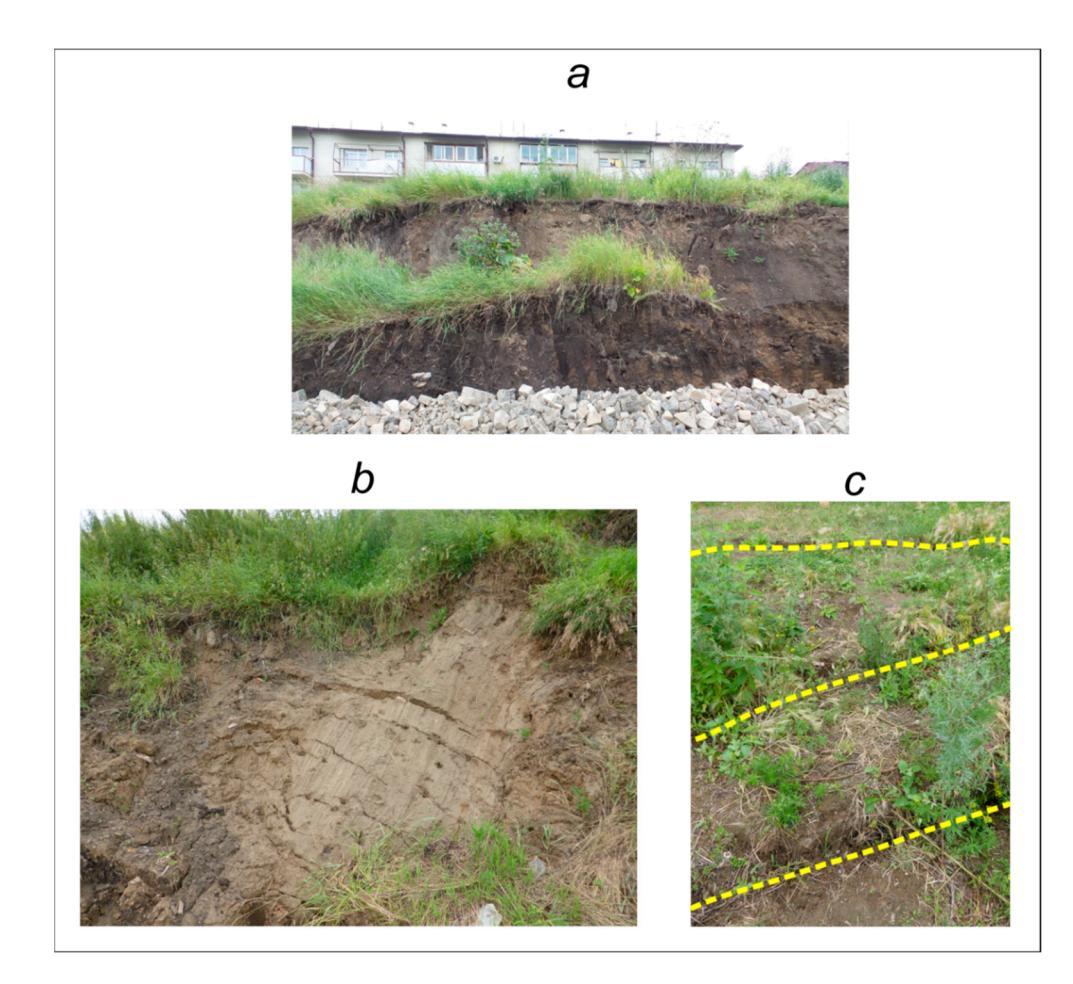
Figure 7. Landslide deformations of the bank line of the second terrace of the IyaRiver (the town of Tulun): (**a**)—frontal part of landslide deformations; (**b**)—landslide block main scarp; (**c**)—extension fracture on the surface of the second terrace.

On the surface of terrace II (10–15 m) composed of boulder-pebble, sand, sandy loam, and loams (8–15 m), we recorded landslide deformations that led to foundation deformations ($54^{\circ}34'13.93''$ N 100°35'41.74'' E) (Figure 1). The southern and central parts of the site hadthe highest concentration of deformations and a series of fracture zones (Figure 7a).

On the terrace, in close proximity to a residential development, in the step zone, a series of strike-slip tension joints was noted. On the edge of the step zone, subsidence of blocks and local soil displacements were noted (Figure 7b). There was a series of blocks separated from each other by cracks (width from 1.12 to 1.8 m), and extension cracks opened up to 0.25 m (opening depth of up to 0.3 m) (Figure 7c).

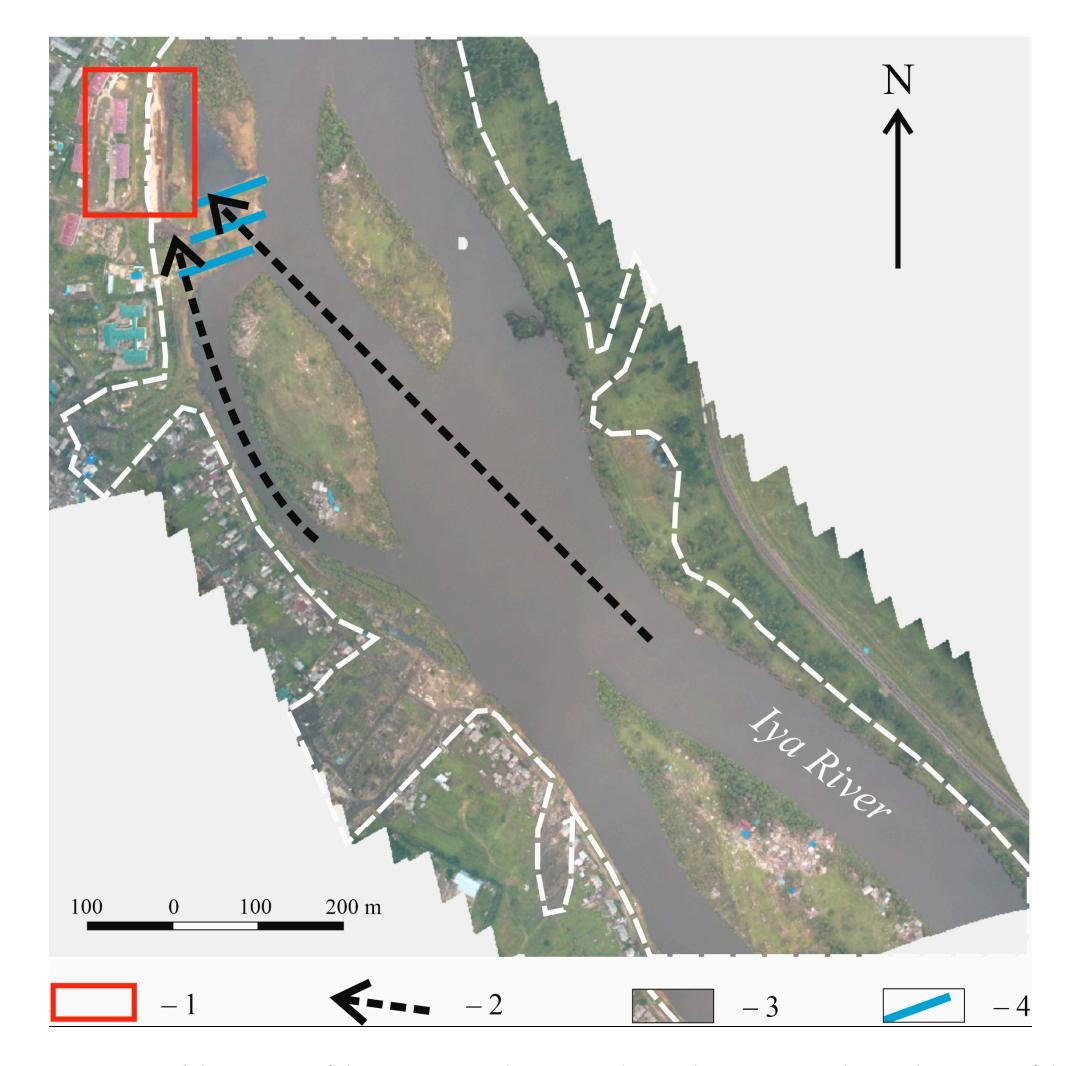
Figure 8. Set of the current of the IyaRiver in the area under study. 1—area under study; 2—set of the current of the IyaRiver; 3—border of the flood zone (7 July 2019); 4—bank protection structure.

Directly in front of this bank section (upstream of the river), bank protection dams had already been erected. Before the flood in July 2019, the dams performed their function properly, preventing the erosion of the bank and contributing to the accumulation of material behind the dams. However, the height of the dams was not designed for the level of this flood. During the flood in July 2019, the level of the IyaRiver exceeded the level allowed for protective structures. The elevation of the dam crest was 457 m, while the level of the IyaRiver exceeded 464 m in this reach.

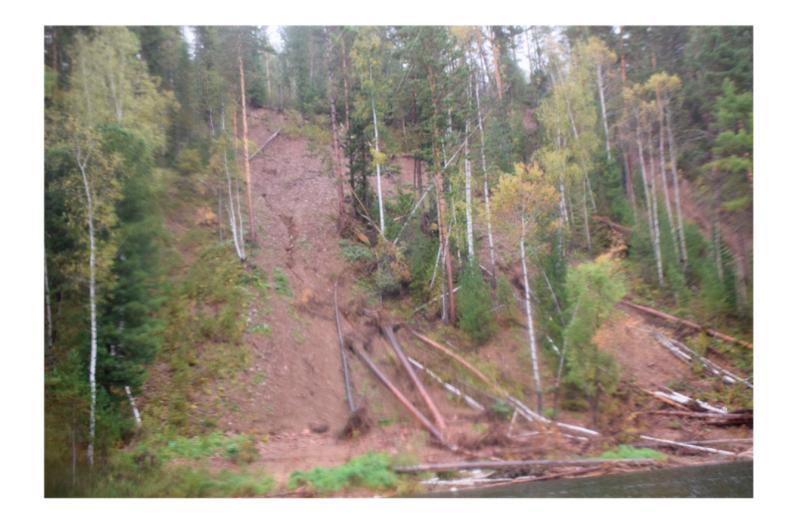
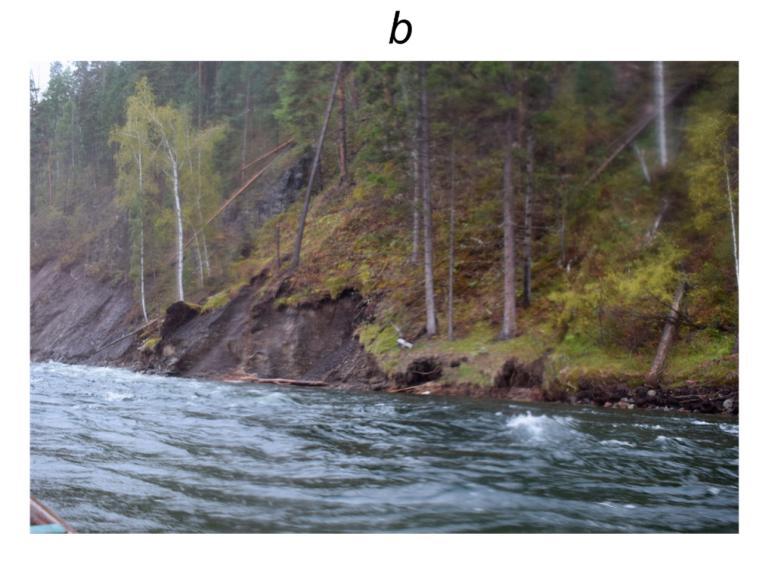
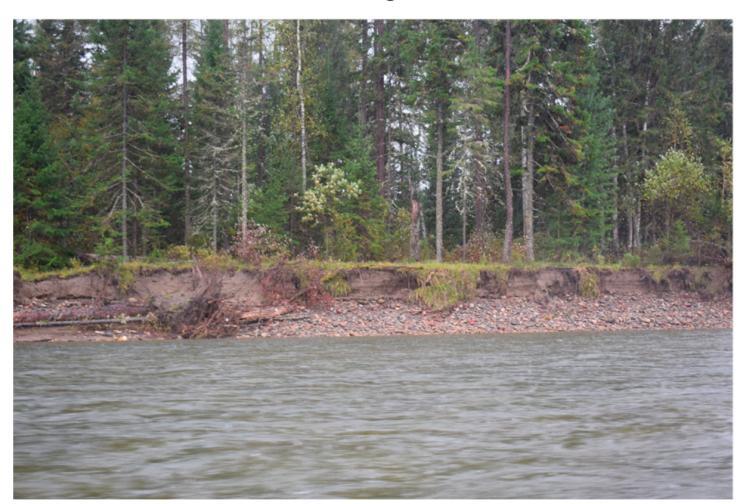
Figure 9. Slope processes of the IyaRiver valley in the piedmont of the Eastern Sayan: (a)—debris flows; (b)—debris slides in the lower part of the root slope; (c)—sliding of the soil in the scarp of the floodplain.

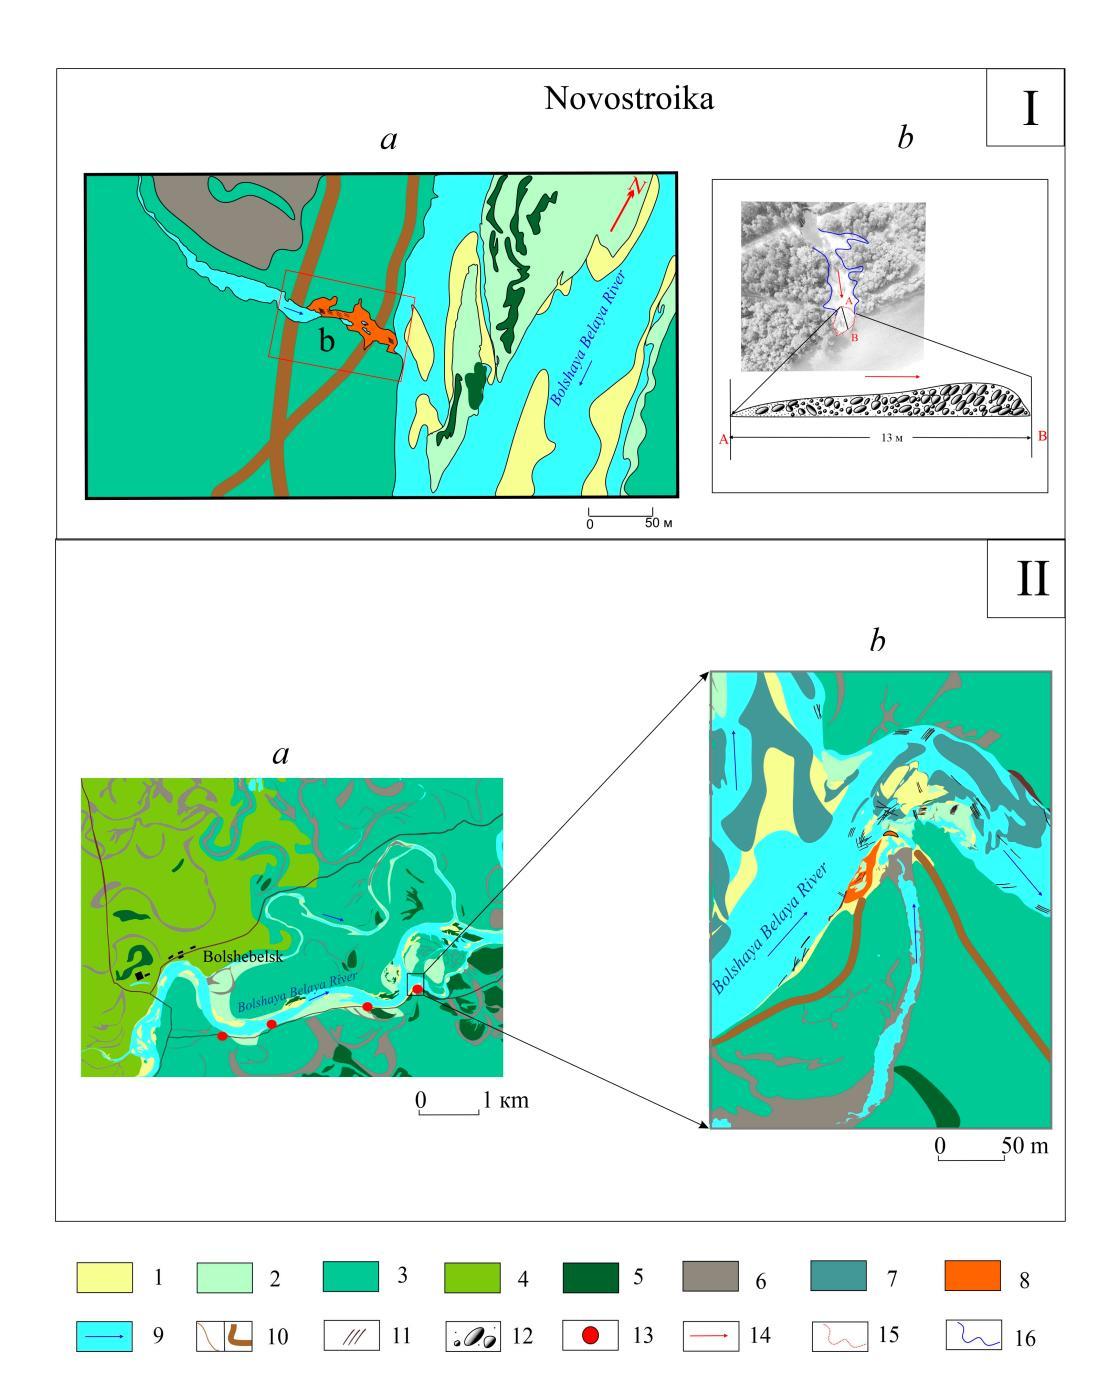
Figure 10. Floodplain–channel complexes of the Bolshaya Belaya River in the area of observation of bank deformations. (**I**) Novostroika: a—an index map compiled according to the orthophotomap (shooting date July 2019); b—an aerial photograph (shooting date July 2019); line AB—a longitudinal profile of the channel-mouth bars. (**II**) "Bolshebel'sk": a—an index map compiled from a satellite image of Google Earth (shooting date June 2019); b—an index map of the relief structure of the site, compiled according to the orthophotomap (shooting date July 2019). Legend: 1—sand and pebble shallows; 2–low floodplains up to 1 m high; 3—high floodplains 2.5 m high; 4—the first terrace up to 6 m high; 5—floodplain crests up to 1.5 m high; 6—hollows eroding up to 1.5 m deep; 7—channel ridges; 8 –a section of relief reformation and formation of the channel-mouth bar; 10—roads; 11—areas of wood accumulation; 12—sandy-pebble deposits; 13—monitoring points for coastal processes; 14—current directions in case of a road break; 15—outlines of the channel-mouth bar; 16—boundaries of flow distribution.

The flow at the Novostroika site was saturated with coarse clastic material and its further redeposition at the mouth was a result of the road's backwater effect, further breakthrough of the embankment body, and destruction of the road (Figure 10Ia).

Upstream, there was a section with signs of intensive destruction of bank scarp (Figure 10b). The volume of material supplied to the channel (Bolshebel'sk section) was 1800 m³ on a segment of the intensively-destroyed bank scarp of a high floodplain 600 mlong with a scarp height of 2 m and an average retreat of the scarp edge of 1.5 m. The average volume of sediments of the destroyed bank that had fallen into the channel was about 300 m³ per 100 m of the bank line in natural conditions, and in the section of the road destruction it increased to 480 m³ per 100 m.

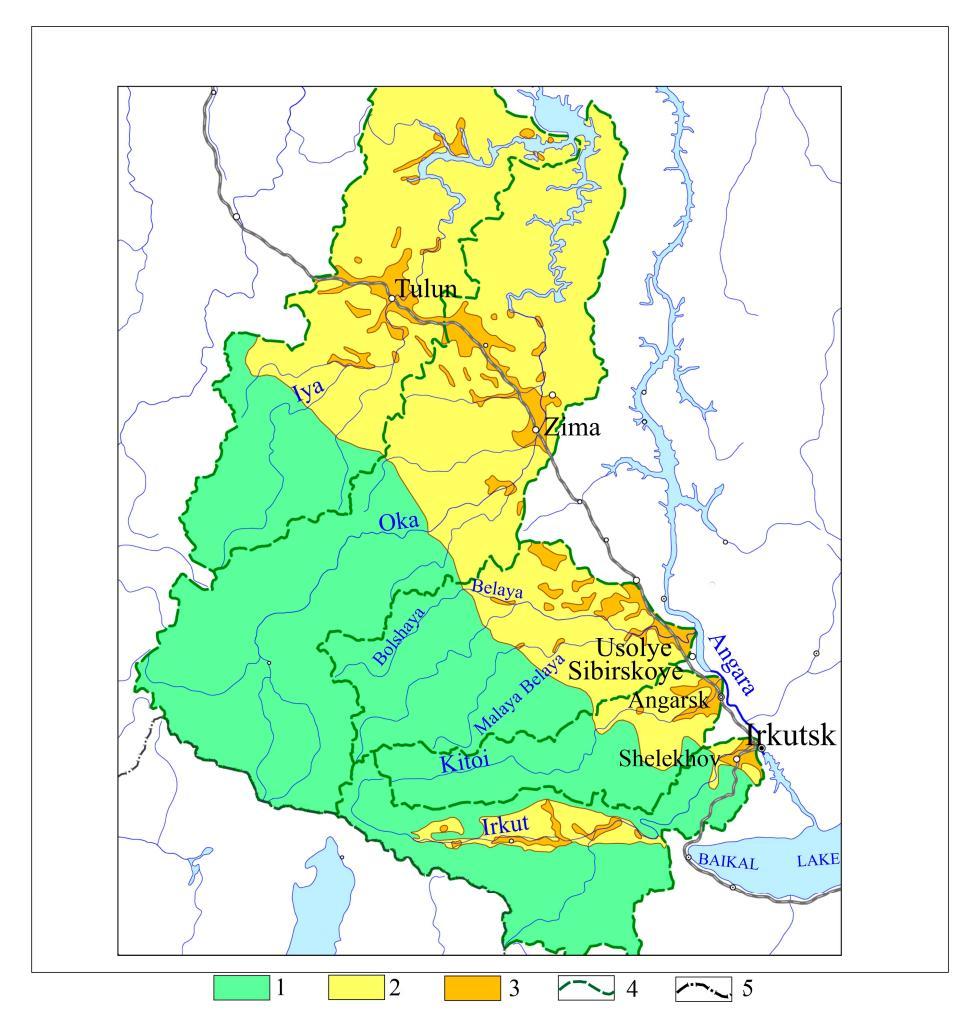
Figure 11. Zoning of floodplain–channel complexes along the rivers of the Upper Angara region and adjacent territories according to the degree of development dynamics. Legend: 1—dynamically-developing floodplain–river complexes; 2—relatively stable floodplain–river complexes; 3—relatively dynamically-developing floodplain–river complexes of anthropogenically-disturbed territories; 4—state borders; 5—basin boundaries.

Such an analysis of the dynamics of the development of floodplain–channel complexes in the Upper Angara region makes it possible to identify zones of dynamically-developing floodplain–channel complexes, including mountains and piedmonts. Relatively stable floodplain–channel complexes have developed mainly in the plain–platform and plain– hollow areas. Anthropogenically-disturbed territories are specially highlighted (Figure 11).
