Experimental Study on Neck Cutoff in Meandering River under Variable Discharges

Xinyu Wu 1,2, Xuyue Hu 3 and Xiang Zhang 2,4,5,*

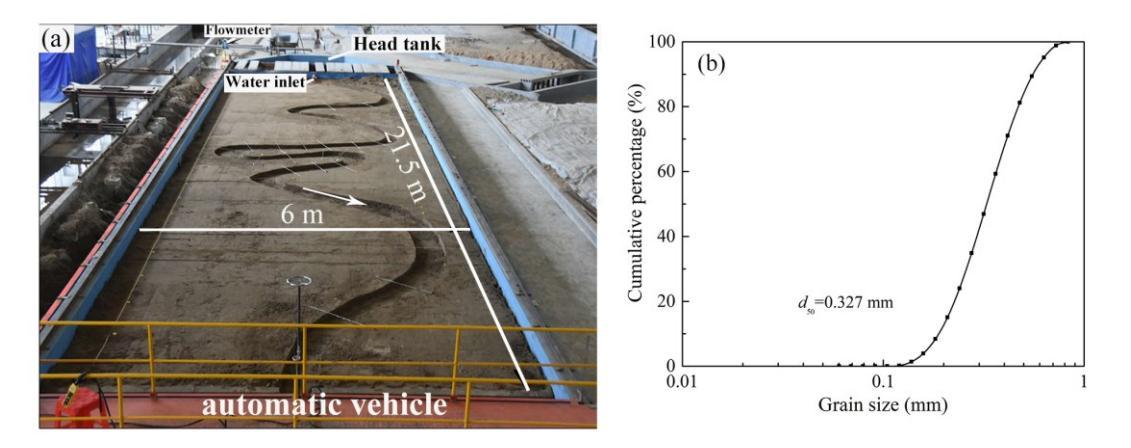
Experiments were performed in a concrete wide-body flume, which was designed and constructed from May 2016 to May 2017. The layout of the flume system is shown in Figure 1a. The wide-body flume was 25 m long, 6 m wide, and 0.4 m deep. The bottom of the flume was horizontal, and the experimental section was 21.5 m long. The front end of the flume was provided with an isosceles trapezoid-shaped forewater storage pool. The upper bottom was 2.2 m long, and the lower bottom was 6.0 m long, 2.2 m high, and 0.6 m deep. A rectangular pool with a length of 1.8 m, a width of 6.0 m, and a depth of 0.4 m was installed behind the forewater storage pool. The main function of the rectangular pool was to stabilize the water flow. After the water flow entered the forewater storage pool, it reached the rectangular pool through a grid and was discharged through the round pipe outlet. The end of the flume was provided with a sand-settling tank and a tailwater tank. The sand-settling tank was 2.0 m long and 6.0 m wide, and the tailwater tank was 1.5 m long and 6.0 m wide. The tailgate was 30 cm wide and 10 cm deep and was set at the center of the flume tail. An LDG electromagnetic flowmeter (nominal diameter DN80) was used to control the flow; the sensor coefficient was 0.8759, and the accuracy class was 0.5. Adjusting the valve of the water inlet pipe could change the reading of the electromagnetic flowmeter to control the discharge. Sediment with a thickness of 20 cm was laid in the flume before the experiment, and the sediment adopted was nonuniform natural sand. The median particle size was $d_{50} = 0.327$ mm, and the non-uniformity coefficient was $\varphi =$ 1.413. The particle size distribution measured with a Mastersize 2000 laser particle size analyzer is shown in Figure 1b.

Figure 1. (a) Experimental system and (b) particle size distribution curve.

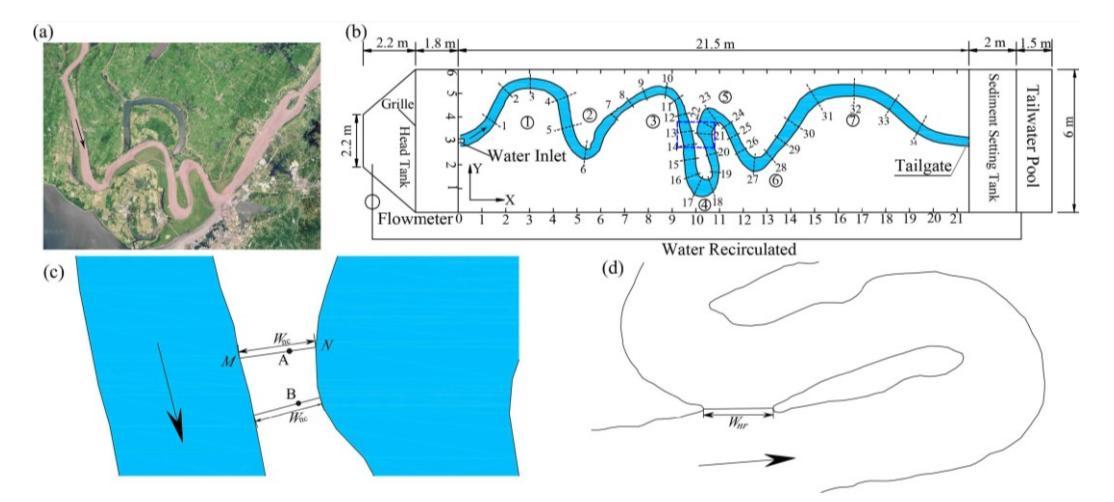
We adopted a generalized model approach using a laboratory flume. The plane shape of the initial channel referred to Qigongling Bend, which is a highly curved channel at the end of the lower Jingjiang River in the middle reaches of the Yangtze River, with a sinuosity of approximately 7. Qigongling Bend (Figure 2a) was scaled down via a plane scale factor of 1:2500. The cross-section of the initial channel was rectangular, and the channel depth was 10 cm. A schematic diagram of the experimental system is shown in Figure 2b. Before conducting the experiment, sediment was first leveled into a flat bed surface with a certain gradient, and control points were then set in the flume, while the initial channel was excavated. During the experiment, the water flow initially entered the forewater storage pool via a pump, reached the river channel through a fixed water inlet at the front of the flume, and then flowed out through the tailgate into the tailwater pond. Washed sediment was captured in a sand-settling tank and recycled in the next experiment. To ensure that the water outlet could smooth the resulting water flow and reduce scouring near the water outlet, an energy dissipation grille was arranged below the water outlet.

There were a total of 7 bends, numbered B1–B7, from upstream to downstream. A total of 34 measurement sections were arranged from upstream to downstream along the river channel (Figure 2b), at intervals ranging from 0.42 to 2.0 m. The sections are represented by a capital letter S followed by a number; for example, section 7 is denoted as S7. The interval from S7 to S26 constituted the studied area; the length was 12.8 m, the average river width was 0.51 m, and the average width-to-depth ratio of the cross-section was 4.38. The researched channel segment was divided into 3 areas: the area upstream of the cutoff position (S7–S13), the bend area (S13–S21) where cutoff occurred, and the downstream area (S21–S26). The time t of the neck cutoff occurrence was defined as the period from the start of the experiment to when the upstream and downstream flow of the neck just connected and the neck width reduced to 0. The ratio of the narrowest part of the neck to the mean river width was 0.43. Since the cutoff position was uncertain, the neck width W_{nc} was defined as the shortest channel width through the cutoff position. For example, points A and B in Figure 2c were the cutoff positions in two runs, and the shortest width W_{nc} passing through these two points was the neck width. The upstream scouring distance of the neck section was expressed as W_{u} , and the downstream scouring distance was expressed as W_d . For example, in Figure 2c, the distance from point A to point M was W_u , and the distance from point A to point N was W_d. The rate at which the neck width decreased over a period was represented by the parameter $M_{\rm D}$. The new channel width $W_{\rm nr}$ was defined as the shortest distance between the left and right banks of the new channel, as shown in Figure 2d. The widening rate of the new river after cutoff was denoted by M_n .

Figure 2. (a) The setup of the experiment was based on Qigongling Bend, a highly curved channel at the end of the lower Jingjiang River in the middle reaches of the Yangtze River, with a sinuosity of approximately 7. (b) Overall schematic diagram of the experimental system. (c) Enlarged schematic diagram of neck width W_{nc} , which was the shortest channel width through the cutoff position; points A and B were possible cutoff locations, and the neck width was the length of section MN. (d) Schematic diagram of the new river width W_{nr} formed after cutoff.

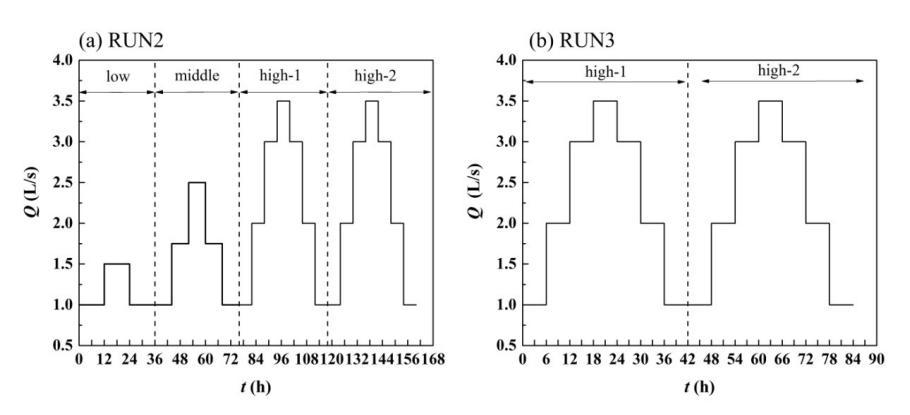
Figure 3. Variable discharges in (a) RUN2 and (b) RUN3.

We designed 3 runs. The initial river topography remained the same, and the water flow conditions differed, as summarized in Table 1. *Re* is the Reynolds number, which is a parameter that reflects the flow pattern, and its physical meaning is the contrasting relationship between the action of inertial force and viscous force. The initial gradient in each run was the same, and *S*_r was set to 1.0‰, which agrees with the conditions of natural meandering rivers. With reference to the change in natural river flow, the flow cycle process was designed in combination with the flow needed for sediment start. The discharge in RUN1 was constant at 2.0 L/s, and the discharges in RUN2 and RUN3 are shown in Figure 3. RUN2 first used a low-discharge cycle (1.0–1.5 L/s, each discharge lasted 12 h), followed by a medium-discharge cycle (1.0-2.5 L/s, each discharge lasted 8 h), and finally a high-discharge circulation (1.0-3.5 L/s, each discharge lasted 6 h). If cutoff still did not occur after the high-discharge cycle was completed, the cycle was continued. The highflow process was repeated twice, and the experiment lasted 160 h. RUN3 only exhibited a high-discharge cycle, the cycle was repeated twice, and the whole experimental process lasted 84 h.

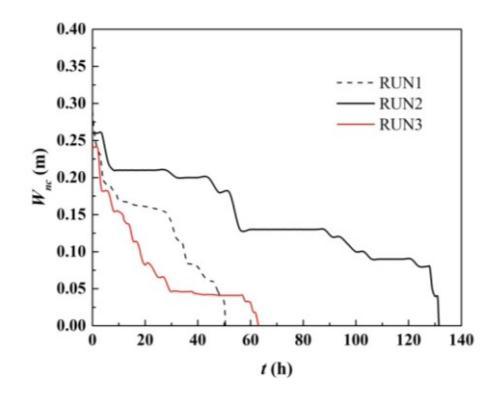
Although the cutoff position, neck width, and time in the three runs differed, the change trend of Wnc was similar, and Wnc gradually decreased overall. During the first few hours, due to riverbank collapse, M_D was large, and the change in M_D during the subsequent period was closely related to the discharge. Under constant discharge, MD was small in RUN1 and sharply increased when approaching cutoff. In RUN2 and RUN3 under the condition of varied discharge, after the discharge increased or decreased, $M_{\rm D}$ accordingly increased or decreased, respectively, and M_{D} also sharply increased when cutoff was imminent. In addition, at a discharge of Q < 2.0 L/s, M_D was almost zero. By analyzing the discharges and times of cutoff in RUN2 and RUN3, it was found that cutoff occurred during medium- and high-discharge periods, and the medium- and high-discharge durations before cutoff were also similar. In RUN2, the discharge at cutoff occurrence reached Q =3.0 L/s, and the duration of the $Q \ge 2.0$ L discharge was 45.5 h. In RUN3, the discharge at cutoff occurrence was Q = 3.5 L/s, and the $Q \ge 2.0$ L/s discharge persisted for 45 h. Under the same initial topography, the cutoff times in RUN2 and RUN3 were shortened by 4.95 h and 5.45 h, respectively, under varied discharge conditions, which were 9.8% and 10.8% shorter, respectively, than that in RUN1 under a constant discharge.

Figure 4. Temporal variations in the neck width *W*_{nc} before cutoff.

All three runs exhibited cutoffs, but the position, time, and neck width varied. In RUN1, the cutoff position was biased toward the downstream area; at 0.32 m downstream of S13, the neck width W_{nc} was 0.29 m. The cutoff positions in RUN2 and RUN3 were similar, only 0.055 m apart. The cutoff position in RUN2 was 0.029 m upstream of S13, and the neck width W_{nc} reached 0.26 m. The cutoff position in RUN3 occurred 0.026 m downstream of S13, and the neck width W_{nc} reached 0.26 m. The cutoff position in RUN3 occurred 0.026 m downstream of S13, and the neck width W_{nc} was 0.24 m. Under constant discharge, the cutoff time in RUN1 was the shortest, at 50.45 h, while the cutoff times in RUN2 and RUN3 were longer, at 131.5 and 63 h, respectively. Before cutoff, the variation in neck width W_{nc} over time is shown in Figure 4, and the reduction rate of the neck width M_D during different periods is shown in Figure 5.

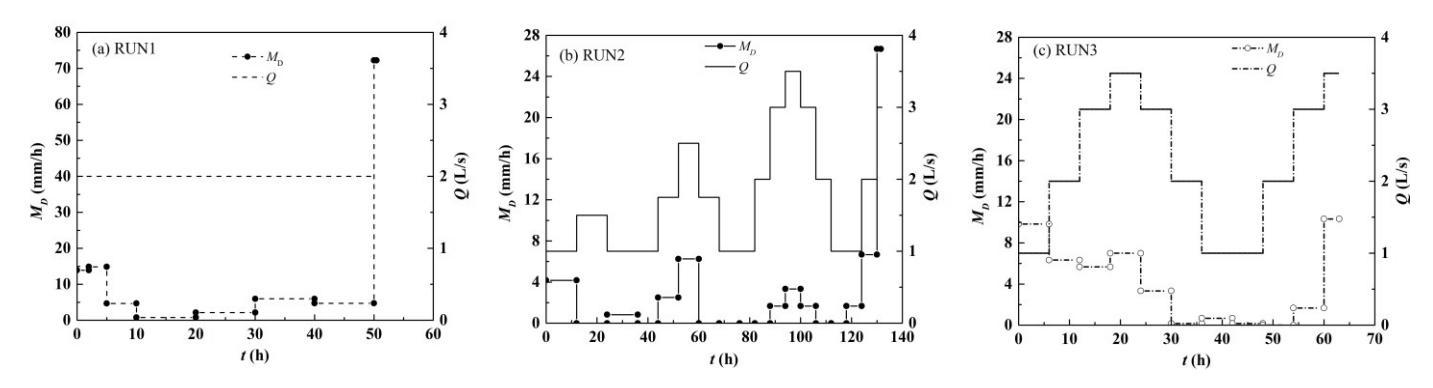
Figure 5. Reduction rates for the neck width *M*_D during different periods with (**a**) RUN1, (**b**) RUN2, and (**c**) RUN3; the variation in *M*_D was closely related to the discharge and increased to different degrees when approaching cutoff in all three runs.

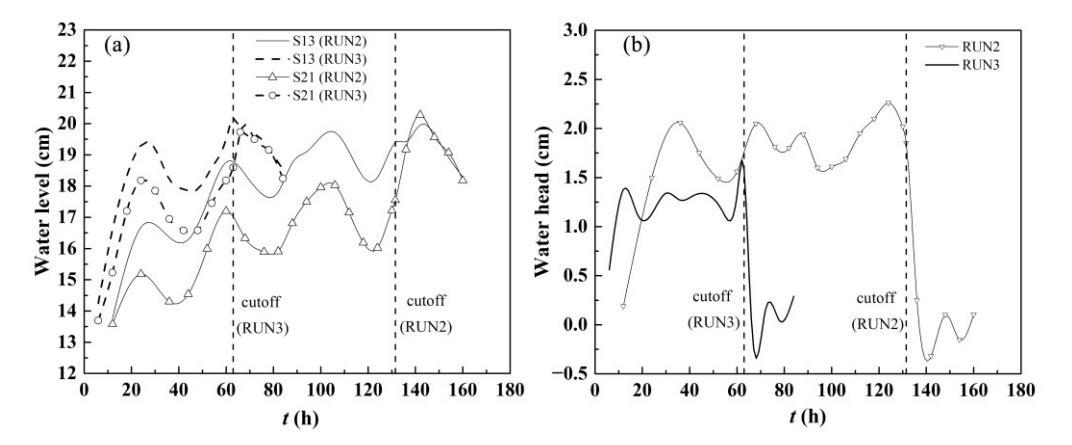
S13 and S21 in RUN2 and RUN3 were selected to analyze the water level and water level difference between the upstream and downstream sections of the neck. The variation process of the water level over time in S13 and S21 is shown in Figure 6a, and the variation process of the water level difference over time is shown in Figure 6b. The variation trends of the water level and water level difference upstream and downstream of the neck in the two runs were the same. Before cutoff, the water level and water level difference fluctuated over time. When cutoff occurred, the water level difference reached the maximum value and then sharply declined, even reaching a negative value, and the downstream water level was higher than the upstream water level. The reason for this was that upon cutoff occurrence, the discharge was high, the water flow turbulence intensity was high, stagnant water was formed downstream, and the upstream water level decreased. After

Figure 6. Variation in the (**a**) water level and (**b**) water level drop from upstream to downstream of the neck.

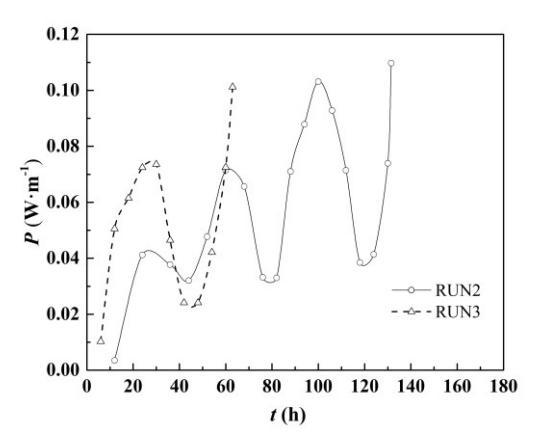
The change process of the stream power per unit length *P* at B4 over time during the period from the start of the experiment to cutoff occurrence is shown in Figure 7. The value of *P* correspondingly fluctuated with the discharge, but the overall trend was increasing. When cutoff occurred, the *P* values in RUN2 and RUN3 increased to maximum values, namely, $P = 0.109 \text{ W} \cdot \text{m}^{-1}$ and $P = 0.101 \text{ W} \cdot \text{m}^{-1}$, respectively, and the *P* values in these two runs were almost equal, as indicated in Table 3. The critical sinuosity and rotation angle at B4 when cutoff occurred are provided in Table 4. In the three runs, the critical sinuosity at B4 increased to 6.71, 7.09, and 7.11, which were 3.79%, 5.89%, and 1.16% higher, respectively, than those in the initial state. In the three runs, bend B4 rotated downstream at an angle of 11°.

Figure 7. Temporal variation in the stream power per unit length.

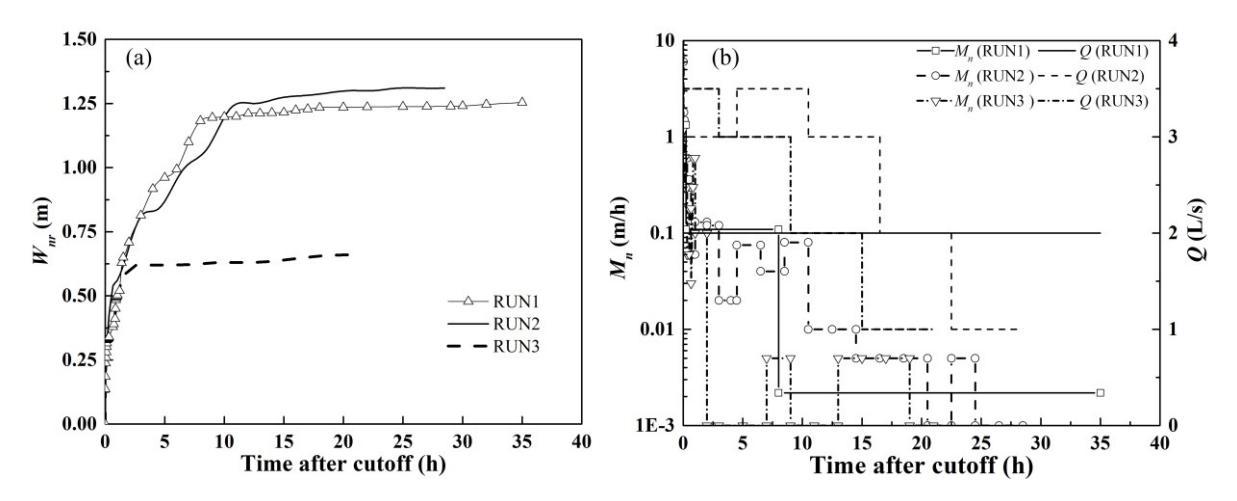
The discharge affected the M_n value but did not affect the change trend of W_{nr} . Within 1 min after cutoff occurrence in RUN1, the width of the new channel $W_{\rm nr}$ reached 0.101 m, and the widening rate M_n of the new channel reached 6.04 m/h. After 10 min, W_{nr} reached 0.329 m. During the experimental period t = 0-10 min, M_n was 1.334 m/h. Within the experimental duration of t = 10 min-5.5 h, M_n was 0.110 m/h, and W_{nr} increased to 0.962 m. Within the experimental duration of t = 5.5-35 h, M_n reached 0.002 m/h, and W_{nr} remained stable at 1.254 m. After cutoff, the discharge remained unchanged, and $M_{\rm B}$ gradually decreased. Within 2 min after cutoff in RUN2, the W_{nr} reached 0.20 m. After 20 min, W_{nr} reached 0.43 m. Due to the increase in the discharge after cutoff, M_n increased. After cutoff at 4.5 h, the widening rate $M_{\rm n}$ decreased to 0.02 m/h at the end of the third-stage discharge Q = 3.0 L/s, and the new channel widened by 0.84 m in total. Throughout the entire process of increasing discharge, M_n increased to 0.08 m/h, and W_{nr} increased to 0.39 m. During the subsequent reduction in discharge, W_{nr} only increased by 0.08 m, and M_n was very small, at approximately 0.005 m/h. In RUN3, the discharge decreased after cutoff, $M_{\rm h}$ continuously decreased, and the change trend of W_{nr} was similar to that under a constant discharge. When cutoff had just occurred, M_n could reach 12 m/h, and W_{nr} could reach 0.24 m within 4 min. After 3 h of cutoff, the maximum discharge had stopped, and the new channel had widened by 0.62 m in total. During the subsequent reduction in the discharge, M_n reached approximately 0.002 m/h, and W_{nr} only increased by 0.04 m.

Figure 8. (a) Width of the new channel W_{nr} and (b) the average broadening rate M_n and corresponding discharge during different periods.

Within a few minutes after cutoff occurrence, a new channel rapidly developed, mainly via longitudinal scouring. During the next few hours, the new channel was mainly widened horizontally, the water-passing section expanded, and the diversion discharge through the new channel gradually increased. Subsequently, the width of the new channel slowly increased, and distributed discharge in the old channel gradually decreased until no flow remained. The changes in the new channel width W_{nr} and average widening rate M_n are shown in Figure 8. The comparison between the initial and final topography of the relative equilibrium after cutoff is shown in Figure 9.

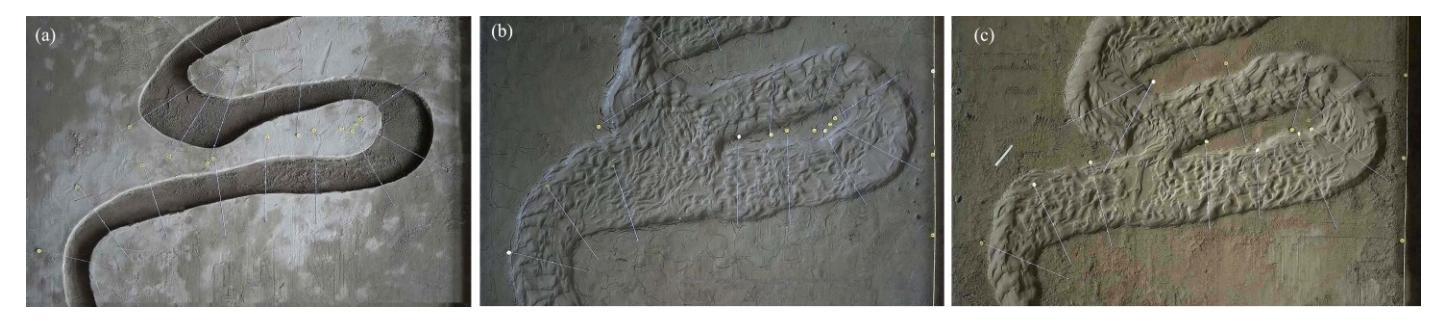
Figure 9. Comparison between (**a**) the initial terrain and the final terrain after cutoff with (**b**) the topography of the relative equilibrium in RUN2 and (**c**) the topography of the relative equilibrium in RUN3. The white line represents the measured cross section. The yellow line on the right marks the length.

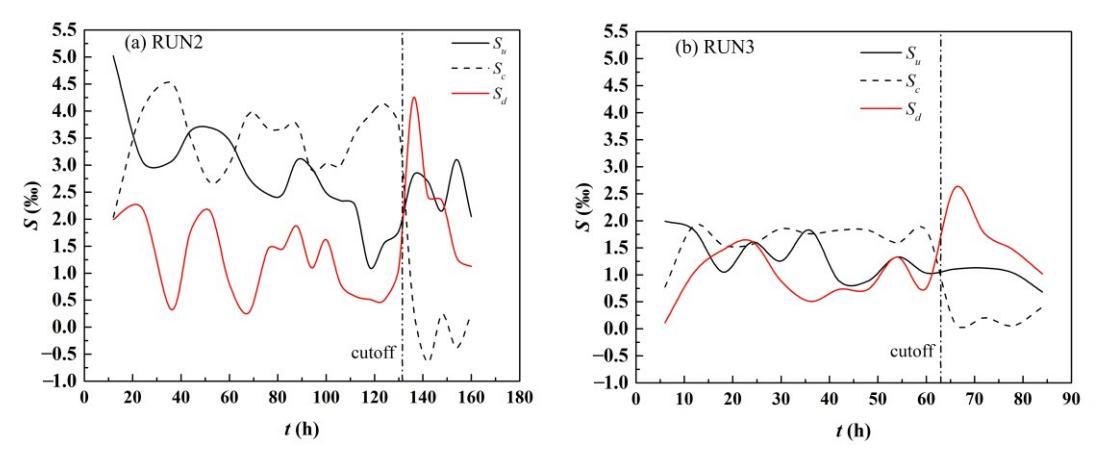
The water surface gradients within the scope of S7–S13 in the upstream area, S13–S21 in the bend area, and S21–S26 in the downstream area were represented by Su, Sc, and Sd, respectively, and the change trends are shown in Figure 10. Before cutoff, the three gradients fluctuated with discharge, and the change trends of S_u and S_d were the same, but the change trend of S_c differed from these two trends. Before cutoff, S_c was the highest, and after cutoff, S_c sharply dropped, while both S_u and S_d increased. At t = 0-130 h before cutoff in RUN2, the three gradient fluctuation ranges were 1.1-5.0‰, 2.0-4.5‰, and 1.3-2.2‰, respectively. When cutoff was imminent, i.e., at t = 130 h, S_c was the highest, at 3.7‰, S_u was moderate, at 1.8‰, and S_d was the lowest, at 1.1‰. After cutoff, both S_u and S_d increased, but S_d increased more. Due to backwater in the bend area, S_c sharply decreased. Under an experimental duration of t = 136 h, S_u and S_d were 2.8‰ and 4.2‰, respectively, which were 57.7% and 287.5% higher, respectively, than that before cutoff; meanwhile, S_c decreased to 0.4‰, which was 89.4% lower than that before cutoff. At t = 0-60 h before cutoff in RUN3, the three gradient fluctuation ranges were 0.9–2.0‰, 0.7–1.9‰, and 0.1– 1.6‰, respectively. Near cutoff, i.e., when the experimental duration reached t = 60 h, S_{u} , Sc, and Sd were 1.0‰, 1.8‰, and 0.8‰, respectively. Sc was still the highest. After cutoff (experimental duration t = 63 h), S_u and S_d increased to 1.1% and 2.6%, respectively, which were 7.1% and 247.1% higher than those before cutoff, respectively; Sc decreased to 0.1‰, which was 94.7% lower than that before cutoff.

Figure 10. Variations in the water surface gradient during (**a**) RUN2 and (**b**) RUN3. Su and Sd showed similar trends, while Sc had the opposite trend. After cutoff, Sc sharply dropped, while both Su and Sd increased.

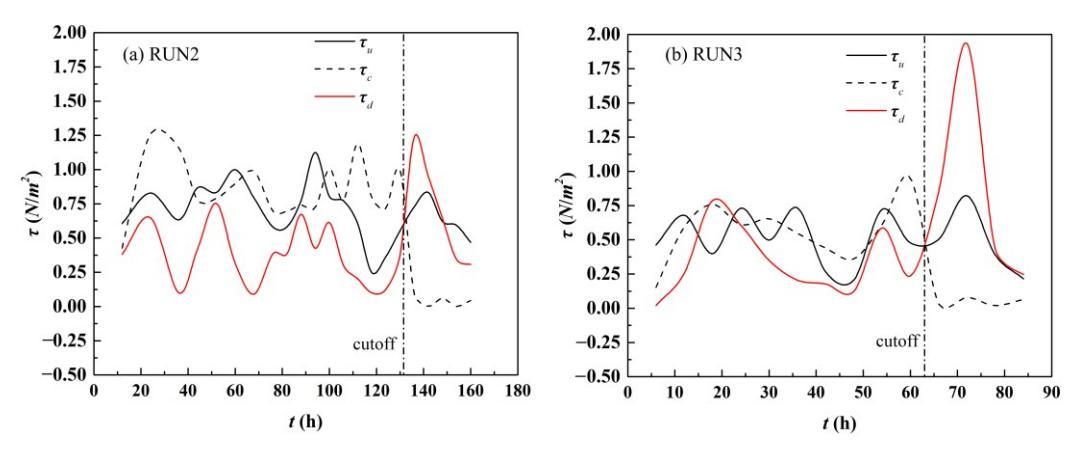
The average shear stress in the upstream area S7–S13, bend area S13–S21, and downstream area S21–S26 were represented by τ_u , τ_c , and τ_d , respectively. The variations in these three average shear stresses are shown in Figure 11. Before cutoff, the change trend of the average shear stress was the same as that of discharge. When cutoff occurred, τ_c was the highest, and τ_d was the lowest. After cutoff, τ_c sharply decreased, while both τ_u and τ_d increased. In RUN2, within t = 0-130 h before cutoff, the variation range of the three average shear forces was 0.25–1.12 N·m⁻², 0.43–1.26 N·m⁻², and 0.1–0.75 N·m⁻², respectively. The experimental duration before cutoff was t = 0-130 h, and the shear forces in the three areas were 0.55, 1.00, and 0.38 N·m⁻², respectively, of which the average shear force in the bend area τ_c was the highest. After cutoff, when the experimental duration reached t = 136 h, τ_u and τ_d increased to 0.73 and 1.24 N·m⁻², respectively, which were 31.3% and 228.9% higher than those before cutoff, respectively. Moreover, τ_c was reduced to 0.09 $N \cdot m^{-2}$, which was 90.7% lower than that before cutoff. At t = 0-60 h before cutoff in RUN3, the three average shear stress ranges were 0.21-0.73 N·m⁻², 0.15-0.95 N·m⁻², and 0.02-0.79N·m⁻², respectively. Before cutoff, when the experimental duration reached t = 60 h, τ_u , τ_c , and τ_d were 0.48, 0.95, and 0.24 N·m⁻², respectively, of which τ_c was still the highest. After cutoff, when the experimental duration was t = 66 h, τ_u and τ_d increased to 0.50 and 0.85 N·m⁻², respectively, which were 5.3% and 258.6% higher than those before cutoff, respectively; τ_c was reduced to 0.03 N·m⁻², which was 96.5% lower than that before cutoff.

Figure 11. Variations in three average shear stresses during (**a**) RUN2 and (**b**) RUN3. When cutoff occurred, τ_c was the highest and τ_d was the lowest. After cutoff, τ_c sharply decreased, while both τ_u and τ_d increased.

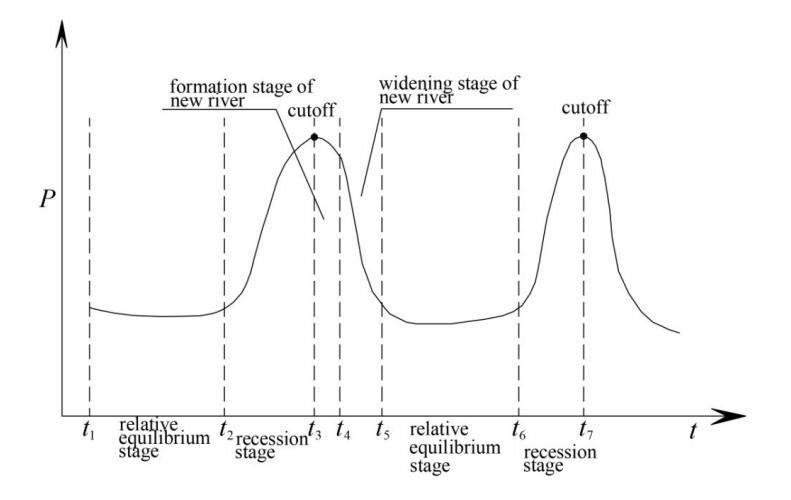
According to the variation in the stream power per unit length *P* over time in this experiment, the relationship between the *P* value at the different stages during the evolution of meandering rivers and cutoff occurrence was summarized, as shown in Figure 12. The river was initially at a relative equilibrium stage $(t_1 - t_2)$, and the P value was maintained at the minimum value. At this stage, the sinuosity gradually increased, forming a river with a high sinuosity suitable for the occurrence of neck cutoff. This stage persisted for a very long time. When the boundary conditions or flow conditions changed, the relative equilibrium stage was disrupted, and the river started to readjust the boundary and flow conditions. The boundary condition of a high-sinuosity river determined that the river was adjusted toward neck cutoff, and gradually moved away from the equilibrium zone. The variation in boundary conditions greatly impacted the riverbed erosion and deposition processes, and the change in P value exhibited an increasing trend overall, although it occasionally decreased in the middle at a certain time; the increased energy consumption was mainly used to adjust the channel shape, scouring and shortening the neck section, which was referred to as the recession stage (t_2-t_3) . When the P value increased to its maximum, a sudden change occurred (at time t_3 in the figure), the neck width decreased to zero, and cutoff occurred. After cutoff occurrence, a new river channel was formed; the *P* value gradually decreased; and the river channel entered a new evolution

period, evolving toward a relatively balanced stage. This stage ended quickly, and the river channel mainly adjusted its longitudinal shape. The *P* value was relatively large, which indicated the formation stage of a new river channel (t_3-t_4) . The widening stage of the new river occurred next (t_4-t_5) . The channel mainly adjusted the shape of the transverse section. This stage persisted for a long time, and the *P* value gradually decreased. When the river was adjusted to adapt to the new boundary and flow conditions, it entered a new relative equilibrium stage (t_5-t_6) , and the *P* value again decreased to its minimum, with no major changes. This period was also long. The *P* value at the new relative equilibrium stage, and they were not necessarily equal. When the new relative equilibrium stage was disrupted, the river channel again entered the recession stage. Cutoff could occur again. This cycle could be repeated. Thus, neck cutoff was a sudden event that occurred when the energy consumption of a meandering river increased to its maximum value upon entry to the recession stage from the relative equilibrium stage.

Figure 12. Schematic representation of the stream power values at the different stages of the river evolution.
