Article Alternative Engineered Soils and Seed Mixes Used for Seepage Troughs

Abstract: Green Infrastructure measures such as seepage troughs are an integral part of sustainable urban rainwater management. In Austria, seepage troughs are currently almost exclusively produced with a 30 cm thick active soil filter passage made of topsoil. A standard seed mix is used as vegetation, which usually consists of only three different turfgrass species. During a three-year trial, engineered soils with improved properties (increased water storage capacity, infiltration rate and pore volume) were tested for their suitability as seepage troughs compared to topsoil. In addition to the standard turf seed mix, a flowering turf seed mix (34 species) and flowering meadow seed mix (53 species) were applied. The engineered and reference soils were analyzed for infiltration rate, vitality, cover ratio and inflorescence. The results were further assessed with the evaluation chart showing quantitatively the suitability of the tested soils for rainwater management. The investigations showed that engineered soils in combination with flowering meadow seed mix lead to the best results. Therefore, this type o

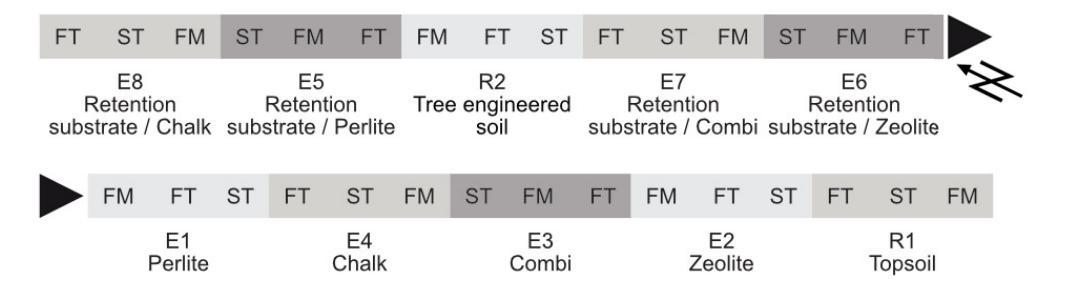
Figure 1. Overview of the tested soil alternatives (R1, R2, E1–E8) in the linear seepage trough in Vienna, constructed in a randomized order and planted with the three different seed mixes (ST = standardized turf, FT = flowering turf, FL = flowering meadow).

The tested soil alternatives were placed randomly next to each other in ten different test plots along the seepage trough. These fields were subdivided into three parts with different alternatives of seed mixes. Figure 1 shows the different engineered soils and the three different seed mix alternatives (ST = standardized turf, FT = flowering turf, FM = flowering meadow). The detailed species list is attached in the Appendix A (Table A1). As specified in the regulations, 15 g/m² were applied for the standard seed mix, 10 g/m² for the flowering turf seed mix and 8 g/m² for the flowering meadow seed mix [45].

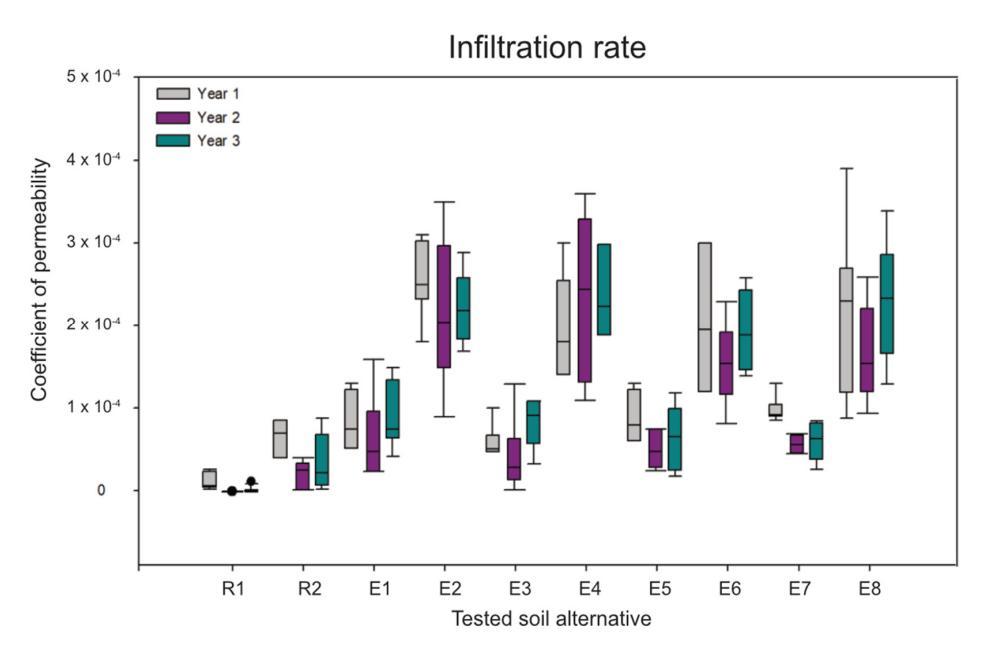
The following Figure 2 shows the coefficient of permeability as a unit for the infiltration rate over the three monitored vegetation periods in 2018–2020. Infiltration was measured (as described in Section 2.2.1) twice a year.

It can be shown that there were no significant differences regarding infiltration rate between the three years (2018–2020) within each tested soil. However, there were high differences in infiltration between the tested soil alternatives. By far, the lowest infiltration rate had R1, followed by R2. The highest infiltration rates were evident for E2 and E4. In contrast to the different infiltration values of the tested soil alternatives, no differences in infiltration were documented for the seed mixes.

Figure 2. Boxplots of infiltration rate for the tested soil alternatives for 2018–2020.

moisture increased rapidly and decreased slowly afterwards. In comparison, R2 showed a rapid decrease in soil moisture after the event. Twelve hours after the heavy rain event, soil moisture of only 10% volumetric water content (VWC) had been assessed for R2, while the soil moisture of the engineered soil alternatives remained higher with values ranging from 13 to 21% volumetric water content (VWC). In contrast to all other alternatives, R1 showed a very slow increase in soil moisture with a maximum of 16% volumetric water content (VWC) after 12 h, which can be explained by the low infiltration rate shown in Figure 2.

Based on the results obtained, it can be shown that there were significant differences in the infiltration performance of the individual engineered soil alternatives (see Figure 2). While all engineered soil alternatives met the requirements of the established technical standards [13,21], the reference soil R1 (topsoil) showed significantly lower infiltration rates. In 2019, *kf*-values of 1×10^{-9} m/s were achieved here, although the limit values according to the technical standards were 1×10^{-5} m/s and 5×10^{-6} m/s [13,21]. Compaction is the main reason why soils can no longer allow water to infiltrate due to the increased silting of sediments [22–24]. Especially during the first years after installation, this results in a of fine grains, as well as organic material, results in low resistance to compaction. As seen in additional carrying capacity measurements (see Appendix A Table A3), R1 had the lowest average carrying capacity of 4.0 MN/m^2 in 2018–2020. This leads to the conclusion that the infiltration rate would diminish even further in case of any compaction caused by e.g., cars or pedestrians. Therefore, the standard alternative R1 cannot be recommended.

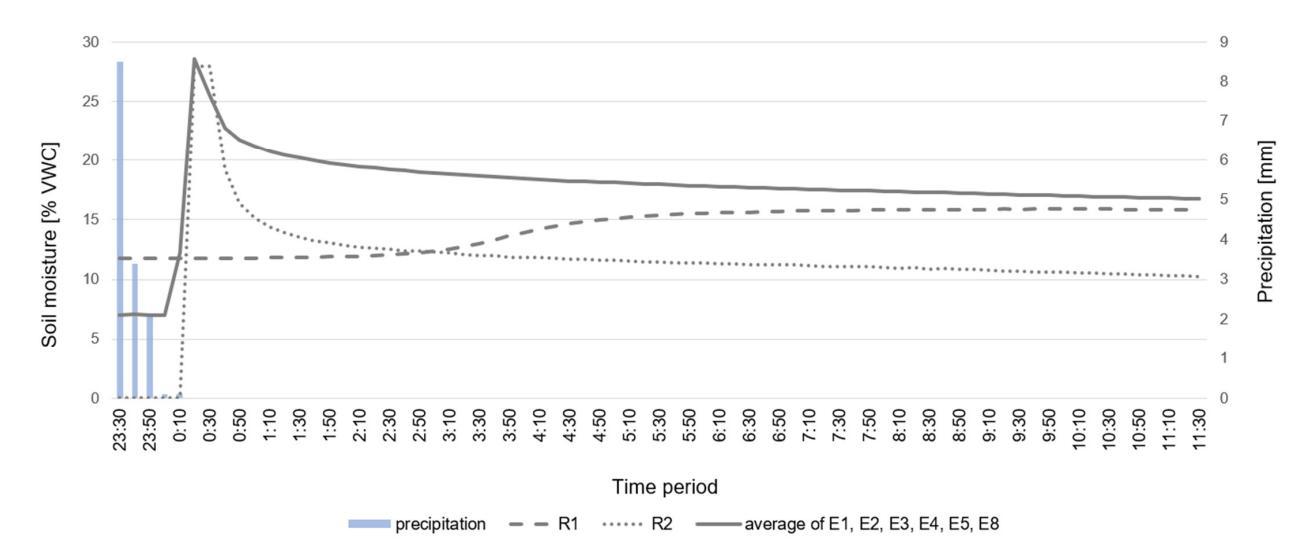
Soil moisture after a heavy rain event (7 June 2019)

Figure 3. Trend of soil moisture after a heavy rain event on 7 June 2019 (22.2 mm within 30 min) for R1, R2 and engineered soils E1, E2, E3, E4, E5 and E8.

During the rain event, 22.2 mm of precipitation occurred within 30 min, which roughly corresponded to a triennial heavy rain event for the site (design precipitation at grid point 2657 of the Austrian Hydrographic Service) [58].

The engineered soils (E1–E5 and E8) showed a similar trend independent of their layering, but a difference in maximum water storage of more than 10% volumetric water content (VWC) was observed (see Figure 3). After the recorded heavy rain event, the soil

Significant findings of infiltration rates were supported by the soil moisture measurements. Thus, the engineered soils E1–E5 and E8 experienced a rapid increase in soil moisture due to the high infiltration already described (see Section 3.1.1, Figure 3). The soil moisture slowly decreased over time. This is an indication that precipitation can be retained in the engineered soils for a long time. In comparison, the tree engineered soil (R2) absorbed water just as quickly as the engineered soils but also dried out again very quickly. Thus, R2 had a significantly lower water retention capacity than the engineered soil.

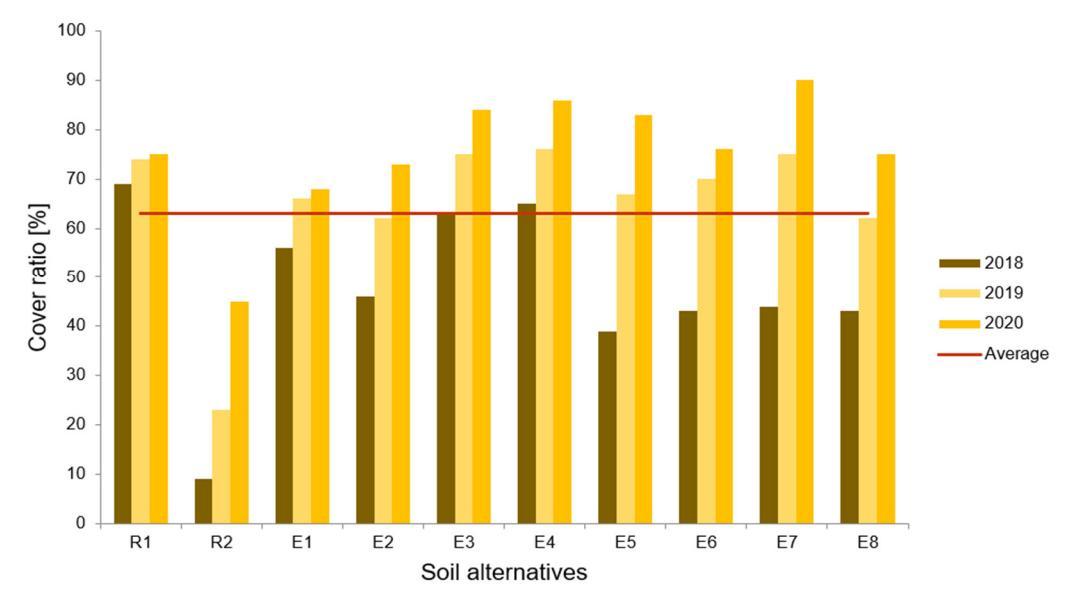
Cover ratio standardized turf 2018-2020

Figure 4. Comparison of the different average cover ratios [%] of standardized turf for the tested soil alternatives in 2018–2020.

The average cover ratio values are presented in Figures 4–6 for 2018, 2019 and 2020, indicated by the red line. The average values for the individual three years were based on the monthly monitoring during the growing season.

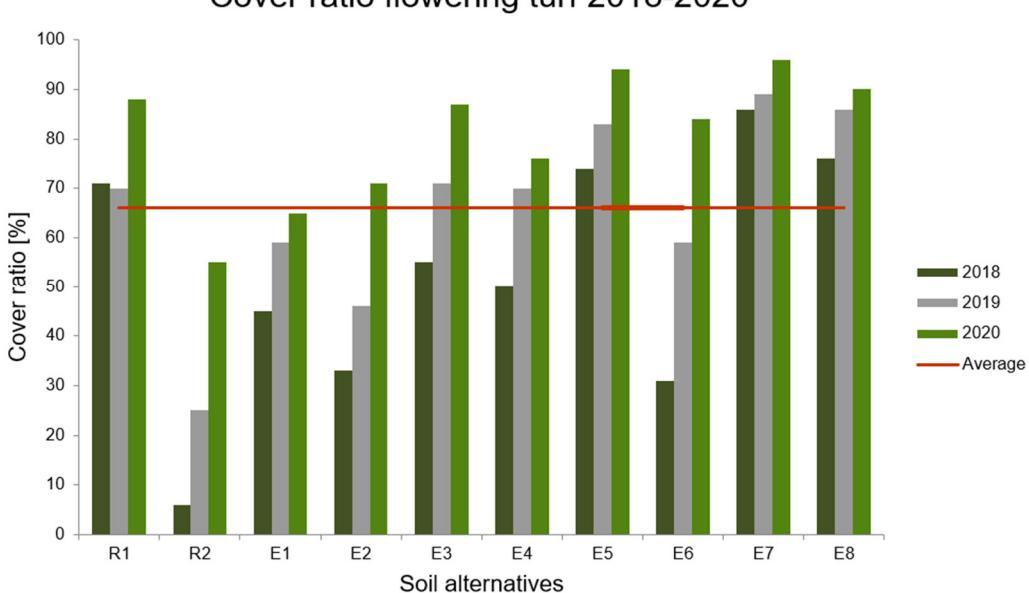
Cover ratio flowering turf 2018-2020

Figure 5. Comparison of the different average cover ratios [%] of flowering turf for the tested soil alternatives in 2018–2020.

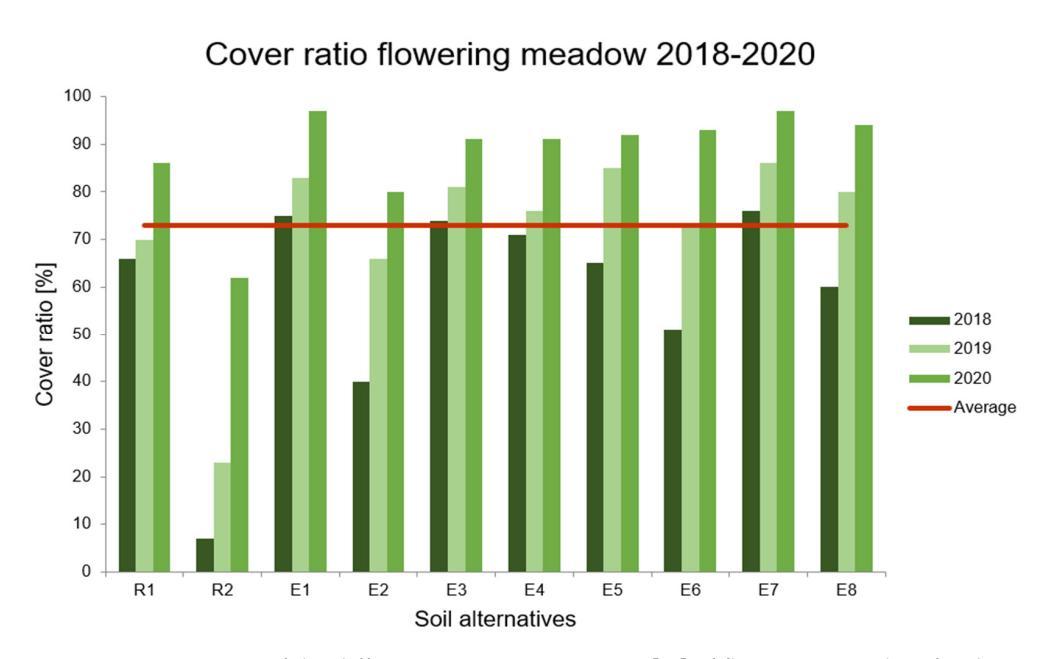
Figure 6. Comparison of the different average cover ratios [%] of flowering meadow for the tested soil alternatives in 2018–2020.

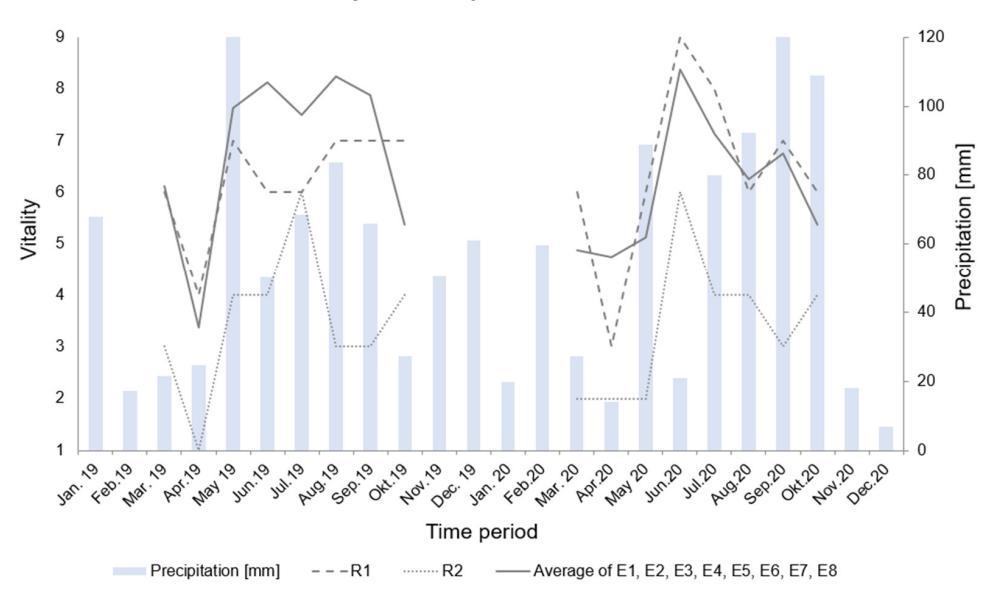
Vitality - Precipitation 2019-2020

Figure 7 shows the vitality in comparison to the monthly sum of precipitation. Especially in 2020, the vitality increased with increasing precipitation delayed by a month. Although a graphical correlation was recognizable, there were no significant correlations (n = 48, $\alpha = 0.05$; p = 0.182, r = 0.196) between vitality and precipitation. Especially in 2020, low precipitation led to an increase and thus improvement of vitality in the following month. Over both vegetation periods, R2 was performing far worse than the engineered soils. No effects of layering have been observed.

Figure 7. Vitality trend of the tested soil alternatives in comparison to precipitation over the vegetation period 2019 and 2020 (grey bars = precipitation, lines = vitality trend).
