Boris I. Khripunov *, Vasily S. Koidan and Evgeny V. Semenov

Abstract: A review of experimental studies carried out at the NRC "Kurchatov Institute" on plasmafacing thermonuclear fusion reactor materials is presented in the paper. An experimental method was developed to produce high-level radiation damage in materials simulating the neutron effect by surrogate irradiation with high-energy ions. Plasma-surface interaction is investigated on materials irradiated to high levels of radiation damage in high-flux deuterium plasma. The total fluence of accelerated ions (3–30 MeV, ${}^{4}\text{He}^{2+}$, ${}^{12}\text{C}^{3+}$, ${}^{14}\text{N}^{3+}$, protons) on the samples was $10^{21}-10^{23}$ m⁻². Experiments were carried out on graphite materials, tungsten, and silicon carbide. Samples have been obtained with a primary defect concentration from 0.1 to 100 displacements per atom, which covers the predicted damage for the ITER and DEMO projects. Erosion dynamics of the irradiated materials in steady-state deuterium plasma, changes of the surface microstructure, and deuterium retention were studied using SEM, TEM, ERDA, TDS, and nuclear backscattering techniques. The surface layer of th

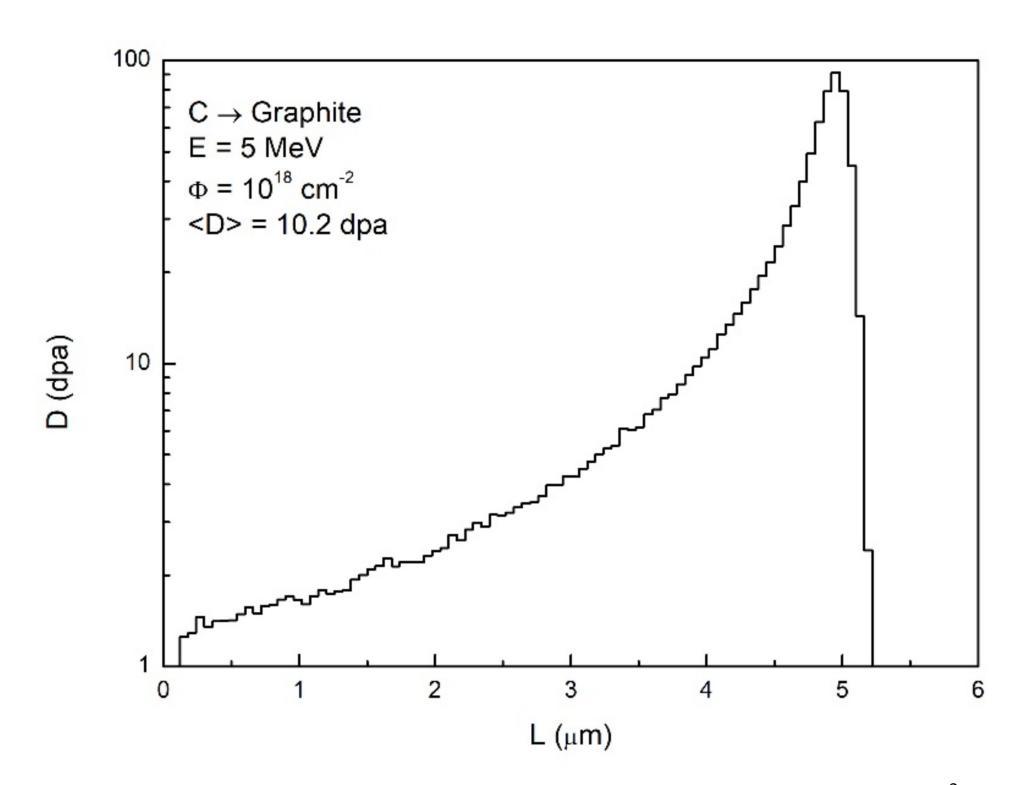
Figure 1. Primary radiation defects as a function of depth for a carbon material ($\rho = 1.7 \text{ g/cm}^3$) irradiated with 5 MeV C-ions to a dose of 10^{18} cm^{-2} .

Maximal damage ~90 dpa is at a depth of about 5 microns corresponding to the range of 5 MeV C-ions in a carbon material of 1.7 g/cm^3 density while average damage is $\langle D \rangle = 10.2$ dpa. The surface structure is modified under irradiation, though sputtering effect is not important. Modification of the surface structure of the SEP NB-31 sample is shown in Figure 2, where the boundary between irradiated and non-irradiated parts is apparent. Development of the surface is seen on the irradiated part of the surface.

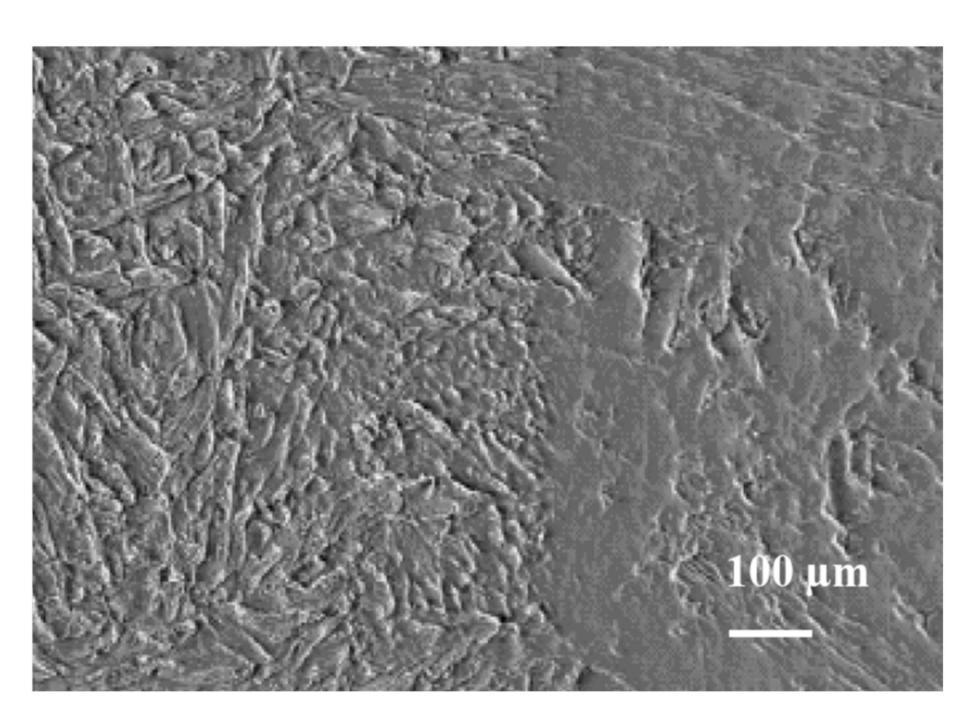
Figure 2. Border on the surface of the SEP NB-31 sample irradiated to $\langle D \rangle = 10$ dpa: damaged area is to the left; the right part was shielded from the irradiation. The scale is 100 µm [21].

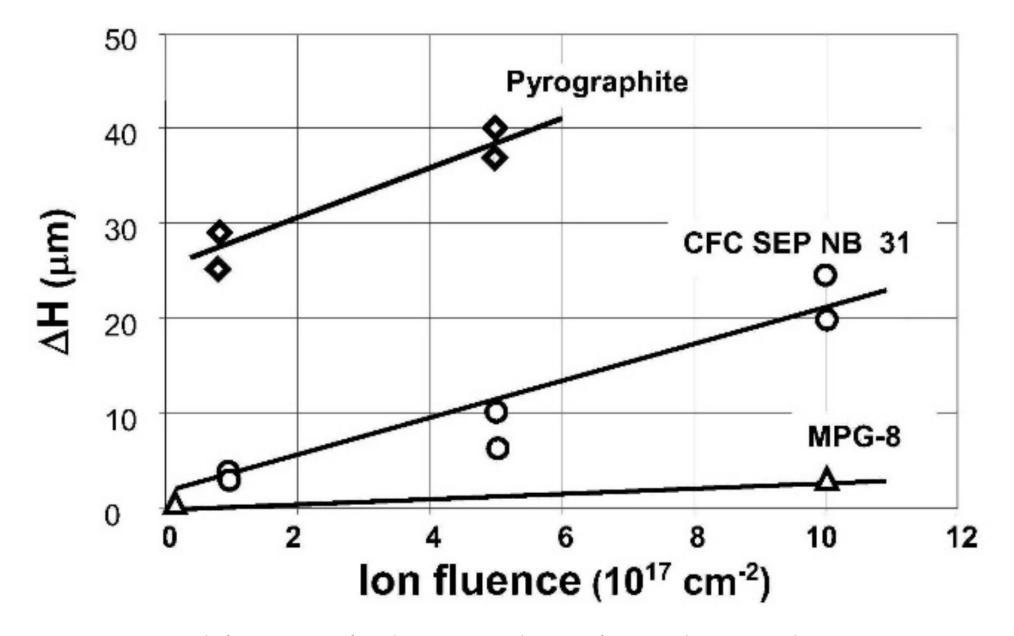
Figure 3. Linear deformation of carbon materials ΔH after irradiation with 5 MeV C-ions.

A large radiation-induced deformation has been found on the carbon materials. This was clearly detected by profiling the surface around the boundary of the irradiated zone shown in Figure 2. Considerable linear deformation measured with a profilometer was found on all ion irradiated graphites under study. The results of these measurements for all three types of materials are summarized in Figure 3 as a function of irradiation dose. The MPG-8 was found as the most radiation-resistant having minimal deformation in our case while the composite SEP NB-31 has shown large deformation: $\Delta H = 20 \ \mu m$ on 10 dpa sample ($10^{18} \ cm^{-2}$). The deformation of the 10 dpa pyrographite sample surpassed the profilometer limit of 160 μm .

Thus, the studied graphites exhibited a great swelling effect after irradiation which was very large as compared with the damaged surface layer ($\sim 5 \mu m$ ion range). Besides the damage induced by fast ions, those materials undergo sputtering. Surface modification due to these effects was detected on all materials (see Figure 2). Splitting of the damage layer was also observed on pyrographite. Cracks were found on 5 and 10 dpa MPG-8.

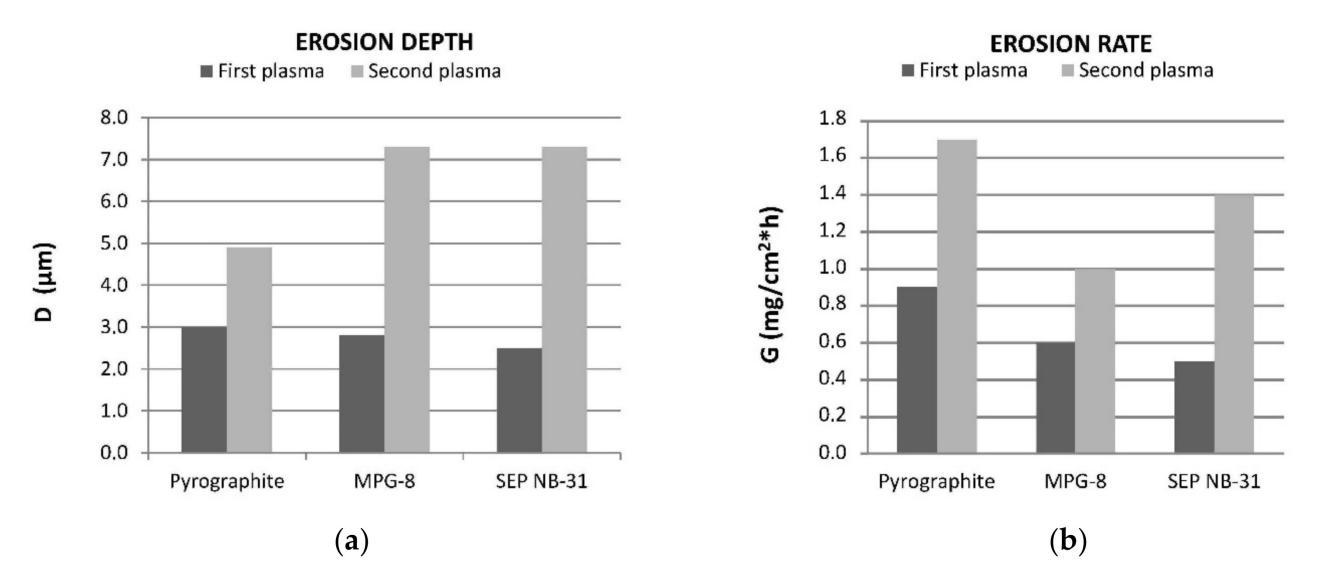
Figure 4. Erosion depth (**a**) and erosion rate (**b**) in double plasma experiment for 1 dpa samples of SEP NB-31, MPG-8 and pyrographite.

The irradiated graphite samples were then exposed to the steady-state deuterium plasma on the LENTA plasma simulator. Exposure parameters were as follows: D-ion current 10 mA/cm², ion energy 100 eV (negative bias), sample temperature during plasma operation \leq 40 °C. The carbon materials were processed in the plasma in two exposures 1 h each. The layer of about a half-fast ion penetration depth was eroded during the first step (about 2–3 µm), and the layer of the maximal radiation damage was eroded in the second plasma exposure (~3–7 µm) [21]. Weight loss due to the plasma bombardment was measured after each plasma exposure. The result of double successive plasma exposure of carbon materials is illustrated in Figure 4. Shown are the erosion depth and erosion rate of the three graphites under study after the first and after the second plasma runs. All materials exhibit increase in erosion rate in the second plasma exposure corresponding to the layer of maximal defect density involved in the erosion. This evidently shows the increase of erosion rate for higher irradiation damage levels of the investigated materials.

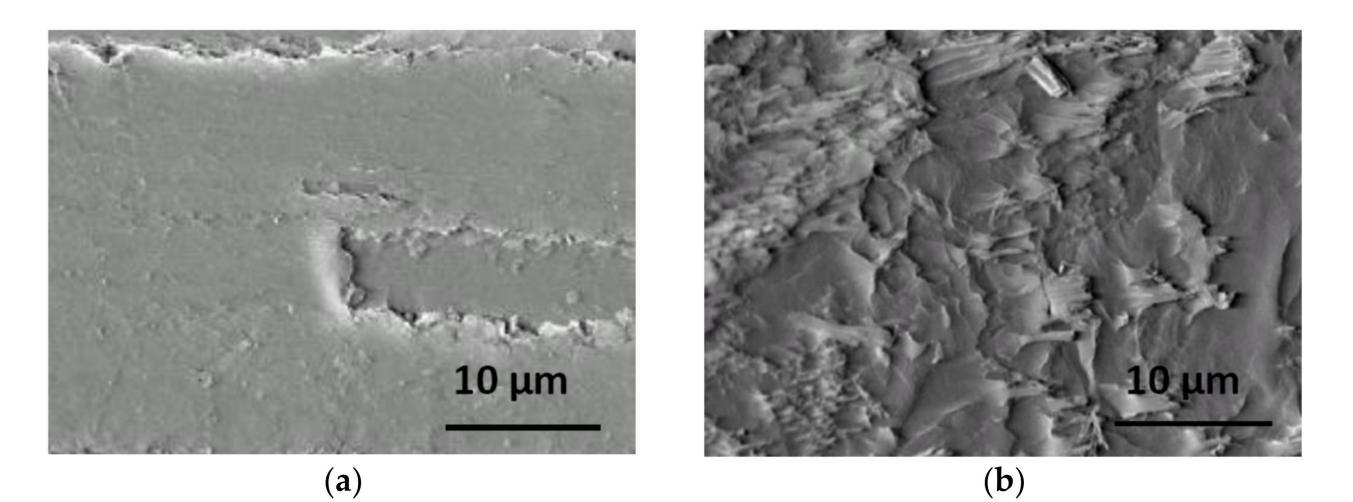
Figure 5. SEP NB-31 surface at initial state (a) and after irradiation with C ions to 10 dpa and plasma exposure (b) [15,21].

Changes in the surface microstructure were observed after each plasma exposure. An example of the SEP NB-31 surface irradiated to 10 dpa after plasma bombardment is shown in Figure 5b.

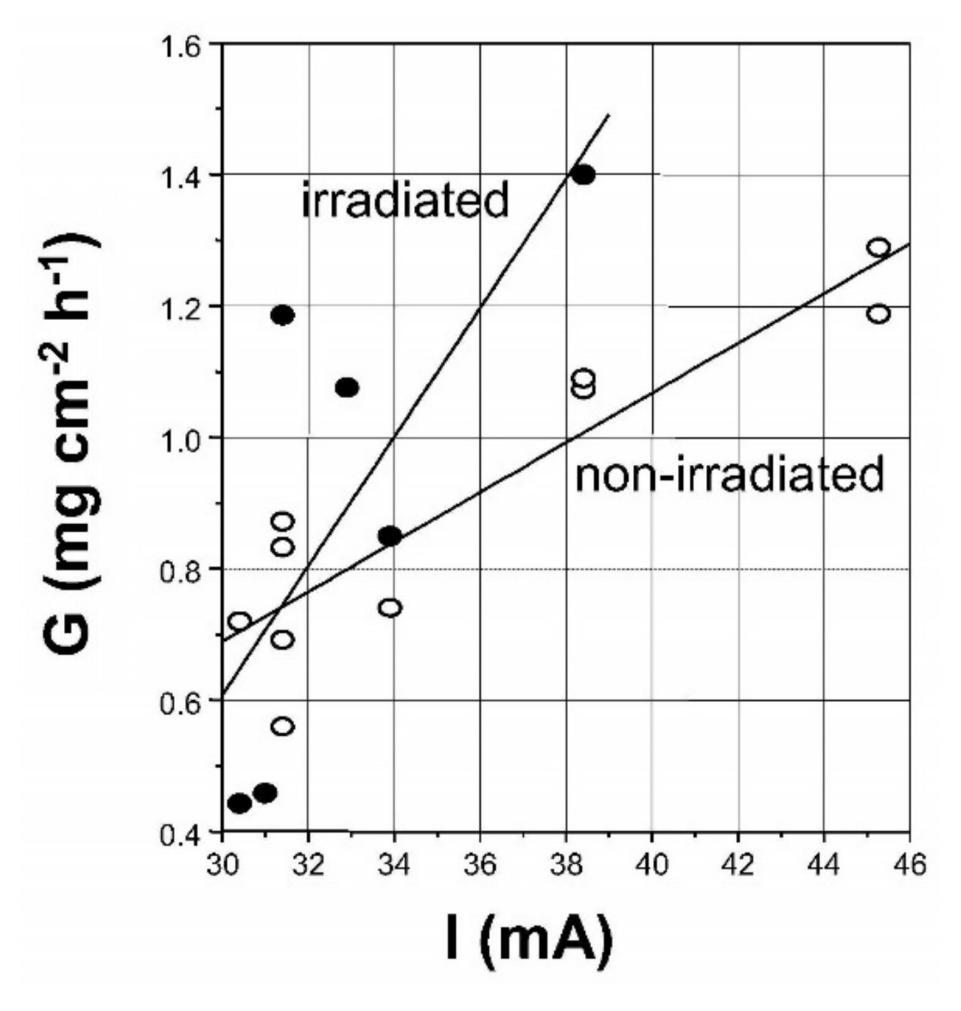
Figure 6. SEP NB-31 erosion rate vs. ion current in D-plasma [15,21].

Changes in the surface took place on the CFC materials. The formation of holes, whiskers, and cones was seen on the SEP and MPG samples. Our observations lead us to the conclusion that the radiation damage has a strong influence on the erosion in plasma of carbon plasma-facing materials increasing with higher damage levels. The effect is supposed to be determined by the radiation damage accumulated in the lattice that results in the material microstructure changing from dense to more friable (loss of regular structure).

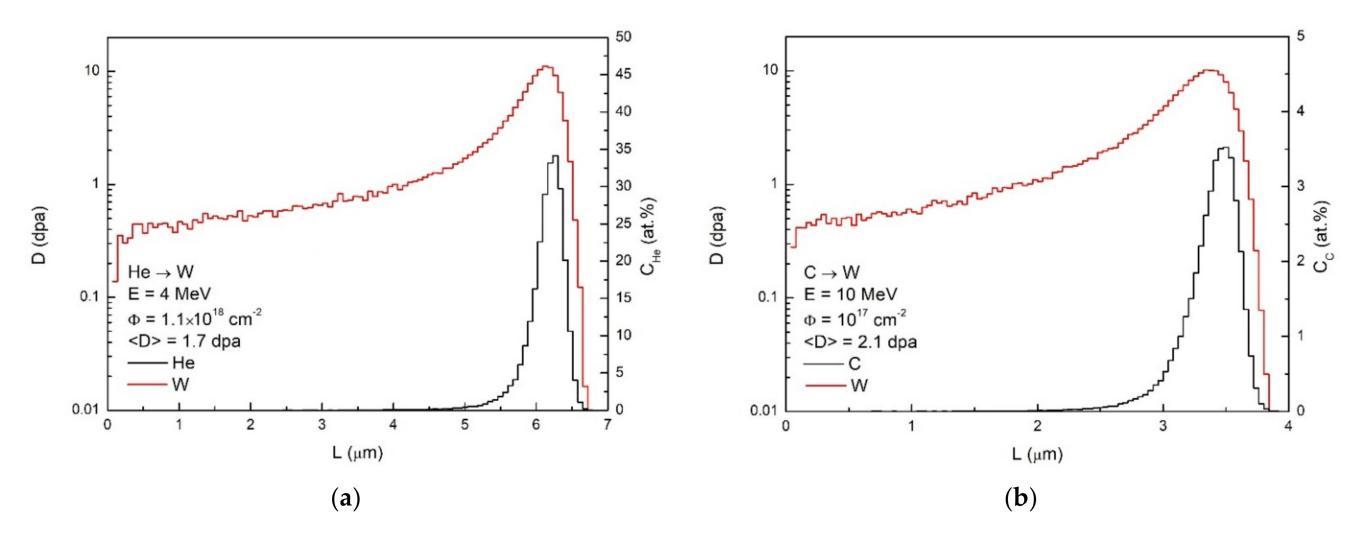
Figure 7. Distributions of primary defects (dpa) and implanted ion concentrations (at.%) in tungsten irradiated with He (**a**) and C (**b**) high-energy ions (SRIM calculations).

Another case of irradiation, namely, by ${}^{12}C^{3+}$ has been investigated, which would help to distinguish effects of the accumulated He and of the damage itself on hydrogen retention in damaged tungsten [18]. Tungsten samples were irradiated with carbon ions ${}^{12}C^{3+}$ accelerated to 10 MeV, the total ion fluence reaching $(1-2) \times 10^{17}$ cm⁻². Ion energy and the total fluence value were chosen so that the resulting damage expressed in dpa was similar to that for He-ion irradiations. Figure 7 shows distributions of primary defects in tungsten produced by ${}^{4}\text{He}^{2+}$ at 4 MeV and by ${}^{12}\text{C}^{3+}$ at 10 MeV (SRIM calculations) in 3–7 µm layer. The concentration of the implanted ions is also presented.

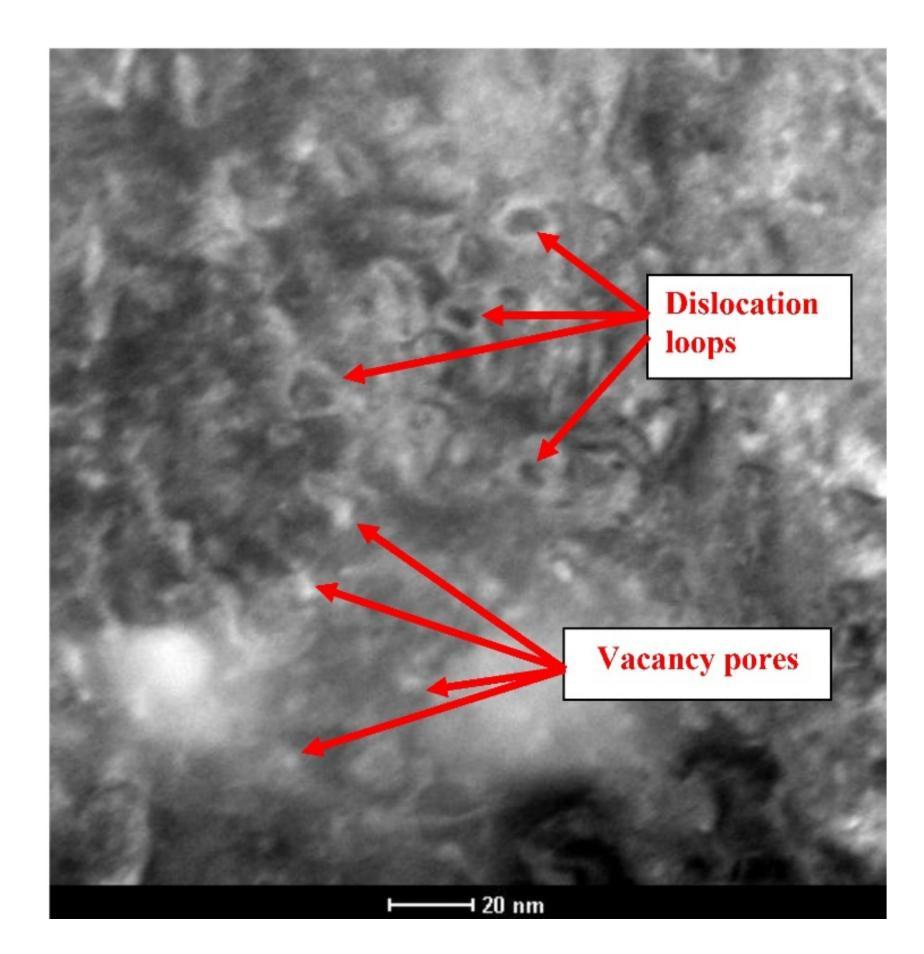
Figure 8. System of dislocation loops and vacancy pores in tungsten irradiated by carbon ions at 10 MeV, $T = 600 \degree C$ [16].

Temperature as an important parameter for the research of a damaged material was also taken into account. Irradiations of tungsten by carbon ions were made at different temperatures, namely, at room temperature (RT) and at 600 °C. Figure 8 shows the damaged structure of tungsten irradiated with C ions at 600 °C taken by the TEM technique. Numerous vacancy pores and dislocation loops are presented in figure.

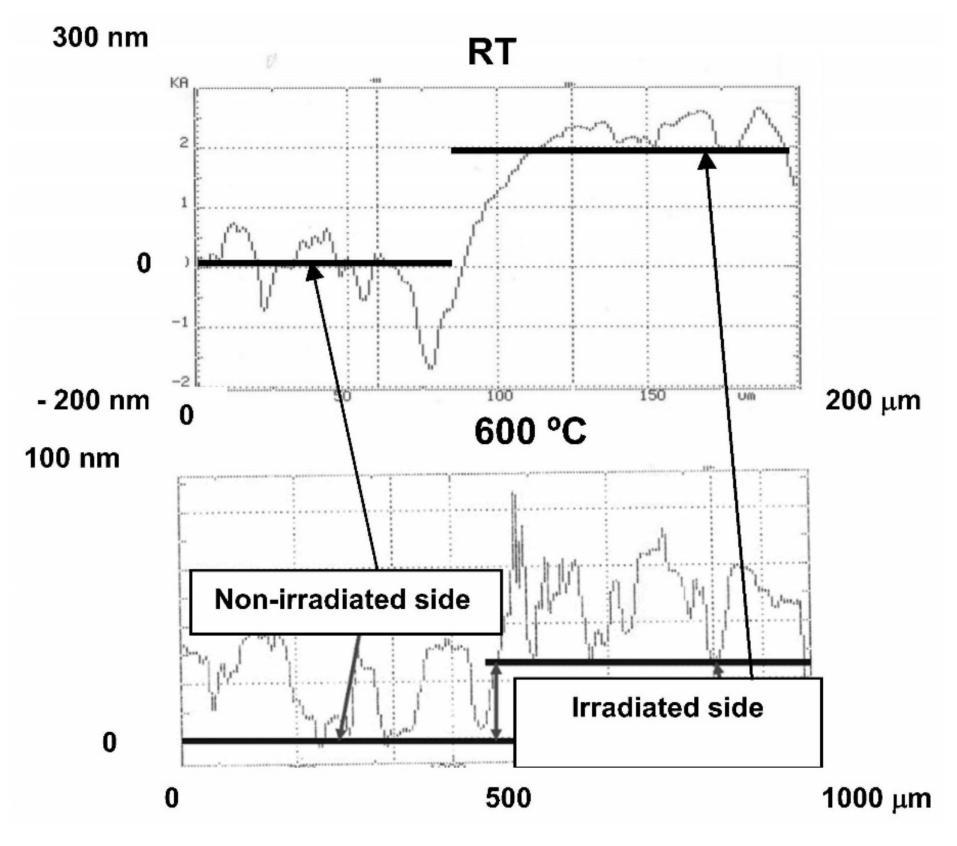
Figure 9. Tungsten profiles around the boundary of the C-irradiated area for the two temperatures of the surface during irradiation—room temperature and 600 °C (the irradiated part is to the right).

Linear deformations have been found on C-irradiated tungsten by surface topography observations. The result of the surface profile measurements is shown in Figure 9. The boundary of the irradiated area was studied for two temperatures of the material during irradiations—room temperature and 600 °C. The step corresponding to the swelling effect is clearly visible on the surface for both cases. The elevated part is on the irradiated area side. The swelling was much higher for the lower temperature irradiation. The measurement was made with necessary statistics in the high temperature case.

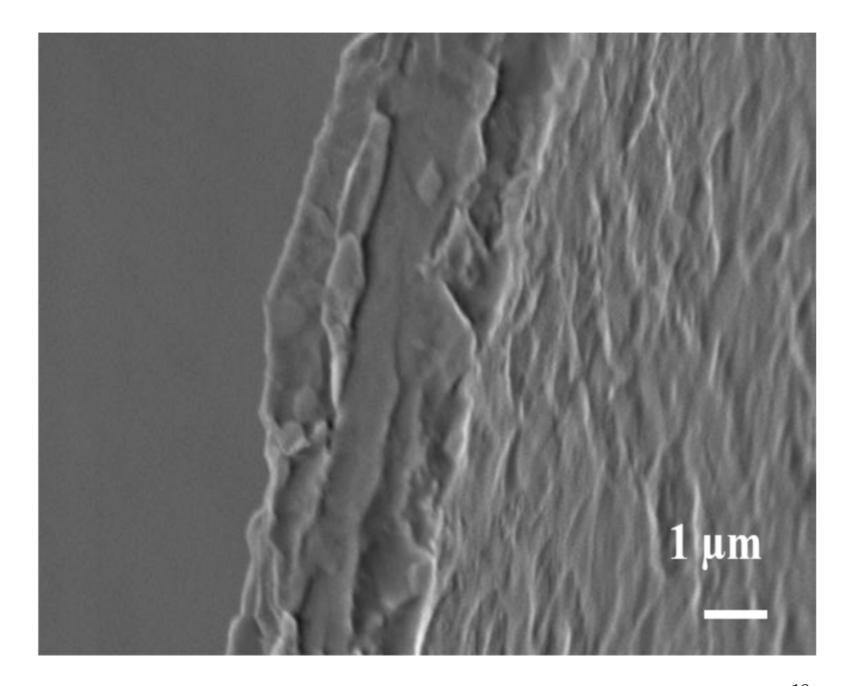
Figure 10. Damaged layer in fracture of He-irradiated tungsten ($\Phi = 10^{19} \text{ cm}^{-2}$) after exposure to deuterium plasma (inclined view) [16].

Figure 10 shows the surface and the damaged layer of the sample irradiated to 90 dpa in average for the case of maximal fast ion fluence He²⁺ ($\Phi_{max} = 10^{19}$ cm⁻², $\Phi_{av} = 3 \cdot 10^{18}$ cm⁻², E = 3-4 MeV) followed by plasma exposure with an erosion of 2 microns as a result. Cavities are displayed presumably filled with helium after irradiation.

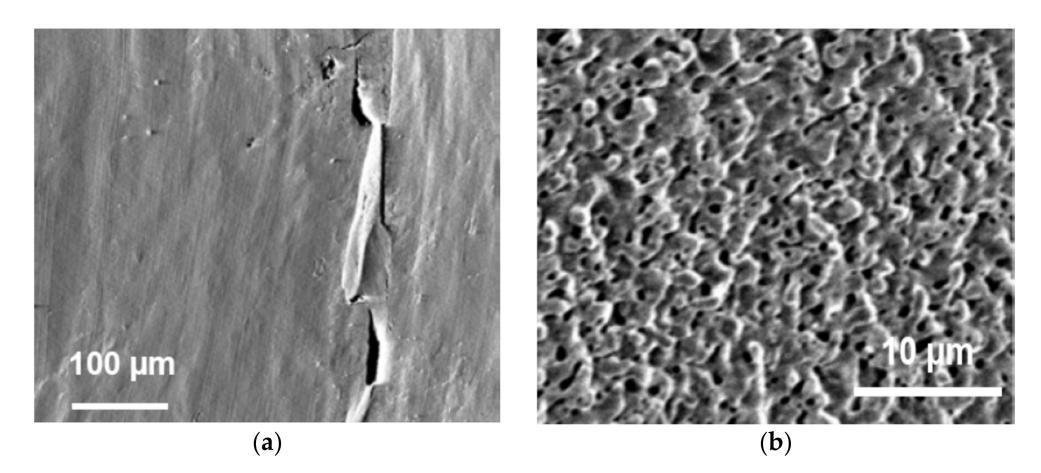
Figure 11. He-irradiated tungsten (3 \times 10¹⁸ cm⁻², 4 MeV): (**a**)—6 dpa at the surface; (**b**)—after D-plasma 2.4 \times 10²¹ cm⁻². The depth of 3.6 μ m eroded to reach the layer of damage corresponding to 15 dpa [16].

An example of surface structure modifications of the He-irradiated sample, after plasma sequential exposures, is presented in Figure 11 where the surface has been changed from initially smooth to porous at higher plasma fluence (and higher damage).

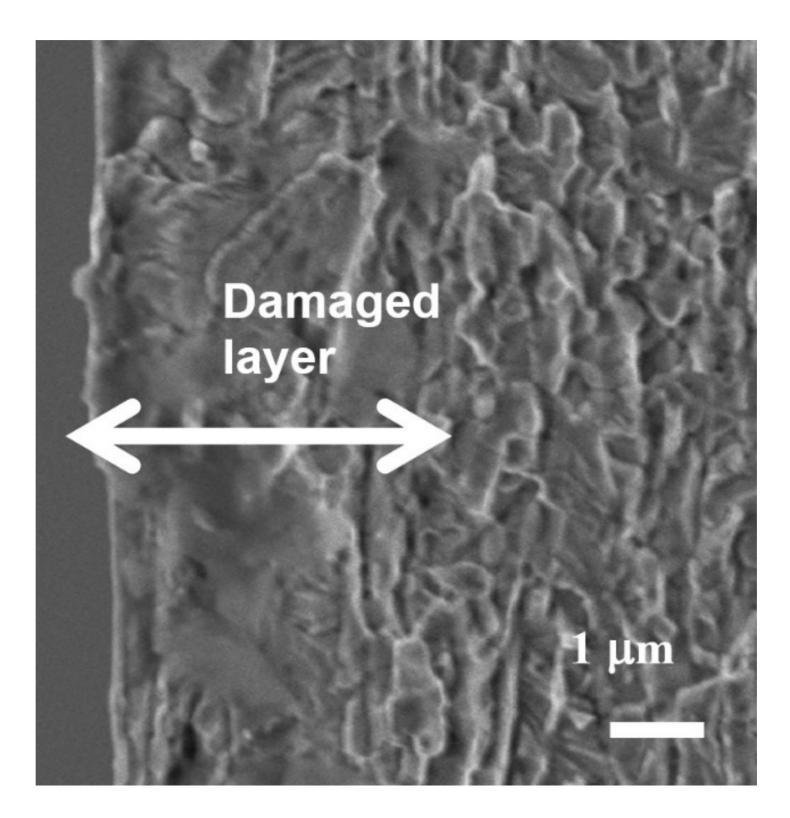
Figure 12. Microstructure (fracture) of C-irradiated tungsten after exposure to deuterium plasma (1 µm eroded by the plasma) [16].

The fracture of C-irradiated tungsten is shown for comparison in Figure 12 as registered after deuterium plasma: the surface layer 1 micron thick was sputtered by plasma bombardment. Considerable changes of microstructure by fast C ions in the layer of about 4 μ m (the range of a carbon ion in tungsten) are clearly seen in figure.

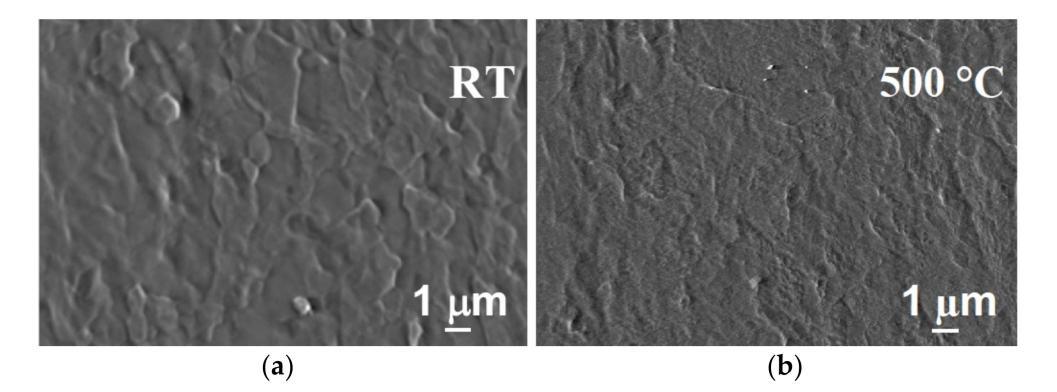
Figure 13. Tungsten surface irradiated and exposed to plasma at different temperatures—room temperature (**a**) and 500 °C (**b**). Ion type, energy and fluence were ¹²C³⁺, 10 MeV, (1.5–2) × 10¹⁷ cm⁻², respectively. Both samples were eroded in deuterium plasma to a depth of 1 μ m.

C-irradiated samples have not shown spectacular changes of the surface structure after plasma as He-irradiated samples. SEM photos of C-irradiated tungsten after deuterium plasma are presented in Figure 13. The two pictures correspond to the close levels of primary defects (5–6 dpa) but to different temperatures of the material during irradiation and plasma exposure—room temperature and 500 °C, the difference between these two cases being though not significant but quite visible.

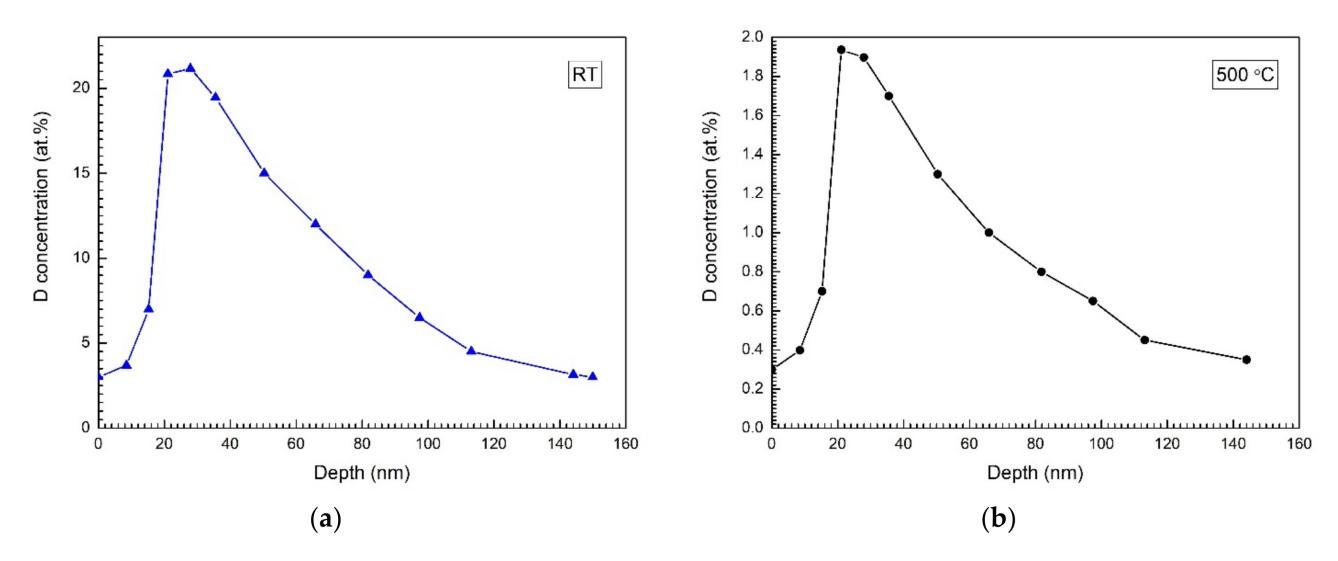
Figure 14. Deuterium retention in tungsten pre-irradiated with C ions at room temperature (**a**) and at 500 $^{\circ}$ C (**b**) after exposure to deuterium plasma (both cases correspond to 1–2 dpa layers).

Deuterium retention on C-damaged tungsten exposed to deuterium plasma was analyzed in experiments conducted at different temperatures of the material. Profiles of the retained deuterium are shown in Figure 14 for two tungsten samples. About tenfold reduction of deuterium uptake has been registered on the high temperature sample in comparison with the room temperature case (8.7×10^{16} cm⁻² to 0.8×10^{16} cm⁻²). Both deuterium distributions have a maximum at about 20–30 nm in the layer between 10–140 nm.

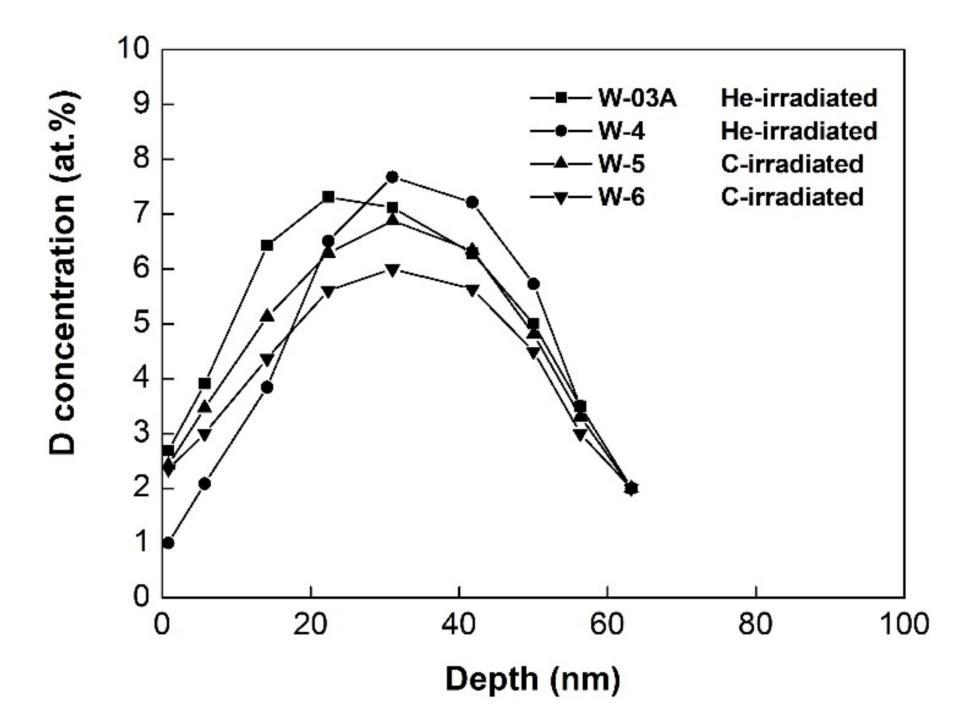
Figure 15. Deuterium concentration in damaged tungsten after plasma exposure: He-irradiated samples to 1–2 dpa W-03A and W-4; samples W-5 and W-6 pre-irradiated with C ions to 2 dpa.

Direct comparison of the deuterium retention for He and C pre-irradiated samples were also performed. The ERDA results for four tungsten samples are presented in Figure 15 for room temperature. Two samples were irradiated with He ions and two others with C ions. The damage level at the surface was nearly the same (1–2 dpa) at the moment of the measurement (at the corresponding stage of the plasma erosion). The result shows that deuterium is concentrated around 20–40 nm (maximum) in a depth of 60 nm in all cases with a total amount of the detected deuterium (1.65–1.85) $\times 10^{16}$ cm⁻².

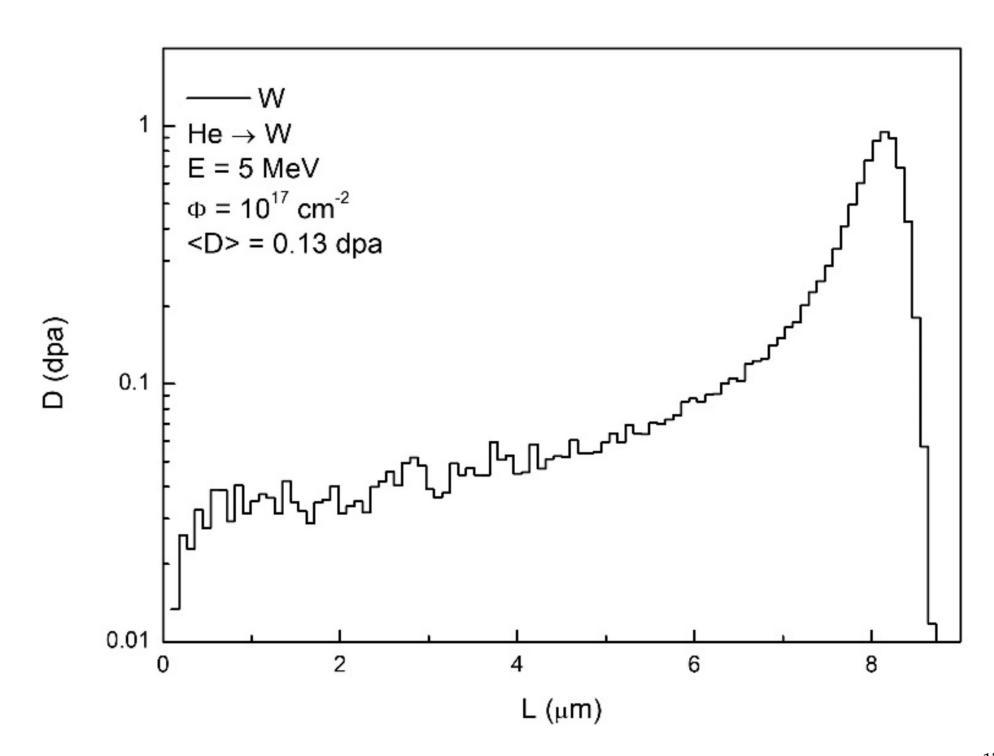
Figure 16. Concentration of primary defects in tungsten produced by He ions at 5 MeV, 10^{17} cm⁻².

Irradiation by ¹⁴N³⁺ ions was explored on PLANSEE and POLEMA tungsten samples suggested for application in the ITER reactor [19]. Numerical calculations were performed to find out irradiation fluence needed to obtain damage comparable with those already obtained in He and C cases at fluence 10^{17} cm⁻². Figures 16–18 present primary defects concentrations in the surface layer along the ion penetration depth for three ion species. Figure 16 shows the result of tungsten irradiation with helium ions at 5 MeV to fluence 10^{17} cm⁻². The corresponding data for carbon ions at 30 MeV is given in Figure 17. The calculation for nitrogen irradiation was made with the data given in Figure 18: ions $^{14}N^{3+}$, energy 30 MeV, fluence 10^{17} cm⁻². This choice gives average irradiation damage $<D_N > = 1.5$ dpa in a layer of 8 µm which is close to $<D_C > = 0.9$ dpa for carbon ions.

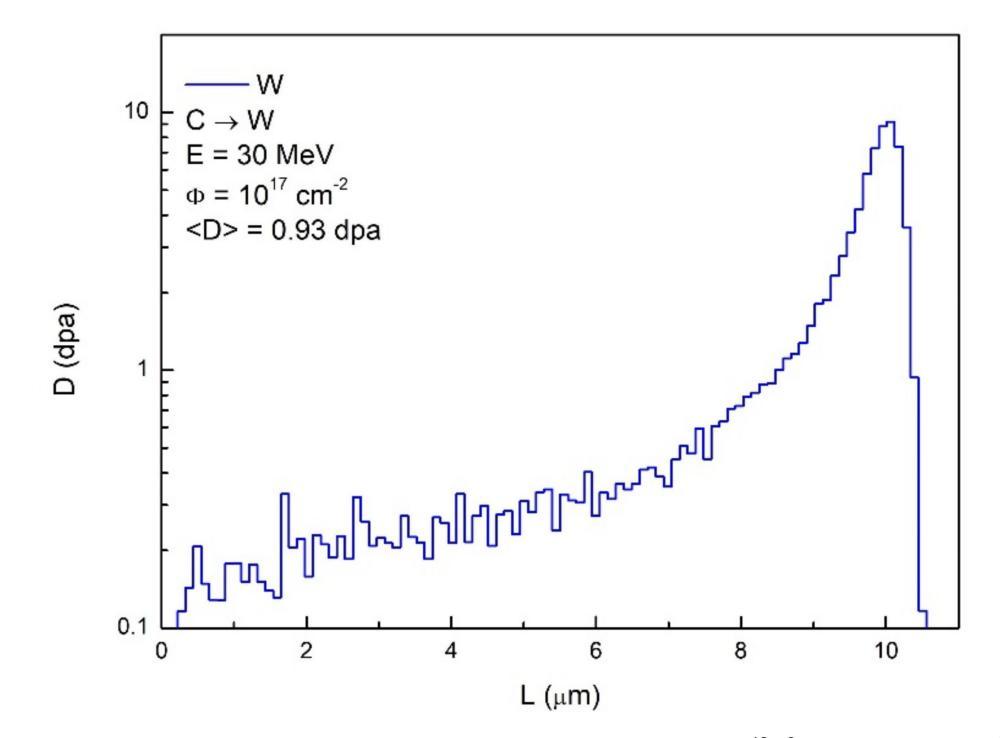
Figure 17. Concentration of primary defects produced in tungsten by ${}^{12}C^{3+}$ ions at 30 MeV, 10^{17} cm⁻².

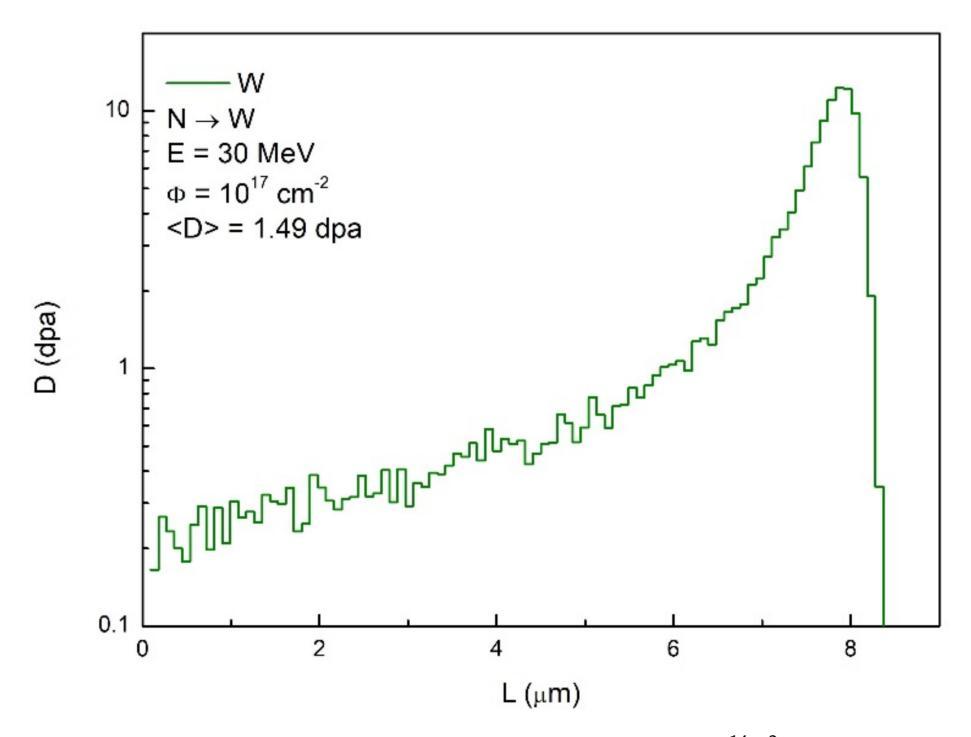
Figure 18. Concentration of primary defects produced in tungsten by $^{14}N^{3+}$ ions at 30 MeV, 10^{17} cm⁻².

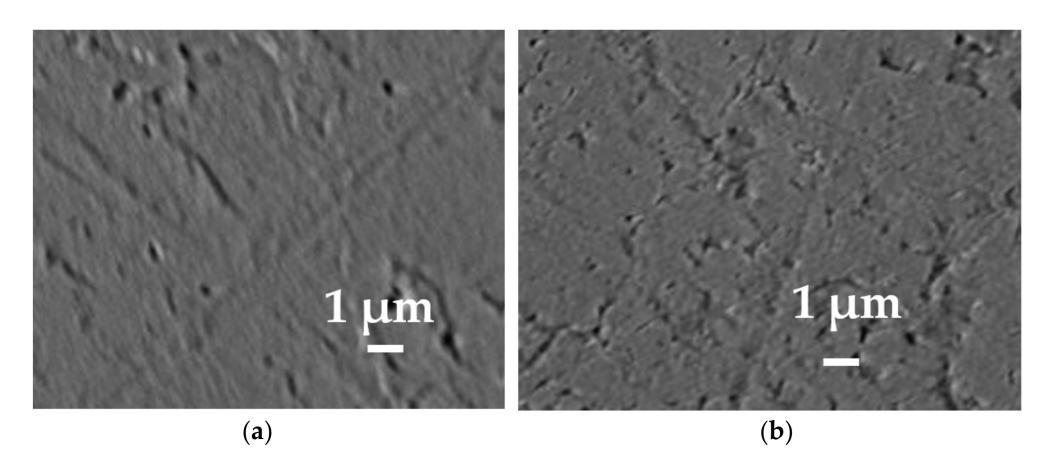
Figure 19. PLANSEE surface before (**a**) and after (**b**) irradiation with ${}^{14}N^{3+}$ ions at 28 MeV to fluence 10^{17} cm⁻².

The surface microstructure of tungsten samples after irradiation by nitrogen ions had no spectacular changes, as was shown by SEM analysis. Given in Figure 19 is the surface of PLANSEE sample at the initial state and after irradiation by $^{14}N^{3+}$ beam at 28 MeV to fluence 10^{17} cm⁻².

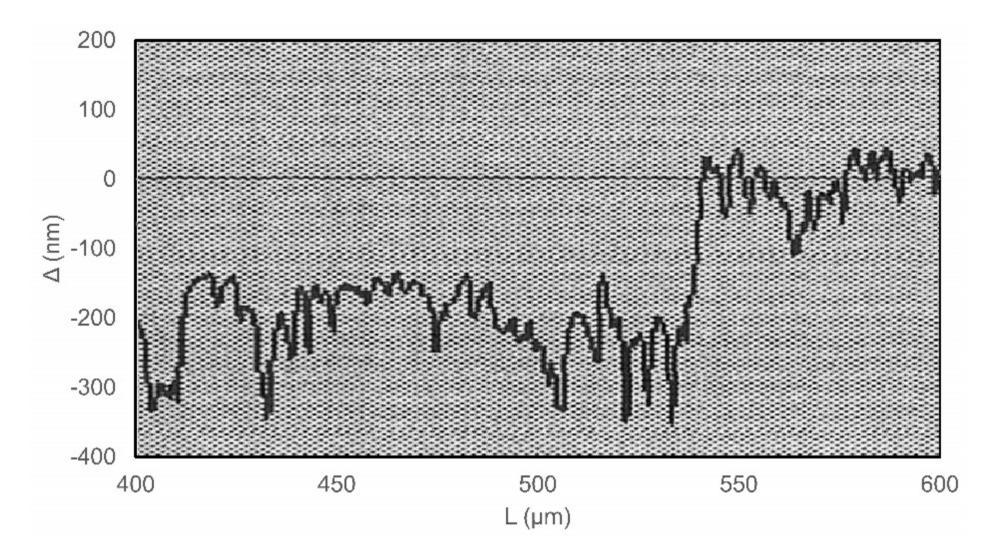
Figure 20. Profile of the irradiated PLANSEE surface: irradiated area is to the right ($^{14}N^{3+}$ ions, 28 MeV, 10^{17} cm⁻²). The left part is masked from irradiation.

The surface of the irradiated tungsten was also examined with a profilometer, and a significant swelling effect was detected as the result of radiation defects accumulated in the layer of 8 μ m. The example of the surface profile registered around the boundary of the irradiated region is shown in Figure 20. The measured elevation values were from 600 Å to 1800 Å for the irradiated PLANSEE samples under study. Taking into account the depth of the damaged layer one may evaluate the swelling effect from 1% to 2.5%. Similar measurements were made on the POLEMA tungsten samples irradiated in the same conditions. The registered elevation step was 2200–2350 Å in this case. This corresponds to the swelling effect of 2.7–2.9% for the investigated material.

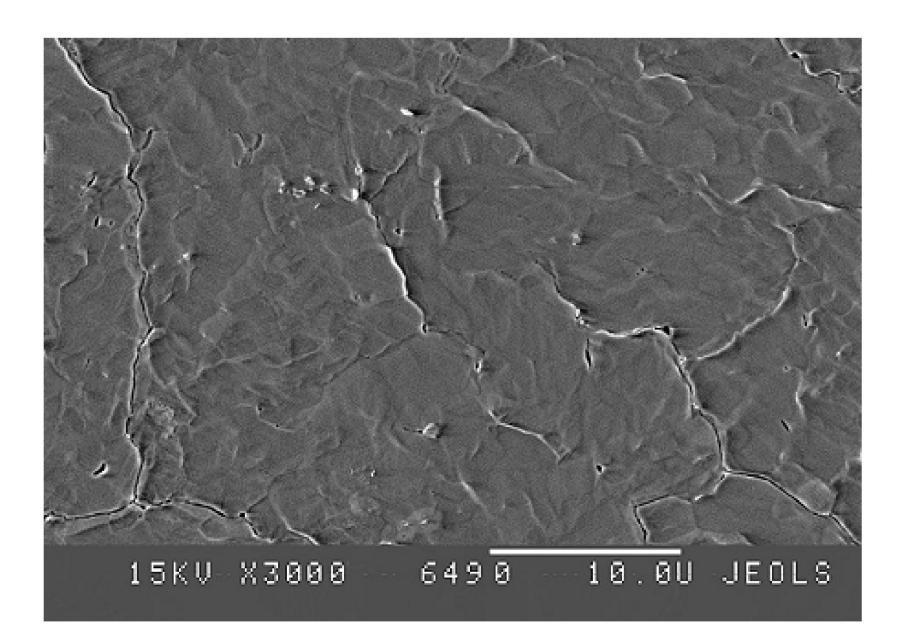
Figure 21. N-irradiated PLANSEE surface after plasma exposure to $\Phi_{Di} = 3.6 \times 10^{21} \text{ cm}^{-2}$ ($E_{Di} = 250 \text{ eV}$) (scale bars in μ m).

SEM analysis of the surface was made at every stage of the experiments—after irradiation with high energy nitrogen ions and after plasma exposure. It was shown that fast ions irradiations did not result in visible changes of the surface structure. On the other hand, the surface exhibits strong transformations after exposure of the materials to deuterium plasma having extensive erosion (ex. 3 μ m shown in Table 1). This effect is due to the changes in the crystal structure, and these are the development of intergranular boundaries where deep caverns appear bound to them. These features are clearly seen in Figure 21, presenting the surface of the pre-irradiated PLANSEE sample after plasma exposure.

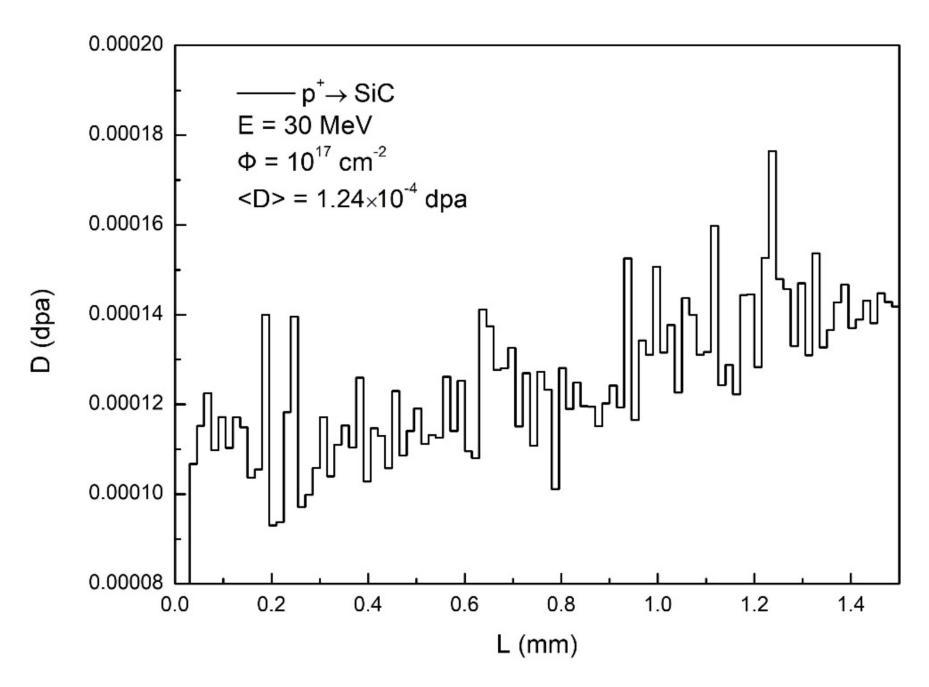
Figure 22. Radiation damage profile produced in SiC by protons with energy 30 MeV to fluence 10^{17} cm⁻².

The calculation was performed in SRIM to obtain damage characteristics for the proton irradiated SiC material. Threshold energy for the defect production was 35 eV and 20 eV for silicon and carbon, correspondingly. The result given in Figure 22 is the primary defect concentrations in SiC for protons accelerated to 30 MeV for $\Phi = 10^{17}$ cm⁻². These protons produce damage to the whole thickness of the samples (1.5 mm) at a level of 1.23×10^{-4} dpa on average.

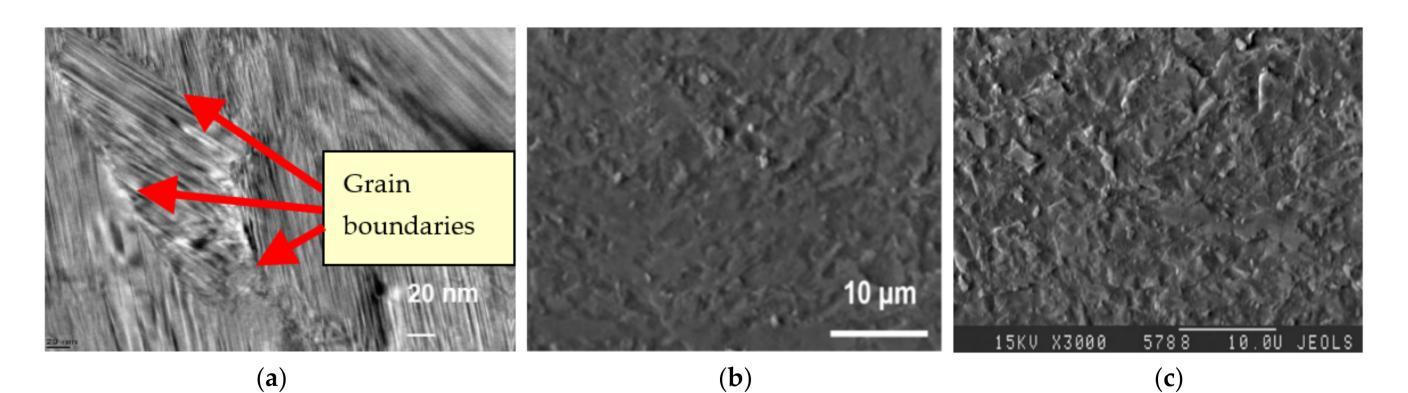
Figure 23. SiC surface at initial state as taken by TEM (a) and SEM microscopy (b,c).

Surface structure was analyzed at different stages of the experiments by SEM and TEM microscopy. Figure 23 shows the initial state of the SiC surface. The result of the plasma exposure of the irradiated and of non-irradiated material is shown in Figure 24.

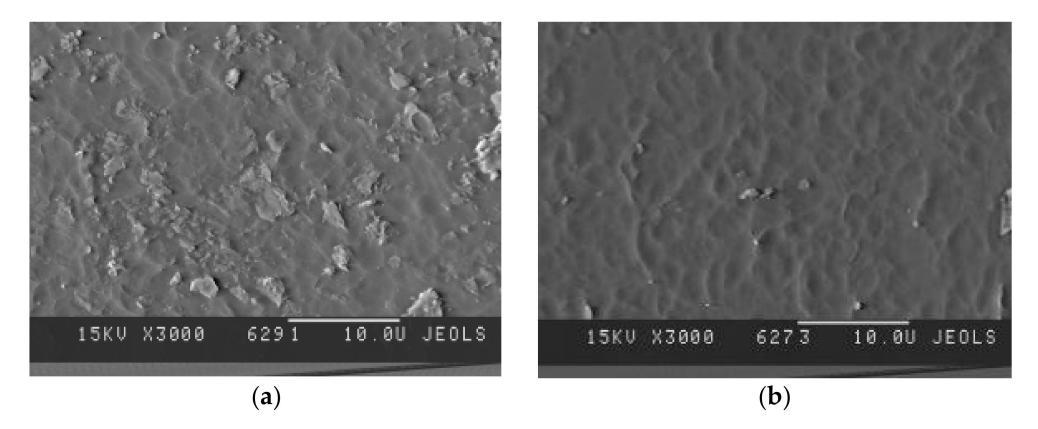
Figure 24. SiC surface after exposure to deuterium plasma ($\Phi_{Di} = 0.4 \times 10^{21} \text{ cm}^{-2}$, $E_{Di} = 100 \text{ eV}$): (a)—sample irradiated with protons, (b)—non-irradiated sample (scale in µm).

The analysis showed that the production of defects in the material by fast protons induces important changes in the surface structure at plasma erosion regime. They are manifested by the appearance of a large number of flaky elements that, in turn, may enhance erosion. The erosion process is evolving on the background of the mosaic structure which is clearly revealed on the wavy surface of the non-irradiated material (Figure 24).
