# Surface Weathering of Tuffs: Compositional and Microstructural Changes in the Building Stones of the Medieval Castles of Hungary

Luigi Germinario <sup>1,2,\*</sup> and Ákos Török <sup>1,\*</sup>

- <sup>1</sup> Department of Engineering Geology and Geotechnics, Budapest University of Technology and Economics, Műegyetem rkp. 3, 1111 Budapest, Hungary
- <sup>2</sup> Department of Civil and Environmental Engineering, Saitama University, 255 Shimo-Okubo, Sakura-ku, Saitama-shi, Saitama-ken 338-8570, Japan
- \* Correspondence: luigi.germinario@gmail.com (L.G.); torokakos@mail.bme.hu (Á.T.)

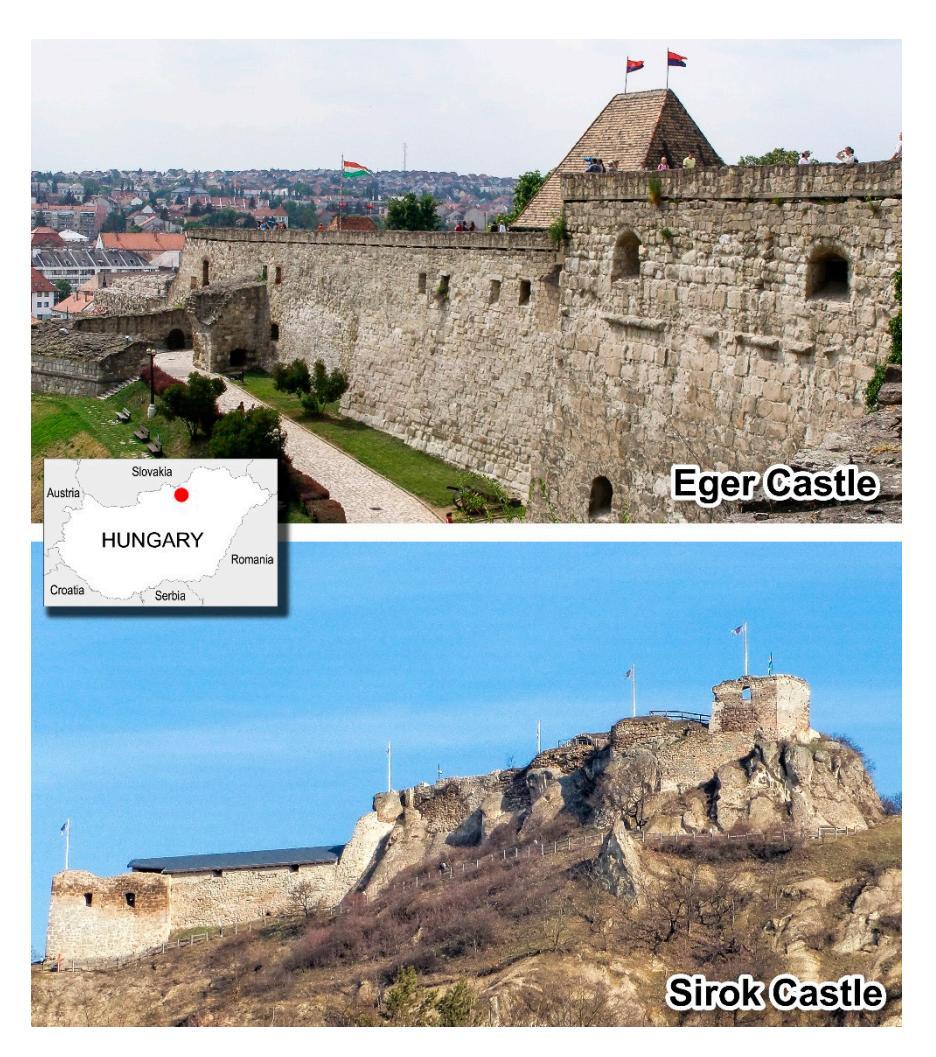
Figure 1. The medieval castles of Eger and Sirok in Northern Hungary.

The castles of the town of Eger and the village of Sirok (Heves County) represent the grandest examples of monumental architecture made almost exclusively of those local stones (Figure 1). Eger Castle was built from 1248 to 1261 from the ruins of a preexisting fortification destroyed during the

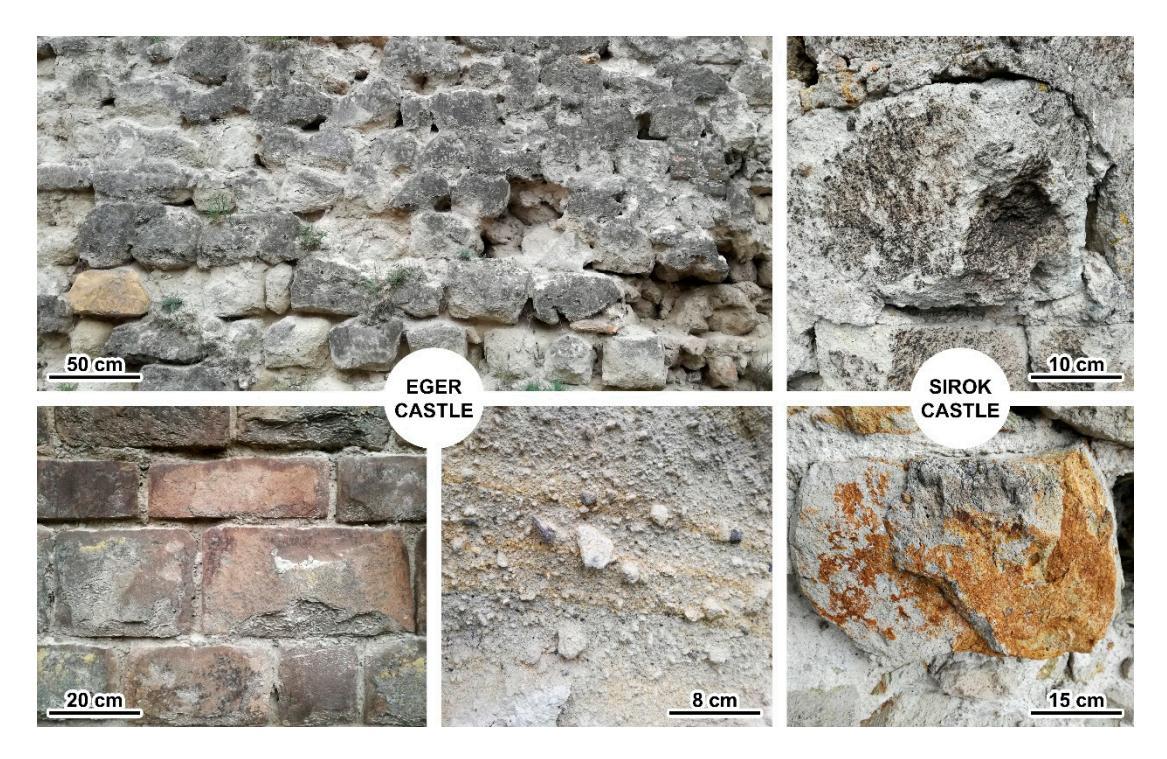
**Figure 2.** Details of the walls and the weathering observed on the tuff ashlars of Eger Castle (black crusts, patinas, and surface recession with detached crusts, and differential erosion) and Sirok Castle (black crusts and orange patinas).

Therefore, metal mobility and its dependence on the rock properties must be taken into account too. The tuff from the historical walls of Eger Castle, if compared to the others, has a significantly higher open porosity (by a factor of 1.4 to 1.6) given almost totally by large pore-size classes (i.e., capillary pores and macropores [11]), those mainly affected by water infiltration and movement. These characteristics allow for a boosted pollutant absorption and deeper migration inwards, even in liquid solution when the surface gets wet. That explains the low heavy-metal concentrations on the surface and the relative geochemical balance with the inner layers. Finally, that tuff is also the softest and most prone to disintegration, so that, during the enhanced surface recession (Figure 2), the accumulation of airborne particulate may reset frequently.

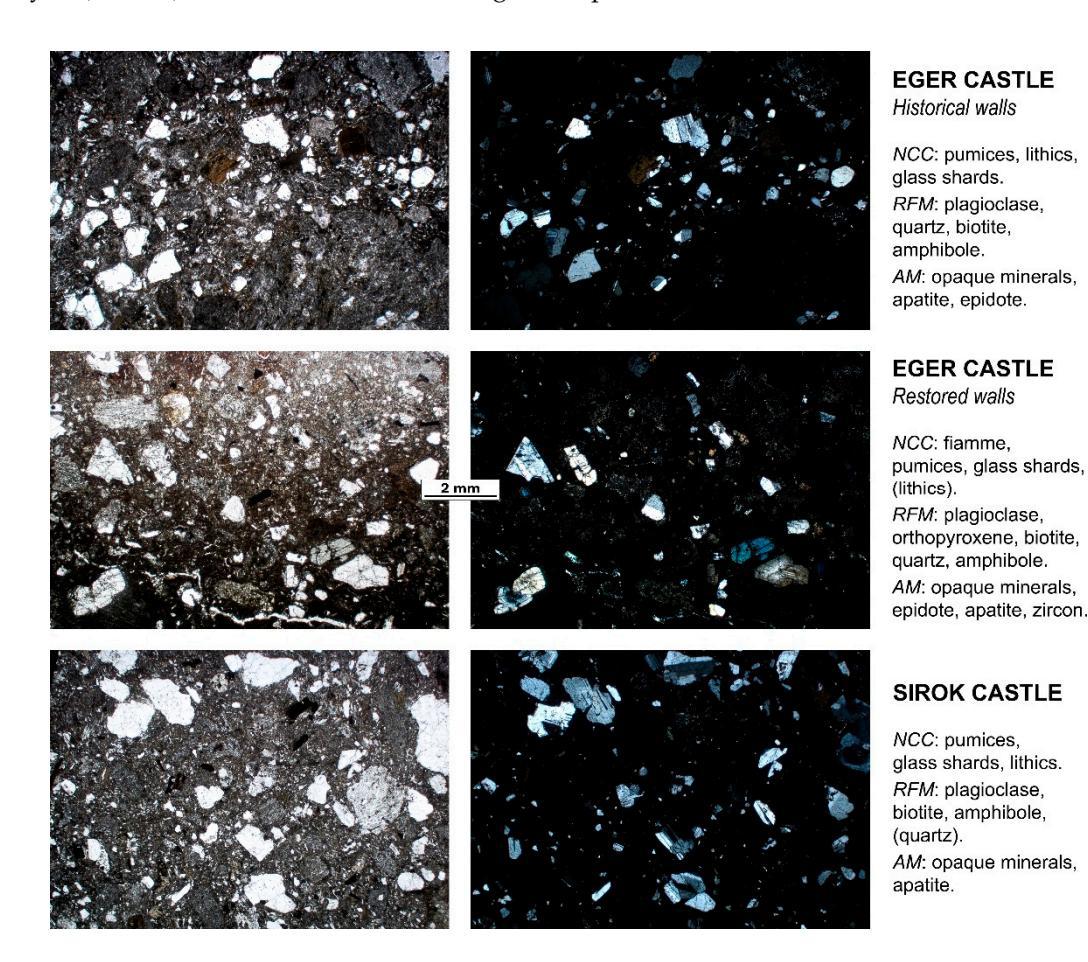
**Figure 3.** Thin-section photomicrographs in plane- and cross-polarized light of the studied tuffs, at the same magnification, with the rock components listed in order of abundance (NCC = non-crystalline components and lithoclasts; RFM = rock-forming minerals; AM = accessory minerals).

The volcanic stone used in the historical walls of the castles of Eger and Sirok is a greyish-creamy pumice tuff, with pseudo-porphyritic texture and glassy matrix. The pumice clasts and phenocryst fragments, typically of plagioclase, display a diverse grain size, which can reach lapilli size, with

dimensions of several centimeters. The quantitative relationships among pumice, crystal fragments, and matrix may be highly variable in Sirok tuff, as per previous findings [11]. The tuff from the restored walls of Eger Castle, instead, is a *fiamme*-bearing pumice tuff with finer and a more seriate grain size, and is easily distinguished by its reddish-brownish color. The microscopic appearance and mineralogical composition of these three tuff types are presented in Figure 3. Further data about the major mineralogical phases are provided by the XRD patterns and the relevant semi-quantitative analysis (Table 2), which also confirm the high amorphous content.

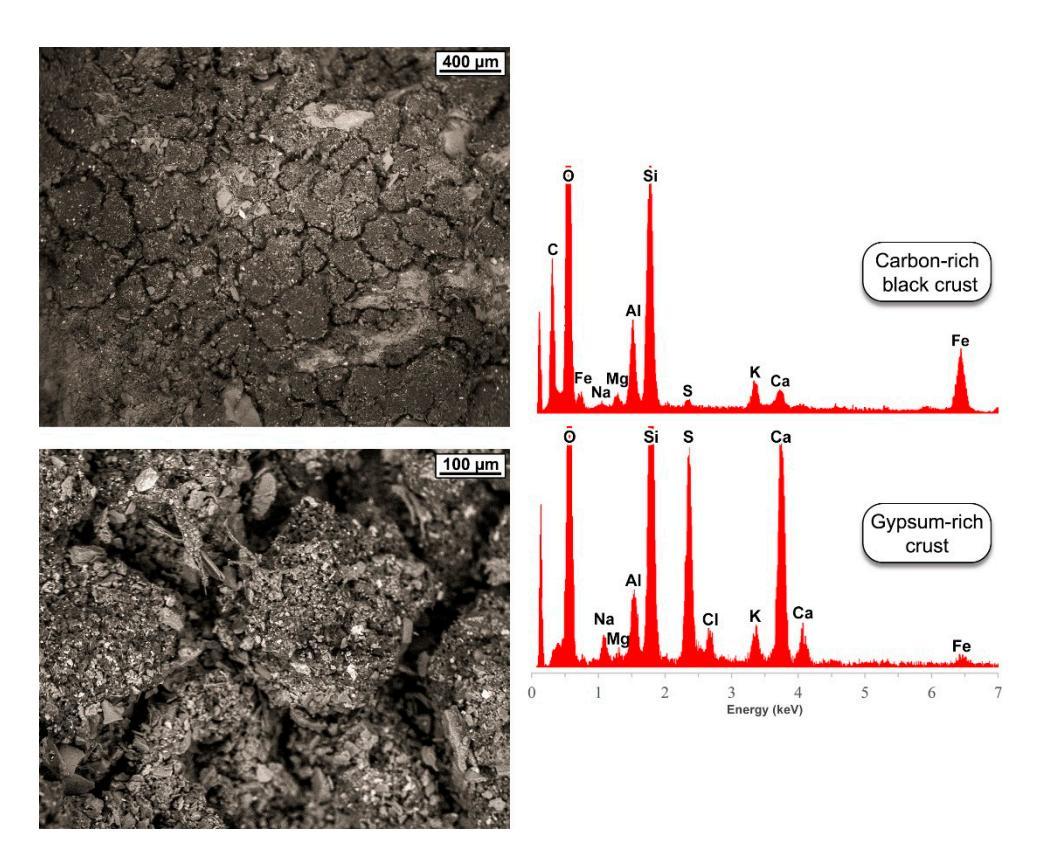
**Figure 4.** SEM-BSE photomicrographs showing at different magnifications a microcracked C-rich black crust on the historical walls of Eger Castle. The EDS spectra show the microchemical composition of the same crust and of a gypsum-rich crust from another sampling point.

Soiling and black crusts contribute to the most typical discolorations, produced by the deposition and cementation at different degrees of blackish C particles (Figure 4). These crusts frequently have mid-high levels of Cl and a variable extension. In Eger Castle, they reach the greatest thickness, exceeding 100  $\mu$ m. This is consistent with the more polluted environment of a larger town like Eger. There, motor vehicle exhaust emissions–typically composed of spherical C particles, coated with NO<sub>x</sub>, VOC, sulfates, metals, etc. [41–43]–are supposedly more abundant, even more so considering that a major road runs just 20–30 m from the castle walls. Likewise, a railway runs a few meters away, between the road and the castle, so that the steam and, later, diesel locomotives in transit since 1908 represent a further source of soot.

The occurrence of gypsum is determined at different degrees, from a general sulfation of the tuff surfaces to the presence of discrete discernible crystals (Figure 4). Their grain size is the largest in Eger Castle. The XRD results indicate that gypsum is the secondary phase most frequently detected (Figure 5). Nevertheless, it is often finely dispersed on the stone surface, without forming compact aggregates of coarse-grained crystals. This last observation is explained by the low air concentration of SO<sub>2</sub> (about 7  $\mu$ g/m<sup>3</sup>, Table 1), typical of a rural environment [44], and the lack of a major intrinsic source of Ca. CaO concentration in the studied tuffs is typically below 3% [33], so that the plausible source is external and represented by lime-mortar joints, from which CaCO<sub>3</sub> dissolves and then

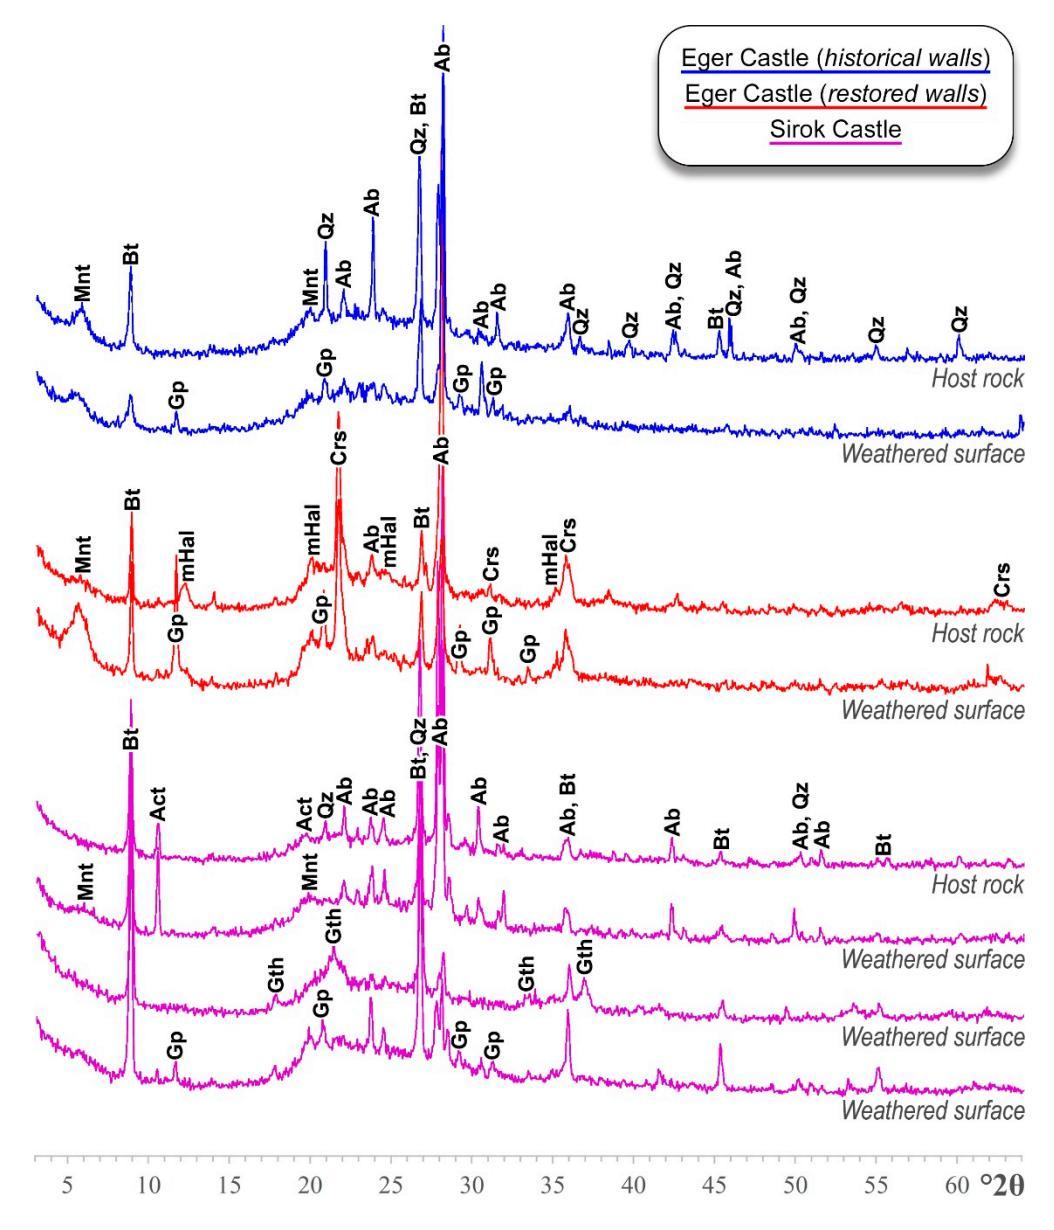
**Figure 5.** Powder XRD patterns indicating the mineralogical composition of the studied tuffs and the extra phases detected on their weathered surfaces (Ab = albite; Act = actinolite; Bt = biotite; Crs = cristobalite; Gp = gypsum; Gth = goethite; mHal = meta-halloysite; Mnt = montmorillonite; Qz = quartz).

As for the clay minerals, specifically montmorillonite, their crystallization seems generally more widespread on the exposed surfaces. This arises after comparing the XRD signals from the host rock and the surface (Figure 5) and the examination of the outermost layers under the microscope: there, the alteration degree of feldspar phenocryst fragments is higher, and the matrix, typically having very low crystallinity, shows several domains of devitrification to cryptocrystalline aggregates (Figure 6a). Indeed, the clay minerals derived from the hydrolysis of the feldspars and, to a greater extent, the glassy matrix. Volcanic glass is thermodynamically unstable and alters more rapidly than the associated minerals and, when it has a silicic composition, montmorillonite is the most common product [54]. Enrichments in swelling clay minerals may enhance stone vulnerability during wetting/drying alternating phases, producing damaging cycles of dilation/contraction [55–58]. Differential erosion may also increase [7,11]. Figure 6b shows a characteristic surface topography of the tuff from the historical walls of Eger Castle (c.f. Figure 2): the surface outline follows the coarse crystals, pumice, and lithic clasts standing out in relief in respect to the weaker matrix, which is further stressed by the action of clay minerals.

Finally, it is worth mentioning a weathering pattern observed more frequently at Sirok Castle, i.e., orange patinas mainly constituted of goethite (Figure 5). This phase might derive from the leaching of

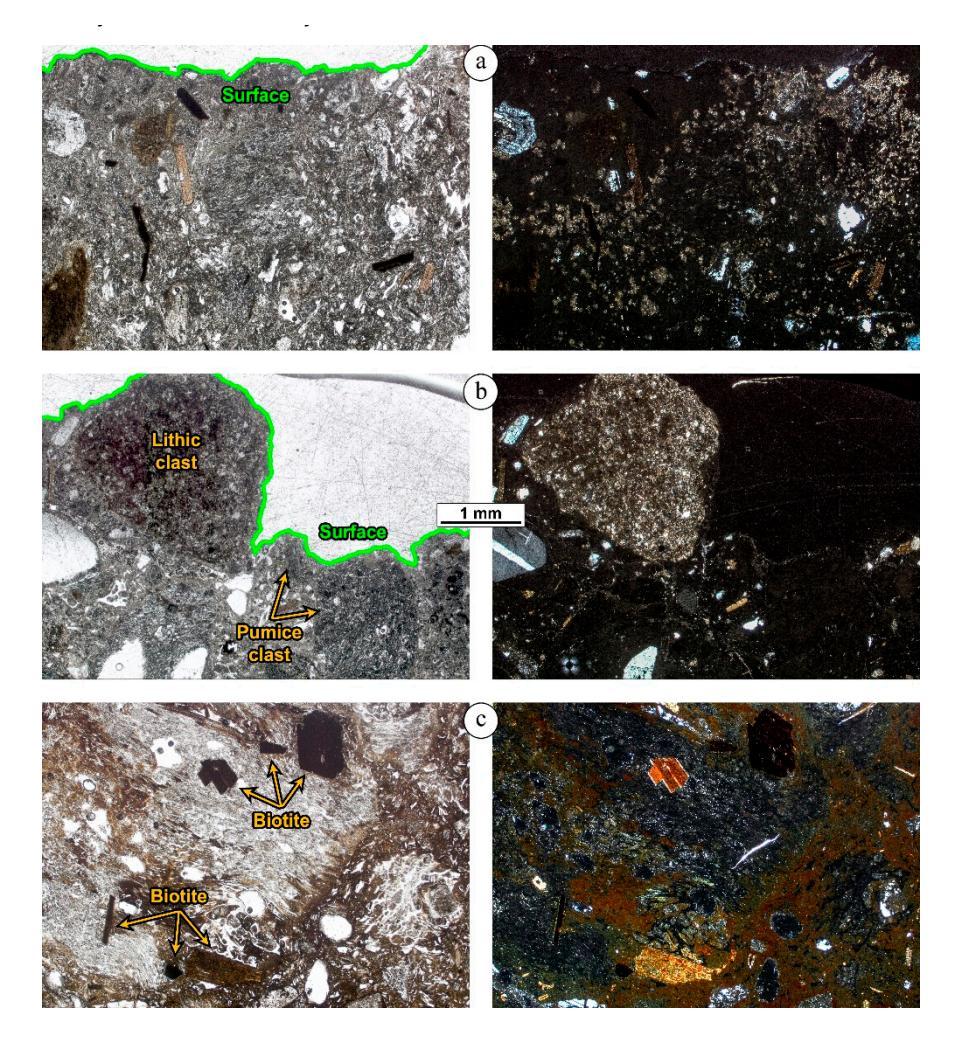
**Figure 6.** Photomicrographs in plane- and cross-polarized light of cross sections, at the same magnification, showing different weathering patterns: (**a**) near-surface alteration and devitrification of the glassy matrix, visible in the birefringent areas (Sirok Castle); (**b**) irregular surface morphology caused by differential erosion (Eger Castle, historical walls); (**c**) dispersion of brownish Fe oxides and hydroxides around biotites, in the matrix, and in the outer pores of pumice clasts (Sirok Castle).

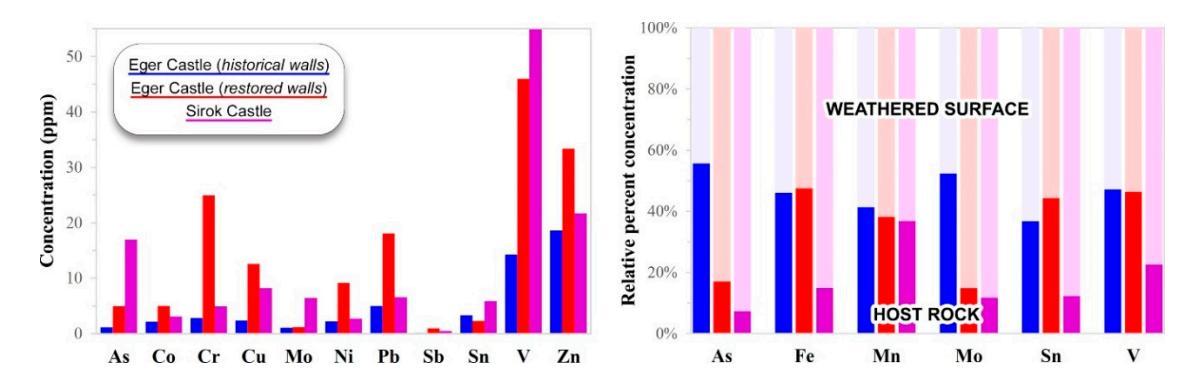
**Figure 7.** Average concentration of heavy metals determined by ICP-MS on the weathered surface of the studied tuffs, and comparison with the relative abundance of selected elements in the host rock.

The ICP-MS analyses of the non-silicate fraction of crusts, patinas, and deposits on the tuff surfaces, as well as of the host rock, allow outlining the concentration patterns of trace elements. The most interesting data are related to heavy metals (Figure 7). Generally, compared to the bulk stone, the weathered surfaces are noticeably richer in As, Co, Cr, Cu, Fe, Mn, Mo, Ni, Pb, Sb, Sn, V, and Zn. The absolute maximum concentrations for some illustrative elements are: As 40 ppm, Cr 28 ppm, Cu 48 ppm, Ni 28 ppm, Pb 89 ppm, V 135 ppm, Zn 79 ppm. The lowest and highest average concentrations are both detected at Eger Castle, on the historical and restored walls, respectively. As for the balance of trace-element concentration between the surface and the host rock, the historical walls of Eger Castle report the lowest decrease of heavy metals in the inner layers, i.e., less than 30% on average: for instance, Fe is 10,027 ppm on the surface and 8579 ppm underneath, instead Pb is 5.6 ppm versus 4.3 ppm. On the contrary, the other tuffs record mean differences between 45% (Eger Castle) and 55% (Sirok Castle), pointing out that the accumulation of those trace elements is mostly superficial.

These observations are only partly concordant with the experimental results. In fact, the concentration of heavy metals determined at Eger Castle can be higher than the levels of Sirok Castle, consistent with the different localization of the monuments in respect to the surrounding pollution sources. However, those somehow narrow geochemical differences do not indicate two much different environmental contexts. Moreover, within Eger Castle, so in the same higher-pollution scenario, stone chemical alteration can even be the least intense, depending on the tuff variety, as already pointed out.

Pb concentration can be taken as a representative example: the average values recorded, ranging from about 5 to 20 ppm, are very far from the 100s and 1000s ppm detected in black crusts from Budapest and other European cities [49]. In other terms, the boundary environmental conditions of the castles of Eger and Sirok and air quality may be less significant than the lithological constraints in defining the accumulation of metallic pollutants.

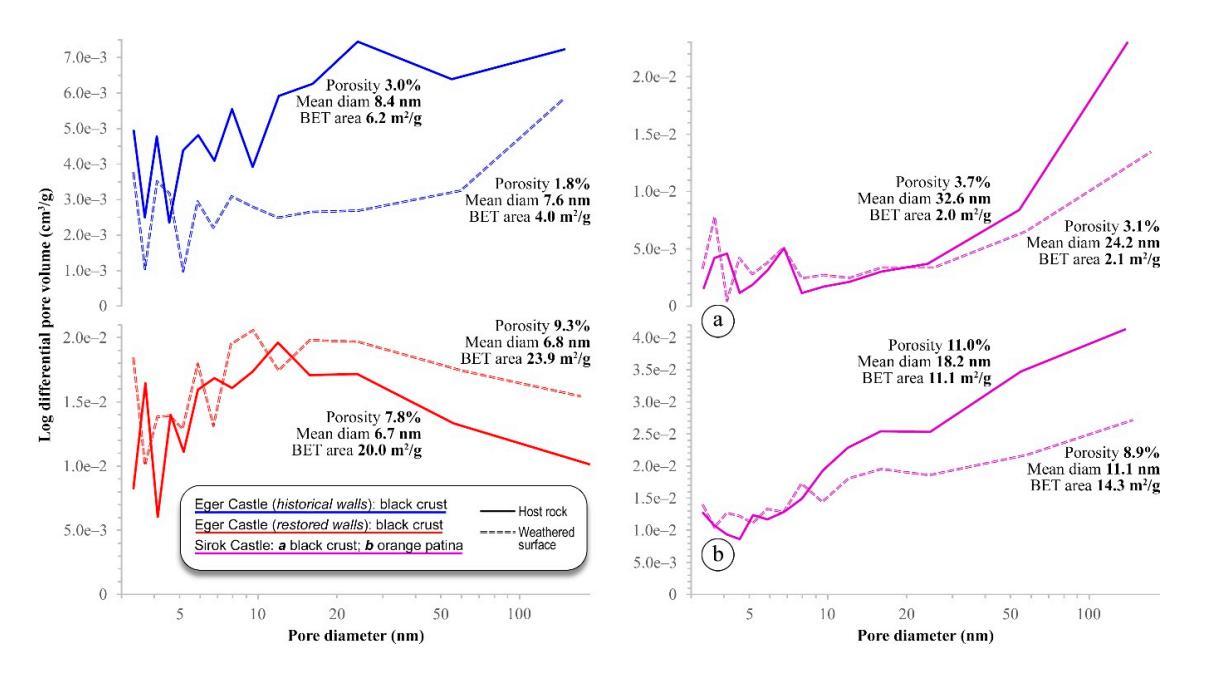
**Figure 8.** Pore-size distribution, porosity, mean pore diameter, and BET surface area of the studied tuffs, measured by N<sub>2</sub> adsorption separately on the host rock (continuous lines) and the weathered surface (dashed lines). Left graphs show samples of Eger Castle, right graphs of Sirok Castle.

The results of the  $N_2$  adsorption tests provide evidence that weathering produces measurable changes even in the pore network, and most importantly may lead to a decrease in microporosity. The microporosity of the surface layers is 3/5 that of the host rock for the tuff from the historical walls of Eger Castle, and about 4/5 for Sirok tuff. The microporosity range measured goes from 11% (host rock) down to 1.8% (weathered surface). The pore-size distributions point out another trend, namely the general decrease of pore size in the weathered surface: while the finest micropores apparently are almost unaffected, the quantity of those with a diameter larger than 5–10 nm decreases significantly (Figure 8).

These data indicate that the deposition of exogenous pollutants and surface crystallization of secondary phases lead to micropore filling, or that the weathering crusts may reach a higher density than the deteriorated underlying host rock. The grain size of the weathering-related components is constrained by the lower limit of 5–10 nm that marks the main pore-size changes. When an increase of

Finally, it is worth mentioning the only data that do not conform to the general trend, obtained on the tuff of the restored walls of Eger Castle. Its weathered surface has a porosity increased by a factor of 1.2, compared to the host rock. This might indicate a less advanced stage of compaction, influenced by, among other things, the shorter exposure time from the restorations and the relative lowest open porosity [11].
