Article Friction and Wear Behavior between Crane Wire Rope and Pulley under Different Contact Loads

Xiangdong Chang ^{1,2}, Xiao Chen ^{3,4,*}, Yaoyuan Dong ⁵, Hao Lu ^{1,2}, Wei Tang ^{1,2}, Qing Zhang ^{1,2} and Kun Huang ^{1,2}

Citation: Chang, X.; Chen, X.; Dong, Y.; Lu, H.; Tang, W.; Zhang, Q.; Huang, K. Friction and Wear Behavior between Crane Wire Rope and Pulley under Different Contact Loads. *Lubricants* **2022**, *10*, 337. https://doi.org/10.3390/ lubricants10120337

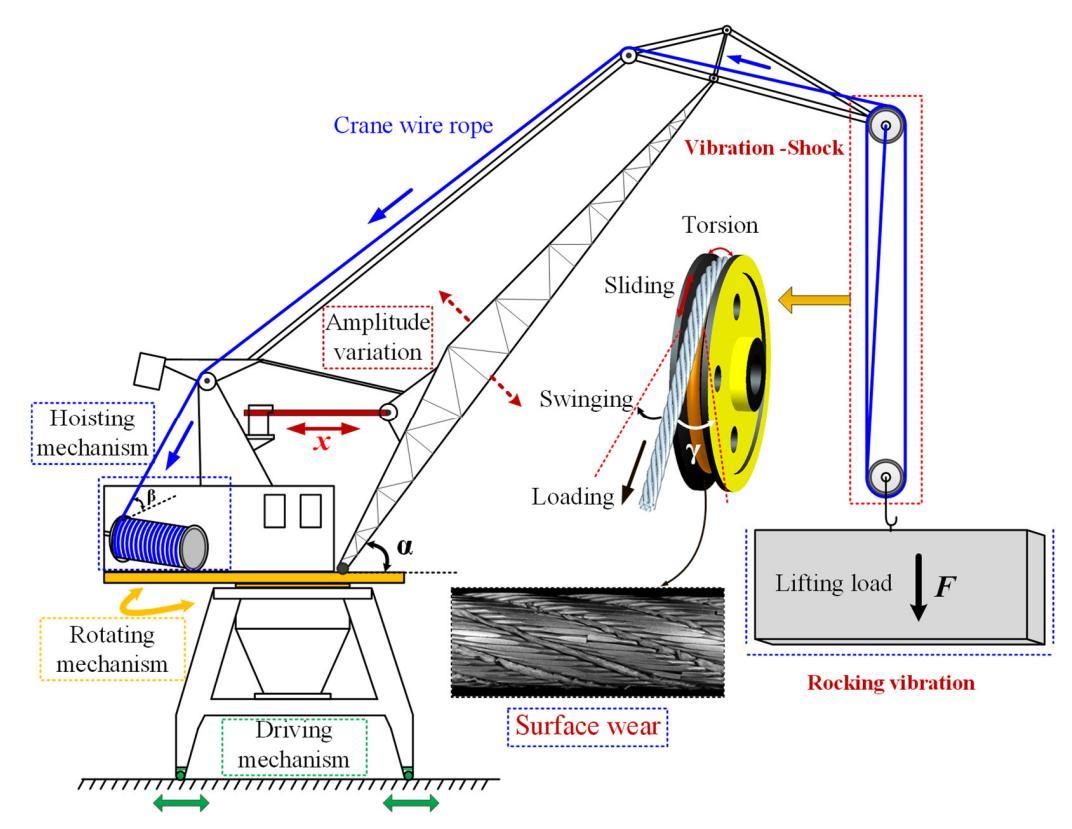
Figure 1. Schematic diagram of operation system of crane wire rope.

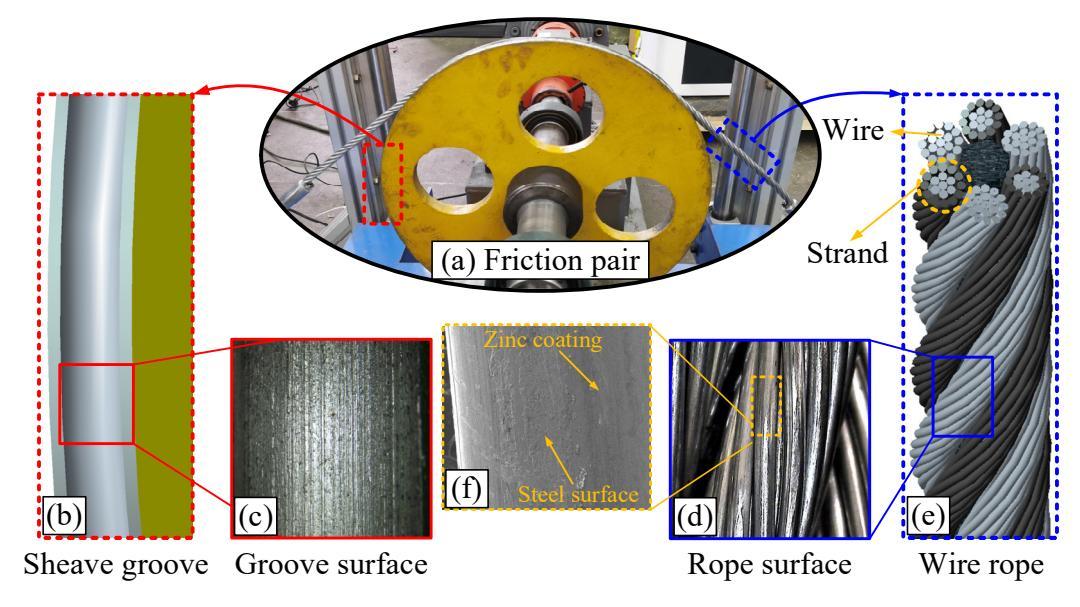
Figure 2. Surface structure of friction pairs: (**a**) contact form, (**b**) and (**c**) pulley, (**d**) and (**e**) wire rope, (**f**) surface morphology of steel wires.

In this paper, the friction pairs include wire rope and pulley, as shown in Figure 2. The pulley is made of Q235 steel plate (see Figure 2b,c). Its chemical composition (in wt%) is 0.18 C, 0.46 Mn, 0.275 Si, 0.045 S and 0.04 P. Additionally, the diameter of the pulley is 400 mm, and the diameter of the rope groove is 14 mm. Furthermore, the structure of the wire rope is presented in Figure 2d,e. It is 6×19 galvanized wire rope with fiber core (SZ-B-0.60-YB/T5294-2009), which contains 6 strands, and each strand consists of 19 steel wires. The internal steel wires are manufactured by the cold drawing process from high-quality carbon structural steel. Additionally, the thickness of galvanized layer of the steel wire is approximately 7 µm to 20 µm. The density of galvanized low carbon steel wire is approximately 7.81 × 103 kg/m³. The surface morphology of steel wires is presented in Figure 2f. The chemical composition of the wire material (in wt%) is 98.69 Fe, 0.87 C, 0.39 Si, 0.03 Mn and 0.01 Ni, and the other elements include S and P. The detailed structural parameters of the wire rope are shown in Table 1.

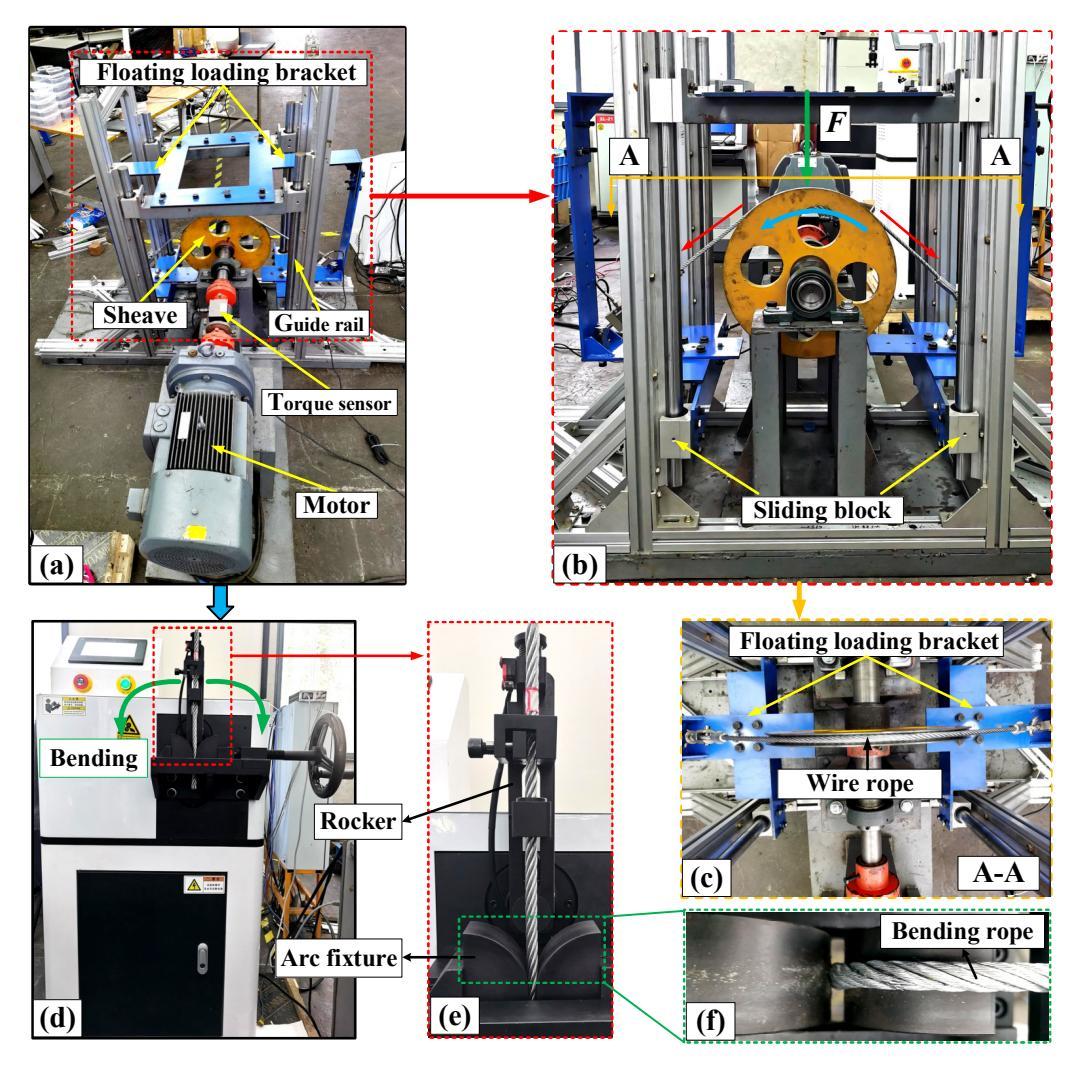
Figure 3. Structure of test rigs: (**a**) sliding friction and wear test rig, (**b**) front view of friction tester, (**c**) top view of the friction tester, (**d**) breaking tensile testing machine, (**e**) tensioning and fixing of wire rope, (**f**) bending contact state of wire rope.

To investigate the tribological behavior between wire rope and pulley and the effect of surface wear on its bending fatigue life, the sliding friction and wear tests were conducted using a homemade test rig, as shown in Figure 3a. The contact angle of the wire rope is 45°. Then, the bending fatigue tests of the damaged rope samples were conducted using a customized testing machine, as shown in Figure 3d. The friction test rig mainly includes drive system, rotation system, loading system and data acquisition system. The pulley is connected with variable frequency motor through a drive shaft. It can realize continuous rotation under the control of frequency converter. Both ends of the wire rope are connected with the floating loading device, and the wire rope is in contact with the pulley rope groove (see Figure 3b,c). During the wear test, the wire rope is clamped firmly at both ends. Additionally, the floating loading device is connected to the linear guide rails by four sliders, allowing it to move freely in the vertical direction. Therefore, the contact load between the wire rope and the pulley is the weight of the floating loading device and the wire rope. Furthermore, the contact load of the friction pair can be adjusted by placing different heavy blocks on the floating loading device. Considering that the crane wire rope is mostly in service under variable loading conditions, sliding friction and wear tests of the wire rope under different contact loads (F) were conducted. The sliding friction torque of the wire rope can be monitored in real time by a dynamic torque sensor (between pulley shaft and the motor) and data acquisition system. The bending fatigue testing machine can realize continuous left and right bending of the damaged rope samples, as shown in Figure 3d. One end of the wire rope is connected to the rocker and the other end is fixed by the arc fixture (see Figure 3e). During the bending fatigue test, the contact state between the wire rope and the arc fixture is shown in Figure 3f. Additionally, the controller of the testing machine can adjust the bending frequency of the wire rope and display the bending times in real time. Therefore, the influence of surface wear on the bending fatigue life of wire ropes can be revealed by analyzing the relationship between the number of broken wires and the bending fatigue times of different damaged ropes. In most engineering applications, wire ropes are judged to be scrapped when the wire breakage rate reaches 10%. The bending fatigue times of the first 12 broken wires were studied in this paper. Moreover, the detailed parameters of the tribological test and the bending fatigue test are shown in Table 2.

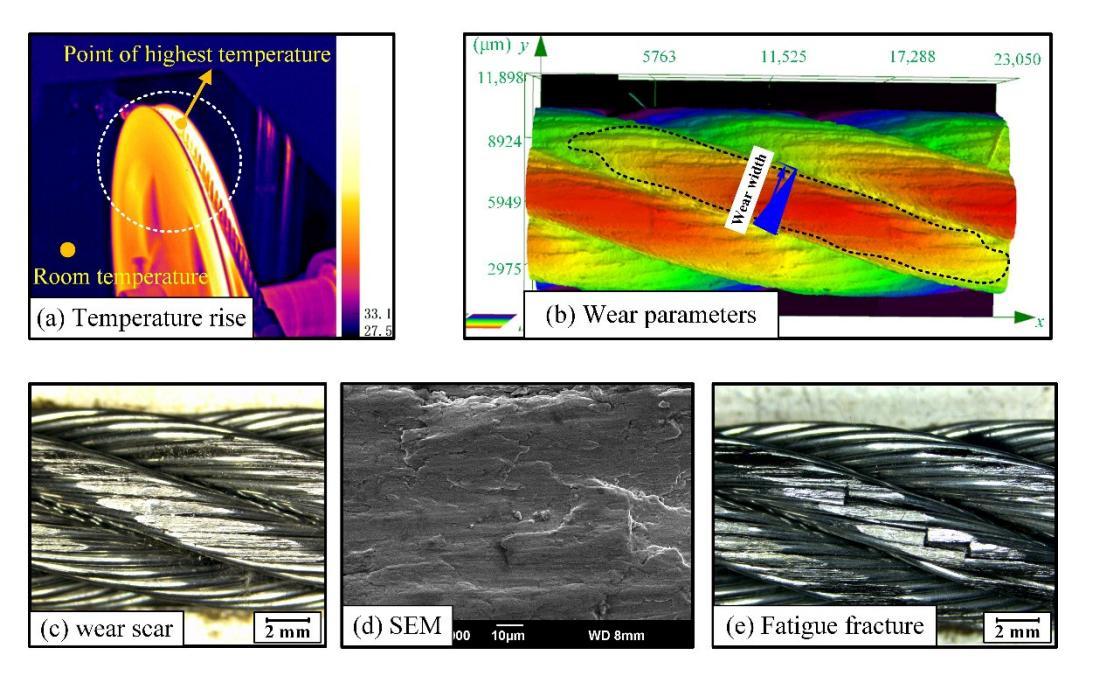
Figure 4. Main research parameters of tribological properties and bending fatigue behavior: (a) infrared thermal image, (b) 3D topography of wear scar, (c) optical micrograph of wear scar, (d) SEM of wear surface, (e) fatigue broken wires.

The sliding friction characteristics between the wire rope and the pulley were analyzed by the COF and the temperature rise (see Figure 4a). The friction force of the wire rope can be obtained by the friction torque measured by the dynamic torque sensor and the radius of the pulley. Then, combined with the contact load between the wire rope and the pulley, the COF of the wire rope can be calculated. Therefore, this paper analyzed the variation in the COF with sliding distance and contact load. During the sliding friction test, the temperature distribution characteristics of the wire rope were monitored and recorded by an infrared thermal imager. It enables real-time detection and data recording of the surface temperature of objects in the observation area. Then, the variation temperature rise in the contact region was analyzed through the maximum temperature and the room temperature (see Figure 4a). Additionally, the distribution of the surface wear scar was observed using an optical microscope. The maximum wear width of the wear scar was measured, as shown in Figure 4b,c. The structural contour of the wire rope is distinguished by the color change in the 3D diagram, and the same color corresponds to the same height. The redder the color, the greater the relative height. Furthermore, the weight of wear debris produced by the friction pair during the wear test was measured by an electronic balance. The measurement accuracy is 0.1 mg. The wear characteristics and wear mechanisms of the crane wire rope were analyzed by the optical microscope and scanning electron microscope (SEM), as shown in Figure 4d. Finally, the variation law of broken wires and bending fatigue times of the rope sample were analyzed (see Figure 4e). The distribution

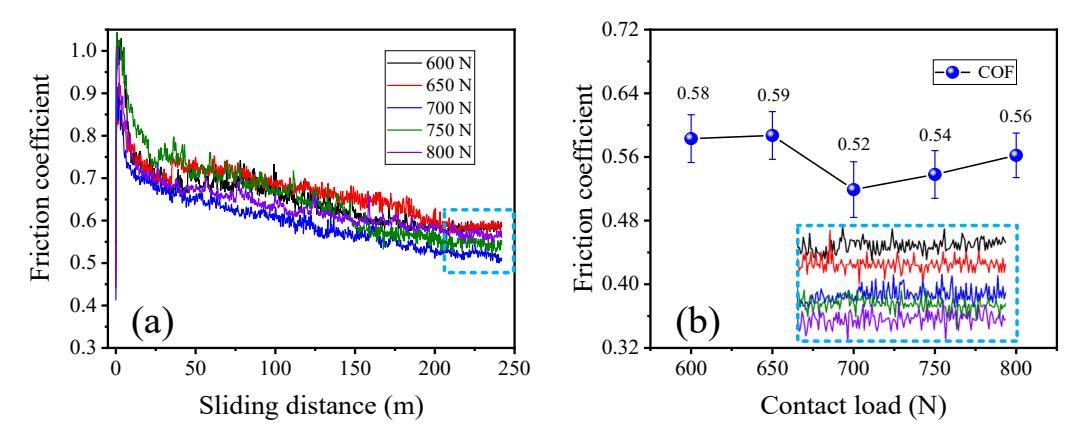
Figure 5. COF curves between wire rope and pulley under different sliding conditions: (**a**) process variation curves with sliding distance, (**b**) average COF in the relatively stable stage.

Figure 5 shows the variation in the COF between wire rope and a pulley under different contact loads. Because the surface structure of the wire rope is complex and is constantly changing during the sliding wear, the variation trend of the COF with increasing sliding distance is obvious (see Figure 5a). In the initial stage of the sliding friction test, the spiral wires of the rope surface contact with the pulley groove directly. The surface of the friction pair is mainly line contact, and the contact area is small. Thus, the COF decreases rapidly from the larger position when the sliding distance is less than approximately 30 m. Additionally, as the structures of the wire rope and steel wires are both cylindrical, the contact area of the friction pair will continue to increase during the sliding process, and the increase rate is fast and then slow. The contact form changes from line contact to surface contact and the contact stress decreases. The COF shows a decreasing trend and its decreasing speed becomes significantly smaller as the sliding distance increases from approximately 50 m to 180 m. Finally, when the sliding distance exceeds 180 m, the COF of the wire rope enters a relatively stable stage. This indicates that the contact state between the wire rope and the pulley is relatively stable, and the increase in the sliding distance does not have a great influence on the surface characteristics. Therefore, the COF between the crane wire rope and the pulley is constantly changing in the process of service. The wear state of the wire rope can be judged by its change rule. Moreover, under different contact loads, the variation trend of the COF with sliding distance is basically the same, but there are some differences in the stable stage. Figure 5b shows the average COF in the relative stable stage under different contact loads. It is clear that the effect of the contact load on the COF is not obvious. The COF fluctuates from approximately 0.5 to 0.6 as the contact load increases from 600 N to 800 N. Additionally, with the contact load increasing from 600 N to 700 N, the COF decreases from 0.58 to 0.52. Then, with the contact load continuing to increase to 800 N, the COF increases linearly to 0.56. This means that the COF of the wire rope is the minimum at the contact load of 700 N. The variation in the COF is due to the change in the surface characteristics of the wire rope under different contact loads. Additionally, the structure of wire rope is complex, and the change in its contact state during the experiment will also have a great influence on the COF [36]. The increase

in contact load will increase the effective contact area of the metal friction pair, resulting in an increase in the COF. However, during the sliding process, the larger load is more likely to cause plastic deformation of the micro-protrusions on the contact surface, which in turn causes the surface pits and protrusions to complement each other. This ultimately results in a smoother sliding contact surface of the wire rope. The COF under this sliding condition is relatively smaller. Therefore, in the process of increasing the contact load, the two COF variation characteristics are balanced with each other. The COF will have a minimum value. This shows that the smooth surface of the wire rope plays a leading role in the COF when the contact load is 700 N. Furthermore, as the contact load continues to increase, the adhesion force increases, and the COF increases during the sliding process. Moreover, the contact load mainly affects the surface wear degree of the wire rope, and the influence on the COF in the stable stage is relatively small. The fluctuation of the COF with contact load is mainly determined by an increase in the temperature in the friction region and the surface wear characteristics of wear scars.

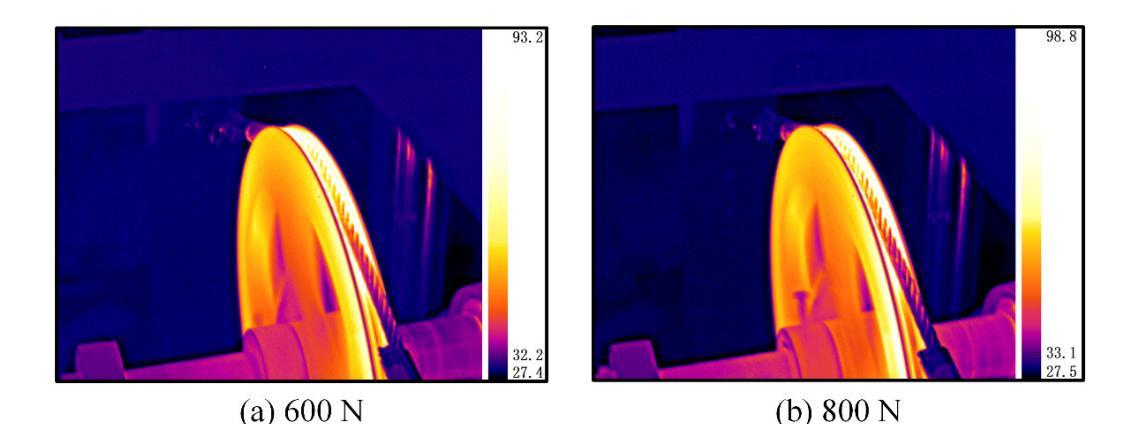
Figure 6. Infrared thermal images of the friction pairs: (**a**) contact load of 600 N, (**b**) contact load of 800 N.

The infrared thermograms of a friction pair under different contact loads are shown in Figure 6. The surface color of the contact area between the wire rope and the pulley is significantly brighter. This means the temperature in the region is higher and a great deal of frictional heat is generated during the friction test. Additionally, the temperature distribution characteristics caused by the continuous sliding between the wire rope and the pulley can be visualized through the infrared thermal image. The bright area spreads from the top of the contact arc between the rope and the groove to the surrounding area. Since the pulley rotates continuously during the test, the temperature of its circumference is the highest, and, the closer to the center of the circle, the lower the temperature. Furthermore, because the wire rope is a complex structure made of many twisted steel wires, its thermal conductivity is relatively poor. The color difference between the contact area and the noncontact area of the wire rope is obvious. This indicates that sliding friction wear only has a significant effect on the temperature of the contact area of the wire rope. Therefore, in the service process of crane wire rope, the temperature rise of the wire rope is a transient process and its impact is not sustainable. However, sliding friction can cause the temperature of the pulley to remain at a high level. Moreover, an increase in contact load will lead to a change in the surface temperature of the wire rope, but it is difficult to distinguish through the color of the infrared thermal images.

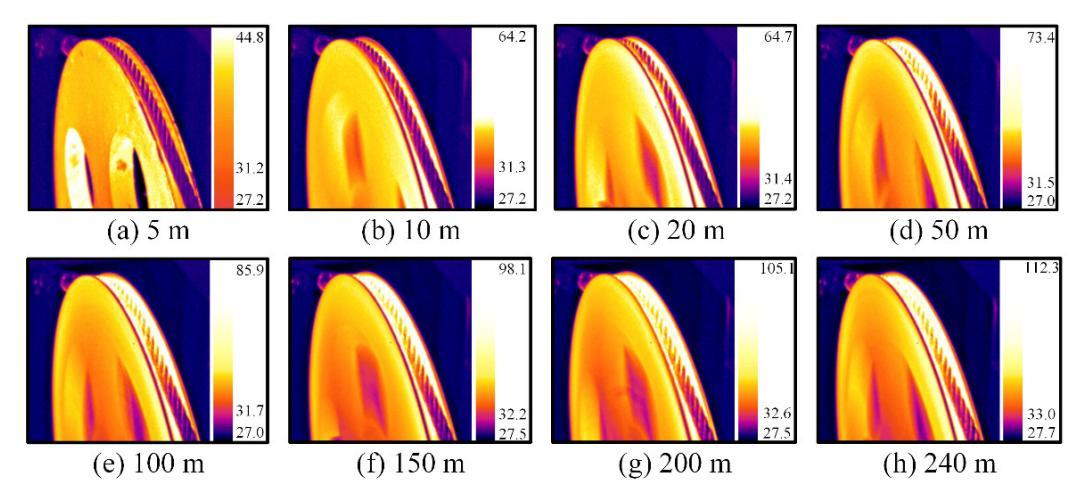
Figure 7. Infrared thermal images of wire rope under different sliding distances.

Figure 7 shows the infrared thermal image of the friction pairs under different sliding distances. It clearly shows the variation characteristics of the surface temperature during the friction test. The color of the wire rope changes greatly with the increasing sliding distance, especially in the early stage of the test. When the sliding distance increases from 5 m to 50 m, the surface color of the wire rope gradually changes from dull to bright, as shown in Figure 7a–d. This means that the surface temperature of the wire rope rises rapidly at this stage. Additionally, the frictional heat generated by the test is gradually diffused from the contact surface, and the temperature of the pulley groove rises significantly faster (see Figure 7c). This is because the structure of the groove is regular and the surface is complete and continuous. The friction heat transfers faster on the pulley. Furthermore, when the sliding distance exceeds 100 m, the surface color of the wire rope is very bright and basically unchanged. However, the temperature of the contact area is still increasing with the sliding distance, as shown in Figure 7e-h. Therefore, the friction heat generated by the rope-pulley friction transfers slowly on the surface of the wire rope, and the temperature rise is mainly concentrated in the sliding contact area. The temperature variation in the wire rope is more easily observed by the infrared thermal imager at the beginning of the test.

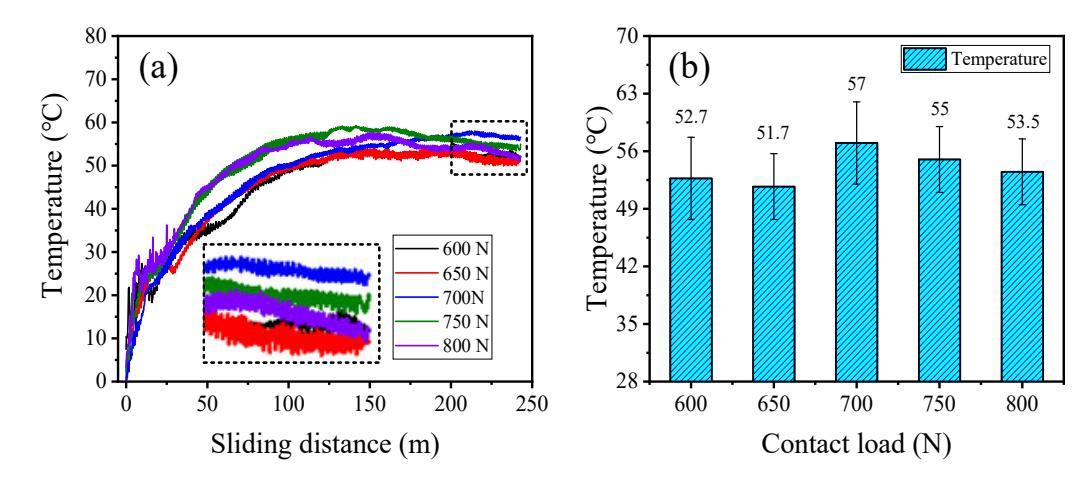
Figure 8. Variation curves of friction temperature rise under different contact loads: (**a**) process variation curves with sliding distance, (**b**) average temperature at the end of the measurement.

The variation in the maximum temperature rise of the wire rope with the sliding distance and the contact load collected by the infrared thermal imager is shown in Figure 8. The difference among the temperature rise curves under different contact loads is small, as shown in Figure 8a. The changing trend of the curves is basically the same. The curves increase rapidly at the beginning of the test but fluctuate greatly. This is because the structure of the rope surface changes greatly in the initial wear stage. The friction pair changes from

discontinuous line contact state to more stable surface contact state. Therefore, the surface temperature of the wire rope changes greatly in a short sliding distance. Additionally, the contact position of the wire rope on the rope groove changes greatly at this stage, and the surface temperature distribution of the wire rope is not uniform (see Figure 7). The location of highest surface temperature monitored by infrared thermography is constantly changing. Thus, the maximum temperature rise curves of the rope surface fluctuates greatly within a sliding distance of approximately 50 m. Furthermore, as the sliding distance continues to increase (from 50 m to 240 m), the temperature curves gradually stabilize after a slow growth stage. This indicates that the sliding wear surface of the wire rope gradually becomes stable. Although friction heat continues to be generated during the test, the surface temperature rise of the wire rope will not always increase. When the sliding distance exceeds 150 m, the heat generated by the rope–pulley sliding friction is balanced with the heat dissipation conditions of the surrounding environment. Thus, the maximum temperature rise of the wire rope is almost constant at the later stage of the friction test. Moreover, when the contact loads are 750 N and 800 N, the temperature rise curves rise significantly faster than other curves in the slow growth stage (from approximately 50 m to 150 m). This means that the increase in contact load will accelerate the increase in surface temperature of the wire rope during the friction test. This is because the larger contact load leads to an increase in the surface stress of the wire rope, and the evolution speed of the wear will be accelerated during the sliding process. Especially in the transition phase, the wear process will be more severe. Additionally, large contact stress will cause plastic deformation of the rope surface and the wear surface will be relatively smooth. Thus, more energy is converted into frictional heat during sliding friction.

To quantitatively compare the influence of different contact loads on the friction temperature rise in the relatively stable stage, the average temperature rise of the rope surface was calculated based on the data collected from the last 50 m sliding distance, as shown in Figure 8b. The influence of contact load on the temperature rise is not obvious, and the change law is opposite to that of the COF. With the contact load increasing from 600 N to 800 N, the friction temperature rise fluctuates in the range of approximately 51 °C to approximately 57 °C. This indicates that the surface wear state of the wire ropes is similar in the relatively stable stage. Because the contact load has a greater influence on the progress and degree of surface wear, the influence on the surface characteristics and friction contact state is relatively small. Furthermore, when the contact load is 700 N, the friction temperature rise is because the frictional heat generated by the wire rope during sliding is closely related to the change in friction and wear morphology [37]. Additionally, the test temperature affects the hardness and tribological properties of metal materials [38]. Under the condition of small COF, the surface of the wire rope is relatively

smooth and the wear rate slows down. At this time, more energy is converted into friction heat during the sliding friction process. Therefore, the friction temperature rise of the wire rope is relatively large. Therefore, by monitoring the temperature change in the wire rope, the wear state can be well judged, but it is difficult to distinguish the change in contact load between the rope and the pulley.

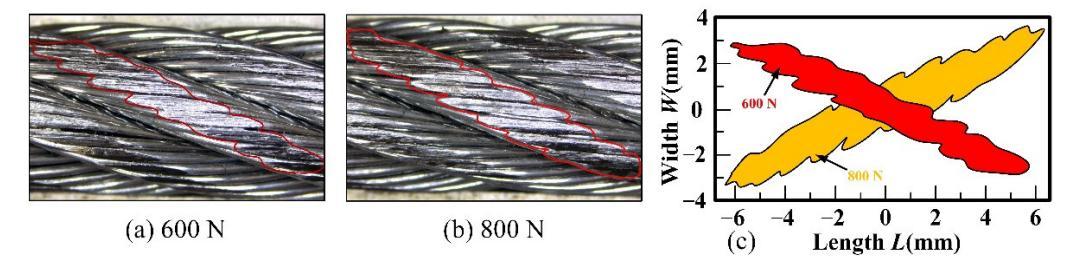
Figure 9. Distribution of wear scars on rope strand under different contact loads: (**a**,**b**) wear scars, (**c**) profile of wear scar under different contact loads.

The wear scar characteristics of the wire rope under different contact loads are presented in Figure 9. The wear surface of the wire rope is divided into many independent areas by the rope strand. This is because, under the condition of wire rope–pulley sliding contact, the rope will have multiple strands in contact with the groove at the same time, resulting in surface wear of multiple strands. Additionally, the contour of the wear scar on the strand surface is very irregular. This is due to the strand being made of multiple steel wires, which are cylindrical in structure. Thus, the wear edge of each wire is a circular arc, resulting in the wear scar on the whole rope strand being elliptical with irregular contours. Furthermore, the size of the wear scar tends to expand, as shown in Figure 9c. The wear scar contour map is measured and extracted by an optical microscope. It can be used to more clearly compare changes in the wear area of the wire rope surface. This is because the steel wire and the rope strand inside the wire rope will deform and move relatively under the action of external force [39]. Thus, the larger contact load will flatten the wire rope and cause structural deformation. Moreover, the larger contact load results in an increase in the surface stress of the steel wire, and the material is more prone to plastic deformation and shear spalling during sliding contact. Therefore, contact load affects the wear rate of the wire rope. In engineering application, the contact load between the rope and pulley should be minimized to protect the crane wire rope.

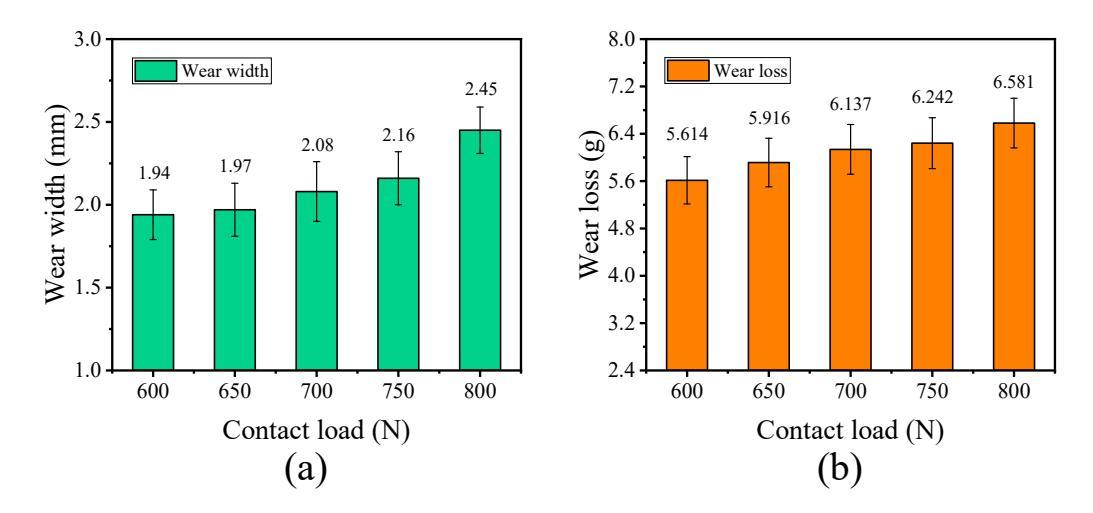
Figure 10. Wear characteristic parameters of wire rope under different contact loads: (**a**) maximum wear width, (**b**) wear loss.

Figure 10 shows the maximum wear width of the wear scar on the rope surface and the wear loss of the friction pairs under different contact loads. Wear width increases significantly with increasing contact load, from approximately 1.94 mm to 2.45 mm. Additionally, when the contact load is small (less than 700 N), the wear width increases slowly. The variation range in the wear width is approximately 0.14 mm. However, when the contact load increases from 700 N to 800 N, the wear width increases rapidly from approximately 2.08 mm to 2.45 mm. This indicates that the wear width increases nonlinearly with increasing contact load. This is not only because the surface wear is more severe but also the result of structural deformation of the wire rope under transverse pressure. The wear loss between the wire rope and the pulley under different contact loads is presented in Figure 9b. It increases linearly with the contact load (from approximately 5.614 g to 6.581 g). There are obvious differences in the change trend between the wear width and the wear loss. This is because the pulley groove during the sliding friction test also resulted in severe wear and produced a large amount of wear debris. Because the wear of the rope groove is relatively uniform during sliding wear, the amount of wear generated by the friction pairs increases steadily as the contact load increases. Therefore, by quantitatively analyzing the wear characteristics, it can be found that the actual damage of the contact load to the wear degree of the wire rope is approximately linear.

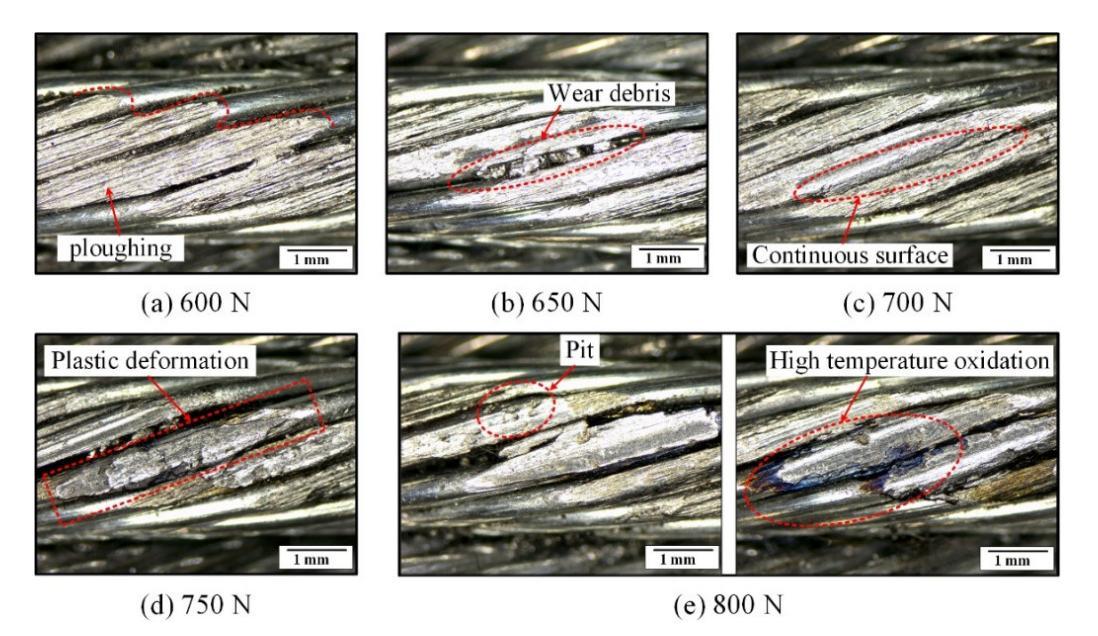
Figure 11. Surface wear characteristics of wire rope under different contact loads: (**a**) 600 N, (**b**) 650 N, (**c**) 700 N, (**d**) 750 N, (**e**) 800 N.

Figure 11 shows the optical microscopy of the wear surface of the rope strand under different contact loads. The difference in surface characteristics among the wear scars is obvious. When the contact load increases from 600 N to 800 N, the wear surface becomes smoother. When the contact load is small (see Figure 11a,b), the wear surface on the wires is rough and there are obvious scratches along the sliding direction. This indicates that a serious ploughing action occurs during the sliding friction between the wire rope and the pulley groove. Additionally, large wear particles in the gap between the wires can be observed (see Figure 11b). This means that there is a large amount of wear debris between the sliding friction pairs and the wear surface is scratched during the test. Furthermore, as the contact load continues to increase, the characteristics of the wear scar surface become clearer. When the load is 700 N (see Figure 11c), the steel wire surface material is squeezed seriously. Part of the material is misaligned and fills the gap between the wires, resulting in a continuous wear surface. This indicates that the main material removal forms of the wire rope change during the sliding wear process. The ploughing begins to weaken, and then the plastic deformation and spalling become more pronounced. As shown in Figure 11d, the surface is smooth and the furrows are difficult to distinguish. This is because the larger contact load makes the surface asperities in the contact area squeezed and deformed. During the sliding process, it will be directly rolled and flatten rather than ploughed. Therefore, the wear surface becomes smoother. Meanwhile, the wear debris in the middle of the sliding friction pairs is also crushed, further weakening the ploughing effect of the material. Moreover, with the contact load increasing to 800 N (see Figure 11e), the wear surface is smoother and the plastic deformation of the steel wire material is more obvious. Additionally, there are significant pitting and high-temperature oxidation characteristics caused by frictional heat on wear surfaces [40]. This is because the temperature of the friction surface of the wire rope increases significantly under large contact load. This causes the material in the contact region to soften, which in turn is more likely to be cut and plastically deformed. The contact surface of the wire rope is more likely to produce material shear and plastic deformation along the sliding direction [41]. Under the combined effect of transient high temperature and friction, the surface of wire rope is oxidized and discolored. Therefore, in the rope–pulley sliding friction and wear system, the variation in the contact load will cause the change in wear surface characteristics. The greater the contact load, the smoother the wear area in which contact stress and friction heat are the key factors affecting the wear characteristics of the crane wire rope.

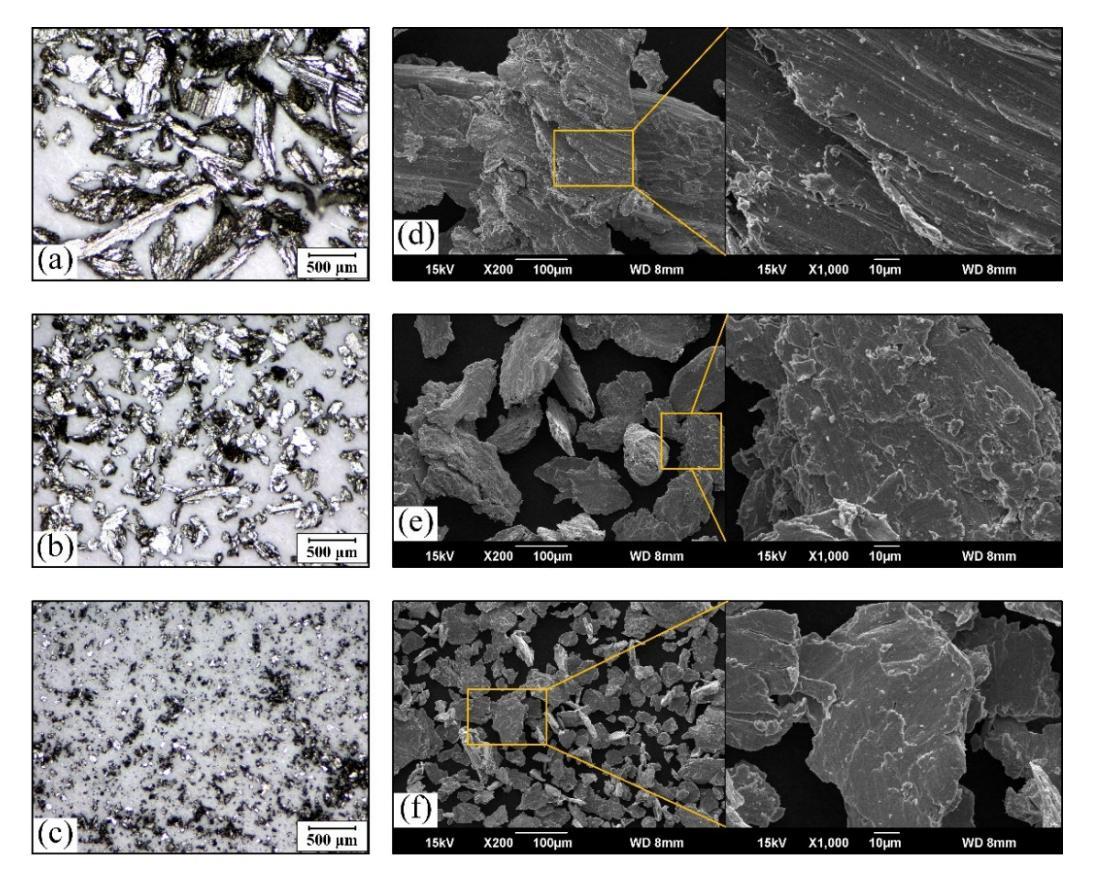
Figure 12. Optical microscopy and SEM of wear debris between wire rope and pulley: (**a**–**c**) macrograph under optical microscope, (**d**–**f**) microtopography under SEM.

The morphological characteristics of the wear debris were obtained by the optical microscope and SEM, as shown in Figure 12. Figure 12a–c shows the optical micrographs of the wear debris in different sizes, and Figure 12d-f shows the SEM images of the wear debris in different sizes. They are taken from different test samples. It is observed that the characteristics of the wear debris produced during the friction test are constantly changing. The particle size of the wear debris is relatively large at the initial stage of the test, as shown in Figure 12a,d. The wear debris is mostly long strip, and there is obvious plastic deformation and furrows on the surface. This is because the contact area between the wire rope and the rope groove is small and the contact stress is large in the early stage of the friction test. The line contact state is easy to produce ploughing on the surface of the rope groove, resulting in removal of large particle materials. Furthermore, with the sliding distance increasing, the contact area between the friction pairs expands rapidly and the size of the wear debris becomes smaller, showing irregular flake particles (see Figure 12b,e). This indicates that the ploughing action of the wire rope on the surface of the groove is weakened, and the removal of the material is mainly caused by adhesion and spalling between the contact surfaces. Moreover, when the friction experiment enters a relatively stable stage, the wear rate of the friction pair slows down and the size of the wear debris becomes smaller (see Figure 12c,f). This is because the surface of the friction pairs becomes more and more smooth, and the material does not easily fall off during the sliding friction process. Additionally, part of the wear debris is crushed between the sliding contact surfaces and the wear particles become smaller and thinner. Therefore, in the process of sliding wear between the wire rope and pulley, the size of wear debris becomes smaller and smaller. In the relatively stable stage, the wear debris is the smallest and plays a role of lubrication in the sliding process, which can reduce the degree of the surface wear.

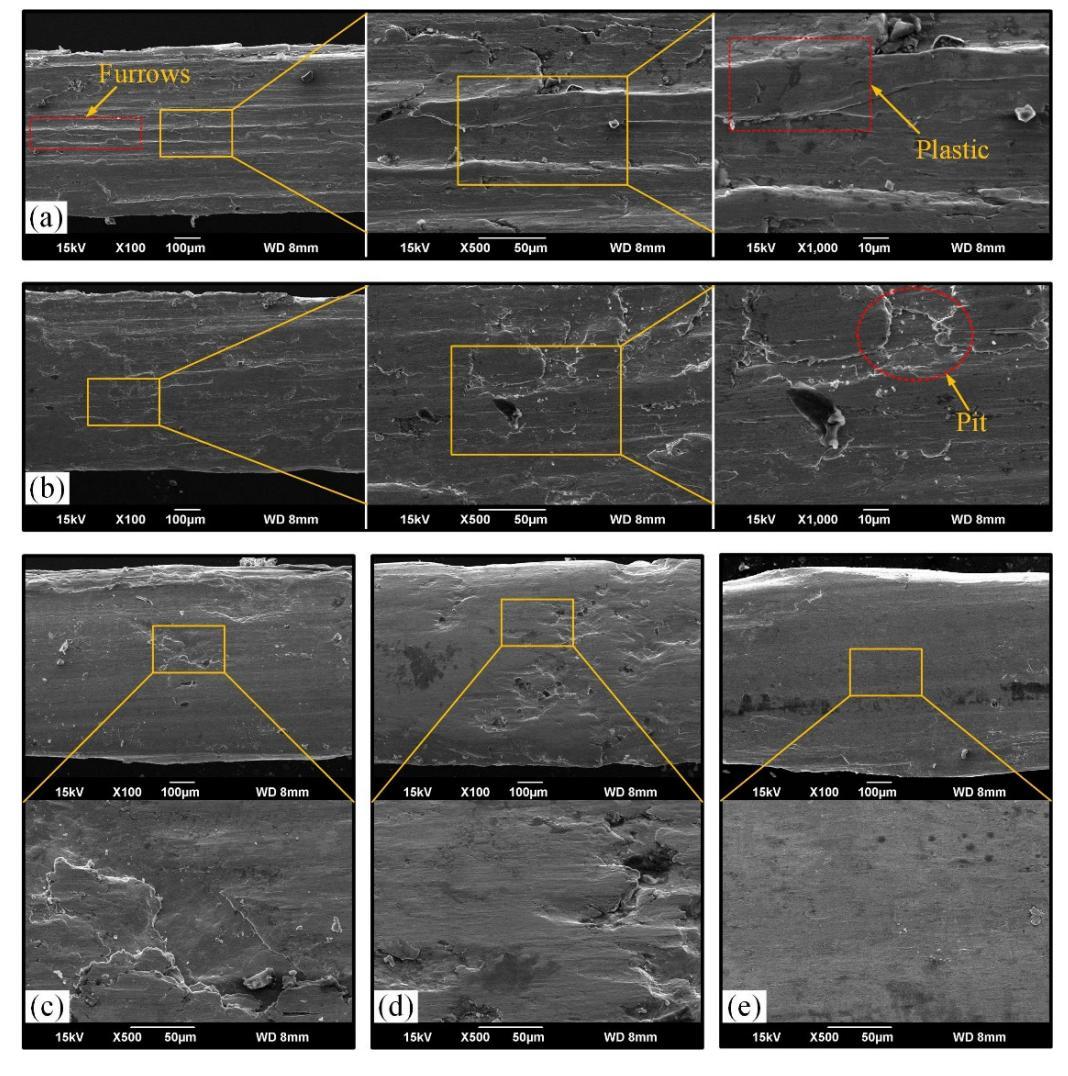
Figure 13. SEM image of worn steel wires under different contact loads: (**a**) 600 N, (**b**) 650 N, (**c**) 700 N, (**d**) 750 N, (**e**) 800 N.

Figure 13 shows the SEM image of the wear surface on the damaged steel wires under different contact loads. This clearly shows the change in wear characteristics on rope surface with increasing contact load. The wear characteristic of the damaged wire is mainly furrows when the contact load is 600 N (see Figure 13a). The surface is uneven, and there are characteristics of plastic deformation caused by large contact stress. This means that the surface damage of the wire rope is obviously affected by its structure, and removal of the material is mainly caused by the mechanical damage. Because the wire rope is a spiral structure, the sliding contact surface is composed of discontinuous steel wires and rope strands. This causes the friction pair contact surface to be very uneven. Thus, the

sliding resistance is larger and the surface scratches and ploughing effect is more obvious. Additionally, the wear particles between the contact surface will exacerbate the surface ploughing. Furthermore, as the contact load changes to 650 N (see Figure 13b), although many furrows are distributed along the sliding direction on the wear surface, the size of the furrows is small and the surface is more regular. This indicates that an increase in the contact load will reduce the size of the furrows and make the spalling and pitting characteristics more pronounced. Moreover, when the contact load exceeds 700 N, the wear surface of the steel wire becomes very smooth (see Figure 13c-e). Especially when the contact load is 800 N, it is difficult to see the obvious damage characteristics in the wear area. This is because the friction temperature rise of the wire rope is larger under the condition of large contact load. The surface material will soften during the sliding wear process, which is more likely to be sheared and plastically deformed. Therefore, the furrow characteristics of the wear surface are weakened, and the adhesion characteristics, such as pitting and spalling, are enhanced. Therefore, with the increases in contact load, the furrows and spalling pits on the wear surface of the wire rope are significantly reduced. The abrasive wear is reduced during this process. Additionally, as the surface becomes smoother, the wear rate slows down, and adhesion is enhanced and the size of the wear debris becomes smaller. This also causes the abrasive wear characteristics to weaken. The sliding wear mechanisms between the wire rope and the pulley are mainly abrasive wear and adhesive wear. Furthermore, the morphology characteristics of abrasive wear on the wire rope surface are more obvious under smaller contact load. The effect of contact load on the wear mechanism is mainly achieved by plastic deformation and friction temperature rise.

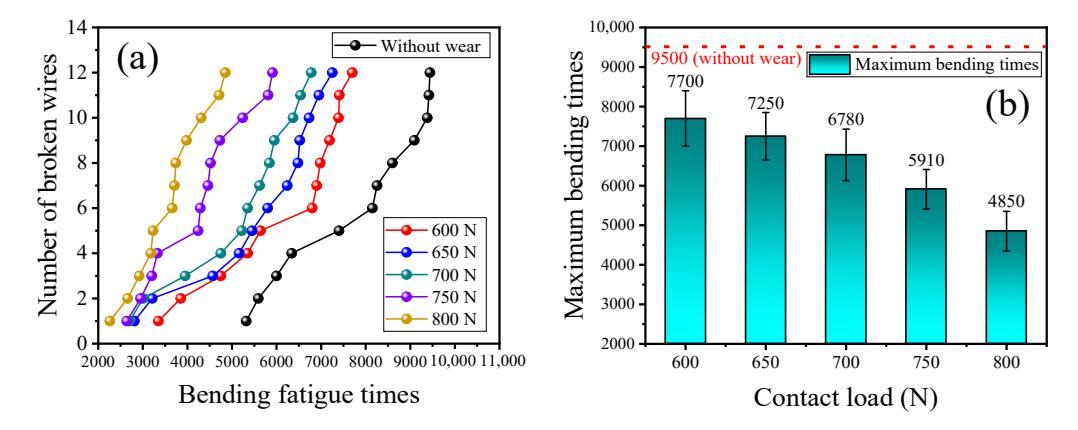
Figure 14. Bending fatigue degradation characteristics of different rope samples: (**a**) variation curves of broken wire number with bending fatigue times, (**b**) maximum bending fatigue times under different contact loads.

The corresponding relationship between number of broken wires and bending cycles is obtained by carrying out bending fatigue tests on the wire rope with different surface wear, as shown in Figure 14. With the accumulation of bending fatigue time, the number of broken wires increases continuously. When the wire rope is not subjected to surface wear, the first broken wire occurs after approximately 5200 bending fatigue cycles, as shown in Figure 14a. Then, as the amount of bending increases, the broken wire increases linearly. However, when the number of broken wires exceeds four, its growth rate begins to slow down. Furthermore, when the number of broken wires exceeds six, its growth rate begins to increase again. With the increase in bending fatigue time, the broken wire curves rise approximately in a straight line. This indicates that the bending fatigue damage to the wire rope is a cumulative deterioration process, and, with an increase in bending fatigue time, the fracture speed of the wires is accelerated. Additionally, the variation trend of the broken wire curves of the rope samples is basically the same, but the anti-fatigue performance is obviously degraded. With an increase in contact load, the bending fatigue times of the wire rope under the same broken wire condition decrease. The first broken wire begins to appear on these rope samples after 2000–3500 bending fatigue cycles. This means that surface wear has a significant effect on the bending fatigue strength of wire ropes and accelerates the fracture speed of internal steel wires [42]. Furthermore, by comparing the change process of the curves, it can be seen that, when the number of broken wires exceeds

approximately seven, the broken wires change more regularly with increasing bending fatigue times. This indicates that the internal wire breaking of the wire rope has a certain randomness in the early stage of the bending fatigue test, and the breaking sequence of different positions is uncertain. However, when the broken wire reaches a certain number, the bending fatigue dangerous area of the wire rope is basically determined, and the stress becomes concentrated near the broken wire of the wire rope. This is more likely to cause a fracture of the surrounding steel wires. Therefore, the rope samples in the bending fatigue test. Moreover, Figure 14b shows the maximum bending fatigue times of the rope sample under different contact loads. The bending fatigue times decrease from approximately 7700 to 4850 with increasing contact load. The bending fatigue life of the wire rope is obviously degraded, and it is proved that the harm of sliding wear to the wire rope increases with increasing contact load. Therefore, controlling the contact load between the crane wire rope and the pulley can effectively extend its bending fatigue life.

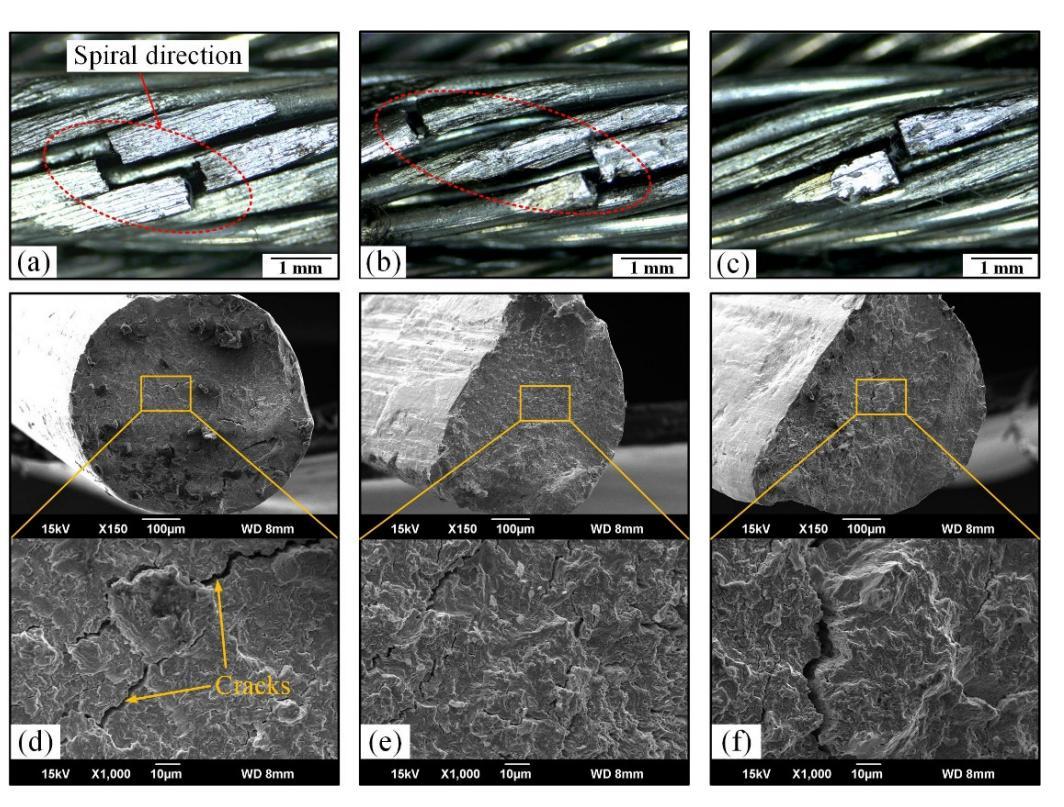
Figure 15. Fracture failure behavior of worn wire rope caused by bending fatigue: (**a**–**c**) distribution characteristics of broken wires, (**d**–**f**) fracture characteristics.

Figure 15 shows the broken wire distribution (Figure 15a–c) and fracture morphology (Figure 15c-e) of rope samples caused by bending fatigue test. The observations in Figure 15 are taken from different rope samples and wire samples. The broken wires produced during the bending fatigue process are mainly concentrated in the wear region. This indicates that surface wear reduces the bending fatigue strength of wire rope [42]. Additionally, the fracture of the steel wire appears in the middle of the wear scar and is distributed along the spiral direction on the rope strand (see Figure 15a–c). This is because wire tension is along the steel wire axial direction in the process of bending and the fracture is along the steel wire radial direction [43]. Therefore, the broken steel wire is continuously distributed along the strand axis. Additionally, the fracture of the steel wire is very neat, indicating that the fracture is a transient process, and no plastic deformation caused by a large load is produced before fracture. Figure 15d shows the fracture characteristics of the unworn steel wire. The fracture profile of the steel wire is very complete and there are many cracks on the fracture surface. This indicates that the internal damage of steel wire under bending fatigue load is a process of continuous cumulative change. The crack propagates with the increase in bending fatigue times until fracture. Furthermore, when the steel wire is subjected to surface wear, the fracture characteristics do not change significantly, but the number of cracks on the surface increase and the size becomes larger. This means that surface wear accelerates growth in fatigue cracks, causing the wire rope to break faster. Moreover, the fracture morphology of the wire rope is relatively regular and the surface is bright crystalline. Therefore, the fracture mechanism of wire rope under bending fatigue load is mainly brittle fracture. Surface wear causes the broken wire to concentrate and speed up, greatly affecting the service life of the wire rope.
