# Article Sliding Corrosion Fatigue of Metallic Joint Implants: A Comparative Study of CoCrMo and Ti6Al4V in Simulated Synovial Environments

**Abstract:** Mechanical contact in a corrosive synovial environment leads to progressive surface damage at the modular interface of the joint implants. The wear debris and corrosion products degrade the synovial fluids and change the lubrication mechanisms at the joints. Consequently, the unstable joint lubrication and corrosion products will further induce the undesirable performance of the joint implants. In this study, the two major joint materials, CoCrMo and Ti6Al4V, were tested during the course of reciprocal sliding contact in simulated synovial liquids. Open circuit potential and coefficient of friction were monitored to describe electrochemical and mechanical responses. Potentiostatic test results illustrated electrochemical damage on both surfaces that modified oxidation chemistry on both surfaces. However, more significant modification of the CoCrMo surface was detected during wear in the simulated joint liquid. Even with a reduced coefficient of friction on the CoCrMo surface in sodium lactate environments, fretting current densi

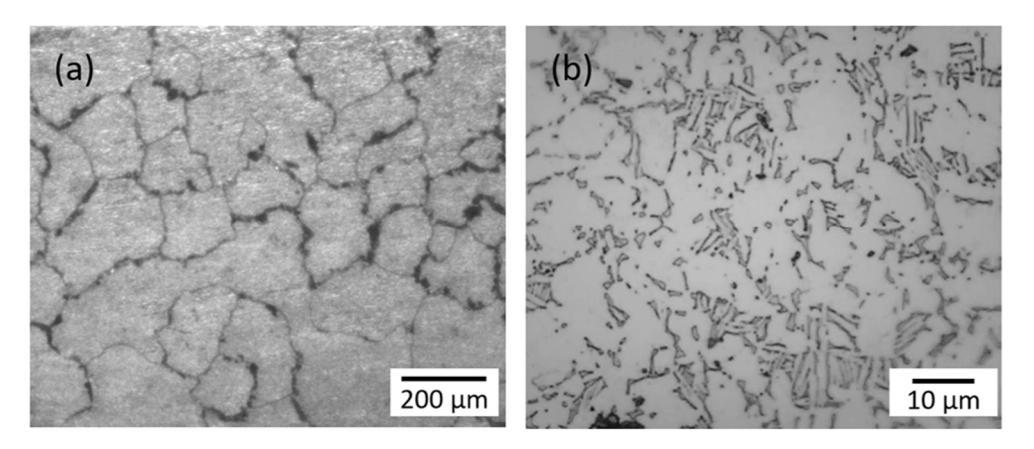
Figure 1. Microstructures of (a) CoCoMo and (b) Ti6Al4V.

CoCrMo (F1537) and Ti6Al4V (F136) rods were manufactured using the electrical discharge machining (EDM) method to rectangular  $1.00 \times 2.54 \times 22.95 \text{ mm}^3$  specimens. The EDM method was used to minimize residual stress, and the specimens were embedded in an epoxy disk for electrochemical tests. Small rectangular  $1.00 \times 2.54 \text{ mm}^2$  areas on top and bottom of the specimens were exposed out of the epoxy holder, and polished using 600, 1200 and 2400 grit silicon carbide papers, and finally a 0.05 µm colloidal silica and alumina on polishing cloths for 10 to 15 min until a mirror finish was obtained. The microstructure was observed by scanning electron microscopy, and the chemical compositions were analyzed. As illustrated in Figure 1, the CoCrMo surface illustrated large grain sizes in the order of 100 µm. The Ti6Al4V surface consisted of mixed ( $\alpha + \beta$ ) phases. The average concentrations of the major chemical components are summarized in Table 1.

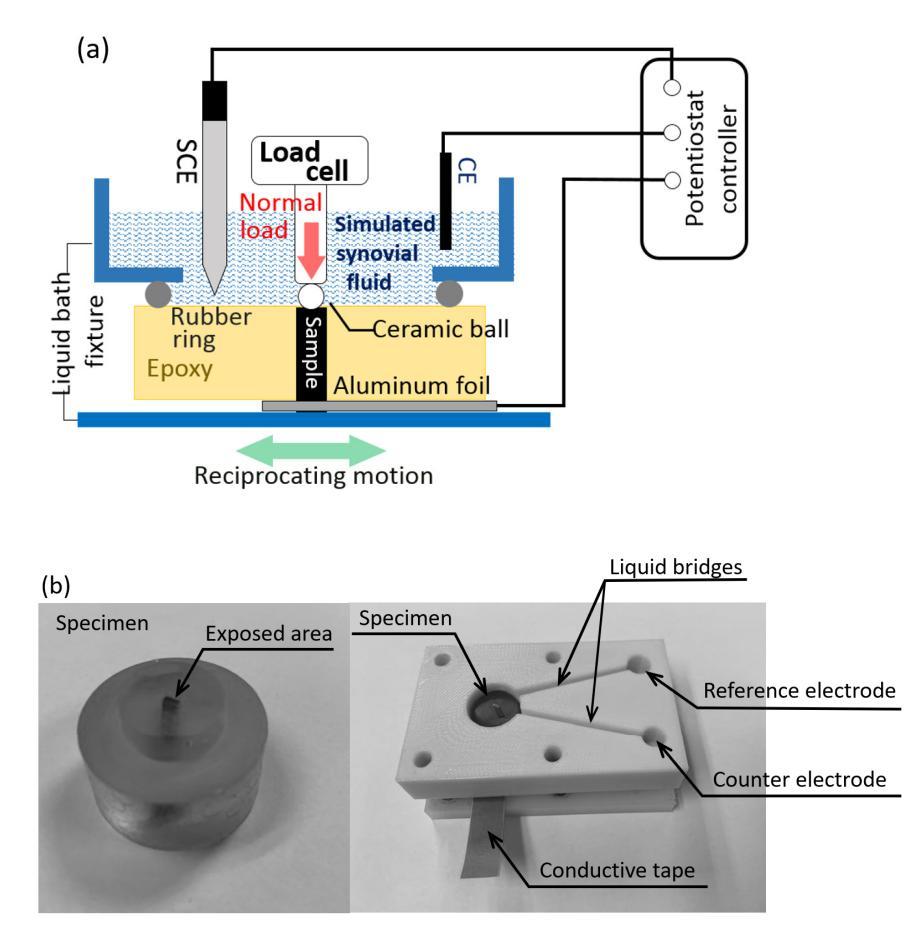
**Figure 2.** (a) Schematic of a tribocorrosion experimental set up that consists of a nanoindenter-based wear tester and a synovial fluid bath; (b) Specimen prepared in epoxy and liquid cell components.

A custom tribochemical bath was designed to conduct the electrochemical tests during active sliding contact against a ceramic ball. This chemical bath consisted of the specimen in the epoxy disk, a rubber ring preventing leakage of electrolyte between the epoxy disk and chemical bath, an aluminum foil to ensure electrical contact of the specimen to the Reference 600 potentiostat controller (Gamry Instruments, PA, USA), and a bath component providing stable electrical contacts of three electrodes including the working electrode (the exposed surface of the specimen), the reference electrode, and the counter electrode. The large cylindrical space in the bath component accommodated a sufficient amount of simulated synovial fluid in contact with the specimen surface and two electrodes. The test bath components were manufactured out of a chemically inactive nylon block. A saturated calomel reference electrode (SCE) and a platinum wire (Gamry Instruments, PA, USA) were employed to detect the electrochemical signals from the specimen surfaces. A silver paste was applied to ensure full electrical connection between the specimen and the aluminum foil. Schematics of the test bath are presented in Figure 2a,b. This electrochemical bath was mounted in the nano tribometer (Nanovea, CA, USA) to perform reciprocal sliding contact experiments while monitoring electrochemical responses and coefficients of friction changes (Nanovea, CA, USA).

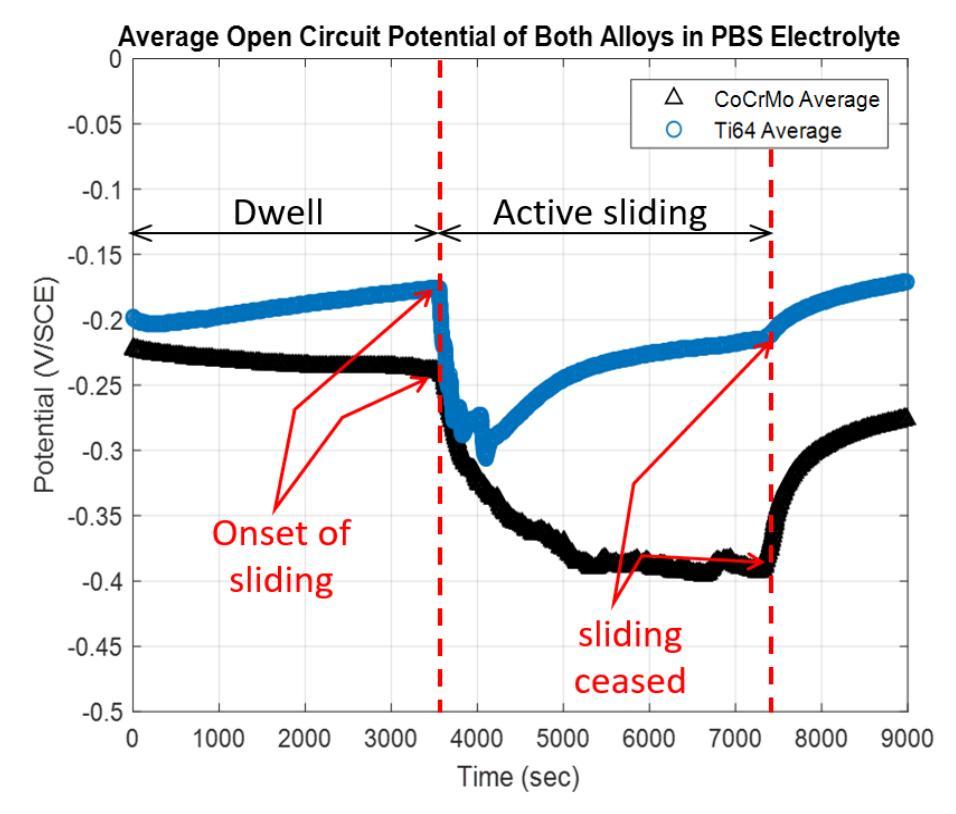
**Figure 3.** Open circuit potential response during the corrosion fatigue test on CoCrMo and Ti6Al4V in phosphate buffered saline (PBS) solution.

The potential change by reciprocating motion, with a constant normal load of 143 mN, was monitored before sliding (dwell), during sliding (active articulations) and after sliding motion (recovery) on the CoCrMo and the Ti6A14V. As shown in Figure 3, the 1-h dwell time was allowed to stabilize, and then the reciprocating motion using the spherical alumina was applied at 143 mN normal force. There was a significant potential drop on both the CoCrMo and the Ti6Al4V surfaces due to the exposure of pure metal, via a damaged oxide layer, to the PBS solution. The potential of the Ti6Al4V dropped instantaneously and gradually increased (positively changed) during continuous reciprocations. The potential of the CoCrMo progressively decreased to negative, and continued at -0.4 V until the active contact ceased. It was evident that the potential of the Ti6Al4V dropped as soon as the slider motion was initiated, but spontaneous repassivation occurred even during active sliding. The potential gradually recovered to the level of its initial dwell potential as the sliding contact continued. It was notable that the presence of the PBS was beneficial to the Ti6Al4V to reform its stable oxide layer. However, during the fatigue wear on the CoCrMo, the potential continuously dropped until the sliding motion ceased. This implied that the chromium oxide layer was progressively degraded by continuous abrasion by the slider head. The chemomechanical response illustrated that the reformed chromium oxide layer was not as stable as the original passive layer formed in ambient. During the sliding fatigue on the CoCrMo surface, rapid fluctuations of OCP response illustrated a repetitive process of breakage-reformation cycles of the oxide layer in the PBS [27–29]. However, after a dramatic potential drop upon initiating contact stroke, the Ti6Al4V surface presented an increase in potential (positive change). This result on the Ti6Al4V surface implied spontaneous titanium oxide recovery during contact corrosion fatigue. After the sliding contact stopped, the CoCrMo surface was repassivated quickly, while the Ti6Al4V was readily repassivated during sliding motions, and continued the recovery process.

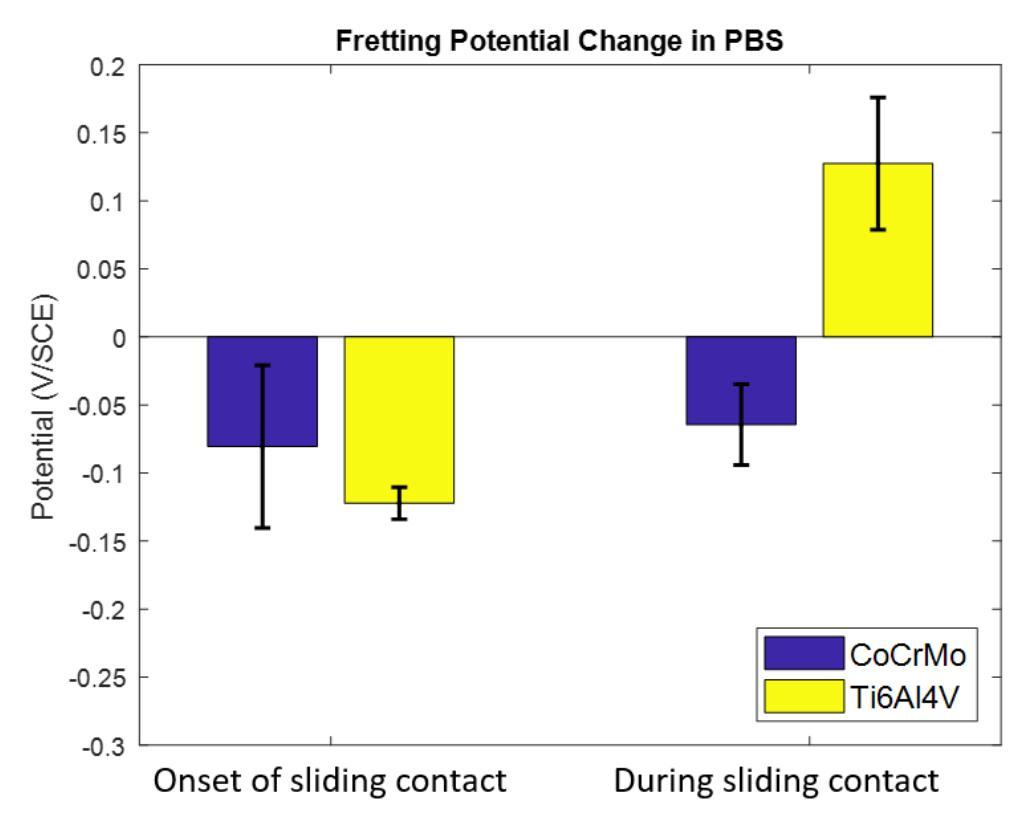
**Figure 4.** The effect of the PBS environment on OCP response on the CoCrMo and the Ti6Al4V during reciprocating sliding contact.

Figure 4 summarizes the OCP responses. Negative potential drops were found on the CoCrMo surfaces at the onset of sliding as well as during the active sliding contacts. However, it is evident that the positive change of OCP on the Ti6Al4V illustrated prompt reformation of chemically protective titanium oxide during the active sliding contacts.

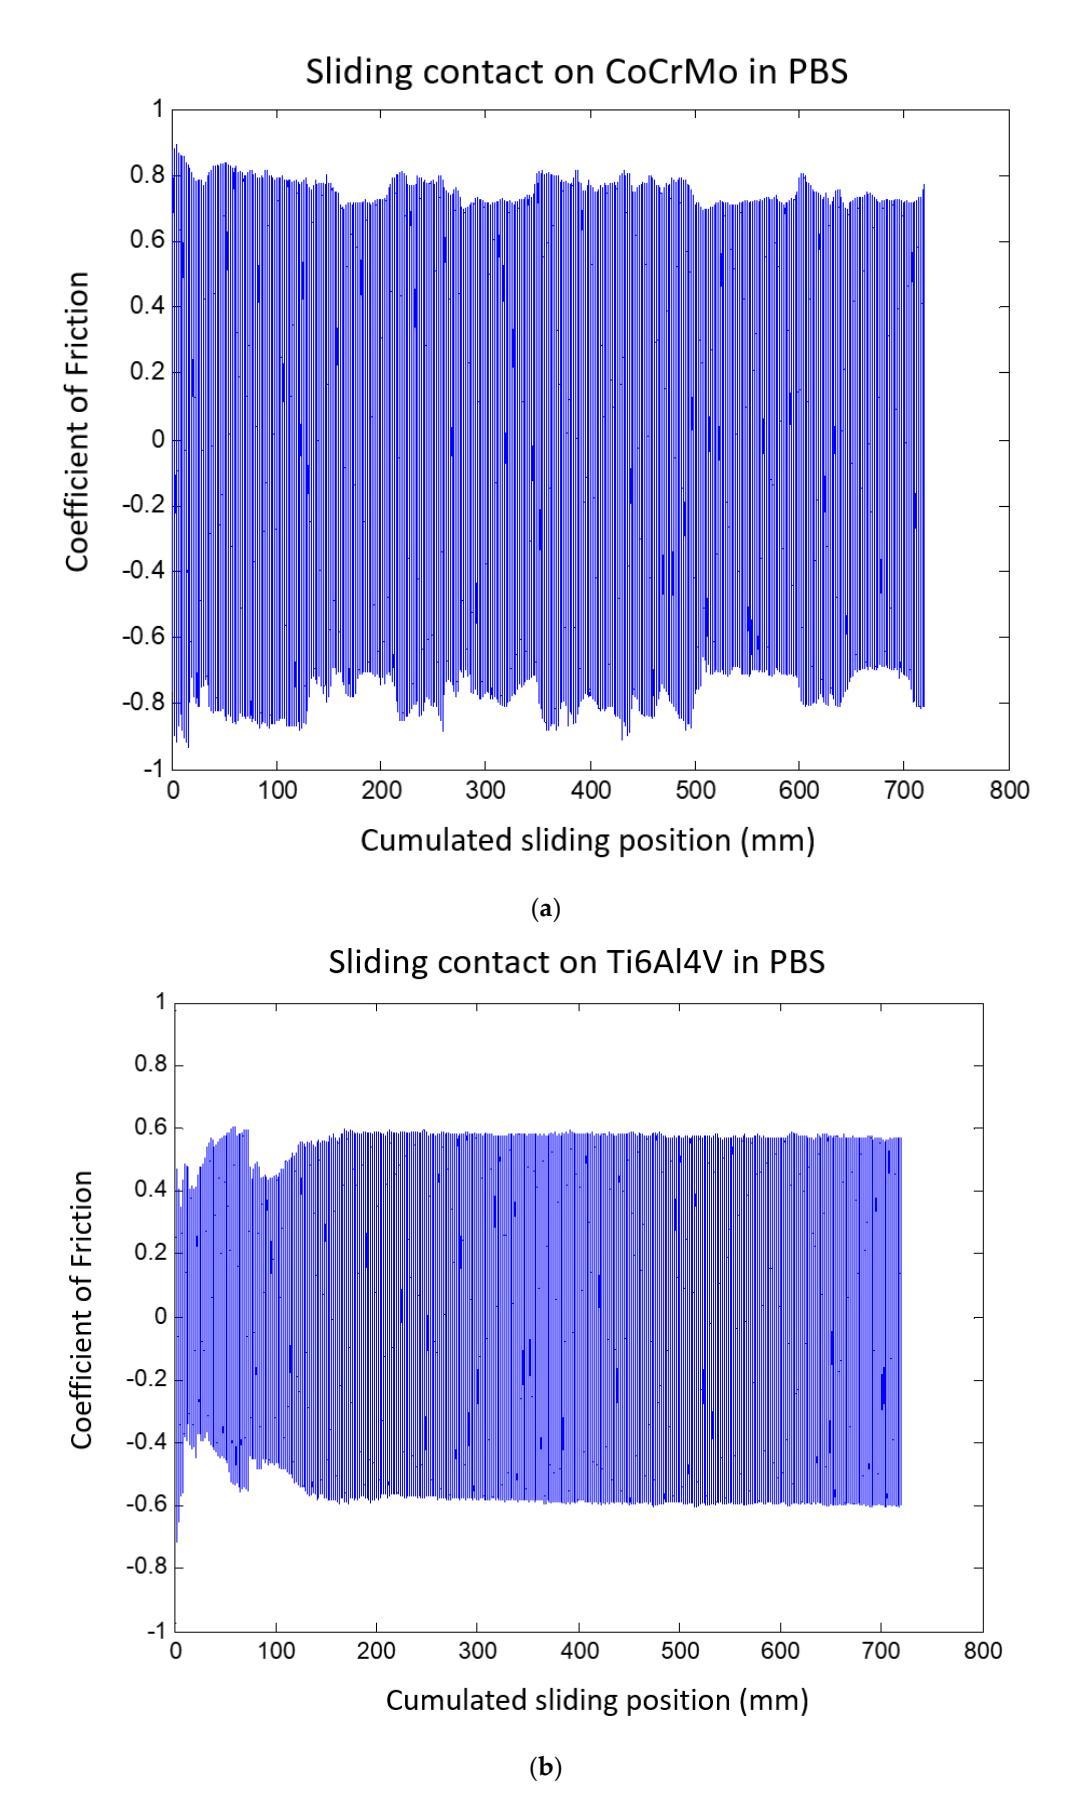
**Figure 5.** (a) Coefficient of friction of the CoCrMo during reciprocating contact in the PBS solution. (b) Coefficient of friction of the Ti6Al4V during reciprocating contact in the PBS solution.

Coefficients of friction (CoF) values were monitored during the sliding test. The positive and negative values of CoF in Figure 5 dictate forward and backward sliding motions, respectively. The results present greater average CoF values on the CoCrMo surface. Throughout the course of sliding contact, CoF variations on the CoCrMo showed unstable frictional interaction. This result was in accordance with the significant oxide damage from OCP responses on the CoCrMo in Figure 3. The CoF values on the Ti6Al4V rapidly evolved in the early stage of reciprocating in the range of 0.4 to 0.6, but soon stabilized to a value less than 0.6 in the cumulative sliding distance of 100 mm that corresponded to 250 reciprocated cycles.

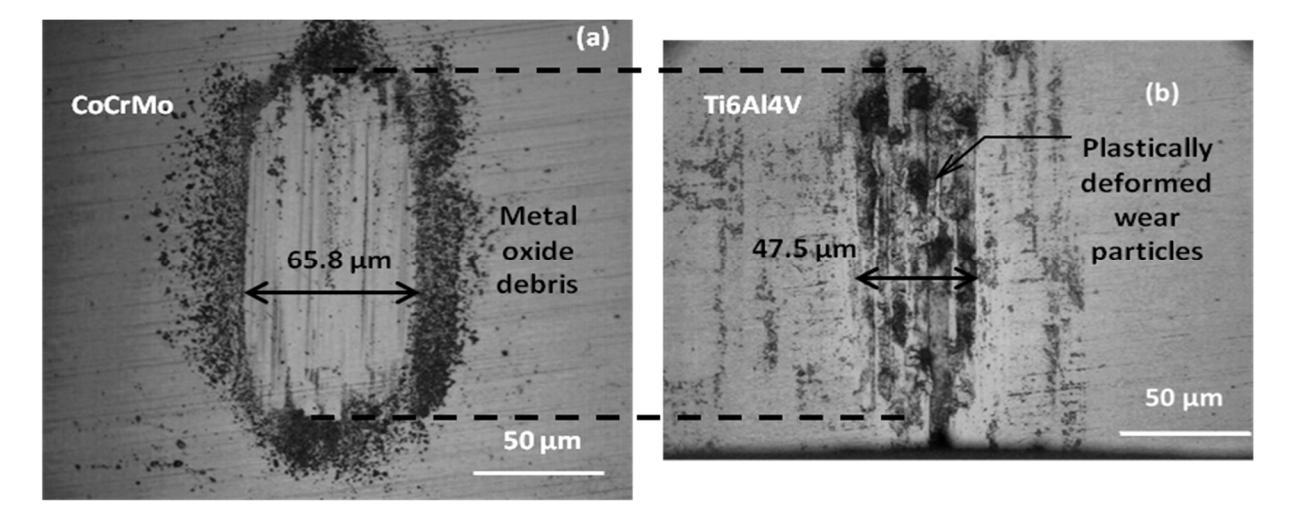
**Figure 6.** Representative micro images of wear tracks on (**a**) CoCrMo surface producing nano size oxide debris and (**b**) Ti6Al4V surface forming wear particle agglomerations by reciprocal sliding contact in PBS.

The CoF values were explained by micro-optical image inspections of wear damage. As shown in Figure 6, the wear debris continuously produced from the thin chromium oxide layer by each sliding stroke continually affected the friction forces on the CoCrMo surface. However, on the Ti6Al4V surface, the sliding motion led to successive plastic deformation on the top layer and the subsurface crack under the deformed layer would be propagated during sliding cycles. Larger agglomerated wear particles are indicative of more ductile behavior on Ti6Al4V surfaces. Therefore, changes in OCP and CoF responses on the Ti6Al4V presented less sensitivity during microcracking under the oxide layer.

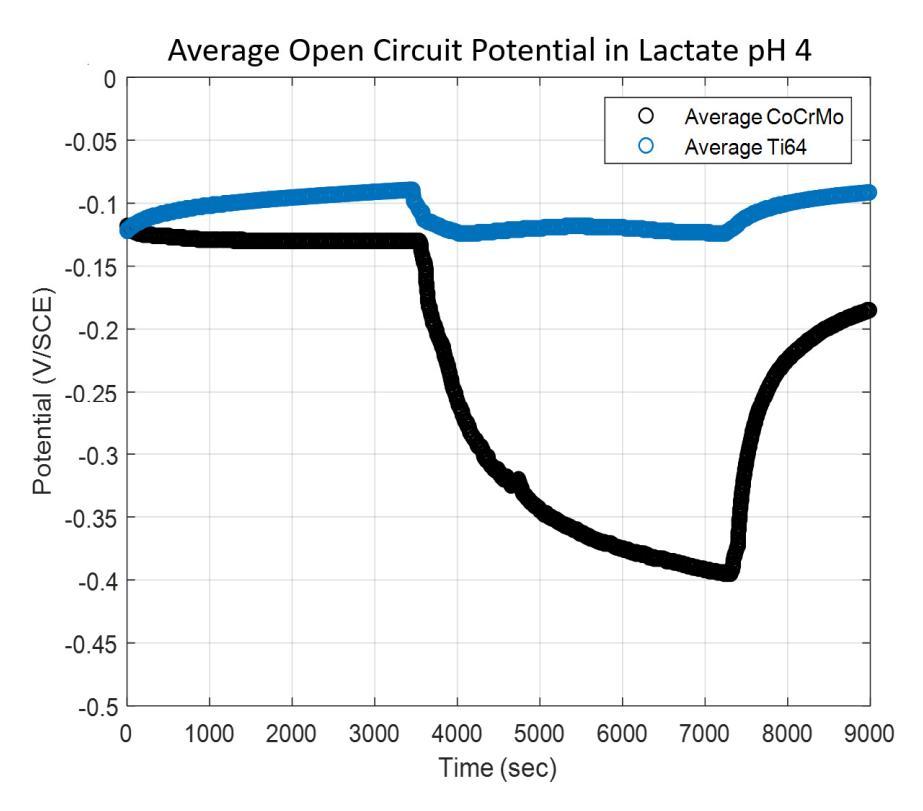
Figure 7. Open circuit potential change by reciprocal contact in sodium lactate pH 4.

The potential change by reciprocating motion with a constant normal load was monitored during sliding contact fatigue on the CoCrMo and the Ti6A14V in a sodium lactate solution. The pH level of the lactate solution was adjusted by adding hydrochloric acid to obtain a controlled acidic environment of pH 4.0. As shown in Figure 7, the overall fatigue corrosion processes in sodium lactate pH 4 presented similar behaviors in PBS pH 7.4. However, there was a significant potential drop on the CoCrMo and a reduced potential drop on the Ti6Al4V surfaces due to the exposure of metal via a damaged oxide layer to the sodium lactate pH 4 solution. During continuous sliding contact on the CoCrMo, the potential continuously dropped until the sliding motion ceased. The potential drop on the CoCrMo surface accelerated up to 5000 s (approximately 1000 cycles), and later decelerated in the rest of the reciprocations, whereas the potential of the Ti6Al4V surface instantaneously decreased and maintained the potential values throughout the cyclic sliding. It was evident that the potential of the Ti6Al4V slightly dropped as soon as the slider motion was initiated, but that it was followed by very steady repassivation. The direct comparison of magnitudes of the potential drop between the CoCrMo and the Ti6Al4V clearly described the different oxidation chemistry processes. It was notable that the presence of the moderate acidic lactate improved the corrosion protection of the Ti6Al4V surface. This result implies that the tribological stability and rapid regrowth of Ti6Al4V is superior to those of CoCrMo in the moderate acidity of lactate fluid. In particular, it is presumable that the fatigue corrosion on the CoCrMo surface was accelerated in the sodium lactate pH 4. This could be explained by the rate of repassivation of titanium oxide being faster than the rate of metal ion dissolutions in the presence of lactate medium. After the sliding cycles stopped, the CoCrMo surface was rapidly repassivated, while the Ti6Al4V was readily under the progressive repassivation during contact fatigue. Therefore, the Ti6Al4V presented desirable oxide chemistry that recovered the damaged surface in the sodium lactate pH 4 solution.

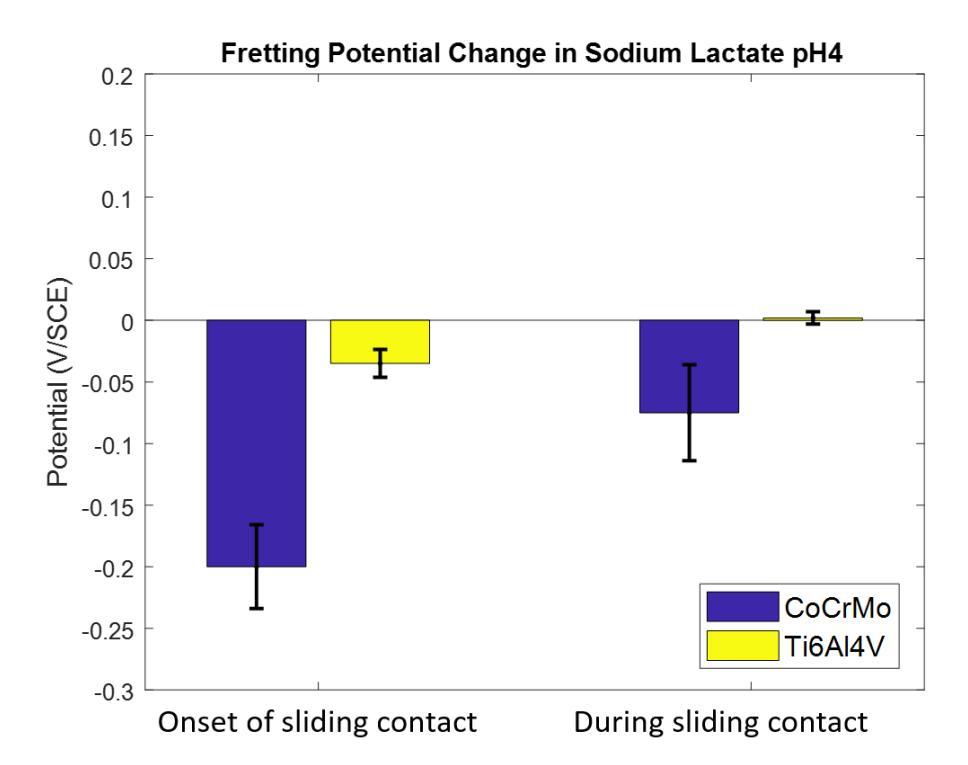
**Figure 8.** The effect of a sodium lactate pH 4 environment on OCP response on CoCrMo and Ti6Al4V during reciprocating sliding contact.

Contact corrosion fatigue responses in a sodium lactate pH 4 environment are summarized in Figure 8. The drastic potential drop on the CoCrMo was observed when sliding contact was initiated and continually lowered during cyclic motions. Potential changes on the Ti6Al4V in sodium lactate were similar to those in PBS, but the positive potential change during contact cycles was reduced when compared to the result from corrosion fatigue in PBS.

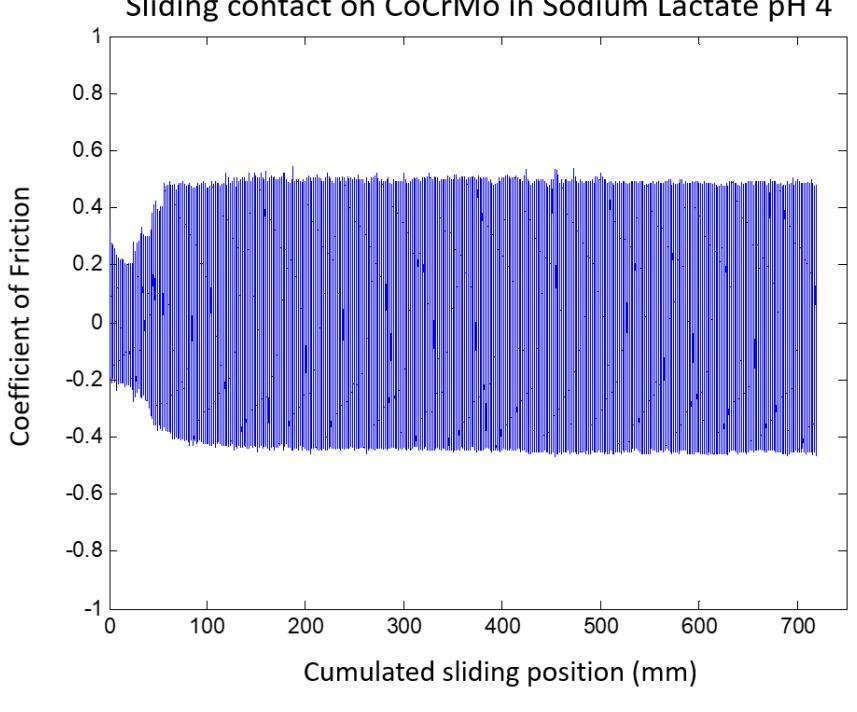
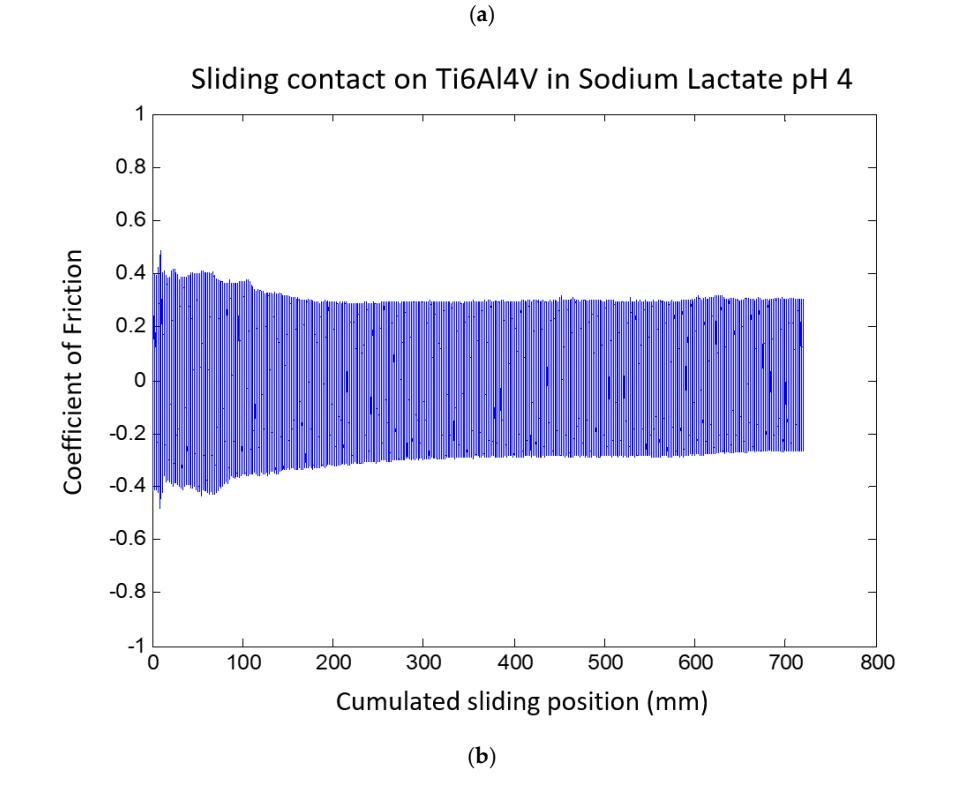
Sliding contact on CoCrMo in Sodium Lactate pH 4

Figure 9. (a) Coefficient of friction of CoCrMo during reciprocal sliding contact in sodium lactate pH 4. (b) Coefficient of friction of Ti6Al4V during reciprocal sliding in sodium lactate pH 4.

Friction responses were significantly modified in the sodium lactate environment as presented in Figure 9a,b. Average CoF values on both surfaces were reduced in the sodium lactate pH 4 compared to the results from tests in the PBS. However, similarly to PBS, the average CoF values on the Ti6Al4V surface presented less than the average CoF values on the CoCrMo in sodium lactate pH 4. It was noticed that the CoF values on the CoCrMo

reached a steady level at approximately 0.5 after 30 mm cumulated sliding distance. It is evident that the CoF change is associated with simultaneous modifications in OCP drops. During the steady state kinetic friction, OCP continually decreased on CoCrMo surface. However, Ti6Al4V surface showed stable responses on both friction coefficients and OCP signals during sliding contact.

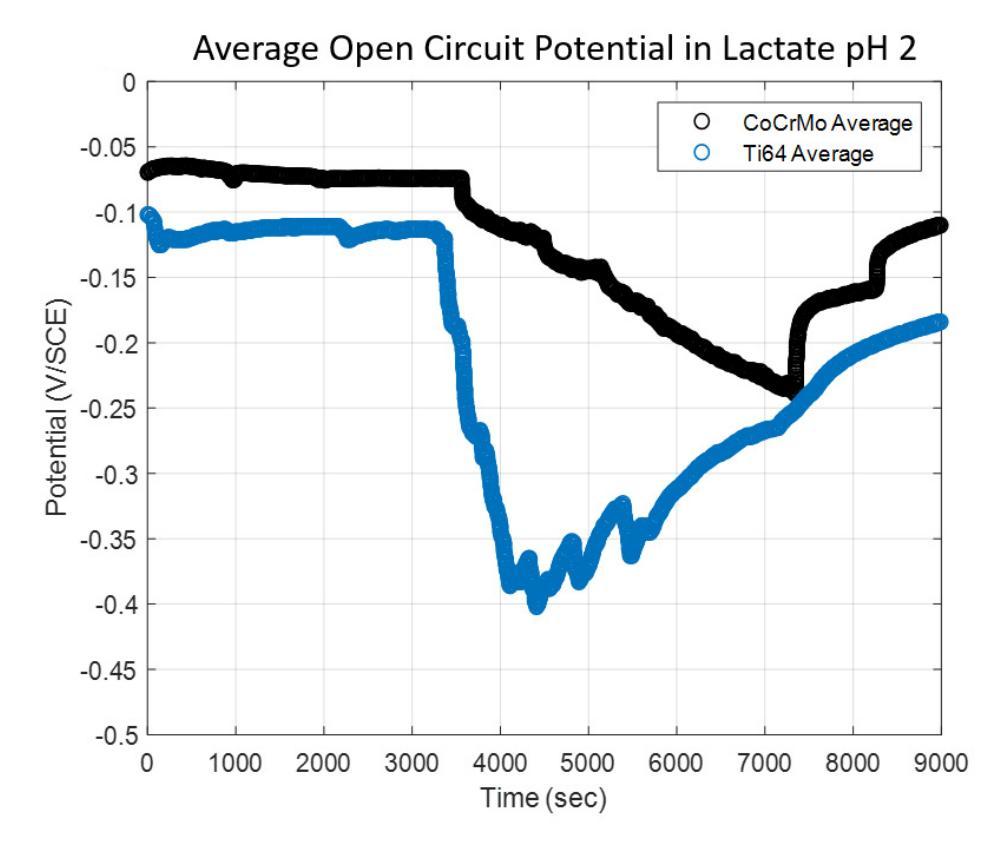
**Figure 10.** The effect of a sodium lactate pH 2 environment on OCP response on CoCrMo and Ti6Al4V during reciprocating sliding contact.

The potential change by reciprocating motion with a constant normal load of 143 mN was monitored in the sodium lactate pH 2. As shown in Figure 10, the potential was allowed to stabilize for an hour, and then the reciprocating motion using the spherical alumina was applied. The potential change of the Ti6Al4V surface in the sodium lactate pH 2 illustrated a dramatic drop as soon as the sliding was initiated, and then during the continuous contact the potential was increased (positive change) in the rest of the test period. In this chemically aggressive environment, potential response varied, and repassivation did not effectively occur on the Ti6Al4V surface. In contrast, the CoCrMo surface presented a small potential drop when the mechanical contact started, but the potential proportionally decreased (negative change) until the sliding was ceased. However, there was a significant change in potential drops in this reactive lactate pH 2 solution. More importantly, the maximum potential drop on the Ti6Al4V during sliding contact was greater than that on the CoCrMo surface. In the other corrosion fatigue tests in PBS and sodium lactate pH 2, the potential drop was more significant on the CoCrMo surface than on the Ti6Al4V surface. This result described how the corrosion sensitivity of the Ti6Al4V was anomalously manifested in the reactive acidic environment. However, the corrosion process was clearly accelerated on the CoCrMo surface, while the recovery process of oxidation on the Ti6Al4V was observed during the course of the sliding contacts. Figure 11 illustrates that the rate of oxide recovery on Ti6Al4V in a reactive environment is not as much as in the neutral PBS pH 7.4. The initial potential drop on the CoCrMo was reduced in an aggressive acidic condition, but the continuous potential drop during the fretting on the CoCrMo was greater in lactate pH 2 when compared to the potential changes in PBS and lactate pH 4 solutions. The potential kinetics of the Ti6Al4V illustrated that if greater potential drop at the onset of fretting was obtained, rapid recovery oxidation took place during contact corrosion fatigue.

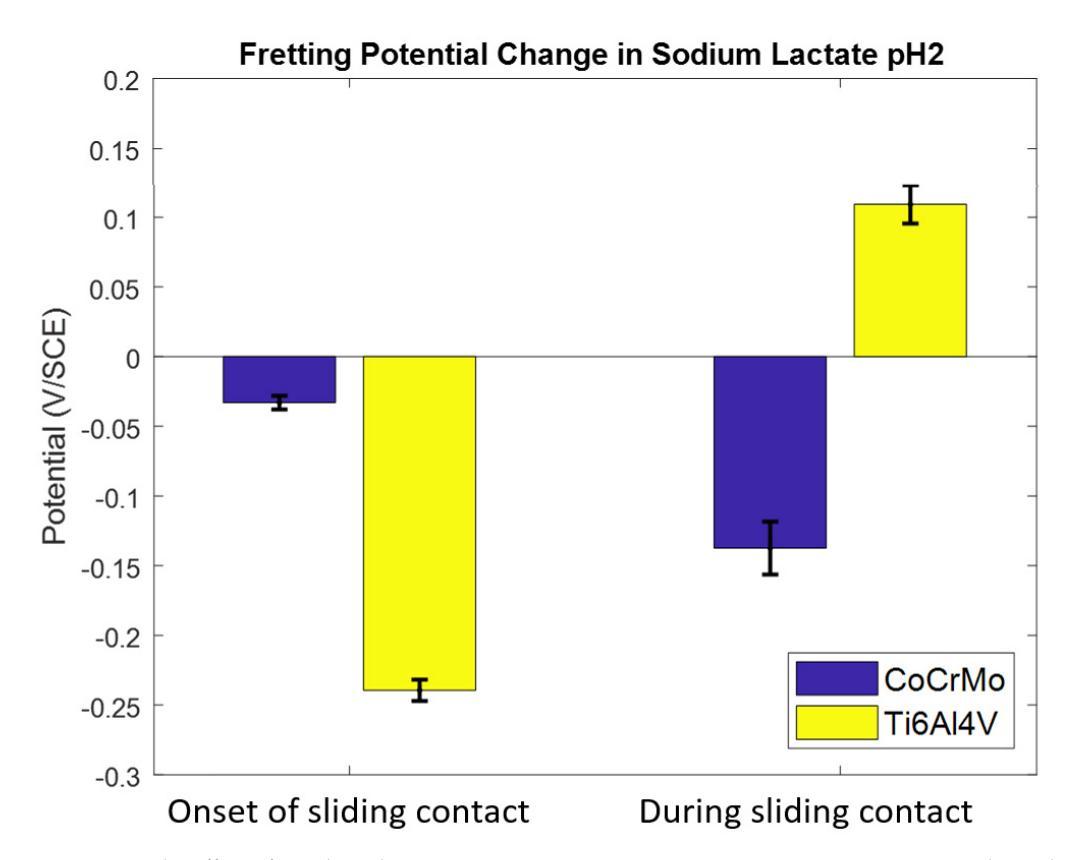
**Figure 11.** The effect of a sodium lactate pH 2 environment on OCP response on CoCrMo and Ti6Al4V during reciprocating sliding contact.

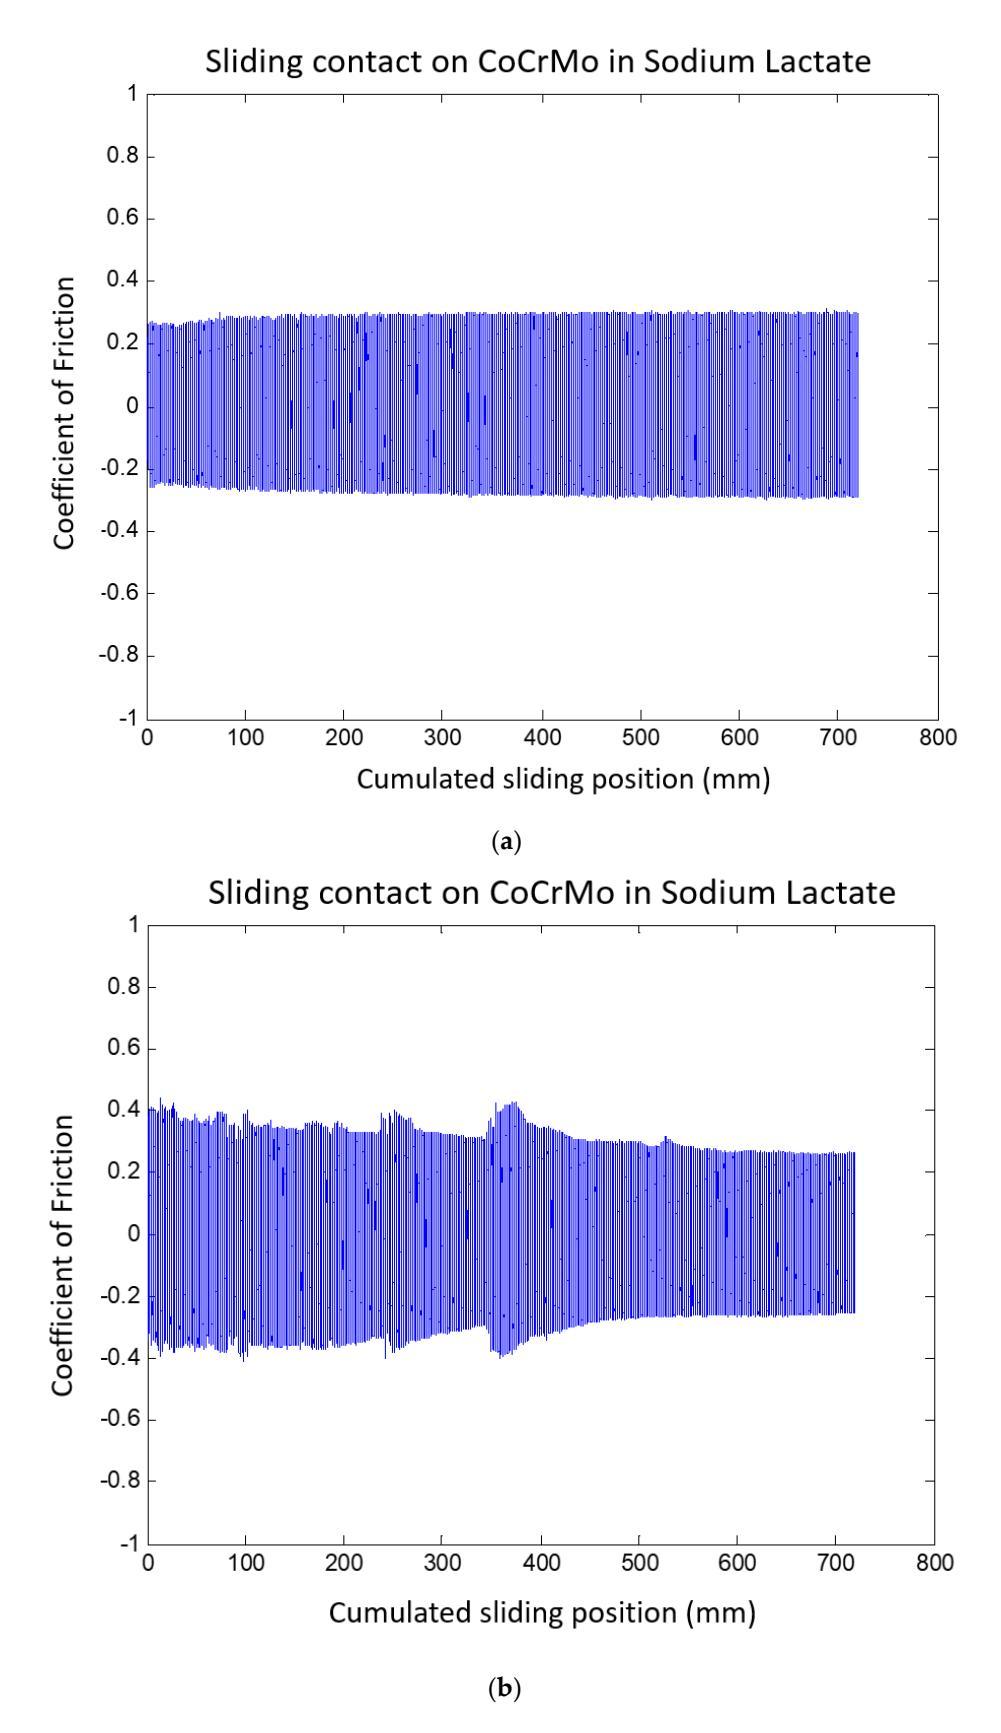
**Figure 12.** (a) Coefficient of friction of CoCrMo during reciprocal sliding in sodium lactate pH 2. (b) Coefficient of friction of Ti6Al4V during reciprocal sliding in sodium lactate pH 2.

The CoF values on the CoCrMo progressively increased during the course of sliding cycles, as presented in Figure 12. The gradual increase in the COF values on the CoCrMo may describe the continuous potential drop during fatigue contact. The average COF values of the Ti6Al4V were greater than those of the CoCrMo in this environment. This result was in accordance with the OCP results; there was a greater potential drop on the Ti6Al4V than on the CoCrMo. At the maximum potential drop on the Ti6Al4V surface, high potential variations were observed. This result was well illustrated in the CoF curves in Figure 12. Interestingly, the average COF values were slightly reduced on the Ti6Al4V surface, while the CoF values on the CoCrMo surface were significantly reduced in lactate pH 2. Figure 13 summarizes the average COF values in three different environments. It presents less sensitivity of CoF values on the Ti6Al4V surface with the different synovial environments. In the reactive solutions of lactate pH 4 and pH 2, the average COF was almost the same. The COF values of the CoCrMo revealed the significance of the environments. With increased acidity, average COF values were reduced.

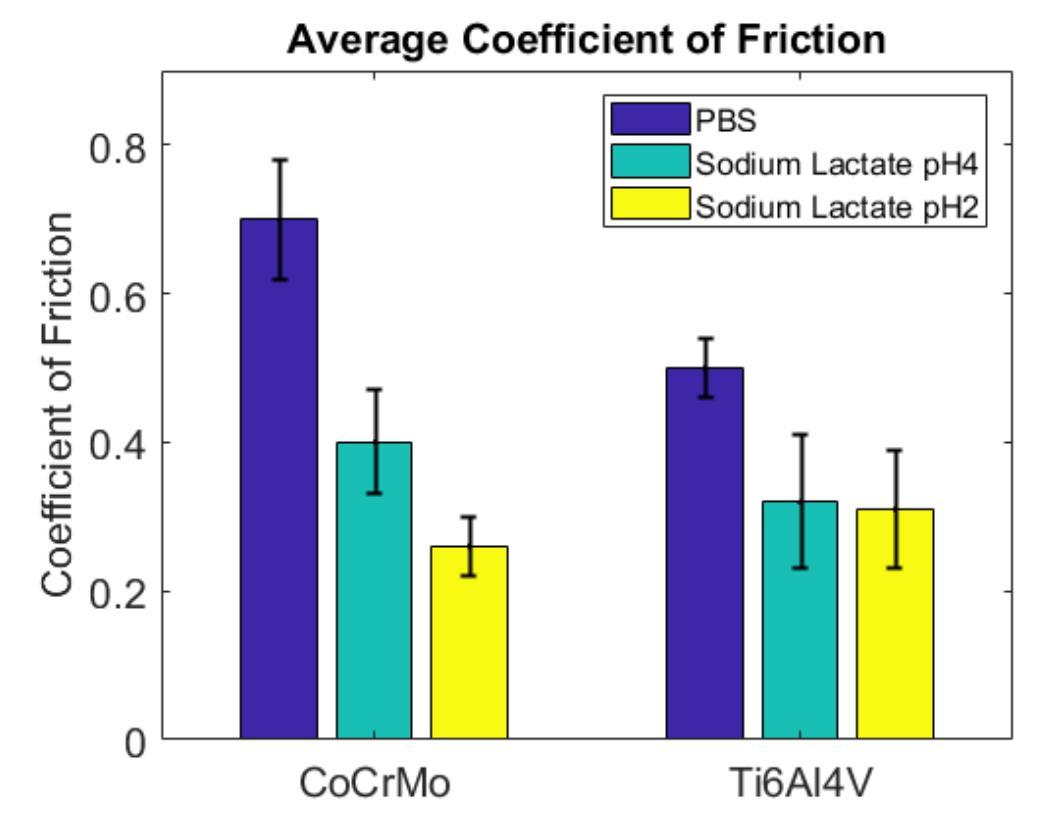
Figure 13. Average coefficient of friction in different simulated synovial environments.

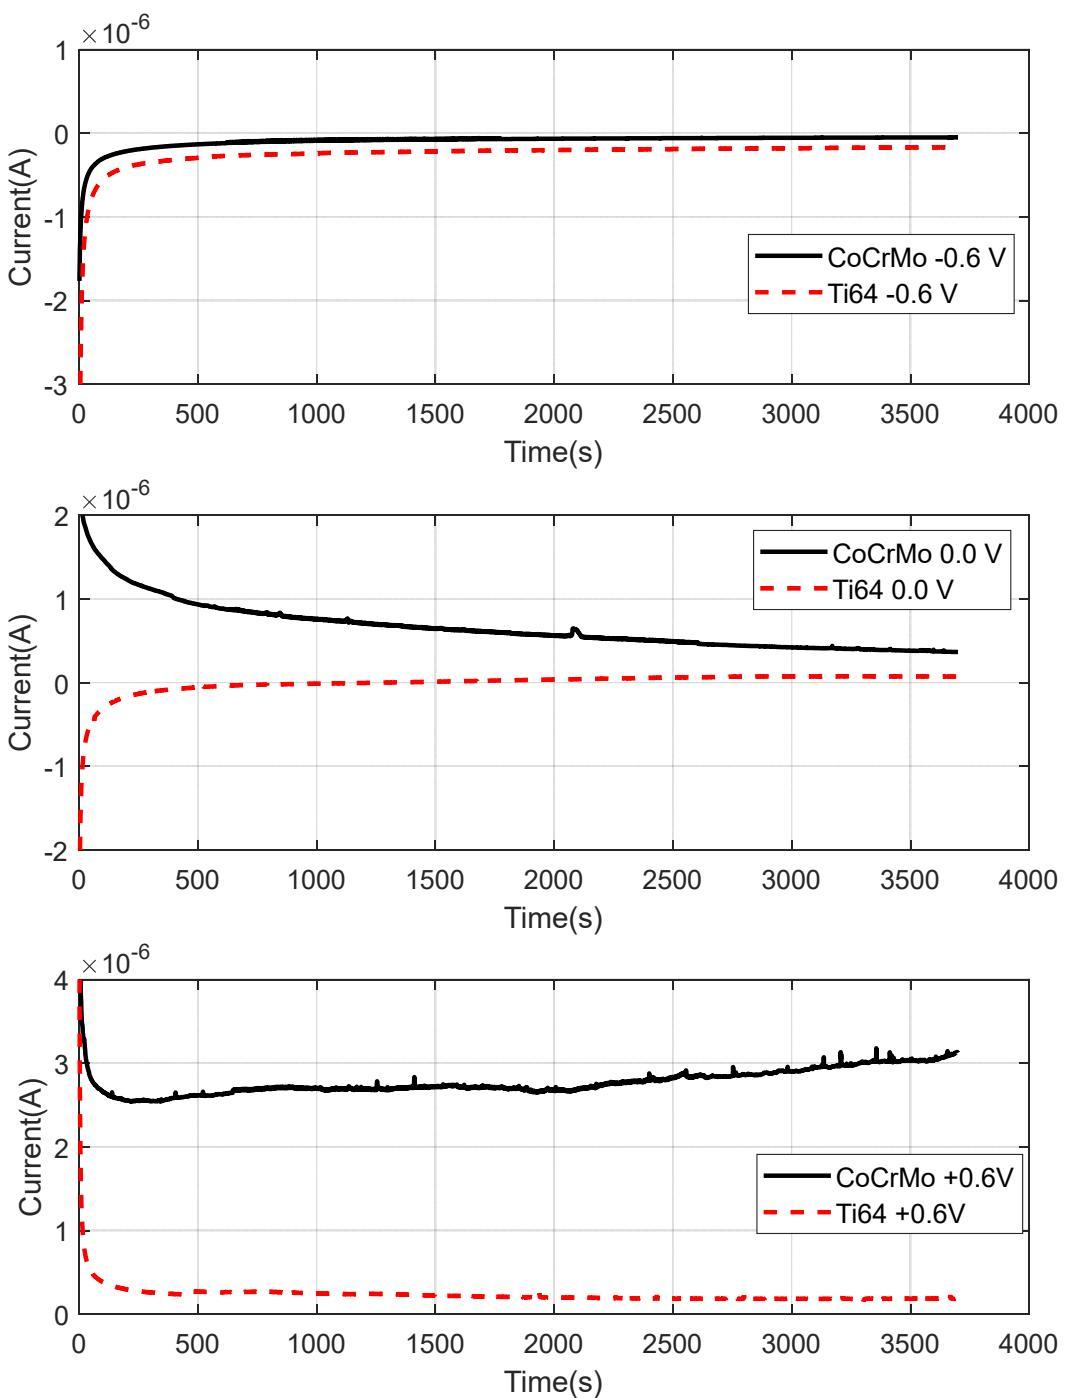
Potentiostatic Polarization of CoCrMo and Ti6Al4V in PBS pH 7.4

**Figure 14.** Fretting current changes through the disturbed areas by reciprocal sliding in PBS with applied potentials. Active surface areas of CoCrMo and Ti6Al4V are  $3.086 \times 10^4 \ \mu m^2$  and  $3.046 \times 10^4 \ \mu m^2$ , respectively after 1800 sliding cycles.

Potentiostatic polarization tests were performed at a series of potential voltages at -0.6, -0.45, 0.0, +0.45 V and +0.6 V in all three environments on both alloys during reciprocal sliding contact. Before sliding contact started, current responses were allowed to stabilize to obtain a baseline current up to 900 s. The baseline current was measured to quantify the change in current when the reciprocal motion was initiated. Figure 14 is a representation of fretting current change against potentials -0.6, 0.0 and +0.6 V in PBS. On both surfaces with all negative and positive potentials, there was no significant current change in PBS during fatigue contact. Small positive peaks on current curve in positive potential (+0.6 V) were observed only on the CoCrMo surface. Current responses of the Ti6Al4V were smooth and continuous throughout the tests. Therefore, the results concluded that there would not be aggressive fretting corrosion damage in PBS. However, in sodium lactate pH 4 shown in Figure 15, significant current changes on the CoCrMo surface were found when zero or positive potentials were applied. Similarly, Ti6Al4V surfaces showed smooth and continuous fretting current in sodium lactate pH 4,. There was no distinctive current change on Ti6Al4V induced by sliding fatigue contact. This implies that the CoCrMo surface was more actively corroded during fictional sliding without and with positive potentials in an acidic environment. In sodium lactate pH 2 as illustrated in Figure 16, amplified current signals were detected on the CoCrMo surface with zero and positive potentials. Similarly, in PBS and sodium lactate pH 2 solutions, Ti6Al4V surfaces showed insignificant current changes induced by sliding contact. These potentiostatic test results agreed with the OPC test results during contact in simulated synovial environments. Hence, this may imply that the CoCrMo surface was vulnerable to fretting corrosion in reactive acidic conditions, while the Ti6Al4V would be more stable against the combined mechanical and electrochemical stimuli.

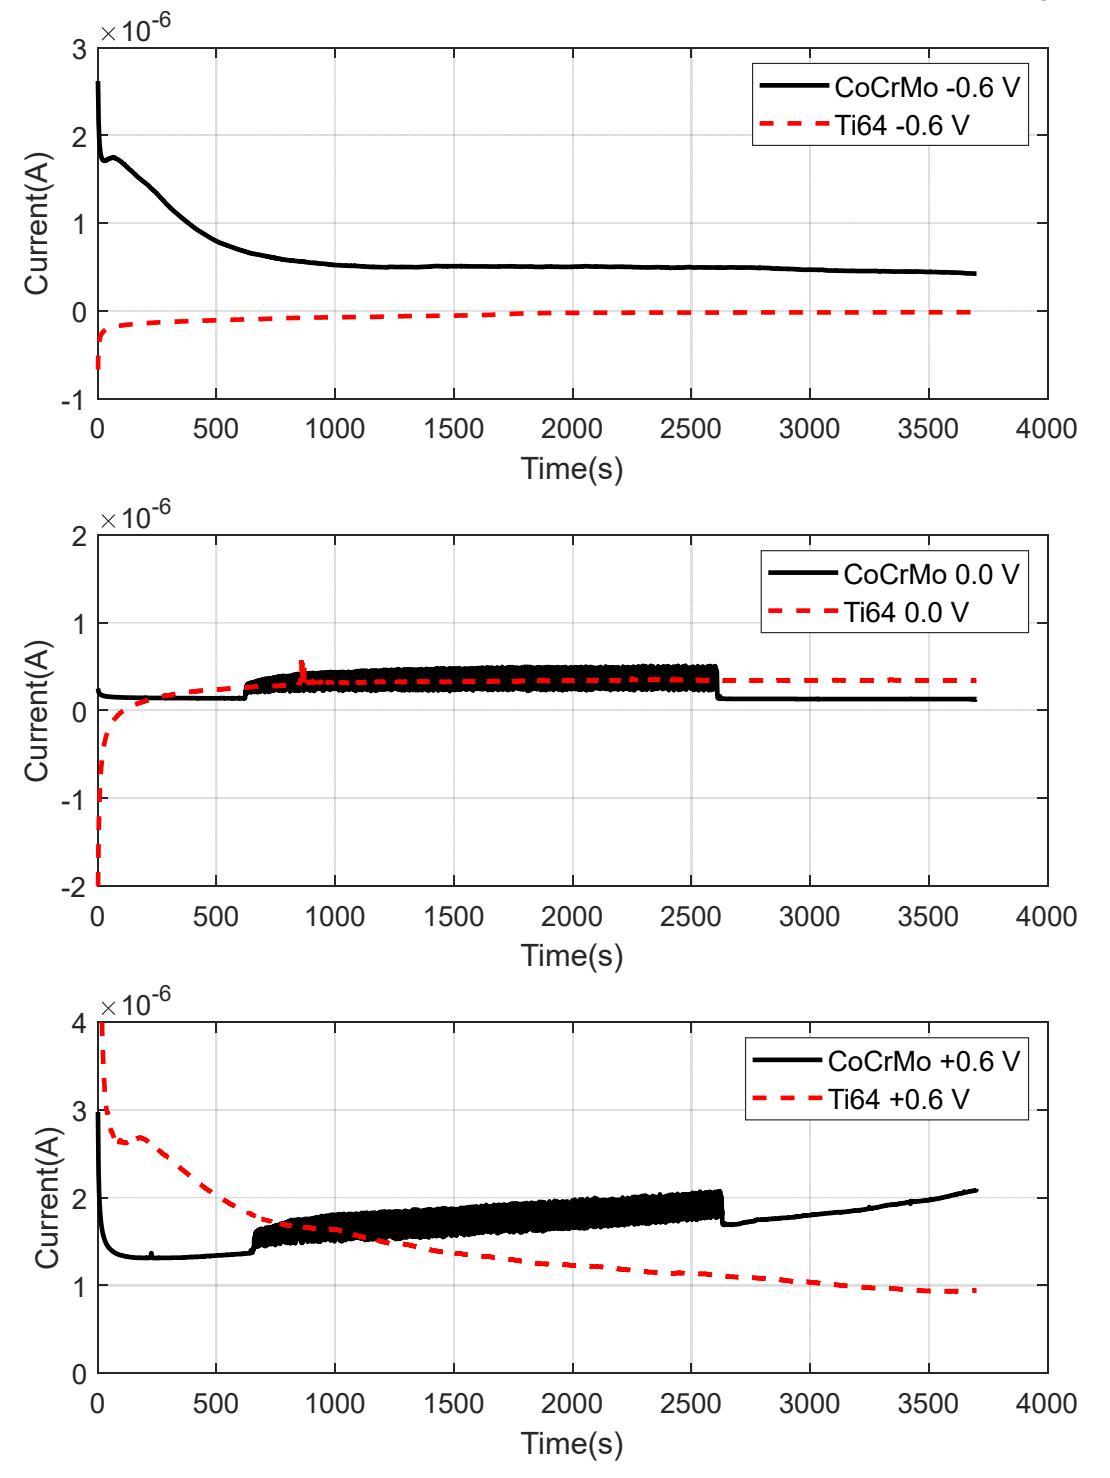
# Potentiostatic Polarization of CoCrMo and Ti6Al4V in Sodium Lactate pH 4

**Figure 15.** Fretting current changes through the disturbed areas by reciprocal sliding in in lactate pH 4 with applied potentials. Active surface areas of CoCrMo and Ti6Al4V are  $3.820 \times 10^4 \ \mu\text{m}^2$  and  $3.410 \times 10^4 \ \mu\text{m}^2$ , respectively after 1800 sliding cycles.
