# Article Sliding Corrosion Fatigue of Metallic Joint Implants: A Comparative Study of CoCrMo and Ti6Al4V in Simulated Synovial Environments

**Abstract:** Mechanical contact in a corrosive synovial environment leads to progressive surface damage at the modular interface of the joint implants. The wear debris and corrosion products degrade the synovial fluids and change the lubrication mechanisms at the joints. Consequently, the unstable joint lubrication and corrosion products will further induce the undesirable performance of the joint implants. In this study, the two major joint materials, CoCrMo and Ti6Al4V, were tested during the course of reciprocal sliding contact in simulated synovial liquids. Open circuit potential and coefficient of friction were monitored to describe electrochemical and mechanical responses. Potentiostatic test results illustrated electrochemical damage on both surfaces that modified oxidation chemistry on both surfaces. However, more significant modification of the CoCrMo surface was detected during wear in the simulated joint liquid. Even with a reduced coefficient of friction on the CoCrMo surface in sodium lactate environments, fretting current densi

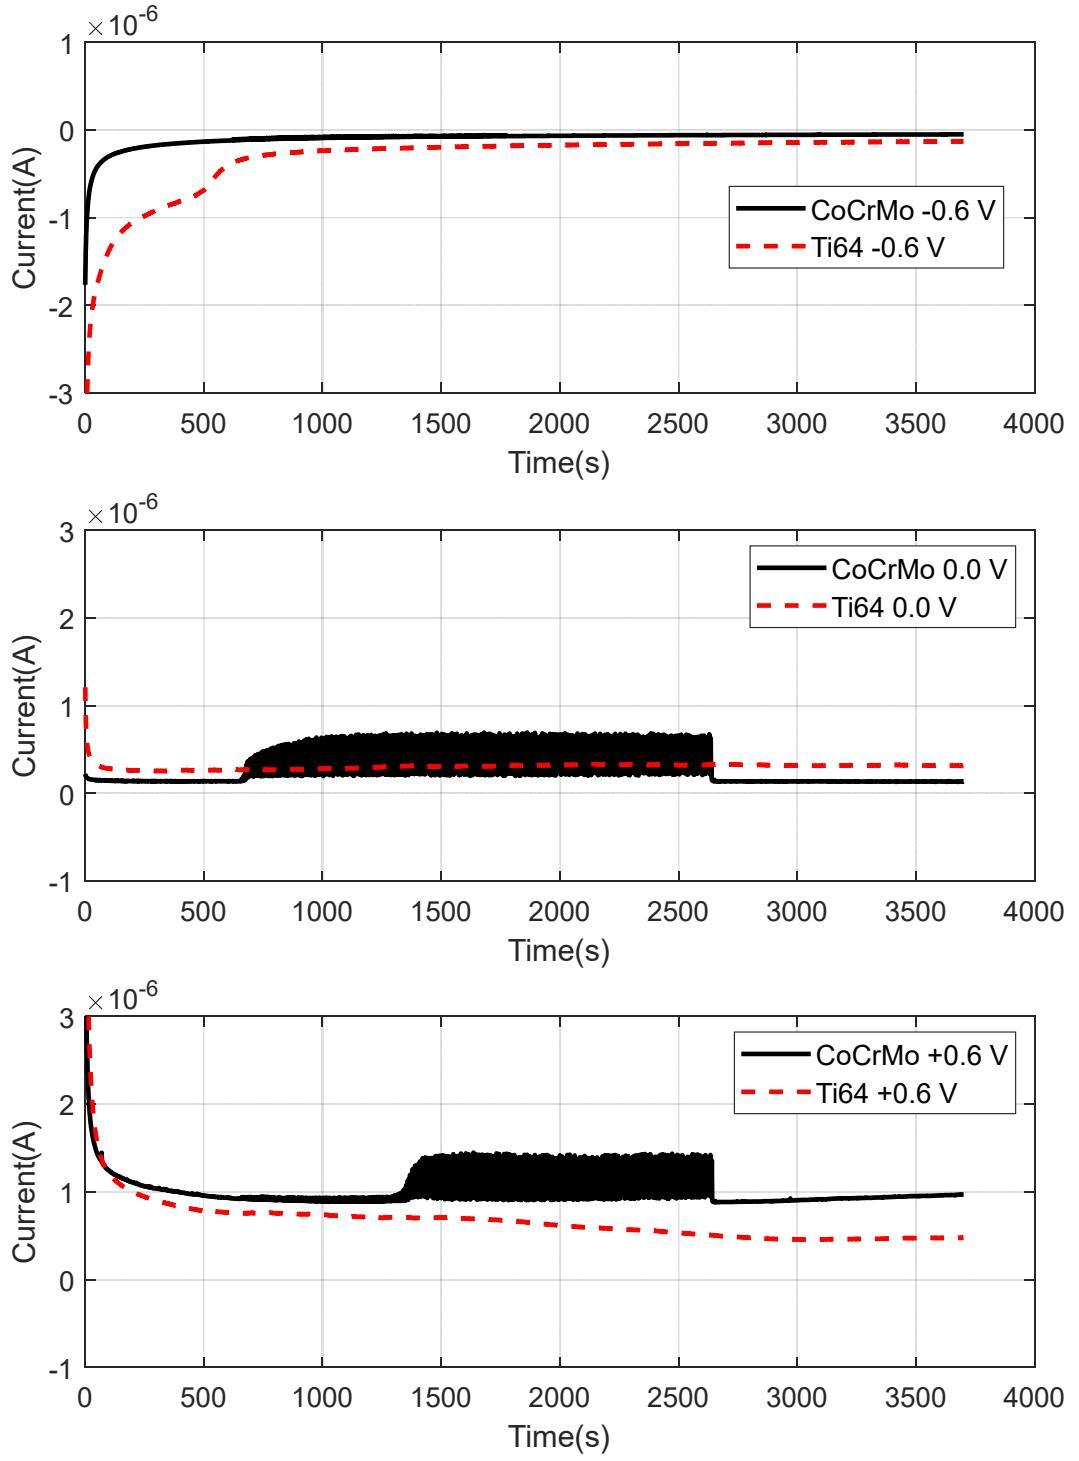
# Potentiostatic Polarization of CoCrMo and Ti6Al4V in Sodium Lactate pH 2

**Figure 16.** Fretting current changes through the disturbed areas by reciprocal sliding in in lactate pH 2 with applied potentials. Active surface areas of CoCrMo and Ti6Al4V are  $5.930 \times 10^4 \ \mu m^2$  and  $4.085 \times 10^4 \ \mu m^2$ , respectively after 1800 sliding cycles.

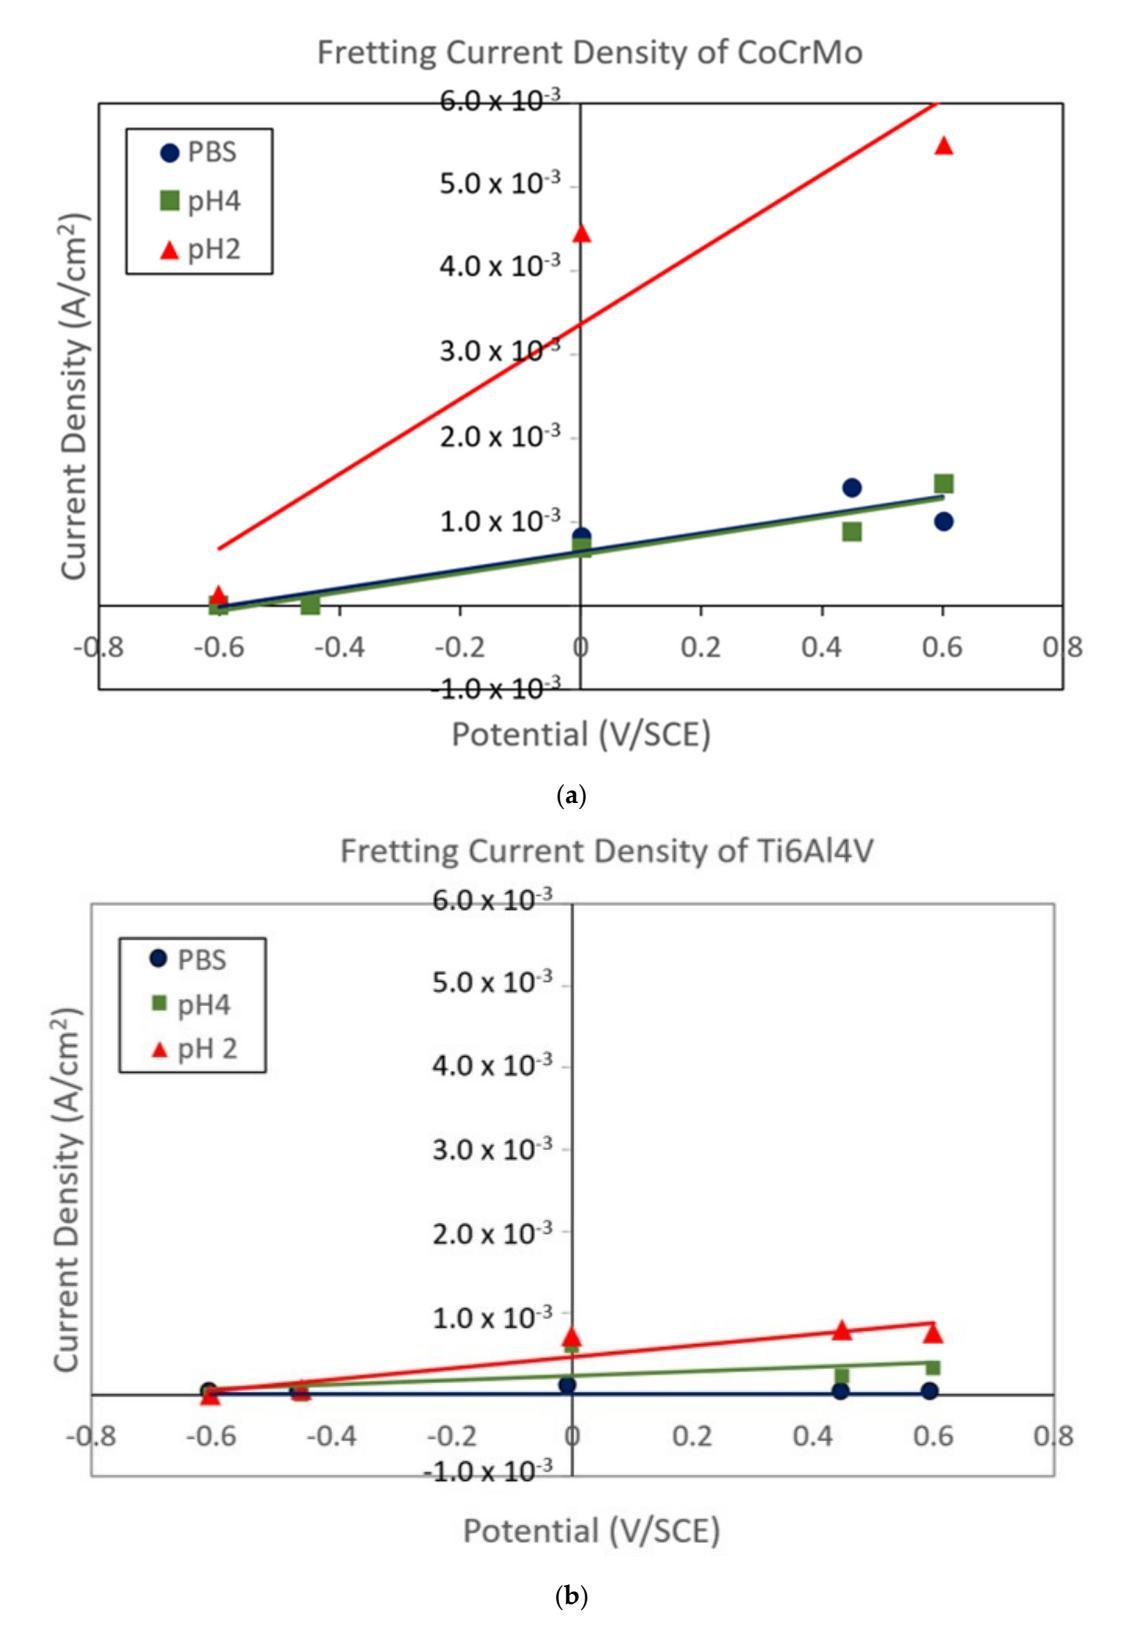
Figure 17. (a) Fretting current density on the CoCrMo surface with variable potentials applied.(b) Fretting current density on the Ti6Al4V surface with variable potentials applied.

The current signals were normalized by the contact damaged area. The wear damage areas were evaluated from the micro images taken after the sliding tests. The fretting current density is summarized in Figure 17a,b. It was evident that positive potential increased fretting corrosion damage, while negative potential suppressed fretting corrosion damage on the CoCrMo surfaces. This result illustrated a strong linear proportionality of

fretting current density with potentials. In particular, the CoCrMo's fretting current density drastically increased in the aggressive acidic lactate solution.

Fretting corrosion damage was not significant on the Ti6Al4V surfaces with all potentials. The overall fretting current density values of the Ti6Al4V were only in the range of 15~17% from fretting current density of the CoCrMo. The result illustrated a week linear proportionality of fretting current density with potentials on Ti6Al4V. Similarly, the fretting current density increased with acidity of the solutions. The results prove that the oxidation chemistry of titanium is not sensitive against electrochemical and mechanical stimuli. We conclude that Ti6Al4V implants would be more stable against tribocorrosion damage process.
