Development of a New PM Tool Steel for Optimization of Cold Working of Advanced High-Strength Steels

Abdulbaset Mussa^{1,*}, Pavel Krakhmalev¹, Aydın Şelte² and Jens Bergström¹

Abstract: In the present study, Uddeholm Vancron SuperClean cold work tool steel was investigated concerning wear resistance and fatigue strength, using laboratory and semi-industrial tests. The Uddeholm Vancron SuperClean was designed with the help of ThermoCalc calculations to contain a high amount of a carbonitride phase, which was suggested to improve tribological performance of this tool steel. In order to investigate the tested steel, galling tests with a slider-on flat-surface tribotester and semi-industrial punching tests were performed on an advanced high-strength steel, CP1180HD. Uddeholm Vanadis 8 SuperClean containing only a carbide phase and Uddeholm Vancron 40 containing a mixture of carbides and carbonitrides were also tested to compare the performance of the tool steels. The microstructure and wear mechanisms were characterized with scanning electron microscopy. It was found that the carbonitrides presented in Uddeholm Vancron SuperClean improved its resistance to material transfer and gall

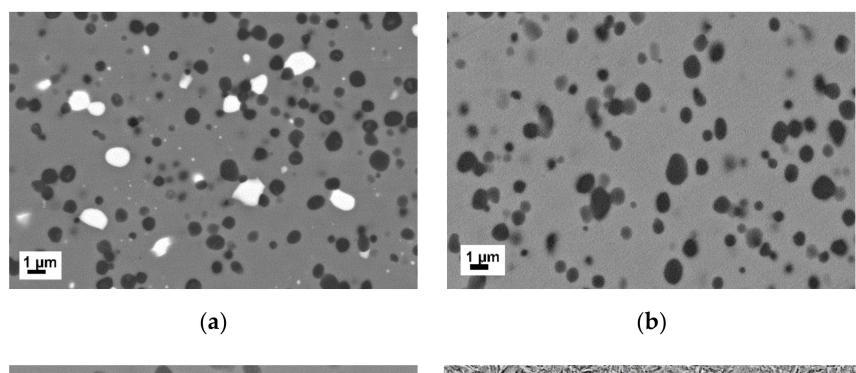
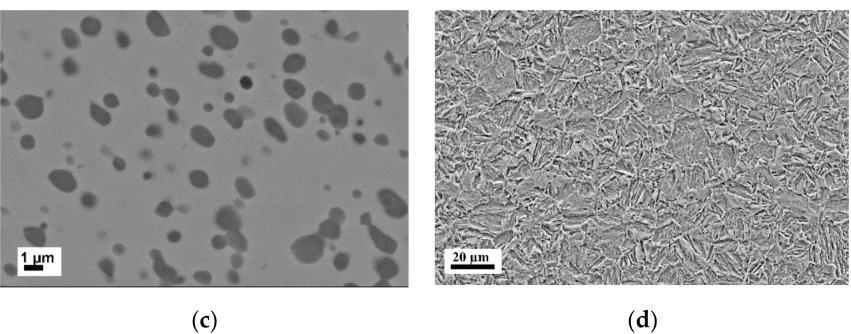
Figure 1. The tested tool steels' microstructure and sheet microstructure, (a) V40, (b) VSC, (c) V8SC and (d) CP1180HD.

The microstructure of the tested tool steels together with their chemical compositions are presented in Figure 1 and Table 2, respectively. The microstructure of PM tool steels contains a fine and evenly distributed hard phase in a relatively tougher matrix of tempered martensite. V40 contains M_6C carbides, the bright phase, and VCN carbonitrides, the dark phase, as shown in Figure 1a. VSC contained only VCN carbonitrides (Figure 1b), while V8SC had VC carbides as the hard phase (Figure 1c).

An AHSS grade, CP1180HD, was utilized to evaluate the galling, wear and fatigue characteristics of the tool steel. The CP1180HD had a complex phase structure containing a fine microstructure of martensite, ferrite and bainite, as shown in Figure 1d. A limited amount of retained austenite of up to 5–15% is also common in its microstructure [22]. The chemical compositions and mechanical properties of the sheet material are presented in Table 3.

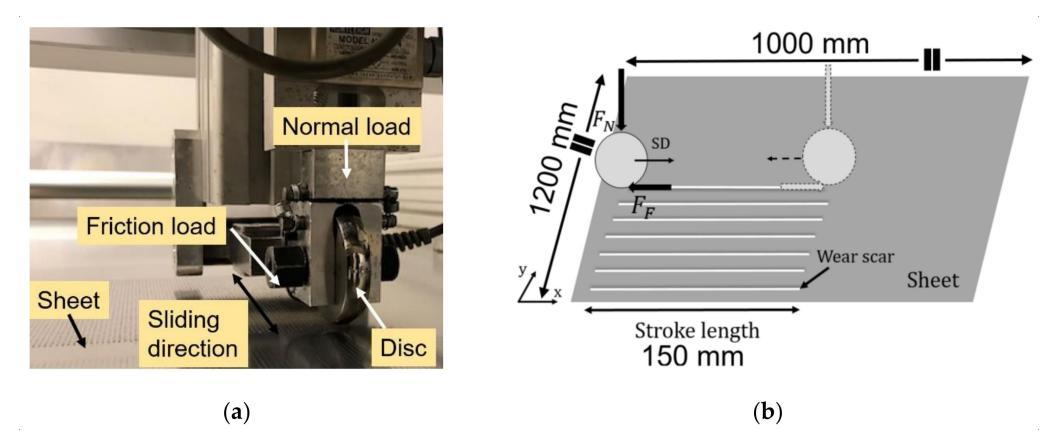
Figure 2. (a) Slider-on-flat-surface (SOFS) tribotester and (b) schematic of the performed tests by SOFS. F_N stands for a normal load, F_F stands for friction force and SD indicates sliding direction.

SOFS tribotester has been used successfully for the simulation of wear in sheet metal forming and to rank the galling resistance of tool steels in sliding contact [2,6,7]. It involves sliding of a disc, made of tool steel, under the action of a normal load against a fixed flat surface (Figure 2a). The discs used in the present study had a thickness of 10 mm and major and minor diameters of 50 mm and 20 mm, respectively. The flat surfaces used as the counterface were sheets of CP1180HD with dimensions of 1200 mm \times 1000 mm \times 2 mm.

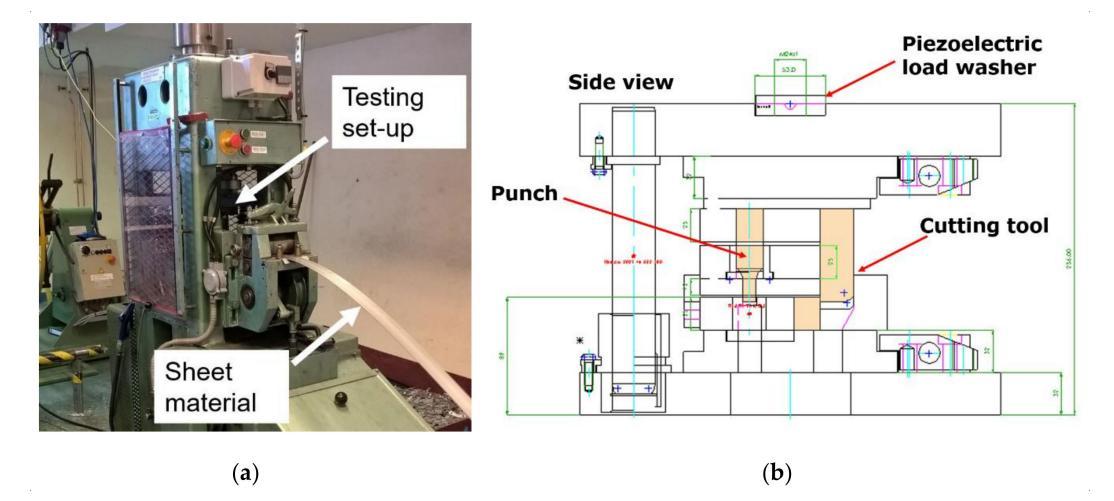
Figure 3. Semi-industrial punching test set-up: (**a**) Uddeholm's 15 ton punching test rig and (**b**) a schematic view of the testing set-up.

The wear characteristics of the tools steels were investigated by performing semi-industrial punching tests on CP1180HD sheets. The punching tests were carried out at Uddeholm AB's laboratory, with a 15,000 kg four-pillar eccentric press, ESSATM, as shown in Figure 3a. The eccentric press was equipped with tooling sets for both punching and trimming operations, as displayed in Figure 3b. These two operations can be performed either separately or simultaneously. Note, in the present work, only the punching operation on sheet metal was carried out. The punches used in the present study were cylindrical with a diameter of 9.8 mm and with a polyurethane ejector mounted at the top of the punches, as shown in Figure 4b. The ejector was used to avoid the adherent of the blanks to the top surface of punches. The tested punches were ground to a surface roughness between 0.15–0.2 μ m with grinding direction parallel to the cutting edge of the punches. The punches' cutting edge was carefully rounded with a SiC P1200 to a radius of 30–40 μ m using a lathe.

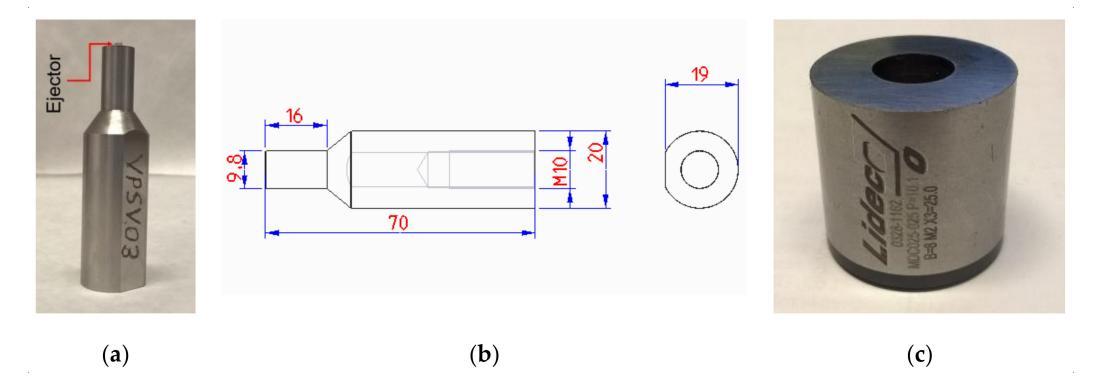
Figure 4. Images of the representative test punches and dies: (**a**) punch, (**b**) drawing of the tested punches, and (**c**) die.

Standard dies of MDC025-025, manufactured by LIDECO in Dalstorp in Sweden, with a die clearance of 0.15 mm (Figure 4c) were selected in the present study. Before the punching tests, the roughness of the punches and the radius of the cutting edges were evaluated and verified by a confocal microscope. The punching tests were performed at a stroke rate of 165 strokes/min. The sheet material used for the punching tests had a thickness of 1.5 mm and a width of 50 mm. The punching tests were stopped after 100,000 strokes. This number of strokes was selected based on the previous experimental tests that are sufficient to produce detectable surface damage on the tested punches.

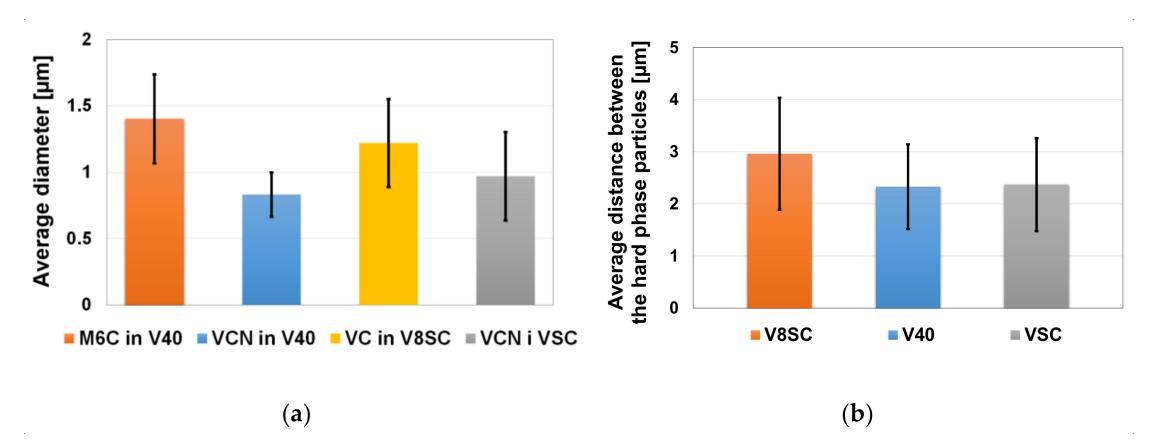
Figure 5. Measurements of the hard phase presented in the tool steel matrices: (**a**) the average diameter of the particles and (**b**) the average distance between the hard phase particles.

To understand the significance of the microstructure on galling and wear characteristics of the tested tool steels, the average diameter of the hard phases presented in each tool steel and the average distance between the particles were analyzed. SEM was used to measure the diameter of the hard phase particles. For each tool steel grade, two samples were used, and on each sample, a diameter of 30 particles was measured. Later, the average diameter of the hard phase particles was calculated. The measurements were taken in different locations on the sample to obtain an accurate average diameter for the particles. The average distances between the hard phase particles were also calculated by measuring the distance between 50 adjacent particles for each sample. It was found that the largest particles were presented in V40, and they were M_6C with an average diameter of 1.4 µm. The smallest particles were VCN in V40 with an average diameter of 0.81 µm. The second largest particles were VC presented in V8SC with an average diameter of 1.21 µm, and the carbonitride hard phase particles particles hard phase particles were VC presented in VSC had an average diameter of 0.9 µm, as shown in Figure 5a.

The shortest average distance between the hard phase particles was found in V40 matrix with a mean distance of 2.33 μ m. The second shortest distance was presented in the VSC matrix with an average distance of 2.37 μ m, whereas the longest distance was found in the V8SC matrix with 2.96 μ m (Figure 5b).

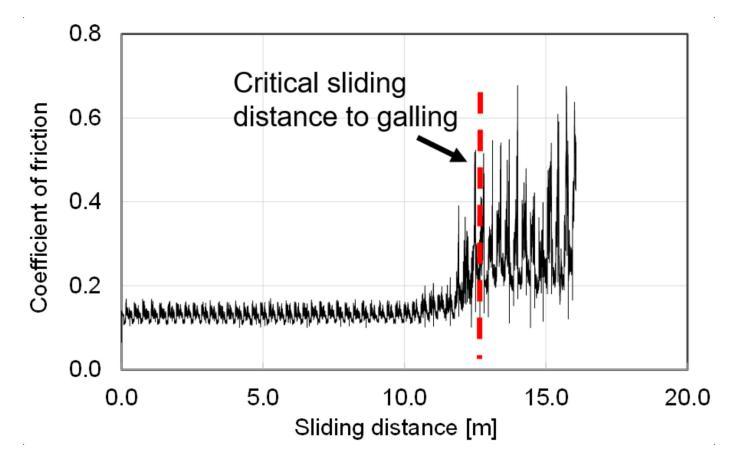
Figure 6. The coefficient of friction (COF) as a function of sliding distance for V40 tested against CP1180HD at 60 N (860 MPa).

The galling tendency of the tested tool steels was investigated by using the COF as an indicator of the galling occurrence. The COF for each test was monitored as a function of the sliding distance. It was observed that the COF for all tests started with a low and a stable value <0.2. During further sliding it increased to a higher value >0.5 with an instable behavior, as shown in Figure 6. The increase in COF to high and unstable values was considered as the occurrence of galling. Changes in friction were associated with extensive material transfer, i.e., galling phenomena. The sliding distance required for the tool steel to reach galling initiation was considered as the critical sliding distance, and it was measured from the COF curves. Furthermore, the critical sliding distance for each test was plotted against the test maximum contact pressure.

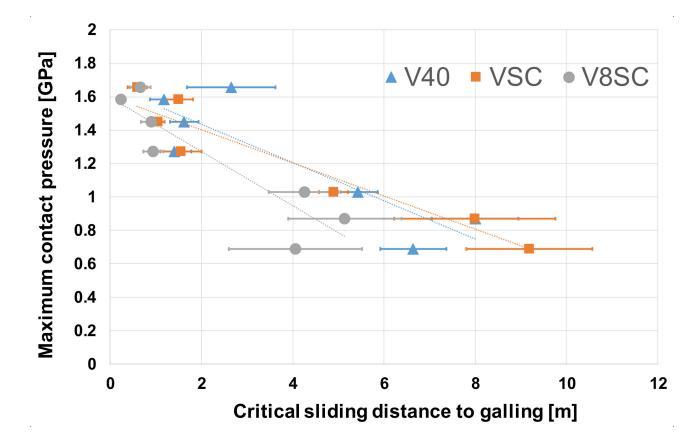
Figure 7. The summary of the galling tests for the tested tool steels.

The summary of the galling tests is presented in Figure 7. The galling tests showed that for all the three tool steels, galling resistance decreased with the increased contact pressure. The trend was noticeable despite the tool steel grade. However, for the tests performed at the same contact pressure, it was found that the critical sliding distance to galling was dependent on the grade of the tool steel. From the galling diagram, it was observed that V40 and VSC showed better galling resistance than

V8SC. This behavior was more pronounced at lower contact pressures (Figure 7). With increased contact pressure, it was observed that V8SC still had the shortest critical sliding distance to galling. Nevertheless, at higher contact pressures, the critical sliding distance for all the three tested tool steels decreased, and, therefore, the trend of better galling resistance of V40 and VSC was less noticeable.

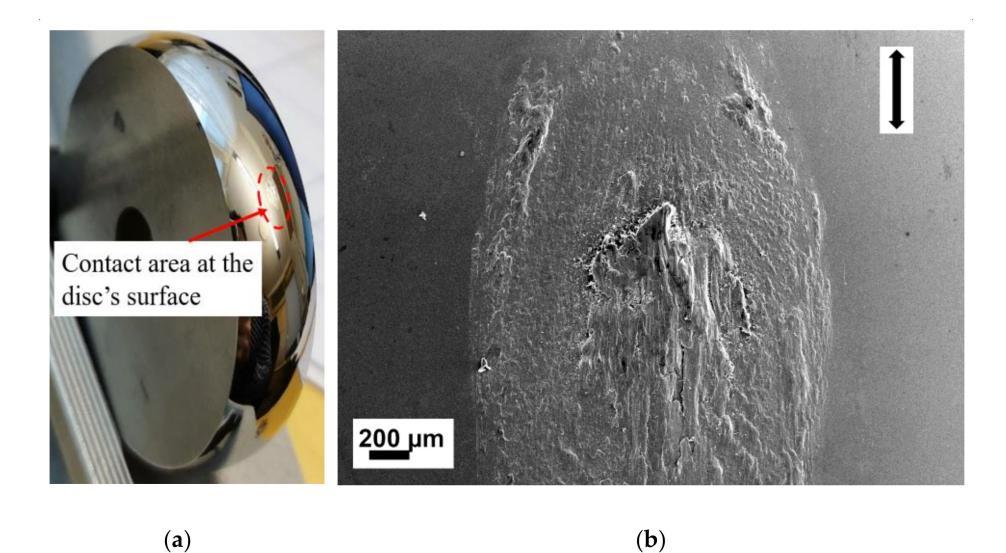
Figure 8. The typical worn surface of the discs after the occurrence of galling: (**a**) image of the disc and (**b**) SEM image of the contact area.

of great interest to run wear tests to a predetermined sliding distance without stopping the tests, even when galling has occurred. It enables the comparison of wear mechanisms of the tool steels tested under similar contact conditions. The results from the wear tests revealed that wear mechanisms were dependent on the type of material and on the contact pressures. At low contact pressures, it was found that the worn surface was plastically deformed as a result of shear stresses generated during contact. In addition, the worn surface was covered by transferred material from the sheets. Additionally, it is believed that sheet material continuously transfers to the tool surface during sliding contact. Depending on the strength of the interface between the transferred material and the tool surface, the transferred material might stick and accumulate during contact, resulting in a high amount of material pick-ups, or, in the case of a weak interface, the transferred material can detach from the tool surface. It might also lead to a situation where tool material together with transferred material is removed from the tool surface due to adhesive wear. The worn surface of the tested tools consisted in regions where the worn surface was totally covered by adhered material and regions with less amounts of adhered material, and, in such regions, other wear mechanisms like abrasive scratches at the tool worn surface were observed, as shown in Figure 8.

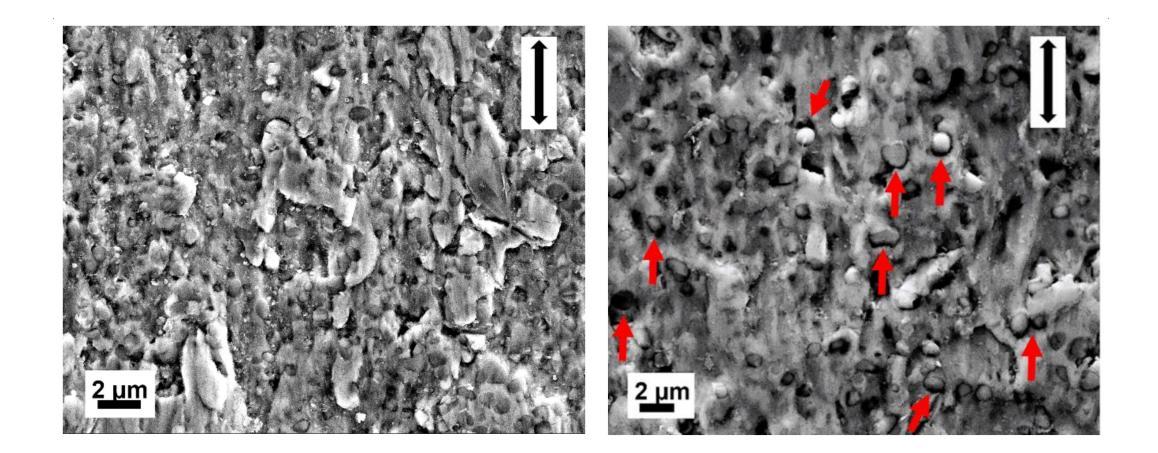
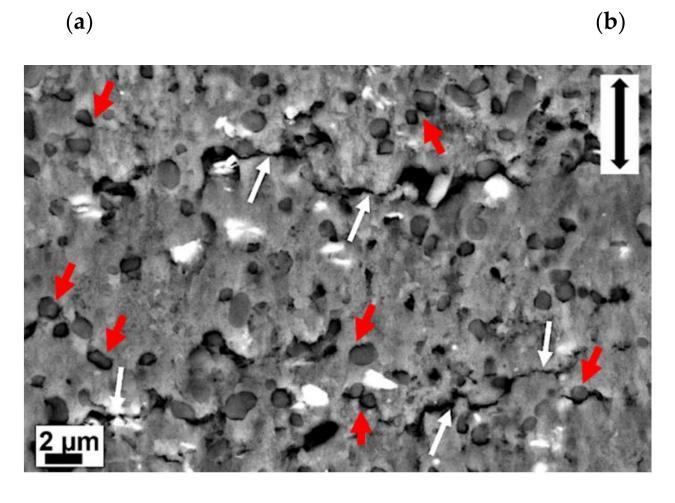
Figure 9. The worn surface of the discs tested against CP1180HD at 500 N (1.65 MPa) and 450 strokes: (a) VSC, (b) V8SC and (c) V40. White arrows indicate the fatigue cracks, and red arrows indicate the hard phase detachment.

SEM investigations carried out at higher magnification revealed wear mechanisms at the micro-scale. Depending on the contact pressure of the tests, the development of surface damage was observed. For the discs tested at contact pressures below 1 GPa, the worn surface of the tested tool steel was sheared, and adhesive wear was the dominating wear mechanism. The partial detachment of hard phase particles from the steel matrix was observed. The minor detachment of carbides from the tool steel matrix was observed for V40 and V8SC tool steels. As the testing contact pressure increased, the surface material was sheared more severely, and adhesive wear was observed for all the tested steels. Additionally, some particle detachment was revealed, and the severity of this wear mechanism depended on the tool steel grade. For VSC and at high contact pressures, the dominant wear mechanism was adhesive wear with a minor detachment of carbonitride particles from the matrix, as shown in Figure 9a. For V8SC, the partial and fully detachment of the hard phase particles was easily detected, as displayed in Figure 9b. The V40 steel was worn the most, and full detachment of the VCN presented in V40 was found at the worn surface. Moreover, it was observed that the M_6C particles at the worn surface were fractured into smaller pieces. Besides detachment and fracture of the hard phase in V40, micro-fatigue and cracks were observed at the worn surface. These cracks were propagated perpendicular to the sliding direction, as shown in Figure 9c.

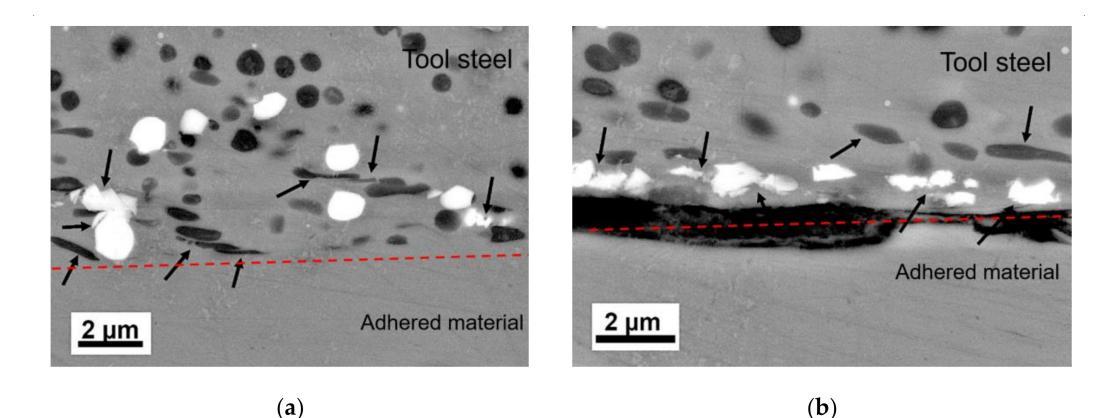
Figure 10. SEM images of the cross-section of the worn tools tested at 500 N (1.65 MPa) and 450 strokes against CP1180HD sheet: (a) V40, (b) V40, (c) VSC and (d) V8SC. Arrows indicate the deformed and fractured hard phase particles.

M6C particles at and beneath the worn surface were fractured into smaller particles. In contrast, the VCN particles were found to be elongated along the sliding direction, as shown in Figure 10a,b. Contrarily, the hard phases presented in VSC and V8SC did not change in shape even after sliding at high contact pressures. The VCN in VSC and VC in V8SC did not show any evidence of fracture or plastic deformation like those observed in the V40. Fatigue cracks formed during sliding contact were also observed when the cross-sections of VSC and V8SC were investigated. However, the cracks were found to be formed at the interface between the tool surface and the adhered material. The propagation of the cracks was found to be in the transferred material, as shown in Figure 10c,d.

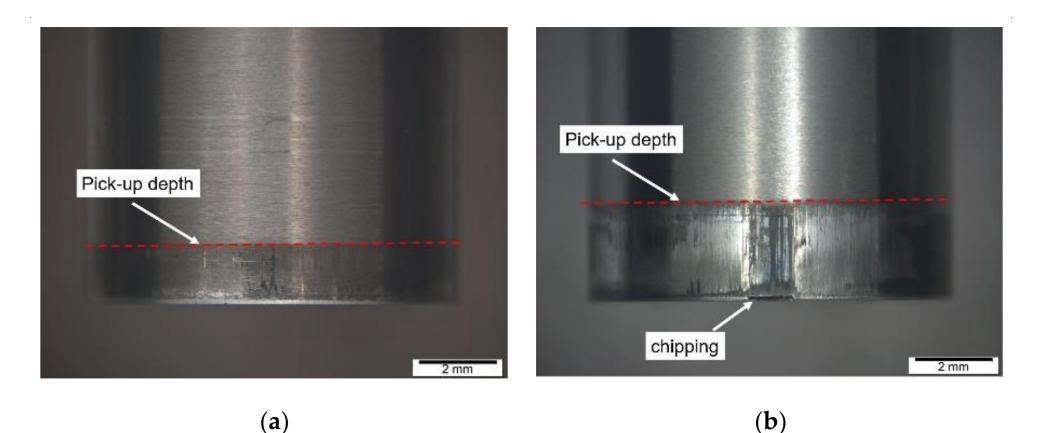
Figure 11. Worn punches after 100,000 strokes against CP1180HD: (a) VSC punch and (b) V8SC punch.

respect to the punching direction while increasing the number of punching strokes. Therefore, the more pick-up gave a larger depth at the punch surface. In addition to the material transfer, other damage mechanisms such as fatigue cracks and chipping were observed. The fatigue cracks were associated with chipped tool steel material from the punch cutting edge. However, the chipping phenomenon was only observed on tested punches made of V8SC tool steel. Chipping results in geometrical changes of the contact between the sheet and the punch, and it limits the punch performance during the forming process. At the cutting edges where macro chipping was observed, the extensive material pick-up was not found compared to the location where no chipping was observed, as demonstrated in Figure 11b.

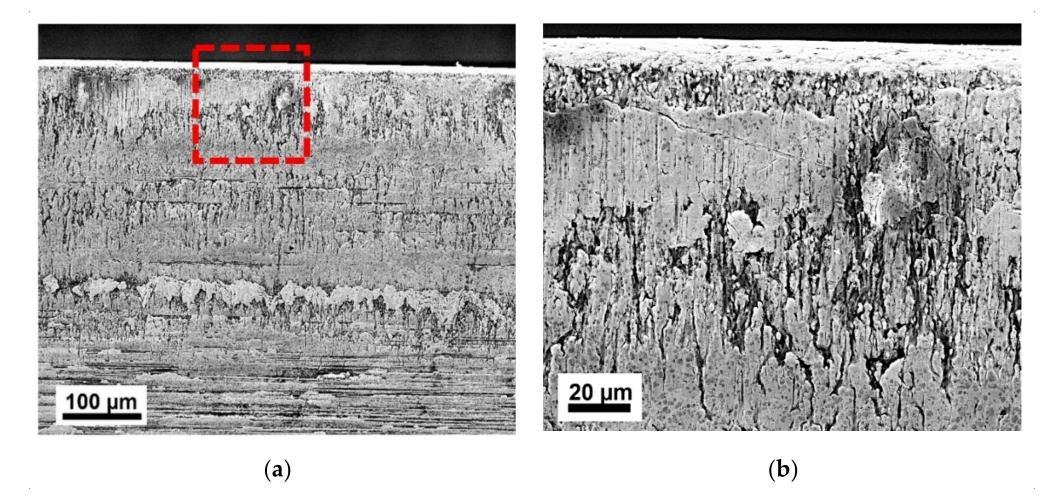
Figure 12. (a) Worn surface of the VSC punch and (b) a higher magnification of the cutting edge.

VSC punches made the 100,000 strokes without any detectable chipping, and, thus, it was further investigated at high magnification by SEM. It was found that almost all grinding marks were removed from the punch surface after the contact with the sheet material (Figure 12a). Picked up material was observed at the side surface. Moreover, it was observed that tool material was removed from the cutting edge and the side surface of the punches due to adhesive wear (Figure 12b). Micro-scratches due to abrasive wear were also observed at the worn surface of the punch. The abrasive scratches were parallel to the punching direction and occurred mainly in the matrix material around the hard phase particles (Figure 12b). The cutting edge for the VSC punches was less worn and without any chipping throughout the entire test duration of 100,000 strokes. VSC punches were further evaluated by the 3D profilometer. It was found that a certain rounding of the cutting edge had occurred after 100,000 strokes. A comparison of the initial cutting edge and worn cutting edge shape of punches made by the VSC punches is illustrated in Figure 13a,b. The edge rounding of worn punches is associated with plastic deformation of the edge material, and micro-abrasive wear occurred during punching.

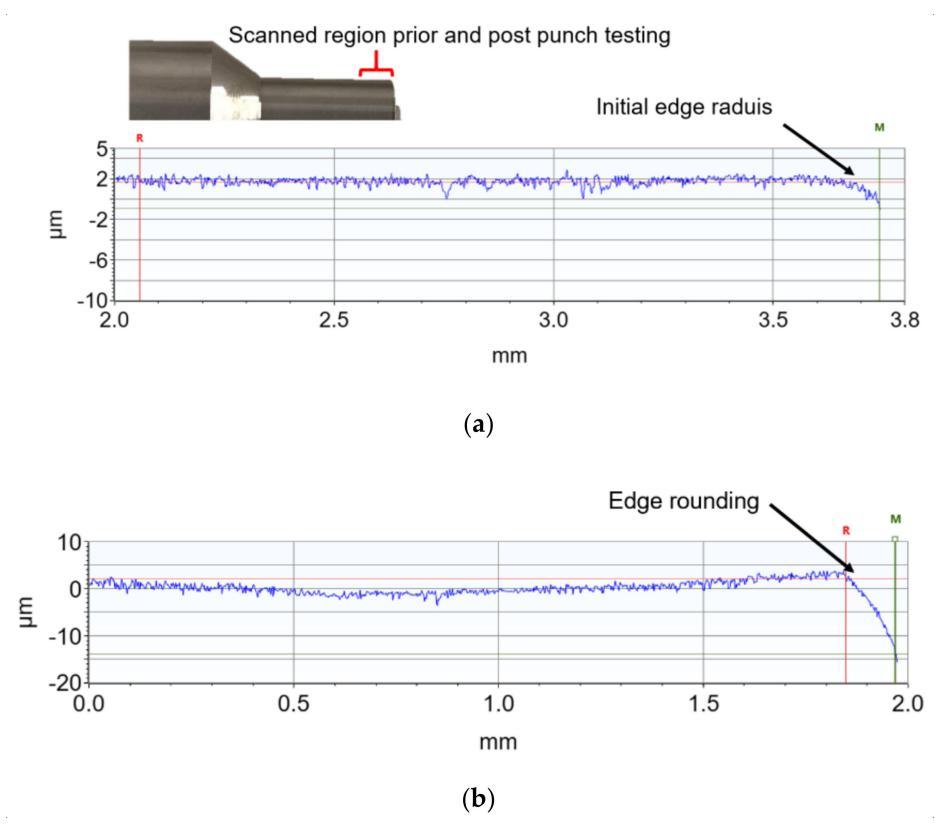
Figure 13. 3D profilometer analysis of the VSC punch: (**a**) unworn prior to punching testing and (**b**) worn punch after 100,000 strokes.
