# Stress Corrosion Cracking in an Extruded Cu-Free Al-Zn-Mg Alloy

**Abstract:** Stress corrosion cracking (SCC) in Cu-free Al-Zn-Mg (7xxx) aluminium alloys limits its use in many applications. In this work, we study in detail the microstructure of a peak and slightly overaged condition in an AA7003 alloy using transmission- and scanning electron microscopy in order to provide a comprehensive understanding of the microstructural features related to SCC. The SCC properties have been assessed using the double cantilever beam method and slow strain rate tensile tests. Grain boundary particles, precipitate free zones, and matrix precipitates have been studied. A difference in the SCC properties is established between the two ageing conditions. The dominating difference is the size and orientation of the hardening phases. Possible explanations correlating the microstructure and SCC properties are discussed.

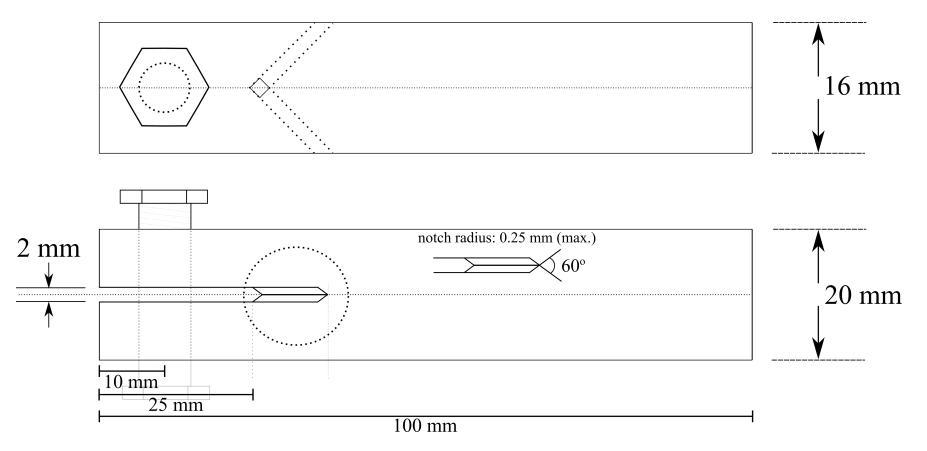
Figure 1. Schematic drawing of the DCB specimens used in this work.

where  $\Delta$ , *E*, *h*, and *a* are the deflection at the load point, elastic modulus (70 GPa), half the specimen height, and the crack length measured from the load point, respectively. An initial bolt loading to 25 MPa $\sqrt{m}$  was applied. The crack tip was kept wet by dripping a few drops of 3.5 wt.% NaCl solution once per day, for a total duration of 1500 h. The crack evolution was measured using an optical microscope. Crack velocity in the stress independent 'region II (plateau)' [4], was interpolated to obtain a mean value with corresponding standard deviation. The SCC threshold stress intensities, K<sub>ISCC</sub>, were determined from the data points with the lowest crack velocity and K<sub>I</sub> value, and represented in a similar manner. In order to study the fracture surfaces, the specimens were cooled in liquid nitrogen and pulled apart using rapid tensile overload. Three parallels for each condition were measured.

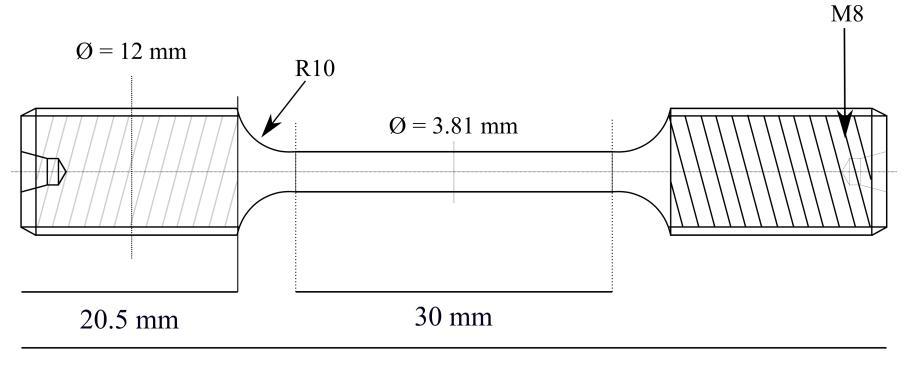
Figure 2. Schematic drawing of the round tensile specimens used for slow strain rate testing.

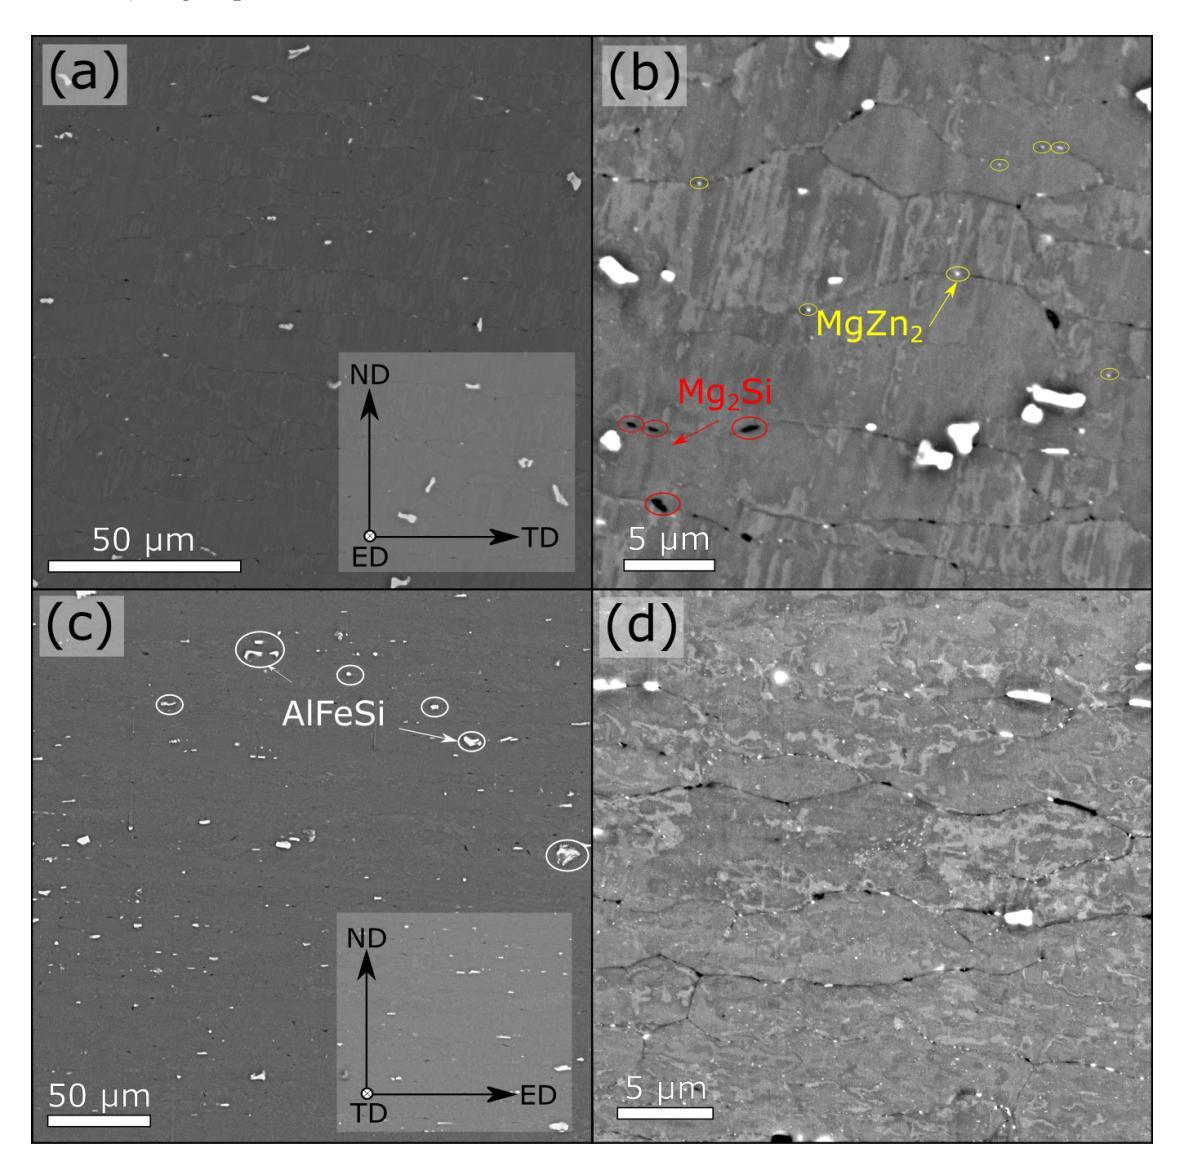
**Figure 3.** Representative BSE-SEM images from sample H-AC-T6, acquired both parallel (**a**,**b**) and normal (**c**,**d**) to the extrusion direction. Large Al-Fe-Si containing primary particles can be seen in (**a**,**c**), and tiny  $\eta$ -MgZn<sub>2</sub> particles are visible on the grain boundaries in (**b**,**d**). The black regions on the grain boundaries in (**b**,**d**), are  $\beta$ -Mg<sub>2</sub>Si particles, which are only present in air-cooled samples.

Representative BSE-SEM images at two different magnifications are shown in Figure 3. The images are acquired both parallel (Figure 3a,b) and normal (Figure 3c,d) to the extrusion direction. The large particles visible in the low-magnification images in Figure 3a,c, are primary particles composed of Al-Fe-Si. In Figure 3b,d, the grain structure is visible, with presence of very small high-intensity particles (<0.5 µm). These are likely to be the  $\eta$ -MgZn<sub>2</sub>, due to their bright contrast, as will be confirmed later using TEM. The images are from the H-AC-T6 condition. In all air-cooled conditions,  $\beta$ -Mg<sub>2</sub>Si particles are also present on grain boundaries, visible as dark regions in Figure 3b,d. This is the only observable difference between the water-quenched and air-cooled samples. No variation in grain boundary particle size or distribution, between the T6 and T7 tempers, could be established using SEM. The low-Si alloy appears similar to the high-Si alloy, but is expected to contain a lower fraction of  $\beta$ -Mg<sub>2</sub>Si particles in the air-cooled conditions.

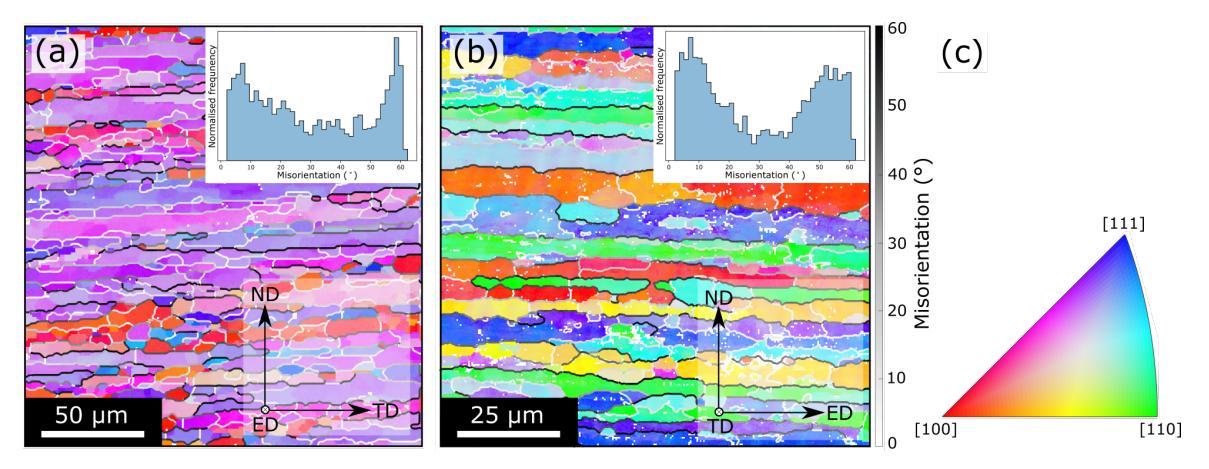
**Figure 4.** Representative EBSD images acquired along two different directions in (**a**,**b**). The inset shows the grain boundary misorientation angle vs. frequency. The grains are coloured according to the colour scheme in (**c**). Grain boundary misorientations are colour coded according to the scale in (**b**).

EBSD images acquired along two different orientations are shown in Figure 4. The grains in Figure 4a,b are coloured according to the colour map in Figure 4c, and the grain boundary misorientations are coloured according to the scale in Figure 4b. Figure 4a shows the cross-section of the extrusion direction (ED), where most of the grains are oriented close to either the  $[111]_{Al}$  or  $[100]_{Al}$  directions. Large amounts of low-angle grain boundaries are found between grains with close to similar orientation, and high-angle grain boundaries are present between grains with dissimilar orientations. Most of the grain boundaries are aligned nearly parallel with the transverse direction (TD). In Figure 4b, the cross-section of the TD is shown. A typical extrusion texture is visible, where large fibrous grains are aligned parallel to the extrusion direction and separated by high-angle grain boundaries. Within the grains, there are mostly low-angle grain boundaries. Additionally, very low-angle (< 2°) sub-grain boundaries are present and distinguished by variations in colour within each grain. Both EBSD images are from the H-WQ-T6 condition and it is representative of all conditions of this study.

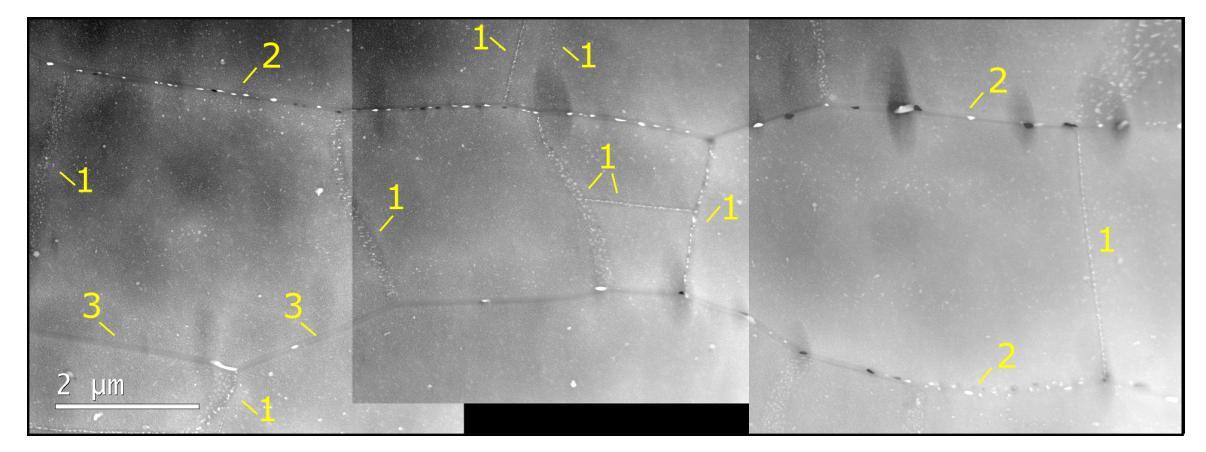
**Figure 5.** HAADF-STEM image showing the typical microstructure found in TEM. Three distinct types of grain boundaries are observed. (1) Low-angle ( $< 2^{\circ}$ ) sub-grain boundaries with high number densities of particles. (2) Grain boundaries with fewer, but larger particles, and (3) grain boundaries with no or very few particles. The image is acquired parallel to the extrusion direction for sample H-AC-T7. Similar observations were made in all conditions.

Three distinct grain boundary 'types' were observed in all conditions and are shown in the HAADF-STEM images acquired parallel with the extrusion direction in sample H-AC-T7 in Figure 5. Type 1 are sub-grain boundaries with <2° in misorientation, and they are clearly distinguishable by their high density of small particles likely to have formed due to preferential nucleation on dislocations. Type 2 and 3 grain boundaries are not distinguished by misorientation angle, but rather by the presence of particles or not. Type 2 contains precipitated particles, which are larger than those found on the sub-grain boundaries, while type 3 has very few or no particles present. The size of 40–60 grain boundary particles, in both type 1 and type 2 grain boundaries, was measured for two conditions, and is presented in Table 2. The average value of the particle size increases slightly in the T7 condition as compared to the T6 condition. However, there are large variations in the measured data that are manifested in the standard deviations. Large scatter in particle sizes and densities are found within the same material, and even along the same grain boundary segment. This is likely related to the particles nucleation plane and/or coherency of the adjacent grains.

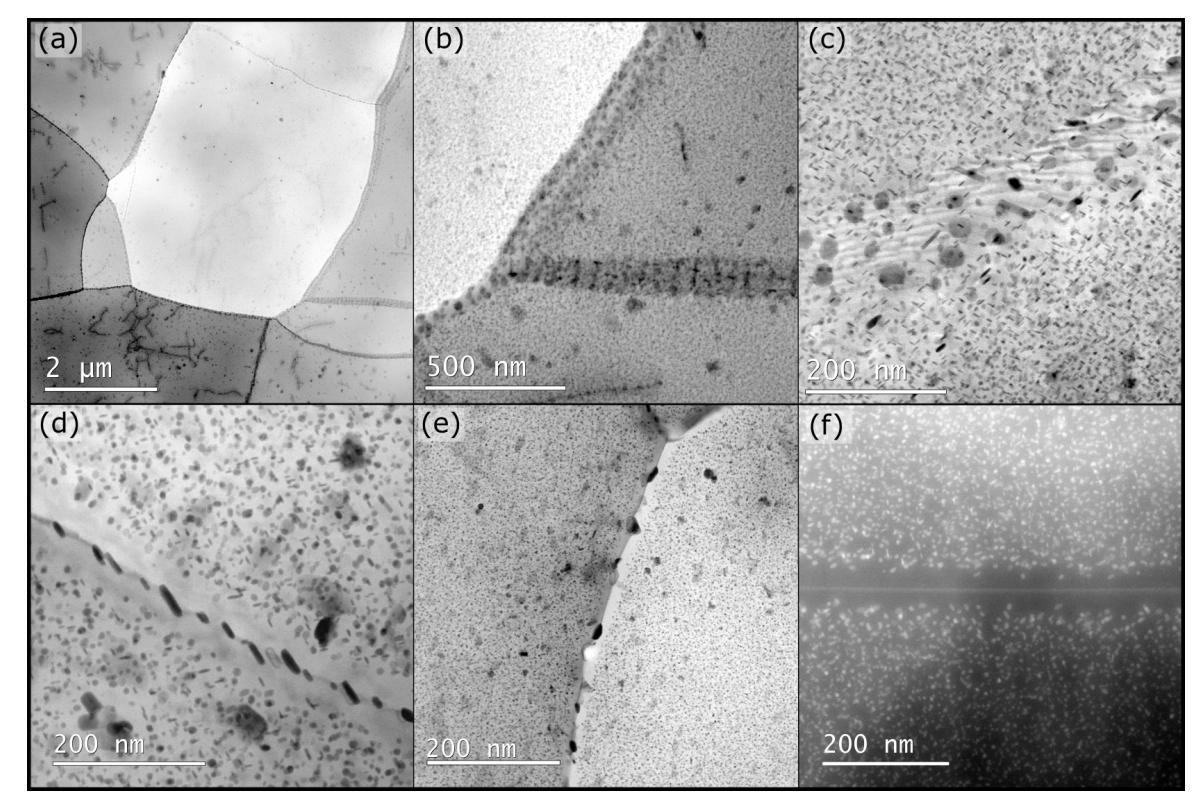
**Figure 6.** BF-STEM images of a cell structure consisting of sub-grain boundaries (type 1) with high density of grain boundary particles in (**a**–**c**). (**d**,**e**) shows two type 2 grain boundaries with particles of different size, shape and distance between. (**f**) is a HAADF-STEM image of a type 3 grain boundary, where no particles are present and the PFZs are clearly visible. (**c**) is acquired in sample H-AC-T6, while the rest is from H-WQ-T6, all obtained parallel to the extrusion direction. The particles are the MgZn<sub>2</sub> phase.

A typical cell structure with high density of MgZn<sub>2</sub> grain boundary particles is shown in Figure 6a–c. These bright-field (BF)-STEM images were acquired viewing perpendicular to the extrusion direction for sample H-WQ-T6. In Figure 6c, the grain boundary particles are seen from different projections and demonstrate their puck-like shape. Type 2 grain boundaries with particles of different size and morphology are shown in the two BF-STEM images in Figure 6d,e. In Figure 6d, the long axes of the particles are aligned in the same direction and show a similar strong diffraction contrast. This indicates that they are all nucleated relative to one of the grains. In Figure 6e, the particles appear more randomly oriented. Figure 6f shows a HAADF-STEM image of a type 3 grain boundary with no particles present. Similar observations were made in all the conditions studied in this work.

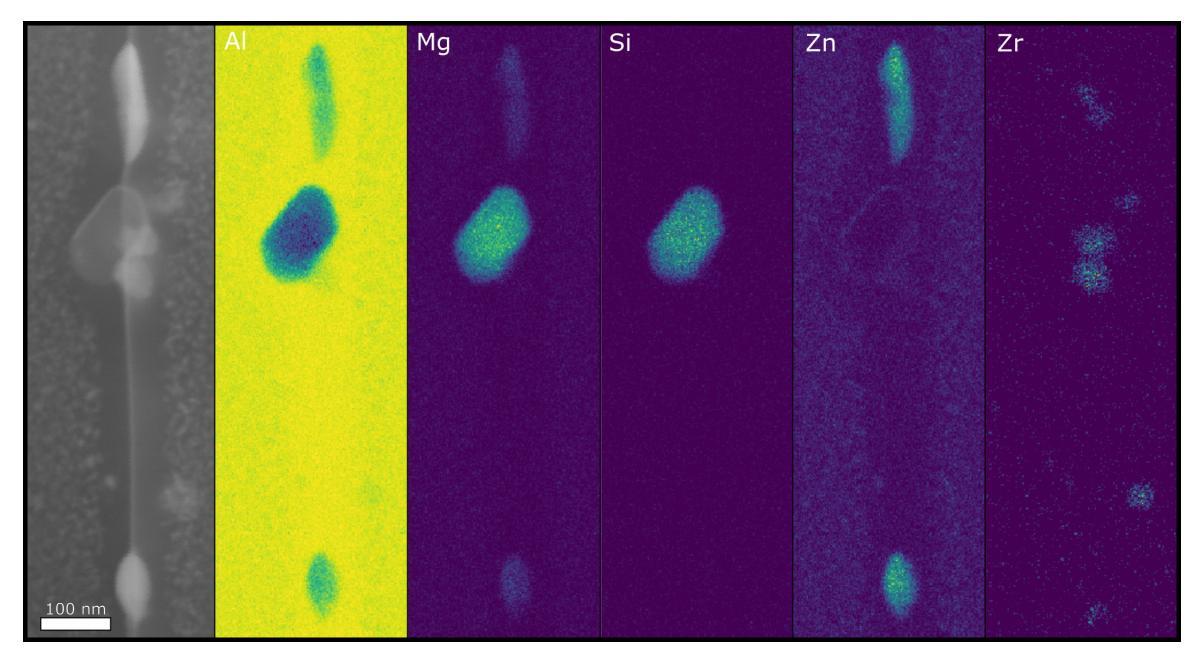
**Figure 7.** A HAADF-STEM image and corresponding EDS maps from a grain boundary in the sample H-AC-T6. Both MgZn<sub>2</sub> and  $\beta$ -Mg<sub>2</sub>Si particles are present if the material has been air-cooled from SHT. Al<sub>3</sub>Zr dispersoids are also found in connection with this grain boundary.

In addition, there are  $\beta$ -Mg<sub>2</sub>Si particles present along grain boundaries for the air-cooled conditions. An example is shown in Figure 7, where a Mg<sub>2</sub>Si and two MgZn<sub>2</sub> particles are present. Note that there are also Al<sub>3</sub>Zr dispersoids close to the Mg<sub>2</sub>Si particles, which makes it uncertain what the nucleation site is in this example.

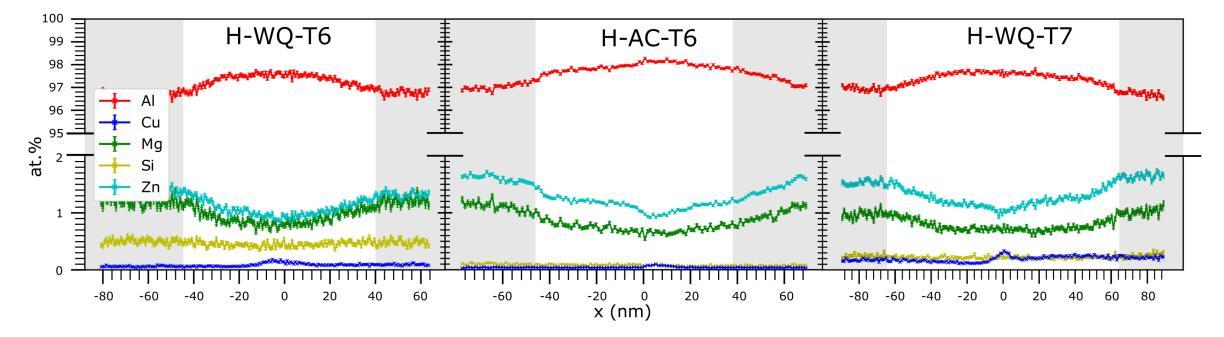
**Figure 8.** Elemental composition profiles across a type 3 grain boundary in three selected conditions. The width of the PFZs is indicated by the white area, and the '0' position marks the location of the grain boundary core. The relative solute levels are similar, but the H-WQ-T6 condition exhibits a Zn/Mg ratio closer to one in addition to an enhanced Si level.

The solute concentrations across grain boundaries viewed edge-on, including the bulk and PFZ of the adjacent grains, were measured using EDS on the type 3 grain boundaries. Data from an EDS map are represented as a linescan where each point represents the average and corresponding standard error of the mean as a function of distance from the boundary. This is shown in Figure 8 for H-AC-T6, H-WQ-T6, and H-AC-T7. It can be observed that both Mg and Zn are depleted in the PFZs as compared to the bulk. In addition, conditions H-AC-T6 and H-WQ-T7 have a higher relative amount of Zn when compared to Mg than condition H-WQ-T6. Moreover, sample H-WQ-T6 consistently demonstrated an enhanced Si signal. In some cases an enhanced Cu signal was found at grain boundaries, but no indications of Mg or Zn segregation were observed in any of the conditions.

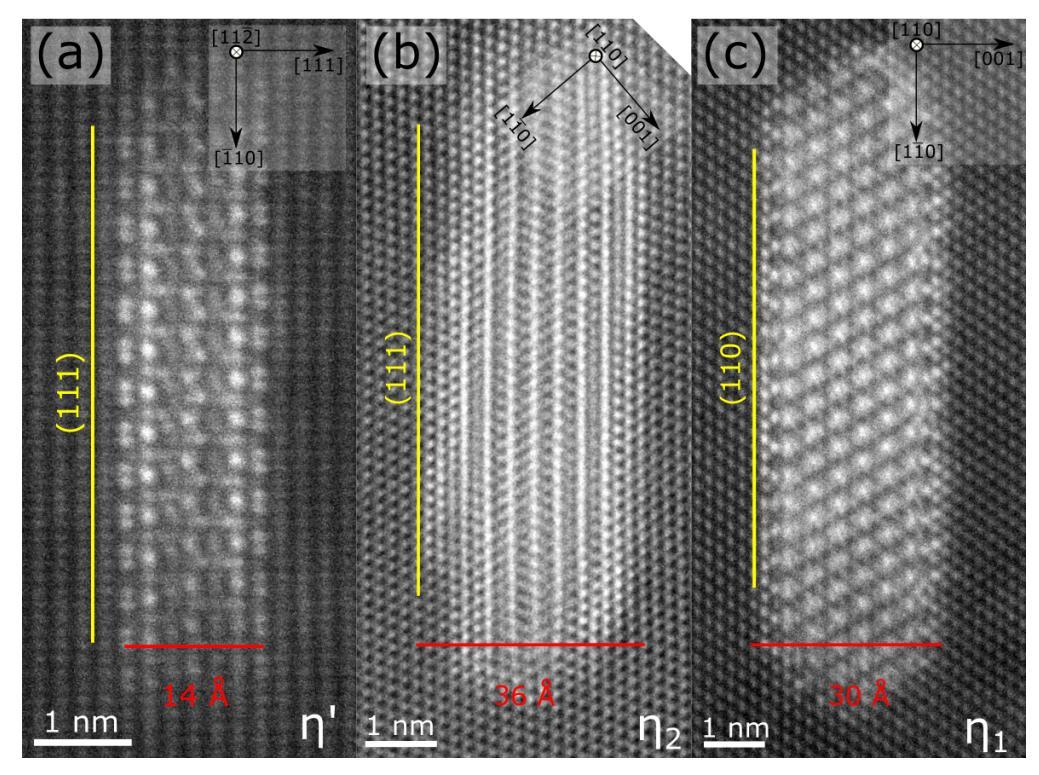
**Figure 9.** HAADF-STEM images of the different precipitates present in the conditions studied. (a) shows the  $\eta'$  precipitate acquired in H-WQ-T6 along  $[11\overline{2}]_{Al}$ . (b,c) are the  $\eta_2$  and  $\eta_1$  precipitates, respectively, projected along  $[110]_{Al}$  in sample H-WQ-T7.  $\eta'$  and  $\eta_2$  are present in T6.  $\eta_1$  and  $\eta_2$  are present in T7.

In our previous work, we demonstrated that the T6 and T7 tempers consisted of bulk precipitates that differed both in orientation relationship and size, independent of the prior cooling rate from SHT [33]. The T6 temper consisted of  $\eta'$  and  $\eta_2$  precipitates, while the T7 temper had  $\eta_1$  and  $\eta_2$  precipitates. Precipitates in the T7 temper are larger both in thickness and diameter. This is shown in Figure 9, where Figure 9a shows an  $\eta'$  precipitate imaged along [112]<sub>Al</sub> in H-WQ-T6. Figure 9b,c are

the  $\eta_2$  and  $\eta_1$  precipitates, respectively, projected along [110]<sub>Al</sub> in sample H-WQ-T7.  $\eta_1$  has a (110)<sub>Al</sub> interface plane, while the two others lie on the (111)<sub>Al</sub> plane.

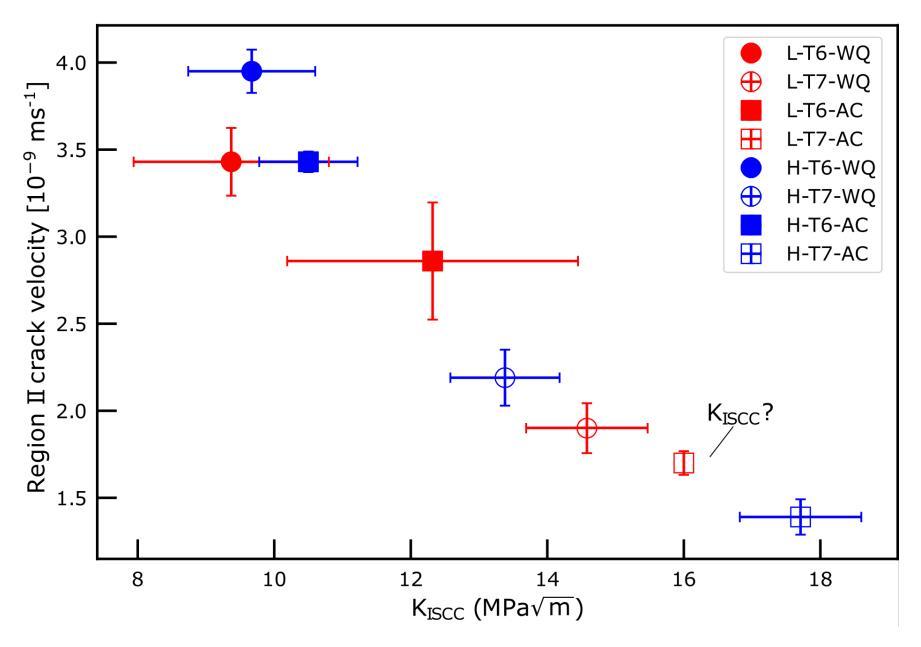
**Figure 10.** Results from the DCB tests. Average region II crack velocity and  $K_{ISCC}$  values from three parallels with corresponding standard deviation. The  $K_{ISCC}$  value of the L-T7-AC temper is uncertain as it did not demonstrate a clear drop in crack velocity at low  $K_I$  values, which all other conditions did. There is a clear trend that the  $K_{ISCC}$  values are higher for the T7 tempers.

The results from the DCB tests are shown in Figure 10, where the region II (plateau) crack velocity is shown together with the estimated  $K_{ISCC}$  values. Region II crack velocities are all within the same order of magnitude ( $10^{-9}$  ms<sup>-1</sup>), with the lowest values in the T7 tempers. A higher  $K_{ISCC}$  value is found in the T7 tempers. Air-cooling increases the  $K_{ISCC}$  value to slightly higher values than their water-quenched counterparts. All conditions, except L-T7-AC, exhibit a clear drop in crack velocity at lower  $K_{ISCC}$  values. The difference in Si levels does not show any clear trend and it has a limited effect on the properties measured here. The conventional crack velocity vs. stress intensity graph, from which the data presented in Figure 10 are obtained, is found in Supplementary Figure S2.

When comparing the DCB results for the T6 and T7 tempers, the T7 tempers have consistently slightly lower region II crack velocities (cf. Figure 10). However, little or no changes in the grain boundary chemistry could be established. This was shown by the microstructural characterisation, where only limited differences in concentration of solute elements in the PFZs, widths of PFZs, electrical conductivity, polarisation behaviour, or in the grain boundary particle compositions, could be established. A large difference in the conductivity would indicate notable differences in the solute levels. The T6 conditions have slightly lower conductivity than the T7 conditions. This means that more solute is consumed by precipitates in the T7 conditions. The average Zn/Mg ratio for grain boundary particles in H-AC-T6 was lower than for the other conditions. A lower Zn content in the grain boundary particles should provide a lower potential difference between the MgZn<sub>2</sub> phases and

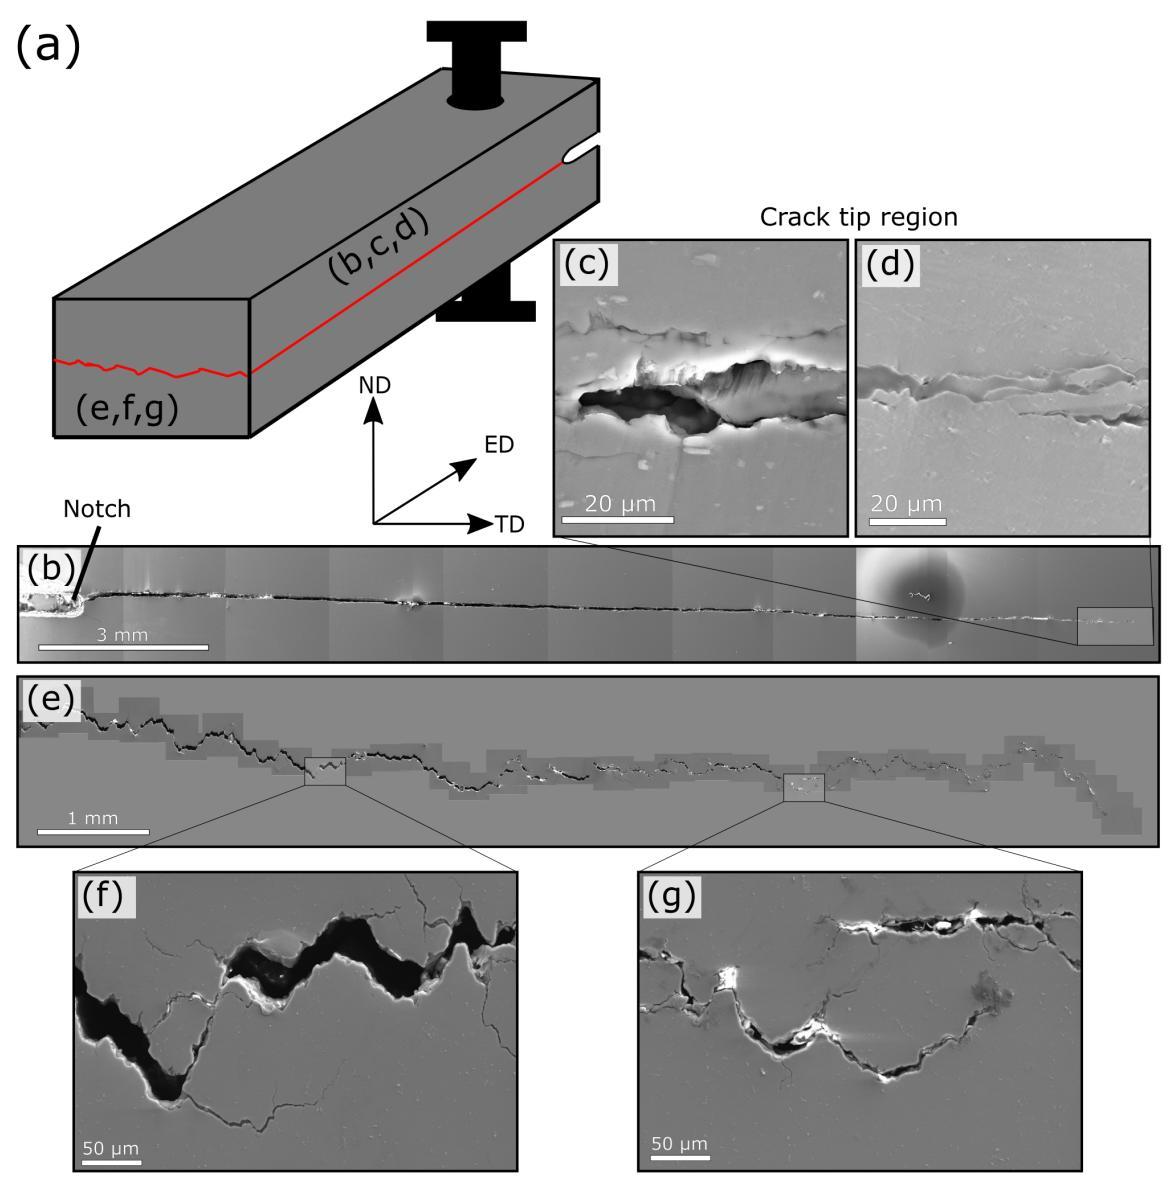
**Figure 11.** A schematic figure of a cracked DCB specimen in (**a**), where the base has been cut along the transverse direction to reveal the crack. SE-SEM images of the crack along the extrusion direction and the transverse directions are shown in figures (**b**,**e**), respectively. (**c**,**d**) are higher magnification SE-SEM images of the crack tip along the extrusion direction. (**f**,**g**) are two higher magnification images of cracks in the transverse direction.

The cracks on the DCB specimens were studied in SEM in the directions both parallel and normal to the extrusion direction. Figure 11a shows a schematic figure, where the red lines indicate the cracks. Along the extrusion direction the cracks follow nearly a straight line as shown in Figure 11b. Higher magnification images of the crack tip region are shown in Figure 11c,d, demonstrating that the cracks follow the grain boundaries between the fibrous grains aligned along the ED direction. In order to see the cracks in the transverse cross-section, DCB samples were cut along the transverse direction, as the crack had not passed through the entire specimen during the test period. This crack is demonstrated in Figure 11e, where two selected SE-SEM images are shown in Figure 11f,g. It can be seen that these cracks are not as straight as the ones along the extrusion direction, and more crack branching can be seen clearly in Figure 11f,g.

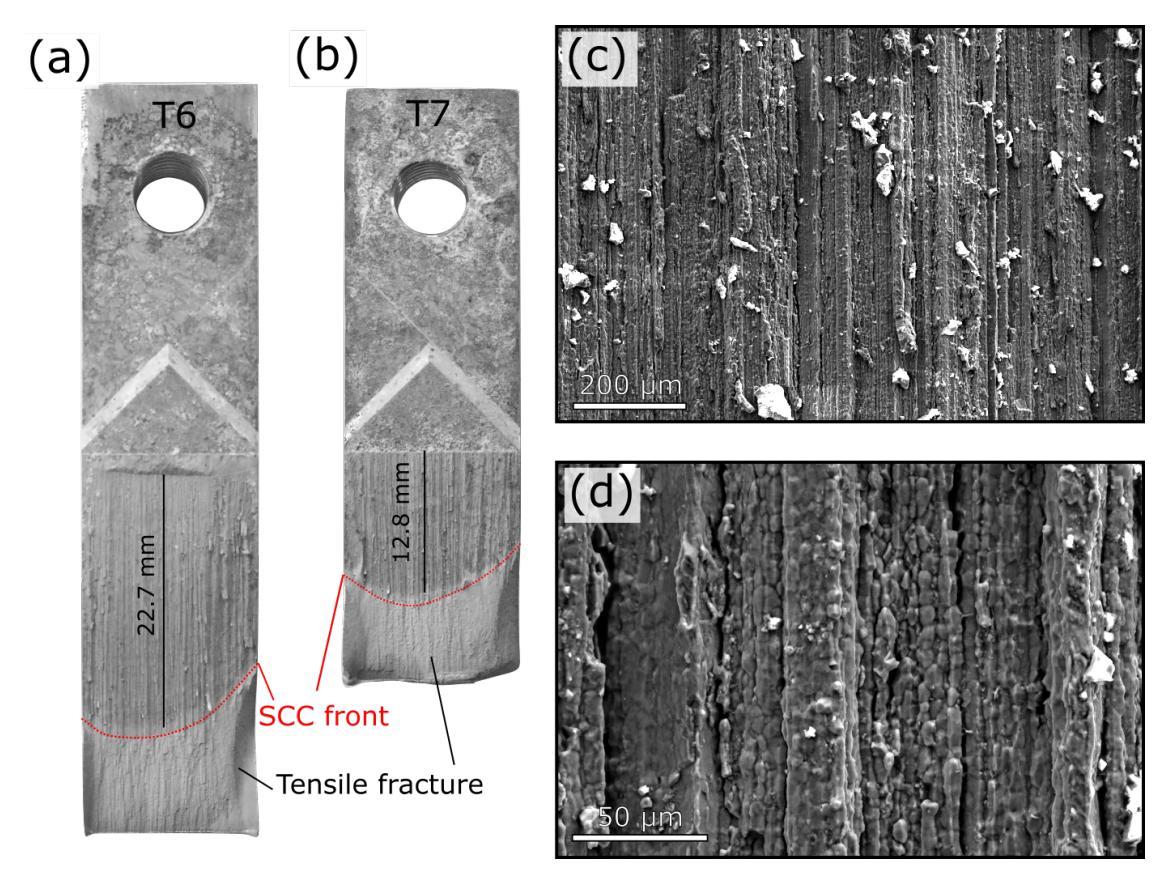
**Figure 12.** DCB specimens pulled apart using a tensile overload for conditions H-WQ-T6 and H-WQ-T7 in (**a**,**b**), respectively. (**c**,**d**) are SE-SEM images aquired at different magnification of the fracture surface within the SCC front area in (**a**).

Figure 12 shows some of the samples were pulled apart and the fracture surface of a T6 and T7 condition. It can be seen that the crack front is slightly deeper in the center of the specimens than at the edges. SE-SEM images of the fracture surfaces are shown in Figure 12c,d, where the fibrous grains are seen to remain along the extrusion direction. The fracture surfaces clearly demonstrate that the cracks are intergranular. Note that the SEM images do not capture the depth of field, which is more clear in the earlier presented Figure 11e.

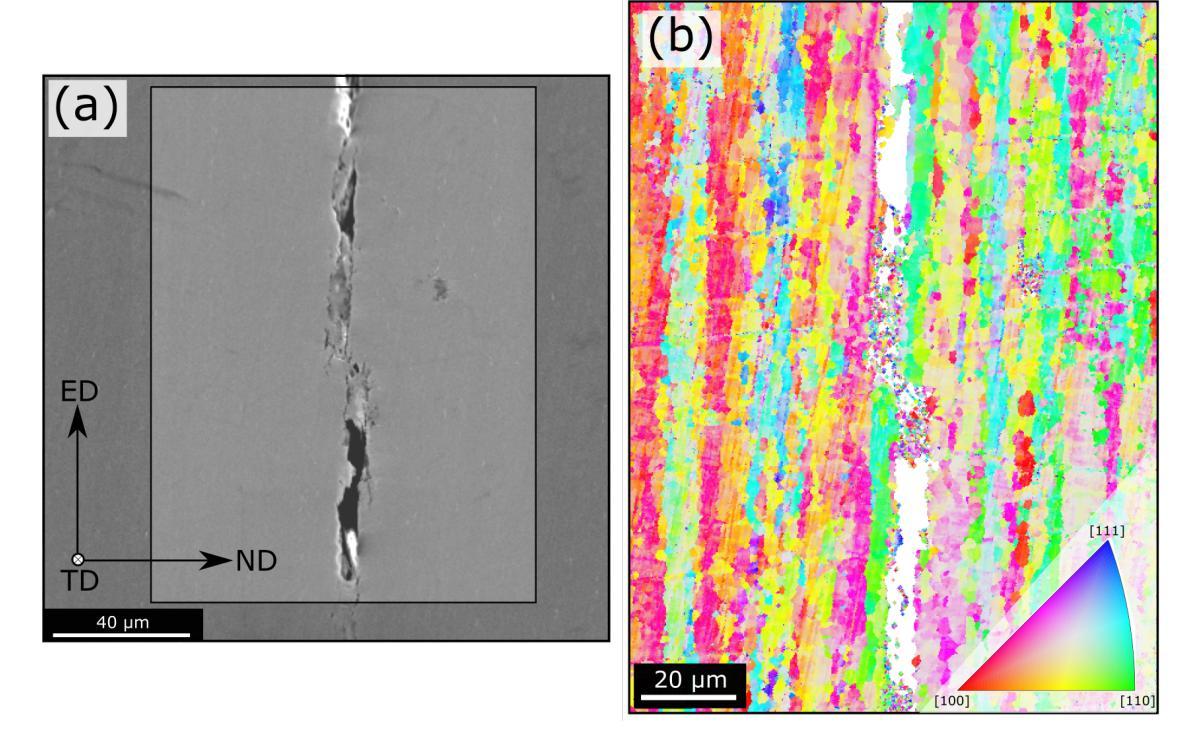
**Figure 13.** (a) SE-SEM image of a DCB crack in sample H-WQ-T6. (b) Corresponding EBSD map from the highlighted area in (a). Cracking predominantly follows the high-angle grain boundaries separating the long fibrous grains aligned along the extrusion direction (ED).

EBSD was conducted on the cracked DCB specimens in order to reveal which grain boundaries are susceptible to SCC, and it is shown in Figure 13. The cracks seem to predominately follow the high-angle grain boundaries that separate the long fibrous grains, as discussed earlier with respect to Figure 4b.

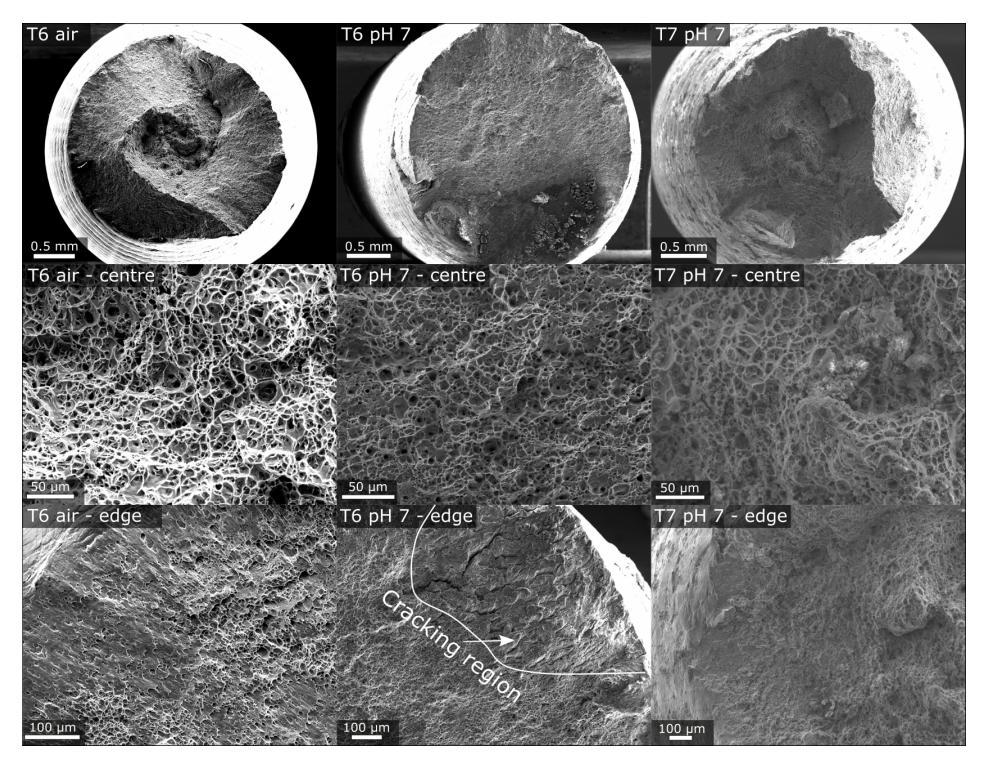
**Figure 14.** Fracture surfaces of selected samples in air and in solution, with highlighted features in the centre and close to the edge. The main difference is the cracking behaviour observed in the T6 tempers when testing in solution, as highlighted for T6 in pH 7.

Representative fracture surfaces of the SSRT specimens are shown in Figure 14. The samples fractured in air, regardless of their ageing parameters, all demonstrate a ductile failure in the center of the specimen. A flat fracture region is found closer to the edge. Samples stressed in 3.5 wt.% NaCl at pH 7 similarly have ductile failure in the centre of the specimen with some corrosion products between. However, there is an apparent difference between the T6 and T7 samples, regardless of the pH in the test solution. This is the appearance of cracks, always present close to the edge in the T6 specimens. These may penetrate up to ~600  $\mu$ m into the specimen from the outer surface. In one case, the crack penetrated through the entire cross-section (Supplementary Figure S4). It is important to emphasise that this cracking behaviour was not observed in the T7 tempers, and also not when the T6 tempers were strained in air. The cracks observed in Figure 14 have a depth along the tensile axis (extrusion direction) of up to 1 mm. This is revealed by embedding the whole specimen in epoxy and polishing the sample in towards the center of the round tensile specimen, and is shown in Supplementary Figure S5 for a T6 condition.

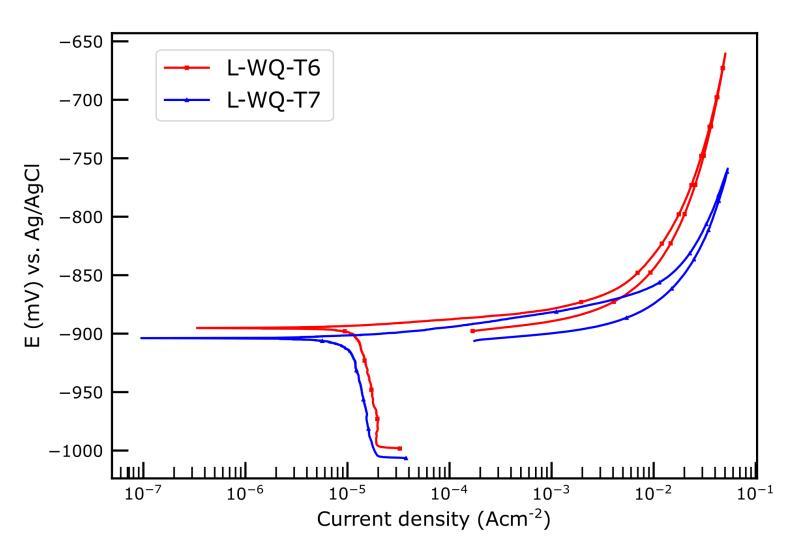
**Figure 15.** Potentiodynamic polarisation curves of two selected samples that demonstrate clear difference in SCC behaviour.

Two of the conditions which demonstrated clear difference in the measured SCC properties were subjected to potentiodynamic polarisation. This result is shown in Figure 15, where it can be seen that the WQ-T6 and the WQ-T7 tempers exhibit similar polarisation behaviour. The corrosion potential is  $\sim$ 10 mV lower for the T7 temper.
