Abstract: As an advanced heat exchanger for aero-turbine applications, a tubular-type heat exchanger was developed. To ensure the optimum performance of the heat exchanger, it is necessary to assess the structural integrity of the tubes, considering the assembly processes such as brazing. In this study, fatigue tests at room temperature and 1000 K were performed for 0.135 mm-thick alloy 625 tubes (outer diameter of 1.5 mm), which were brazed to the grip of the fatigue specimen. The variability in fatigue life was investigated by analyzing the locations of the fatigue failure, fracture surfaces, and microstructures of the brazed joint and tube. At room temperature, the specimens failed near the brazed joint for high  $\sigma_{max}$  values, while both brazed joint failure and tube side failure were observed for low  $\sigma_{max}$  values. The largest variability in fatigue life under the same test conditions was found when one specimen failed in the brazed joint, while the other specimen failed in the middle of the tube. The specimen with brazed joint failure showed multiple crack initiations circumferentially near the surface of the filler metal layer and growth of cracks in the t

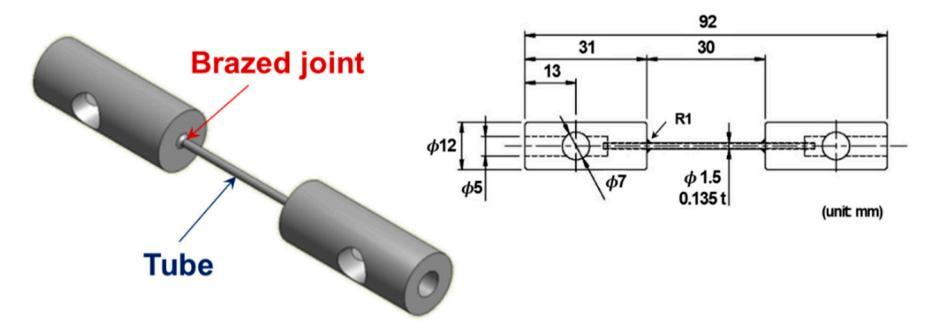
An alloy 625 tube with a thickness of 0.135 mm and an outer diameter of 1.5 mm was prepared by repeated drawing and heat treatment processes after initial tubing via tungsten inert gas welding of a 0.2 mm thick strip roll. Figure 1 shows the geometry of the newly designed thin-tube fatigue specimen. As can be seen, the thin tube was connected to the grip (also made of alloy 625) using brazing, in the same way that a tube is brazed to a tube sheet in an actual heat exchanger. This type of fatigue specimen allows us to investigate the fatigue behavior of the thin tube, including the influence of the brazed joint. The filler metal used for brazing was BNi-2, containing boron and silicon as melting point depressants. The chemical compositions of the alloy 625 tube and filler metal are listed in Table 1.

Figure 1. Geometry of the thin-tube brazed fatigue specimen.

Fatigue tests were performed using the MTS 810 system (MTS Systems Corp., Eden Prairie, MN, USA). The fatigue specimen shown in Figure 1 was connected to a ball-joint grip with a pin for the tilt- and twist-free alignment of the specimen along the loading direction. The applied load was measured using a 2 kN load cell (BCA-200K, TESTA Corp., Gyeonggi-do, Korea). Fatigue tests were performed under cyclic loading with a stress ratio (R) of 0.1 and a frequency of 10 Hz. Fatigue tests were performed at six different maximum stresses ( $\sigma_{max}$ ) for the two temperatures as follows: 495, 526, 557, 587, 618, and 649 MPa for room temperature (RT), and 355, 371, 386, 402, 418, and 433 MPa for 1000 K. Here, three to seven tests were conducted for each test condition. Fatigue test conditions are summarized in Table 2. After the tests, fractography was performed on the failed specimens to clarify the failure mechanisms and fatigue variability of the thin-tube brazed specimens.

Because the thin-tube fatigue specimen has an unusual geometry, i.e., a thin tube brazed to the grip (Figure 1), further analysis was performed to clarify whether the brazed joint affected the variability of the fatigue life. In Figure 7, the fatigue fracture locations of all tested specimens are plotted as a function of  $N_{\rm f}$  for different applied stresses ( $\sigma_{\rm max}$ ). Here, the fracture location (%) is the percentile fracture location relative to the distance from the grip section: 0% for fracturing at the brazed joint and 50% for fracturing in the middle of the thin tube. As can be seen, the fatigue fracture at RT was mainly near the brazed joint for high  $\sigma_{\rm max}$  (approximately  $\sigma_{\rm max} \ge 557$  MPa and  $N_{\rm f} < 400,000$  cycles), while the fatigue fracture was either near the brazed joint or in the thin tube for low  $\sigma_{\rm max}$  ( $N_{\rm f} > 400,000$  cycles). However, the fatigue fracture at 1000 K was mainly in the thin tube away from the brazed joint, regardless of the magnitude of  $\sigma_{\rm max}$ . This result implies that the presence of the brazed joint affects the fatigue life mainly for RT fatigue at a high  $\sigma_{\rm max}$ .

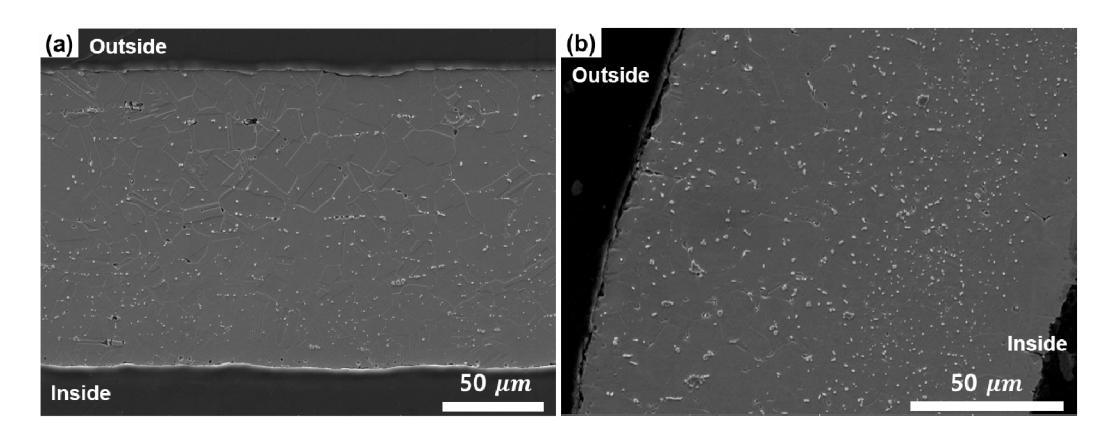
Figure 2 shows the SEM images of the longitudinal and radial cross-sections of an alloy 625 thin tube prior to the fatigue test. The EDS analysis indicated that carbides of (Nb, Ti)C were present in the tube. The size of the carbides distributed outside the tube was larger than those distributed inside the tube. Carbide streaks along the drawing direction were also observed, which originated from the drawing process. Figure 3 shows the metallographs of the radial cross-section of the tube, including the weld zone in Figure 3b. As can be seen, the grain size appears to be finer in the weld zone than in the other regions (base metal). Despite the repeated annealing process after every drawing step, microstructural differences between the weld zone and the base metal are still observed. Therefore, the grain size distribution through the thickness is quite heterogeneous in the range of approximately 1–8 grains.

**Figure 2.** SEM images of an alloy 625 thin tube prior to the fatigue test: (**a**) longitudinal and (**b**) radial cross-sections.

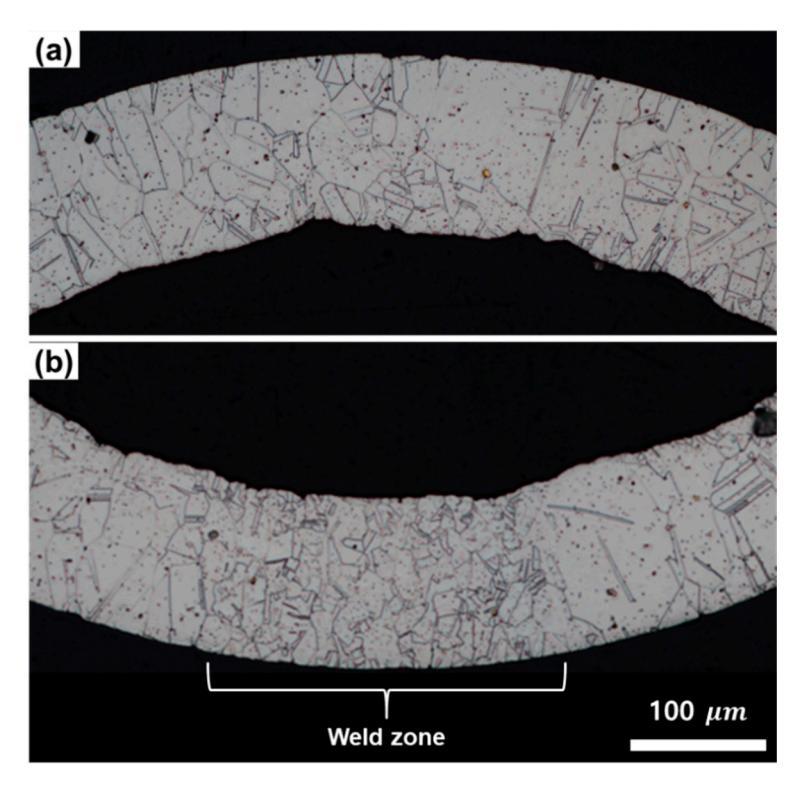
**Figure 3.** Metallographs at the radial cross-section of the tube: (**a**) typical base metal region and (**b**) region including the weld zone.

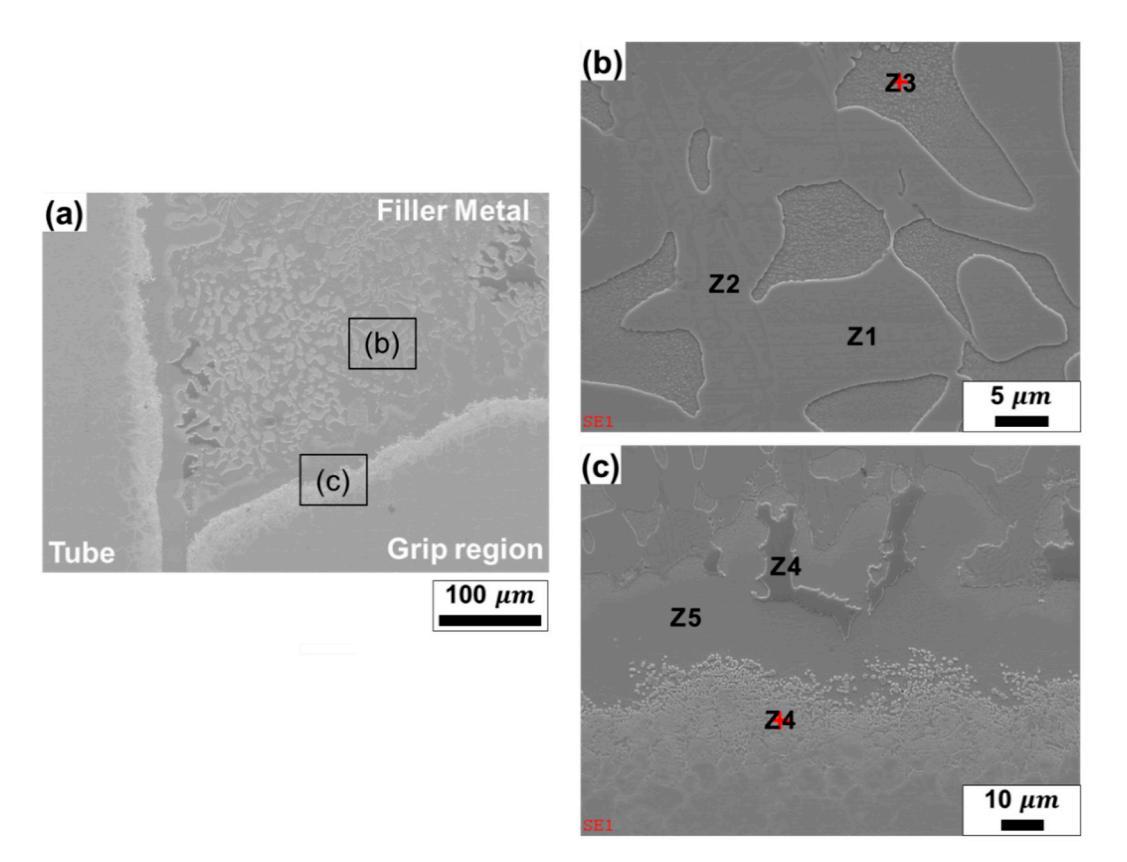
Figure 4 shows the SEM images of the cross-section for the as-brazed fatigue specimen. Here, Figure 4b,c presents enlarged images of the areas labeled in Figure 4a. A typical brazing microstructure of Ni-base alloys is apparent, comprising various intermetallic phases [28,29]. An EDS analysis in an athermal solidification zone (Figure 4b) demonstrated that the phases marked by Z1, Z2, and Z3 are nickel boride, Ni–Si–B ternary intermetallic, and eutectic of  $\gamma$ -nickel and fine nickel silicide, respectively. The microstructure at the interface between the filler metal and the base metal shown in Figure 4c consisted of phases marked by Z4 and Z5, which are chromium boride, and the  $\gamma$ -nickel solid solution, respectively. In addition, the microhardness profile across the brazed joint was measured, as displayed in Figure 5. The microhardness in the tube was approximately 182 HV. In the filler metal region, however, the hardness increased to as high as 710 HV. This high hardness value is attributed to intermetallic constituents, including nickel boride, chromium boride, and nickel silicide, which are known for hard and brittle phases.

Figure 4. (a) SEM image of the brazed region; (b,c) enlarged SEM images of the areas marked in (a).

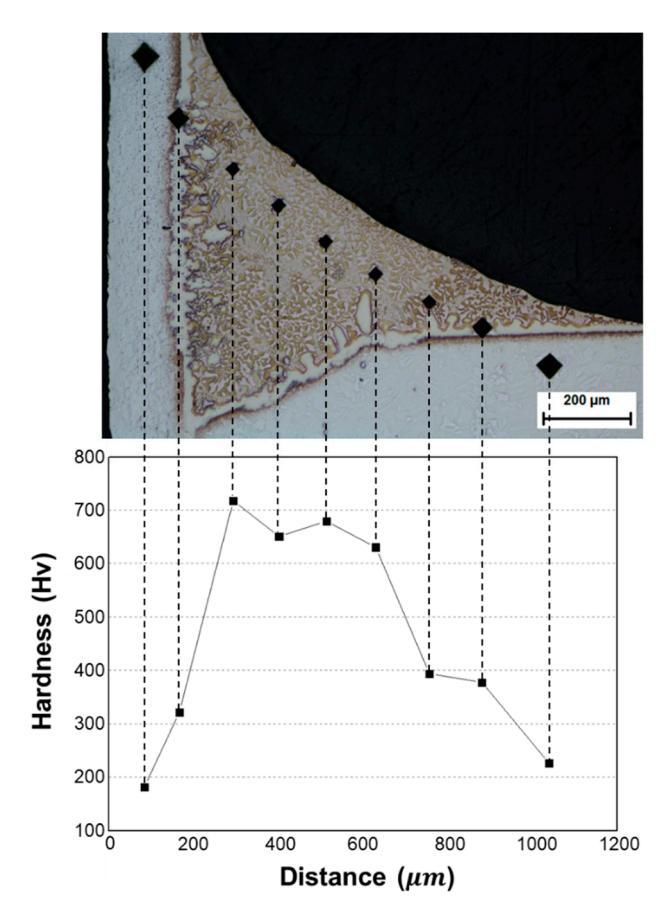
Figure 5. Microhardness profile across the brazed region.

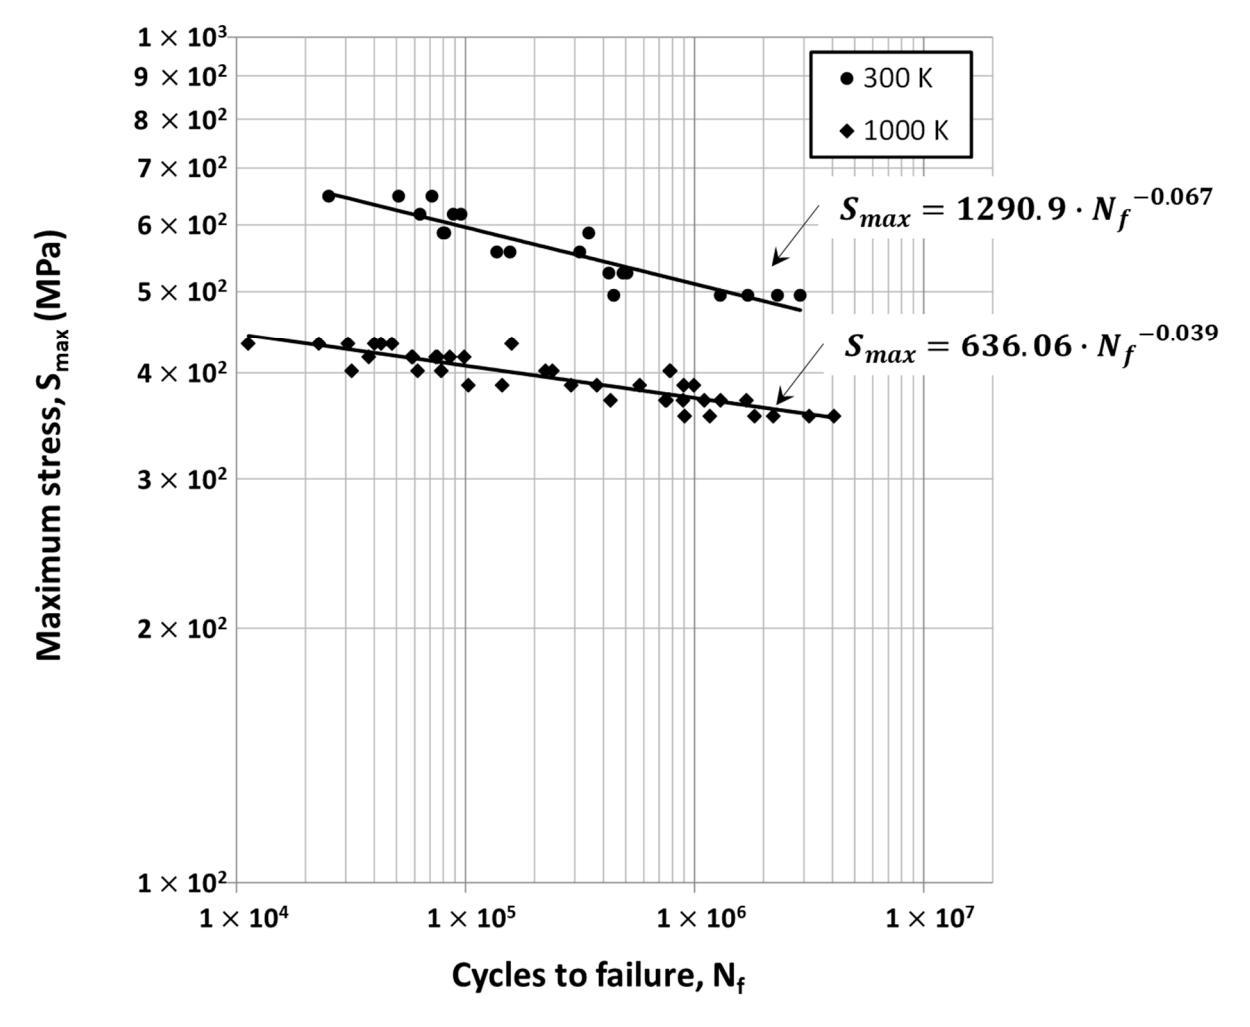
Fatigue tests were conducted at RT and 1000 K on the thin-tube brazed specimens, and the S–N curves are plotted in Figure 6. Each fatigue test condition shows different variabilities in the fatigue life ( $N_f$ ). For the RT fatigue tests, the maximum variability in  $N_f$  was found at  $\sigma_{max} = 495$  MPa, which exhibited maximum and minimum  $N_f$  values of 2,891,024 and 444,361 cycles, respectively. For the 1000 K fatigue tests, however, an even higher maximum variability in  $N_f$  was found at  $\sigma_{max} = 402$  MPa, which showed maximum and minimum  $N_f$  values of 781,877 and 31,909 cycles, respectively. In addition, such a variability in  $N_f$  does not seem to show any particular relationship with the level of the maximum stress applied, particularly for the 1000 K fatigue tests. The fatigue strengths determined at  $N_f = 1 \times 10^6$  cycles were 511 and 371 MPa at RT and 1000 K, respectively. The modified fatigue strengths with various standard deviations are listed in Table 3.

Figure 6. S–N plots for all fatigue data tested at RT and 1000 K.

The fatigue lives at 1000 K also exhibited large variability, as shown in Figure 6. However, almost all fatigue fractures were observed in the region of the thin tube and not in the brazed joint, as shown in Figure 7b. Accordingly, fractography was performed for the two specimens, which showed a difference of approximately 10 times in fatigue life ( $N_{\rm f}$  = 781,887 and 78,621 cycles for the long-life and short-life specimens, respectively) at 1000 K and  $\sigma_{\rm max}$  = 402 MPa. As shown in Figure 10, both specimens displayed failure in the tube region away from the brazed joint. Figure 11 presents the fracture surfaces

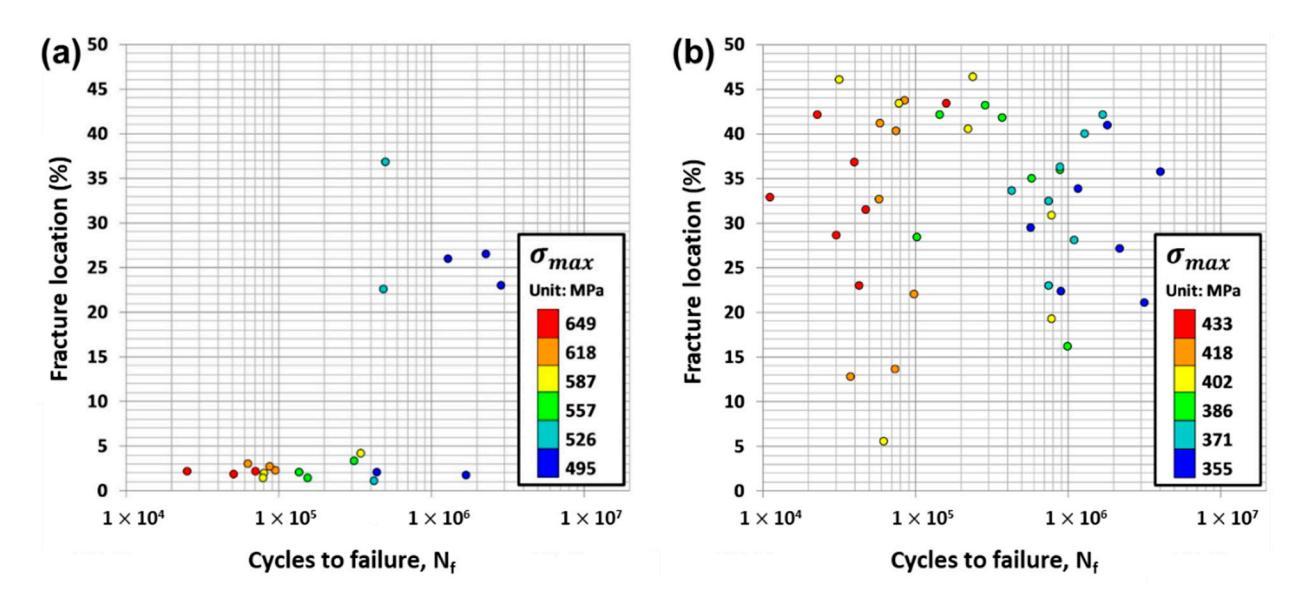
**Figure 7.** Variations of the fracture location as a function of fatigue life ( $N_f$ ) for different  $\sigma_{max}$  values at (**a**) RT and (**b**) 1000 K.

For 1000 K fatigue, however, no apparent brazed joint failure was observed, as shown in Figure 7b. This is because the deformation incompatibility among different intermetallic phases in the filler metal layer was fully accommodated (even under cycling loading) at such a high temperature [32]. In this case, the spatial distribution of the grain size and carbides seems to affect the fatigue life variability. The presence of a large near-surface grain (corresponding to the weld zone), which has approximately 1–2 through-thickness grains and can facilitate the initiation of a fatigue crack near the outer surface, as shown in Figure 11b,c, leads to a short fatigue life. In particular, the fatigue life will be even shorter if multiple crack initiations at carbides inside the tube occur simultaneously, as shown in Figure 11b,c, in addition to the crack initiation at a large near-surface grain.

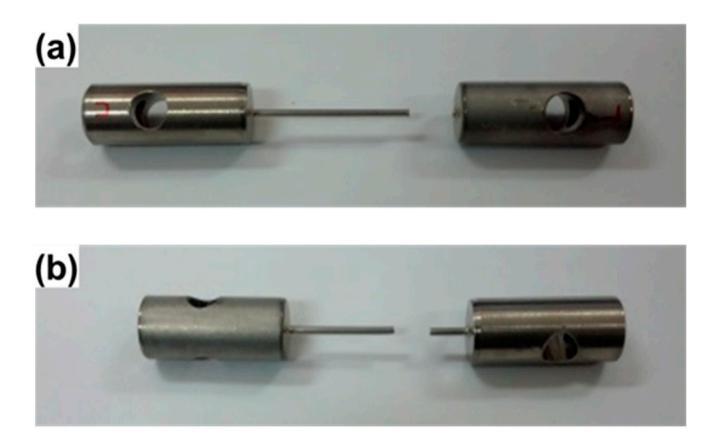
To further investigate the relationship between the fracture location and the fatigue life at RT, fractography was performed for the two specimens, which showed a difference of approximately seven times in fatigue life even under the same test conditions ( $\sigma_{\text{max}}$  = 495 MPa). Here, the short-life tube specimen fractured near the brazed joint at 444,361 cycles, whereas the long-life tube specimen fractured in the middle of the tube at 2,891,024 cycles, as shown in Figure 8a,b, respectively. Figure 9 shows the fractography of the two specimens tested at RT and  $\sigma_{max}$  = 495 MPa. In Figure 9, the crack initiation sites are indicated by arrows. The fracture surfaces of the short-life specimen presented in Figure 9a,b show typical brittle fractures with multiple crack initiations (indicated by the arrow in Figure 9b) almost everywhere near the surrounding filler metal surfaces. These initial cracks circumferentially formed on the surfaces of the filler metal seem to propagate toward the inside of the thin tube, leading to premature fatigue failure. The gradual change in the fracture type from the transgranular quasi-cleavage fracture in the filler metal layer of the outer tube to the relatively dimpled fracture of the inner tube indirectly supports crack propagation. The microhardness profile displayed in Figure 5 indicates that the filler metal layer in the vicinity of the brazed joint is brittle, as expected, compared with the thin tube, owing to the presence of various intermetallic compounds (see Figure 4). Moreover, a certain degree of stress concentration is expected at the brazed joint owing to the geometric discontinuity (a notch effect) between the thin tube and the grip. The stress concentration factor of the fillet in the brazed joint can be calculated quantitatively using the factor of  $k_f$ shown in Equation (1) [30]:

**Figure 8.** (a) Short-life (444,361 cycles) and (b) long-life (2,891,024 cycles) tube specimens at RT and  $\sigma_{max} = 495$  MPa.

In contrast to the short-life specimen, the long-life specimen, which fractured in the middle of the tube (Figure 8b), exhibited single crack initiation near the outer surface, as shown in Figure 9c,d. It can be seen that the initial crack formed a facet perpendicular to the loading direction (Figure 9d), which is typical for high-cycle fatigue. Unlike the short-life specimen, which displays simultaneous crack propagation from the filler metal layer of the outer tube to the inner tube, the long-life specimen shows a single crack propagating from the outer tube surface through the thickness, then spreading out to the neighboring area.

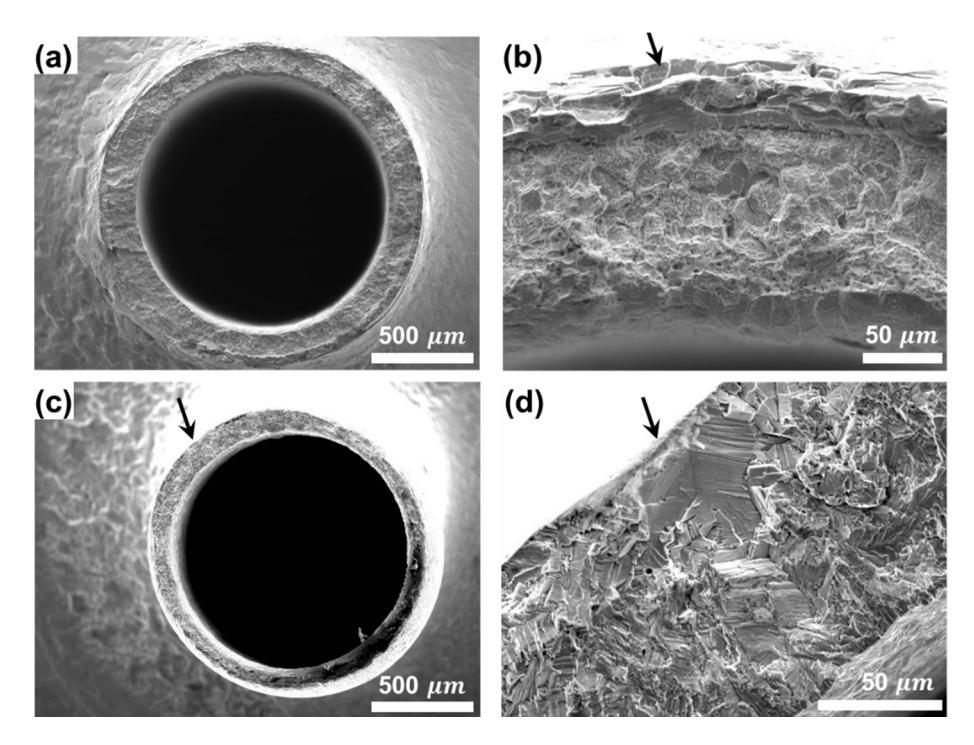
**Figure 9.** Fracture surfaces for (**a**,**b**) short-life (444,361 cycles) and (**c**,**d**) long-life (2,891,024 cycles) specimens tested at RT and  $\sigma_{max}$  = 495 MPa.

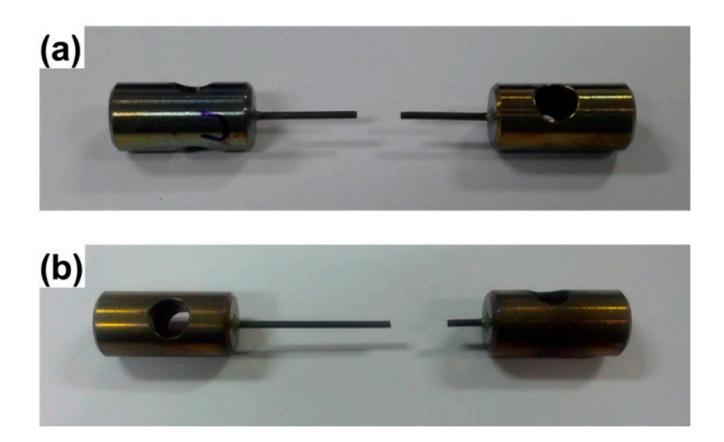
**Figure 10.** (a) Short-life (78,621 cycles) and (b) long-life (781,887 cycles) tube specimens at 1000 K and  $\sigma_{max} = 402$  MPa.

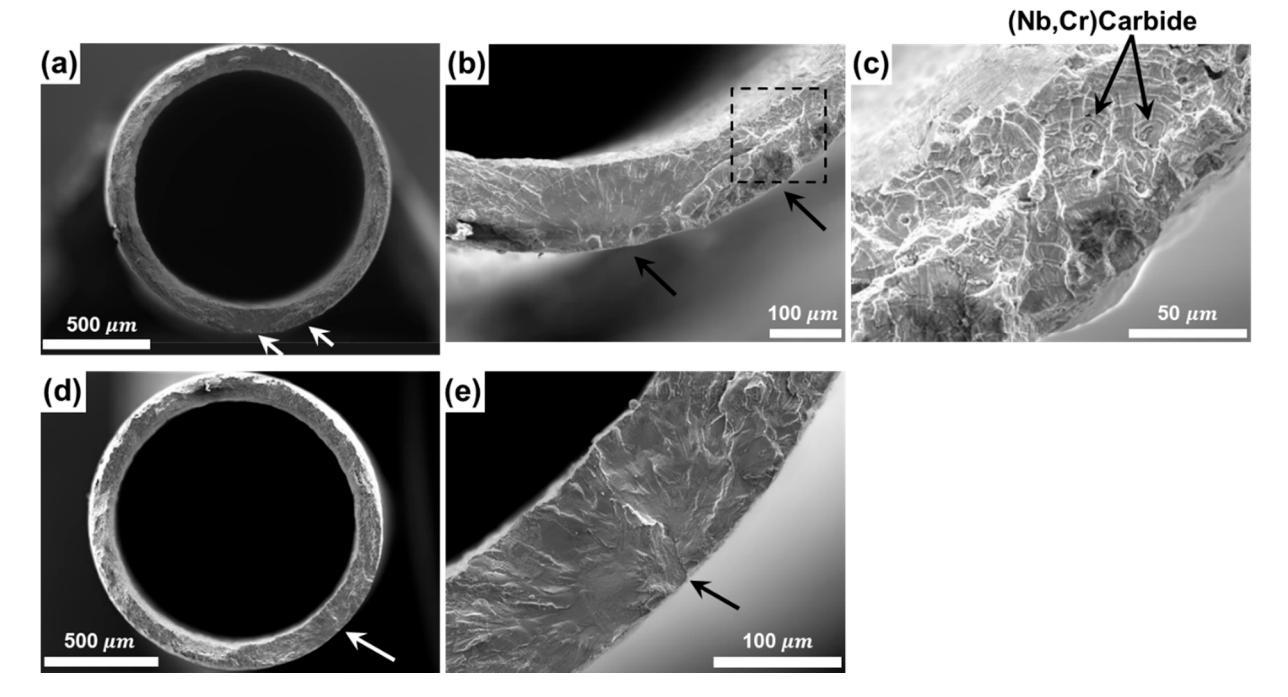
for the short- and long-life specimens tested at 1000 K and  $\sigma_{max} = 402$  MPa. Regarding the short-life specimen, multiple crack initiations both at the outer surface and carbides inside the tube were observed, as indicated by the arrows in Figure 11b,c. In particular, cracks initiated at the outer surface (arrow in Figure 11b) showed progress through the tube thickness. Metallographs (Figure 12a,c) taken directly underneath the fracture surface presented in Figure 11a indicate that the grain size at the crack initiation site (marked with an arrow) is very large (only approximately two grains through the thickness). In addition, based on the non-uniform microstructure distribution compared to the surrounding area, the crack initiation site corresponds to the weld zone. Hence, during cyclic loading at 1000 K, the heterogeneous grain distribution can cause premature fracture, particularly in the weld zone.

**Figure 11.** Fracture surfaces for (**a**–**c**) short-life (78,621 cycles) and (**d**,**e**) long-life (781,887 cycles) specimens tested at 1000 K and  $\sigma_{max} = 402$  MPa. The arrows in (**a**,**b**,**d**,**e**) indicate the crack initiation sites. (**c**) presents the enlarged image of the area highlighted in (**b**).

For the long-life specimen, a single crack initiation was observed near the outer surface, as shown in Figure 11d,e. Here, the initial surface crack is indicated by an arrow in Figure 11e. Metallographs (Figure 12b,d) obtained directly underneath the fracture surface presented in Figure 11d show homogeneous grain distribution over the tube. This indicates that, for the long-life specimen, if the inhomogeneity of the weld zone does not directly lead to fracture at the beginning of the fatigue test, the effect of grain size on the fatigue life is reduced owing to homogenization by long-term exposure at 1000 K.

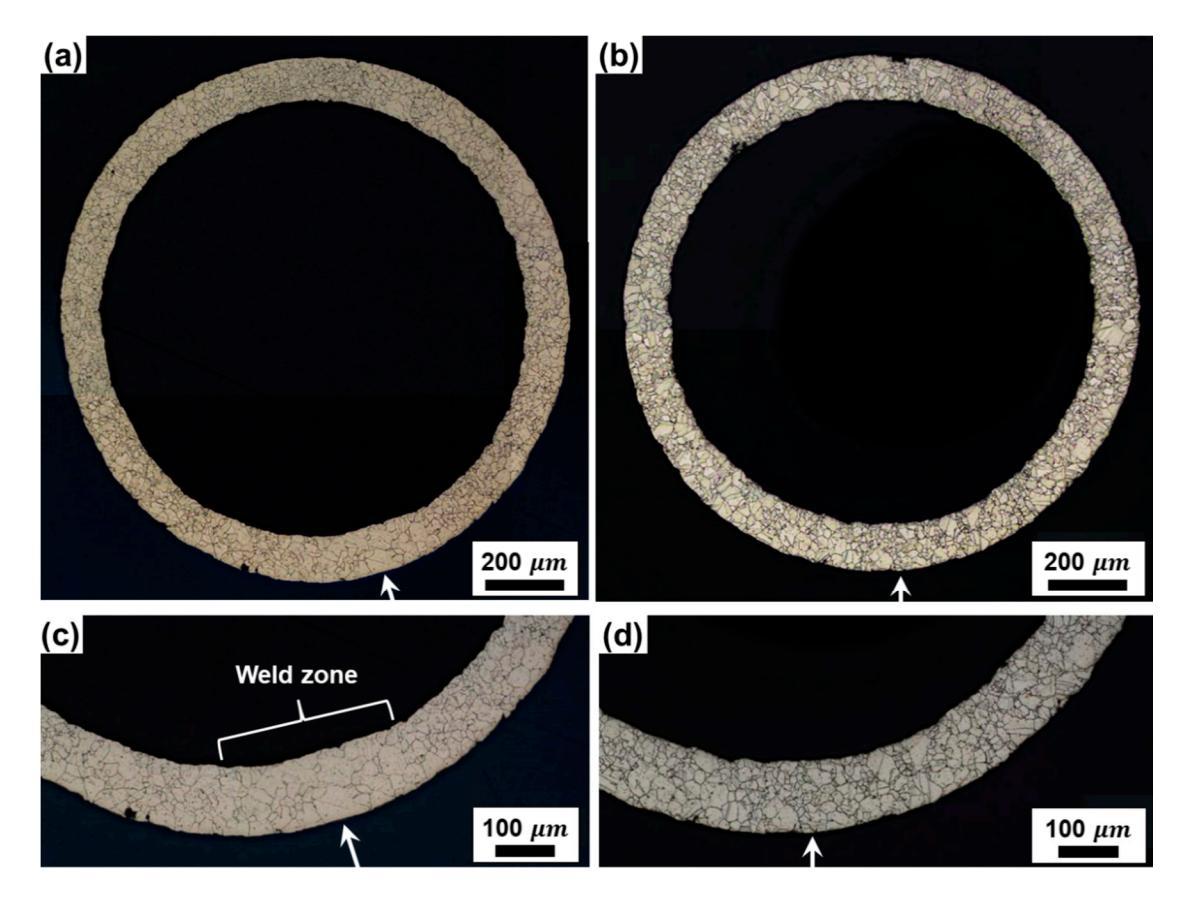
**Figure 12.** Microstructures directly underneath the fracture surfaces fatigue-tested at 1000 K and  $\sigma max = 402$  MPa for (**a**,**c**) short-life (78,621 cycles) and (**b**,**d**) long-life (781,887 cycles) specimens. The arrows indicate the locations of the fatigue crack initiation.
