Article

The Effect of Multilayer Architecture and Ta Alloying on the Mechanical Performance of Ti-Al-N Coatings under Scratching and Uniaxial Tension

Keywords: Ti-Al-N coatings; multilayer architecture; mechanical properties; alloying; scratch testing; uniaxial tension

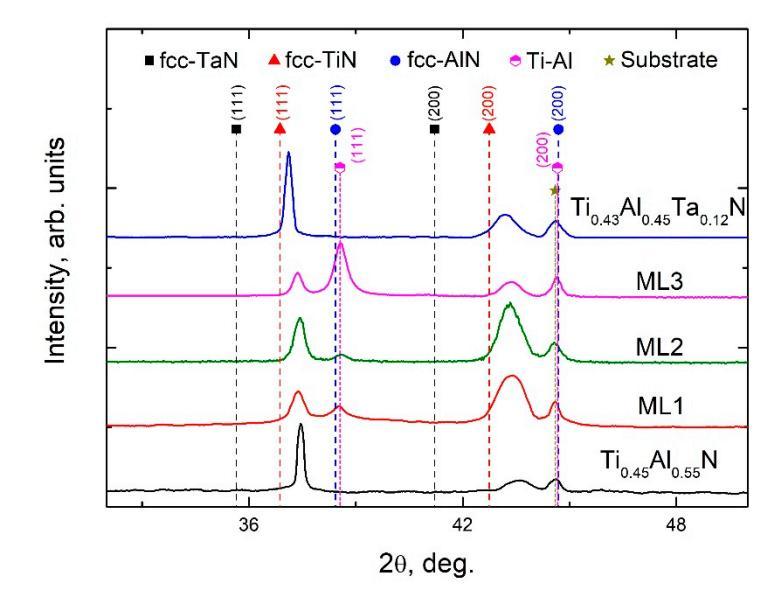
Figure 1. XRD patterns of the $Ti_{0.45}Al_{0.55}N$ and $Ti_{0.43}Al_{0.45}Ta_{0.12}N$ monolithic coatings, and $Ti_{0.45}Al_{0.55}N/Ti_{0.45}Al_{0.55}$ multilayers.

EDS analysis revealed that the $Ti_{1-x}Al_xN$ monolithic coating as well as the $Ti_{1-x}Al_xN$ layers in the multilayers were characterized by a Ti/Al ratio of 45/55 at %. The same Ti/Al ratio was also found in the Ti-Al layers. The Ta-alloyed coating was represented as $Ti_{0.43}Al_{0.45}Ta_{0.12}N$. The X-ray diffraction patterns of the coatings are shown in Figure 1. An analysis of the XRD patterns showed that the Ti_{0.45}Al_{0.55}N and Ti_{0.43}Al_{0.45}Ta_{0.12}N monolithic coatings are $Ti_{1-x-y}Al_x(Ta_y)N$ solid solutions with single-phase cubic B1 (NaCltype) structure. The XRD patterns of the Ti_{0.45}Al_{0.55}N/Ti_{0.45}Al_{0.55} multilayer coatings also exhibit the diffraction peaks of the same phase. In addition, the peaks of the TiAl γ -phase with tetragonal L10 structure are seen in the XRD patterns of the multilayers. The strongest TiAl peak appears on the XRD pattern of the coating with the thickest metal layers (ML3). It is worth noting that the $Ti_{1-x-y}Al_x(Ta_y)N$ diffraction peaks at the XRD pattern of the Ti_{0.43}Al_{0.45}Ta_{0.12}N coating are shifted towards lower diffraction angles compared to other samples. This can be attributed to the higher residual stress in this coating as well as to the presence of the fcc-TaN phase, which lattice constant (0.434 nm) is larger than that of TiN. The XRD analysis also indicates the texture changes in the multilayer coatings compared with the monolithic ones. Crystallites in both monolithic coatings preferentially grow along (111) direction, while the multilayers exhibit (200) $Ti_{1-x}Al_xN$ texture.

It has been shown that high residual stresses favor the formation of (111) texture in TiN [47] and Ti-Al-N coatings [48], while (200) crystallites preferentially grow at low residual stresses. Therefore, the (200) texture indicates partial relaxation of the residual stresses in the multilayer coatings due to the fact that the ductile metal layers allow the $Ti_{0.45}Al_{0.55}N$ layers to fit their dimensions by sliding over each other. This is strongly supported by the results of residual stress evaluation by substrate curvature measurements. The $Ti_{0.45}Al_{0.55}N$ and $Ti_{0.43}Al_{0.45}Ta_{0.12}N$ monolithic coatings are characterized by compressive stresses of -1.6 and -3.0 GPa, respectively, whereas the compressive stresses in the multilayers are reduced to ~ -0.5 (see Table 1).

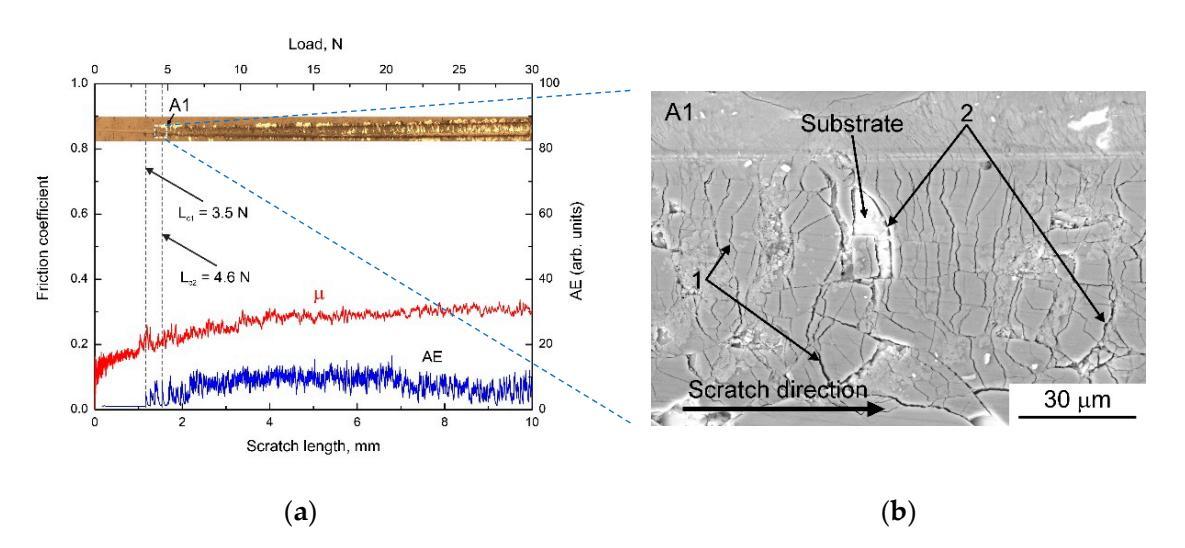
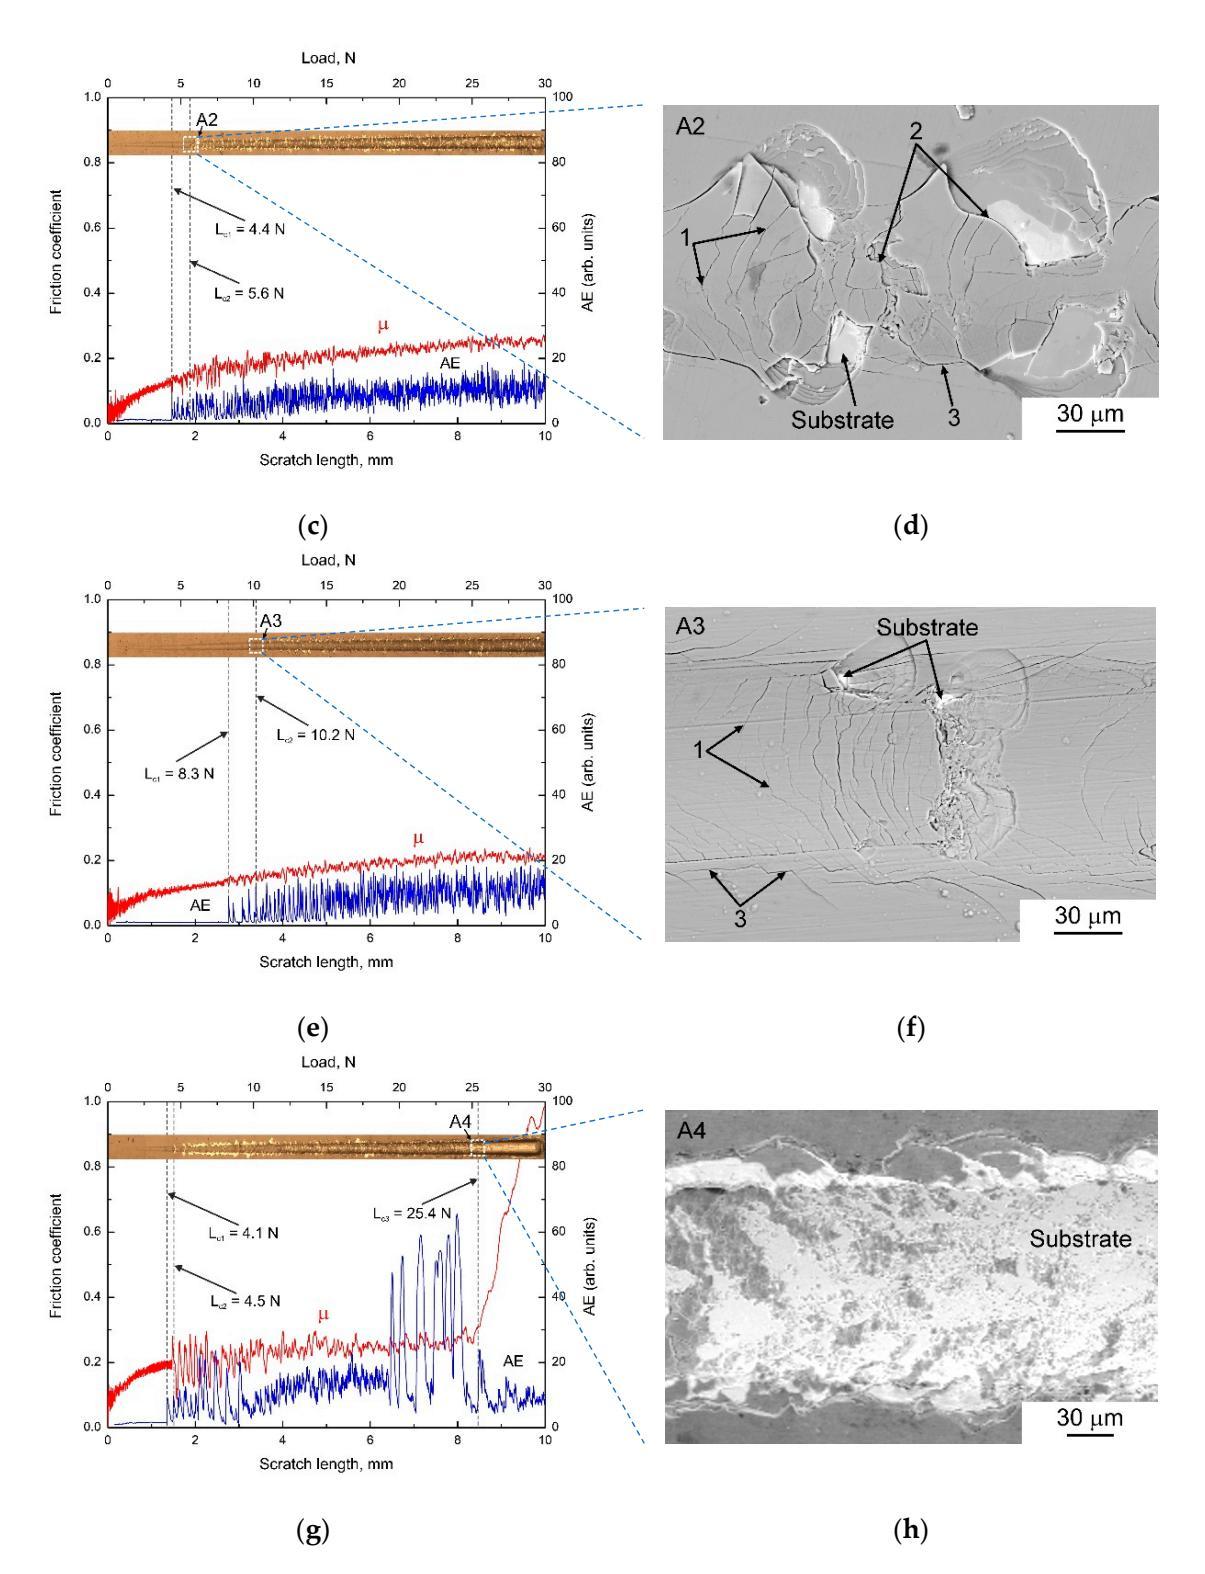
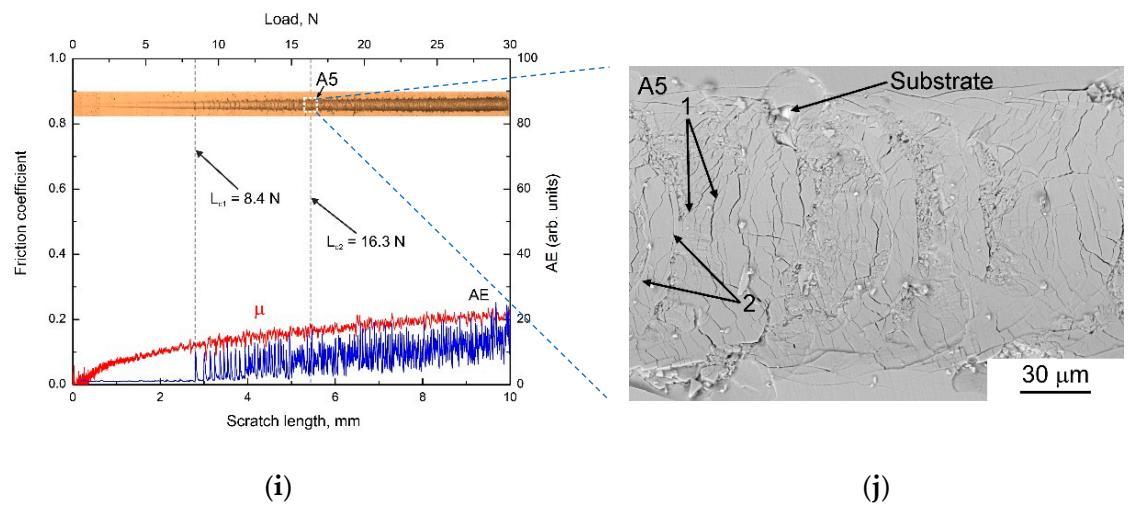
Figure 2. Scratch tracks, friction coefficients (μ), acoustic emission signals (AE) and critical loads (left panel), and corresponding SEM micrographs of specific areas of the scratch tracks denoted as A1–A5 (right panel) of (**a**,**b**) Ti_{0.45}Al_{0.55}N; (**c**,**d**) ML1; (**e**,**f**) ML2; (**g**,**h**) ML3; and (**i**,**j**) Ti_{0.43}Al_{0.45}Ta_{0.12}N coatings, respectively. Arrows in the right panel indicate different types of cracks: 1—tensile cracks; 2—conformal cracks; 3—edge cracks.

Figure 2 (left panel) shows the evolution of the friction coefficient and the acoustic emission signal during scratching of the coatings with a progressively increasing applied normal load. The corresponding optical micrographs of the scratches are shown above the curves. The right panel of Figure 2 exhibits the corresponding SEM micrographs of specific areas of the scratch tracks outlined by dashed lines and denoted as A1-A5. Due to the rather low hardness (~5 GPa) the steel substrate underwent plastic deformation already at the initial stage of scratching, which led to the formation of a residual scratch groove. The hard tip ploughed the substrate, i.e., displaced its material from the bottom of the scratch groove to the edges resulted in the formation of pile-ups at scratch flanks and ahead the tip. This was accompanied by coherent bending of the coatings, which induced the concentration of tensile stresses at the pile-up ridges. As a result, the coatings tend to crack in these areas. Microscopic examination of the scratch tracks revealed that the coating failure started from the emergence of parallel cracks along the edges of the grooves. However, the edge cracks were formed out of the contact area and did not generate significant acoustic emission output. In all the coatings the first sudden AE peak corresponding to the first critical load L_{c1} was attributed to the nearly simultaneous appearance of semicircular backward tensile and forward conformal cracks inside the scratch tracks. These two failure modes are common for scratching of hard coatings on ductile substrates [52,53]. The tensile cracks are caused by the friction-induced tensile stresses behind the moving tip and tensile stresses resulting from coating bending at the rear of the contact area under the action of normal load. The conformal cracking is concerned with the formation of the pile-up ahead the

tip, which results in transfer of a large amount of the applied load to the front half of the tip substantially enhancing the contact stress [52]. In addition, the tangential friction generates compressive stresses ahead the tip, which lead to increasing bending curvature of the coatings at the pile-up and therefore promote their buckling failure. The $Ti_{0.45}Al_{0.55}N$ coating is characterized by the lowest critical load $L_{c1} = 3.5 N$, whereas highest L_{c1} values of 8.3 and 8.4 N correspond to the multilayer with the thickest $Ti_{0.45}Al_{0.55}N$ layers (ML2) and the $Ti_{0.43}Al_{0.45}Ta_{0.12}N$ coating, respectively.

The formation of the conformal cracks ahead of the tip was followed by the tip passing over and pushing the piled-up material into the substrate. This resulted in the formation of new cracks and coating fragmentation inside the scratch tracks. Chipping of the coatings was also observed, which was especially pronounced close to the conformal cracks and in the areas of overlapping of the tensile, conformal and edge cracks. In the $Ti_{0.45}Al_{0.55}N$, ML1, and ML3 coatings this soon resulted in spallation of their fragments with partial substrate exposure (see, e.g., Figure 2b,d), which defined the second critical load L_{c2} commonly used to rank coating adhesion. A lowest Lc2 value of 4.5 N was determined in the ML3 coating. Moreover, in contrast to the other samples, continuous spallation of this coating occurred at a critical load L_{c3} of 25.4 N. This resulted in complete substrate exposure in the scratch groove (Figure 2h), which was accompanied by a sharp increase in the friction coefficient (see Figure 2g). The $Ti_{0.45}Al_{0.55}N$ and ML1 coatings were not completely removed from the scratch groove despite the large areas of substrate exposure. The ML2 and $Ti_{0.43}Al_{0.45}Ta_{0.12}N$ coatings have exhibited substantially higher L_{c2} loads, which are equal to 10.2 N and 16.3 N, respectively. These coatings are also characterized by significantly smaller areas of the substrate exposure compared with other samples (Figure $2f_{,g}$). This is especially true for the $Ti_{0,43}Al_{0,45}Ta_{0,12}N$ coating, which scratch track contains a few of small isolated areas of coating spallation.

The scratch testing of the coatings showed that the introduction of the ductile Ti_{0.45}Al_{0.55} layers into the $Ti_{0.45}Al_{0.55}N$ coating and alloying with Ta led to their significant toughening. As can be seen from Figure 2b, cracks easily propagate throughout the Ti_{0.45}Al_{0.55}N coating without deflection that leads to substrate exposure all over the chipping area. In contrast, the chipping of the multilayer and Ti_{0.43}Al_{0.45}Ta_{0.12}N coatings is accompanied by deflection of the through-thickness cracks so that either the chipping does not result in the substrate exposure or the exposed area is substantially smaller than the total chipped area (Figure $2d_{f}$). In the case of the multilayers, the crack deflection primarily occurs at the interfaces between the layers, because their toughening is only provided by the ductile metal layers. Crack propagation in ductile materials is accompanied by the development of a zone of plastic flow around the crack tip [54], therefore the $Ti_{0.45}Al_{0.55}$ layers result in a substantial increase in the amount of work dissipated during propagation of the throughthickness cracks. In contrast, in the Ti_{0.43}Al_{0.45}Ta_{0.12}N coating the cracks are deflected throughout its thickness, since the toughening is attributed to the changes in the chemical bonding [10,28]. In addition, the $Ti_{0.43}Al_{0.45}Ta_{0.12}N$ coating is also characterized by the highest compressive residual stresses, which hinder crack nucleation and propagation [55]. Therefore, this coating demonstrated the strongest resistance to cracking and spallation among the samples studied. Despite the evident toughening, the ML1 and ML3 coatings exhibited poor scratch resistance. The ML3 performance was even worse than that of the Ti_{0.45}Al_{0.55}N coating. This can be attributed to poor load-bearing capacity of the ML1 and ML3 coatings due to their reduced hardness and elastic modulus. In the former case, the hard $Ti_{0.45}Al_{0.55}N$ layers are too thin to prevent deformation of the underlying $Ti_{0.45}Al_{0.55}$ layers. In the latter case, the metal layers are too thick to provide a good support for the ceramic layers. Therefore, the tip deeper penetrates into these samples resulting in a larger amount of plastic deformation of the substrate and stronger bending of the coatings. The latter facilitates their cracking and spallation. Thus, the optimal multilayer architecture, which can provide benefits in mechanical performance under applying normal loads, should balance enhanced toughness with good load-bearing capacity. Evidently, only the ML2 coating, which is comprised of rather thick $Ti_{0.45}Al_{0.55}N$ layers and thin $Ti_{0.45}Al_{0.55}N$ layers, meets this requirement.

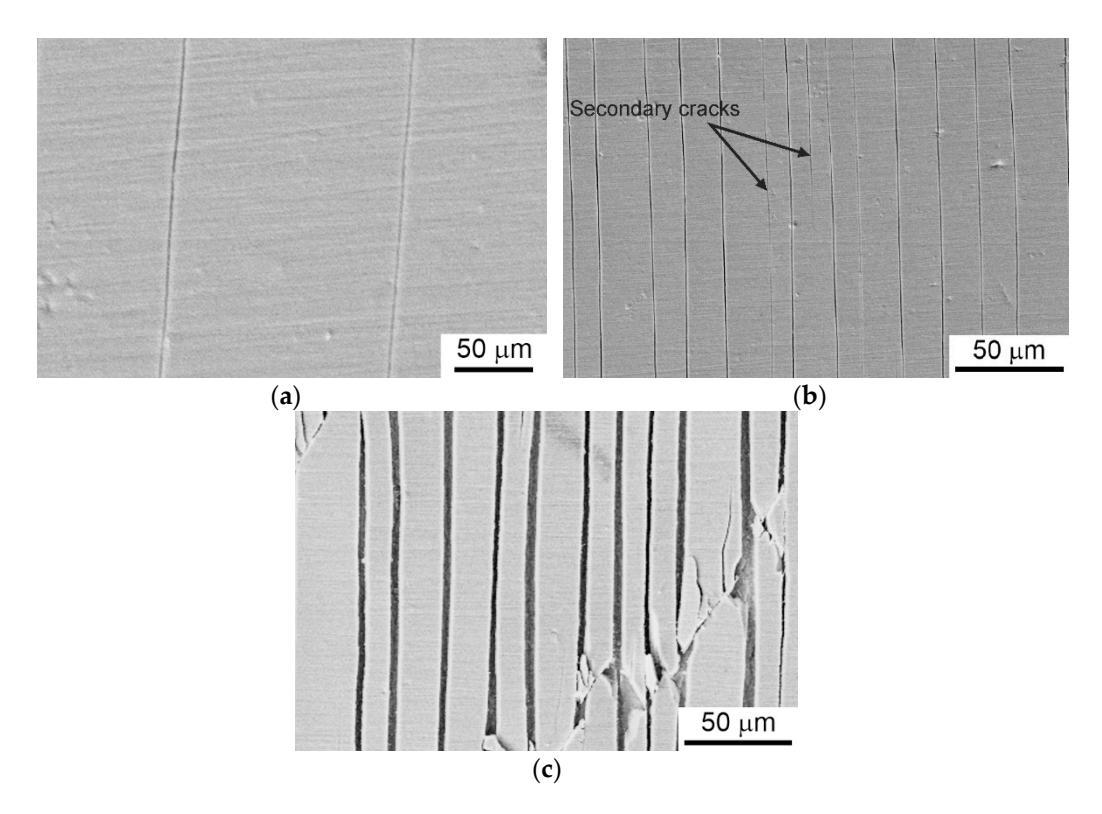
Figure 3. Different failure stages of the Ti_{0.45}Al_{0.55}N coating: **a**—primary cracking (stage I); **b**—secondary cracking (stage II); **c**—diagonal cracking (stage III). The SEM micrographs correspond to (**a**) 1.4%; (**b**) 2.0%; and (**c**) 5.0% substrate elongation.

in Table 2. Stage I (primary cracking) began with sudden appearance of numerous cracks oriented perpendicular to the tensile axis (transverse cracks) (Figure 3a). It has been shown that such cracks provide relaxation of the tensile stress only near the free edges of the coating fragments, while the stress rapidly increases at a distance from the edges [56]. Therefore, stage I was characterized by sharply increasing crack density Nt (the number of cracks per unit length of the samples) with increasing substrate elongation (Figure 4). This resulted in the formation of a system of parallel cracks, which distribution was initially random, but became quasi-periodical to the end of stage I. The reason for this is that the tensile stress reaches its maximum value at the middle point of the coating fragments [56]. Therefore, the formation of new cracks becomes increasingly probable at this point. The Ti_{0.45}Al_{0.55}N, ML1, and ML2 coatings exhibited the similar crack multiplication rate at stage I. The crack multiplication rate was lower for the Ti_{0.43}Al_{0.45}Ta_{0.12}N and ML3 coatings, but the duration of stage I increased, especially in the case of the ML3 coating. As a result, the $Ti_{0.45}Al_{0.55}N$, ML1, ML2, and $Ti_{0.43}Al_{0.45}Ta_{0.12}N$ coatings were characterized by close N_t values (61–65 mm⁻¹) to the end of stage I, while the crack density in the ML3 coating was 49 mm^{-1} .

Because of the above-mentioned stress distribution in the coating fragments, at stage II (secondary cracking) new transverse cracks primarily initiated in the middle between the existing cracks (Figure 3b). This failure stage was characterized by the reduced crack multiplication rate (which was similar for all the coatings), since the greater strain increment was needed to exceed the coating tensile strength with decreasing the dimensions of its fragments.

Stage III of the coating failure was characterized by the formation of diagonal cracks propagated at an angle of 50–65° to the tensile loading (Figure 3c). The formation of these cracks can be attributed to (i) the shear deformation of the steel substrate [57], which is confirmed by the observed shift of coating fragments along the diagonal cracks and their rotation; and (ii) the Poisson's contraction and necking of the substrate, which cannot be accommodated by the brittle coatings [42,58]. Due to the rigid bonding between the coating and substrate, the latter effects generate the lateral compressive stresses in the coating axis promotes the formation of the diagonal cracks. Figure 5 shows that the density of the diagonal cracks demonstrates virtually linear growth until the substrate fracture. In contrast, the multiplication of the transverse cracks at stage III slowed down significantly, since the diagonal cracks provided partial relaxation of the tensile stresses.

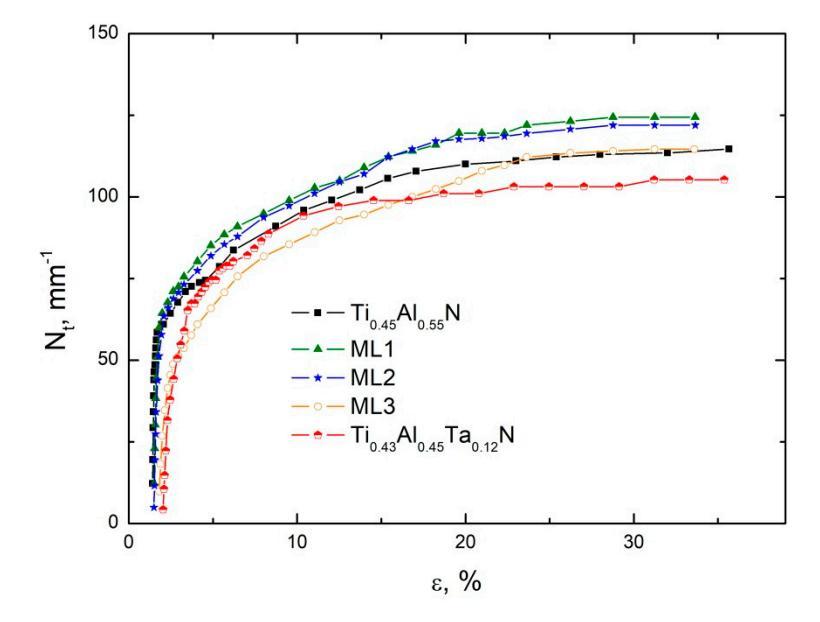
Figure 4. Density of transverse cracks in the coatings subjected to uniaxial tension as a function of substrate elongation.

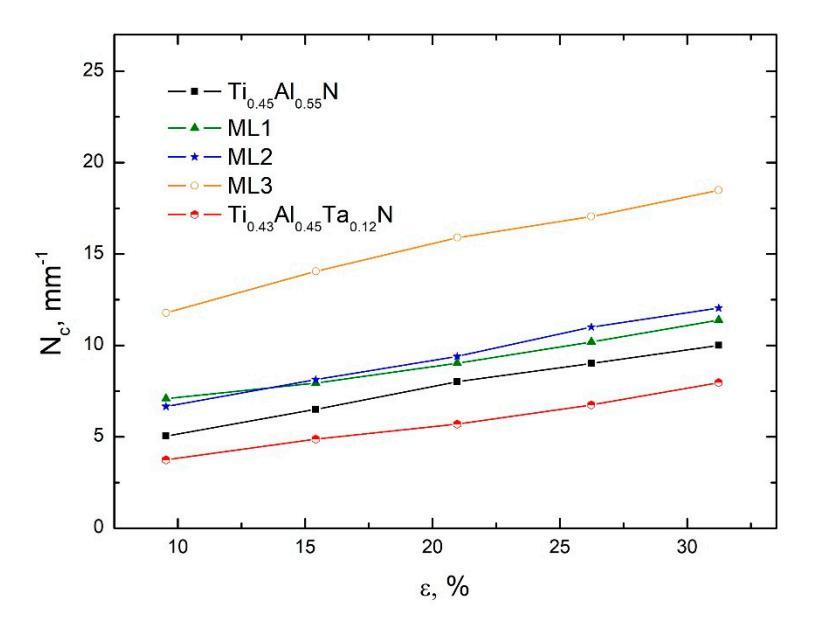
Figure 5. Density of diagonal cracks in the coatings subjected to uniaxial tension as a function of substrate elongation.

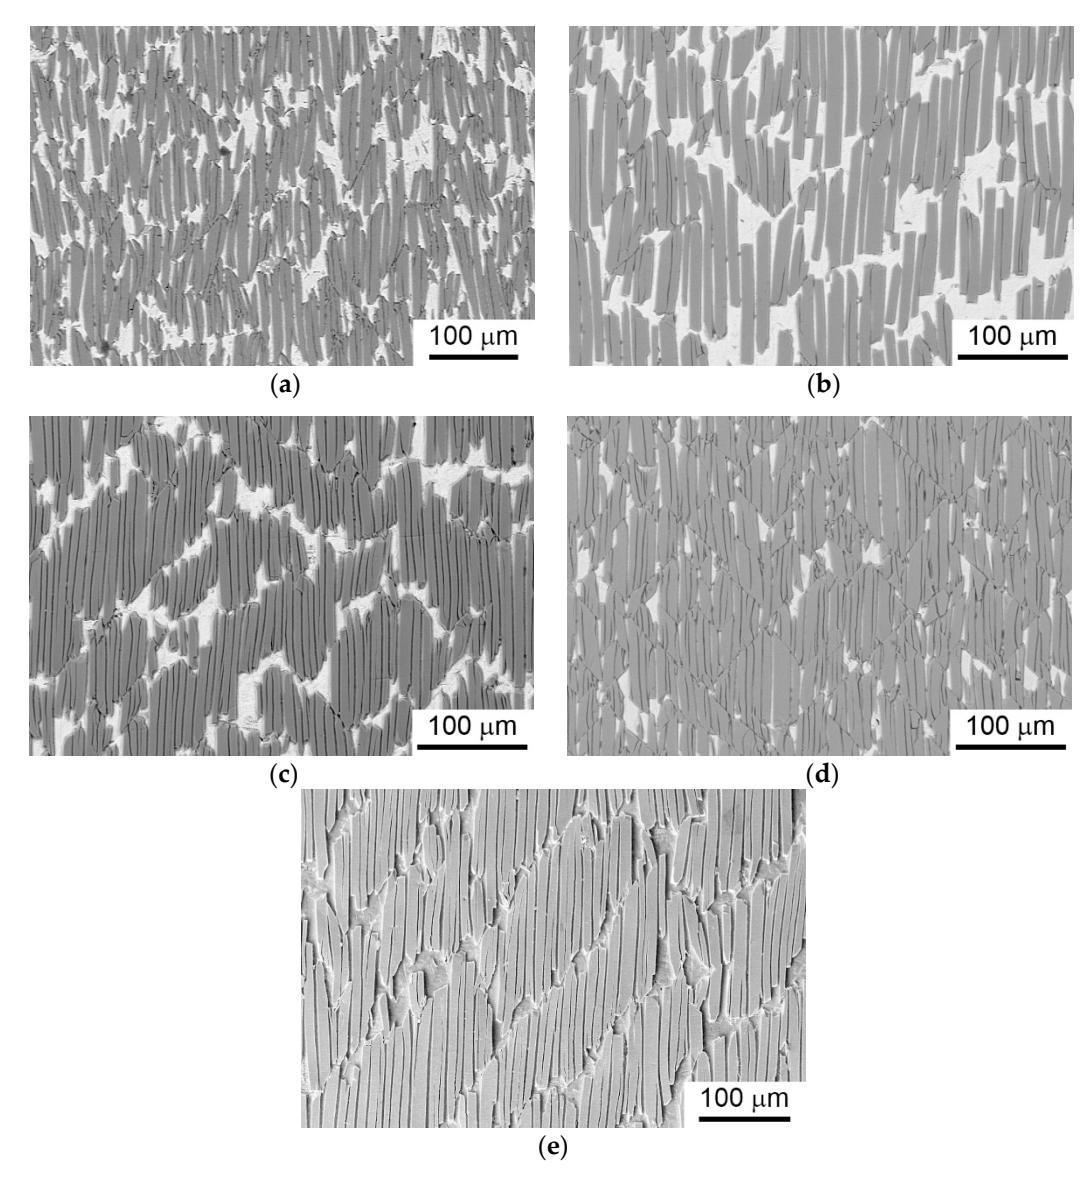
Figure 6. SEM micrographs of the (a) $Ti_{0.45}Al_{0.55}N$; (b) ML1; (c) ML2; (d) ML3 and (e) $Ti_{0.43}Al_{0.45}Ta_{0.12}N$ after uniaxial tension to fracture of the substrates.

The last stage of the coating failure (stage IV) started with beginning delamination and spallation of coating fragments and continued to the fracture of the substrates. All the multilayers started to delaminate at larger strains than the $Ti_{0.45}Al_{0.55}N$ and $Ti_{0.43}Al_{0.45}Ta_{0.12}N$ coatings (see Table 2). Average values of the relative spallation area (S) of the coatings after the fracture of the substrates are given in Table 2. It is seen that the most pronounced spallation happened in the $Ti_{0.45}Al_{0.55}N$ coating, while the ML3 coating was characterized by the least spallation area. This is also visible in Figure 6, which exhibits plan-view SEM micrographs of the samples after tension to fracture of the substrates obtained in the backscattered electron mode. The areas of the Ti_{0.45}Al_{0.55}N and multilayer coatings have dark contrast because they are rich with light elements such as aluminum and nitrogen. Only the $Ti_{0.43}Al_{0.45}Ta_{0.12}N$ coating has similar contrast with the substrate due to the presence of Ta. It should be noted that the spallation predominantly occurred near the diagonal cracks and at their intersections (Figure 6), where it was stimulated by contact interaction of coating fragments due to their displacements relative each other caused by shears in the

The interplay between the above-mentioned factors determines the cracking behavior of the coatings studied. The higher toughness and lower stiffness of the ML1 and ML2 multilayers hinder their cracking and are responsible for the shift of the onset of I and II failure stages towards higher strains compared with the $Ti_{0.45}Al_{0.55}N$ coating. However, the lower compressive residual stresses and stronger adhesion to the substrates, which is evidenced by the smaller spallation areas, lead to somewhat higher resultant crack density in these coatings. Even higher toughness and lesser stiffness of the ML3 coating due to the presence of the thick ductile $Ti_{0.45}Al_{0.55}$ interlayers provide even later onset of I and II failure stages and decreases the resultant crack density to that of $Ti_{0.45}Al_{0.55}N$. Finally, the $Ti_{0.43}Al_{0.45}Ta_{0.12}N$ coating is characterized by the combination of the enhanced toughness, reduced stiffness and highest compressive residual stress. This leads to the highest critical strains ε_{I} and ε_{II} and the lowest resultant cracking density among the samples studied. Thus, the Ta-alloyed coating exhibited the best crack resistance under uniaxial tension. However, it should be noted that in some applications—e.g., under exposure to extreme environments—the most important parameter can be the area of coating spallation rather than the cracking density. This is due to the crack healing phenomena—e.g., by means of chemical reactions with atmospheric oxygen at high temperatures—which results in filling the cracks and prolonging the coating durability [60–62]. In contrast, the spallation can potentially remove the entire coating resulting in rapid degradation of the underlying substrate [63,64]. Therefore, the ML3 coating can be the most promising for such applications because it is characterized by the enhanced spallation resistance compared with the other coating. This results in its significantly lower elastic modulus, and therefore the reduced tensile stresses under loading, decreasing the energy release rate for coating delamination [34]. In addition, the ML3 coating is obviously characterized by the lower shear strength that leads to the highest density of the diagonal cracks among the coatings studied. These cracks provide relaxation of both the tensile and compressive stresses in the coating fragments, hindering their delamination.
